MASH EVALUATION OF TxDOT ROADSIDE SAFETY FEATURES— PHASE III

Test Report 0-6946-R3-Rev1 (Revised 2023-12-14)

TEXAS A&M TRANSPORTATION INSTITUTE

TEXAS DEPARTMENT OF TRANSPORTATION

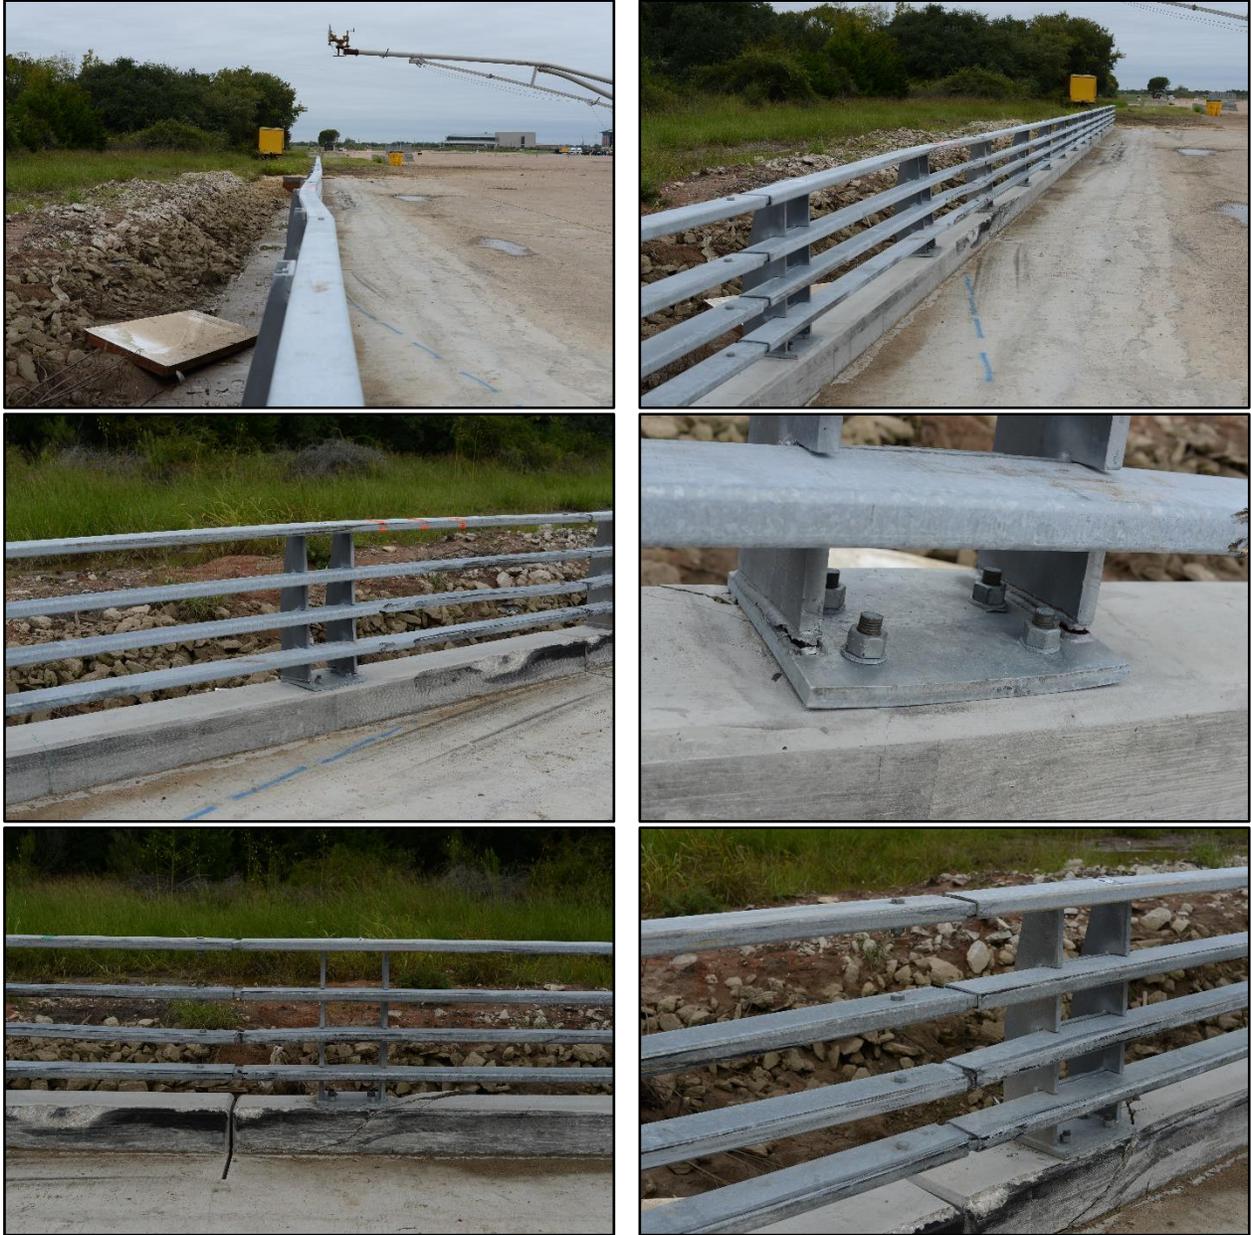
Figure 2.5. C1W Bridge Rail after Test No. 469469-1.

Figure 2.5 shows the damage to the C1W bridge rail. The bridge rails were deformed at the location of impact. The concrete was fractured around posts 4, 5, and 6. Post 5 was leaning back 3.1° from vertical. Post 4 was leaning back toward the protected side 5.9° from vertical and was fractured at the weld where the vertical plates are connected to the base plate. There was a secondary contact at post 14 to the end of the bridge rail. No damage was noticed, other than black marks from the tire. Working width was 4 ft, and the height of the working width was 13.1 ft. Maximum dynamic deflection during the test was 0.9 ft, and maximum permanent deformation was 0.3 ft.

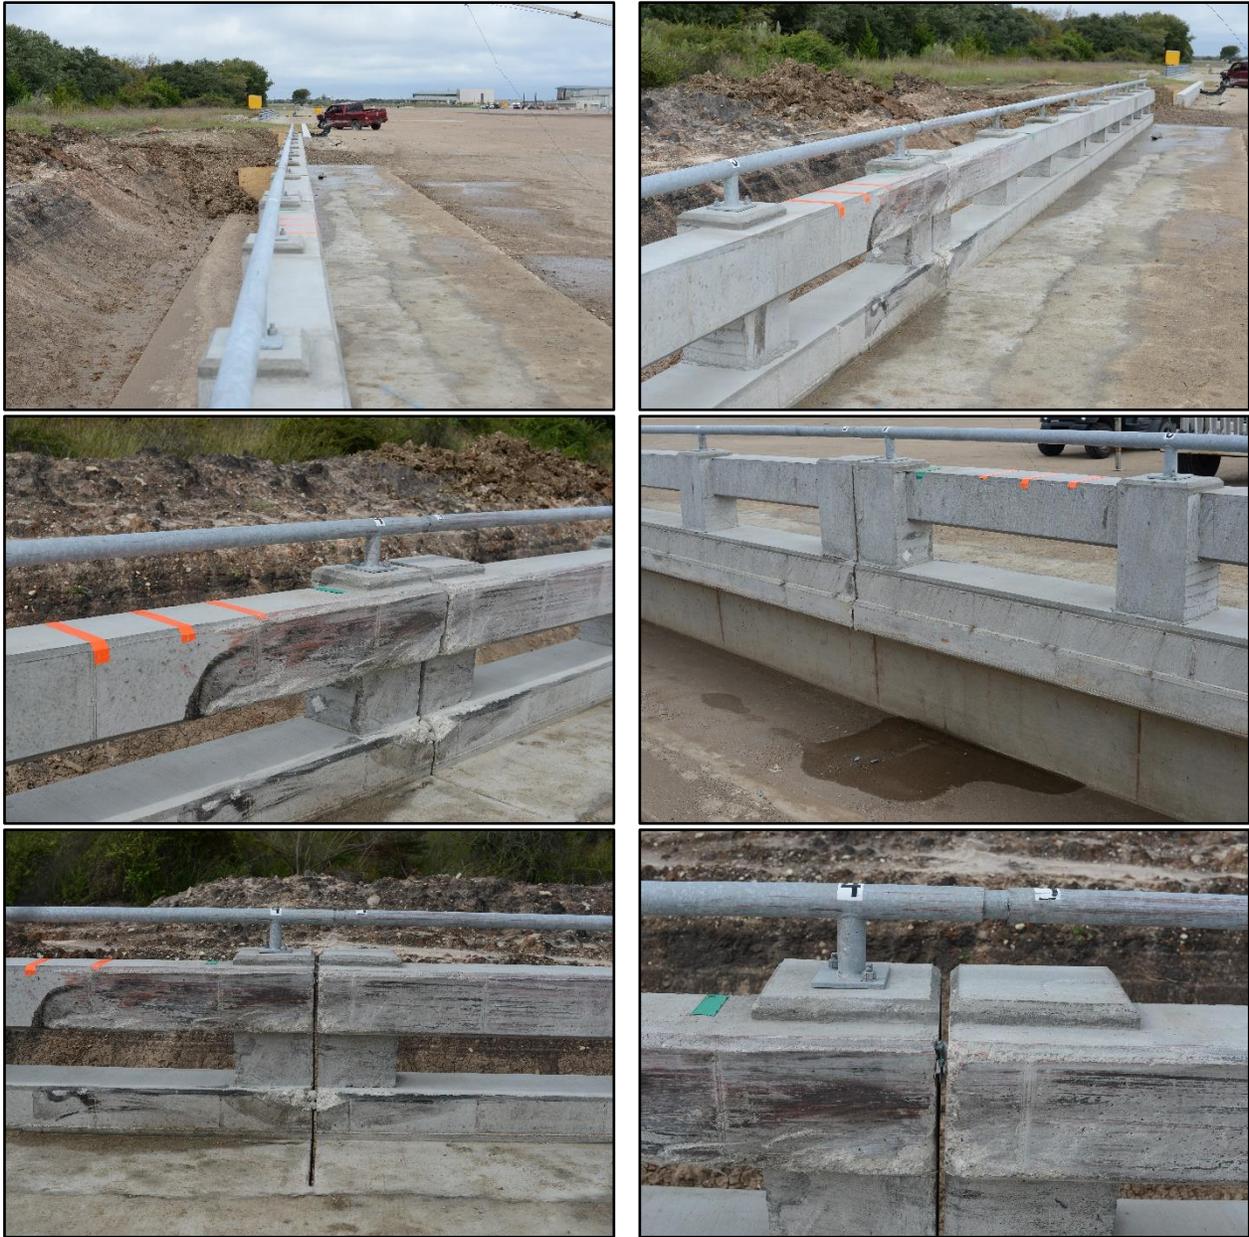
Figure 3.5. Modified C66 Bridge Rail after Test No. 469469-2-1.

Figure 3.5 shows the damage to the Modified C66 bridge rail. Some of the edges of the concrete at the joint between posts 4 and 5 were damaged and missing a small amount of material. No further damage to the bridge rail was noted. Working width was 20.5 inches, and the height of the working width was 58 inches. Maximum dynamic deflection during the test was 1.1 inches for the steel rail element on top of the concrete parapet. There was no measurable dynamic deflection of the concrete parapet. There was no measurable permanent deflection in either the concrete parapet or the steel rail element.

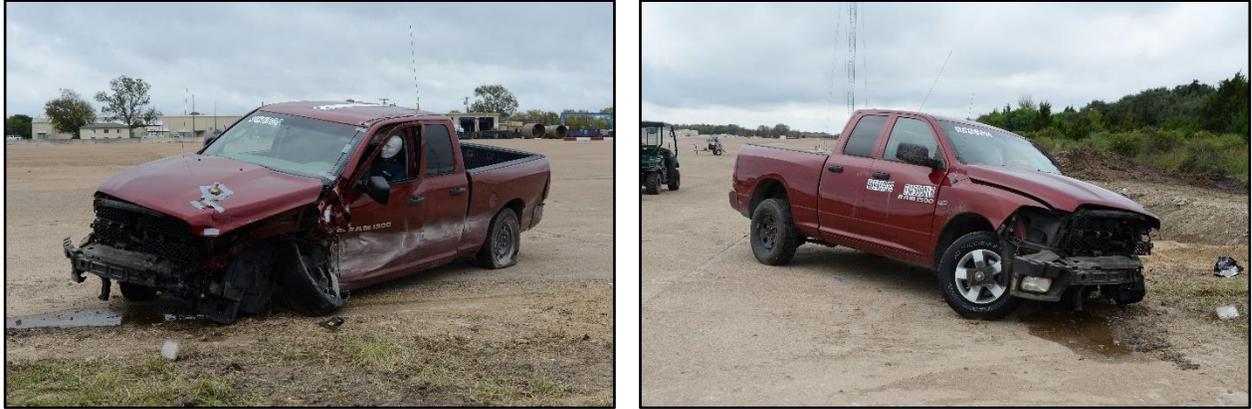
Figure 3.6. Test Vehicle after Test No. 469469-2-1.

Figure 3.6 and Figure 3.7 show the damage sustained by the vehicle. The front bumper, hood, radiator and support, left front fender, left front tire and rim, left frame rail, left upper and lower A-arms, left front floor pan and kick panel, left front door and glass and left rear door, left cab corner, left rear fender, and left rear tire and rim were damaged. Maximum exterior crush to the vehicle was 14.0 inches in the side plane at the left front corner at bumper height. Maximum occupant compartment deformation was 2.0 inches in the left side firewall area. Table B.3 and Table B.4 in Appendix B.3.1 provide the exterior crush and occupant compartment measurements of the vehicle.

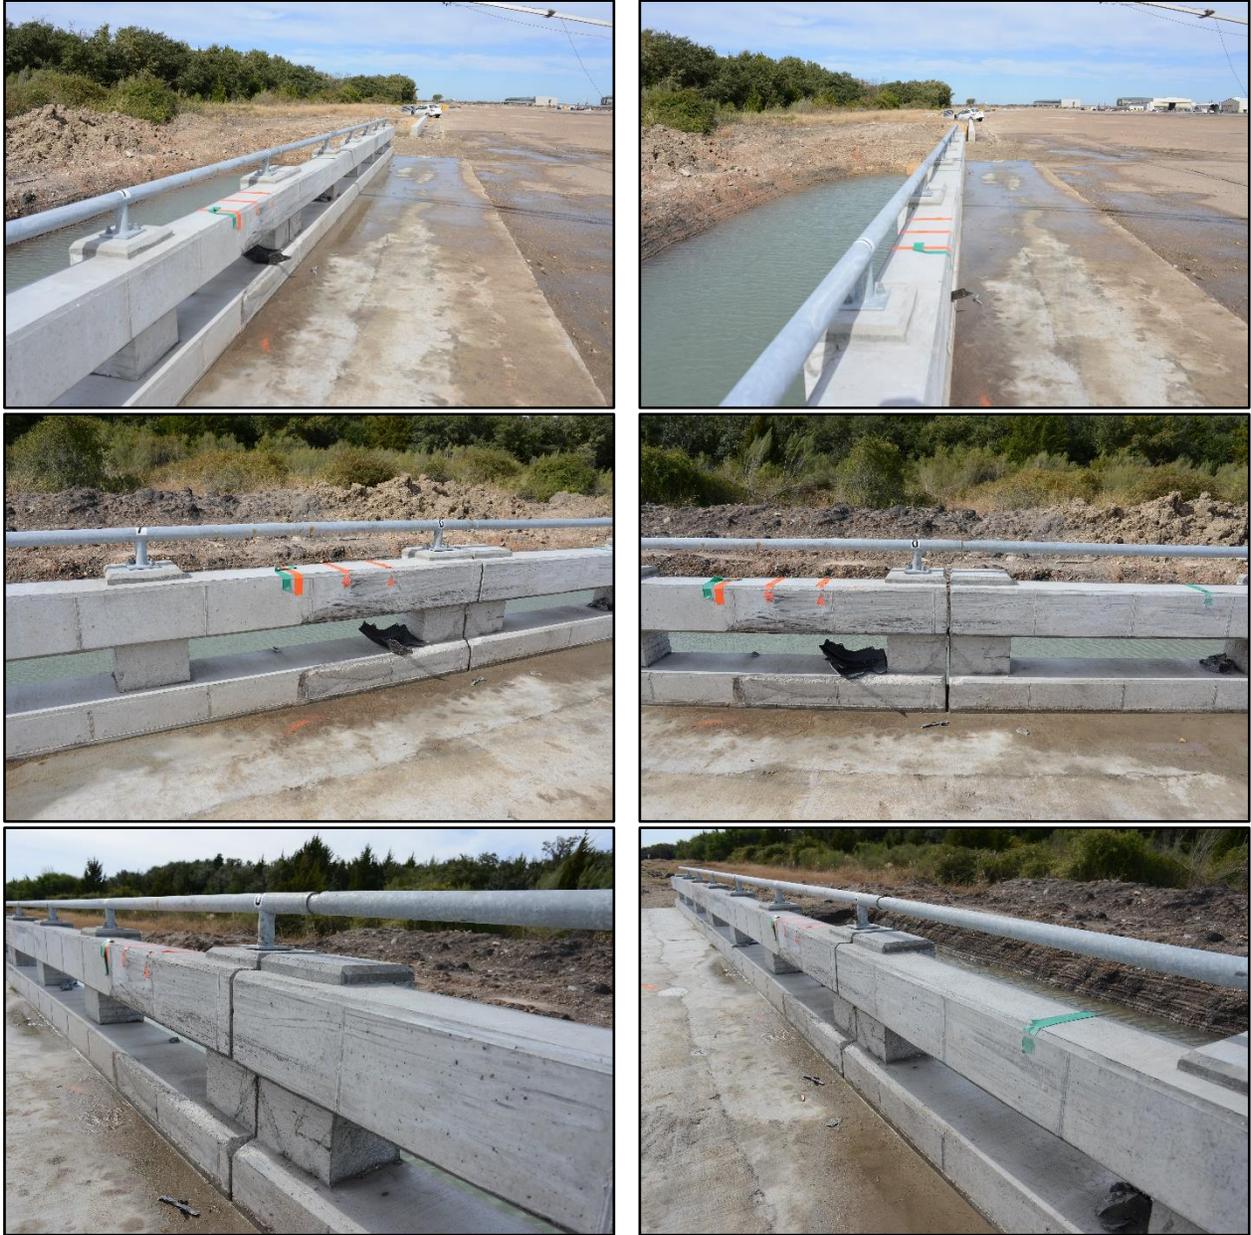
Figure 3.11. Modified C66 Bridge Rail after Test No. 469469-2-2.

Figure 3.11 shows the damage to the Modified C66 bridge rail. Some of the edges of the concrete at the joint between posts 8 and 9 were damaged and missing a small amount of material. No further damage to the bridge rail was noted. Working width was 16 inches, and the height of the working width was 32 inches. There was no measurable dynamic or permanent deflection in either the concrete parapet or the steel rail element.

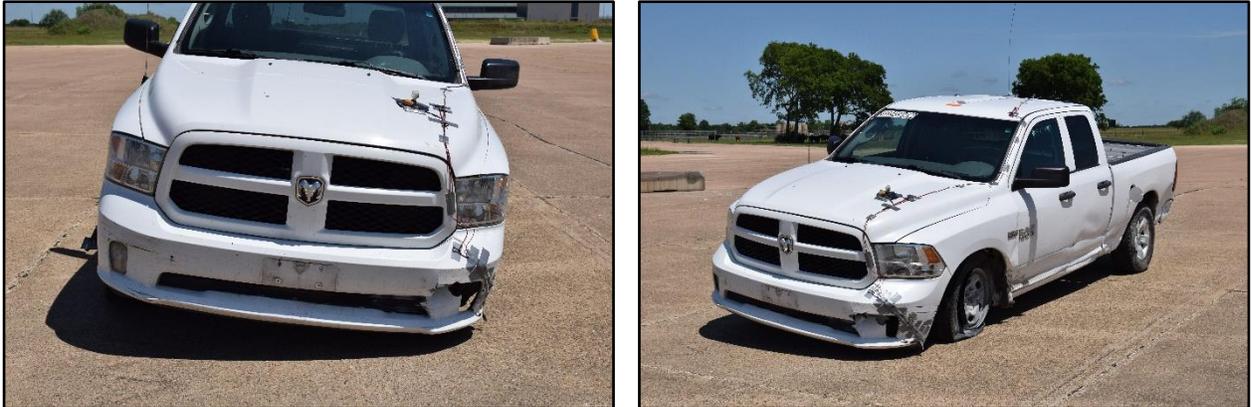
Figure 4.6. Test Vehicle after Test No. 469469-3-2.

Figure 4.6 and Figure 4.7 show the damage sustained by the vehicle. The front bumper, left front fender, left front tire and rim, left front door, left rear door, left rear door, left cab corner, left rear fender, left rear rim, and rear bumper were damaged. Maximum exterior crush to the vehicle was 2 inches in the side plane at the left front corner at bumper height. There was no observed occupant compartment deformation. Table C.3 and Table C.4 in Appendix C.3.1 provide exterior crush and occupant compartment measurements.

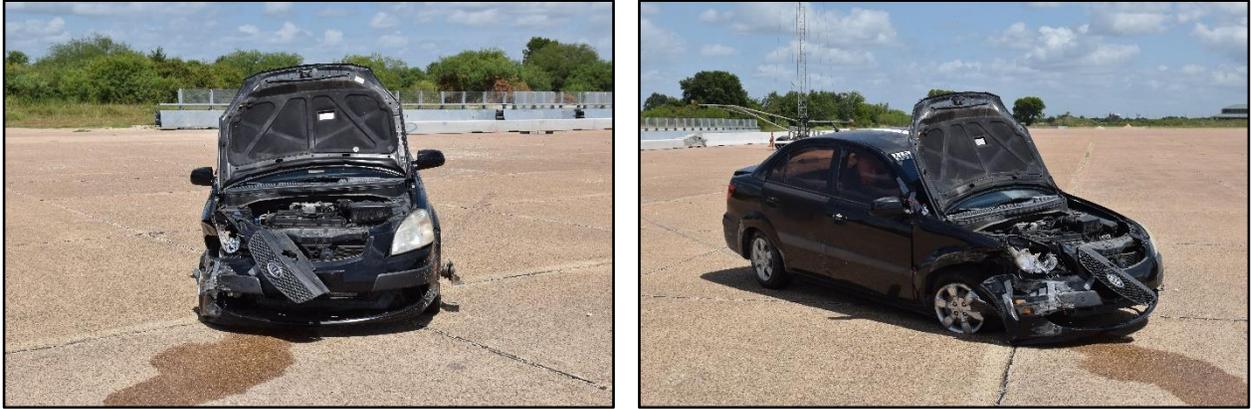
Figure 5.6. Test Vehicle after Test No. 469469-4-1.

Figure 5.6 and Figure 5.7 show the damage sustained by the vehicle. The front bumper, right front fender, right front tire and rim, right strut tower, right rear door, right head light, hood, right rear fender, right rear tire and rim, and rear bumper were damaged. Maximum exterior crush to the vehicle was 7 inches in the side plane at the right front corner at bumper height. There was no measurable occupant compartment deformation. Table D.2 and Table D.3 in Appendix D.3.1 provide exterior crush and occupant compartment measurements.

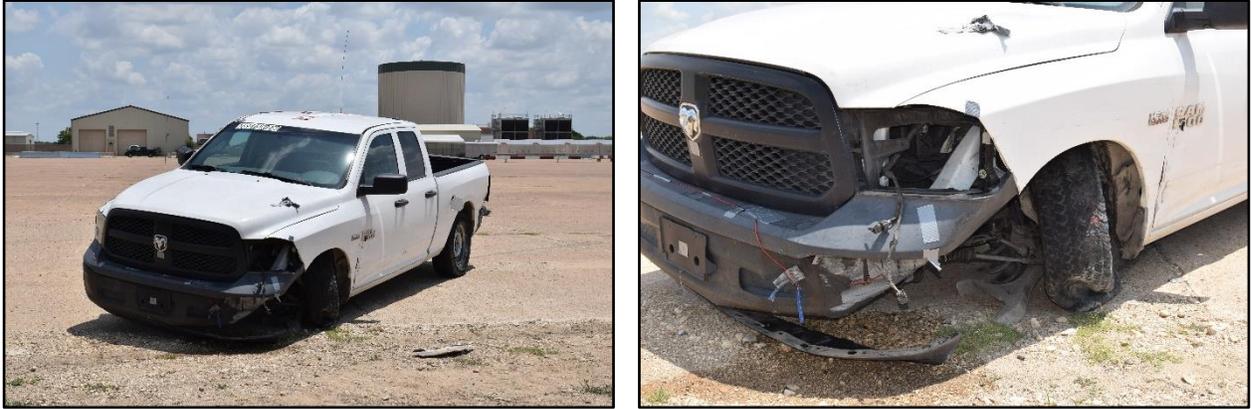
Figure 5.12. Test Vehicle after Test No. 469469-4-2.

Figure 5.12 and Figure 5.13 show the damage sustained by the vehicle. The front left bumper, left front tire and rim, left front door, left front fender, left headlight, and left front A-arm were damaged. Maximum exterior crush to the vehicle was 13 inches in the side plane at the left front corner at bumper height. There was no measurable occupant compartment deformation. Table D.6 and Table D.7 in Appendix D.4.1 provide exterior crush and occupant compartment measurements.
