Evaluation of Corrosion Prevention and Mitigation Approaches Used on Texas Bridges—Volume 2: Reinforced Concrete Bridges

Technical Report 0-7040-R1-Vol2

TEXAS A&M TRANSPORTATION INSTITUTE
COLLEGE STATION, TEXAS

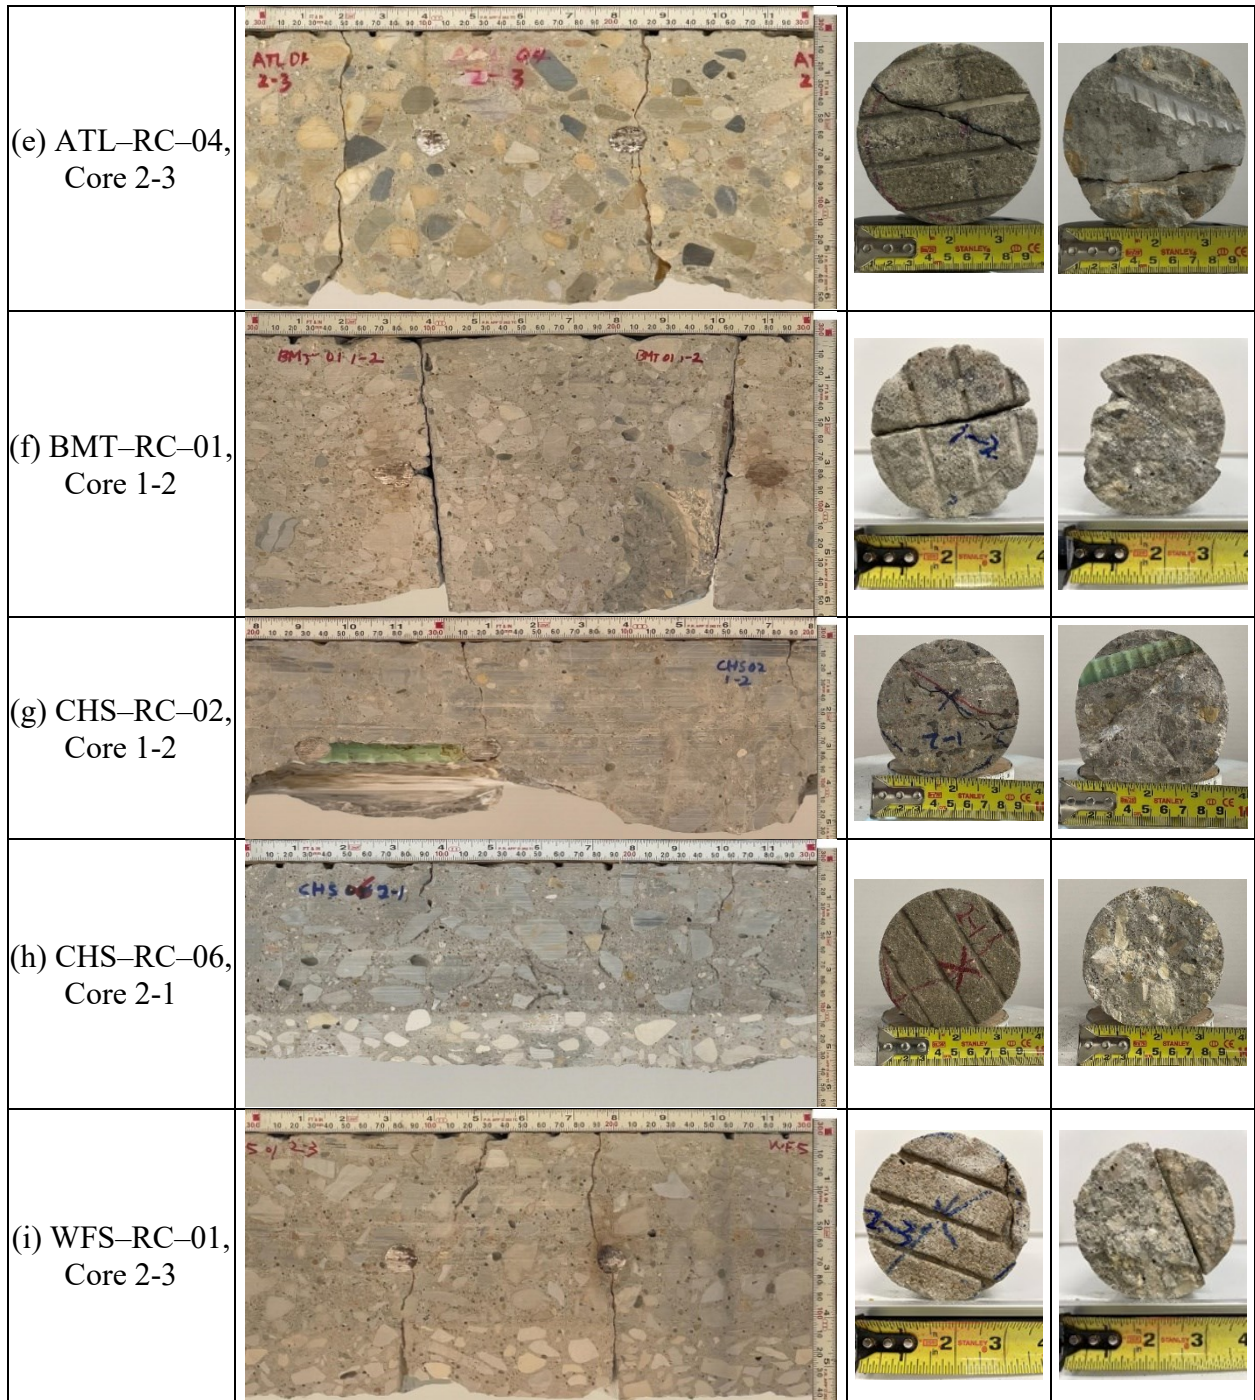
Figure 3.28. Pictures of Cores with Deterioration.

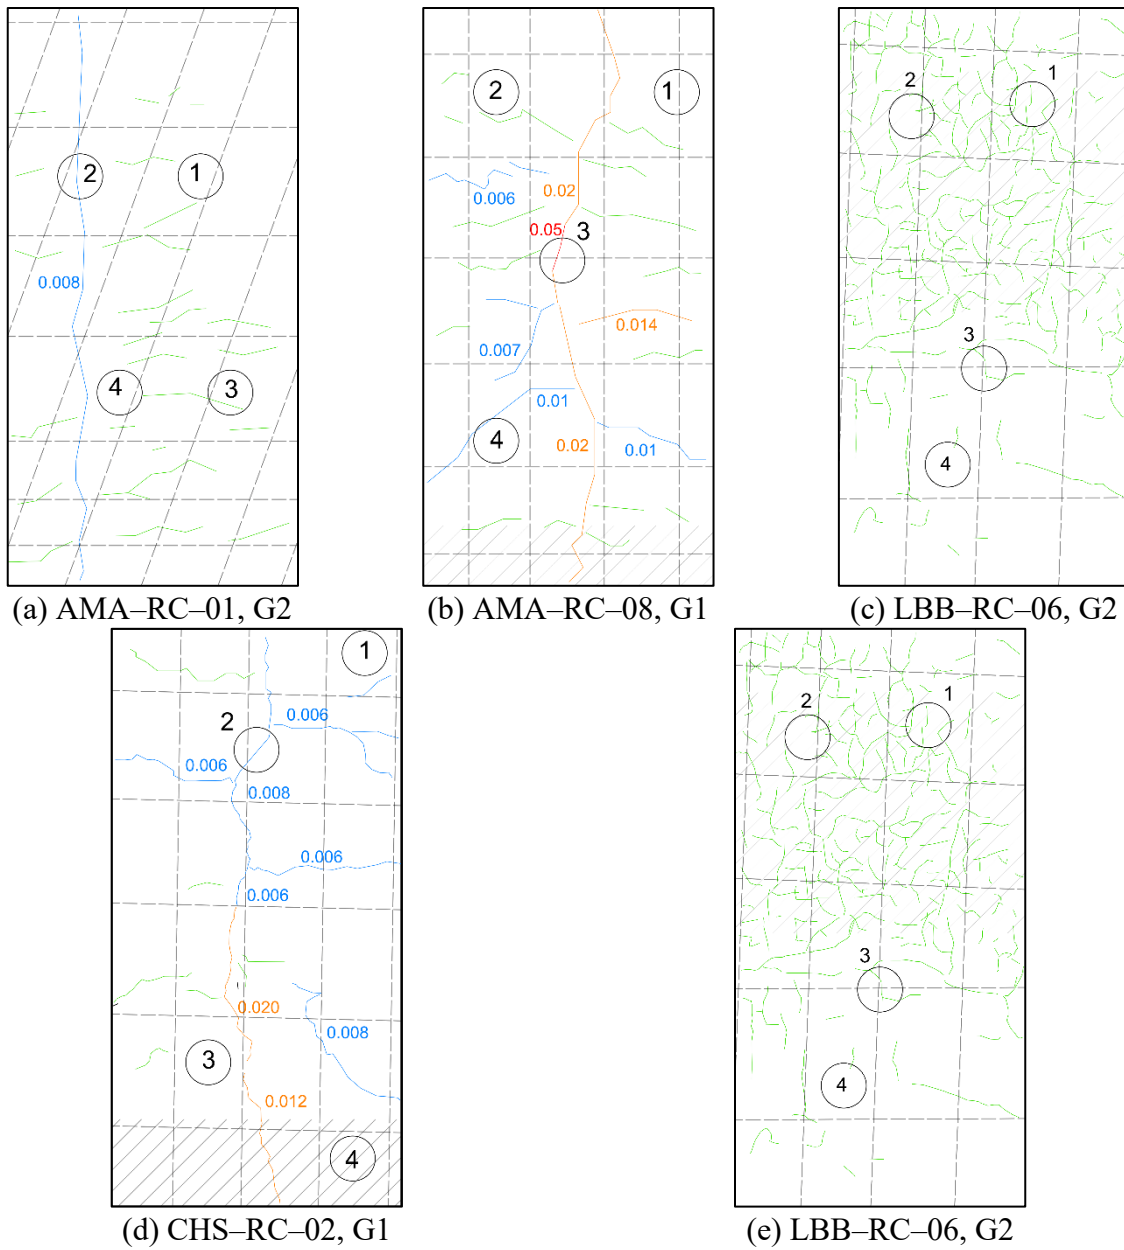
Figure 3.32. Crack Mapping of Concrete Decks in Region 5.

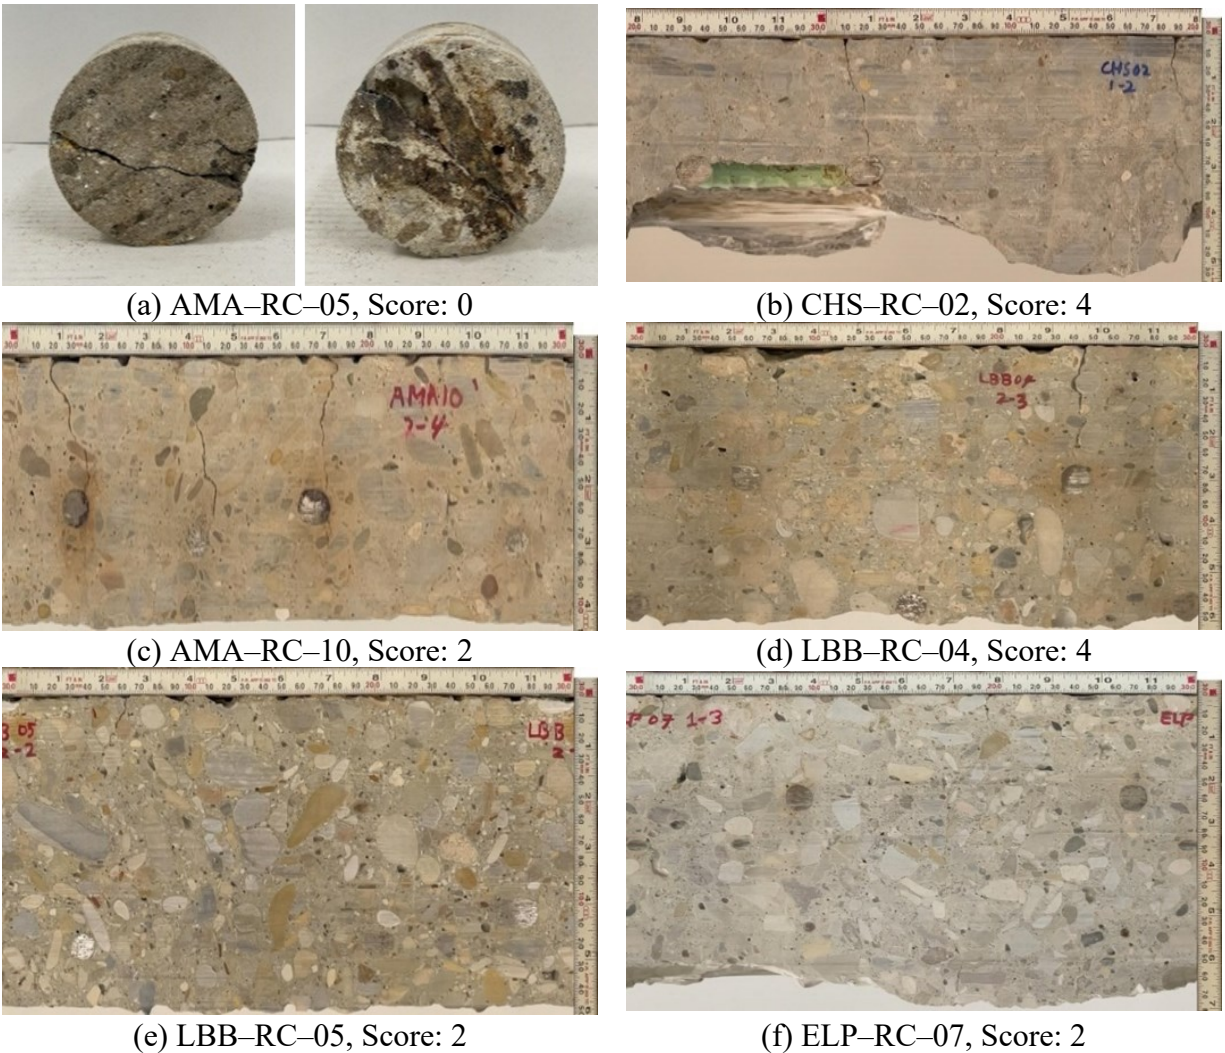
Figure 4.37. Condition of Cores of Low Adhesion Rating Bridges.
