# Design and Rehabilitation Strategies for Permeable Friction Course Pavements

Technical Report 0-7110-R1

TEXAS A&M TRANSPORTATION INSTITUTE  
COLLEGE STATION, TEXAS

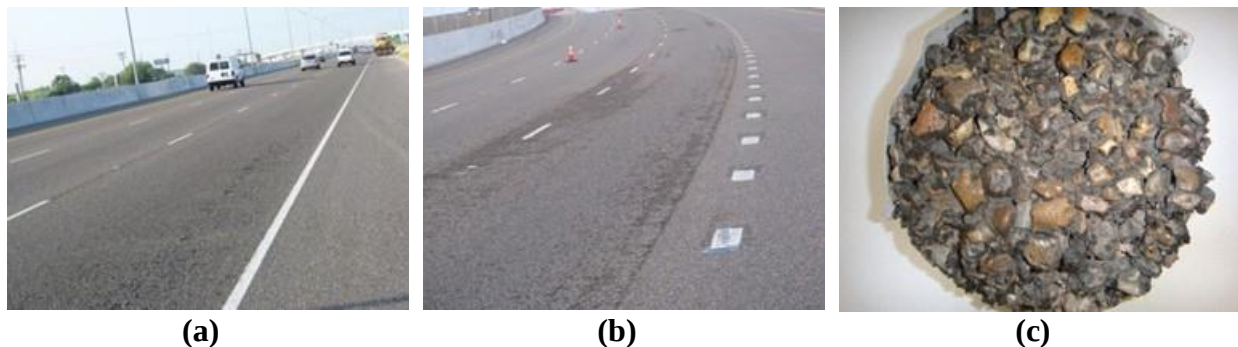
In Texas, PFC pavements have an average life of 7–10 years, with some projects failing early and others lasting longer. For example, a PFC pavement found on US 281 in Pharr, Hidalgo County, showed excessive amounts of raveling on the outside (far right) lane. A section of the pavement had minor to no distress, while another section had severe raveling. The pavement was constructed in 2004 using river gravel and a design binder content of 9.1 percent AC-10 with 17.7 percent crumb rubber. Pictures captured during the forensic inspection of the pavement conducted in 2010 are shown in Figure 2. Field measurements showed that the raveled section had faster water flow; also, measurements on field cores obtained from the pavement showed higher average AV content (i.e., 24.8 percent versus 19.3 percent) and lower total binder content (i.e., 4.5 percent versus 5.7 percent) in the raveled section (Arámbula et al. 2013).

**Figure 2. PFC pavement located in Pharr: (a) general view of raveled section, (b) detailed view of raveled section, and (c) field core with apparent stripping (Arámbula et al. 2013).**

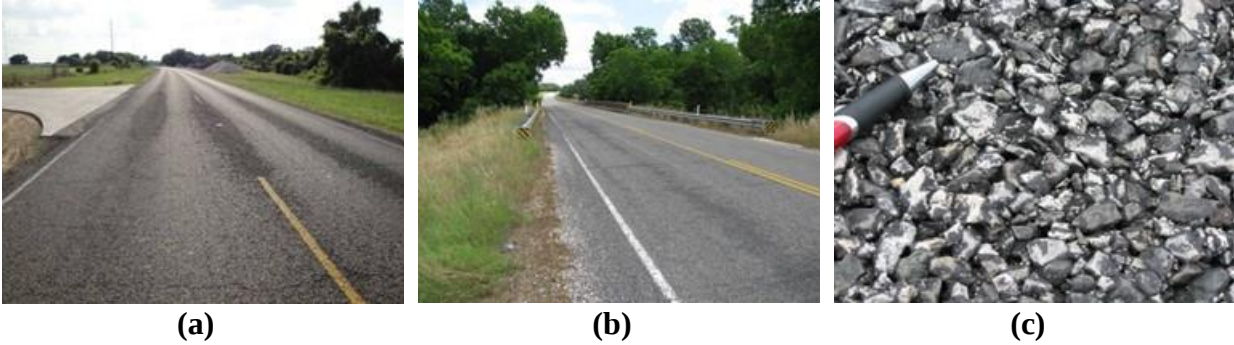
Another instance of raveling in Texas after several years in service was a PFC pavement located on US 90 in Houston, Waller County. The pavement was built in 2004 using a design 8.3 percent AC-10 with 18 percent Centex Grade B rubber. The performance of this PFC pavement was adequate during the first years of service; however, after this period, excessive stripping and raveling were observed throughout the pavement surface. Figure 3 illustrates the condition of the pavement. Field measurements showed that the pavement was impervious, and measurements on field cores yielded an average AV content of 11.5 percent. Potential causes of the observed distress were attributed to excess fines in the mix and low AV content on the wheel paths, which likely trapped water on the other areas of the lane, promoting raveling.

**Figure 3. PFC pavement located in Houston: (a) raveling distress near a turning access, (b) raveling distress near a bridge, and (c) close-up view of the pavement surface (Arámbula et al. 2013).**

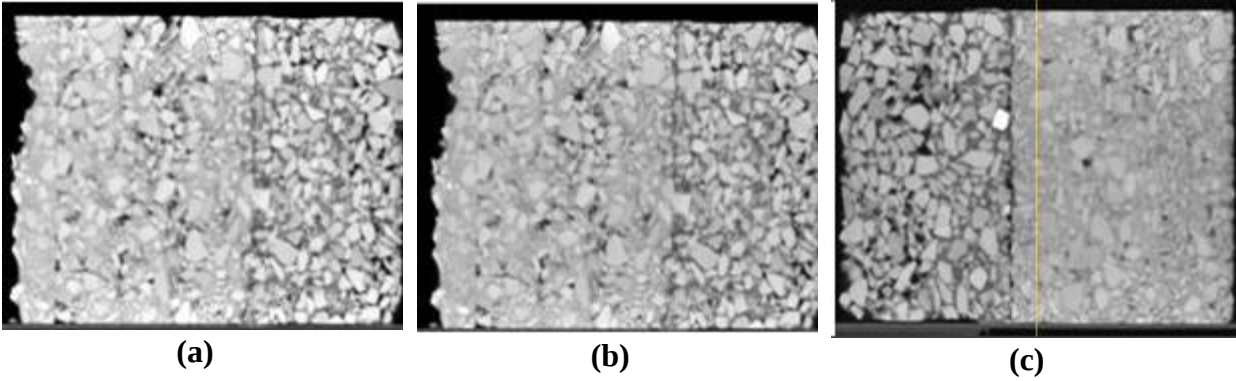
Figure 15 shows images of the computed tomography scans and Figure 16 the estimated AV for the cores extracted from US 359. The results indicate that the estimated AV was higher at the top half-inch of the PFC and reduced toward the center, where the AV detected was below 10 percent (the typical AV of a new PFC pavement is about 20 percent). The reduction was more prominent on the inner lane (3W) than the outer lane (1W) and shoulders (3S). A similar trend was noted during the field flow test. There is a spike in the middle of the AV plot, which represents the joint between the pavement bottom dense layer and the PFC mix. At that point, there was no effect on water flow initiating from the surface.

**Figure 15. Images of the X-ray computed tomography scans obtained from the PFC pavement on US 359: (a) outer lane 1W, (b) inner lane 3W, and (c) Shoulder 3S (Scullion et al. 2020).**

The recommendation to the district was that no seal was necessary since this pavement had already ceased to drain and was no longer truly functioning as a PFC pavement. While it may have been a suitable candidate to overlay, the district ultimately milled off the PFC pavement.

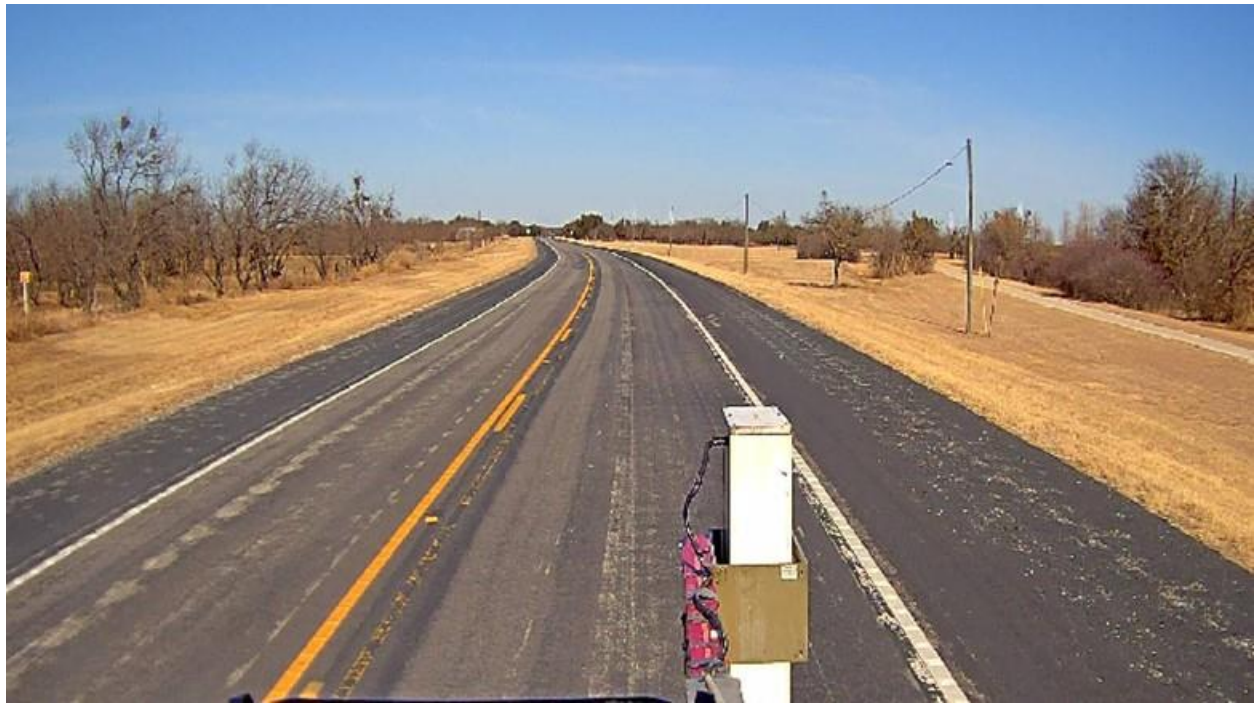
**Figure 33. Condition of US 183 after about 2 years of traffic (February 2022).**

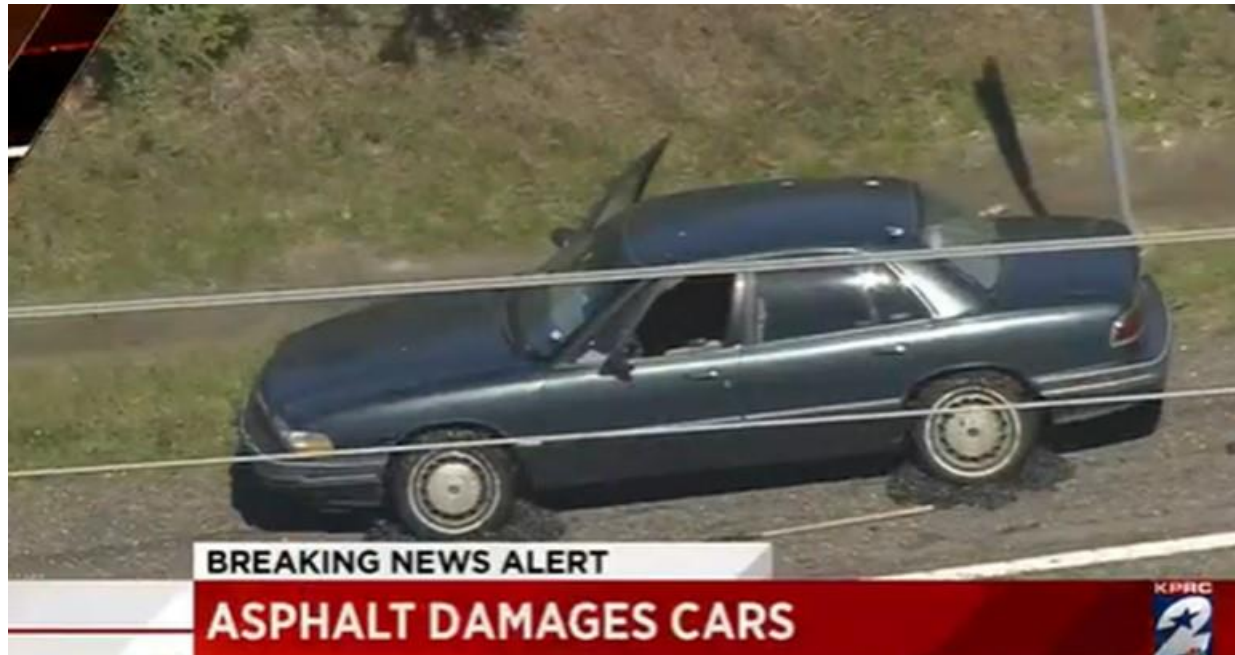
**Figure 47. Seal coat stuck to vehicle tires (from TV news report).**

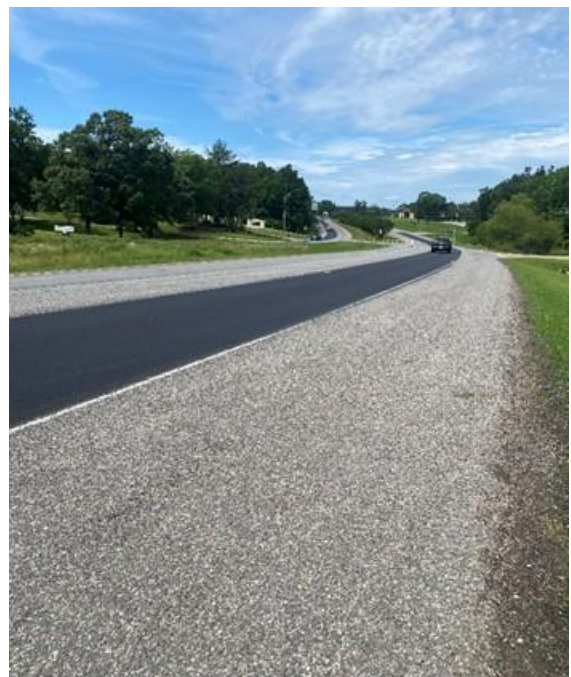
**Figure 9. PFC repaired with inlaid, dense-graded hot-mix asphalt since PFC on shoulder was clogged.**
