# Rehabilitation Recommendations for FM 468 in La Salle County

Technical Memorandum TM-14-03

Prepared for Texas Department of Transportation  
Maintenance Division

Prepared by  
Texas A&M Transportation Institute

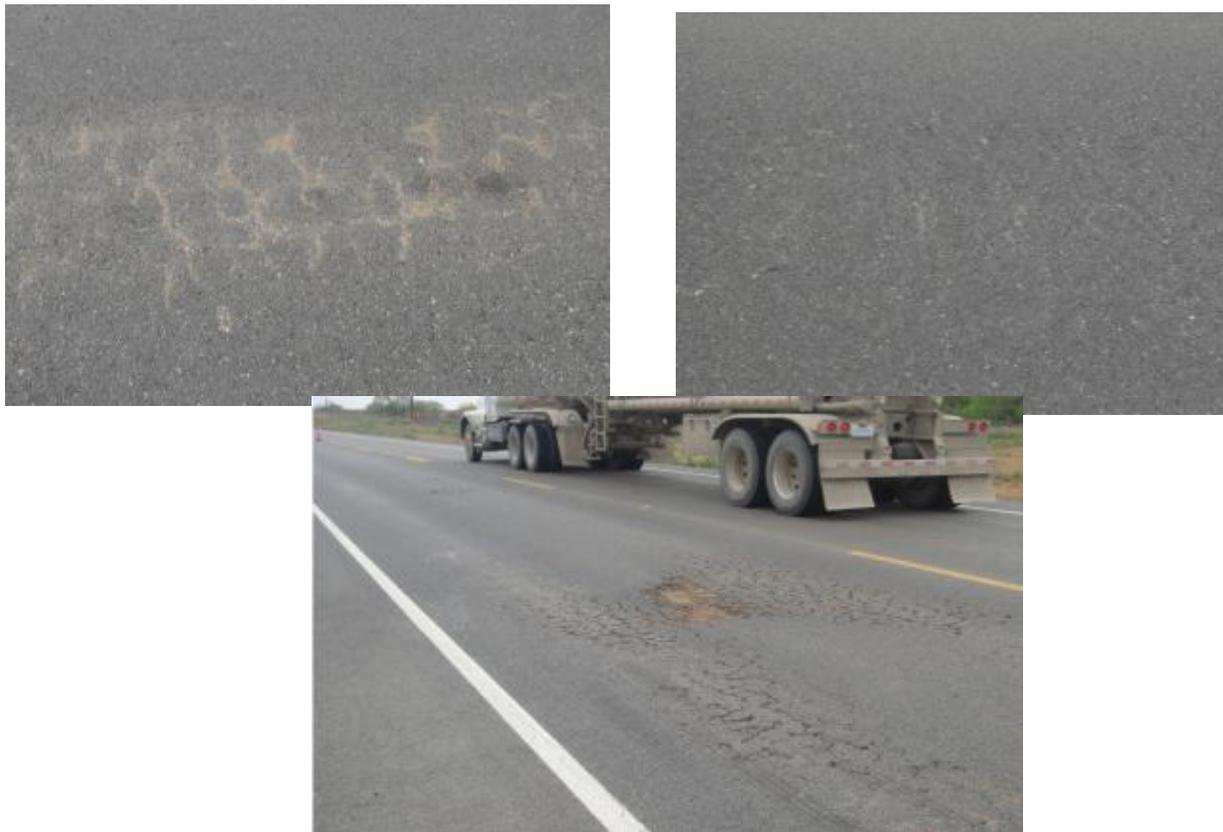
**Figure 1. Progression of Observed Pavement Failure on FM 468.**

The mode of failure of FM 468 was primarily fatigue cracking of a stiff HMA overlay placed on a weak thin pavement with very high deflections. The multiple chip seals on the existing pavement were removed and a relatively thin (3 inches), stiff HMA layer was placed. The HMA layer prematurely cracked under the heavy loads letting water into the base. The unusually heavy rainfall in the early months of 2014 was also a contributing factor. The addition of full depth shoulders potentially attributed to trapping moisture in the base. The failure sequence is shown below.

Initially fine hairline cracks were observed in the wheel paths; these rapidly deteriorate into the classical fatigue pattern with evidence of base pumping. Rapid failure then occurred under the extremely heavy traffic.

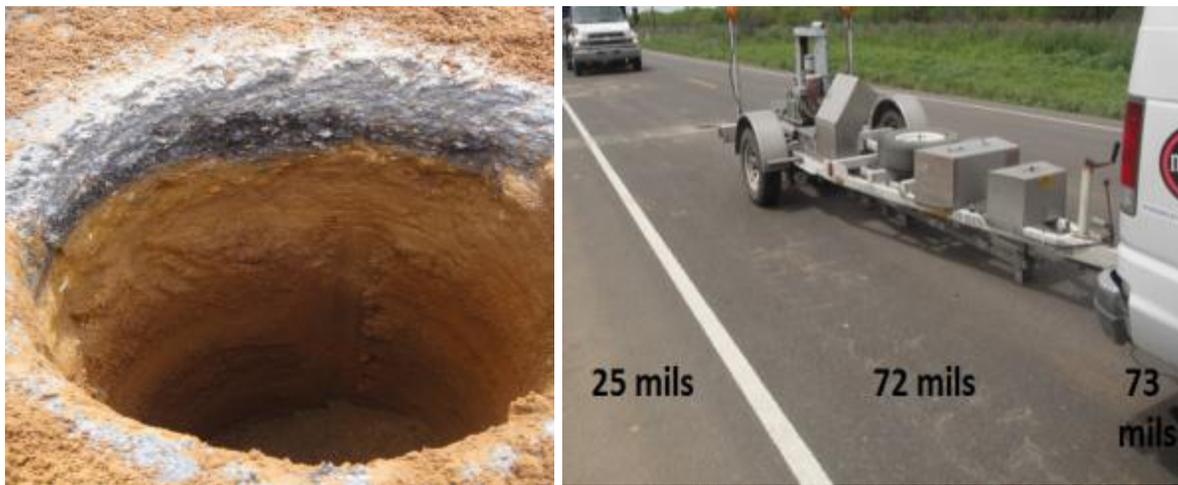
**Figure 2. Inadequate Foundation Layer.**

- The pavement did not have an adequate base. As shown below, the base was less than 2 inches in thickness.
- FWD deflections in the lanes were measured to be extremely high. Deflections in the 70 and 80 mil range at the 9000 lb load on a pavement with 3 inches of HMA are indicative of a weak or inadequate foundation layer.

- **Option 1b** remove existing HMA; cement stabilize the existing sandy subgrade with 6 percent cement and place full depth HMA.
- **Option 6** Undercut section, cement stabilize subgrade and add both flexible base and a two course surface treatment (CST).

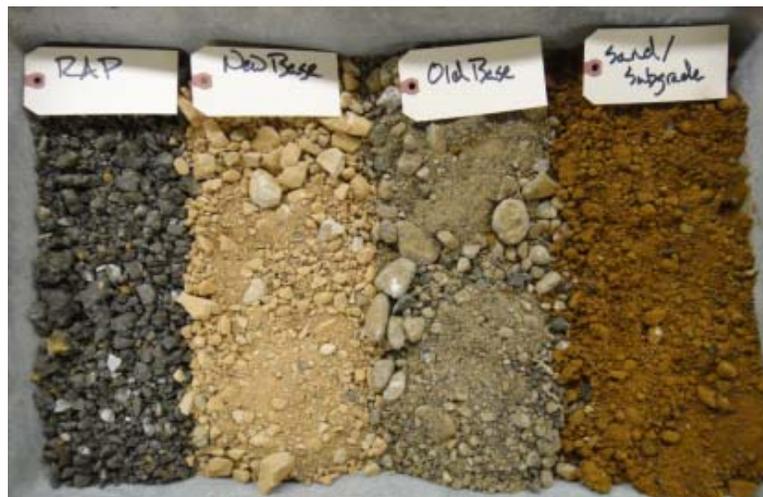
**Figure 3. Materials from Existing Pavement.**

Six pavement rehabilitation options were proposed. All options included the construction of some type of stabilized base or subbase layer. The materials taken from the existing pavement are shown below. The new base was taken from a stockpile at a TxDOT yard in Cotulla.

- The use of 6 percent Portland cement in the sandy subgrade created a stiff layer that was not moisture susceptible. The 7 day Unconfined compressive strength (UCS) was 220 psi, and the indirect tension strength was 53 psi, with no loss of strength after submerging the sample in water for 4 hours.
- A combination of 50 percent new base, 38 percent reclaimed asphalt pavement (RAP), and 12 percent old base was effectively stabilized with either 3 percent Portland cement or a combination of 2.4 percent foamed asphalt and 1 percent Portland cement. Both these options will produce an acceptable stabilized base.
