# Rehabilitation Recommendations for SH 87 in Gonzales County

## Technical Memorandum TM-14-07

Prepared for Texas Department of Transportation  
Maintenance Division

Prepared by  
Texas A&M Transportation Institute

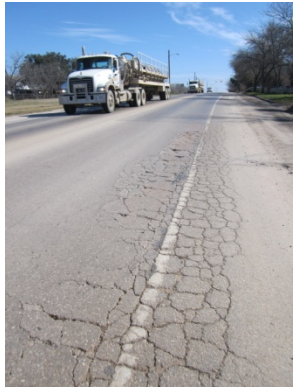
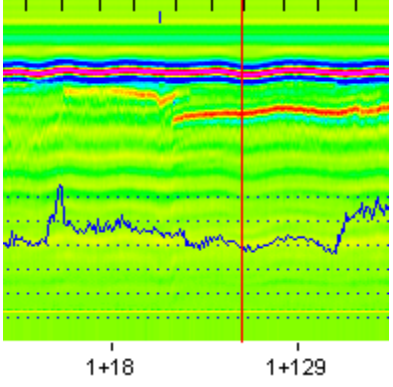
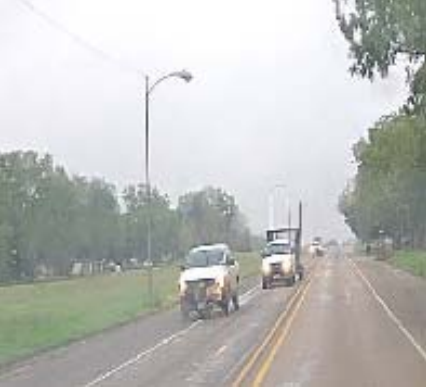
<b>US 87 in Nixon</b>	<b>County: Gonzales</b>	<b>TRM 744 – 745.127</b>
Pavement Structure: Varies Base: Total HMA: 3.5 to 12 in.		Last Treatment: unknown
Current Condition:

Distress: Extensive fatigue and reflection cracking. Numerous patches exist as shown in the above GPR excerpt.		
Cause of Problem:		
From GPR profiles, numerous sections exist as follows:		
<ul style="list-style-type: none"> <li>• TRM 744 to 744.132: 6 in. HMA over flexible.</li> <li>• TRM 744.132 to 744.303: 3.5 to 5 in. HMA over flexible.</li> <li>• TRM 744.303 to 744.659: 6 in. HMA over 7 in. JCP.</li> <li>• TRM 744.659 to 744.802: 9 to 12 in. HMA over flexible.</li> <li>• TRM 744.802 to 745.127: 3.5 to 6 in. HMA over flexible.</li> </ul>		
High counts of slow moving heavy truck traffic, combined with poor soils and oftentimes thin HMA all are contributing to the pavement distress. Reflection cracks from the JCP also exist where the HMA is placed over a concrete pavement.

Recommended Approach:		
Localized pavement structure repair is needed now. For this repair, removing the distressed materials and increasing the asphalt mixture thickness to between 9 and 12 in. appears to be working reasonably well as repairs. For the long term, a detailed evaluation of the existing materials may be required and possible deep reconstruction may be necessary.		
Priority: Several locations need pavement structure repair now

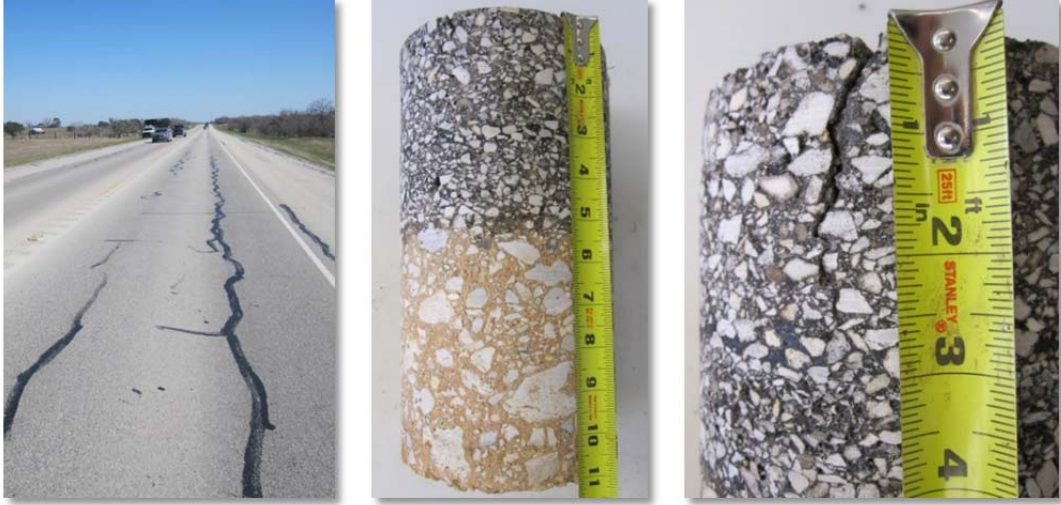
<b>US 87 Section 1</b>	<b>County: Gonzales</b>	<b>TRM 745.127 – 757.250</b>
Pavement Structure: Base: 6 in. CTB over old roadbed Total HMA: 4.5 in.		Last Treatment: ~2005 Type: asphalt mixture overlay
Current Condition:

Distress: Longitudinal cracking in wheel paths, some transverse cracking, and some random cracking.		
Cause of Problem: Some of the cracking is reflective cracking from the CTB. The primary distress of longitudinal cracking is top-down cracking in the HMA. The FWD shows the base modulus averaging 485 ksi, and the subgrade modulus 18 ksi.		
Recommended Rehabilitation Approach: Mill 3 in. to remove top down cracking, place new overlay(s) to meet FPS requirements.		
Priority: 2

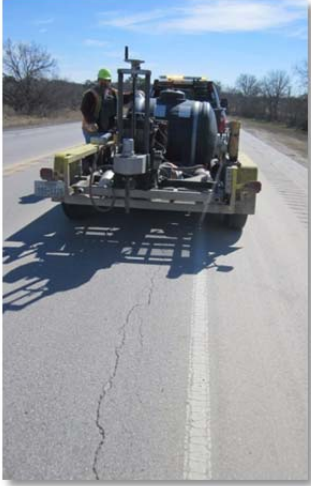
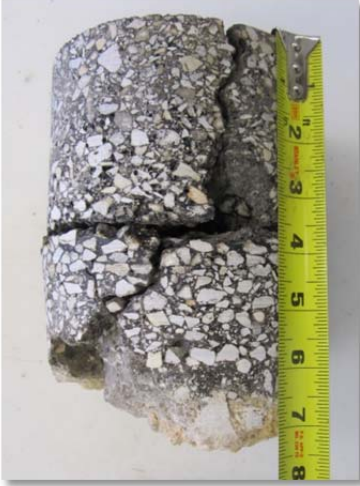
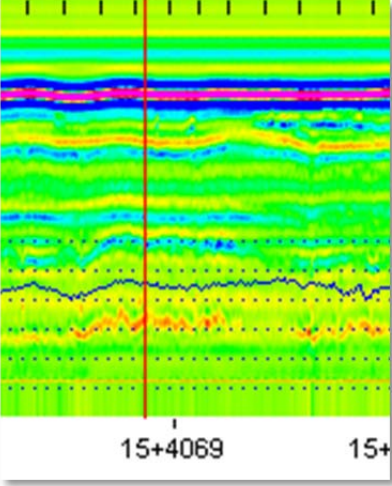
<b>US 87 Section 2</b>	<b>County: Gonzales</b>	<b>TRM 757.250 – 764</b>
Pavement Structure: Base: 6 in. CTB Total HMA: 5 in.		Last Treatment: ~2005 Type: Asphalt mixture overlay
Current Condition:

Distress: Longitudinal wheelpath cracking with some transverse cracking and random cracking.		
Cause of Problem: In this section, the cracking is through the entire thickness of HMA, suggesting a traditional fatigue failure. Additionally, FWD deflections are significantly higher, and the base and subgrade modulus values much lower in this section. FWD data show the average base modulus to be 258 ksi and the average subgrade modulus as 8 ksi. However, in many instances the FWD backcalculations hit their lower limits, suggesting the stabilized base may be deteriorating into the range of a flexible base course.		
Recommended Rehabilitation Approach: Mill 2 in.; perform FDR and additional thickness as required to meet FPS. In the FDR process, consider a flexible base overlay on top of the stabilized layer, as this cross section has provided good performance elsewhere in the District.

Priority: 1
