VOLUME XI: APPENDIX J -
CRASH TESTING AND EVALUATION OF
EXISTING GUARDRAIL SYSTEMS

"Testing of State Roadside Safety Systems"

FEBRUARY 1998

1. Report No. FHWA-RD-98-046	2. Government Accession No.	3. Recipient's Catalog No.	
4. Title and Subtitle TESTING OF STATE ROADSIDE SAFETY SYSTEMS VOLUME XI: APPENDIX J - CRASH TESTING AND EVALUATION OF EXISTING GUARDRAIL SYSTEMS		5. Report Date

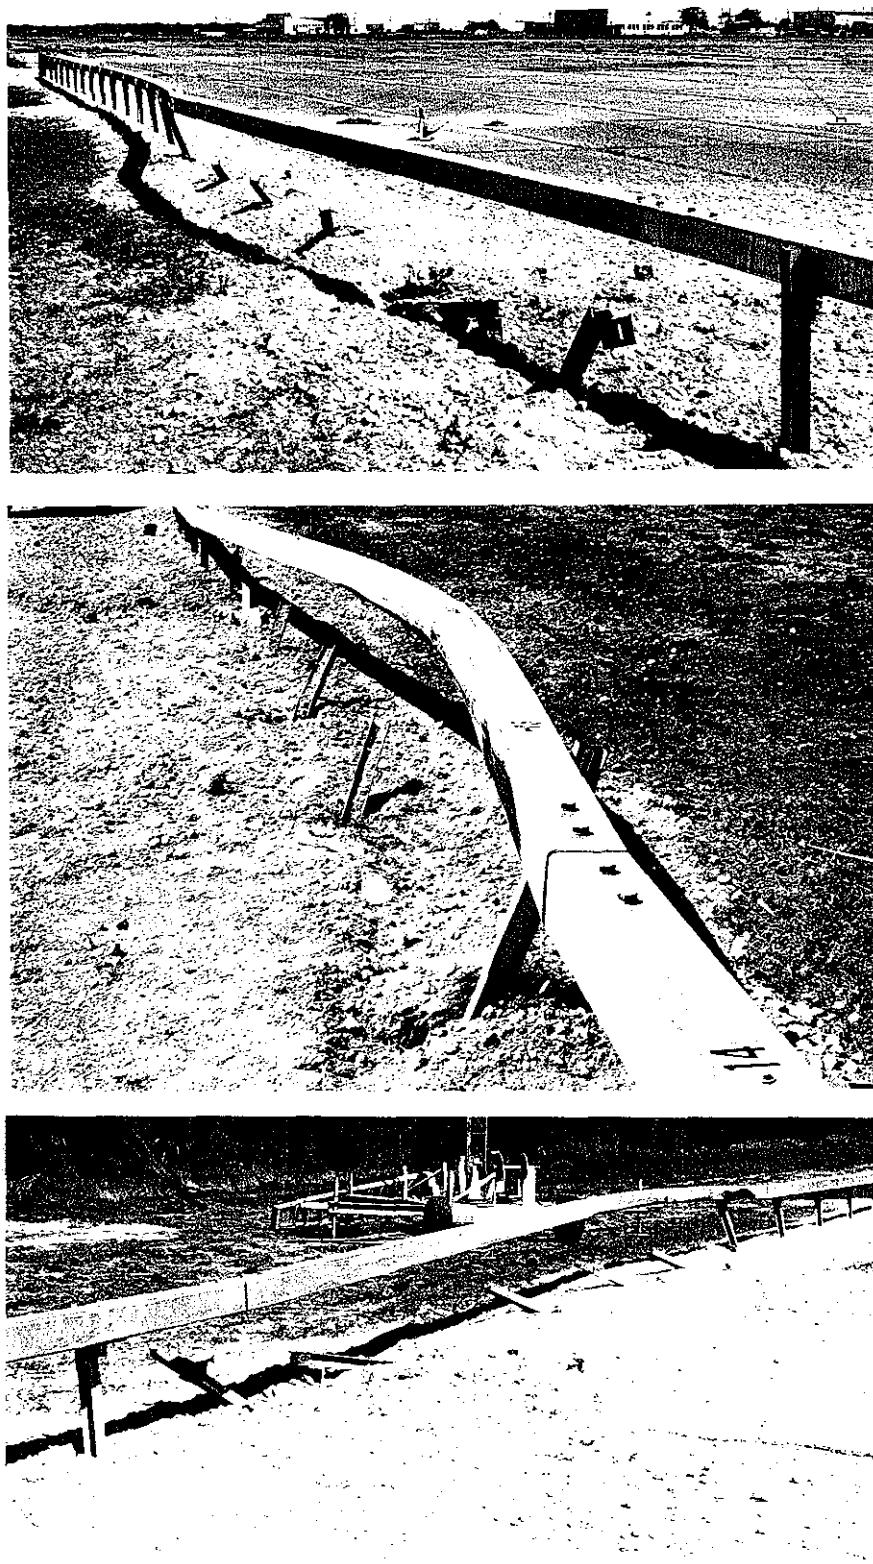
Figure 60. Damage at posts 14 through 21, test 471470-33.

As seen in figures 59 through 61, the guardrail installation received moderate damage. There were tire marks on the face of the box-beam rail element from posts 15 through 21, and on posts 15 through 20. The box-beam rail element was separated from posts 16 through 20, and these posts were bent at ground level. The lateral deflections recorded at posts 12 through 22 are noted in table 3.

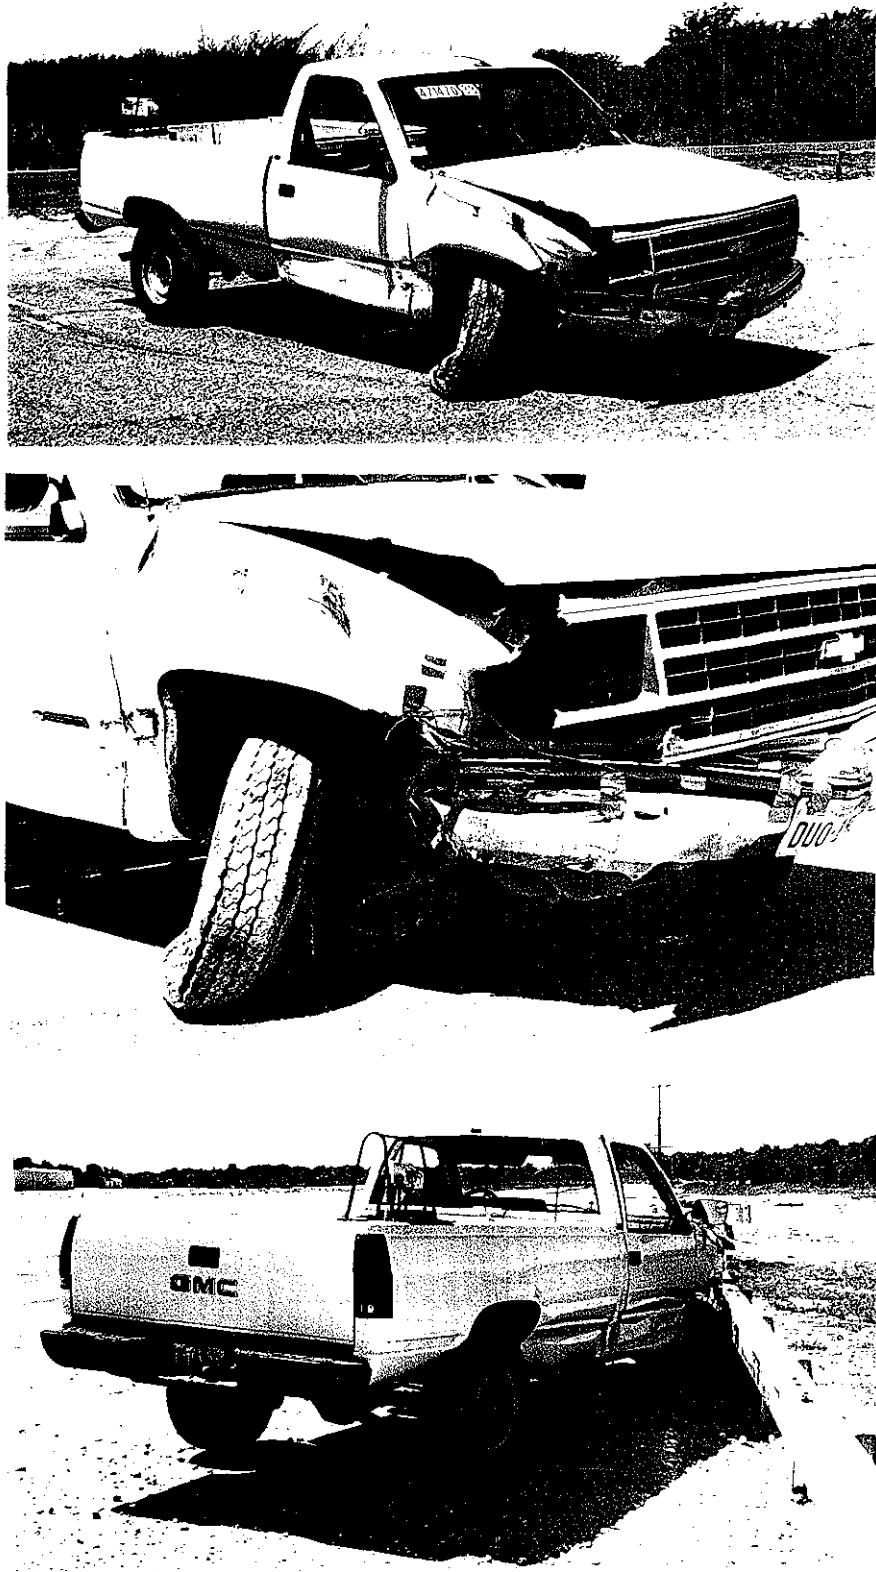
Figure 62. Vehicle after test 471470-33.

The vehicle sustained moderate damage as shown in figure 62. The right lower A-arm, stabilizer bar, and tie rod ends on the right side were damaged. The front bumper, grill, right front quarter panel, right door, right rear quarter panel, and the right front wheel also were damaged. Maximum exterior crush at the right front corner of the vehicle was 530 mm (20.9 in), and maximum deformation of the occupant compartment was 9 mm (0.4 in) at the instrument panel area on the passenger side.

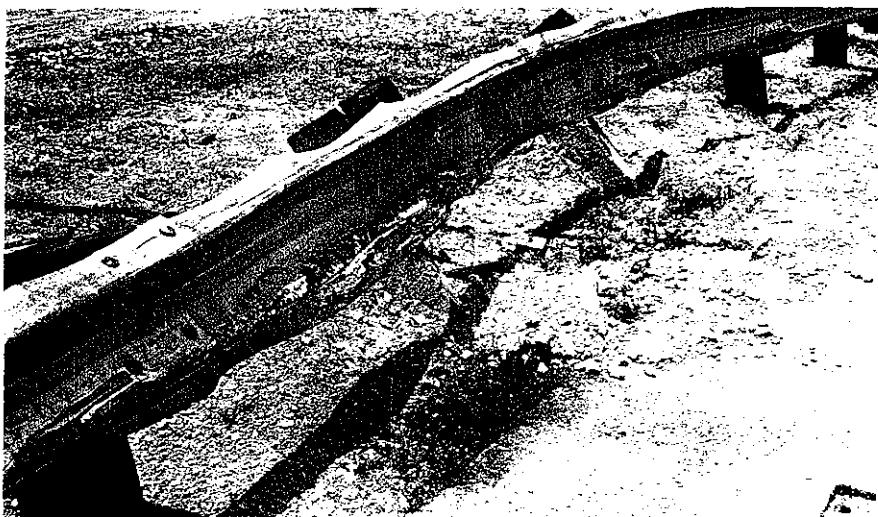
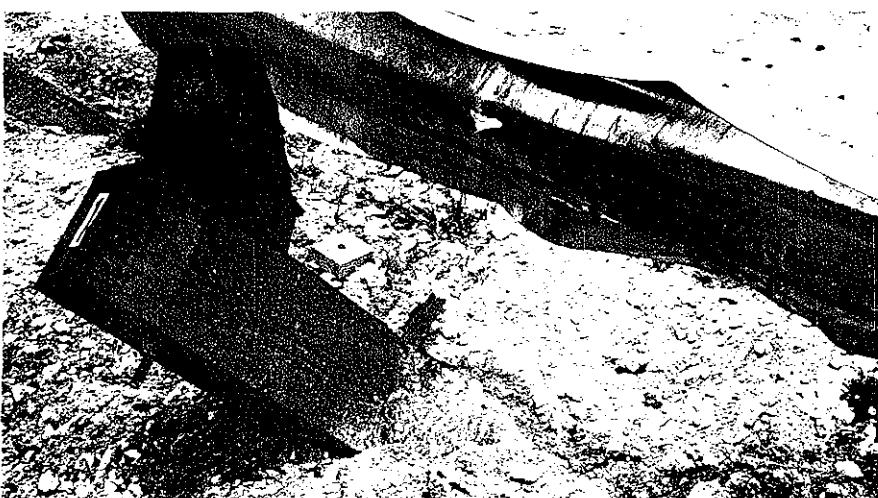
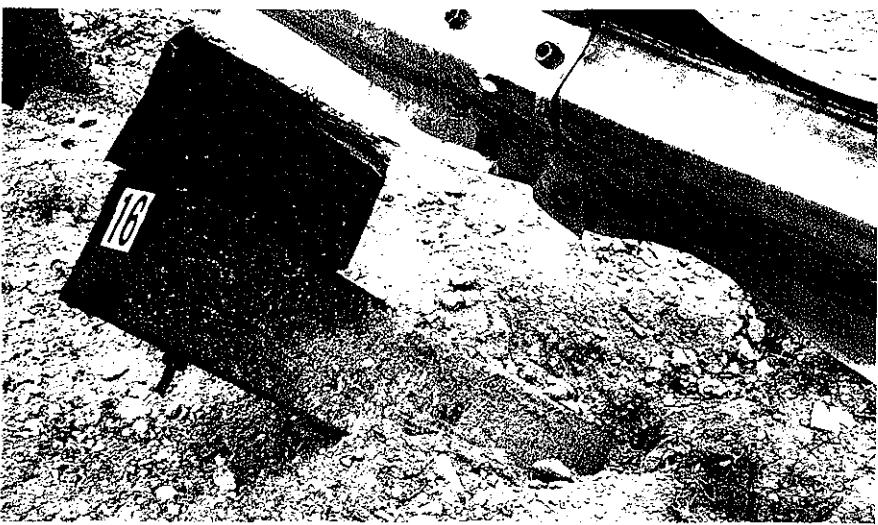
Figure 76. Damage at posts 15 and 16, test 471470-26.

As can be seen in figures 75 and 76, the installation received moderate damage. The bolts were pulled out of the W-beam rail element at posts 15 and 16, and the blockout on post 16 was split. None of the posts broke off, but some posts were pushed back. The displacements of the posts are shown in table 4.

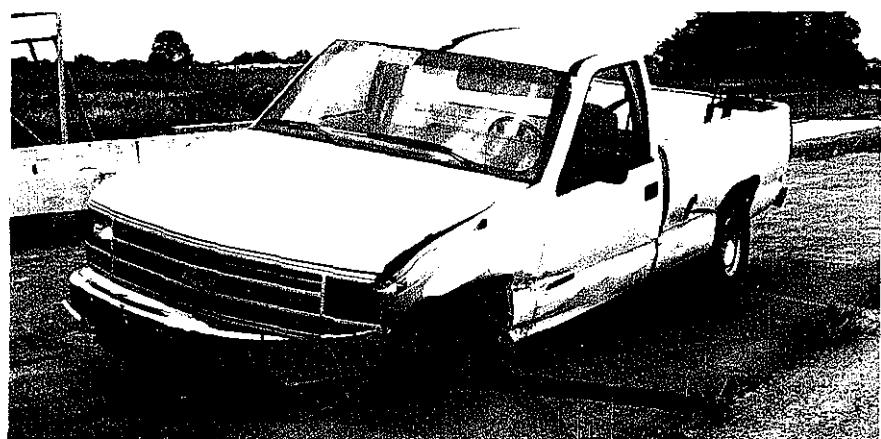
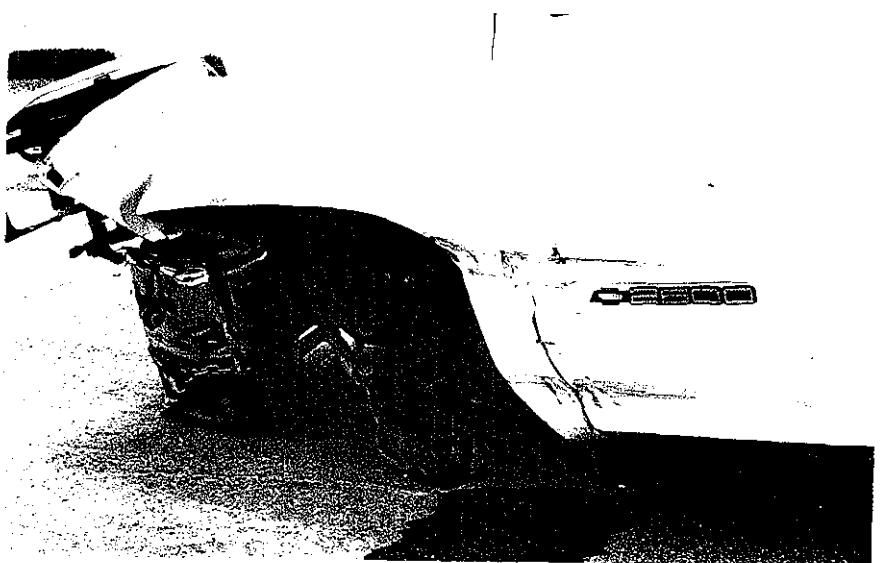
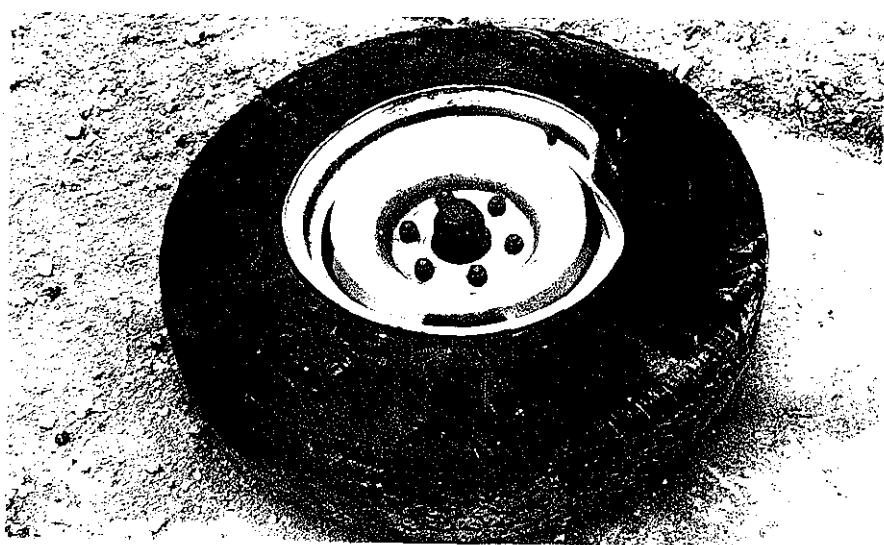
Figure 77. Vehicle after test 471470-26.

The vehicle sustained moderate damage, as shown in figure 77. The stabilizer bar, upper and lower A-arms, and tie rods on the left side were damaged, and the frame at the left front was bent. The left front spindle, wheel, and tire were separated from the vehicle. The front bumper, grill, and entire left side were also damaged. Maximum exterior crush at the left front corner of the vehicle was 370 mm (14.6 in) at bumper height. There was 44-mm (1.7-in) deformation of the occupant compartment in the floor pan area near the transmission tunnel.

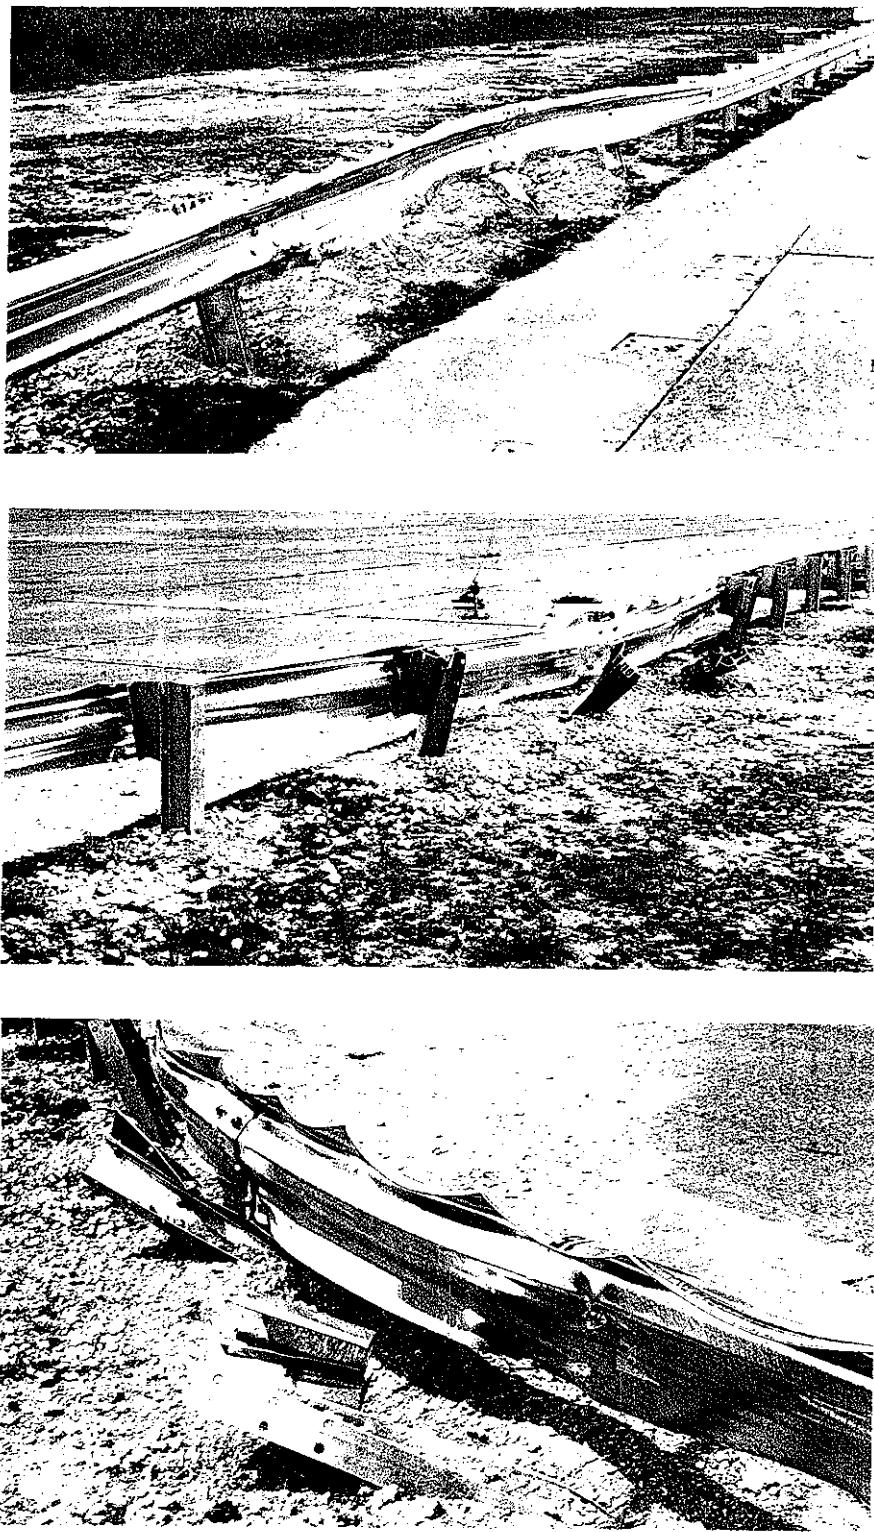
Figure 91. Damage at posts 14 through 17, test 471470-27.

As can be seen in figures 90 and 91, the installation received moderate damage. The MELT anchor on the upstream end had pulled up slightly and moved laterally 44.5 mm (1.75 in). The buffered end nose was pulled off the end post (post 1). The bolts were pulled out of the W-beam rail element at posts 15, 16, and 17, and the posts and blockouts were bent. All the steel posts upstream of impact were disturbed, with measurable displacements as shown in table 5.

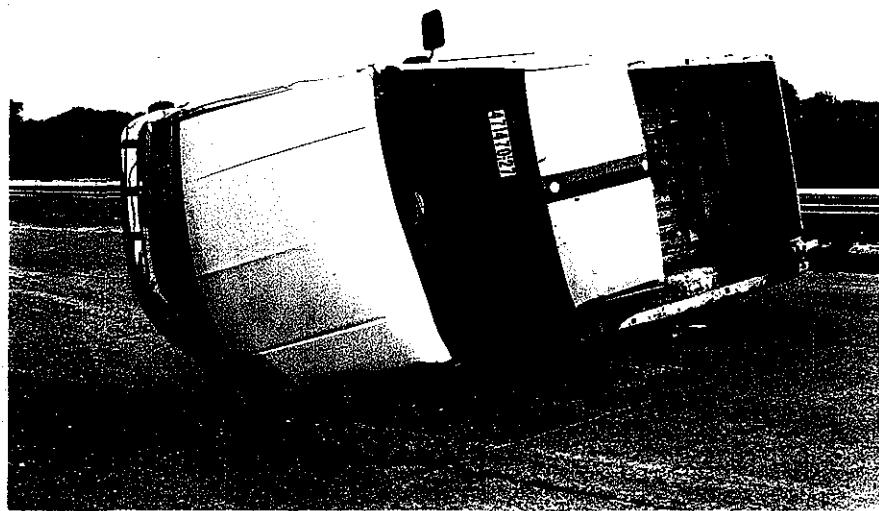
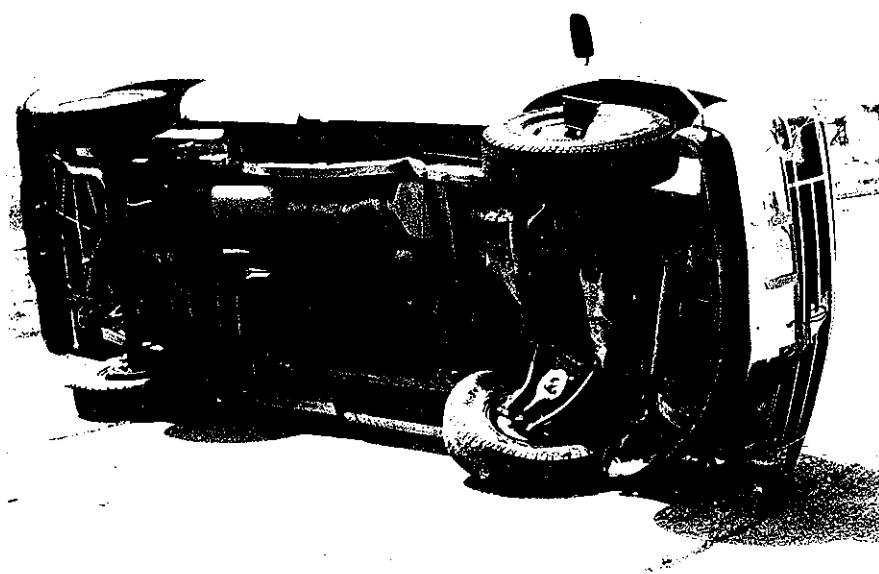
Figure 92. Vehicle after test 471470-27.

The vehicle sustained moderate damage, as shown in figures 92 and 93. The stabilizer bar, upper and lower A-arms, and tie rods on the left side were damaged, and the frame at the left front was bent. The left front spindle, wheel, and tire were damaged. The front bumper, grill, hood, radiator, windshield, and entire left side also were damaged. Maximum exterior crush at the left front corner of the vehicle was 570 mm (22.4 in) at bumper height. There was 53-mm (2.1-in) deformation of the occupant compartment in the floor pan area on the driver's side.

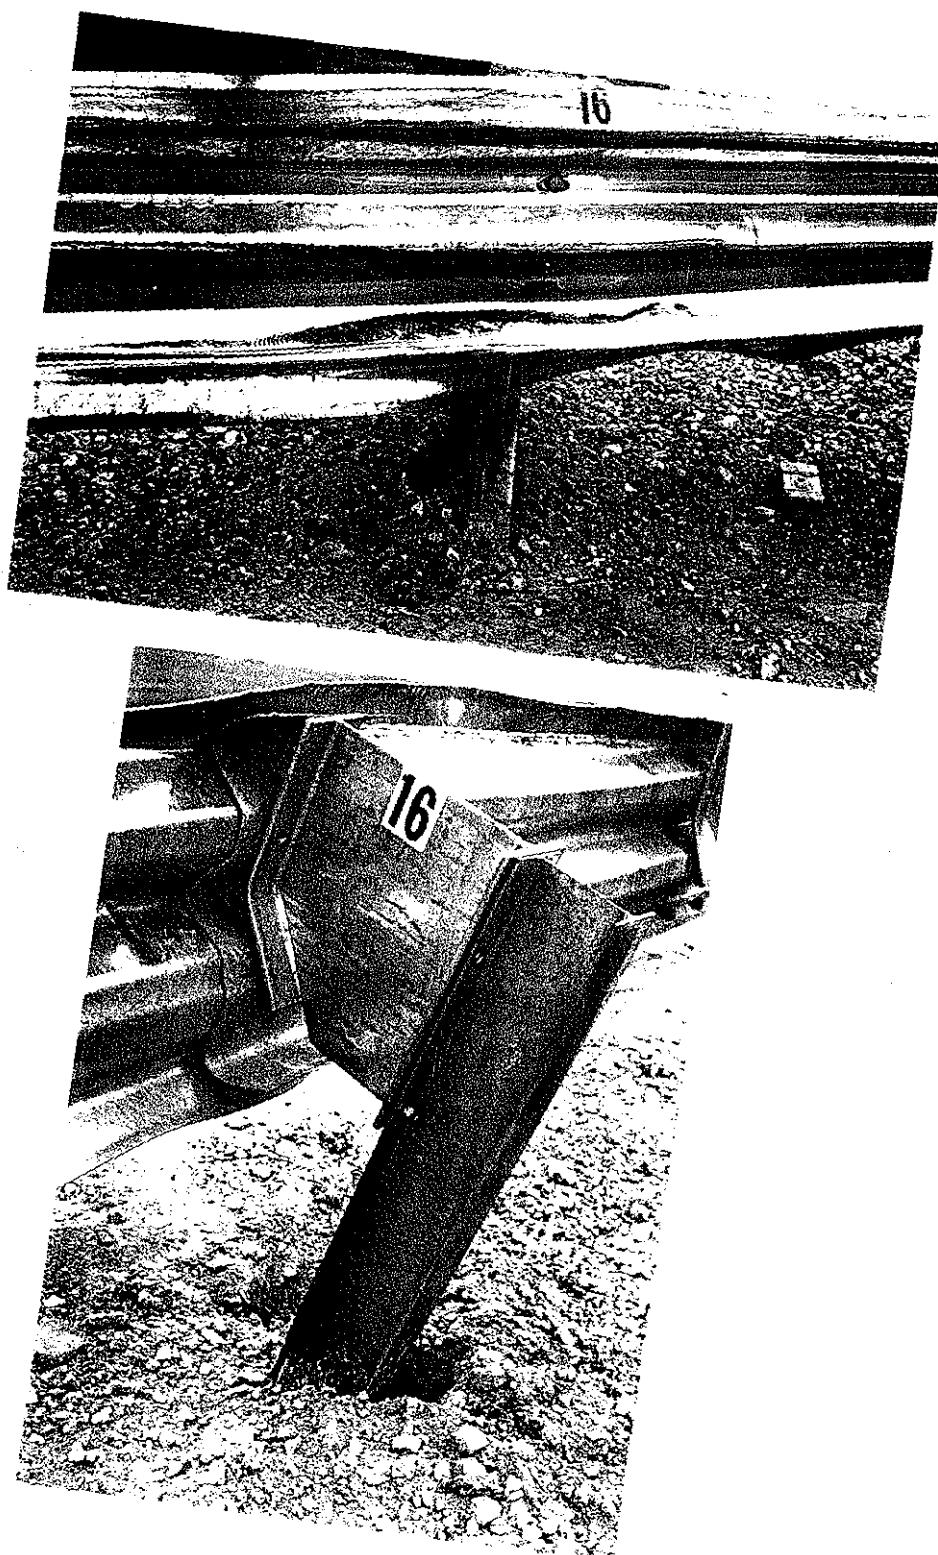
Figure 125. Damage at post 16, test 471470-30.

As seen in figures 124 through 128, the installation received moderate damage. There were tire marks on the face of the thrie-beam rail element from post 15 through post 19, and on
