Test Report No. 469940-03, 469942-01, and 469943-01

**DEVELOP A RETROFIT DESIGN FOR GUARD FENCE SYSTEM TO  
ENHANCE MOTORCYCLE SAFETY**  
COOPERATIVE RESEARCH PROGRAM

Texas Department of Transportation  
<https://tti.tamu.edu/documents/0-6994-R1.pdf>

**TEXAS A&M TRANSPORTATION INSTITUTE PROVING GROUND**

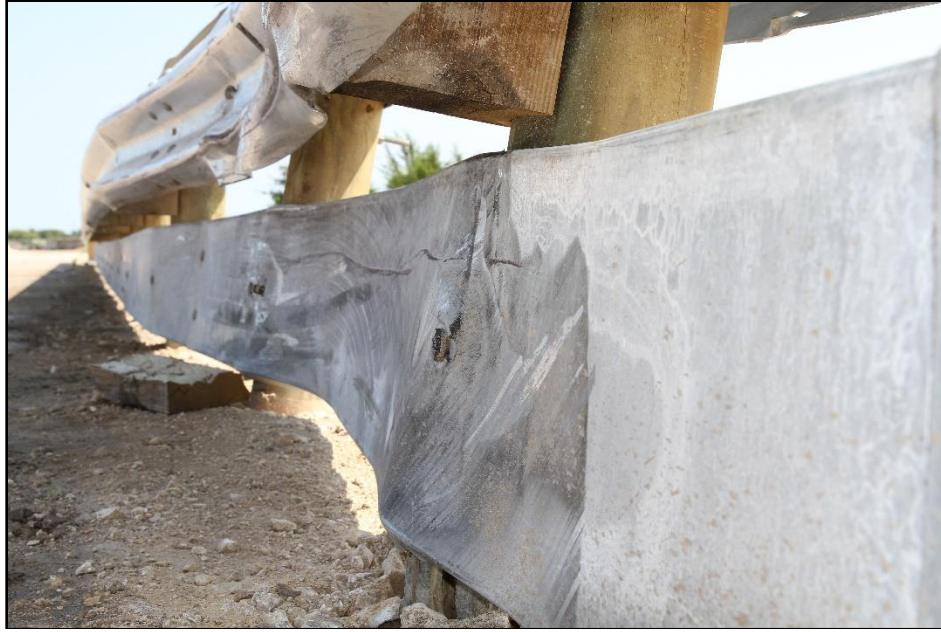
**Figure 9.6. Enhanced Motorcycle Guard Fence System at the Rubrail at Impact after Test 469940-03-1.**

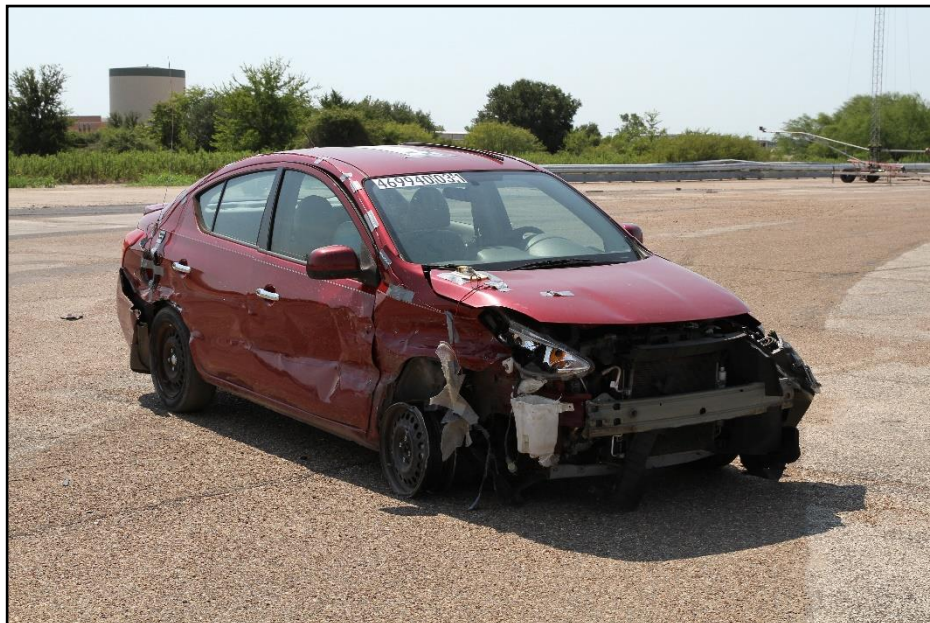
Figure 9.7 and Figure 9.8 show the damage sustained by the vehicle. Figure 9.9 and Figure 9.10 show the interior of the test vehicle. Table 9.8 and Table 9.9 provide details on the occupant compartment deformation and exterior vehicle damage. Figures C.2 and C.3 in Appendix C.1 provide exterior crush and occupant compartment measurements.

**Figure 9.7. Impact Side of Test Vehicle after Test 469940-03-1.**

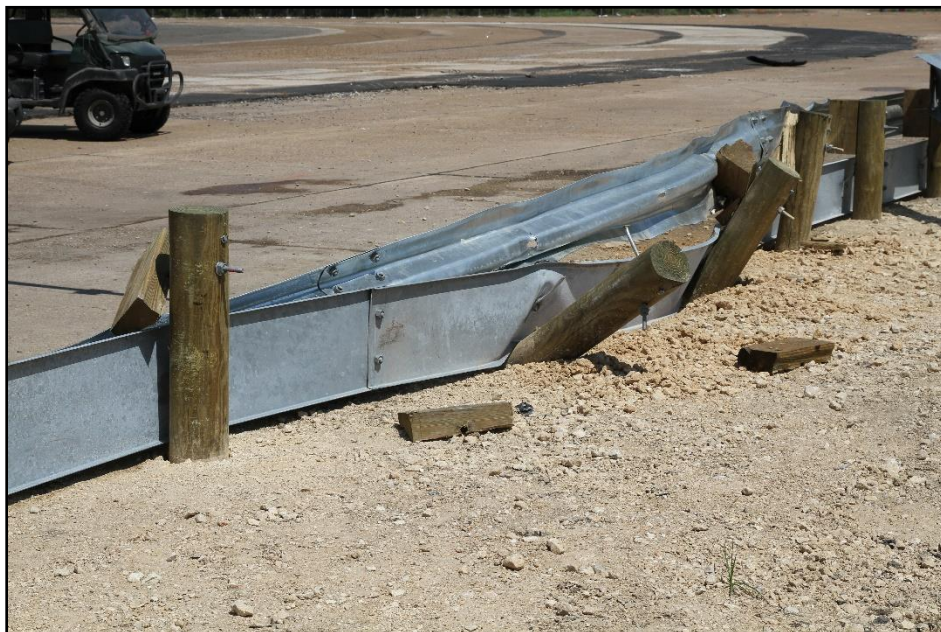
**Figure 10.6. Enhanced Motorcycle Guard Fence System at Impact Location on the Field Side after Test 469940-03-2.**

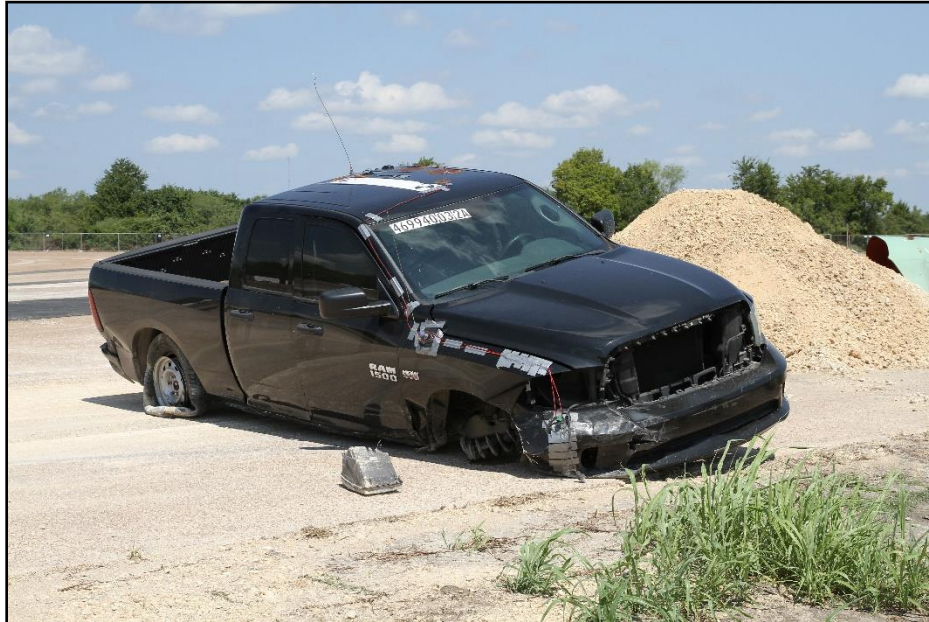
Figure 10.7 and Figure 10.8 show the damage sustained by the vehicle. Figure 10.9 and Figure 10.10 show the interior of the test vehicle. Table 10.7 and Table 10.8 provide details on the occupant compartment deformation and exterior vehicle damage. Figures D.2 and D.3 in Appendix D.1 provide exterior crush and occupant compartment measurements.

**Figure 10.7. Impact Side of Test Vehicle after Test 469940-03-2.**

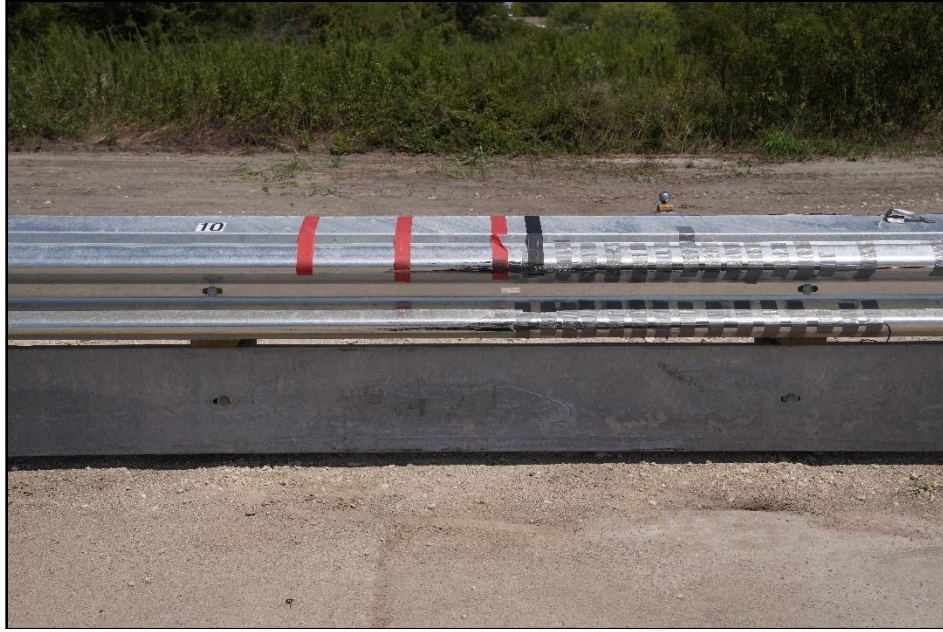
**Figure 11.6. Elevation View of the Enhanced Motorcycle Guard Fence System at Impact Location after Test 469940-03-3.**

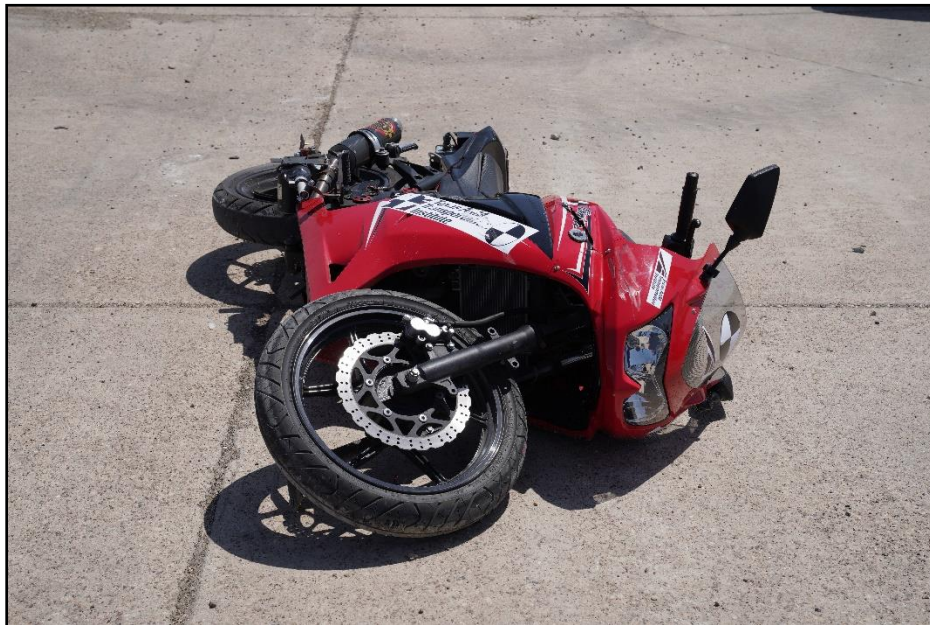
Figure 11.7, Figure 11.8, and Figure 11.9 show the damage sustained by the vehicle.

**Figure 11.7. Impact Side of Test Vehicle after Test 469940-03-3.**

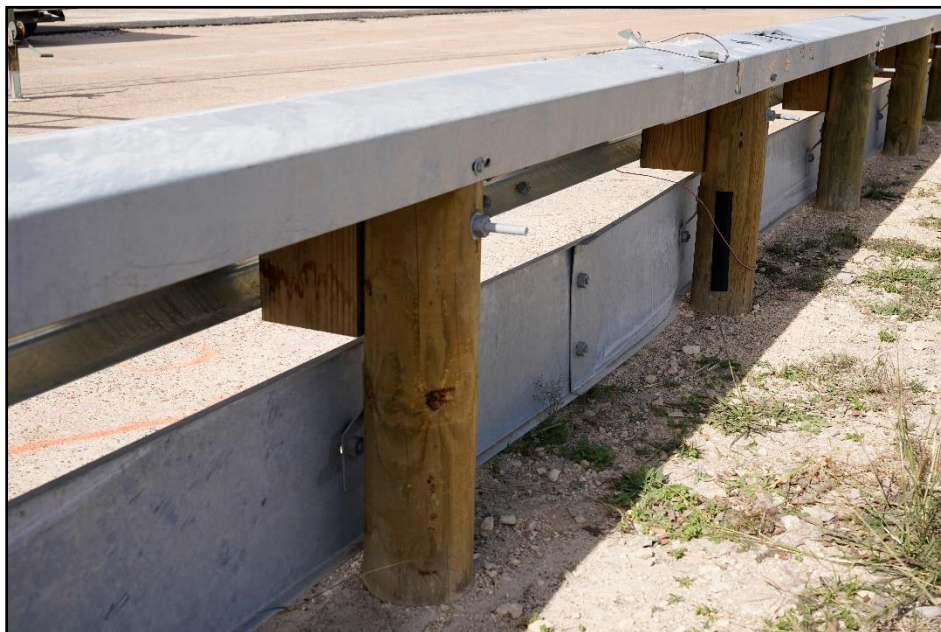
**Figure 12.4. Enhanced Motorcycle Guard Fence System at Impact Location on the Field Side after Test 469940-03-4A.**

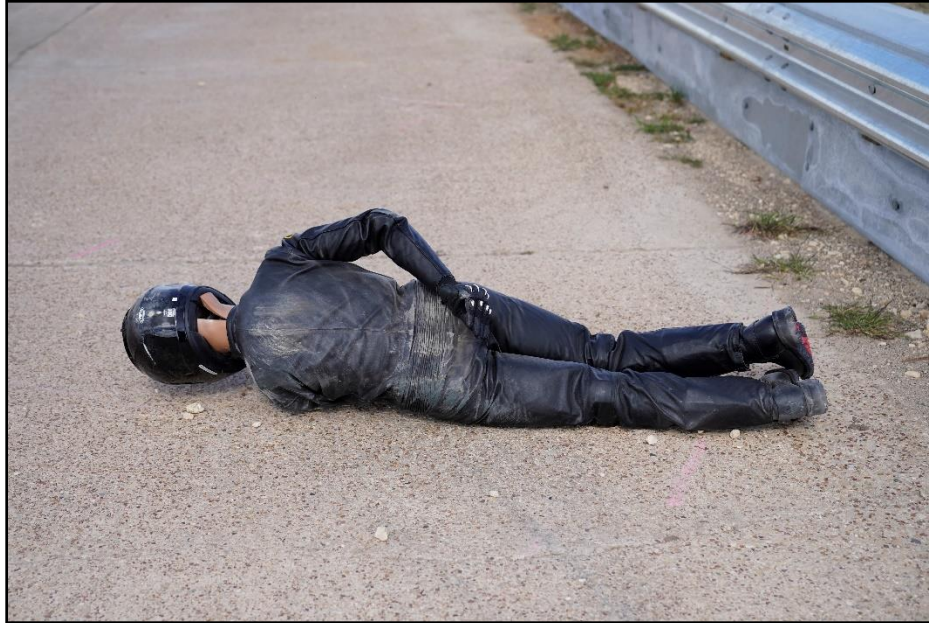
Figure 12.5 and Figure 12.6 show the overall damage sustained by the ATD. Figure 12.7 and Figure 12.8 show the helmet and neck damage sustained by the ATD. Table 12.6 provides details on the calculated injury criteria for the head and neck of the ATD.

**Figure 12.5. Backside of the ATD after Test 469940-03-4A.**

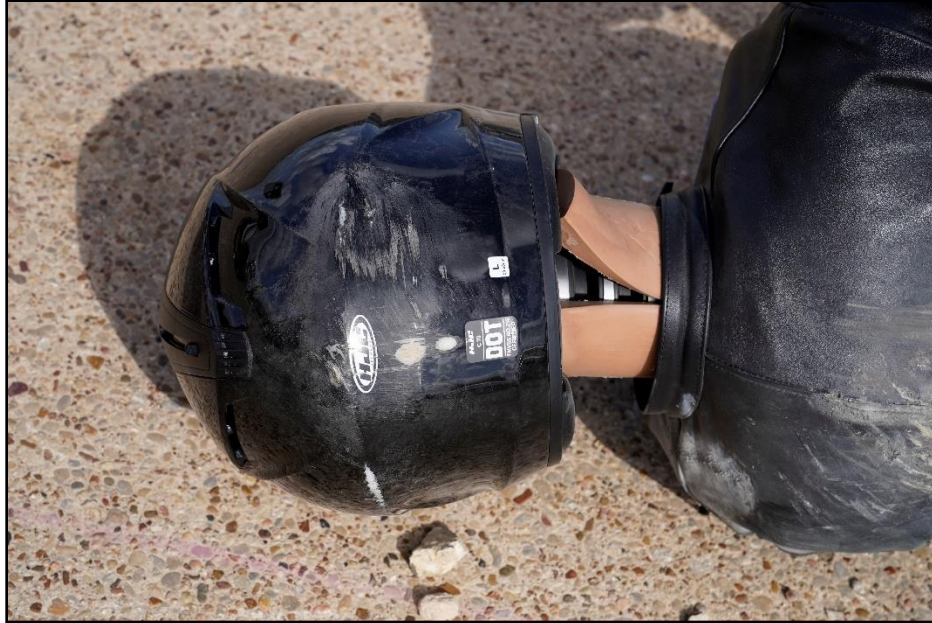
**Figure 12.7. Back Helmet and ATD Neck Damage after Test 469940-03-4A.**

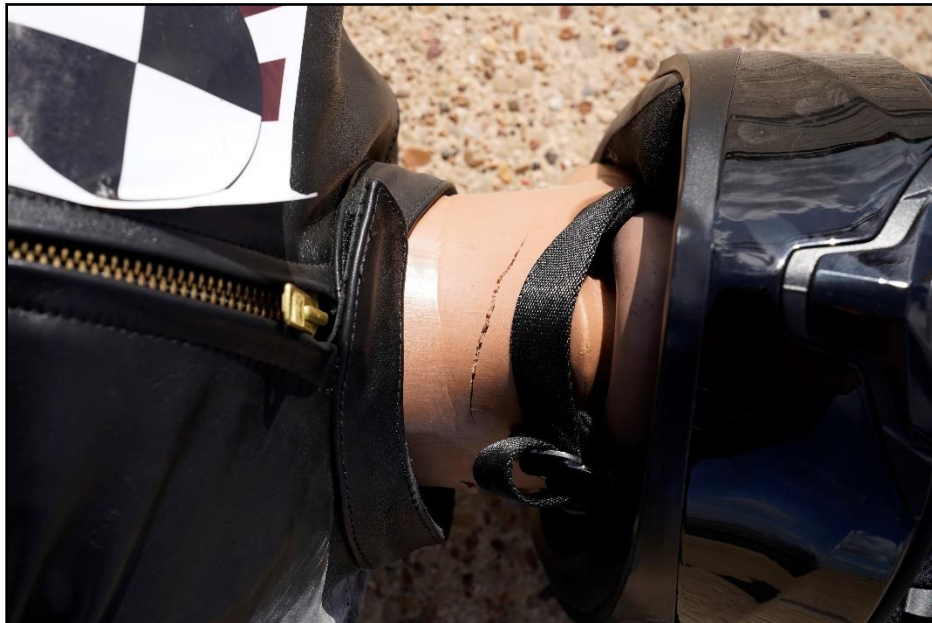
**Figure 12.8. ATD Neck Damage after Test 469940-03-4A.**

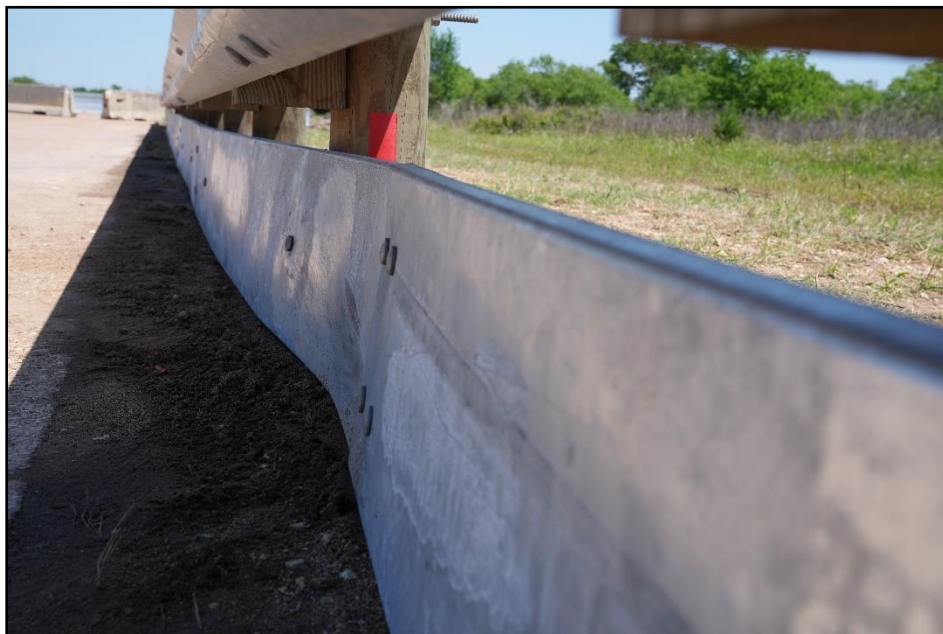
**Figure 14.4. Enhanced Motorcycle Guard Fence System Rubrail at Impact Location after Test 469942-01-1.**

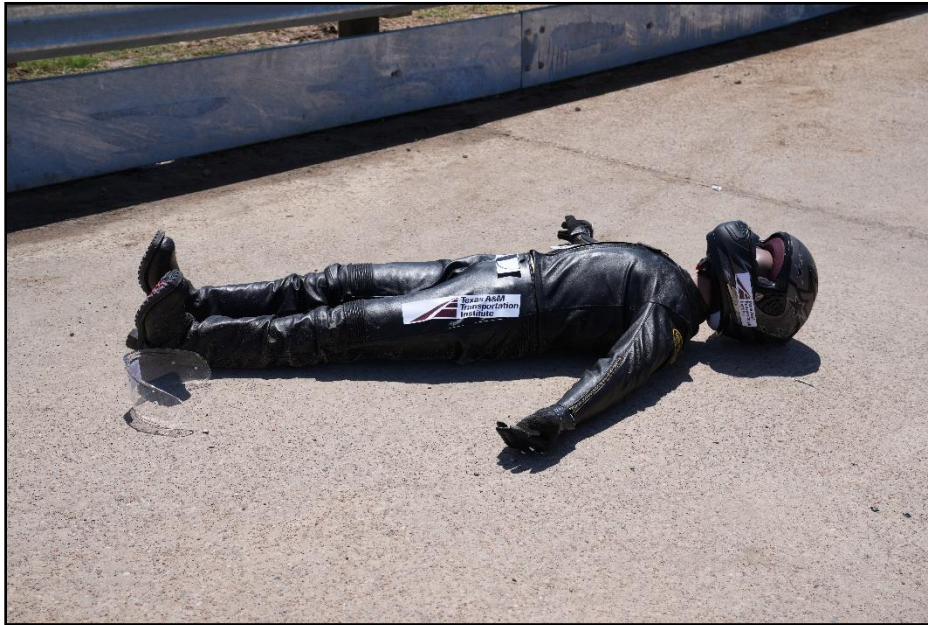
Figure 14.5 and Figure 14.6 show the damage sustained by the front of the ATD. Figure 14.7 and Figure 14.8 show the damage sustained by the back of the ATD. Table 14.6 provides details on the calculated injury criteria for the head and neck of the ATD.

Figure 14.5. Left Side of ATD after Test 469942-01-1.

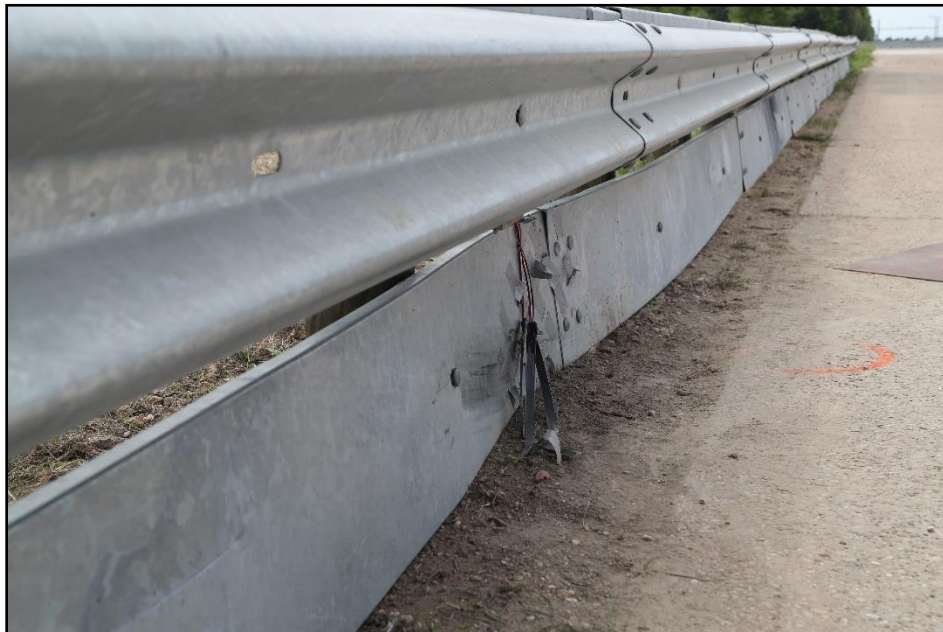
**Figure 16.4. Enhanced Motorcycle Guard Fence System Rubrail at Impact Location after Test 469943-01-1A.**

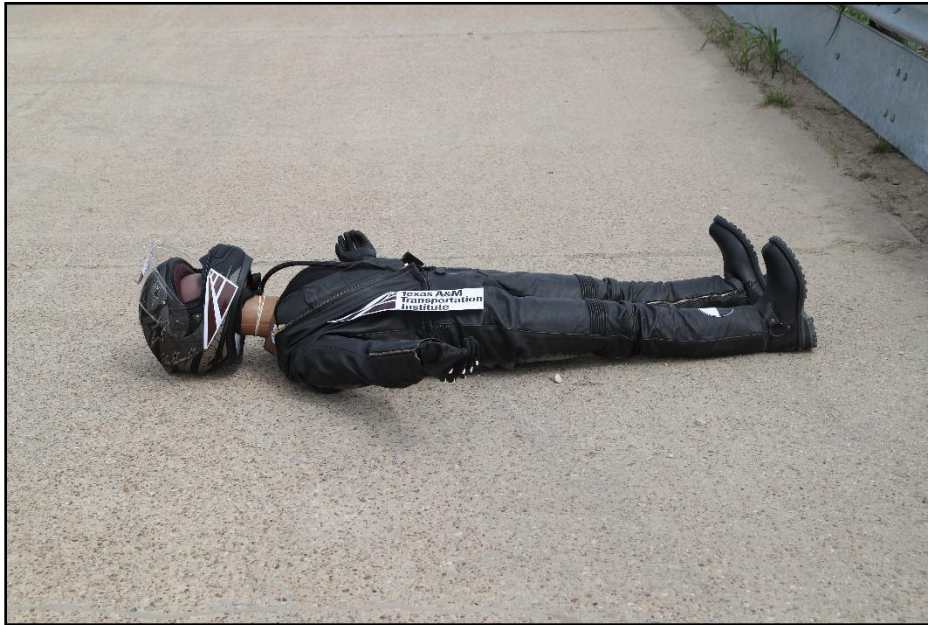
Figure 16.5 and Figure 16.6 show the damage sustained by the front of the ATD. Figure 16.7 and Figure 16.8 show the damage sustained by the back of the ATD. Table 16.6 provides details on the calculated injury criteria for the head and neck of the ATD.

**Figure 16.5. Right Side of ATD after Test 469943-01-1A.**

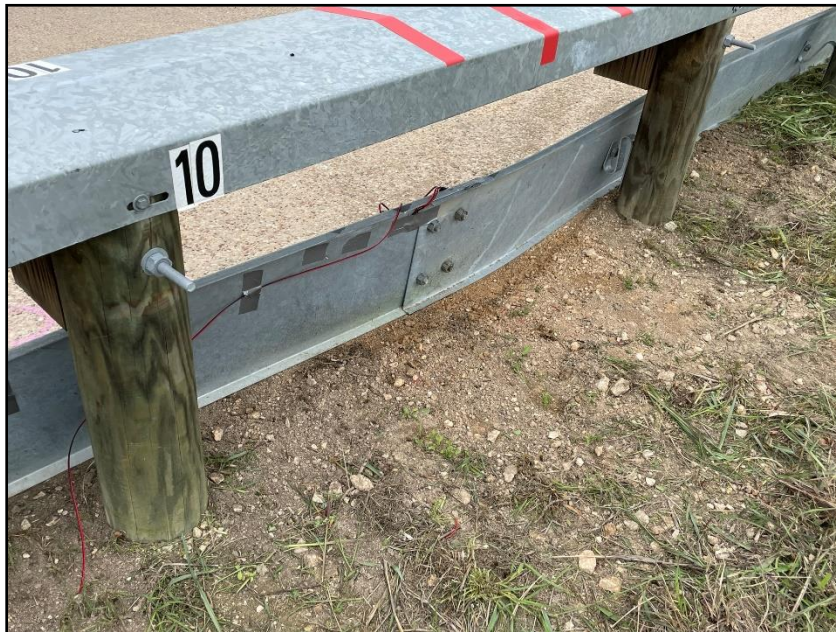
**Figure 17.4. Field Side of the Enhanced Motorcycle Guard Fence System at Impact Location after Test 469943-01-2.**

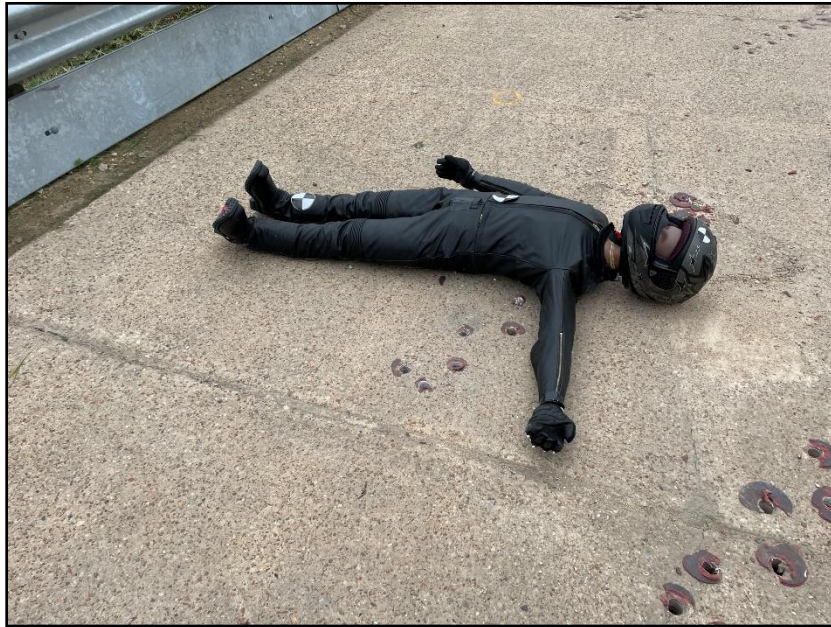
**Figure 17.5. Left Side of the ATD after Test 469943-01-2.**

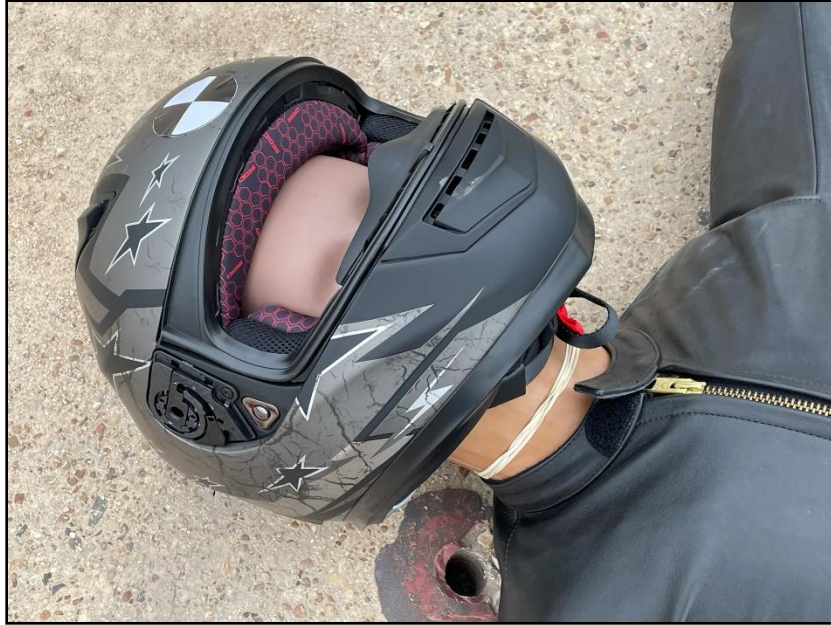
**Figure 17.7. Helmet Damage after Test 469943-01-2.**

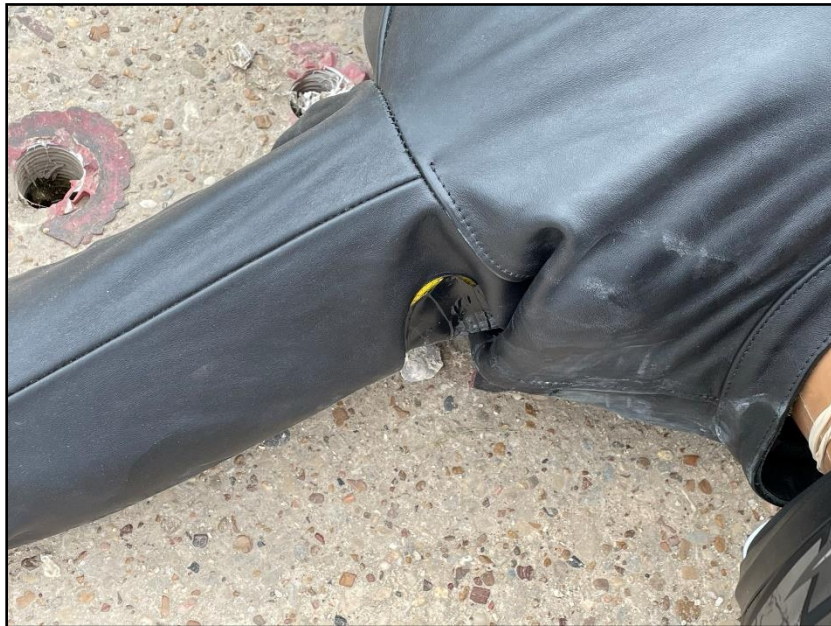
**Figure 17.8. Shoulder Damage after Test 469943-01-2.**

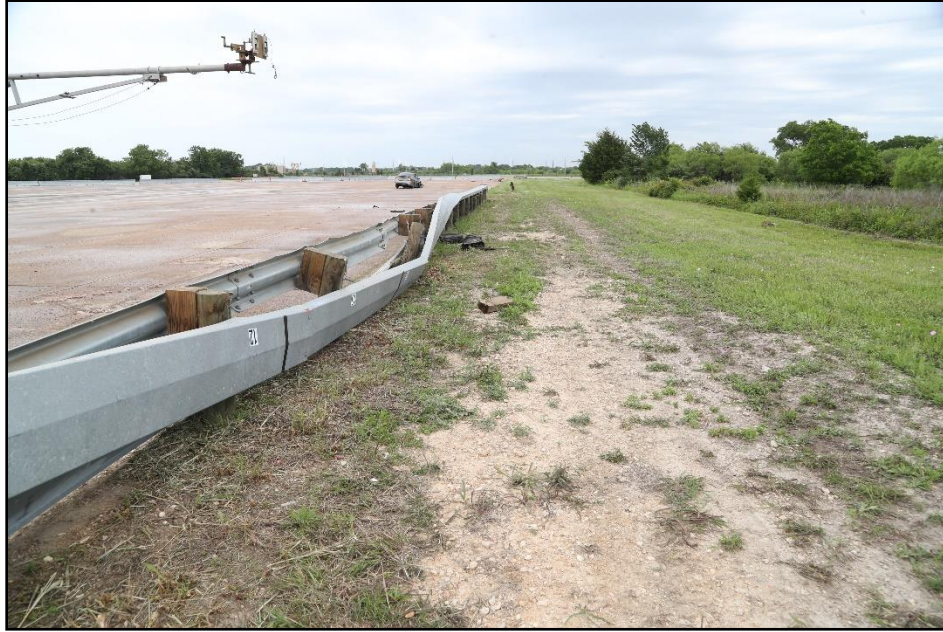
**Figure 18.6. Field-Side View of the Enhanced Motorcycle Guard Fence System at Impact Location after Test 469943-01-3.**

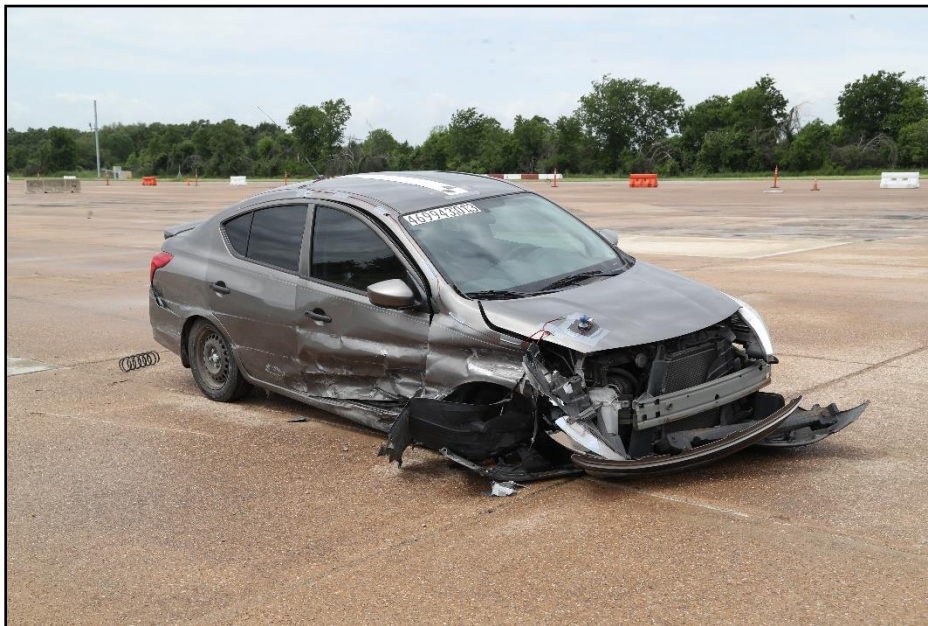
**Figure 18.7. Impact Side of Test Vehicle after Test 469943-01-3.**

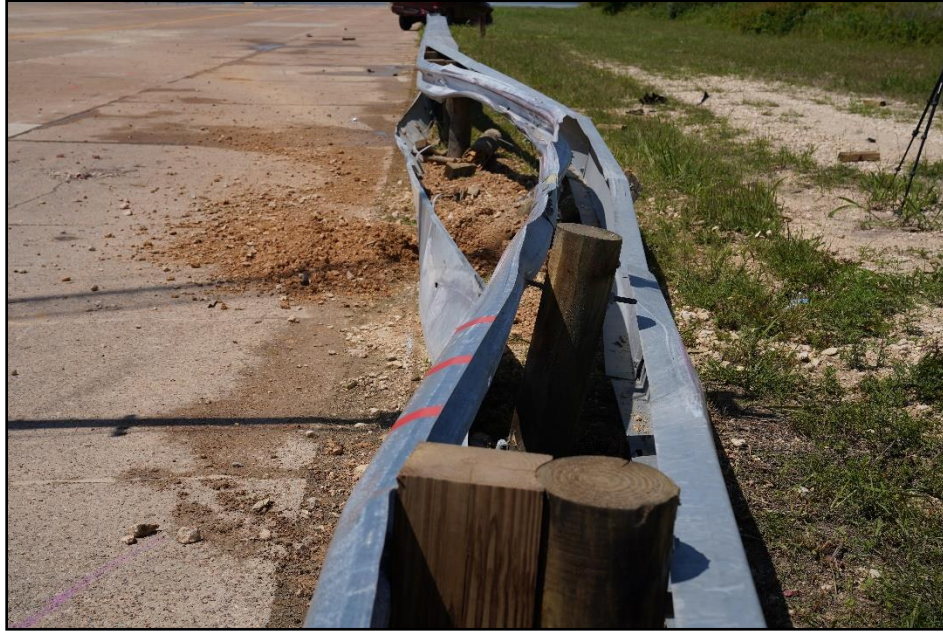
**Figure 19.6. In-Line View of the Enhanced Motorcycle Guard Fence System at Impact Location after Test 469943-01-4.**

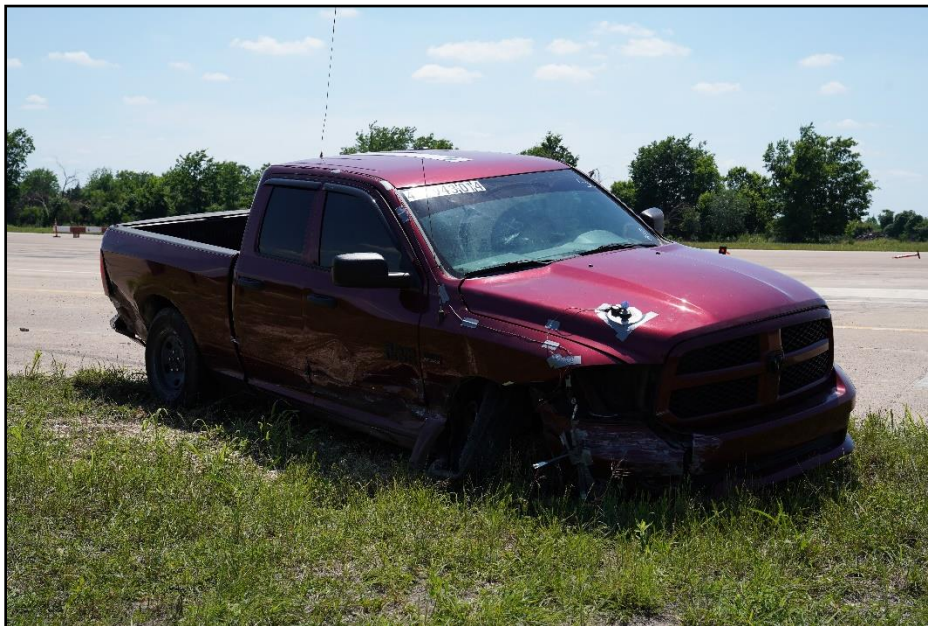
**Figure 19.7. Impact Side of Test Vehicle after Test 469943-01-4.**
