RESEARCH REPORT 0-1405-9

# CONCLUSIONS, RECOMMENDATIONS, AND DESIGN GUIDELINES FOR CORROSION PROTECTION OF POST-TENSIONED BRIDGES

R. M. Salas, A. J. Schokker, J. S. West, J. E. Breen, and M. E. Kreger

FEBRUARY 2004

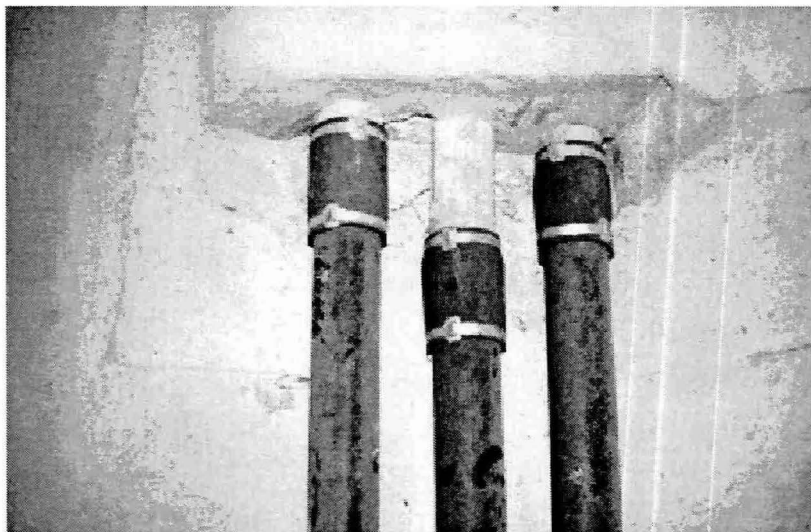
**Figure 2.5 Plan View of Slipped Tendon at Deviation Saddle – Niles Channel Bridge<sup>16</sup>**

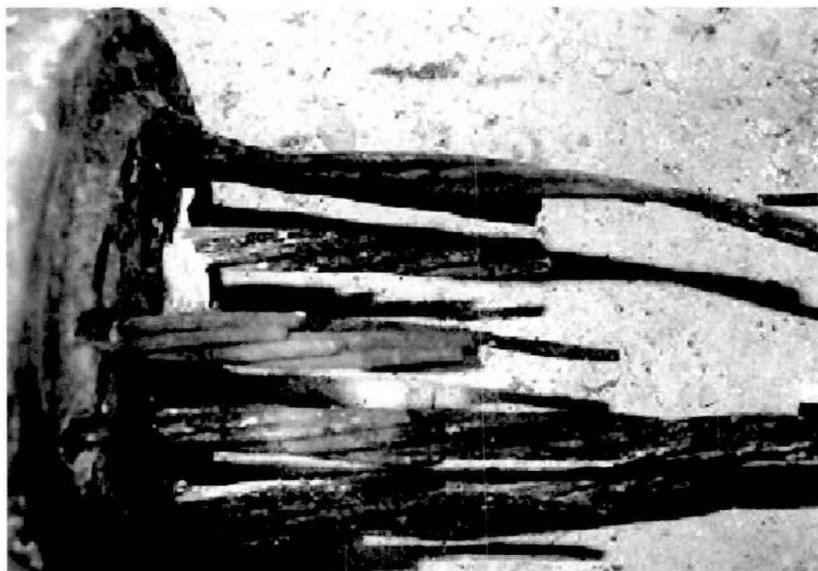
**Figure 2.6 Advanced Corrosion of Strands within Anchorage –  
Niles Channel Bridge<sup>16</sup>**

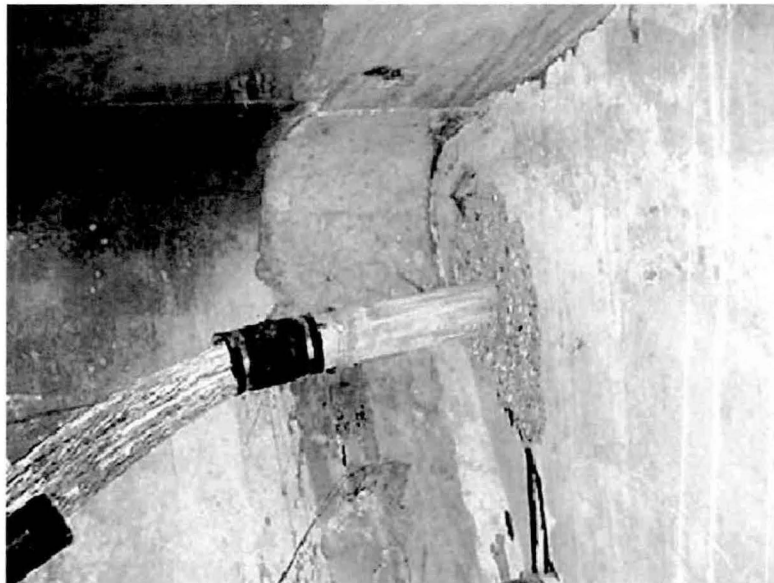
**Figure 2.9 Failure of Tendon 57-1 on the Mid-Bay Bridge  
at Expansion Joint Diaphragm<sup>16</sup>**

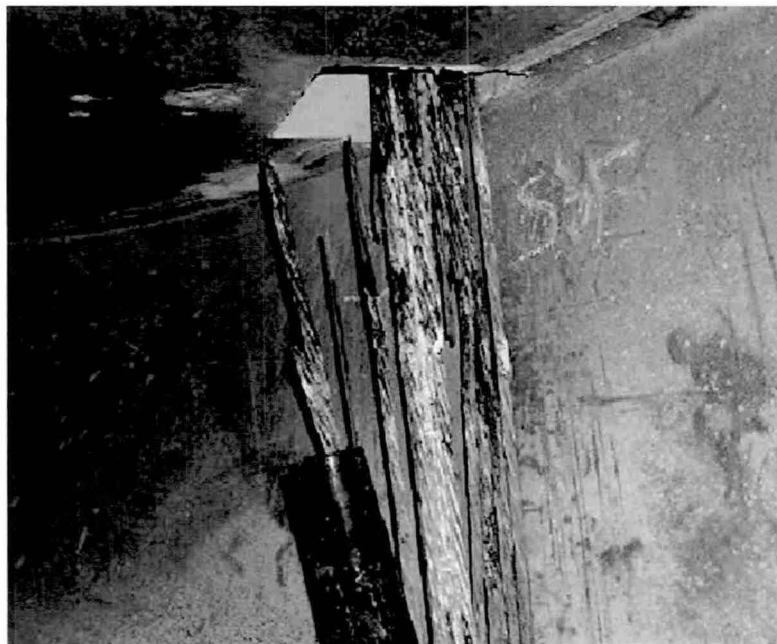
**Figure 2.11 Tendon Corrosion inside the Sunshine Skyway Bridge Piers (Refer to Figure 2.3)<sup>16</sup>**

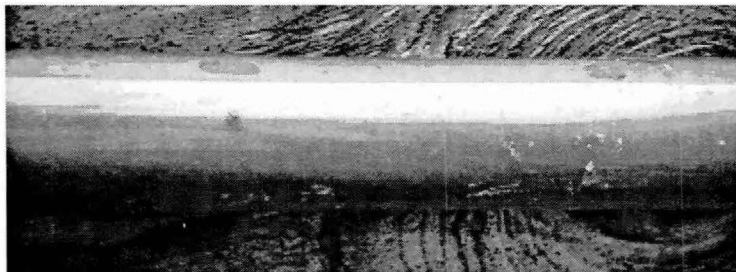
**Figure 3.5 TxDOT Grout – Bubbles Traveling Toward Intermediate Crest<sup>34</sup>**

Observation of grouts during pumping and setting (See Figures 3.5 and 3.6) as well as examination of slices cut from the large scale grouted ducts (See Figure 3.7) indicated:

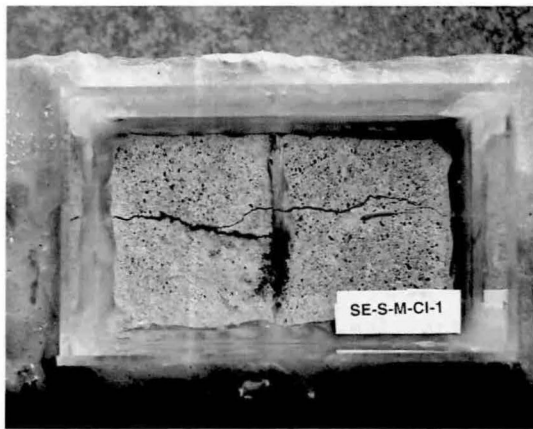
**Figure 3.12 Top View of the Effect of a Faulty Epoxy Joint (SE-S-M-CI-1)  
Compared to a Sound Epoxy Joint (SE-S-L-CI-1)**

- Superiority of plastic ducts was evident. Specimens with plastic duct had the best overall performance (quantified in terms of strand, mild steel and duct corrosion).
- All galvanized steel duct specimens showed some degree of duct corrosion, from moderate uniform corrosion up to severe duct destruction (see Fig. 3.11).
- Thin epoxy joints provided substantially improved corrosion protection when compared to dry joints. Incompletely filled epoxy joint performance was very similar to that of a dry joint (see Fig. 3.12).

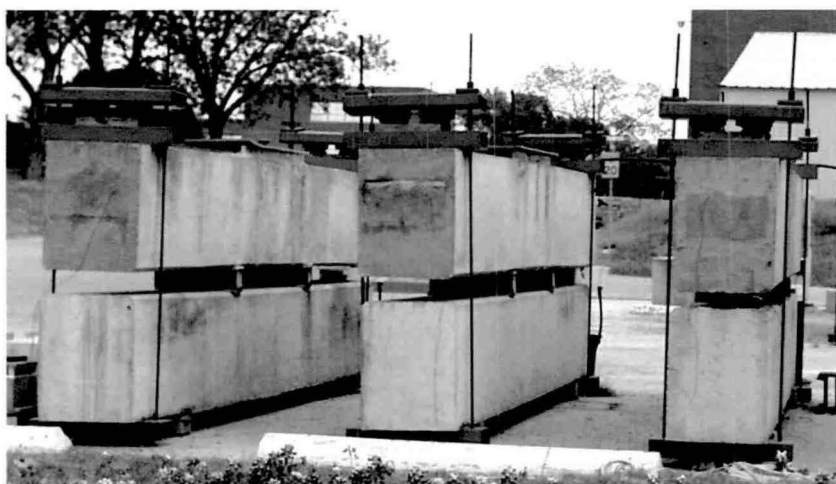
Figure 3.13 Beam Test Setup at North End of Ferguson Laboratory<sup>37</sup>

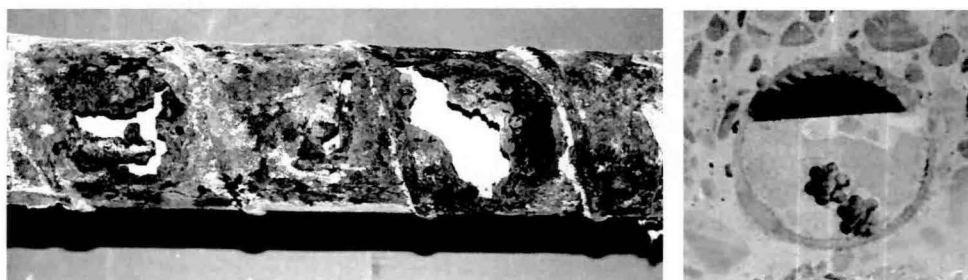
**Figure 3.16 Bleed Water Void and Duct Corrosion**

- Galvanized duct performed poorly. No plastic duct was used in the specimens of the first set of full autopsies.
- Bleed water voids were present in the ducts even after “good grouting procedures.” Anti-bleed grout was not evaluated in the first set of full autopsies, but it is included in one of the remaining specimens for future autopsy.
- Voids from bleed water in grout were shown to be very detrimental to the duct (see Fig 3.16).
