## Development of a Real-Time Transverse Pavement Profile Measurement System: Summary Report

This report discusses the results from Project 0-1782 between the Texas Department of Transportation and The University of Texas at Arlington, titled "Development of a Real-Time Transverse Pavement Profile Measurement System." The project was initiated to investigate the uses of scanning laser technology for measurement of rut that

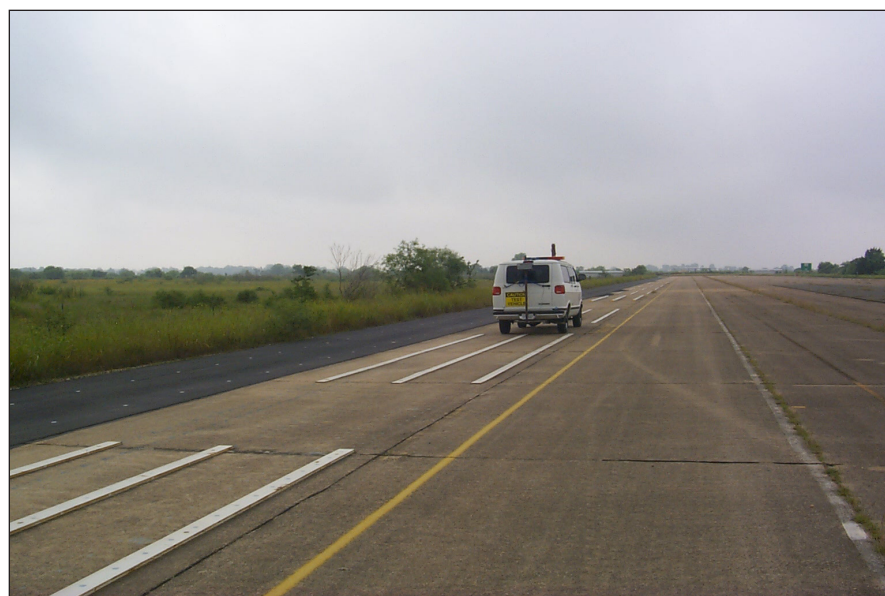
Figure 1 illustrates the laser scanning system (laser and housing shown on the back of the vehicle) being used at the Texas Transportation Institute (TTI) ride-rut facility at the Texas A&M Riverside Campus. Tests were also made on road sections in south Texas and around Austin.

Figure 1. Scanner on Vehicle at the TTI Ride-Rut Facility.

A number of data collection tests were performed to determine the capabilities of the system. TxDOT and project personnel devised a mounting procedure so the system could be placed on the back of the vehicle for high-speed measurements. Once all of the initial data acquisition and processing procedures were ready, the scanner was taken to a number of locations for field tests. These tests were instrumental

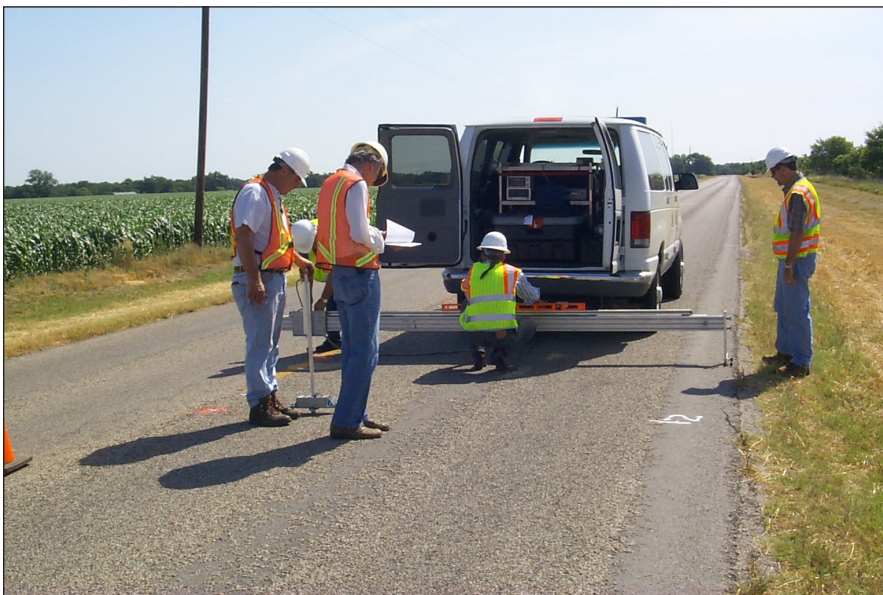
These measurements were all compared to those obtained from the scanning laser rut reports. The tests were conducted on the eastbound lane of FM 971 approximately 2 miles west of Granger. In Figure 2 the dip stick (foreground) and TMV profiler

(background) are shown during measurements on one of the Granger sections.

Figure 2. Dip Stick and TMV Profiler in Use at a Test Section near Granger, Texas.

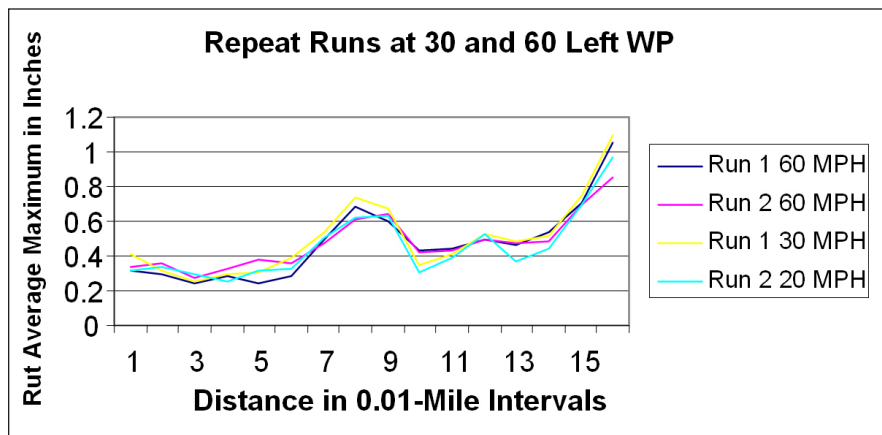
scanning laser rut measurement procedures) was applied to the set of profile points from both the TMV and dip stick. Figure 3 illustrates repeat rut measurements at 30 and 60 mph made every 0.01 mile by the Scanning Laser Rut Measurement System over all four test sites.

Figure 3. Plots of Left Wheel Path (WP) Rut Measurements Using Scanning Laser System.

For the tests near Granger, the scanning laser processing procedures were used on the raw scanned data to compute rut for both the left and right wheel paths. To compare these readings with the other devices, the string line algorithm (used in the
