1. Report No. FHWA/TX-04/0-4475-1		2. Government Accession No.		3. Recipient's Catalog No.	
4. Title and Subtitle EVALUATION OF DYNAMIC SPEED DISPLAY SIGNS (DSDS)				5. Report Date September 2003

EVALUATION OF DYNAMIC SPEED DISPLAY SIGNS (DSDS)

Report 0-4475-1
Project Number 0-4475
Research Project Title: Effectiveness of Dynamic Speed Display Signs (DSDS)

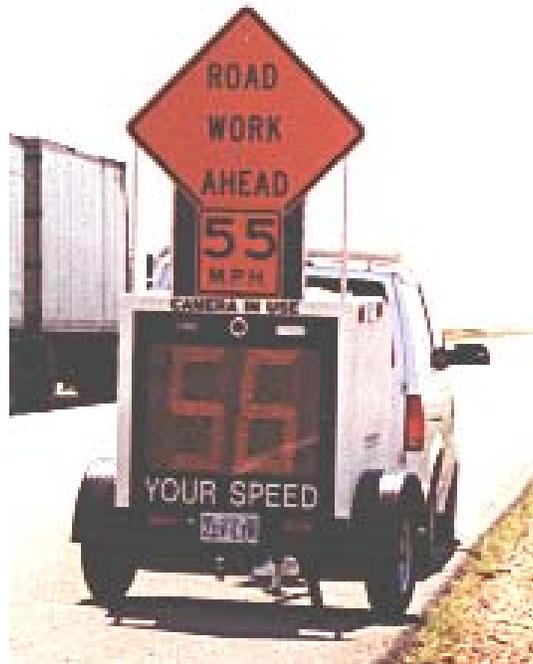
Eventually, CMS and speed detection technology were further simplified together to provide drivers an indication of their current speed as a DSDS. These first DSDS were combined into self-contained portable trailer units and deployed in residential neighborhoods as part of speed control programs (4). The success experienced in these applications led transportation agencies to consider their use in work zone locations as well. [Figure 1](#) illustrates a typical system used in some Texas work zones.

Figure 1. Example of a Portable Dynamic Speed Display System for Work Zones.

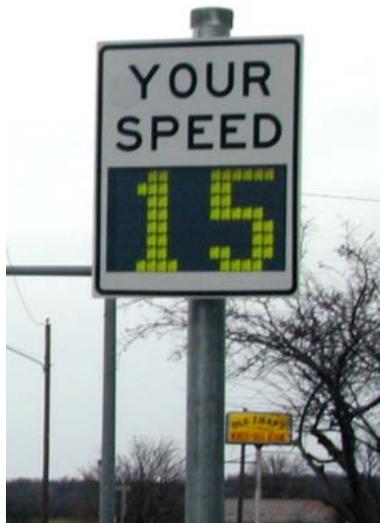
The DSDS utilized for this research project was a fairly recent off-the-shelf product that a vendor offered to loan to TxDOT for evaluation purposes. This particular device combines a black-on-white rectangular sign with a “YOUR SPEED” message over two light-emitting diode (LED)/flip-disk (with strong yellow-green reflective sheeting attached to the flip disks) CMS characters (see [Figure 2](#)). The LED pixels outline the character and provide adequate visibility at night. The sign houses a K-band radar antenna aimed at approaching vehicles. As a speed is detected, the CMS characters switch and display that speed to the approaching motorist. If no vehicle is detected, the DSDS returns to a no-display status (the characters show no speed). The CMS characters approximate the size of numerals on a regulatory speed limit sign (i.e., at least 10 inches on a 24 by 36 inch sign; at least 16 inches on a 36 by 48 inch sign). Sizes of the DSDS units utilized depended on the appropriate size of regulatory speed limit signs required at each of the study sites.

Figure 2. Example of a Permanently Installed Self-Contained DSDS Unit.

The radar antenna was calibrated to detect vehicles up to 500 feet in advance of the DSDS. The radar signal broadcasts in a 12-degree cone perpendicular to the face of the sign. The vendor literature for the DSDS indicated that the sign was capable of displaying characters between 5 and 99 mph, although thresholds could be set to limit how large a speed indication the sign would allow (to avoid motorists attempting to “max out” the speed indication). It should be noted, however, that TTI researchers did see instances where the sign displayed “00” for short periods of time. These indications appeared to occur when traffic volumes were fairly high, suggesting that the radar signal logic may have been confused by a large numbers of vehicles within the detection zone at one time.

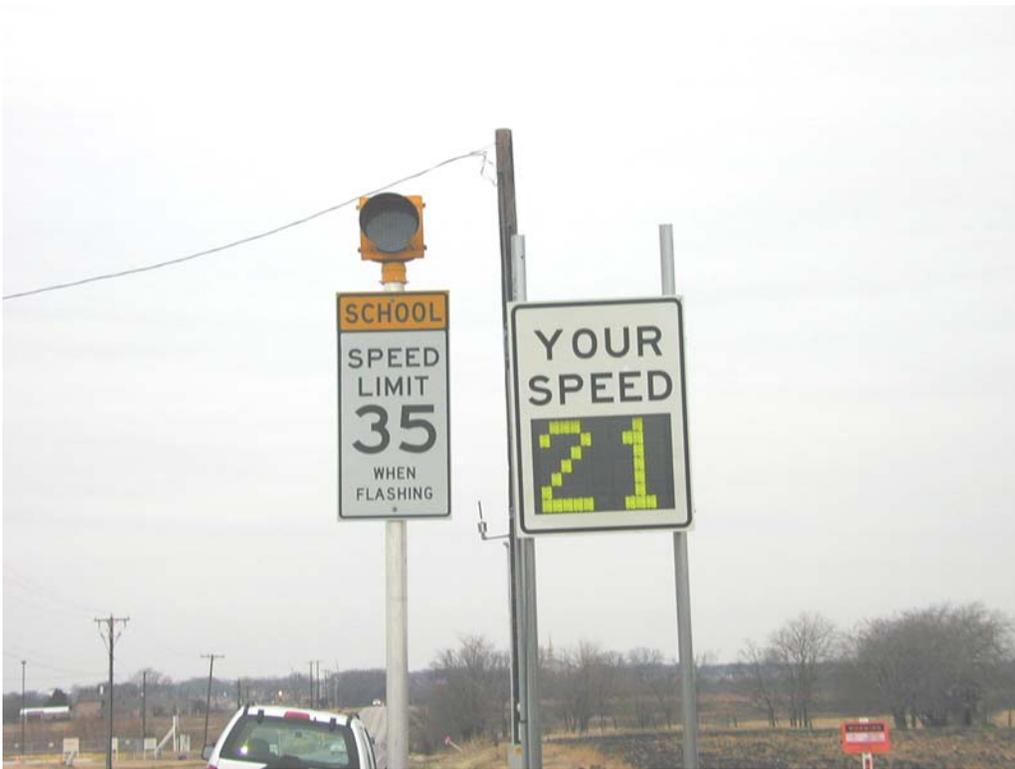
Dynamic speed display signs (DSDS), also termed driver feedback signs or speed display signs, measure the speed of an approaching vehicle and present that speed back to the motorist. Typically, a “your speed” or similar type of message is presented above or before the speed numbers. [Figure B-1](#) depicts a common type of DSDS.

Figure B-1. A Typical DSDS Installation.
