# Thermal Segregation Influence on Current Asphalt Mixtures

Technical Report 0-7075-R1

TEXAS A&M TRANSPORTATION INSTITUTE  
COLLEGE STATION, TEXAS

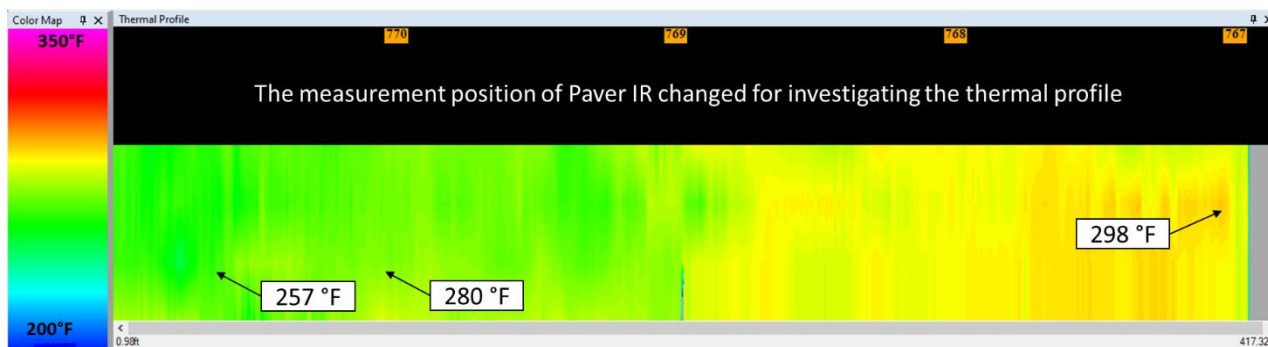
**Figure 72. SH 105 Thermal Profile.**

Thermal profile data were collected from STA 771+00 to STA 766+83 for this demonstration project. At that point, the plant broke down, and operations were suspended. Figure 72 shows the thermal plot and illustrates minimal thermal variations.

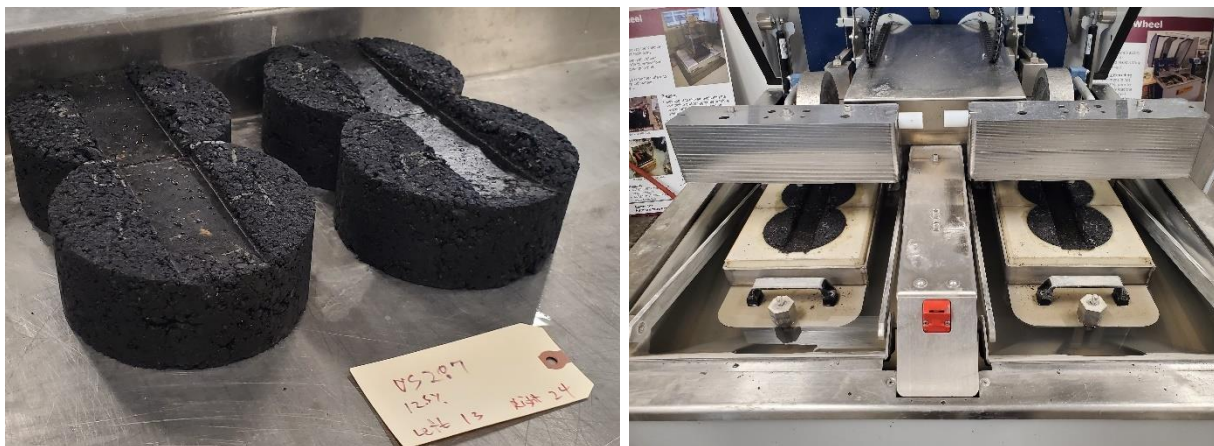
**Figure 77. Example Hamburg Test (Tex-242-F).**

The Hamburg wheel tracking test (Tex-242-F) determines the premature failure susceptibility of bituminous mixtures due to weakness in the aggregate structure, inadequate binder stiffness, moisture damage, and other factors, including inadequate adhesion between the asphalt binder and aggregate. Researchers followed the preparation guidelines outlined in Tex-241-F for each Hamburg test specimen. However, a modification was made on the density of the specimens. The specimens were intentionally prepared to have low, medium, and high AV contents, as specified in Table 34. Researchers performed the Hamburg test in duplicate for each mix/AV combination. Figure 77 shows example specimens after this wheel track test.

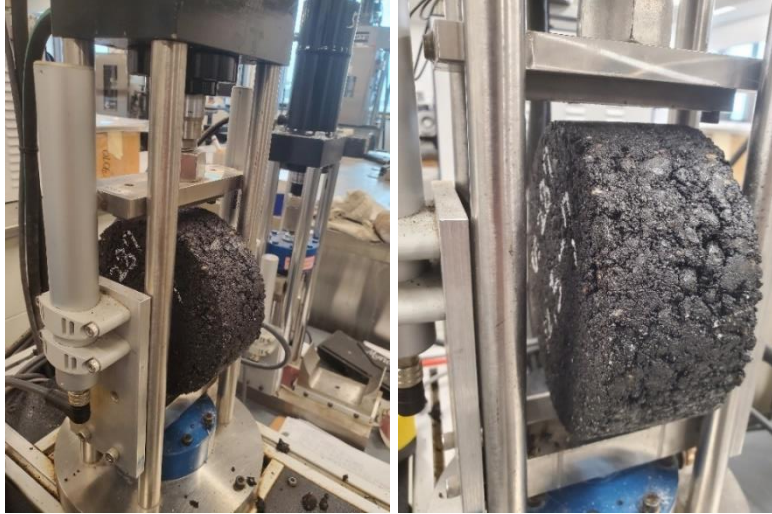
**Figure 79. Example IDEAL-CT Test.**

The IDEAL-CT, Tex-250-F, determines the cracking tolerance index of compacted bituminous mixtures. Researchers prepared three laboratory specimens for each target AV on the mixes from US 69, US 287, US 183, SH 6, and SH 105. For lab-molded specimens, Tex-250-F requires a specimen diameter of 5.9 in. (150 mm) and a height of 2.4 in. (62 mm)  $\pm$  0.1 in. (2 mm), as well as an AV content of  $7 \pm 0.5$  percent. Thus, the different AV contents used in this lab program represent a deviation from the underlying parameters in the development of the IDEAL-CT. Figure 79 shows the test in progress.

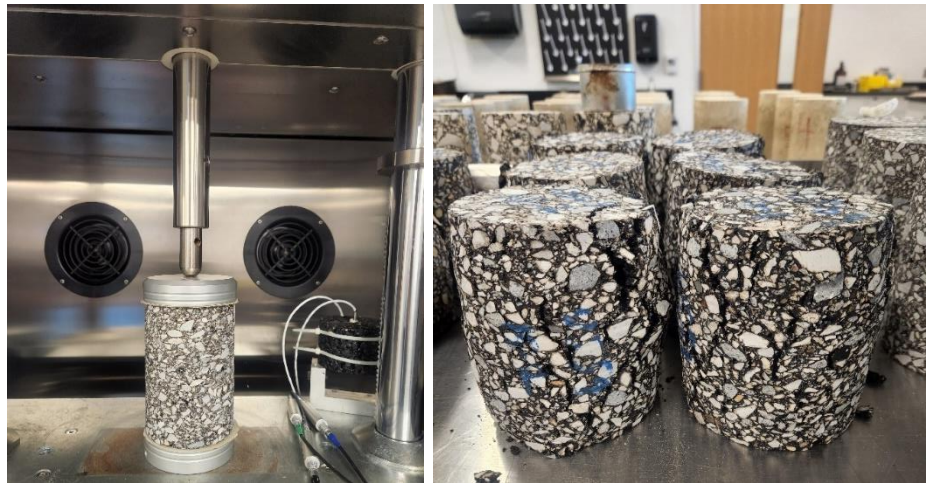
**Figure 84. FN Test (Left) and Specimens after Testing (Right).**

Researchers followed the guidelines specified in AASHTO T378-17 by using a deviator stress of 600 kPa and a contact stress of 30 kPa. The test was set to terminate at either 10,000 loading cycles or an accumulated 100,000 microstrains, whichever occurred first. For selecting the test temperature, researchers referred to the High Adjusted PG Temperature from LTPP Bind Version 3.1 and chose the climate data from the weather station nearest to the project location. As a result, test temperatures of 154.76, 155.84, and 154.4°F were assigned to the mixes from US 69, US 287, and US 183, respectively. Figure 84 shows the FN test in progress and examples of tested specimens after completion.

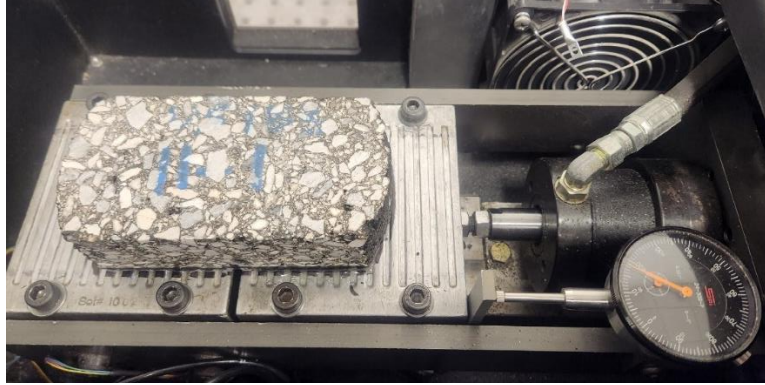
**Figure 88. Overlay Test.**

Tex-248-F: Test Procedure for Overlay Test (OT) and its modified version are employed to evaluate the crack resistance of asphalt mixtures, as shown in Figure 88. In the OT, the specimen is glued on two plates; one plate is fixed, and the other moves horizontally. From repeatedly moving horizontally, a vertical crack will develop in the specimen and propagate from bottom to top.
