# Traffic Control Device Analysis, Testing, and Evaluation Program: FY2023 Activities

Technical Report 0-7096-R3

TEXAS A&M TRANSPORTATION INSTITUTE  
COLLEGE STATION, TEXAS

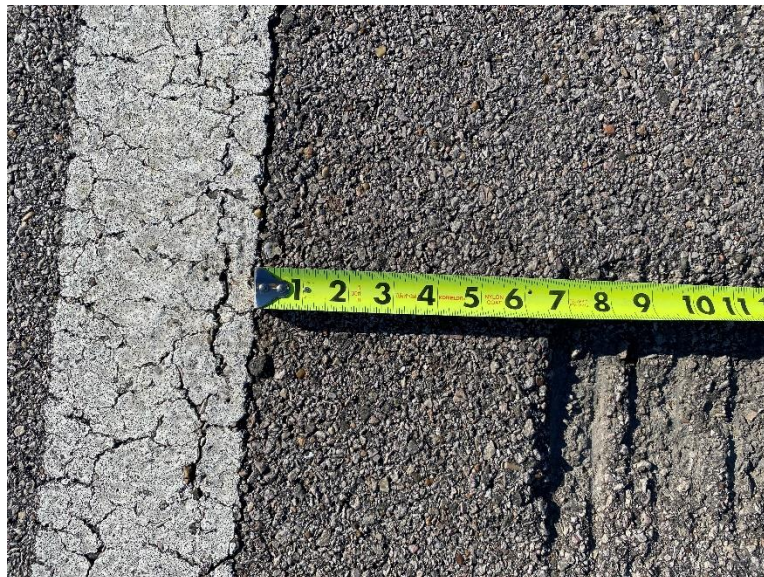
**Figure 2. Location of Rumble Strips in Before Condition.**

Researchers collected video footage for the before condition (i.e., rumble strips near the right edgeline) on January 29–31, 2020 (see Figure 2) and the after condition (i.e., rumble strips in the center of the right shoulder) on July 13–15, 2020 (see Figure 3). Each time period included approximately 24 hours of footage at each site in daytime, clear-weather conditions. The rumble strips were moved in June 2020.

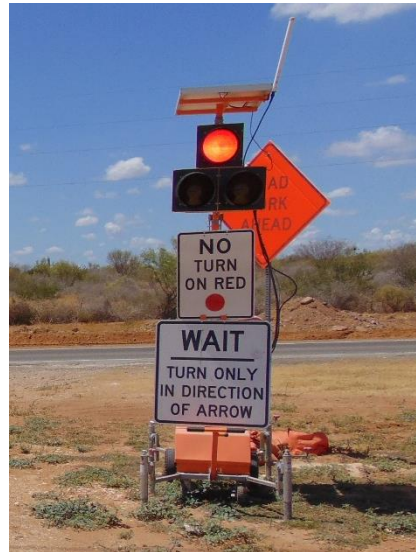
**Figure 10. DAD Design.**

In August 2022, TTI researchers documented and evaluated the use of DADs on a construction project in La Salle County. The project (CSJ 1545-02-023) consisted of the rehabilitation of FM 468 from the Dimmit County line to 0.28 mi west of FM 469 (see Figure 9). TxDOT used the three-section doghouse DAD design for this project (see Figure 10). The second supplemental sign was slightly different than the current design shown in Figure 7 (i.e., does not include FLASHING YELLOW) because the standard design at the time the project began used a TURN ONLY IN DIRECTION OF ARROW sign with the three-section doghouse DAD.

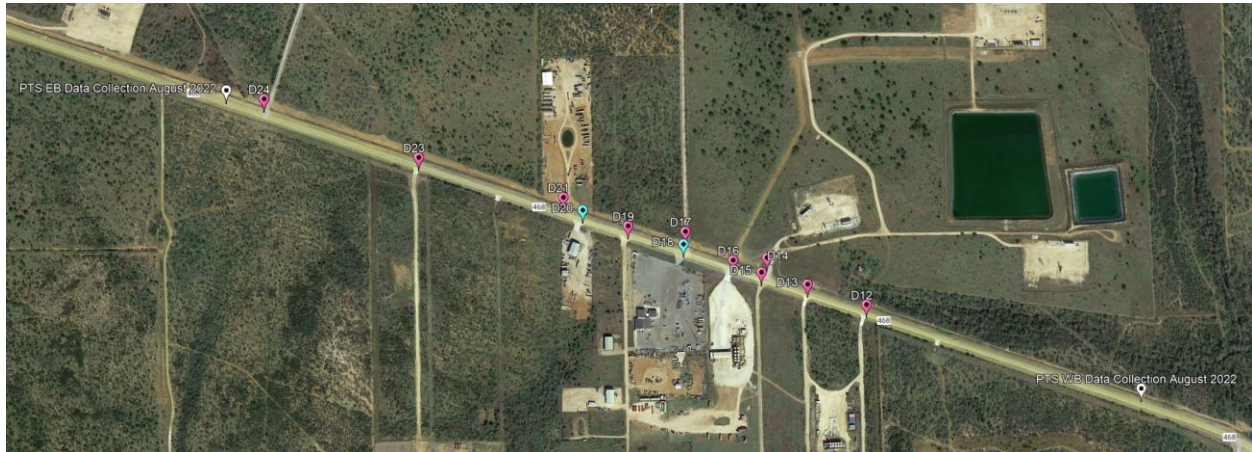
**Figure 11. FM 468 August 2022 Entire One-Lane Study Section.**

Figure 11 shows the section of roadway under construction in August 2022. The one lane section was approximately 1.4 mi long. DADs were used at 12 locations (see pink pins with circles and aqua pins with diamonds in Figure 11). On August 9–11, 2022, TTI researchers observed traffic

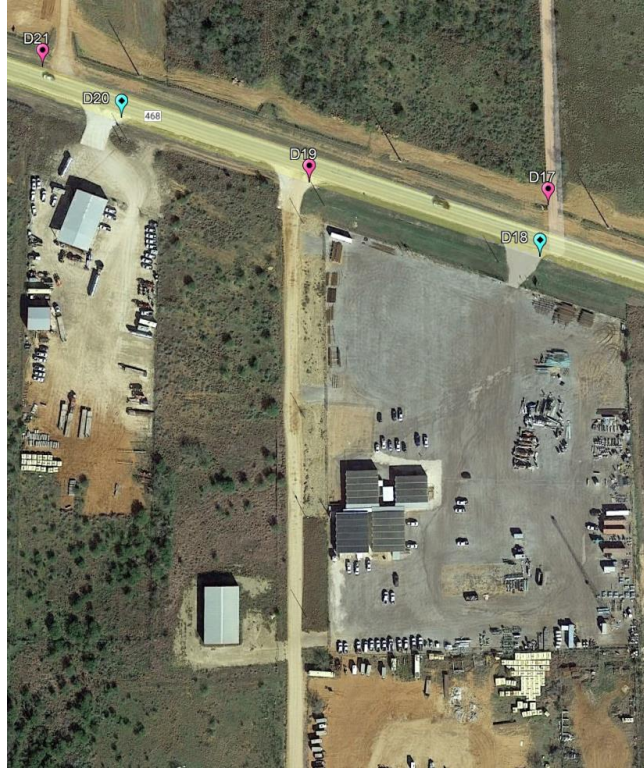
**Figure 12. FM 468 August 2022 One-Lane Section near Driveways 18 and 20.**

approaching FM 468 from driveway 18, which served a petroleum industry business (see Figure 12 and Figure 13). Driveway 18 was in the middle of the one-lane section (i.e., approximately 3600 ft from both PTSs). Data collection began around 11:50 p.m. on Tuesday and ended around 12:30 p.m. on Thursday.

On August 16–18, 2022, TTI researchers observed traffic approaching FM 468 from driveway 20, which served an equipment rental business (see Figure 12 and Figure 14). Driveway 20 was closer to the west end of the one-lane section (i.e., approximately 2800 ft from the PTS controlling the eastbound traffic). Data collection began around noon on Tuesday and ended around 12:30 p.m. on Thursday.

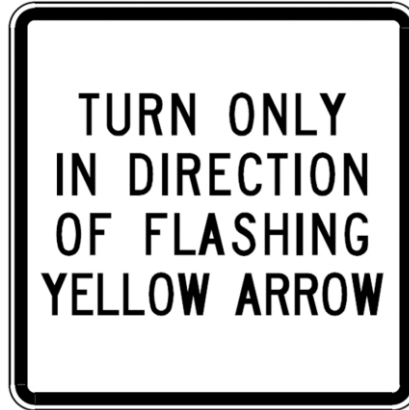
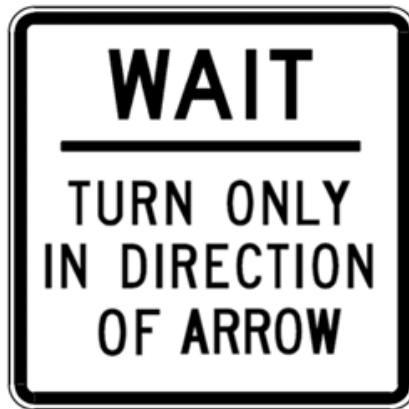
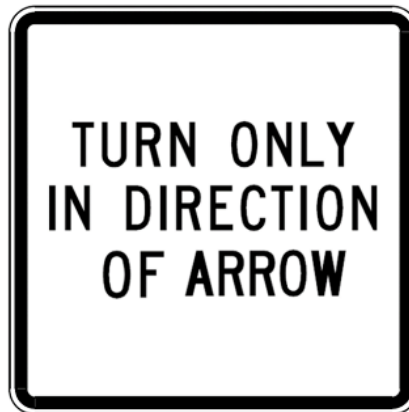
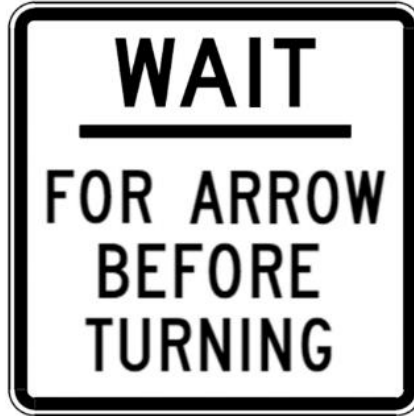
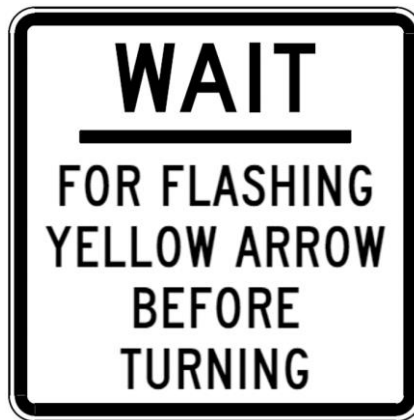
Figure 15 through Figure 20 contain the second supplemental signs studied. Treatment 1 is the sign currently used by TxDOT. Treatment 2 is the same message as Treatment 1 but without WAIT. TxDOT previously used Treatment 2 with the three-section doghouse DAD. Treatment 3 is the same message as Treatment 1 but without FLASHING YELLOW. Treatment 4 is the same message as Treatment 1 but without WAIT and FLASHING YELLOW. Treatment 5 is another sign that was recommended by Gates et al. (4). Treatment 6 is the same message as Treatment 5 but with FLASHING YELLOW added. Researchers tested treatments 1 through 6 with the three-section doghouse DAD to compare motorist understanding of these signs with and without WAIT and with and without FLASHING YELLOW. Researchers tested treatments 1, 2, and 6 with the four-section stacked DAD to compare motorist understanding with the three-section doghouse DAD.

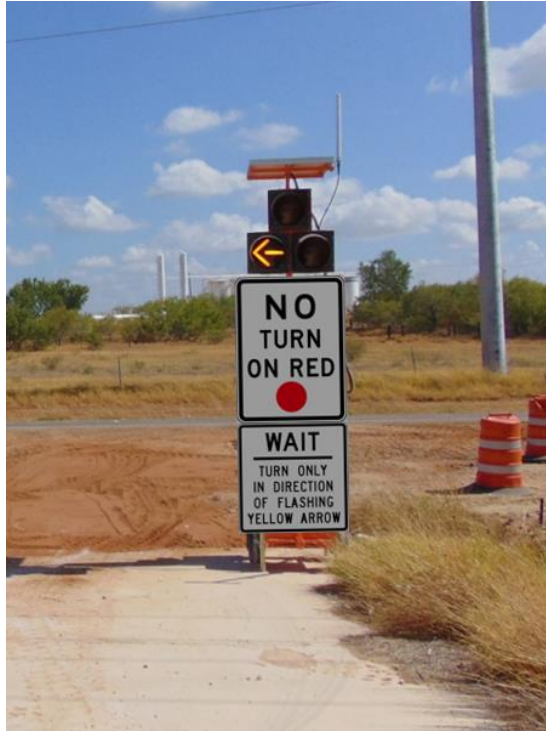
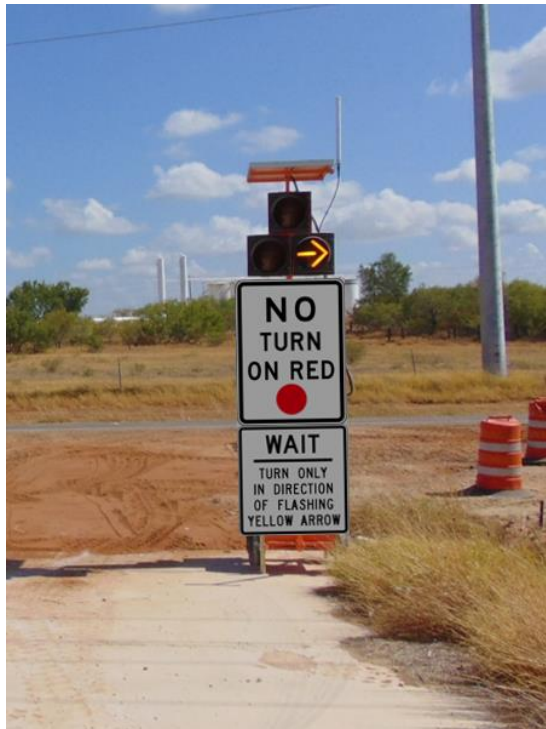
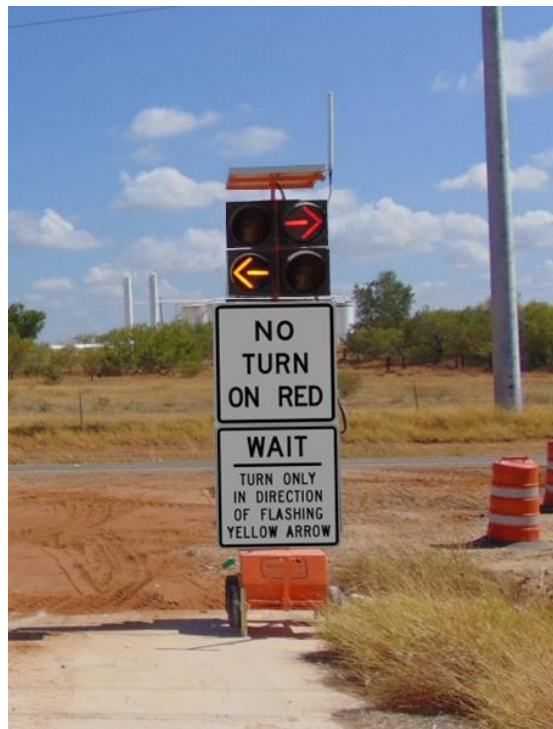
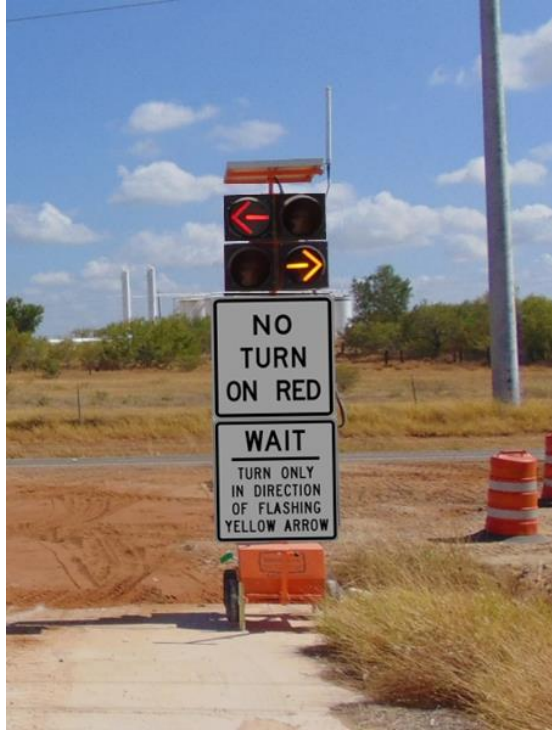
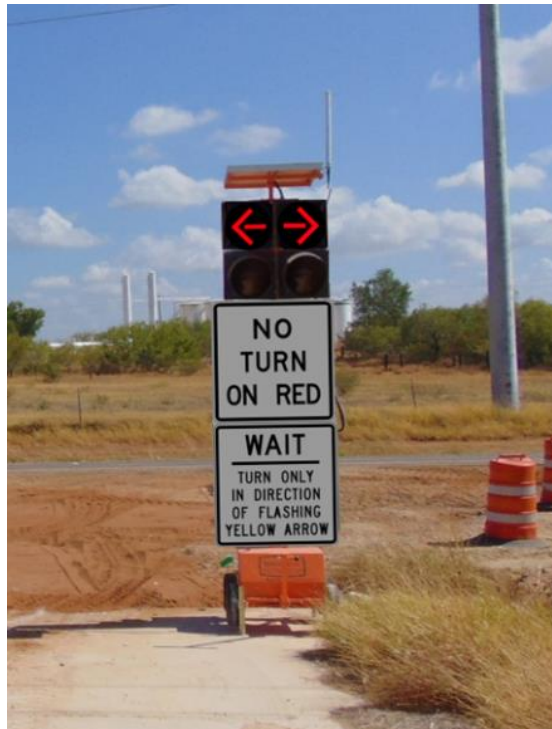
Researchers used graphics editing software to create scene view images for each desired top and bottom sign combination. Then researchers developed graphics interchange format (GIF) files to create various flashing lens indications for both DAD designs. Researchers overlaid the GIF files on the scene view images to create the displays used in the online survey. The Treatment 1 displays are shown in Figure 21 through Figure 26.

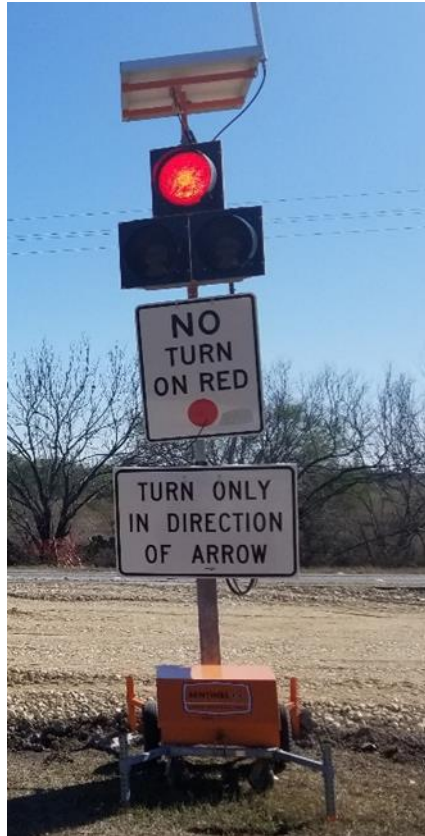
**Figure 28. Example of Recommended DAD Design.**

Based on the field study findings analyzed to date (i.e., those documented herein and those in prior reports [3]), researchers recommend the use of the three-section doghouse DAD with a NO TURN ON RED sign (R10-11) and TURN ONLY IN DIRECTION OF ARROW sign. An example of the recommended DAD design is shown in Figure 28.
