# Using Surface Geometry to Identify Potential Hydroplaning Locations

Technical Report 0-7098-R1

Project Title: Determine Drainage Basin Mapping and Estimation of Hydroplaning Potential

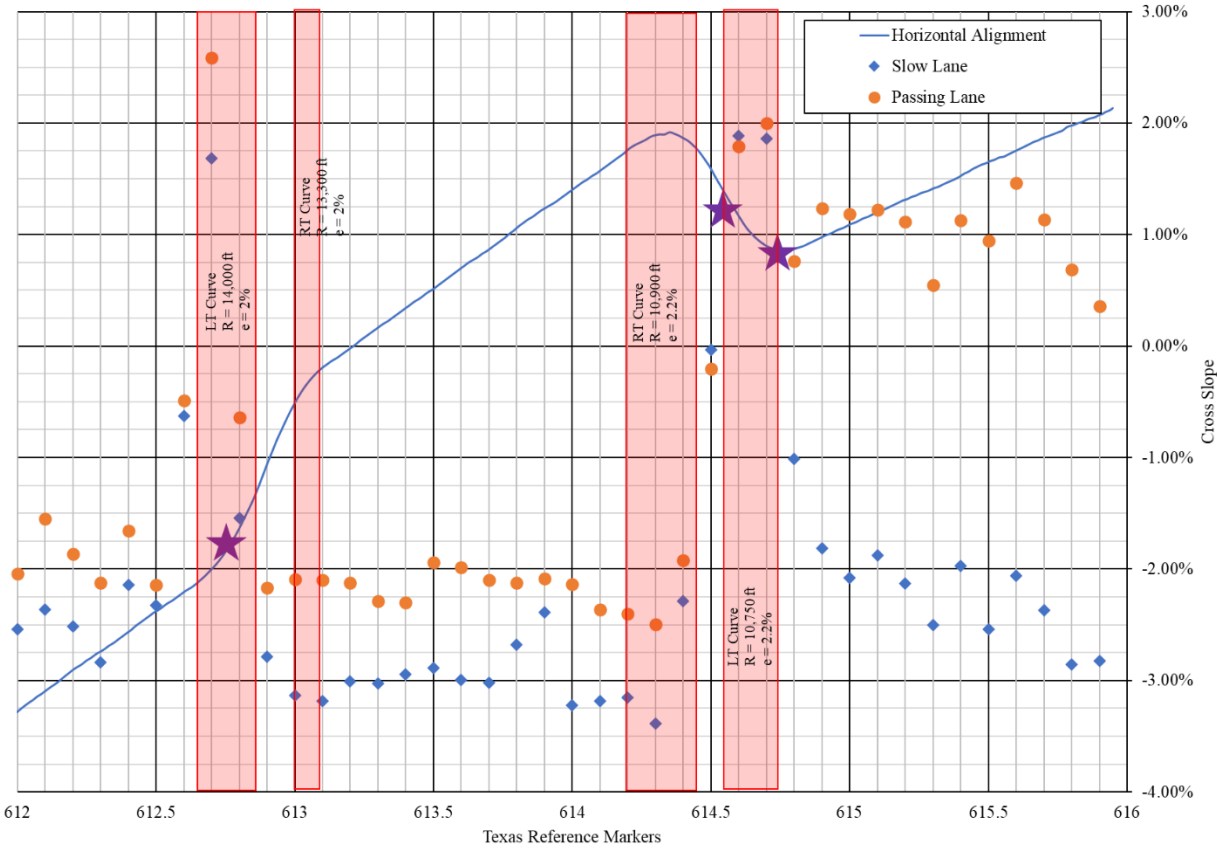
Eastbound Section 4 (TRM 612 to TRM 616) Horizontal Alignment and Cross Slopes

**Figure 2. Example Chart for Horizontal Alignment and Cross Slopes.**

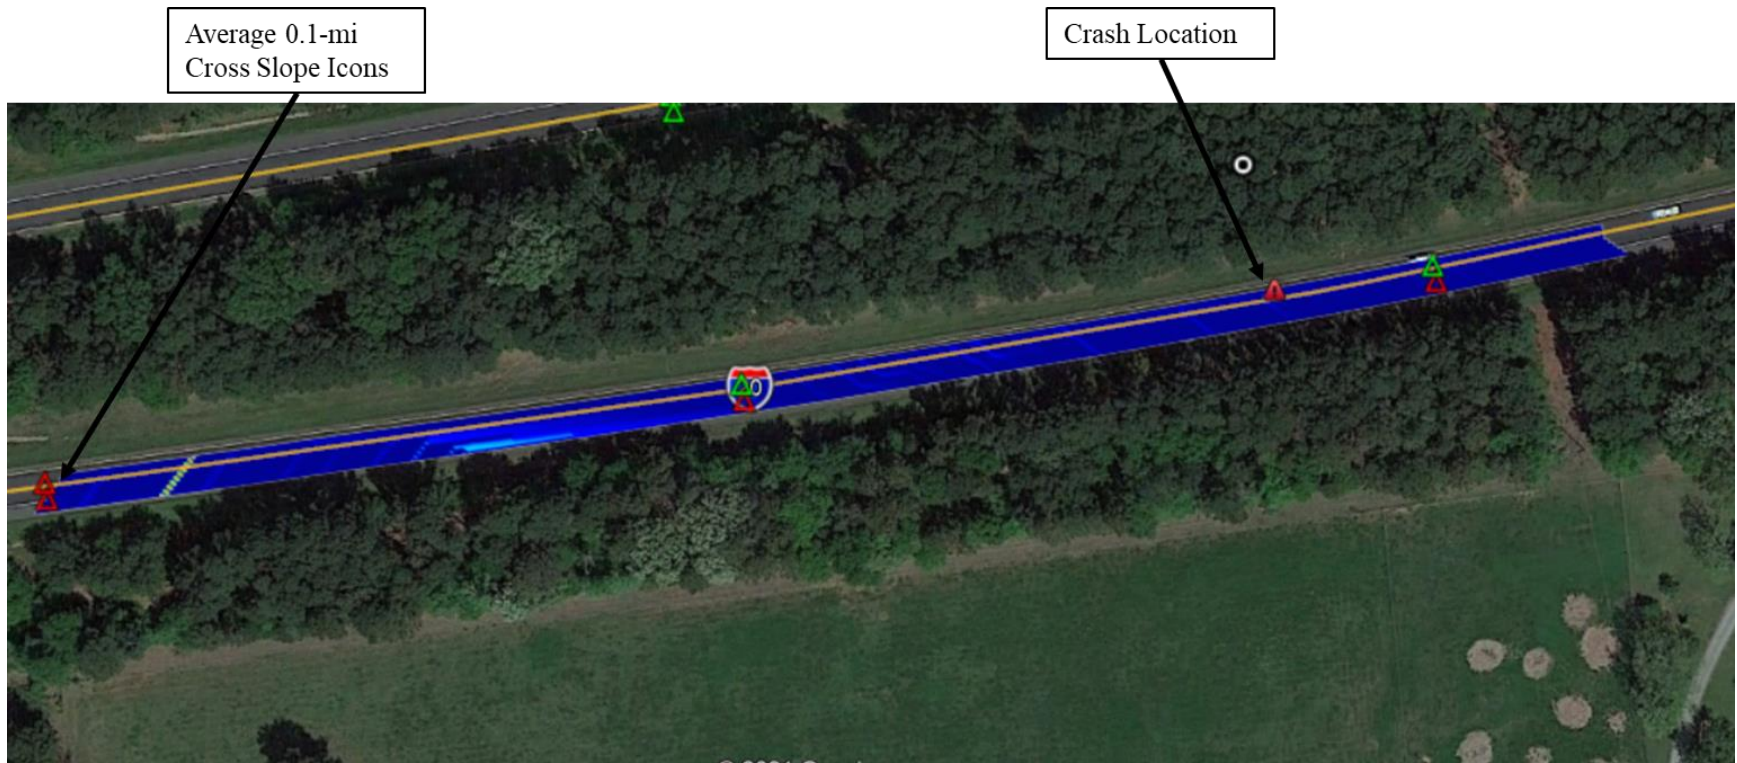
**Figure 4. Zoomed Google Earth Location of Vulnerable Area.**

Figure 3 through Figure 7 show examples of the visualization within Google Earth. Figure 3 shows the Google Earth window created when opening the .kmz file. Figure 4 is created in Google Earth by double-clicking on one of the vulnerable areas on the right side of Figure 3. Figure 4 provides a better view of the data visualized within the .kmz file. All icons in Figure 4 have additional information attached. Additional information can be displayed for each of these icons by clicking them within Google Earth. Figure 5 shows the additional data for cross-slope information obtained by clicking on a triangle, while Figure 6 shows crash record information obtained by clicking on the triangled exclamation mark. Finally, Figure 7 shows the pop-up window created in Google Earth by double-clicking on a vulnerable area. The table within Figure 7 provides additional information on the drainage basin.

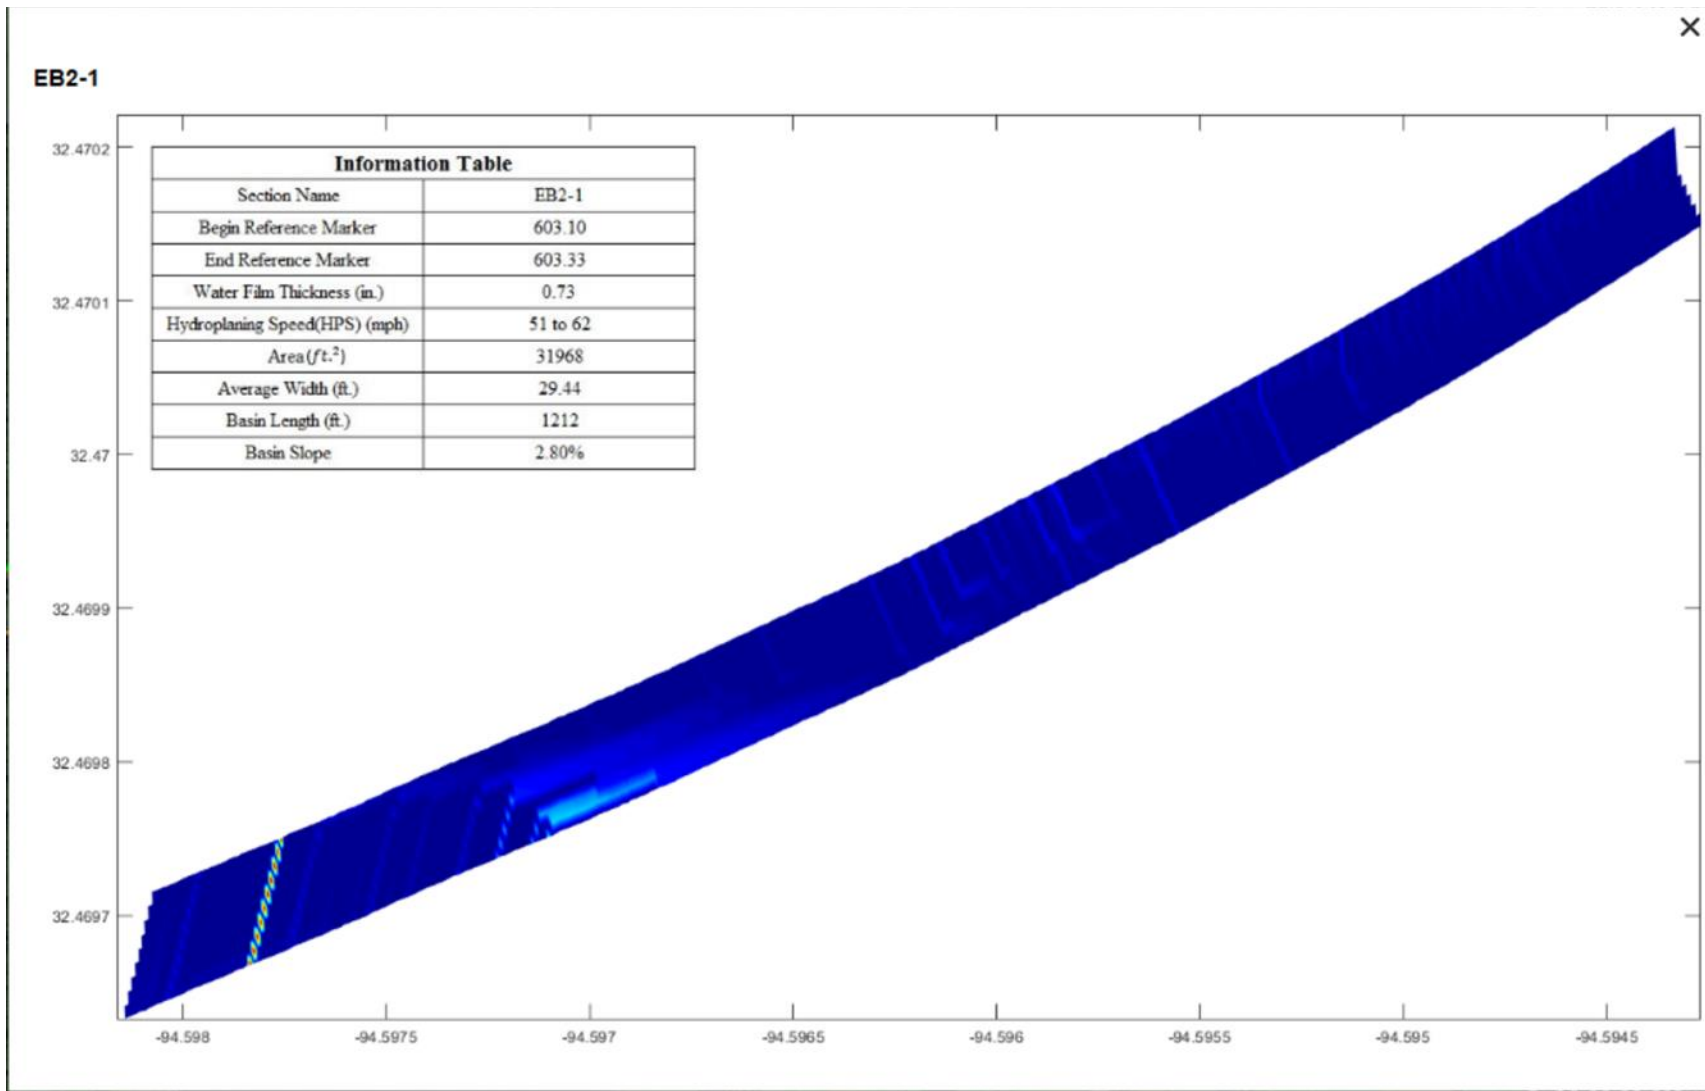
**Figure 7. Pop-Up Window in Google Earth with Vulnerable Basin Information.**

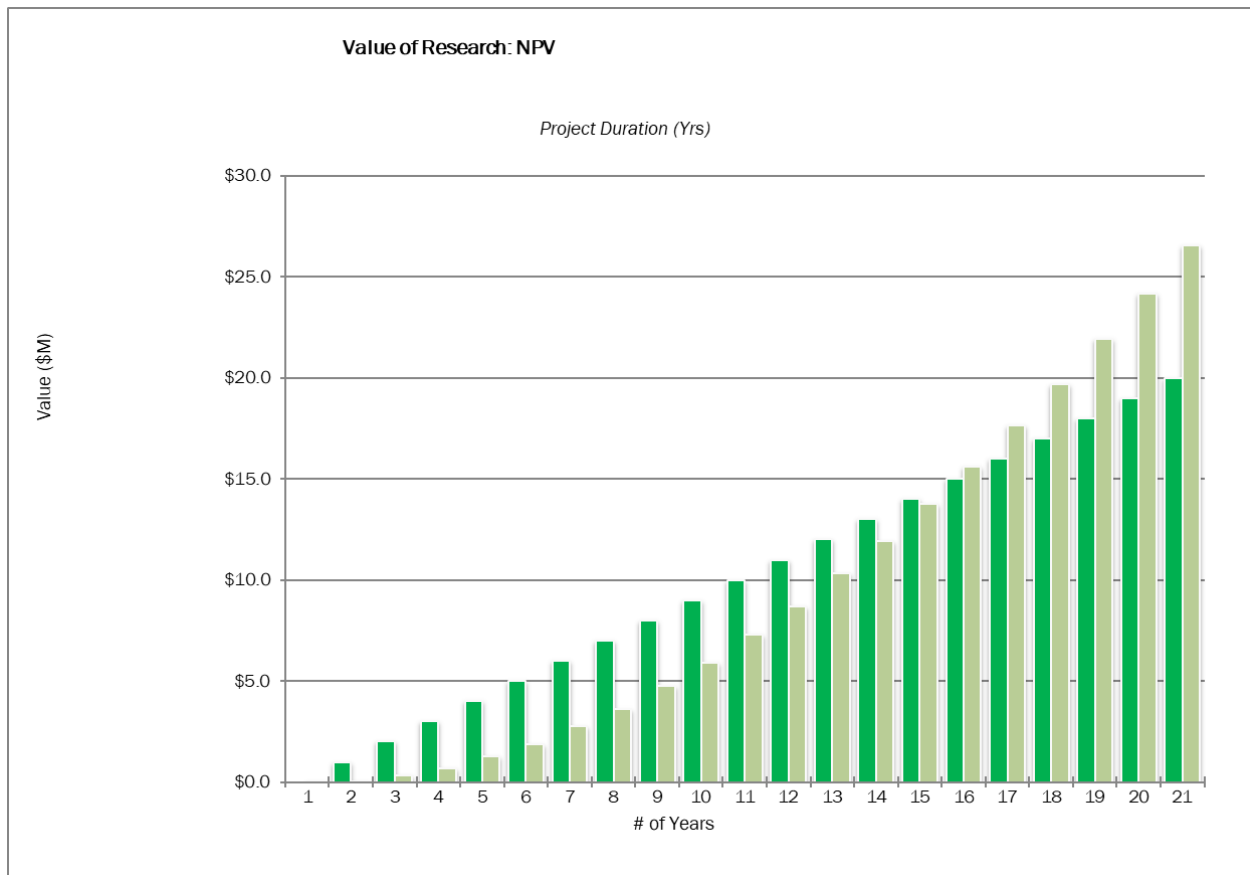
**Figure 1. Value of Research**

Using these assumptions, over a 20-year analysis period, 10 districts begin using the tool. Only two districts have reached complete effectiveness with the tool, essentially reducing their wet weather crashes by 15%. In Year 20, these assumptions result in the elimination of 310 wet weather crashes. That alone totals over \$3 million in 2018 dollars.

These assumptions result in a **cost benefit ratio (CBR) of \$1:\$26**. Even with conservative estimates on the number of wet weather crashes the tool will mitigate, the large monetary value associated with crashes creates a large CBR. Figure 1 graphs these results. These results are also provided in the VOR spreadsheet.
