# Traffic Control Device Analysis, Testing, and Evaluation Program: FY 2024 Activities

Technical Report 0-7198-R1

TEXAS A&M TRANSPORTATION INSTITUTE  
COLLEGE STATION, TEXAS

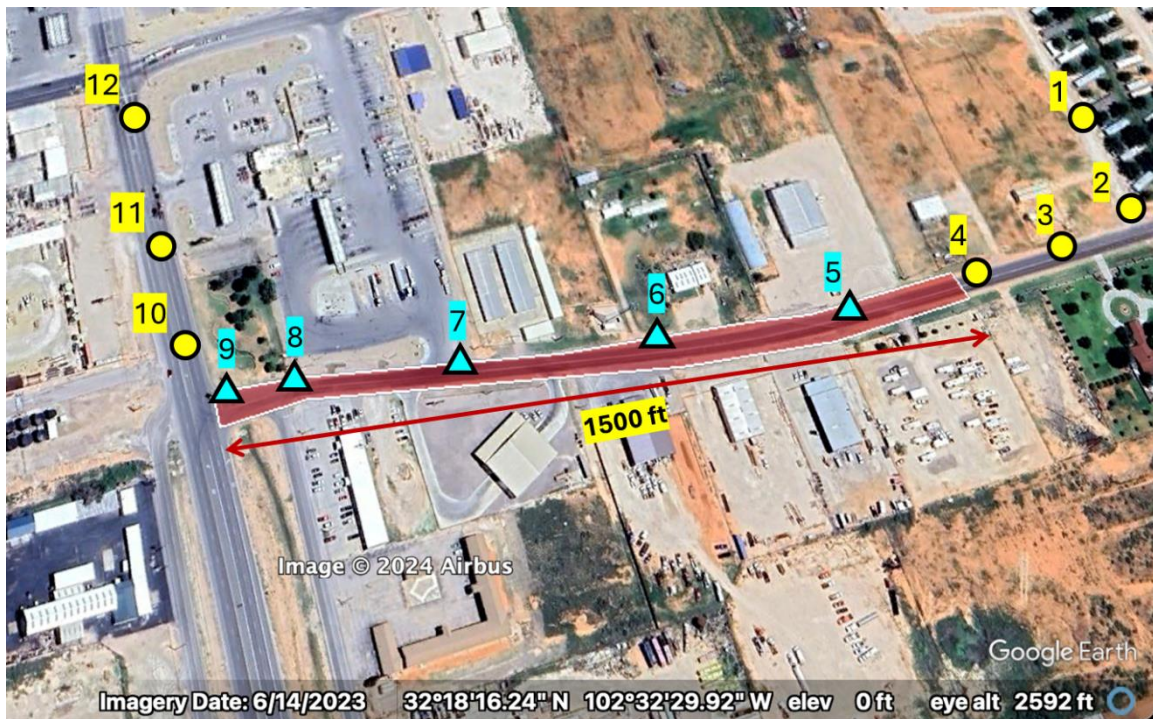
Figure 19. Data Points Selection (Subsetting) along a Trace at Site R-Bea-ODA-AND-005.
