Traffic Control Device Analysis, Testing, and Evaluation Program: FY 2025 Activities

Technical Report 0-7198-R2

TEXAS A&M TRANSPORTATION INSTITUTE
COLLEGE STATION, TEXAS

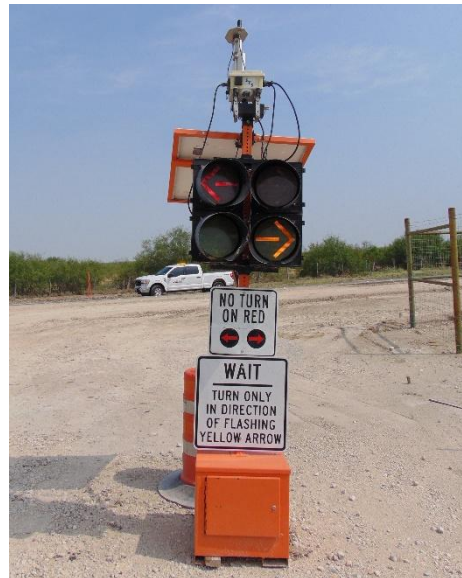
Figure 1. Four-Section Stacked DAD Deployed on FM 2688 at D9.

design for this project was the four-head stacked DAD, which included two 12-inch steady red arrow indications and two 12-inch flashing yellow indications. The steady red arrows indicated which direction a driver could not turn, while the flashing yellow arrows indicated which direction a driver could turn. During the all-red phase, both steady red arrows were illuminated. Since the four-section stacked DAD displayed steady red arrow indications, a modified R10-11 sign was included with a second supplemental sign (WAIT TURN ONLY IN DIRECTION OF FLASHING YELLOW ARROW) (see Figure 1).

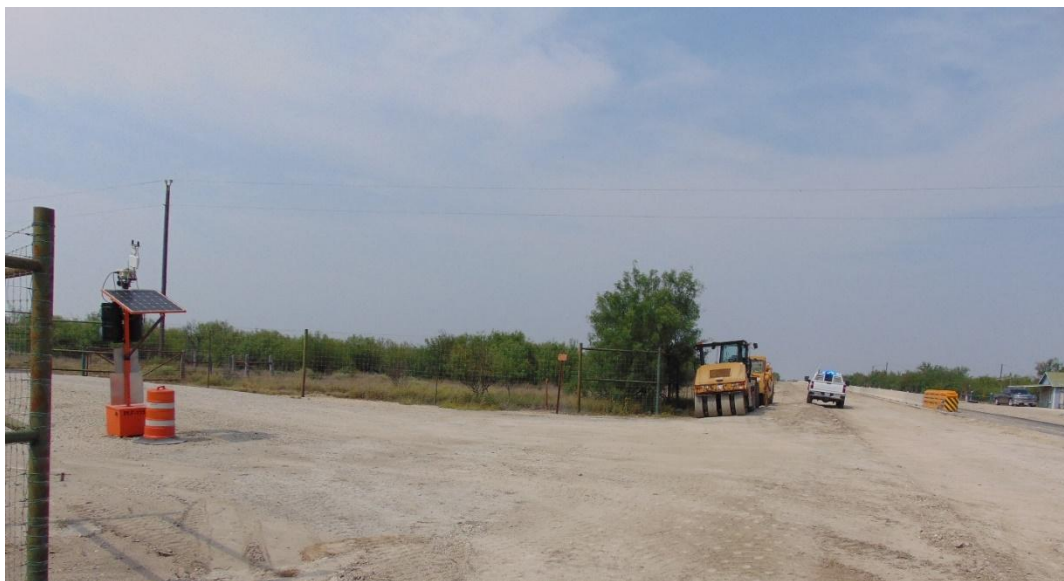
Figure 3. DAD at D9 Looking Westbound.

On June 4–6, 2024, TTI researchers observed traffic approaching FM 2688 from D9. The driveway was located approximately 0.3 miles from the westbound PTS and approximately 1.4 miles from the eastbound PTS. Although D9 was located near the westbound PTS, drivers approaching FM 2866 from D9 could not see the westbound PTS. At D9, the DAD was located on the nearside of the intersection, and construction was occurring in the eastbound lane (see Figure 3). Data collection began at 11:06 a.m. on Tuesday and ended at 10:05 a.m. on Thursday.

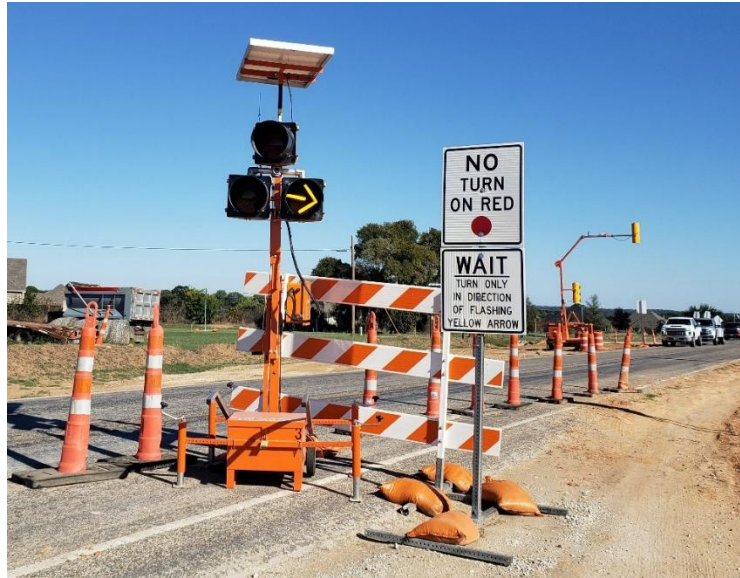
Figure 4. Three-Section Doghouse DAD Deployed on FM 730 at D18.

Project 15 involved the rehabilitation of existing sections of FM 730 in Wise County from SH 114 in Boyd, Texas, to just south of the intersection of FM 730 with CR 4384 (approximately 3.5 miles). The DAD design for this project was the three-section doghouse design, which includes two 12-inch flashing yellow indications, a single 12-inch solid red indication, a R10-11a sign, and a second supplemental sign (WAIT TURN ONLY IN DIRECTION OF FLASHING YELLOW ARROW) (see Figure 4).

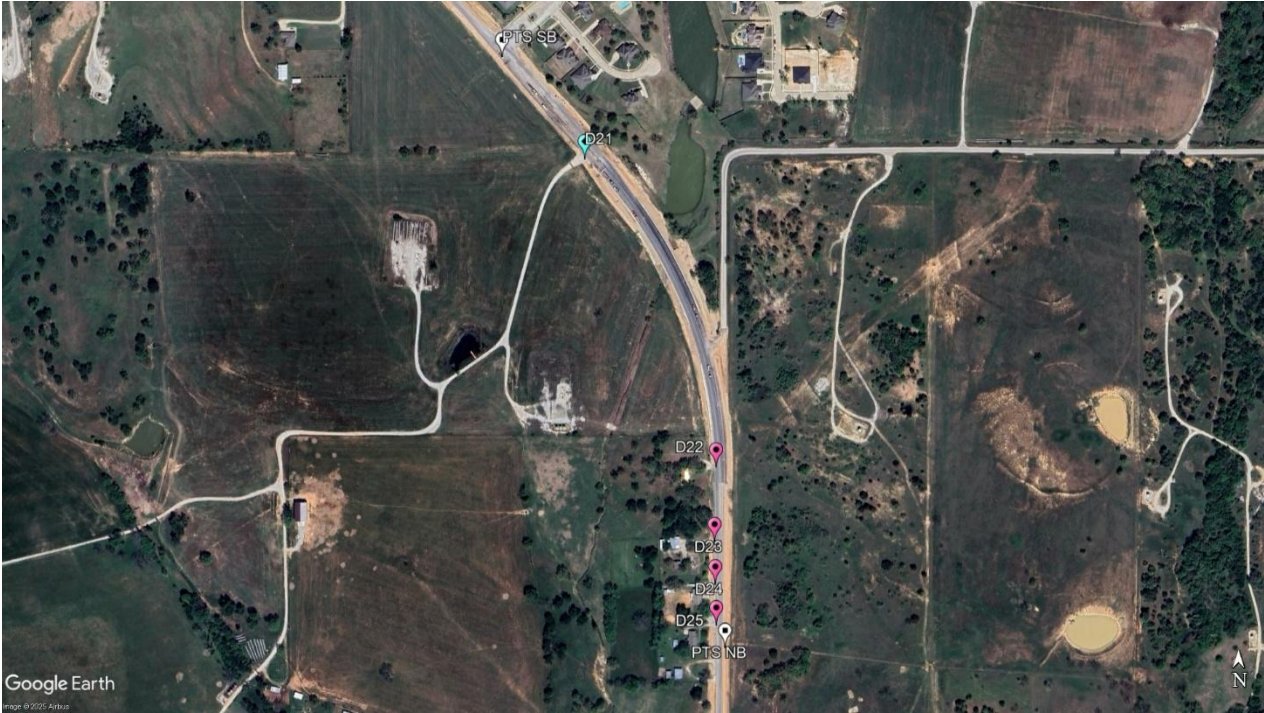
Figure 5. Project 15 FM 730 July 2024 One-Lane Study Section.

TTI researchers collected data at two different DADs (D21 and D18) in July and September 2024, respectively. Figure 5 shows the section of roadway under construction in July 2024 and the location of D21 (see aqua pin with diamond). The one-lane section was controlled by PTSs and was approximately 0.54 miles (see white pins with squares in Figure 5). This section included five DADs deployed at five private driveways (see pink pins with circles and aqua pin with diamond in Figure 5). Four of the driveways served residences (see pink pins with circles in Figure 5). The DAD deployed at D21 served a driveway that led to multiple oil and gas pads (see aqua pin with diamond in Figure 5). The intersection of FM 730 and CR 4460, in the middle of the one-way section, was closed and CR 4460 traffic was detoured. For the D21 DAD, the eastbound and westbound cycle times were approximately the same at 2 minutes and 4 seconds. The red time was 1 minute and 20 seconds, while the green time was 44 seconds.

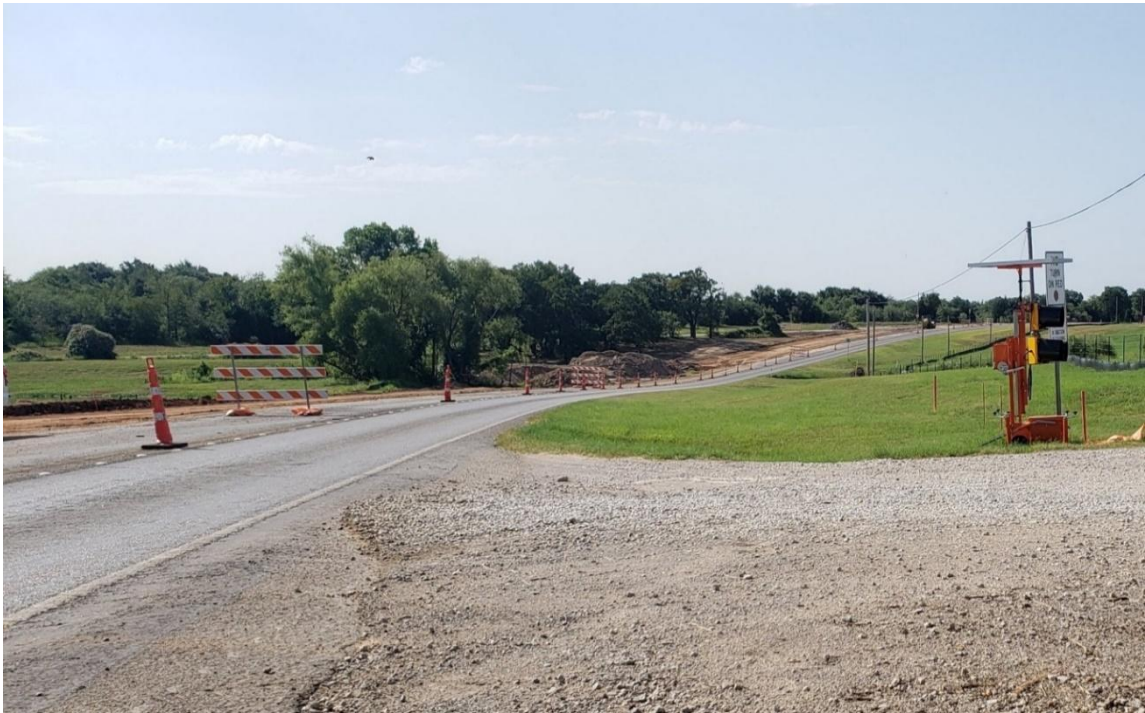
Figure 6. DAD at D21 Looking Southbound.

On July 9–11, 2024, TTI researchers observed traffic approaching FM 730 from D21. The driveway was located approximately 545 feet from the southbound PTS and approximately 2,257 feet from the northbound PTS. Vehicles entering FM 730 from D21 could see the southbound PTS and queue associated with it, if any. At D21, the DAD was located on the

nearside of the driveway, and construction was occurring in the northbound lane (see Figure 6). Data collection began at 10:24 a.m. on Tuesday and ended at 10:09 a.m. on Thursday.

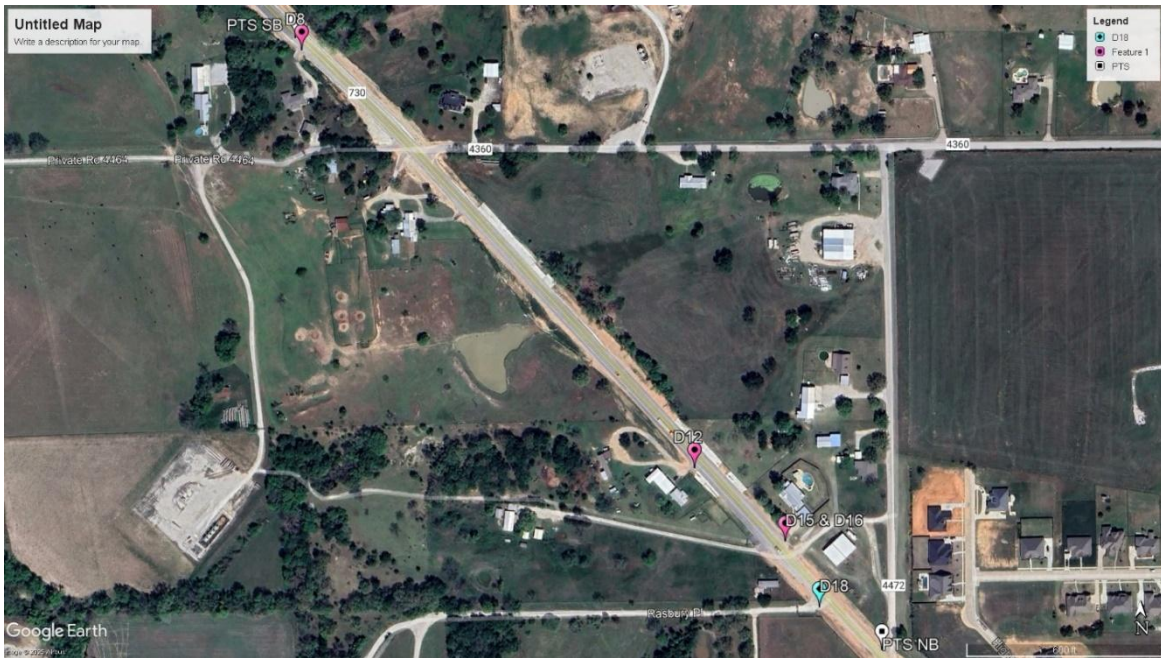
Figure 7. Project 15 FM 730 September 2024 One-Lane Study Section.

Figure 7 shows the section of roadway under construction in September 2024 and the location of D18 (see aqua pin with diamond). The one-lane section was controlled by PTSs and was approximately 0.48 miles (see white pins with squares in Figure 7). This section included four DADs deployed at four private driveways (see pink pins with circles and aqua pin with diamond in Figure 7). The DAD deployed at D18 served a driveway that led to multiple oil and gas pads and private residences. The intersection of FM 730 and CR 4360, in the middle of the one-way section, was closed and CR 4360 traffic was detoured. For the D18 DAD, the eastbound and westbound cycle times were approximately the same at 2 minutes and 4 seconds. The red time was 1 minute and 20 seconds, while the green time was 44 seconds.

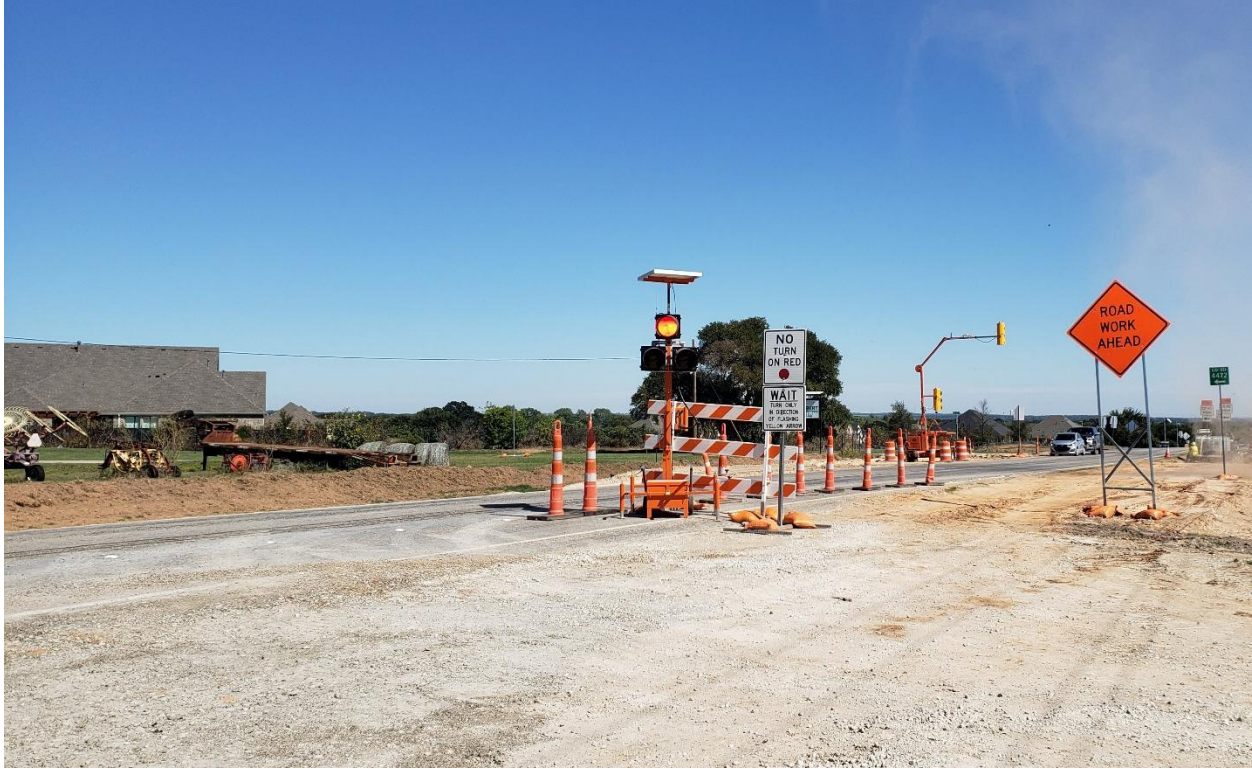
Figure 8. DAD at D18 Looking Southbound.

On September 24–26, 2024, TTI researchers observed traffic approaching FM 730 from D18. The driveway was located approximately 2,328 feet from the southbound PTS and approximately 235 feet from the northbound PTS. Vehicles entering FM 730 from D18 could clearly see the northbound PTS and any queue that might be associated with it. At D18, the DAD was located on the nearside of the driveway, and construction was occurring in the southbound lane (see Figure 8). Data collection began at 1:40 p.m. on Tuesday and ended at 4:27 p.m. on Thursday.

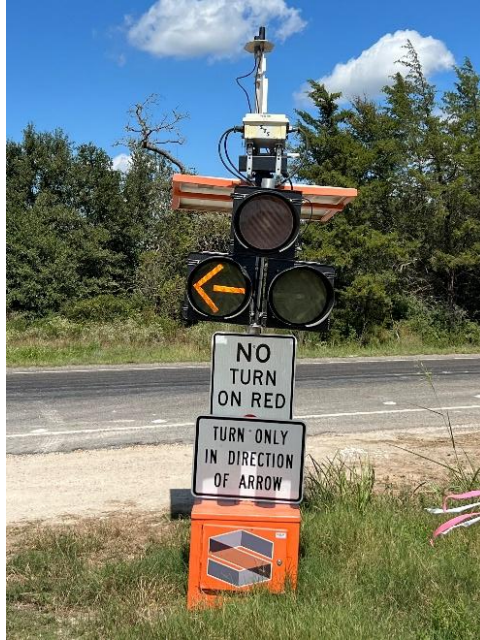
Figure 9. DAD at D1.

Project 16 entailed a bridge replacement taking place at a section of FM 46 that intersects with Cedar Creek in Franklin County just southeast of Franklin, Texas. The work zone and one-lane section spanned the bridge plus additional space around the bridge for an approximate total length of 0.2 miles. The DAD design for this project was the three-section doghouse, which included two 12-inch flashing yellow indications, a single 12-inch solid red indication, a R10-11a sign, and a second supplemental sign (TURN ONLY IN DIRECTION OF ARROW) (see Figure 9). However, the red ball graphic on the R10-11a sign was covered by the second supplemental sign (see Figure 9).

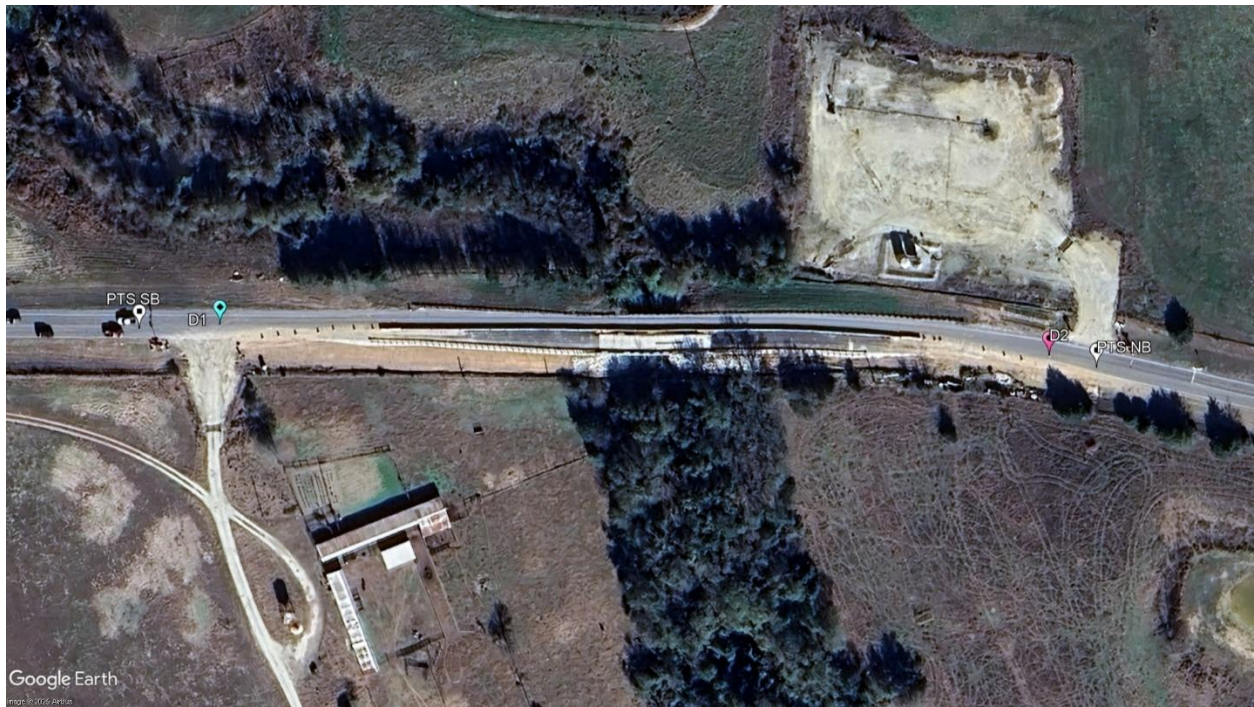
Figure 10. Project 16 FM 46 September 2024 One-Lane Study Section.

Figure 10 shows the section of roadway under construction in September 2024. The one-lane section was controlled by PTSs and was approximately 955 feet long (see white pins with squares in Figure 10). Two DADs were used for this project, one on each side of the bridge (see pink pin with circle and aqua pin with diamond in Figure 10). The DAD deployed at the southern end of the bridge (D2) provided access to a single oil pad, while the DAD deployed on the northern end of the bridge (D1) serviced multiple oil pads and residences. TTI collected data at D1 (see aqua pin with diamond in Figure 10), and the northbound and southbound cycle times were both approximately 1 minute and 8 seconds. The average red time was approximately 39 seconds, and the average green time was approximately 30 seconds.

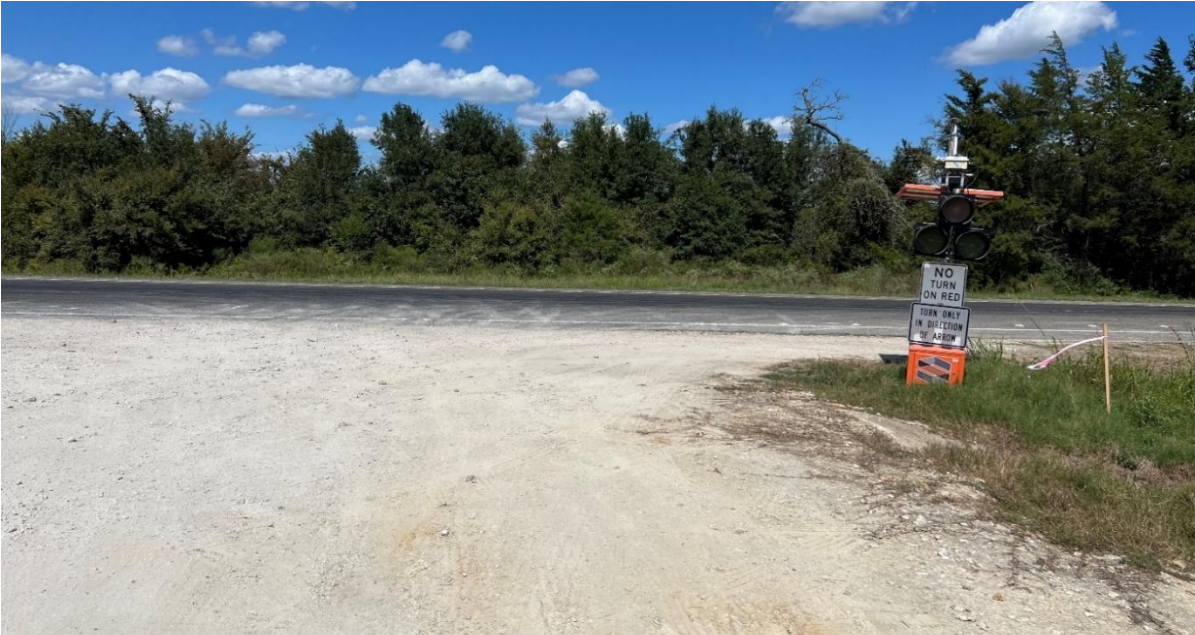
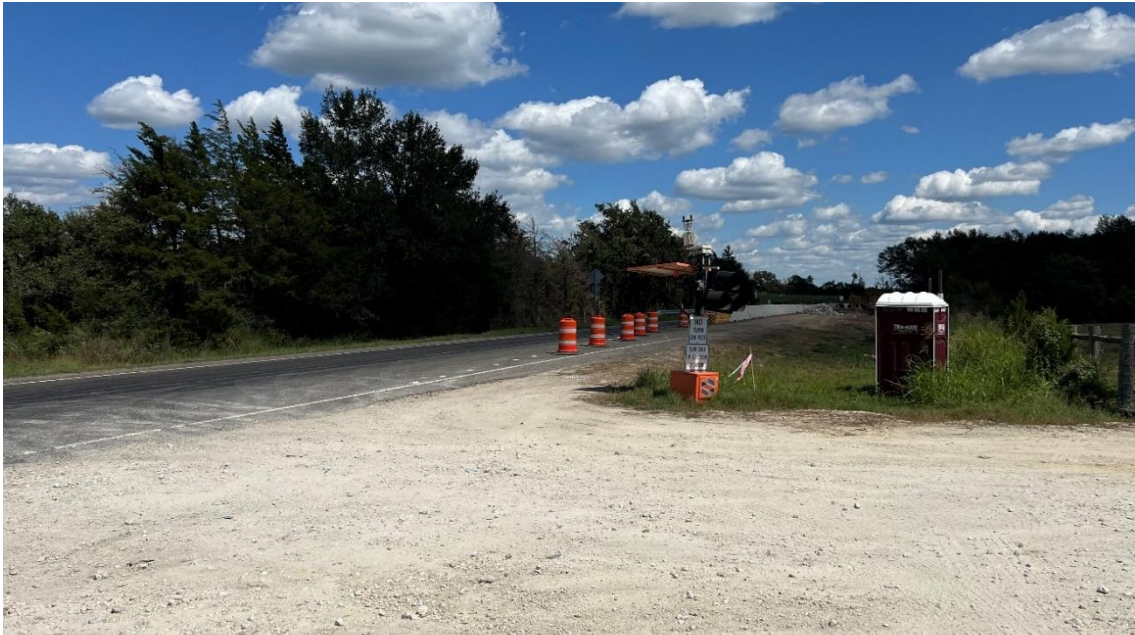
On September 17–19, 2024, TTI researchers observed traffic approaching FM 46 from D1. This driveway was located approximately 55 feet from the southbound PTS and approximately 900 feet from the northbound PTS. The DAD located at D1 was on the nearside of the intersection with FM 46, with construction occurring south of the DAD’s location in the

southbound lane (see Figure 11 and Figure 12). Vehicles entering FM 46 from D1 could see the southbound PTS and associated queue (if present) with ease due to the proximity of the PTS in relation to the driveway. However, vehicles entering FM 46 from D1 could not see the northbound PTS due to the presence of vegetation and a slight horizontal curve in the southbound direction on the south side of the bridge. Data collection began at 2:15 p.m. on Tuesday and ended at 2:08 p.m. on Thursday.

Figure 11. DAD at D1 from Approaching Traffic Viewpoint.

Figure 12. DAD at D1 Looking Southbound.

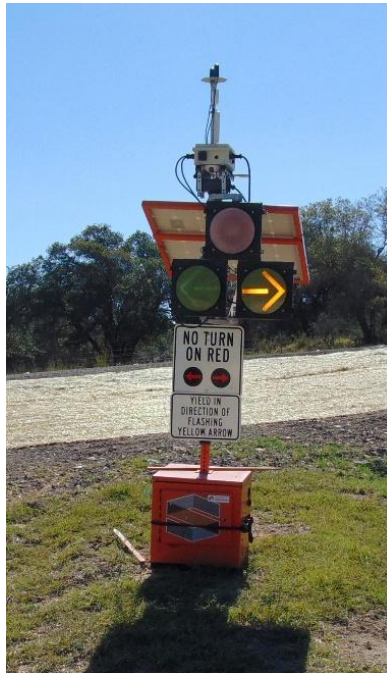
Figure 13. DAD Deployed on RM 1376 at D3.

Project 25 involved several safety improvement projects along a north-south stretch of RM 1376 in Kendall County from RM 473 to 0.8 miles south of Upper Sisterdale Road (approximately 3 miles). TTI began discussions with TxDOT staff and the contractor in April 2024 but were unable to collect data until September 2024 during Phase 4 of the project. The DAD design used for this project was the three-section doghouse, which included two 12-inch flashing yellow indications, a single 12-inch solid red indication, a modified R10-11 sign, and a second supplemental sign (YIELD IN DIRECTION OF FLASHING YELLOW ARROW) (see Figure 13).

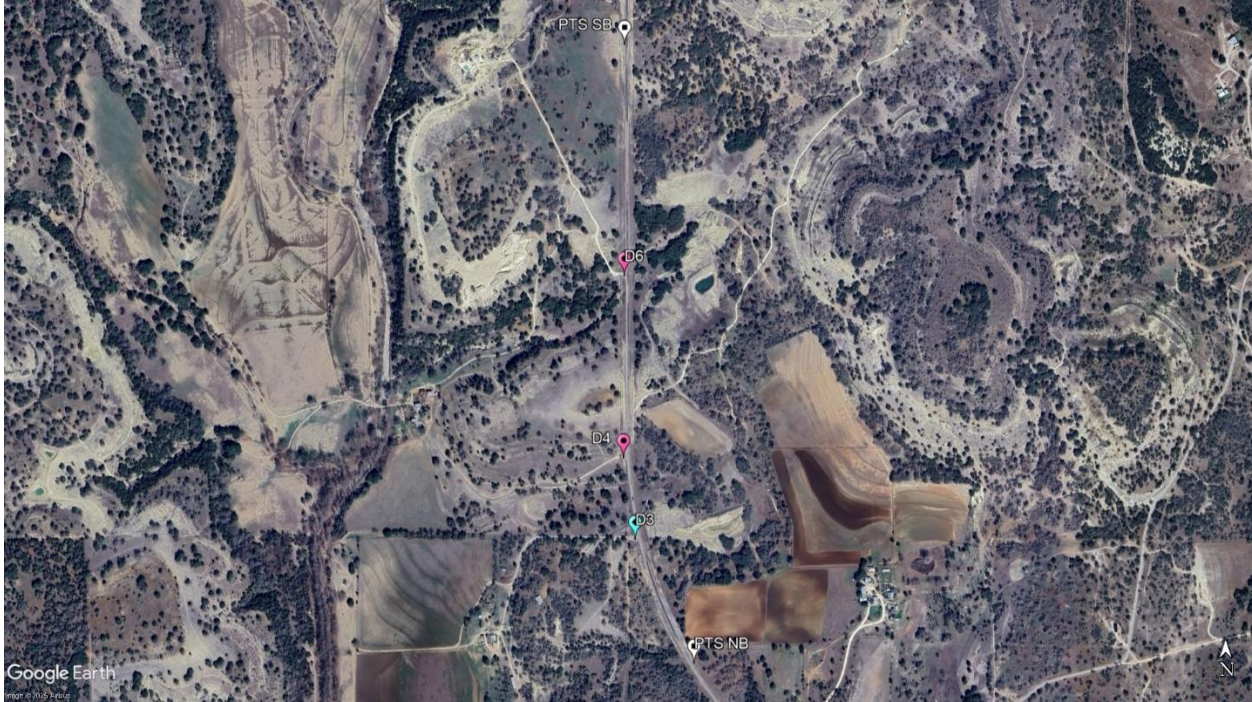
Figure 14. Project 25 RM 1376 September 2024 One-Lane Study Section.

Figure 14 shows the section of roadway under construction in September 2024. The one-lane section was approximately 1 mile long and controlled by PTSs (see white pins with squares in Figure 14). Three DADs were used at three driveways, all serving private residences (see pink pins with circles and aqua pin with diamond in Figure 14). TTI collected data at the southernmost DAD (D3) (see aqua pin with diamond in Figure 14). High variability was present in the cycle times both for the southbound and northbound cycles. On average, a total cycle lasted approximately 3 minutes and 26 seconds. The average red time was approximately 2 minutes and 52 seconds, while average green time was 29 seconds.

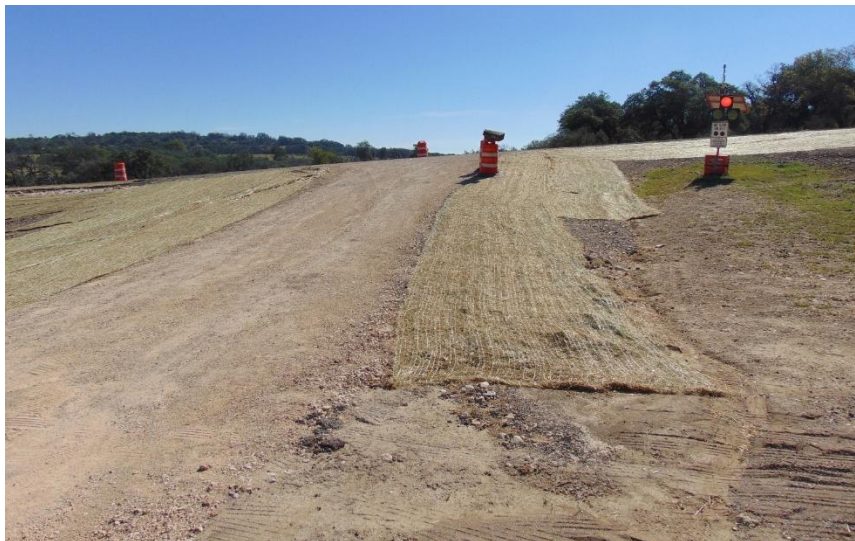
Figure 15. DAD at D3 from Approaching Traffic Viewpoint.

On September 10–12, 2024, TTI researchers observed traffic approaching RM 1376 from D3. The driveway was located approximately 0.25 miles from the northbound PTS and approximately 0.75 miles from the southbound PTS. Vehicles entering RM 1376 from the driveway could not see either PTS due to horizontal curvature, vegetation, and distance from the driveway to either PTS. At D3, the DAD was located on the nearside of the driveway’s intersection with RM 1376, and construction was occurring in the southbound lane (see Figure 15). Data collection began at 10:42 a.m. on Tuesday and ended at 6:14 a.m. on Thursday.

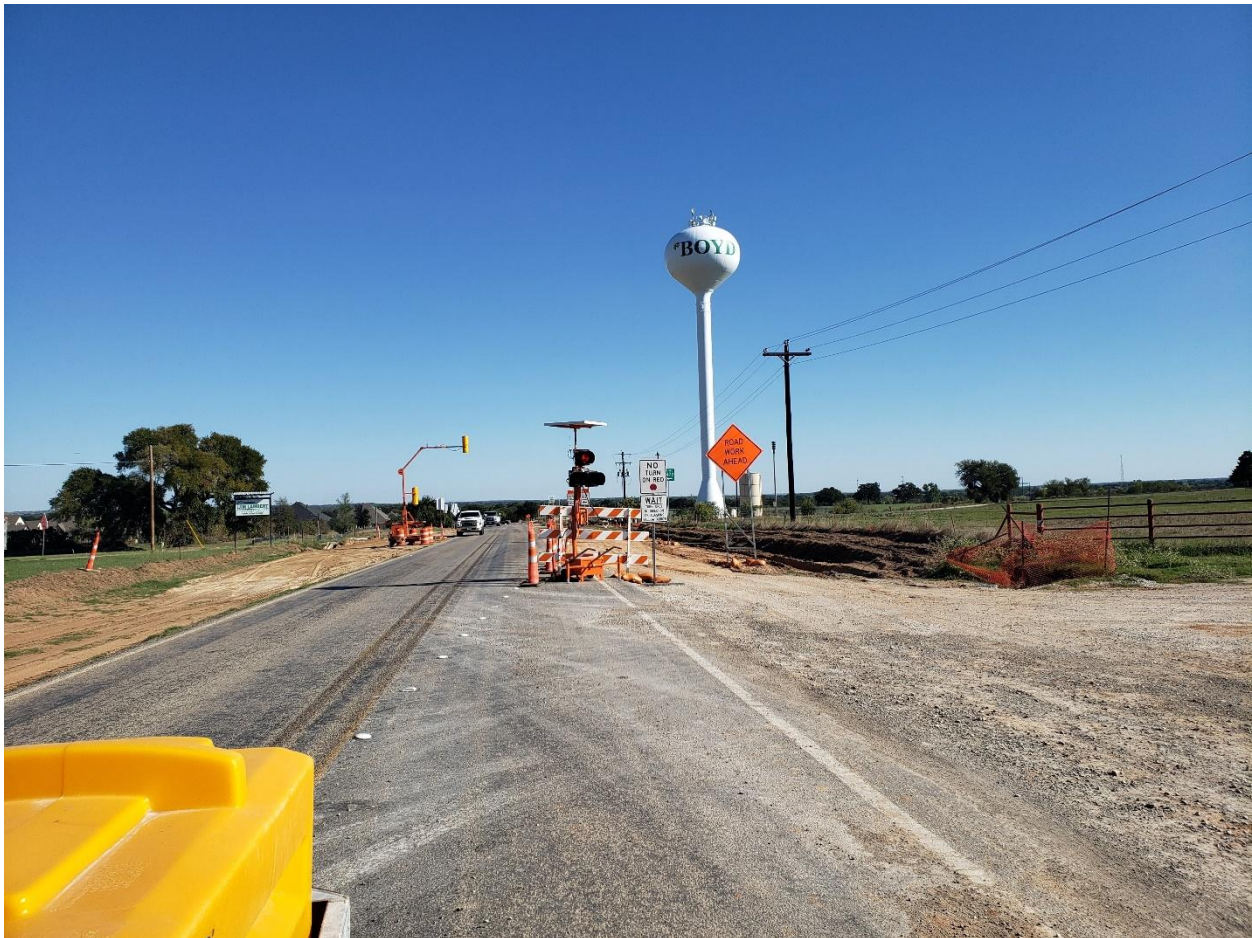
Figure 16. End of Concrete Barrier and DAD at D18 Looking Southbound.

Over 50 hours and 46 minutes of data were collected at D18 on FM 730. During this time, 55 vehicles arrived at the DAD. Twenty-eight vehicles (51 percent) did not comply. However, at least 17 of those vehicles were construction-related vehicles with an additional four vehicles potentially being construction-related. Of these 28 violations, 10 (36 percent) were related to “jumping” the flashing yellow arrow, six (21 percent) were related to flashing yellow arrow violations (turning in opposite direction of FYA), and 12 (43 percent) were related to red violations. All the violations may have been attributed to the proximity of the DAD to the northbound PTS, which allowed vehicles at D18 to very clearly see if main lane traffic was coming from the northbound direction (see Figure 8). In addition, a concrete barrier was used to separate the closed lane (work area) from the open travel lane. The end of the concrete barrier terminated at D18, which led to construction workers often using this driveway as an exit from the work area (see Figure 16). Overall, the violation rate for this site was 1.83 violations per 100 stop cycles (28 violations divided by 1,529 stop cycles multiplied by 100).

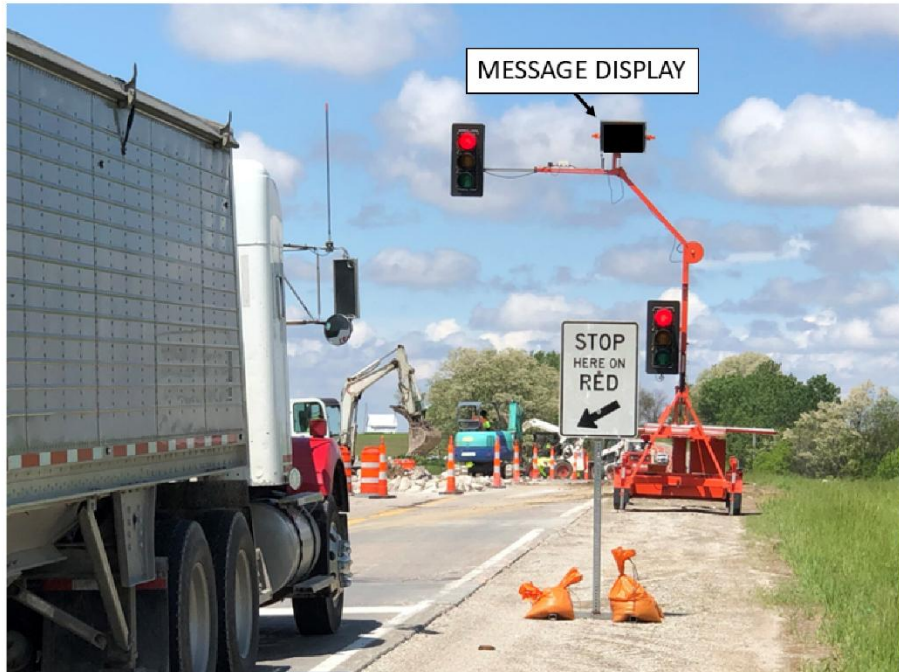
Figure 23. Study Explanatory Screen.

Participants who met the requirements and decided to participate were advanced to an explanation screen that showed a PTS with a wait time display board attached (see Figure 23). Text positioned above the image highlighted the message board on top of the signal as the focus of the study.

Please review the image below. It shows an approach to a portable traffic signal that is alternating one-way traffic on a two-lane roadway that is under construction. In addition to the signal, there is a message display that may provide additional information to you. During this survey, you will be asked a few questions about your interpretation of messages that may appear on the display.

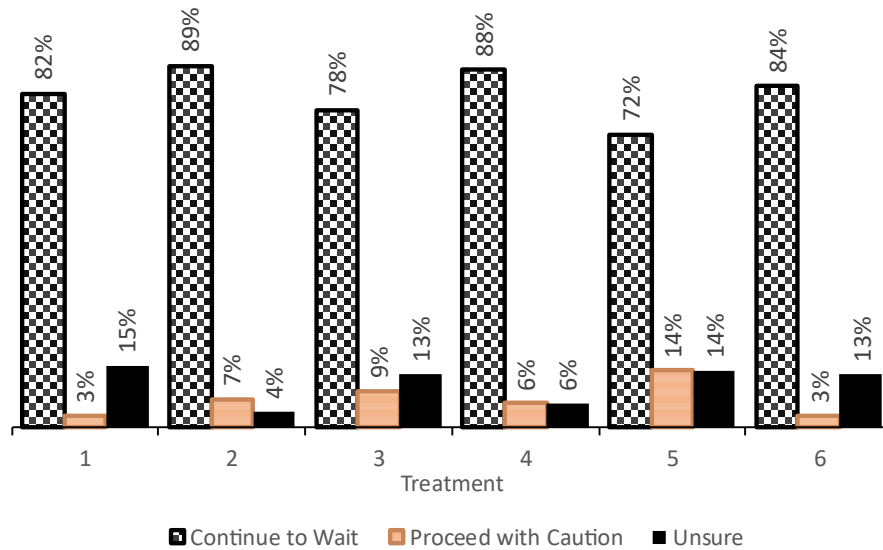
Figure 25. Participant Responses to Question About Proper Action to Take If Wait Time Display Reaches Zero and Signal Indication Is Still Red.

Participant responses to the question concerning the appropriate action to take if the wait time display counted down to zero but a red indication was still showing are presented in Figure 25. Overall, most participants correctly indicated that they would continue to wait until the signal turned green (none of the “continue to wait” percentages differed significantly from the 85 percent acceptable threshold value). However, over one-quarter (28 percent) of participants viewing Treatment 5 indicated that they would either proceed with caution into the work zone or were unsure what to do if the wait time indication displayed a zero while the red signal indication was still showing. Similarly, 22 percent of participants viewing Treatment 3 responded the same way. When those participants were asked why they would proceed with caution or were unsure what to do if the wait time display was at zero but the signal indication was still red, all of them stated that the signal could be malfunctioning. These participants apparently assumed that since the wait time display was actively counting down, it must be operating correctly rather than the signal itself.

Although very few participants (3 percent) viewing Treatment 1 or Treatment 6 indicated they would proceed with caution, 15 percent and 13 percent of the participants viewing those treatments, respectively, were unsure what they would do in that situation. The researchers hypothesize that this question may have confused participants viewing Treatment 1 since it displayed a static number (WAIT UP TO 3 MIN) that did not change. It is unclear why participants viewing Treatment 6 were unsure since none of them entered an explanation in the survey.

Interestingly, only 11 percent of participants viewing Treatment 2 indicated that they would proceed with caution or were unsure what to do, even though the wait time display for that treatment also included a minutes:seconds message that counted down second by second. Researchers hypothesize that the WAIT statement included in the display may have heightened participants’ wariness about the display and resulted in a higher percentage of “continue to wait” responses. Conversely, while only 12 percent of participants viewing Treatment 4 said they would proceed with caution or were unsure what to do, researchers hypothesized that this was due more to the fact that several participants did not associate the decreasing bar display as a traffic signal countdown and so only considered how they would respond to the red indication when answering that question.

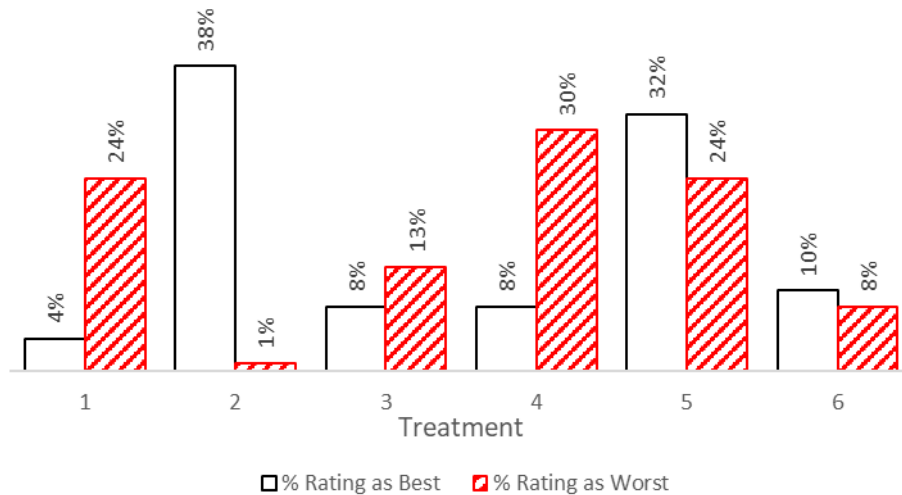
Figure 27. Percent of Participants Rating Each Treatment as “Best” or “Worst.”

The percentage of participants ranking each treatment as best or as worst is provided in Figure 27. Treatments 1, 4, and 5 received the greatest percentage of “worst” rankings, whereas Treatments 2 and 5 received the greatest percentage of “best” rankings. The lack of a changing time on Treatment 1 was cited as a main reason by several participants for ranking it worst (e.g., “no real time information, I have no idea if the light just changed or how long you will be waiting”). Several participants noted that the use of a decreasing bar to indicate the wait time in

Treatment 4 was not intuitive but rather confusing. The fact that it did not present a specific time was also cited as reasons for ranking it as worst.

Interestingly, Treatment 5 received significant numbers of both “best” and “worst” rankings, indicating that participants were highly opinionated regarding that treatment. Some of the reasons offered by participants for rating this treatment as best or worst are shown in Table 6. Whereas some participants focused on the larger font that this type of display allows (since no text is included in the display) as the reason for their preference, other participants perceived the simple numerical display as possibly confusing, especially since it lacked context. The fact that Treatment 5 only displayed seconds rather than minutes:seconds was disconcerting for some of the participants.
