TREATMENTS FOR CRASHES ON RURAL TWO-LANE HIGHWAYS IN TEXAS

for
Texas
Department of
Transportation

by
Texas
Transportation
Institute

April 2002
Report 4048-2

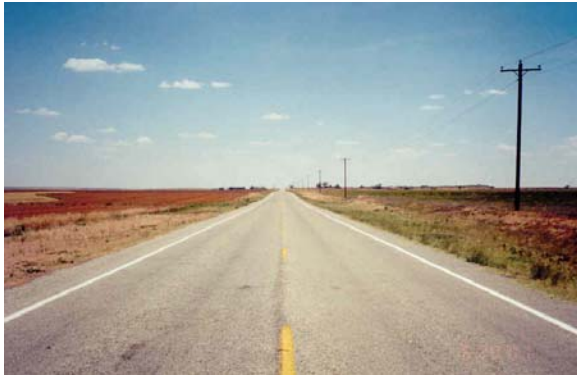
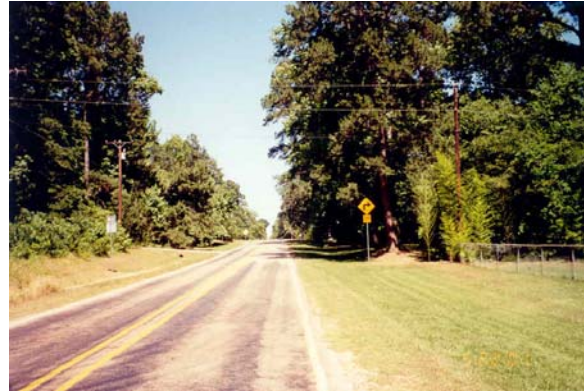
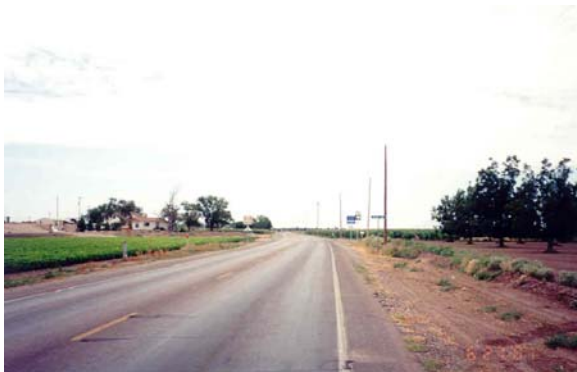
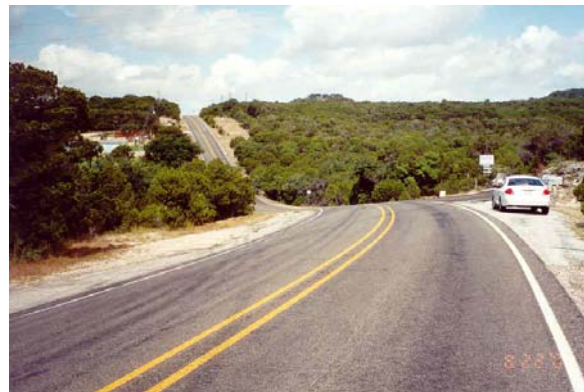
Figure 3-4. Samples of Study Sites in Four Texas Counties.

Analysis identified two counties with the highest average KAB rates on low-volume, rural two-lane highways for 1992 to 1998: Angelina and Travis. Selecting two western counties with low KAB rates for comparison could result in a county that has a low KAB rate because it only had a few miles that met the less than 2000 ADT criteria. If so, then the difference in KAB rate could be because of the lack of opportunity for a crash (because of the low number of miles) rather than a true difference between the east and west regions. To control for that issue, counties that had a similar number of miles of low-volume, rural two-lane roads to Angelina and Travis Counties were identified. Martin County with 185 miles (297.9 km) of low-volume, rural two-lane roads was matched to Angelina County (189 miles [304.3 km]). Travis County with 22 miles (35.4 km) was matched to El Paso County (35 miles [32.2 to 48.3 km]). [Figure 3-4](#) includes pictures of one of the study sites within each county.

- A The observed roadside development is quite different between east and west, with farmland being predominant in the west and trees in the east (see [Figure 3-4](#)).

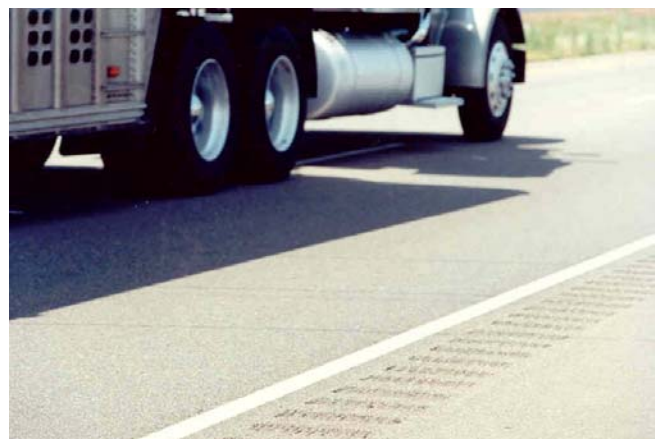
Rumble strips warn motorists that they are leaving or about to leave the lane (see [Figure 5-1](#)). Specific concerns that affect the design of rumble strips and the locations where rumble strip installation is appropriate include: placement, weather, degradation of the pavement, type of pavement, pavement thickness, pavement overlay, noise, maintenance, motorist concerns, bicyclist concerns, motorcyclist concerns, and potential for increase in head-on crashes caused by drivers overreacting to the edge line rumble strip on a two-lane highway. [Figure 5-2](#) contains examples of thermoplastic profile markings.

Figure 5-1. Example of Edge Line Rumble Strips (2).

Shoulder rumble strips (SRS) have proven to be an effective method for warning drivers that they are leaving, or about to leave, the roadway. Studies show that shoulder rumble strips are effective against run-off-road (ROR), fixed object, and rollover type crashes (17). Nationwide, ROR crashes account for approximately one-third of all traffic fatalities, with about two-thirds of these ROR fatalities occurring in rural areas.

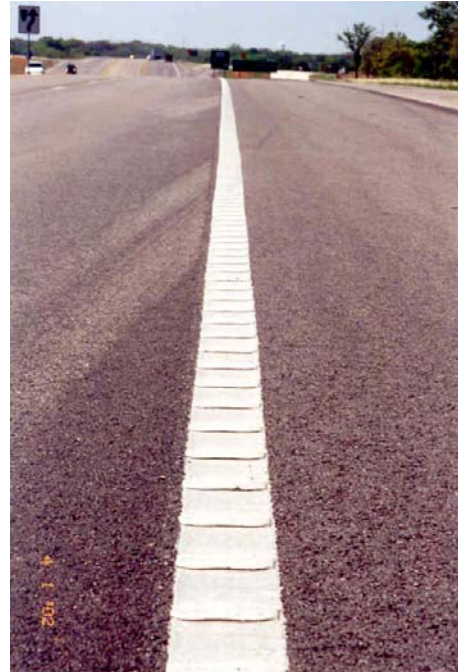
Figure 5-2. Examples of Thermoplastic Profile Markings.

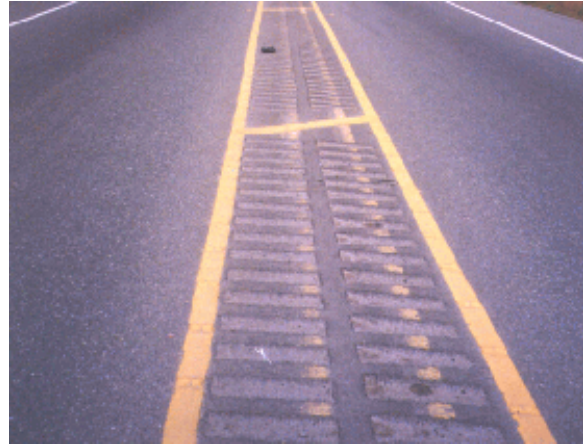
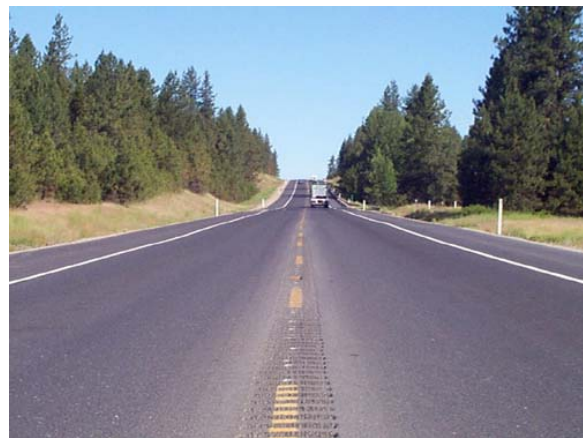
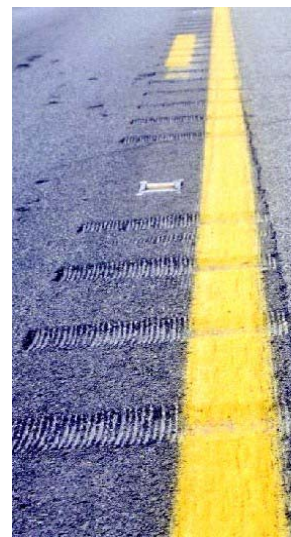
Figure 5-3. Examples of Centerline Rumble Strips.

- A An increase in the number of fatal crashes on a state route in California in 1995 generated concerns from the local community and elected officials. Both centerline and edge line rumble strips were installed as part of the project. A feature of the treatment included markers in the center of the roadway in passing sections to provide audible warning to motorists crossing the center of the road. The installation of the pavement treatments was completed in November 1996. The estimated cost of the work in January 1996 was \$789,000. Fewer crashes per month occurred on the 23.5 mi (37.8 km) segment in the 25 months after installation as compared to the 34 months in the before period. An average of 4.5 crashes occurred per month in the before period and 1.9 crashes per month occurred in the after period. In the before period, 10 crashes resulted in fatalities while the after period included only one fatal crash.

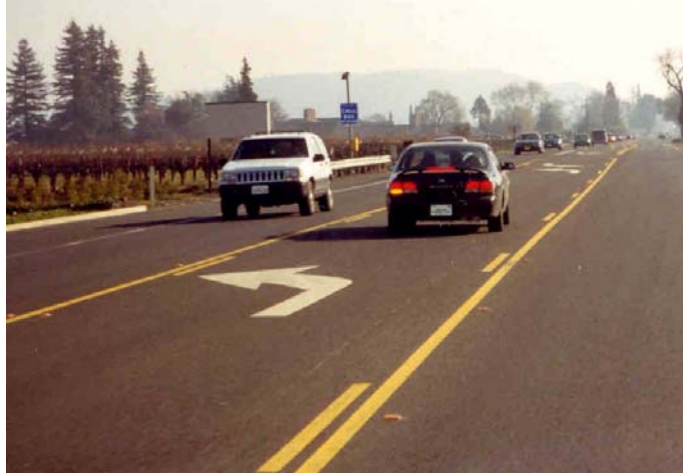
Figure 5-6. Example of Two-Way Left-Turn Lane in Rural Area (2).

TWLTLs are particularly appropriate at locations where high left-turn volumes are distributed across a range of driveways or intersections and at locations where there is a documented pattern of left-turn crashes spread over several intersections or driveways. Care should be taken not to overuse TWLTLs on two-lane highways because passing is prohibited in TWLTL sections. If used in areas with minimal development, TWLTLs can be operationally detrimental by denying drivers the opportunity to pass slow-moving vehicles, without any corresponding safety benefit. When evaluating whether to install a TWLTL, highway agencies should consider the availability of passing opportunities on the adjacent highway section. If the only good passing zone for miles in either direction is replaced by a TWLTL, illegal passing maneuvers are likely, and the potential for conflicts between passing and turning vehicles is increased.

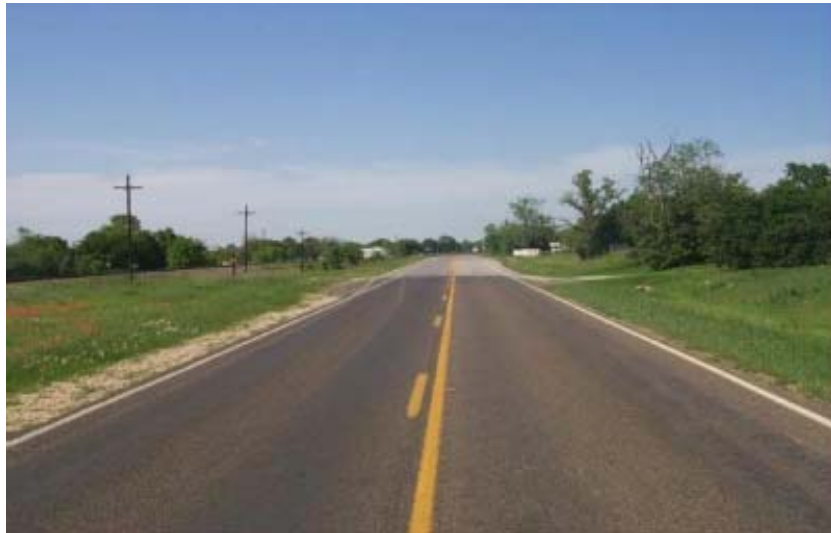
Figures 5-7 and 5-8 illustrate an upstream cross section with narrow shoulders and one with a wide shoulder.

Figure 5-7. Example of Previous Cross Section.

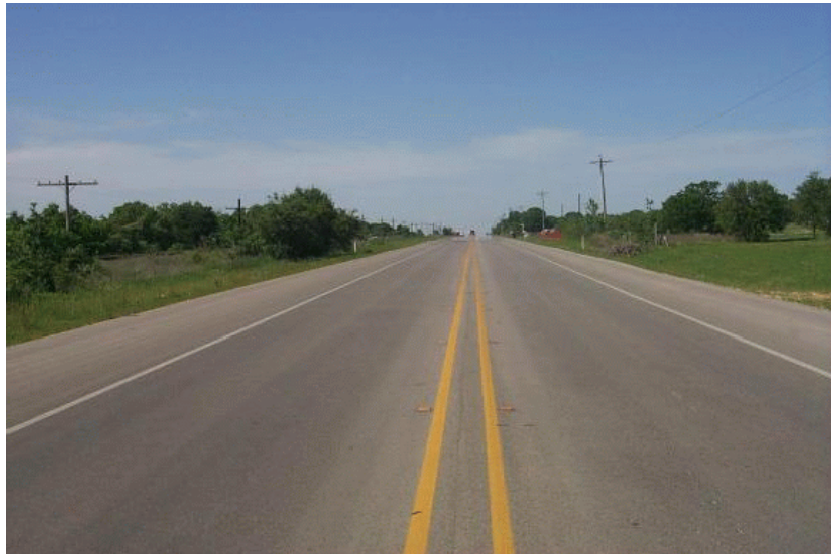
Figure 5-8. Example of Wider Shoulders.

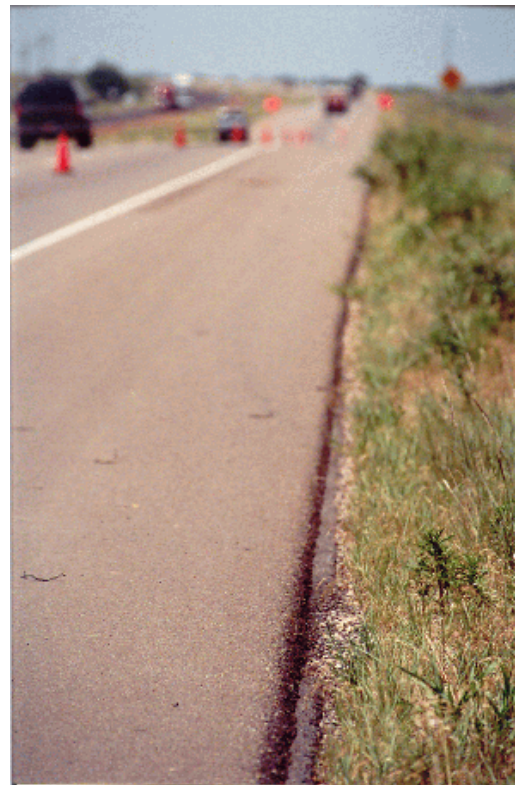
Figure 5-9. Shoulder Drop-Off.

Drop-offs are caused when the edges of pavement are unstabilized and eroded, resulting in a difference in height between the pavement surface and the roadside surface (see [Figure 5-9](#)). This height difference could be anywhere from a fraction of an inch to several inches, depending on the level of erosion. The potential hazard of this drop-off is realized when one or more of a vehicle's tires leaves the pavement surface and drops onto the roadside. In attempting to return to the paved surface, the driver can over-correct to compensate for the change in surface height, as it becomes more difficult for the vehicle to return to the lane at a shallow angle. If the driver over-corrects, this could cause the vehicle to spin out in the lane or cross the centerline, increasing the potential for a crash. Shoulder drop-offs can also be a significant issue for liability, if it is determined that the responsible agency did not properly maintain the surface at the edge of the roadway.

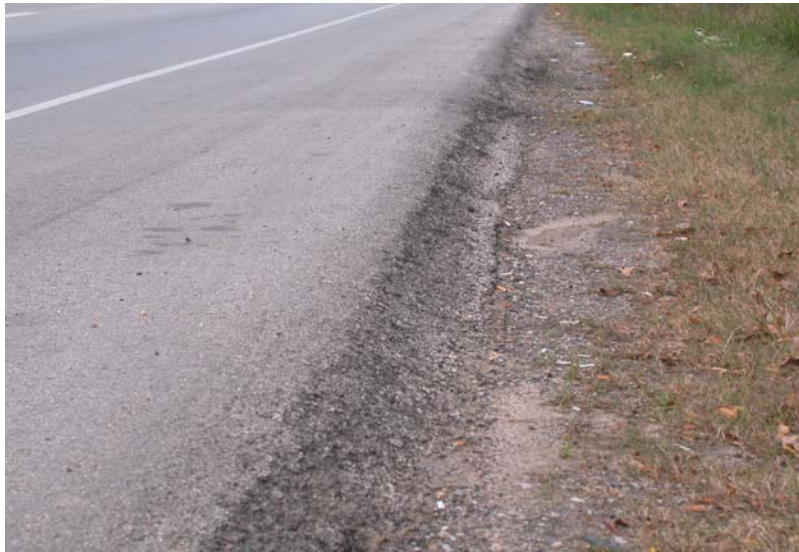
Figure 5-10. Gradual Change in Height Between Shoulder and Roadside.

There was no recorded research prior to 1977, but since then there have been several efforts to investigate this situation. One study by Glennon suggests that at speeds of 60 mph (97 km/h) or greater, a tolerable vertical drop-off is 1 inch or less. The value for a tolerable drop-off could be increased if the edge is rounded or beveled (31).

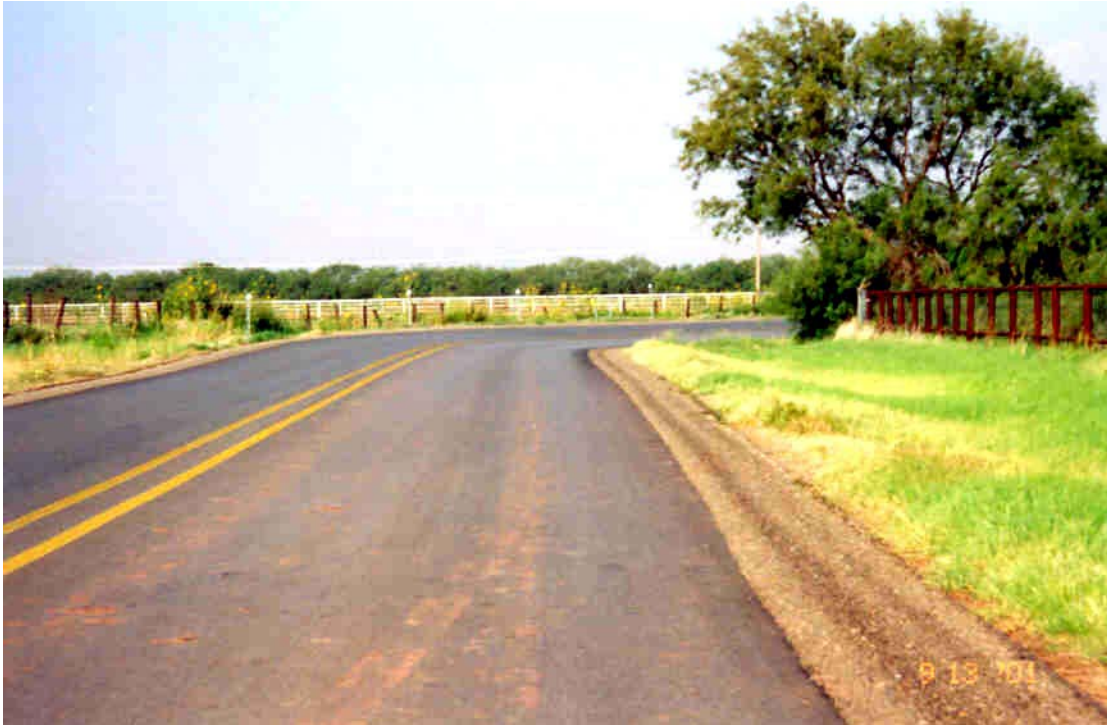
Figure 5-11. Example of Centerline Only Pavement Markings.

Figures 5-11 and 5-12 show examples of centerline-only pavement markings and both centerline and edge line pavement markings.

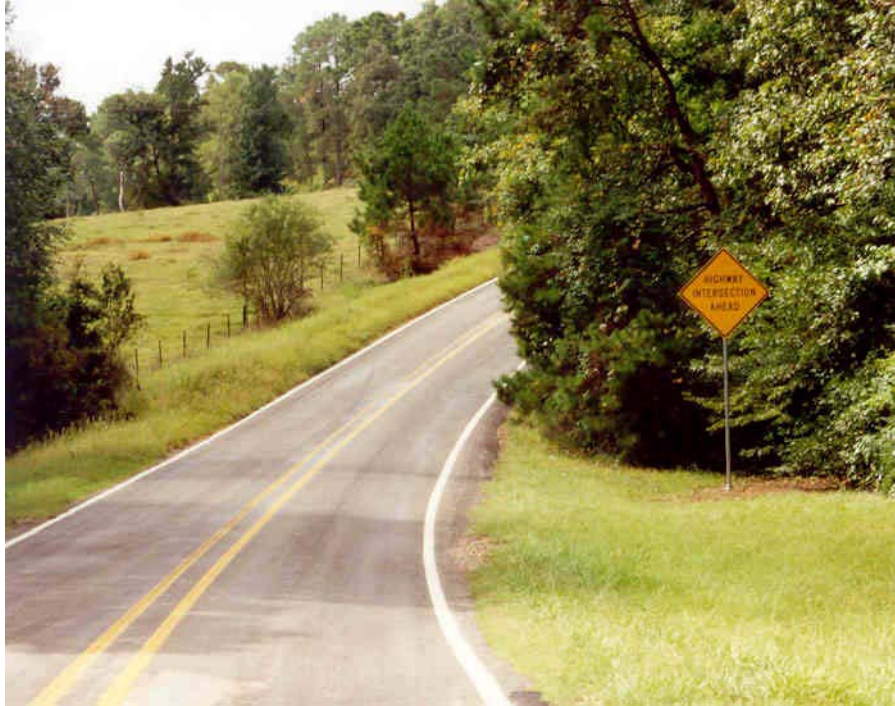
Figure 5-12. Example of Centerline and Edge Line Pavement Markings.

The use of 4-inch (10.2 cm) edge lines significantly reduced the number of crashes as compared with those sites with no edge lines (33). The use of 4-inch (10.2 cm) edge lines has also shown a significant reduction in the number of crashes at access points (i.e., driveways and intersections) (34). Adding edge lines and centerlines to roadways where no delineation had been provided reduced crashes by 36 percent in a 1970s study (35). Adding centerlines reduced crashes by 29 percent; adding edge lines to centerlines yielded an 8 percent reduction. A Kansas study involved control and treatment sites comprising 384 mi (618 km) of rural highway servicing between 550 and 3600 vehicles per day. Using these findings, it was determined that edge lines will yield benefits exceeding their costs if an average of one non-intersection crash occurs annually every 15.5 mi (25 km) of roadway (36).

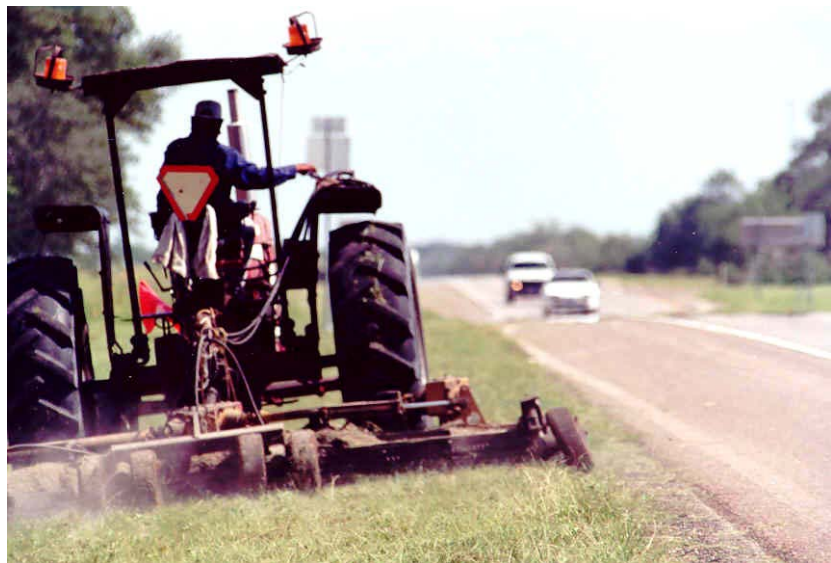
Mowing is a standard method for eliminating weeds and woody brush from highway roadsides (see [Figure 5-13](#)). Mowing programs are often designed to keep signs and other traffic control devices visible, and to help inform the driver of the characteristics of the roadside terrain (see [Figure 5-14](#)). Where the right-of-way is wide enough and has suitable terrain, the clear zone can assist the driver who loses control of a vehicle to recover control and possibly avoid a collision. Mowing is also important to the maintenance of roadside grass, which helps the soil be resistant to damage by storm runoff from the pavement ([41](#)).

Figure 5-13. Mowing Activity.

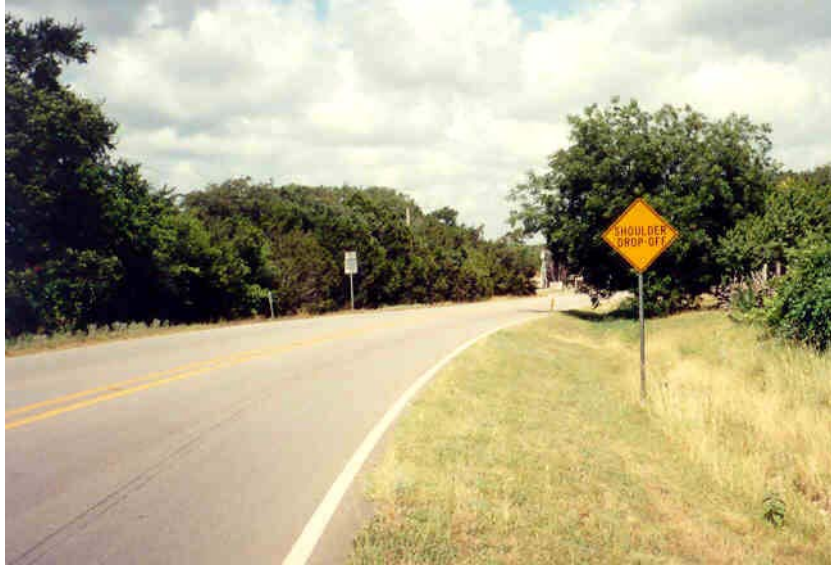
Figure 5-14. Mowed Area on an Inclined Shoulder.

Various states have different standards for mowing height and frequency, and many states have some measure of “chemical mowing” as part of their overall program. Thus, the measurable benefits of mowing on highway roadsides have yet to be fully determined or quantified.

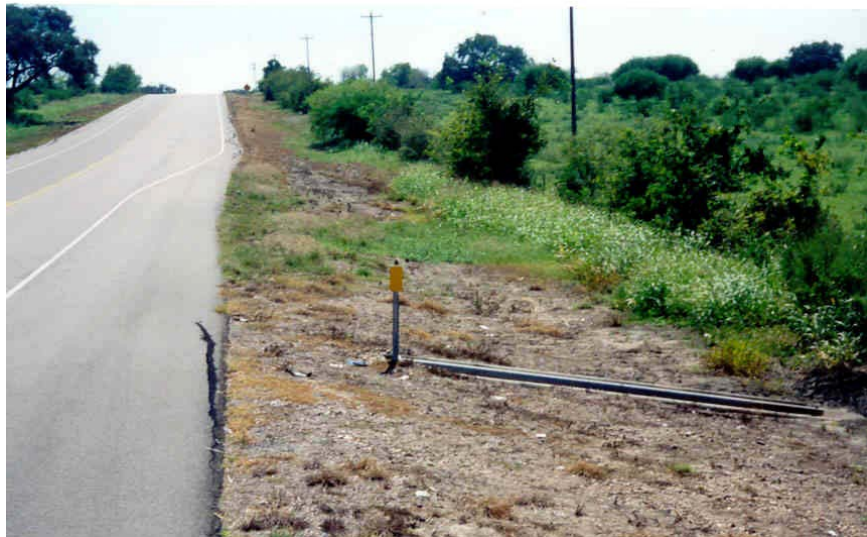
The concept of a forgiving roadside recognizes that motorists do run off the roadway and that a traversable recovery area could lessen serious crashes and injuries (see [Figure 5-18](#)). Ideally, this recovery area or “clear zone” should be free of obstacles such as unyielding sign and luminary supports, non-traversable drainage structures, utility poles, and steep slopes. Designers generally consider options for the treatment of these features in the following order:

Figure 5-18. Example of Traversable Culvert within the Recovery Distance.

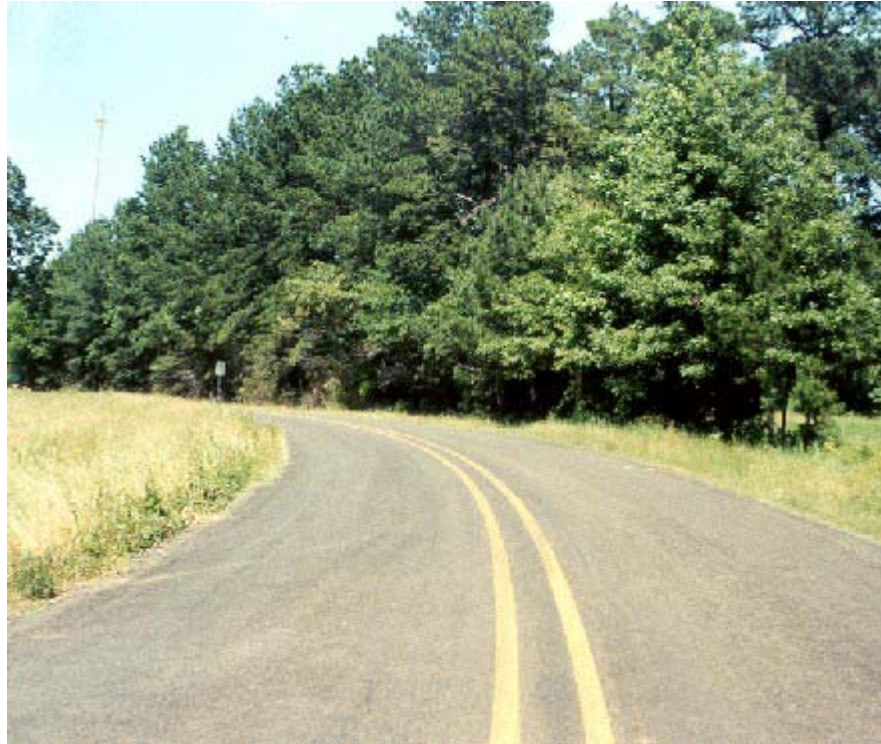
Trees become potential obstructions by virtue of their size and location in relation to vehicular traffic (see [Figure 5-19](#)). Generally, a single tree with a trunk diameter greater than 4 inches (100 mm) is considered a fixed object. When trees or shrubs with multiple trunks or groups of small trees are together, they may be considered as having the effect of a single tree with their combined cross-sectional area. Tree removal should be considered when those trees are determined both to be obstructions and to be in a location where they are likely to be hit. If tree removal is impractical or infeasible, then shielding the trees with some type of roadside barrier may be justified. AASHTO's *Roadside Design Guide* (9) offers more information about the warranting and design of roadside barriers for protecting trees.

Figure 5-19. Example of Trees near Roadside.

Tree crashes can be reduced based on crash reductions shown in [Table 5-9](#). [Table 5-9](#) also includes the findings for guardrails and fences/gates. Clearing trees by 10 ft (3.1 m) (e.g., from 8 to 18 ft [2.4 to 5.5 m]) will reduce tree crashes by an expected 57 percent. These values assume that by clearing trees back from the roadway, run-off-road vehicles would have an additional roadside area to recover provided the trees were not on a steep side slope. Since trees are the fixed object most often struck on many rural roads, clearing trees back from the road (particularly on roads with severe alignment) can be an effective roadside safety treatment (16).

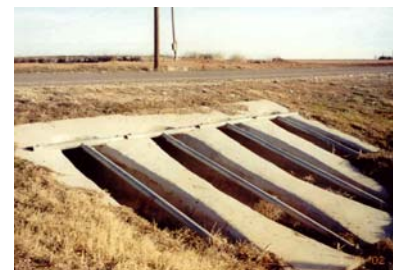
- A Eliminate non-essential drainage structures.
- A Design or modify drainage structures so they are traversable or present a minimal hazard to an errant vehicle (see example in [Figure 5-20](#)).
- A If a major drainage feature cannot effectively be redesigned or relocated, it should be shielded by a suitable traffic barrier if it is in a vulnerable location. AASHTO's *Roadside Design Guide* (9) should be consulted for details on the design of these structures.

Figure 5-20. Example of a Culvert.

Culvert headwalls can result in serious injury or death when struck at moderate or high speeds on rural roadways. While relocating such culverts further from the roadway may be feasible under certain conditions, the ideal solution would be to reconstruct the drainage facilities so that they are flush with the roadside terrain and present no obstacle to motor vehicles. Such designs would essentially eliminate culvert crashes, although run-off-road vehicles could still strike other obstacles (e.g.,

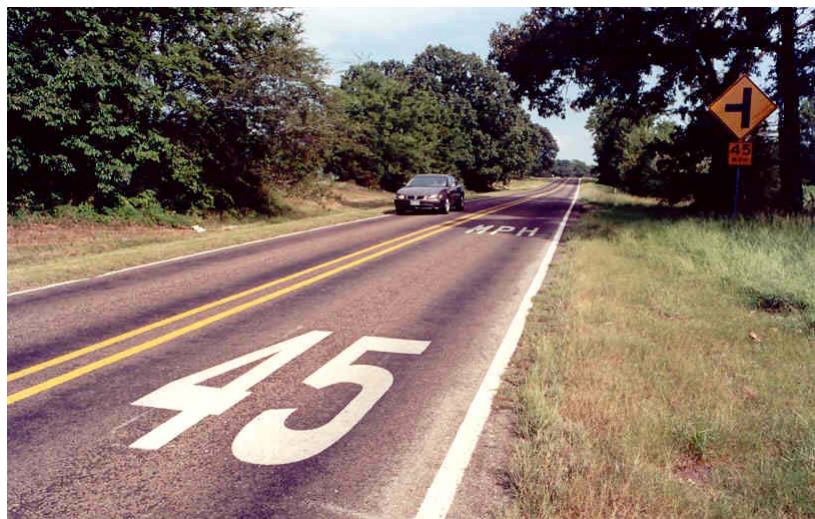
Signs, pavement markings, and delineators in advance and at a horizontal curve can provide drivers with additional information concerning the upcoming roadway. Figures 5-21 and 5-22 are examples of advance pavement markings and signing, respectively, for a horizontal curve.

Figure 5-21. Example of Advance Pavement Markings for a Horizontal Curve.

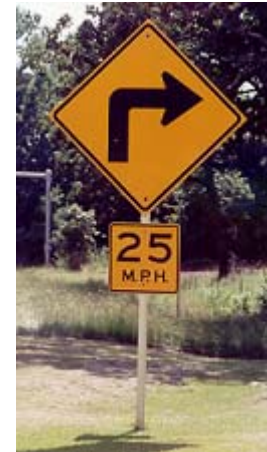
Figure 5-22.
Example of
Advance Sign for a
Horizontal Curve.

A 1980s study in Ohio examined the effectiveness of advisory speed signs used in conjunction with curve warning signs (44). Based upon the findings from the 40 test drivers, the author concluded that advisory speed signs are not more effective in causing drivers to reduce their speeds through curves than curve and turn signs alone. Other studies have also found that various sign treatments for reducing traffic speeds in the vicinity of horizontal curve have generally been ineffective (45, 46).

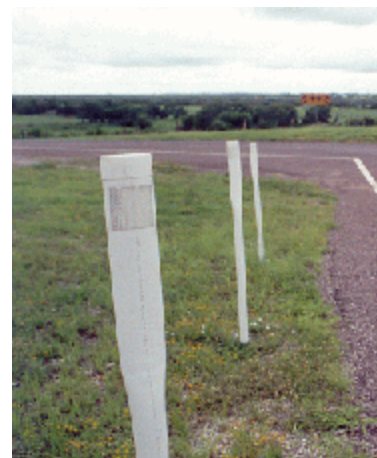
Figure 5-24. Example of Post-Mounted Delineator.

Raised pavement markers can be used to show roadway alignment or to replace or supplement other pavement markings. Post-mounted delineators (PMDs) are light-reflecting devices mounted at the side of the roadway, in series, to show the roadway alignment (see examples in Figures 5-24 and 5-25). Their purpose is to outline the edges of the roadway and to accent critical locations.

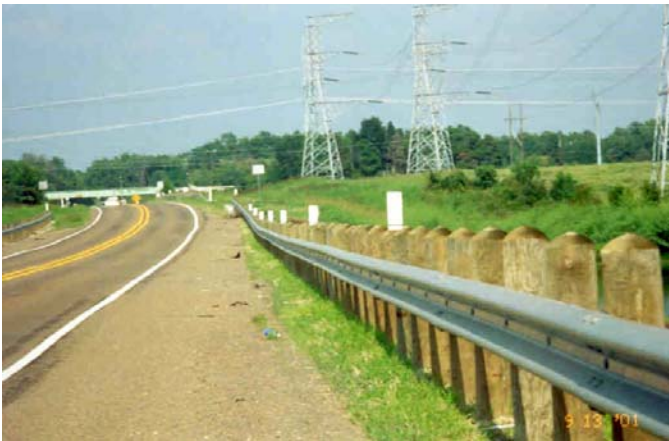
Figure 5-25. Post-Mounted Delineators with a Guard Rail.

Several researchers (50, 51, 52, 53) have reported that post-mounted roadside delineation reduced the crash rate only on relatively sharp curves during periods of darkness. Studies by the Arizona Highway Department (54) suggest that neither edge lines nor post-mounted delineation have any significant effect on the crash rate on open tangent sections. Other studies indicate that post delineators do have an effect and that highways with post delineators (in the presence or absence of edge lines) do have lower crash rates than those without post delineators. Further,

Three post-mounted delineator systems used in Virginia were tested in the 1980s at five sites for their effectiveness in controlling run-off-road crashes (56). The changes in speed and lateral placement with the systems in place were taken as driver responses to the systems. The study indicated that drivers react most favorably to chevron signs on sharp curves greater than or equal to 7 degrees and to standard delineators on curves less than 7 degrees.

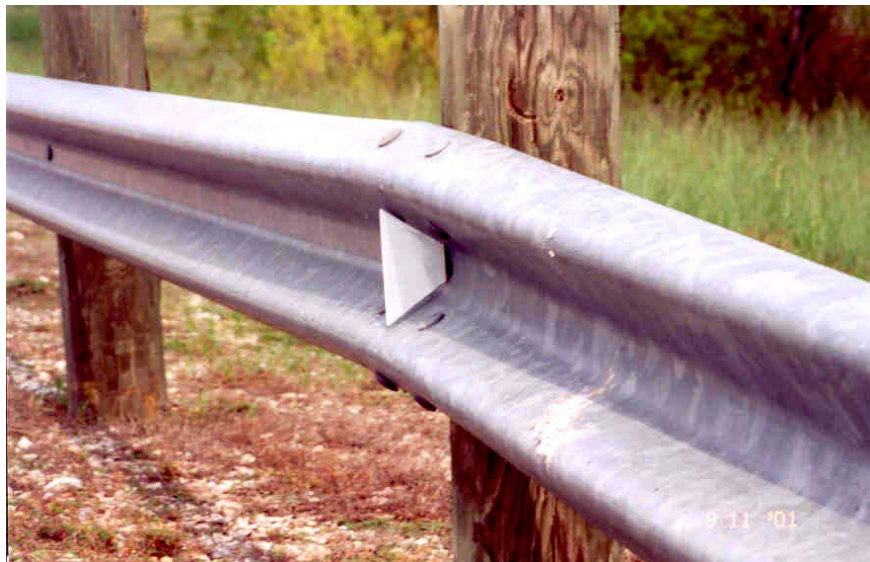
Figure 5-26. Reflector Installed in Guardrail.

Barrier reflectors primarily consist of the reflective surface and the mounting apparatus. The reflective surface may be trapezoidal or circular in shape, and may be white/crystal or yellow/amber in color (see Figures 5-26 and 5-27). Also, reflectors may be one-way or bi-directional, based on the needs of the site. Depending on reflective surface, color, and directionality, reflectors are sold for approximately \$3.00 each, often purchased in quantities of 50 or 100 (62).

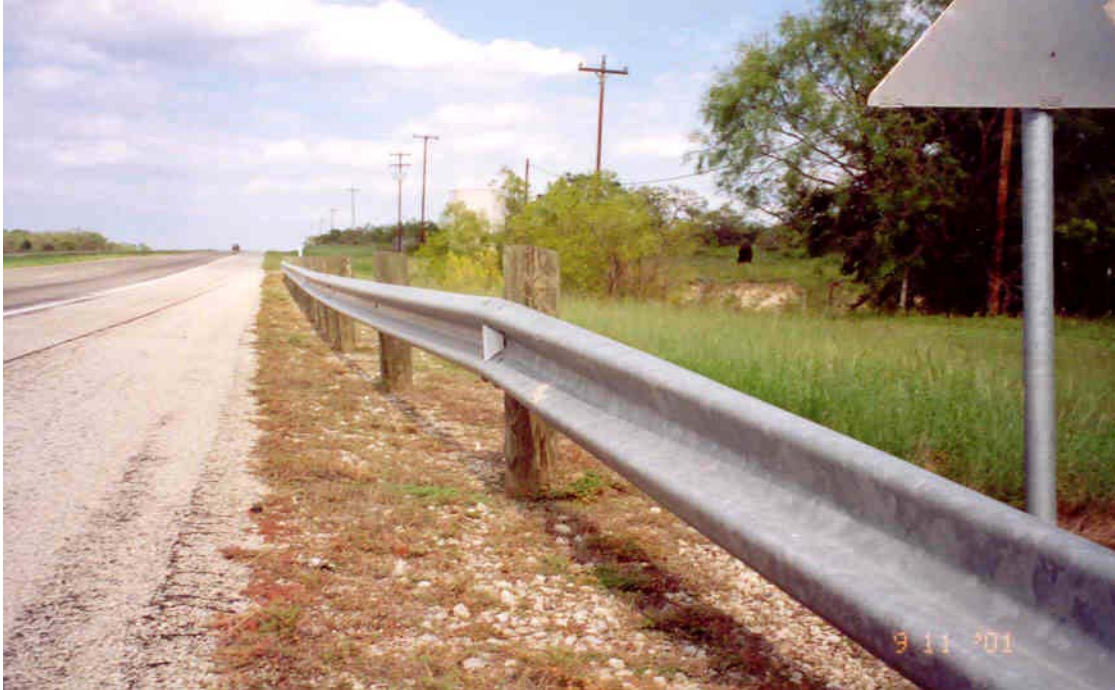
Figure 5-27. Two-Lane Highway with Barrier Reflectors.

Installation of barrier reflectors is fairly simple. Some reflectors come with a sticky base surface that is made to adhere to the surface of the guardrail, forming a seal bond. Others have a base that is bolted or screwed into the guardrail to permanently attach it.

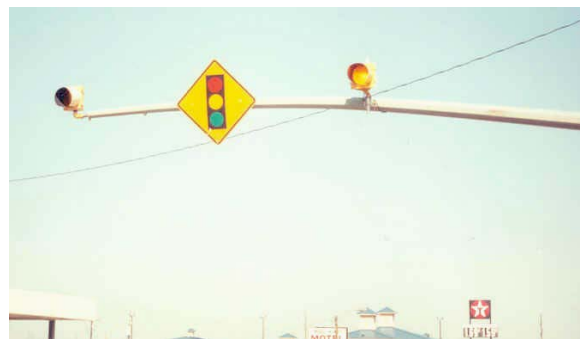
Figure 6-1. Example of Overhead Advance Signing.

The combination of infrequent intersections and high speeds along a rural two-lane highway creates a situation where conflicts are unexpected. Signs and pavement markings have been used to inform drivers of an intersection or a signal. Figures 6-1 to 6-4 are examples of advance signs and pavement markings used in Texas. Figure 6-5 is an example of using flashers on a Stop sign to increase the visibility of the sign.

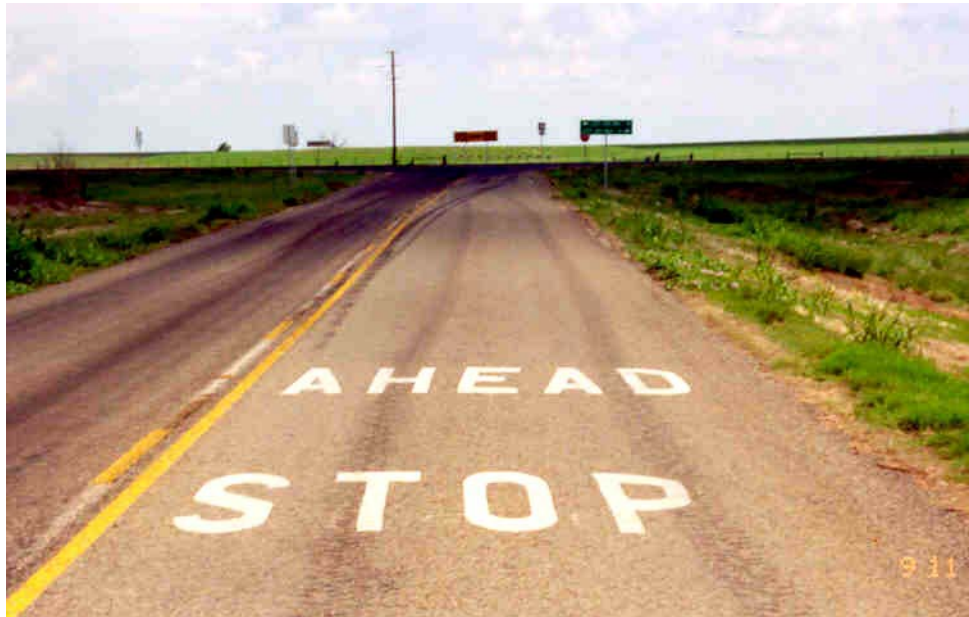
Figure 6-2. Example of Advance Warning Pavement Markings.

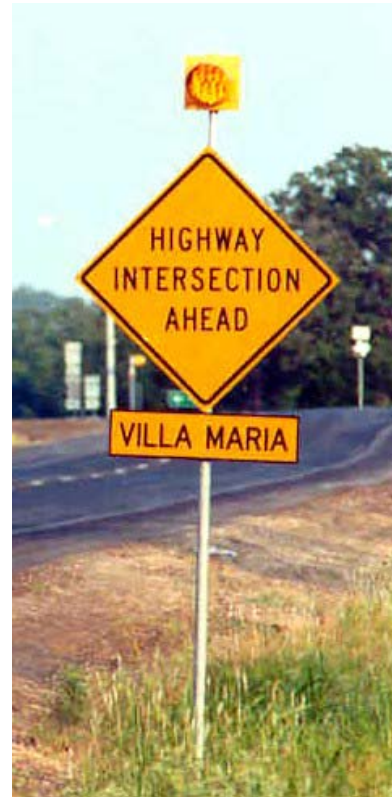
Figure 6-3. Example of Flasher on Advance Intersection Sign.

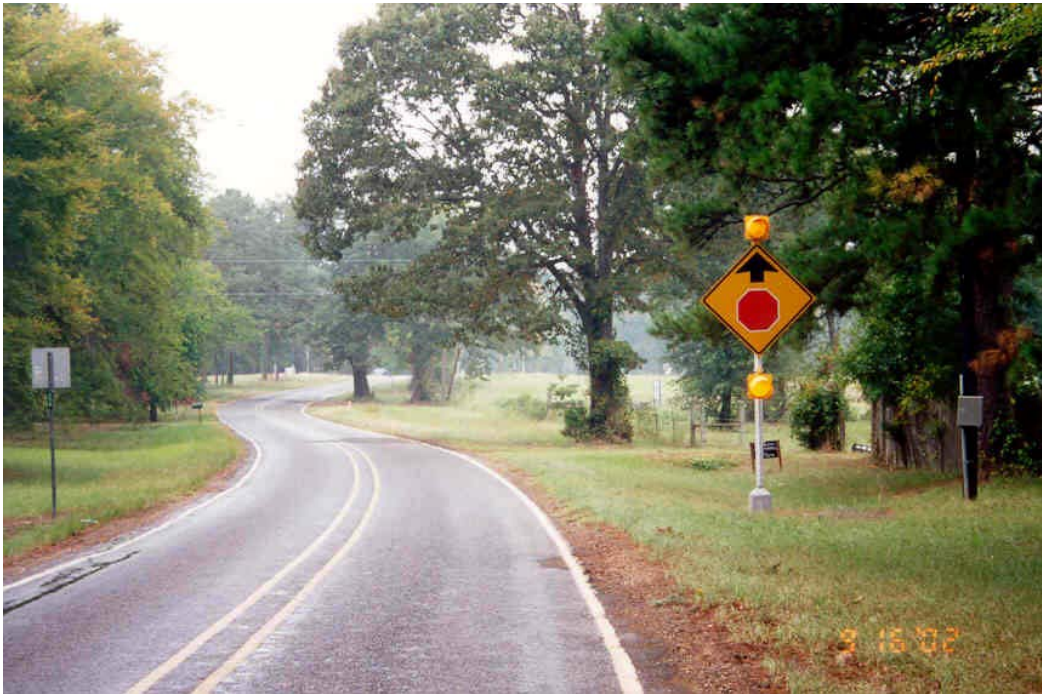
Figure 6-4. Example of Flasher on a Stop Ahead Sign.

A two-year study (87) being conducted for TxDOT is testing the use of Be Prepared to Stop When Flashing signs. These signs are being implemented at two locations in Waco and Brenham. The study results and recommendations should be available in 2003.

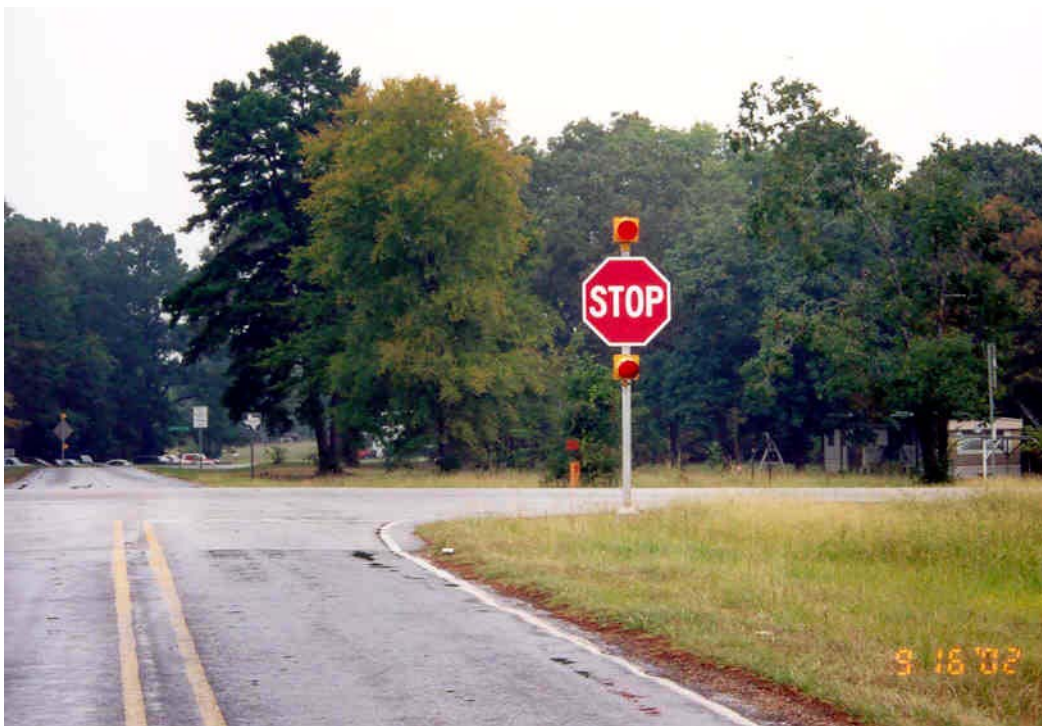
Figure 6-5. Example of Stop Sign with Flashers.

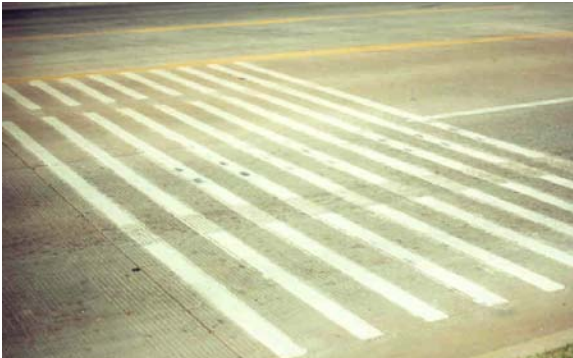
Figure 6-6. Example of Full-Width Approach Rumble Strips.

- A Rumble strips consist of intermittent narrow, transverse areas of rough-textured or slightly raised or depressed road surface that alert drivers to unusual motor vehicle traffic conditions. Through noise and vibration they attract the driver's attention to such features as unexpected changes in alignment and to conditions requiring a stop.

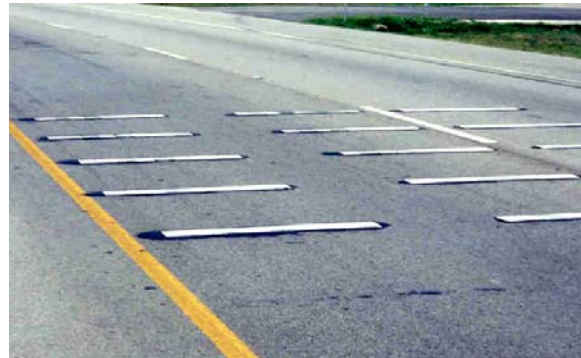
Figure 6-7. Application of Partial-Width Approach Rumble Strips.

Figures 6-6 and 6-7 show examples of rumble strips approaching intersections. While the *Texas MUTCD* (5) does not provide information on the use of rumble strips at an intersection, it does provide the following support for transverse rumble strips as temporary traffic control zone devices and as approach end treatments for curb islands.

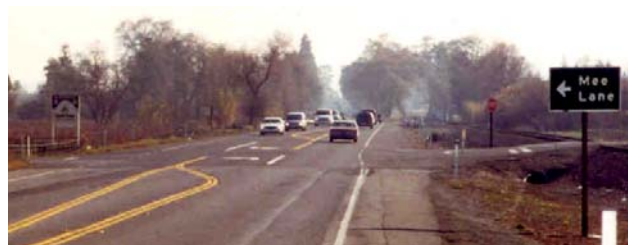
Figure 6-8. Examples of Left-Turn Lanes (2).

The left-turn lane is generally the key auxiliary lane at an intersection (see [Figure 6-8](#) for an example). It creates the opportunity to separate and avoid speed differences between the turning vehicle and the through vehicles. It also decreases the delay that can be experienced by through vehicles behind a turning vehicle. By increasing the operational efficiency of the intersection, the capacity and safety are also increased. In addition, left-turn lanes can provide increased visibility to the turning vehicle by the opposing traffic.

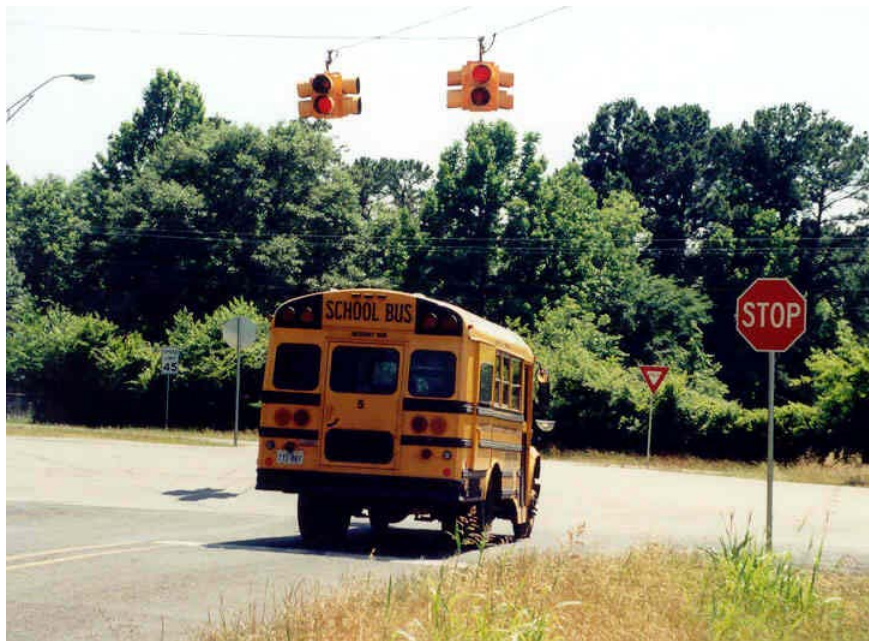
Figure 6-10. Intersection Flashing Beacons.

Intersection control beacons have flashing yellow or red indications on each face (see [Figure 6-10](#)). They are intended for use at intersections where traffic or physical conditions do not justify conventional traffic signals but where high crash rates indicate a special hazard. Intersection control beacons are used in conjunction with Stop signs at isolated intersections or intersections having sight distance obstructions. Research findings recommend that they not be used at “Y,” offset, or intersections with more than four legs because the geometry of these intersections frequently does not provide an adequate line of sight from all intersection legs to a center-mounted beacon.

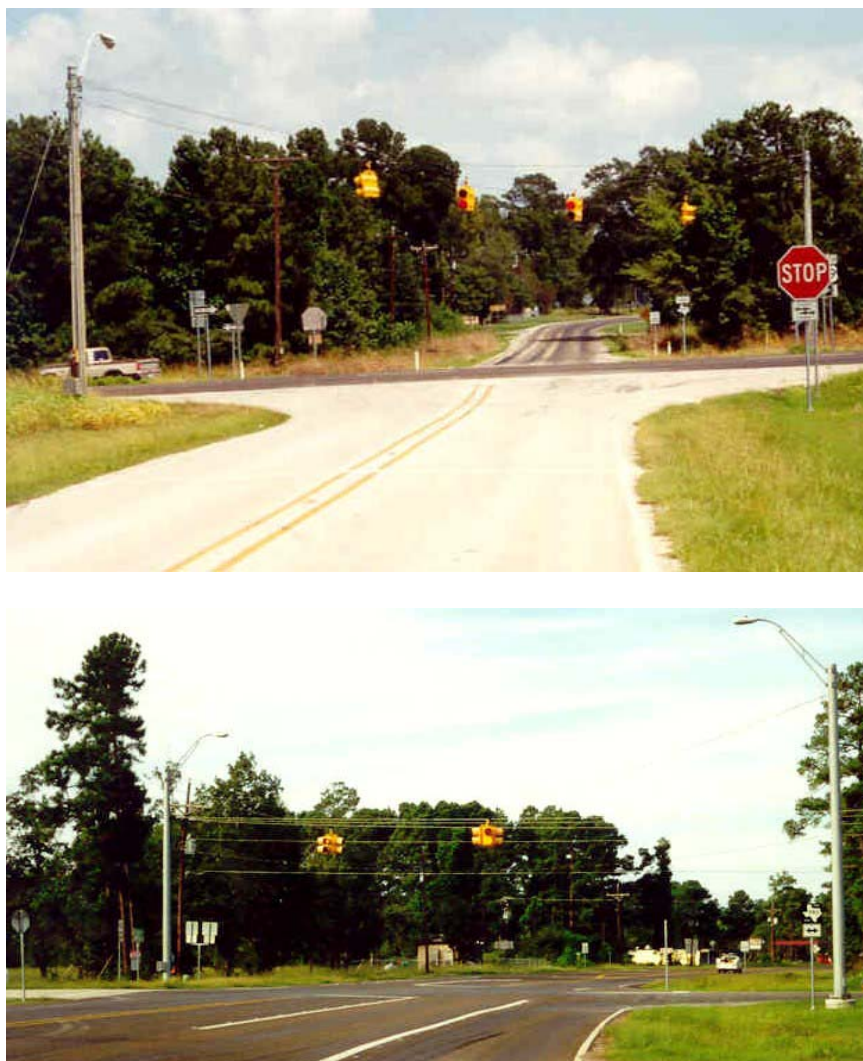
Figure 6-11. Examples of Intersections with Flashing Beacons.

The characteristics of traffic flow at rural, low-volume intersections controlled by Stop signs and by intersection control beacons in conjunction with Stop signs were examined in a 1990s study (102). The study found that intersection control beacons generally reduced vehicular speeds in the major directions, particularly at intersections with inadequate sight distance. The intersection control beacons had, in general, little or no impact on accepted or rejected gaps. A large proportion of drivers (40 to 90 percent) violated Stop sign laws by not completely stopping at the intersections. The intersection control beacons were not necessarily effective in reducing Stop sign violations or crashes (see examples in Figure 6-11).

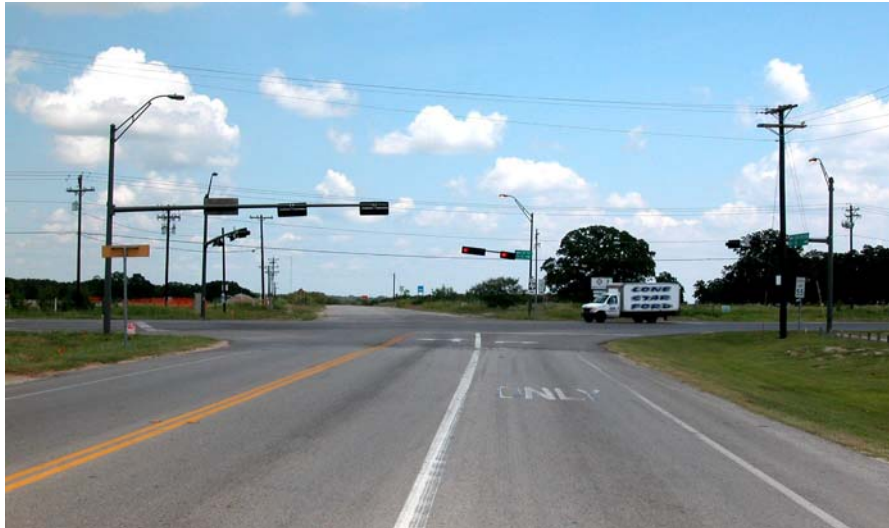
Figure 6-12. Example of Signalization.

Traffic control measures, such as signalization, are used at intersections where traffic volumes or conflicts are sufficiently large to require the management of the flows of individual movements and/or where crash rates are undesirably high (see [Figure 6-12](#)).

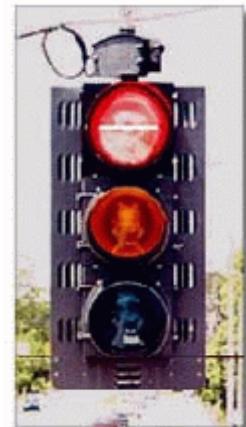
Figure 6-13.
Example of a High-Intensity Strobe (73).

Strobe-enhanced signals primarily consist of a standard signal head, with a custom visor and the strobe light components (see Figures 6-13 and 6-14). The strobe system provides a pulsating white strobe with the solid red indication. It is set to flash at a predetermined rate and duration whenever the red signal head is activated. A common flash rate is once per second for the entire duration of a red signal's interval (108). The idea is that the added visual stimulus of the flashing strobe will draw the driver's attention to the signal, thus improving visibility and available time to respond.

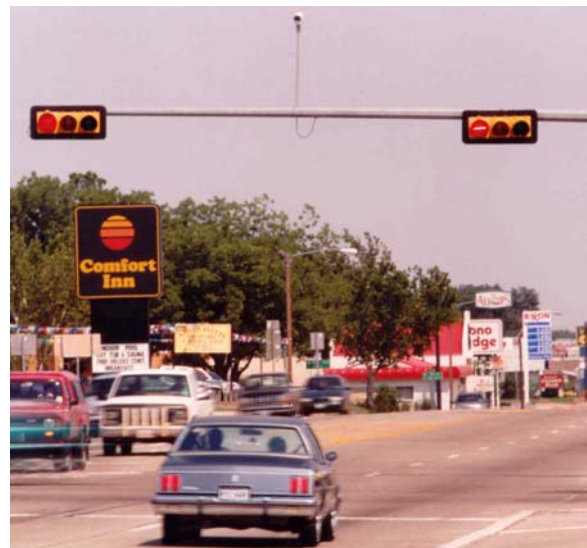
Figure 6-14. Strobe-Enhanced Signal Heads.

Virginia sponsored a study to evaluate the effectiveness of using strobe lights in the red lens of traffic signals (109). Its before-and-after analyses of six intersections found no statistical evidence indicating that strobe lights are effective in reducing crashes. Findings showed marginal improvements at some locations and no effect or negative effects at other locations. Changes in number of crashes varied from a 75 percent decrease (from four before to one after angle crash) to a 400 percent increase (from one to five angle crashes). The results from this study led the researchers to conclude that they had no basis to recommend the use of strobe lights. They did note that although the sample size was too small to allow definitive conclusions, the use of two strobe lights per approach appeared to be more effective than the use of one per approach.

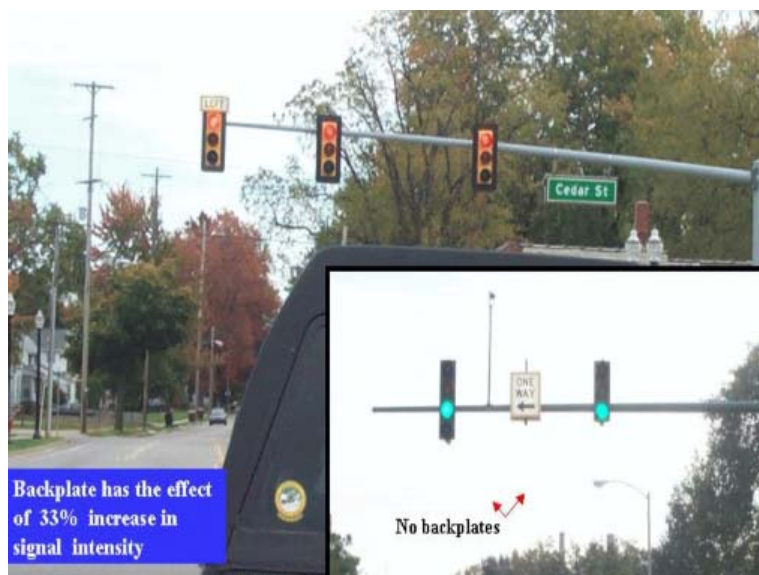
Figure 6-15. Heads with and without Backplates (111).

Backplates make it easier for the motorist to distinguish traffic signal displays from tree or sky background (see Figure 6-15). While a backplate would be helpful at any signal, areas of greatest need include:

Backplates can attach easily to signals on mast arm poles. If a backplate is installed on a signal head that is suspended by a single span wire, it is recommended that a second span wire is attached to the bottom of the signal head.

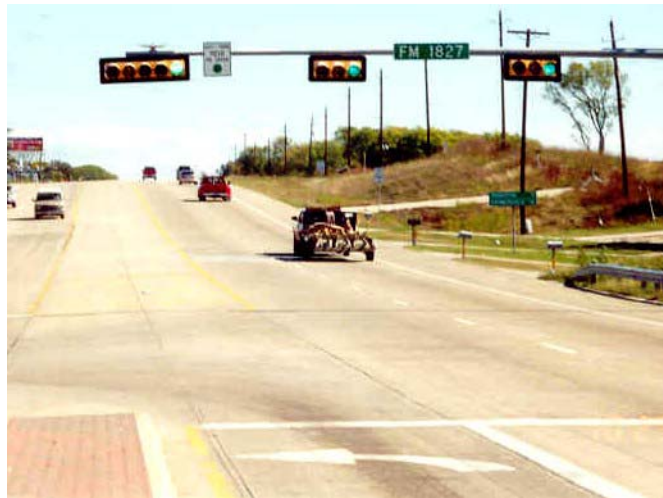
Figure 6-16. Backplates at Local Intersection.

The front surfaces of backplates are to have a dull black finish to minimize light reflection and to increase contrast between the signal indication and its background (see [Figure 6-16](#)) (5).
