TREATMENTS FOR CRASHES ON RURAL TWO-LANE HIGHWAYS IN TEXAS

for
Texas
Department of
Transportation

by
Texas
Transportation
Institute

April 2002
Report 4048-2

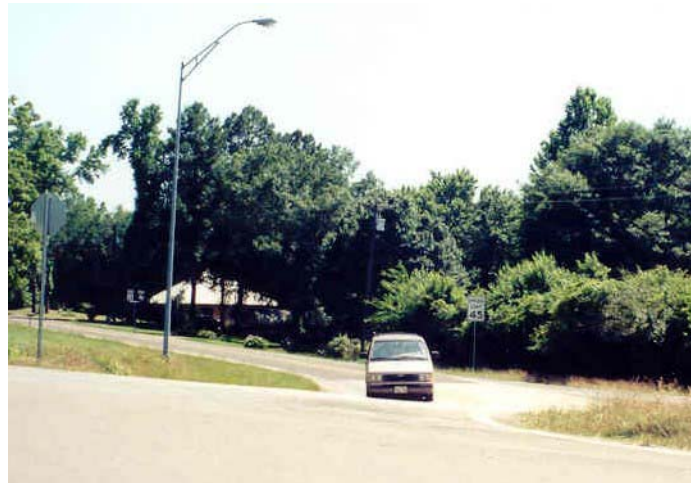
Figure 6-17. Example of Lighting at Complex Intersection.

The objective of a fixed lighting system is to supplement the headlights of automobiles and to render objects that are distant, complex, or that have low contrast more visible to motorists and pedestrians. Figures 6-17 and 6-18 are examples of lighting used at a complex intersection. Because of costs, continuous lighting systems are not generally employed in rural areas; however, lighting systems can improve safety at isolated, rural at-grade intersections. The reader can consult the following for more information on the design of a lighting system:

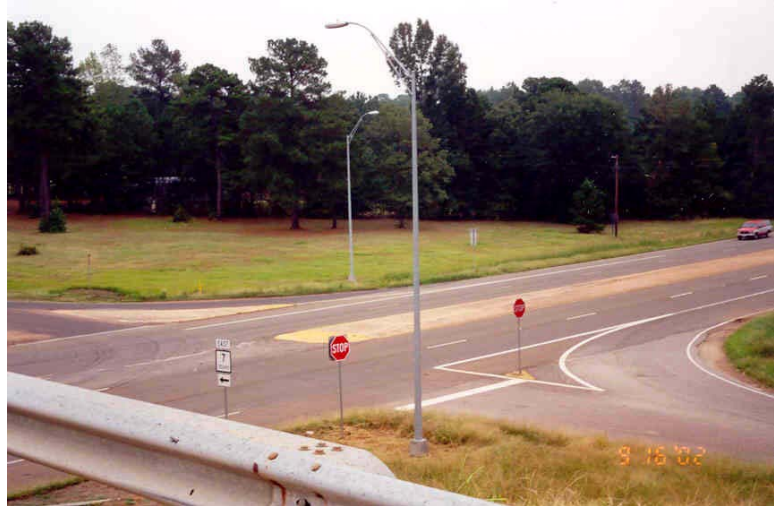
Figure 6-18. Example of Lighting at Complex Intersection.

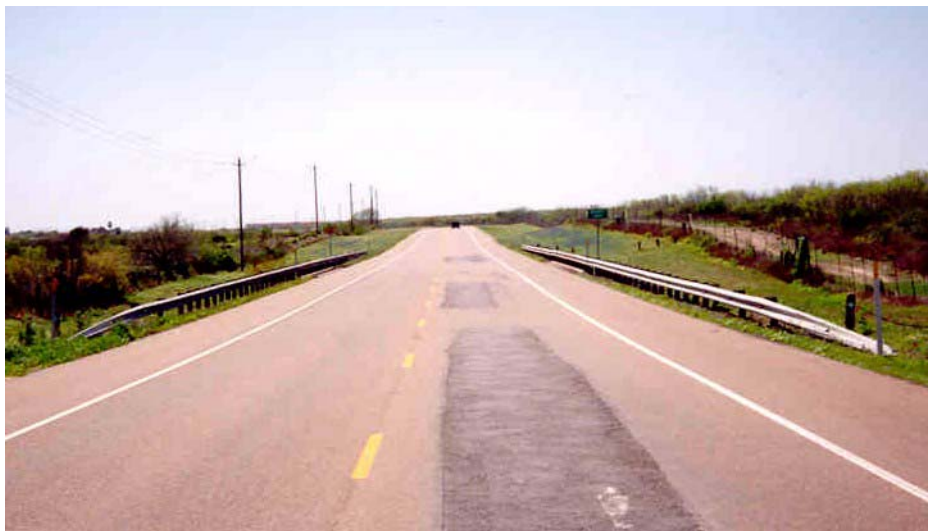
Figure 7-2. Guardrails on SH 16, North of Hebbronville.

In July 1998, TxDOT Pharr District personnel installed barrier reflectors (also known as in-line reflectors) on SH 16 north of Hebbronville (see Figures 7-2 to 7-4). The reflectors were installed because TxDOT personnel saw how they helped delineate guardrail locations in other parts of the state and wanted to try them in the Pharr District. The cost for the installation was minimal; TxDOT sign crews installed the reflectors while they were in the area for other activities. The material cost for the reflectors is \$2.72 per reflector (TxDOT inventory stock number 153915), although another TxDOT district provided the materials for the installation at this site.

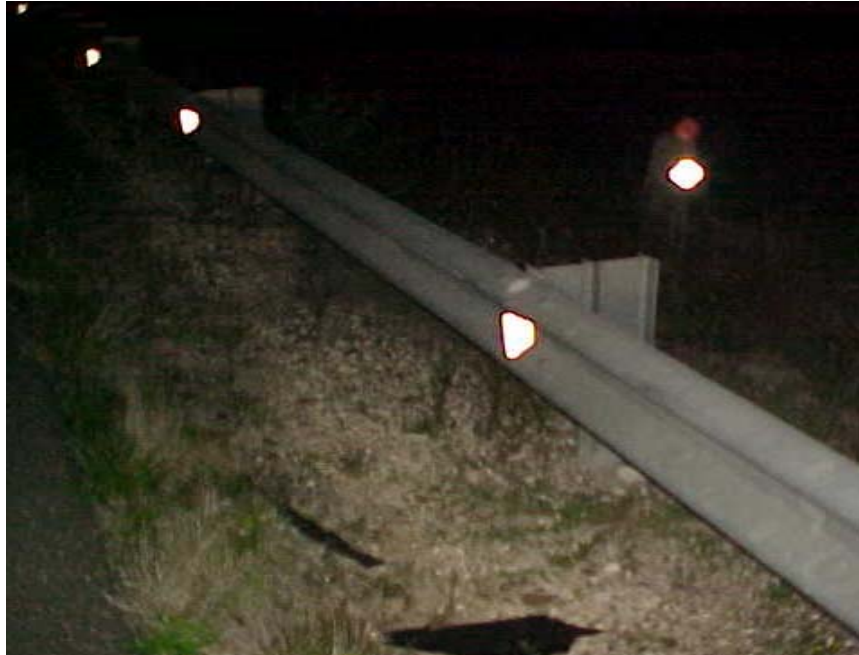
Figure 7-3. Barrier Reflectors on SH 16 at Night.

TxDOT has received positive comments from the public, including comments that the bi-directional reflectors help guide drivers down the center of the road between the guardrails during fog or heavy rain. Additionally, long-haul truck drivers have stated that the reflectors help to delineate the guardrails from a much greater distance. Older drivers have noted that the rails are much more visible with the barrier reflectors.

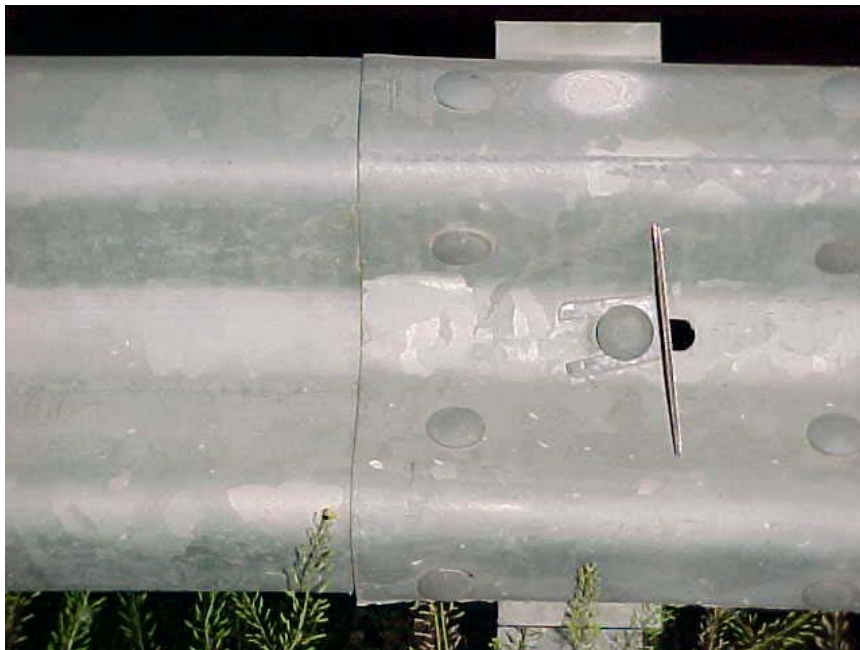
Figure 7-4. Close-Up of Barrier Reflector.

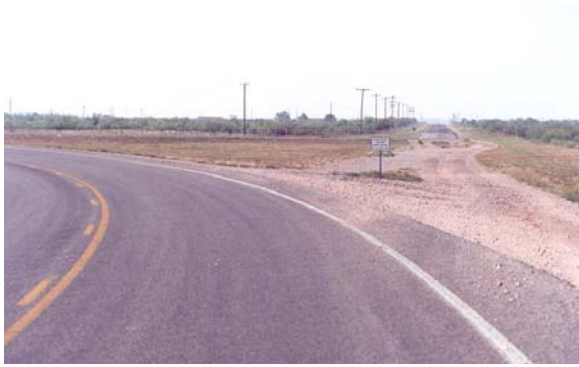
Figure 7-7. Obliterated Roadway Section.

Figures 7-7, 7-8, and 7-9 illustrate the realigned roadway and intersection. Older drainage structures were also replaced with safety end treatments (SETs) as part of this project (see Figure 7-10). The cost for the roadway realignment in 1999 was \$52,751, and the cost for the SETs was \$78,190.

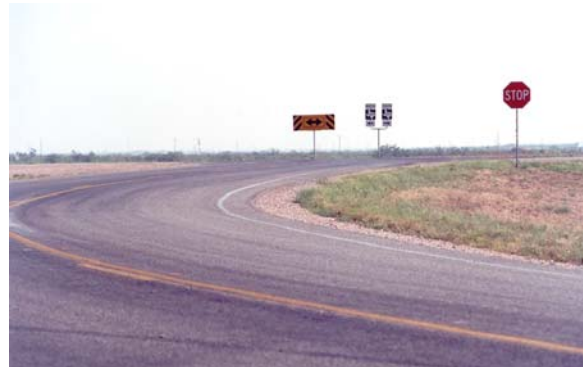
Figure 7-8. New Roadway Section.

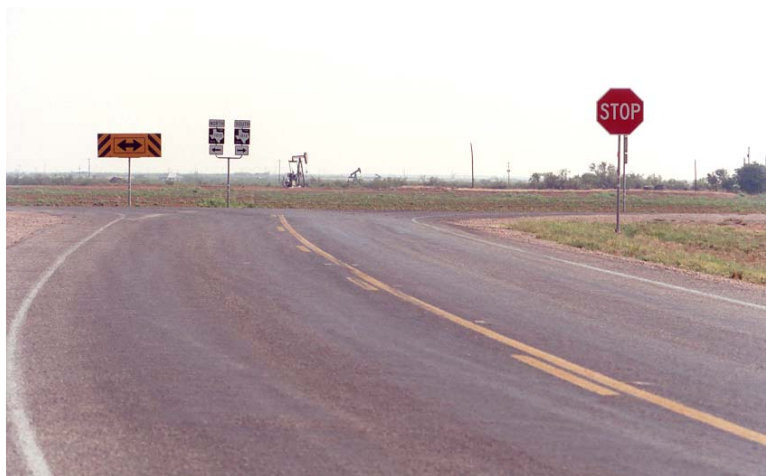
Figure 7-9. New Roadway Intersection.

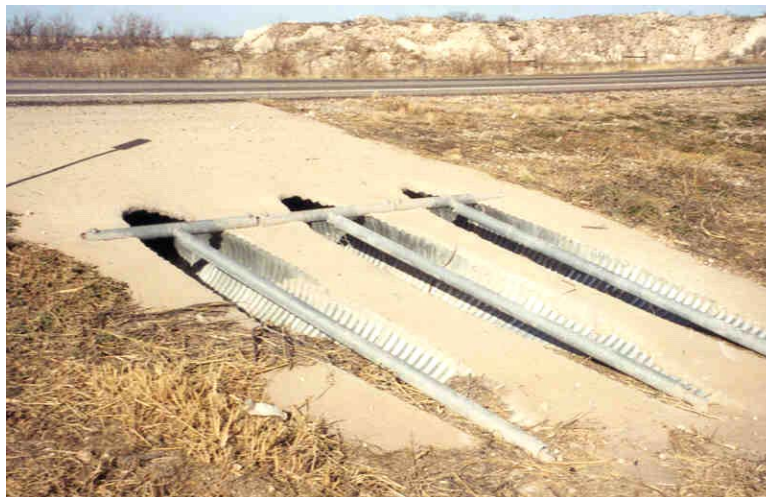
Figure 7-10. New Safety End Treatment on FM 1212.

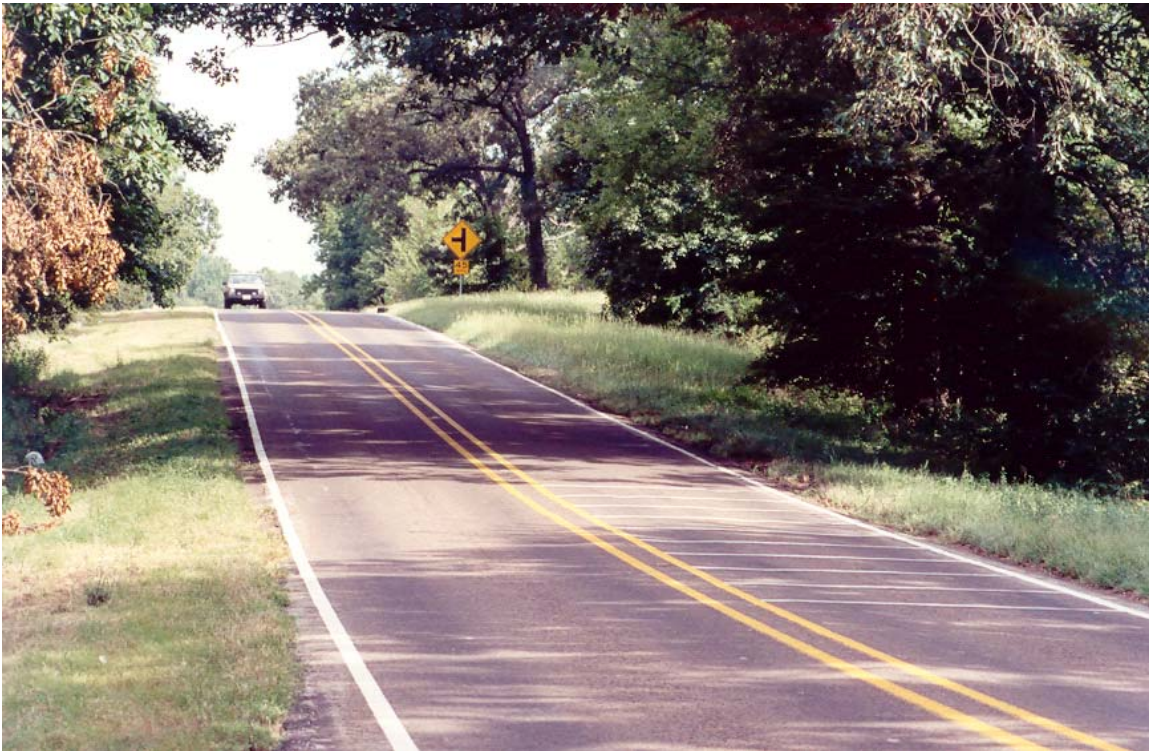
Figure 7-11. Grade Change Sight Distance Restriction.

FM 21 is a 60 mph (97 km/h) roadway with an ADT of 1650 vehicles per day located in Titus County. There is a severe sight distance restriction in one direction prior to the intersection with CR 2347 (see [Figure 7-11](#)). Although there was very little history of crashes at this intersection, there were several complaints about the intersection and the lack of sight distance. The district decided to warn drivers of the upcoming intersection.

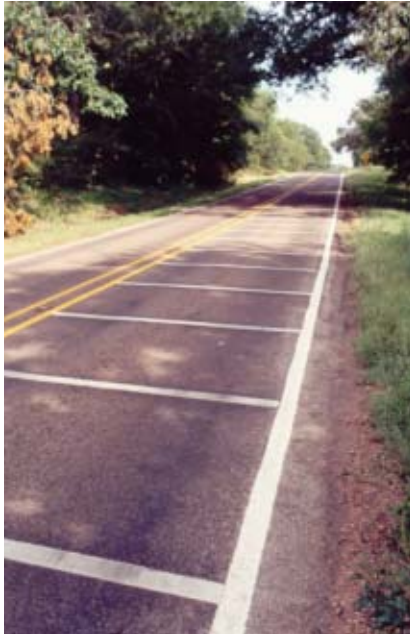
Figure 7-12. Rumble Strips Warning of Approaching Intersection.

In October 2000, the Atlanta District installed rumble strips and “45 MPH” pavement markings on FM 21 on the approach with the sight distance restriction as shown in [Figures 7-12](#) and [7-13](#). Although these measures were installed primarily in response to complaints, they may also be considered as preventative treatments for future traffic, as a subdivision is being developed on CR 2347. The cost for the rumble strips and pavement markings was approximately \$2000.

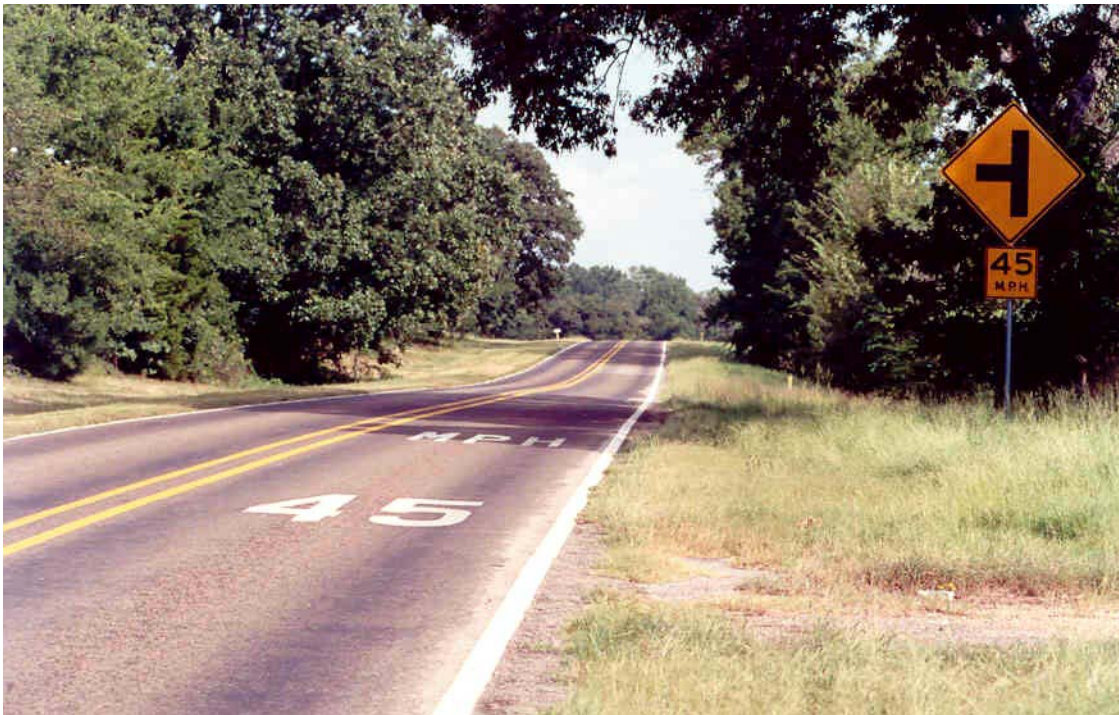
Figure 7-13. Pavement Markings Supplementing Advisory Speed Sign.

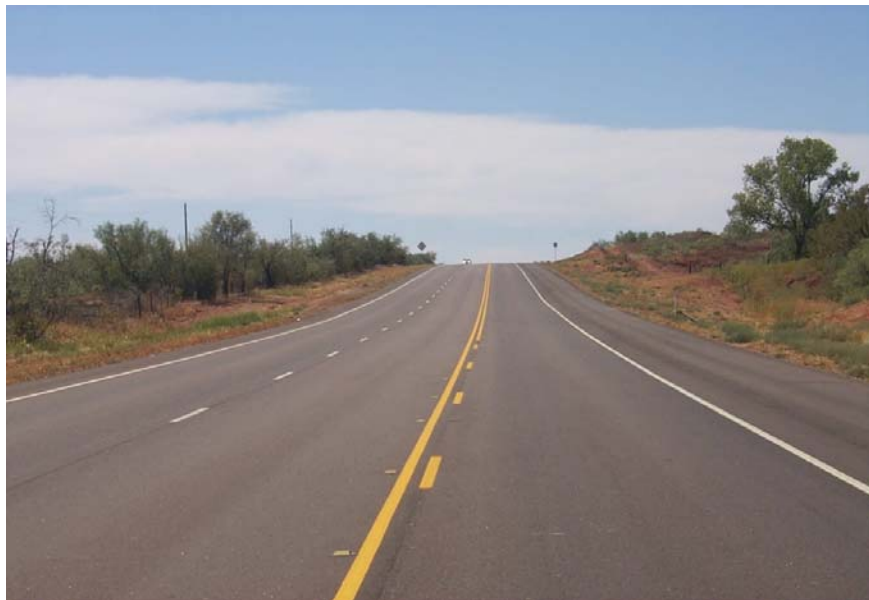
Figure 7-14. Passing Lane Section on US 83.

TxDOT installed a Super 2 section on US 83 when upgrading the roadway section (see [Figure 7-14](#)). The Super 2 design provides alternating passing lane sections on a previous two-lane, two-way roadway (see [Figure 7-15](#)). The Childress District installed the Super 2 section because it believed the roadway would be an economically feasible solution to provide safe passing maneuvers on US 83. [Figure 7-16](#) shows an example of a passing lane transition section.

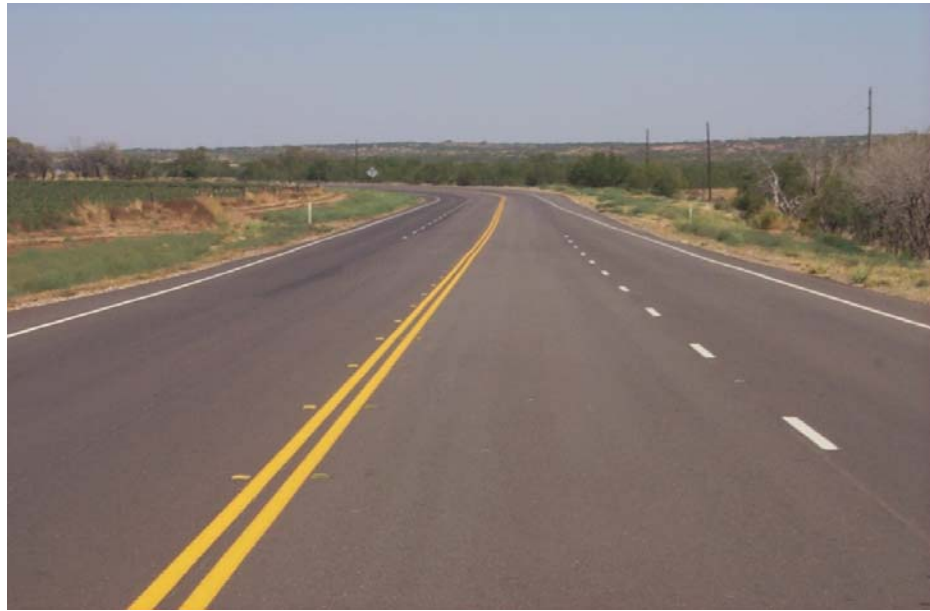
Figure 7-16. Passing Lane Transition.

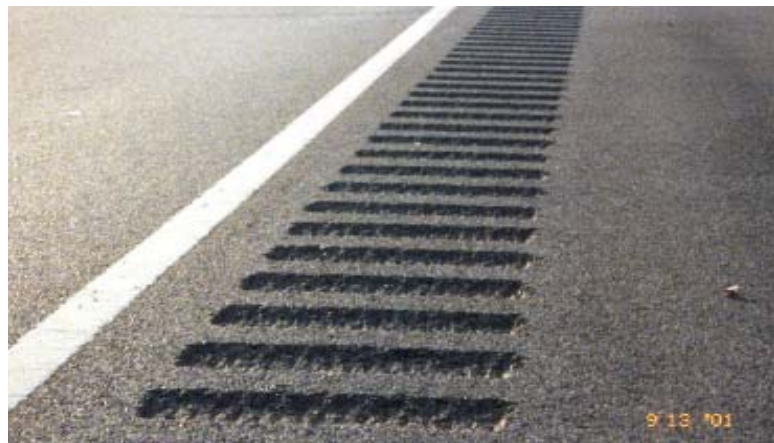
Figure 7-17. Close-Up of Edge Line Rumble Strips.

Edge line rumble strips were also installed as a part of this project (see [Figure 7-17](#)).

Based on positive feedback on the use of rumble strips on divided highways, TxDOT was willing to try the rumble strips on the Super 2 roadway to determine how the traveling public felt about their use on this type of roadway. TxDOT installed the rumble strips in accordance with TxDOT Standard ST (1)-96 for Depressed Shoulder Texturing, and the cost of installation was approximately \$480 per mile (1.61 km) for both shoulders. TxDOT believes that the rumble strips have helped to prevent run-off-road crashes, keep vehicles in the driving lane, and help prevent driving on the shoulders. As an additional benefit, snow plow crews were able to feel the rumble strips during snow plowing operations and were warned that they were drifting onto the shoulder.

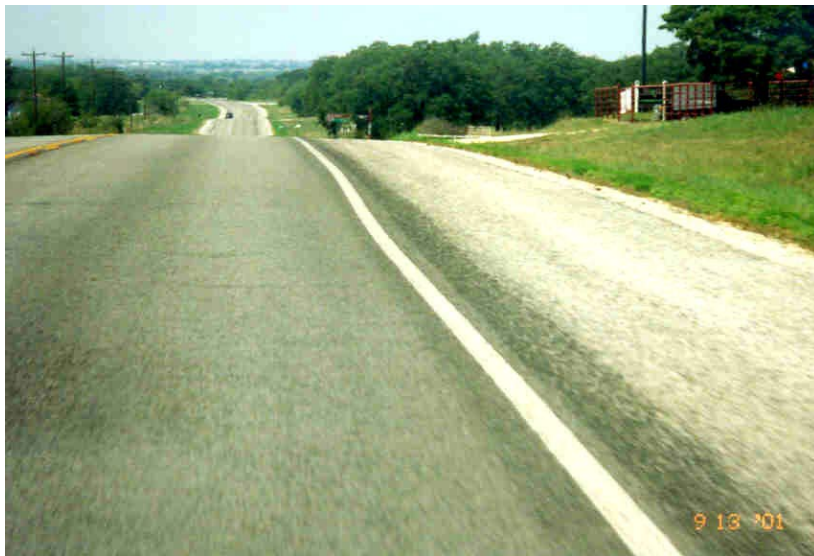
Figure 7-18. Shoulder Treatment on FM 3002.

FM 3002 in Cooke County is located in the southeast corner of the county. It is a 40-ft (12 m) section, including two 12-ft (3.7 m) lanes and two 8-ft (2.4 m) shoulders. FM 3002 serves as a commuter route to Dallas-Ft. Worth, and it also carries tourist traffic to Ray Roberts State Park. The roadway was constructed in the mid-1980s with 8-inch (20.3 cm) base (but no surface) on the shoulders. Due to the increasing traffic, the need for paved shoulders, and some run-off-road crashes, TxDOT reconstructed the shoulders. It removed and recompactd 6 inches (15.2 cm) of the shoulders and surfaced the entire roadway width. As a part of this project, the shoulders were also texturized in order to provide visual, audible, and tactile clues when a vehicle was leaving the travel lane (see Figures 7-18 and 7-19). The texturing was accomplished by applying a larger, uncoated seal coat on the shoulder while using a smaller, coated aggregate seal coat on the driving lanes. (The entire roadway was surfaced with straight white aggregate, while an additional black surface was added to the driving lanes.) This work was completed in February 2001.

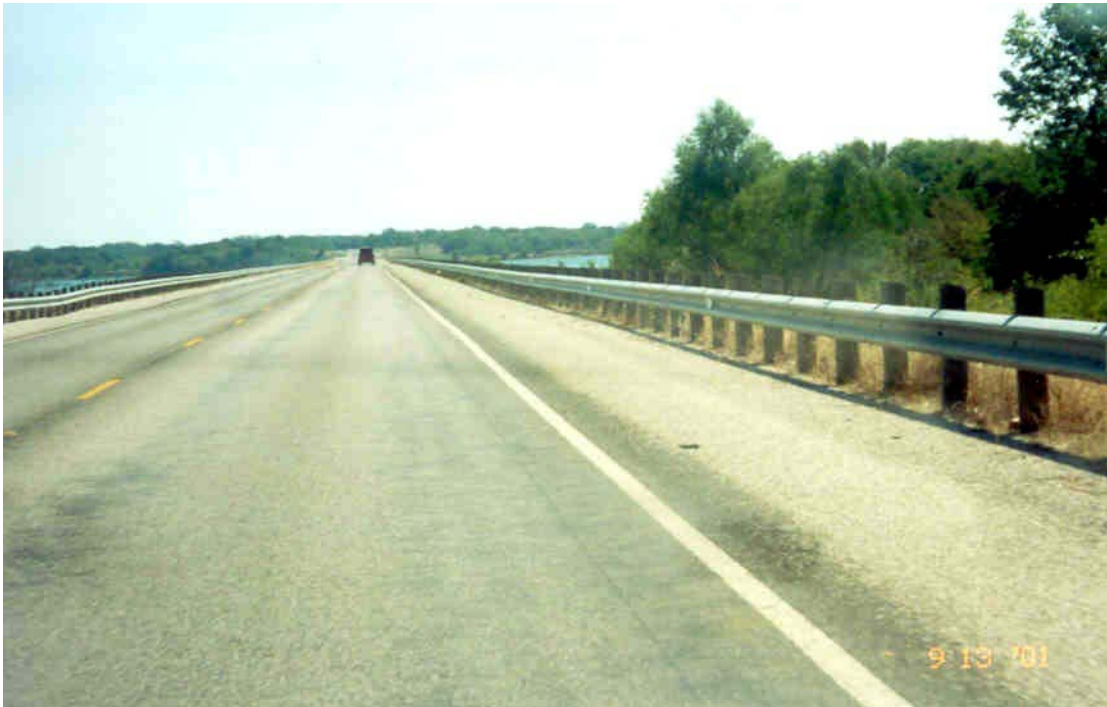
Figure 7-19. Another View of Shoulder Treatment.

The TxDOT district believes this treatment has been effective operationally due to the visual, audible, and tactile cues when a vehicle strays onto the shoulder. It is also perceived to have reduced the number of single-vehicle run-off-road crashes. This treatment had also received positive public comments regarding the drastic visual effect it has for nighttime travel. TxDOT is now adding shoulders and using this treatment on two other roadways.

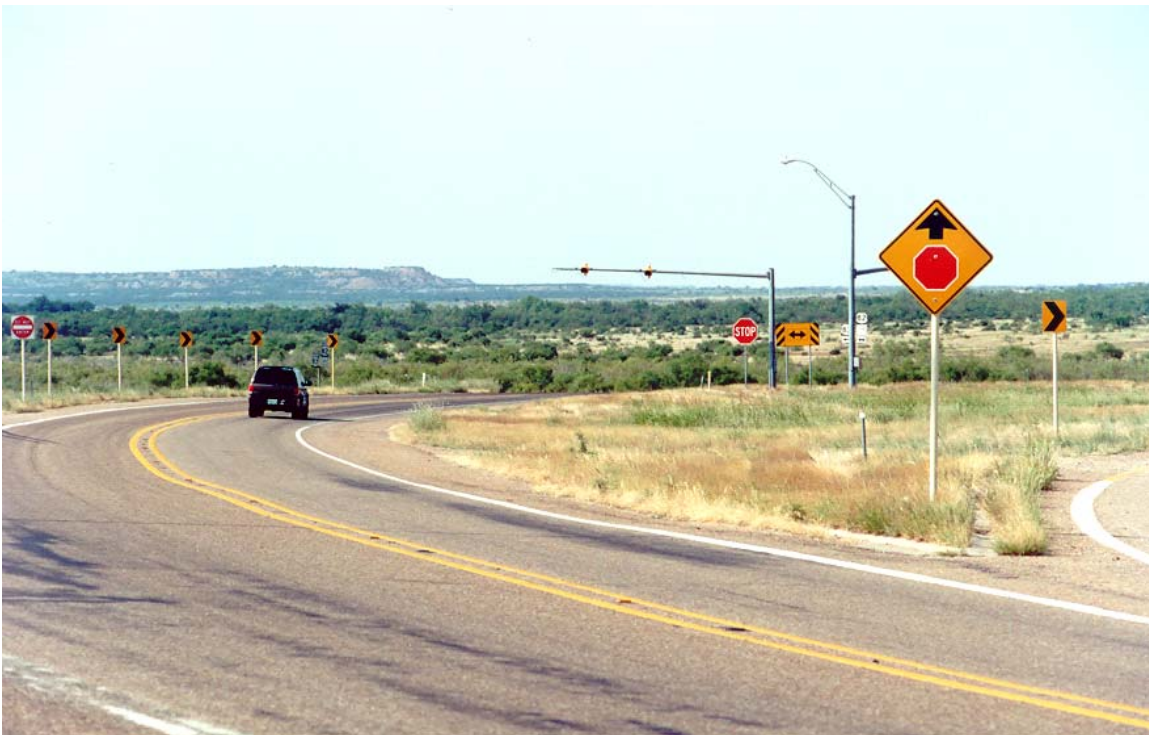
Figure 7-20. Signs and Flashers at Intersection of US 62/82 with US 83.

US 62/82 (SH 114) tees into US 83 in Guthrie, Texas in King County. Crashes were occurring where the drivers were not stopping at the intersection; instead, they drove through the intersection and into the property owner's fence. The Highway Intersection 1500 ft sign, Stop Ahead symbol sign with flashing beacons, and red flashing beacons on the mast arm post were installed in the summer of 1997 (see [Figure 7-20](#)).

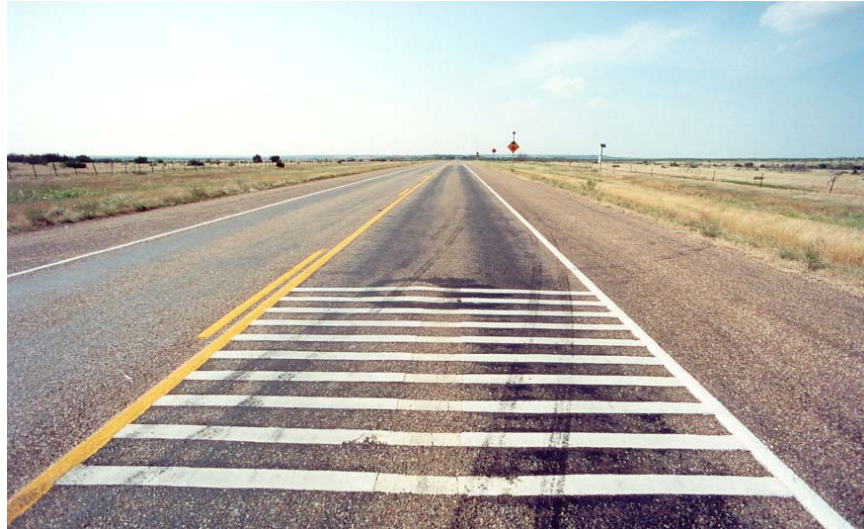
Figure 7-21. Rumble Strips Preceding Flasher and Sign on US 62/82.

In April 1998, TxDOT installed two sets of rumble strips on US 62/82 approaching the intersection in order to provide additional warning of the intersection (see [Figure 7-21](#)). The rumble strips consist of 10 strips that are 4.5-inches (11.4 cm) wide with a space of 9.5 inches (24.1 cm) between the rumble strips. The cost for materials and labor was \$456. The sets of rumble strips were located at 480 ft (146 m) and 1236 ft (377 m) from the intersection. TxDOT also installed “Stop Ahead” pavement markings (see [Figure 7-22](#)) and a Rumble Strips Ahead sign during the summer of 1998.

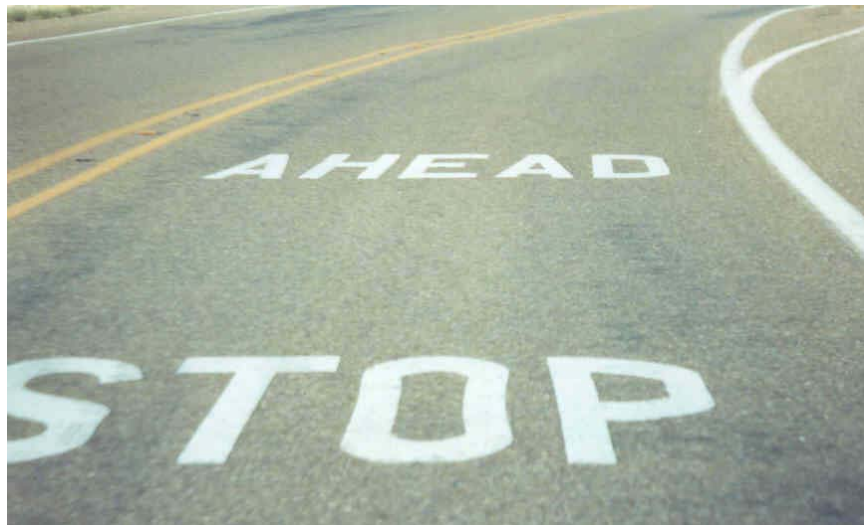
Figure 7-22. "Stop Ahead" Pavement Marking on US 62/82.

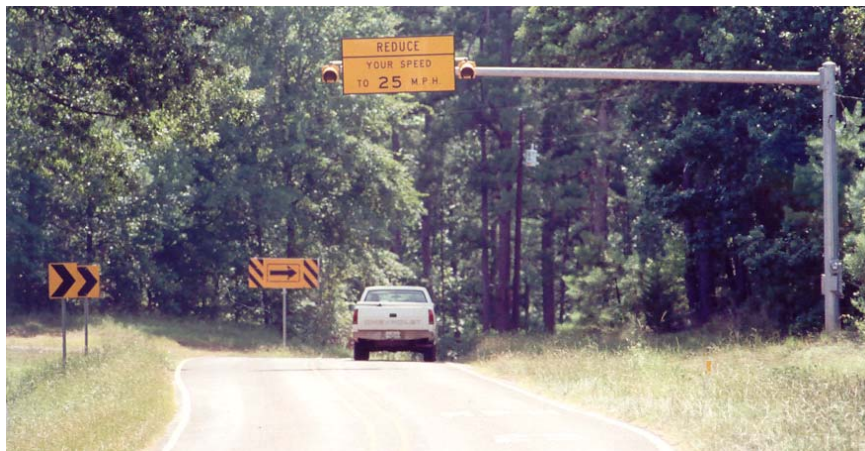
Figure 7-23. Various Warning Devices for Horizontal Curve.

When TxDOT responded to requests to improve the existing conditions, standard curve warning signs were in place. The W1-1 signs were located at 625 ft (191 m) prior to the curve on each approach. In September 1998, TxDOT added these measures in an effort to improve the safety on the curve (see Figures 7-23 and 7-24):

A Rumble strips, which were 4-inch (10 cm) lines of layers of hot tape. The original hot tape rumble strips have recently been replaced with preformed rumble strips, which are also 4 inches (10 cm) wide with 0.5-inch (1 cm) grooves (see Figure 7-25). These strips are installed with bituminous adhesive,

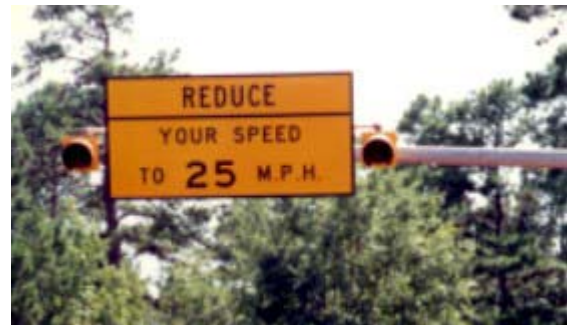
Figure 7-24. Flashers Activated When Speeds Exceed 30 MPH.

TxDOT had looked for a dynamic solution that did not involve reconstruction. The solution was the addition of a speed notification and detection device—a flashing sign that advises drivers to reduce their speed when they are detected to be driving more than 5 mph (8 km/h) over the speed limit. A radar detector measures speeds and displays them using a speed display sign stating: “YOUR SPEED IS . . .”. The setup was modified for this project so that when a speed is determined, a contact closure is opened or closed depending upon whether the beacons need to be activated.

When approaching the curve, drivers see the W1-1 warning sign at 625 ft (191 m) prior to the curve. Knowing that drivers don't normally slow to 25 mph (40 km/h) at this point, the overhead sign is located in the point of curvature for the curve to again warn drivers to slow. The radar is set to start processing the speed data about 300 ft (92 m) before reaching the overhead sign. The beacons will start flashing within 0.5 second if a vehicle is traveling at 30 mph (48 km/h) or over, will stop flashing if the vehicle slows to below 30 mph (48 km/h), and will be triggered again if the vehicle speeds up. The intent is that the beacons are flashing only for vehicles that are traveling at 30 mph (48 km/h) or greater rather than flashing continuously, making the system more dynamic and driver responsive. The cost for the sign system and installation was approximately \$18,000.

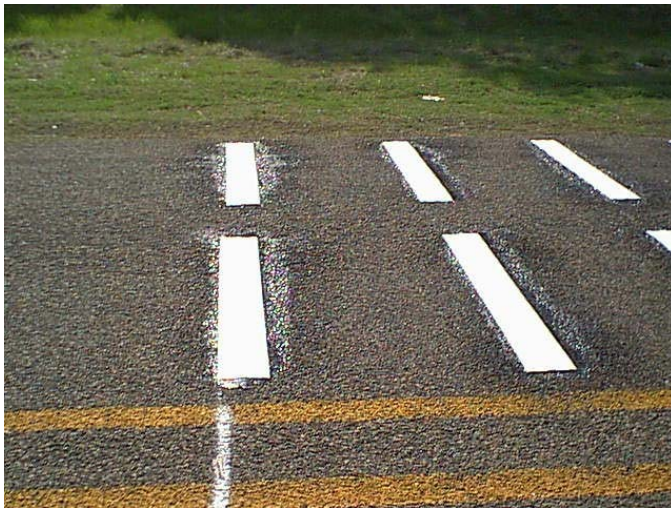
Figure 7-25. Recently Replaced Rumble Strips.

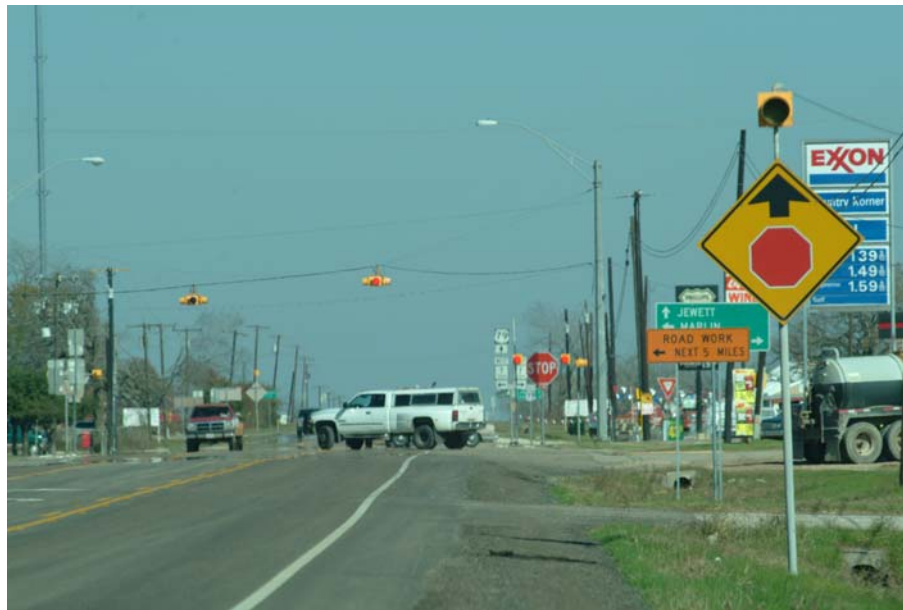
Figure 7-26. Beacons on Stop Ahead Sign.

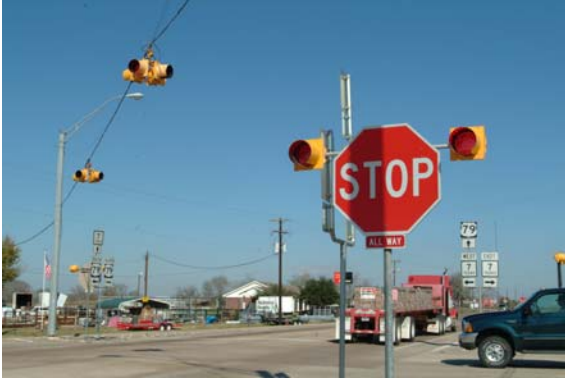
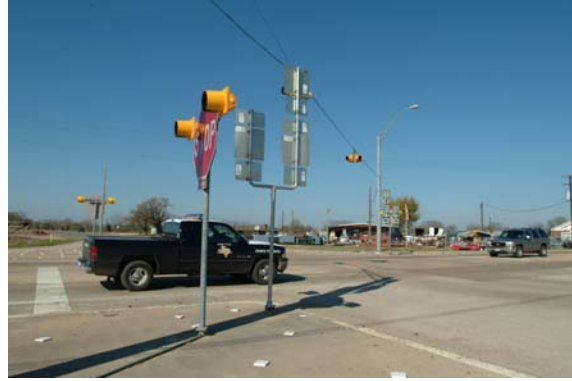
Figure 7-27. Different Views of Beacons on Stop Sign.

In September 1994, right-turn lanes were added to all four approaches with Cross Street Does Not Stop advance warning signs on the minor approach. Severe crashes in 1997 prompted a review of the location. In December 1997, a decision was made to remove the overhead flashers and to convert the intersection to all-way stop control. In addition to converting the control at the intersection to an all-way stop, additional signing and beacons were added. District personnel installed advance flashing beacons with Stop Ahead signs on all approaches (see [Figure 7-26](#)). At the intersection, flashers were added to the Stop signs (see [Figure 7-27](#)). The project was completed in March of 1998.

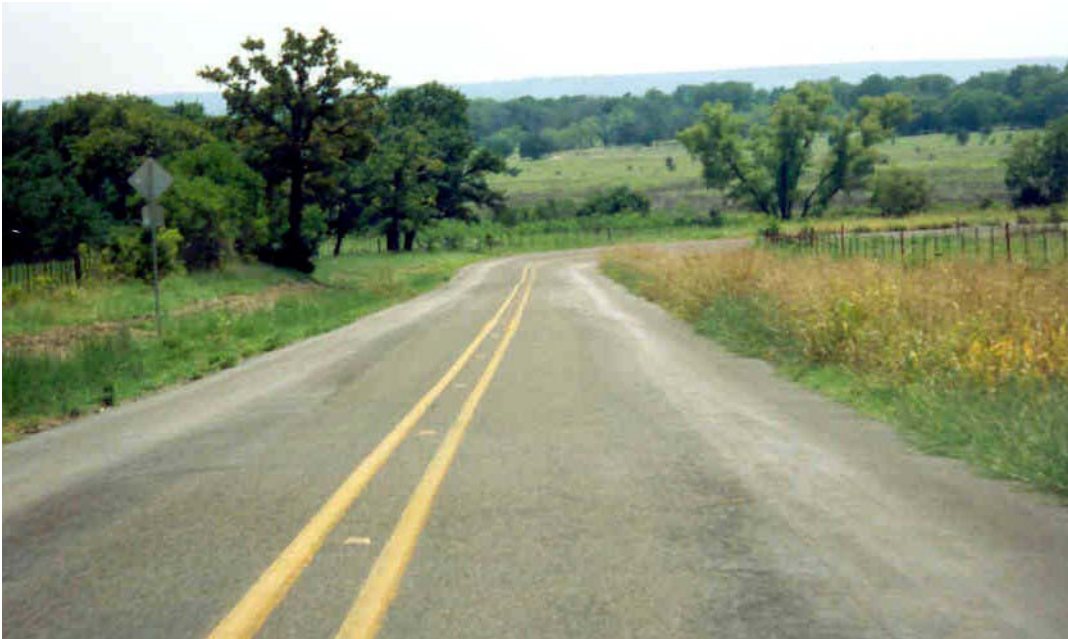
Figure 7-28. Widened Section of FM 183.

In April and May of 2001, the TxDOT Waco District widened 10 miles of the roadway by adding a total width of 4 ft (1.2 m) (2 ft [0.6 m] on each side). Figures 7-28 and 7-29 show views of the roadway. The additional roadway width was added in order to provide a more permanent roadway upgrade. The cost of the roadway widening was \$199,000.

The roadway widening provides better driving conditions, including lanes that are 11 ft (3.4 m) wide versus 8.5 to 9 ft (2.6 to 2.7 m) wide. The TxDOT district believes that this treatment would be beneficial for other narrow farm-to-market roads that do not require a lot of subgrade work.

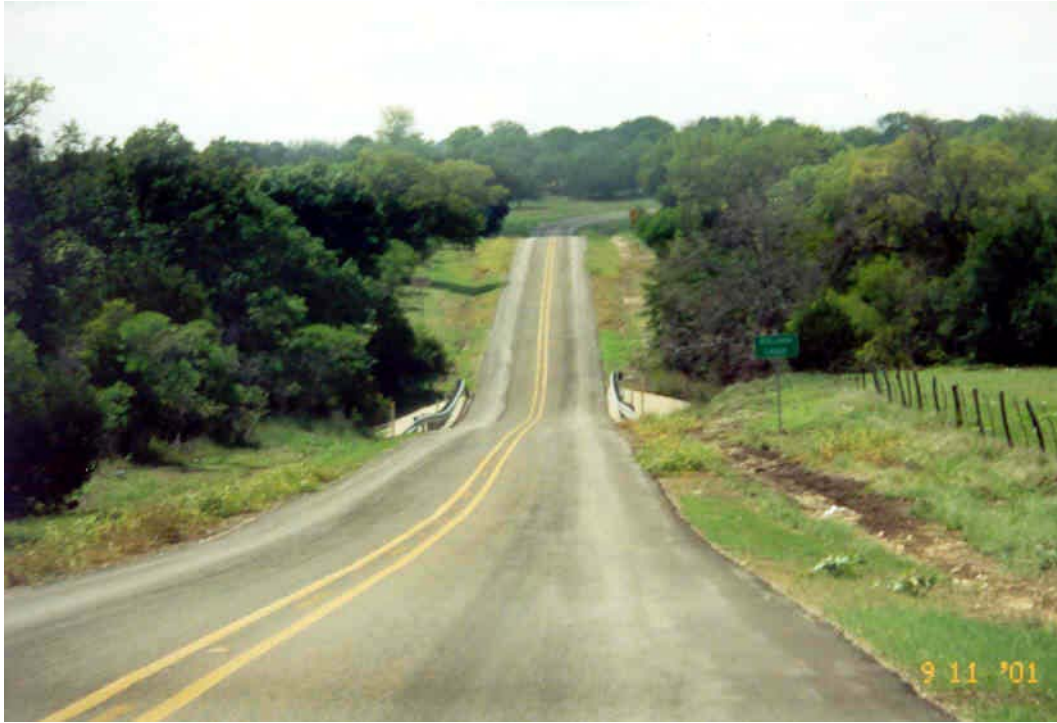
Figure 7-29. Another View of FM 183.

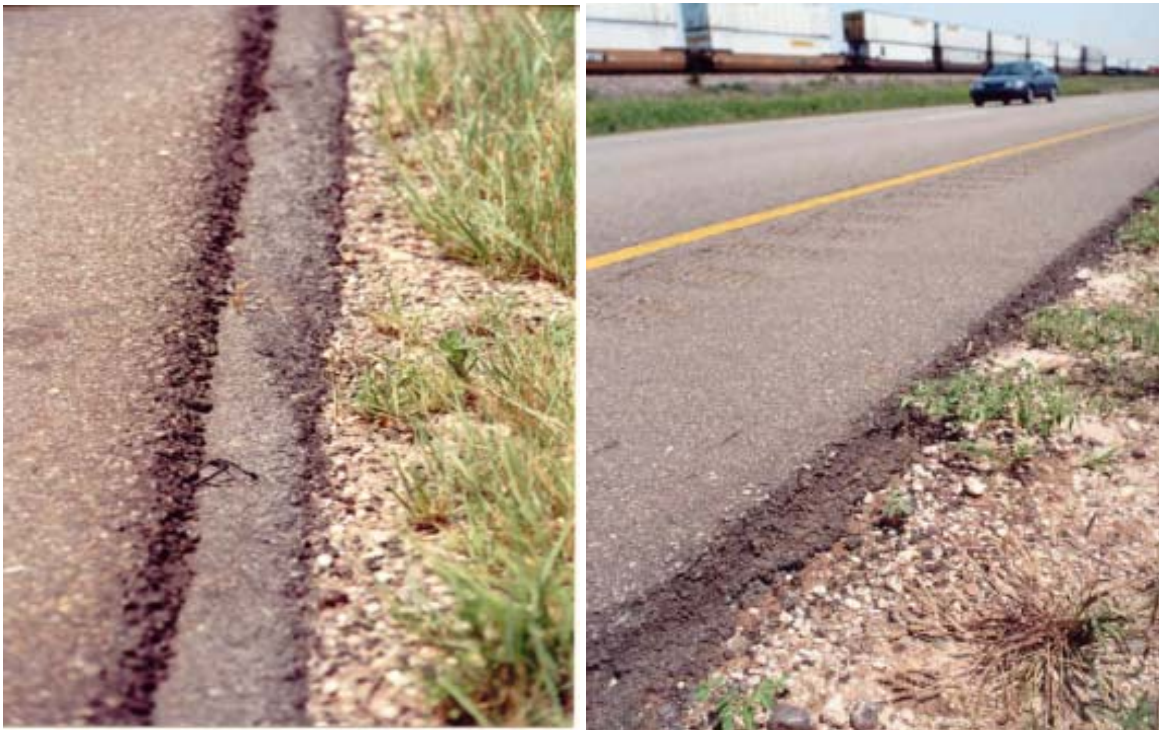
Figure 7-30. Shoulder Drop-Off Examples.

US 287 in Hall County near Memphis, Texas, was overlaid as part of a TxDOT construction project. Rains and wind gradually eroded the shoulder backfill in the one- to two-year period following the construction. A result of the resurfacing was pavement edge drop-offs, as shown in [Figure 7-30](#).

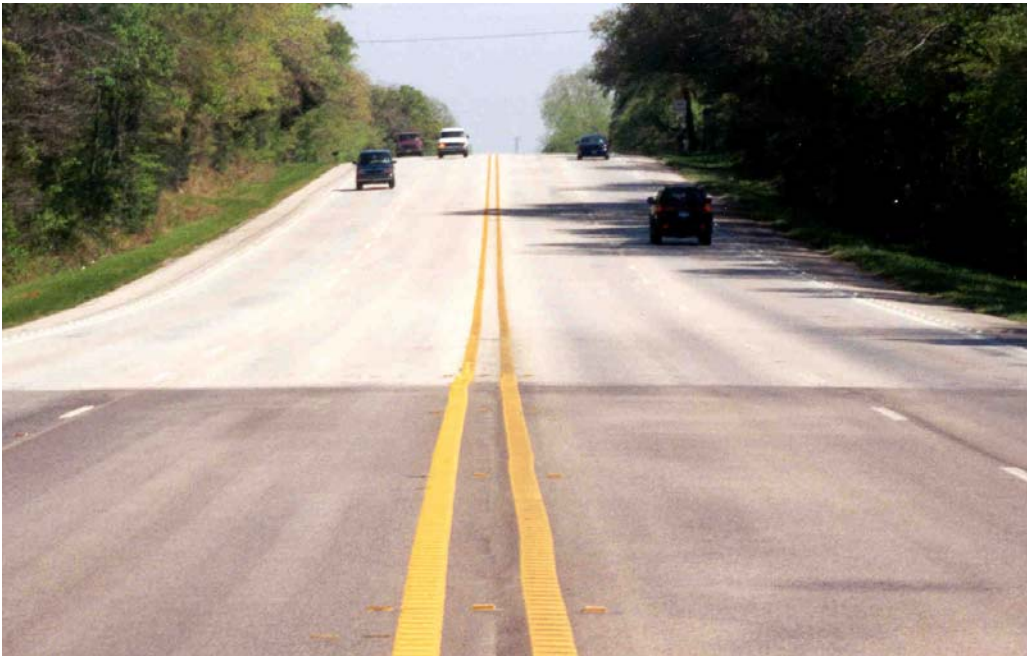
Figure 7-32. State Highway 6 South of College Station.

A section of SH 6 between College Station and Navasota has experienced ongoing safety challenges for the past several years. SH 6 is a divided four-lane highway just south of College Station which changes to a four-lane non-divided highway a few miles further south (see Figures 7-32 and 7-33).

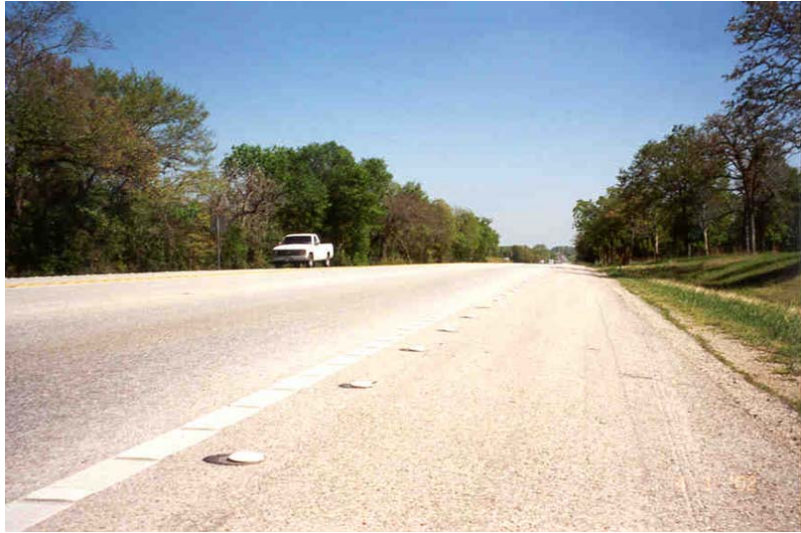
Figure 7-34. Shoulder Texturing with Traffic Buttons.

-
-
- A In September and October 1999, TxDOT provided for shoulder texturing by placing traffic buttons (Figure 7-34) along the outside edge of the edge line to produce an audible warning and to alert errant vehicles before they run off the sides of the travel lanes. The traffic buttons were designed to address the significant number of single-vehicle run-off-road crashes in this roadway section.

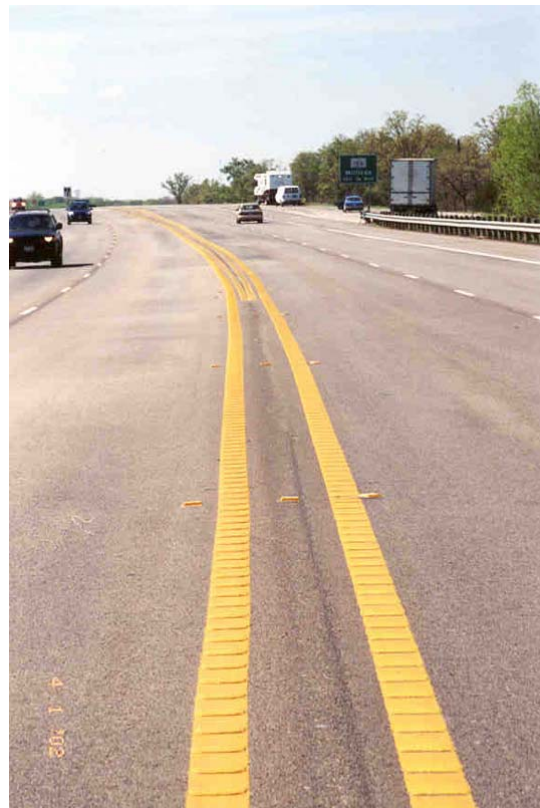
Figure 7-35. Centerline Profile Markings.

- A In April 2000, TxDOT installed profile markings on the edge lines and centerlines (see Figures 7-35 and 7-36).
- A In July and August 2000, a Selective Traffic Enforcement Program was initiated in this area.
- A In August 2000, TxDOT installed two portable message trailers (one northbound and one southbound) with varying messages such as “Speed Limits Strictly Enforced” and “Watch for Turning Vehicles.”
- A In November 2000, TxDOT closed the rest area south of FM 159.
- A In August 2001, TxDOT constructed a center barrier south of FM 159 and removed the frontage road access points near Peach Creek.
- A In April 2002, TxDOT constructed a two-way left-turn lane between Paradise Way and Westward Ho (two county roads south of FM 159).

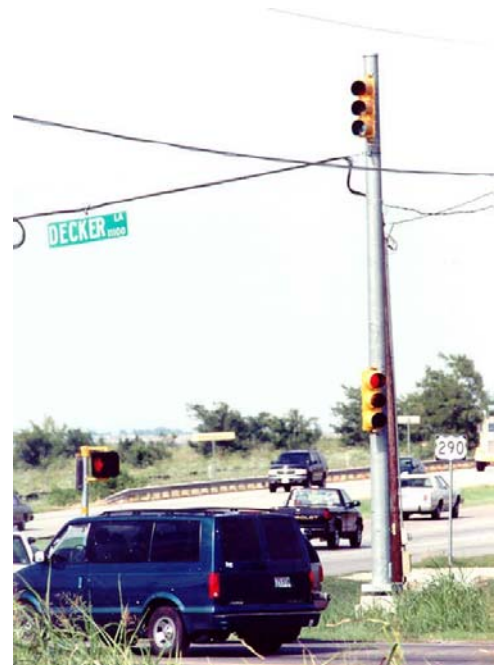
Figure 7-38. Close-Up of Traffic Signal on High Center on US 290 at FM 3177.

In mid-September 2000, TxDOT installed three, three-section, vertical signal heads for eastbound and westbound traffic to supplement the existing signals and to provide additional visibility to the signal indication. The two eastbound signal heads and one westbound signal head are mounted on high centers so that they can be seen earlier when approaching the intersection (see signal heads mounted high on posts in [Figures 7-38](#) and [7-39 a](#) and [b](#)).

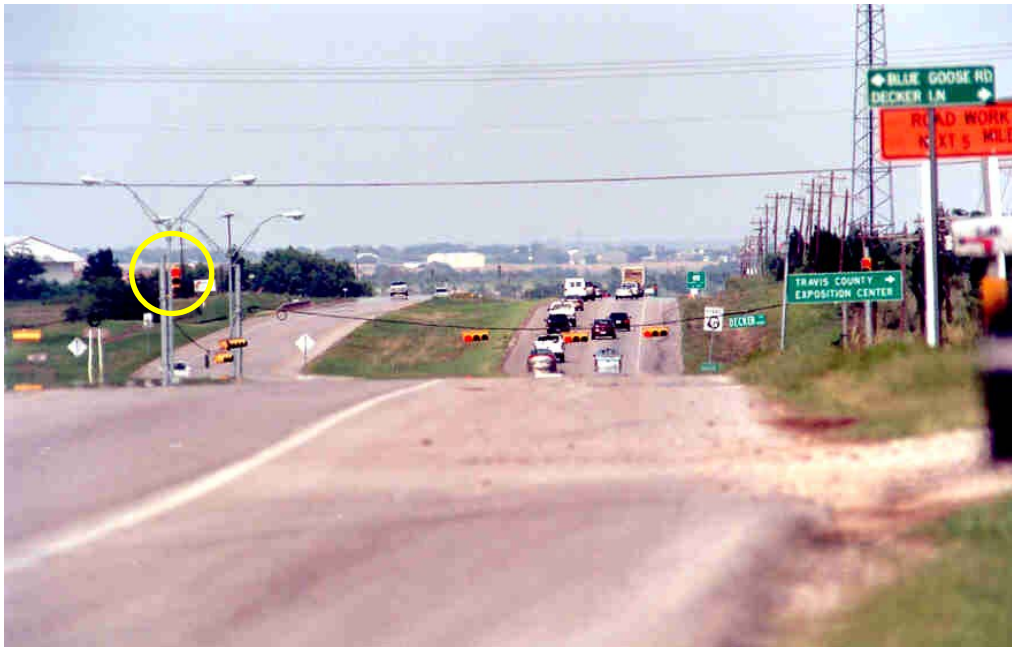
(a) Traffic Signal Just Visible Beyond Crest of Hill.

Figure 7-39. Approach to Traffic Signal at Intersection of US 290 and FM 3177 (Decker Lane).

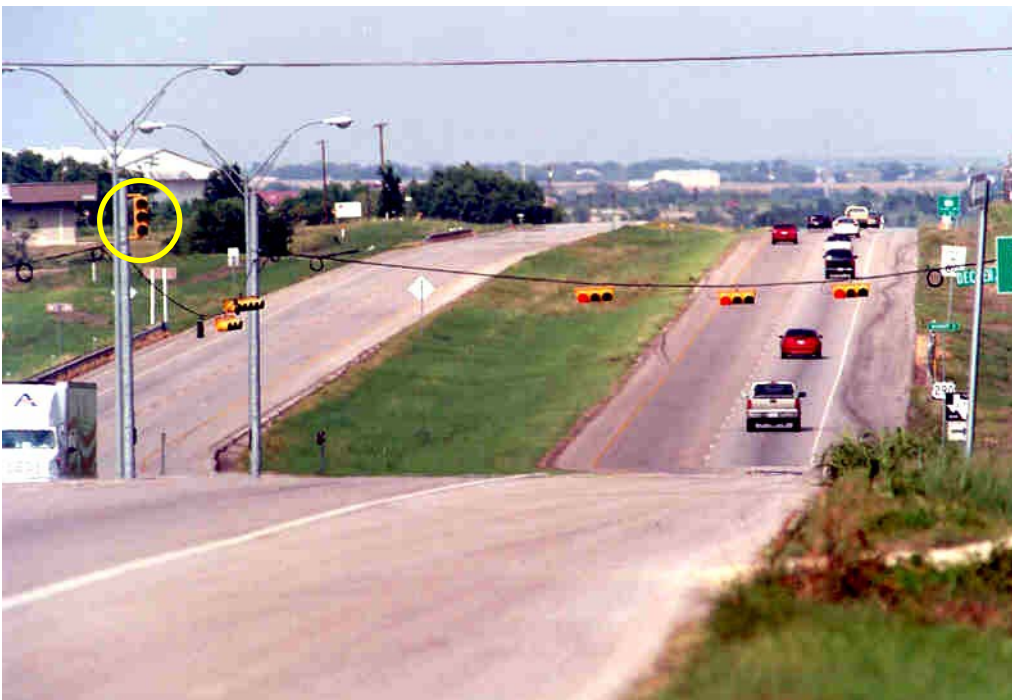
(b) Traffic Signal More Visible Beyond Crest.

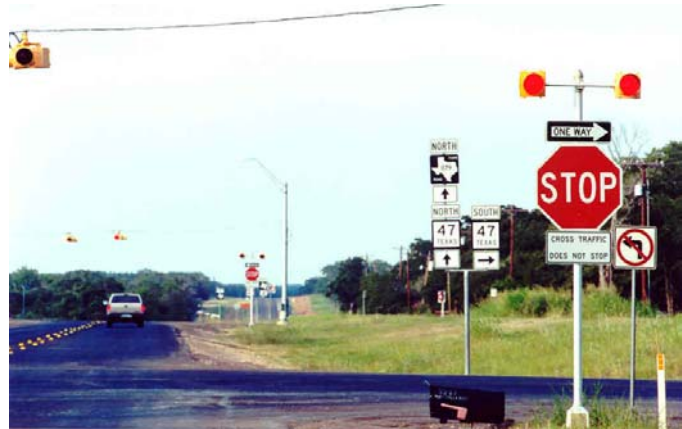
Figure 7-40. Intersection of Villa Maria and SH 47.

SH 47 in College Station is a four-lane divided highway that serves as a connector from College Station to SH 21. It was opened to traffic in August 1996. FM 1179 (Villa Maria) intersects and crosses northbound and southbound SH 47. The traffic on Villa Maria stops at the intersection with SH 47, while the SH 47 traffic does not stop (see Figures 7-40 and 7-41). Stop signs were installed on Villa Maria when the road was opened to the public. Various traffic control improvements have been installed at this intersection during the previous five years in response to safety concerns.

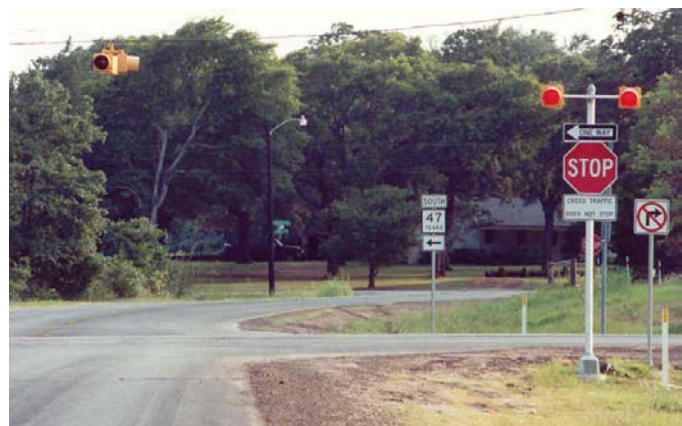
Figure 7-41. Another View of the Intersection of Villa Maria and SH 47.

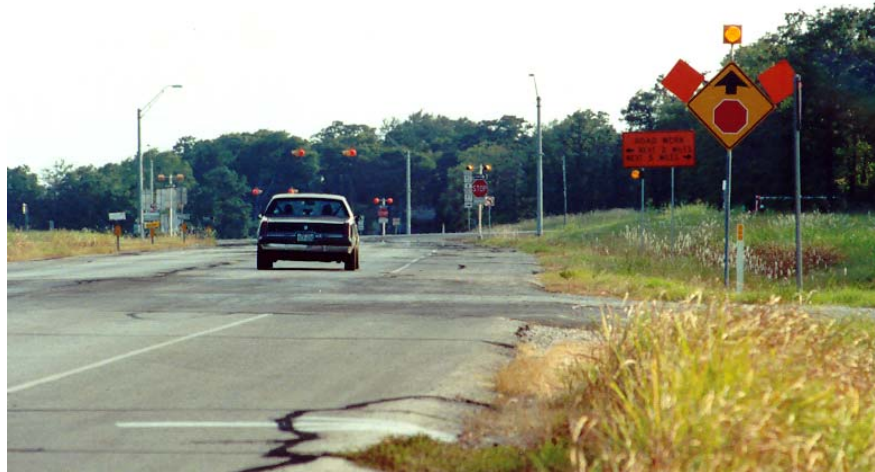
Figure 7-42. Orange Warning Flags on Stop Ahead Sign.

- A 48-inch Stop signs on Villa Maria,
- A Orange warning flags on the Stop signs and Stop Ahead signs (see Figure 7-42),
- A Three sets of approach rumble strips (to alert drivers of approaching stop conditions on the westbound approach), and
- A Relocated the Stop signs to address potential visibility issues.
