TREATMENTS FOR CRASHES ON RURAL TWO-LANE HIGHWAYS IN TEXAS

for
Texas
Department of
Transportation

by
Texas
Transportation
Institute

April 2002
Report 4048-2

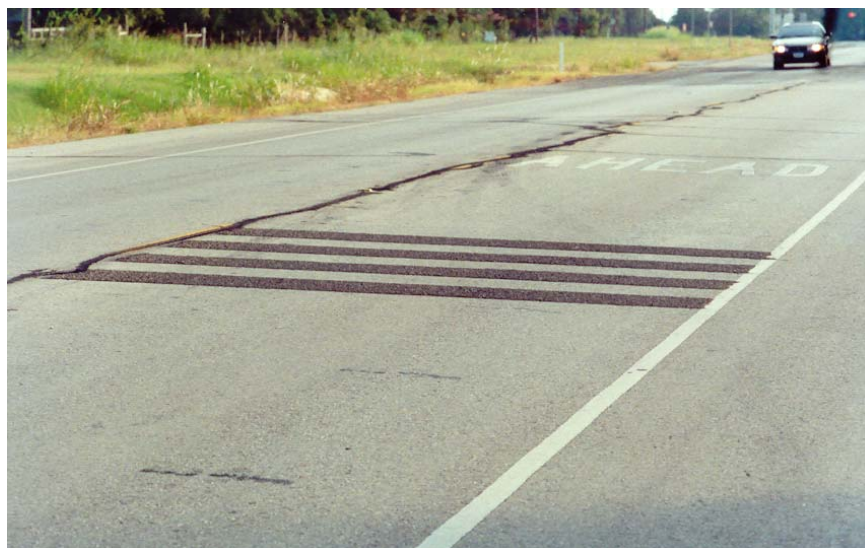
Figure 7-43. Rumble Strips and Pavement Markings on FM 1179.

The first set of rumble strips begins at 1770 ft (540 m) from the Stop sign at the intersection (see Figure 7-43). Other signs and pavement marking locations are illustrated in Figure 7-44.
