**NCHRP REPORT 350 TEST 3-10 ON THE  
MODIFIED PennDOT TYPE 2 GUIDE RAIL - TEST 4**

Work Order No. 50  
Project No. RF473750-4

Sponsored by  
**Pennsylvania Department of Transportation**

**July 2000**

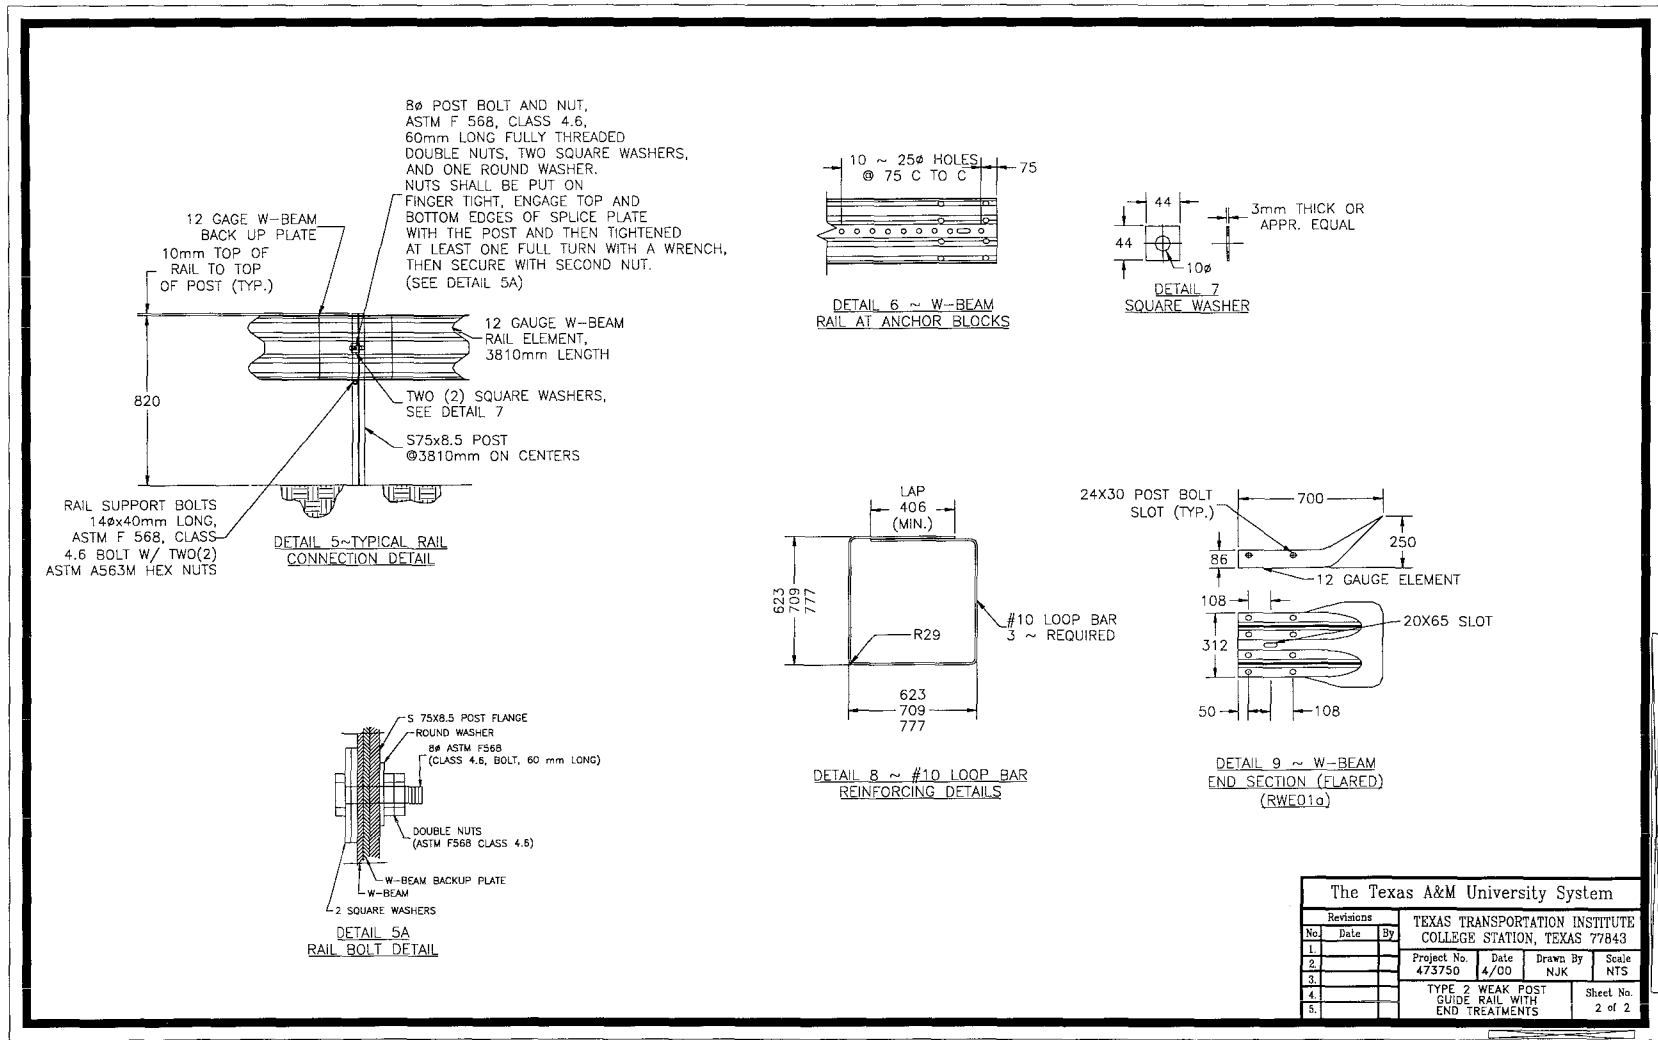
Figure 1. Details of the PennDOT Type 2 guide rail for test 473750-4 (continued).

Drawn By	Scale	Sheet No.
NJK	NTS	
TYPE 2 WEAK POST GUIDE RAIL WITH END TREATMENTS		2 of 2

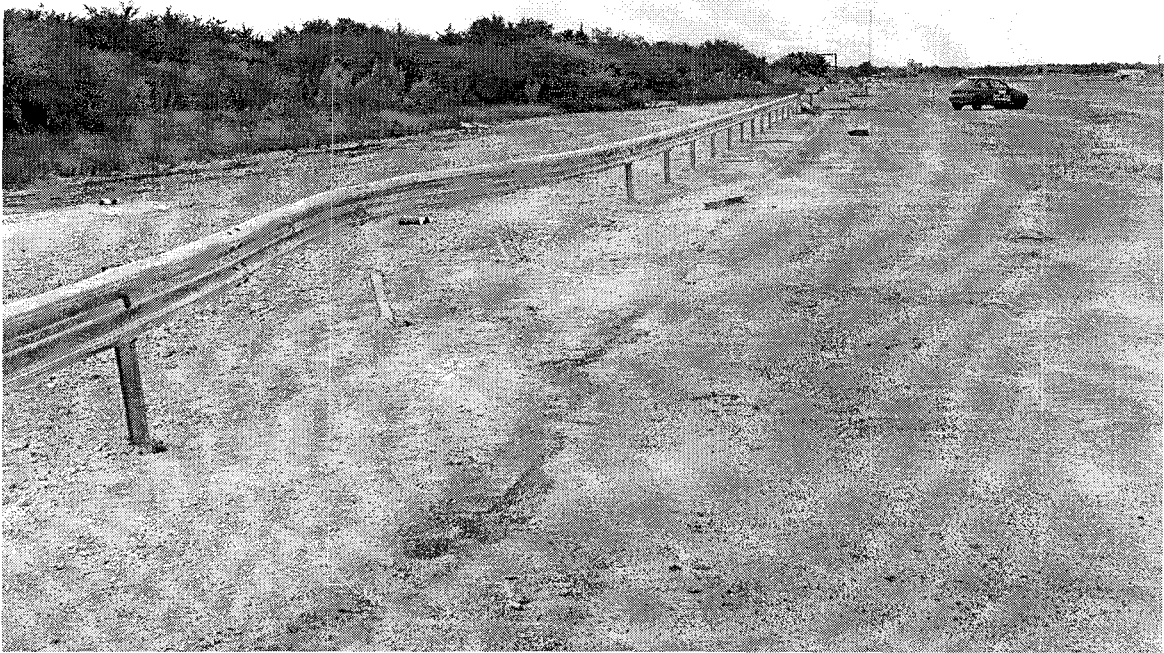
Figure 6. Vehicle trajectory after test 473750-4.

vehicle were applied at 5.0 s after impact and the vehicle subsequently came to rest 73.2 m (240.2 ft) down from impact and 7.6 m (24.9 ft) toward traffic lanes. Sequential photographs of the test period are shown in appendix C, figures 13 and 14.

K.	After collision, it is preferable that the vehicle's trajectory not intrude into adjacent traffic lanes.	The 820C vehicle would intrude into adjacent traffic lanes as it came to rest 73.2 m (240.2 ft) down from impact and 7.6 m (24.9 ft) forward of the traffic face of the barrier.	Fail*

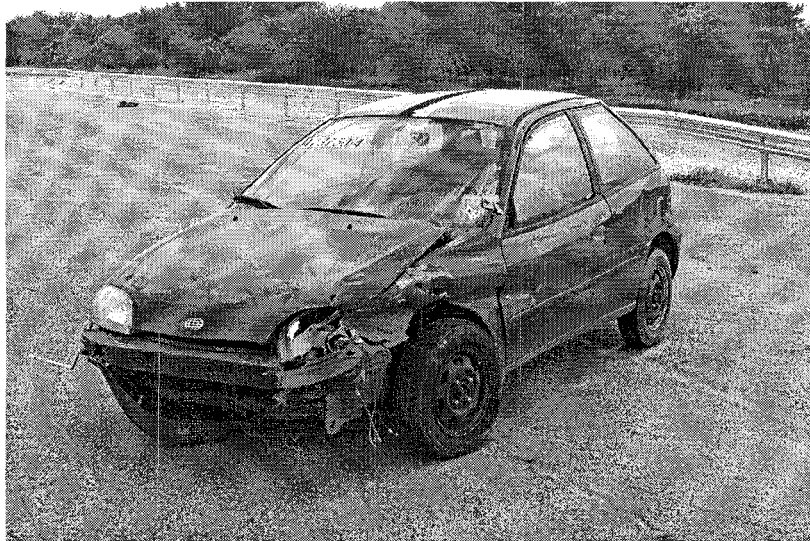
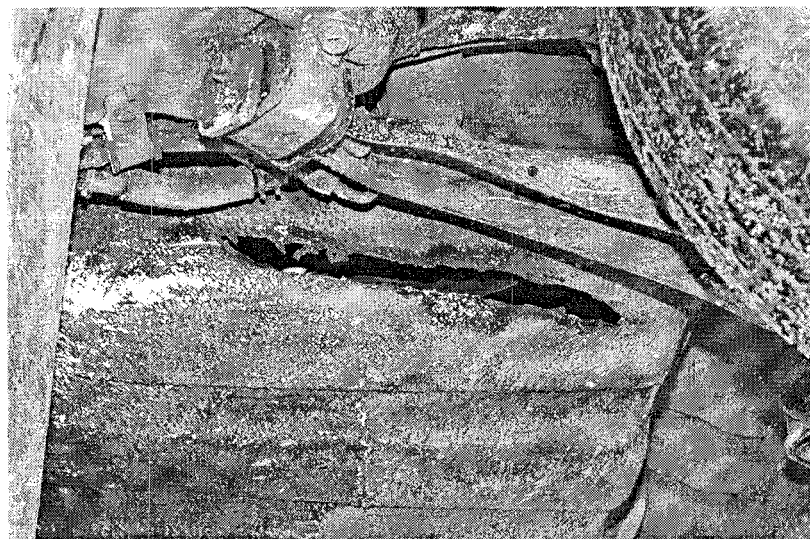
Figure 8. Vehicle after test 473750-4.

The vehicle sustained relatively minor damage as shown in figure 8. Structural damage included damage to the left strut and C.V. joint. Also damaged were the front bumper, radiator, fan, radiator support, hood, left door, and left front and rear quarter panels. The windshield sustained some stress cracking and the gas tank was torn as shown in figure 8. Maximum crush to the exterior of the vehicle was 200 mm (7.9 in) at the left front corner. Maximum occupant compartment deformation was 6 mm (0.25 in) in the left front floor pan area. The interior of the vehicle is shown in figure 9. Exterior vehicle crush and occupant compartment measurements are shown in appendix B, tables 2 and 3.

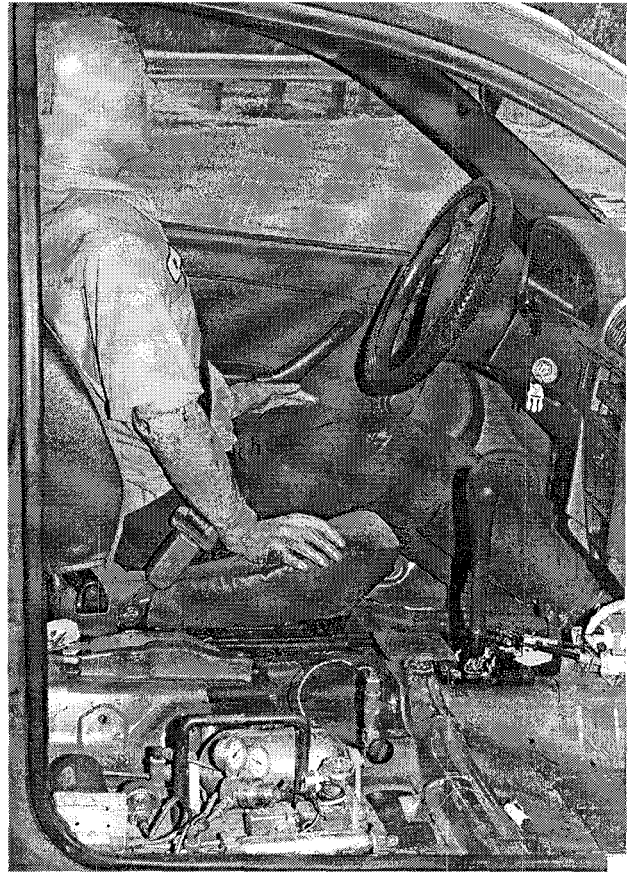
Figure 9. Interior of vehicle for test 473750-4.

Before test

After test
