MASH EVALUATION OF TxDOT ROADSIDE SAFETY FEATURES— PHASE III

Test Report 0-6946-R3-Rev1 (Revised 2023-12-14)

TEXAS A&M TRANSPORTATION INSTITUTE

TEXAS DEPARTMENT OF TRANSPORTATION

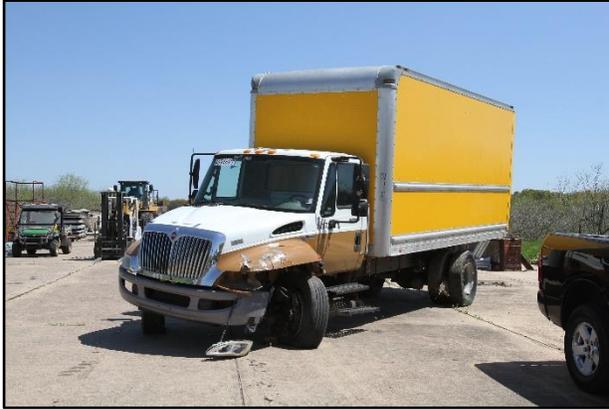
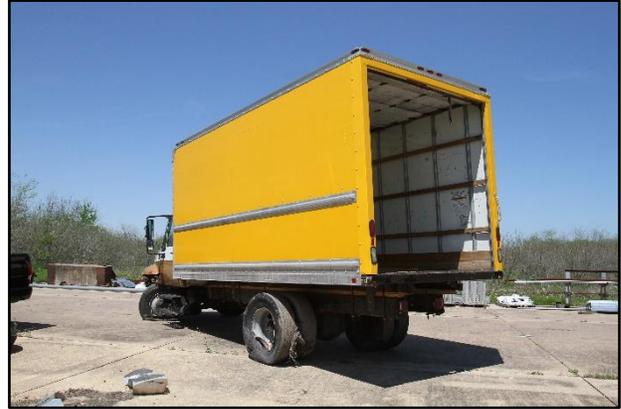
Figure 2.6. Test Vehicle after Test No. 469469-1.

Figure 2.6 and Figure 2.7 show the damage sustained by the vehicle. The front bumper, hood, left head light, left front tire and rim, left front spring and U-bolts, left side step, left corner of floor pan, left front corner of box, and left rear outer tire and rim were damaged. Maximum exterior crush to the vehicle was 14.0 inches in the front left corner. Maximum occupant compartment deformation was 5.5 inches in the front left corner of the floor pan. Table A.3 in Appendix A.3.1 provides details on the damage to the test vehicle.

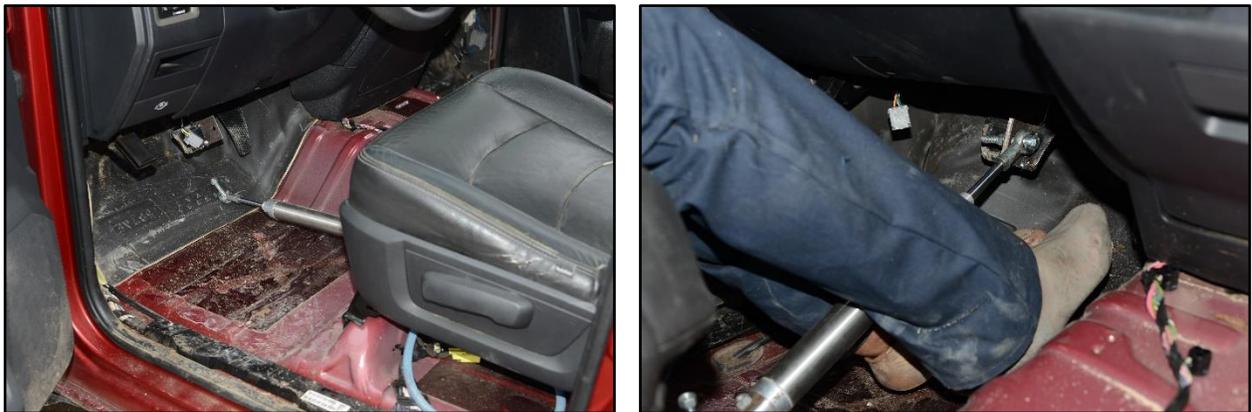
**Figure 3.7. Interior of Test Vehicle for Test No. 469469-2-1
(before Test on Left; after Test on Right).**

Figure 3.6 and Figure 3.7 show the damage sustained by the vehicle. The front bumper, hood, radiator and support, left front fender, left front tire and rim, left frame rail, left upper and lower A-arms, left front floor pan and kick panel, left front door and glass and left rear door, left cab corner, left rear fender, and left rear tire and rim were damaged. Maximum exterior crush to the vehicle was 14.0 inches in the side plane at the left front corner at bumper height. Maximum occupant compartment deformation was 2.0 inches in the left side firewall area. Table B.3 and Table B.4 in Appendix B.3.1 provide the exterior crush and occupant compartment measurements of the vehicle.

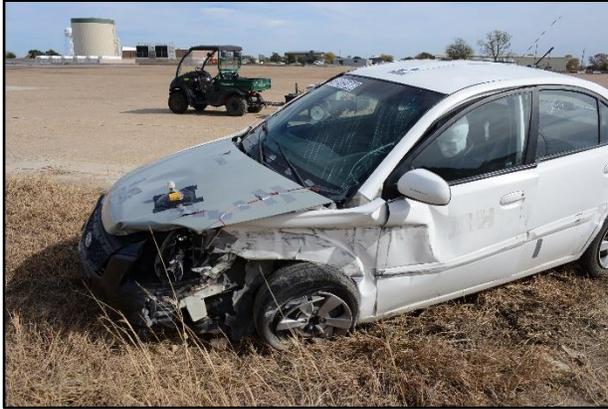
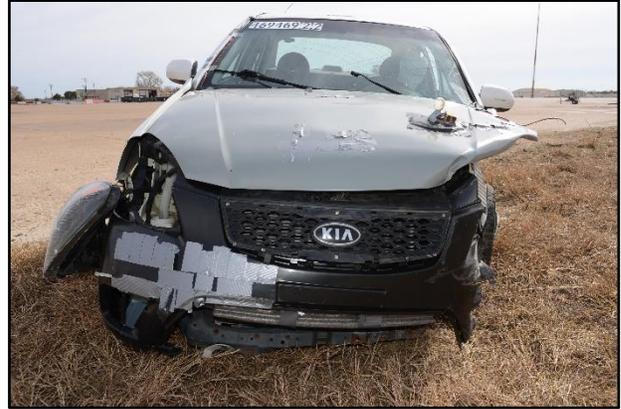
Figure 3.12. Test Vehicle after Test No. 469469-2-2.

Figure 3.12 and Figure 3.13 show the damage sustained by the vehicle. The front bumper, hood, radiator and support, left front head light, left front fender, left front strut and tower, left front tire and rim, left A post, windshield, left front floor pan, left front and rear door, left rear fender, rear bumper, and roof were damaged. Maximum exterior crush to the vehicle was 12.0 inches in the side plane at the left front corner above front bumper height. Maximum occupant compartment deformation was 2.0 inches for the interior height. Table B.6 and Table B.7 in Appendix B.4.1 provide exterior crush and occupant compartment measurements.

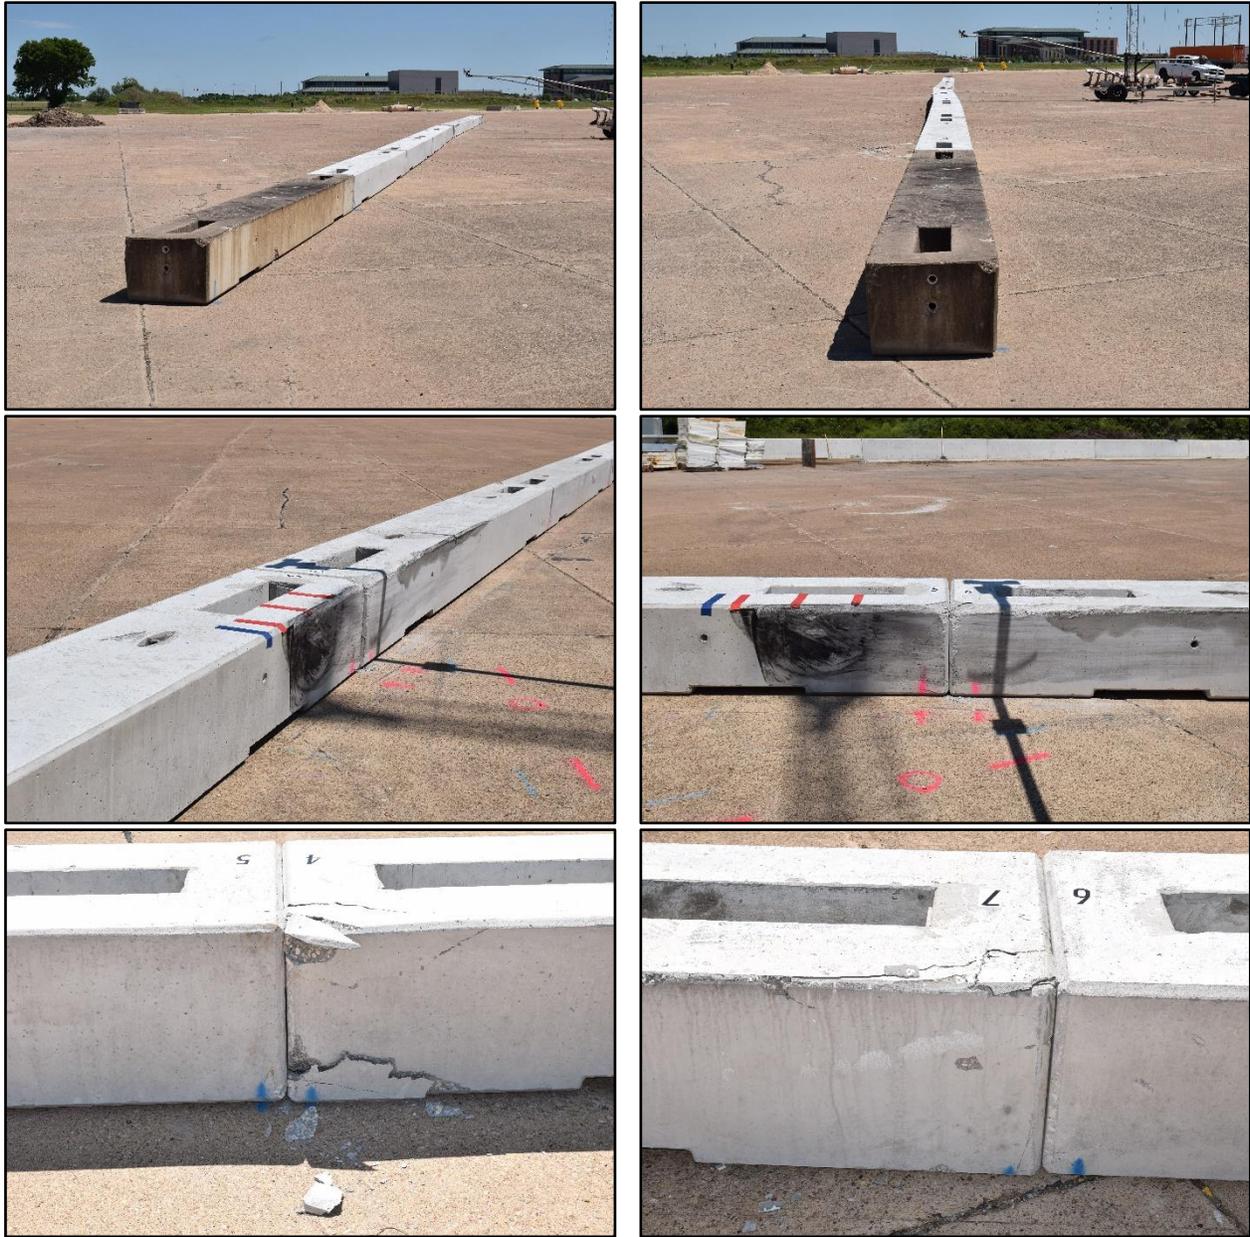
Figure 4.5. Low-Profile Barrier after Test No. 469469-3-2.

Figure 4.5 shows the damage to the low-profile barrier. The field side top corners were broken for a distance ranging from 10 to 18 inches on the downstream end of barrier segments 4, 5, and 7. There was minor cosmetic damage on the traffic side of barrier segments 5 and 6 near the joint. Table 4.2 shows the permanent field side displacement measured at the joints between segments.

Working width² was 36.6 inches, and the height of maximum working width was 20 inches. Maximum dynamic deflection during the test was 8.6 inches, and the maximum permanent deflection was 8.5 inches.

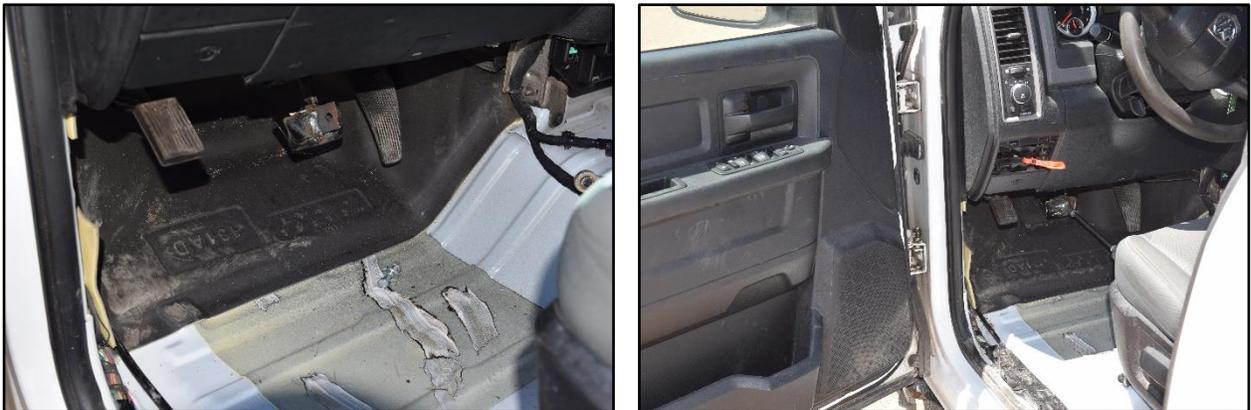
Figure 4.7. Interior of Test Vehicle for Test No. 469469-3-2 (before Test on Left; after Test on Right).

Figure 4.6 and Figure 4.7 show the damage sustained by the vehicle. The front bumper, left front fender, left front tire and rim, left front door, left rear door, left rear door, left cab corner, left rear fender, left rear rim, and rear bumper were damaged. Maximum exterior crush to the vehicle was 2 inches in the side plane at the left front corner at bumper height. There was no observed occupant compartment deformation. Table C.3 and Table C.4 in Appendix C.3.1 provide exterior crush and occupant compartment measurements.

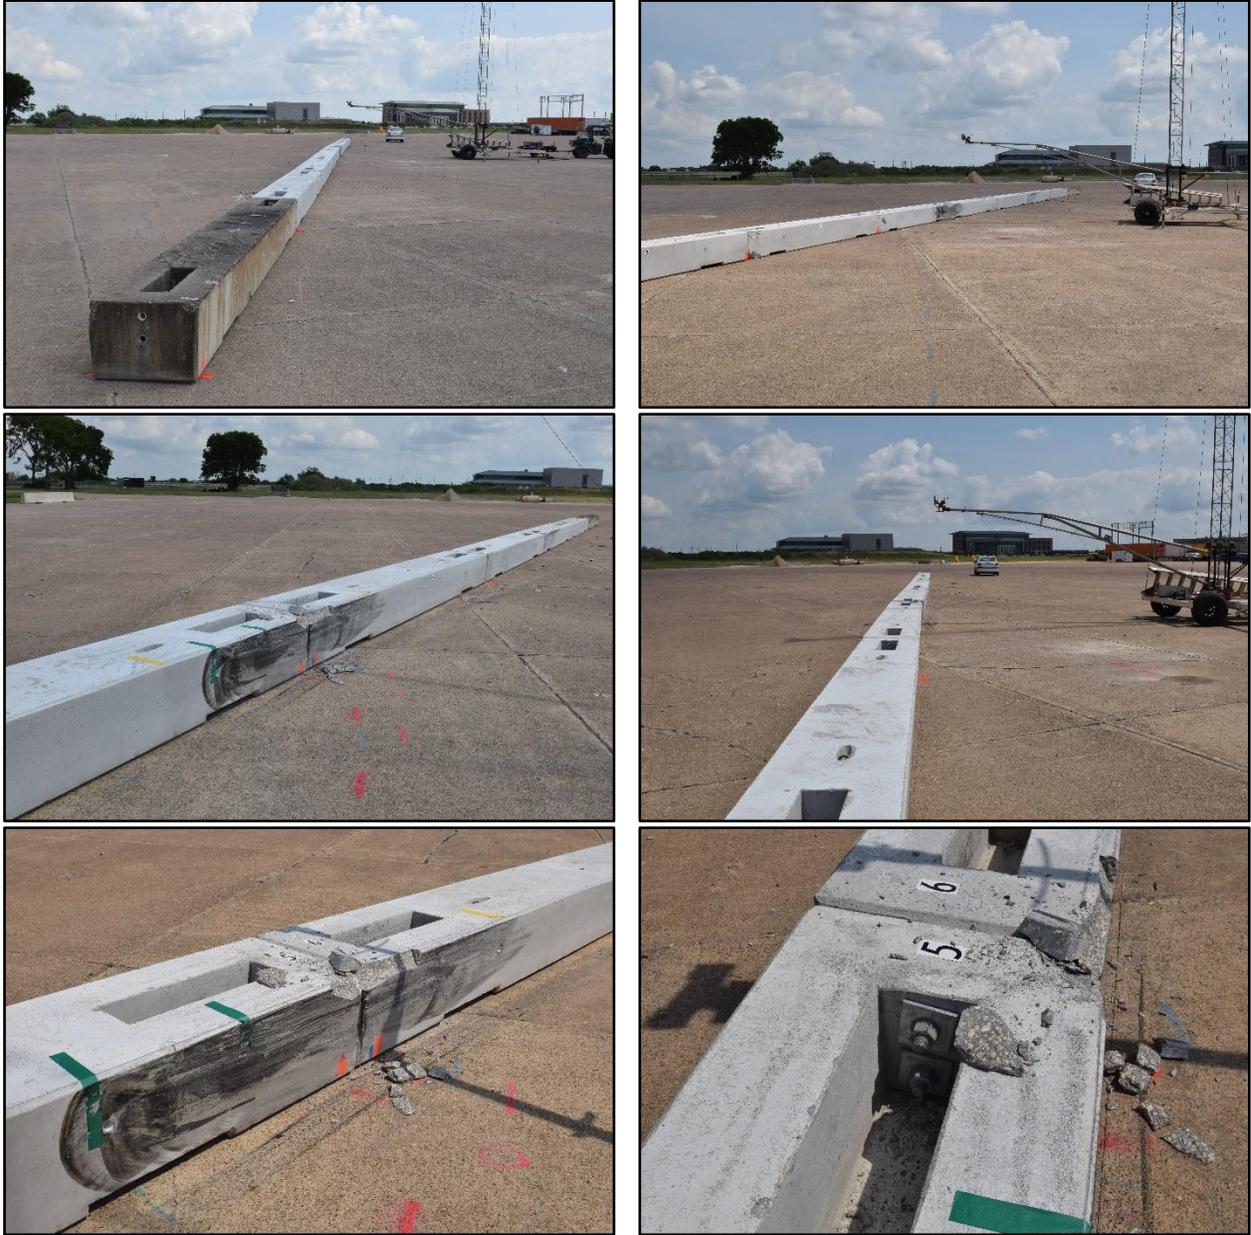
Figure 4.11. Low-Profile Barrier after Test No. 469469-3-1.

Figure 4.11 shows the damage to the low-profile barrier. There was concrete spalling, approximately 1½ inches wide and 16 inches long, and cracks on the traffic face upstream end top edge of barrier 6. Table 4.6 shows the permanent field side displacement measured at the joints between segments.

Working width⁴ was 32.9 inches, and the height of maximum working width was 20 inches. Maximum dynamic deflection during the test was 4.9 inches, and maximum permanent deflection was 4.3 inches.

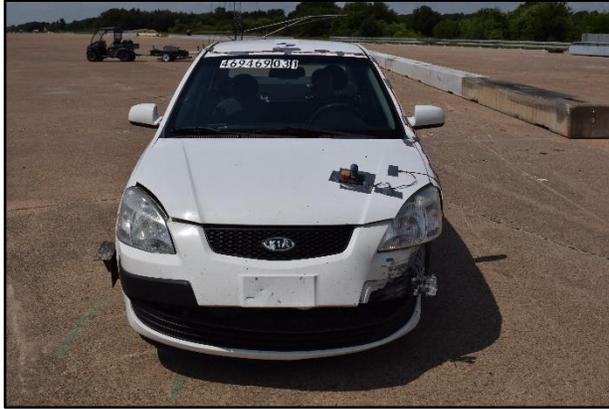
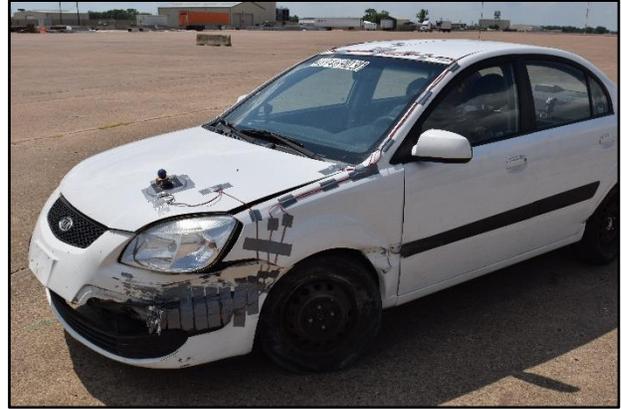
Figure 4.12. Test Vehicle after Test No. 469469-3-1.

Figure 4.12 and Figure 4.13 show the damage sustained by the vehicle. The front bumper, left front tire and rim, left rear door, left front fender, rear bumper, and left rear fender were damaged. Maximum exterior crush to the vehicle was 6 inches in the side plane at the left front corner at bumper height. There was no observed occupant compartment deformation. Table C.6 and Table C.7 in Appendix C.4.1 provide exterior crush and occupant compartment measurements.

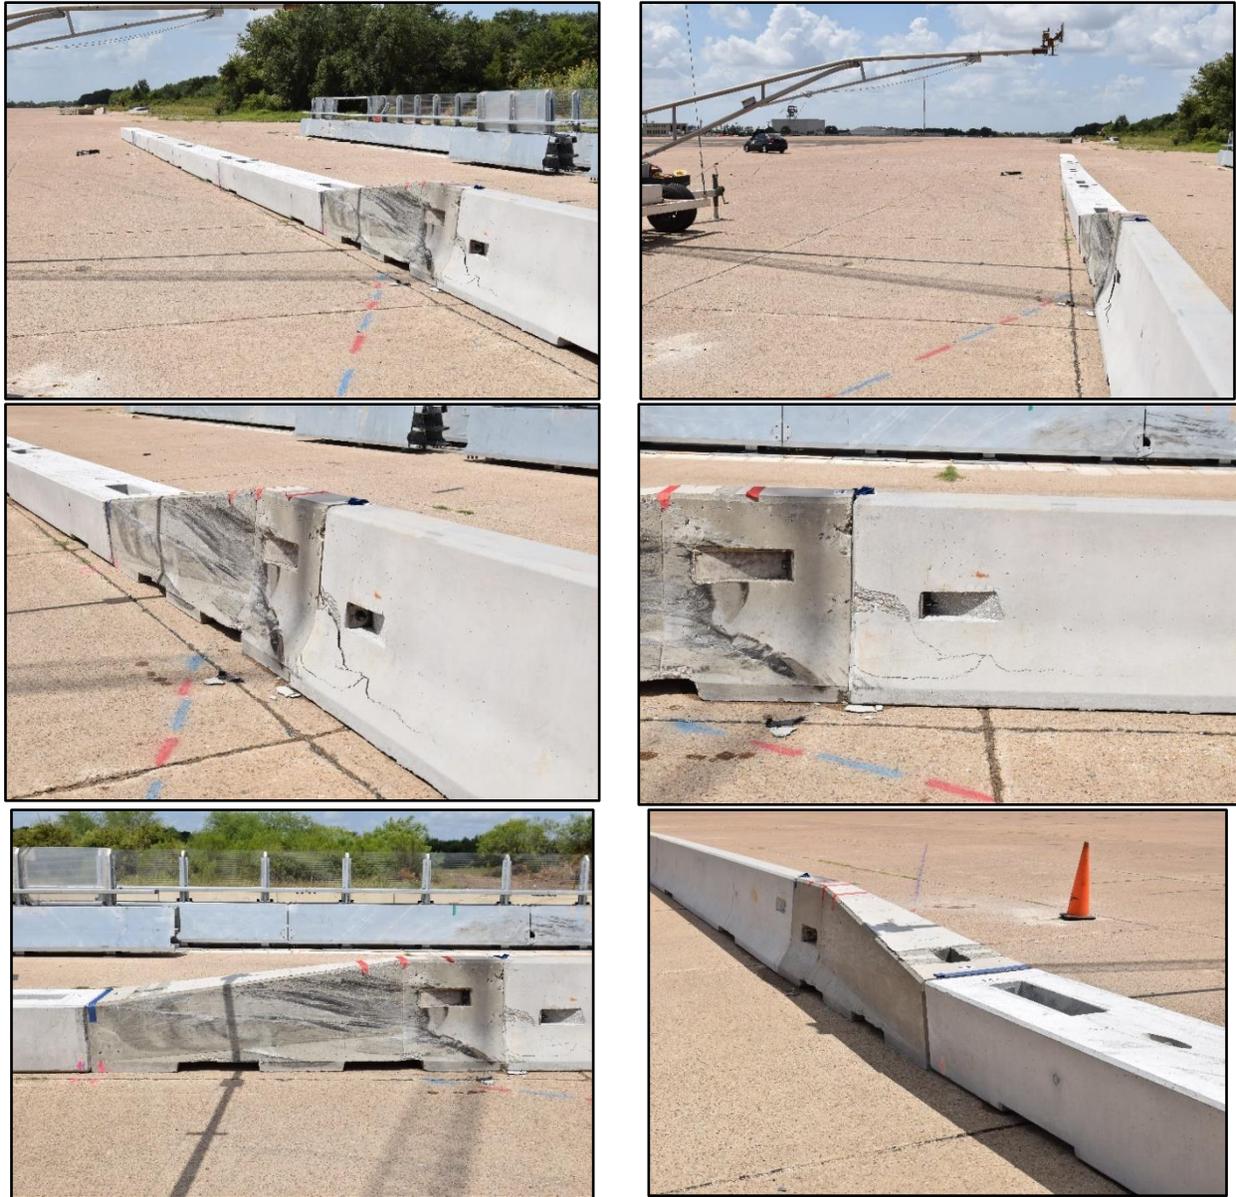
Figure 5.5. Low-Profile-to-F-Shape Transition after Test No. 469469-4-1.

Figure 5.5 shows the damage to the low-profile-to-F-shape transition system. The barriers were pushed toward the field side 8 inches at the joint between barriers 3 and 4, 6 inches at the joint between barriers 4 and 5, and 2 inches at the joint between barriers 5 and 6. There was an area of concrete damage 18 inches up from the bottom and 48 inches long on the traffic-side downstream end of barrier 3.

Working width⁶ was 36 inches, and the height of maximum working width was 0 inches (toe of the barrier). Maximum dynamic deflection during the test was 8 inches, and maximum permanent deflection was 8 inches.

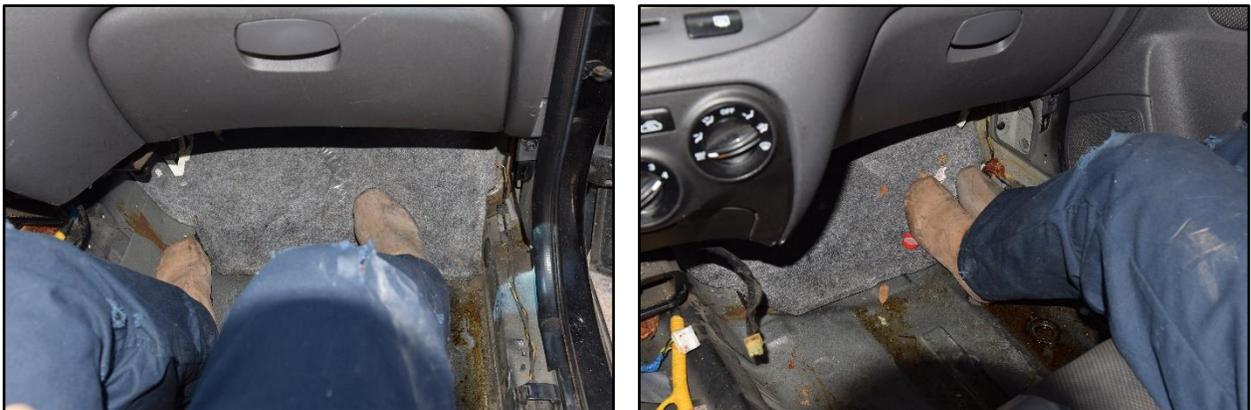
**Figure 5.7. Interior of Test Vehicle for Test No. 469469-4-1
(before Test on Left; after Test on Right).**

Figure 5.6 and Figure 5.7 show the damage sustained by the vehicle. The front bumper, right front fender, right front tire and rim, right strut tower, right rear door, right head light, hood, right rear fender, right rear tire and rim, and rear bumper were damaged. Maximum exterior crush to the vehicle was 7 inches in the side plane at the right front corner at bumper height. There was no measurable occupant compartment deformation. Table D.2 and Table D.3 in Appendix D.3.1 provide exterior crush and occupant compartment measurements.

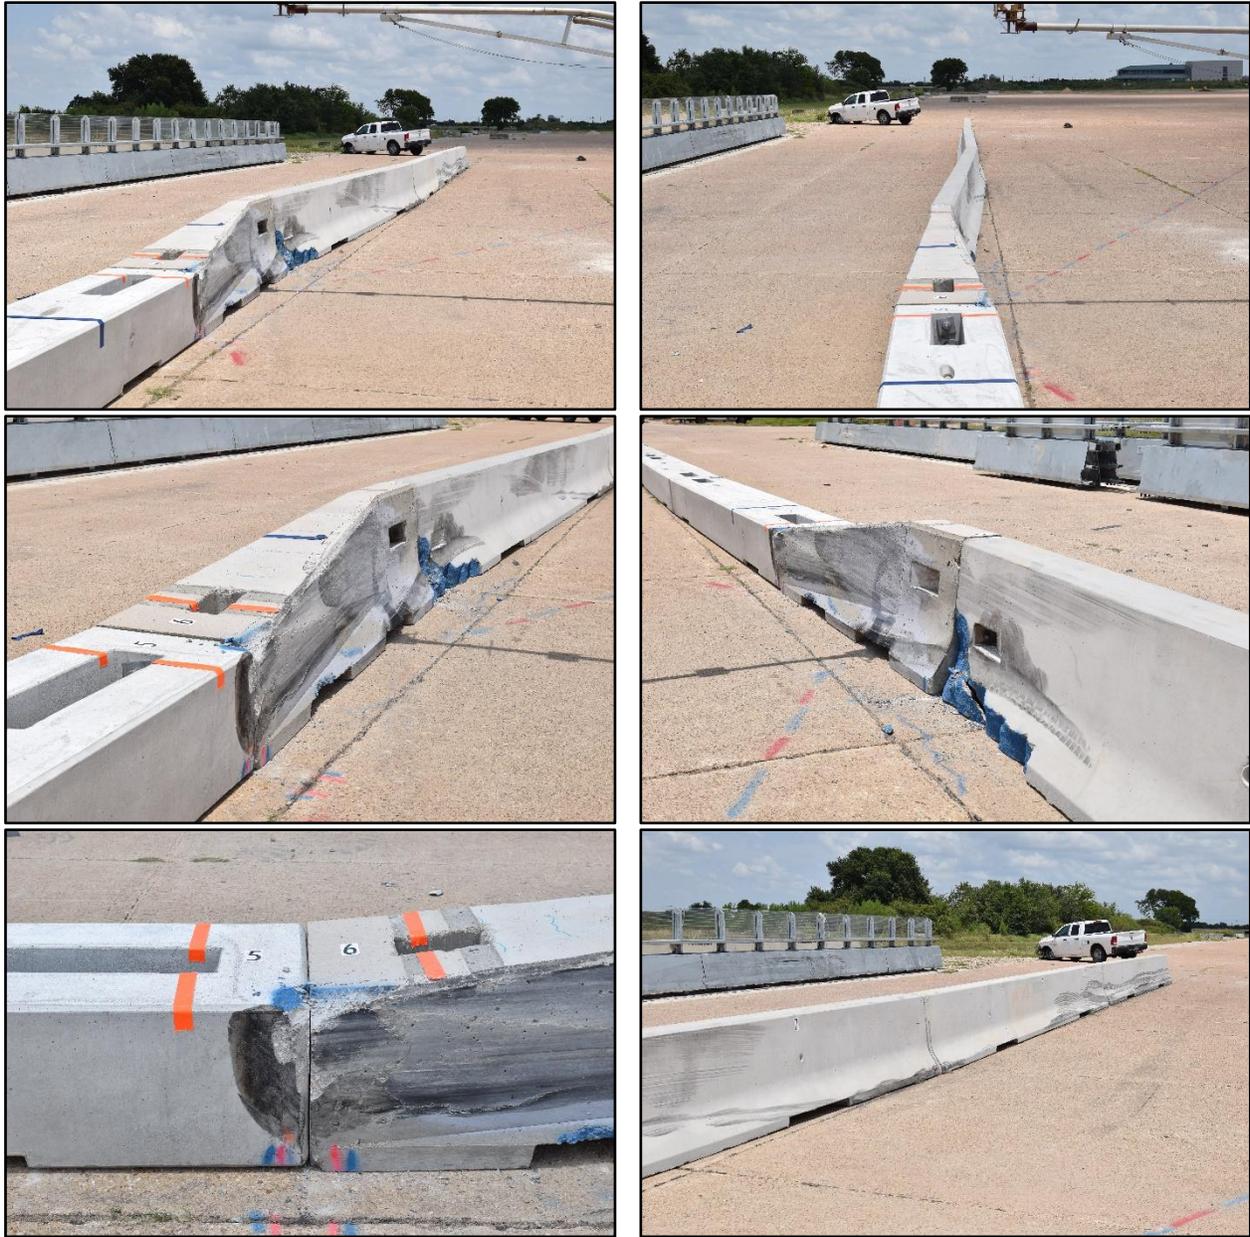
Figure 5.11. Low-Profile-to-F-Shape Transition after Test No. 469469-4-2.

Figure 5.11 shows the damage to the low-profile-to-F-shape transition system. The barriers were pushed toward the field side 1 inch at the joint between barriers 4 and 5, 9 inches at the joint between barriers 5 and 6, and 14 inches at the joint between barriers 6 and 7. There was concrete damage to the upstream traffic faces of barriers 6 and 7, and the concrete face was spalled on the upstream end of the field side of barrier 5. Working width⁷ was 38.5 inches, and the height of maximum working width was 0 inches (at the toe of the barrier). Maximum dynamic deflection during the test was 14.5 inches, and the maximum permanent deflection was 14.0 inches.

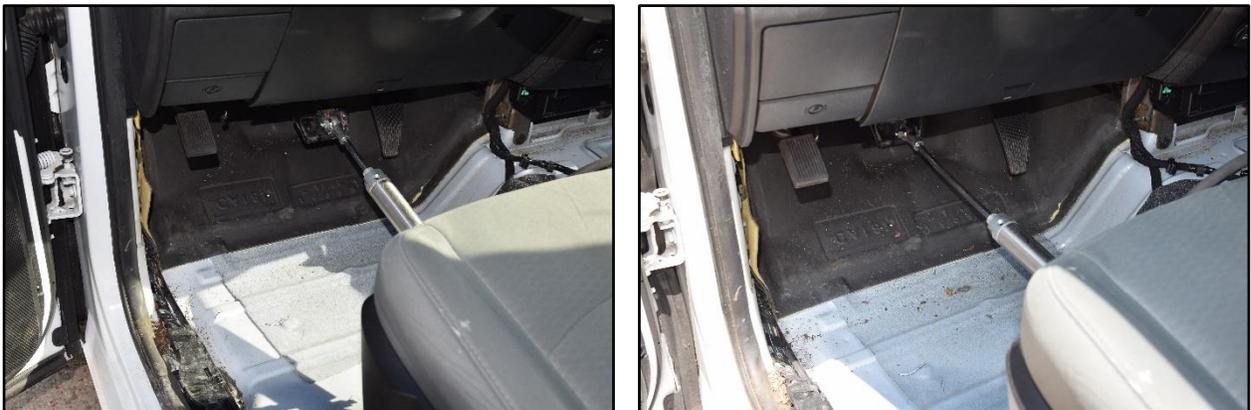
**Figure 5.13. Interior of Test Vehicle for Test No. 469469-4-2
(before Test on Left; after Test on Right).**

Figure 5.12 and Figure 5.13 show the damage sustained by the vehicle. The front left bumper, left front tire and rim, left front door, left front fender, left headlight, and left front A-arm were damaged. Maximum exterior crush to the vehicle was 13 inches in the side plane at the left front corner at bumper height. There was no measurable occupant compartment deformation. Table D.6 and Table D.7 in Appendix D.4.1 provide exterior crush and occupant compartment measurements.

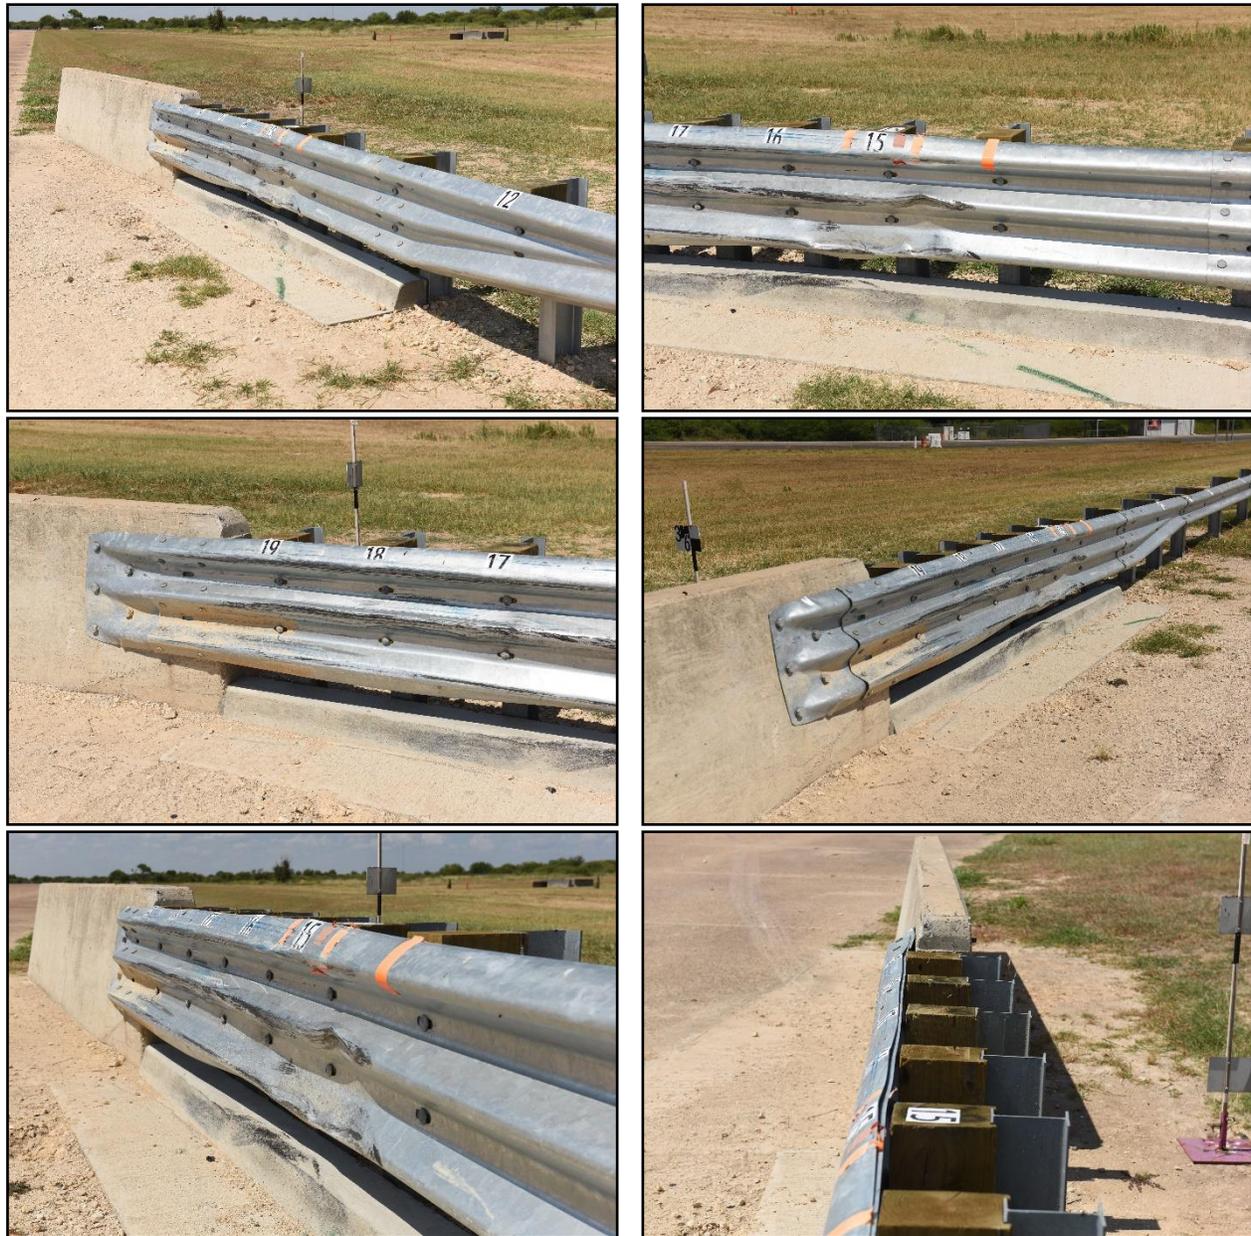
Figure 6.5. Thrie-Beam Transition without End Shoe Block after Test No. 469469-5.

Figure 6.5 shows the damage to the thrie-beam transition without end shoe block. There was a ½-inch gap between the curb and soil on the field side, and the rail was scuffed and deformed.

Working width⁸ was 18.5 inches, and the height of maximum working width was 48.8 inches (side mirror). Maximum dynamic deflection was 4.0 inches in the nested thrie-beam section. Maximum permanent deflection was ½ inch between posts 16 and 17.

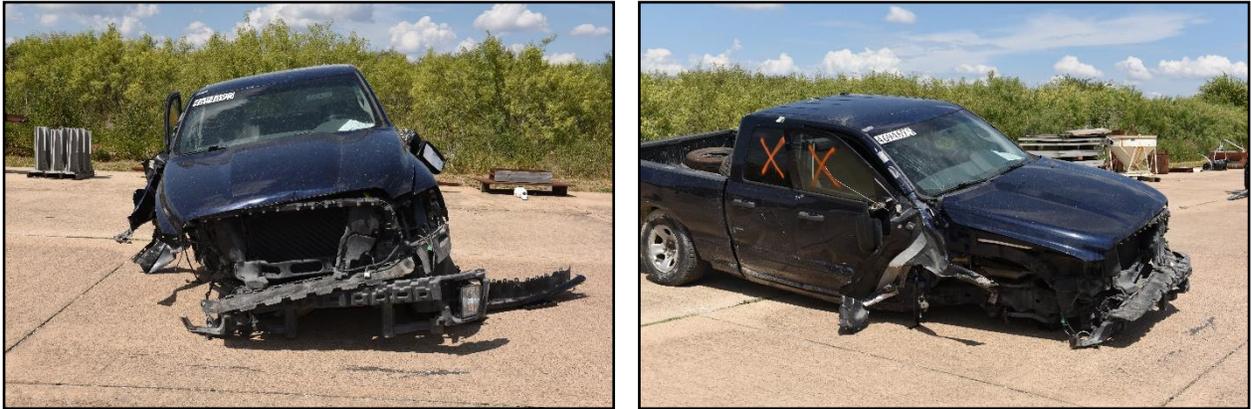
Figure 6.6. Test Vehicle after Test No. 469469-5.

Figure 6.6 and Figure 6.7 show the damage sustained by the vehicle. The front right bumper, hood, grill, radiator and supports, right front tire and rim, right front fender, right frame rail, right front upper and lower ball joints, right front upper and lower A-arms, front sway bar, right front door (8-inch gap at top), right front floor pan, right rear door, right cab corner, right rear fender, right rear rim, rear bumper, and right tail light were damaged. The windshield sustained stress cracks originating at the lower right and lower left corners. Maximum exterior crush to the vehicle was 10 inches at the front bumper at bumper height. The maximum occupant

compartment deformation was 4 inches at the lower right floor pan. Table E.5 and Table E.6 in Appendix E.3.1 provide exterior crush and occupant compartment measurements.

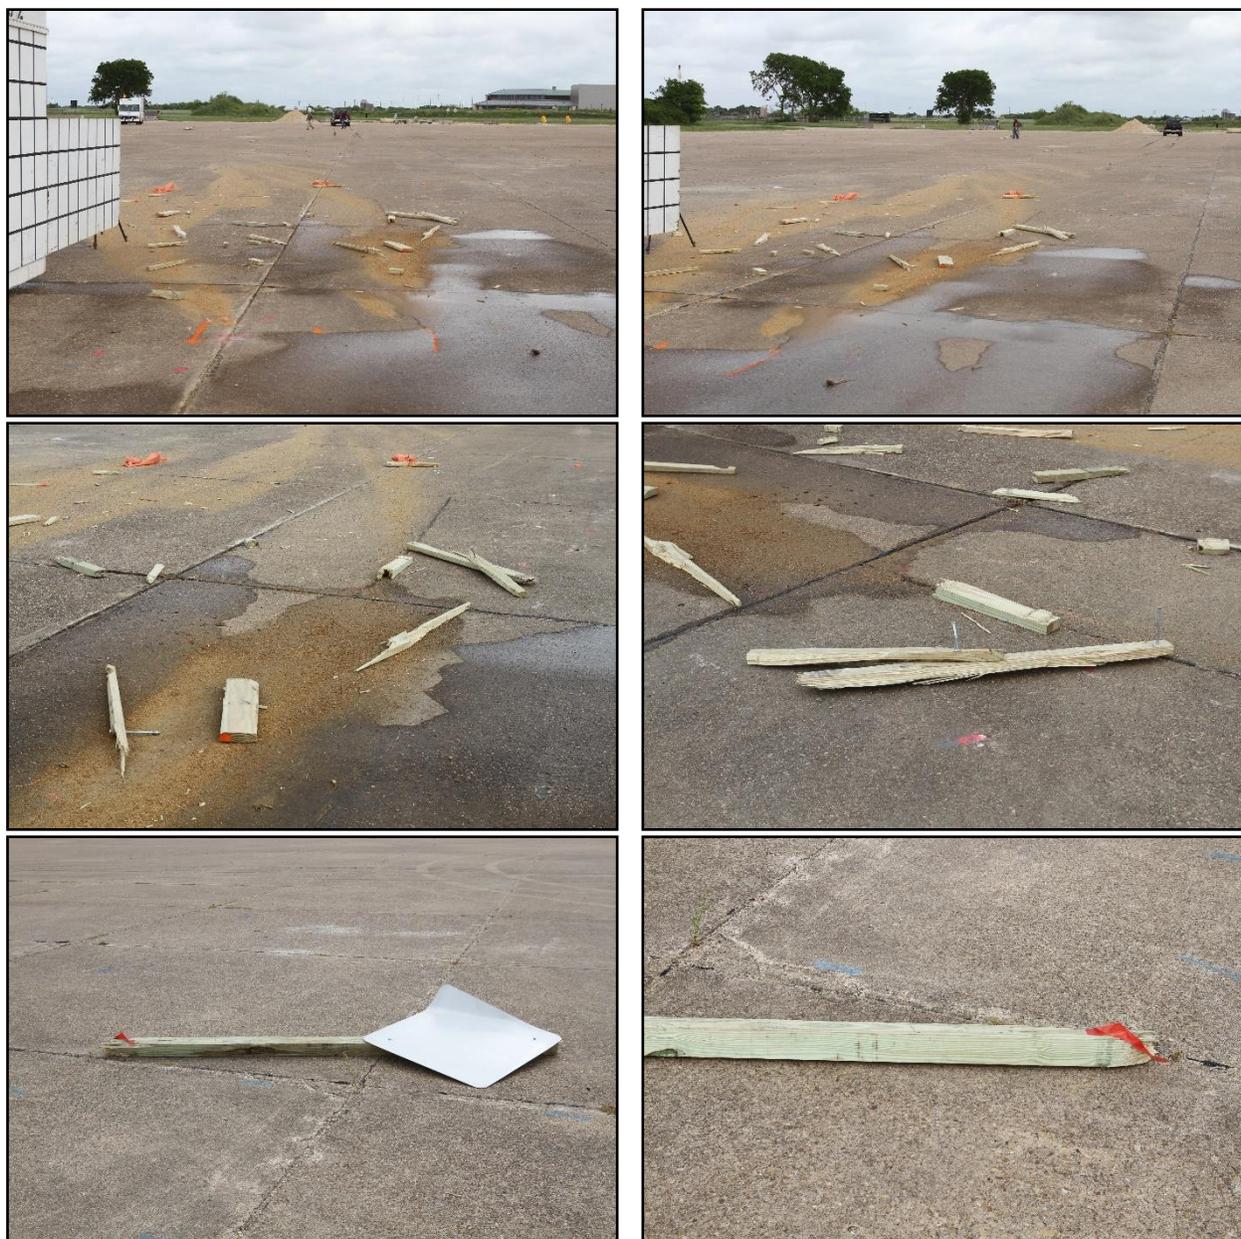
Figure 7.5. Single Wood Post Skid-Mounted Sign after Test No. 469469-06-02.

Figure 7.5 shows the damage to the single wood post skid-mounted sign. Components of the wood base fractured into multiple pieces that were scattered from the impact point to 50 ft downstream. The 4×4 wood support post fractured 24 inches above grade. The sign remained attached to the upper section of the fractured wood support post and came to rest 245 ft downstream and 50 ft to the left of the original impact position.

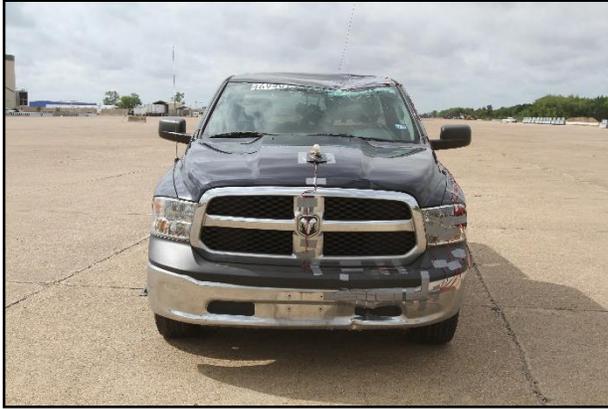
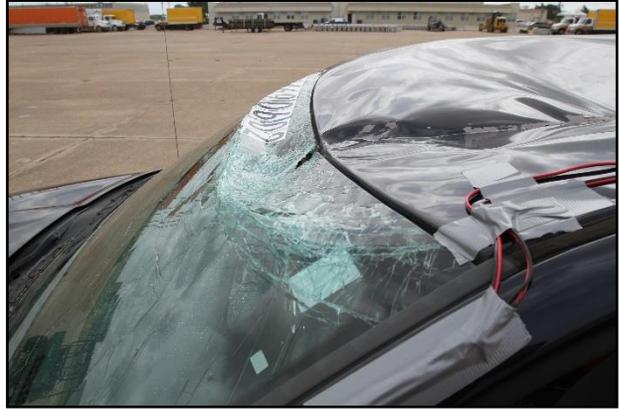
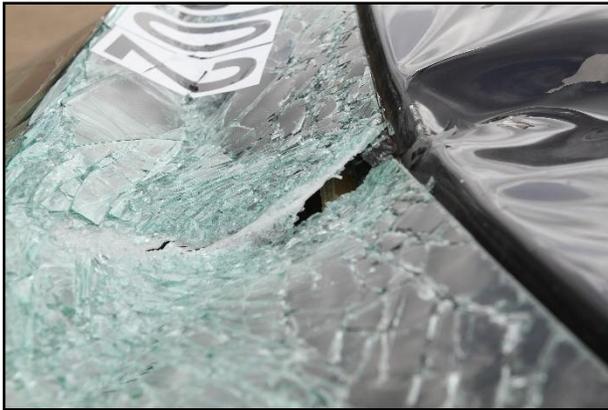
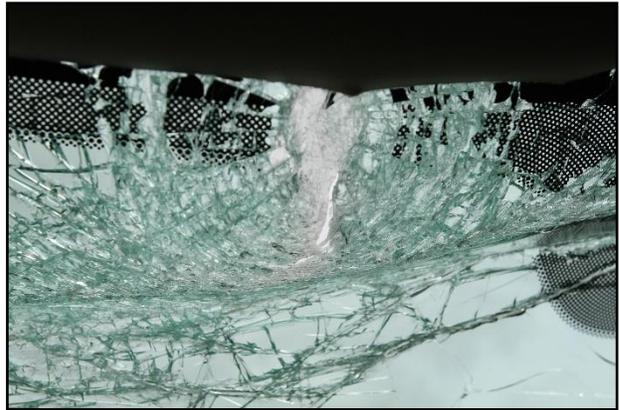
Figure 7.6. Test Vehicle after Test No. 469469-06-02.

Figure 7.6 and Figure 7.7 show the damage sustained by the vehicle. There was a 7-inch by 12-inch by 1-inch-deep dent in the front bumper, a 4-inch by 2.5-inch by 0.3-inch-deep dent in the hood, and a 33-inch by 48-inch by 3.3-inch-deep dent in the roof. The windshield had a 48-inch by 8-inch by 2.8-inch-deep area of damage, and there was a 4-inch-long tear in the windshield laminate. The maximum exterior crush of the vehicle was 1 inch. Maximum occupant compartment deformation was 3.5 inches at the center of the roof. Table F.3 and Table F.4 in Appendix F.2.1 provide exterior crush and occupant compartment measurements.

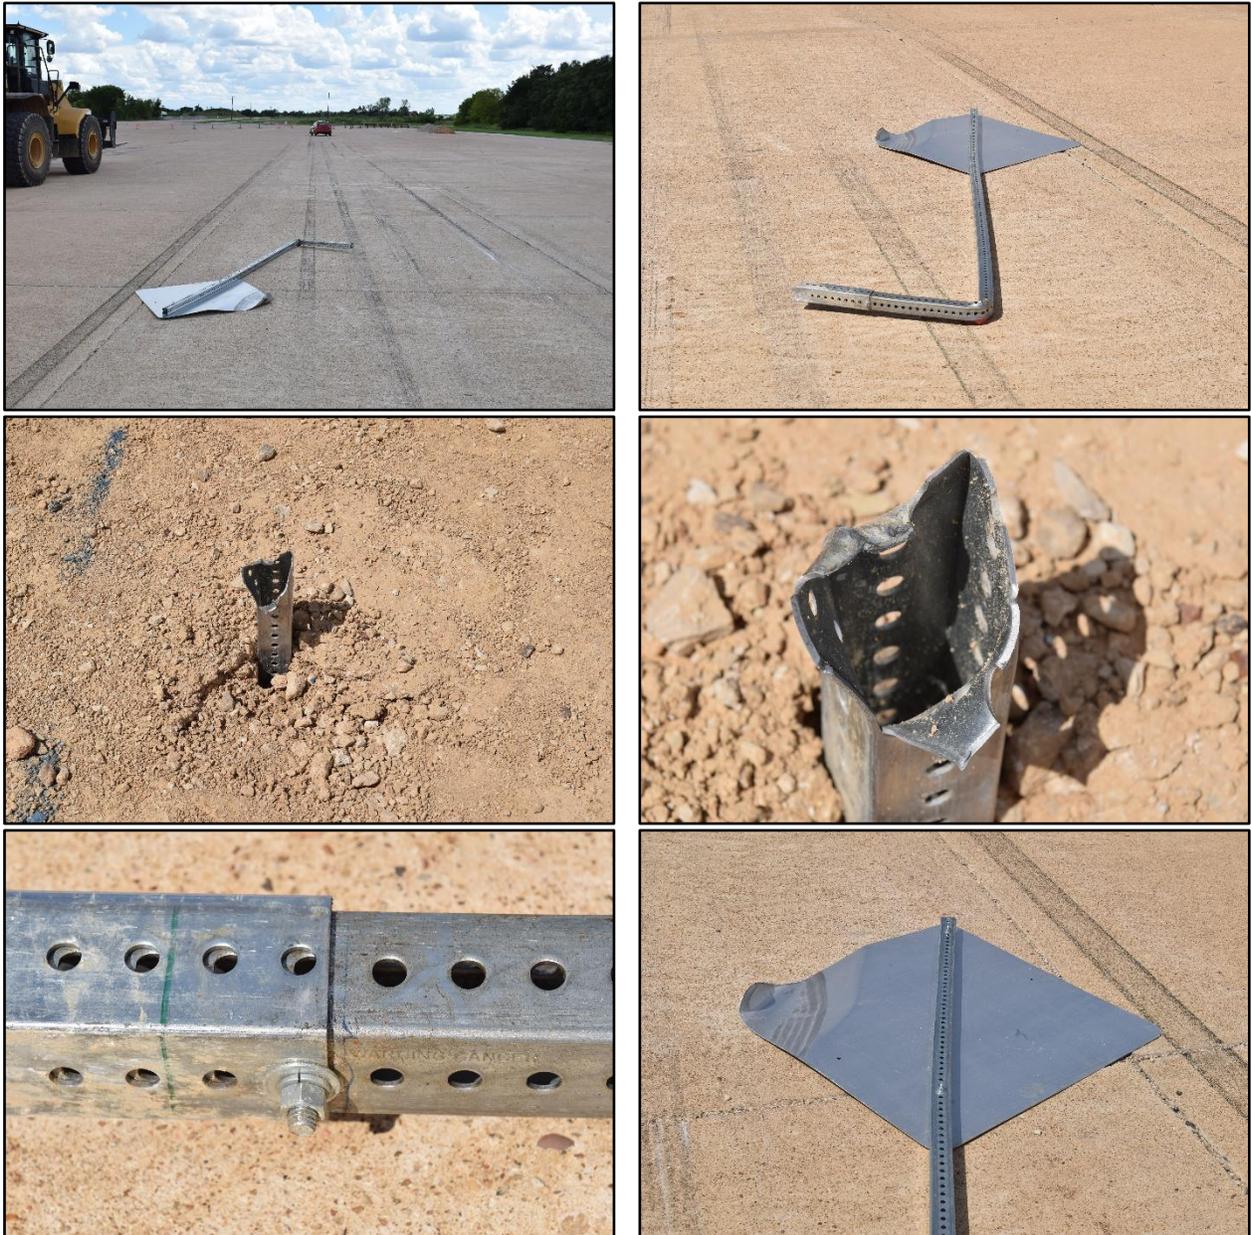
Figure 8.5. PSST Sign Support in Anchor Stub System after Test No. 469469-07-02.

Figure 8.5 shows the damage to the PSST sign support in anchor stub system. The anchor stub displaced 2½ inches rearward in the soil and fractured 9 inches below the top end as it was pulled out of the ground. The support post was bent 90° approximately 18 inches above grade. The sign panel remained attached to the post, and the assembly landed 240 ft downstream of the point of impact and in line with the impact path.

The anchor stub fractured as it was pulled out of the ground. After the anchor stub fractured, the sign panel and support rotated toward the vehicle and impacted the windshield and roof. The sign penetrated into the occupant compartment through the windshield and roof. Consequently, the PSST sign support in anchor stub system did not satisfy *MASH* criteria for breakaway support structures.

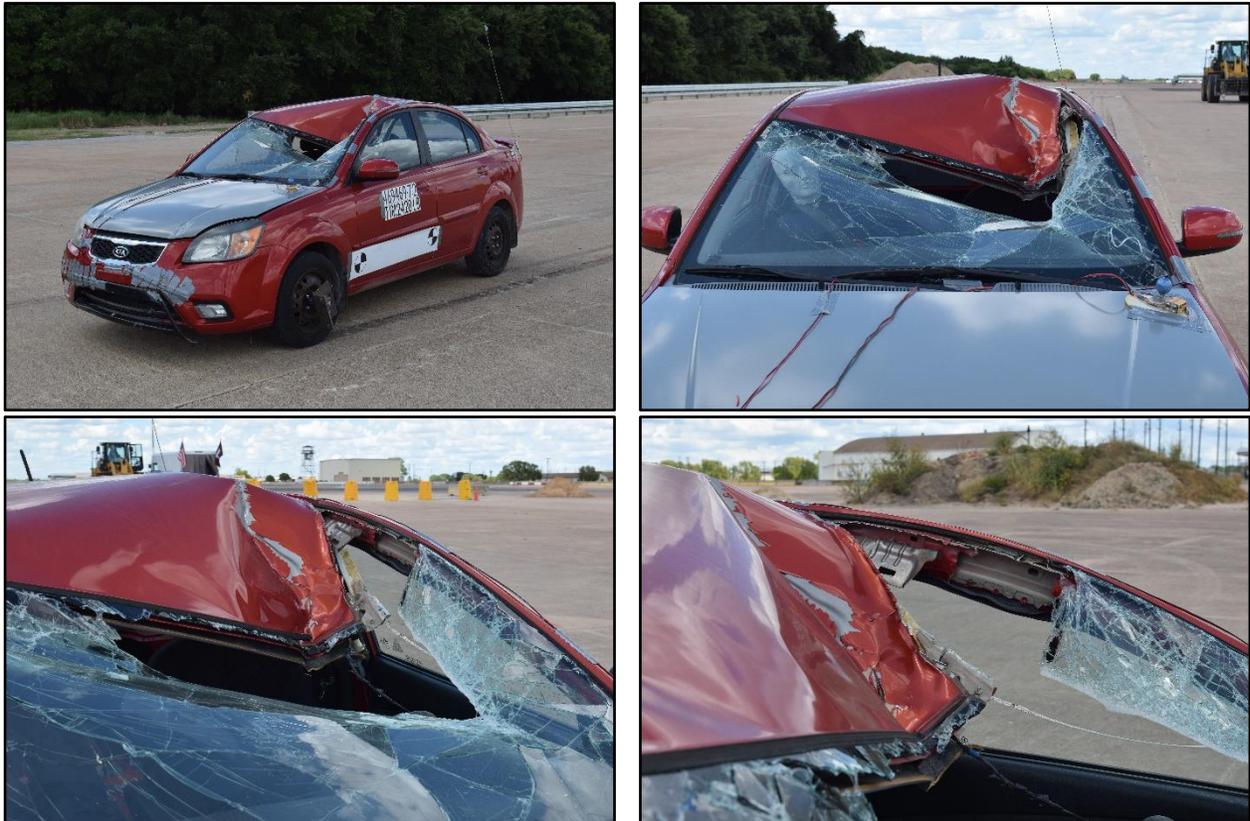
Figure 8.6. Test Vehicle after Test No. 469469-07-02.

Figure 8.6 and Figure 8.7 show the damage sustained by the vehicle. There was a dent 14 inches to the left of the vehicle centerline in the front bumper and hood. The windshield had a 44-inch by 31-inch by 13-inch-deep dent with a 6-inch by 24-inch cut in the laminate. The roof sustained a 41-inch by 27-inch by 12-inch-deep dent. There was also a 16-inch-long tear in the roof along the left seam line. There was no measurable exterior crush of the vehicle. The roof was pushed 11½ inches into the occupant compartment. Table G.4 and Table G.5 in Appendix G.1.2 provide exterior crush and occupant compartment measurements.

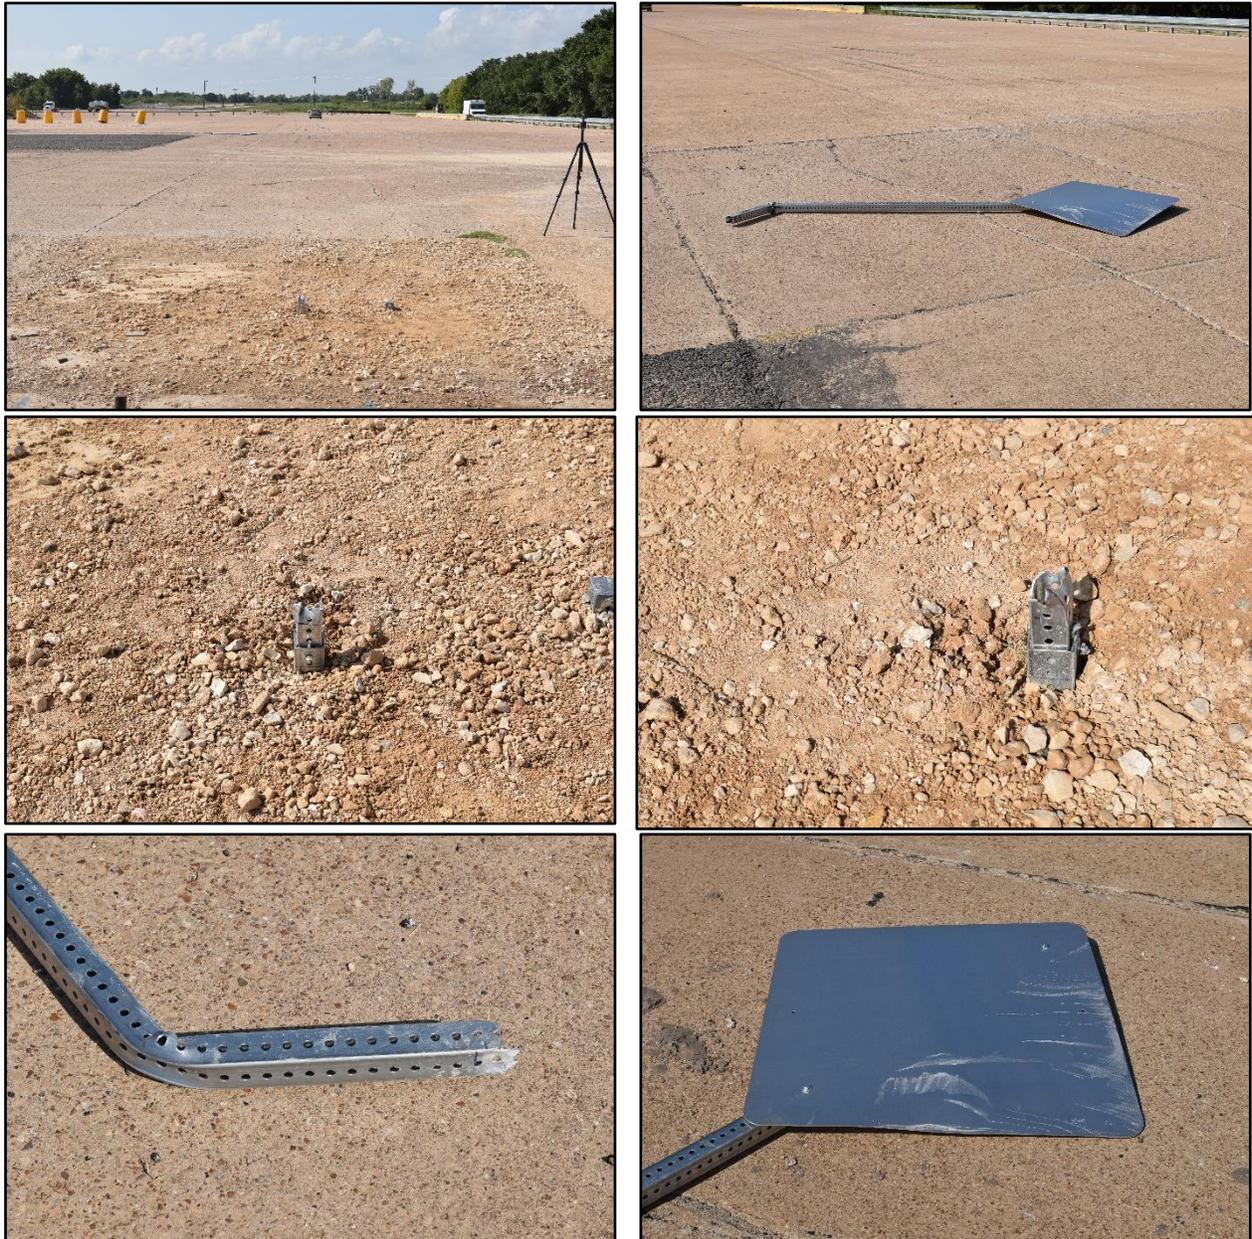
Figure 8.13. PSST Sign Support in Anchor Stub System after Test No. 469469-07-05.

Figure 8.13 shows the damage to the PSST sign support in anchor stub system. The soil was disturbed around the anchor stub and reinforcing sleeve. The corner bolt was fractured. The support post lifted about 2 inches out of the anchor stub and fractured approximately 4 inches above grade. The sign panel remained attached to the post, and the assembly landed 150 ft downstream of the point of impact and 13 ft to the left of the impact path.

The sign support fractured near the ground line as designed. After the support post fractured, the sign panel and support rotated toward the vehicle and impacted the windshield and roof. The sign penetrated through the roof into the occupant compartment, and the roof sustained 11¼ inches of deformation into the occupant compartment. Consequently, the PSST sign support in reinforced anchor stub system did not satisfy *MASH* criteria for breakaway support structures.
