MASH EVALUATION OF TxDOT ROADSIDE SAFETY FEATURES— PHASE III

Test Report 0-6946-R3-Rev1 (Revised 2023-12-14)

TEXAS A&M TRANSPORTATION INSTITUTE

TEXAS DEPARTMENT OF TRANSPORTATION

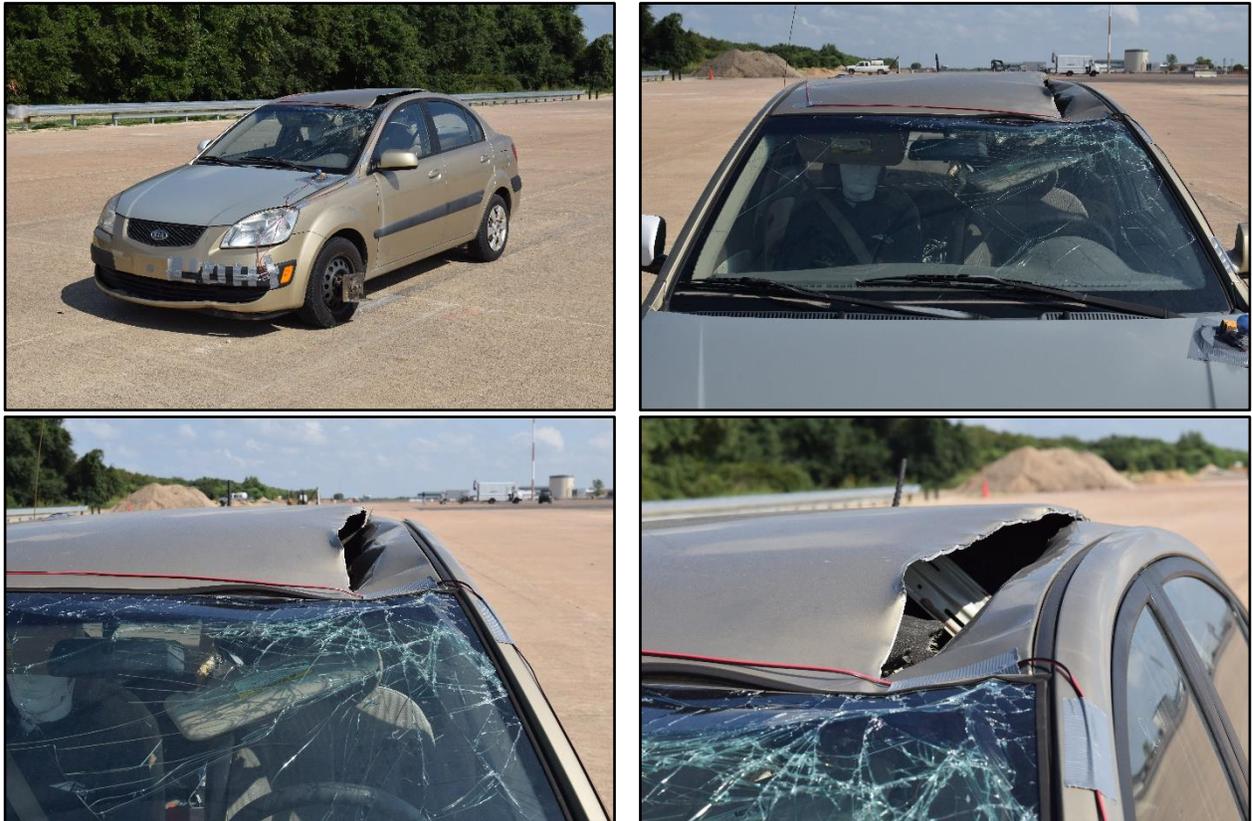
Figure 8.14. Test Vehicle after Test No. 469469-07-05.

Figure 8.14 and Figure 8.15 show the damage sustained by the vehicle. There was a dent located 14 inches to the left of the vehicle centerline in the front bumper and hood. The windshield was shattered in an area measuring 34 inches by 16 inches by 1 inch deep. The roof sustained a 4-inch-wide by 46½-inch-long cut. There was no measurable exterior crush of the vehicle. The deformation of the roof extended 11¼ inches into the occupant compartment. Table G.9 and Table G.10 in Appendix G.2.2 provide exterior crush and occupant compartment measurements.

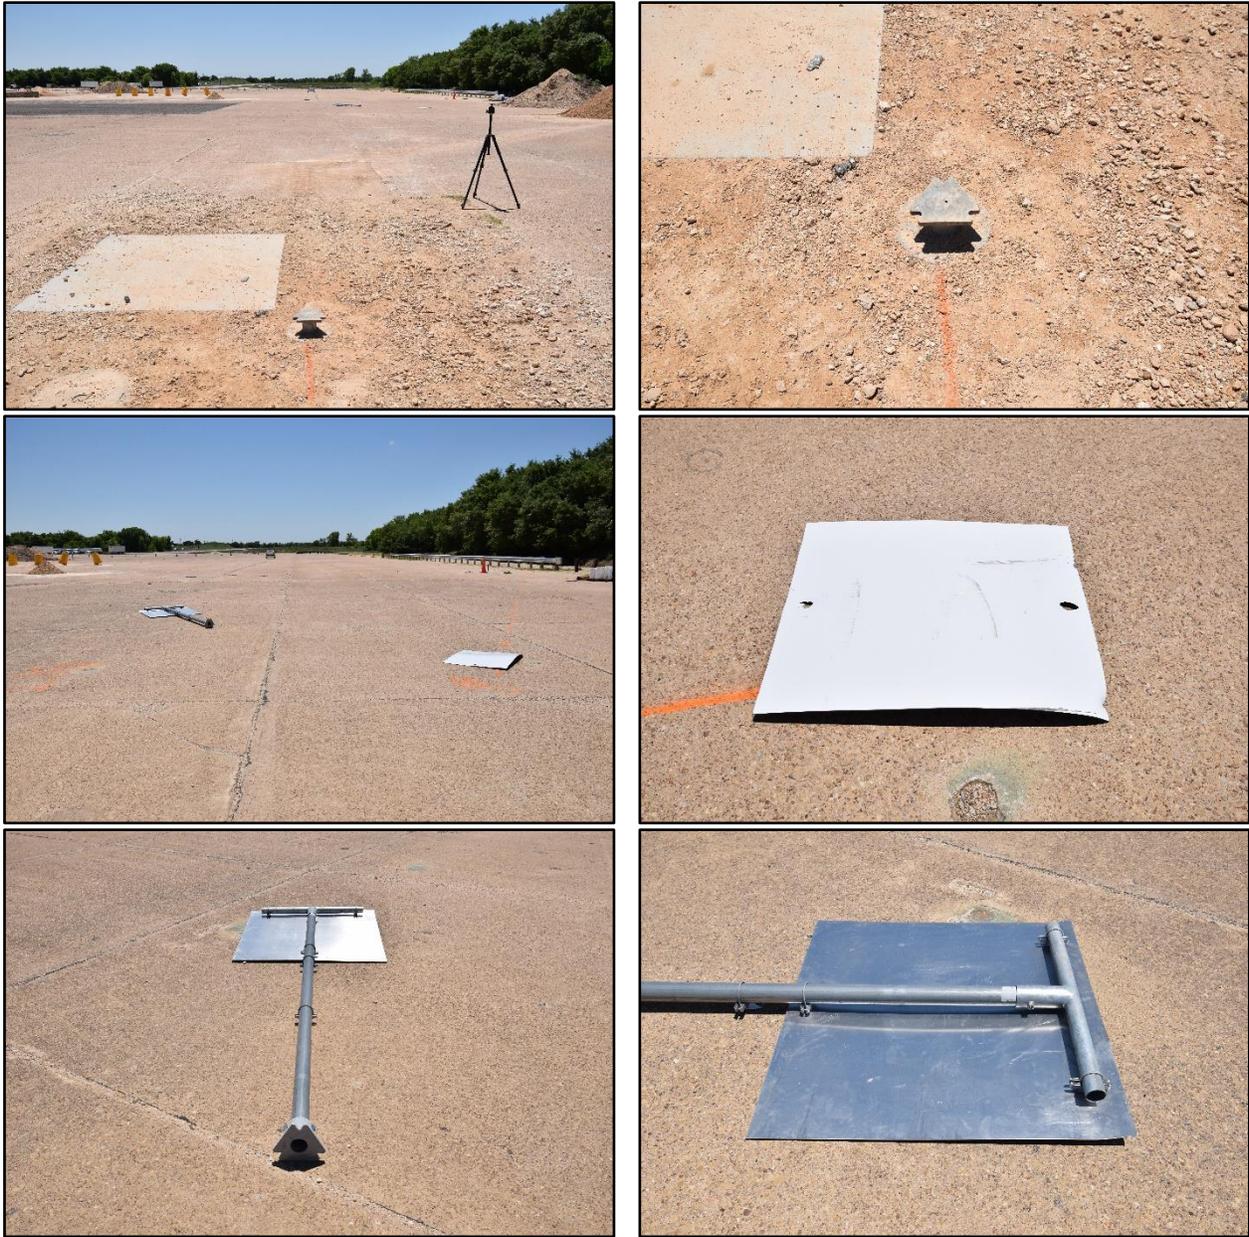
Figure 9.5. Burn Ban Sign with Slip Base Support after Test No. 469469-08-01.

Figure 9.5 shows the damage to the burn ban sign on slip base support. The slip base system activated as designed, and the stub and foundation were undisturbed. The lower burn ban sign released from the pipe support and came to rest 105 ft downstream and 20 ft right of the original location. The remaining components of the sign support system stayed together and came to rest 120 ft downstream and 8 ft right of the original location.

The burn ban sign on slip base support did not comply with *MASH* criteria. After release from the slip base, the sign support system rotated over the impacting vehicle, and the top of the sign panel and support contacted and penetrated the rear window.

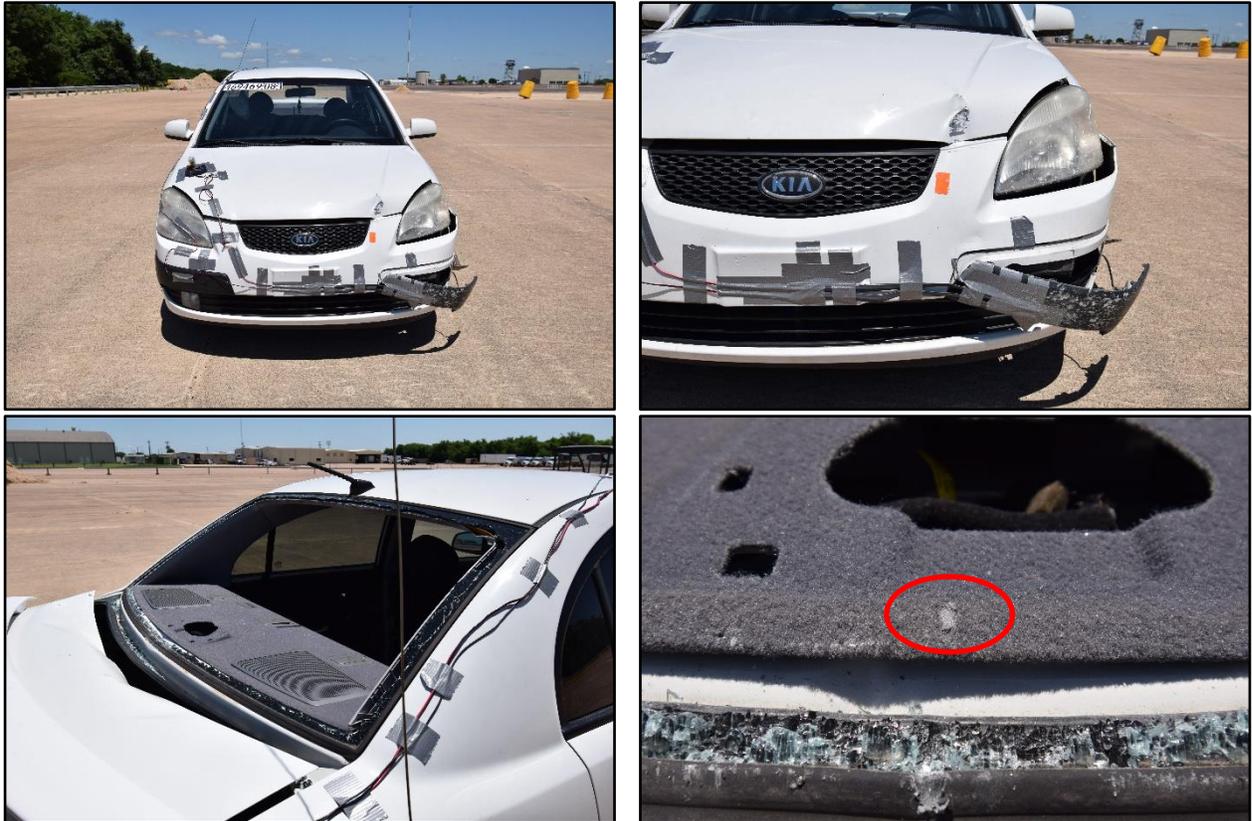
Figure 9.6. Test Vehicle after Test No. 469469-08-01.

Figure 9.6 and Figure 9.7 show the damage sustained by the vehicle. There was a 4-inch by 6-inch by 2.5-inch-deep dent in the front bumper and a 3-inch by 4-inch by 1-inch-deep dent in the hood, the trunk lid was dented, and the rear window was ejected. The maximum exterior crush of the vehicle was 2.5 inches at the front bumper. There was no measurable occupant compartment deformation. The package deck (shelf) under the rear window showed signs of penetration by the hardware that attached the sign to the support (Figure 9.6). Table H.2 and Table H.3 in Appendix H.3.1 provide exterior crush and occupant compartment measurements.

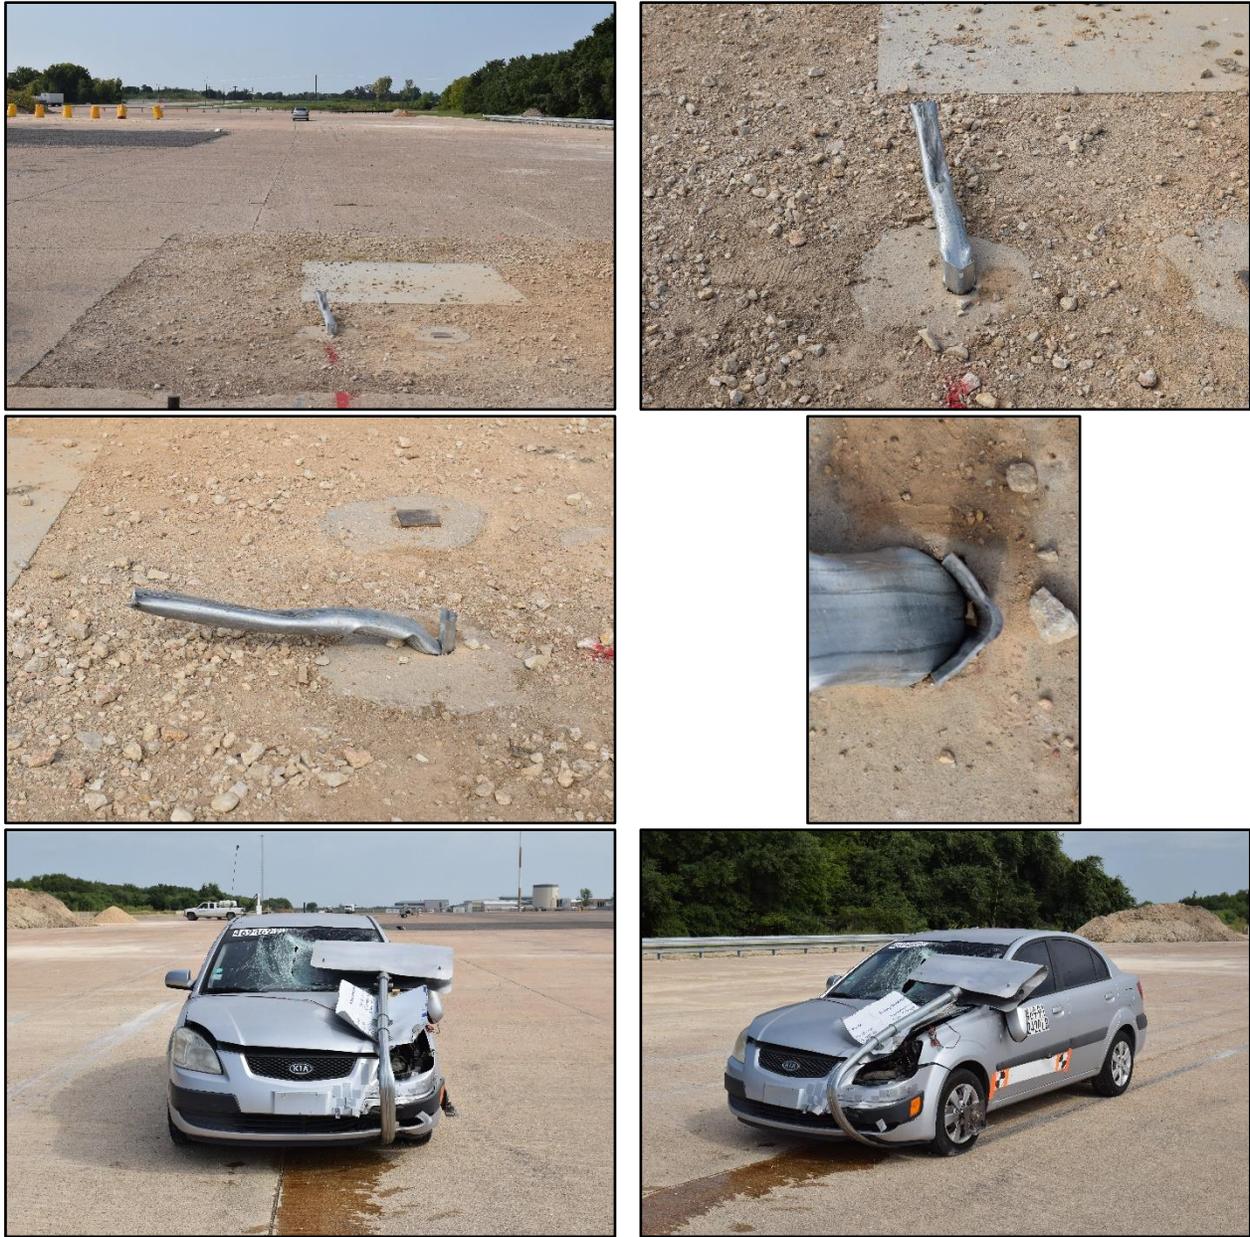
Figure 10.5. Burn Ban Sign on Wedge and Socket Support after Test No. 469469-09-01.

Figure 10.5 shows the damage to the burn ban sign on wedge and socket support. The support post partially pulled out of the socket and fractured 24 inches above the ground line. The lower portion remaining in the socket was bent over approximately 85° such that it was nearly parallel with the ground. Both sign panels remained attached to the upper portion of the fractured support post, and this assembly wrapped around the front of the test vehicle and remained intact with the vehicle until it came to a stop.

Upon impact with the burn ban sign on wedge and socket support, the support post initially began to pull out of its socket, but it subsequently fractured about 24 inches above grade. After fracture of the support post, the upper portion wrapped around the front of the vehicle, and the upper sign panel and support contacted and penetrated the windshield. Consequently, the burn ban sign on wedge and socket support did not meet *MASH* criteria.

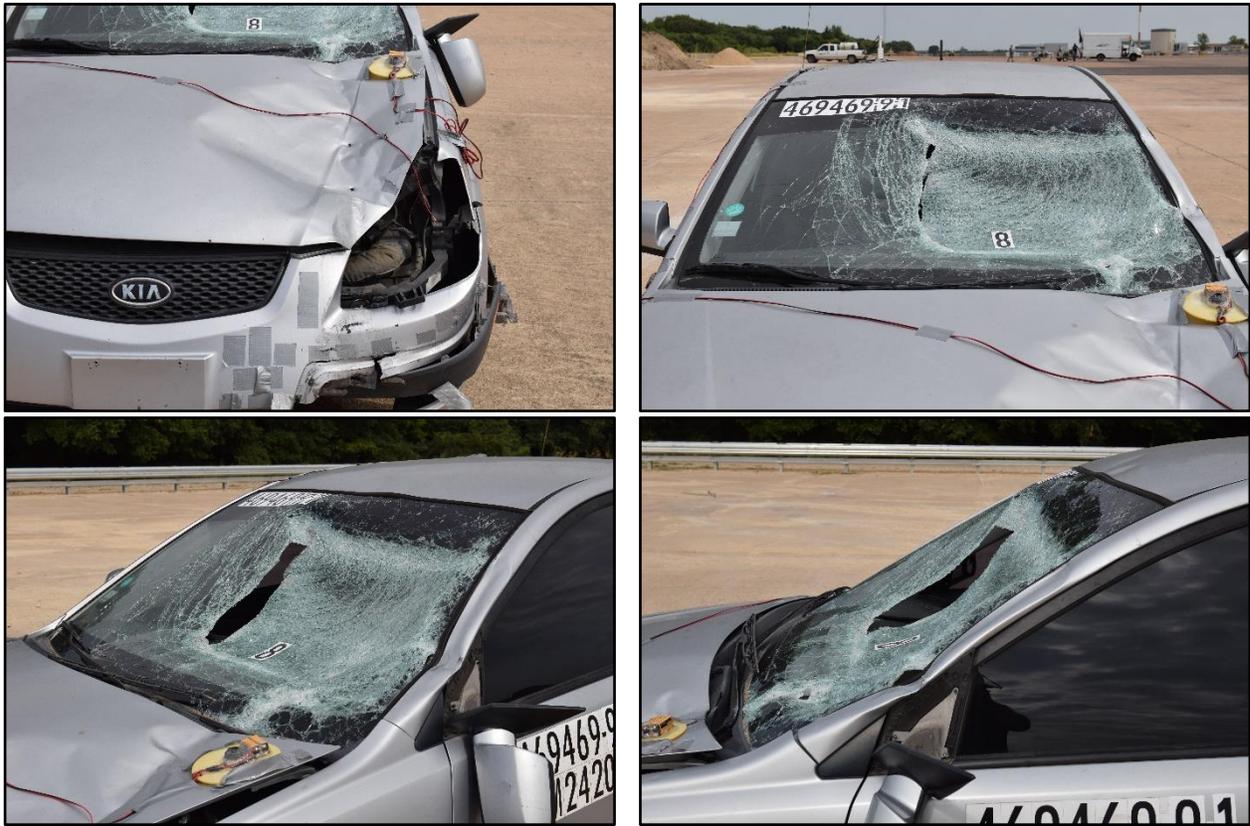
Figure 10.6. Test Vehicle after Test No. 469469-09-01.

Figure 10.6 and Figure 10.7 show the damage sustained by the vehicle. There was a dent in the front bumper and a 24-inch by 34-inch by 4.25-inch-deep dent in the hood including two 0.25-inch round holes that were 7 inches apart. The left headlight, left side mirror, left A-pillar, and radiator support were damaged. The windshield had a 37-inch by 32-inch by 6-inch-deep indentation and two cuts/tears in the laminate, one 16 inches long and one 3 inches long. There was no measurable exterior crush of the vehicle. The windshield deformed 6 inches into the occupant compartment and had a large cut in it as explained previously. Table I.2 and Table I.3 in Appendix I.2.1 provide exterior crush and occupant compartment measurements.

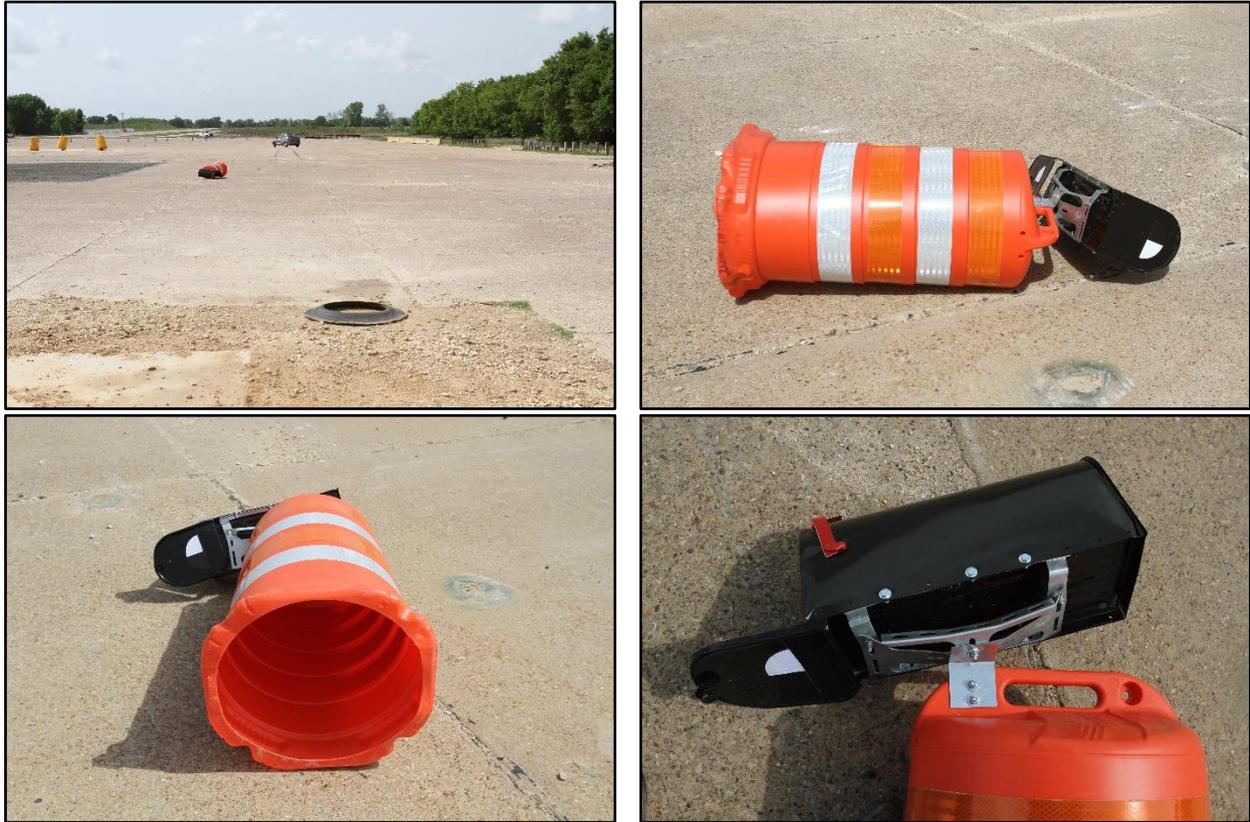
Figure 11.6. Single Temporary Mailbox on Plastic Drum after Test No. 469469-10-1.

Figure 11.6 shows the damage to the single temporary mailbox on a plastic drum. The mailbox was deformed but still attached to the drum. The single temporary mailbox on a plastic drum assembly came to rest 90 ft downstream and 10 ft to the left of its original location.

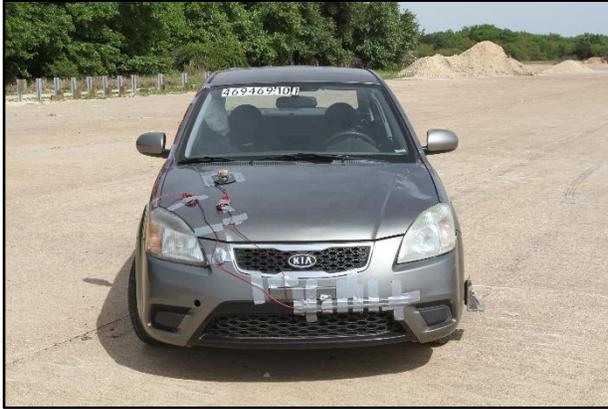
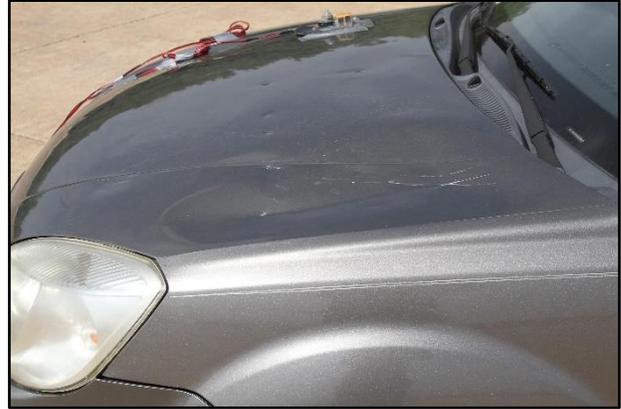
Figure 11.7. Test Vehicle after Test No. 469469-10-1.

Figure 11.7 and Figure 11.8 show the damage sustained by the vehicle. The hood of the vehicle suffered an 8-inch by 20-inch by $\frac{3}{4}$ -inch-deep dent, and there were minor scuff marks on the bumper at the point of impact. There was neither measurable exterior crush nor interior deformation to the vehicle. Table J.2 and Table J.3 in Appendix J.1.2 provide further details.

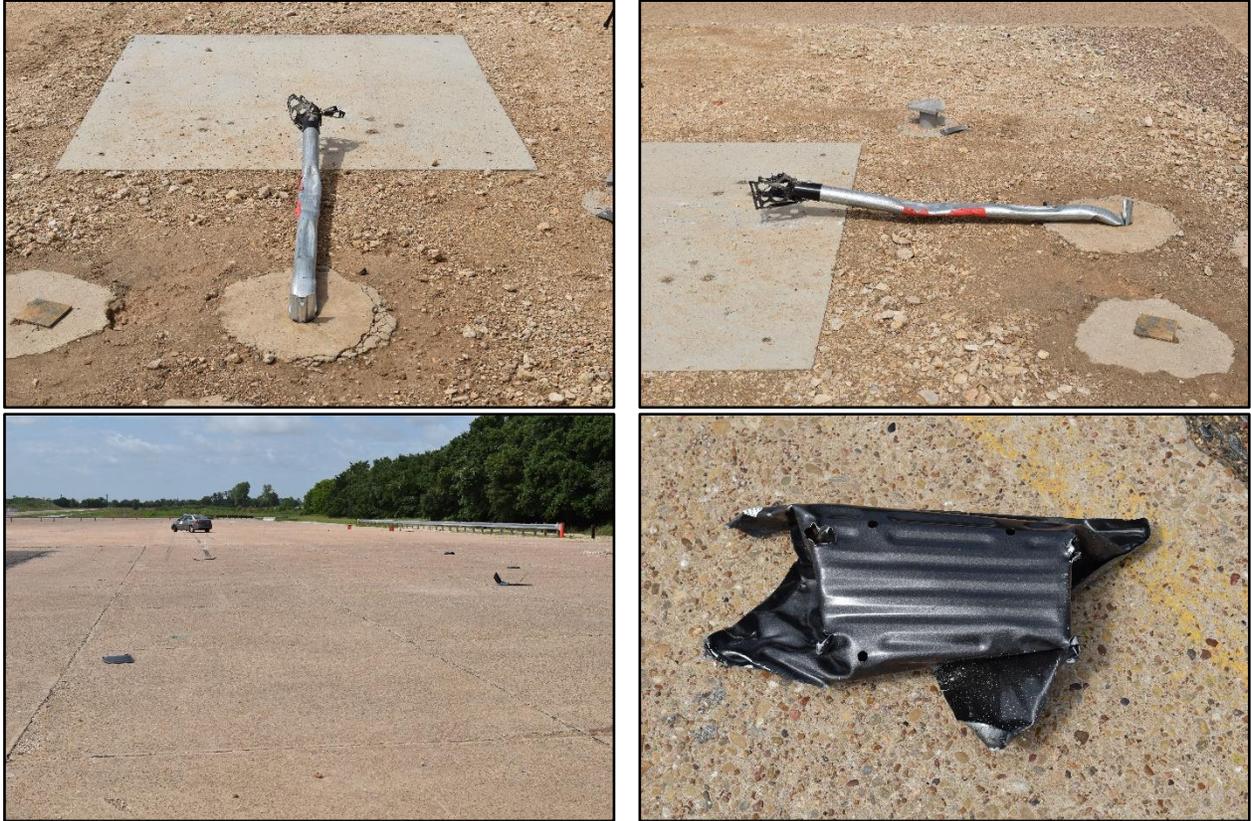
Figure 11.14. Extra-Large Mailbox on Thin-Wall Galvanized Tube with Type 2 Foundation after Test No. 469469-10-2.

Figure 11.14 shows the damage to the Centennial model mailbox on Type 2 foundation. The post pulled out of the socket 5 inches and then bent over flat against the soil/concrete. The mailbox was detached from the bracket and separated into four pieces that came to rest in an area ranging from 55 to 95 ft downstream of the point of impact and 5 ft left to 31 ft right of the travel path of the vehicle.

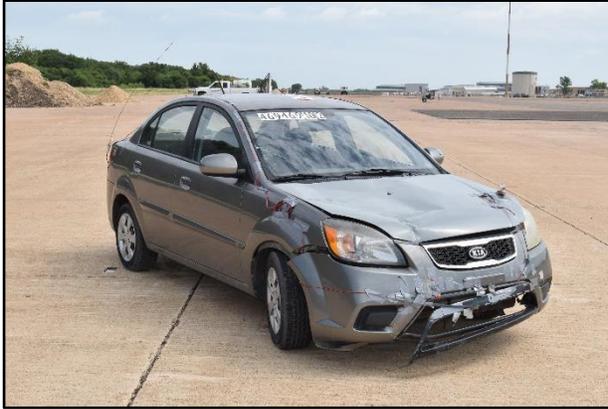
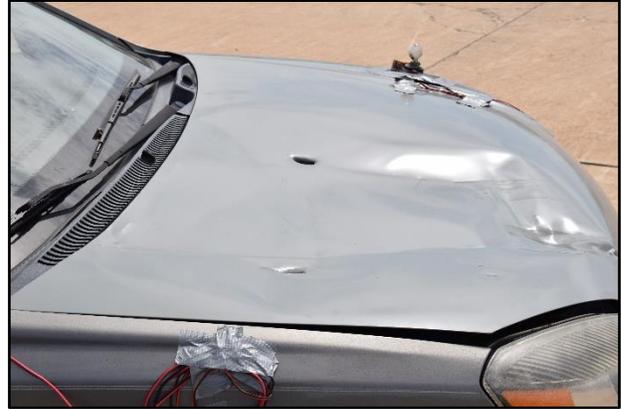
Figure 11.15. Test Vehicle after Test No. 469469-10-2.

Figure 11.15 and Figure 11.16 show the damage sustained by the vehicle. The right side of the bumper had a 3-inch dent, and the right side of the hood of the vehicle had a 29-inch by 31-inch by 1.3-inch-deep dent with 2.5-inch by 2-inch cuts. There was a small dent in the right A-pillar, and the bottom right of the windshield was fractured over an 8-inch by 8-inch area; however, there was no penetration of the windshield. There was a 3-inch dent in the bumper and no interior deformation to the vehicle. Table J.6 and Table J.7 in Appendix J.2.2 provide further details.

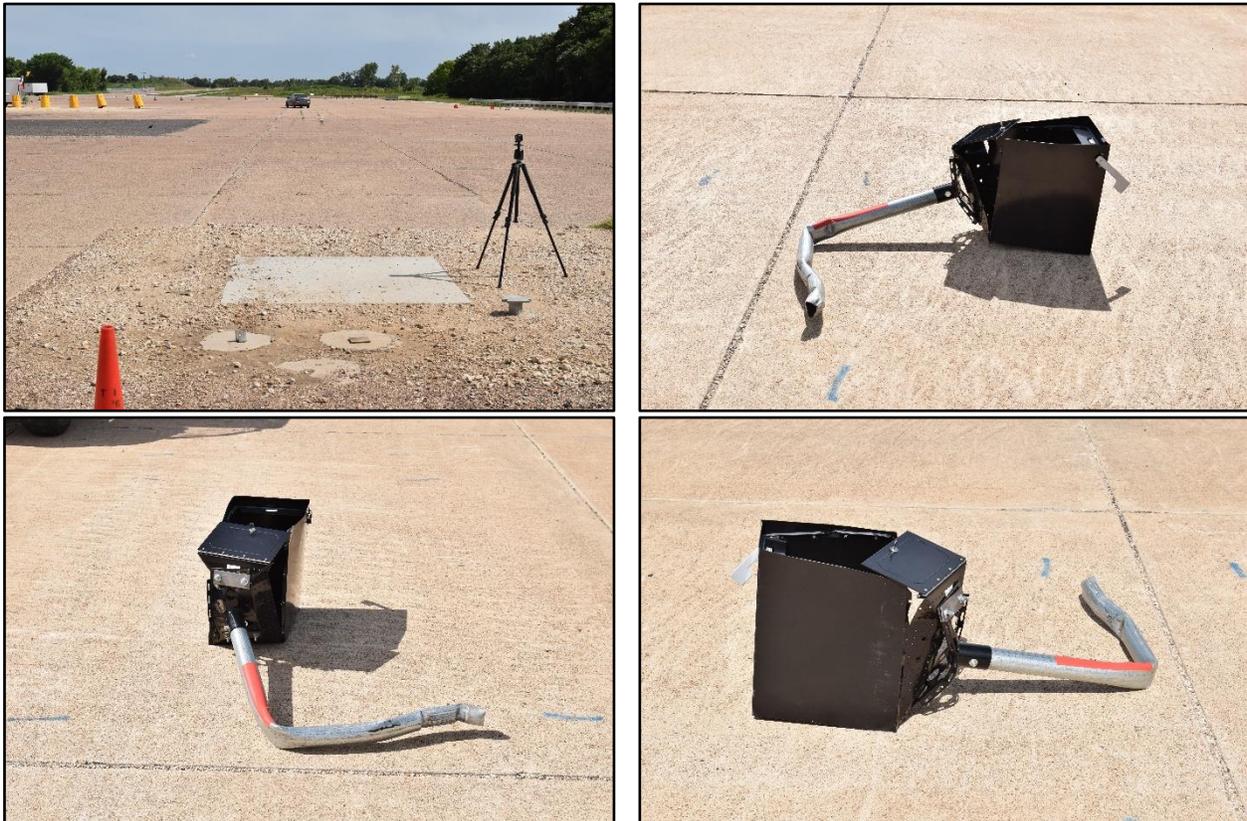
Figure 11.22. Lockable Mailbox on Thin-Wall Galvanized Tube with Type 2 Foundation after Test No. 469469-10-3.

Figure 11.22 shows the damage to the lockable mailbox on thin-wall galvanized tube with Type 2 foundation. The mailbox-post assembly remained intact. The mailbox, bracket, and support post were deformed. The lockable mailbox on thin-wall galvanized tube with Type 2 foundation assembly came to rest 311 ft downstream of its original location.

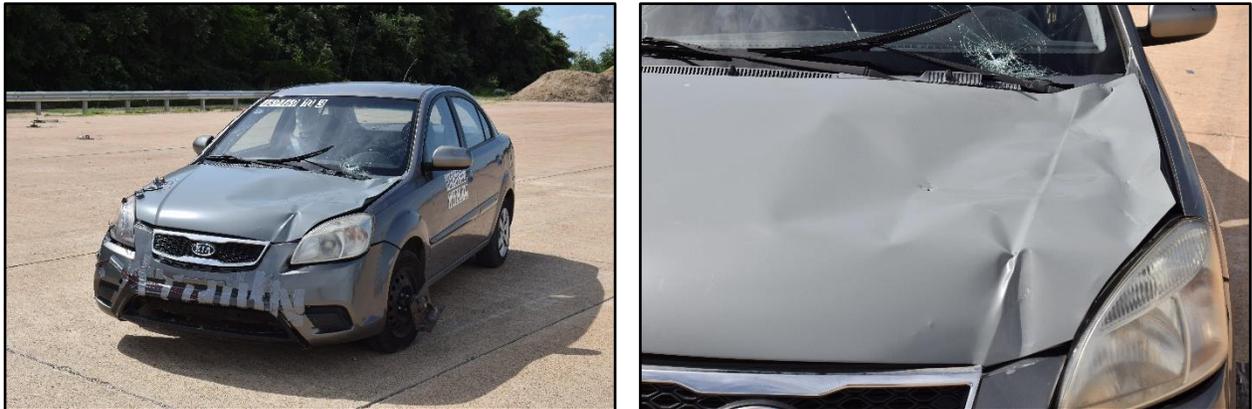
Figure 11.23. Test Vehicle after Test No. 469469-10-3.

Figure 11.23 and Figure 11.24 show the damage sustained by the vehicle. The front bumper sustained a 3-inch-deep dent, 14 inches from the centerline of the vehicle. The left side hood of the vehicle had a 26-inch by 33-inch by 1.5-inch-deep dent with a ¼-inch by ½-inch cut. The lower left area of the windshield was cracked over an area approximately 8 inches by 8 inches. There was no measurable exterior crush or interior deformation to the vehicle. Table J.10 and Table J.11 in Appendix J.3.2 provide further details.

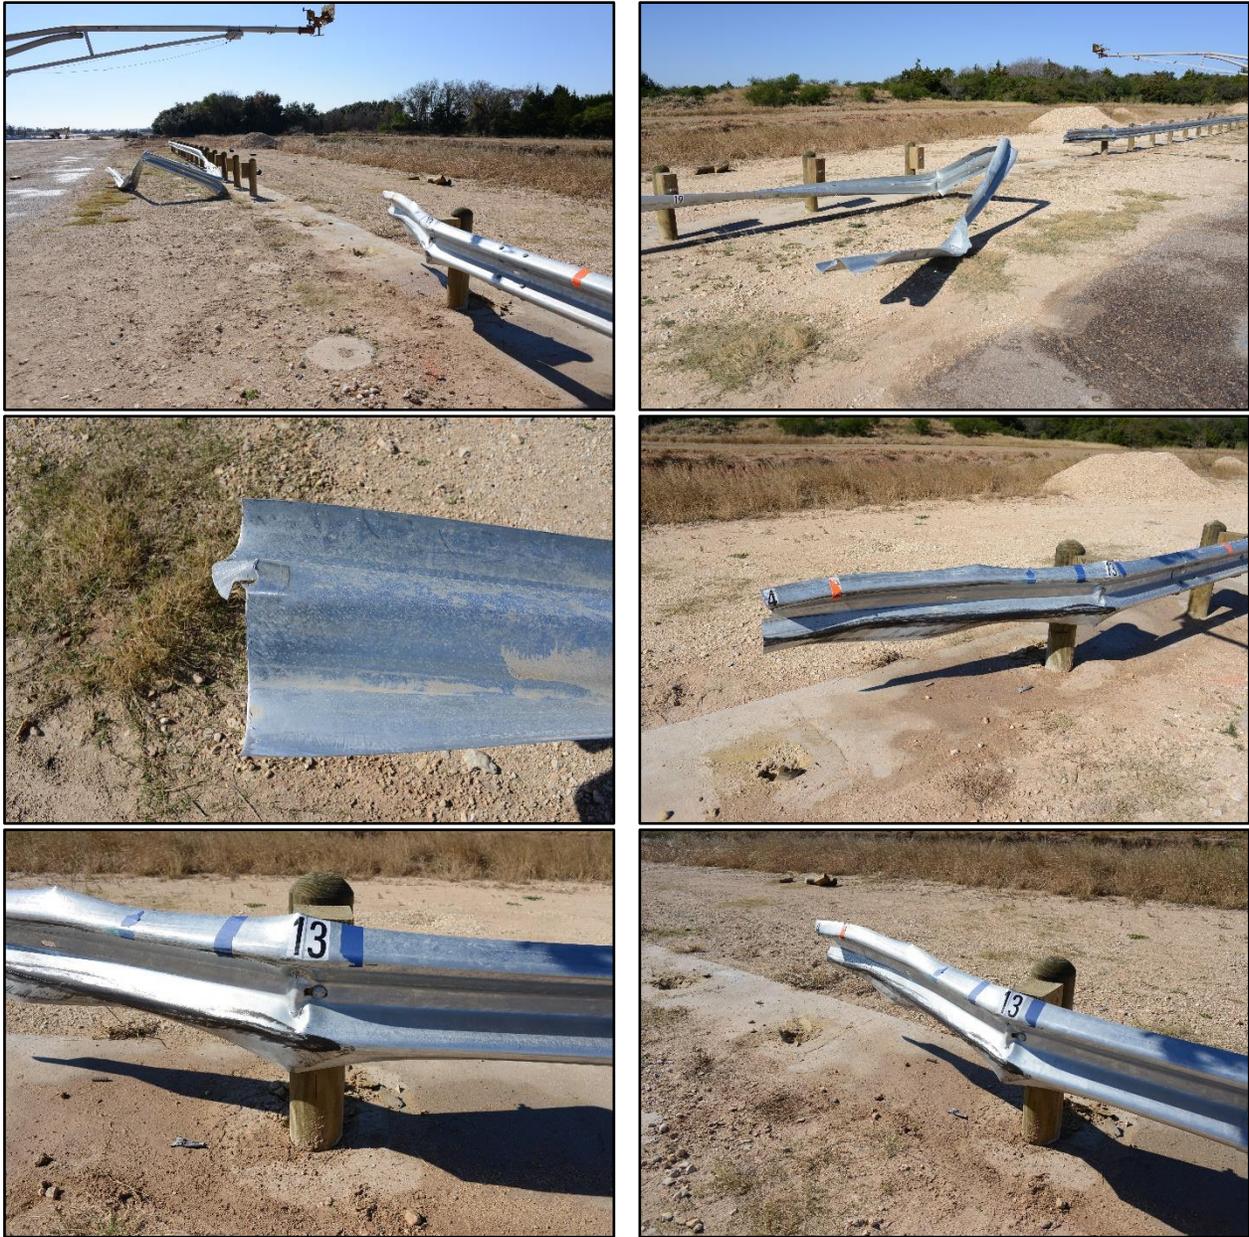
Figure 12.5. Round Wood Post Guardrail in a Concrete Mow Strip after Test No. 469469-11.

Figure 12.5 shows the damage to the round wood post guardrail in a concrete mow strip. The rail released from posts 14 to 20 and ruptured at post 14. Post 13 was leaning 1.5° toward the field side, and posts 14, 15, and 16 broke off at grade. The vehicle passed through the barrier to the field side.

The round wood post guardrail in a concrete mow strip did not meet *MASH* criteria. The 2270P vehicle penetrated through the guardrail and was not contained or redirected by the round wood post guardrail in a concrete mow strip.

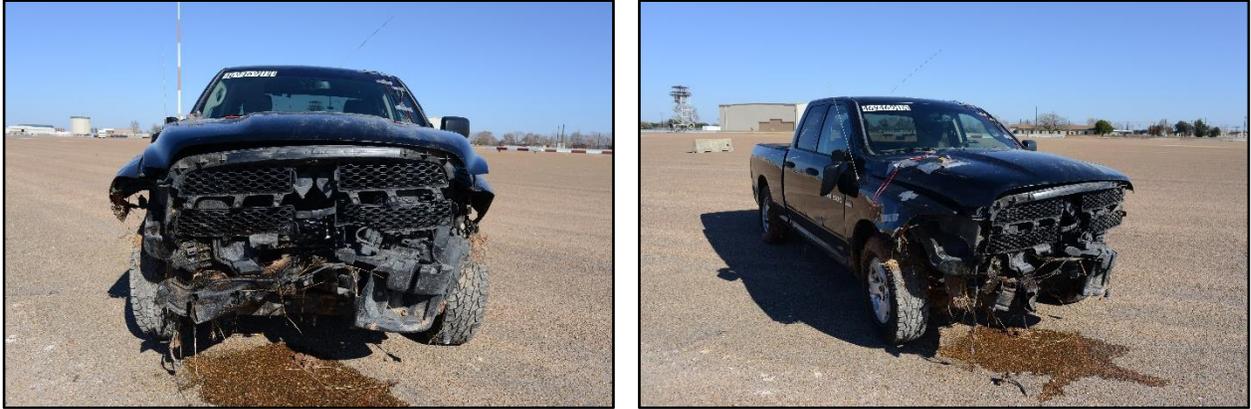
Figure 12.6. Test Vehicle after Test No. 469469-11.

Figure 12.6 and Figure 12.7 show the vehicle after the test. The front bumper, hood, grill, radiator and support, right and left front fender, right front and rear door, right and left head lights, right rear fender, and right rear tire and rim were damaged. Maximum exterior crush to the vehicle was 17.0 inches at the front bumper. There was no measurable occupant compartment deformation. Table K.5 and Table K.6 in Appendix K.3.1 provide exterior crush and occupant compartment measurements.

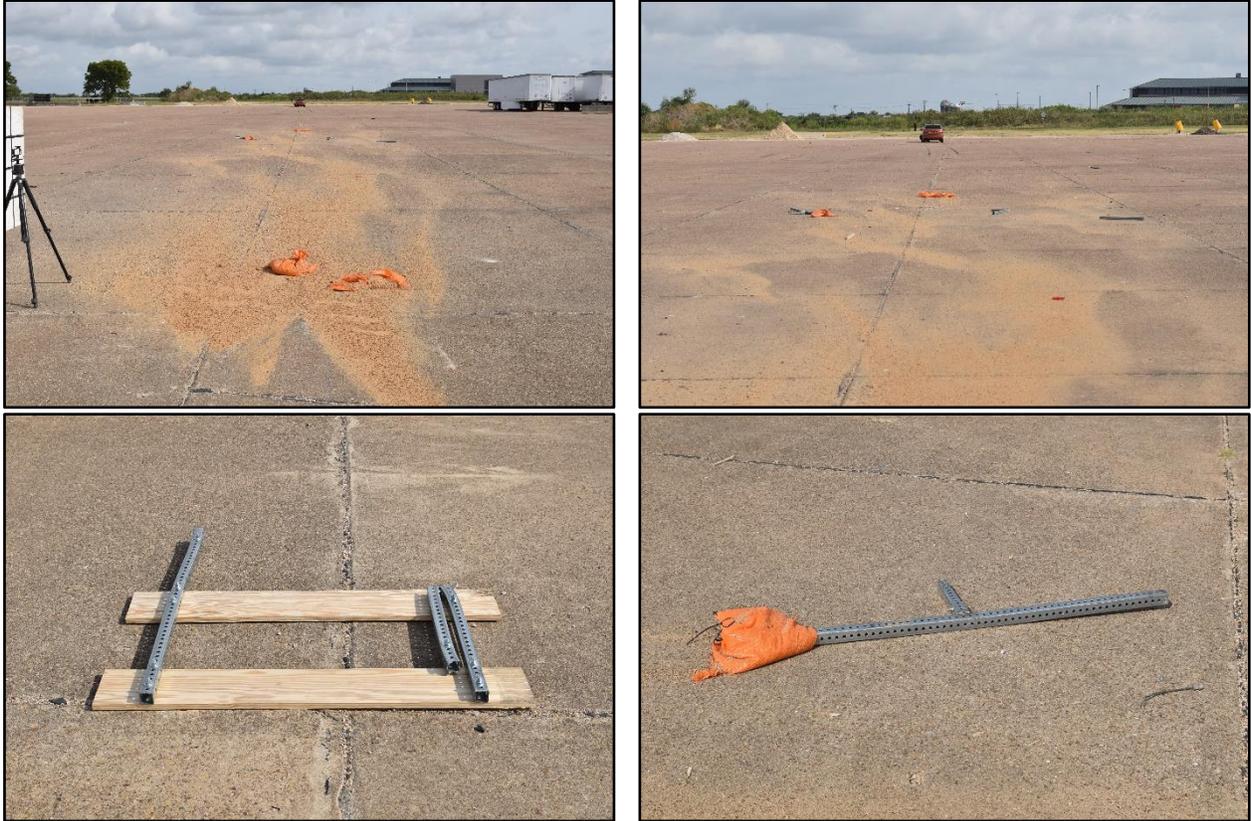
Figure 13.5. Type III Barricade after Test No. 469469-12-01.

Figure 13.5 shows the damage to the Type III barricade. Components of the barricade fractured into multiple pieces that were scattered 165 ft downstream, 13 ft to the right and 43 ft to the left of the original position. The largest section of debris consisting of two wood rails and the fractured uprights came to rest 142 ft downstream and 43 ft to the left of the original impact location.

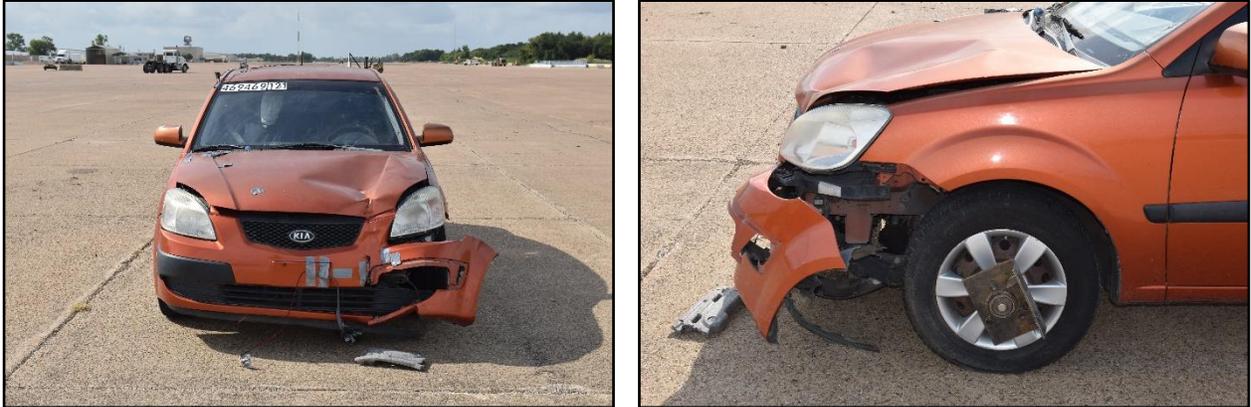
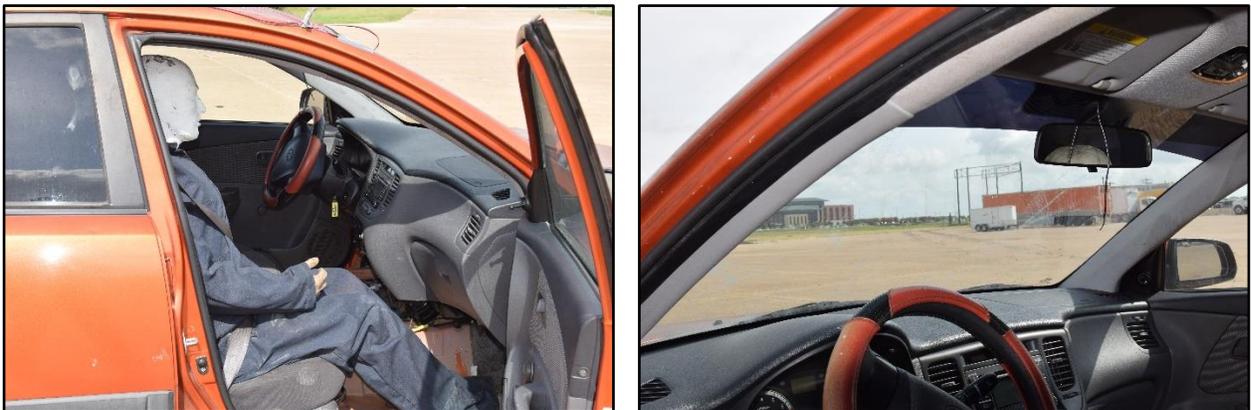
Figure 13.6. Test Vehicle after Test No. 469469-12-01.

Figure 13.6 and Figure 13.7 show the damage sustained by the vehicle. There was a 4-inch by 8-inch by 1.75-inch-deep dent in the front bumper and hood edge, and a 24-inch by 24-inch by 2.5-inch-deep dent in the top left side of the hood. There was no measurable occupant compartment deformation. Table L.2 and Table L.3 in Appendix L.2.1 provide exterior crush and occupant compartment measurements.

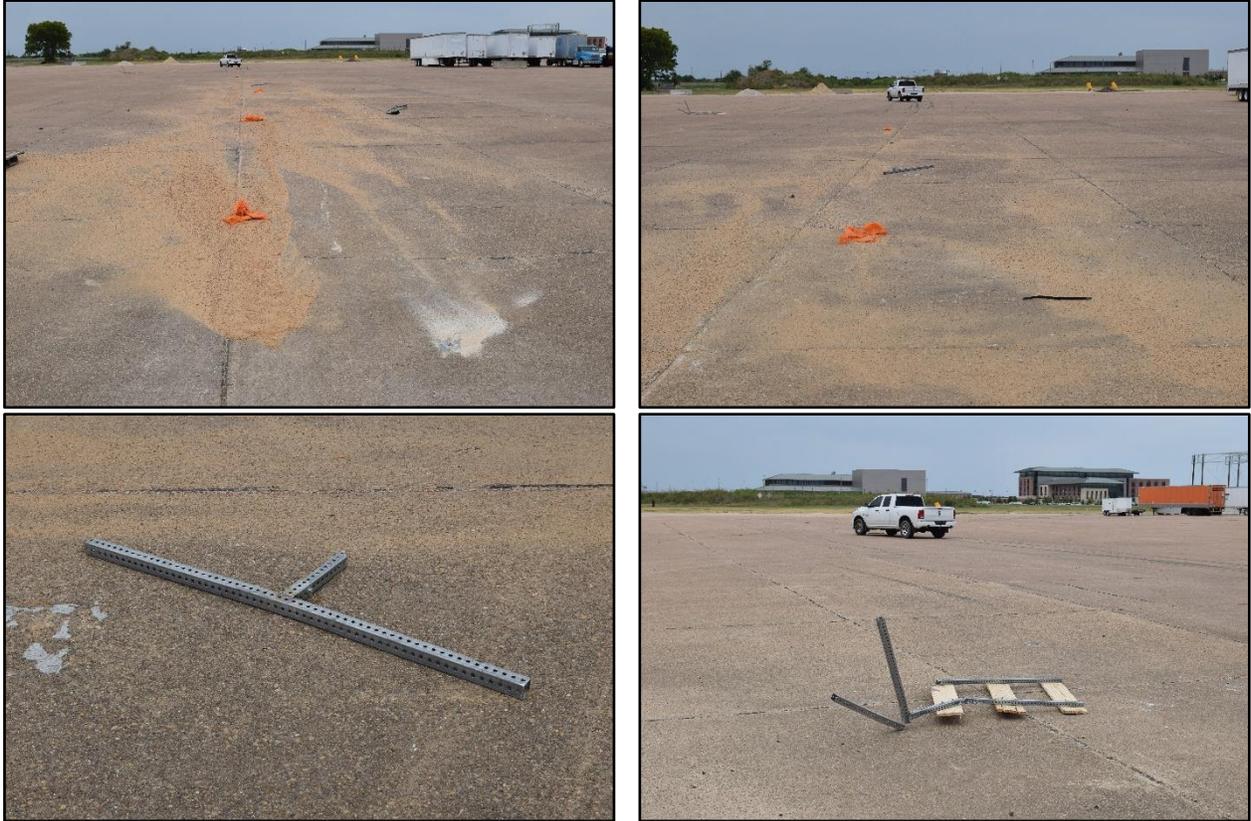
Figure 13.11. Type III Barricade after Test No. 469469-12-02.

Figure 13.11 shows the damage to the Type III barricade. The barricade separated into two pieces. One of the uprights fractured approximately 15 inches above grade. The lower portion of this upright and the attached skid came to rest 218 ft downstream and 40 ft to the left of the impact point. The remaining portion of the fracture upright, the other upright and skid, and the three rails remained together and came to rest 105 ft downstream of the impact point.

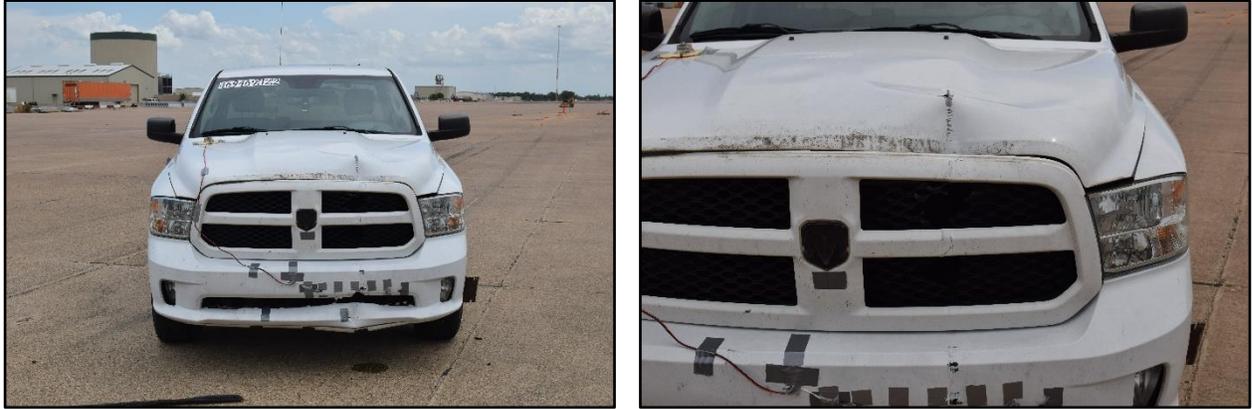
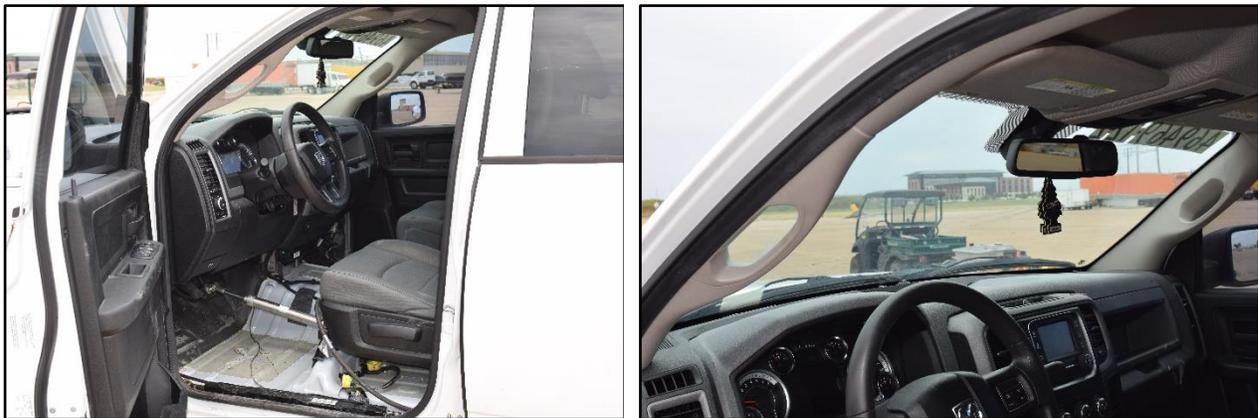
Figure 13.12. Test Vehicle after Test No. 469469-12-02.

Figure 13.12 and Figure 13.13 show the damage sustained by the vehicle. There was an 8-inch by 8-inch dent in the hood, including a 1-inch hole located 1 ft to the left of the centerline of the hood at the front. The front bumper and grill also sustained damage. There was no measurable occupant compartment deformation. Table L.6 and Table L.7 in Appendix L.3.1 provide exterior crush and occupant compartment measurements.

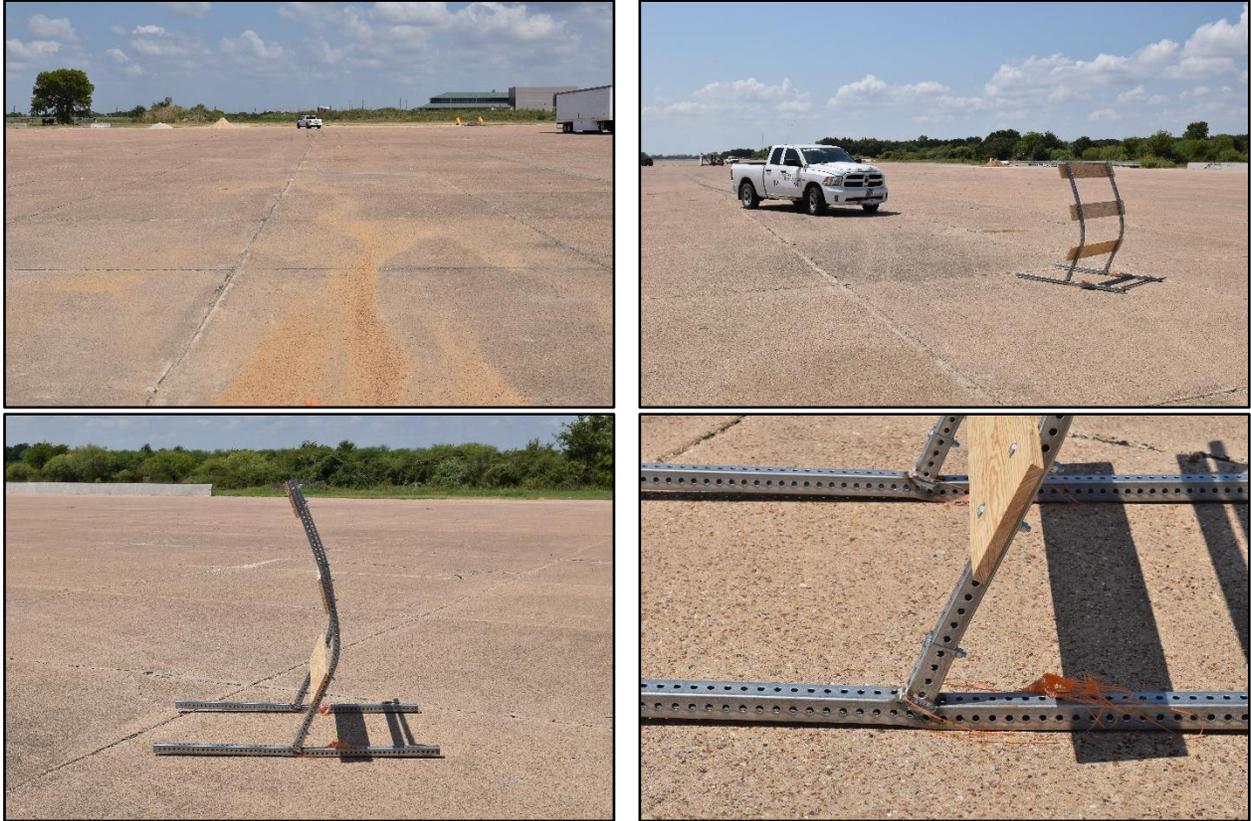
Figure 13.17. Type III Barricade after Test No. 469469-12-03.

Figure 13.17 shows the damage to the Type III barricade. The barricade remained mostly intact and came to rest 462 ft downstream and 14 ft to the left of the impact location. The welds were cracked at the base, and the supports were bent at 18 inches up from the base.

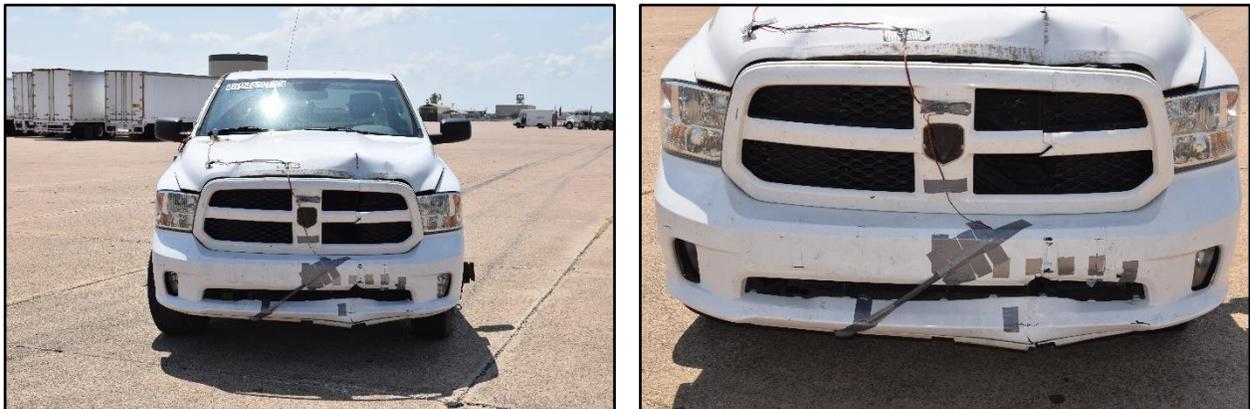
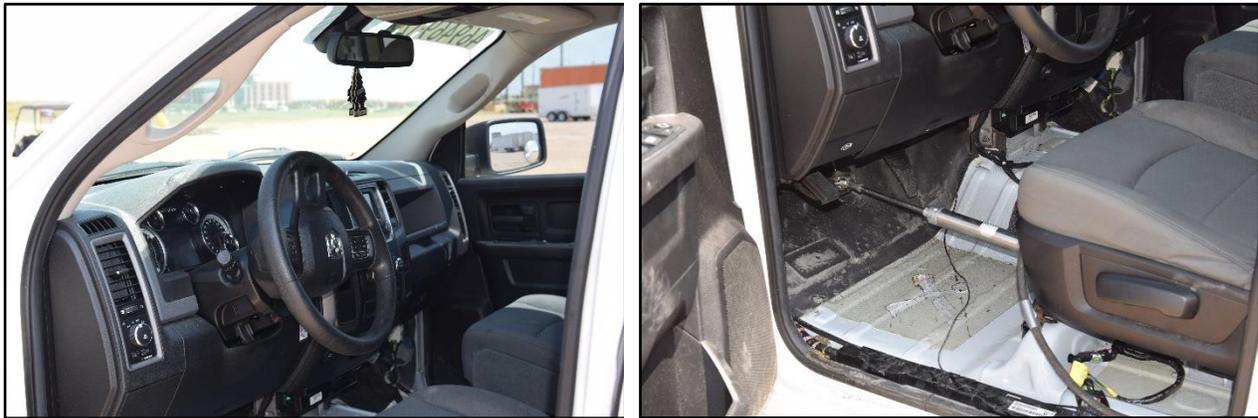
Figure 13.18. Test Vehicle after Test No. 469469-12-03.

Figure 13.18 and Figure 13.19 show the damage sustained by the vehicle. There were scuffs marks on the bumper and grill. There was neither measurable exterior crush on the vehicle nor occupant compartment deformation. Table L.10 and Table L.11 in Appendix L.4.1 provide exterior crush and occupant compartment measurements.
