MASH EVALUATION OF TxDOT ROADSIDE SAFETY FEATURES— PHASE III

Test Report 0-6946-R3-Rev1 (Revised 2023-12-14)

TEXAS A&M TRANSPORTATION INSTITUTE

TEXAS DEPARTMENT OF TRANSPORTATION

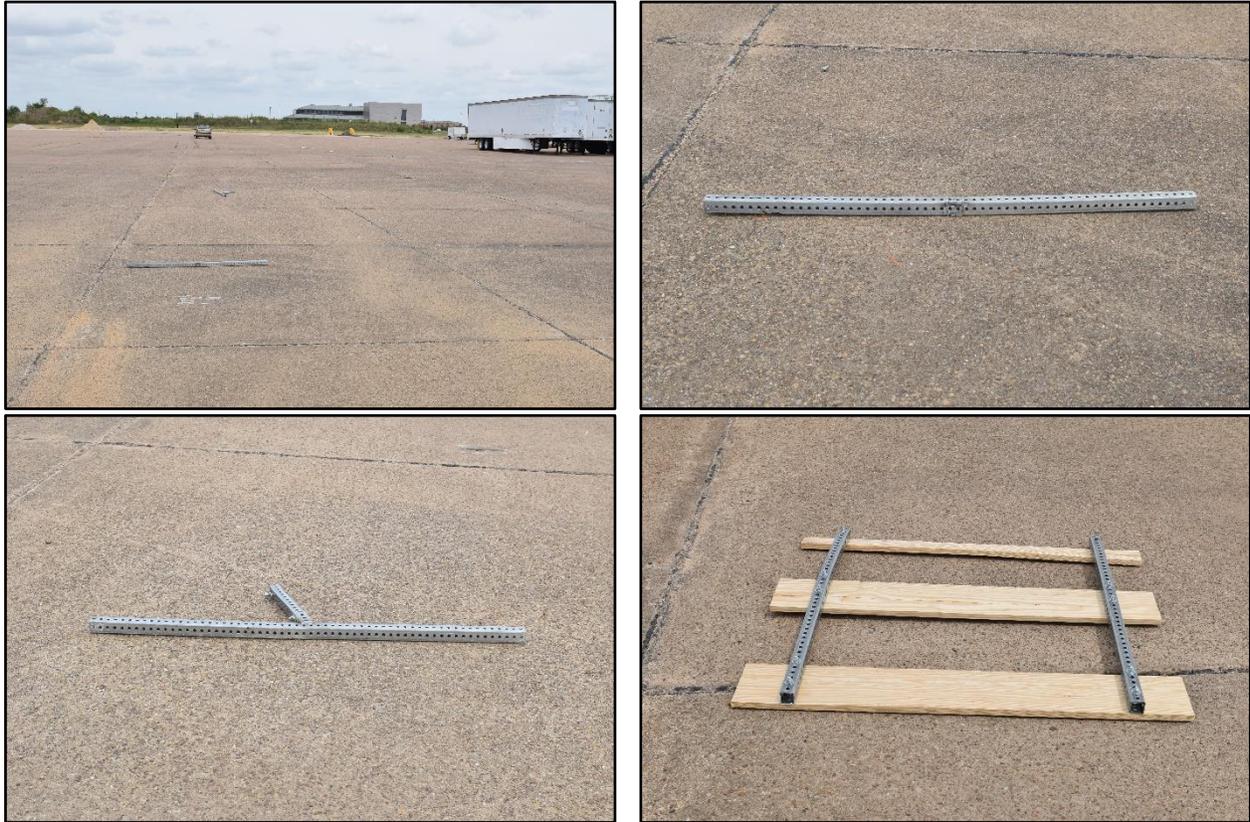
Figure 13.23. Type III Barricade after Test No. 469469-12-04.

Figure 13.23 shows the damage to the Type III barricade. The assembly separated into multiple pieces and came to rest in an area 105 to 262 ft downstream of the impact location and 24 ft right to 15 ft left of the impact path.

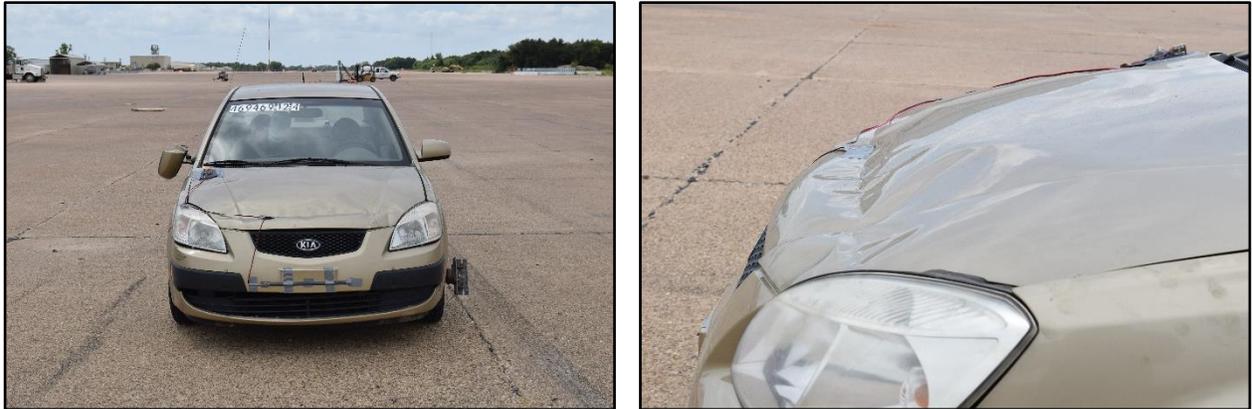
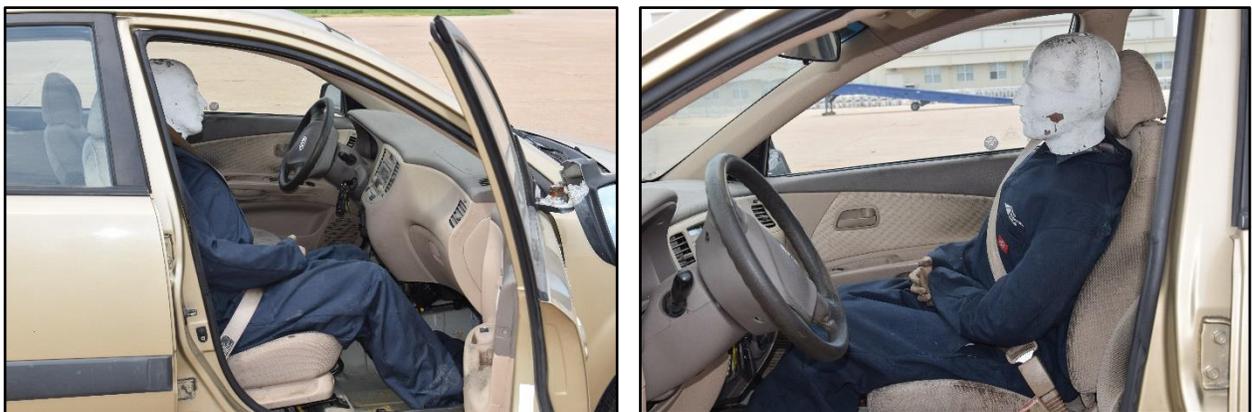
Figure 13.24. Test Vehicle after Test No. 469469-12-04.

Figure 13.24 and Figure 13.25 show the damage sustained by the vehicle. There was a 42-inch by 8-inch by 1.25-inch-deep dent along the front of the hood, and additional damage was sustained by the right head light. There was no measurable occupant compartment deformation. Table L.13 and Table L.14 in Appendix L.5.1 provide exterior crush and occupant compartment measurements.
