Test Report No. 469940-03, 469942-01, and 469943-01

**DEVELOP A RETROFIT DESIGN FOR GUARD FENCE SYSTEM TO  
ENHANCE MOTORCYCLE SAFETY**  
COOPERATIVE RESEARCH PROGRAM

Texas Department of Transportation  
<https://tti.tamu.edu/documents/0-6994-R1.pdf>

**TEXAS A&M TRANSPORTATION INSTITUTE PROVING GROUND**

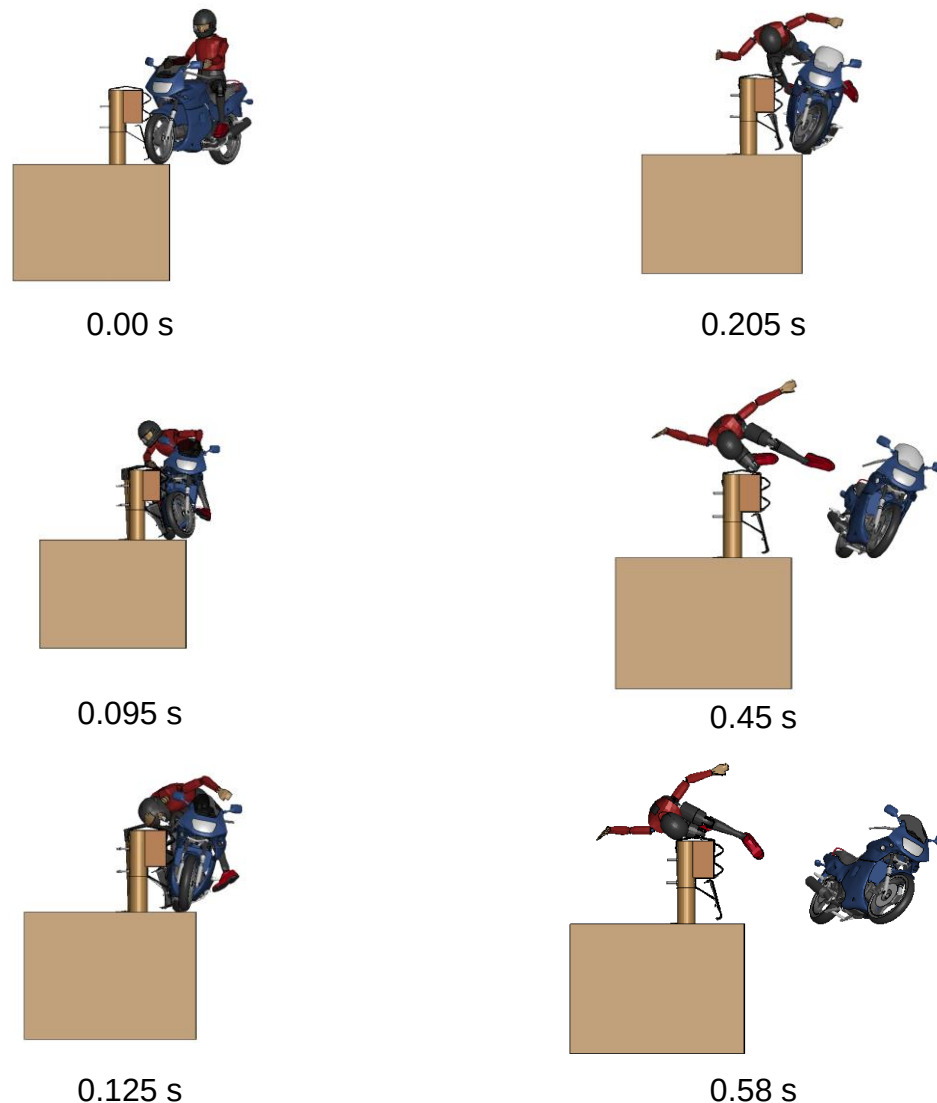
**Figure 5.3. Sequential Images of Upright Motorcyclist Impact with Barrier.**

During initial impact with the guardrail, the ATD began ejecting from the motorcycle and sliding across the top of the system. The ATD eventually traversed to the field side of the system. No significant snagging of any ATD limbs with the guardrail system was observed. Thus, the system appeared adequate in minimizing ATD interaction with discrete elements of the guardrail system.

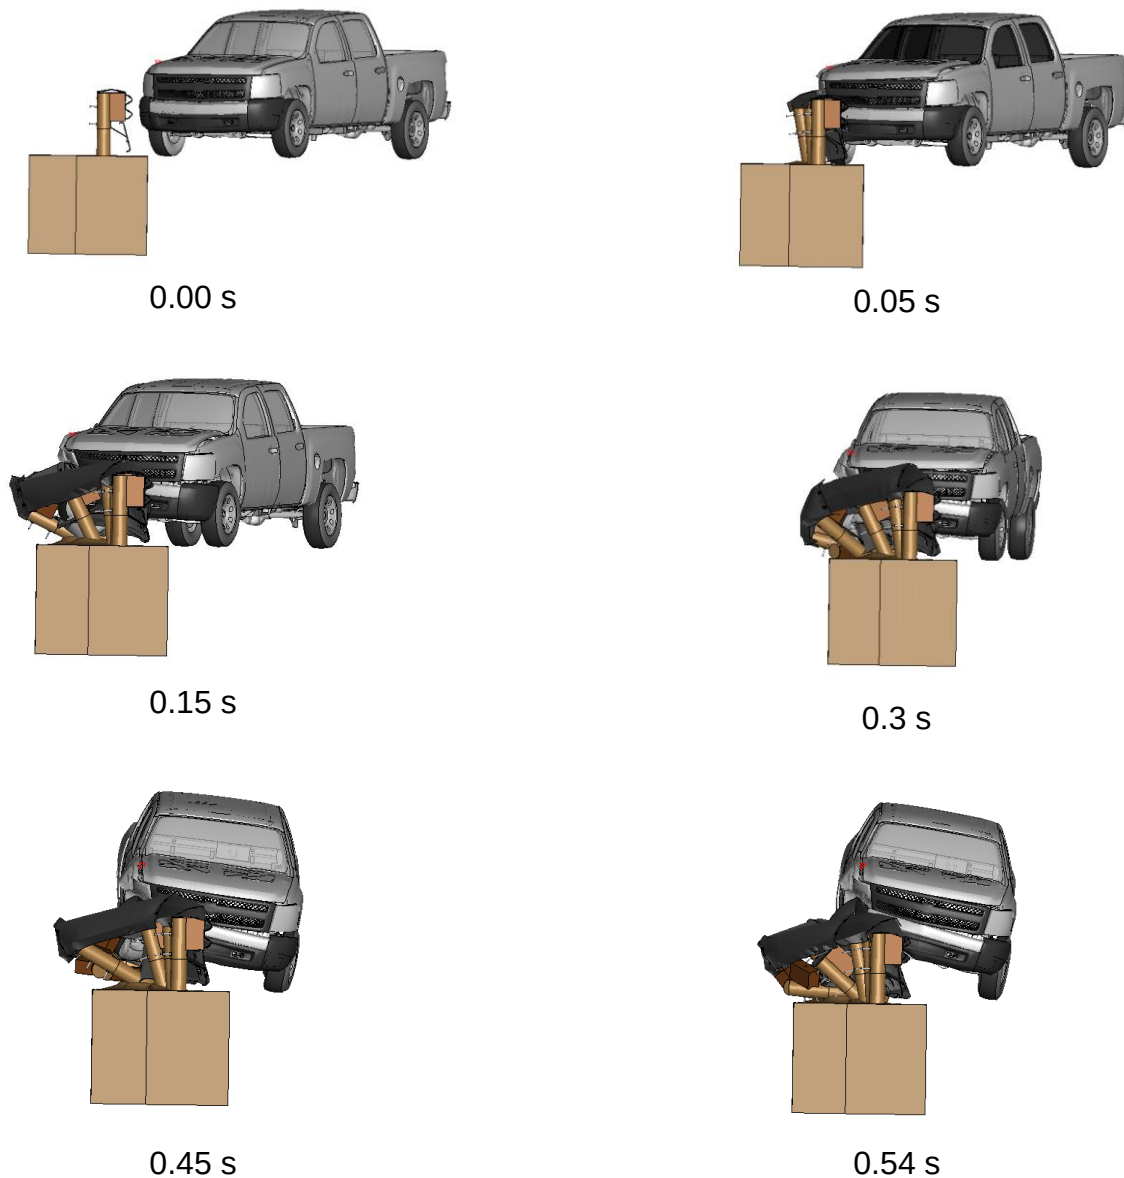
**Figure 5.4. Sequential Images of *MASH* Test 3-11 Impact with Barrier.**

The pickup truck was successfully contained and redirected during impact with the guardrail system. The vehicle remained stable throughout the event, and the occupant risk values were below the *MASH* limit. During the impact event, however, it was noted that the pickup truck pushed down on the rubrail element and seemed to keep riding on top of it. Although it appeared that riding on top of the rubrail did not

A modification was made to the system to attach the rubrail with minimal offset from the wood posts to reduce some of the noted pickup truck interaction with the rubrail. Figure 5.5 shows a cross-section view of the modified system.

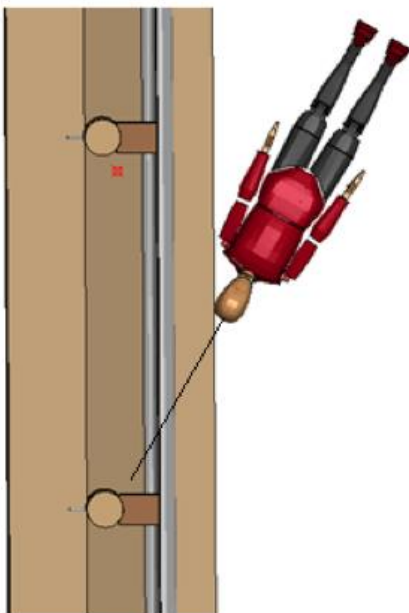
**Figure 5.6. ATD Sliding Impact with System.**

After the system was modified, simulations were conducted with the ATD model sliding into the system at a speed of 37 mi/h and an angle of 30 degrees. Figure 5.6 shows a layout of the simulation event with the ATD impacting in line with the wood post. The rubrail indicated the ability to contain and redirect the ATD during impact, and no snagging of limbs on discrete elements was observed.

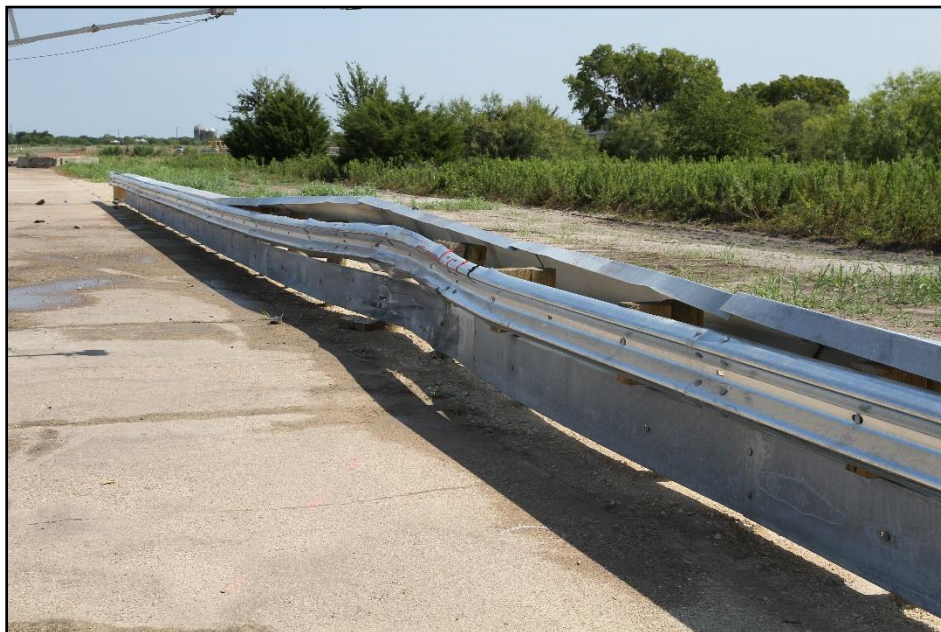
**Figure 9.5. Enhanced Motorcycle Guard Fence System at Impact Location after Test 469940-03-1.**

There was no movement at the end terminals. Post 13 was cracked at grade, the blockout was missing from post 14, and the lower channel was detached from post 14. Table 9.6 details the soil gap and post lean information.

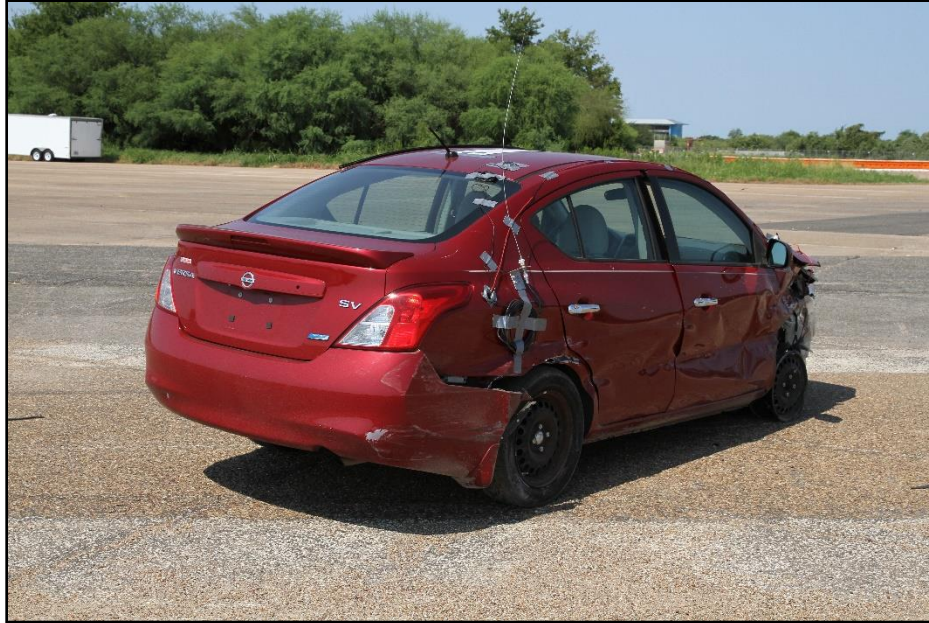
**Figure 9.8. Rear Impact Side of Test Vehicle after Test 469940-03-1.**

| <b>Description of Damage to Vehicle:</b> | The front bumper, hood, grill, right front fender and headlight, radiator support, right front strut and tower, right front control arm, right front tire and rim, right front door, right rear door, and right rear fender and bumper were damaged. The right front door had a 2-inch gap at the top. |

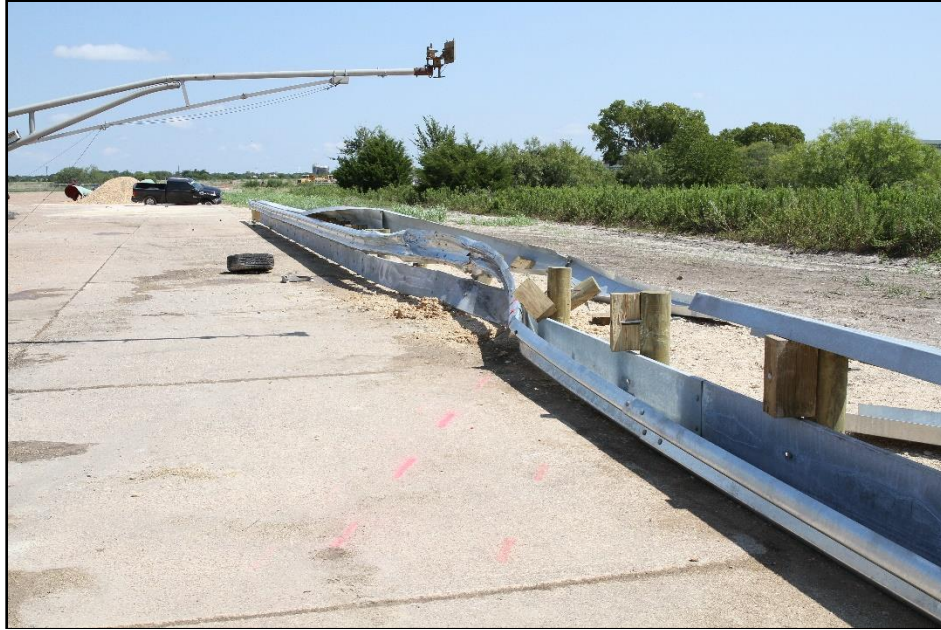
**Figure 10.5. Enhanced Motorcycle Guard Fence System at Impact Location on the Traffic Side after Test 469940-03-2.**

Table 10.6 describes the deflection and working width of the enhanced motorcycle guard fence system. Figure 10.5 and Figure 10.6 show the damage to the enhanced motorcycle guard fence system.

| Test Parameter | Measured |
|---|---|
| Working Width <sup>a</sup> and Height | 113.8 inches, at a height of 1.0 inch, at the top rail at the midspan of posts 12 and 13 |

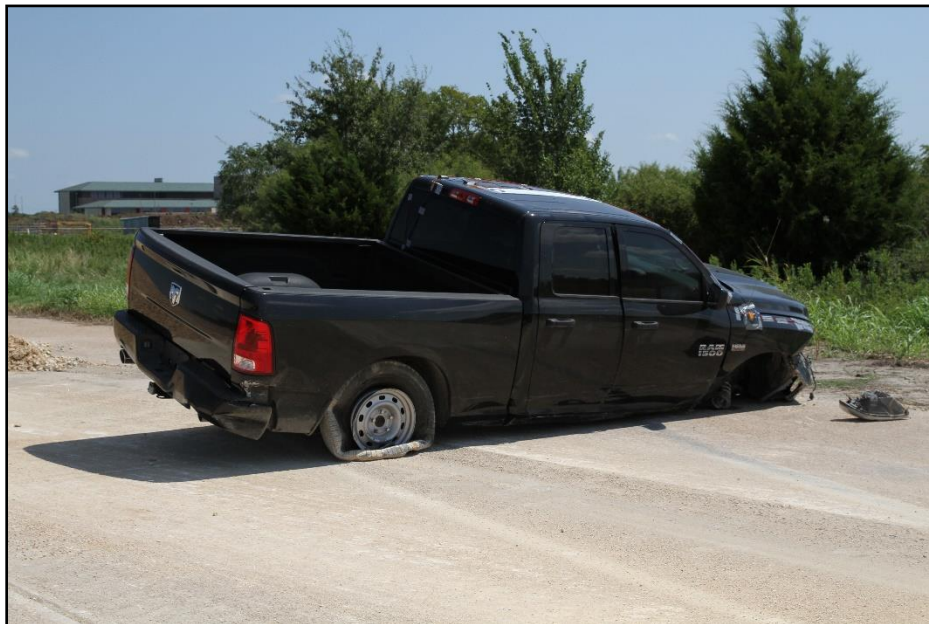
**Figure 10.8. Rear Impact Side of Test Vehicle after Test 469940-03-2.**

| <b>Description of Damage to Vehicle:</b> | The front bumper, hood, grill, right headlight, right front fender, right front upper and lower control arms, right front tire and rim, right front door, right rear door, right rear fender, right rear tire and rim, and rear bumper were damaged. The right front door had a 1.5-inch gap at the top. |

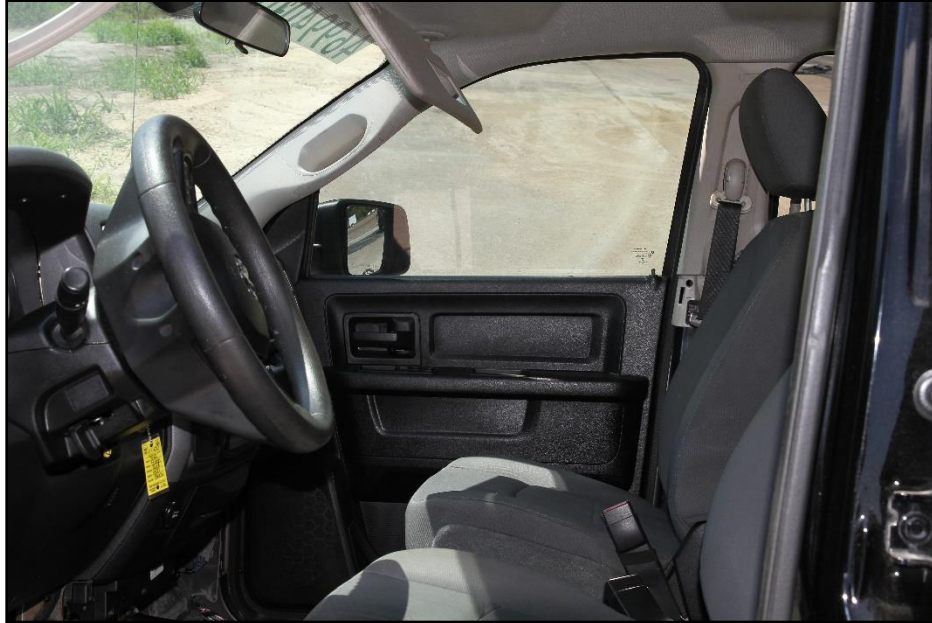
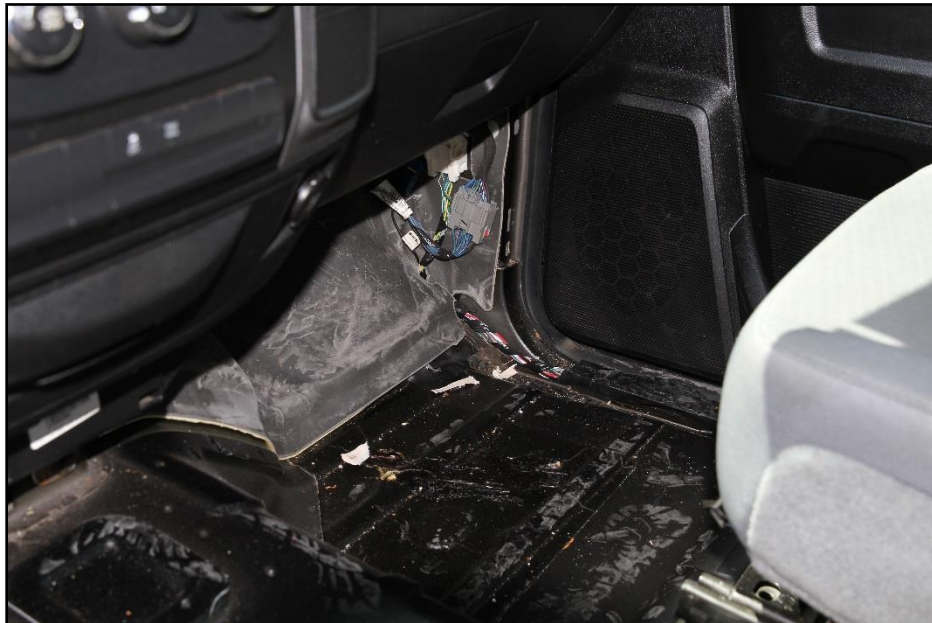
**Figure 10.9. Overall Interior of Test Vehicle after Test 469940-03-2.**

**Figure 10.10. Interior of Test Vehicle on Impact Side after Test 469940-03-2.**

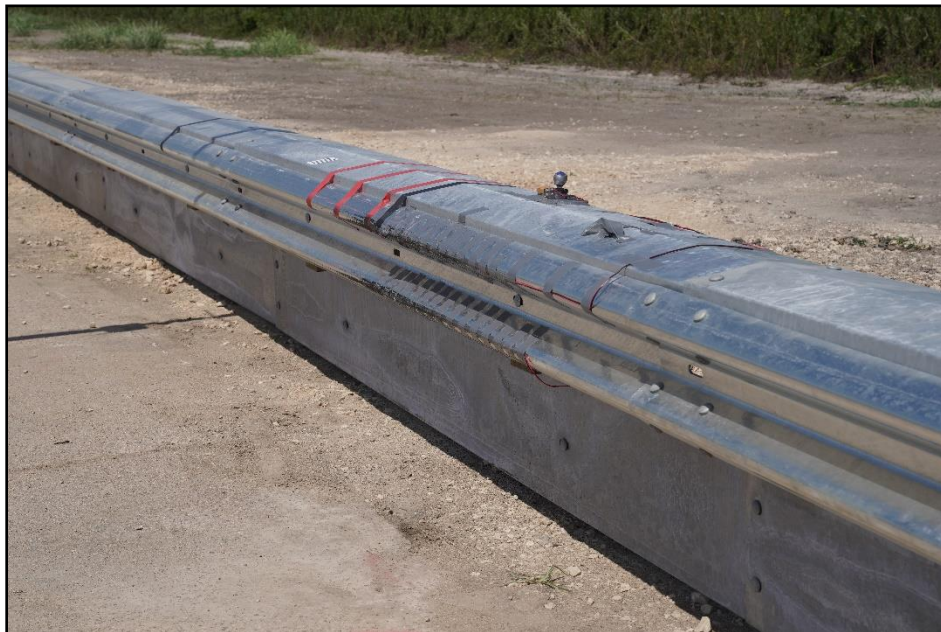
**Figure 11.5. Isometric View of the Enhanced Motorcycle Guard Fence System at Impact Location after Test 469940-03-3.**

There was some scuffing on the rail at impact. Table 11.6 describes the deflection and working width of the enhanced motorcycle guard fence system. Figure 11.5 and Figure 11.6 show the damage to the enhanced motorcycle guard fence system.

| Test Parameter | Measured |
|---|---|
| Working Width <sup>a</sup> and Height | 18.5 inches, at a height of 31.1 inches, at the field side of the top of the post. |

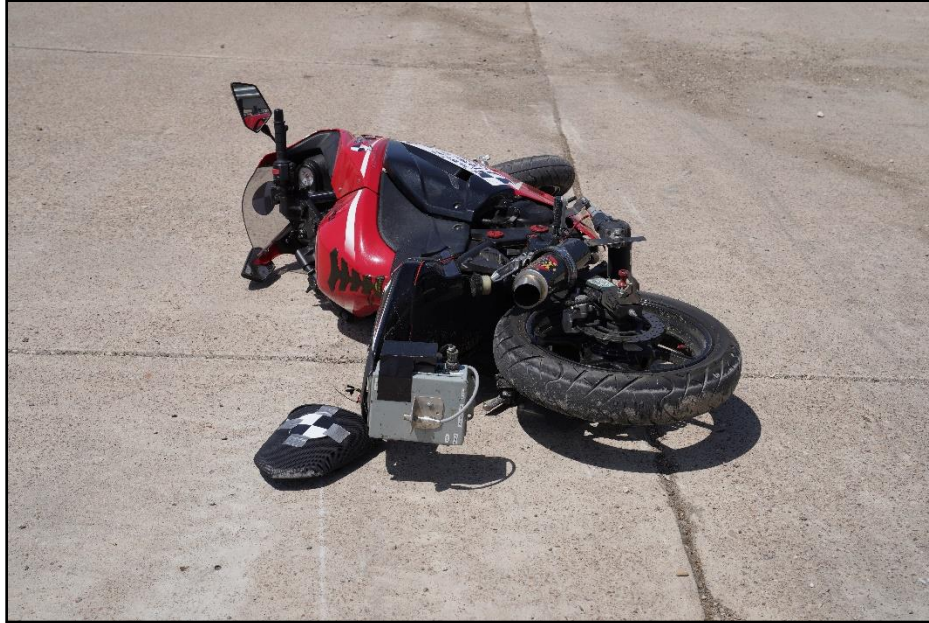
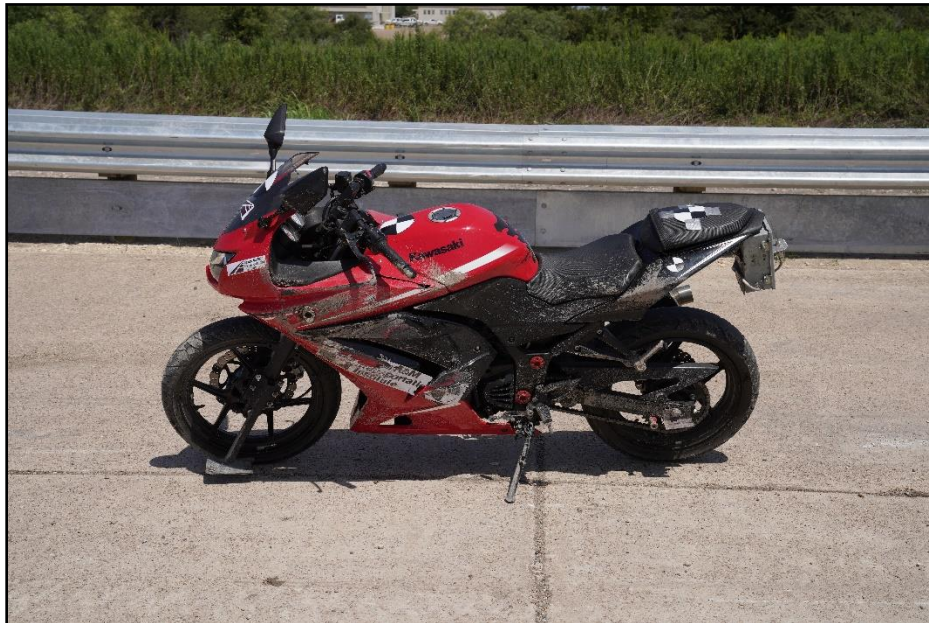
The front fairing, right and left side fairings, and right turn signal were damaged. No damage to the fuel tank was observed.

**Figure 11.8. Rear Impact Side of Test Vehicle after Test 469940-03-3.**

**Figure 11.9. Opposite Impact Side of Test Vehicle after Test 469940-03-3.**

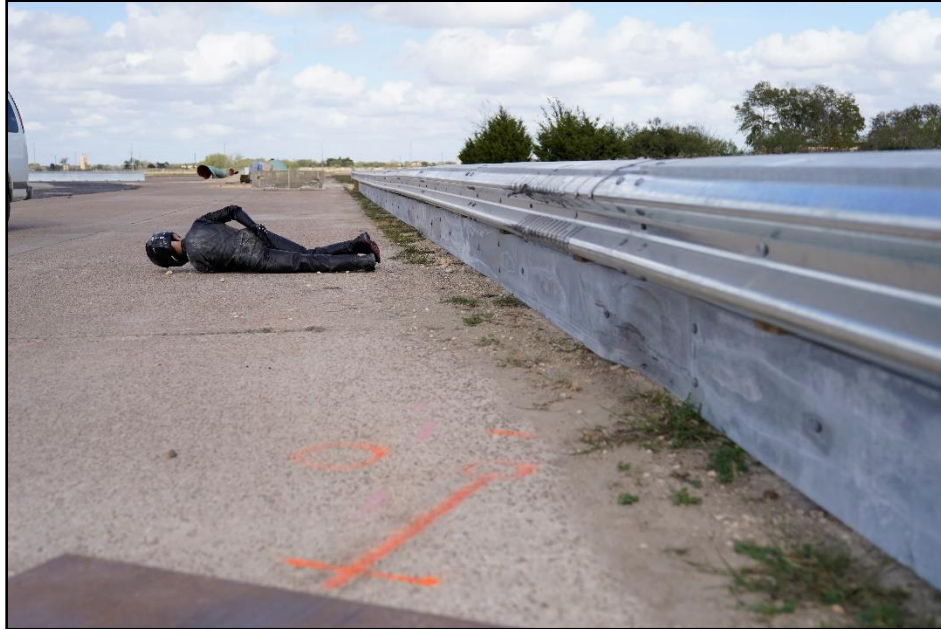
**Figure 12.3. Enhanced Motorcycle Guard Fence System at Impact Location on the Traffic Side after Test 469940-03-4A.**

The rubrail was deformed and scuffed at impact. Table 12.5 describes the deflection and working width of the enhanced motorcycle guard fence system. Figure 12.3 and Figure 12.4 show the damage to the enhanced motorcycle guard fence system.

| Test Parameter | Measured |
|---|---|
| Working Width <sup>a</sup> and Height | 18.6 inches, at a height of 31.1 inches, at the guardrail bolt on the field side of post 9 |

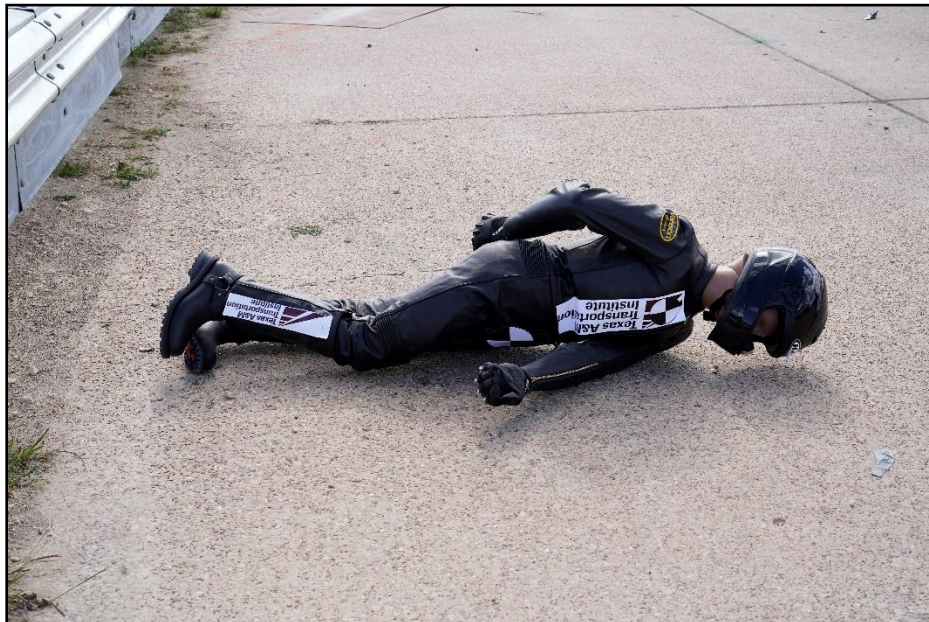
**Figure 12.6. Front of the ATD after Test 469940-03-4A.**

The enhanced motorcycle guard fence system successfully redirected the ATD during impact. There was no snagging of the ATD limbs with the wood posts or other elements of the longitudinal barrier. The ATD neck axial tension and compression forces measured during the impact did exceed the EN 1317-8 limits. Modifications were investigated, as described in Chapter 13, to potentially reduce the injury criteria for the sliding ATD impact.

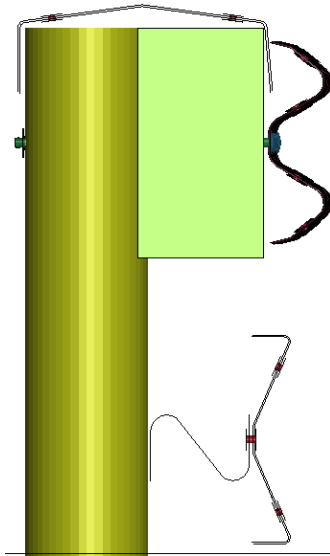
**Figure 13.3. V-Shape Rubrail Design Option.**

Different design options to reduce possible injury to a sliding motorcyclist were developed and evaluated. It was necessary to reduce the high neck axial forces observed in the crash test with the vertical rubrail design. These design options are discussed in the following subsections.

A modified version of the vertical channel rubrail that had a V-shape profile with attachment to an S-shape bracket was developed. Figure 13.3 shows a cross-section view of the rubrail shape.

Both design options were investigated with the sliding dummy impacting at the midspan splice between the posts. The 14-gauge W-beam performed well and resulted in injury criteria values below the limit. However, the cost to manufacture a 14-gauge W-beam was found to be significant and made this option impractical. The channel rubrail resulted in neck compressive force injury criteria above the limit when impacted at the midspan splice. Further modifications were made to this design to help reduce the neck forces in the dummy. However, no design modifications were identified that helped reduce the neck compressive forces and did not cause injury criteria values above the limit for other indices.

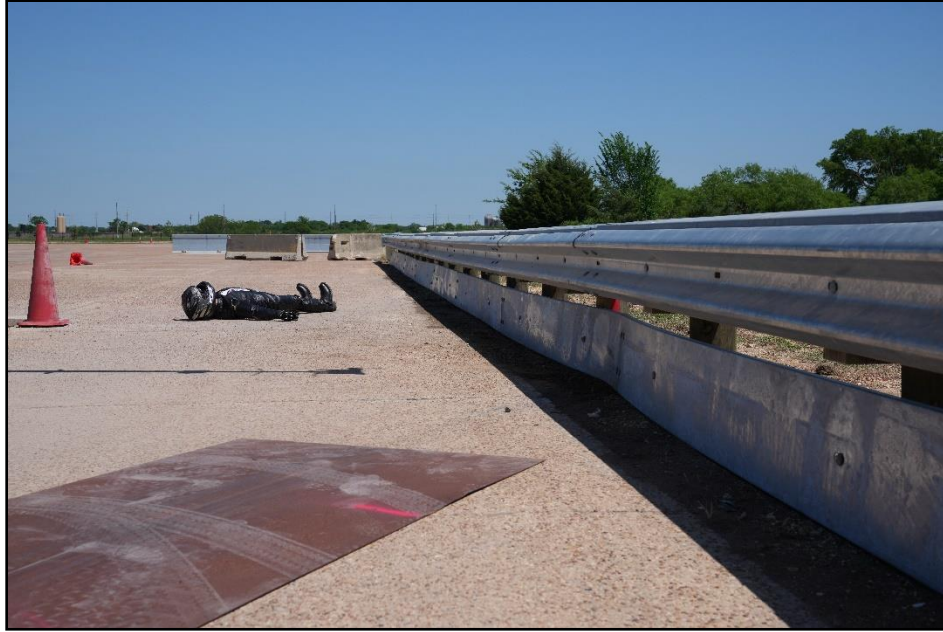
**Figure 14.3. Enhanced Motorcycle Guard Fence System at Impact Location after Test 469942-01-1.**

The rubrail was deformed and scuffed at impact, and there were also scuffs on the W-beam at impact. Table 14.5 describes the deflection and working width of the enhanced motorcycle guard fence system. Figure 14.3 and Figure 14.4 show the damage to the enhanced motorcycle guard fence system.

| <b>Test Parameter</b> | <b>Measured</b> |
|---|---|
| Working Width <sup>a</sup> and Height | 19.5 inches, at a height of 30.0 inches, at the guardrail bolt on the field side of post 15 |

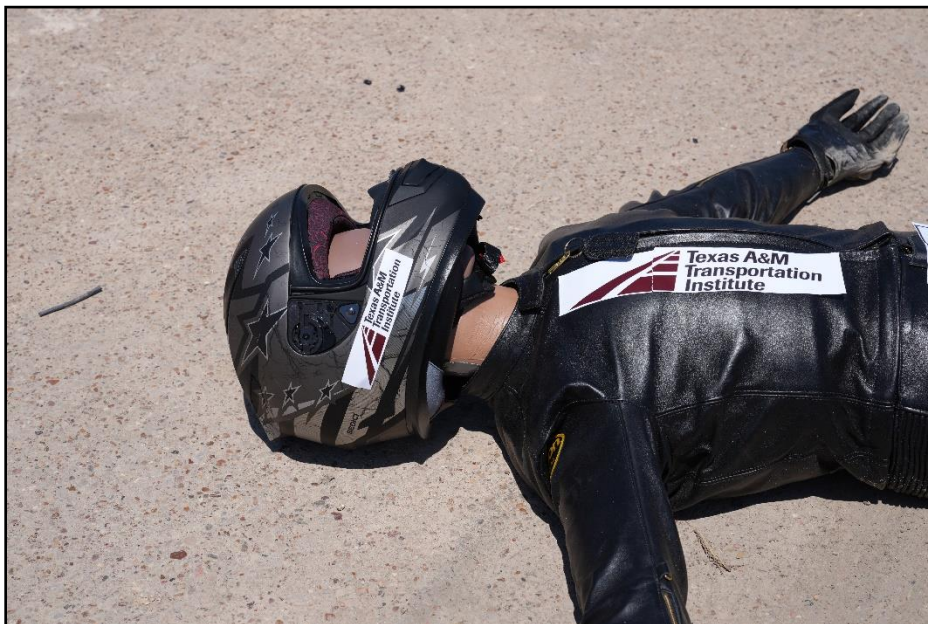
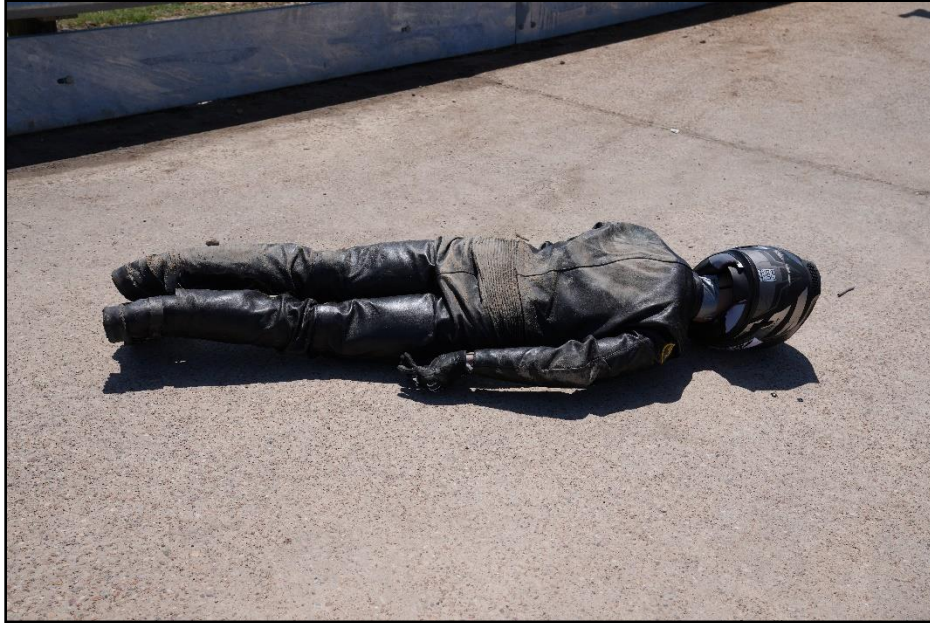
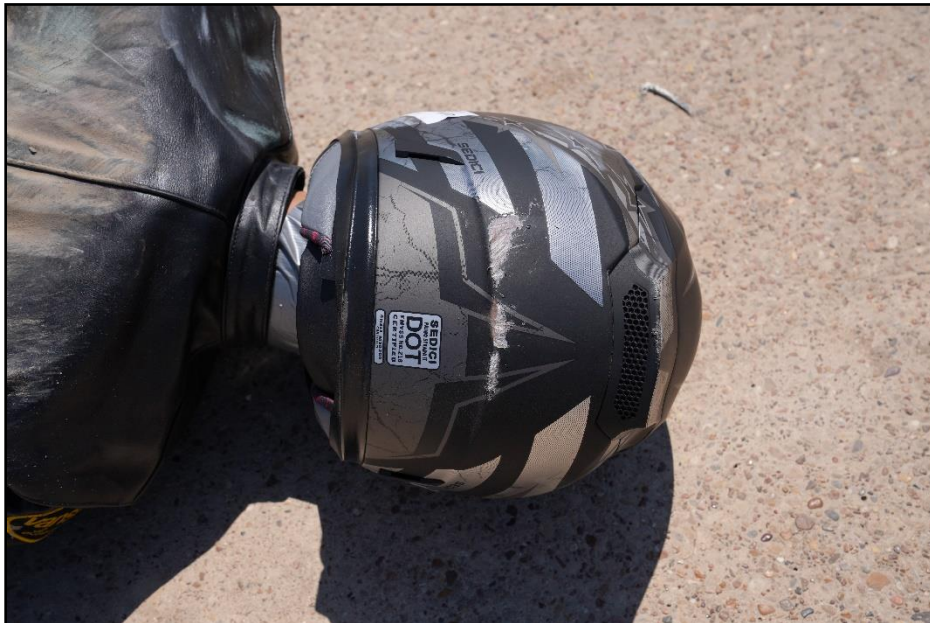
Figure 14.6. Upper Torso Detail of the ATD after Test 469942-01-1.

**Figure 14.7. Backside of the ATD after Test 469942-01-1.**

**Figure 14.8. Backside Detail of the ATD Helmet after Test 469942-01-1.**

The enhanced motorcycle guard fence system successfully redirected the ATD during impact. There was no snagging of the ATD limbs with the wood posts or other elements of the longitudinal barrier. The ATD neck axial tension was significantly reduced with the modified design and was below the specified limit. However, the ATD neck compression forces still exceeded the EN 1317-8 limit. Modifications were investigated, as described in Chapter 15, to potentially reduce the neck compression force for the sliding ATD impact.

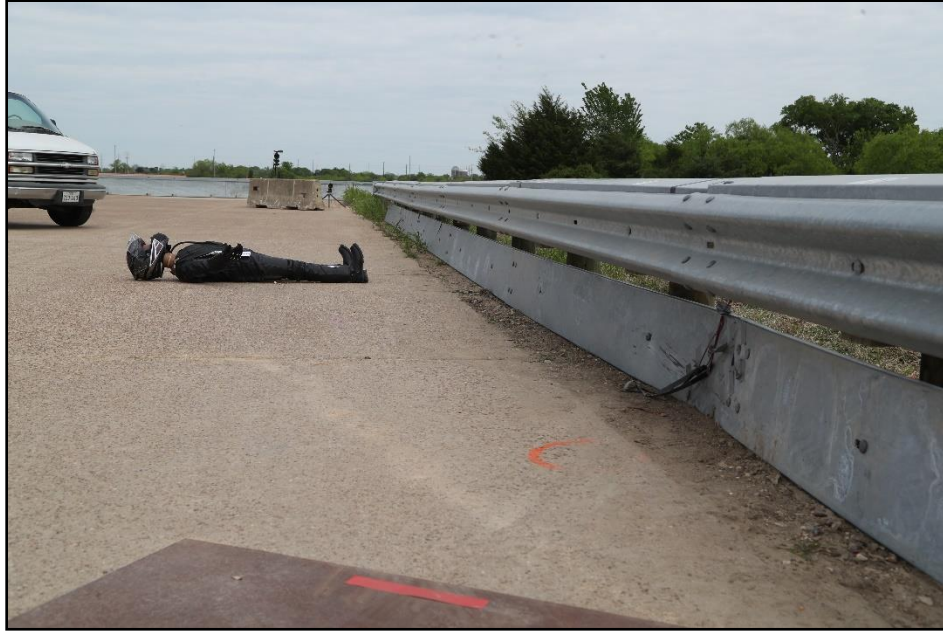
The rubrail was deformed and scuffed at impact. Table 16.5 describes the deflection and working width of the enhanced motorcycle guard fence system. Figure 16.3 and Figure 16.4 show the damage to the enhanced motorcycle guard fence system.

**Figure 16.3. Enhanced Motorcycle Guard Fence System at Impact Location after Test 469943-01-1A.**

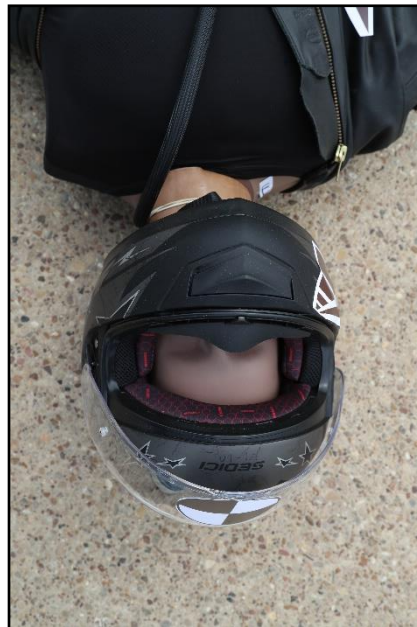
Figure 16.5 and Figure 16.6 show the damage sustained by the front of the ATD. Figure 16.7 and Figure 16.8 show the damage sustained by the back of the ATD. Table 16.6 provides details on the calculated injury criteria for the head and neck of the ATD.

**Figure 16.6. ATD Head and Helmet after Test 469943-01-1A.**

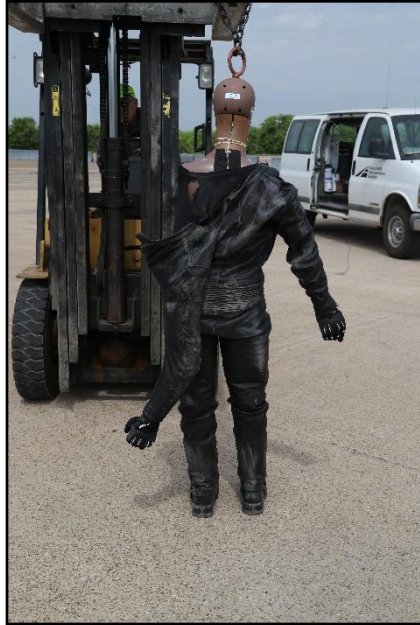
**Figure 16.7. ATD after Test 469943-01-1A.**

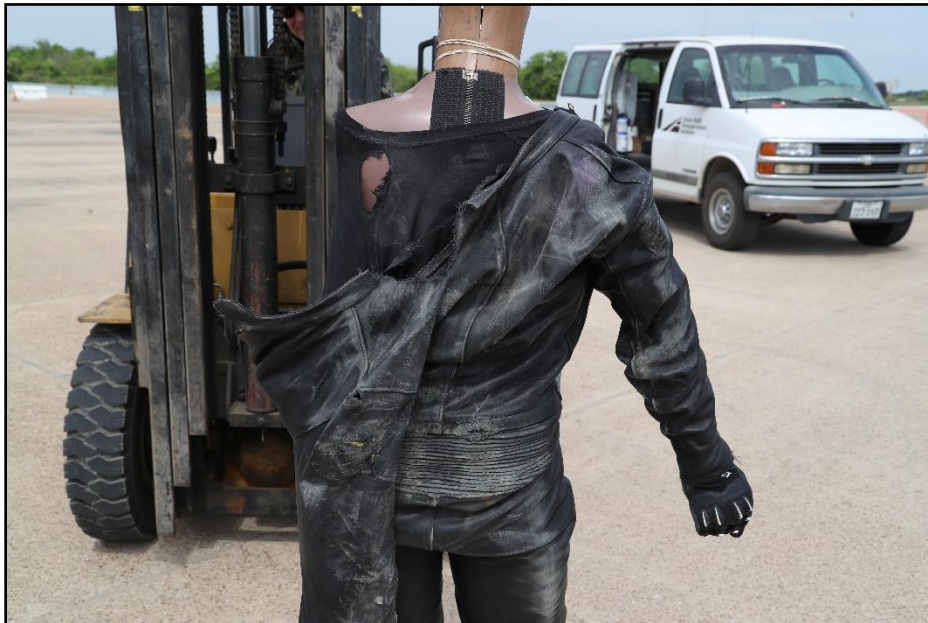
**Figure 16.8. Rear Side of ATD after Test 469943-01-1A.**

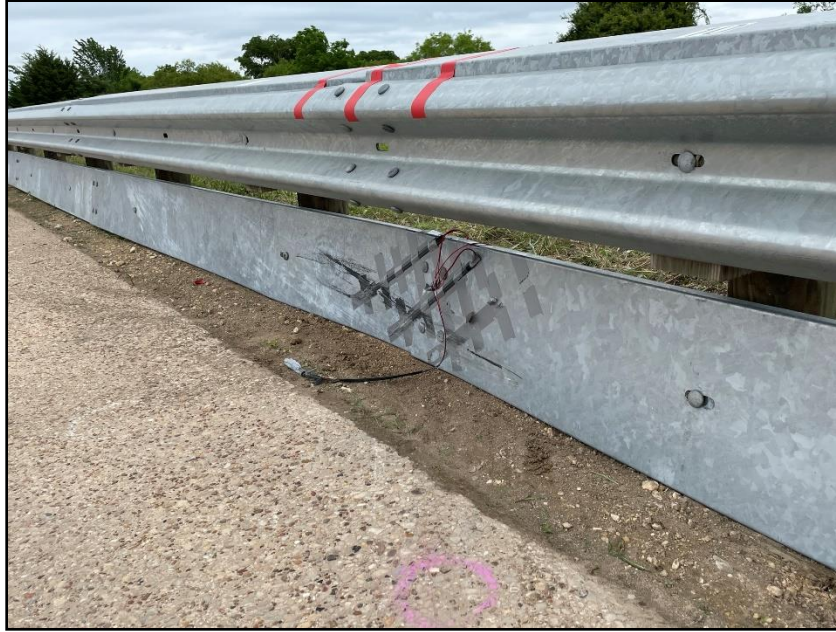
There was some scuffing on the rubrail at impact, and the rail was deformed. Table 17.5 describes the deflection and working width of the enhanced motorcycle guard fence system. Figure 17.3 and Figure 17.4 show the damage to the enhanced motorcycle guard fence system.

**Figure 17.3. Traffic Side of the Enhanced Motorcycle Guard Fence System at Impact Location after Test 469943-01-2.**

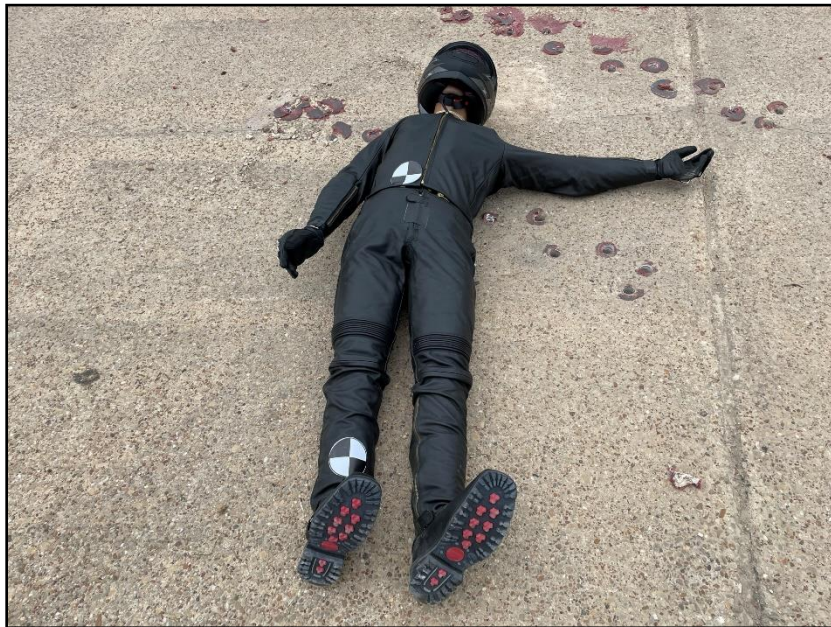
Figure 17.5 and Figure 17.6 show the damage sustained by the front of the ATD. Figure 17.7 and Figure 17.8 show detailed damage of the head and shoulder of the ATD. Table 17.6 provides details on the calculated injury criteria for the head and neck of the ATD.

**Figure 17.6. Front of the ATD after Test 469943-01-2.**

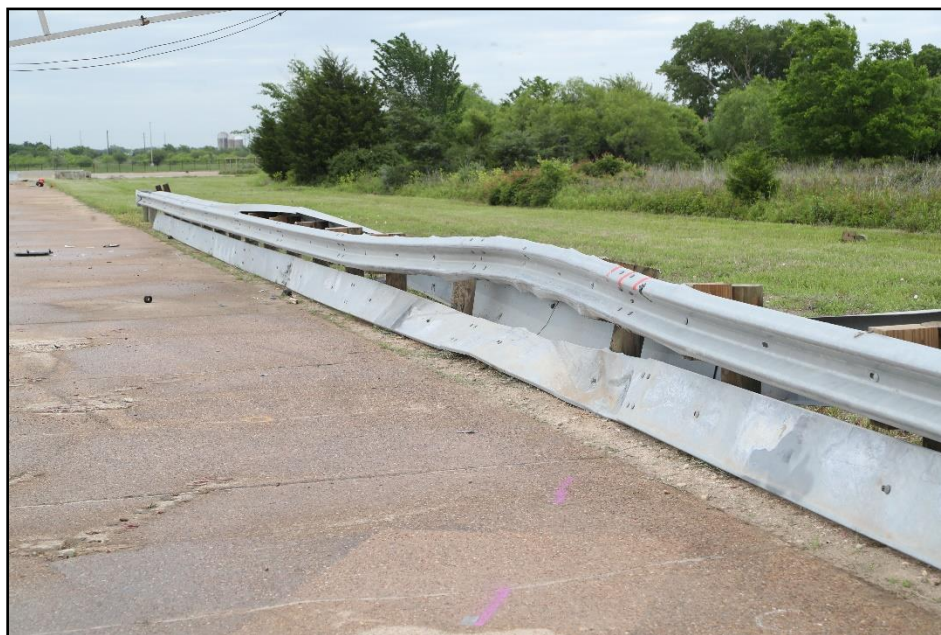
**Figure 18.5. Traffic-Side View of the Enhanced Motorcycle Guard Fence System at Impact Location after Test 469943-01-3.**

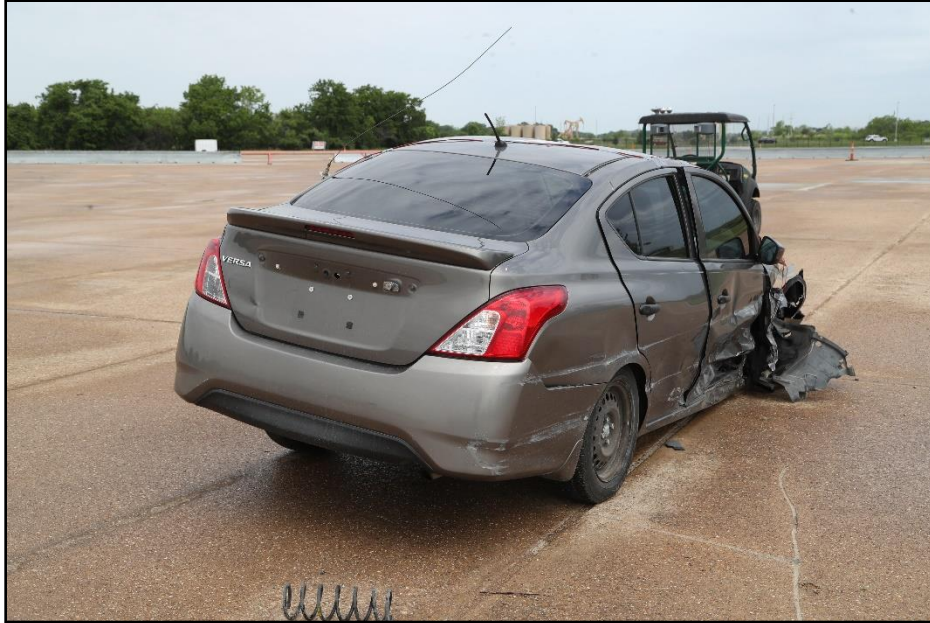
**Figure 18.8. Rear Impact Side of Test Vehicle after Test 469943-01-3.**

| <b>Description of Damage to Vehicle:</b> | The front bumper, grill, right front headlight, right front fender, right front frame rail, right front tire, wheel, strut, right front drive axle, right front door, right rear door, right rear quarter panel, and rear bumper were damaged. The lower portion of the right front door was pulled up 3 inches, and there was a 5-inch long, 1.5-inch wide hole in the front right door. The right front door had a 1.25-inch gap at the top. |

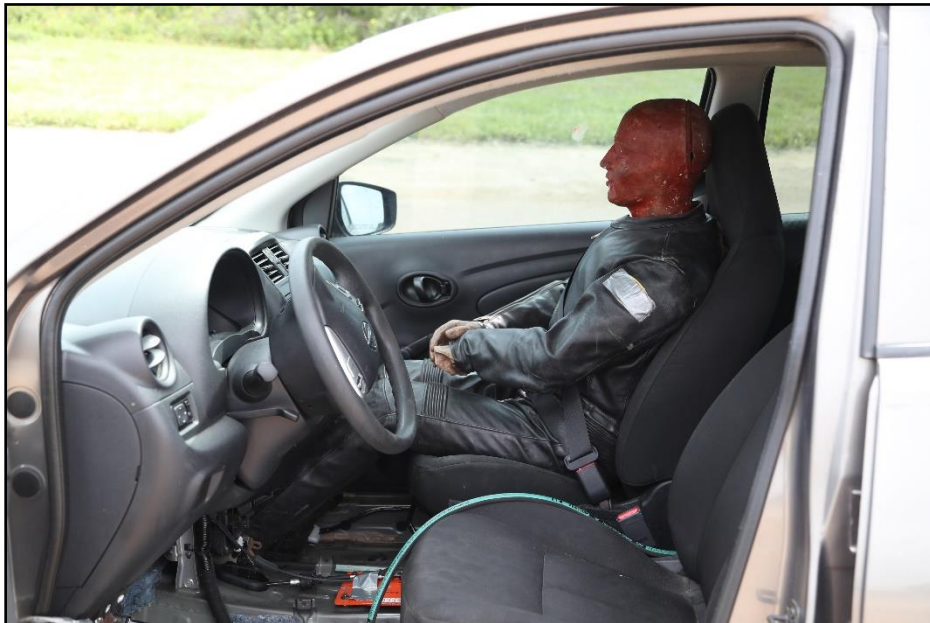
**Figure 18.9. Overall Interior of Test Vehicle after Test 469943-01-3.**

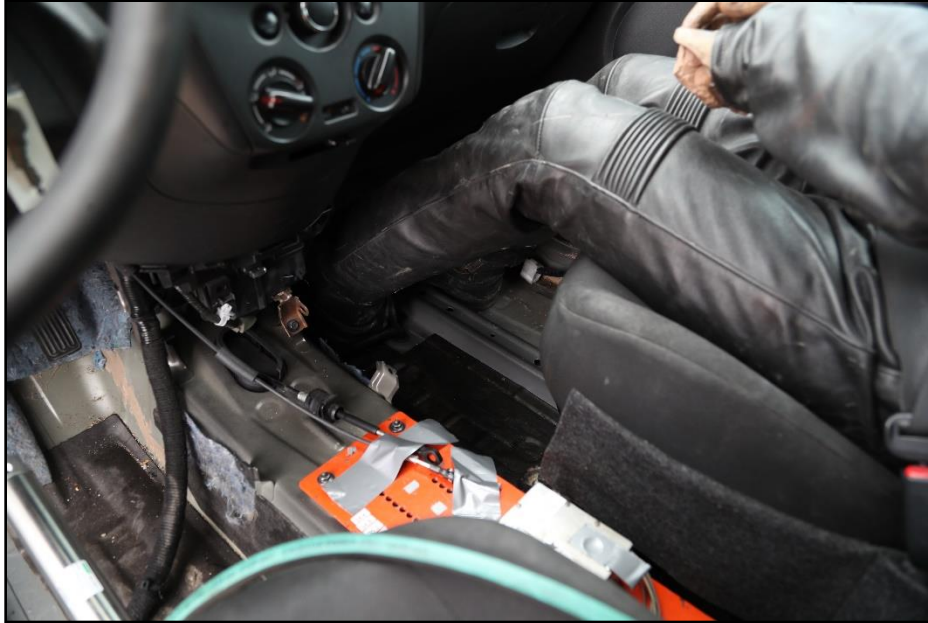
**Figure 18.10. Interior of Test Vehicle on Impact Side after Test 469943-01-3.**

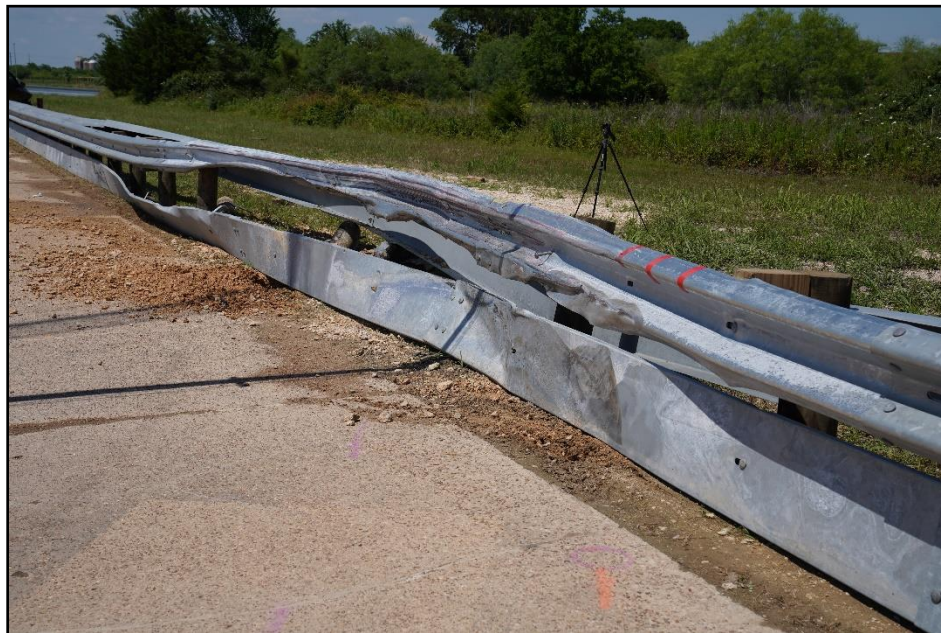
**Figure 19.5. Traffic-Side View of the Enhanced Motorcycle Guard Fence System at Impact Location after Test 469943-01-4.**

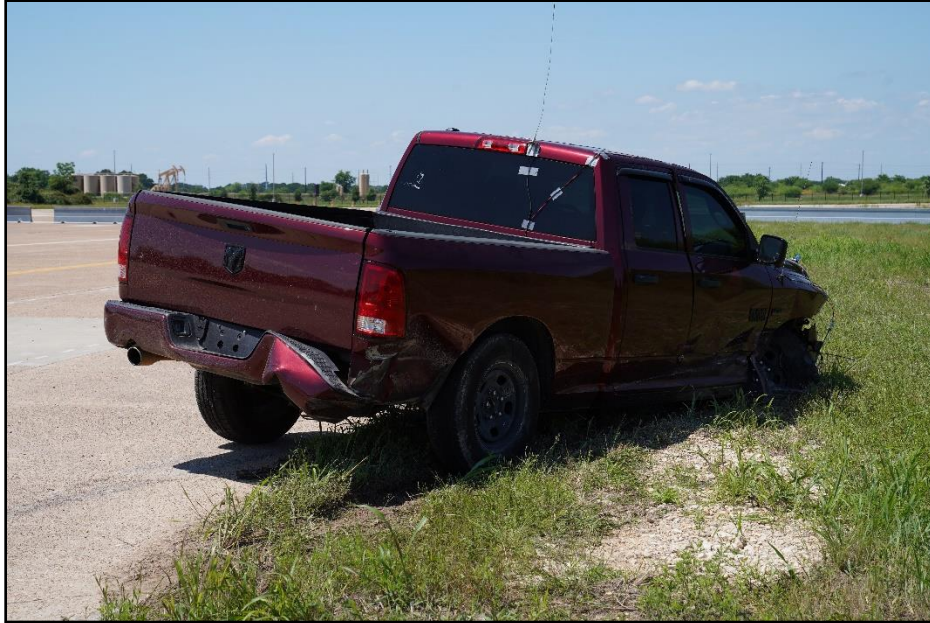
**Figure 19.8. Rear Impact Side of Test Vehicle after Test 469943-01-4.**

| <b>Description of Damage to Vehicle:</b> | The right front bumper, right headlight, right front lower A arm, right front tire and wheel, right front fender, right side quarter panels, and rear bumper were damaged. The right front door had a 1-inch gap at the top. |

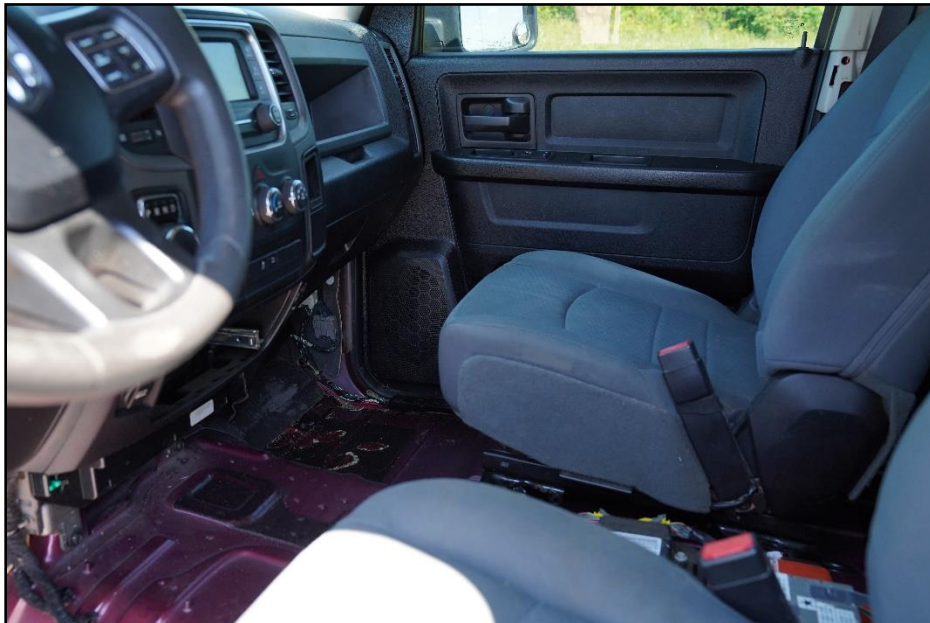
**Figure 19.9. Overall Interior of Test Vehicle after Test 469943-01-4.**

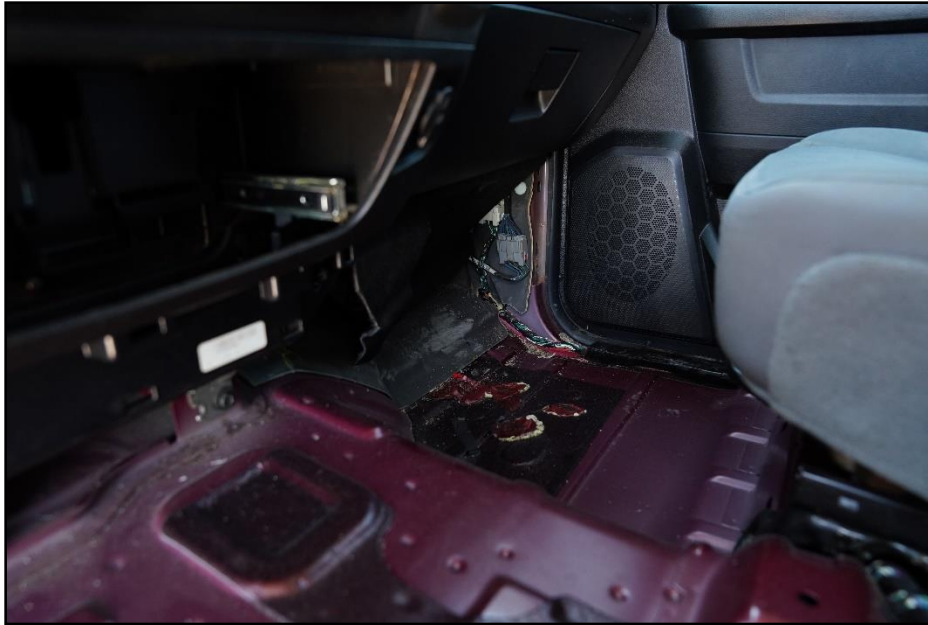
**Figure 19.10. Interior of Test Vehicle on Impact Side after Test 469943-01-4.**
