Evaluation of Corrosion Prevention and Mitigation Approaches Used on Texas Bridges—Volume 2: Reinforced Concrete Bridges

Technical Report 0-7040-R1-Vol2

TEXAS A&M TRANSPORTATION INSTITUTE
COLLEGE STATION, TEXAS

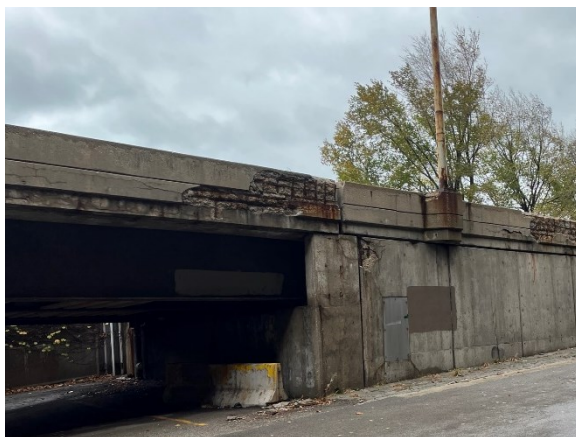
(a) Spalling at Rail Due to Corrosion

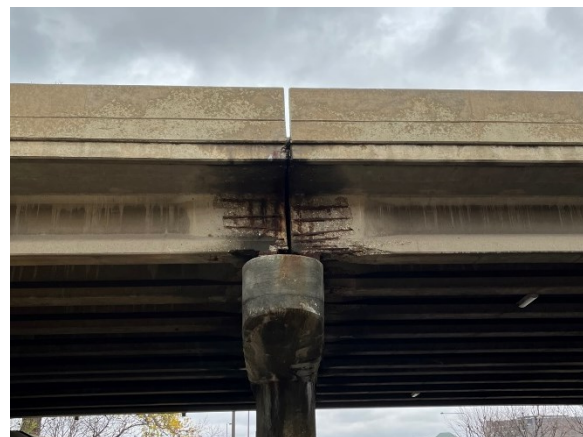
(b) Spalling at Girder End Due to Corrosion

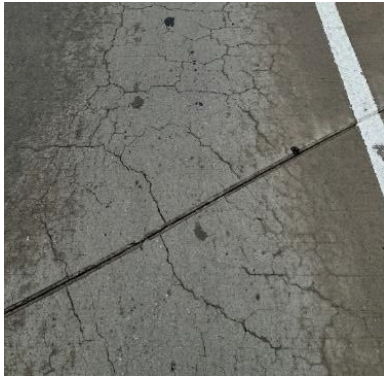
(a) Cracks at Deck Joint

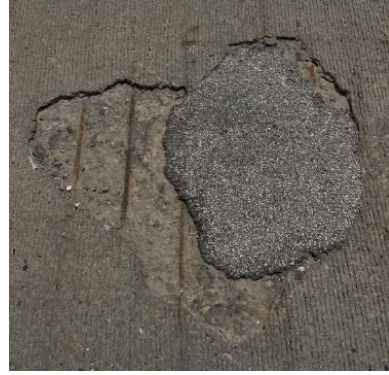
(b) Exposed Rebar on Deck due to Delamination

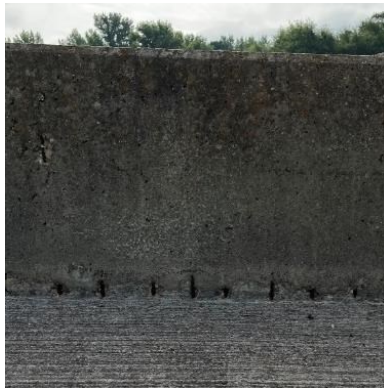
(c) Exposed Rebar on Concrete Rail

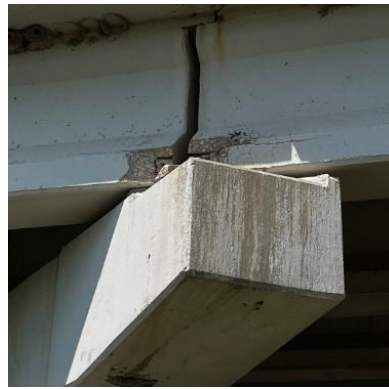
(d) Spalling at a Girder End

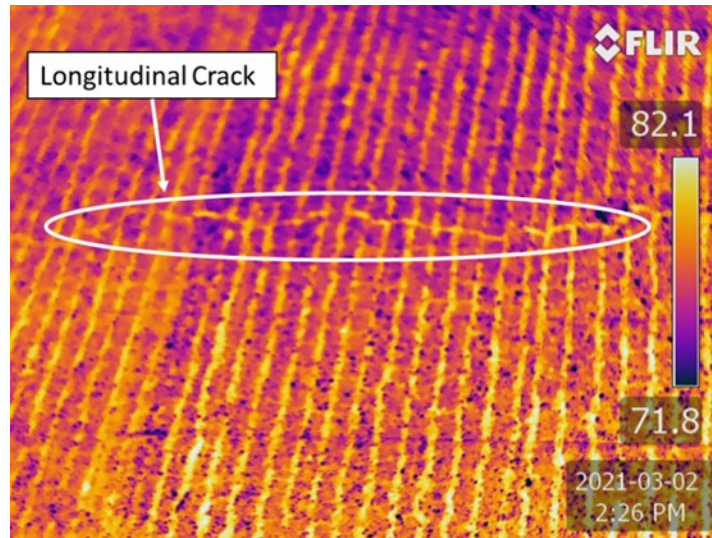
IRT was used for detecting any surface damage on concrete structures. During and after the visual inspection, infrared pictures were taken at the grids and at places where severe deteriorations were visible. Figure 3.7 shows longitudinal surface cracking that was visible in thermal imaging. The thermal imaging results are documented in the appendix.

Figure 3.7. Infrared Picture of a Deck Showing a Transverse Crack.

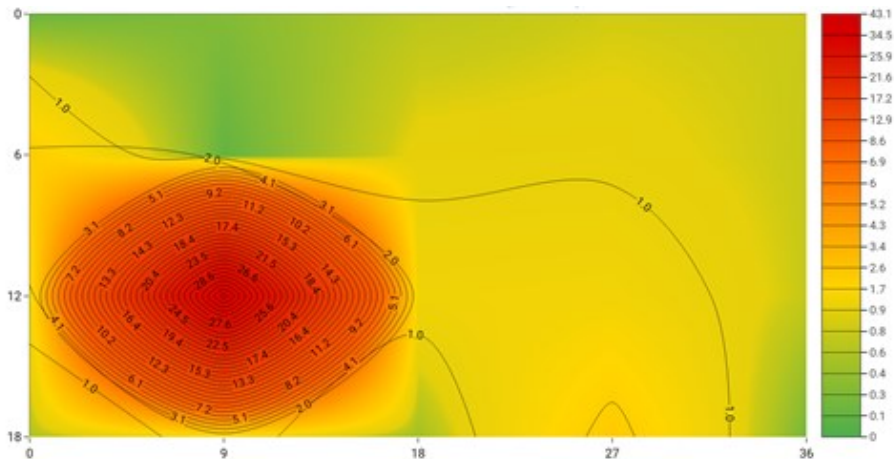
iCOR was used to measure the instantaneous corrosion rate of the rebar and in-situ resistivity. The device measured the corrosion rate without making a direct connection with the rebar, which made this process an advantage during scanning of the concrete decks. The iCOR readings from intersections of rebars identified from the GPR scanning were documented for further analysis and to develop corrosion rate mapping and evaluate the in-situ resistivity of concrete. Figure 3.10 shows a typical corrosion rate mapping developed for AMA-RC-10.

Figure 3.10. Result of AMA-RC-10 Bridge Corrosion Rate Mapping, Corrosion Current Density ($\mu\text{A}/\text{cm}^2$).

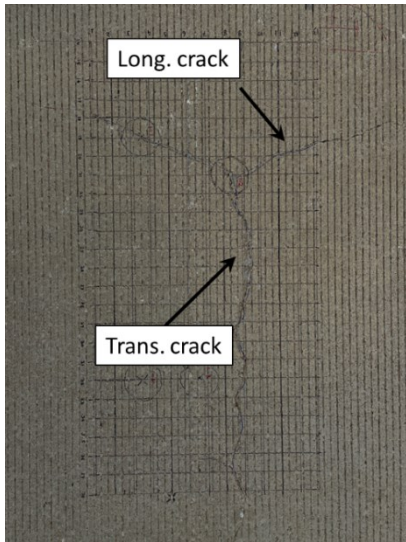
(a) Transverse and Longitudinal Cracks at PCP Joints (ATL-RC-05)

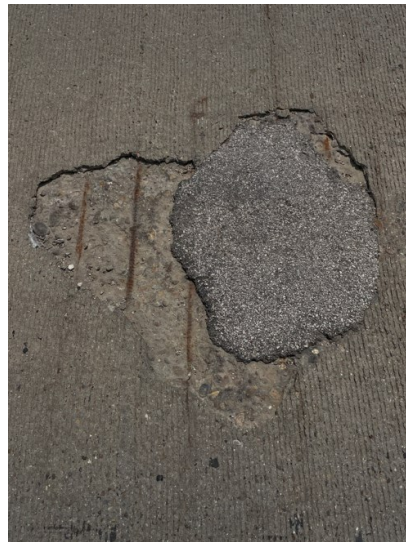
Apart from cracking, the extent of damage to the decks was generally minimal. On some bridges, minor spalling was observed along the cracks at poor boy joints or at the edges of sealed expansion joints. Occasionally, there were small areas of spalling on some bridges. Exposed steel reinforcement was found on one bridge deck (LBB-RC-04). This specific region, measuring approximately 8 in² in the main lane, is depicted in Figure 3.13(b) and indicated a lack of sufficient overlay cover.

(b) Exposed Rebar on Deck (LBB-RC-04)

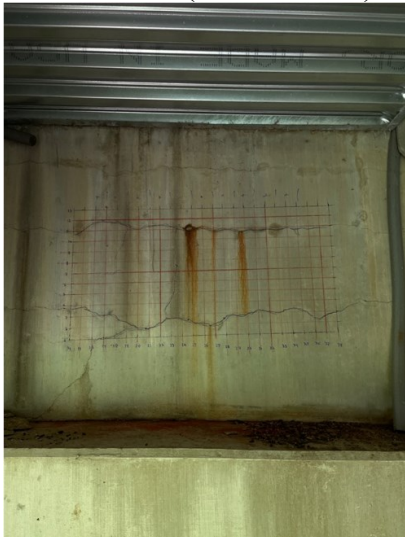
widths for most bridges. The horizontal cracks often extended between the girders, as shown in Figure 3.13(c). Damage was observed in the backwall, where girder expansion led to the ends bearing against the backwall, as shown in Figure 3.13(c).

(c) Cracks and Efflorescence on Abutment (LBB-RC-06)

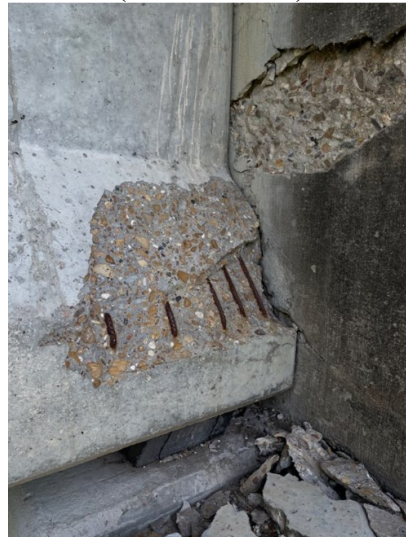
Cracks that appeared on the girders of the most inspected bridges were limited to hairline cracks. In addition, horizontal cracks were frequently observed to form at the interface of girder webs and flanges. Spalling was also observed at the ends of girders in some bridges, which caused corrosion damage to mild steel and prestressing strands. One potential reason for the concrete spalling was because of thermal expansion and settlement of the abutment, which resulted in bearing of the girder against the backwall, as shown in Figure 3.13(d). Concrete spalling of the girders was observed in the Amarillo and Lubbock Districts.

(d) Exposed Rebar on the Girder (LBB-RC-06)

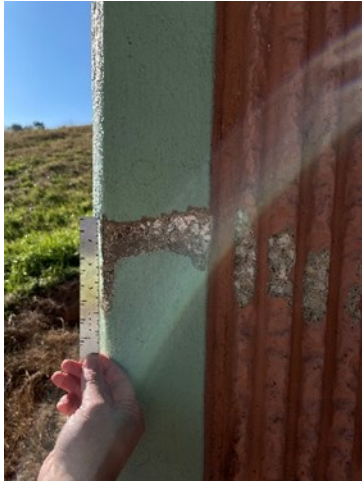
(a) Spalling at abutment wall (TYL-RC-03) (b) Crack at abutment wall (TYL-RC-03)

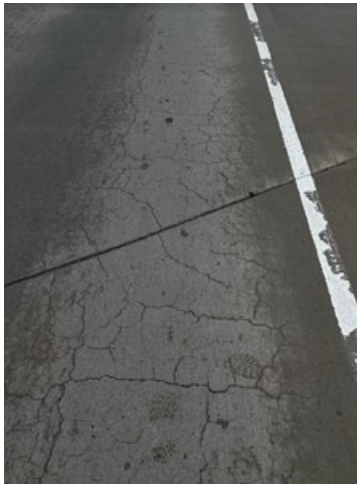
(a) Map cracks propagating from a joint
(ELP-RC-01)

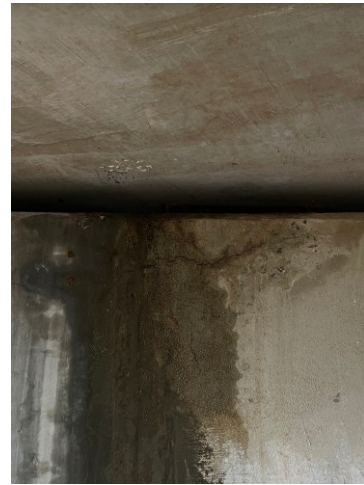
(b) Water leakage from crack at abutment
(ELP-RC-01)

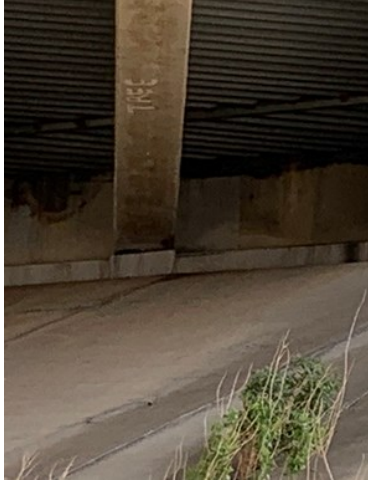
(c) Corrosion at metal deck from an abutment (ELP-RC-06)

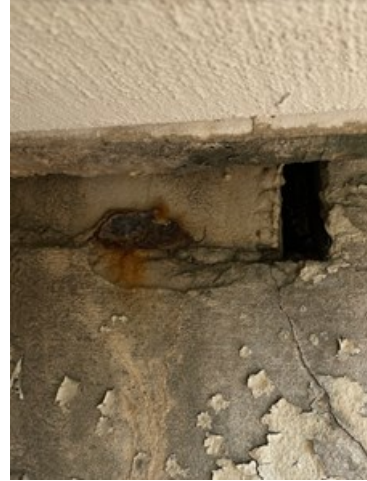
Figure 3.15(d) shows corrosion near the bearing pad on FTW-RC-03. Figure 3.15(e) illustrates the corroded metal deck form near the abutment joint on FTW-RC-04. Figure 3.15(f) displays cracks and efflorescence on the abutment backwall on FTW-RC-05, and Figure 3.15(g) shows exposed and corroded rebar on the abutment due to spalling of concrete on TYL-RC-02. Spalling of concrete frequently leads to exposure of rebar, which is prone to corrosion. Consequently, it is necessary to address spalling, implement appropriate maintenance, and repair strategies to prevent corrosion. Figure 3.16 shows exposed and corroded rebar on the concrete rail on ATL-RC-01 in Region 4. The rebar corroded due to concrete spalling, as well.

(d) Corrosion near bearing pad (FTW-RC-03)

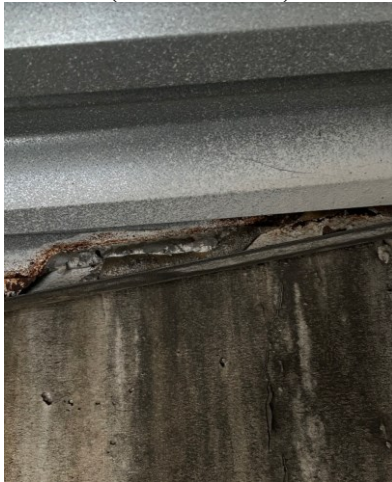
(e) Corrosion detected at deck (FTW-RC-04)

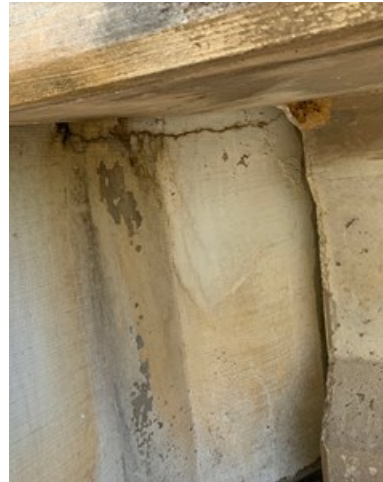
(f) Crack and efflorescence at abutment backwall (FTW-RC-05)

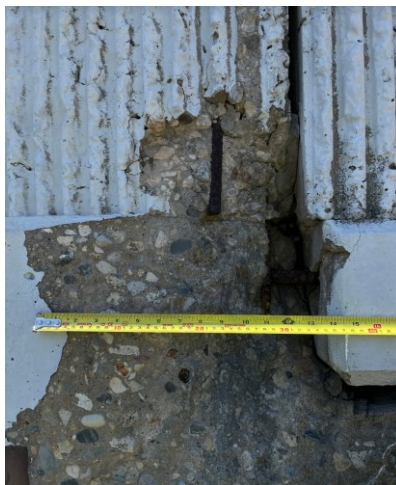
(g) Exposed and corroded rebar at abutment (TYL-RC-02)
Figure 3.15. Deterioration of Bridges in Region 3 (Cont.).

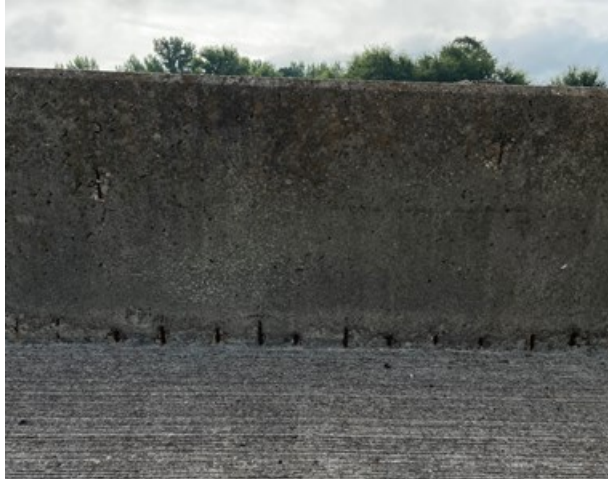
Figure 3.16. Exposed and Corroded Rebar at Concrete Rail at ATL–RC–01 in Region 4.

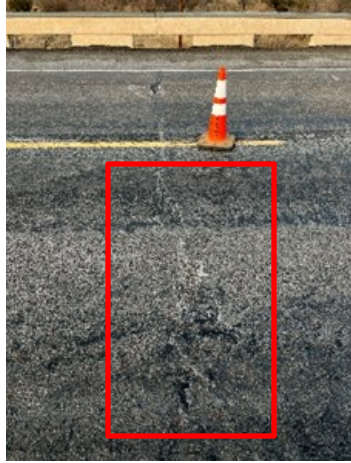
Figure 3.17 illustrates the deterioration of bridges in Region 5. Figure 3.17(a) shows cracks and delamination of the asphalt overlay. Cracks and delamination allow moisture to penetrate the asphalt overlay and reach the concrete underneath, which can cause further corrosion of reinforcement steel in bridge decks. Figure 3.17(b) depicts cracks on the bottom surface of the deck. Figure 3.17(c) shows cracks and rust on the abutment backwall on CHS–RC–06. This type of cracking was probably caused by settlement of the abutment and often leads to corrosion of rebar. Figure 3.17(d) shows exposed and corroded rebar at the concrete rail in the WFS–RC–03 bridge, which may be due to spalling of concrete from corrosion formation on the rebar surface. Figure 3.17(e) also shows a similar crack to the one in Figure 3.17(c), but it perhaps developed as a result of water leakage on the abutment backwall on WFS–RC–03. Cracks on the abutment wall are common types of concrete cracking due to settlement. Figure 3.17(f) displays a corroded metal deck form near a joint on WFS–RC–04 that was generally visible on bridges with a permanent metal deck form (PMDF) at joints due to water leakage from the joints. Figure 3.17(g) illustrates horizontal cracks and efflorescence on the abutment backwall on WFS–RC–05, while Figure 3.17(h) shows a hole that formed within the pavement and extended into the deck. Severe pitting corrosion and metal loss of the reinforcement steel as a result of the hole are evident in Figure 3.17(i).

(a) Cracks and delamination of asphalt overlay (CHS-RC-05)

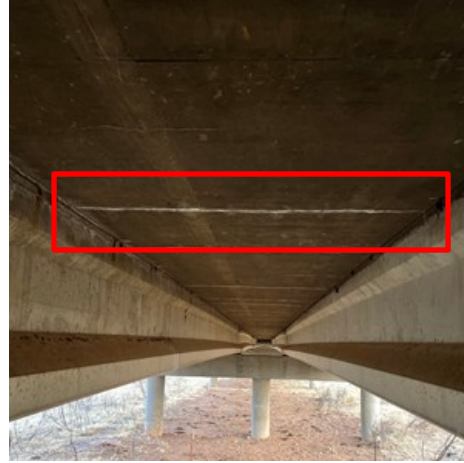
(b) Moderate cracks on bottom surface of deck (CHS-RC-05)

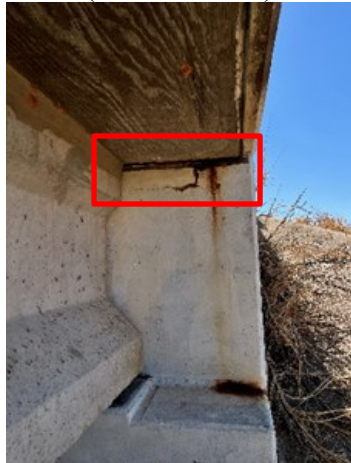
(c) Cracks at abutment backwall (CHS-RC-06)

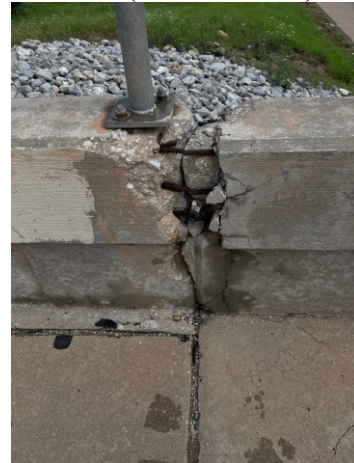
(d) Exposed and corroded rebar at concrete rail (WFS-RC-03)

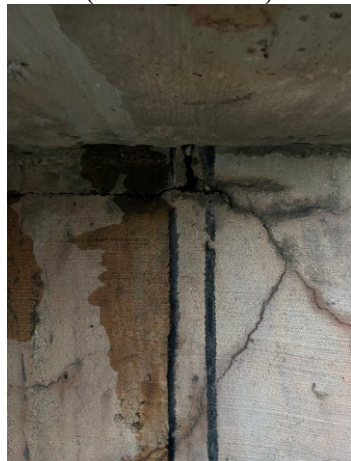
(e) Crack at abutment backwall (WFS-RC-03)

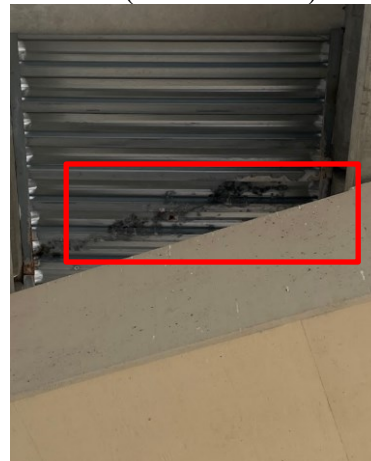
(f) Corroded metal deck form near joint (WFS-RC-04)

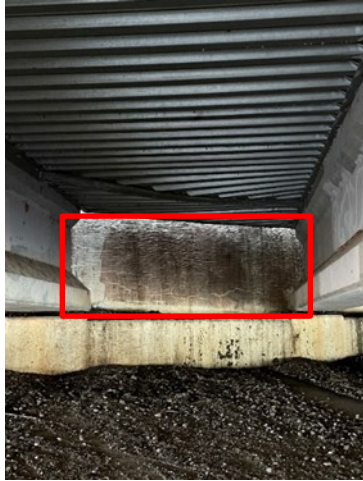
(g) Horizontal cracks and efflorescence at abutment backwall (WFS-RC-05)

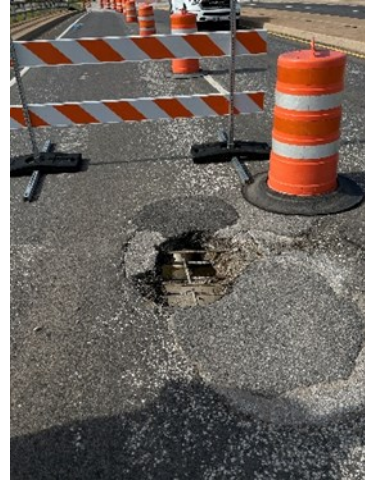
(h) Development of a hole on deck (WFS-RC-07)

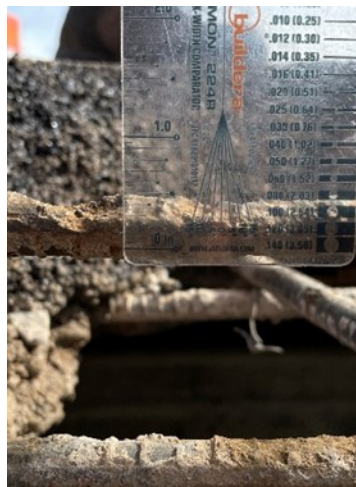
(i) Pitting corrosion where the hole was (WFS-RC-07)

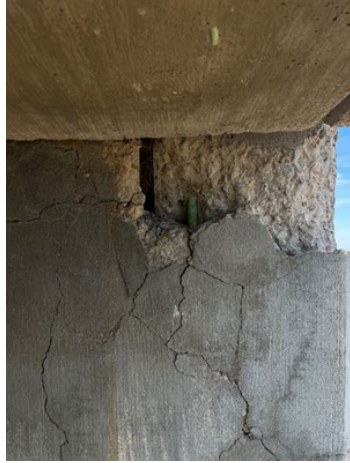
Figure 3.18 shows deterioration of bridges in Region 6. Figure 3.18(a) shows exposed and corroded ECR due to settlement on AMA-RC-02. As the abutment wall fell off, the ECR was exposed to air, thus damaging the coating and potentially causing corrosion of the rebar. Rust propagated and caused further spalling on the abutment wall. Figure 3.18(b) displays rust on the concrete rail on AMA-RC-04. Rebar was not exposed to air, but water penetration within cracked spaces still remains possible. Figure 3.18(c) shows typical corrosion on the PMDF near a joint on AMA-RC-04 that was also observed on WFS-RC-04.

(a) Exposed and corroded ECR due to spalling at abutment (AMA-RC-02)

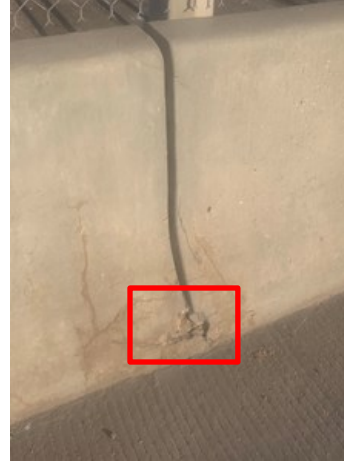
(b) Rust at rail bottom (AMA-RC-04)

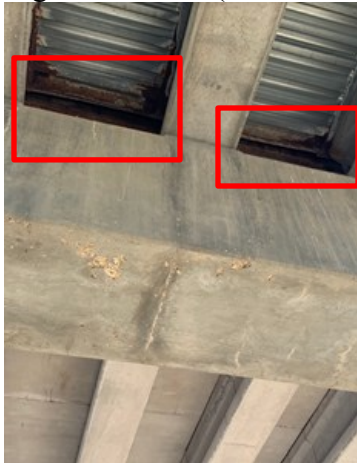
(c) Corrosion on the metal deck form near a joint (AMA-RC-04)

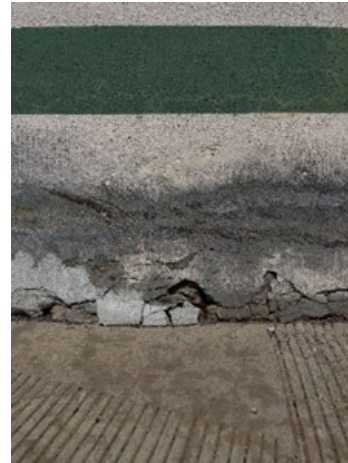
Figure 3.18(d) shows the condition of exposed rebar due to impact damage on the rail on AMA-RC-06 where corrosion of the rebars were detected. Figure 3.18(e) displays cracks and

(d) Exposed rebar due to impact damage on a rail (AMA-RC-06)

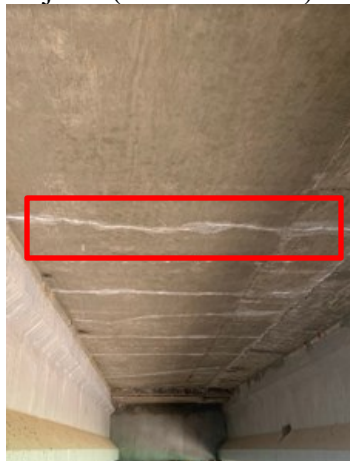
efflorescence on the bottom surface of the deck on AMA–RC–08 that can potentially lead to the corrosion of either black rebar or ECR, particularly if the coating has been damaged.

(e) Cracks and efflorescence on bottom surface of deck (AMA-RC-08)

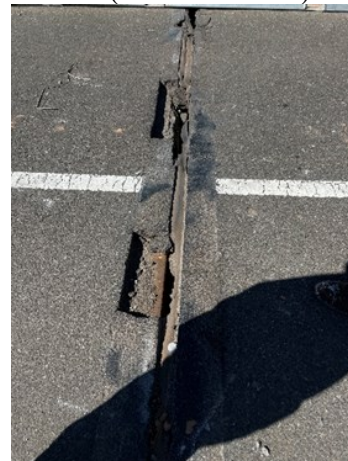
Figure 3.18(f) to Figure 3.18(k) display various issues on CHS–RC–01, including spalling at a joint, exposed and corroded rebar at the girder end due to spalling, sealed cracks on a bent cap, corroded uncoated black rebar at the bottom rebar mesh near the overhang, and concrete fall-off at the intersection of the replaced overhang. Note that CHS–RC–01 was in poor condition at the time of inspection, and rehabilitation was in progress. In Region 6, the use of ECR in both the top and bottom mesh of reinforcement (in addition to other mitigations such as HPC) is recommended to prevent corrosion initiation and propagation within concrete decks. Figure 3.18(l) shows transverse and longitudinal cracks on the deck surface. In general, longitudinal cracks located above girders are caused by girders, while transverse cracks are caused by concrete precast panels. Figure 3.18(m) shows hairline cracks on the abutment back wall on CHS–RC–04.

(f) Spalling of overlay at joint (CHS-RC-01)

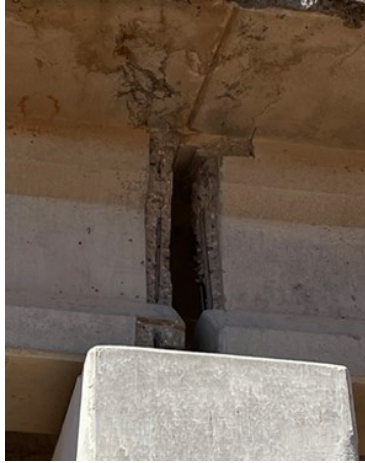
(g) Spalling and exposed rebar at girder ends (CHS-RC-01)

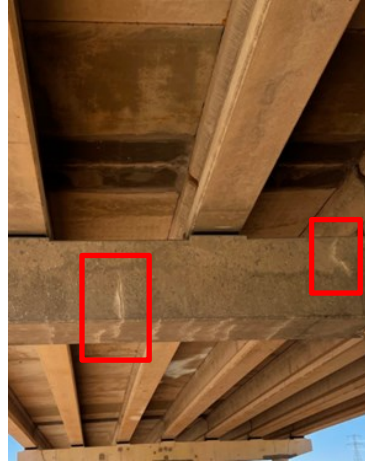
(h) sealed cracks on a bent cap (CHS-RC-01)

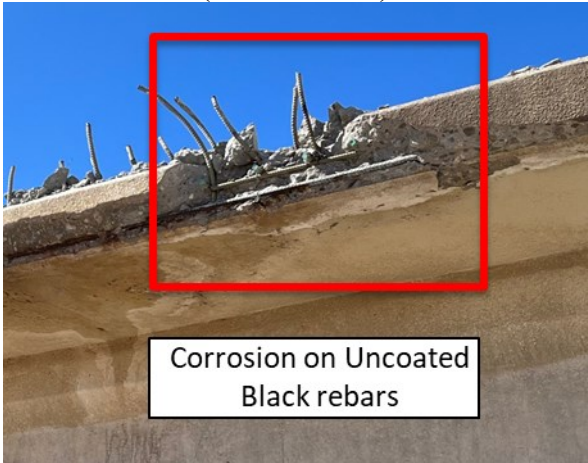
(i) Location of the corroded uncoated black rebar (CHS-RC-01)

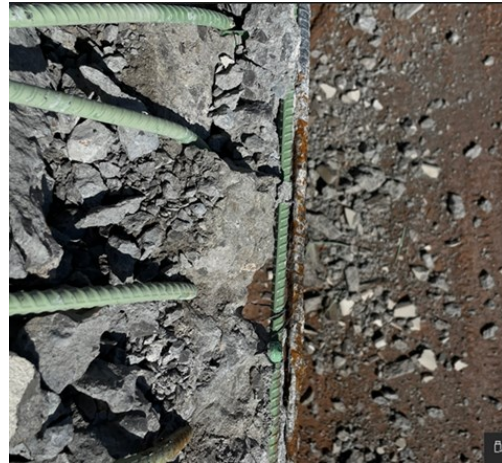
(j) Corrosion on uncoated black rebar at the bottom mesh near overhang (CHS-RC-01)

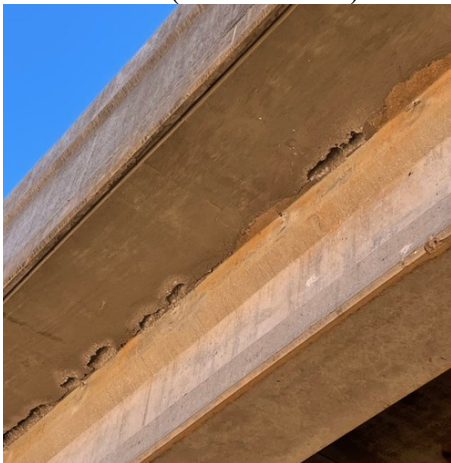
(k) Concrete fall-off at intersection of replaced overhang (CHS-RC-01)

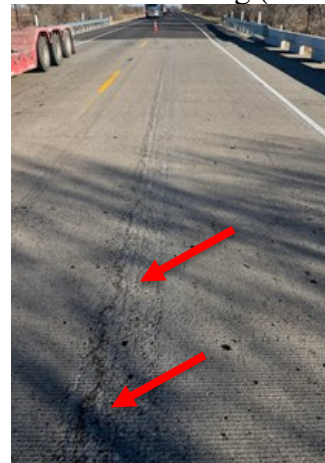
(l) Transverse and longitudinal cracks on deck surface (CHS-RC-02)

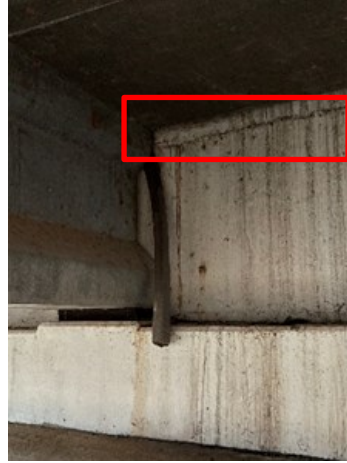
(m) Hairline cracks at abutment back wall
(CHS-RC-04)

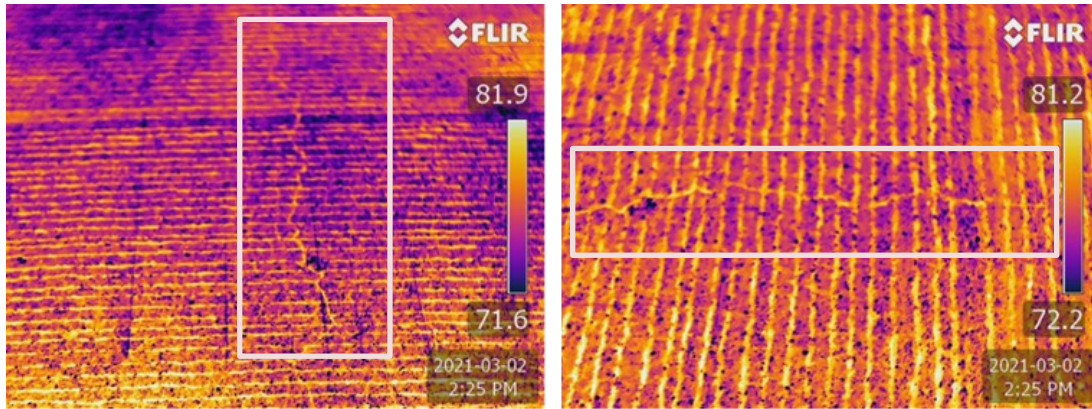
Thermal images taken from bridge structures were used to analyze surface cracking on concrete elements. Figure 3.19 shows longitudinal cracks that are visible from the IRT photos. As shown in Figure 3.19, thermal imaging enables quick and efficient assessment of cracks. It can detect superficial defects on the bridge decks, including cracks that may not be easily visible to the unaided eye. IRT detects temperature differences caused by cracks, enabling precise identification and mapping of surface cracking.

Figure 3.19. Thermal Imaging of CRP-RC-02 Showing Cracks.

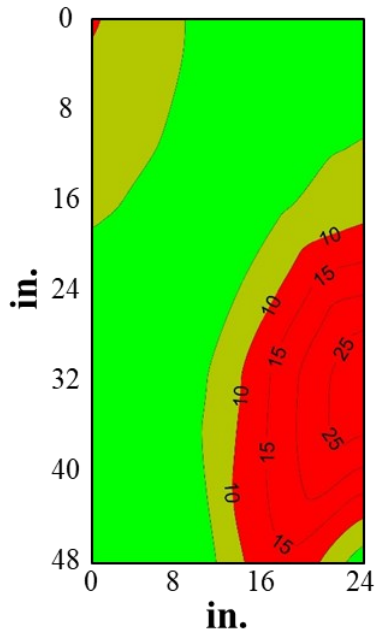
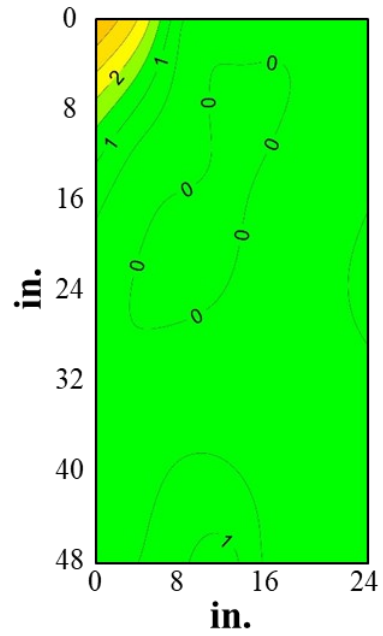
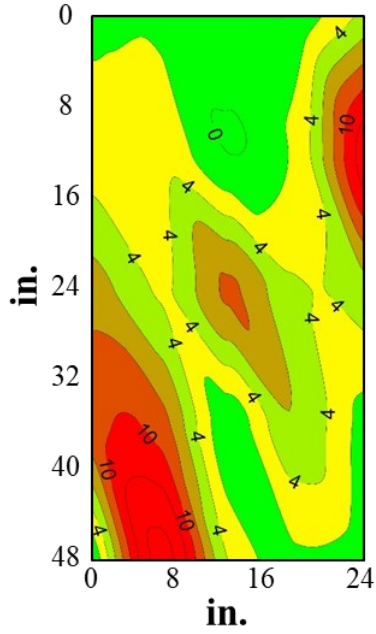
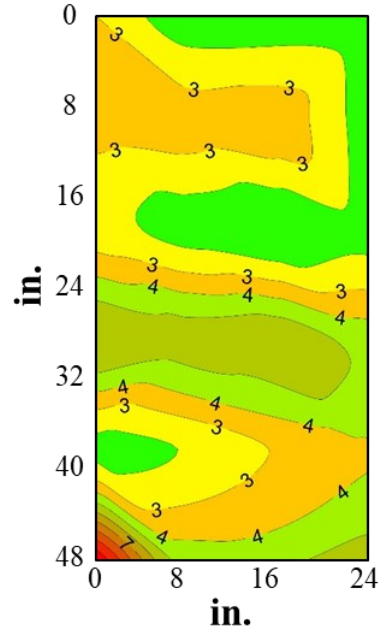
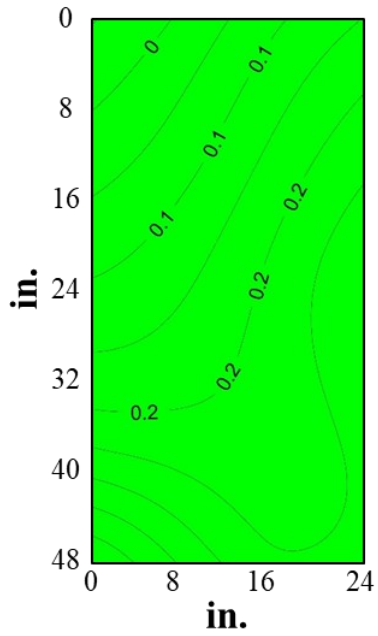
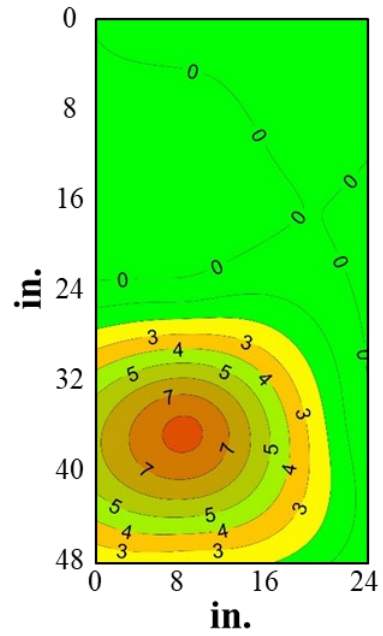
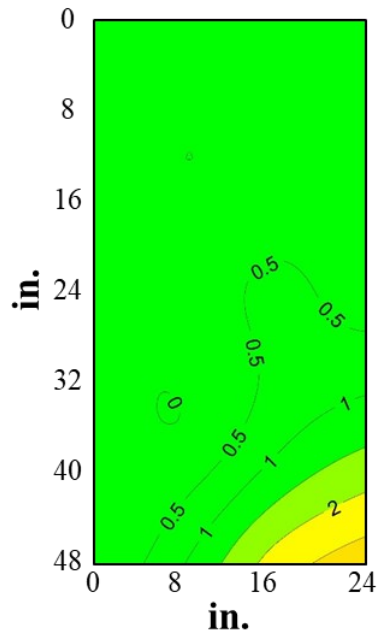
Figure 3.25 shows results of corrosion rate mapping of bridges in Region 3, including ELP-RC-03, ELP-RC-05, ELP-RC-07, and ELP-RC-08. Among the bridges, ELP-RC-03 G2, ELP-RC-07, and ELP-RC-08 were classified as being in moderate condition in terms of corrosion rate. These bridges exhibited corrosion damage within the range of 10 to 15 years according to the corrosion rate mapping. On the other hand, ELP-RC-03 G1 and ELP-RC-05 had a high corrosion rate and were expected to have some corrosion damage within the range of 2 to 10 years; particularly, ELP-RC-08 and ELP-RC-05 had corrosion rates of 7 and 10 $\mu\text{A}/\text{cm}^2$, respectively, which is close to the moderate range. Additionally, it is worth mentioning that ELP-RC-03 exhibited a high corrosion rate only in a limited area, while all other locations exhibited low to no corrosion rates.

Figure 3.25. Corrosion Rate Mapping Results of Bridges in Region 3, Corrosion Current Density ($\mu\text{A}/\text{cm}^2$).

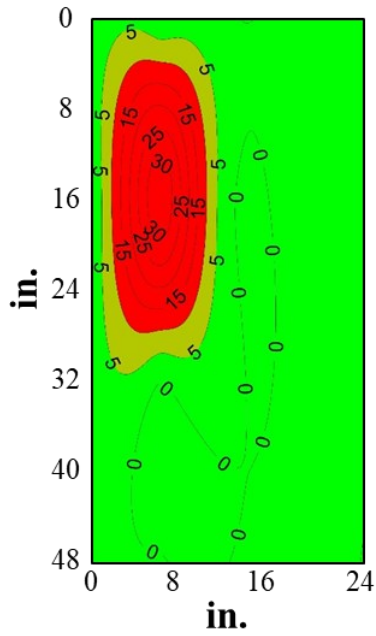
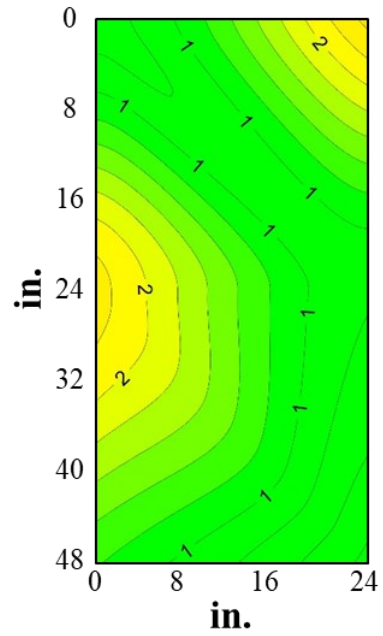
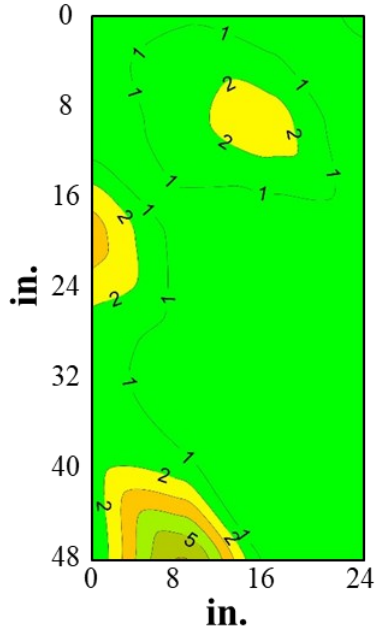
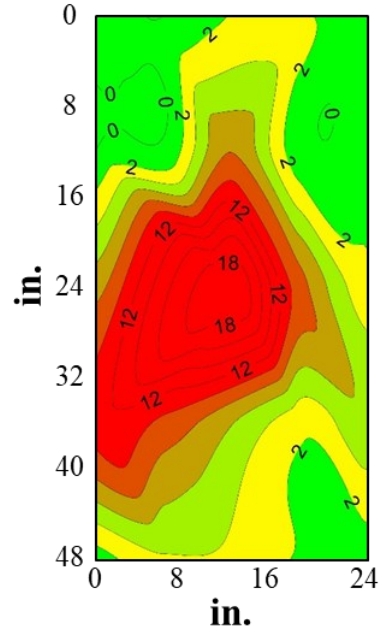
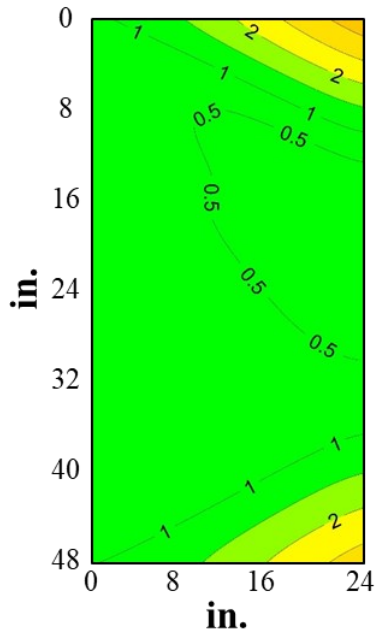
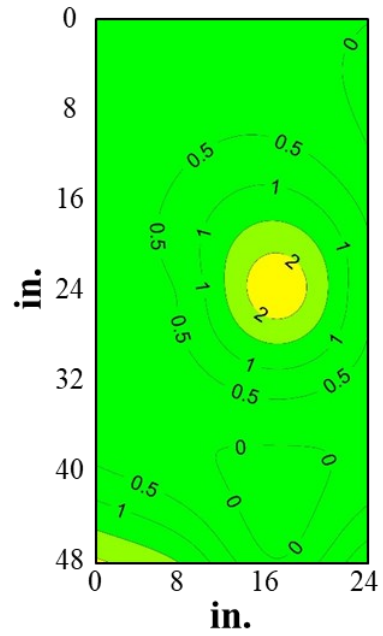
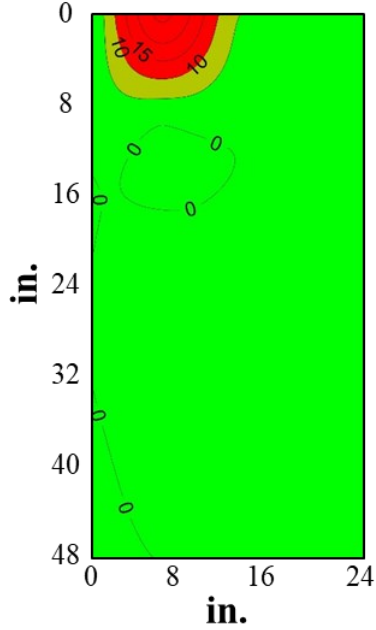
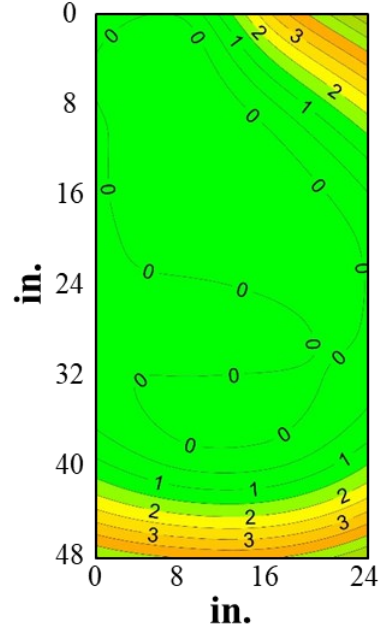
Figure 3.26 illustrates the corrosion rate mapping developed for concrete decks in Region 6, including AMA-RC-10, LBB-RC-01, LBB-RC-02, LBB-RC-03, LBB-RC-04, LBB-RC-05, LBB-RC-06, and LBB-RC-07. Among these bridges, LBB-RC-01, LBB-RC-02, LBB-RC-04, LBB-RC-05, and LBB-RC-07 were determined to be in a moderate condition in terms of corrosion rate. These concrete structures exhibited corrosion damage within the range of 10 to 15 years. On the other hand, AMA-RC-10, LBB-RC-03, and LBB-RC-06 had high corrosion rates and were expected to have corrosion damage within the range of 2 to 10 years. Only limited areas of LBB-RC-03 and LBB-RC-06 showed corrosion rates of 18 and 15 $\mu\text{A}/\text{cm}^2$, respectively. AMA-RC-10 G1 exhibited a corrosion rate of 30 $\mu\text{A}/\text{cm}^2$ in a very limited area.

Figure 3.26. Corrosion Rate Mapping Results of Bridges in Region 6, Corrosion Current Density ($\mu\text{A}/\text{cm}^2$).

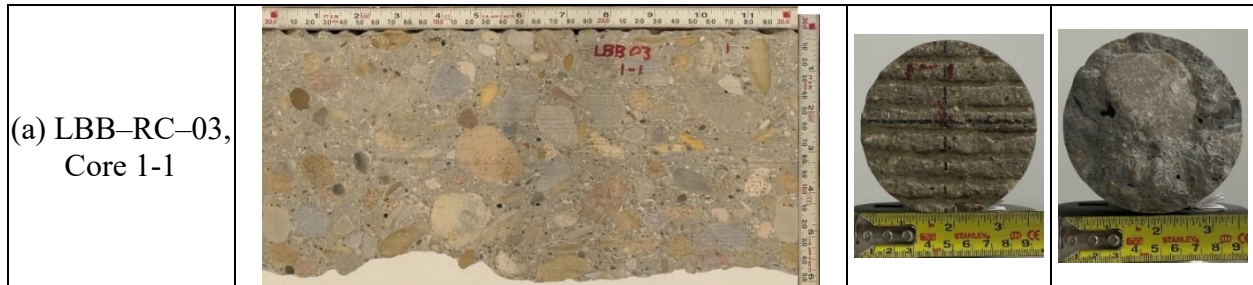
Overall, the rebar and cores were found to be in good condition and showed no sign of corrosion. However, laboratory examinations were also conducted to determine the corrosion condition of core specimens, and the results will be reported in Chapter 4. Figure 3.27 shows a core from its side, top, and bottom. The core, labeled 1-1, is a core from Grid 1 of LBB-RC-03, and it represents an example of a core in good condition. Upon examination, there were no visible cracks on its top surface, no delamination on the bottom surface, and no visible voids or cracks on the side surface.

Figure 3.27. Pictures of Core 1-1 of LBB-RC-03 in Good Condition.

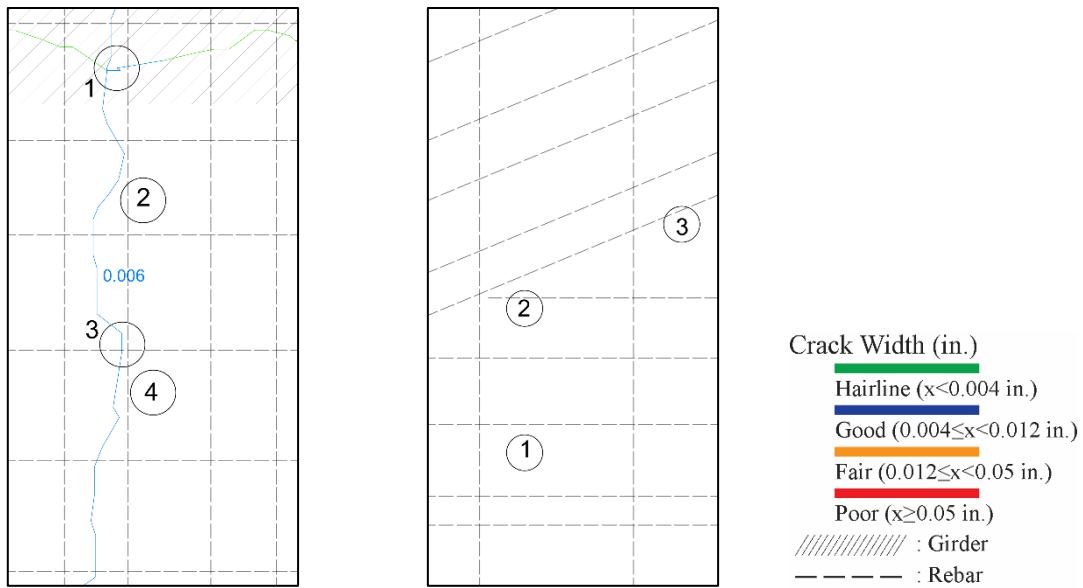
Figure 3.29 provides surface crack mapping of the concrete decks in Region 3, highlighting the variations in crack conditions. As shown in this figure, the crack mapping of Grid 2 in ATL-RC-05 illustrates a 0.006-in.-wide transverse crack as well as a hairline crack. Although surface cracking was detected in Grid 2, the crack mapping represented in Figure 3.29 shows the absence of any kind of surface cracking developed in Grid 1 of TYL-RC-03. The transverse cracking observed in ATL-RC-05 is a common type of crack that can develop at the joint of PCPs. This variation in crack conditions among bridges in the same region suggests the influence of different factors such as construction methods or environmental conditions, which may contribute to the varying levels of cracking observed on the bridge decks. Cracking can occur either during construction or as a result of stress concentration after installation. If the interior diagram of

concrete panels is not properly positioned to support the concrete deck, it can result in increased rates of transverse crack development due to the production of negative longitudinal bending moments. Additionally, factors like thermal and shrinkage effects can also contribute to development of transverse cracking (Buth et al., 1972).

Figure 3.29. Crack Mapping of Concrete Decks in Region 2.

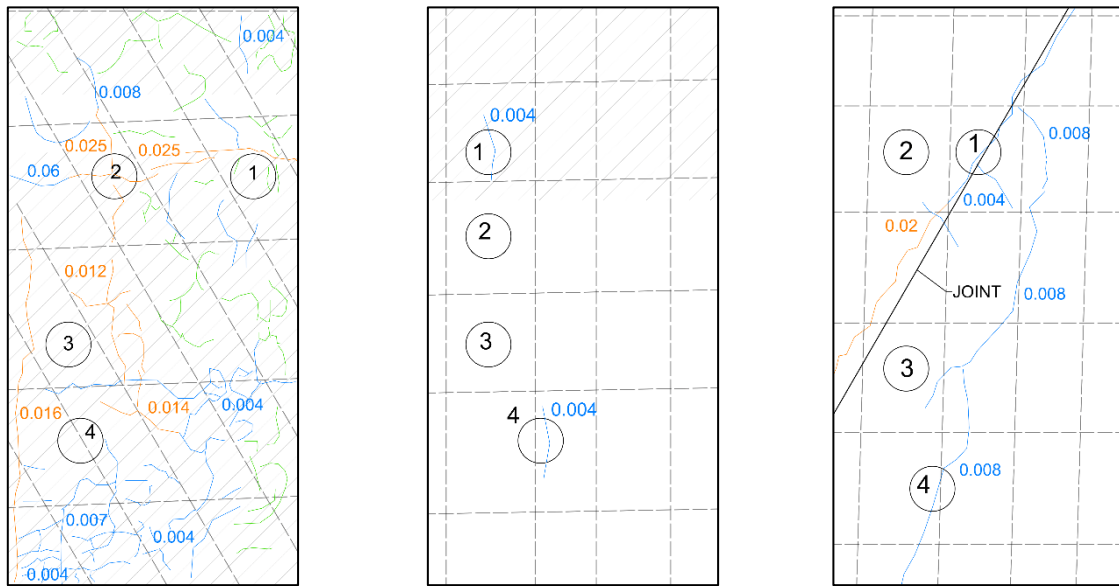
Figure 3.30 provides insights into the condition of bridge decks in Region 3. Figure 3.30(a) shows crack distribution on the deck of ELP-RC-01, which is classified in bad condition despite not having wide enough cracks to be considered a poor-quality concrete. However, the crack density of ELP-RC-01 was found to be significantly high, indicating a high fraction of surface cracking on the deck. In contrast, in Grid 1 of ATL-RC-04 (Figure 3.30[c]), a wider crack was observed, but the associated crack density was calculated as low. The cracks in this case are seen to propagate from a poor boy joint (PBJ). Figure 3.30(b) shows Grid 2 of ELP-RC-04, wherein the concrete deck is in a very good condition with only a few cracks, thereby justifying a good rating.

Figure 3.30. Crack Mapping of Concrete Decks in Region 3.

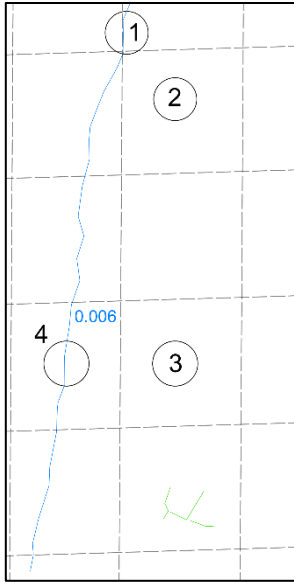
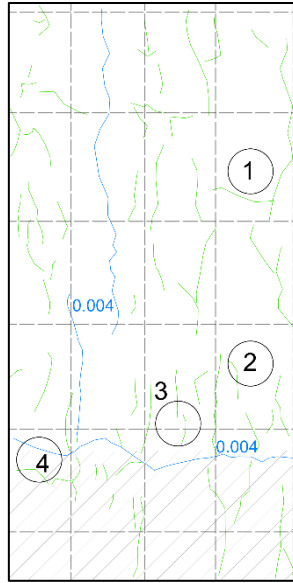
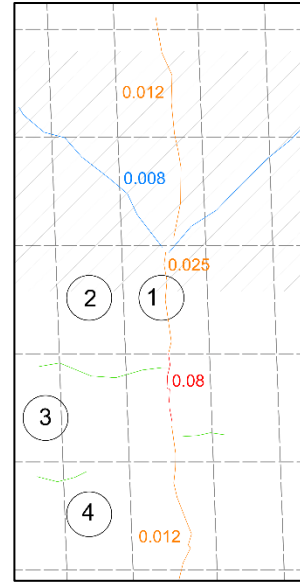
Figure 3.31 shows crack mapping of bridges in Region 4. Figure 3.31(a) shows an example of a moderate crack condition from Grid 1 of ATL-RC-01, while Figure 3.31(b) depicts a similar crack mapping from ATL-RC-02 with additional hairline cracking. ATL-RC-02 was found to be in good condition in terms of crack width; however, many hairline cracks were visible inside the grid.

Figure 3.31. Crack Mapping of Concrete Decks in Region 4.

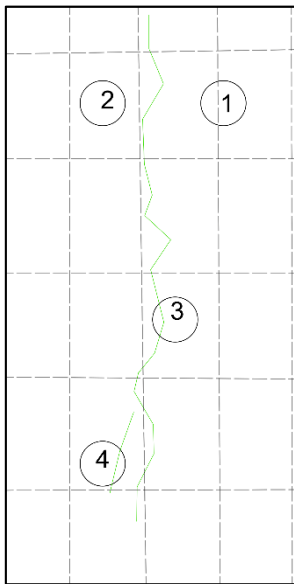
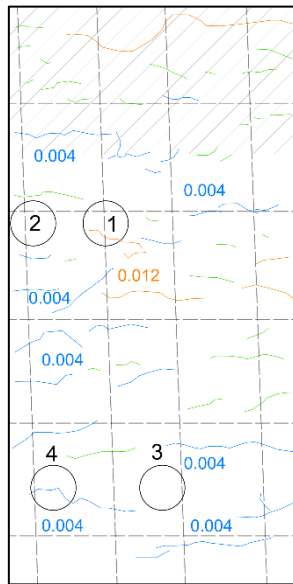
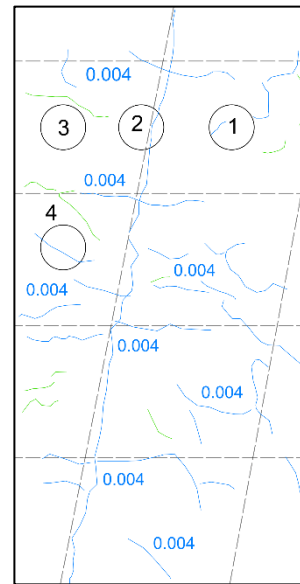
Figure 3.32 includes crack mapping of bridges in Region 5, which contains concrete bridges such as CHS-RC-05, WFS-RC-06, and WFS-RC-07. Although Figure 3.32(a) shows a grid with only few hairline cracks, Figure 3.32(b) and (c) illustrate grids with several cracks ranging between 0.004 in. and 0.012 in. width. Figure 3.33 displays surface crack mapping of concrete decks located in Region 6. AMA-RC-01, AMA-RC-02, and AMA-RC-08 exemplify such concrete structures. Figure 3.33(a) and (b) show bridges in Amarillo in moderate and severe conditions, and Figure 3.33(c) illustrates a concrete deck in Lubbock with several hairline cracking. As noted previously, these observations suggest that the condition of bridge decks can vary within the same region since they were captured from a limited area of the bridge deck.

Figure 3.32. Crack Mapping of Concrete Decks in Region 5.

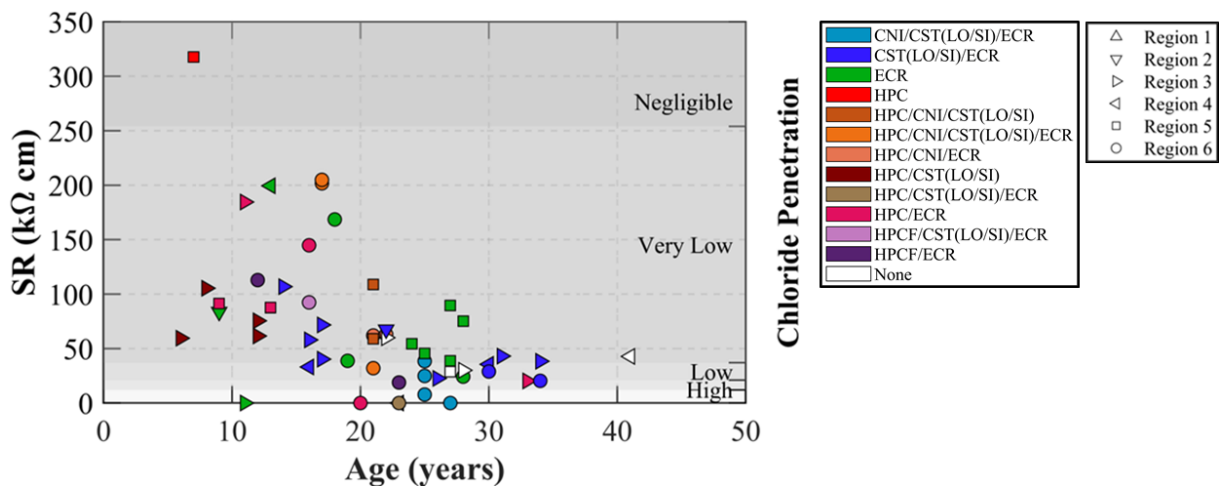
Figure 4.4. Surface Resistivity Recorded for Concrete Core Specimens.

The results shown in Figure 4.4 are further categorized based on the corrosivity level of the environmental risk, which ranges from low-risk environments to high-risk environments. As shown in Figure 4.4, the surface resistivity decreases over time from Region 1 to Region 6.

Another classification used in Figure 4.4 is based on chloride ion penetration, as recommended by AASHTO T358 (2015) (Table 4-2). According to this classification, if the surface resistivity of a concrete specimen measures lower than 12 kΩ cm, it indicates a relatively high concentration of chloride ions in the sample. When the resistivity falls between 12 kΩ cm to 21 kΩ cm, the level of chloride penetration in the concrete specimen is considered moderate. If the resistivity is 21 kΩ cm or greater, it suggests a low concentration of chloride ions in concrete specimens.

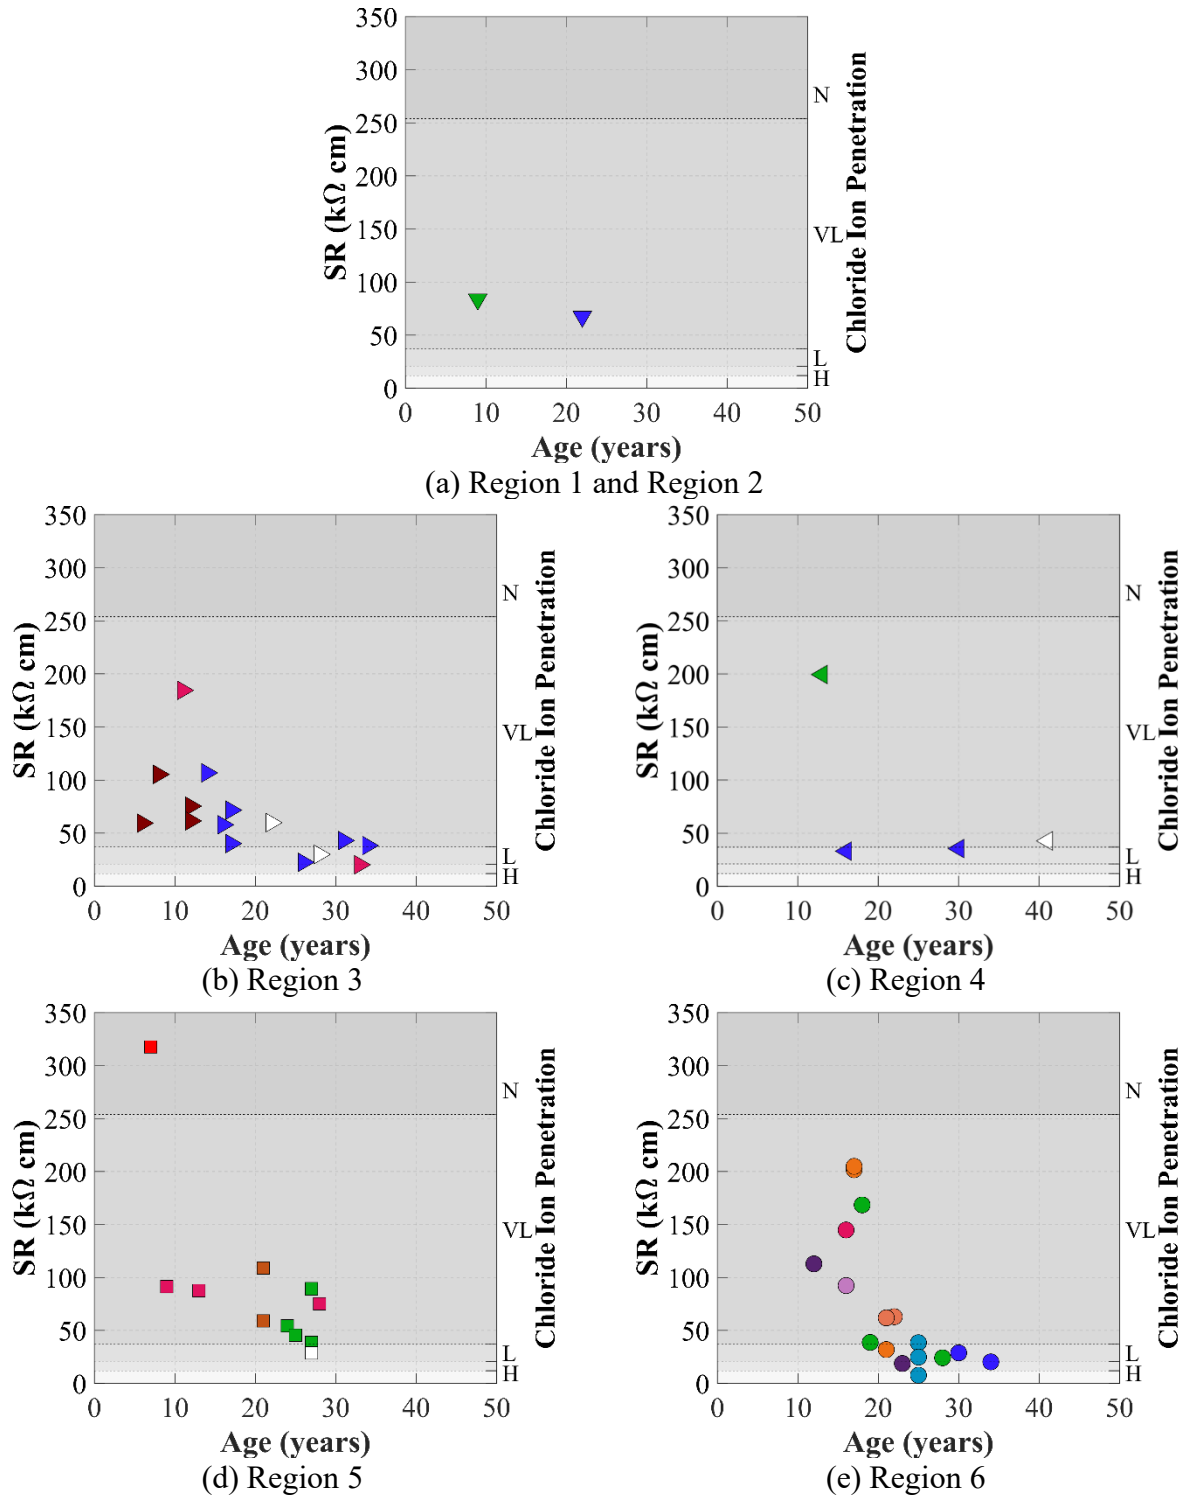
Figure 4.5 illustrates the surface resistivity of concrete core specimens extracted from TxDOT concrete decks with varying ages of construction. In low corrosion risk environments such as Region 1 and Region 2, the surface resistivity of the concrete samples (ATL–RC–05 and TYL–EC–03) was greater than 50 kΩ cm, indicating a low concentration of chloride ions in the specimens. However, as the environment became more corrosive, the surface resistivity gradually decreased below 37 kΩ cm over time, which suggests that the volume of moisture absorbed in concrete decks was higher for older bridges.

In Region 6, which represents a severe corrosion risk environment, the surface resistivity of samples aged over 25 years fell into the moderate and high categories of chloride ion penetration. This finding indicates that corrosion issues might have emerged in the bridge decks located in this region (AMA–RC–05, LBB–RC–04 and LBB–RC–06), and further investigation is needed to assess the extent of corrosion and its impact on the concrete structures.

The moisture and chloride content of the specimens taken from bridges aged less than 25 years for concrete decks located in Region 3, Region 4, and Region 5 and aged less than 20 years for concrete decks located in Region 6 were estimated to be low; surface resistivity was recorded above 37 kΩ cm for most of these specimens except for FWT–RC–07 in Region 4, which had a lower surface resistivity reading.

Figure 4.5. Surface Resistivity Measured for Aged Concrete Specimens Based on Different Corrosion Risk Environments.
