Evaluation of Corrosion Prevention and Mitigation Approaches Used on Texas Bridges—Volume 2: Reinforced Concrete Bridges

Technical Report 0-7040-R1-Vol2

TEXAS A&M TRANSPORTATION INSTITUTE
COLLEGE STATION, TEXAS

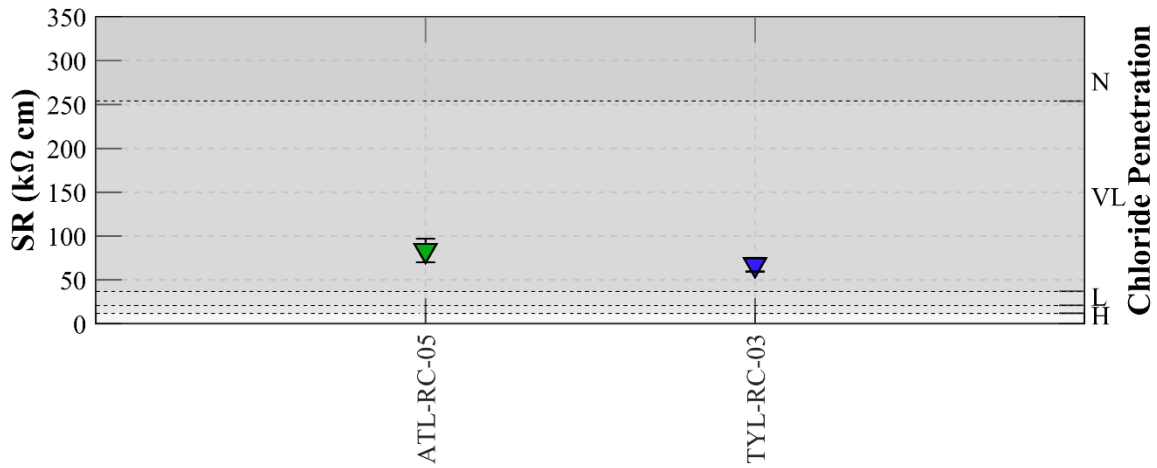
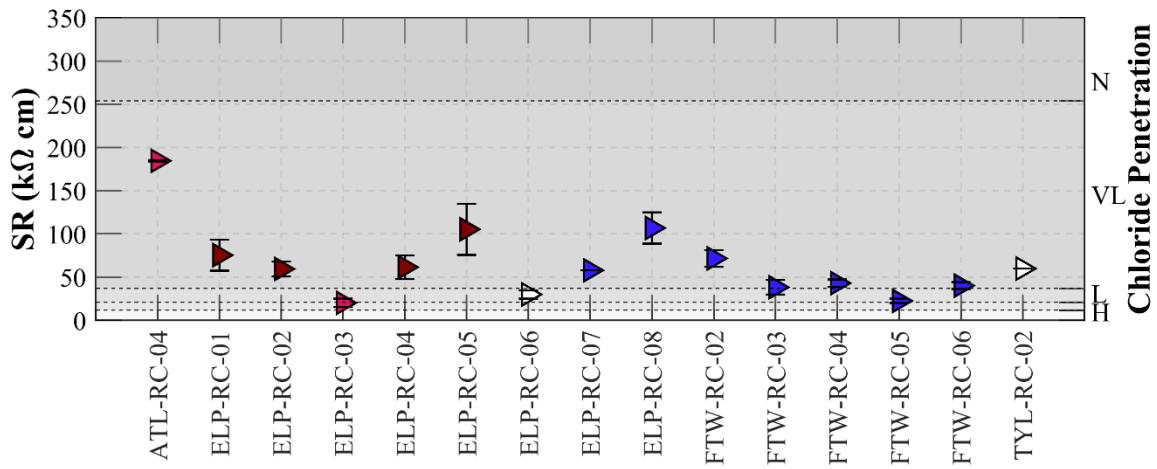
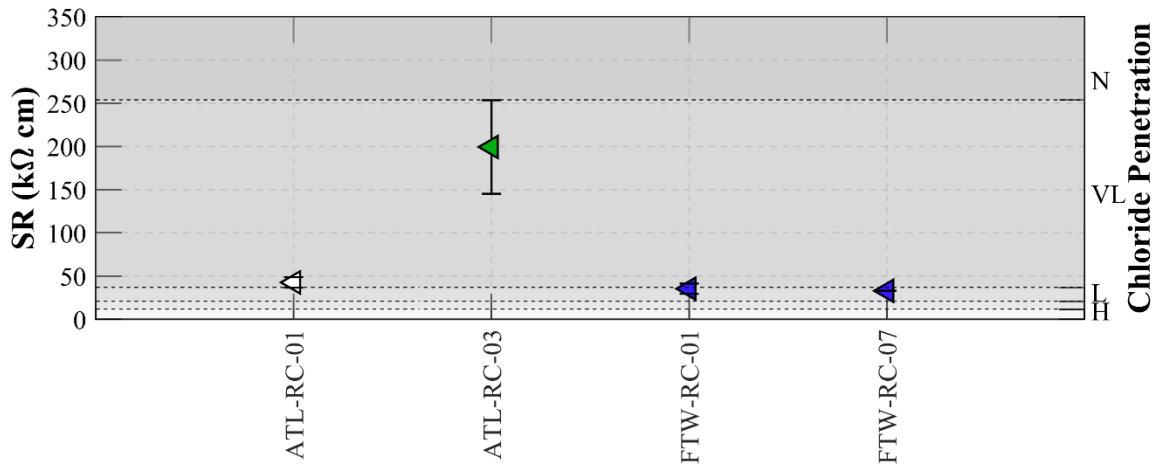
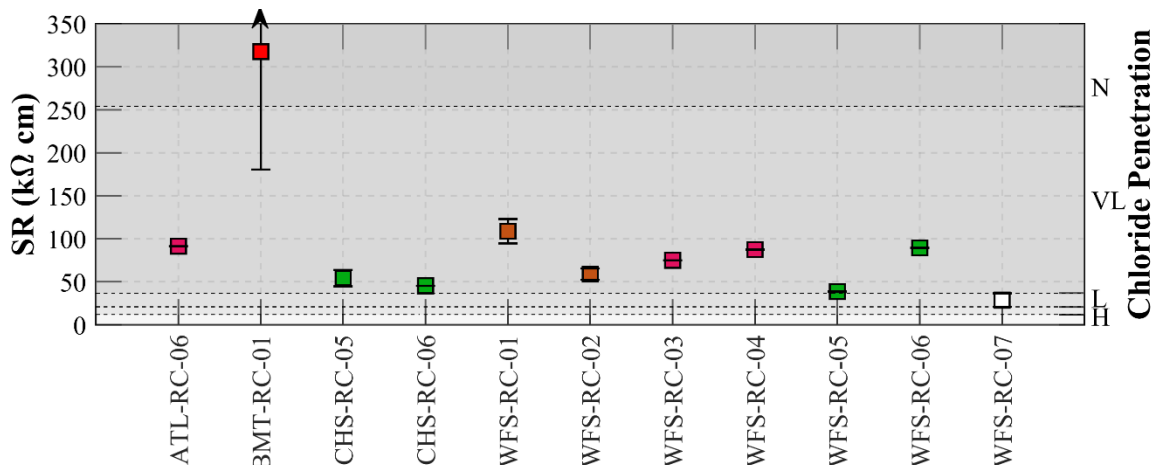
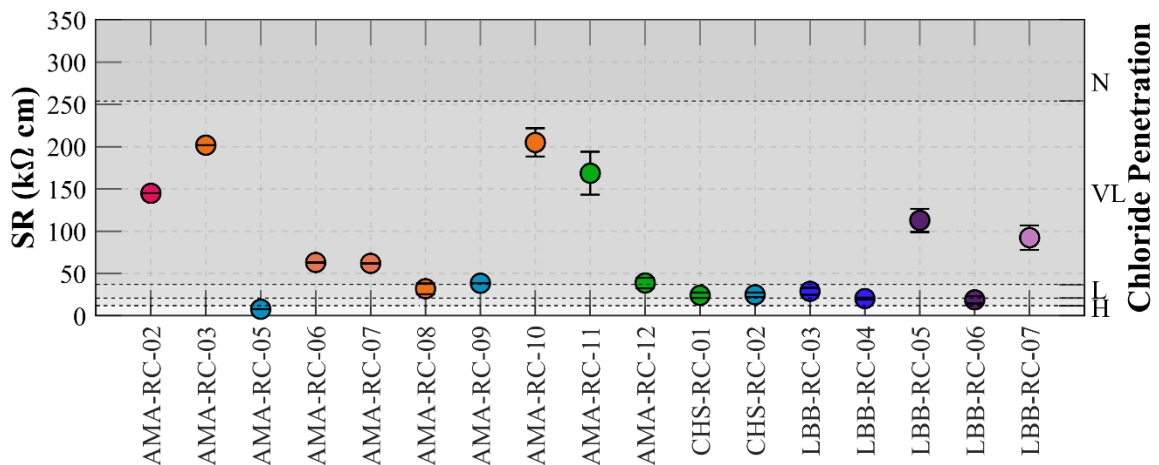
Figure 4.6 shows the surface resistivity measurements obtained from concrete specimens taken from each individual bridge inspected in this study. The surface resistivity could not be recorded on the core specimens obtained from ATL-RC-02 and ATL-RC-07 because of their shorter length or because of the presence of embedded steel bars.

Figure 4.6. Surface Resistivity Measured for Concrete Bridges.

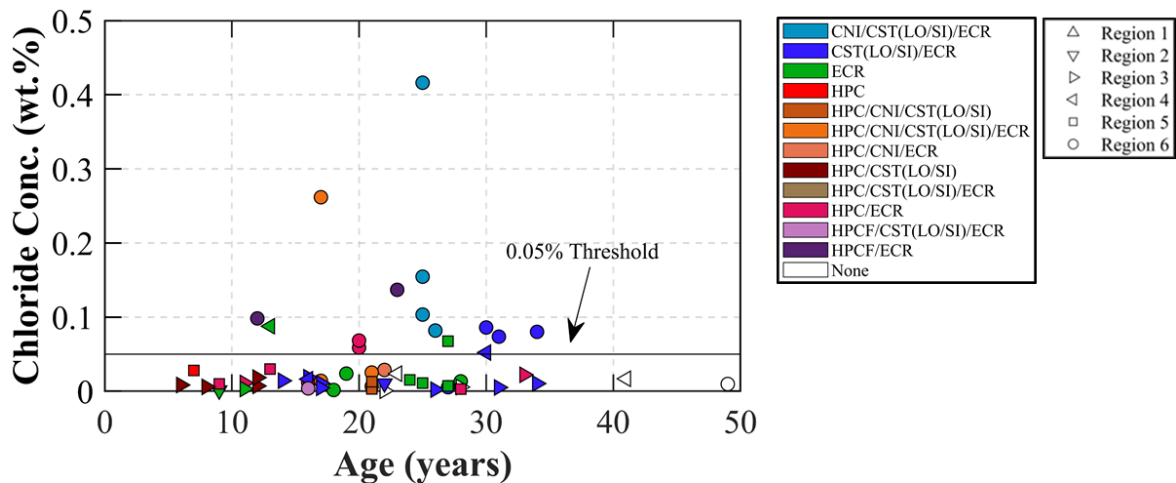
Figure 4.27. Chloride Concentration at the Concrete and Steel Reinforcement Interface.

Figure 4.27 shows the concentration of chloride ions at the concrete and steel reinforcement interface. The chloride threshold was lower than 0.05 % wt. conc. for most of the specimens examined in this study. However, in a highly corrosive environment such as Region 6, chloride ions diffused deep into the concrete, regardless of the employed mitigation method. Chloride concentration at the rebar level was determined to be on average greater than 0.05 % wt. conc. for most concrete decks in Region 6, two bridge decks in Region 4 (ATL-RC-03 and FTW-RC-01), and one deck located in Region 5 (WFS-RC-06). However, the concentration was still less than 0.1 % wt. conc. for the structures in Region 4 and Region 5.

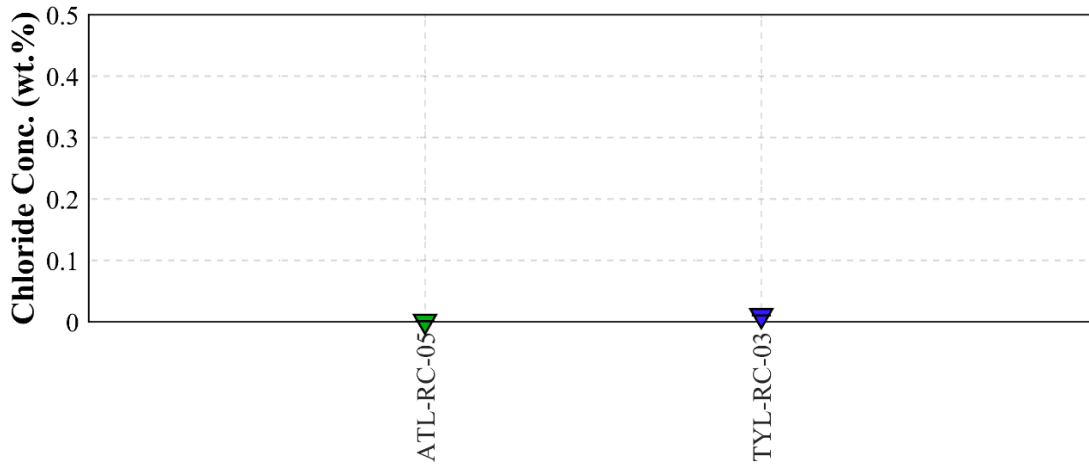
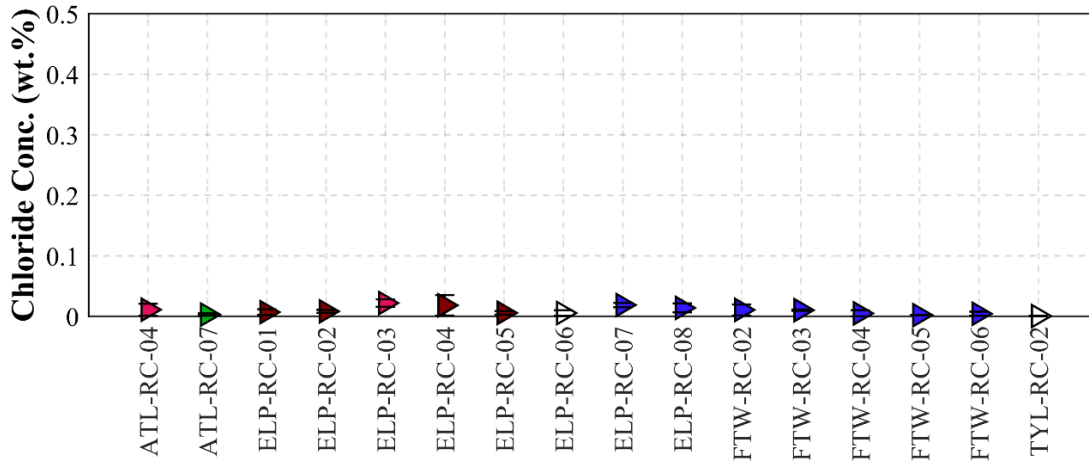
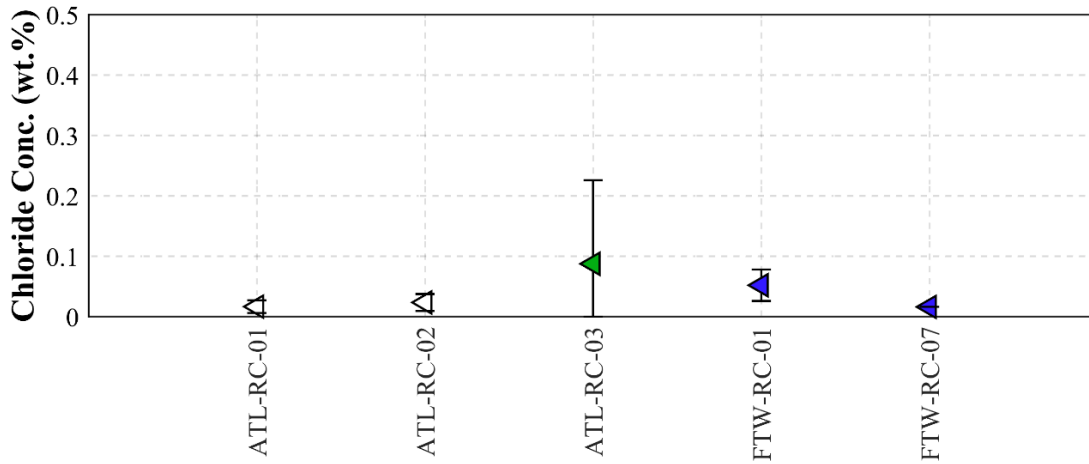
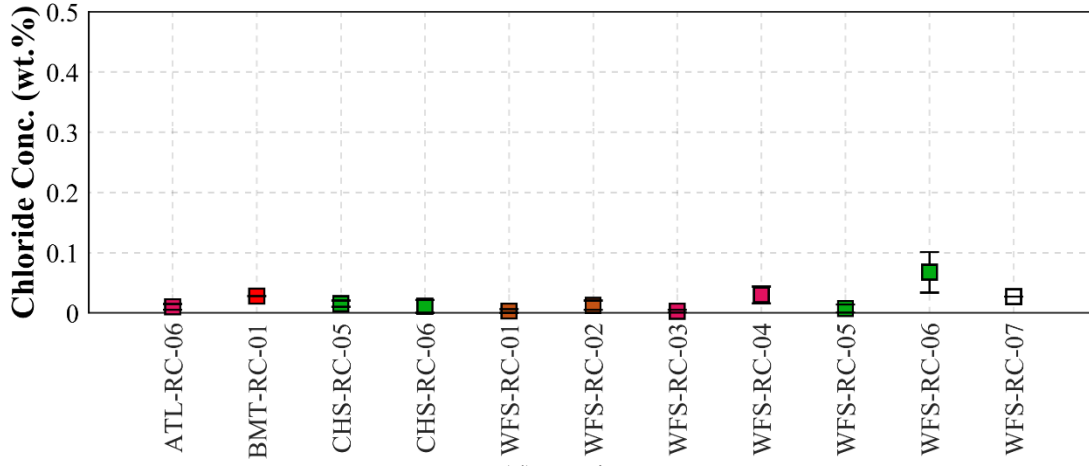
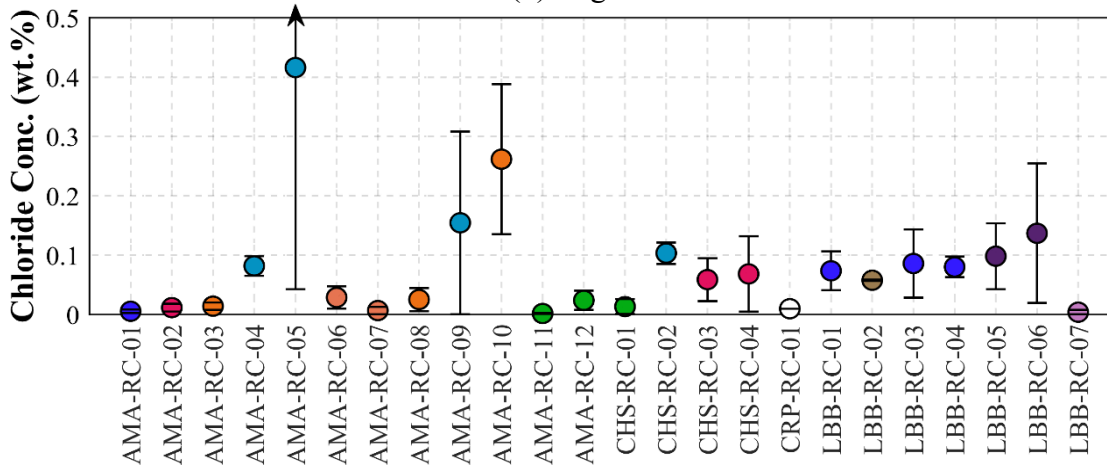
Figure 4.28. Chloride Concentration at Rebar Level for Concrete Bridges.

Figure 4.28 shows the range of chloride concentration at the rebar level of every individual bridge. The diffusion of chloride ions in concrete was negligible at the interface of steel and concrete for most of the concrete decks across Texas, except those located in Region 6 (as discussed). The concentration of chloride in concrete cores extracted from AMA-RC-05 and LBB-RC-04 measured significantly high, particularly for specimens taken from the concrete shoulders (as referred to in the appendix). The recorded bulk resistivity for these specimens was remarkably low, whereas the calculated initial sorptivity was high. A similar pattern was observed for AMA-RC-09; the level of chloride ions was considerably high for the specimen extracted from the concrete shoulders. Bulk resistivity measured for this concrete deck was also low, but the initial sorptivity of this structure is not known because no specimen from this structure was examined during the water absorption test.

Although the chloride level increased to 0.4 % wt. conc. at the surface, the chloride concentration at the HPCF concrete and steel rebar interface was negligible for core specimens obtained from LBB–RC–07, which implies resistance of the concrete deck to chloride diffusion, even though salt accumulates at the top layers of the concrete cover. The average of bulk resistivity measured for specimens taken from LBB–RC–07 was about 20 k Ω cm, and the initial sorptivity was measured at 6×10^{-3} mm/s^{1/2}. It was concluded that the concrete deck of LBB–RC–07 is in good condition. A similar pattern was observed for LBB–RC–02. The average of chloride concentration at the rebar level for other specimens extracted from concrete decks in the Lubbock District exceeded the chloride threshold of 0.05 % wt. conc. recommended by Angst et al. (Angst et al., 2009).

Chloride content at the rebar level measured higher than the chloride threshold for specimens taken from concrete decks in the Childress District, with the exception of CHS–RC–01. Note that the results obtained from potentiometric titration for specimens examined in this district agree with the measurements obtained from the resistivity, UPV, and water absorption examinations.

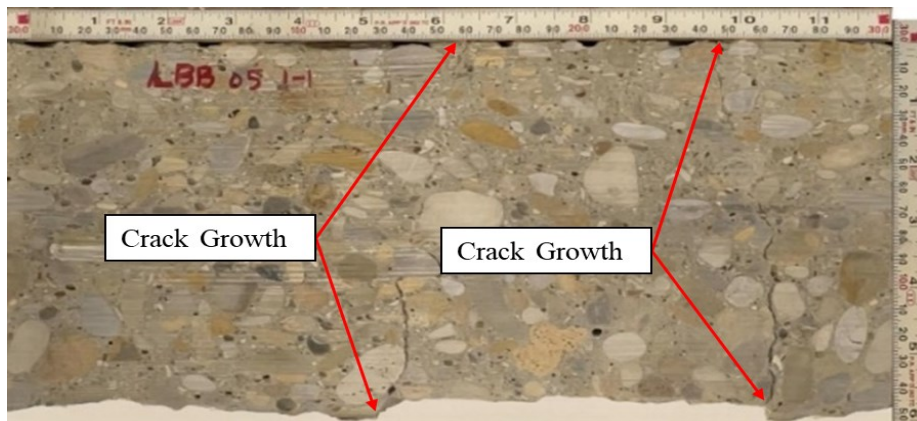
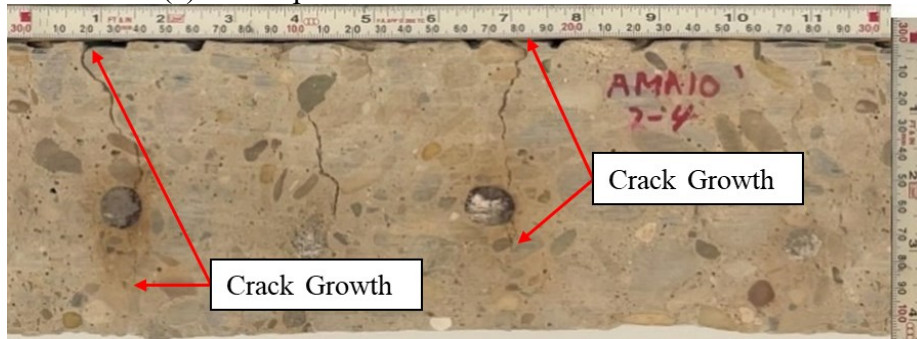
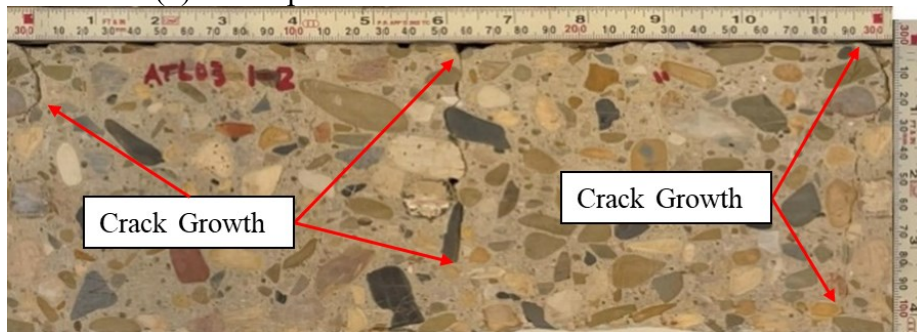
Figure 4.29. Propagation of Cracks in Concrete Specimens.

The accumulation of chloride ions at the concrete and steel interface (at least for the three concrete decks shown in Figure 4.29) was due to crack formation on the top surface of the concrete. These cracks propagated within the concrete, reaching the level of the rebar. Chloride ions can transport through these cracks and subsequently aggregate near the steel reinforcement. Particularly in the Amarillo and Lubbock Districts, where the application of deicing salt on bridge roads is substantial, the average chloride content at the steel rebar was high. In fact, corrosion rust and peeling of the epoxy coating were detected for core specimens taken in Region 6.

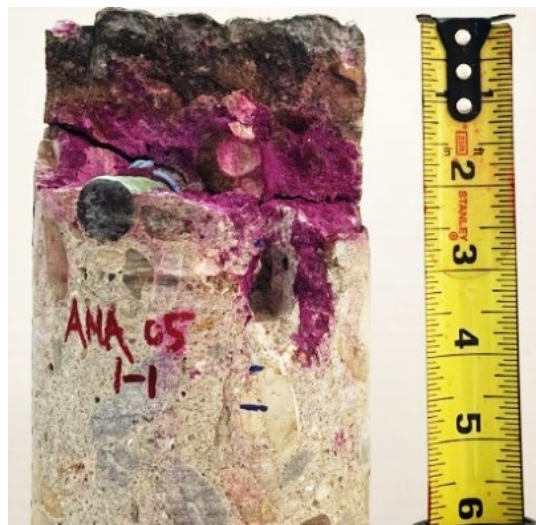
Figure 4.31. Measurement of Carbonation Depth for Concrete Specimens.

example, Figure 4.31 illustrates the procedure taken for measuring the carbonation depth of a concrete specimen extracted from AMA–RC–05. As shown in this figure, the top layers of the core sample remained colorless after applying the phenolphthalein solution, but the rest turned pink, indicating an alkaline environment. After a day, researchers measured the length of the colorless sections at four different locations to the nearest 0.04 in., and the average of the measurements was recorded as the crack depth or carbonation depth. In this example, the colorless surface turned into a blackish color after a while because the location was a crack face exposed to air for long time. Therefore, the testing area was documented as crack depth rather than carbonation depth.

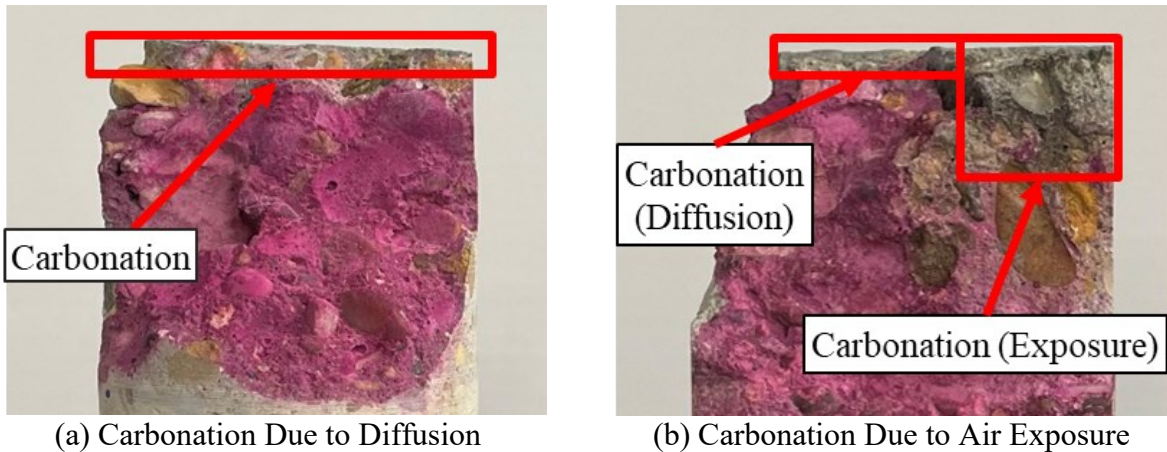
Figure 4.32. Carbonation Depth Measurement—AMA–RC–03; Core Sample 1–4.

Figure 4.32 depicts the carbonation of concrete specimens obtained from AMA–RC–03 after applying the phenolphthalein solution on the fresh broken face. If the tested surface was colorless after applying the solution, as shown in Figure 4.32(a), the depth of the colorless area was considered as carbonation due to diffusion of carbon dioxide in concrete. When the concrete surface was exposed to air for a long period, carbonation might already have happened, and the tested area turned to a dullish color, as shown in Figure 4.32(b). Therefore, it was concluded that the area with the dullish color had been exposed to air because of cracks on the top surface and had been carbonated over a period of time. The carbonation depth was then only measured from the locations without any cracks to only consider carbonation depth due to diffusion of carbon dioxide in concrete.

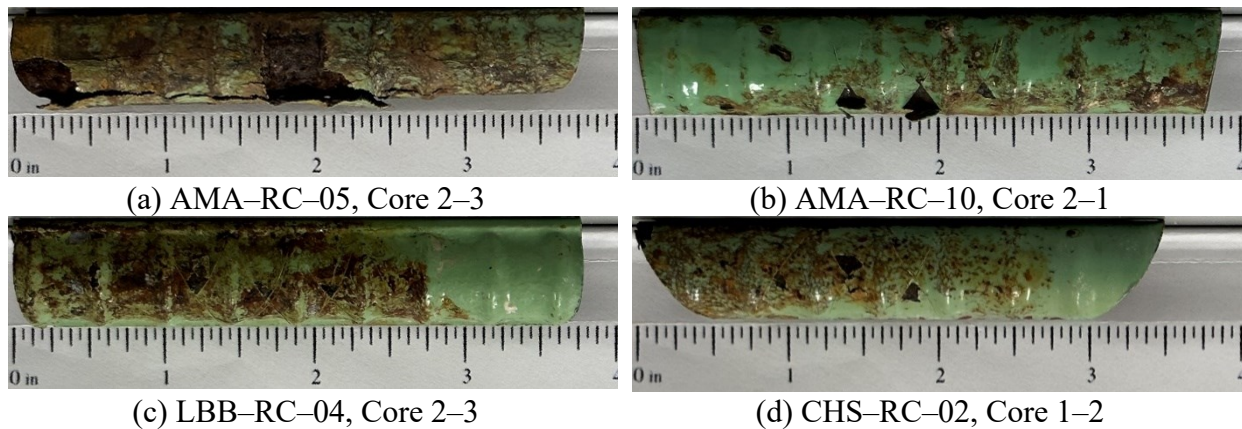
Figure 4.35. Severely Deteriorated Coating Samples.

Figure 4.35 depicts rebars with severe corrosion extracted from concrete decks located in highly corrosive environments such as Amarillo, Lubbock, and Childress. Figure 4.36 shows some moderately deteriorated coatings that were ranked between 2 and 6, depending on the quality of coating adhesion. These coatings that were susceptible to chipping when subjected to light pressure were identified as “ease of removal.” Among these coatings, traces of corrosion were sometimes observed on steel substrate. For example, light corrosion was detected for the samples taken from ELP-RC-07 and LBB-RC-05 as the coat was peeled off.

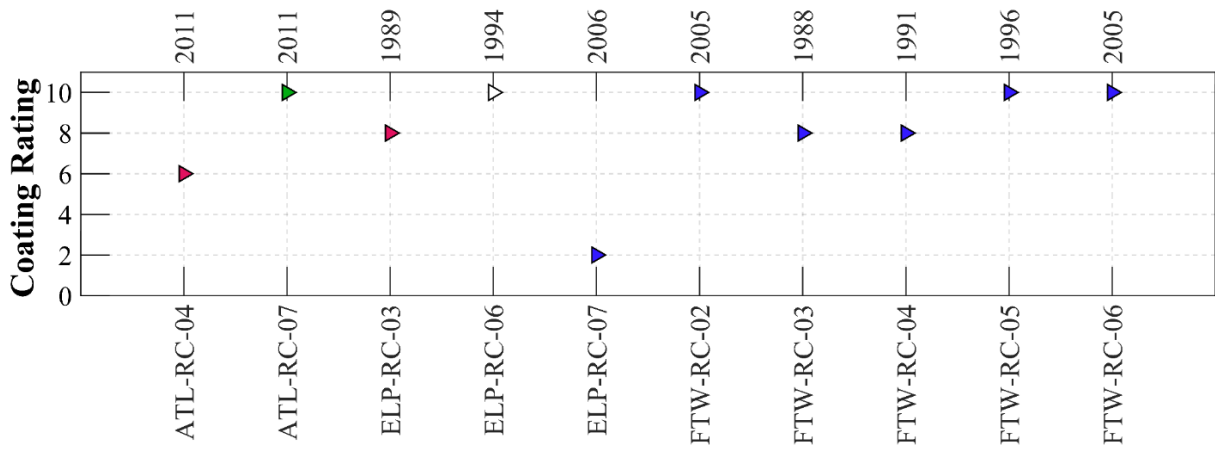
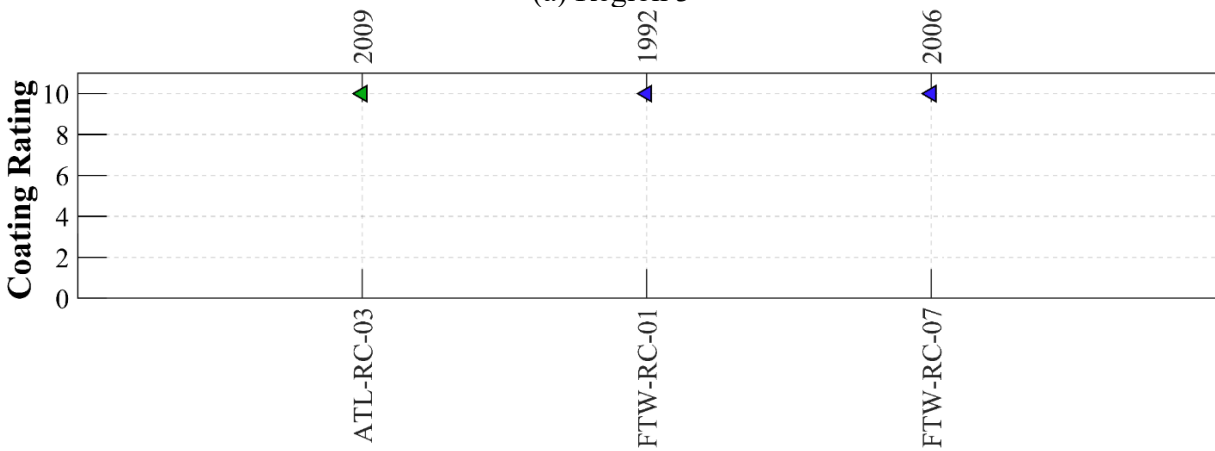
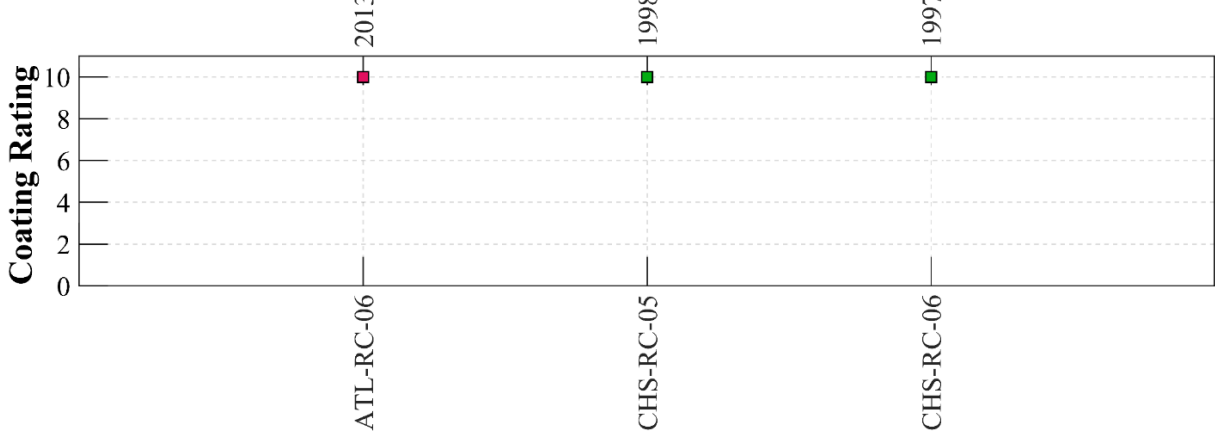
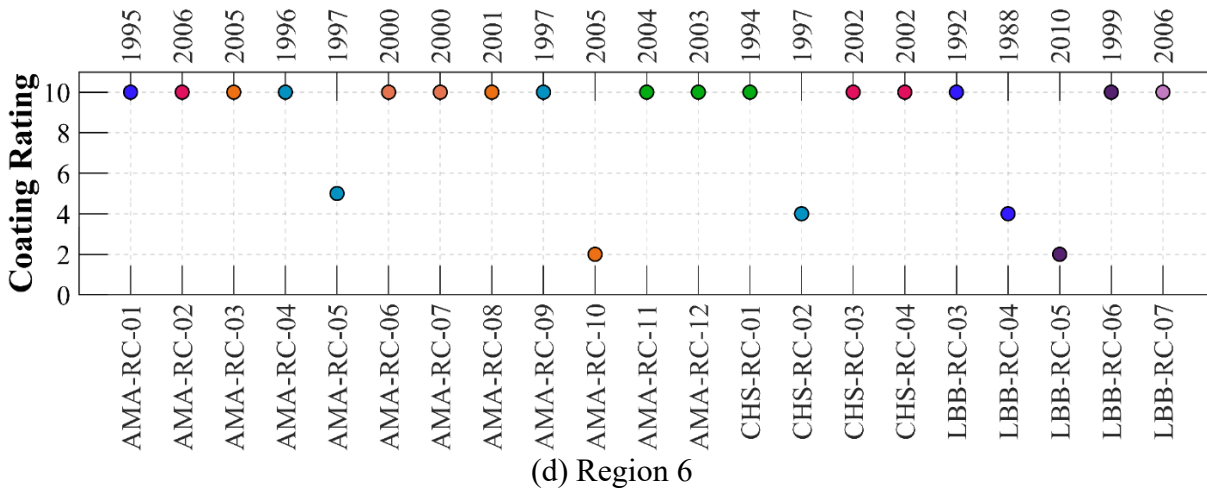
Figure 4.38. Rankings Obtained for Adhesion of Epoxy Coating.

In general, researchers concluded that the bond between the steel reinforcement and epoxy coating was in good condition. However, some samples exhibited weak bonding to the steel substrate because of corrosion initiation (Figure 4.38). As shown in Figure 4.38, age of the rebar did not correlate with the condition of the coating and adhesion rating.

The epoxy-coated layer was not sufficiently adhering to the steel substrate for the specimen obtained from LBB-RC-05, suggesting poor surface preparation during the manufacturing of the epoxy-coated reinforcement. This issue can result in the loss of the adhesion bond and the initiation of corrosion in the future. Particularly, the chloride content at the rebar level was measured on average 0.1 % wt. conc. for the specimens extracted from LBB-RC-05 despite the good quality concrete evidenced by the result obtained during resistivity and water absorption tests.

The coating of the sample taken from AMA-RC-10 deteriorated and was ranked 2. As discussed previously, the concentration of chloride at the concrete and rebar interface was recorded as being high for the specimen obtained from this concrete deck—on average 0.14 % wt. conc.

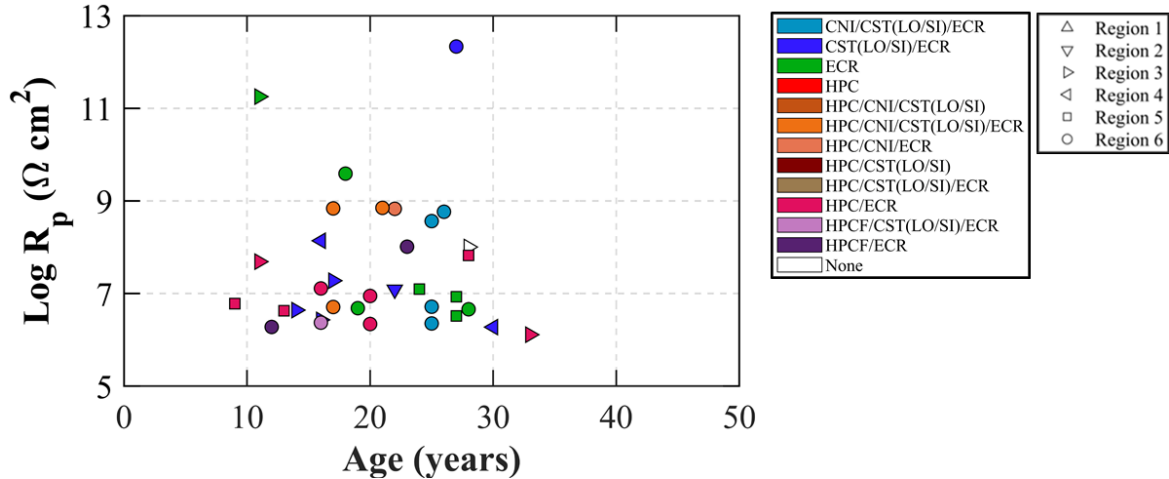
Figure 4.43. Polarization Resistance Recorded for ECR.

Figure 4.44 shows the electrical resistance or redox reactions occurring at the steel-coating interface in logarithmic order. The corrosion rate of the specimens embedded in concrete cores was determined to be negligible because the polarization resistance of the samples was relatively high at the metal-coating interface. For epoxy-coated steel, smaller polarization resistance indicates a higher possibility of corrosion. As the coating resistance decreases, it is indicative of an increase in corrosive agents within the concrete and the formation of corrosion products (Lau & Sabbir, 2015). Kamde and Pillai (2021) suggested that the coating resistance of an intact fusion-bonded epoxy is greater than $1 \times 10^3 \text{ k}\Omega \text{ cm}^2$, which agrees with our findings from the EIS measurements conducted on the core samples taken from concrete decks. In general, the logarithmic R_p values of all the specimens was measured at or over $6 \Omega \text{ cm}^2$, except AMA-RC-10 and FTW-RC-04, whose resistances were measured at $5.75 \Omega \text{ cm}^2$ and $5.88 \Omega \text{ cm}^2$, respectively. No sign or trace of corrosion was detected during the visual inspection of all the ECR after removing them from concrete. It was found from the EIS results documented for black rebar that electrochemical reactions proceed steadily when the logarithmic R_p value is less than $5.4 \Omega \text{ cm}^2$. This feature is equivalent to a polarization resistance of $240 \text{ k}\Omega \text{ cm}^2$ and a corrosion rate of 0.05 mpy .

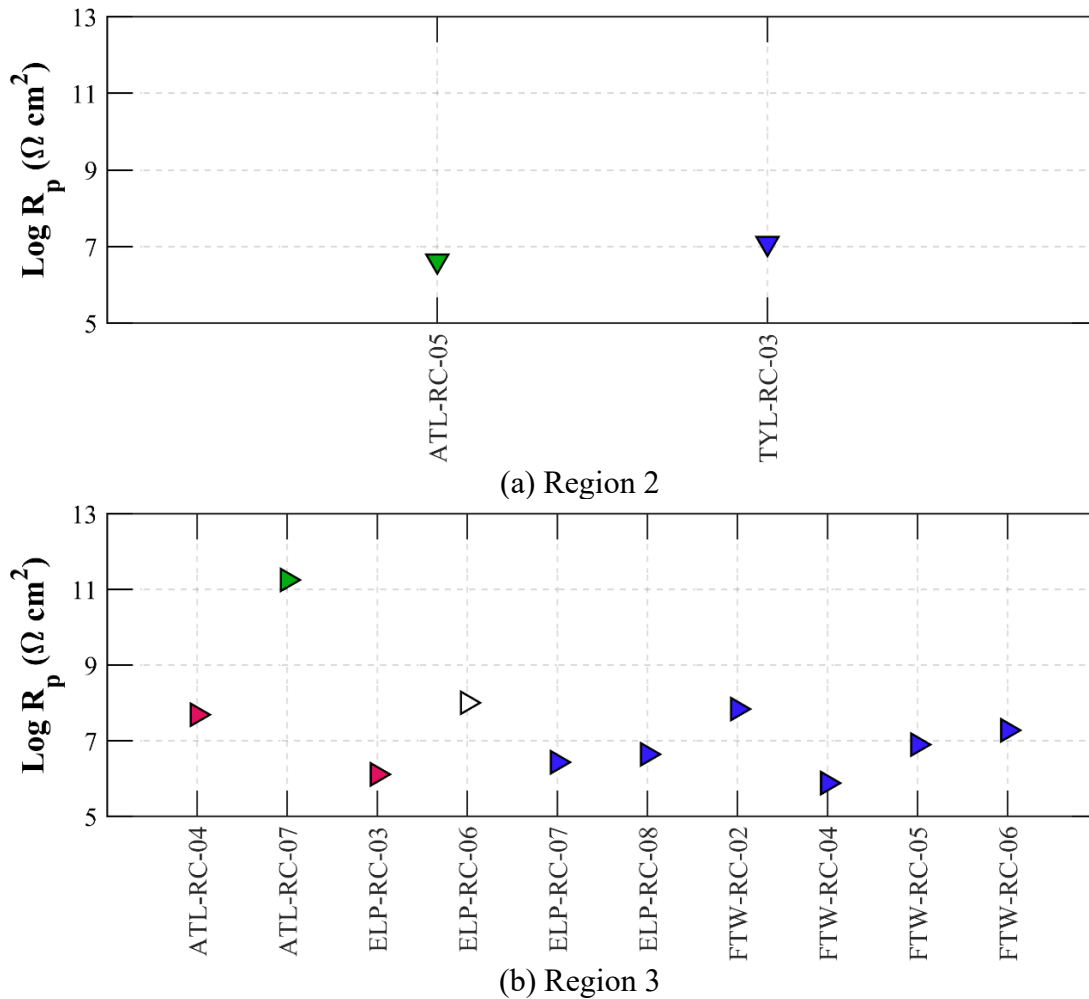
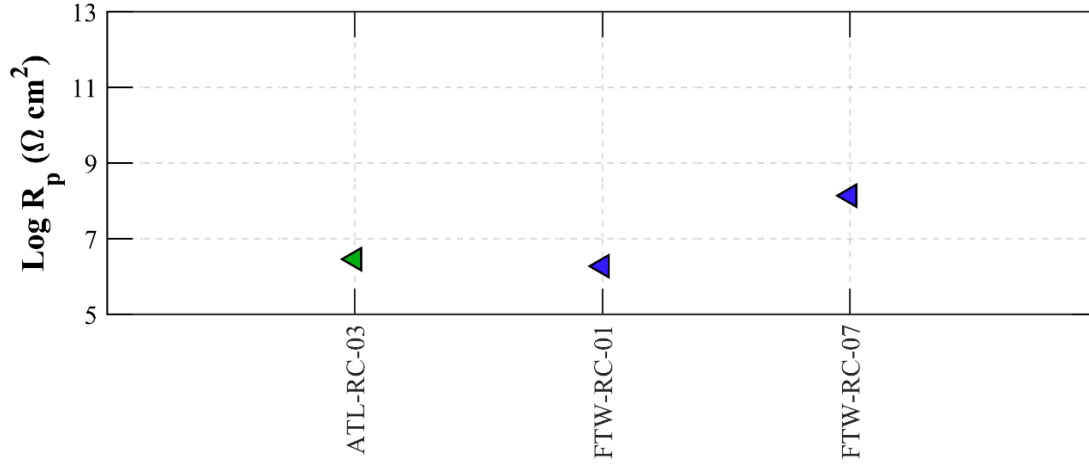
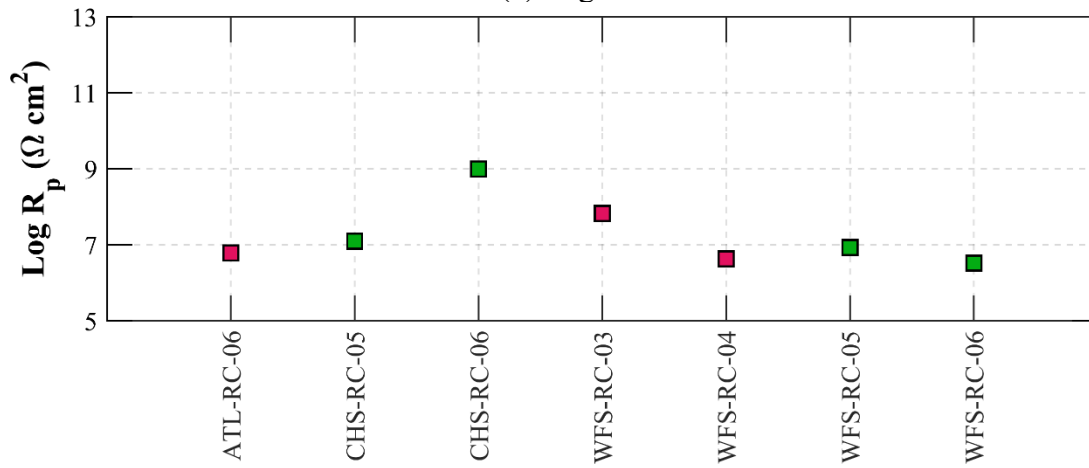
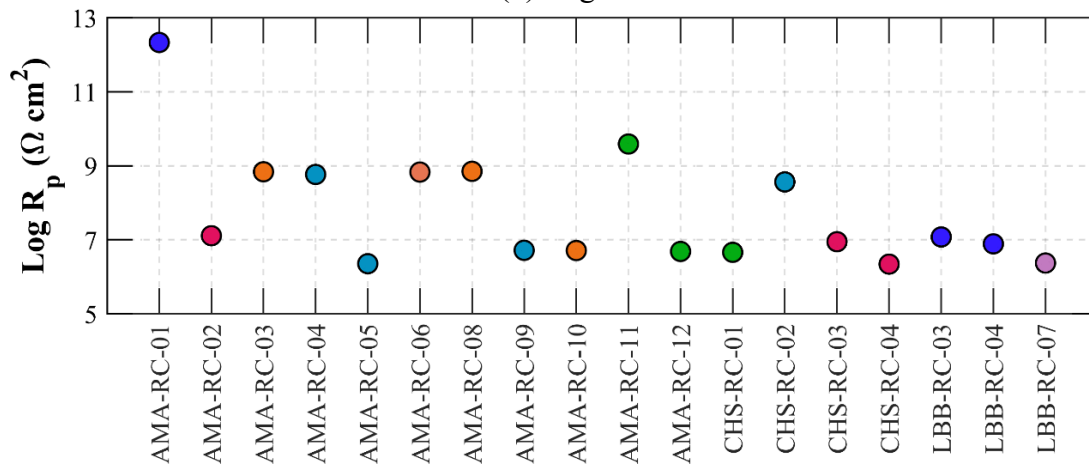
Figure 4.44. Coating Resistance (R_p) Calculated for ECR.

The color of the epoxy coating of specimens extracted from ELP-RC-03, FTW-RC-04, and CHS-RC-01 was found to be dark green; in comparison, other samples were bright green. The logarithmic resistance of these specimens measured low— $6 \Omega \text{ cm}^2$ or lower. The average initial sorptivity of cores obtained from ELP-RC-03 was calculated as $12 \times 10^{-3} \text{ mm/s}^{1/2}$, and the bulk resistivity was lower than $5.2 \text{ k}\Omega \text{ cm}$, both findings indicating a poor-quality concrete.

However, the core of the other specimens had the initial sorptivity higher than $6 \times 10^{-3} \text{ mm/s}^{1/2}$, and the resistivity lower than $10 \text{ k}\Omega \text{ cm}$. Although analyzing the EIS results revealed that the quality of epoxy coating of the specimens tested in the impedance examination was generally good, damage on some coatings with severe corrosion and deterioration of the steel substrate was detected on specimens obtained from AMA-RC-05, AMA-RC-10, LBB-RC-04, and CHS-RC-02 (Figure 4.35). These specimens were not tested in the EIS examination, and they were obtained from a different location of the concrete decks. In all four cases, a deep crack was discovered that had been initiated on the top surface of the concrete and propagated over the steel reinforcing rebar.

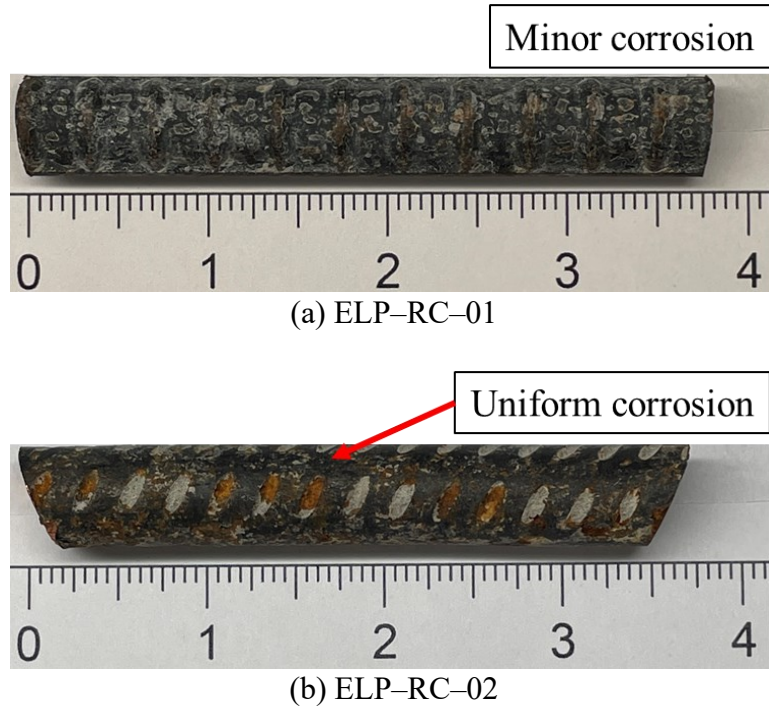
Figure 4.45. Extracted Black Rebar from Concrete Core Specimens.

Figure 4.45 shows the extent of corrosion on the black rebar extracted from core specimens. The polarization resistance and corrosion rate of these steel bars are given in Table 4-8. For the specimen obtained from ELP-RC-02, uniform corrosion was observed where the corrosion

propagated around the surface surrounding the rebar. Severe corrosion was also detected on the top of the rebar taken from WFS-RC-01, and pitting corrosion was detected in several locations on the specimen obtained from LBB-RC-01. This pitting corrosion was more evident at crevices near the transverse and longitudinal ribs. Uniform corrosion happened on transverse and longitudinal ribs of the specimen extracted from ATL-RC-01, and uniform corrosion was detected on one side of the steel taken from ATL-RC-02. This flaw was also apparent at the crevices of the longitudinal ribs of TYL-RC-02 and ELP-RC-04. No sign of corrosion was seen on samples extracted from ELP-RC-01 and ELP-RC-05. Similarly, a minor trace of corrosion was observed on samples taken from WFS-RC-02 and BMT-RC-01 (just over the cross-sectional area). It is speculated that minor volume rust occurred on these samples after the cores were obtained.

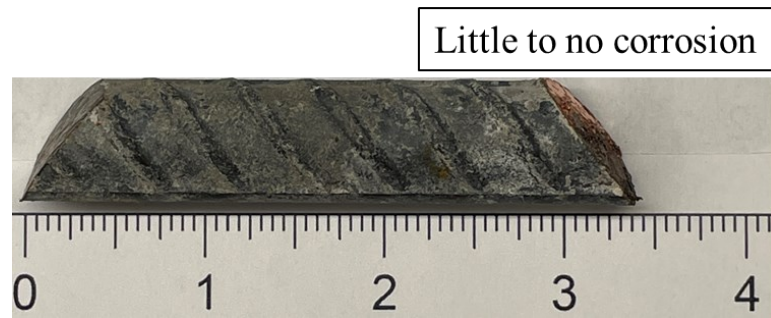
(d) ELP-RC-05

The maximum corrosion current density observed on the concrete deck of ELP-RC-05 was $10 \mu/\text{cm}^2$, which is equivalent to 4.57 mpy, indicating significant corrosion in the rebar (Figure 3.25[c]). The concrete deck of this specific bridge utilized black rebar for reinforcement. The

average initial sorptivity recorded for the specimen taken from this concrete deck was lower than 6×10^{-3} mm/s^{1/2}, and the average bulk resistivity was 17 kΩ cm, indicating the concrete deck was of decent quality. However, surface cracking was detected in areas displaying high corrosion current density, with a crack width of 0.025 in. During the EIS examination, the corrosion rate of the rebar embedded in the core specimen measured very low, 0.01 mpy, thus suggesting no significant signs or traces of corrosion. The visual inspection of the rebar specimen extracted from the core further confirmed the findings of EIS (Figure 4.45[d]).

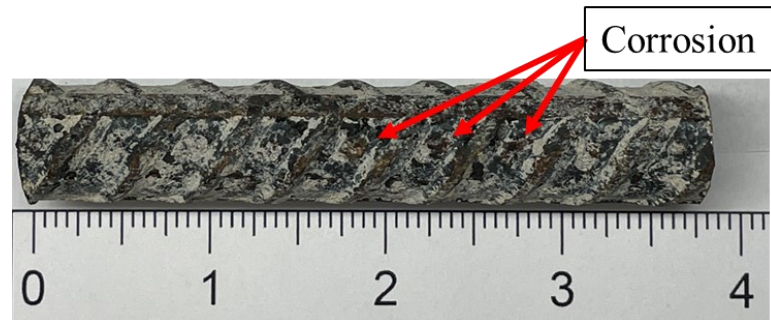
(f) ATL-RC-01

In Region 4, the corrosion rate of ATL-RC-01 was almost 0.05 mpy, indicating a moderate rate of corrosion. The initial sorptivity calculated for this specimen was generally greater than 6×10^{-3} mm/s^{1/2}, and the bulk resistivity was lower than 10 kΩ cm. The corrosion rate of the black rebar in the core sample extracted from ATL-RC-02 was 0.05 mpy. The average initial sorptivity of the specimen was 6×10^{-3} mm/s^{1/2}, but the bulk resistivity is not known for this specimen. The average velocity of the sound wave in the specimens taken from ATL-RC-02 was measured at 13×10^3 ft/s, which was lower than what was measured for ATL-RC-01.

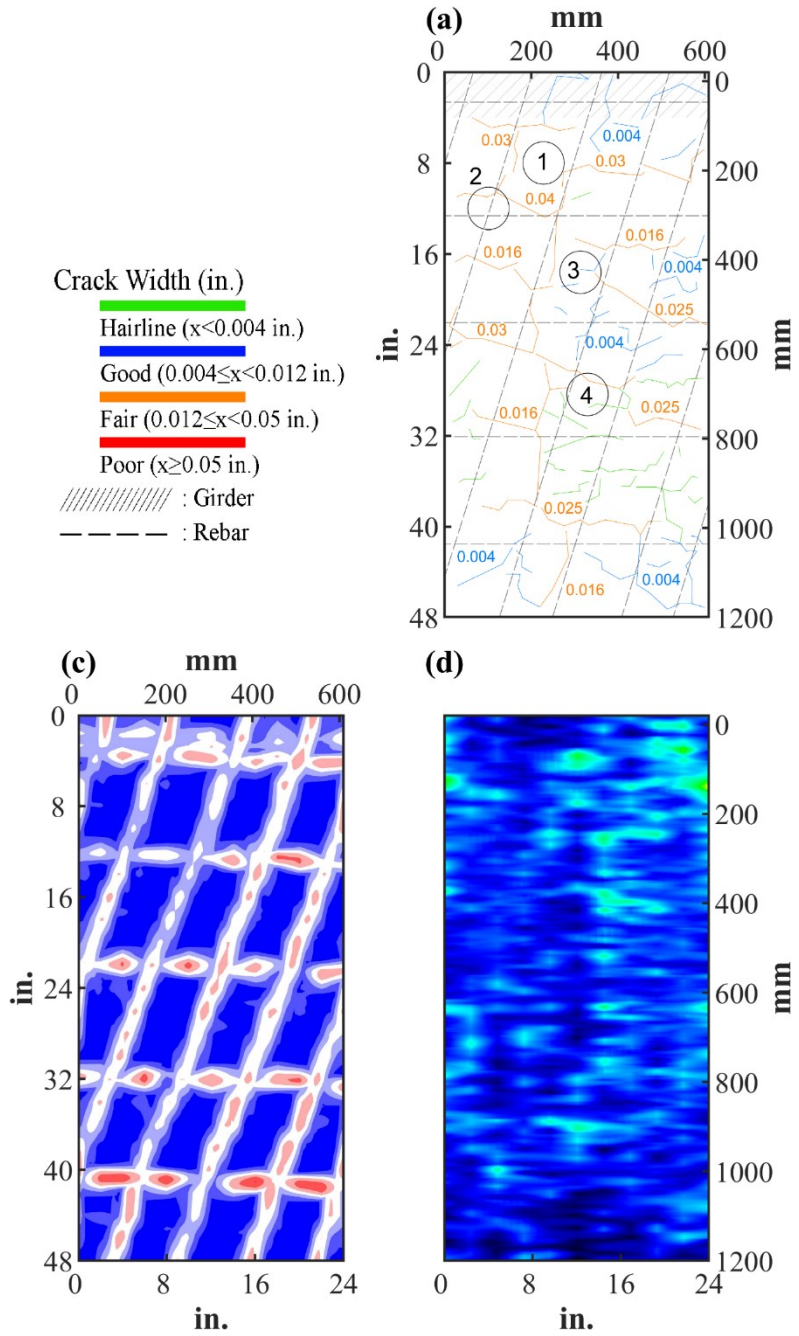
Figure B.11. Crack Map and NDE Results of Grid 1: (a) Crack Map and Location of Cores; (c) GPR C-scan at 1.2 in. to 2.25 in. Depth; (d) UST C-scan at 2.56 in. Depth

As shown in Figure B.11 (a), grid 1 had various range of cracks from a hairline crack to 0.025 in. crack. As shown in Figure A.1.5 (a), grid 2 had hairline cracks mostly, with one 0.008 in. transverse crack possibly caused by joint of two PCPs.

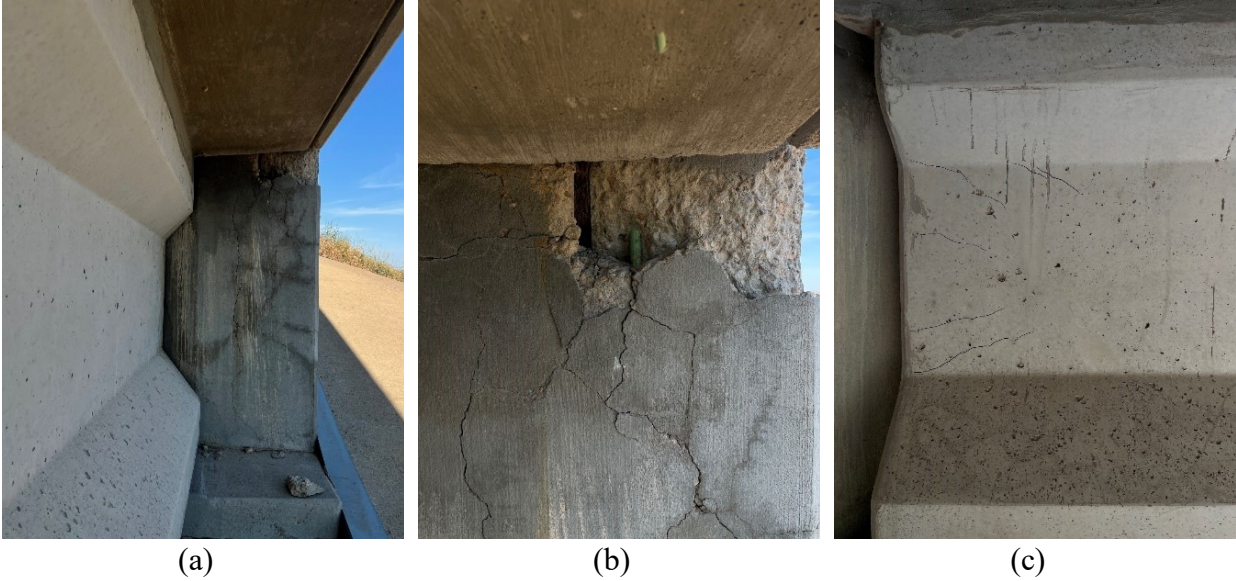
Spalling occurred on the abutment backwall possible due to the settlement of the bridge approach, and the exposed and corroded rebar is found inside as shown in Figure B.15 (a) and (b). There is hairline diagonal cracking on the web of prestressed beam at the end of support as shown in Figure B.15 (c).

Figure B.15. Deteriorations on the Bridge: (a) Severe Cracks and Corroded Rebar On the abutment; (b) Spalling at abutment and Exposed, Corroded Rebar; (c) Hairline Diagonal Cracking on the Web of Girder

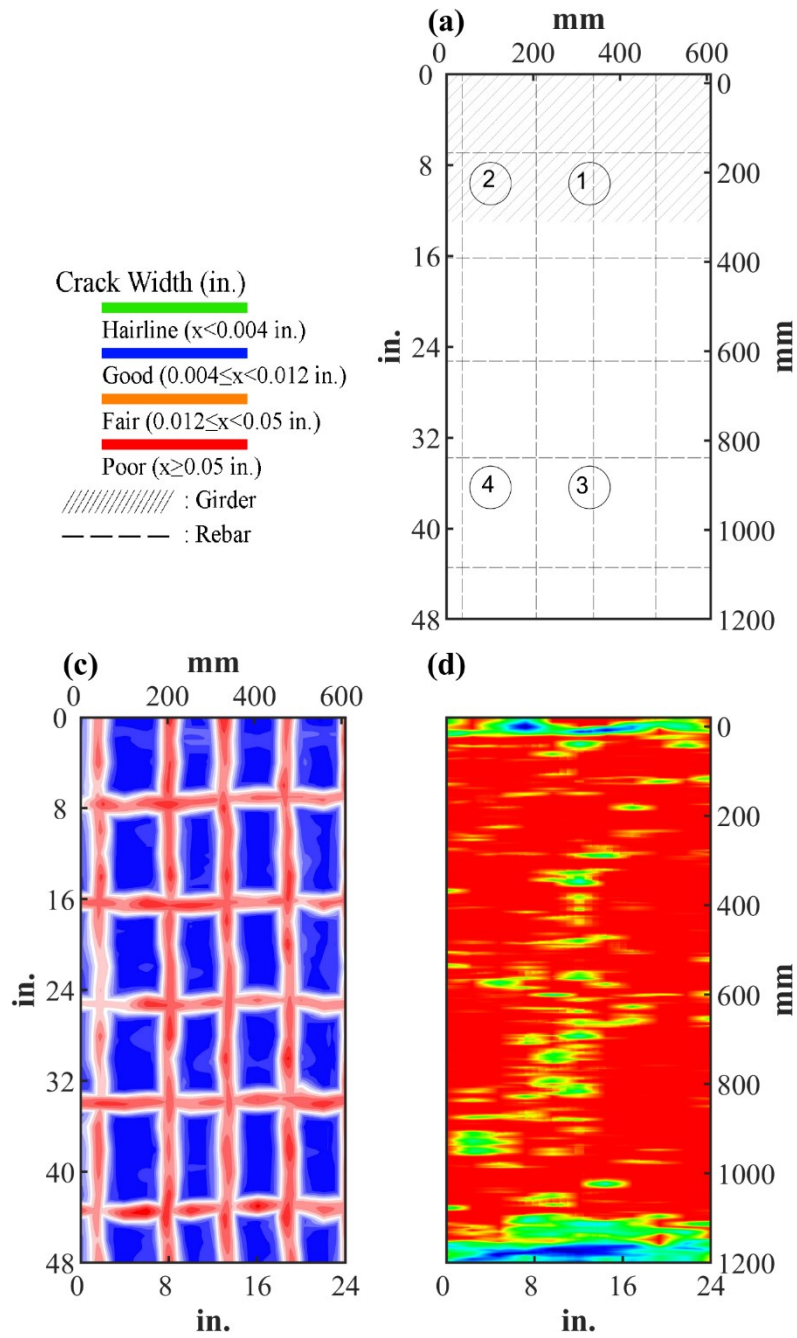
As there was MLPO on the bridge, both grids did not have any cracks.

Figure B.17. Crack Map and NDE Results of Grid 1: (a) Crack Map and Location of Cores; (c) GPR C-scan at 1.85 in. to 2.85 in. Depth; (d) UST C-scan at 2.7 in. Depth

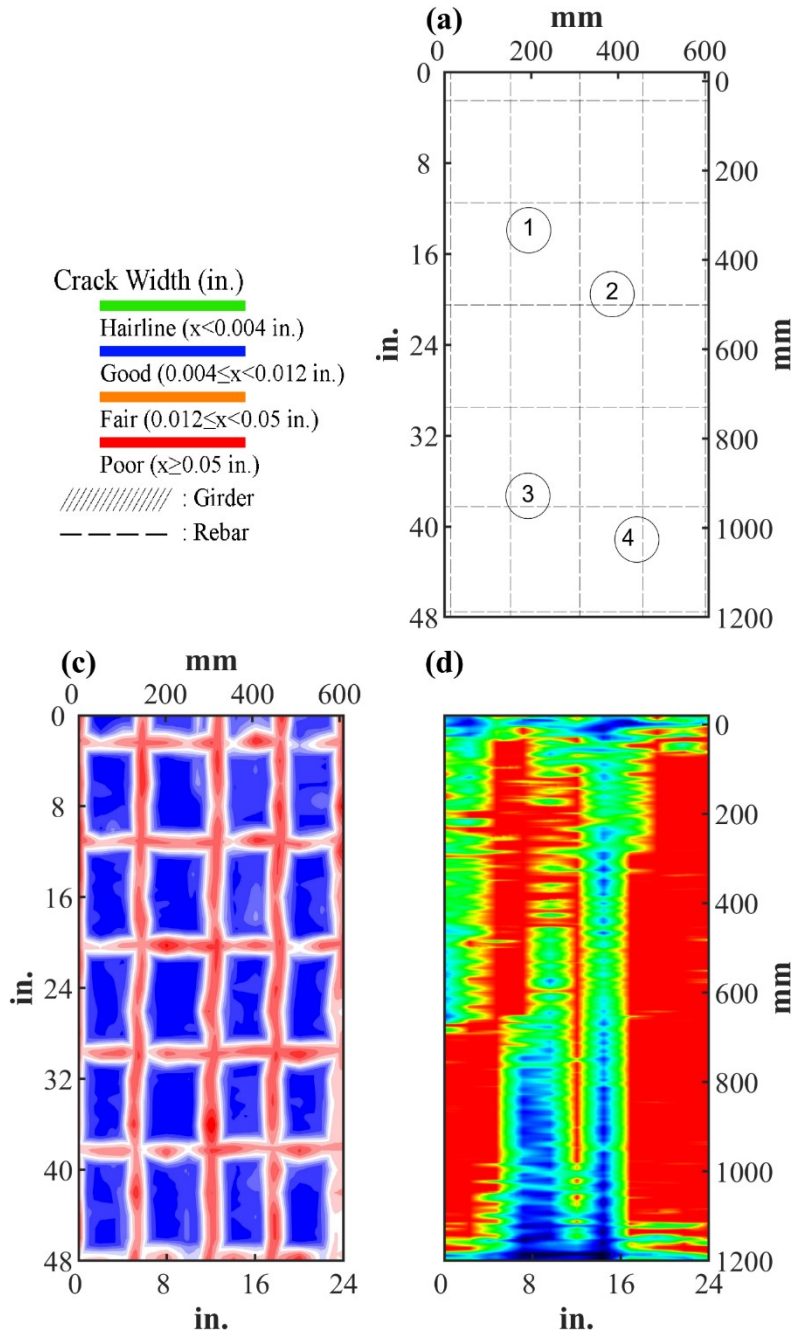
Figure B.18. Crack Map and NDE Results of Grid 2: (a) Crack Map and Location of Cores; (c) GPR C-scan at 2.25 in. to 3.25 in. Depth; (d) UST C-scan at 2.0 in. Depth
