Evaluation of Corrosion Prevention and Mitigation Approaches Used on Texas Bridges—Volume 2: Reinforced Concrete Bridges

Technical Report 0-7040-R1-Vol2

TEXAS A&M TRANSPORTATION INSTITUTE
COLLEGE STATION, TEXAS

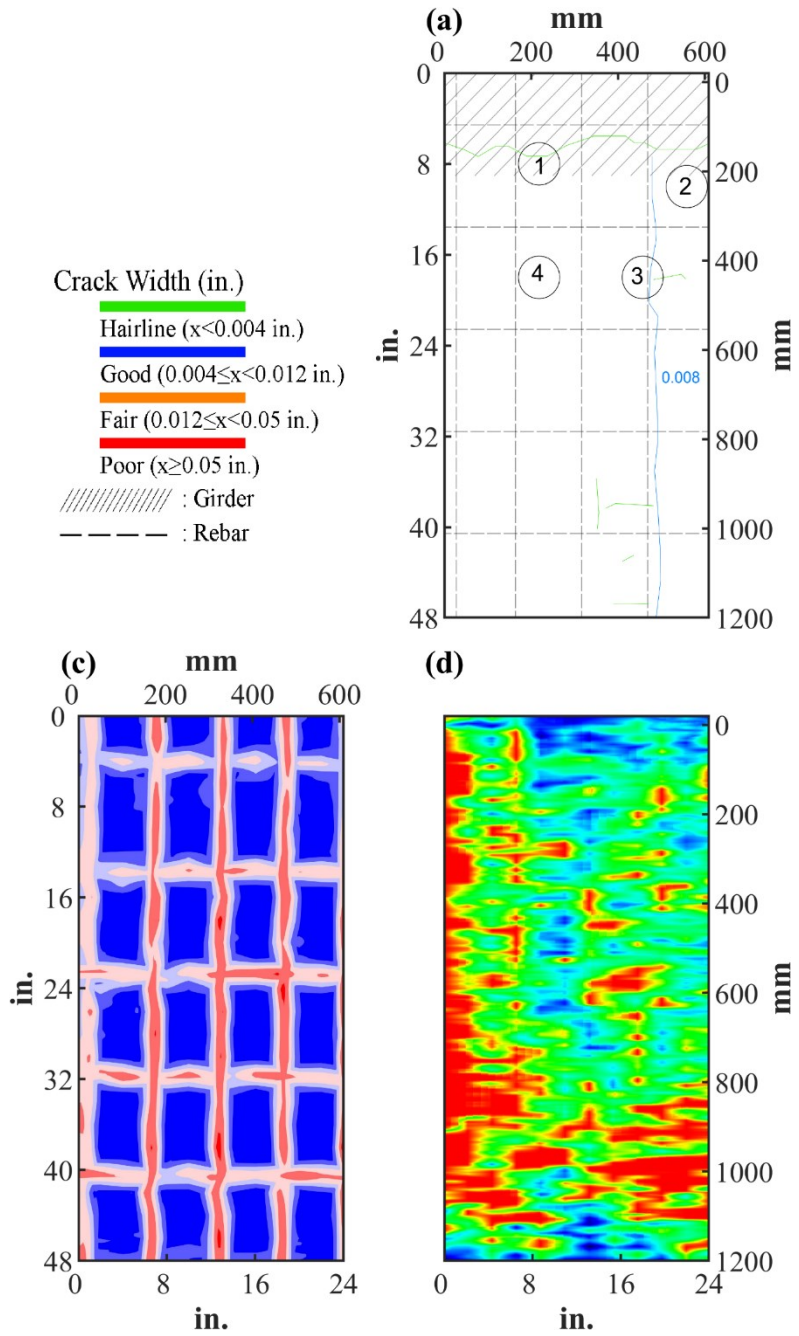
Figure B.23 and Figure B.24 show detailed information of the grids. As shown in Figure A.3.3 (a), grid 1 had little to no hairline cracks with one 0.008 in. transverse crack possibly caused by a joint of precast concrete panels. As shown in Figure A.3.4 (a), grid 2 had few hairline cracks with one 0.008 in. longitudinal crack.

Figure B.23. Crack Map and NDE Results of Grid 1: (a) Crack Map and Location of Cores; (c) GPR C-scan at 1.45 in. to 2.45 in. Depth; (d) UST C-scan at 2.37 in. Depth

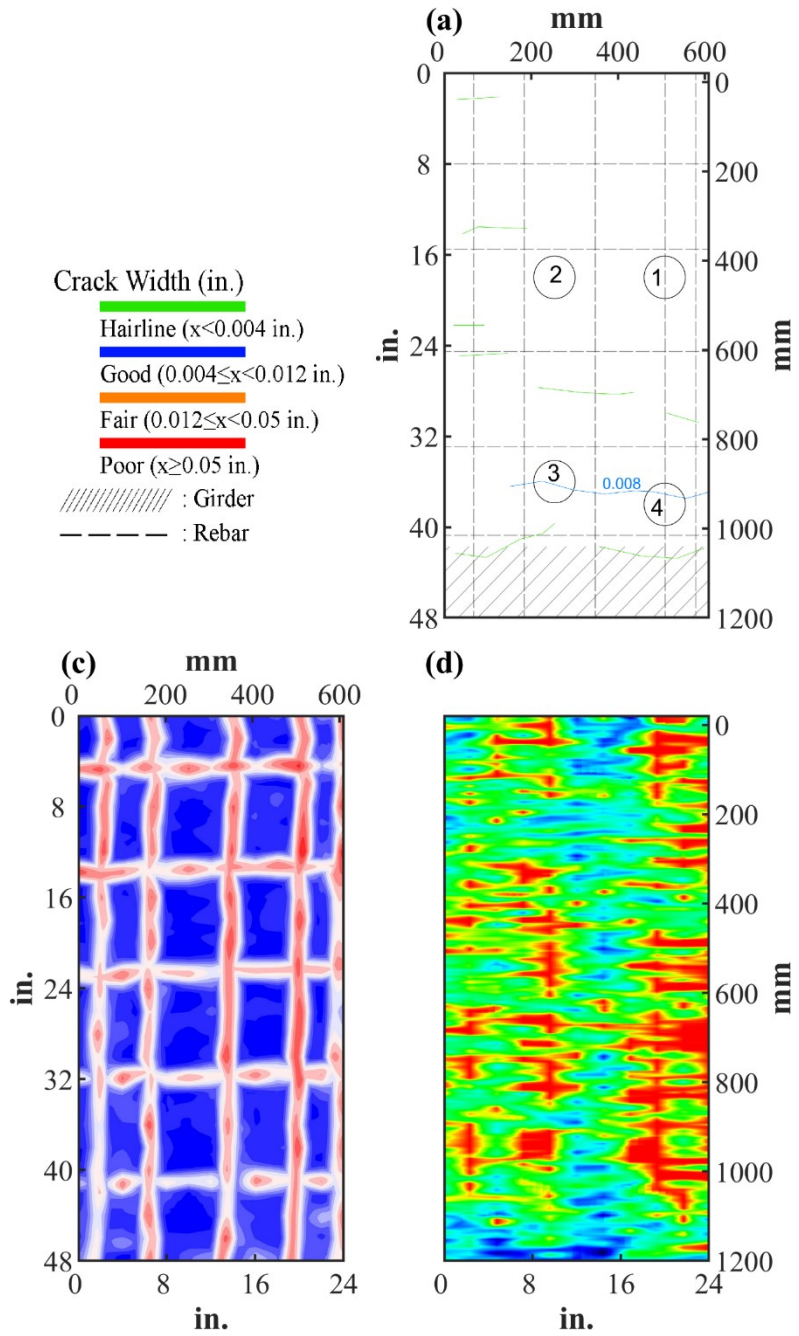
Figure B.24. Crack Map and NDE Results of Grid 2: (a) Crack Map and Location of Cores; (c) GPR C-scan at 2.25 in. to 3.25 in. Depth; (d) UST C-scan at 2.78 in. Depth

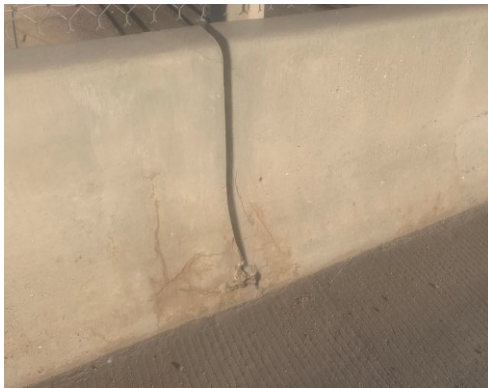
Hairline map cracking is found on the top surface of the deck. There is minor delamination and spalling along the railing bottom as shown in Figure B.28 (a). There is spalling at the end of girders and shows sign of corrosion as shown in Figure B.28 (b). And severe rust on the permanent metal deck from under expansion joint is present as shown in Figure B.28 (c).

Figure B.28. Deterioration on the Bridge: (a) Spalling at Railing Bottom; (b) Spalling and Exposed Rebar and Strands on Bottom of a Beam; (c) Corrosion on the Metal Deck Form

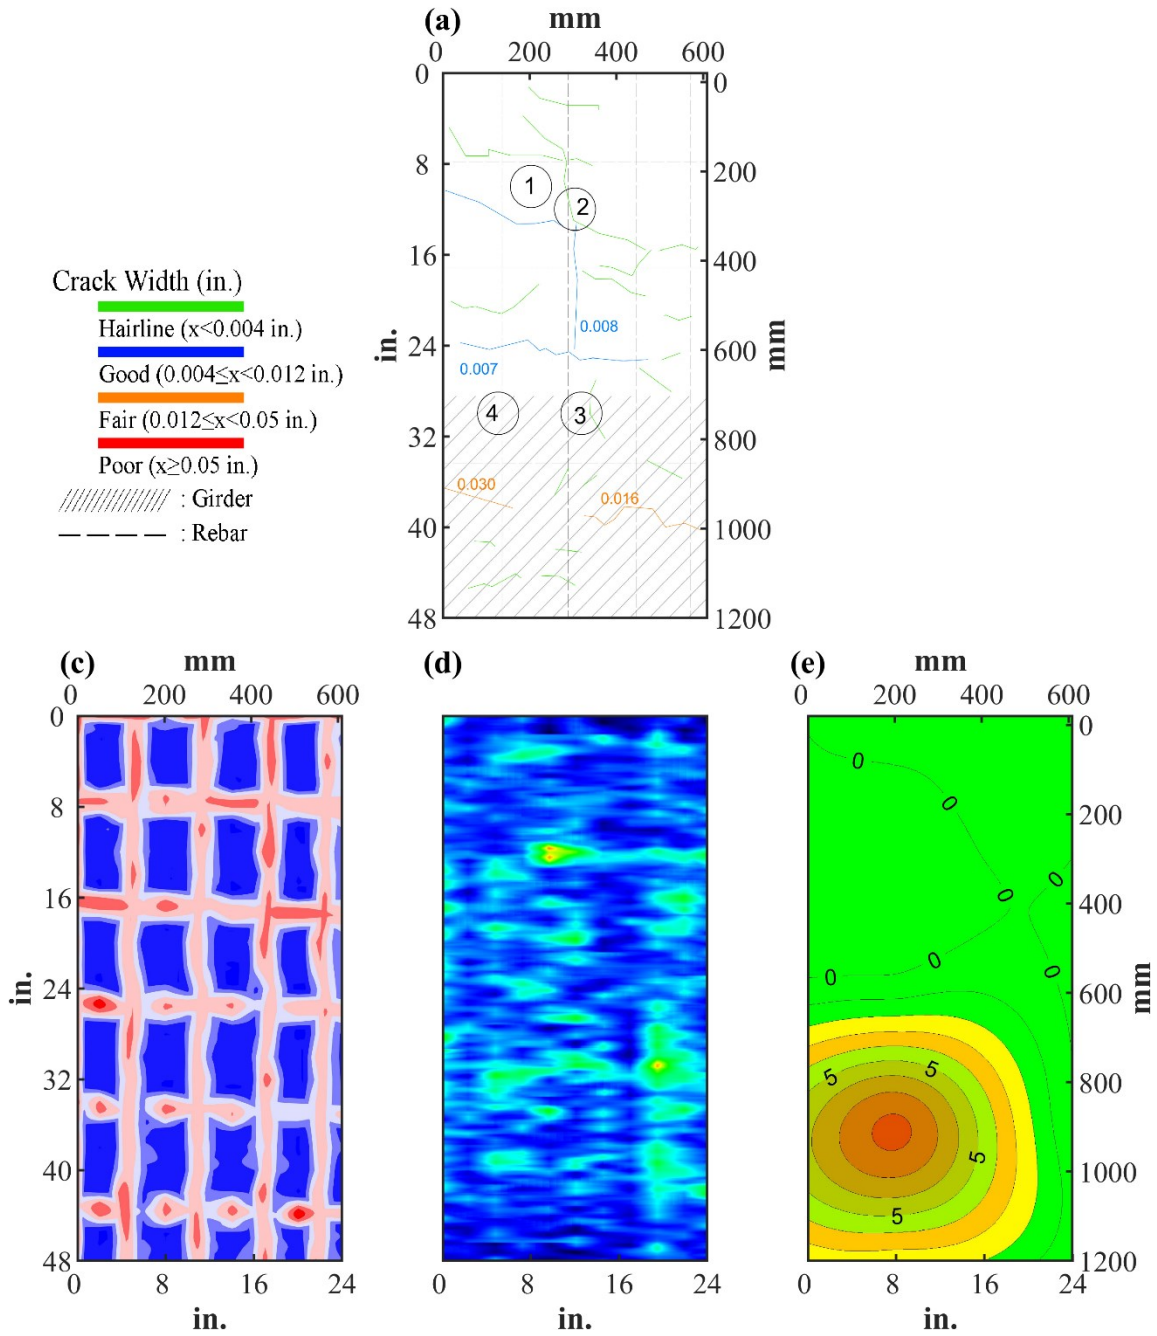
As shown in Figure B.30 (a) cracks with different width exist. On grid 1, the widest crack with 0.3 in. width was located on top. Figure B.30 (e) shows possibility of corrosion near lower left of the grid. Based on Figure A.4.5 (b), the widest crack on grid 2 was also 0.3 in. wide, but in overall, cracks were wider in grid 2. Based on Figure B.31 (e) grid 2 has very low possibility of corrosion.

Figure B.30. Crack Map and NDE Results of Grid 1: (a) Crack Map and Location of Cores; (c) GPR C-scan at 1.9 in. to 3.1 in. Depth; (d) UST C-scan at 4.32 in. Depth; (e) Corrosion Rate Map

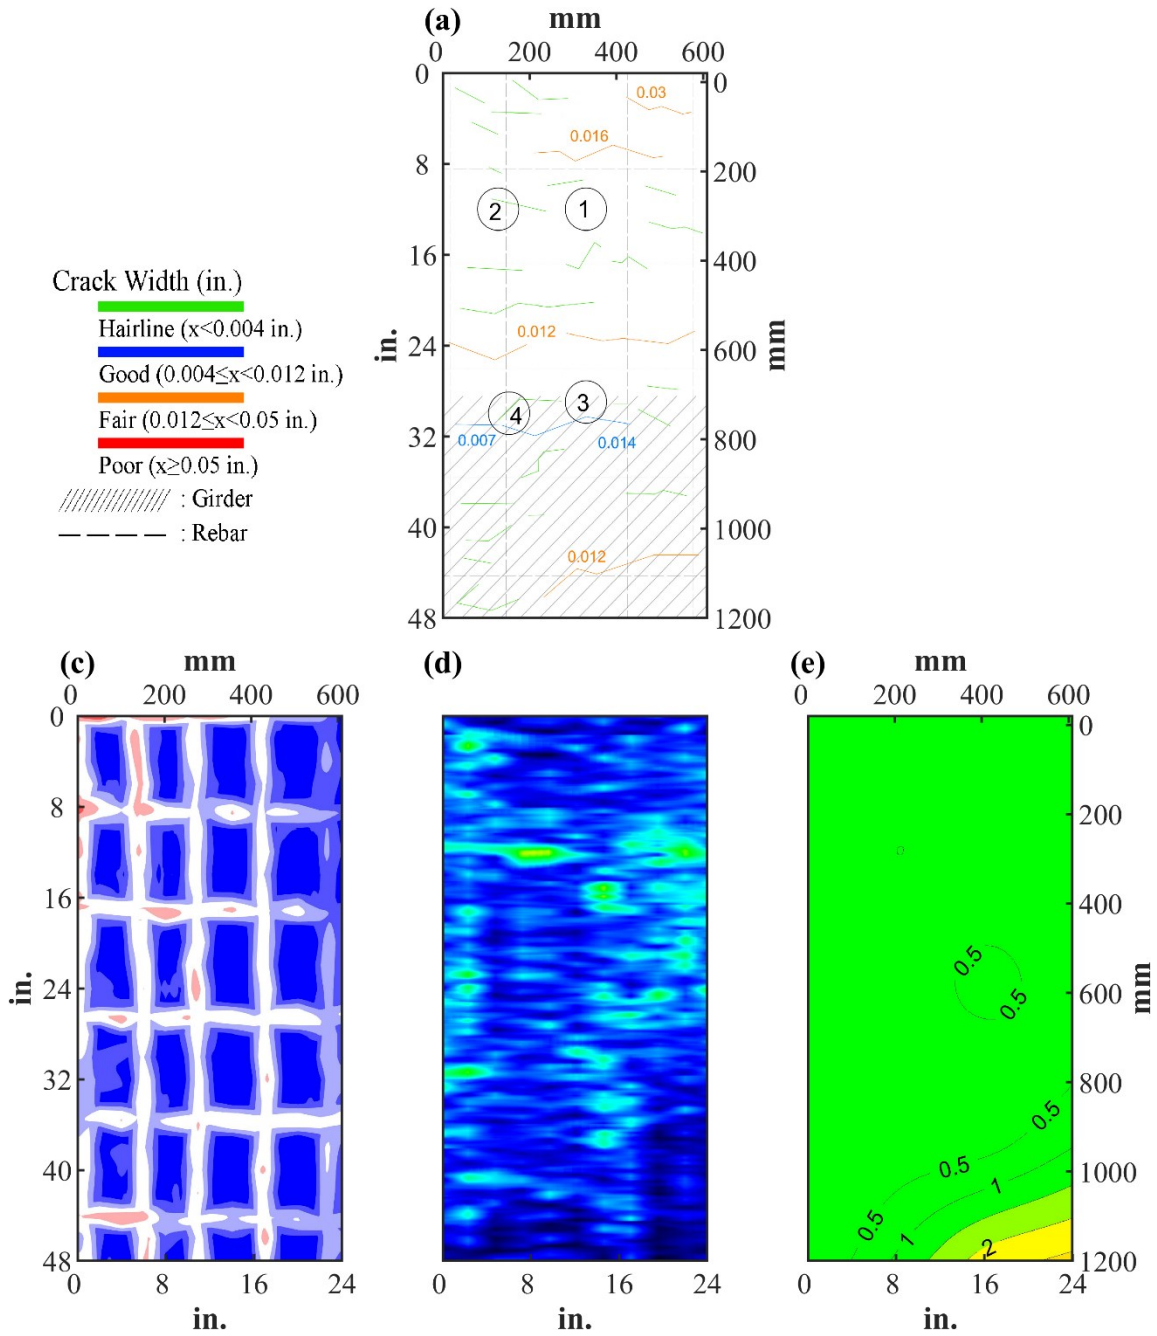
Figure B.31. NDE Results of Grid 2: (a) Crack Map; (c) GPR C-scan at 2.25 in. to 3.25 in. Depth; (d) UST C-scan at 2.01 in. Depth; (e) Corrosion Rate Map

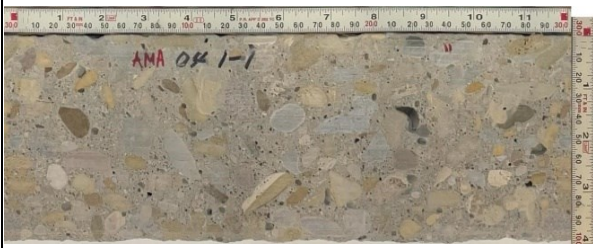
Core	Side	Top	Bottom
1-1

Core	dia. × height (in.)	Rebar depth (in.)	Rebar size (#)	Epoxy (Y/N)	Crack type	Crack width (in.)	Notes
1-1	3.75 × 4.3	-	-	-	-	-	Void at 1.5 in. depth; Delamination between CIP and PCP
1-2	3.75 × 4.3	2.5	5	Y	-	-	Delamination between CIP and PCP
1-3	3.75 × 6.2	2.5	5	Y	longitudinal	HL	-
1-4	3.75 × 5.7	-	-	-	-	-	Void near CIP and PCP intersection
2-1	3.75 × 6.0	-	-	-	-	-	-
2-2	3.75 × 4.1	2.8	5	Y	longitudinal	HL	Delamination between CIP and PCP
2-3	3.75 × 6.2	-	-	-	-	-	Void at 1 in. depth
2-4	3.75 × 4.0	2.8	5	Y	diagonal	HL	Delamination between CIP and PCP

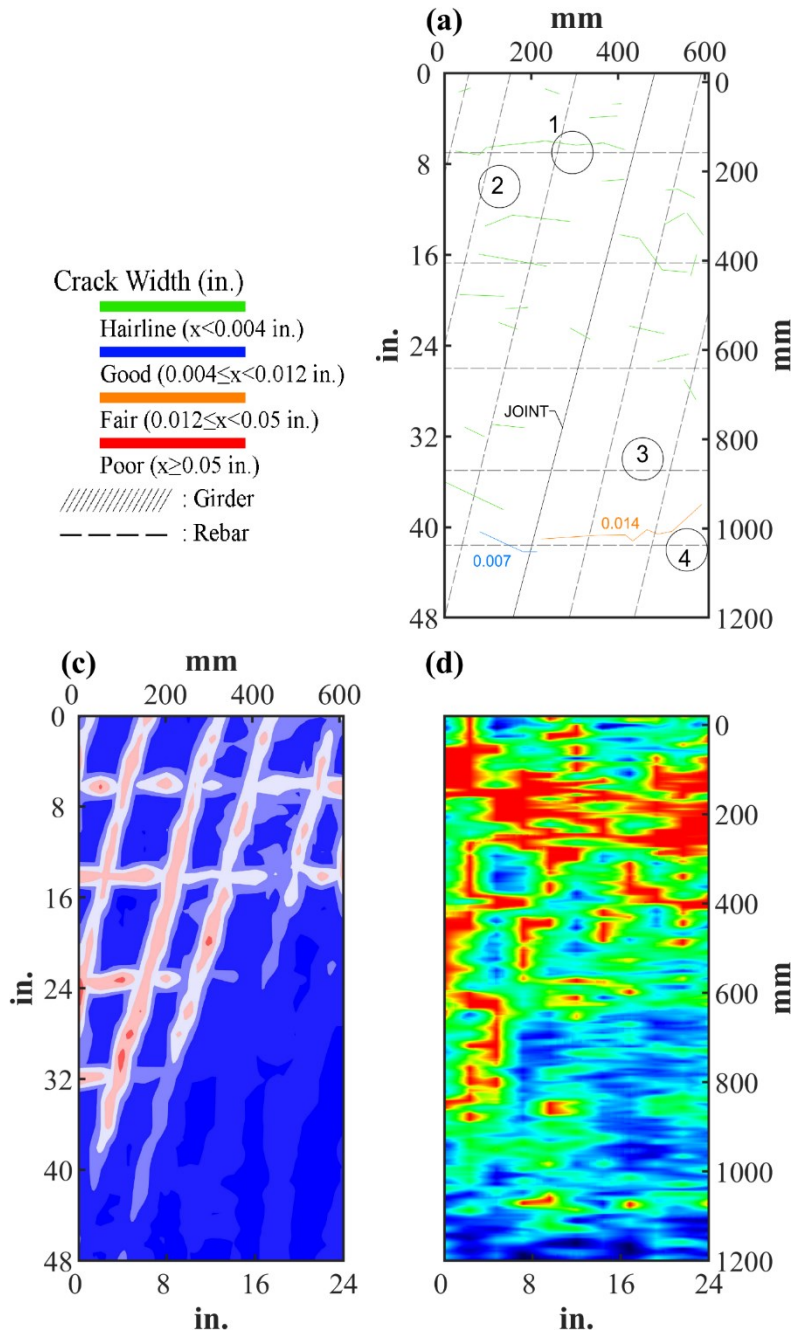
Figure 0.37. Crack Map and NDE Results of Grid 1: (a) Crack Map and Location of Cores; (c) GPR C-scan at 1.85 in. to 2.85 in. Depth; (d) UST C-scan at 2.97 in. Depth

As shown in Figure 0.37 (a), grid 1 was drawn on top of the joint and 0.007 in. wide crack and 0.014 crack were spreading from the joint. Other than the two cracks, it only showed hairline cracks. As shown in Figure 0.38 (a), the widest crack on grid 2 was 0.02 in. wide, but hairline cracks were dominant.

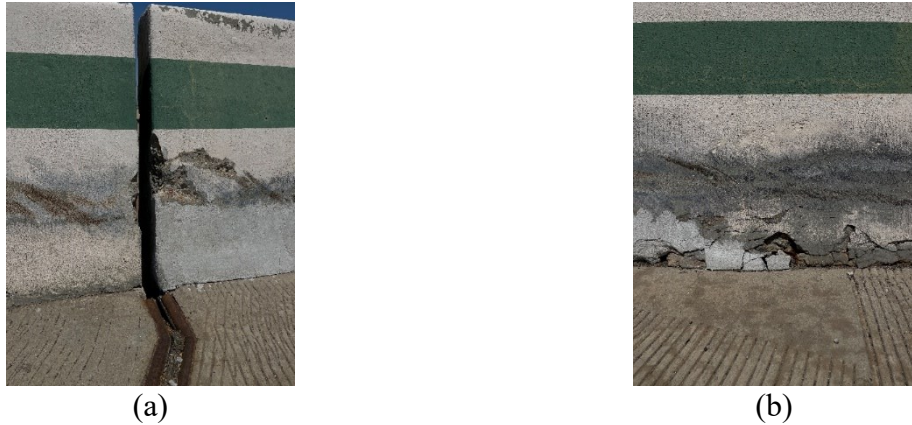
Figure 0.43. Deterioration on the Bridge: (a) Impact Damage on the East Rail of the Bridge; (b) Exposed and Corroded Rebar

The east bridge rail is damaged due to an impact, and exposed rebar is corroded as shown in Figure 0.43 (a) and (b).

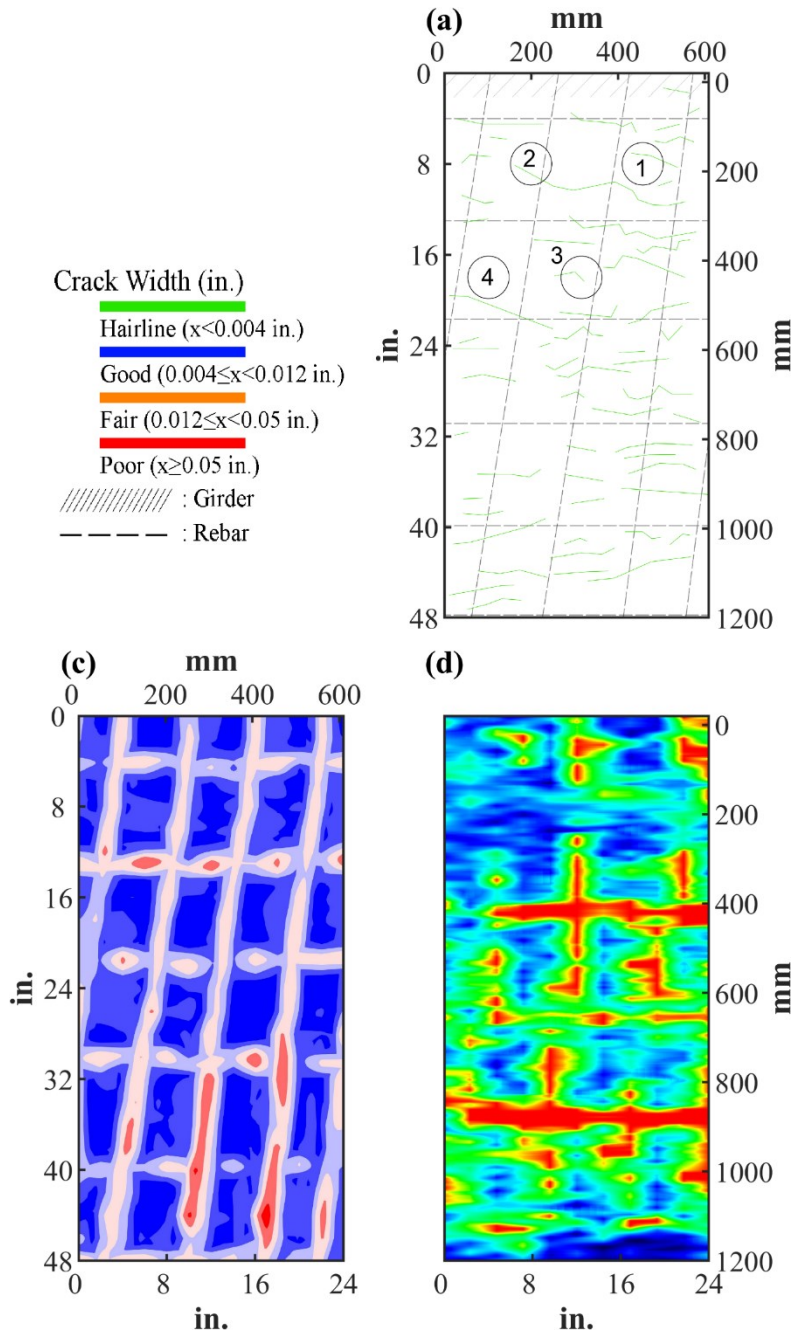
Figure 0.45. Crack Map and NDE Results of Grid 1: (a) Crack Map and Location of Cores; (c) GPR C-scan at 2.1 in. to 3.4 in. Depth; (d) UST C-scan at 3.93 in. Depth

As shown in Figure 0.45 (a), there was hairline cracks throughout the grid. On the other hand, as shown in Figure 0.46 (a), grid 2 did not have any cracks on its surface.

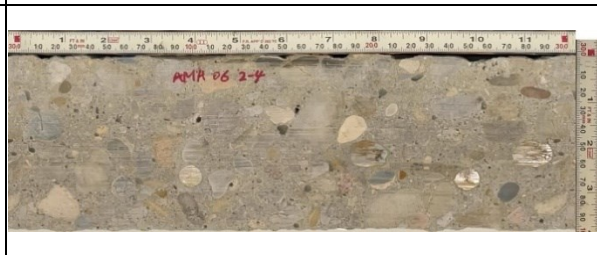
2-4

All rebar was epoxy coated and showed no sign of corrosion.

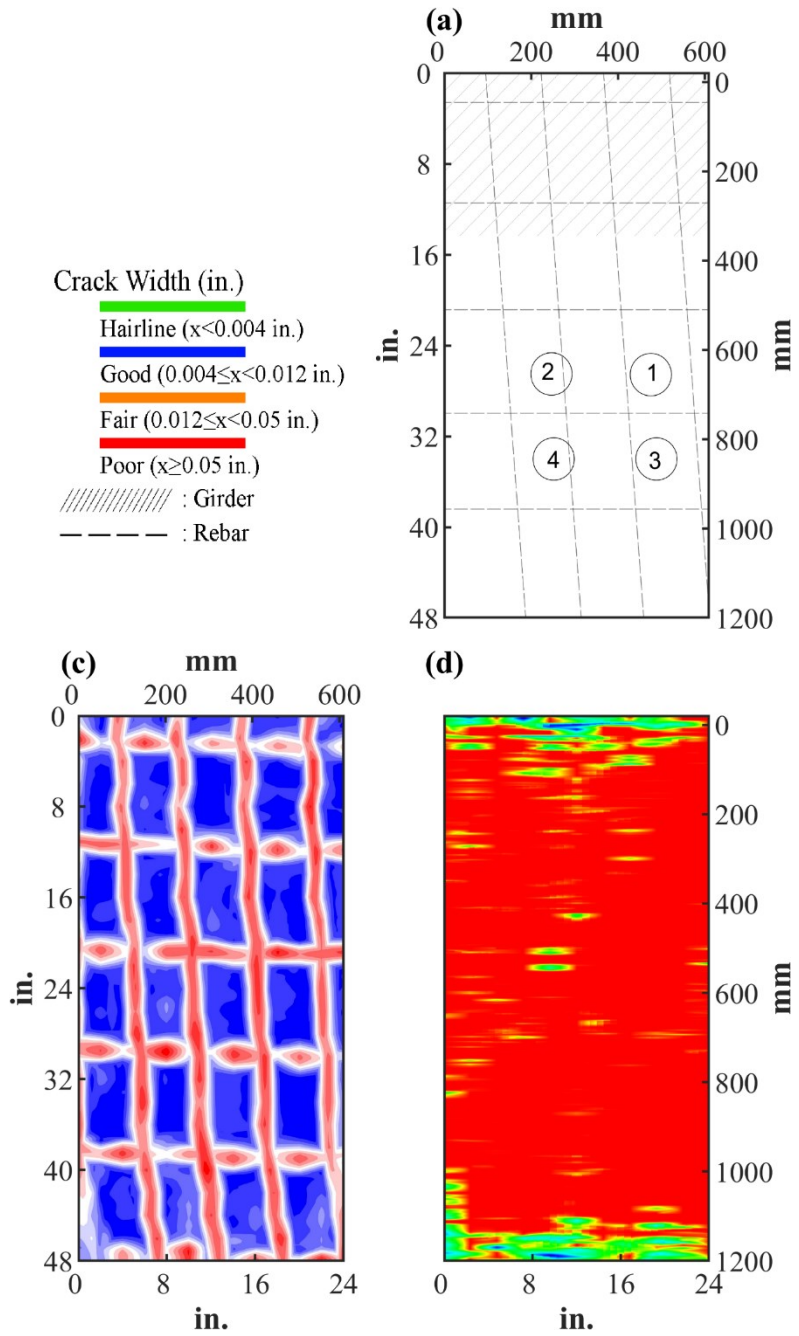
Figure 0.52. Crack Map and NDE Results of Grid 1: (a) Crack Map and Location of Cores; (c) GPR C-scan at 1.85 in. to 2.85 in. Depth; (d) UST C-scan at 1.97 in. Depth

Epoxy overlay was applied to the bridge deck surface. As a result, no cracks were visible as shown in Figure 0.52 (a) and Figure 0.53 (a)

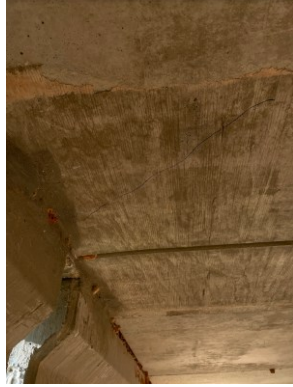
There are hairline longitudinal and transverse cracks on the top surface of deck. The bottom surface of deck around joint has diagonal cracks as shown in Figure 0.57 (a). The undersurface of one span is with seepage in progress and obvious stains as shown in Figure 0.57 (b). There is moderate map crack at the epoxy surface of south approach pavement.

Figure 0.57. Deterioration on the Bridge: (a) Diagonal Crack at the deck bottom surface; (b) Leakage and stains on bottom surface of deck

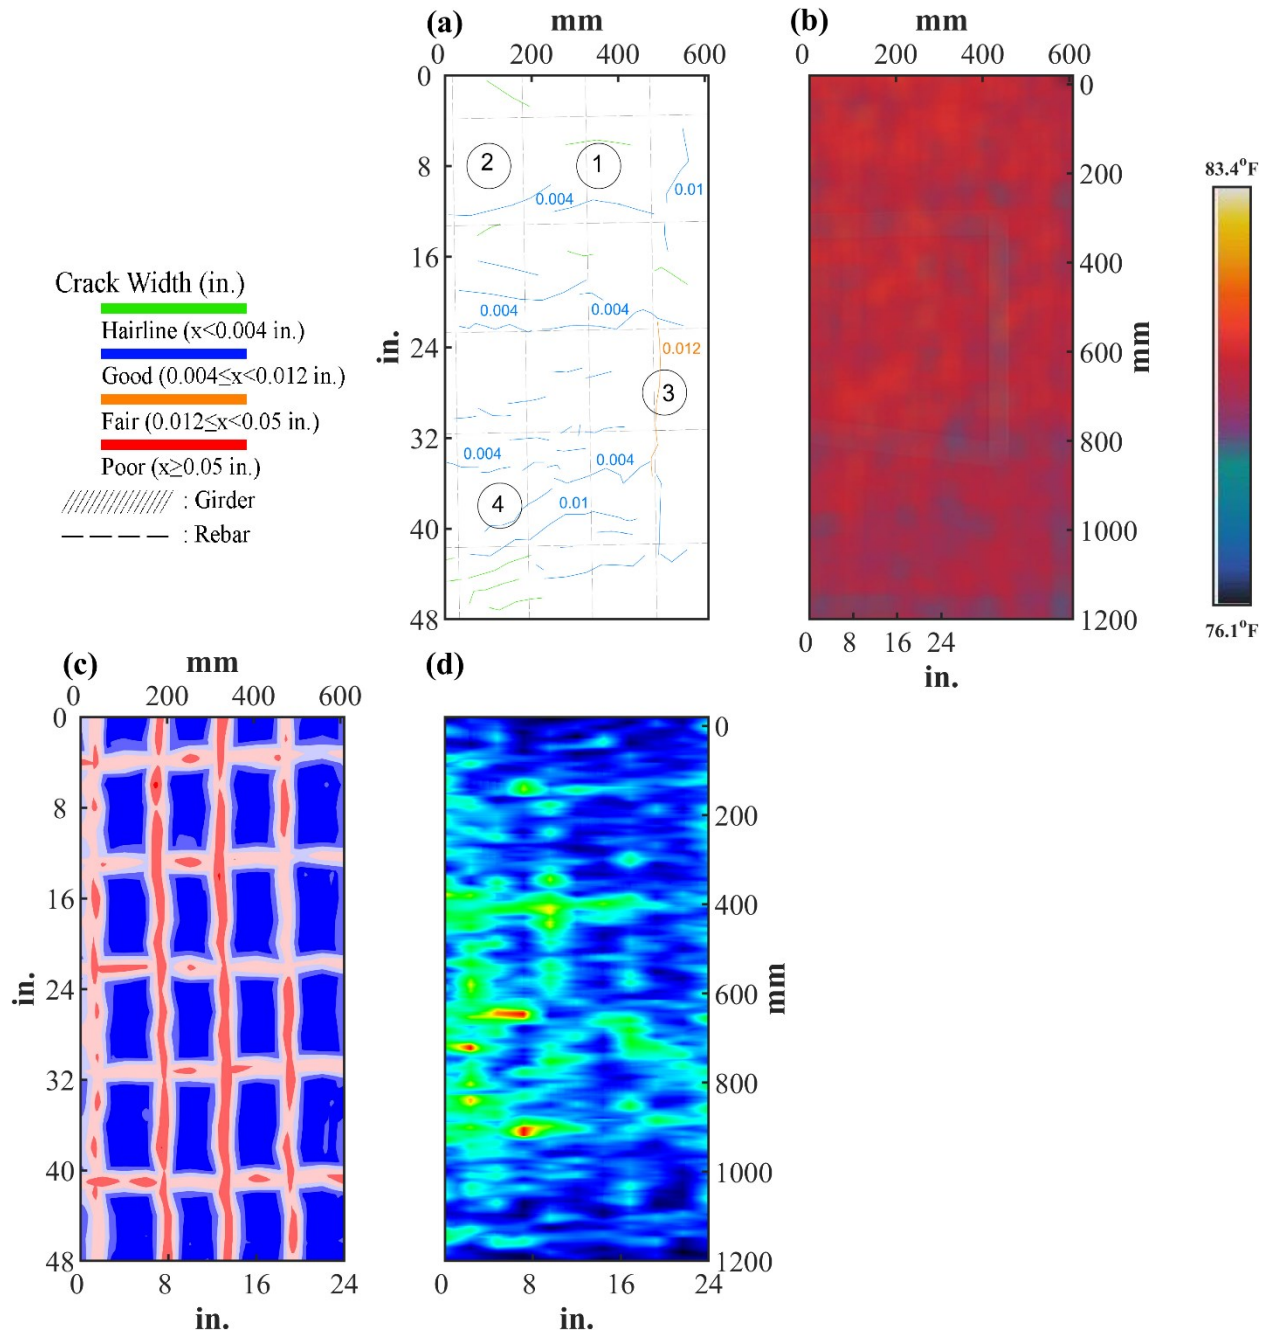
Figure 0.67. Crack Map and NDE Results of Grid 1: (a) Crack Map and Location of Cores; (b) Infrared Picture; (c) GPR C-scan at 1.8 in. to 2.9 in. Depth; (d) UST C-scan at 4.11 in. Depth

Figure 0.67 (a) shows that there was widespread of 0.004 in. wide cracks with one 0.012 wide transverse crack. The Grid 2 had one crack that was 0.004 in. wide as shown in Figure 0.68 (a).

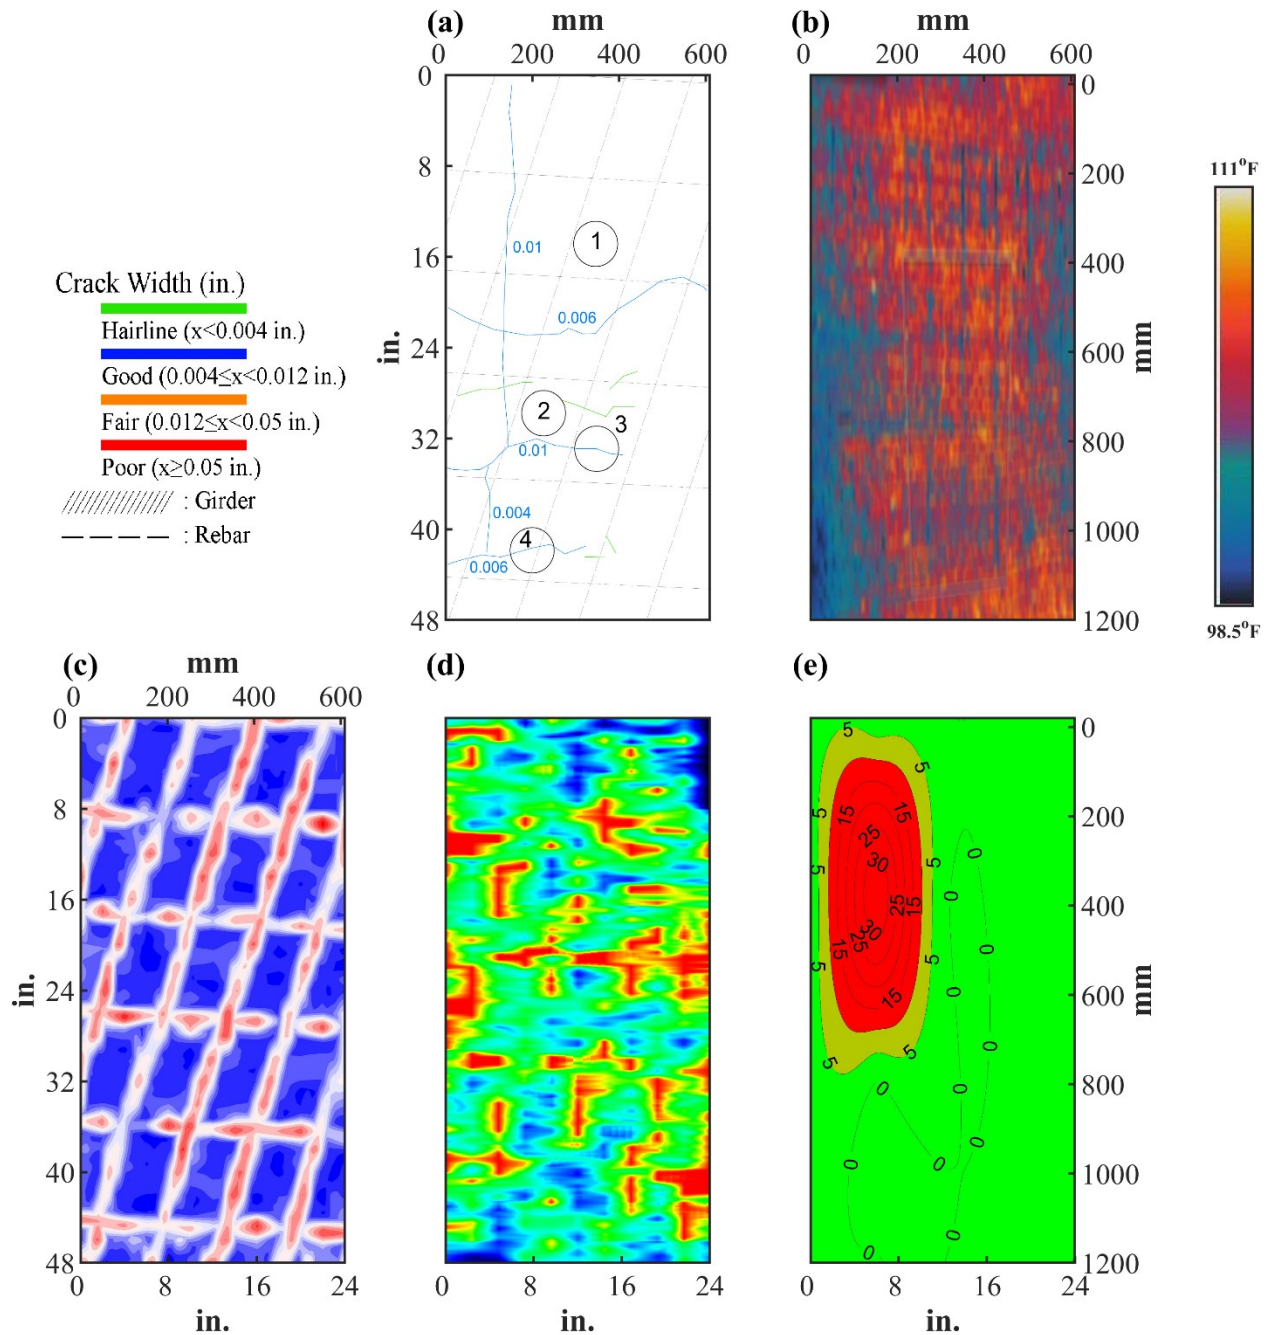
Figure 0.74. Crack Map and NDE Results of Grid 1: (a) Crack Map and Location of Cores; (b) Infrared Picture; (c) GPR C-scan at 1.8 in. to 2.9 in. Depth; (d) UST C-scan at 3.97 in. Depth; (e) Corrosion Rate Map

As shown in Figure 0.74 (a), there were cracks with width ranging from 0.006 in. to 0.01 in. 0.01 in. transverse crack could have been caused by panel joints. Based on the Figure A. 10.3 (e), there is a possibility of corrosion on upper left corner of the Grid 1. Grid 2 has cracks ranging from 0.004 in. to 0.006 in. as shown in Figure 0.75 (a). The cracks could have been caused by panel joints.

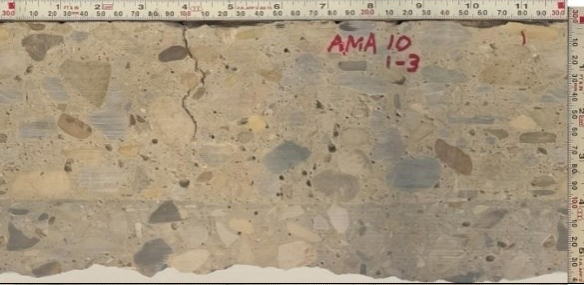
Core	dia. × height (in.)	Rebar depth (in.)	Rebar size (#)	Epoxy (Y/N)	Crack type	Crack width (in)	Notes
1-1	3.75 × 5.9	-	-	-	-	-	-
1-2	3.75 × 5.9	-	-	-	-	-	-
1-3	3.75 × 5.9	-	-	-	diagonal	0.25	A crack propagates along intersection of aggregates
1-4	3.75 × 5.5	2.0	5	Y	diagonal	0.25	-
2-1	3.75 × 4.3	-	-	-	transverse	0.2	A crack propagates along intersection of aggregates; delamination between CIP and PCP
2-2	3.75 × 4.3	-	-	-	-	-	Delamination between CIP and PCP
2-3	-	-	-	-	-	-	Crushed core
2-4	3.75 × 4.5	2.2, 2.7	5, 4	Y, Y	diagonal	0.3	Delamination between CIP and PCP; Crack propagating from rebar

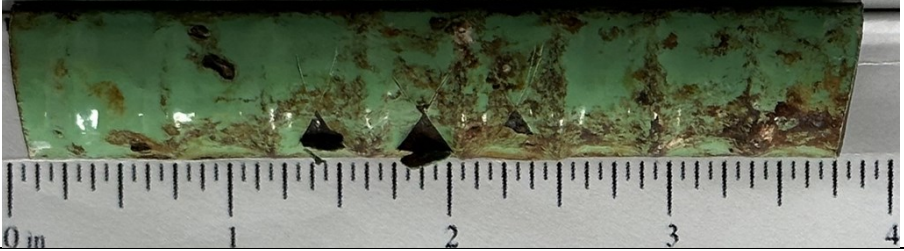
Core Number	Score	Picture
2-4	2

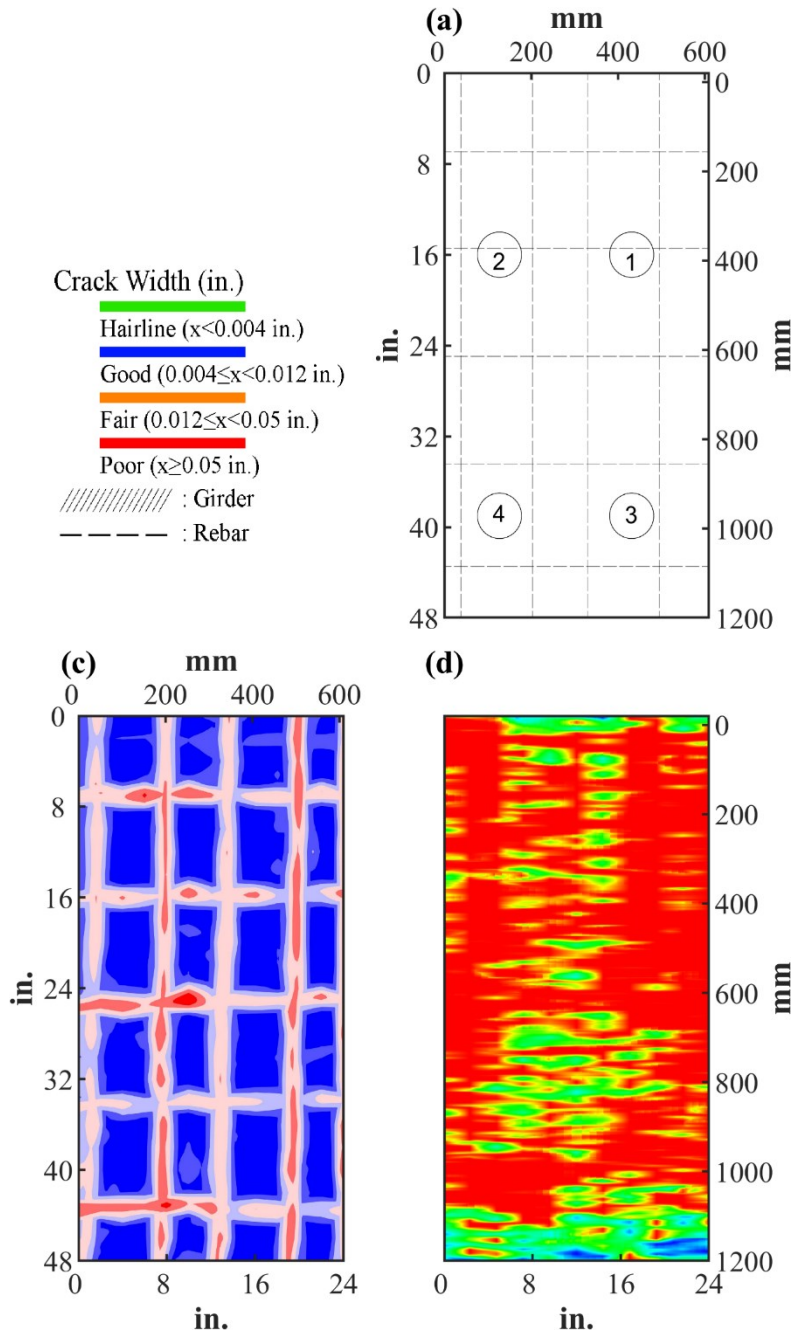
Figure 0.80. Crack Map and NDE Results of Grid 1: (a) Crack Map and Location of Cores; (c) GPR C-scan at 1.8 in. to 2.9 in. Depth; (d) UST C-scan at 1.96 in. Depth

Asphalt overlay was applied on the bridge, and as a result, no cracks were visible on the deck as shown in Figure 0.80 (a) and Figure 0.81 (a).

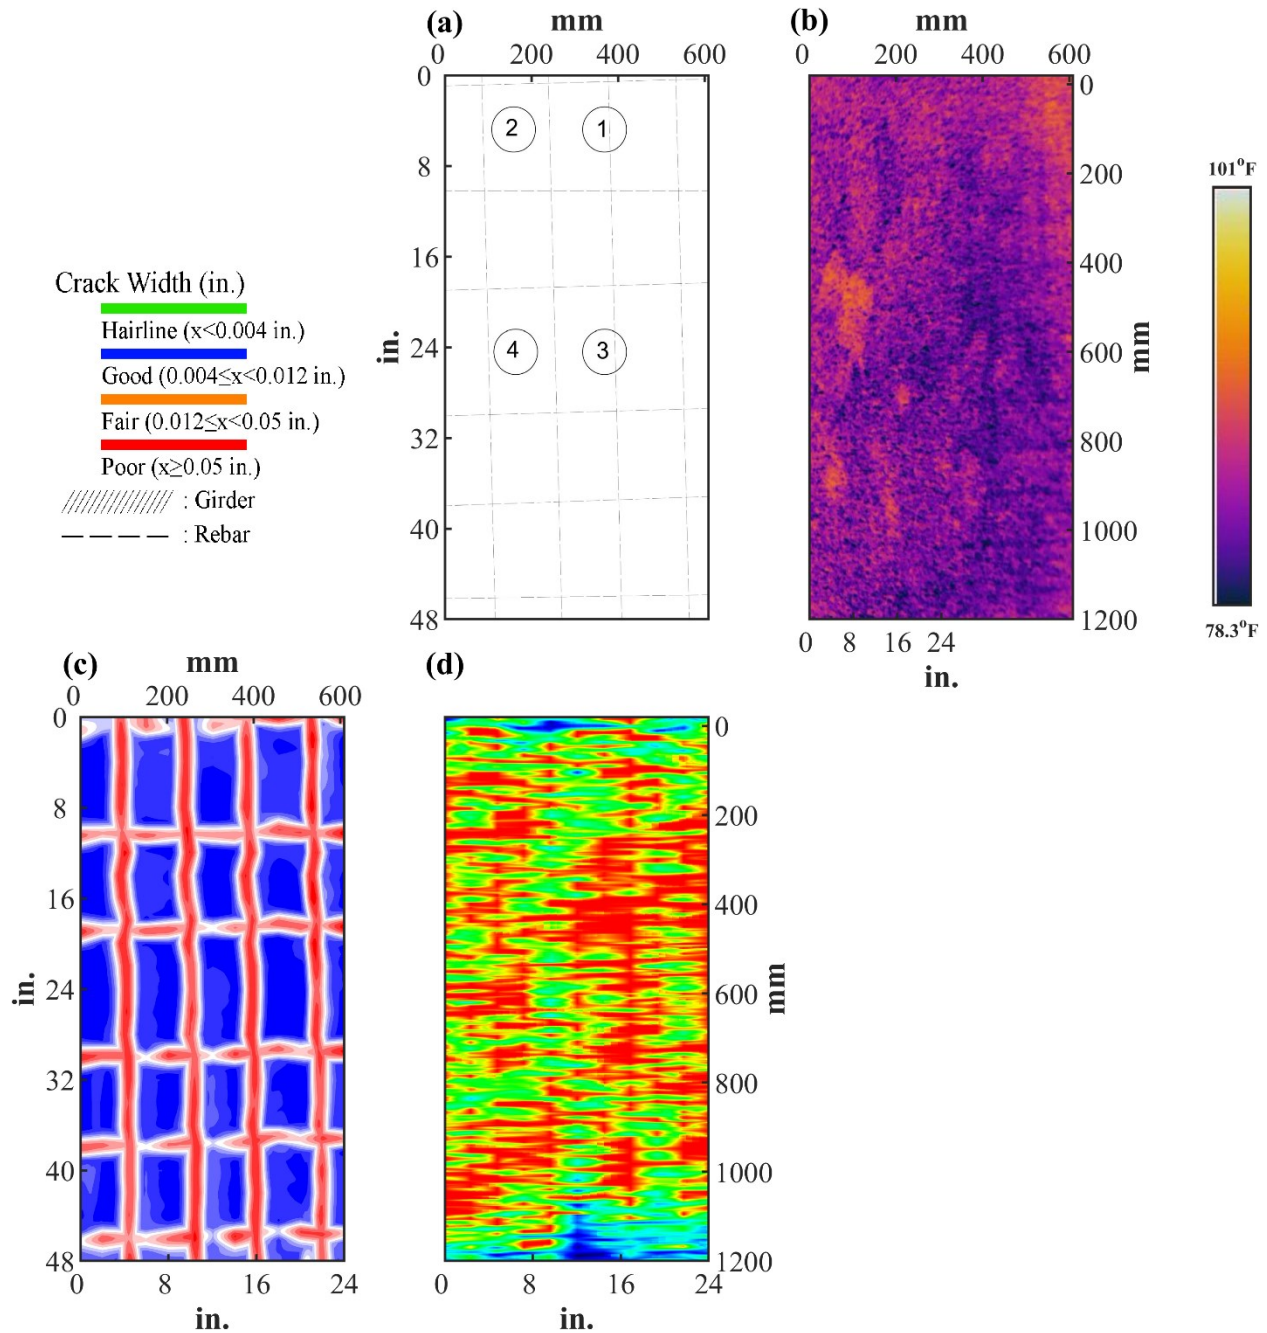
Figure 0.87. Crack Map and NDE Results of Grid 1: (a) Crack Map and Location of Cores; (b) Infrared Picture; (c) GPR C-scan at 1.95 in. to 3.05 in. Depth; (d) UST C-scan at 1.96 in. Depth

Asphalt overlay was applied on the bridge, and as a result, no cracks were visible on the deck as shown in Figure 0.87 (a) and Figure 0.88Figure 0.81 (a).

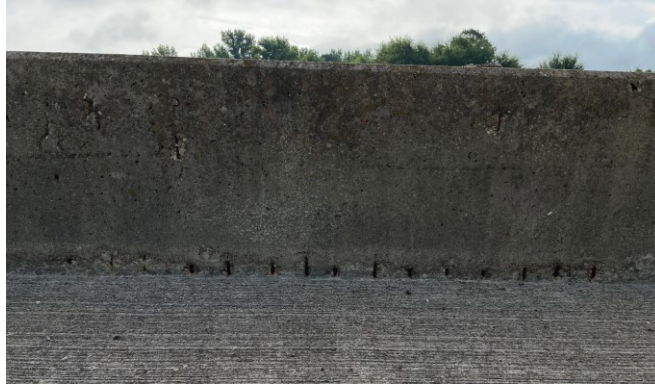
Figure 0.93. Exposed and Corroded Rebar at the Bottom of Railing

The top surface of deck has hairline and some transverse, longitudinal cracks. The west rails have minor spalling and exposed rebar along its bottom is corroded as shown in Figure 0.93. Spalling at the both west and east end of the backwall of Abutment 1. Water staining was visible at the bottom of the overhang, but no cracks were apparent. The girders bottom flanges exhibited honeycombing. Water leakage through the west overhangs at the bents was apparent.

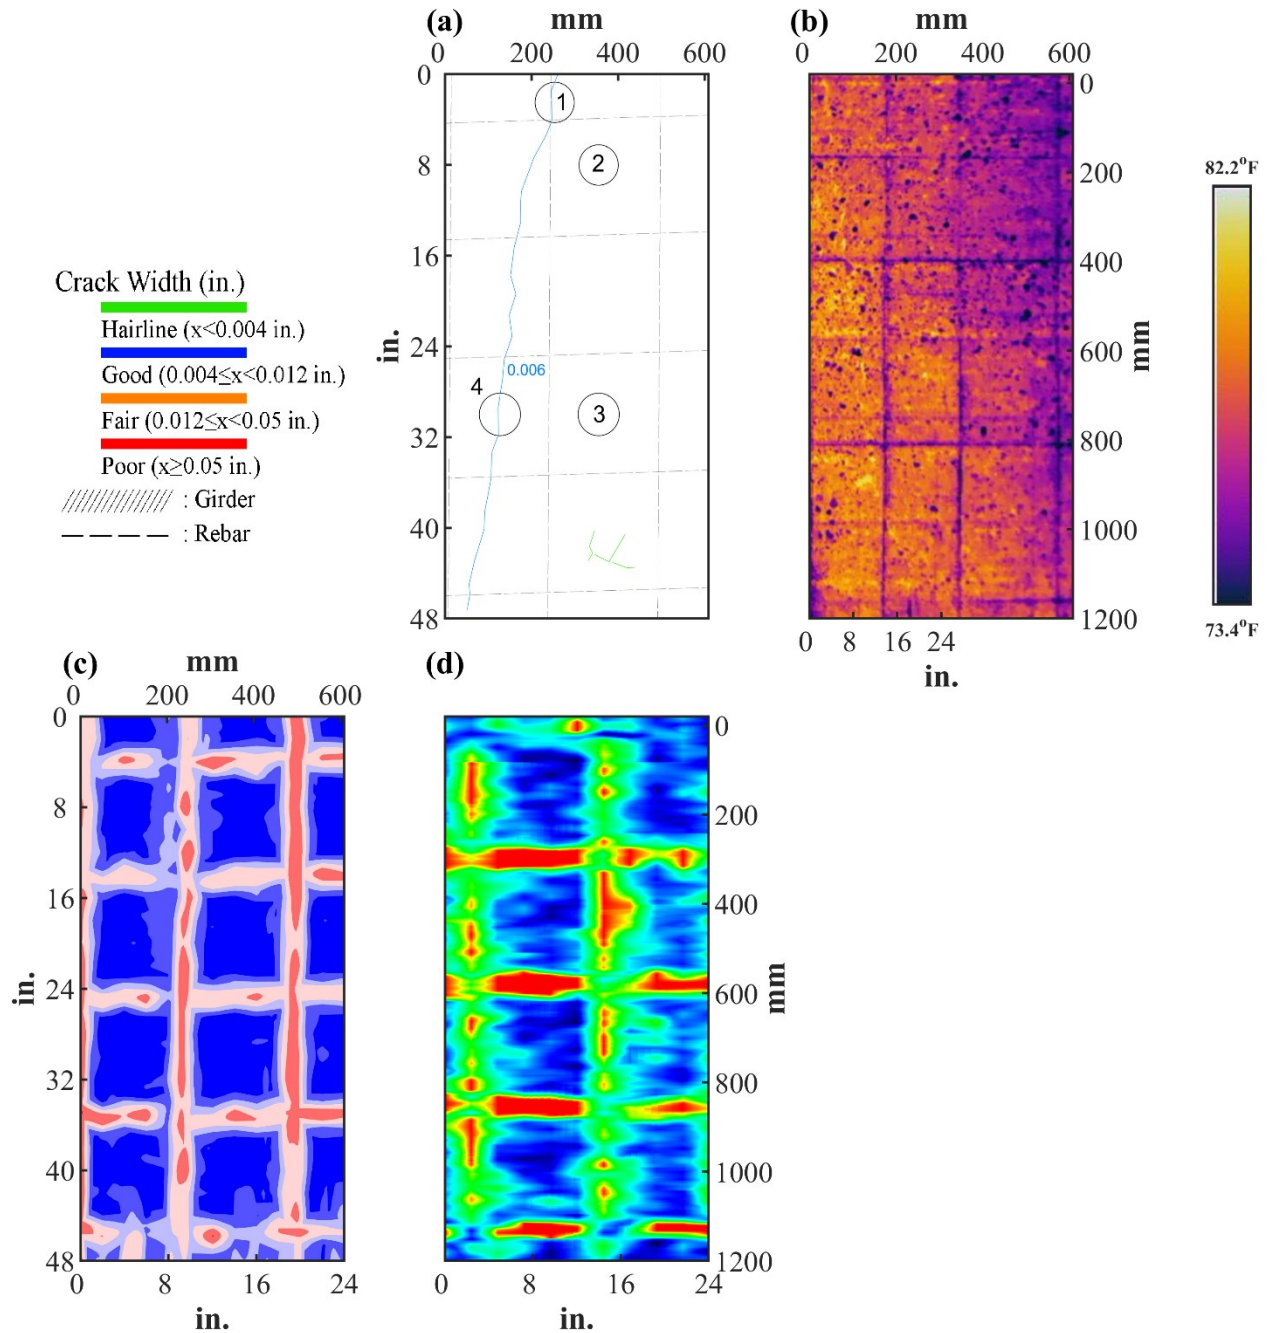
Figure 0.95. Crack Map and NDE Results of Grid 1: (a) Crack Map and Location of Cores; (b) Infrared Picture; (c) GPR C-scan at 2.2 in. to 3.3 in. Depth; (d) UST C-scan at 4.3 in. Depth

As shown in Figure 0.95 (a), one 0.006 in. wide crack in transverse direction was visible, possibly caused by panel joints. The Grid 2 had transverse cracks that are 0.007 in. and 0.008 in. wide as shown in Figure 0.96. It is possible that the cracks were caused by panel joints.

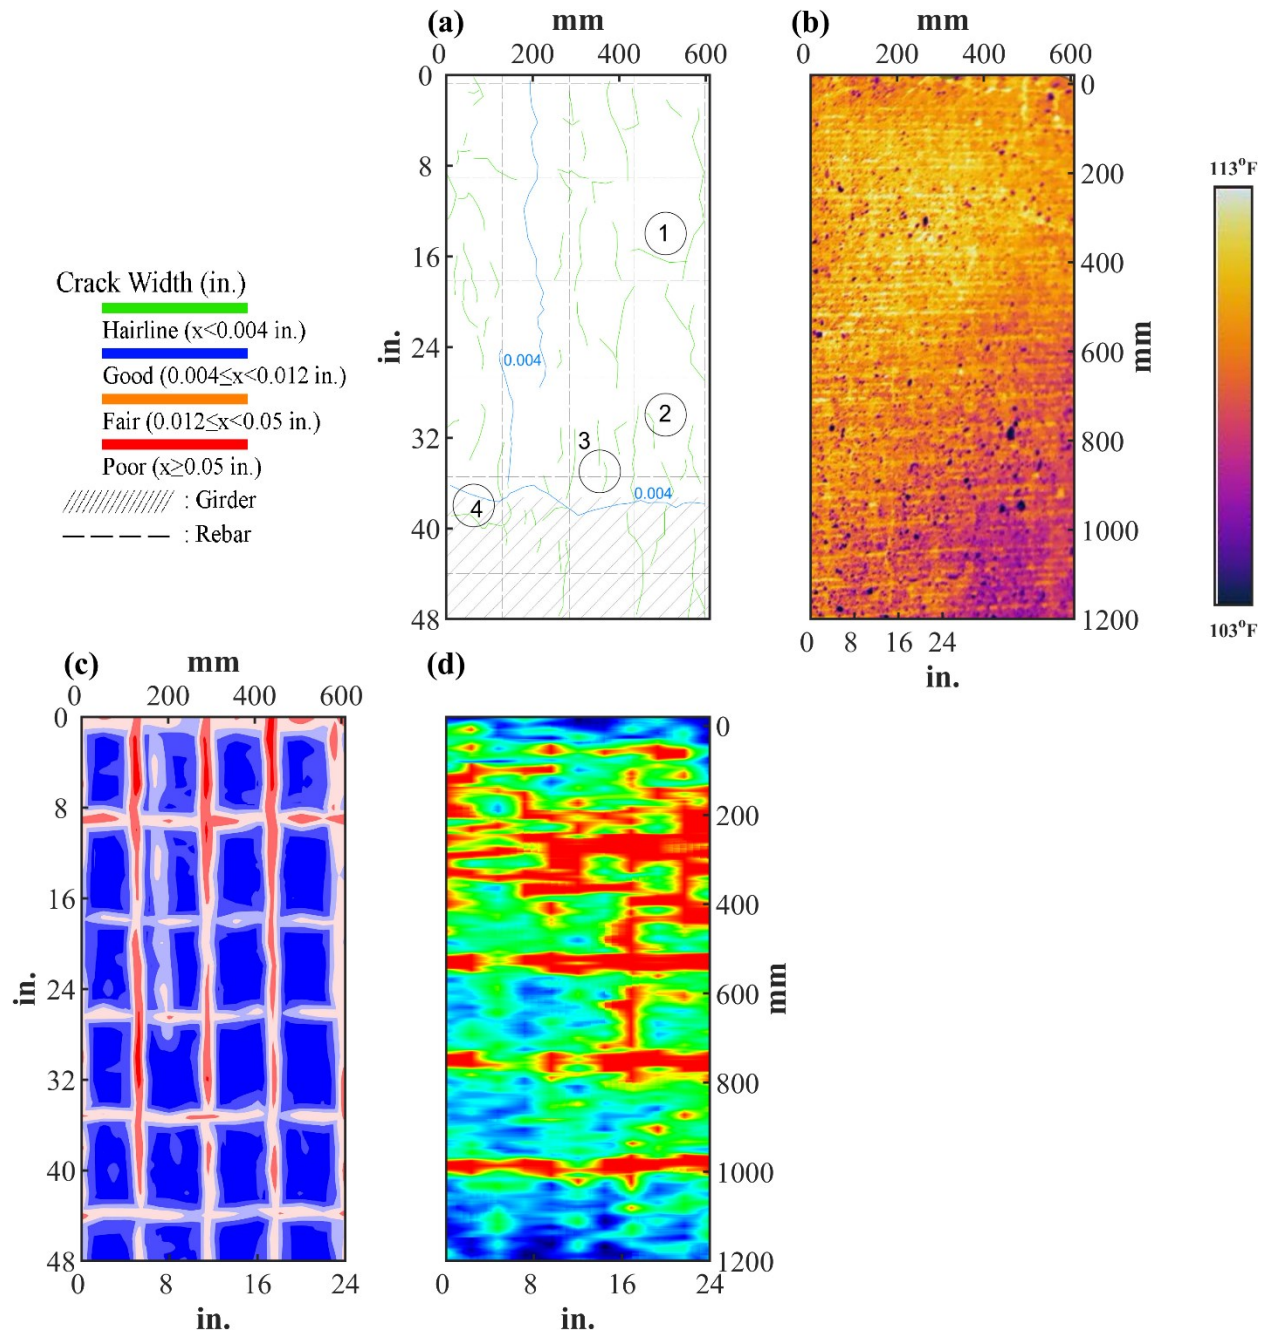
Figure 0.101. Crack Map and NDE Results of Grid 1: (a) Crack Map and Location of Cores; (b) Infrared Picture; (c) GPR C-scan at 1.2 in. to 2.3 in. Depth; (d) UST C-scan at 3.1 in. Depth

As shown in Figure 0.101 (a), G1 had widespread of hairline cracks with one 0.004 in. wide transverse crack and one 0.004 in. wide longitudinal cracks. It is possible that the longitudinal crack was caused by a girder and transverse crack was caused by panel joints. As shown in Figure 0.102 (a), hairline cracks were wide spread, and there were two 0.004 in. wide transverse cracks.
