Evaluation of Corrosion Prevention and Mitigation Approaches Used on Texas Bridges—Volume 2: Reinforced Concrete Bridges

Technical Report 0-7040-R1-Vol2

TEXAS A&M TRANSPORTATION INSTITUTE
COLLEGE STATION, TEXAS

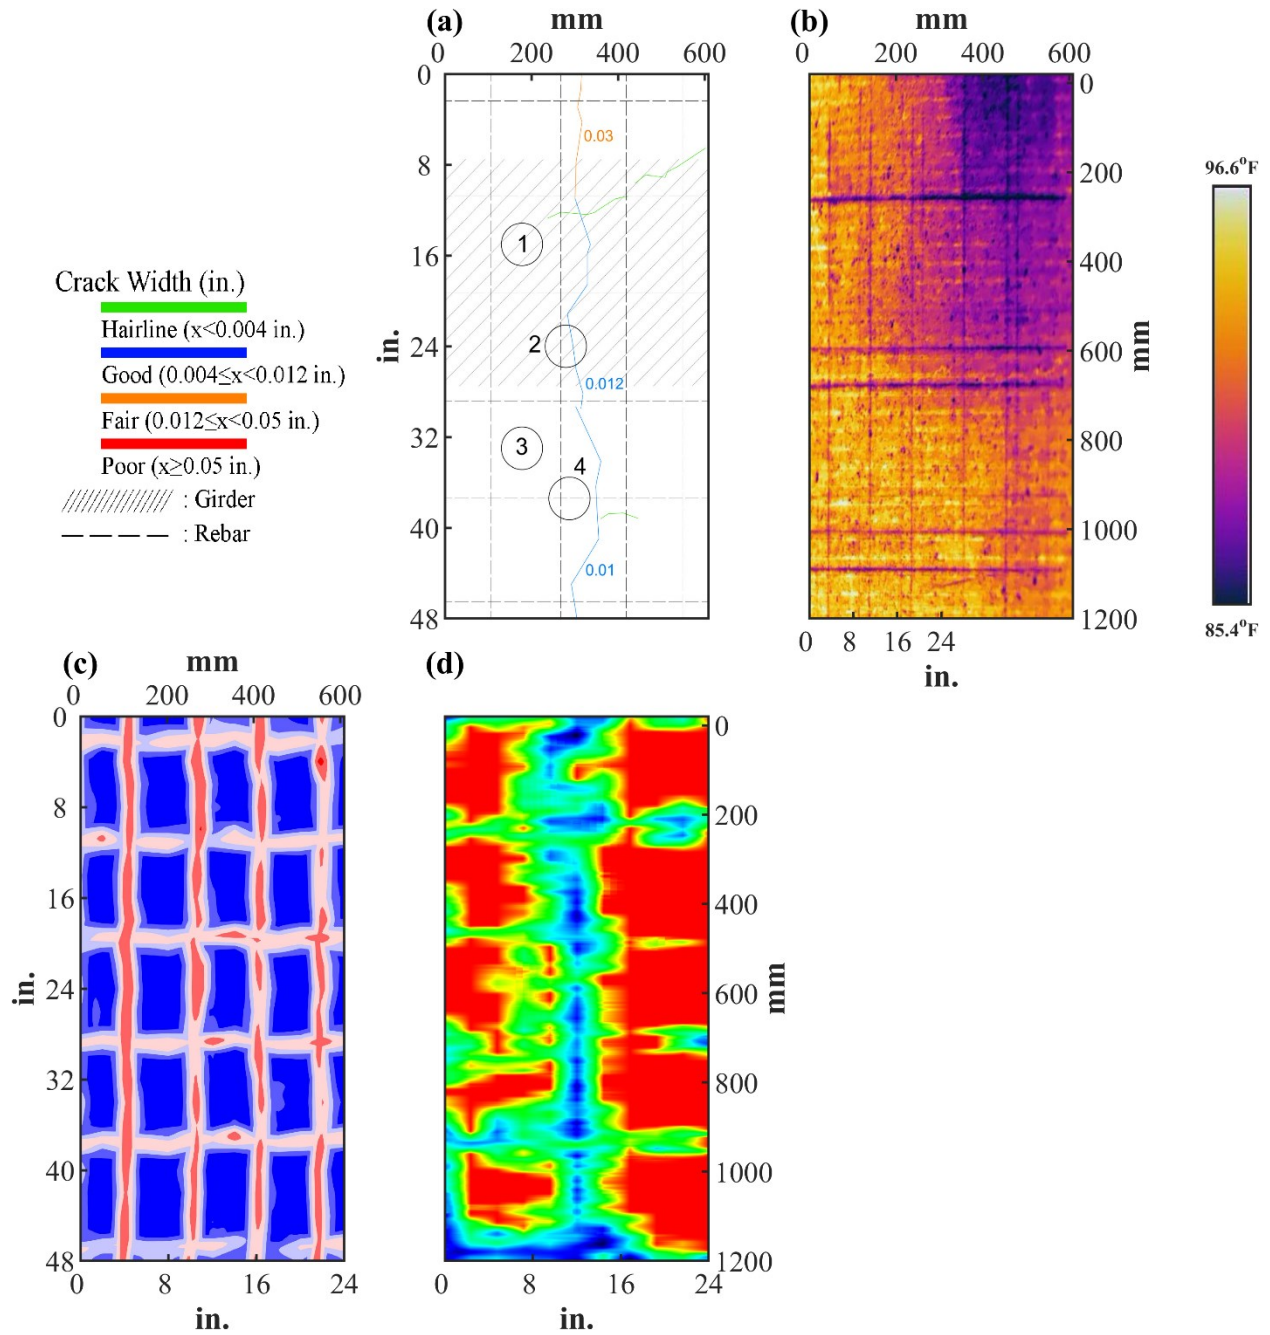
Figure 0.108. Crack Map and NDE Results of Grid 1: (a) Crack Map and Location of Cores; (b) Infrared Picture; (c) GPR C-scan at 1.7 in. to 2.8 in. Depth; (d) UST C-scan at 4.6 in. Depth

As shown in Figure 0.108 (a), the width of a transverse crack ranged from 0.01 in. to 0.03 in. It is possible that panel joints caused the crack. The Grid 2 had 0.004 in wide diagonal cracks and some hairline cracks as shown in Figure 0.109 (a). The Grid 3 had sealant applied on the crack as shown in Figure 0.110 (a).

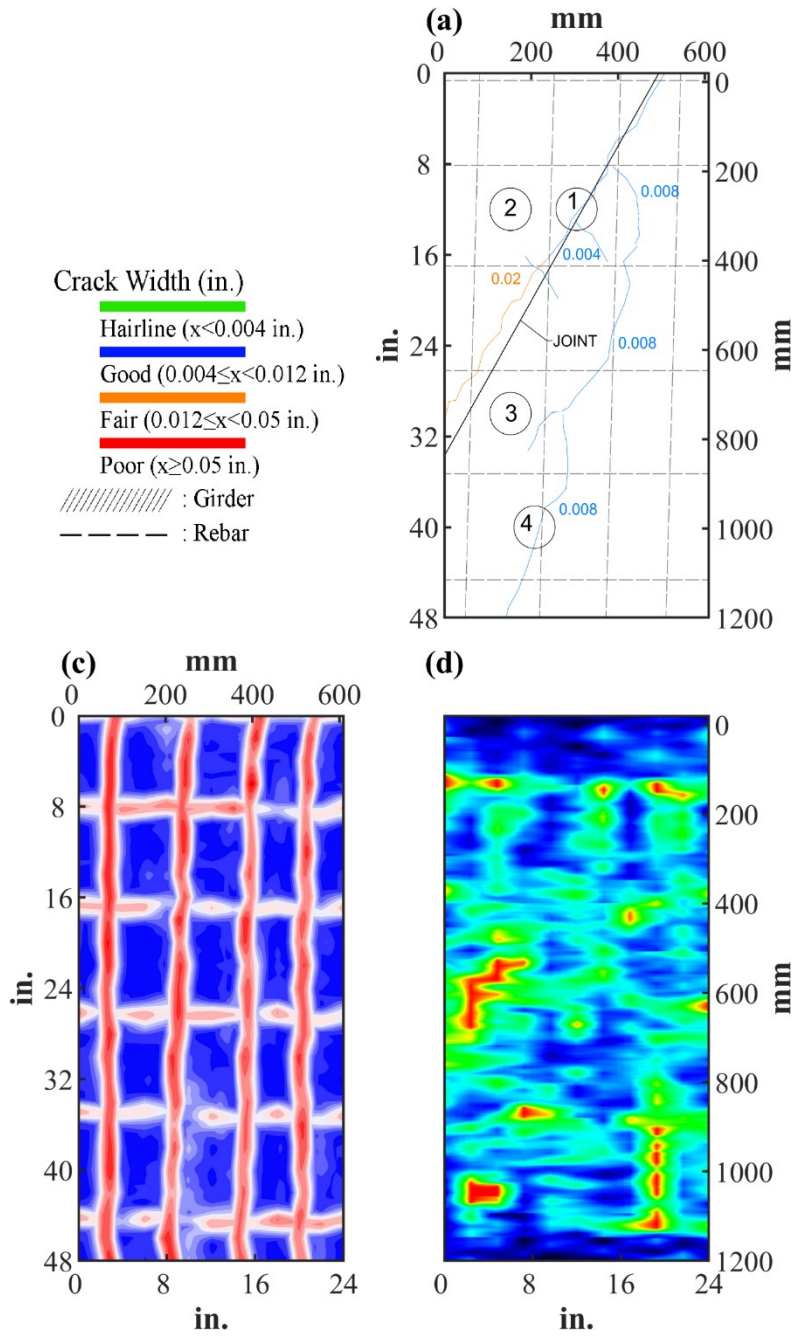
Figure 0.116. Crack Map and NDE Results of Grid 1: (a) Crack Map and Location of Cores; (c) GPR C-scan at 1.7 in. to 2.8 in. Depth; (d) UST C-scan at 6.2 in. Depth

As shown in Figure 0.116 (a), the Grid 1 had cracks with their widths ranging from 0.004 in. to 0.02 in. wide. The grid 1 was located on the joint and cracks propagate from the joint. The grid 2 was also located on the joint, and a crack ranging from 0.02 in. wide to 0.03 in. wide was propagating from the joint as shown in Figure 0.117 (a).

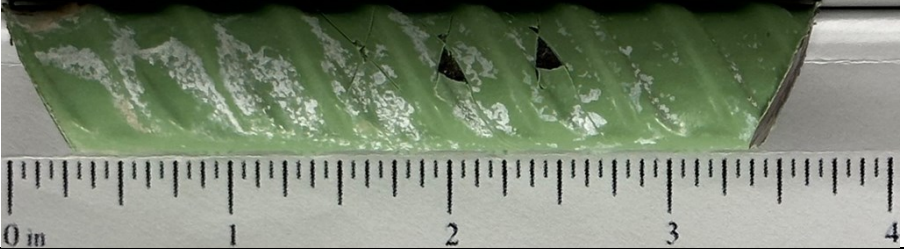
Core Number	Score	Picture
2-3	6

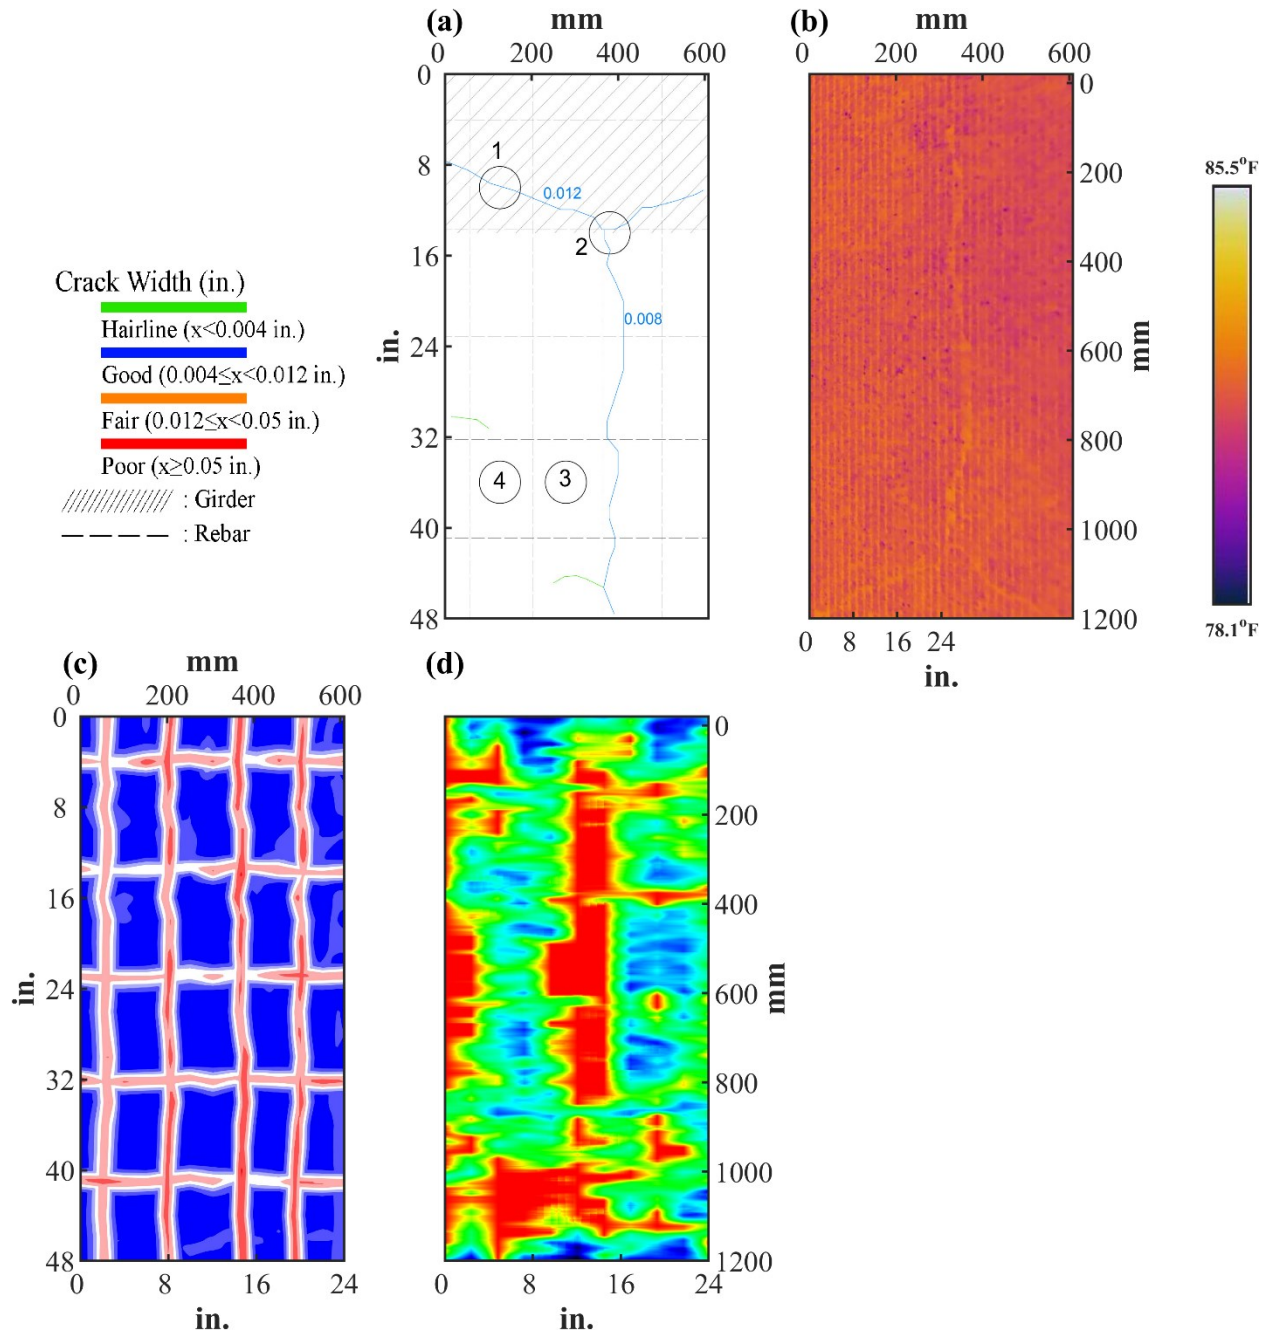
Figure 0.122. Crack Map and NDE Results of Grid 1: (a) Crack Map and Location of Cores; (b) Infrared Picture; (c) GPR C-scan at 2.7 in. to 3.8 in. Depth; (d) UST C-scan at 4.6 in. Depth

As shown in Figure 0.122 (a), it is possible that longitudinal and transverse cracks are caused by panel joints and they were 0.008 and 0.012 wide, respectively. The Grid 2 had 0.006 in. wide transverse crack, possibly caused by panel joints as shown in Figure 0.123 (a).

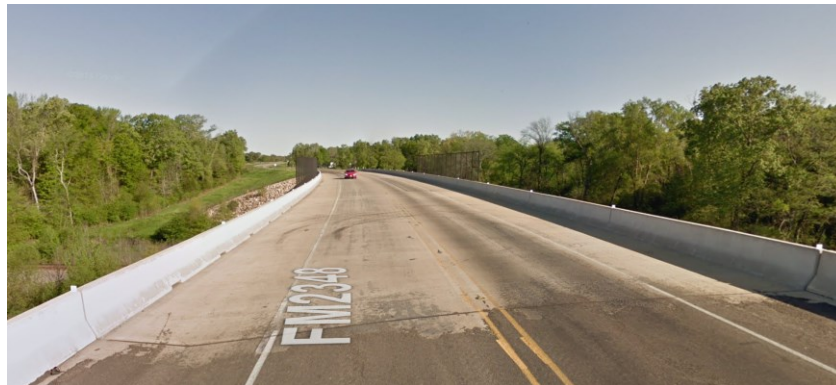
Figure 0.127. Concrete Deck of the Bridge (source: google maps)

Numerous transverse cracks were observed on the deck. Notably, a wide crack with up to 0.035 in. width and spalling was observed south of the SEJ. The west side of Abutment 1 back wall exhibited a 0.008 in. wide vertical crack, with the top of the abutment displaying longitudinal and transverse cracks up to 0.014 in. wide. The backwall showed various cracks, primarily horizontal and up to 0.016 in. wide, along with diagonal and vertical cracks. Significant cracking was present between the west exterior and interior of Beam 6. Additional issues included erosion under the bent cap, spalling, exposed rebar and strand on the west girder, and deformation of the bearing pad.

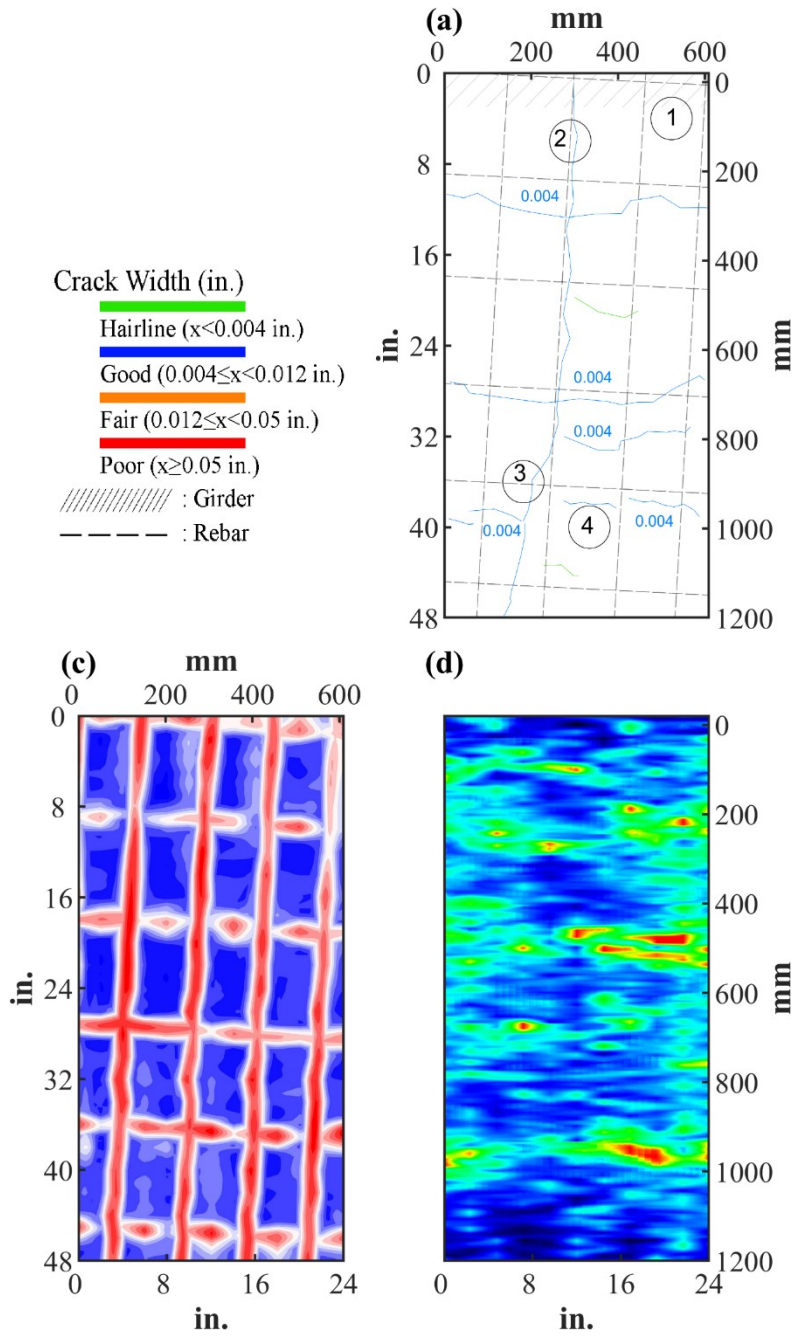
Figure 0.129. Crack Map and NDE Results of Grid 1: (a) Crack Map and Location of Cores; (c) GPR C-scan at 1.7 in. to 2.8 in. Depth; (d) UST C-scan at 1.6 in. Depth

As shown in Figure 0.129 (a), the Grid 1 had cracks that are 0.004 in. wide in both transverse and longitudinal directions. The Grid 2 had short cracks that were 0.006 in wide and 0.012 in. wide as shown in Figure 0.130 (a).

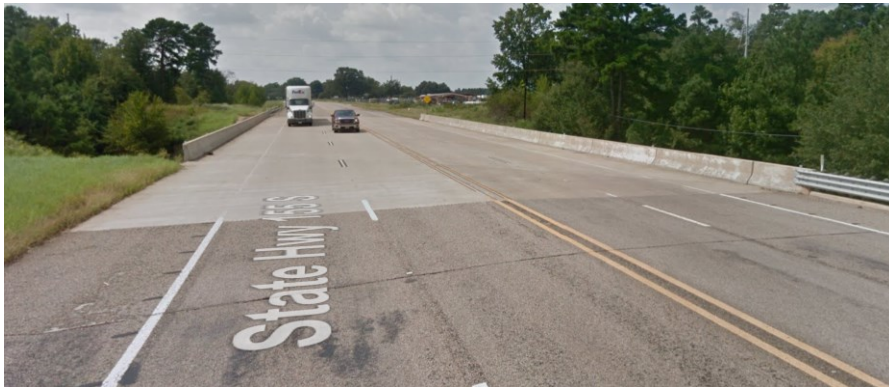
Figure 0.134. Concrete Deck of the Bridge (source: google maps)

The top surface of deck has transverse cracks. These cracks are perpendicular to the skew joints. The overall condition of the bridge was deemed to be in good shape.

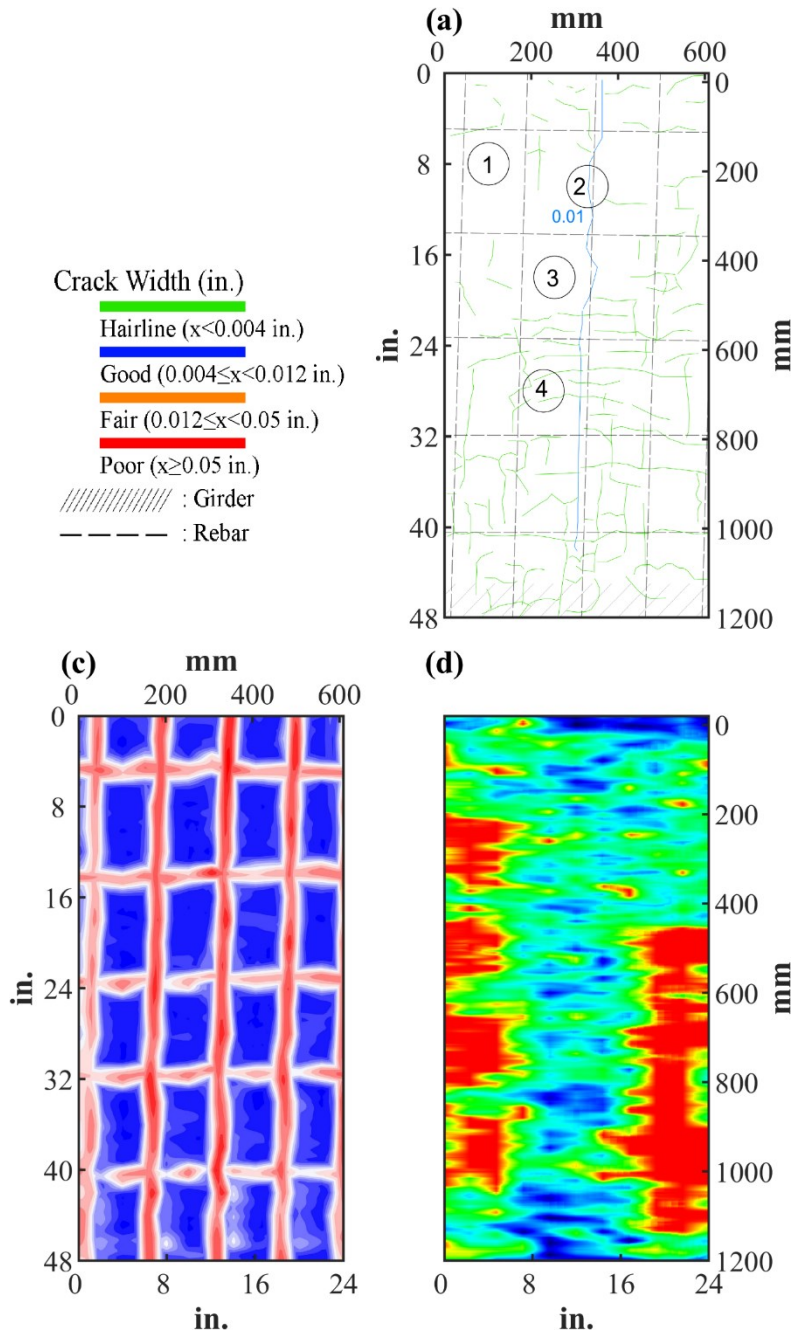
Figure 0.136. Crack Map and NDE Results of Grid 1: (a) Crack Map and Location of Cores; (c) GPR C-scan at 1.7 in. to 2.8 in. Depth; (d) UST C-scan at 6.7 in. Depth

As shown in Figure 0.136 (a), there were widespread of hairline cracks and 0.01 in. wide transverse crack which was possibly caused by panel joints. On Grid 2, 0.004 in. wide transverse crack was observed which was possibly cause by panel joints as well as shown in Figure 0.137 (a).

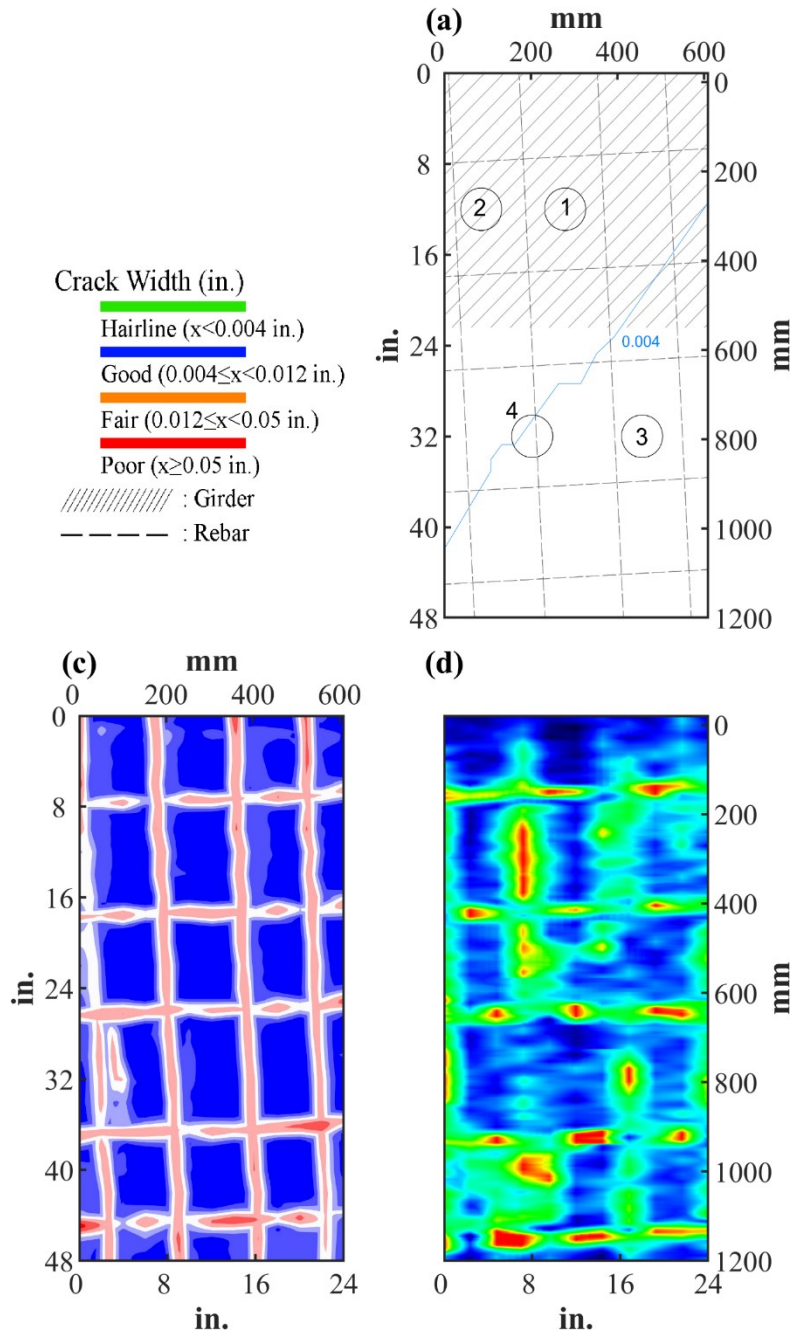
Figure 0.144. Crack Map and NDE Results of Grid 1: (a) Crack Map and Location of Cores; (c) GPR C-scan at 1.7 in. to 2.8 in. Depth; (d) UST C-scan at 6.7 in. Depth

As shown in Figure 0.143 (a), Grid 1 was located on the longitudinal construction joint. On Grid 2, there was a 0.004 in. wide diagonal crack as shown in Figure 0.144 (a). The deck was in very good condition with almost no cracks.

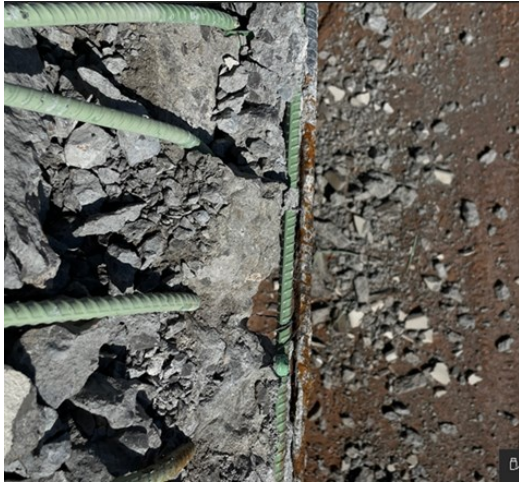
(a)

The concrete railing had been demolished, and some corroded rebar was found on the edge of railing as shown in Figure 0.148 (a). It was noted that the epoxy-coated rebar was used for top rebar whereas the bottom rebars were black rebars without any coating. As can be seen from Figure A.1.2 (a), bottom black rebar displayed severe corrosion. Expansion joint is partially failed and full of dirt and debris as shown in Figure A.1.2 (b). In the superstructure, extensive delamination was found along the deck overhang as shown in Figure A.1.2 (c). Spalling and exposed rebar were found on the end of beam at bent 25 as shown in Figure 0.148 (d). Severe vertical cracking was found the bent 29 as shown in Figure 0.148 (e).

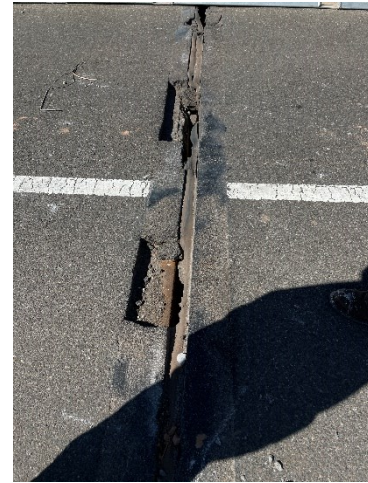
Figure 0.148. Deteriorations on the Bridge Deck: (a) Corroded black rebar at the railing edge; (b) Spalling of overlay at Joint; (c) Delamination along the west overhang of Span 26; (d) Spalling and exposed rebar of girders at bent 25; (e) Sealed cracks at bent 29

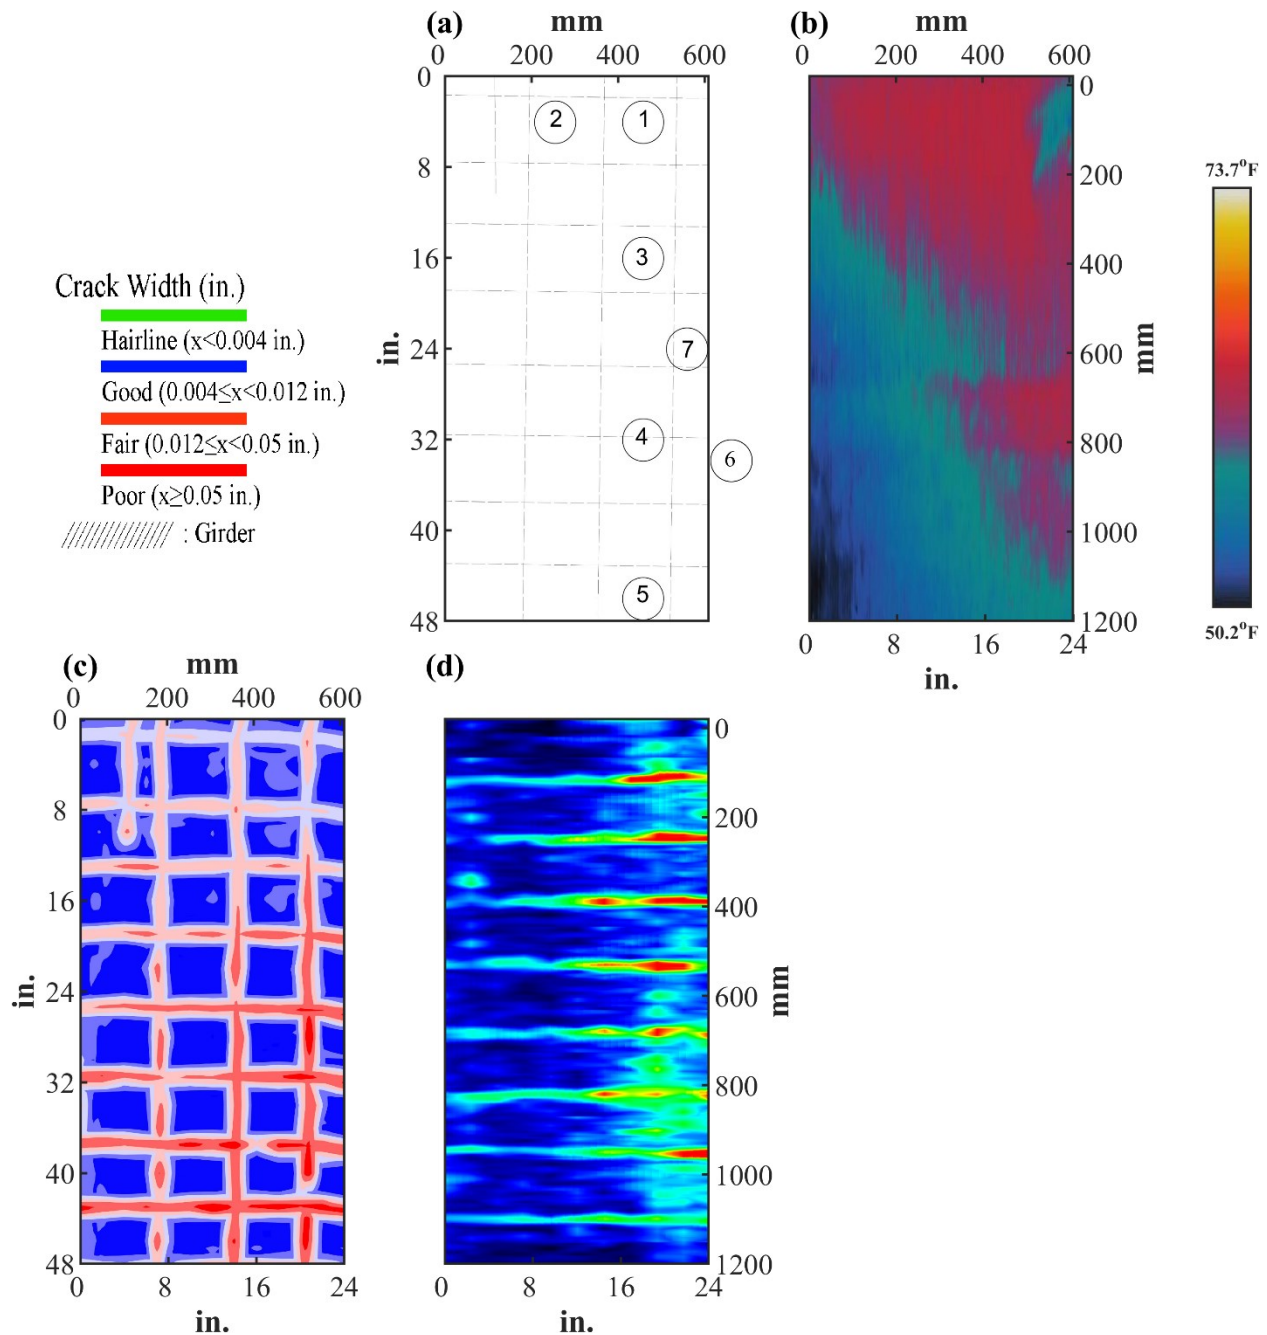
Figure 0.149. Crack Map and NDE Results of Grid 1: (a) Crack Map and Location of Cores; (b) Infrared Picture; (c) GPR C-scan at 1.5 in. to 3.4 in. Depth; (d) UST C-scan at 2.0 in. Depth

Grid 1 was located on SB shoulder lane. Because bridge was under construction and had asphalt overlay, an arbitrary location on the shoulder of span 29 where the asphalt overlay could be taken out was decided. As shown in Figure 0.149 (a), grid 1 did not have any cracks partly because the deck was originally covered by asphalt overlay.

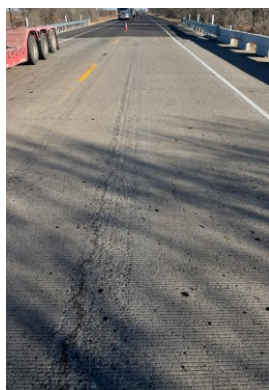
(a)

Deck surface has transverse and longitudinal cracks as shown in Figure 0.154 (a), and there were hairline cracks on the abutment.

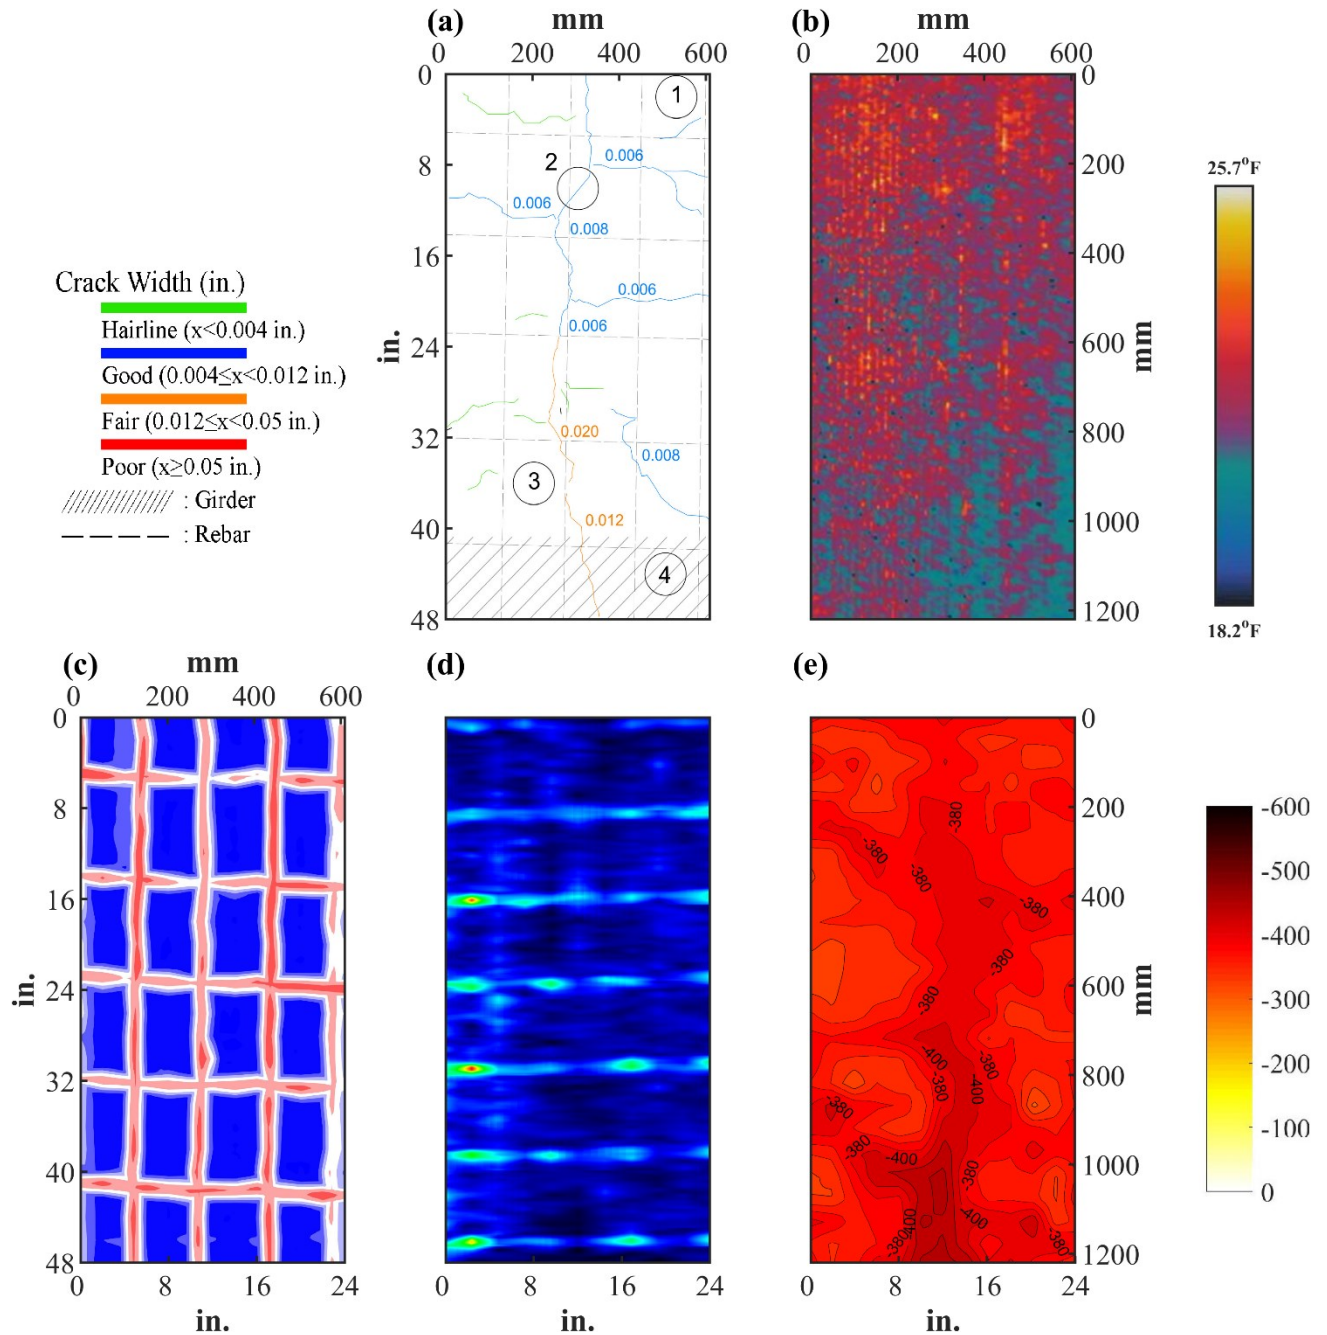
Figure 0.156. NDE Results of Grid 1: (a) Crack Map and Location of Cores; (b) Infrared Picture; (c) GPR C-scan at 1.75 in. to 3.15 in. Depth; (d) UST C-scan at 2.9 in. Depth; (e) Corrosion Rate Map

As shown in Figure 0.156 (a), there are widespread of cracks that range from 0.006 in. and 0.008 in. wide. The widest crack width was 0.02 in. transverse crack. It is possible that transverse crack was caused by panel joints. The Grid 2 had one 0.004 in. wide transverse crack as shown in Figure 0.157 (a).

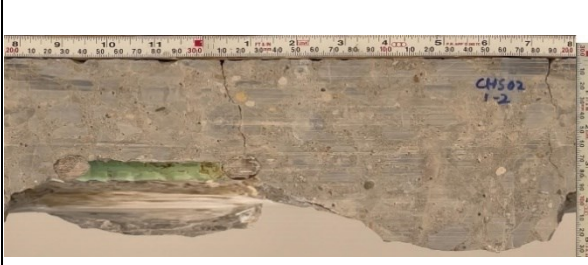
Core	dia. x height (in.)	Rebar depth (in.)	Rebar size (#)	Epoxy (Y/N)	Crack type	Crack width (in)	Notes
1-1	3.75 x 5.5	-	-	-	-	-	-
1-2	3.75 x 2.4	2.4	5	Y	diagonal	0.008	Corroded rebar; A crack propagates from rebar
1-3	3.75 x 5.1	-	-	-	-	-	-
1-4	3.75 x 5.5	-	-	-	-	-	-
2-1	3.75 x 5.3	-	-	-	transverse	0.004	-
2-2	3.75 x 6.3	2.2	5	Y	-	-	-
2-3	3.75 x 6.5	2.3	5	Y	-	-	-
2-4	3.75 x 5.0	2.4	5	Y	-	-	-

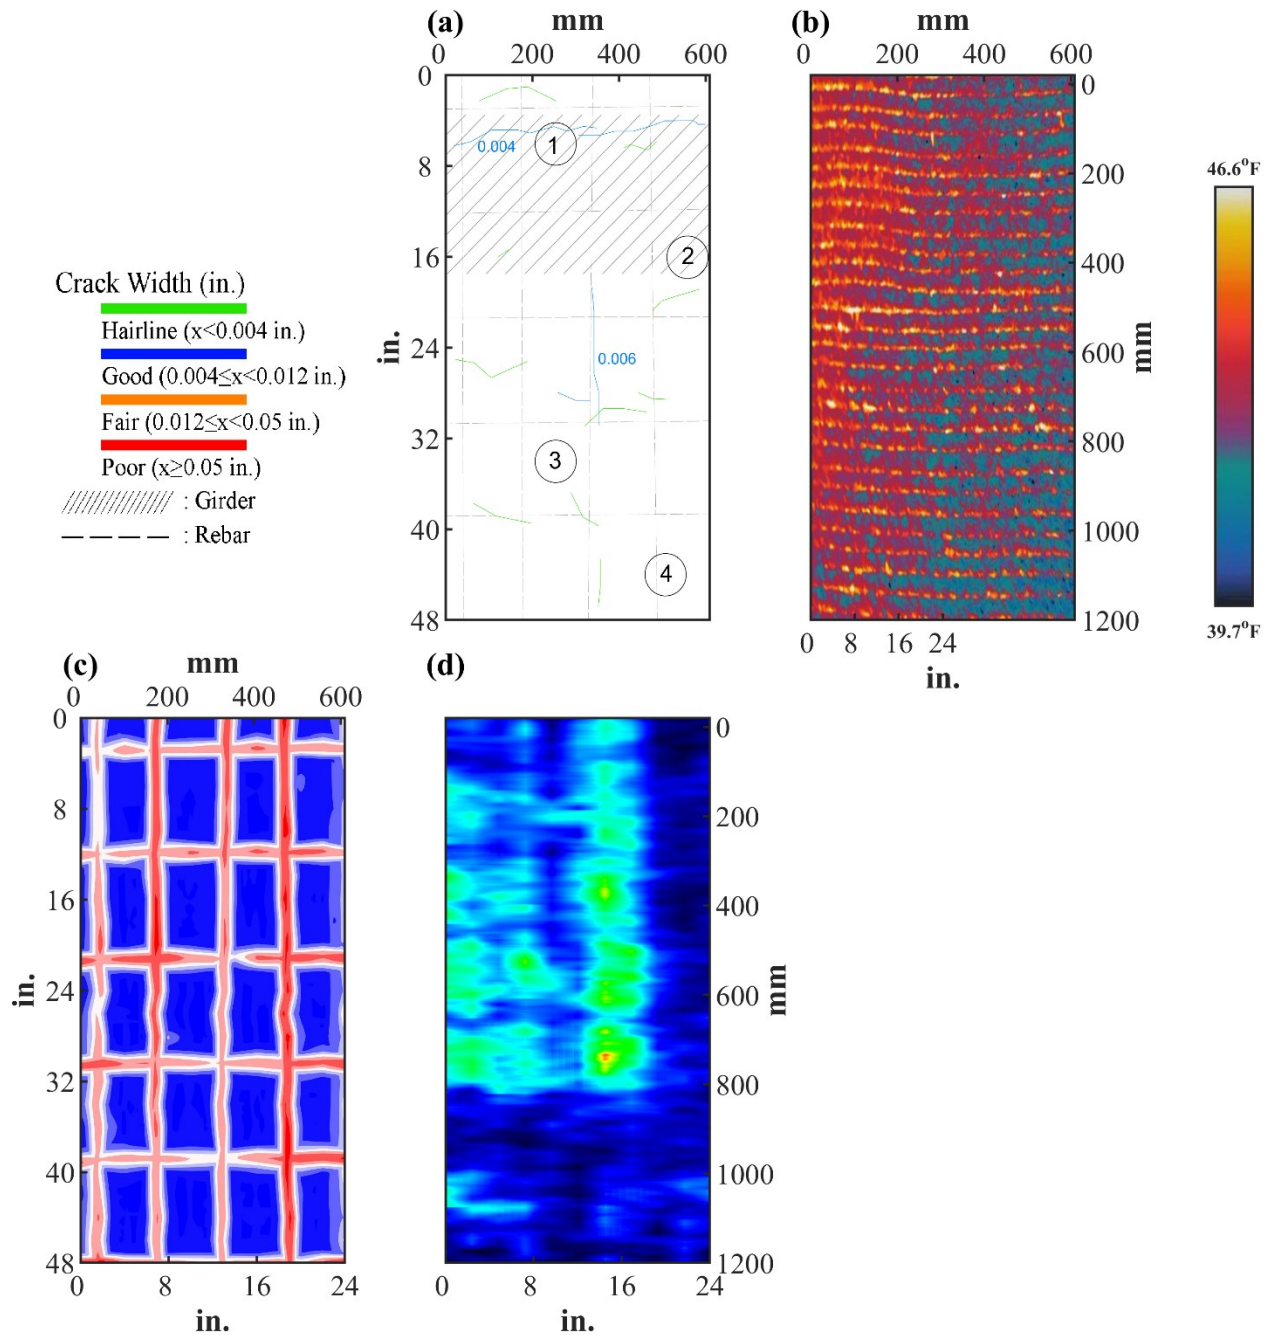
Figure 0.163. NDE Results of Grid 1: (a) Crack Map and Location of Cores; (b) Infrared Picture; (c) GPR C-scan at 1.25 in. to 2.65 in. Depth; (d) UST C-scan at 4.5 in. Depth

As shown in Figure 0.163 (a), there was a 0.004 in. wide longitudinal crack on top of girder and 0.006 in. wide transverse crack on grid 1. On grid 2, there was two short cracks that are 0.004 in. wide as shown in Figure 0.164 (a).

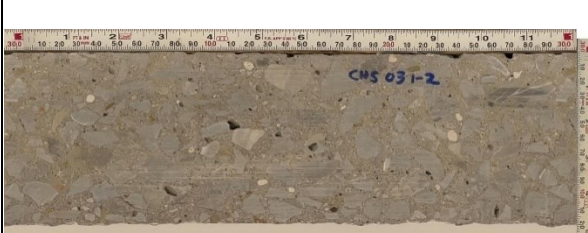
Core	dia. x height (in.)	Rebar depth (in.)	Rebar size (#)	Epoxy (Y/N)	Crack type	Crack width (in)	Notes
1-1	3.75 x 4.2	-	-	-	longitudinal	0.004	-
1-2	3.75 x 4.1	-	-	-	-	-	Delamination between CIP and PCP; A crack propagates from CIP and PCP intersection
1-3	3.75 x 4.1	-	-	-	-	-	Delamination between CIP and PCP
1-4	3.75 x 3.9	2.9	5	Y	-	-	A void near rebar; Delamination between CIP and PCP
2-1	3.75 x 3.7	-	-	-	longitudinal	0.004	A crack propagates along intersection of aggregates
2-2	3.75 x 3.7	2	5	Y	transverse	0.004	A crack propagates from rebar
2-3	3.75 x 3.7	-	-	-	-	-	-
2-4	3.75 x 3.7	-	-	-	-	-	-

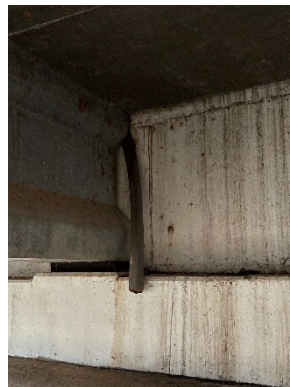
Figure 0.169. Deteriorations on the Bridge: Hairline Cracks on Abutment

There were hairline cracks on abutment backwall as shown in Figure 0.169.

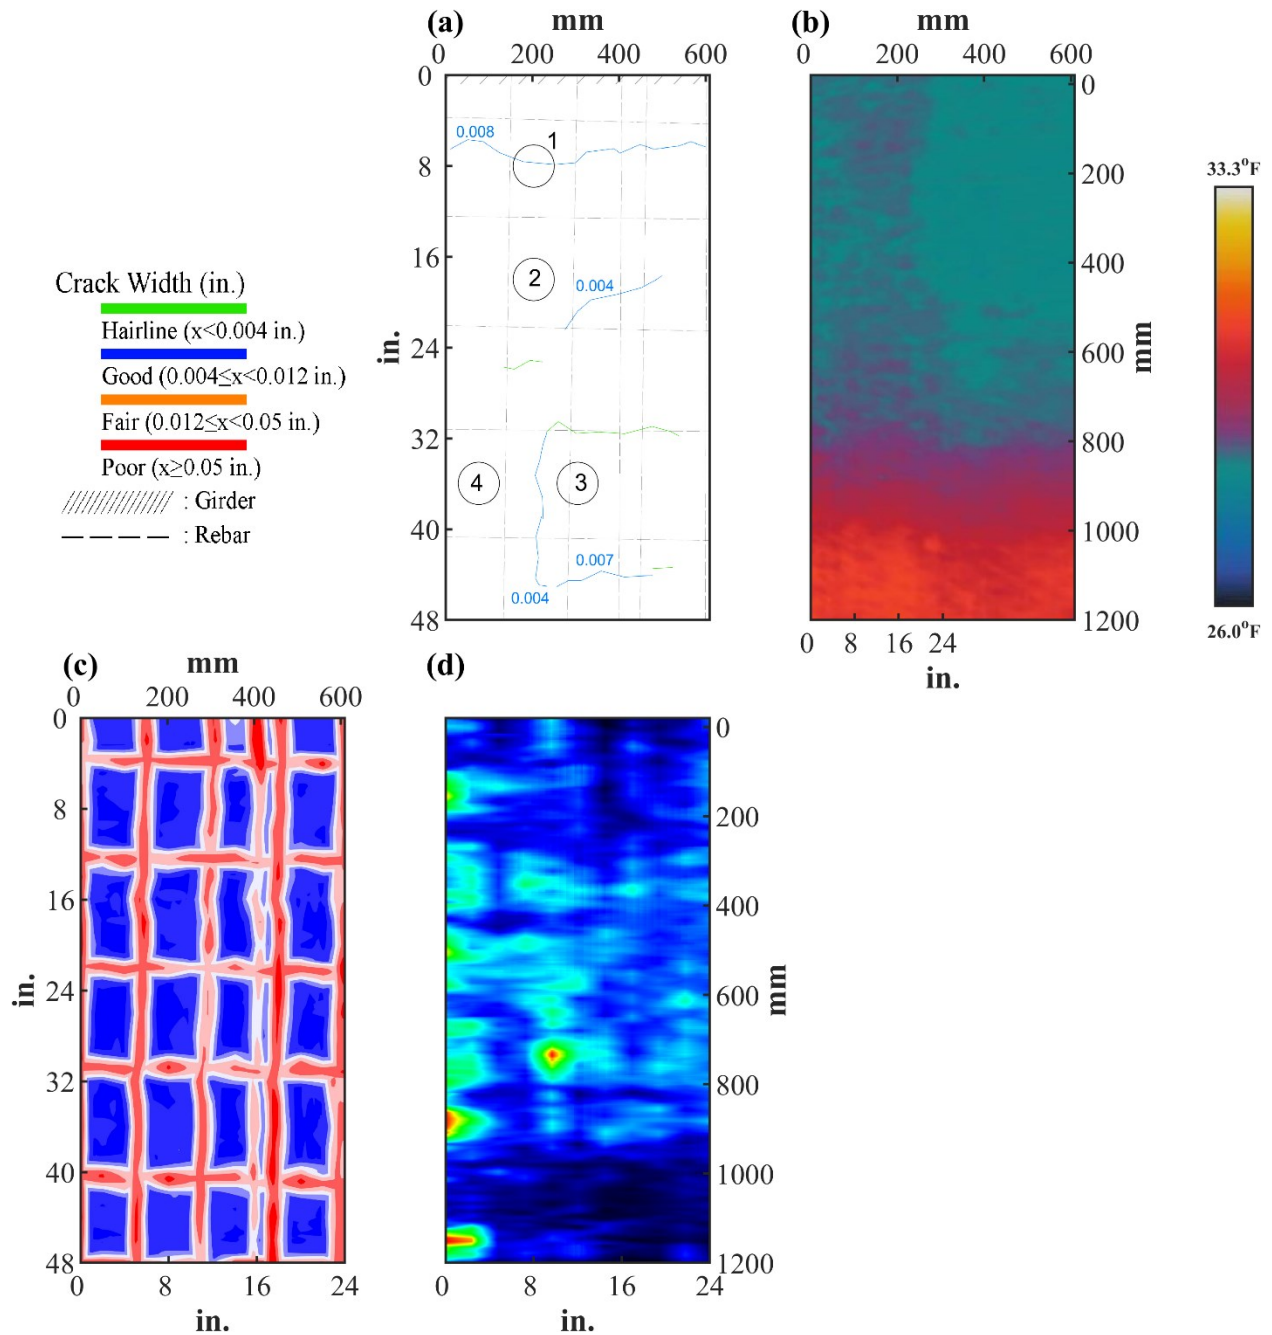
Figure 0.171. NDE Results of Grid 1: (a) Crack Map and Location of Cores; (b) Infrared Picture; (c) GPR C-scan at 1.25 in. to 3.15 in. Depth; (d) UST C-scan at 4.0 in. Depth

As shown in Figure 0.171 (a), grid 1 had a 0.008 in. wide longitudinal crack, maybe caused by panel joints, and some cracks that are 0.004 in. and 0.007 in. wide. On grid 2, there wasn't any cracks as shown in Figure 0.172 (a).

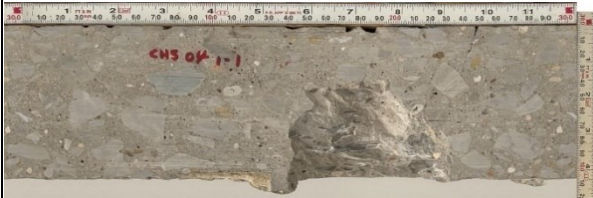
Core	Pictures of the Cores		
1-1

Core	dia. x height (in.)	Rebar depth (in.)	Rebar size (#)	Epoxy (Y/N)	Crack type	Crack width (in)	Notes
1-1	3.75 x 3.9	-	-	-	longitudinal	0.008	Delamination between CIP and PCP
1-2	3.75 x 3.9	-	-	-	-	-	Delamination between CIP and PCP
1-3	3.75 x 3.9	2	5	Y	-	-	Delamination between CIP and PCP
1-4	3.75 x 4.3	-	-	-	-	-	Delamination between CIP and PCP
2-1	3.75 x 4.3	-	-	-	-	-	Delamination between CIP and PCP
2-2	3.75 x 4.3	2	5	Y	-	-	Delamination between CIP and PCP
2-3	3.75 x 4.3	-	-	-	-	-	Delamination between CIP and PCP
2-4	3.75 x 4.1	-	-	-	-	-	Delamination between CIP and PCP

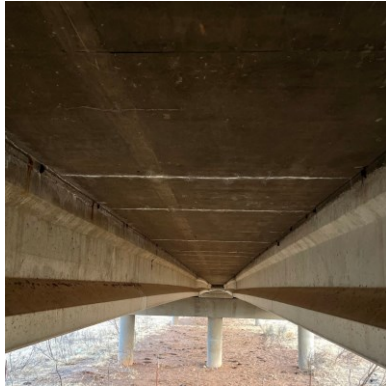
Moderate shrinkage cracks are found on the bottom of deck as shown in the Figure 0.177 (a). There were some cracks and delamination of asphalt overlay on the deck as shown in Figure 0.177 (b).

Figure 0.177. Deteriorations on the Bridge: (a) Moderate Cracks on Bottom Surface of Deck; (b) Cracks and Delamination of Asphalt Overlay

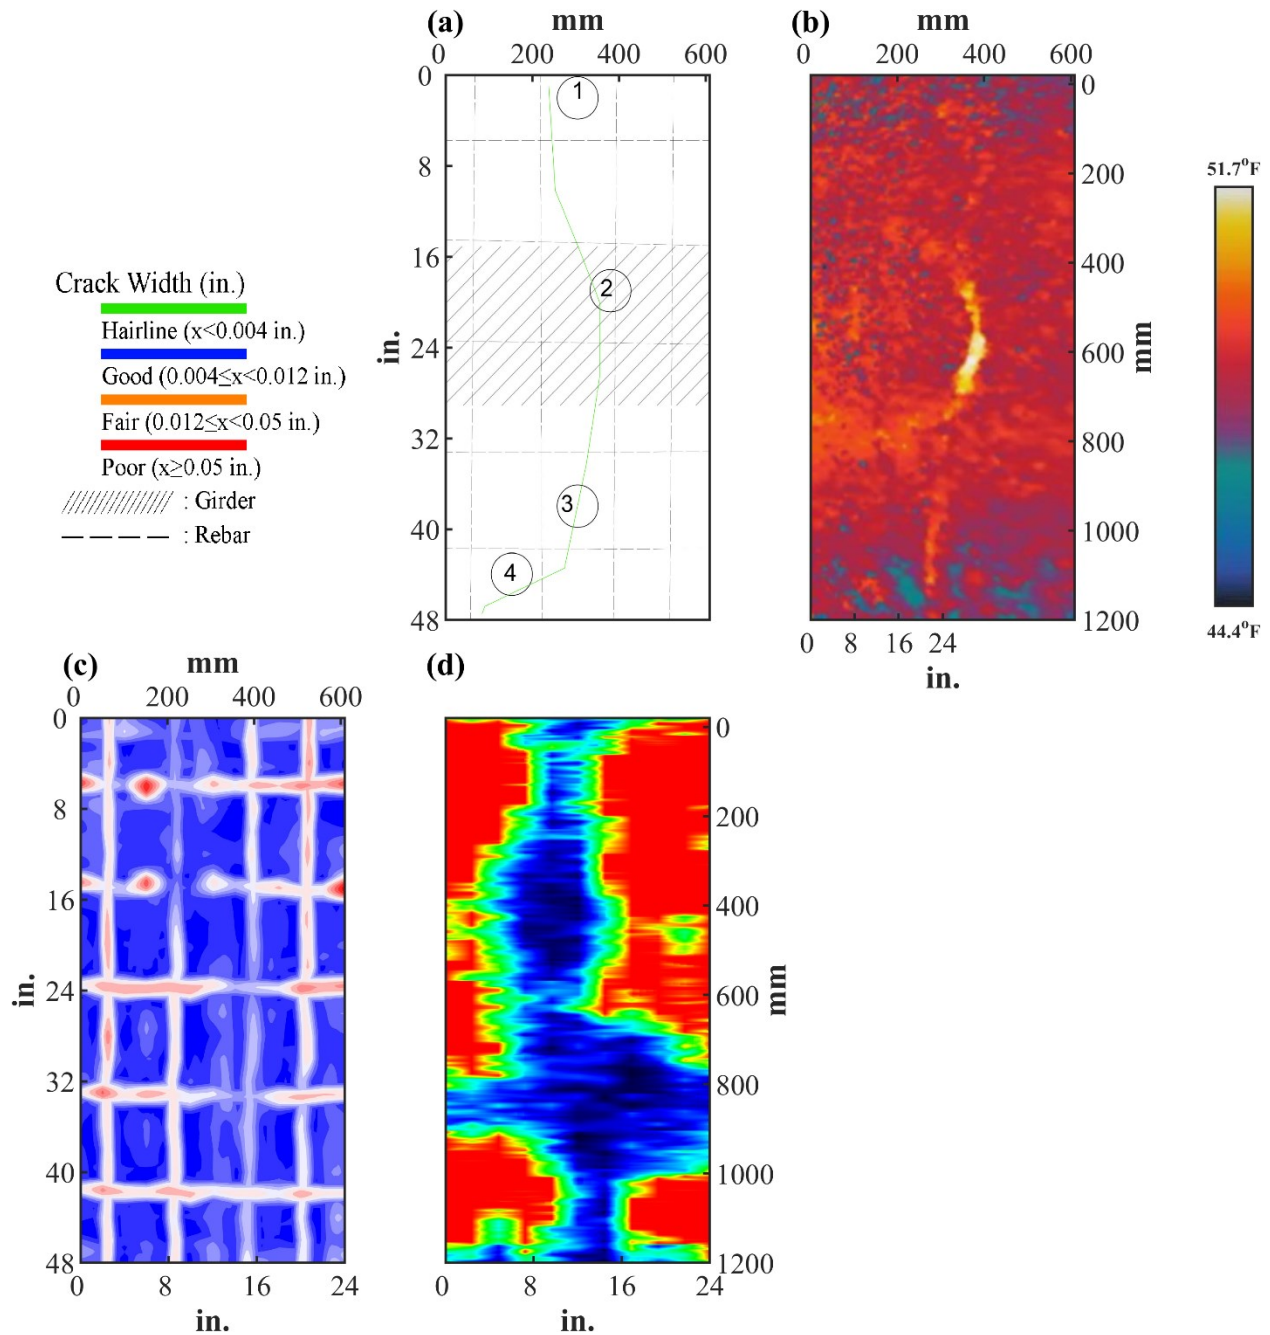
As shown in Figure 0.179 (a) and Figure 0.180 (a), both grid 1 and 2 had only one hairline crack.

Figure 0.179. NDE Results of Grid 1: (a) Crack Map and Location of Cores; (b) Infrared Picture; (c) GPR C-scan at 4.4 in. to 6.4 in. Depth; (d) UST C-scan at 2.4 in. Depth

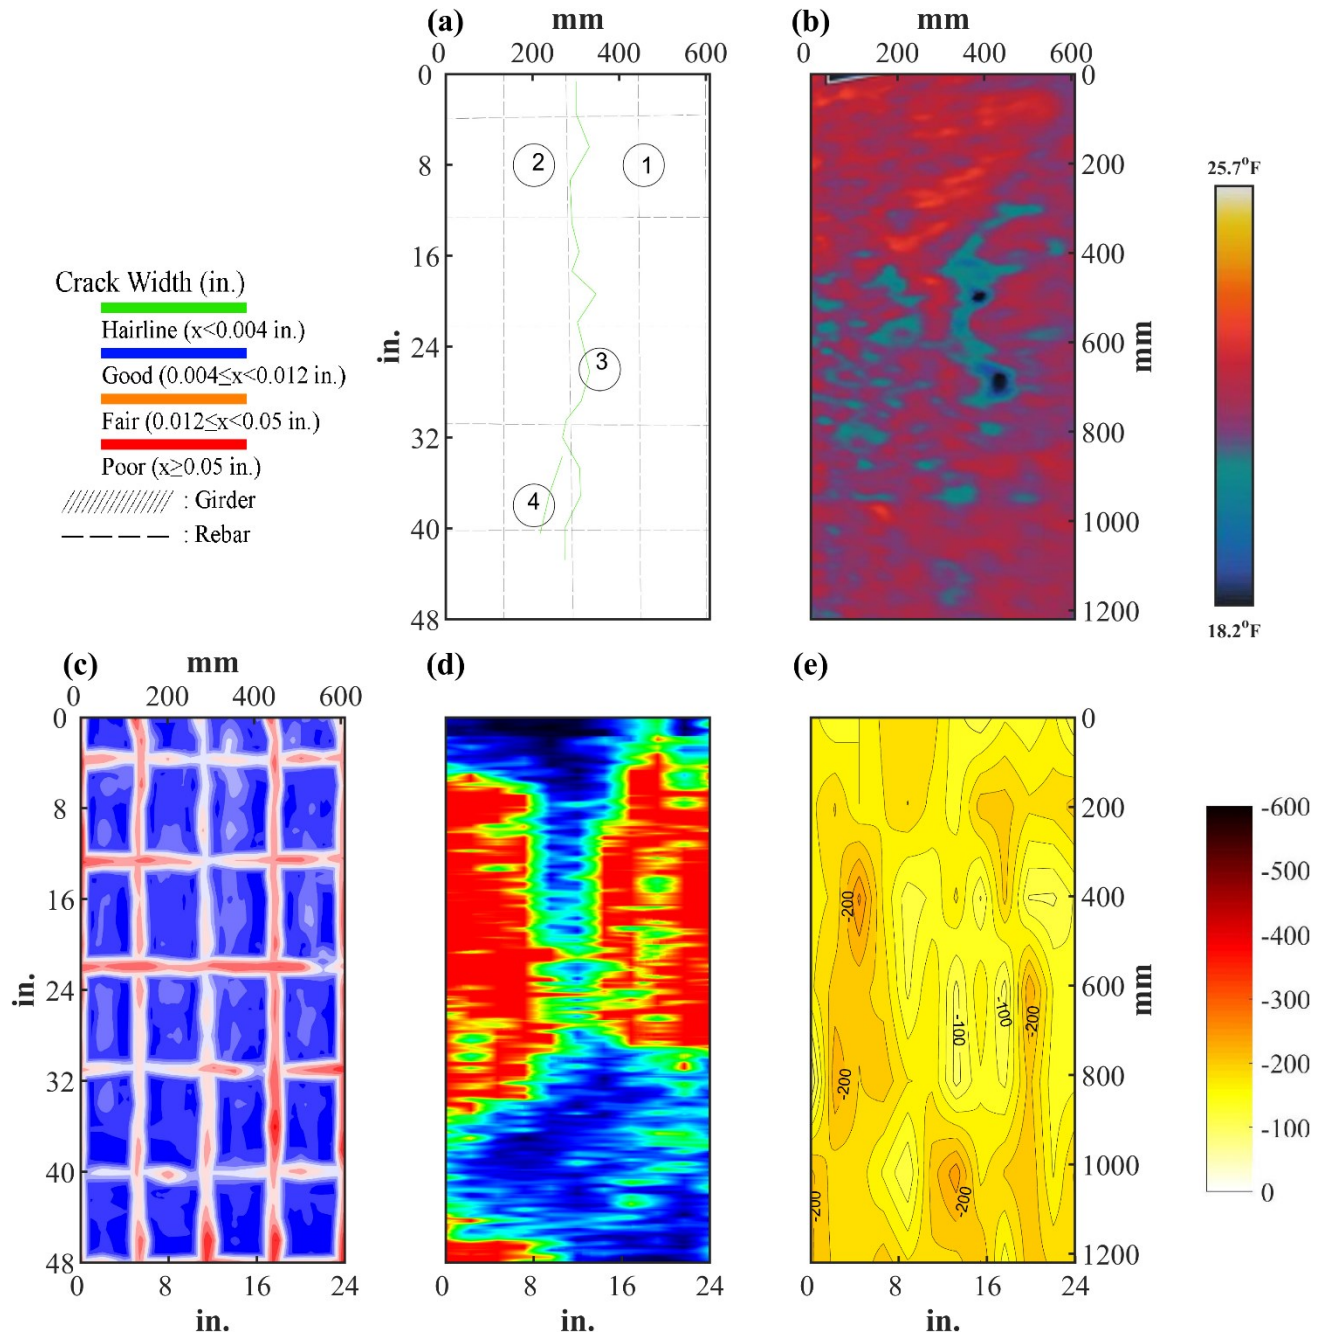
Figure 0.180. NDE Results of Grid 2: (a) Crack Map and Location of Cores; (b) Infrared Picture; (c) GPR C-scan at 4.1 in. to 6.3 in. Depth; (d) UST C-scan at 2.4 in. Depth; (e) Corrosion Rate Map

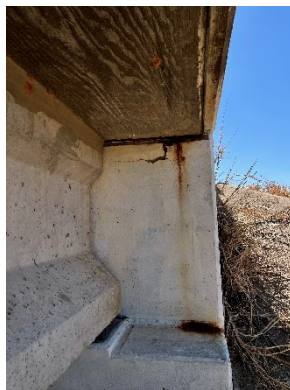
Deck surface has moderate transverse and longitudinal cracks. There are moderate cracks on the abutment backwalls as shown in

Figure 0.185. Deteriorations on the Bridge: (a) Cracks at Abutment Backwall
