Evaluation of Corrosion Prevention and Mitigation Approaches Used on Texas Bridges—Volume 2: Reinforced Concrete Bridges

Technical Report 0-7040-R1-Vol2

TEXAS A&M TRANSPORTATION INSTITUTE
COLLEGE STATION, TEXAS

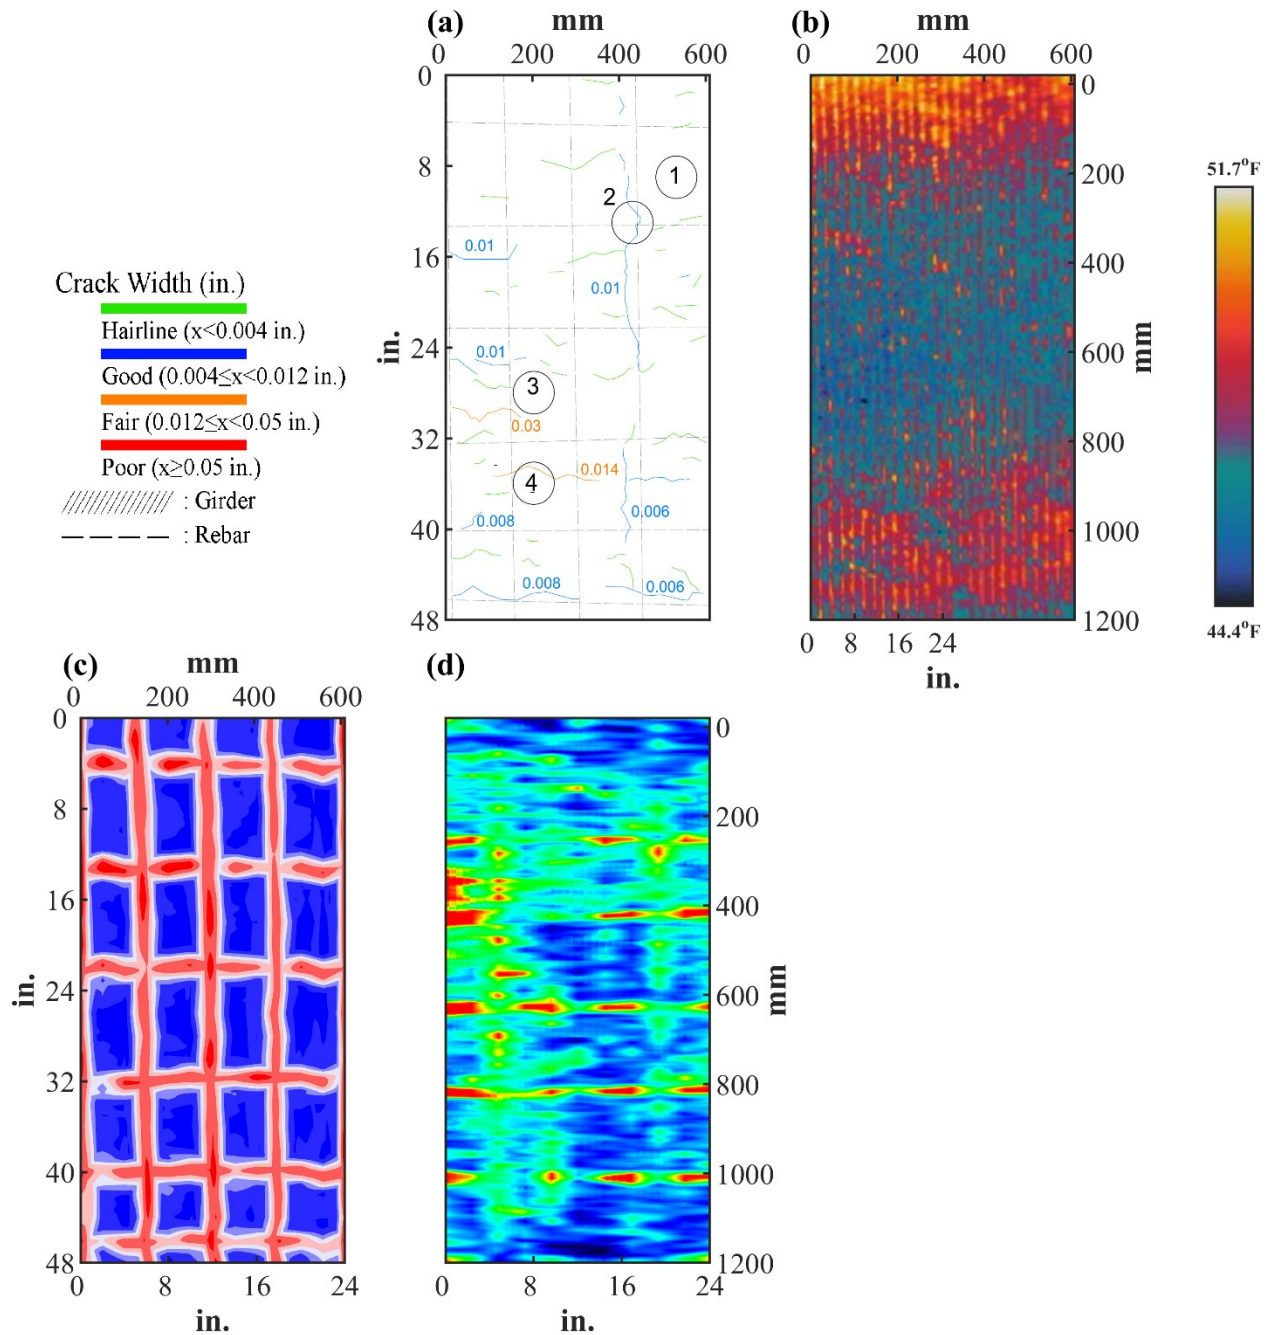
As shown in Figure 0.187 (a), there are widespread of transverse and longitudinal cracks with them width ranging from 0.006 in. to 0.03 in. wide on grid 1. On grid 2, there are longitudinal and diagonal cracks, and they are 0.01 in. and 0.012 in., and 0.01 in. wide, respectively, as shown in Figure 0.188 (a).

Figure 0.187. NDE Results of Grid 1: (a) Crack Map and Location of Cores; (b) Infrared Picture; (c) GPR C-scan at 1.25 in. to 3.15 in. Depth; (d) UST C-scan at 6.3 in. Depth

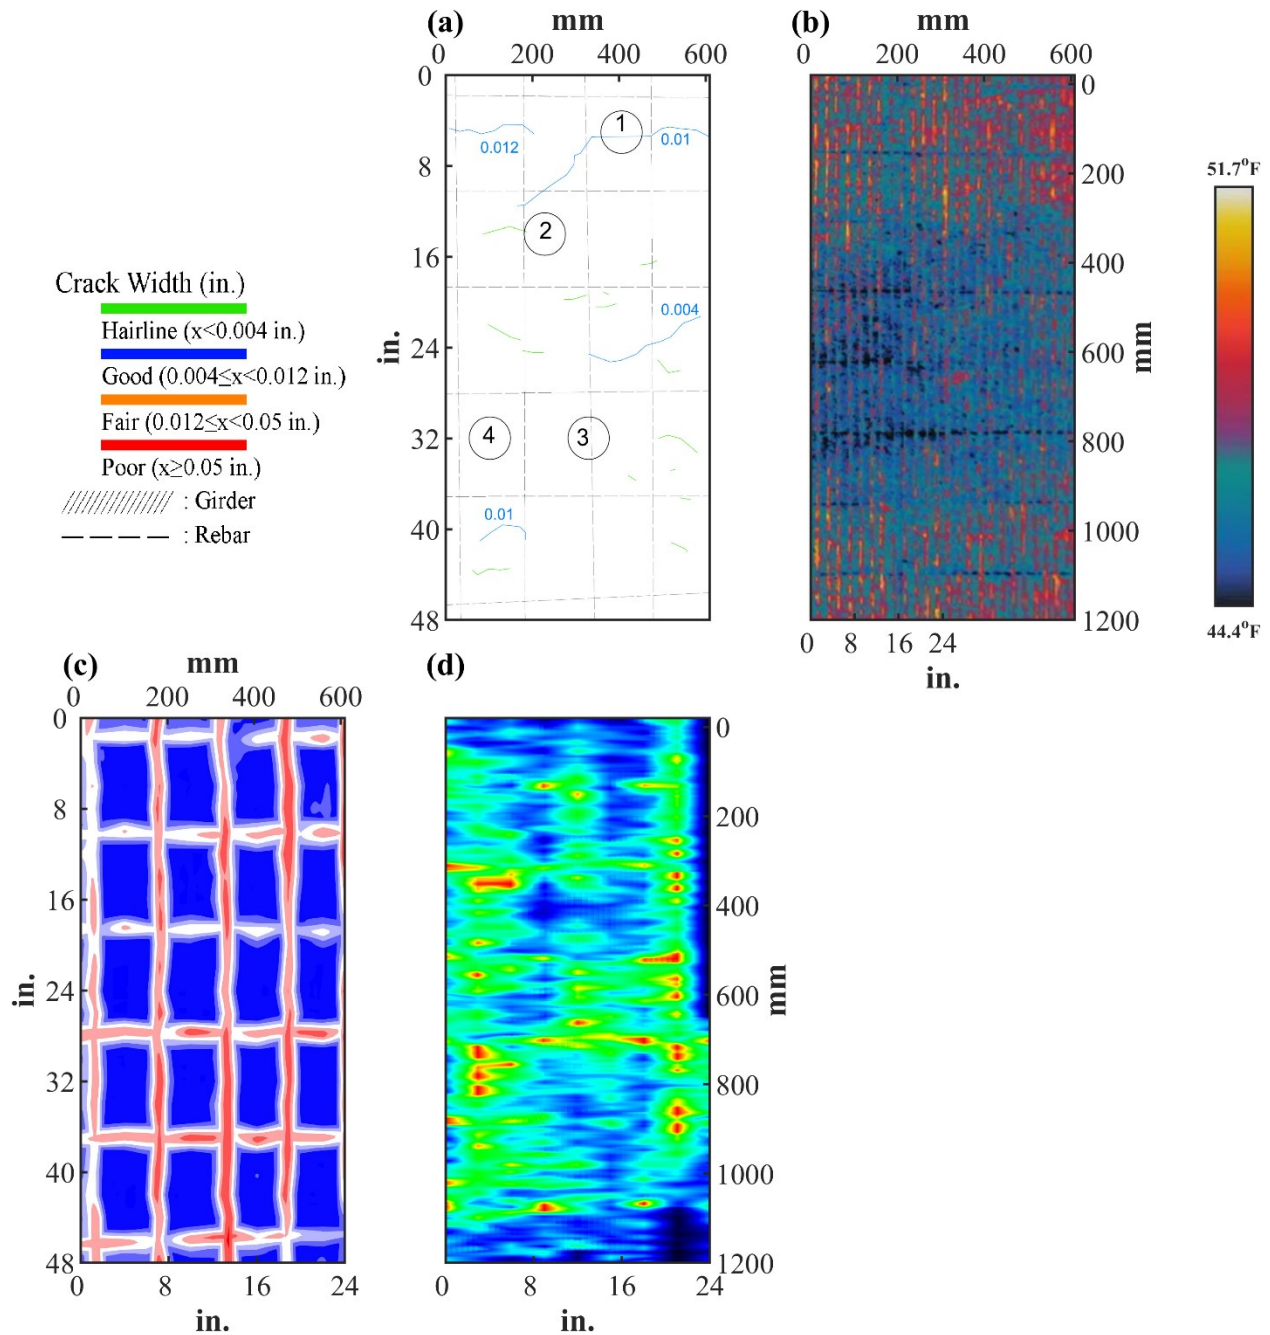
Figure 0.188. NDE Results of Grid 2: (a) Crack Map and Location of Cores; (b) Infrared Picture; (c) GPR C-scan at 1.25 in. to 3.15 in. Depth; (d) UST C-scan at 2.4 in. Depth

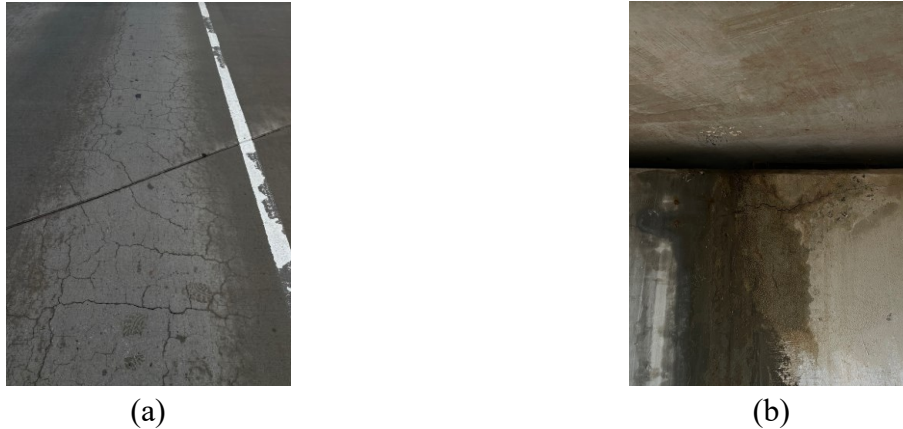
There are isolated transverse and longitudinal hairline cracks that are propagating from a joint as shown in Figure 0.193 (a). The leakage and cracks are found on the abutment as shown in Figure 0.193 (b).

Figure 0.193. Deterioration on the Bridge: (a) Map Cracks Propagating from a Joint; (b) Cracks and Leakage at Abutment

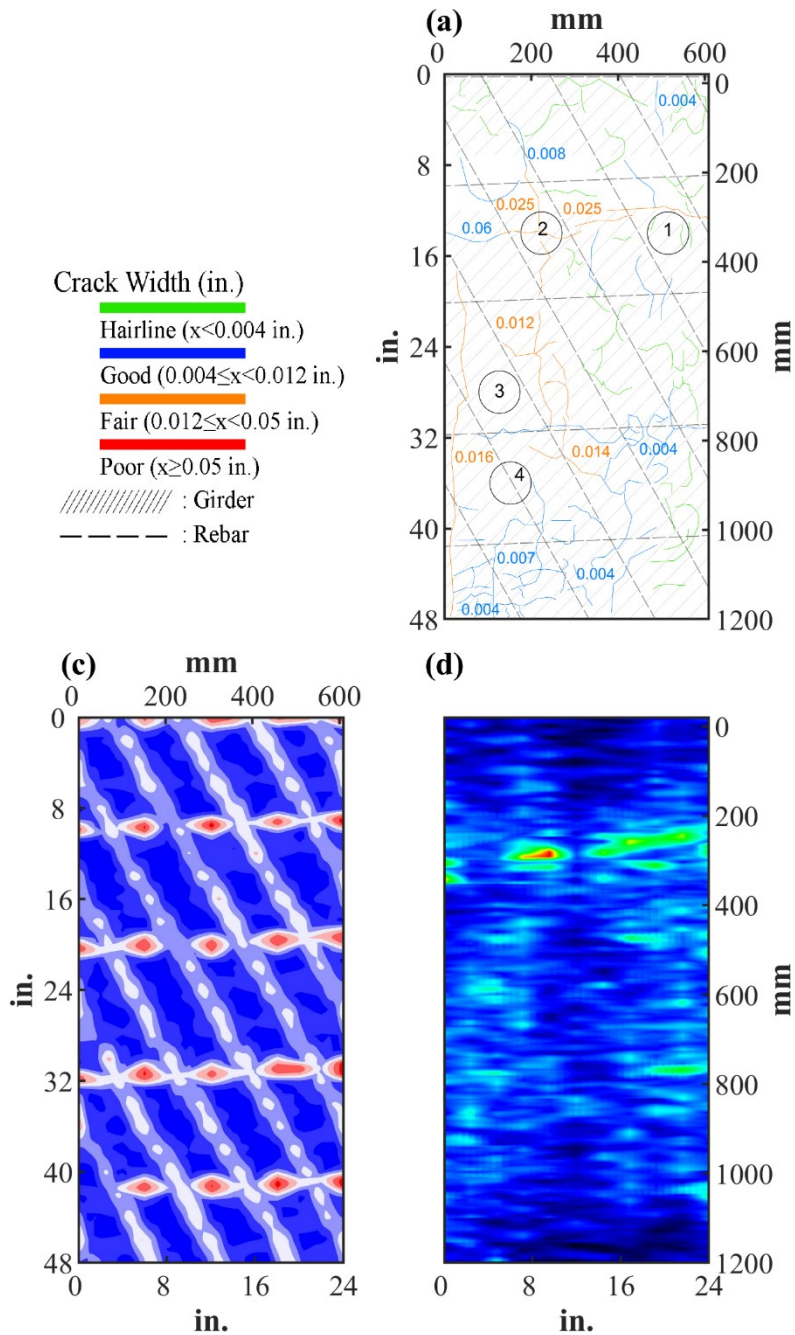
As shown in Figure 0.195 (a), there are widespread of hairline cracks and cracks that are 0.004 in. to 0.025 in. wide on grid 1. Map, transverse, and longitudinal cracks exist on grid 1. On grid 2, there are widespread of hairline cracks, and transverse cracks that are 0.004 in. to 0.012 in. wide as shown in Figure 0.196.

Figure 0.195. Crack Map and NDE Results of Grid 1: (a) Crack map and Location of Cores; (c) GPR C-scan at 1.5 in. to 3.2 in. Depth; (d) UST C-scan at 2.0 in. Depth

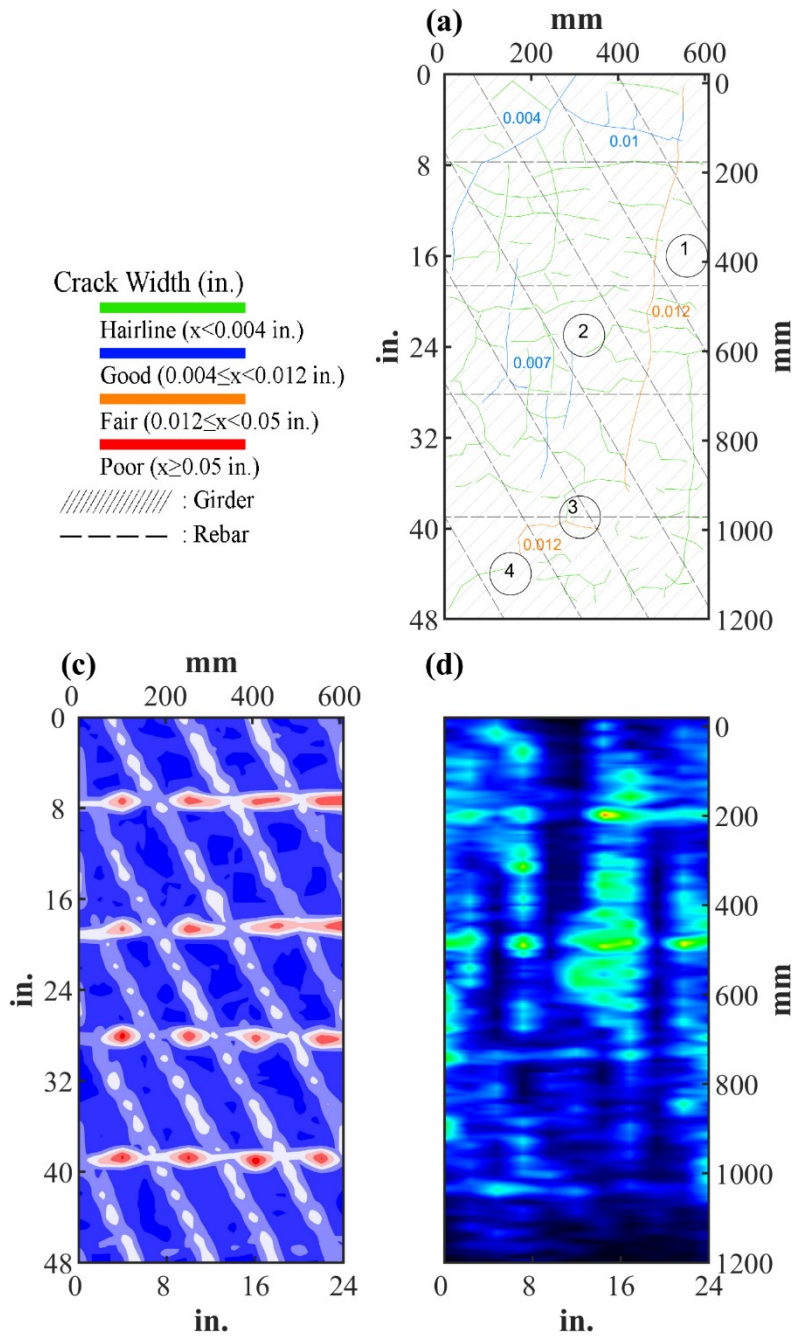
Figure 0.196. Crack Map and NDE Results of Grid 2: (a) Crack map and Location of Cores; (c) GPR C-scan at 2.55 in. to 4.0 in. Depth; (d) UST C-scan at 3.3 in. Depth

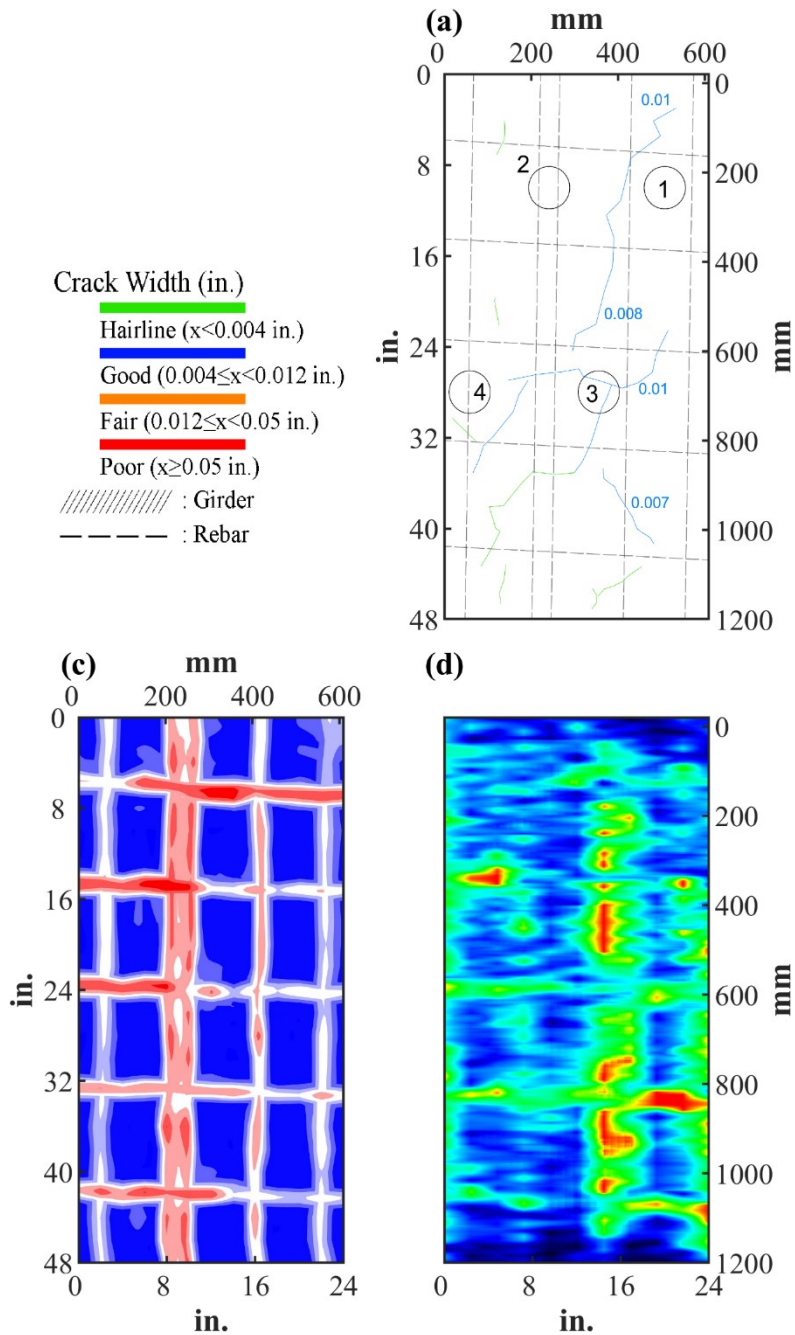
Figure 0.202. Crack Map and NDE Results of Grid 1: (a) Crack map and Location of Cores; (b) Infrared Picture; (c) GPR C-scan at 3.8 in. to 5.2 in. Depth; (d) UST C-scan at 4.3 in. Depth

As shown in Figure 0.202 (a), there are transverse and diagonal cracks that are 0.007 in. to 0.01 in. wide on grid 1. On grid 2, there were only hairline cracks and 0.004 in. wide cracks as shown in Figure 0.203 (a).

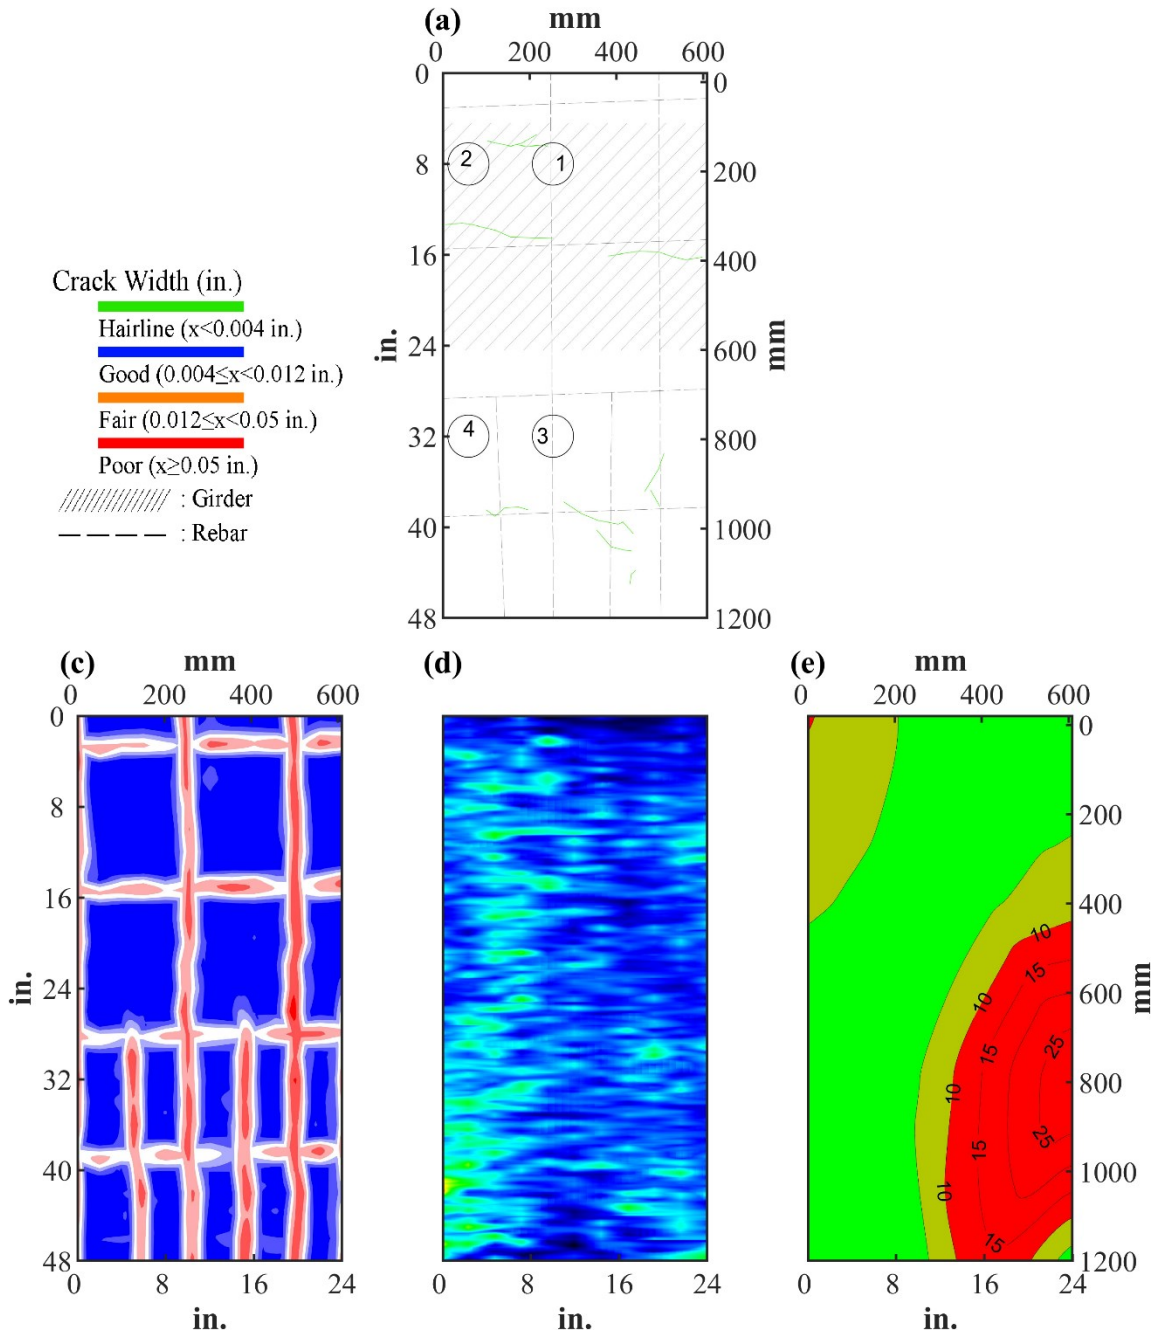
Figure 0.209. Crack Map and NDE Results of Grid 1: (a) Crack map and Location of Cores; (b) Infrared Picture; (c) GPR C-scan at 1.0 in. to 2.4 in. Depth; (d) UST C-scan at 2.0 in. Depth; (e) Corrosion Rate Map

As shown in Figure 0.209 (a), only hairline cracks were visible on grid 1. On grid 2, 0.004 in. wide transverse cracks were visible as shown in Figure 0.210 (a).

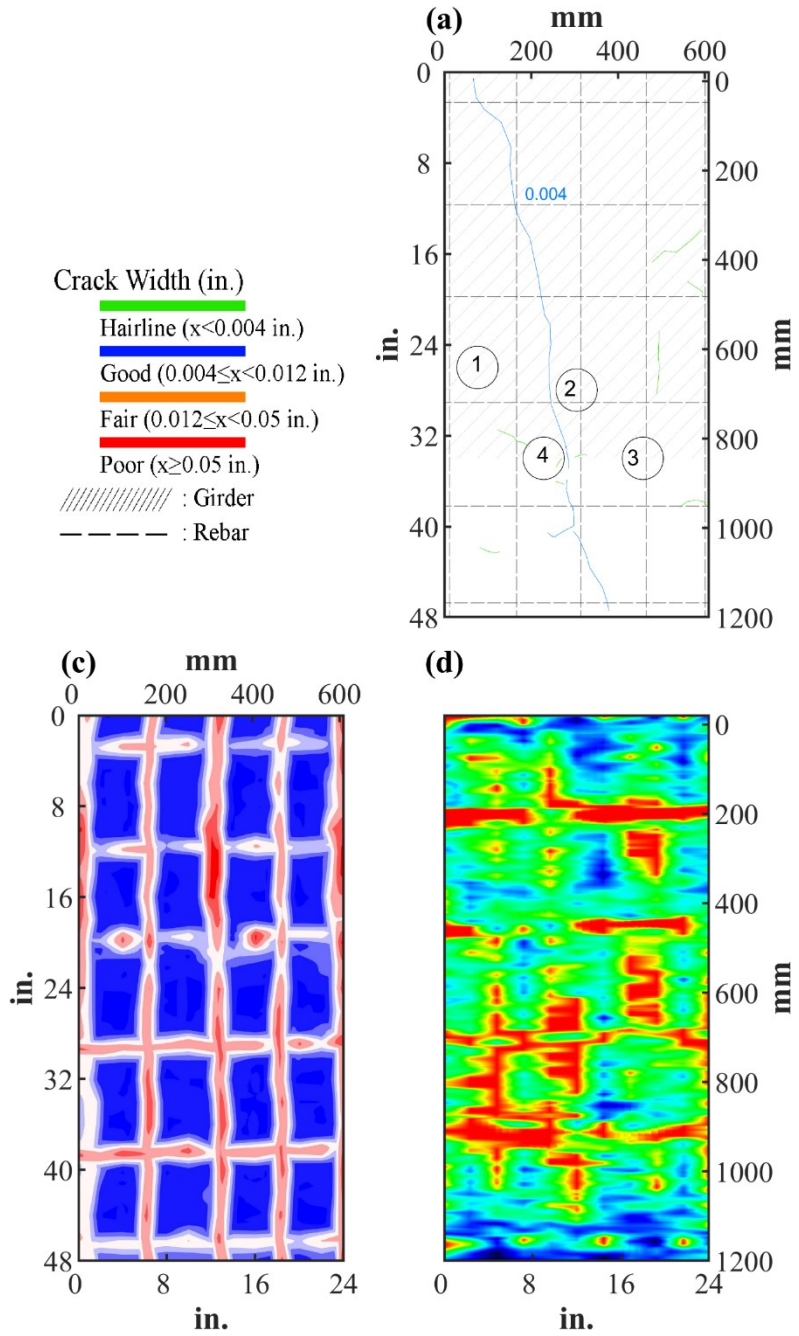
Figure 0.216. Crack Map and NDE Results of Grid 1: (a) Crack map and Location of Cores; (c) GPR C-scan at 2.6 in. to 4.0 in. Depth; (d) UST C-scan at 3.4 in. Depth

As shown in Figure 0.216 (a), one 0.004 in. wide transverse crack was visible on grid 1. On grid 2, there were two short transverse crack that are 0.004 in. wide as shown in Figure 0.217 (a).

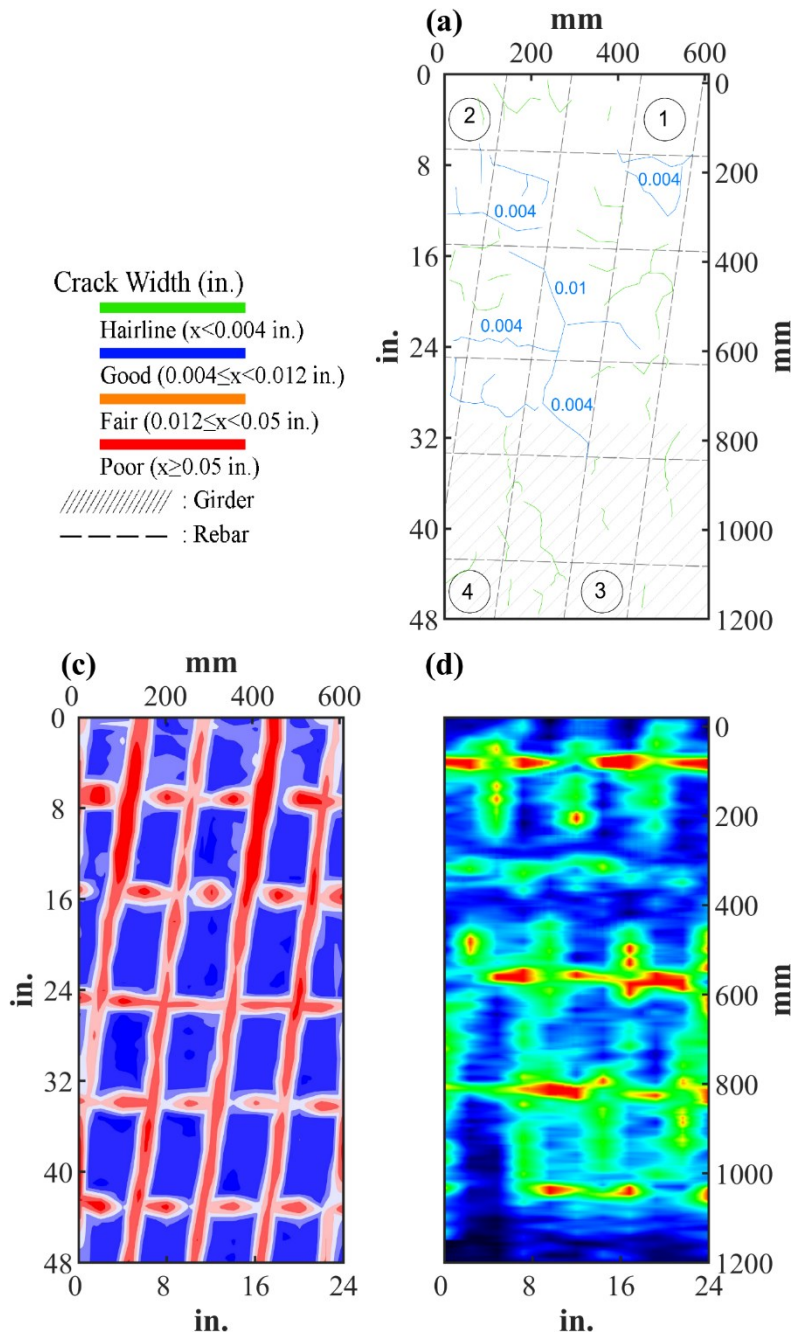
Figure 0.223. Crack Map and NDE Results of Grid 1: (a) Crack map and Location of Cores; (c) GPR C-scan at 2.3 in. to 3.5 in. Depth; (d) UST C-scan at 3.7 in. Depth

As shown in Figure 0.223 (a), there are widespread of hairline cracks and cracks ranging from 0.004 in. to 0.01 in. wide. 0.01 in wide crack was in transverse direction and 0.004 in. cracks were mostly in longitudinal direction on grid 1. On grid 2, most of the cracks were in longitudinal direction and their width ranged from 0.004 in. to 0.025 in. wide as shown in Figure 0.224 (a).

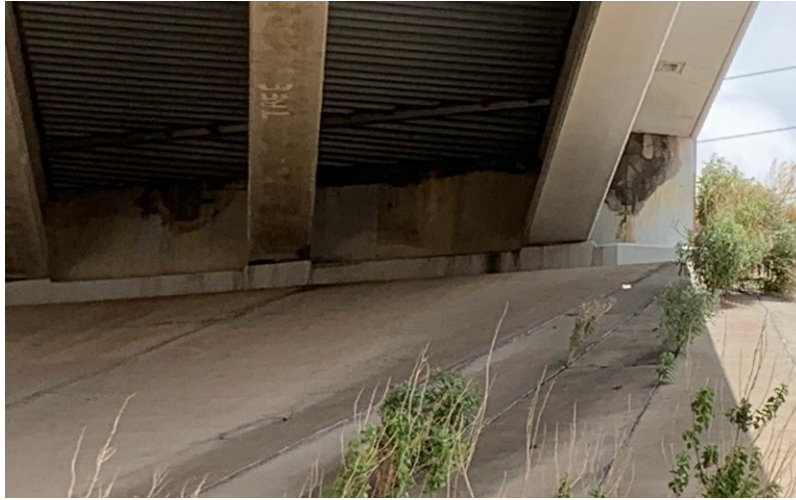
Figure 0.229. Corrosion at metal deck form and abutment

There are transverse and longitudinal hairline to minor cracks on the top surface of deck. The joint is partially failed and full of debris. The concrete railing has minor vertical cracks. Obvious soot stains are found on the beams over the railroad tracks. The metal deck form at the end of abutment has serious corrosion. The abutment has deep spalling and exposed rebar as shown in Figure 0.229

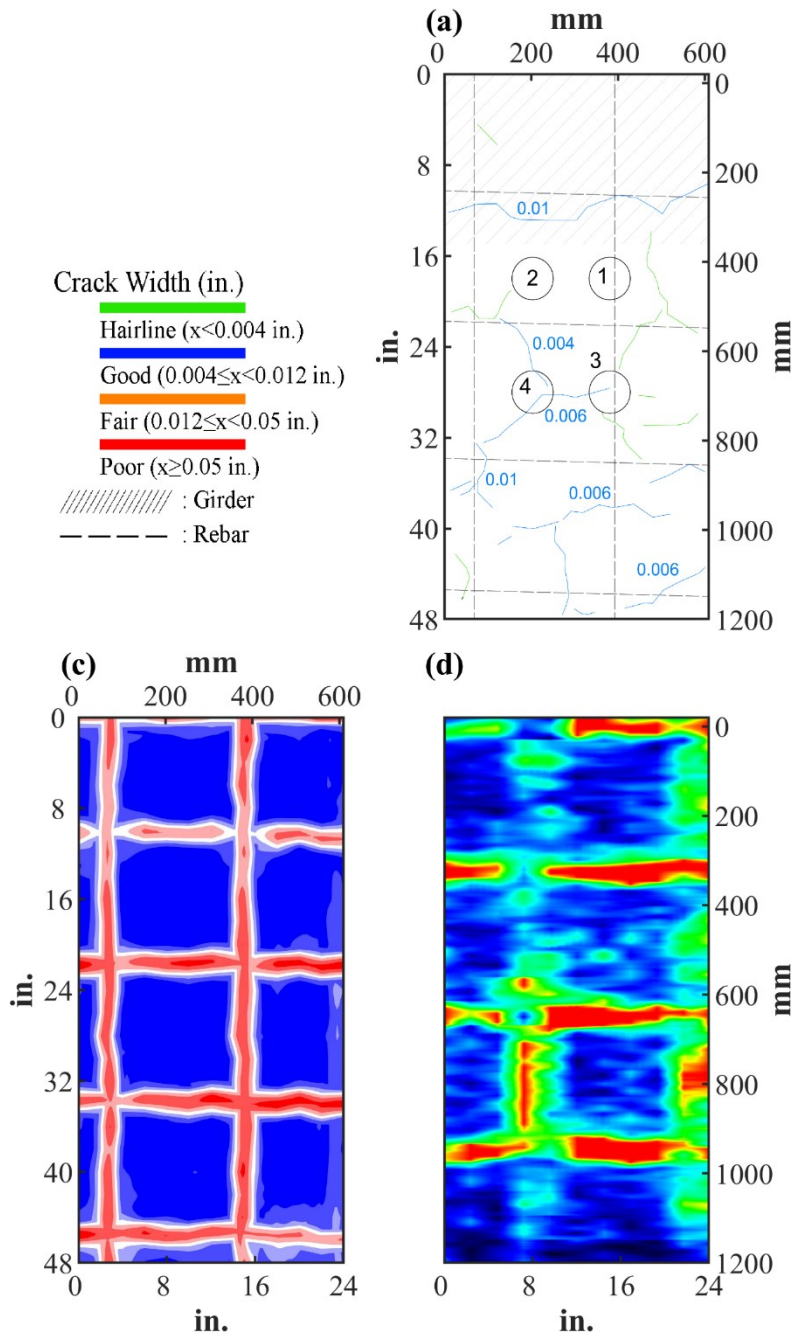
Figure 0.231. Crack Map and NDE Results of Grid 1: (a) Crack map and Location of Cores; (c) GPR C-scan at 2.2 in. to 3.6 in. Depth; (d) UST C-scan at 4.2 in. Depth

As shown in Figure 0.231 (a), there were widespread of cracks range from 0.004 in. to 0.01 in. wide on grid 1. There was one 0.01 in. wide crack that was caused by girder. On grid 2, there were cracks ranging from 0.004 in. to 0.008 in. wide. The direction of cracks was transverse, longitudinal, and diagonal as shown in Figure 0.232 (a).

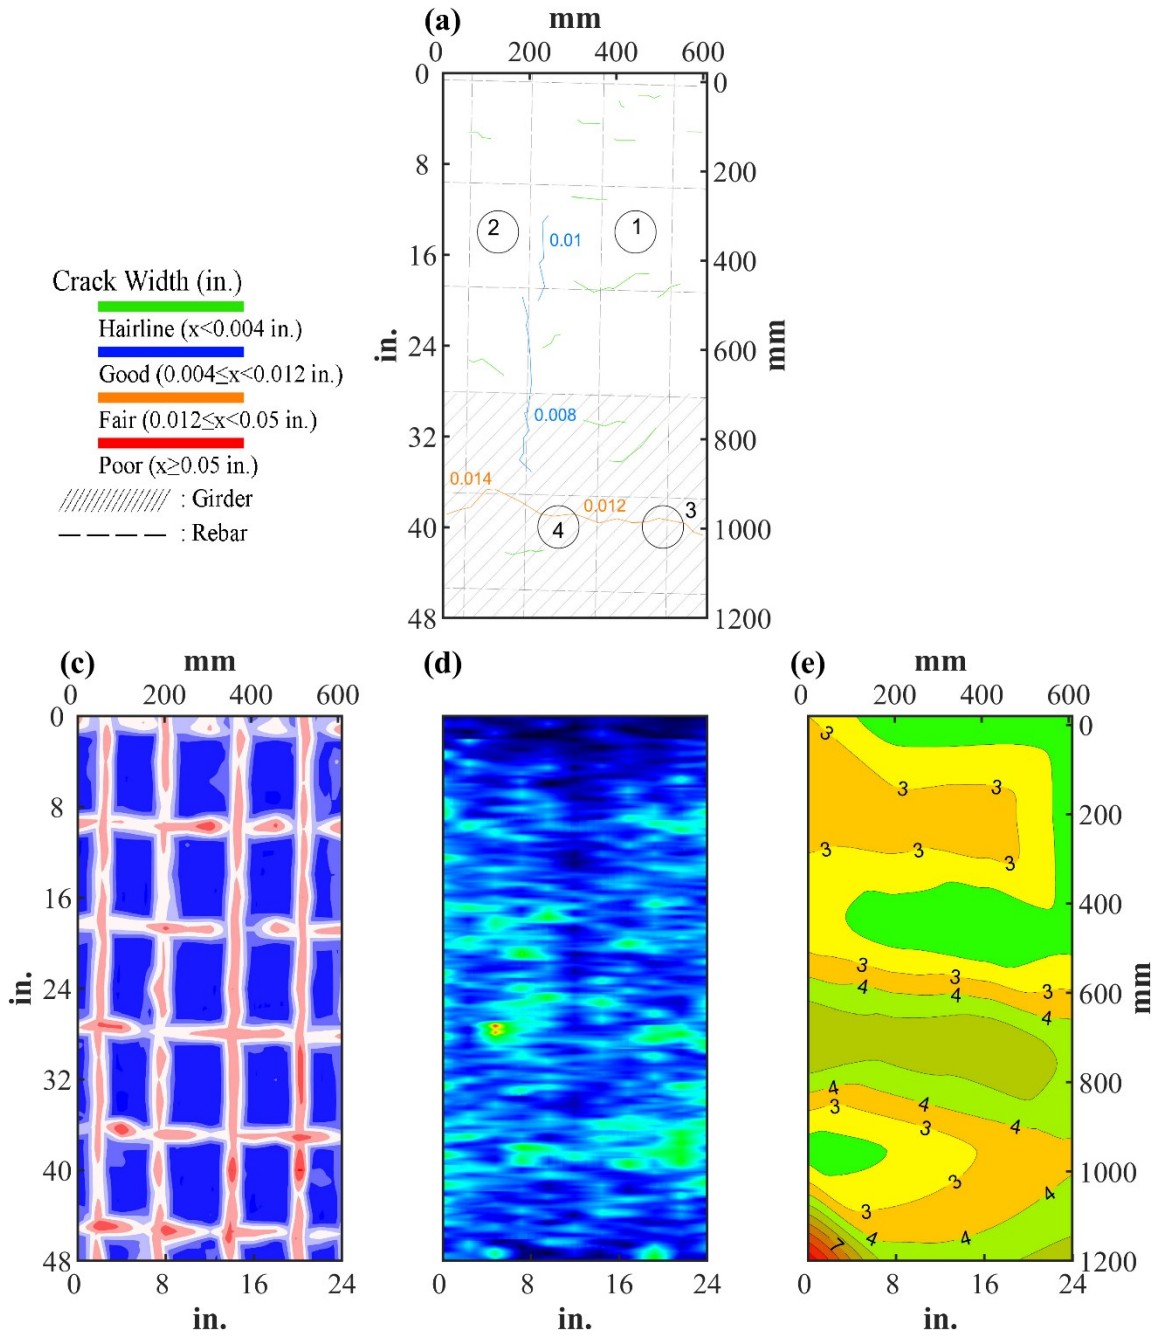
Figure 0.238. Crack Map and NDE Results of Grid 1: (a) Crack map and Location of Cores; (b) Infrared Picture; (c) GPR C-scan at 1.9 in. to 3.3 in. Depth; (d) UST C-scan at 3.9 in. Depth; (e) Corrosion Rate Map

As shown in Figure 0.238 (a), there was one 0.012 in. to 0.014 in wide longitudinal crack on top of a girder and transverse cracks that were 0.008 in and 0.01 in. wide on grid 1. On grid 2, there were no cracks as shown in Figure 0.239 (a).

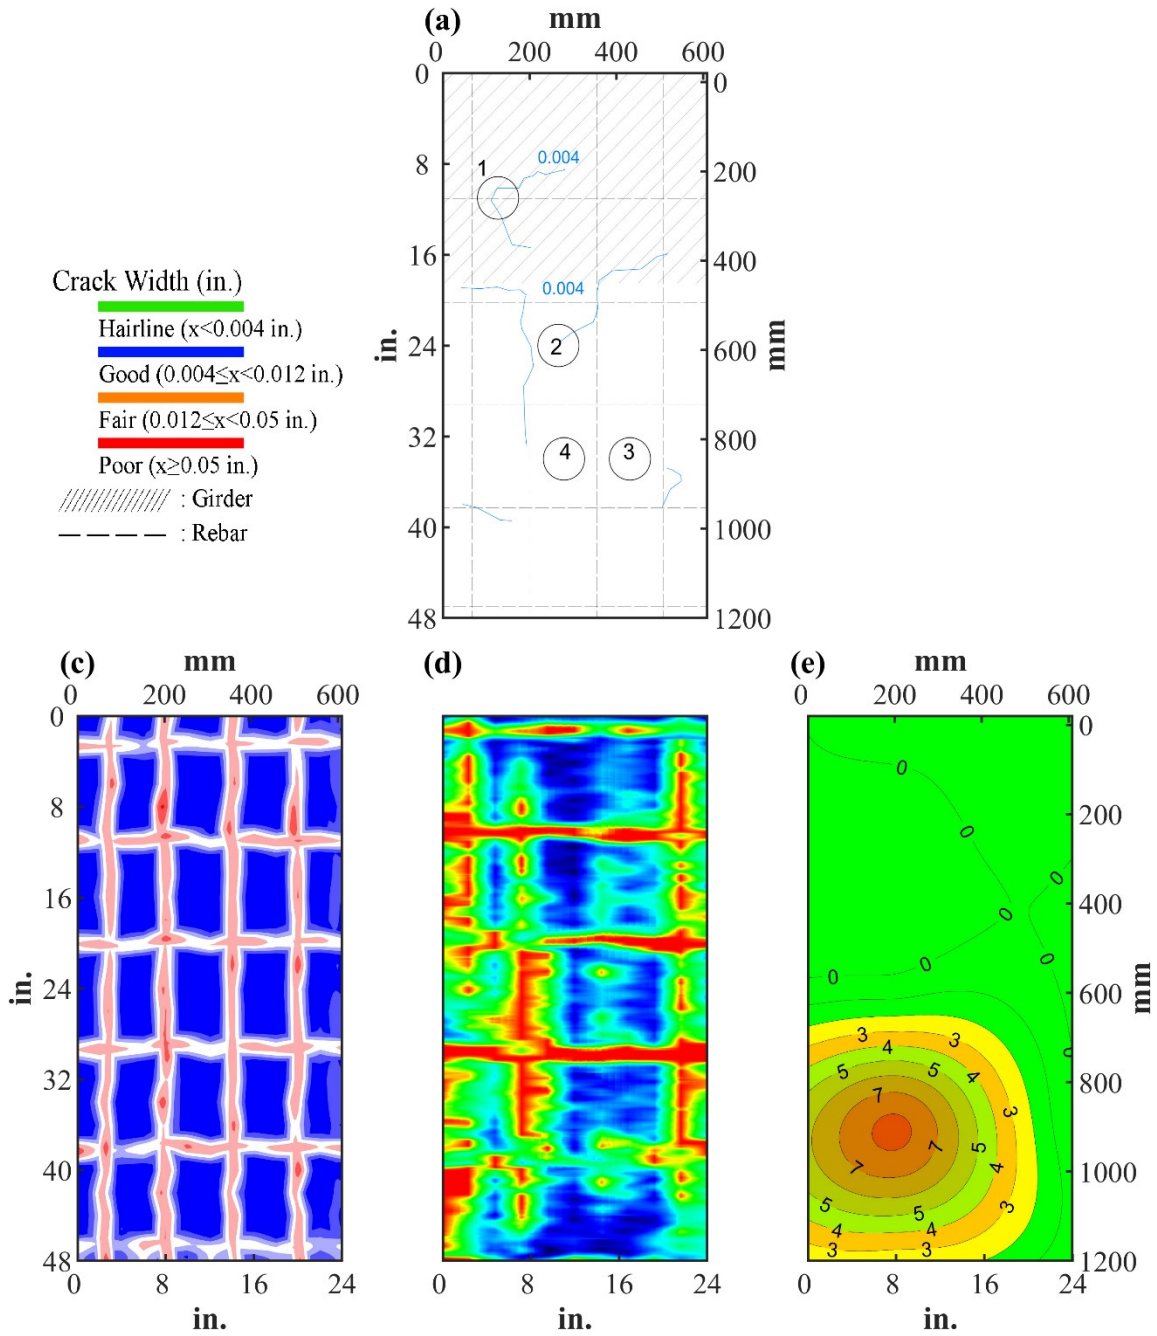
Figure 0.245. Crack Map and NDE Results of Grid 1: (a) Crack map and Location of Cores; (b) Infrared Picture; (c) GPR C-scan at 1.9 in. to 3.3 in. Depth; (d) UST C-scan at 3.5 in. Depth; (e) Corrosion Rate Map

As shown in Figure 0.245 (a), 0.004 in. wide cracks were visible on grid 1. Grid 2 was located on the joint, and 0.004 in. and 0.006 in wide cracks were propagating from the joint. In addition, there was a short diagonal crack that was 0.012 wide as shown in Figure 0.246 (a).

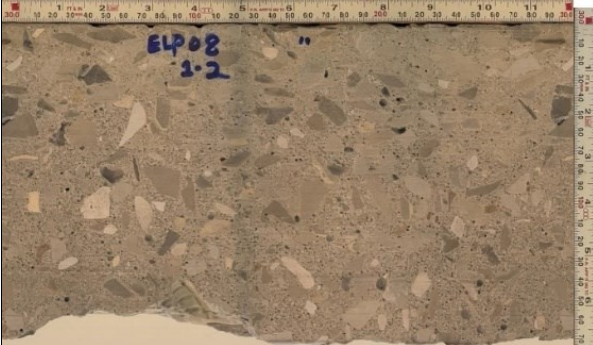
Core	dia. x height (in.)	Rebar depth (in.)	Rebar size (#)	Epoxy (Y/N)	Crack type	Crack width (in)	Notes
1-1	3.75 x 6.9	3.1	4	Y	transverse	0.004	-
1-2	3.75 x 6.3	-	-	-	map	0.004	0.08 in. diagonal void at 8.5 in. depth
1-3	3.75 x 7.1	-	-	-	-	-	-
1-4	3.75 x 7.6	-	-	-	-	-	-
2-1	3.75 x 3.9	-	-	-	-	-	0.4 in. void at 4.7 in. depth
2-2	3.75 x 3.9	-	-	-	-	-	-
2-3	3.75 x 7.0	2.6	5	Y	diagonal	0.012	-
2-4	3.75 x 3.9	3.3	4	Y	-	-	-

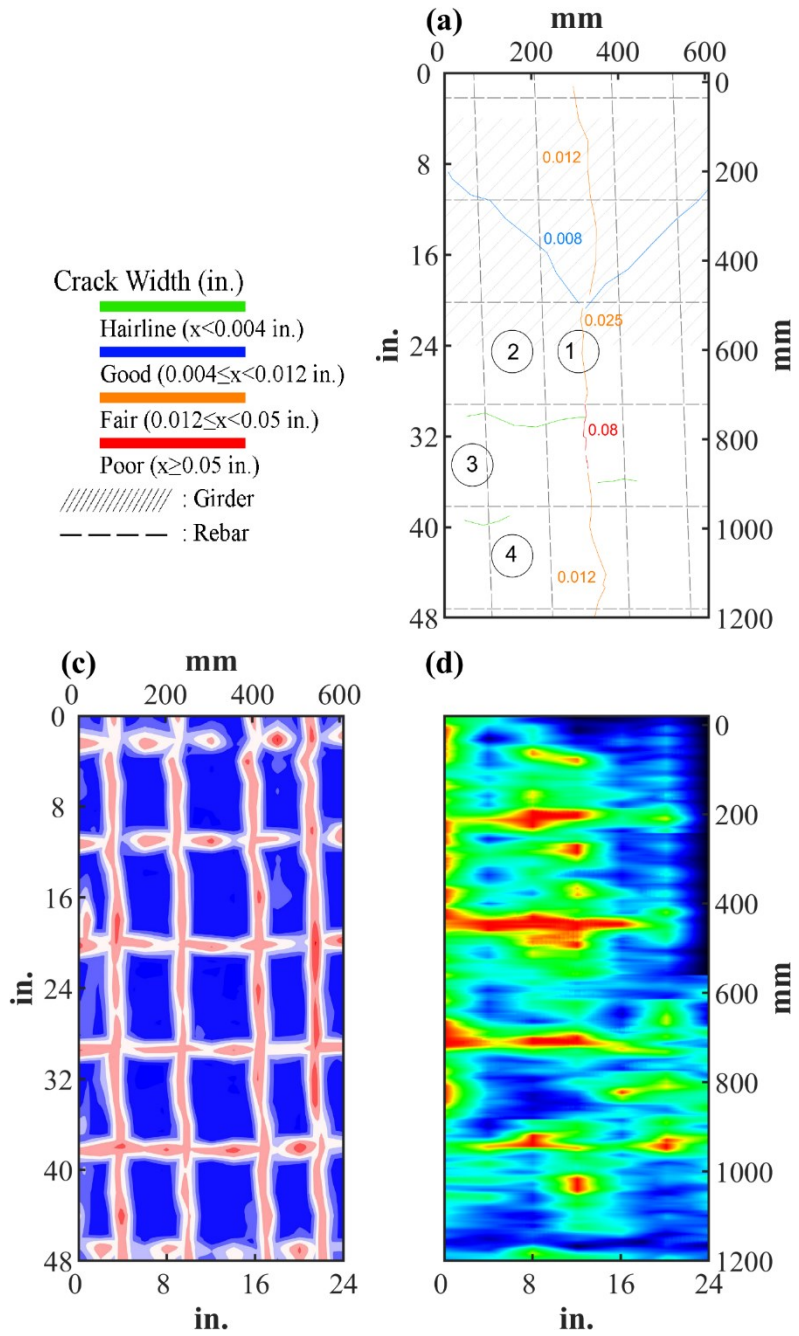
Figure 0.252. Crack Map and NDE Results of Grid 1: (a) Crack Map and Location of Cores; (c) GPR C-scan at 2.0 in. to 3.2 in. Depth; (d) UST C-scan at 4.1 in. Depth

As shown in Figure 0.252 (a), there were two diagonal cracks that were 0.008 in. wide and one transverse crack that ranged from 0.012 in. to 0.08 in. wide on grid 1. On grid 2, one 0.004 in. wide longitudinal crack and 0.012 in. wide transverse crack were visible as shown in Figure 0.253 (a).

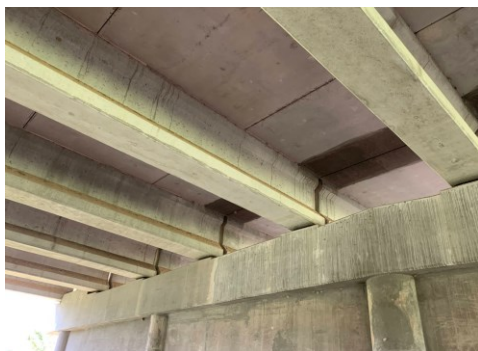
There are cracks on the top surface of deck. The deck overhang has minor cracks with efflorescence. Damage to the edge of joints results in leakage as shown in Figure 0.258 (a). The concrete railing is in good condition. There is 0.08 in. crack at the back wall of abutment as shown in Figure 0.258 (b).

Figure 0.258. Deteriorations on the Bridge: (a) Leakage at Joint; (b) Moderate Crack at Abutment

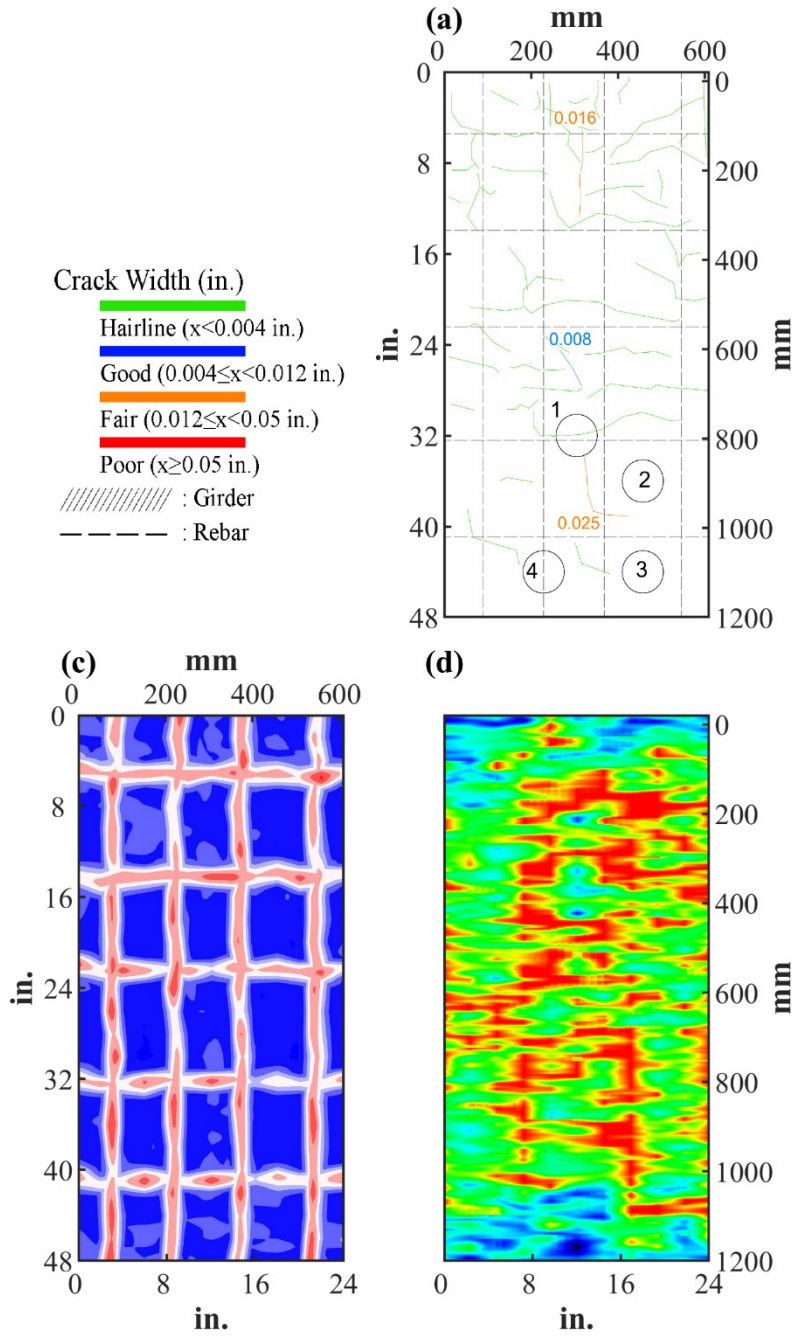
Figure 0.260. Crack Map and NDE Results of Grid 1: (a) Crack Map and Location of Cores; (c) GPR C-scan at 3.1 in. to 4.7 in. Depth; (d) UST C-scan at 3.1 in. Depth

As shown in Figure 0.260 (a), there were cracks ranging from 0.008 in to 0.025 in. wide on grid 1. On grid 2, there were transverse cracks that were 0.004 in. and .008 in. wide as shown in Figure 0.261 (a).

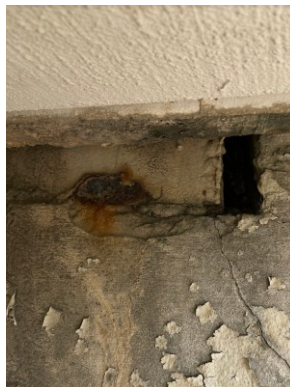
There are spalling on the top surface of deck. The concrete railing near southwest corner has severe cracking and minor spalling. Abutment back wall has serious corrosion and 0.15 in. crack as shown in Figure 0.266.

Figure 0.266. Corrosion near Bearing Pad

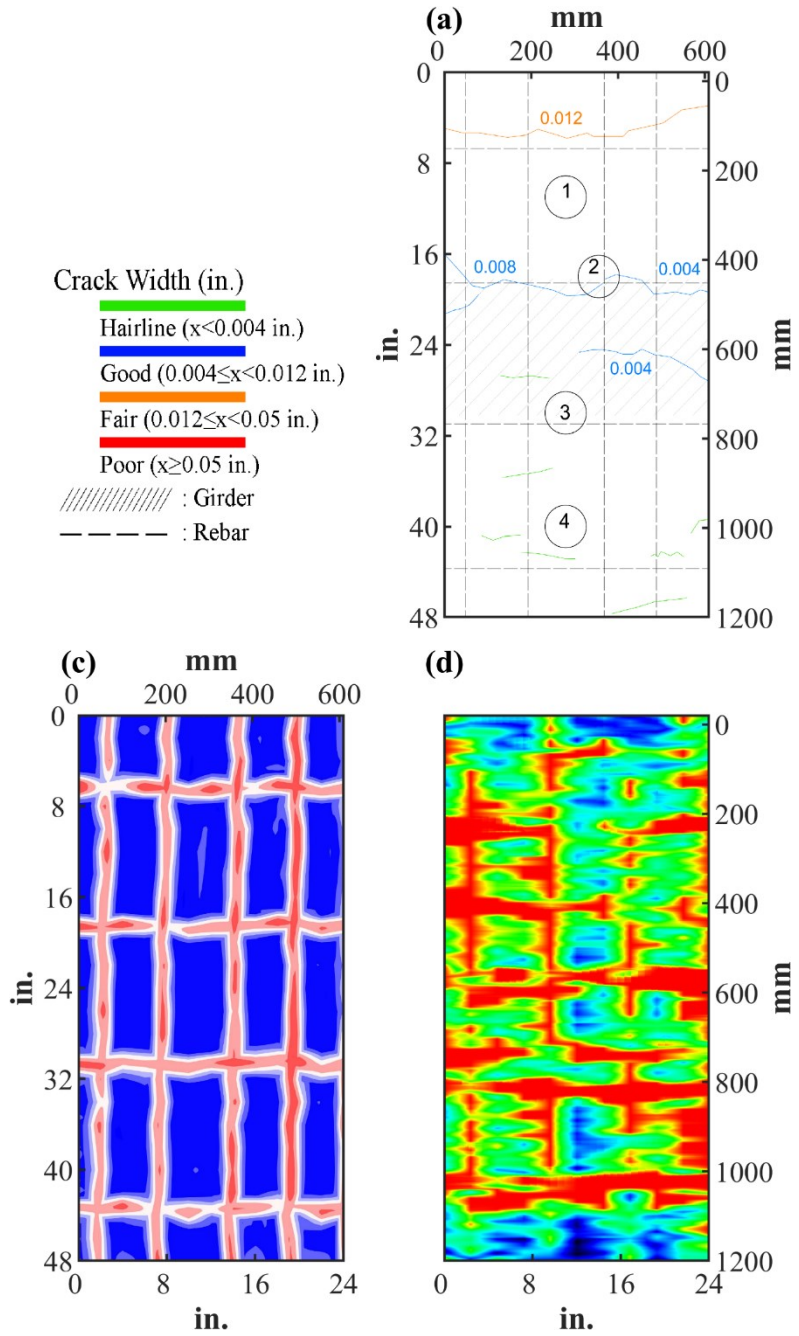
Figure 0.268. Crack Map and NDE Results of Grid 1: (a) Crack Map and Location of Cores; (c) GPR C-scan at 1.9 in. to 3.3 in. Depth; (d) UST C-scan at 4.0 in. Depth

As shown in Figure 0.268 (a), longitudinal racks ranging from 0.004 in. to 0.008 in. were located on top of a girder and 0.012 in. wide longitudinal crack was about 8 in. away from a girder on grid 1. On grid 2, there were no cracks as shown in Figure 0.269 (a).

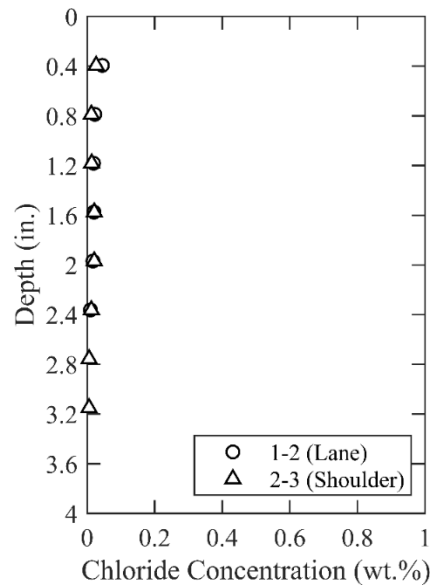
Figure 0.270. Chloride Content at Different Depth

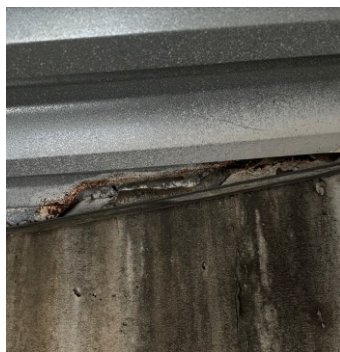
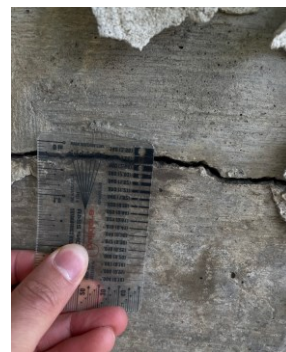
The main superstructure members are in good condition; however, there is corrosion at the metal deck form as shown in Figure 0.273 (a). A horizontal crack is found at the abutment as shown in Figure 0.273 (b).

Figure 0.273. Deteriorations on the Bridge: (a) Corrosion at Metal Deck Form; (b) Serious Crack at Abutment
