Evaluation of Corrosion Prevention and Mitigation Approaches Used on Texas Bridges—Volume 2: Reinforced Concrete Bridges

Technical Report 0-7040-R1-Vol2

TEXAS A&M TRANSPORTATION INSTITUTE
COLLEGE STATION, TEXAS

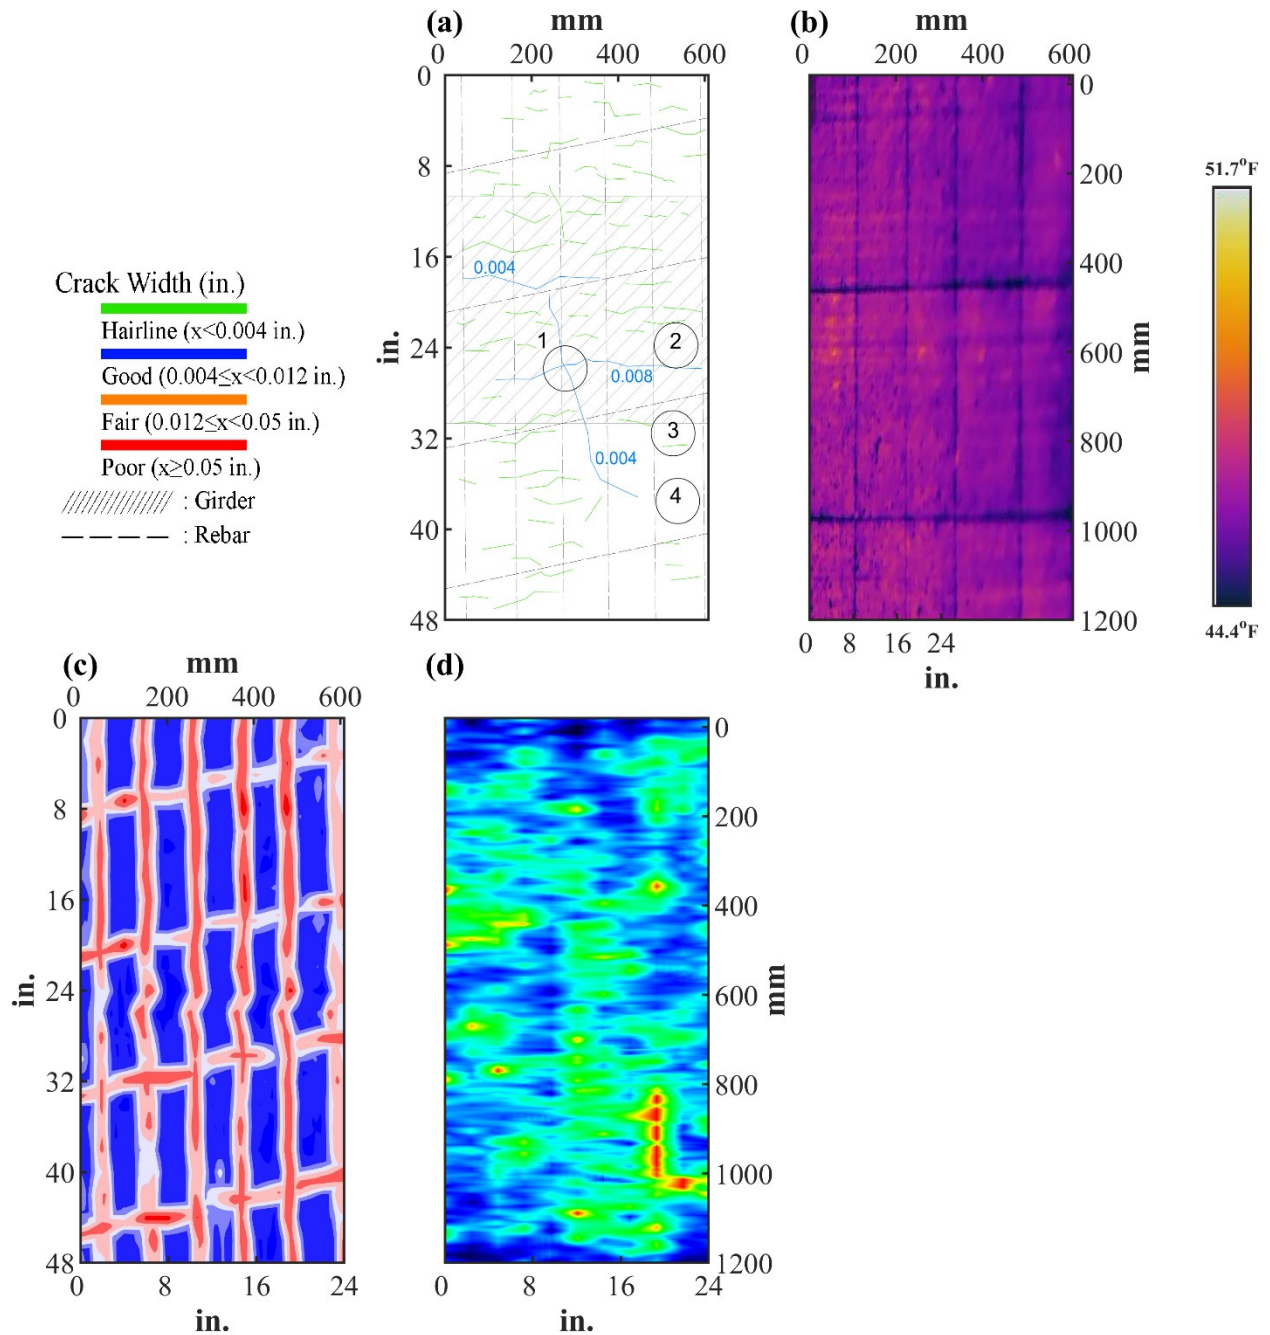
As shown in Figure 0.275 (a), there were widespread of hairline cracks and some cracks ranging from 0.004 in. to 0.008 in. wide were located on top of a girder on grid 1. On grid 2, some hairline cracks and 0.004 in. wide longitudinal cracks were visible as shown in Figure 0.276 (a).

Figure 0.275. Crack Map and NDE Results of Grid 1: (a) Crack Map and Location of Cores; (b) Infrared Picture; (c) GPR C-scan at 2.0 in. to 3.2 in. Depth; (d) UST C-scan at 4.0 in. Depth

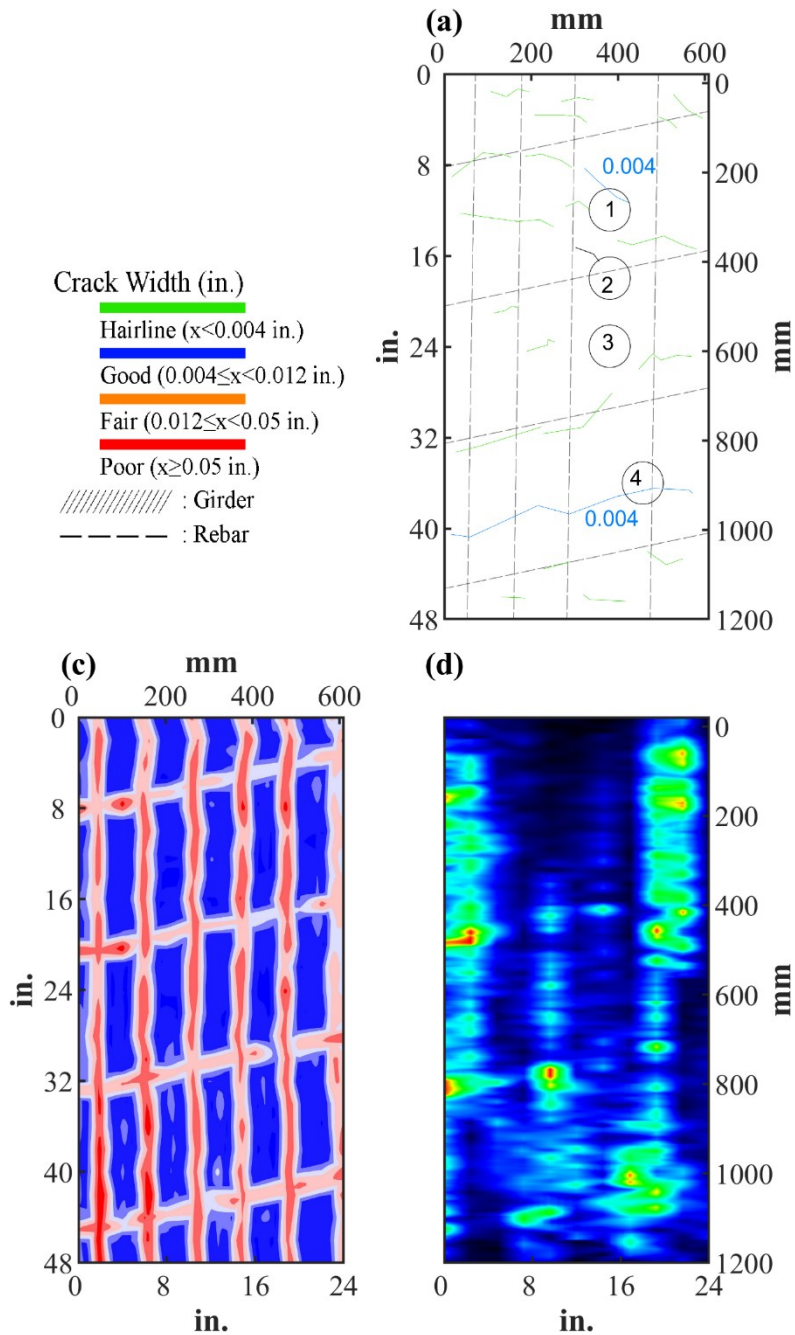
Figure 0.276. Crack Map and NDE Results of Grid 2: (a) Crack Map and Location of Cores; (c) GPR C-scan at 1.9 in. to 3.3 in. Depth; (d) UST C-scan at 4.0 in. Depth

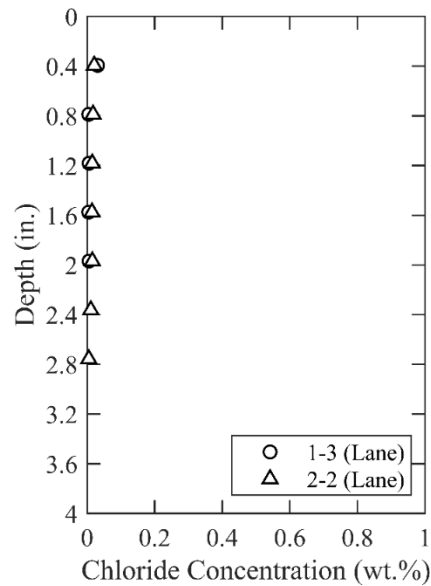
Figure 0.277. Chloride Content at Different Depth

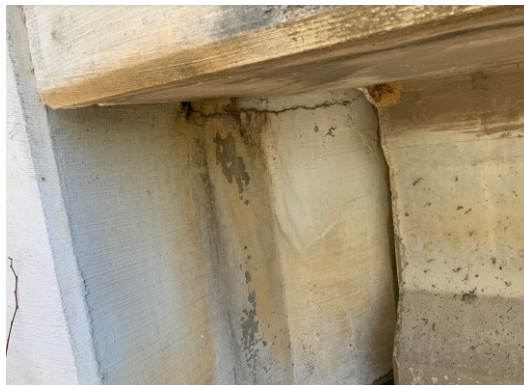
Deck surface has transverse cracks. The main superstructure members are in good condition; however, abutment backwall has minor cracks and efflorescence as shown in Figure 0.281.

Figure 0.281. Crack and Efflorescence at the Abutment Wall

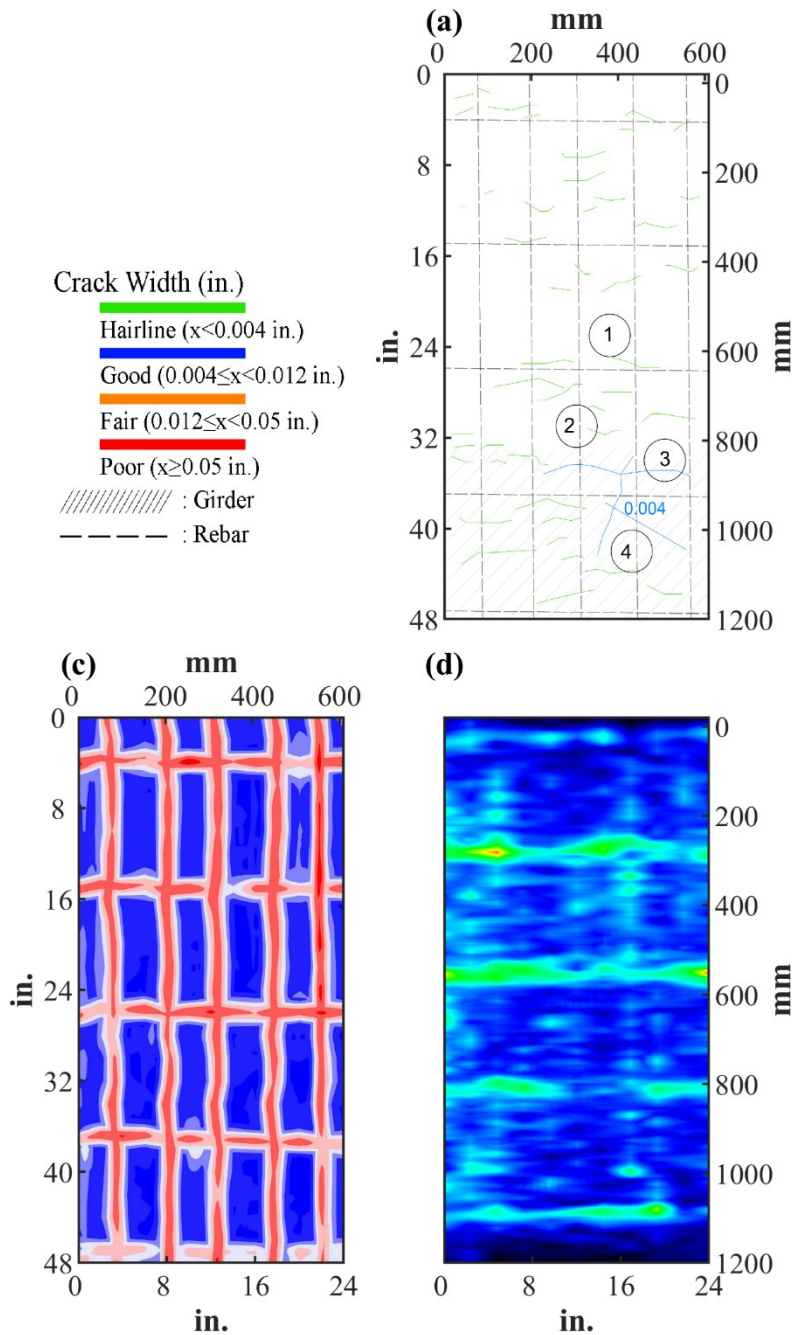
As shown in Figure 0.283 (a), there were widespread of hairline cracks and 0.004 in. wide cracks on top of a girder on grid 1. On grid 2, there were no cracks as shown in Figure 0.284 (a).

Figure 0.283. Crack Map and NDE Results of Grid 1: (a) Crack Map and Location of Cores; (c) GPR C-scan at 1.9 in. to 3.3 in. Depth; (d) UST C-scan at 4.0 in. Depth

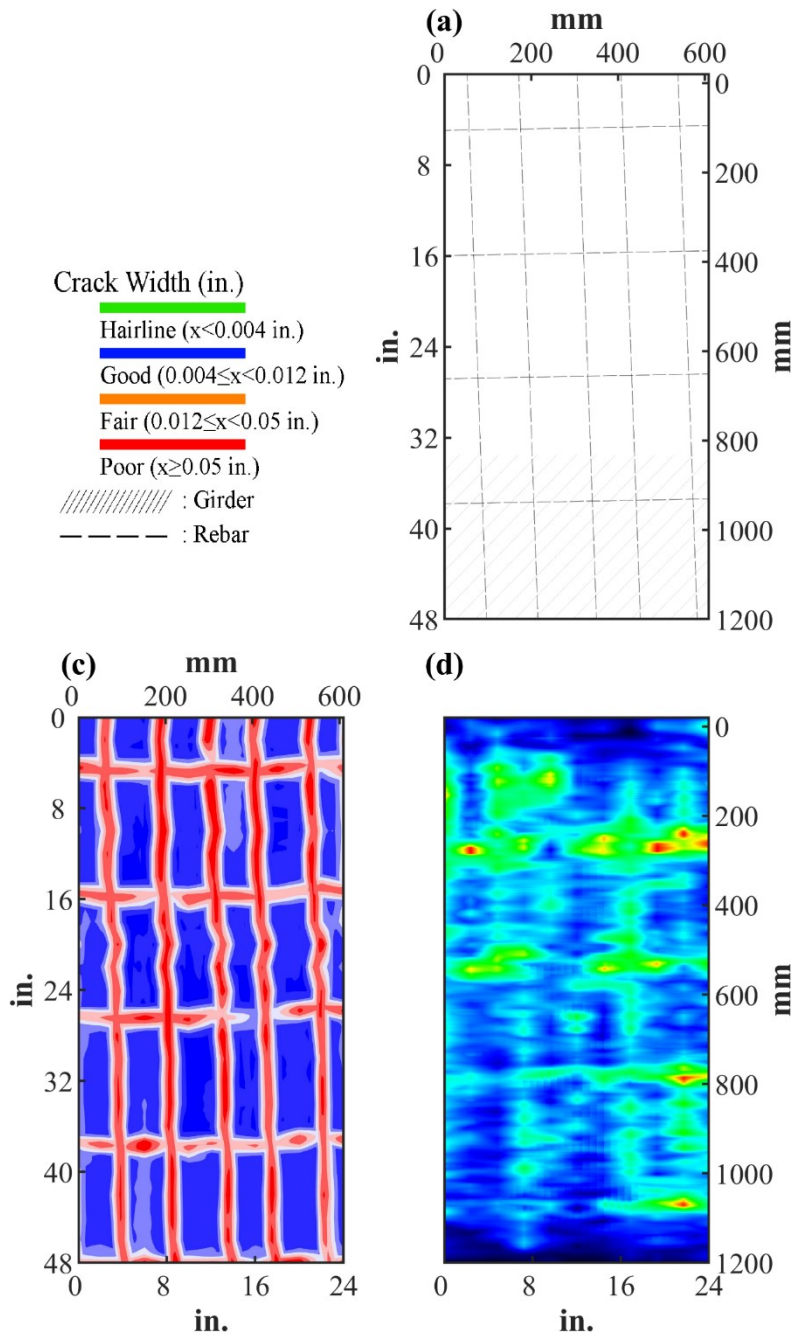
Figure 0.284. Crack Map and NDE Results of Grid 2: (a) Crack Map and Location of Cores; (c) GPR C-scan at 1.4 in. to 3.0 in. Depth; (d) UST C-scan at 3.1 in. Depth

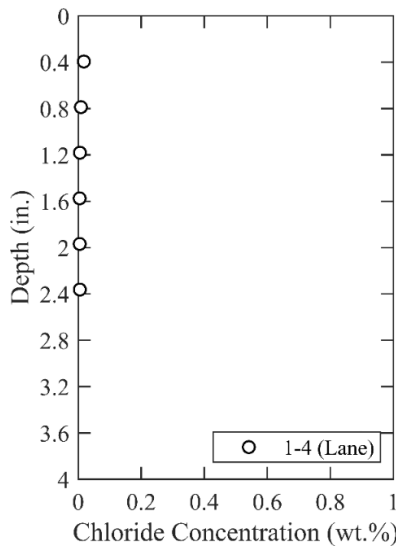
Figure 0.285. Chloride Content at Different Depth

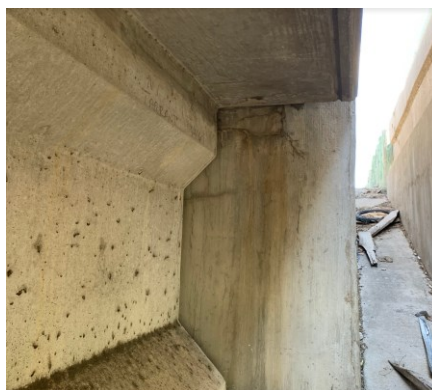
Deck surface has transverse cracks. The main superstructure members are in good condition; however, a vertical crack is found at the abutment wall as shown in Figure 0.289

Figure 0.289. Cracks at Abutment Wall

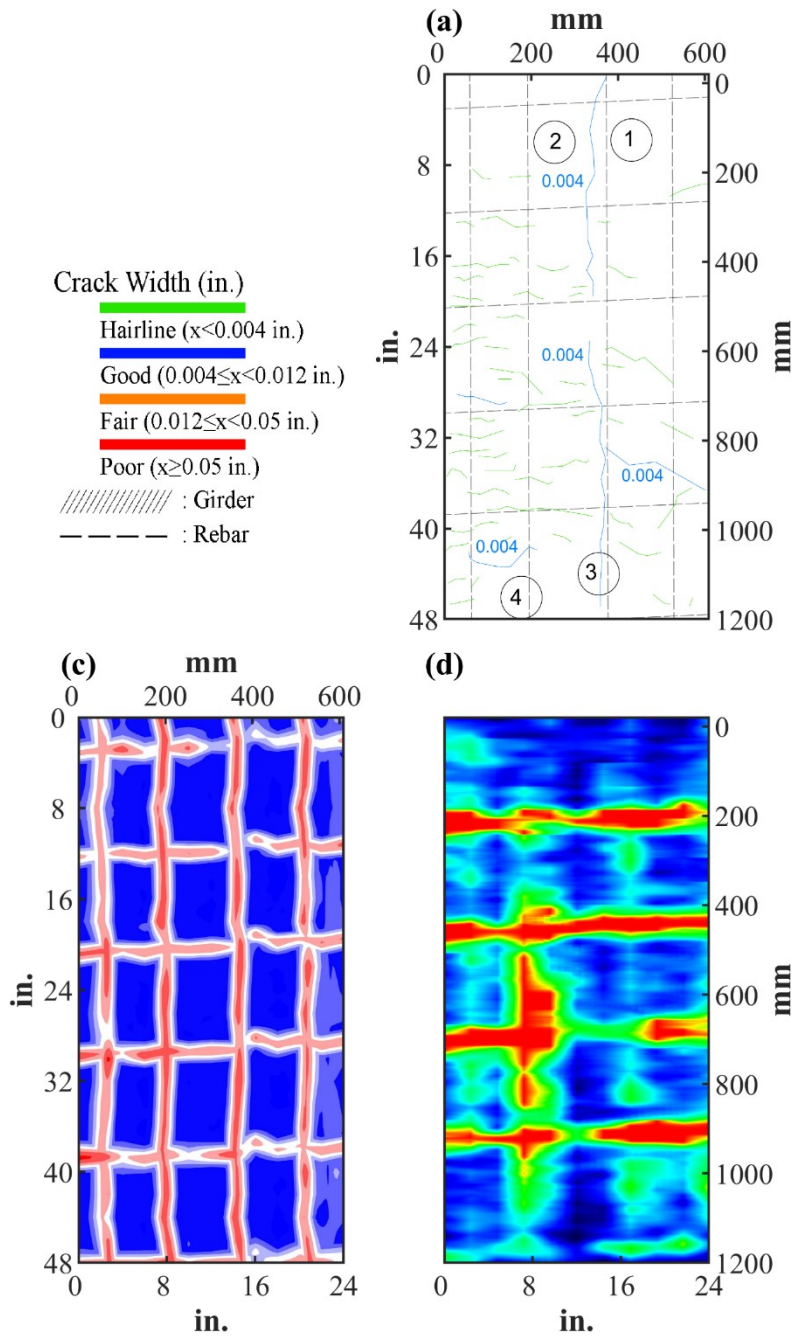
Figure 0.291. Crack Map and NDE Results of Grid 1: (a) Crack Map and Location of Cores; (c) GPR C-scan at 2.6 in. to 4.0 in. Depth; (d) UST C-scan at 4.9 in. Depth

As shown in Figure 0.291 (a), there were widespread of hairline cracks and 0.004 in. wide transverse and longitudinal cracks on grid 1. On grid 2, there were only hairline cracks as shown in Figure 0.292 (a).

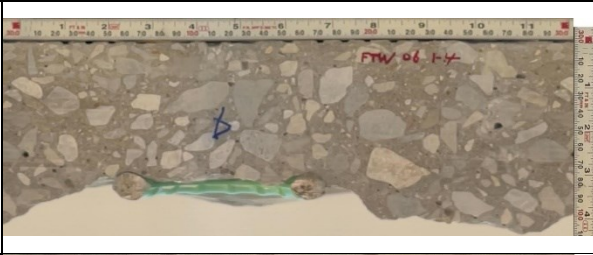
Core	dia. x height (in.)	clear cover (in.)	Rebar size (#)	Epoxy (Y/N)	Crack type	Crack width (in)	Notes
1-1	3.75 x 5.9	-	-	-	-	-	
1-2	3.75 x 6.1	-	-	-	-	-	
1-3	3.75 x 5.0	2.9	5	Y	transverse	0.004	A crack propagates from panel joint
1-4	3.75 x 3.1	3.1	5	Y	-	-	
2-1	3.75 x 7.1	-	-	-	-	-	
2-2	3.75 x 9.6	3.2	4	Y	-	-	
2-3	3.75 x 7.1	-	-	-	-	-

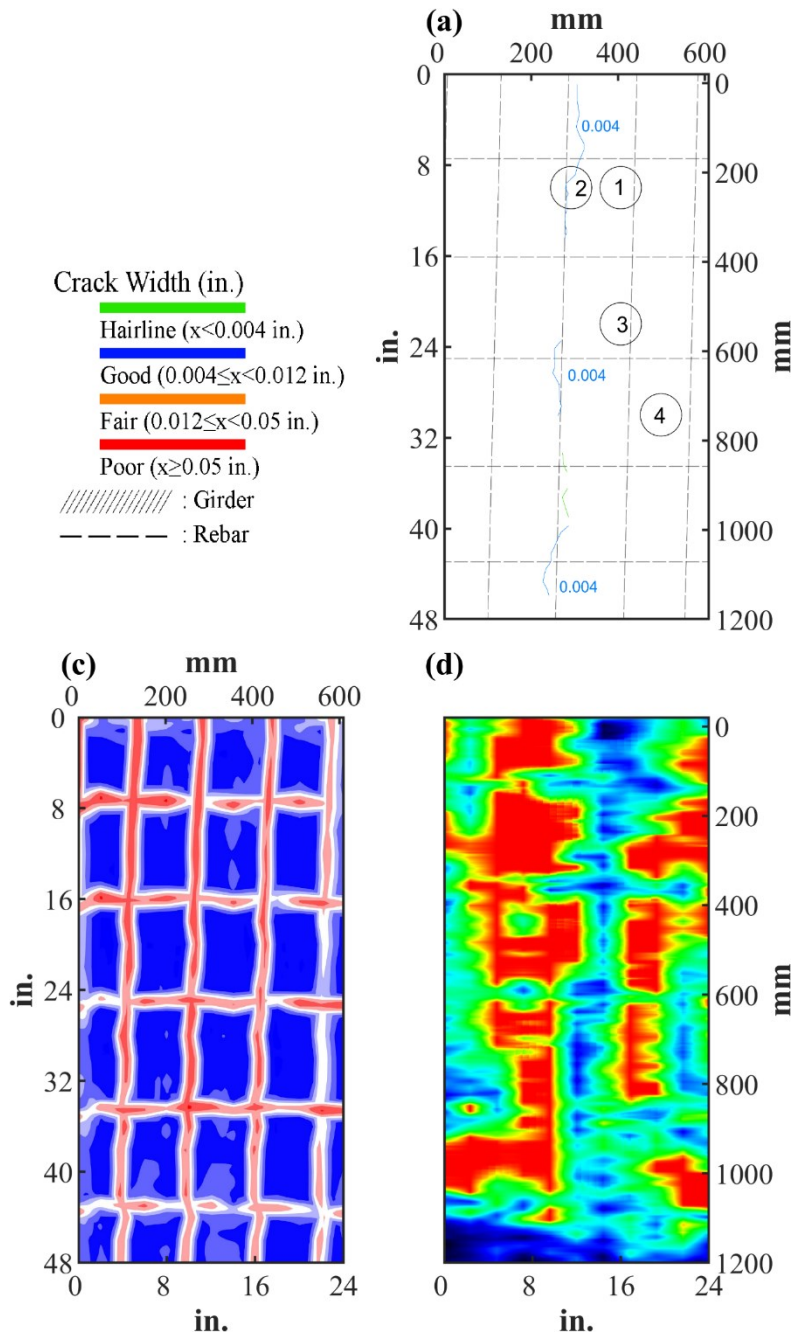
Figure 0.297. Crack Map and NDE Results of Grid 1: (a) Crack Map and Location of Cores; (c) GPR C-scan at 2.5 in. to 4.0 in. Depth; (d) UST C-scan at 4.0 in. Depth

As shown in Figure 0.297 (a), 0.004 in. wide transverse cracks were propagating from a girder on grid 1. On grid 2, 0.004 in. wide longitudinal crack was on top of a girder and 0.004 in. wide transverse crack was propagating from a girder as shown in Figure 0.298 (a).

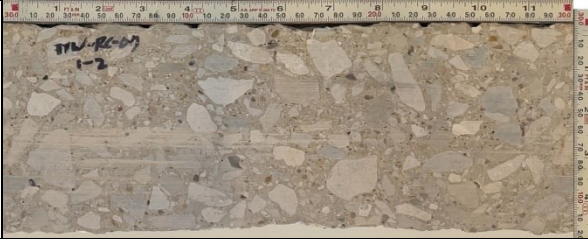
Core	Pictures of the Cores		
1-1

Core	dia. x height (in.)	clear cover (in.)	Rebar size (#)	Epoxy (Y/N)	Crack type	Crack width (in)	Notes
1-1	3.75 x 4.5	2.6	5	Y	-	-	Delamination between CIP and PCP
1-2	3.75 x 4.9	-	-	-	diagonal	0.004	Delamination between CIP and PCP
1-3	3.75 x 4.9	-	-	-	-	-	Delamination between CIP and PCP
1-4	3.75 x 5.0	2.7	5	Y	-	-	Delamination between CIP and PCP

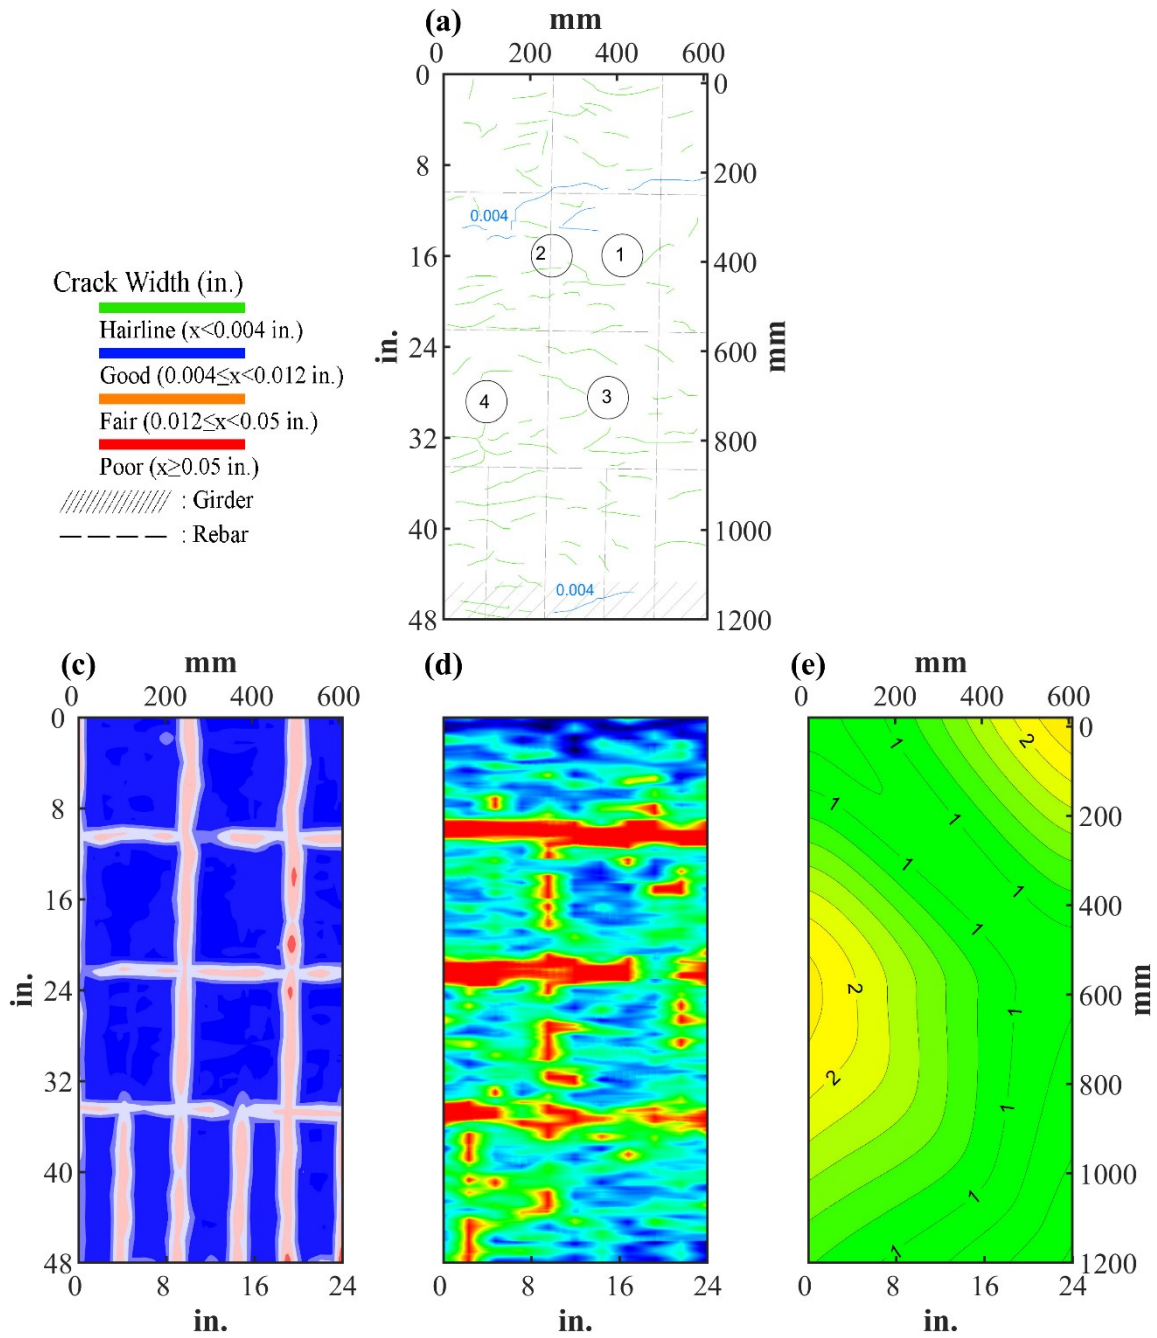
Figure 0.304. Crack Map and NDE Results of Grid 1: (a) Crack Map and Location of Cores; (c) GPR C-scan at 1.55 in. to 2.9 in. Depth; (d) UST C-scan; (e) Corrosion Rate Map

As shown in Figure 0.304 (a), widespread of hairline cracks and 0.004 in. wide cracks were observed on grid 1. Based on Figure A.1.3 (e), corrosion rate map shows low possibility of corrosion on grid 1. On grid 2, there were widespread of hairline cracks with a couple of cracks that were 0.004 in. wide in longitudinal and diagonal direction as shown in Figure 0.305 (a).

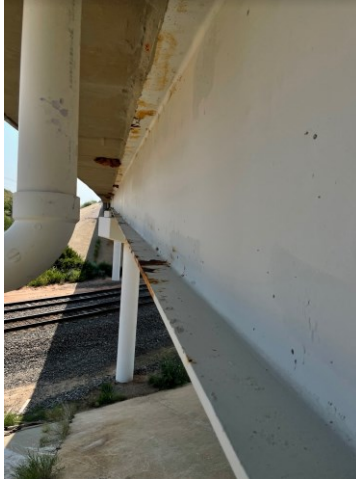
The deck and rails were replaced at 2010. The steel beam 1 at span 1 has isolated moderate pitting corrosion in its web and bottom flange as shown in Figure 0.310. Transverse cracks were observed on the deck of the bridge, with a diagonal crack near the Abutment 1. Diagonal cracks were observed at the transition from a skew to a straight section on the overhang. The north side backwall of Abutment 1 has some water leaking through. In addition, some cracks (0.012 in.) were observed between girders.

Figure 0.310. Pitting Corrosion on the Web and Bottom Flange

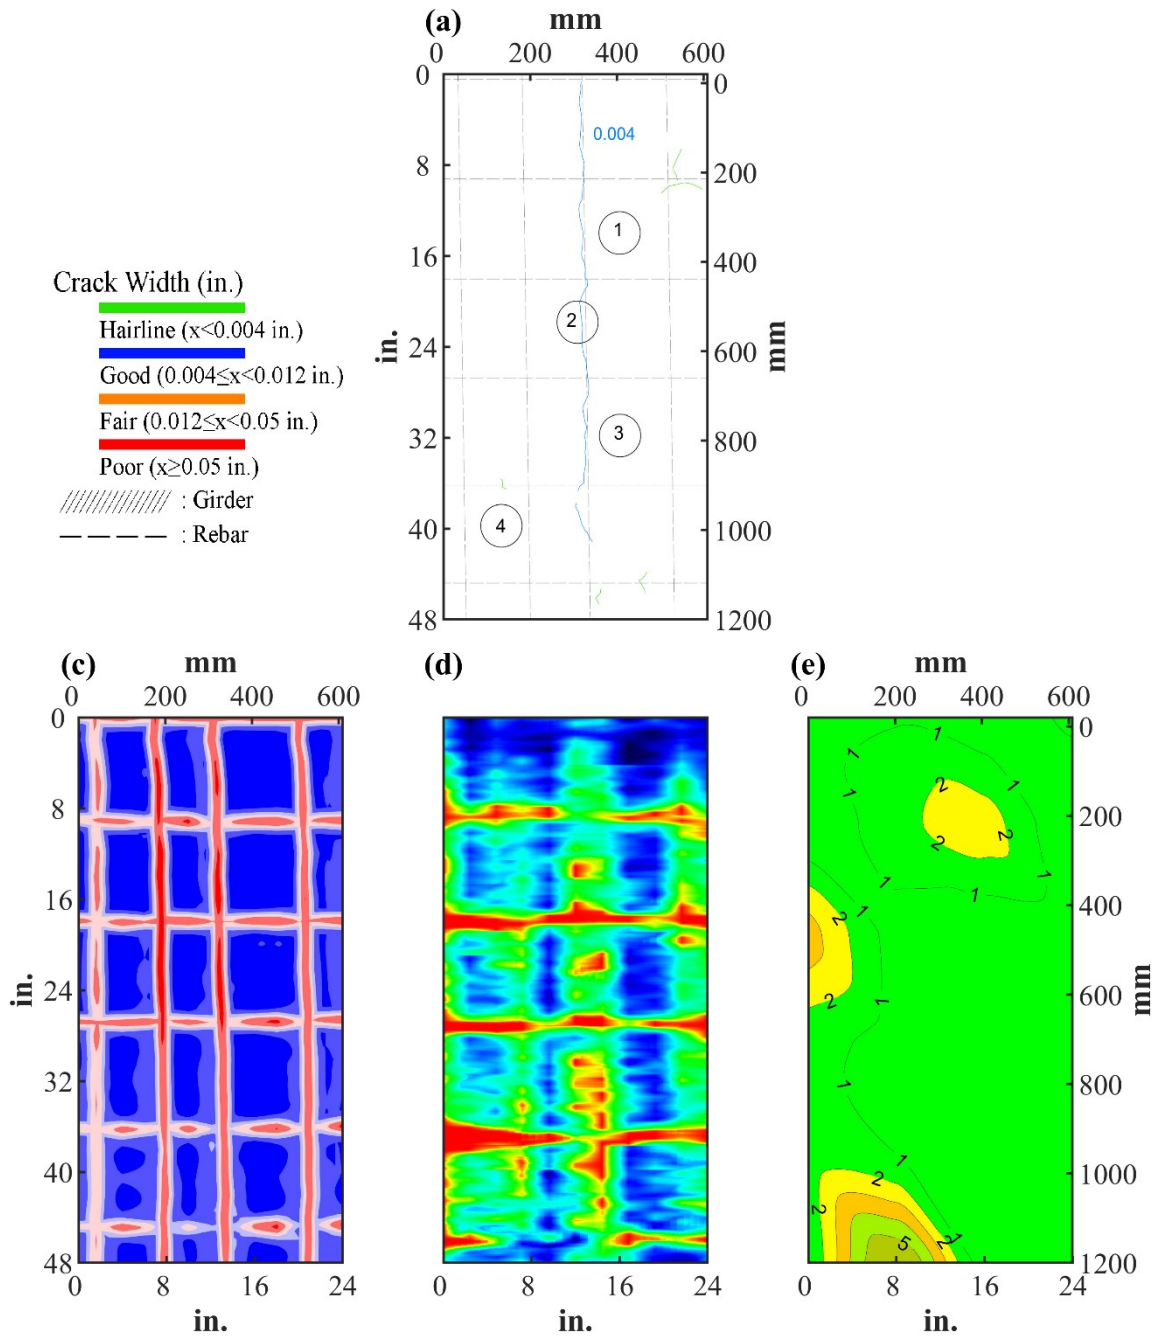
As shown in Figure 0.312 (a), there was 0.004 in. wide transverse crack which is possibly caused by panel joints on grid 1. Based on Figure A.2.4 (e), there is a small possibility of corrosion on grid 1. On grid 2, one diagonal 0.004 in. diagonal crack and 0.04 in. wide transverse crack propagating from a girder as shown in Figure 0.313 (a).

Figure 0.312. Crack Map and NDE Results of Grid 1: (a) Crack Map and Location of Cores; (c) GPR C-scan at 1.7 in. to 3.0 in. Depth; (d) UST C-scan; (e) Corrosion Rate Map

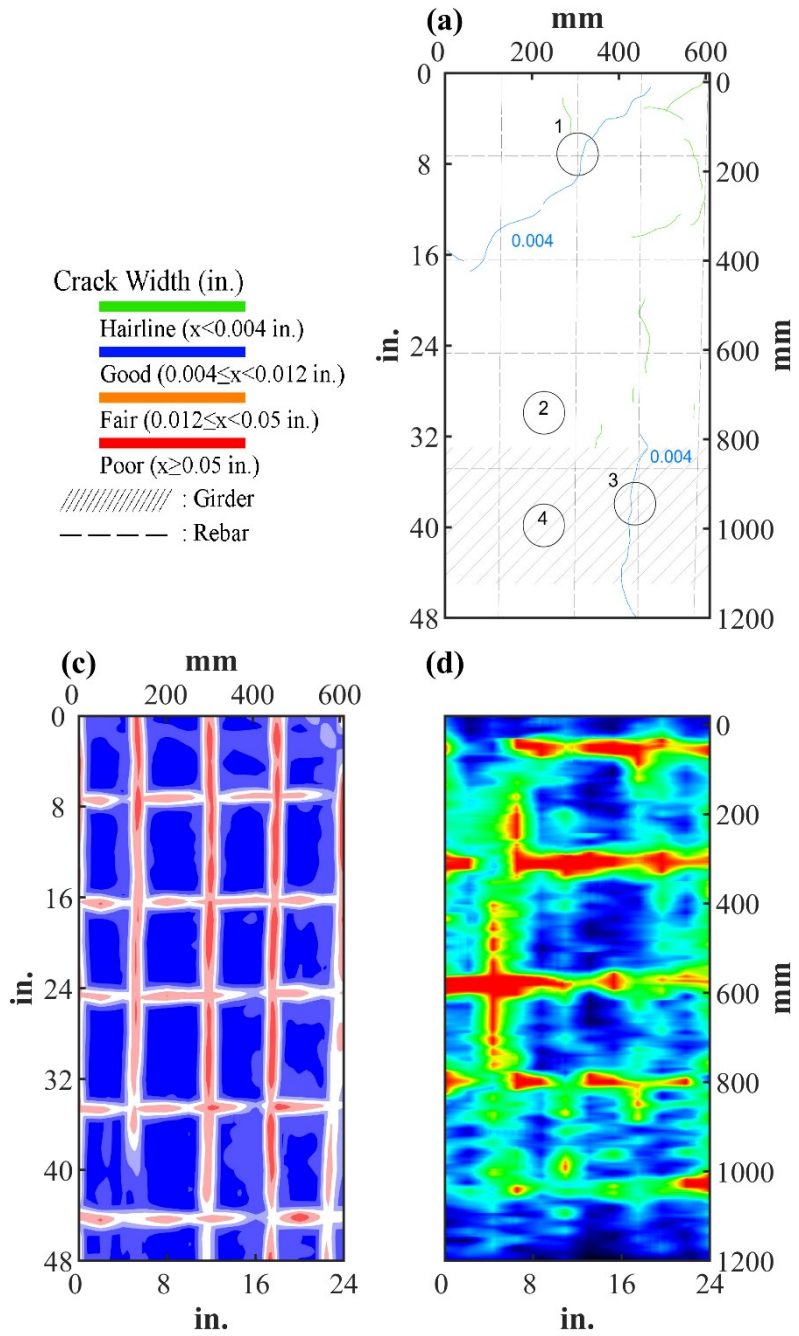
Figure 0.313. Crack Map and NDE Results of Grid 2: (a) Crack Map and Location of Cores; (c) GPR C-scan at 2.3 in. to 3.7 in. Depth; (d) UST C-scan

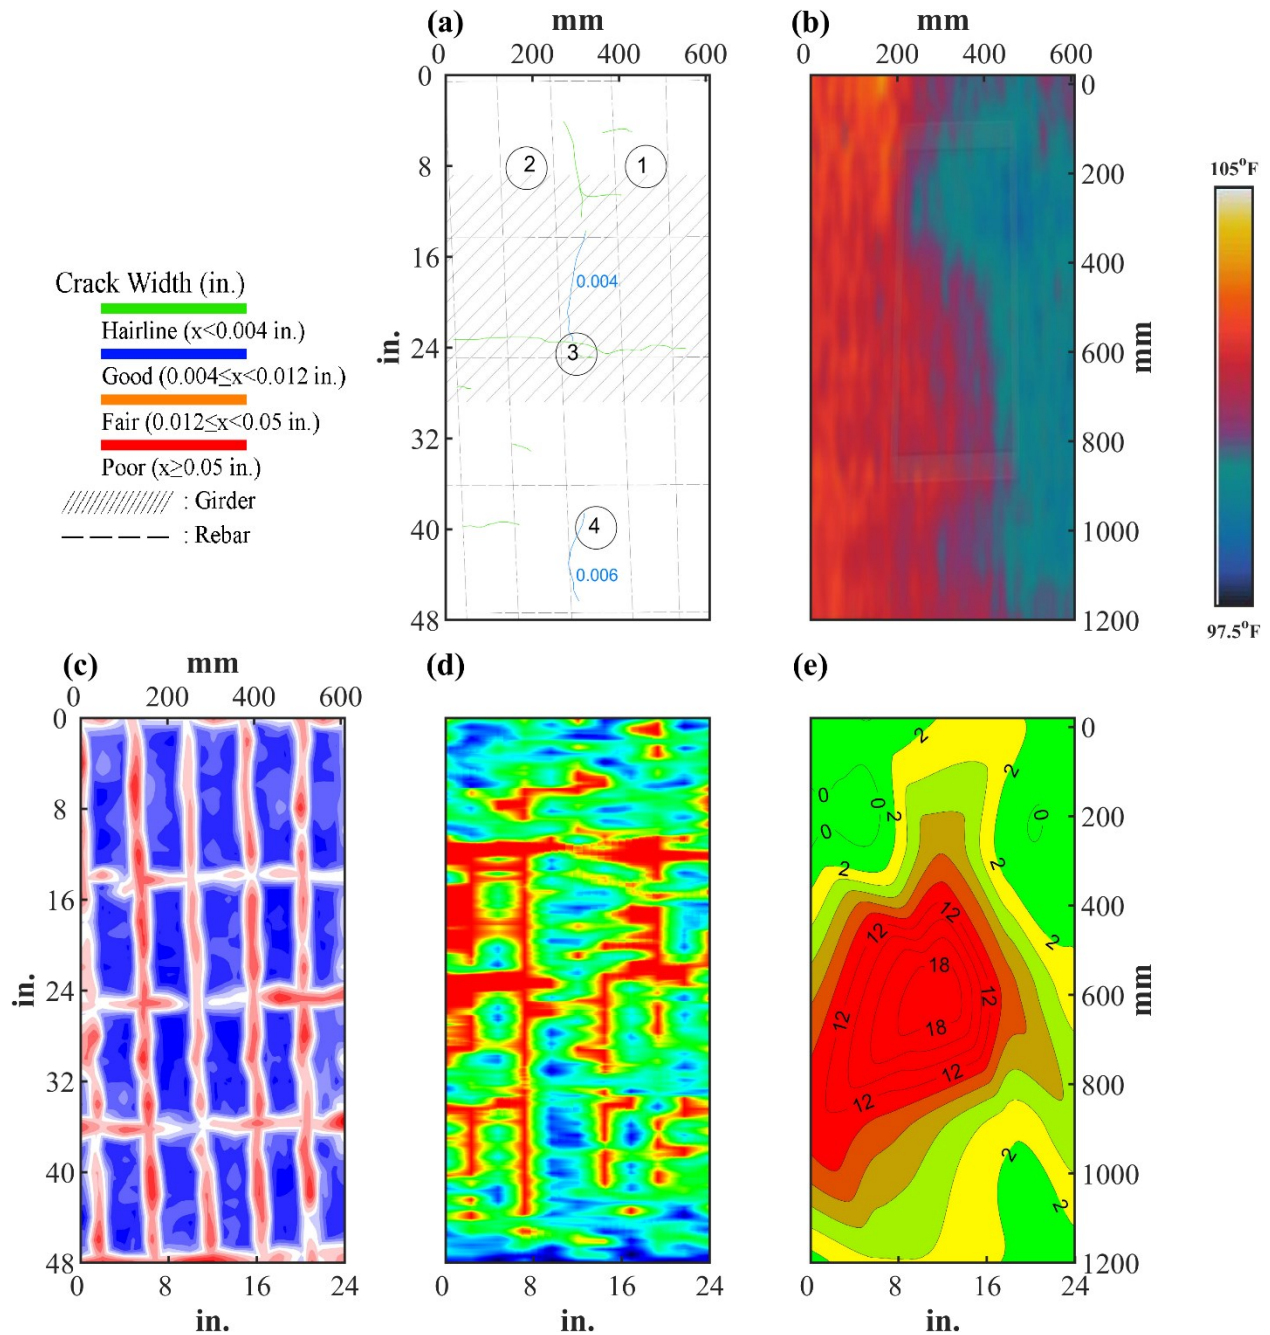
As shown in Figure 0.319 (a), a 0.004 in. wide transverse crack was observed on top of a girder on grid 1. Based on Figure A.3.3 (e), there is a high possibility of corrosion on grid 1 where the color is red. On grid 2, there were 0.006 in longitudinal crack and 0.008 in. wide transverse crack on top of a girder and propagating from a girder, respectively, as shown in Figure 0.320 (a).

Figure 0.319. Crack Map and NDE Results of Grid 1: (a) Crack Map and Location of Cores; (b) Infrared Picture; (c) GPR C-scan at 3.0 in. to 4.1 in. Depth; (d) UST C-scan; (e) Corrosion Rate Map

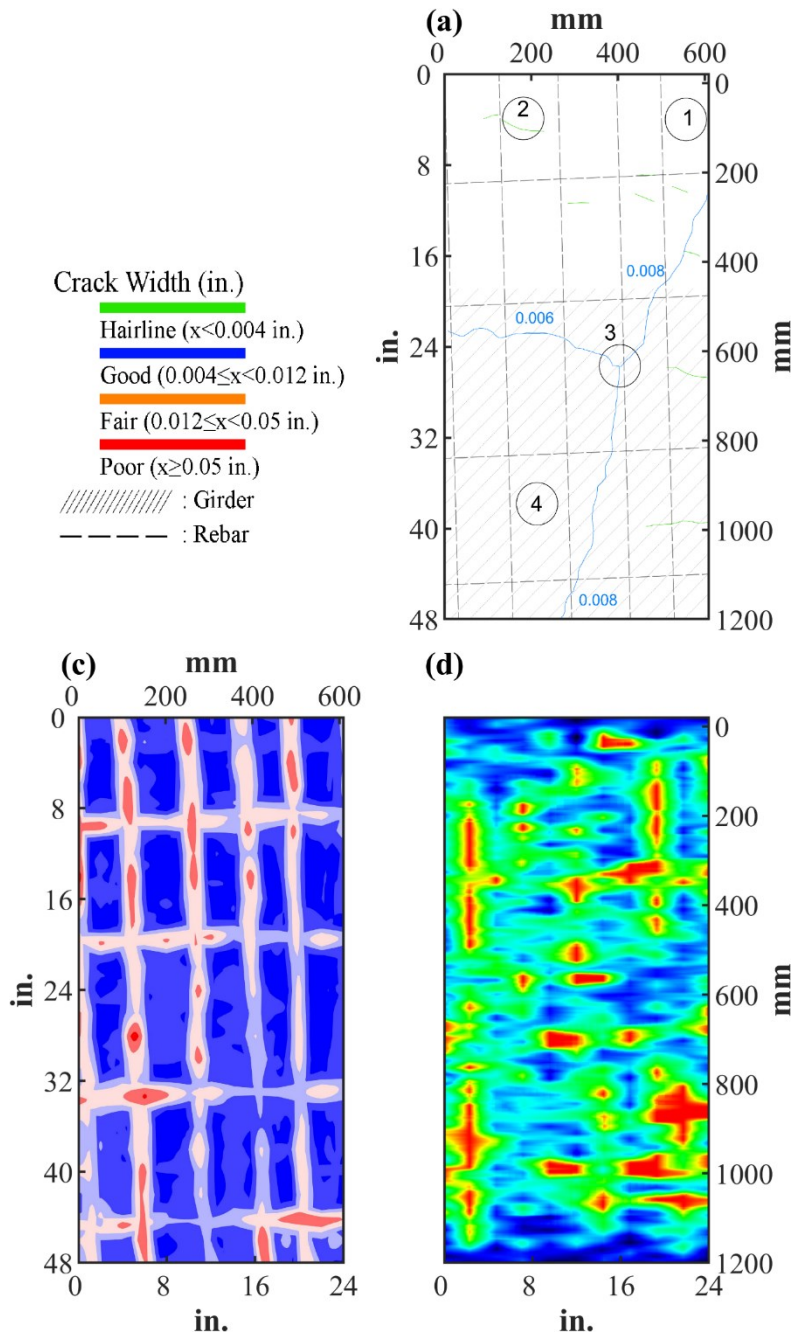
Figure 0.320. Crack Map and NDE Results of Grid 2: (a) Crack Map and Location of Cores; (c) GPR C-scan at 3.0 in. to 4.1 in. Depth; (d) UST C-scan

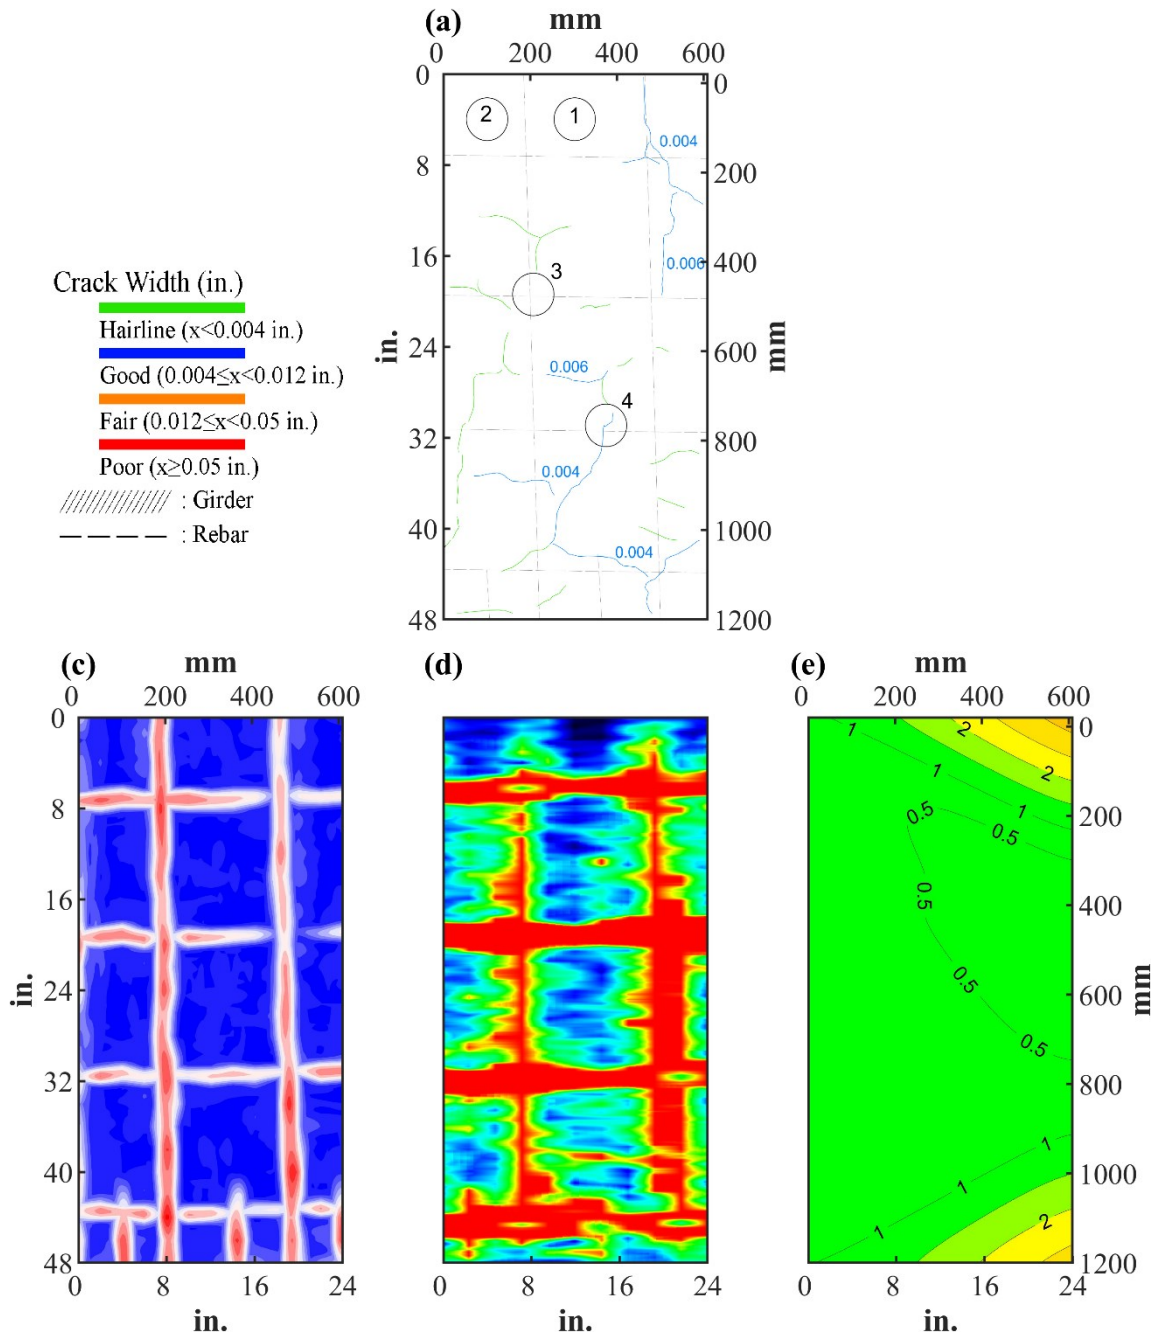
As shown in Figure 0.326 (a), 0.004 in. and 0.006 in. wide cracks were observed in grid 1 in longitudinal, transverse, and diagonal directions. Based on Figure A.4.3 (e), there is a low possibility of corrosion on grid 1. On grid 2, there was one 0.006 in. wide crack as shown in Figure 0.327 (a). It is possible that the crack is caused by panel joints.

Figure 0.326. Crack Map and NDE Results of Grid 1: (a) Crack Map and Location of Cores; (c) GPR C-scan at 1.7 in. to 3.0 in. Depth; (d) UST C-scan; (e) Corrosion Rate Map

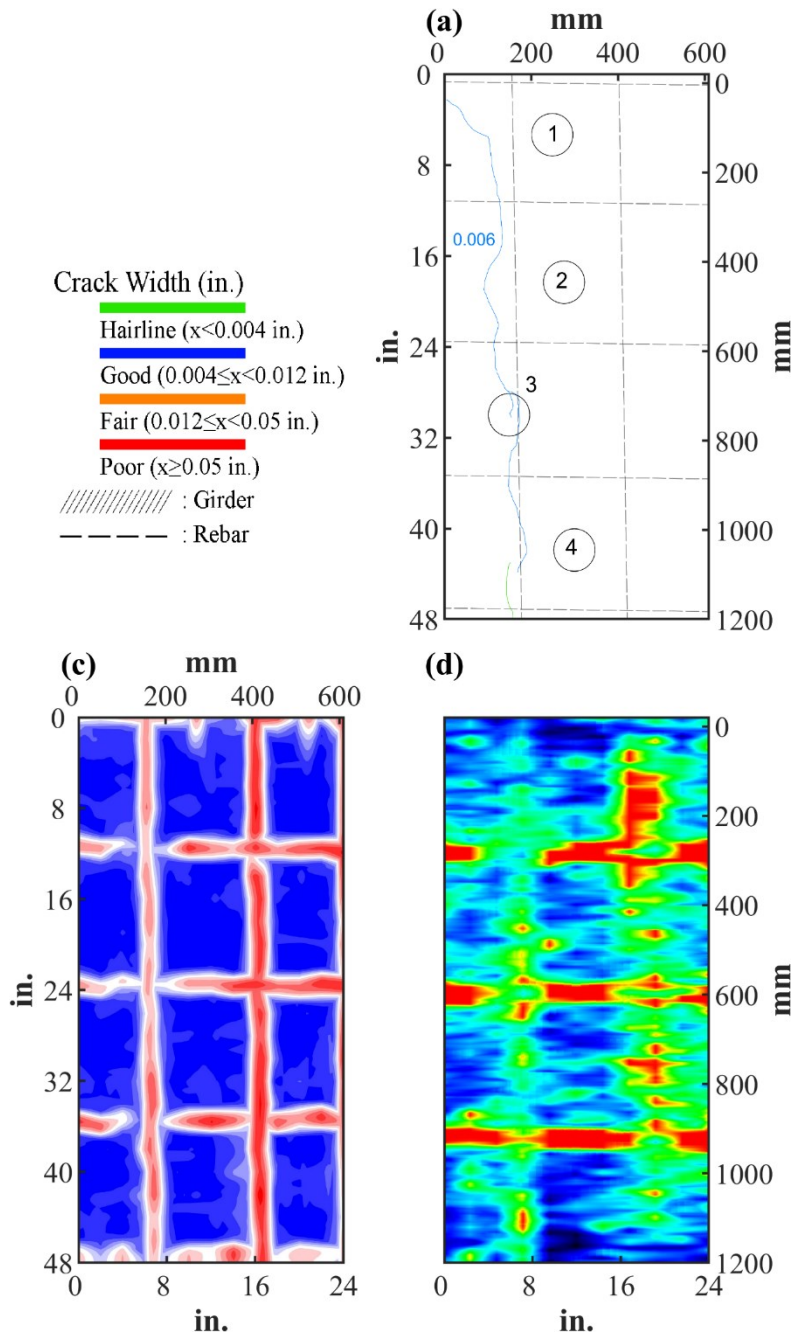
Figure 0.327. Crack Map and NDE Results of Grid 2: (a) Crack Map and Location of Cores; (c) GPR C-scan at 2.2 in. to 3.3 in. Depth; (d) UST C-scan

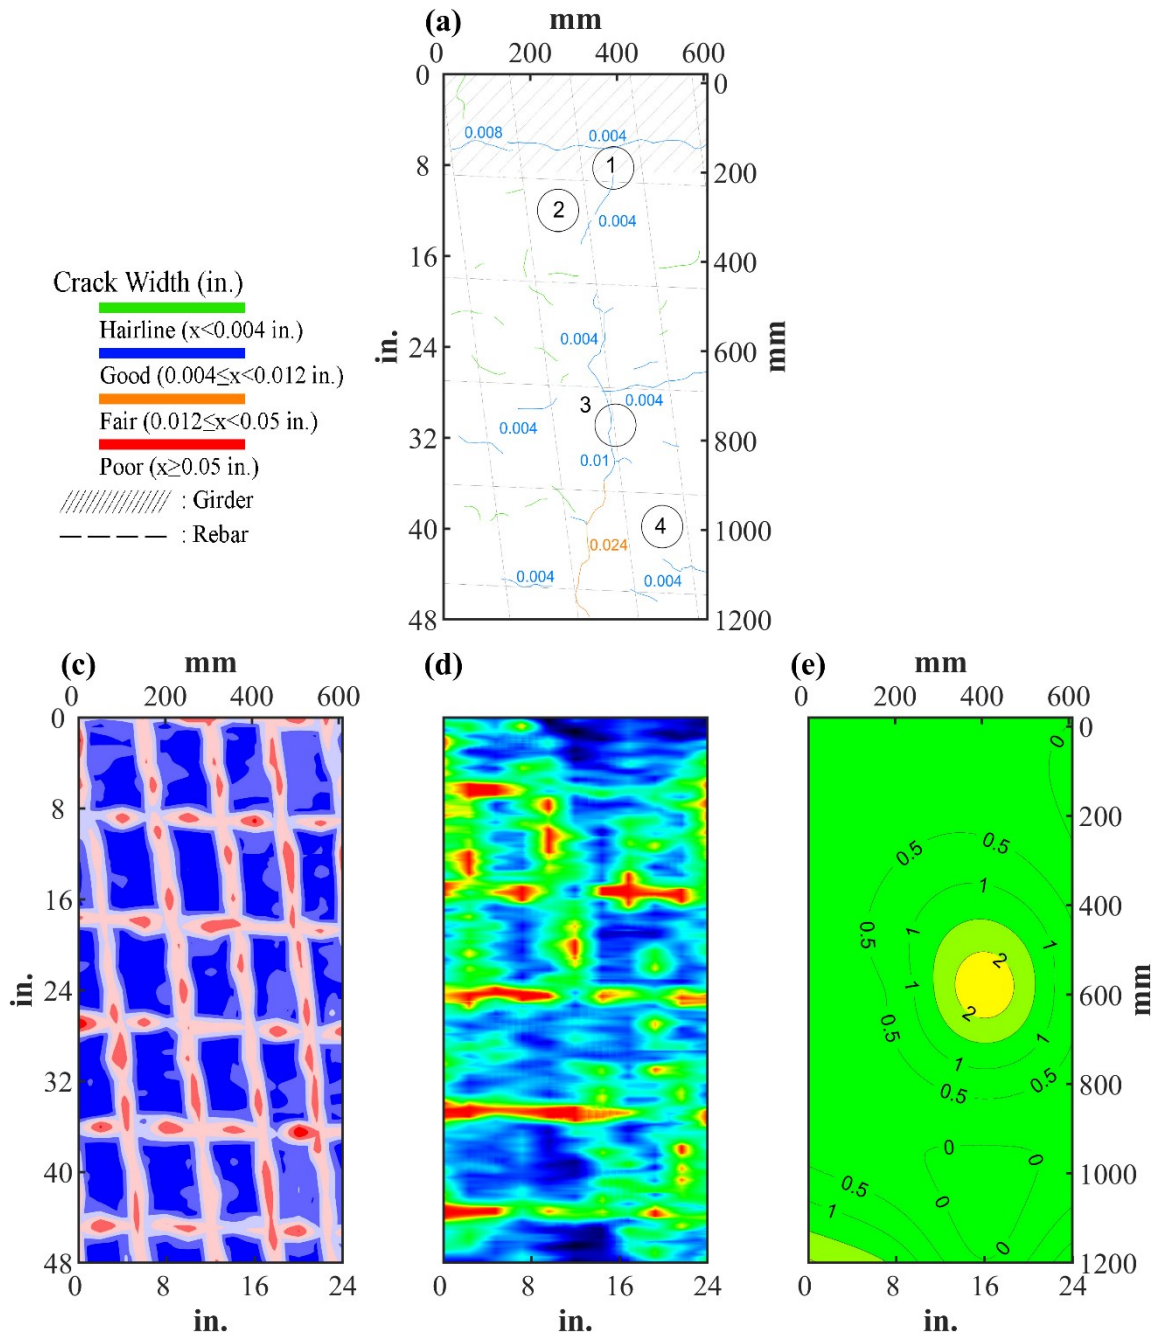
As shown in Figure 0.333 (a), a 0.008 in. wide longitudinal crack was located on top of a girder and 0.004 in., 0.01 in., and 0.024 in. cracks were propagating from a girder. Based on Figure A.5.3 (e), there is a low possibility of corrosion on grid 1. On grid 2, 0.004 in. wide cracks were in longitudinal and transverse direction, and 0.006 in. wide crack was in diagonal direction as shown in Figure 0.334 (a).

Figure 0.333. Crack Map and NDE Results of Grid 1: (a) Crack Map and Location of Cores; (c) GPR C-scan at 2.05 in. to 3.15 in. Depth; (d) UST C-scan; (e) Corrosion Rate Map

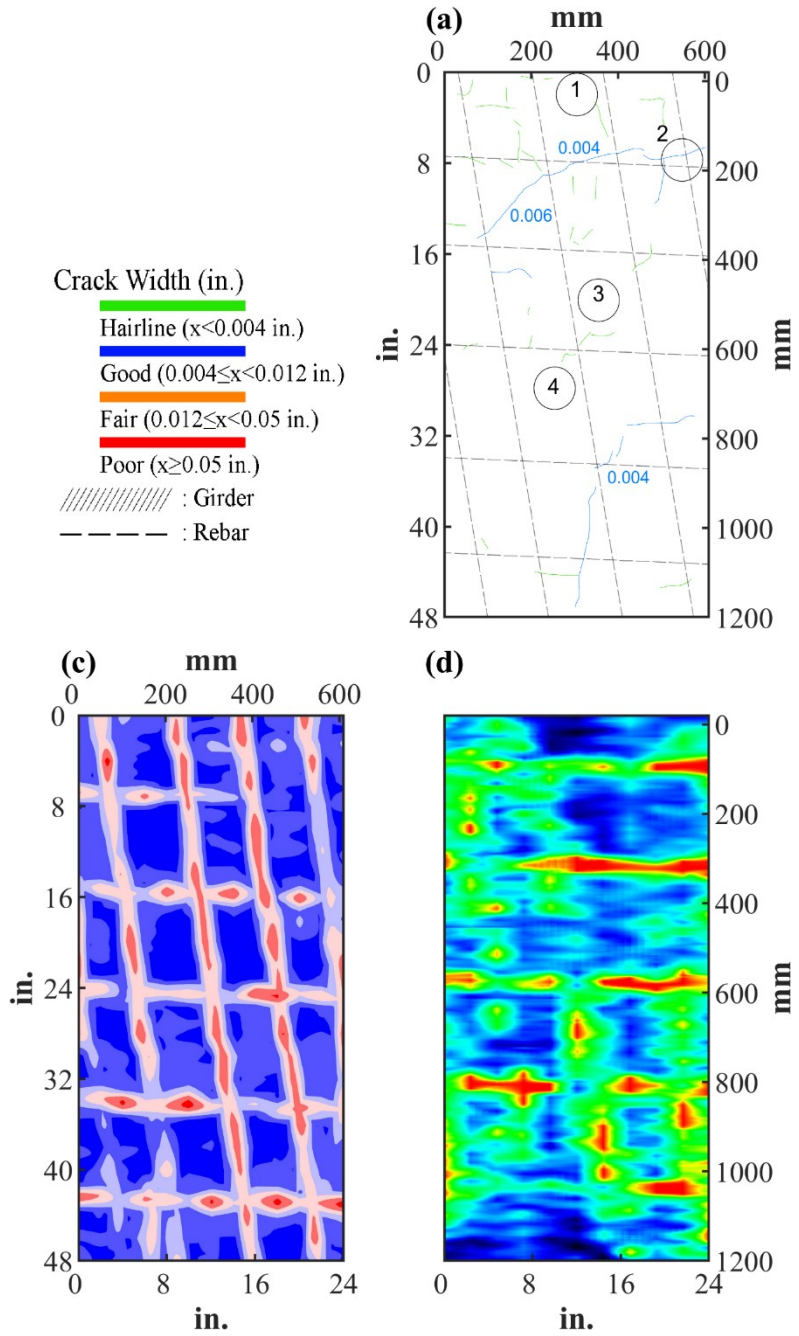
Figure 0.334. Crack Map and NDE Results of Grid 2: (a) Crack Map and Location of Cores; (c) GPR C-scan at 3.4 in. to 4.5 in. Depth; (d) UST C-scan

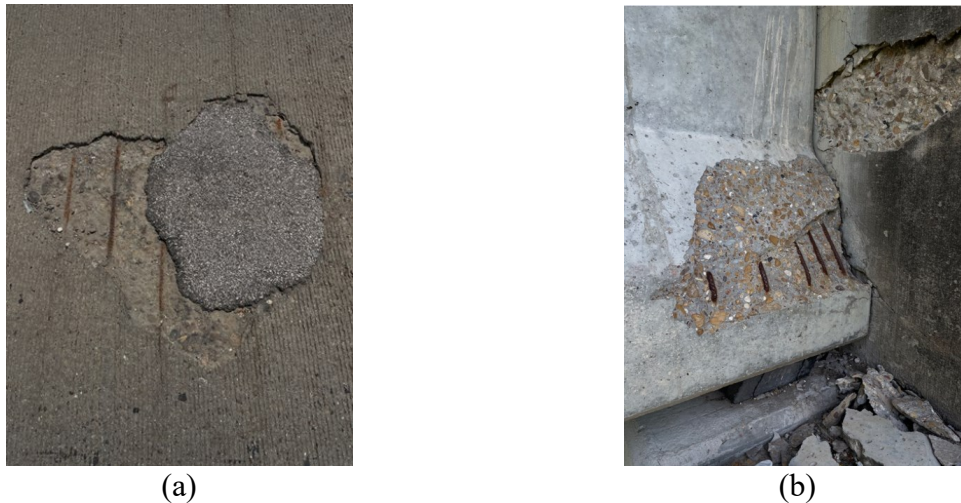
The top surface of deck has transverse, longitudinal, and diagonal cracks. There are minor hairline vertical, horizontal cracks, and impact scrapes at concrete railings. As shown in Figure 0.339 (a), spalling on the deck and corroded rebar was observed, and spalling on the girder end was also observed as shown in Figure 0.339 (b).

Figure 0.339. Deteriorations on the Bridge: (a) spalling on deck; (b) Exposed rebar on the girder end
