Evaluation of Corrosion Prevention and Mitigation Approaches Used on Texas Bridges—Volume 2: Reinforced Concrete Bridges

Technical Report 0-7040-R1-Vol2

TEXAS A&M TRANSPORTATION INSTITUTE
COLLEGE STATION, TEXAS

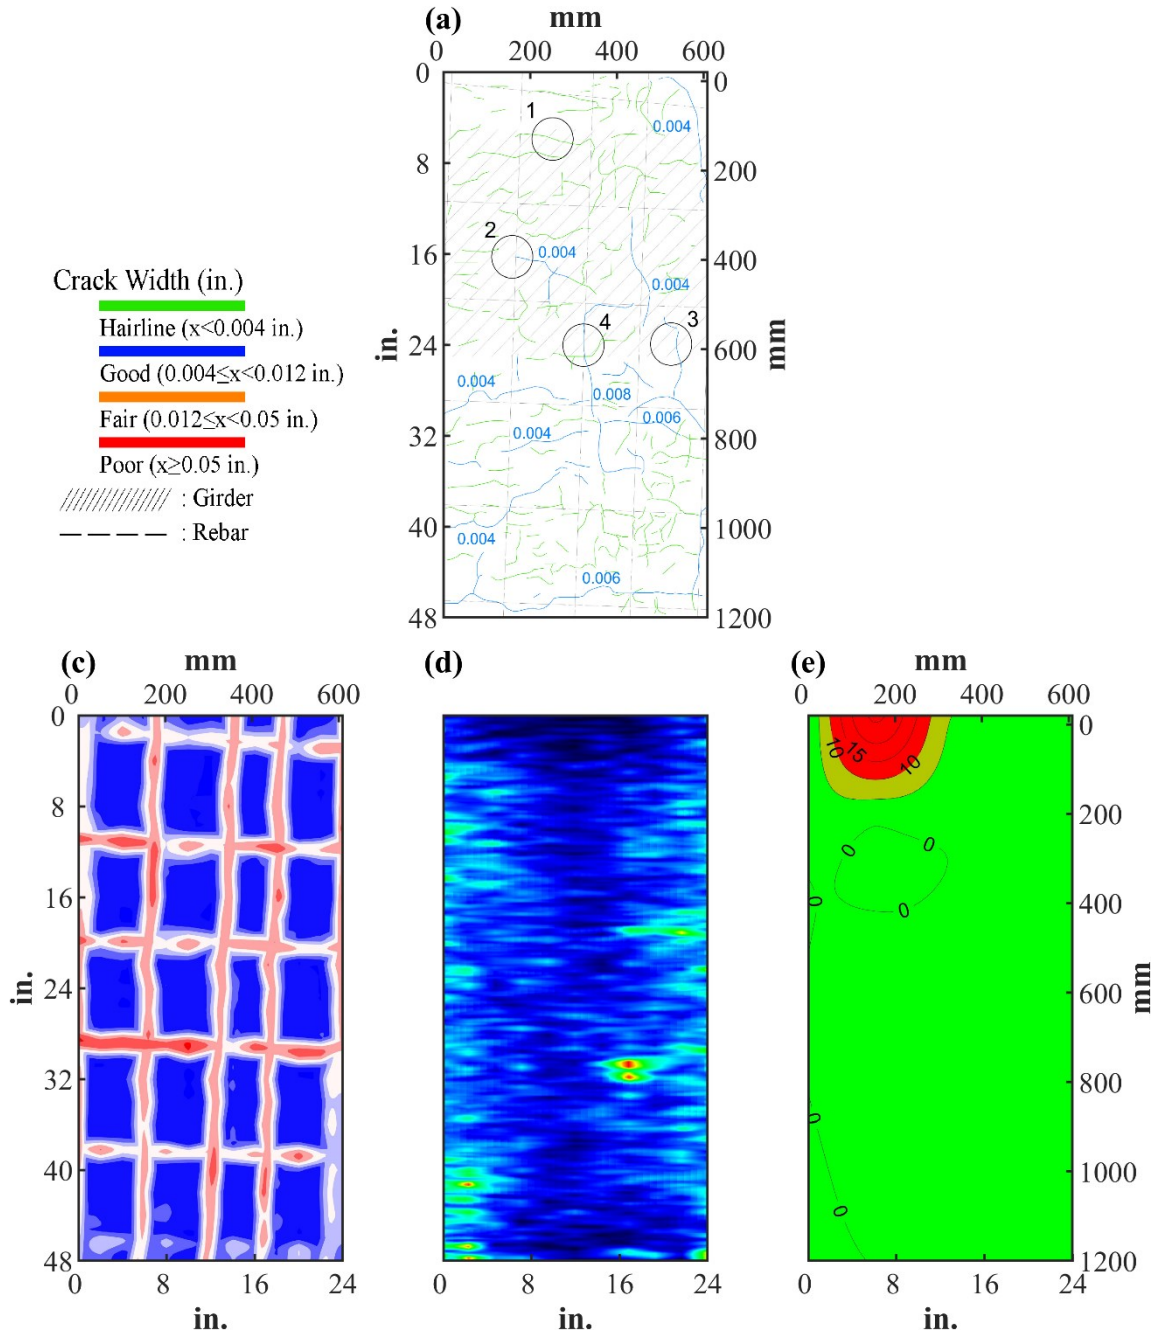
As shown in Figure 0.341 (a), there was a widespread of hairline cracks and narrow cracks ranging from 0.004 in. to 0.008 in. wide. Based on Figure A.6.3 (e), there was a high possibility of corrosion at the upper left corner of grid 1, but all other area had almost zero to no risk of corrosion. On grid 2, only hairline cracks were observed as shown in Figure 0.342 (a).

Figure 0.341. Crack Map and NDE Results of Grid 1: (a) Crack Map and Location of Cores; (c) GPR C-scan at 2.7 in. to 3.8 in. Depth; (d) UST C-scan; (e) Corrosion Rate Map

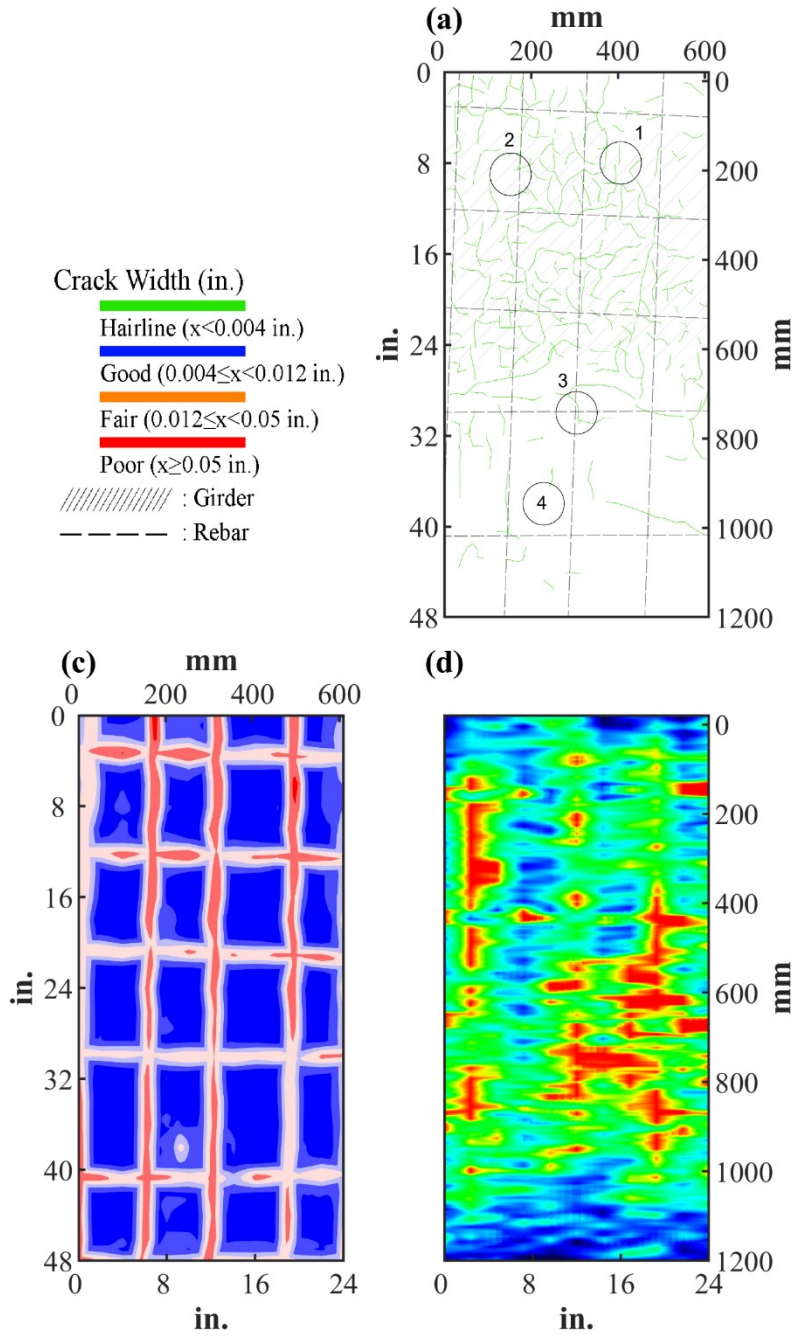
Figure 0.342. Crack Map and NDE Results of Grid 2: (a) Crack Map and Location of Cores; (c) GPR C-scan at 2.85 in. to 3.95 in. Depth; (d) UST C-scan

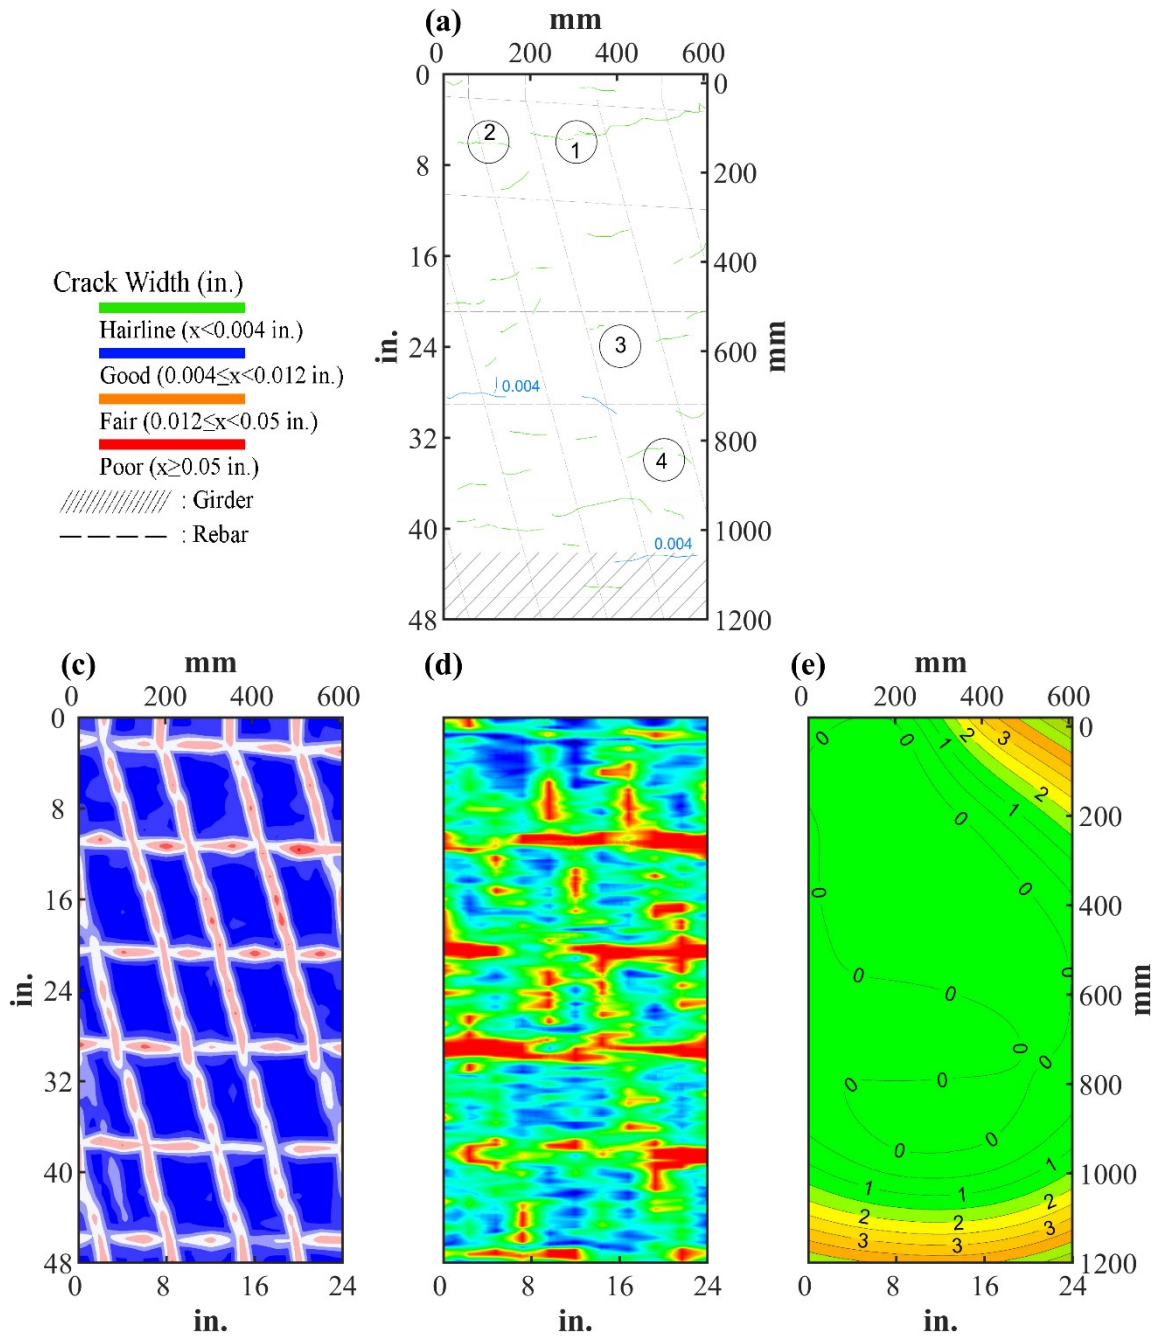
As shown in Figure 0.348 (a), hairline cracks were mostly observed from grid 1 with one 0.004 in. wide longitudinal crack along a girder. Based on Figure A.7.3 (e), there was low possibility of corrosion on grid 1. On grid 2, no cracks were observed as shown in Figure 0.349 (a).

Figure 0.348. Crack Map and NDE Results of Grid 1: (a) Crack Map and Location of Cores; (c) GPR C-scan at 1.8 in. to 2.9 in. Depth; (d) UST C-scan; (e) Corrosion Rate Map

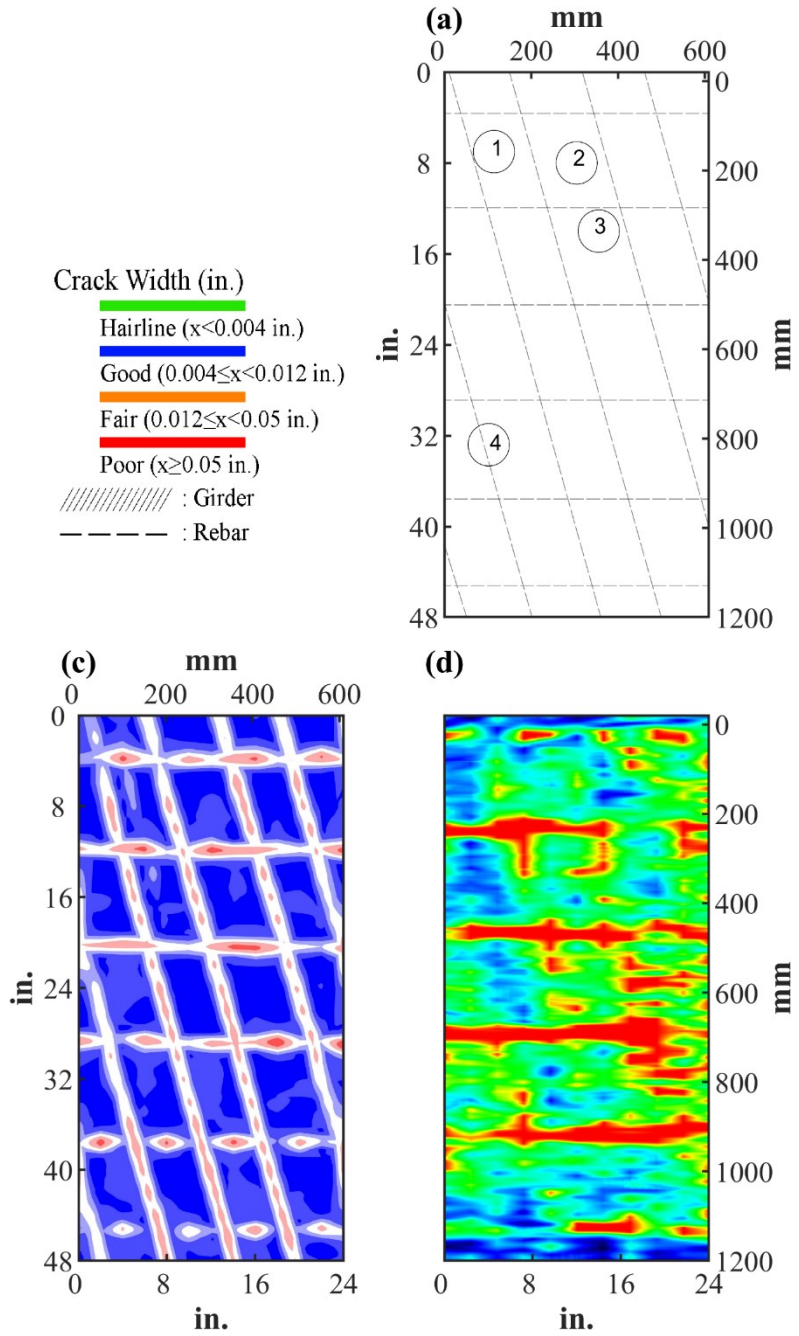
Figure 0.349. Crack Map and NDE Results of Grid 2: (a) Crack Map and Location of Cores; (c) GPR C-scan at 2.45 in. to 3.55 in. Depth; (d) UST C-scan

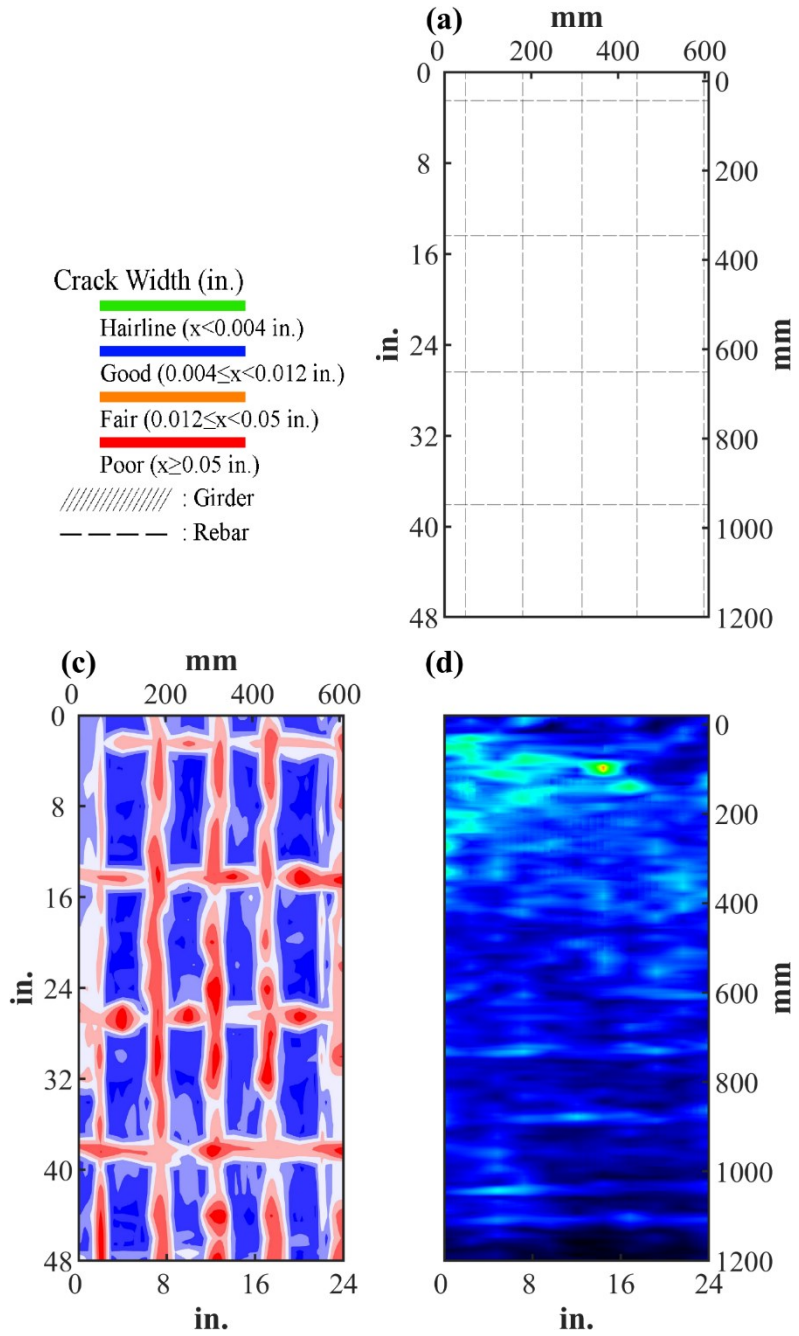
The deck was covered with asphalt overlay; therefore, there was no crack on the bridge as shown in Figure 0.355 (a) and Figure 0.356 (a)

Figure 0.355. Crack Map and NDE Results of Grid 1: (a) Crack Map and Location of Cores; (b) GPR C-scan at 3.9 in. to 5.3 in. Depth; (c) UST C-scan

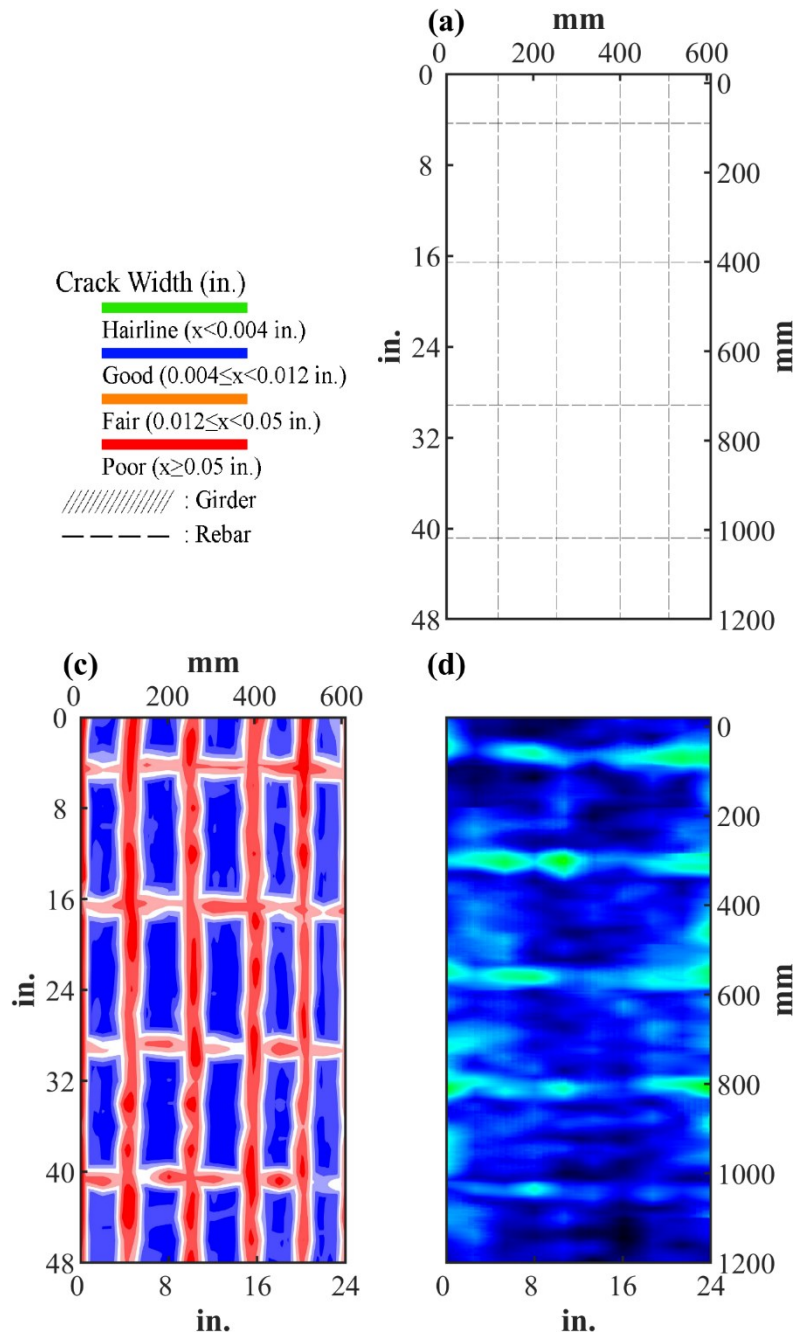
Figure 0.356. Crack Map and NDE Results of Grid 2: (a) Crack Map and Location of Cores; (c) GPR C-scan at 3.4 in. to 4.7 in. Depth; (d) UST C-scan

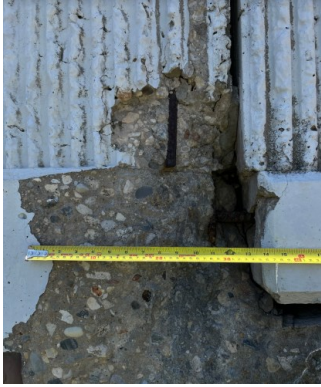
The top surface of deck has hairline to minor transverse cracks. The west railing has moderate spalling at its end. There is exposed and corroded at the exterior surface of abutment as shown in Figure 0.358 (a). The abutment cap between beam 7 and 8 has leakage issue as shown in Figure 0.358 (b).

Figure 0.358. Deteriorations on the Bridge: (a) Exposed and Corroded Rebar at Abutment; (b) Leakage and cracks at abutment cap

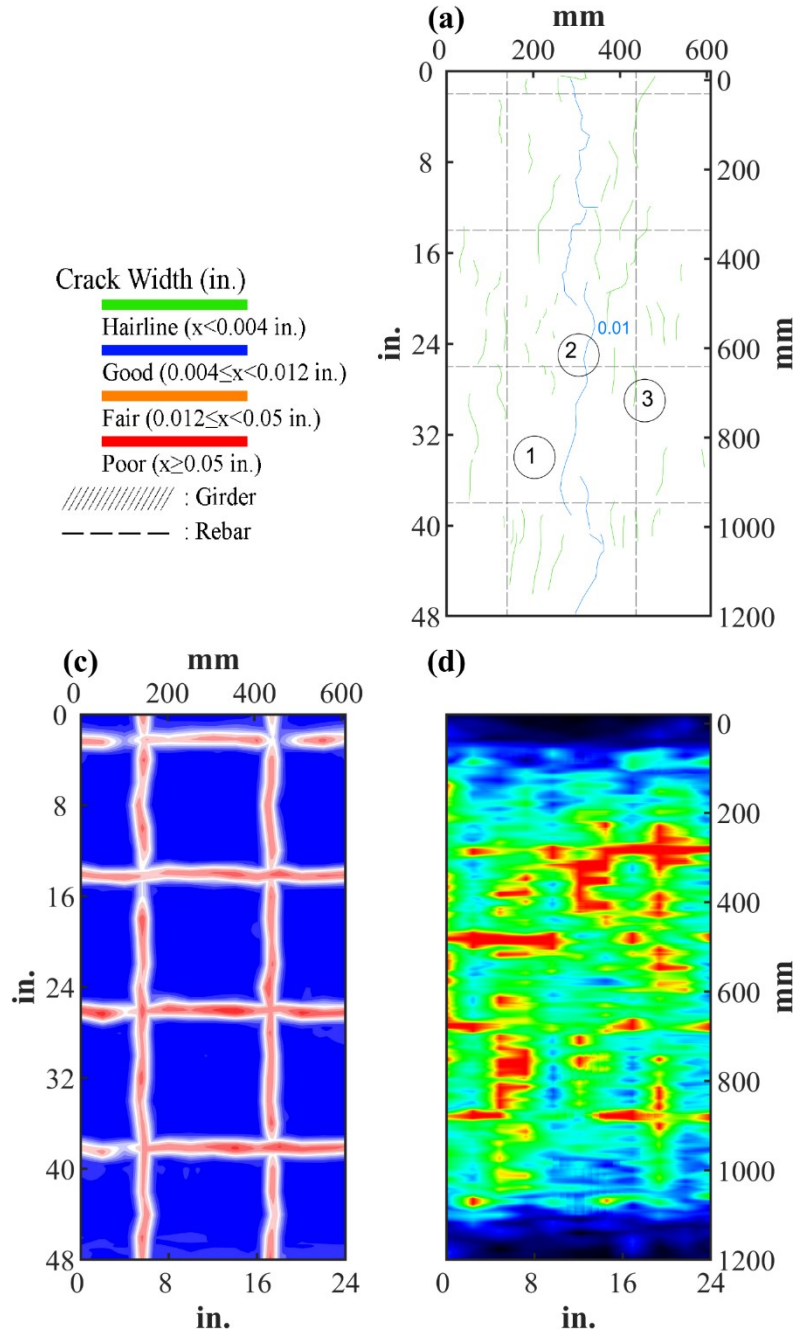
As shown in Figure 0.359 (a), grid 1 mostly had hairline cracks with 0.01 in. wide transverse crack that is possibly due to panel joint. And as shown in Figure A.2.4 (a), there was no crack on grid 2.

Figure 0.360. Crack Map and NDE Results of Grid 1: (a) Crack Map and Location of Cores; (c) GPR C-scan at 1.9 in. to 3.2 in. Depth; (d) UST C-scan

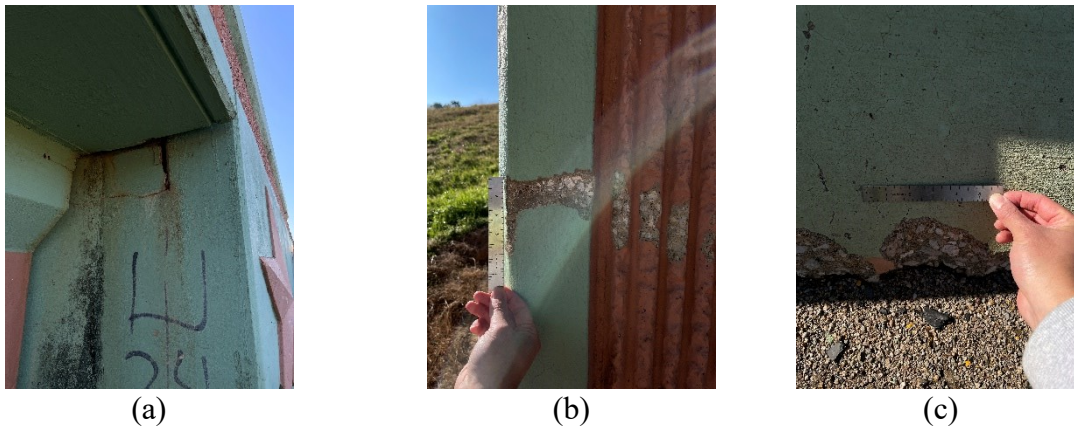
There is a crack at the exterior abutment wall and a sign of corrosion is visible as shown in Figure 0.366 (a). In addition, As shown in Figure A.3.2 (b) and (c), there were spalling at abutment wall and concrete rail, respectively.

Figure 0.366. Deteriorations on the Bridge: (a) Crack at Abutment Wall; (b) Spalling at Abutment Wall; (c) Spalling at Concrete Rail

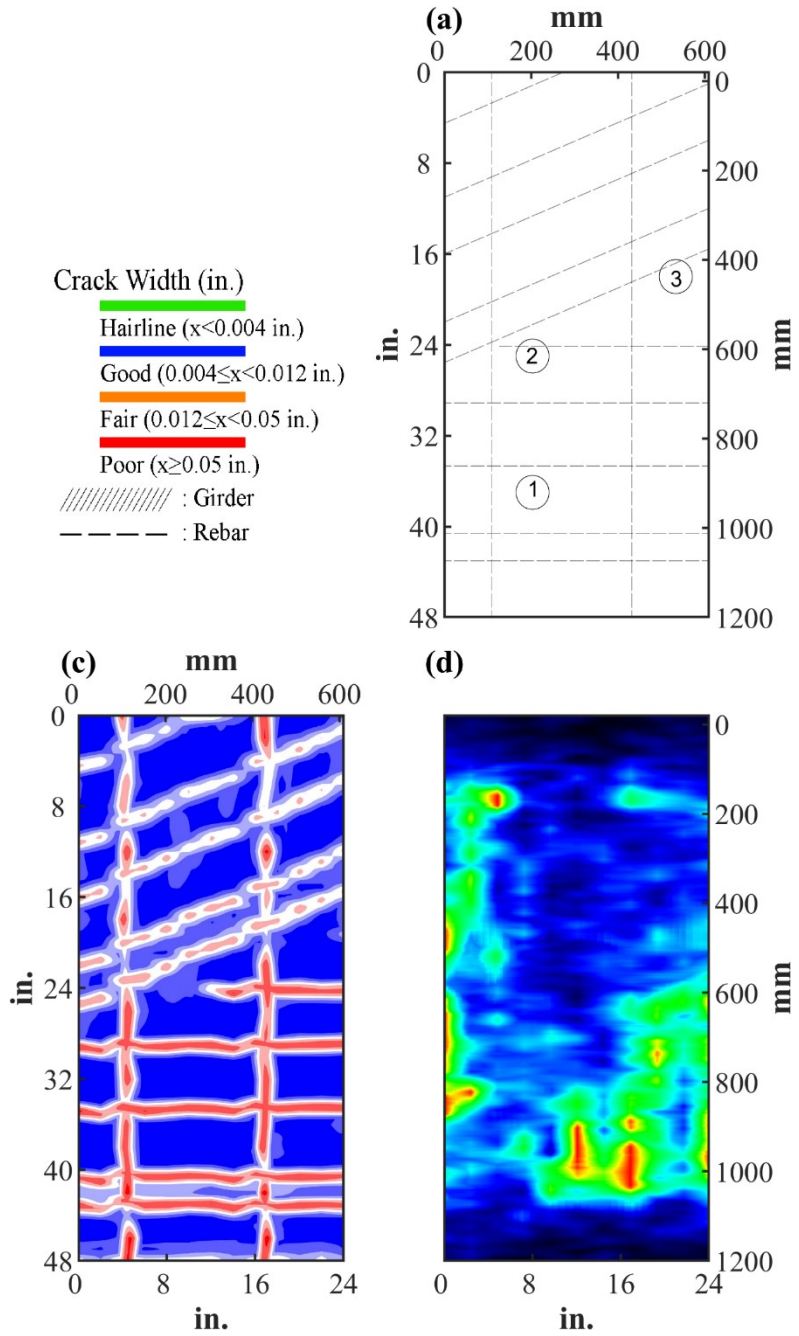
As shown in Figure 0.368 (a), there were no cracks on grid 1. On the other hand, grid 2 had a transverse crack that ranged from 0.004 in. to 0.007 in. wide. Based on its pattern, it is possible that the crack is due to panel joint.

Figure 0.368. Crack Map and NDE Results of Grid 1: (a) Crack Map and Location of Cores; (c) GPR C-scan at 1.8 in. to 2.9 in. Depth; (d) UST C-scan

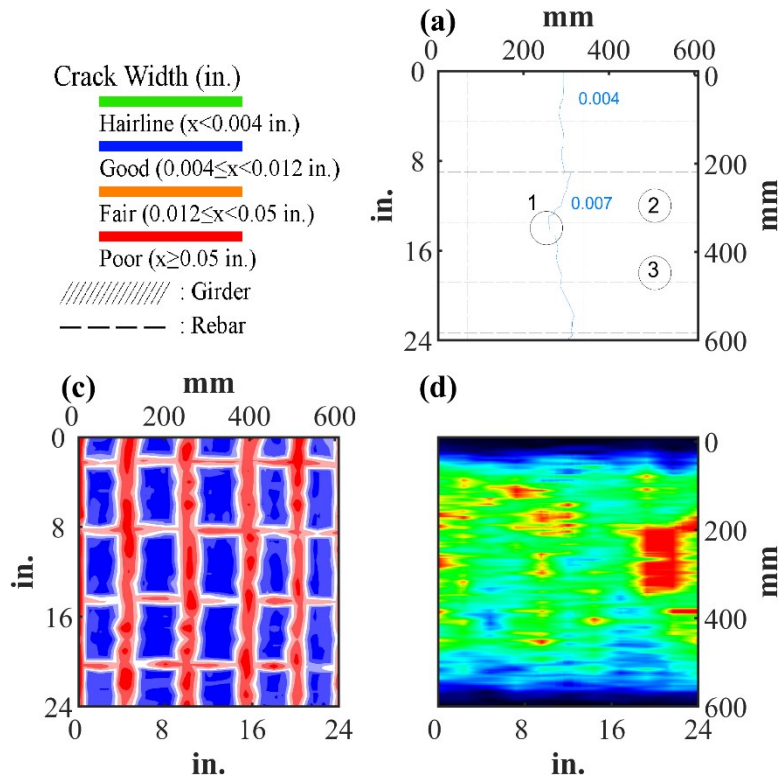
Figure 0.369. Crack Map and NDE Results of Grid 2: (a) Crack Map and Location of Cores; (c) GPR C-scan at 1.7 in. to 2.8 in. Depth; (d) UST C-scan

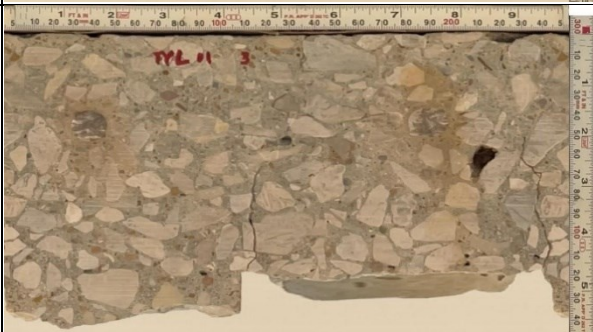
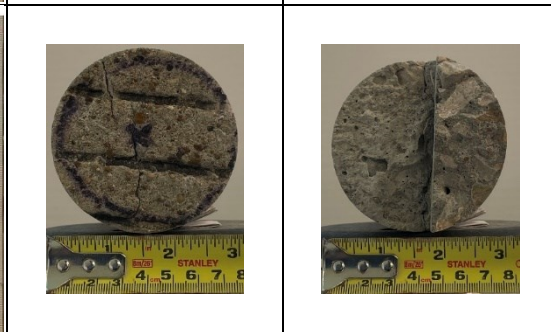
Core	dia. x height (in.)	Rebar depth (in.)	Rebar size (#)	Epoxy (Y/N)	Crack type	Crack width (in)	Notes
1-1	3.0 x 14.4	-	-	-	-	-	-
1-2	3.0 x 16.0	-	-	-	-	-	-
1-3	3.0 x 15.4	1.6	5	Y	longitudinal	0.008	A crack propagating from panel joint; Avoid around rebar
1-4	3.0 x 13.2	1.6	5	Y	-	-	-
1-5	3.0 x 13.2	1.6	5	Y	-	-	-
1-6	3.0 x 13.7	-	-	-	-	-	-

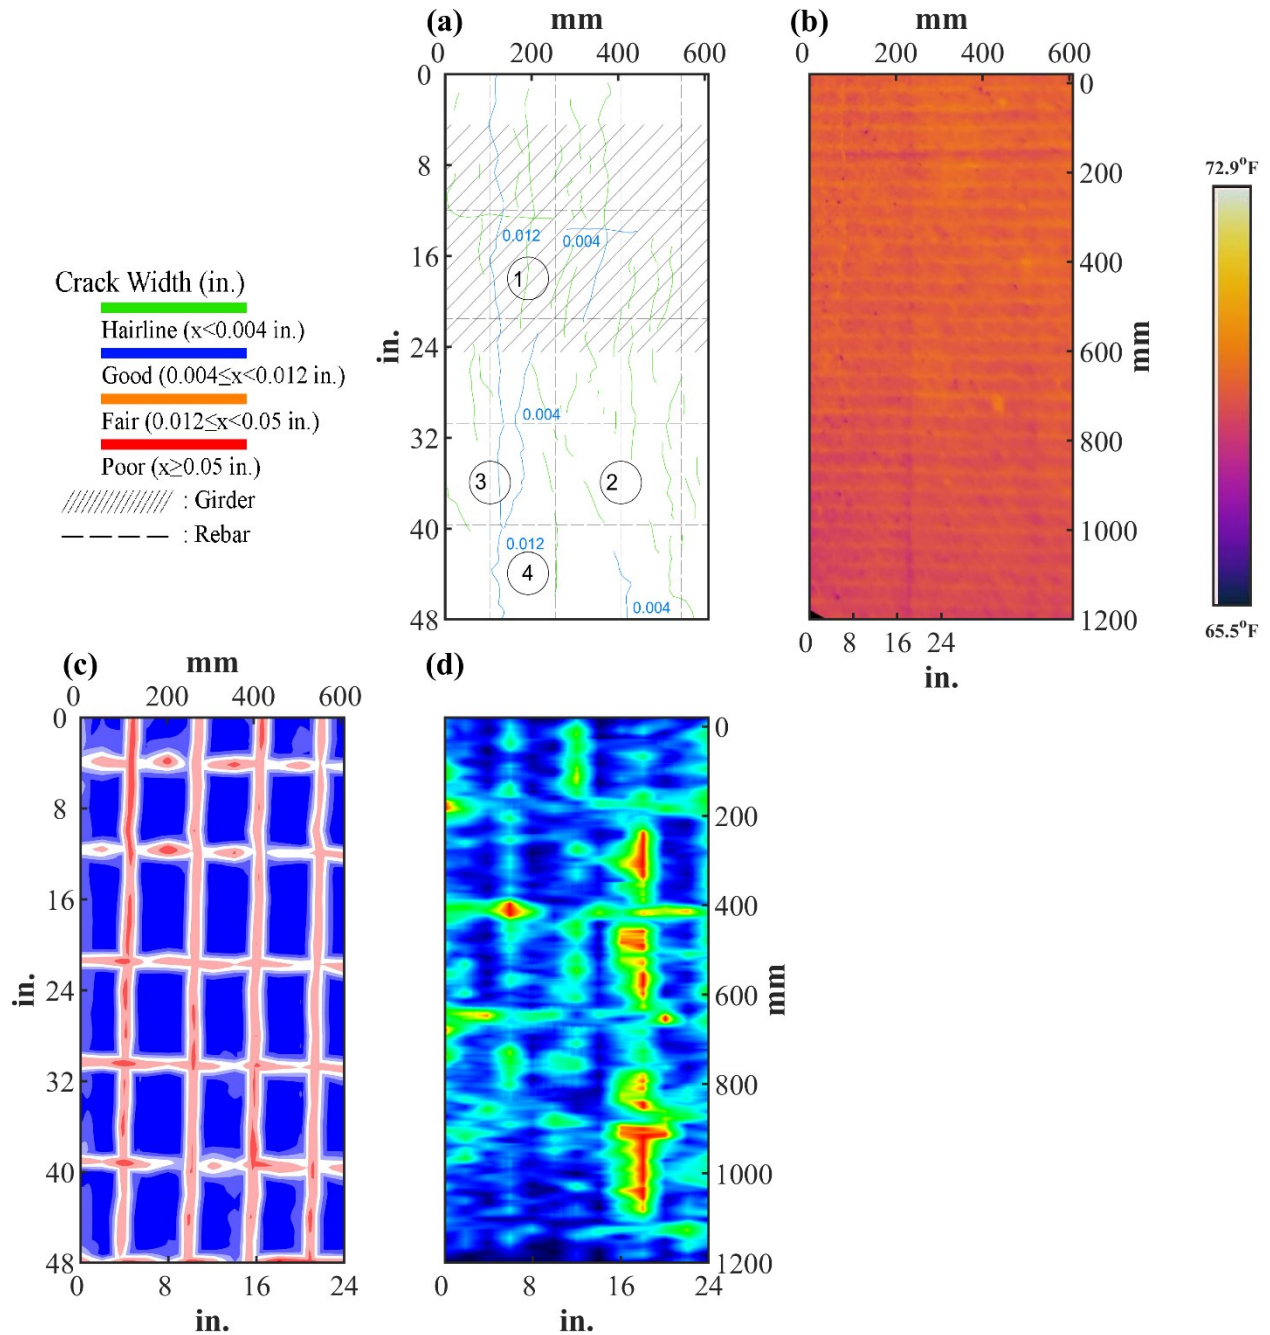
Figure 0.375. Crack Map and NDE Results of Grid 1: (a) Crack Map and Location of Cores; (b) Infrared Picture; (c) GPR C-scan at 1.9 in. to 3.3 in. Depth; (d) UST C-scan at 3.1 in. Depth

As shown in Figure 0.149 (a), there are widespread of hairline cracks and transverse cracks that range from 0.004 in. to 0.012 in. wide on grid 1. Transverse cracks were on top of a girder and propagated from it. On grid 2, hairline cracks and a 0.018 in. wide transverse crack were observed that was possibly caused by panel joints as shown in Figure 0.376 (a).

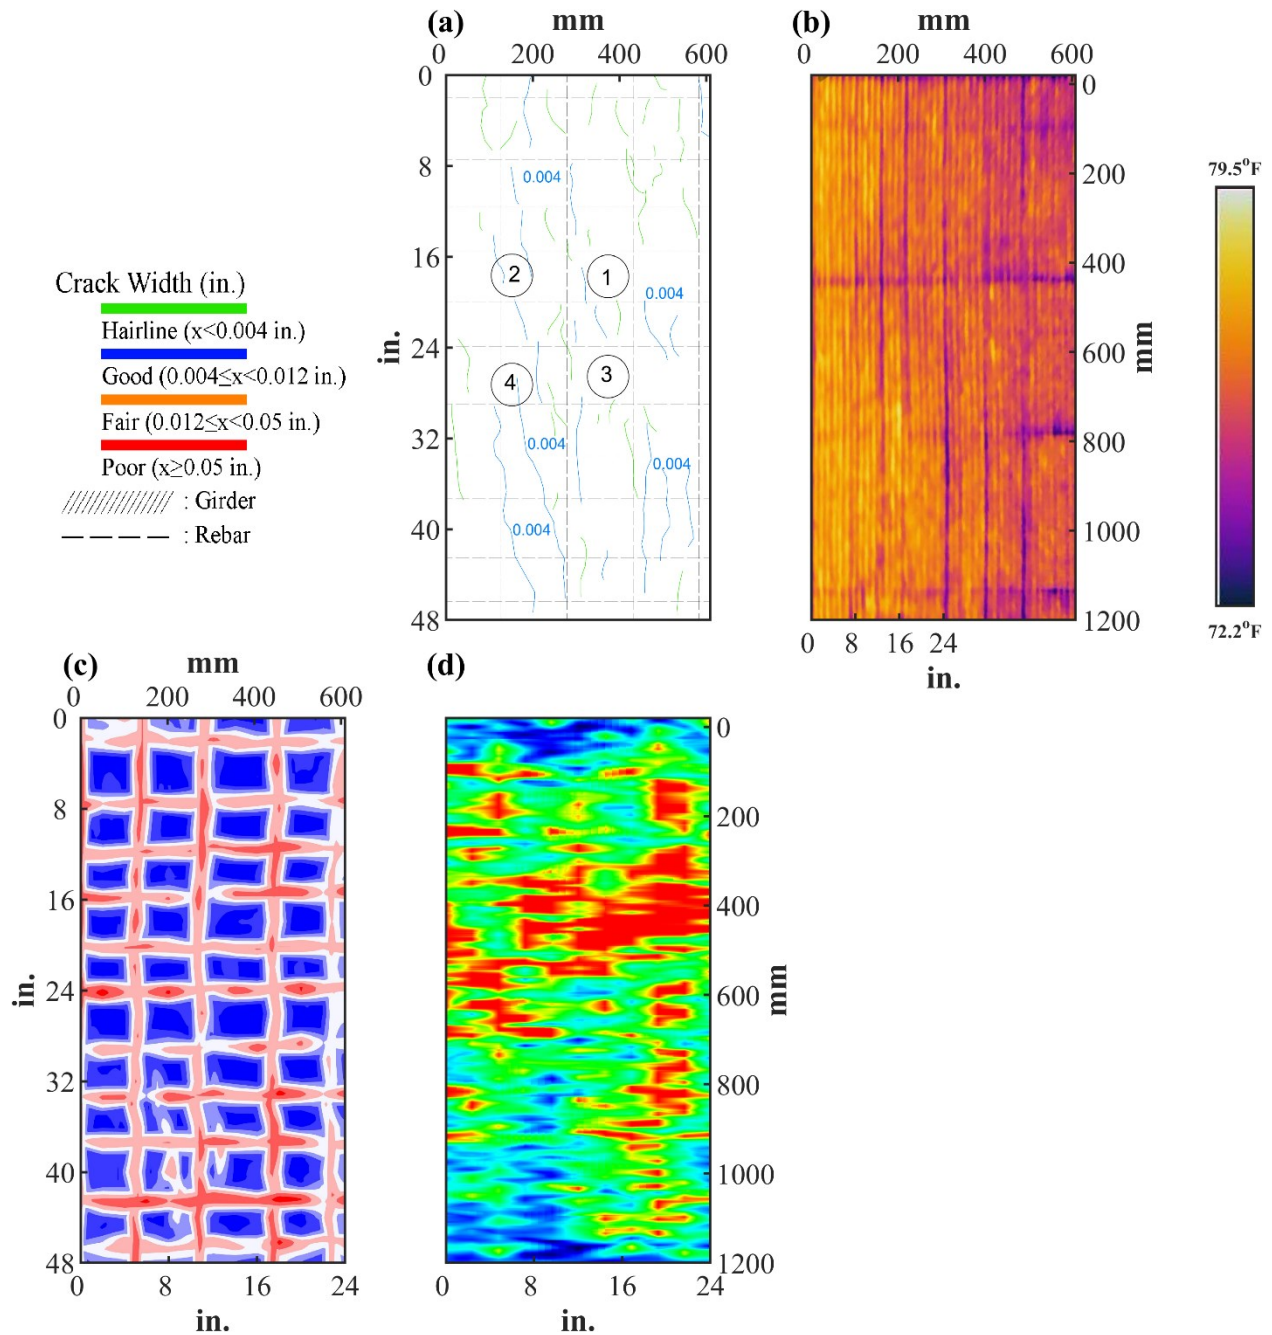
Figure 0.382. Crack Map and NDE Results of Grid 1: (a) Crack Map and Location of Cores; (b) Infrared Picture; (c) GPR C-scan at 1.9 in. to 3.3 in. Depth; (d) UST C-scan at 2.6 in. Depth

As shown in Figure 0.156 (a), there were widespread of transverse hairline cracks and 0.004 in. wide transverse cracks throughout grid 1. On grid 2, there was one 0.004 in. wide transverse crack that is possibly caused by panel joints as shown in Figure 0.157 (a).

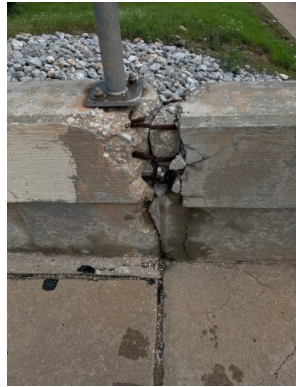
Deck surface has transverse and longitudinal cracks. Concrete rail at north has spalling and exposed rebar at its west end as shown in Figure 0.388 (a). The abutment caps have vertical cracks with efflorescence as shown in Figure 0.388 (b).

Figure 0.388. Deteriorations on the Bridge: (a) Exposed and Corroded Rebar at Concrete Railing; (b) Crack on the Abutment Wall

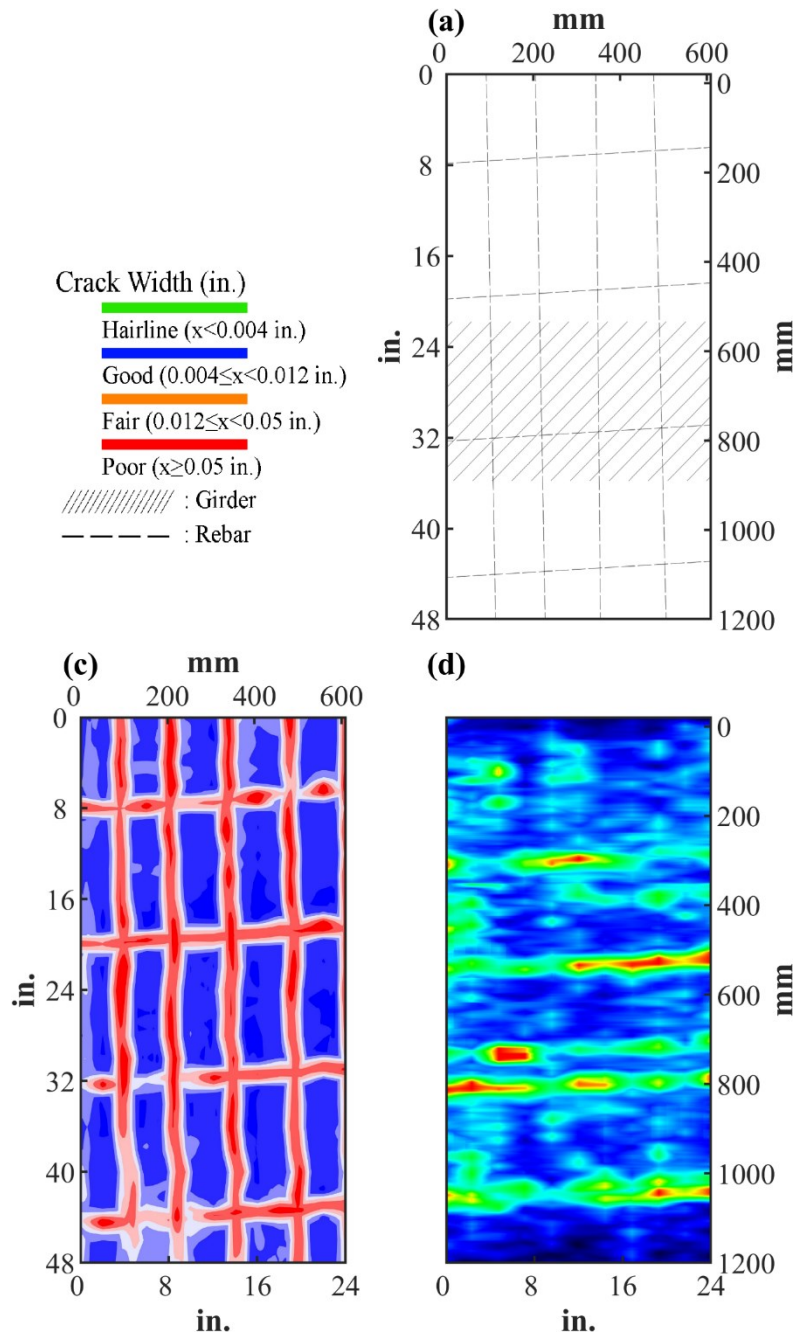
Figure 0.390. Crack Map and NDE Results of Grid 1: (c) GPR C-scan 2.5 in. to 3.8 in. Depth; (d) UST C-scan at 4.4 in. Depth

Due to a weather condition, crack map was not drawn for both grid 1 and grid 2, and GPR and UST of grid 2 was not measured.

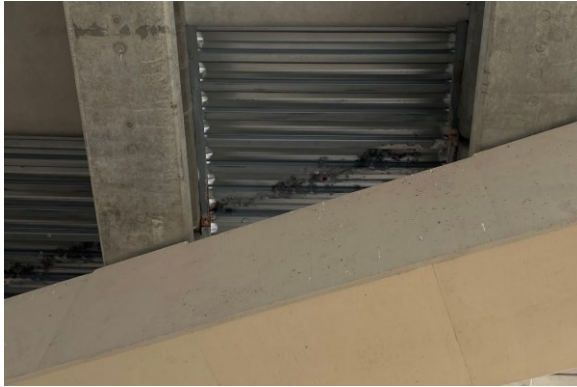
Deck surface has hairline diagonal, transverse, and longitudinal cracks. Deck joints are partially filled with debris and dirt. Its metal arms has minor corrosion. The metal deck form at its end has corrosion rust as shown in Figure 0.395 (a). The columns have hairline cracks as shown in Figure 0.395 (b).

Figure 0.395. Deteriorations on the Bridge: (a) Rust at Metal Deck Form; (b) Cracks on Column

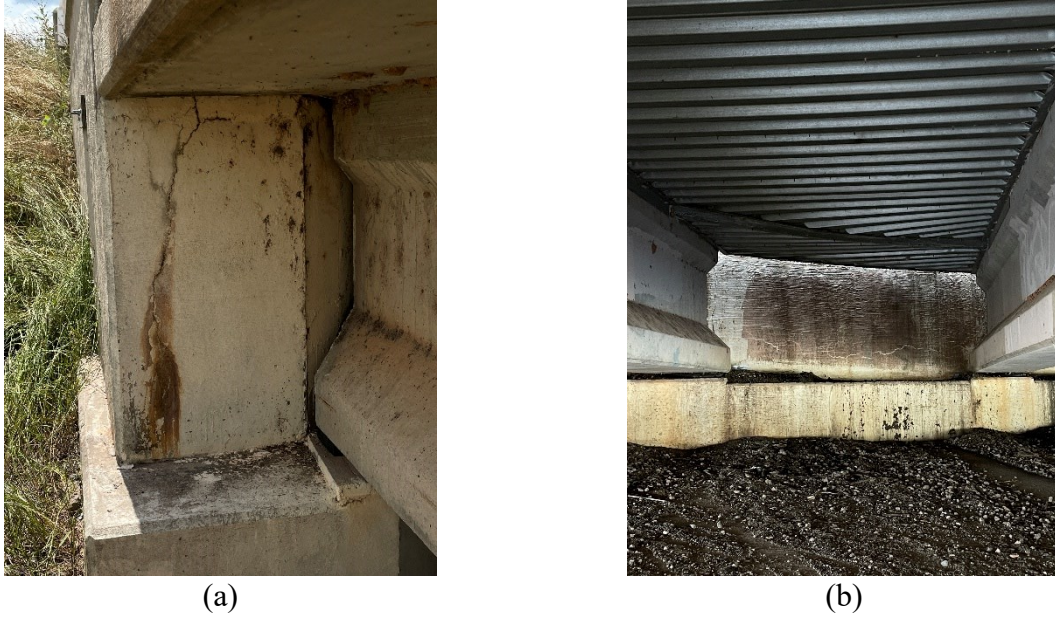
Figure 0.403. Deteriorations on the Bridge: (a) Vertical Crack and Efflorescence at Abutment Wall; (b) Horizontal Crack and Efflorescence at Abutment Wall

Deck surface has hairline transverse cracks. Abutment back wall has vertical and horizontal crack with efflorescence as shown in Figure 0.403 (a) and (b).

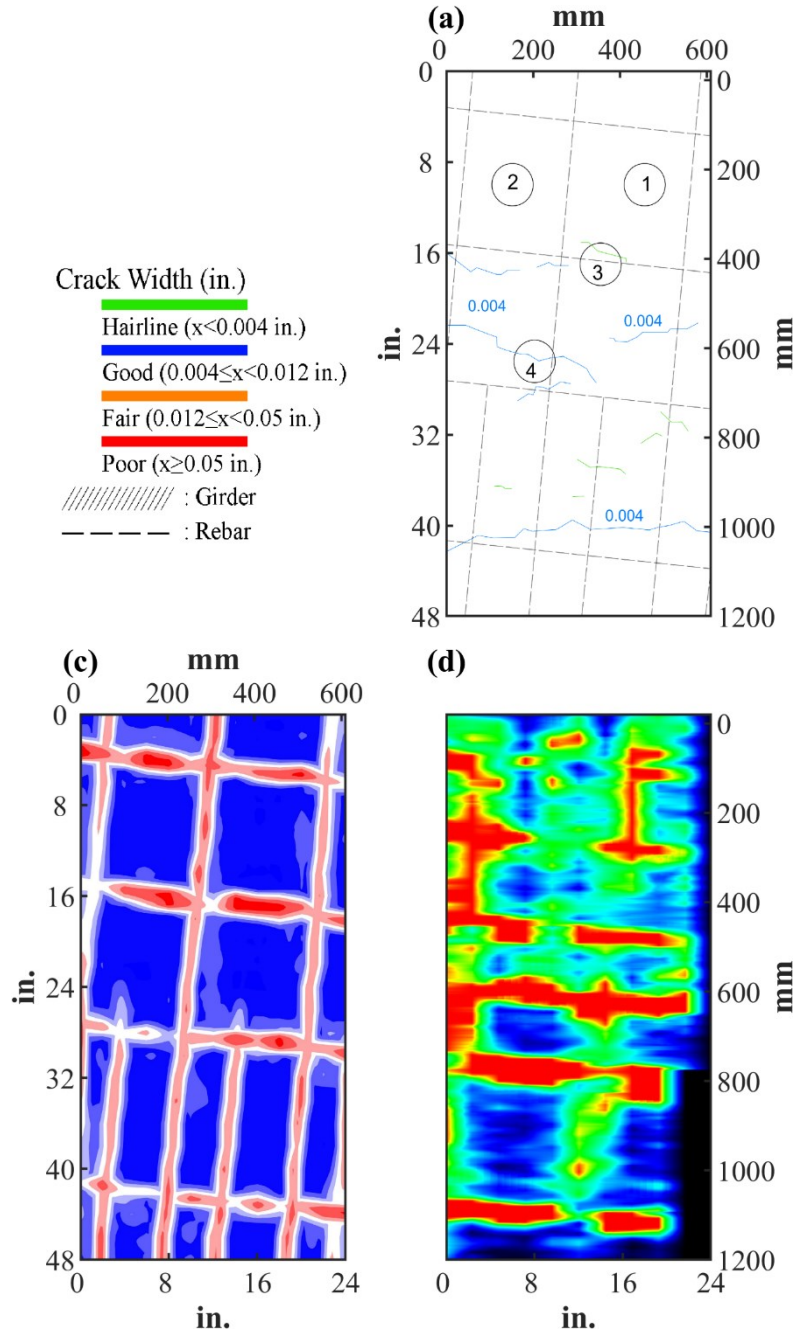
Figure 0.405. Crack Map and NDE Results of Grid 1: (a) Crack Map and Location of Cores; (c) GPR C-scan at 2.7 in. to 4.1 in. Depth; (d) UST C-scan at 4.4 in. Depth

As shown in Figure 0.405 (a), there were 0.004 in. wide longitudinal cracks on grid 1. On grid 2, there were 0.004 in. longitudinal and diagonal cracks as shown in Figure 0.406 (a). Due to a weather condition, UST was not conducted on grid 2.

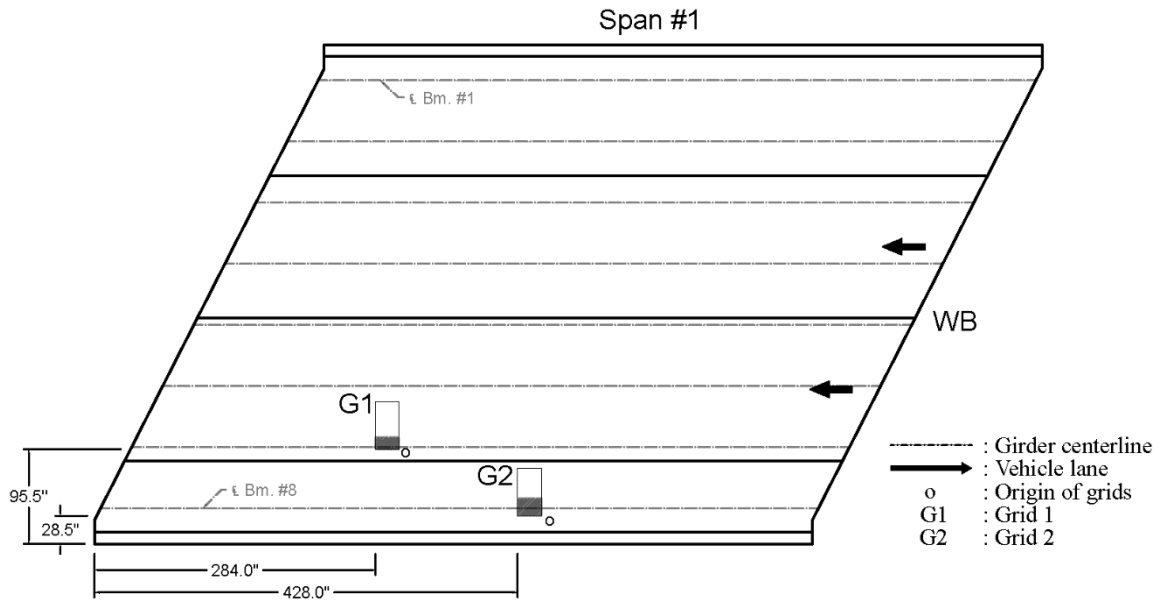
Figure 0.411. Plan View of the Bridge and Location of Grids

Grid 1 was located on the WB lane and grid 2 was located on the WB shoulder lane of the span 1 of the bridge.

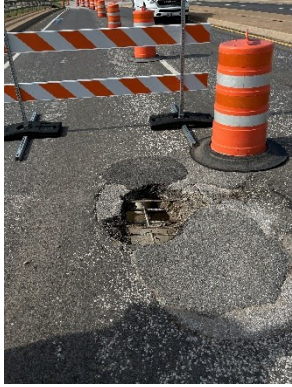
(a)

There are cracks on the top surface of deck. Crack is more widespread on span 2. There is a hole on a deck between beam 2 and 3 as shown in Figure 0.417 (a). Rebar had pitting corrosion as shown in Figure 0.417 (b). The joint is paved over by asphalt.

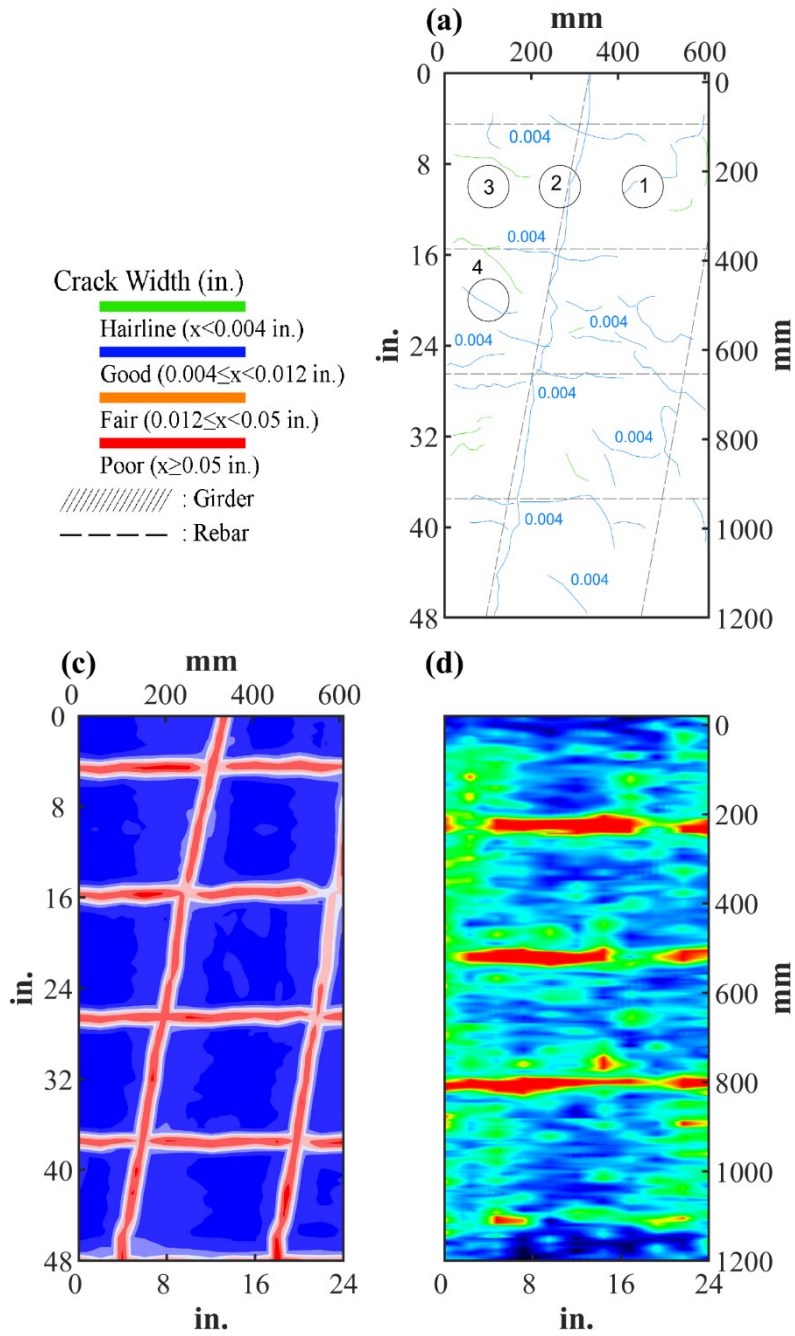
Figure 0.418. Crack Map and NDE Results of Grid 1: (a) Crack Map and Location of Cores; (c) GPR C-scan at 1.3 in. to 2.6 in. Depth; (d) UST C-scan at 2.4 in. Depth

As shown in Figure 0.418 (a), there was widespread of 0.004 in. wide cracks on grid 1, and a diagonal crack propagated along a rebar. It is possible that this crack might have been caused by panel joints.
