# Design and Rehabilitation Strategies for Permeable Friction Course Pavements

Technical Report 0-7110-R1

TEXAS A&M TRANSPORTATION INSTITUTE  
COLLEGE STATION, TEXAS

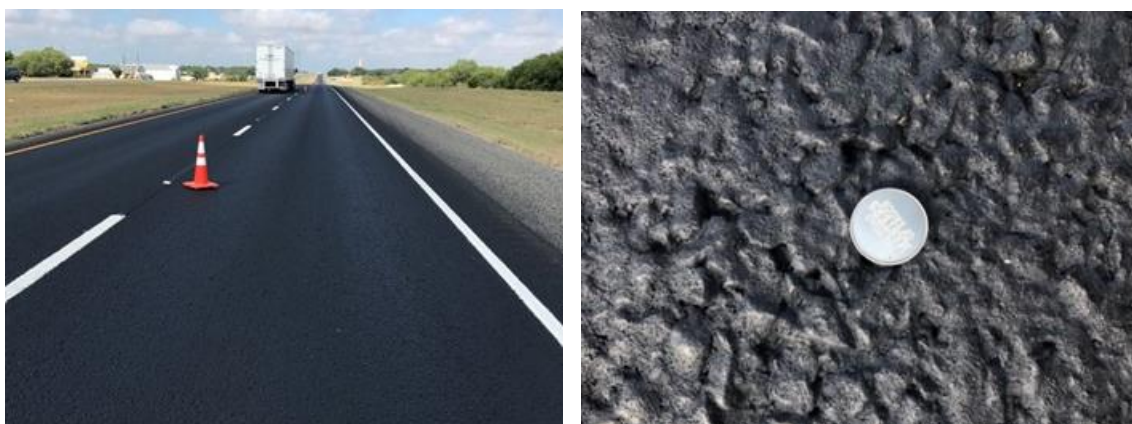
The San Antonio District constructed a 1-mi test section in the southbound lanes of IH 35 in June of 2017. This portion of IH 35 was surfaced with an older PFC that was about at the end of its life and beginning to exhibit significant raveling, and the district wanted to see if Onyx could retard the raveling and extend the life of the PFC. Figure 26 shows the treatment soon after application.

**Figure 26. IH 35 PFC surfaced with Onyx.**

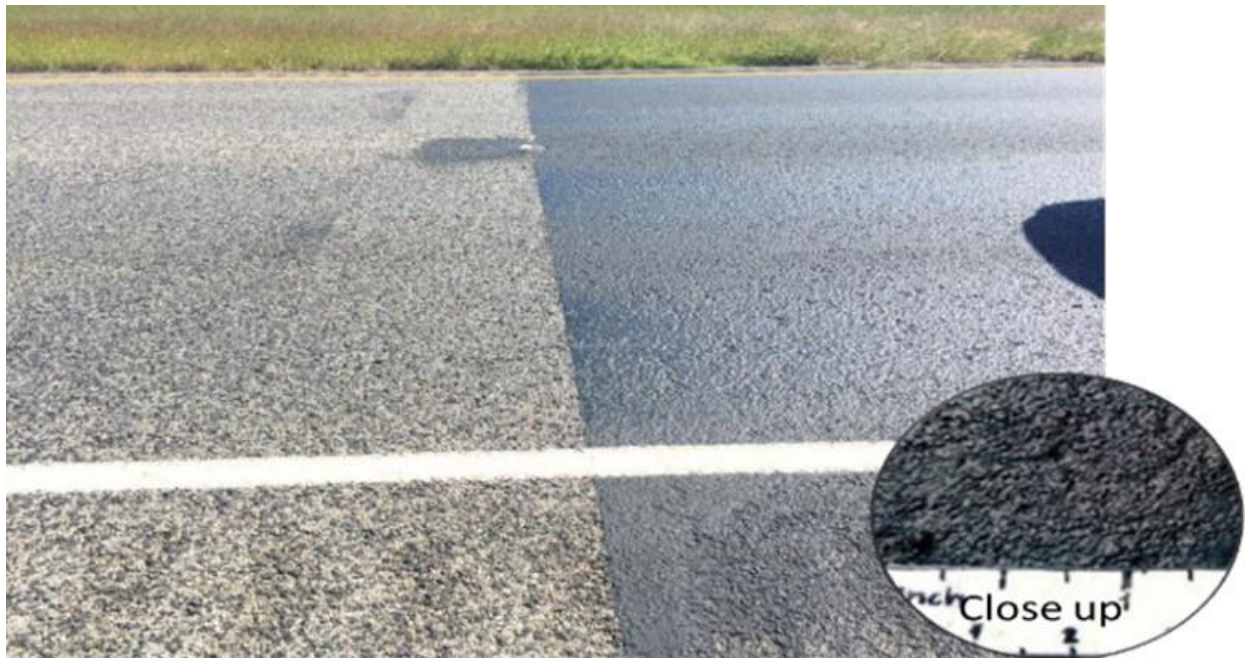
The old PFC surface along with the beginning of the Onyx application can be seen in Figure 27. Skid measurements taken on the Onyx surface and on the existing PFC at either end of the Onyx section are shown in Figure 28. These data are concerning because the skid numbers seem to have dropped by about 10 points. Some improvements in skid were noted in the last set of measurements from April 2019, but all measurements were observed to increase, and it was concluded that this increase was attributed to either (a) the slurry wearing off (Figure 29); or (b) the continuation of the raveling (Figure 30), which was visually apparent. Figure 29 and Figure 30 show the pavement surface condition 3 years after placement of the Onyx.

Figure 27. IH 35 existing PFC and beginning of Onyx application.

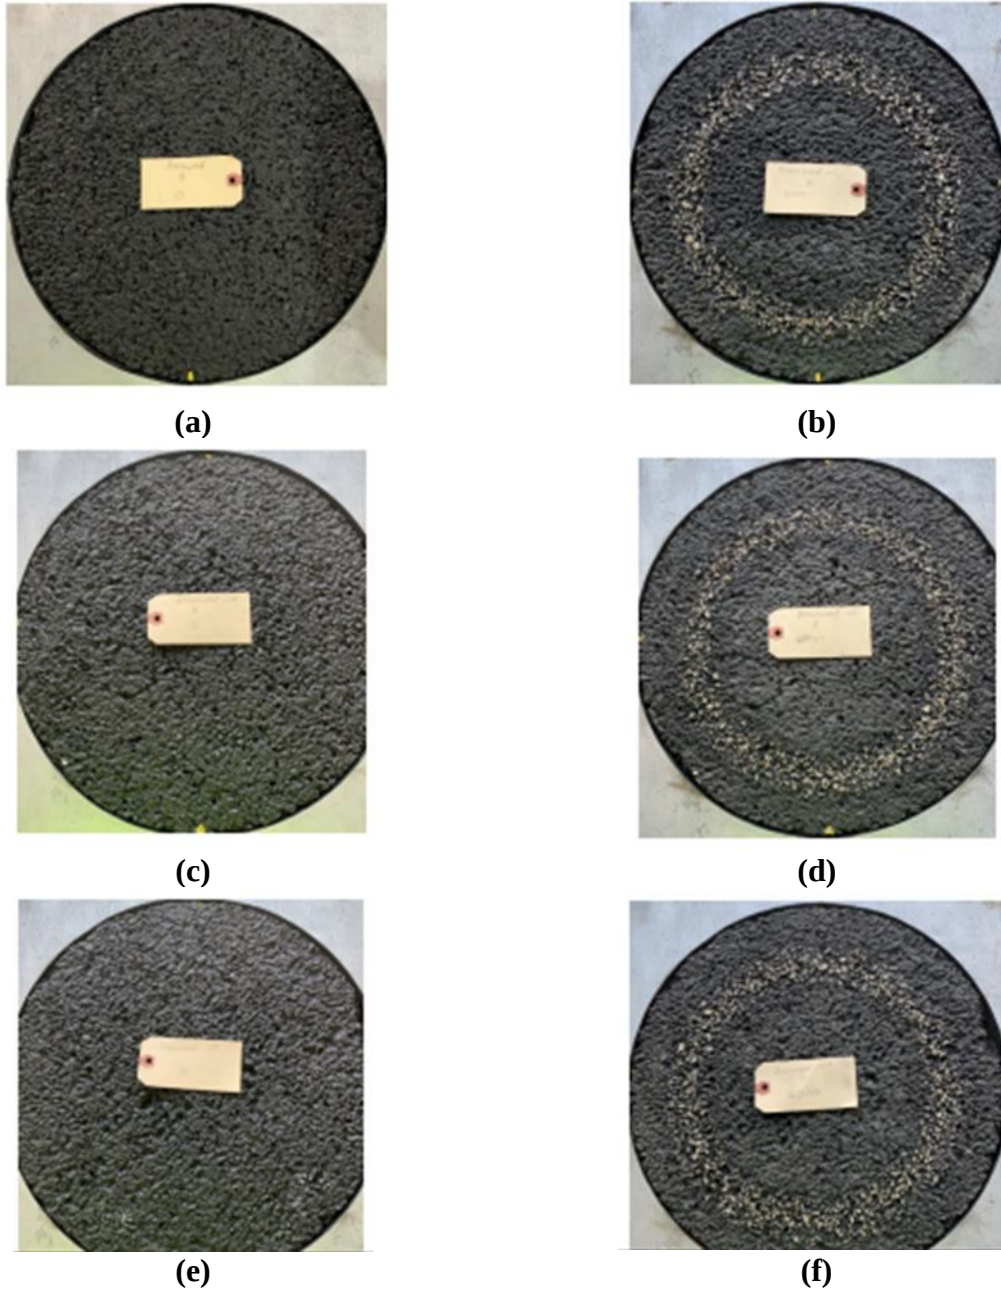
**Figure 32. 16-inch cores before and after three-wheel polisher trafficking: (a) core A at zero passes with 0.12 gal/yd<sup>2</sup>, (b) core A after 16,000 passes, (c) core B at zero passes with 0.16 gal/yd<sup>2</sup>, (d) core B after 16,000 passes, (e) core C at zero passes with 0.20 gal/yd<sup>2</sup>, and (f) core C after 16,000 passes.**

The laboratory testing revealed that there was a relationship of increasing skid numbers with the increase of passes with the three-wheel polisher. There did not seem to be significant visual differences between the three application rates. The lowest application rate had the quickest skid number recovery. Based on balancing friction needs and sealing the surface, the district selected 0.12 gal/yd<sup>2</sup> as the application rate. The condition of the PFC is illustrated in Figure 33, and details on the GPR evaluation are shown in Figure 34.

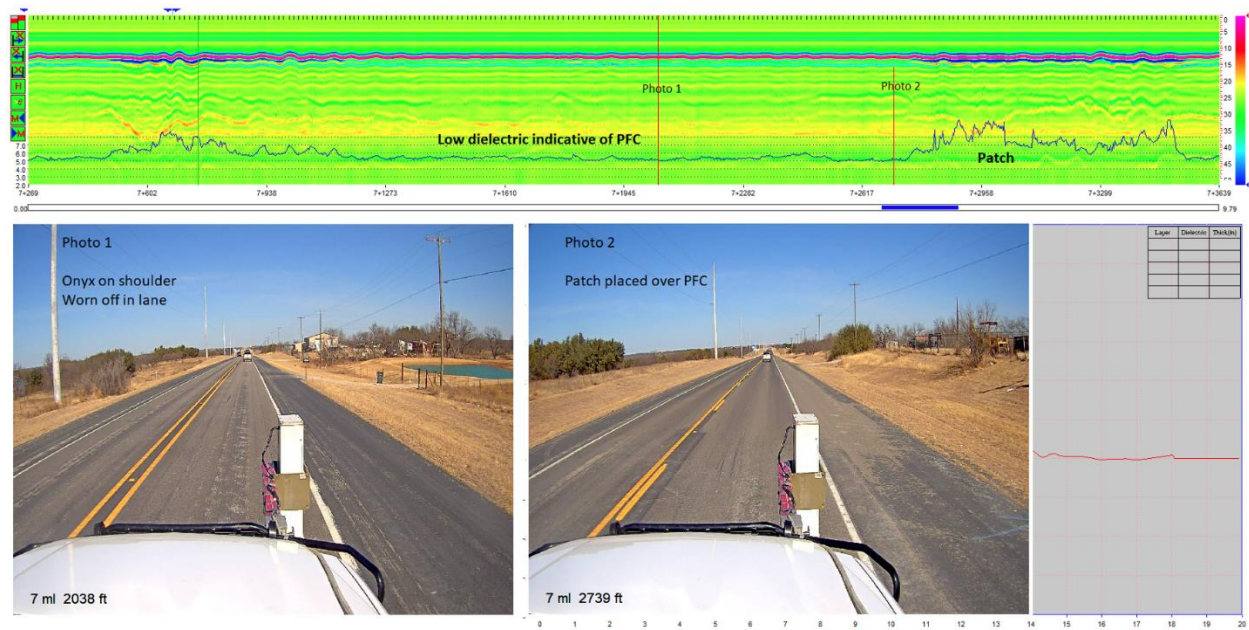
**Figure 34. GPR evaluation of US 183 in Brownwood District.**

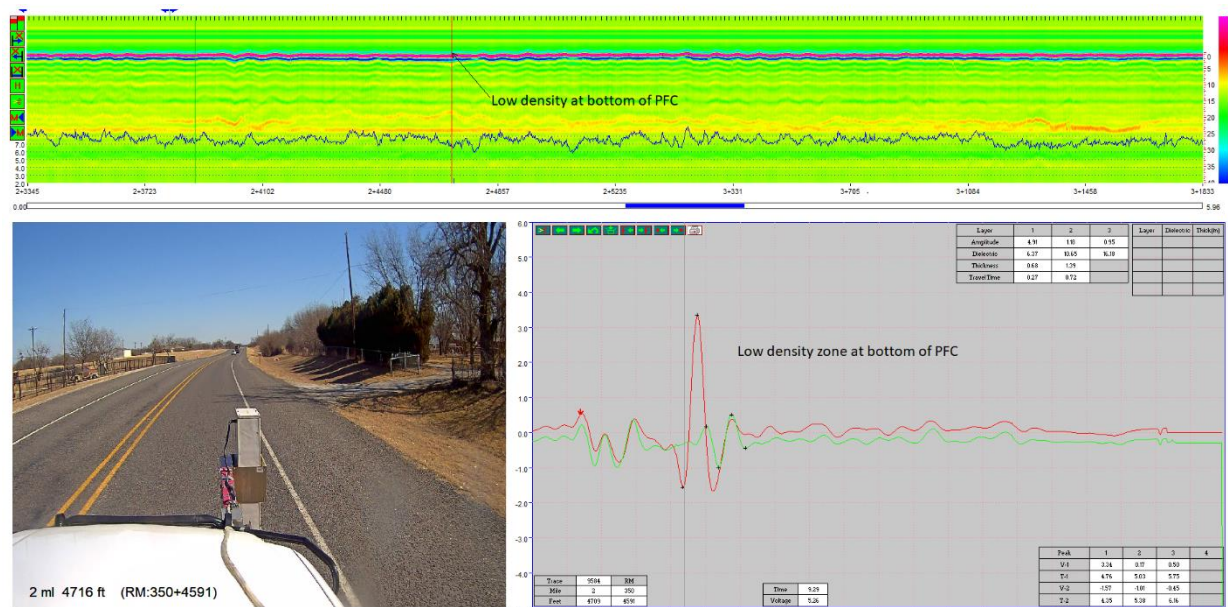
A GPR survey was conducted in February of 2022, and examples of the GPR survey are shown in Figure 36 and Figure 37. Based on the GPR, most of the project seems to be clogged (not draining) since there is no variation in density with depth, as shown in Figure 36 and schematically depicted in Figure 38. This finding indicates that the pavement was no longer functioning as a PFC at the time of seal coating. However, in some areas (as shown in Figure 37), there appears to be a portion of low density at the bottom of the PFC, meaning that the PFC is clogged in the top portion but open in the bottom portion (as illustrated in the schematic of Figure 39). While this could be an area to potentially hold water, there do not appear to be any surface distresses causing concern.

**Figure 37. GPR evaluation of SH 36 showing isolated areas of low density at the bottom of the PFC layer.**

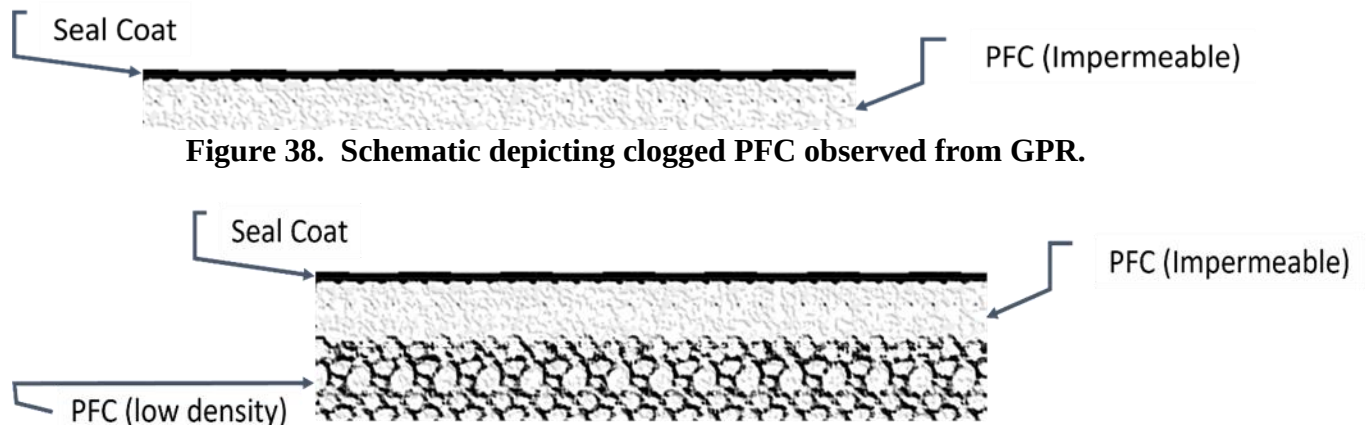
**Figure 38. Schematic depicting clogged PFC observed from GPR.**

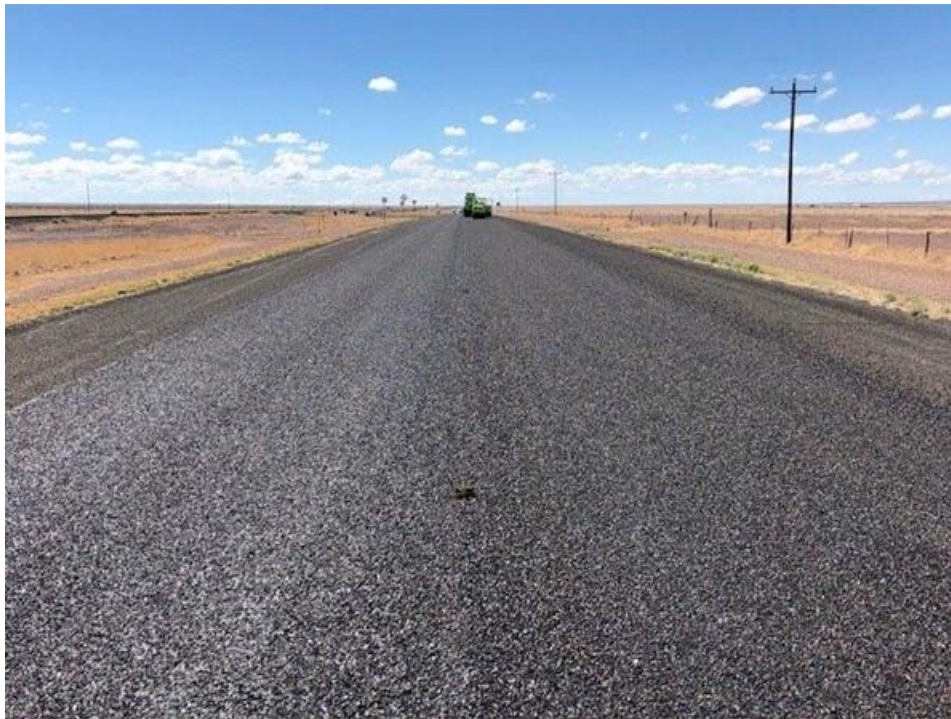
**Figure 40. Seal coat construction on US 90 in El Paso District.**

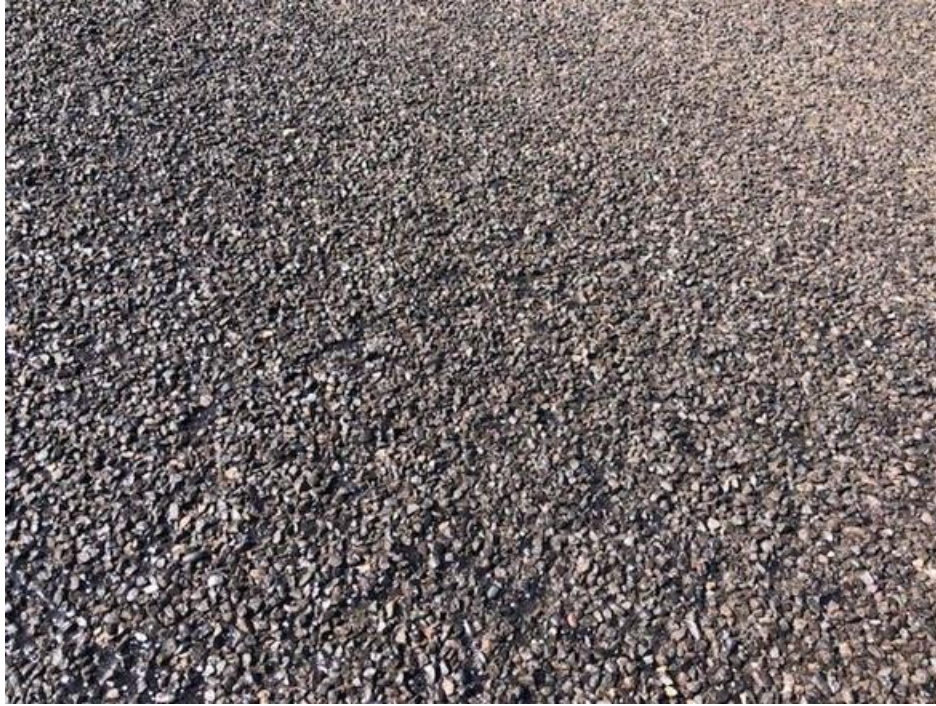
**Figure 41. Seal coat at time of construction on US 90 in El Paso District.**

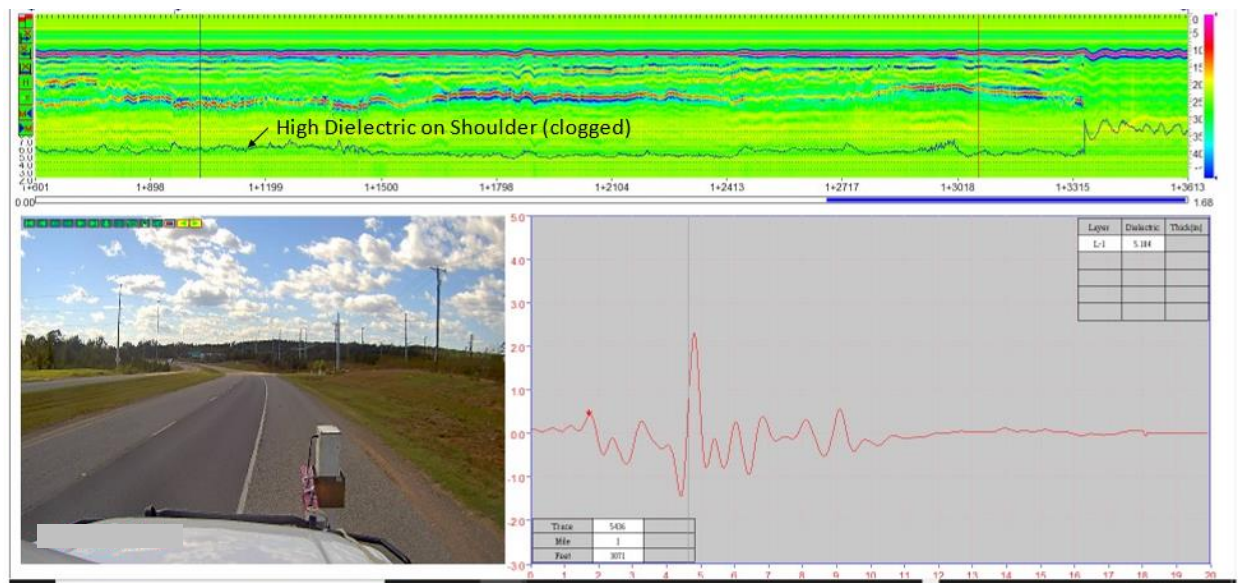
The Superpave mix was placed across the full width of the test section. GPR data for the left lane, right lane, and shoulder are shown in Figure 53 through Figure 55. When a PFC becomes clogged and is no longer draining, the GPR dielectric is higher and is more like a dense-graded HMA. Most of this older PFC tended to have a higher dielectric, indicating that it was clogged. The newer PFC inlaid patch (Figure 54) was draining a little better, but because the shoulder was also clogged, there was nowhere for the water to drain off, which created a bathtub effect within the patched area.

**Figure 55. GPR data for shoulder of US 69.**

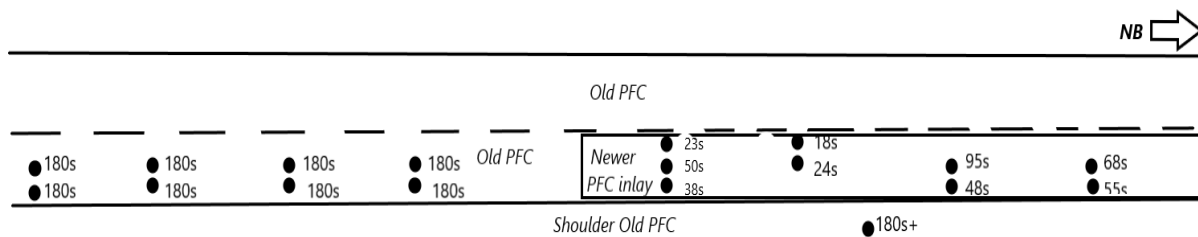
To verify these findings, the Lufkin District provided traffic control for the researchers to conduct field water flow tests and to take cores of the PFC pavement. The older PFC was not draining. At 180 seconds, as shown in the photo in Figure 56, if there was still no water flowing, the test was discontinued. The newer inlaid PFC patch performed better in terms of drainability, and these field tests confirmed the GPR data. A schematic of the test section layout and locations of field water flow tests along with results is shown in Figure 57.

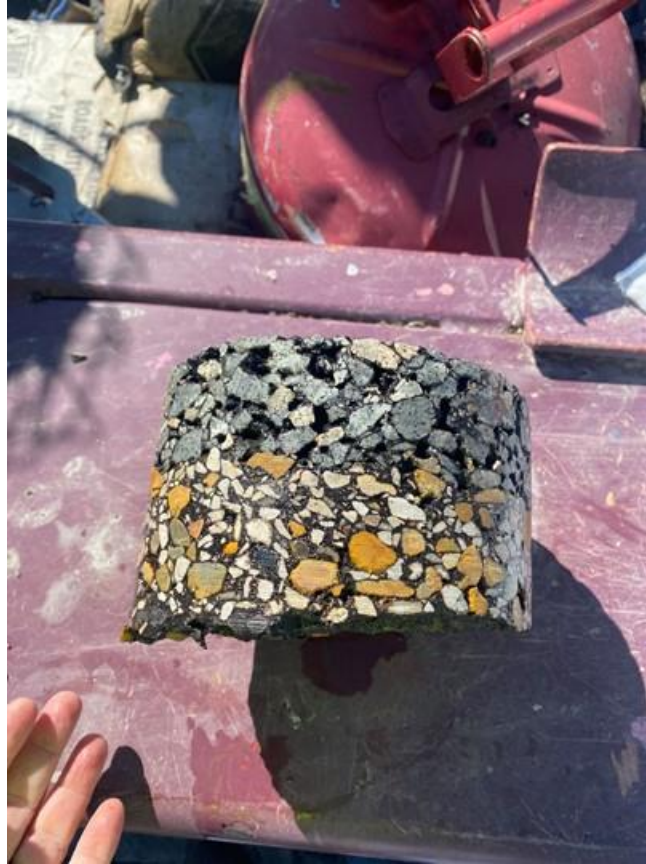
Cores were also taken of the old PFC and the PFC inlaid patch. The PFCs were well bonded to the underlying HMA layer (Figure 58). The PFCs did not ravel or disintegrate from the coring operation.

**Figure 58. Core from US 69 showing PFC bonded to underlying HMA.**

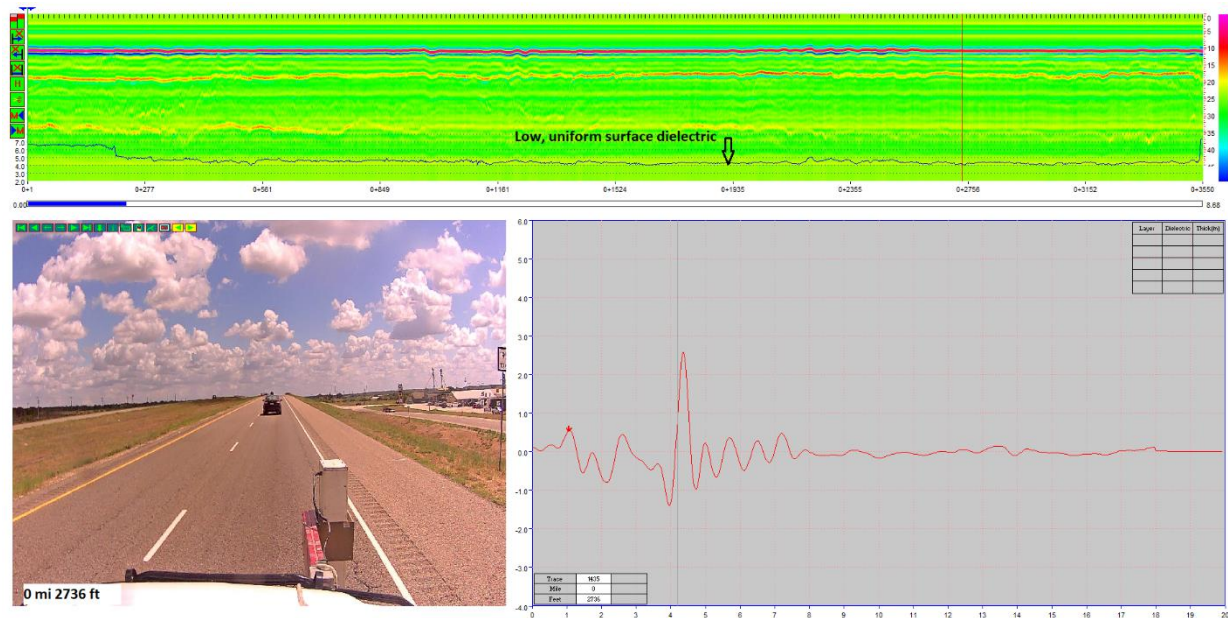
TTI collected GPR and HD video in August 2022 (8 years later), as shown in Figure 67. While the PFC is showing some signs of raveling and some cracking, it has performed remarkably well given initial concerns.

**Figure 67. GPR data for SH 195 collected in August 2022.**

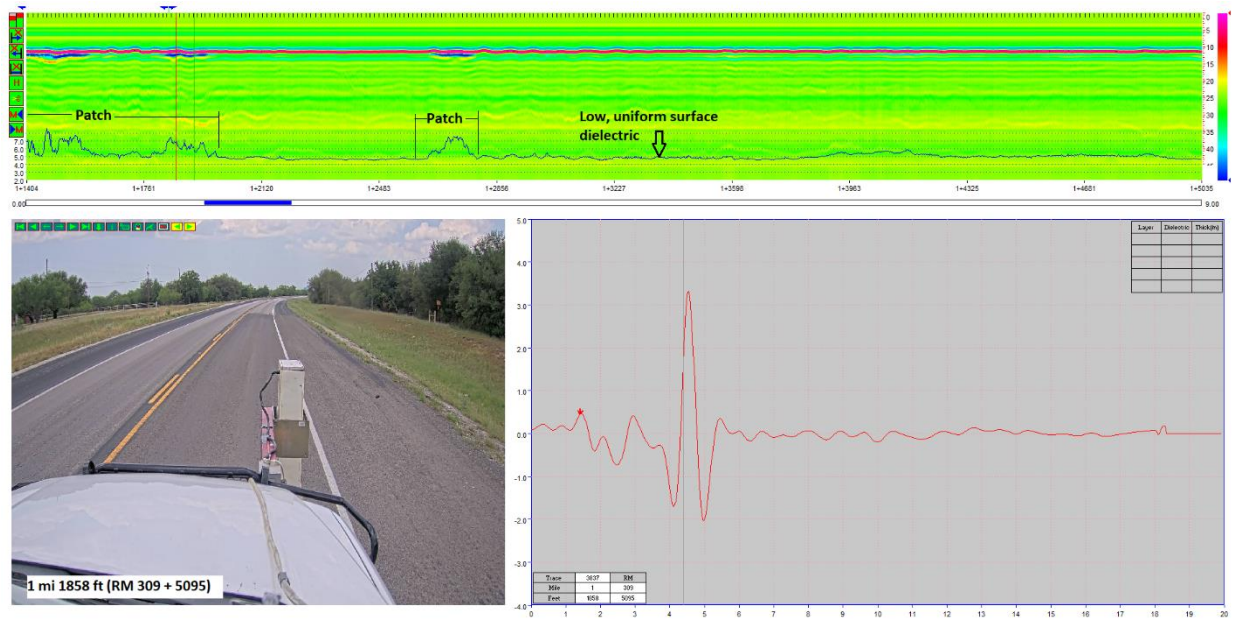
**Figure 69. GPR data on US 183 south of Breckenridge.**

In 2012, the Brownwood District placed a fine PFC on US 183 south of Breckenridge. This section of roadway had a surface treatment exhibiting some flushing, which is why a PFC was selected as the overlay. In 2020, the district applied a frictional asphalt surface preservation treatment (Onyx, SS 3028) to this PFC to extend its life (Figure 69 and Figure 70). After a couple of years in service, the Onyx surface was almost completely worn off.

Since the Onyx surface has worn off, the district is planning to place a seal coat. This PFC cannot be milled off since any milling would probably damage the flex base underneath because it is very thin.

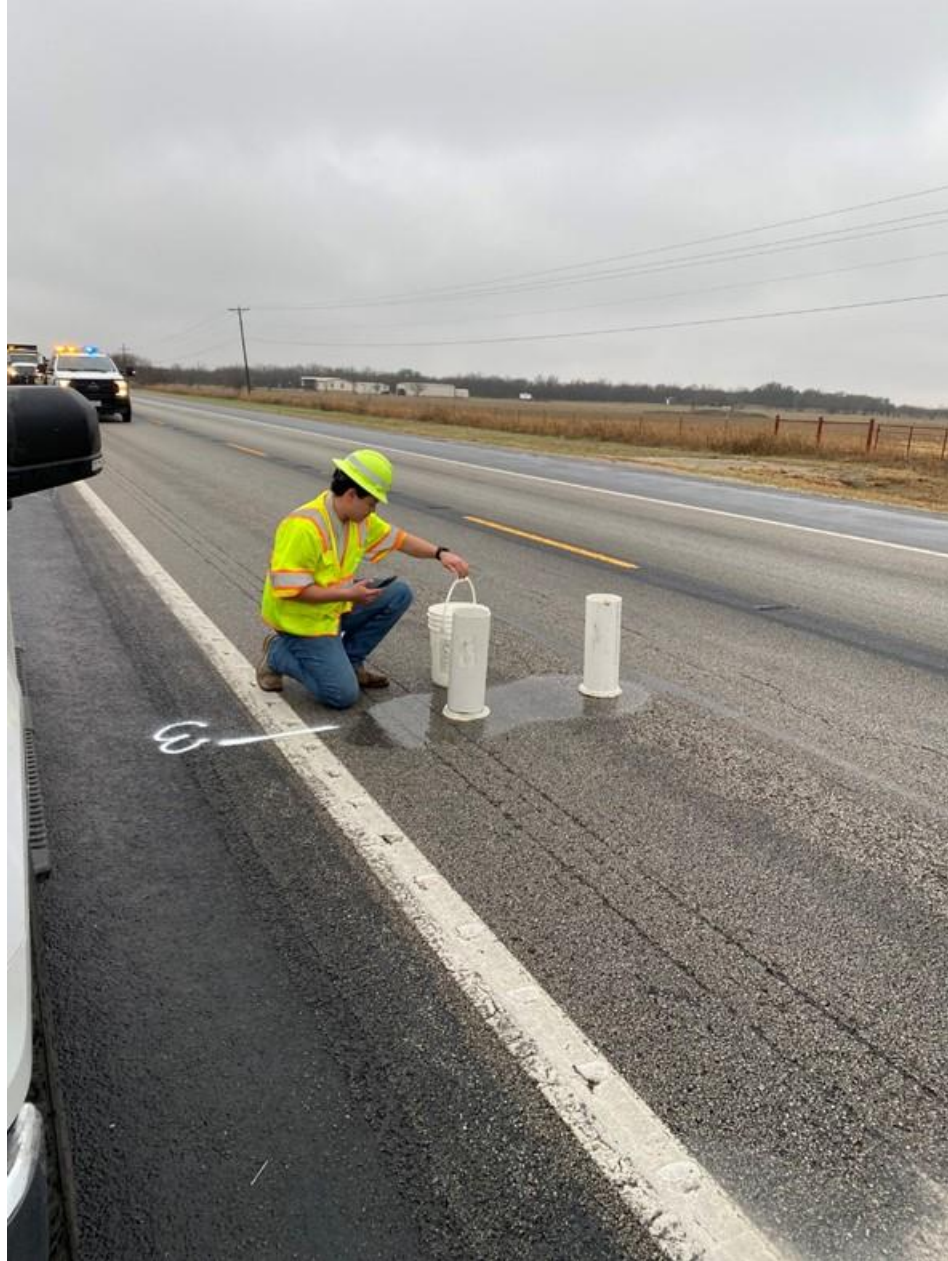
**Figure 71. Water flow testing.**

In March of 2023, TTI researchers conducted field testing on this section of roadway. Five locations were selected for water flow testing and for coring. Water flow tests were conducted in the outside wheel path and between the wheel paths, as shown in Figure 71. For the most part, the PFC was clogged, but there were a few locations where the PFC could be taking in water. The results of the water flow tests are shown in Figure 72.

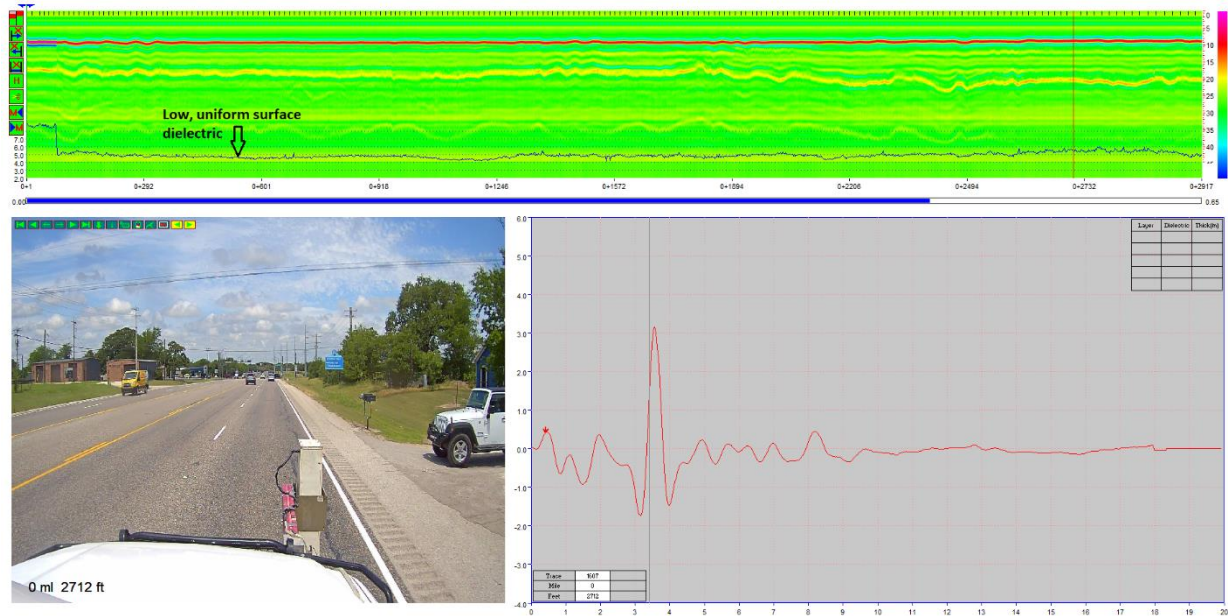
Figure 75. GPR data from SH 30 in the Bryan District.

The research team reached out to the Bryan District, which is considering maintenance strategies for a PFC on SH 30 in Bryan. This is a relatively short section (less than 1 mi) placed at an intersection to improve safety, and it is starting to show some signs of raveling.

Video and GPR data are shown in Figure 75 and indicate that the surface is still draining.

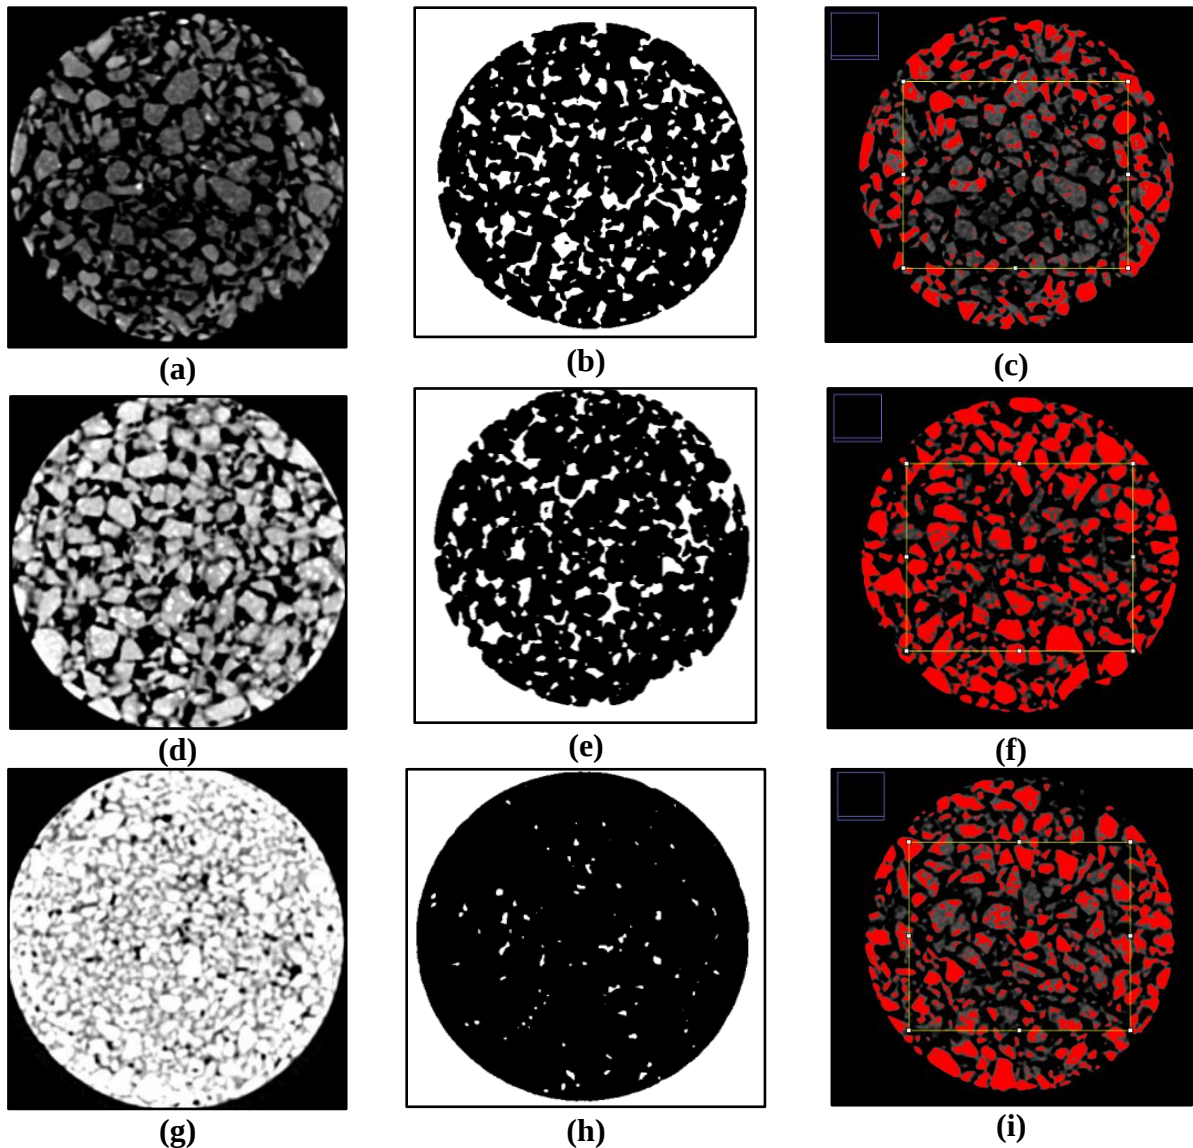
The upper layer of the core (i.e., the PFC layer) was the area of interest. Sample images obtained from the X-ray CT scan for the three cores are shown in Figure 91. These results seem to align well in terms of water flow with the field observations previously described in Chapter 5.

**Figure 91. Images from the X-ray CT scan: (a), (d), and (g) show grayscale images; (b), (e), and (h) show black and white images; (c), (f), and (i) show images after ImageJ analysis; (a), (b), and (c) are the Lufkin US 69 core on the inlaid patch; (d), (e), and (f) are the Lufkin US 69 core of the older PFC; and (g), (h), and (i) are the Breckenridge US 183 core.**

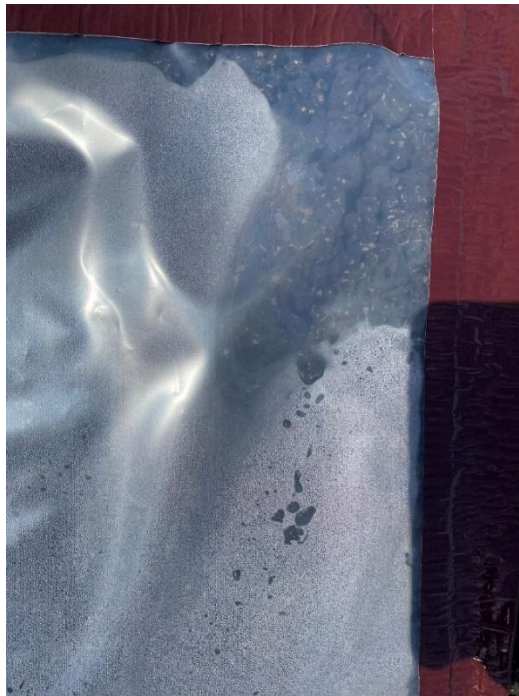
Within 5 minutes, moisture became visible on the underside of the plastic sheet, as shown in Figure 94. Some condensation was also observed under the roofing paper (Figure 95); however, it was much easier to see the condensation through the plastic as it began to appear. After 10 minutes, a significant amount of moisture was visible on the underside of the plastic, as shown in Figure 96, after it was removed from the pavement surface.

**Figure 94. Moisture condensation on the underside of the plastic.**

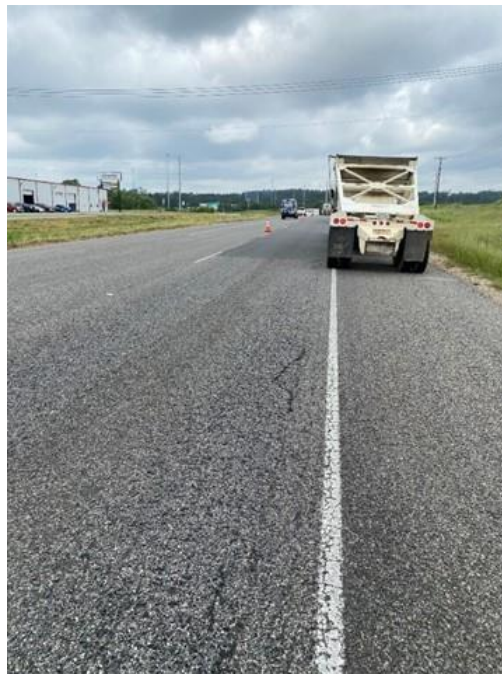
The Lufkin District constructed a 1,200-ft test section consisting of a Superpave C mix placed over an old PFC. This test section was part of a larger contract that included milling sections of the old PFC and inlaying with Superpave C. The test section was located in the NB lanes of US 69 just north of FM 2251, and it extended across the travel lane, passing lane, and shoulder. In the last 600 ft of the travel lane, there was a newer PFC inlaid patch that can be seen in Figure 97 and Figure 98. The condition of the old PFC included a moderate amount of cracking and raveling, as shown in Figure 99. The newer PFC patch was in excellent condition and had no distress. Based on GPR and water flow testing, as reported in Chapter 5, the older PFC was clogged and not draining, including on the shoulder, but the newer inlaid PFC patch was still draining. Unfortunately, this created a bathtub situation since the water trapped in the newer PFC inlaid patch had nowhere to drain.

**Figure 97. Newer PFC inlaid patch in the travel lane.**

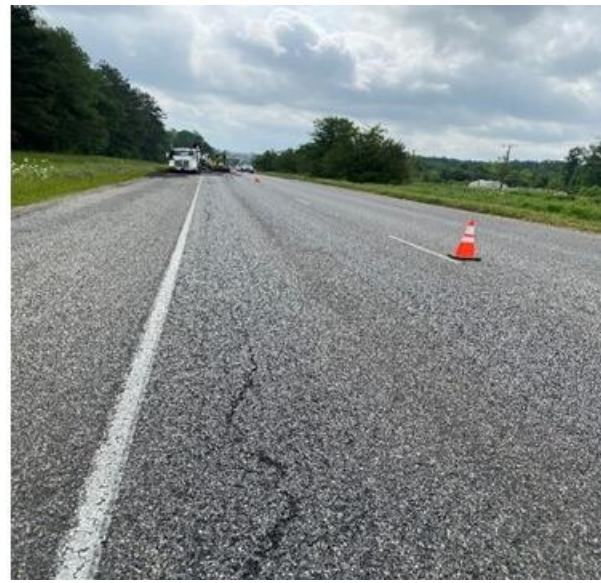
**Figure 99. Typical distress shown in test section area of the old PFC: (a) raveling, and (b) cracking.**

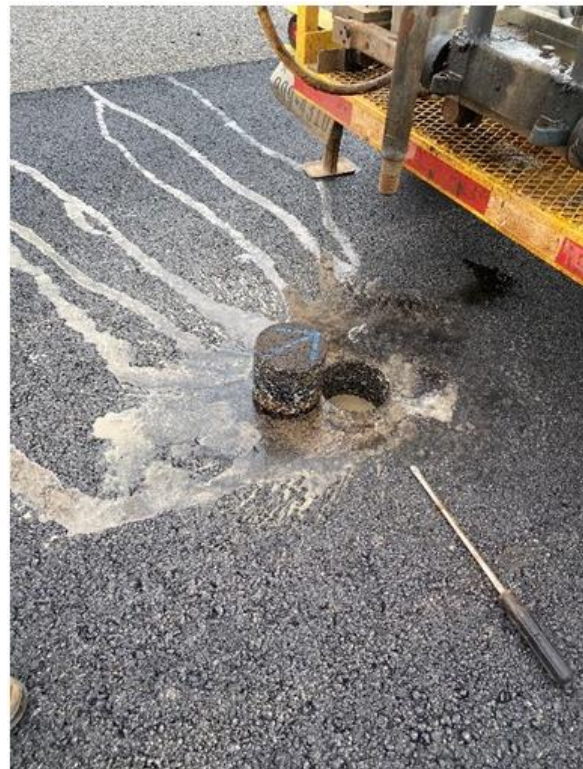
behaving as if it were tender or unbonded and was moving laterally, causing the edges to crack (Figure 104). The roller operator immediately ceased all rolling, paving was halted, and the district lab was called out to take cores to check the bond. Cores were taken immediately over the bulged areas (Figure 105). The cores came out intact, and the bond was secure. Later, the district lab measured the shear strength of the bond (Table 21), and the bond strengths of the two cores were 21.8 and 11.9 psi. While this may not be a great bond, nonetheless there was a bond of the new surface to the old, so the bond did not appear to be the culprit for the problems seen in the field. A photo of the core after shear testing is shown in Figure 106. After this occurred, the tack rate was also increased to 0.1 gal/yd<sup>2</sup> for the rest of the test section construction.

**Figure 105. Coring operation over bulged pavement area: (a) coring rig, and (b) cores taken showing the new overlay bonded to the old PFC.**

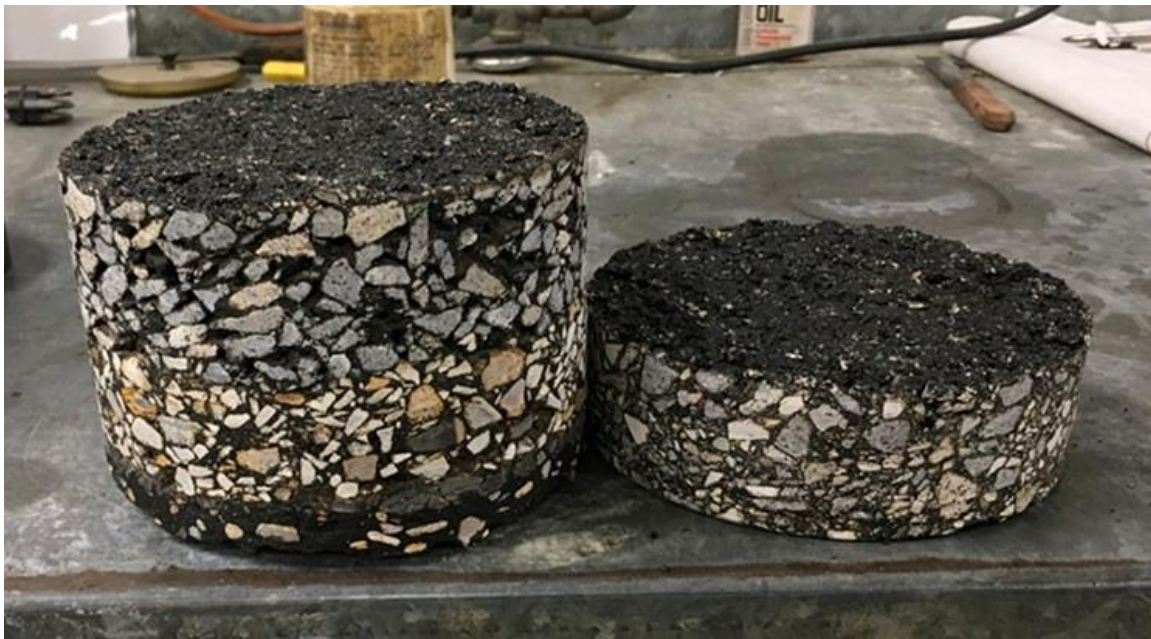
**Figure 106. Photo of core after shear test.**

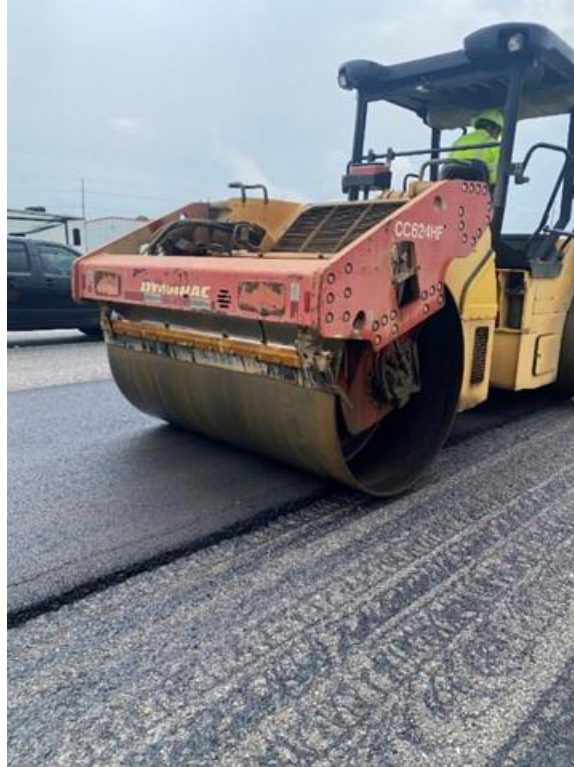
**Figure 107. Additional static rolling on the problem areas after mat cooled down.**

After coring, and after the mat had cooled significantly, a few more static passes of the roller were made in the problem areas, which smoothed the mat (Figure 107). There was still a slight visible crack on each edge of the mat (Figure 108).

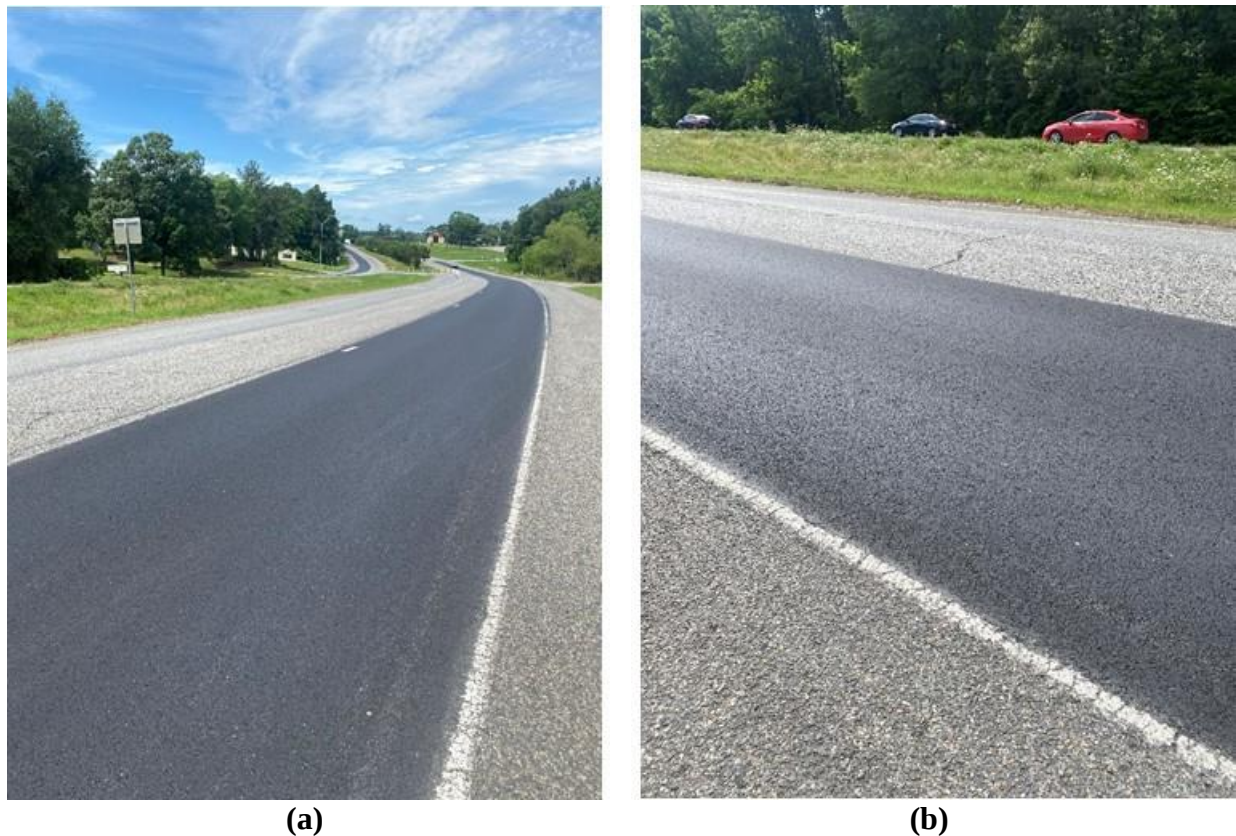
**Figure 110. Other portions of the greater contract where old PFCs were milled and inlaid with Superpave C: (a) general view, (b) closeup view.**
