VOLUME XI: APPENDIX J -
CRASH TESTING AND EVALUATION OF
EXISTING GUARDRAIL SYSTEMS

"Testing of State Roadside Safety Systems"

FEBRUARY 1998

1. Report No. FHWA-RD-98-046	2. Government Accession No.	3. Recipient's Catalog No.	
4. Title and Subtitle TESTING OF STATE ROADSIDE SAFETY SYSTEMS VOLUME XI: APPENDIX J - CRASH TESTING AND EVALUATION OF EXISTING GUARDRAIL SYSTEMS		5. Report Date

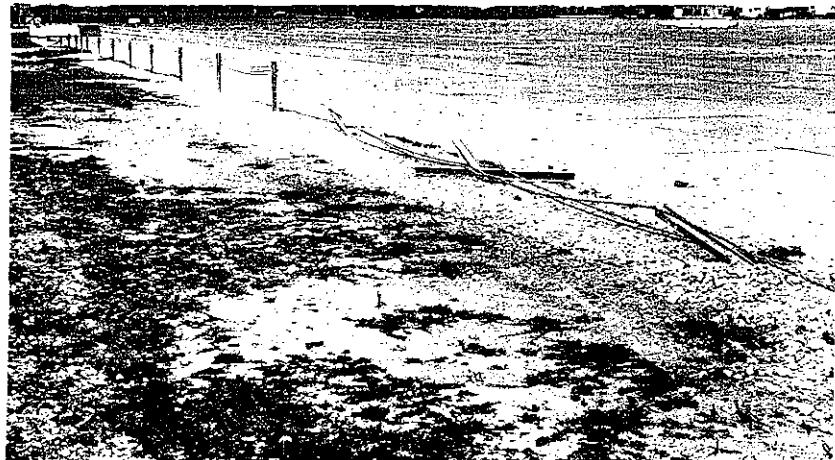
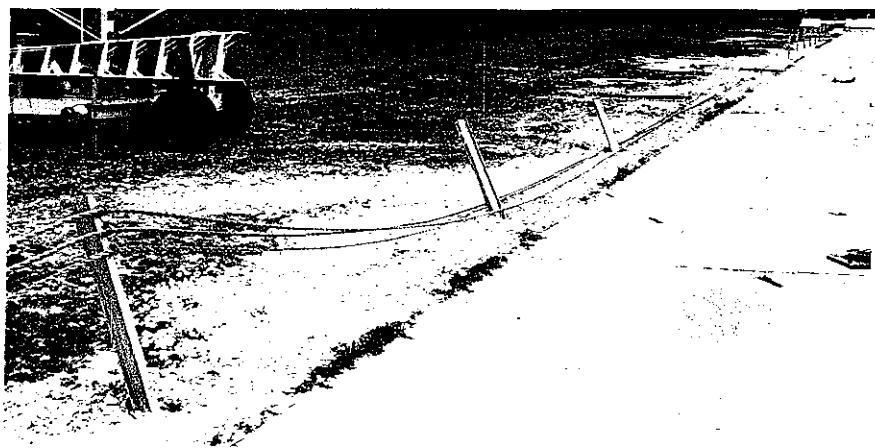
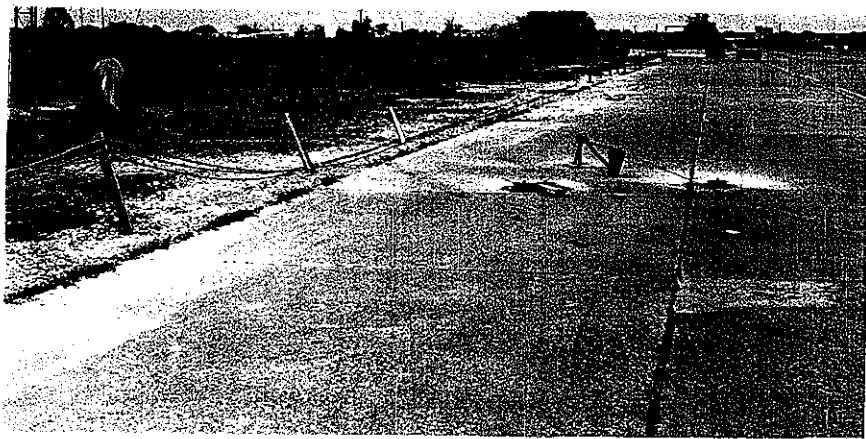
Figure 16. Cable (G1) guardrail installation after test 471470-28.

As seen in figures 16 and 17, the test installation received moderate damage. The cables were separated from the posts between posts 10 through 16. The lateral deflections recorded at posts 8 through 16 are noted in table 2.

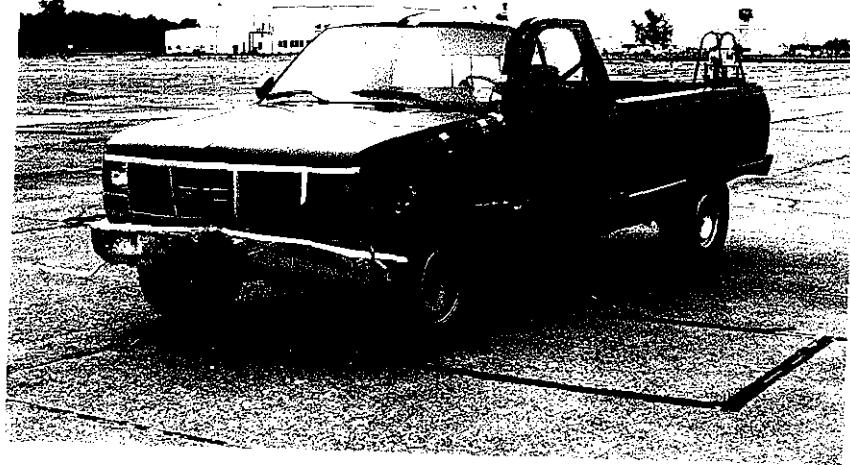
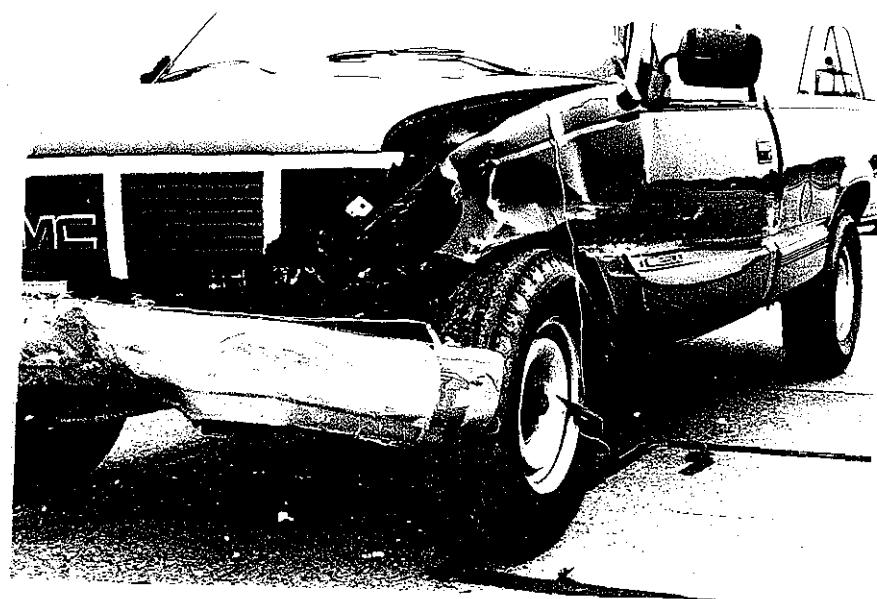
Figure 18. Vehicle after test 471470-28.

The vehicle sustained minimal damage, as shown in figure 18. The front bumper and grill were damaged, and the entire left side of the vehicle was scraped by the wire rope. Maximum exterior crush at the left front corner of the vehicle was 360 mm (14.2 in), and there was no deformation or intrusion into the occupant compartment.

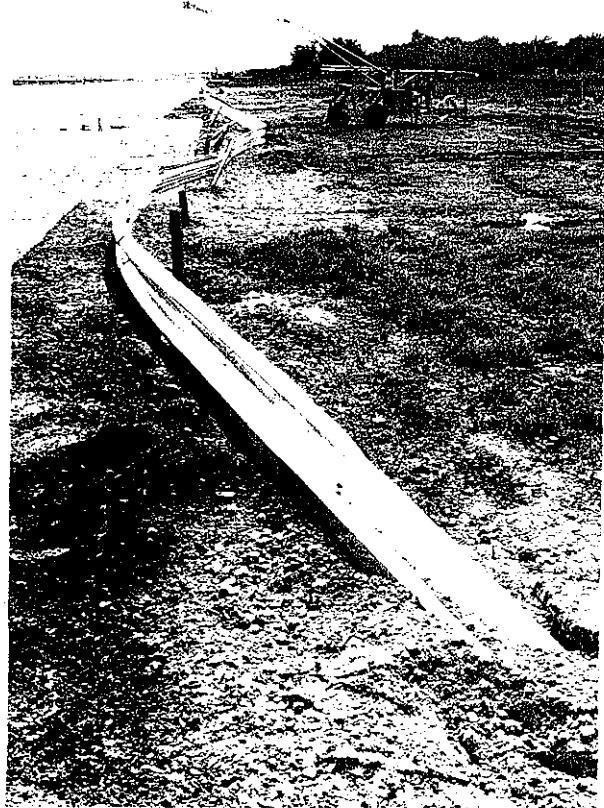
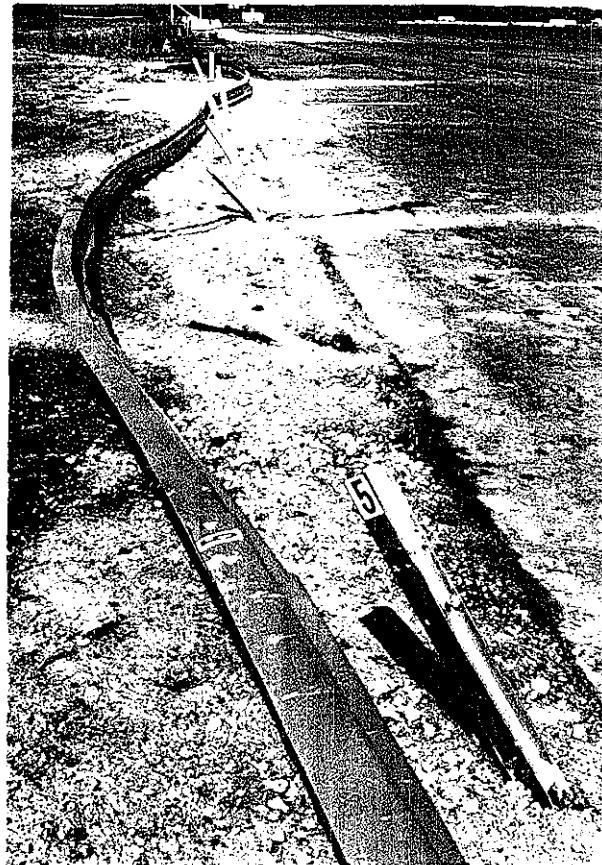
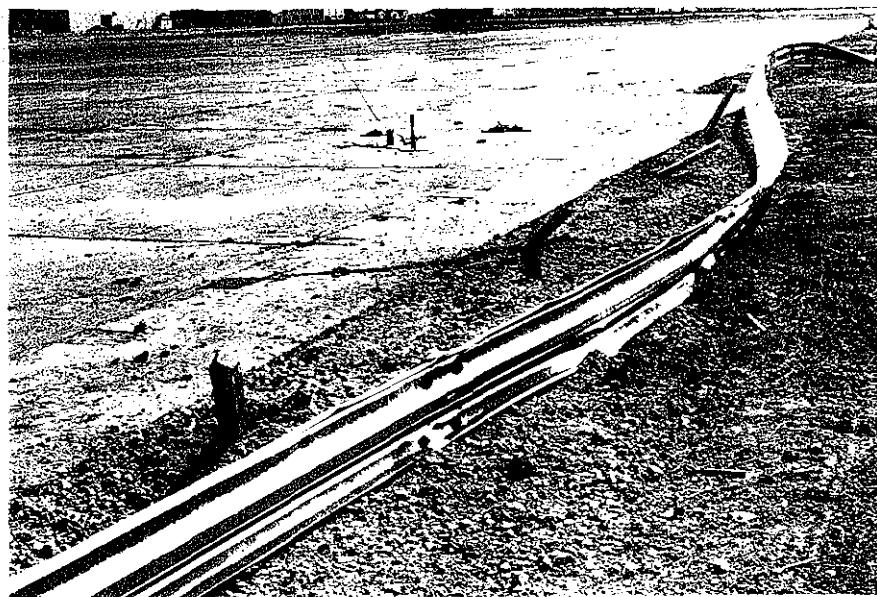
As can be seen in figure 31, the test installation received considerable damage. There was evidence of movement on all of the posts and the W-beam slipped over the tops of post 5 through 13 and the maximum permanent deformation of the W-beam was 1.8 m (5.9 ft). The vehicle was in contact with the installation from impact to the end of the guardrail.

Figure 31. W-beam, weak-post (G2) guardrail after test 471470-21.

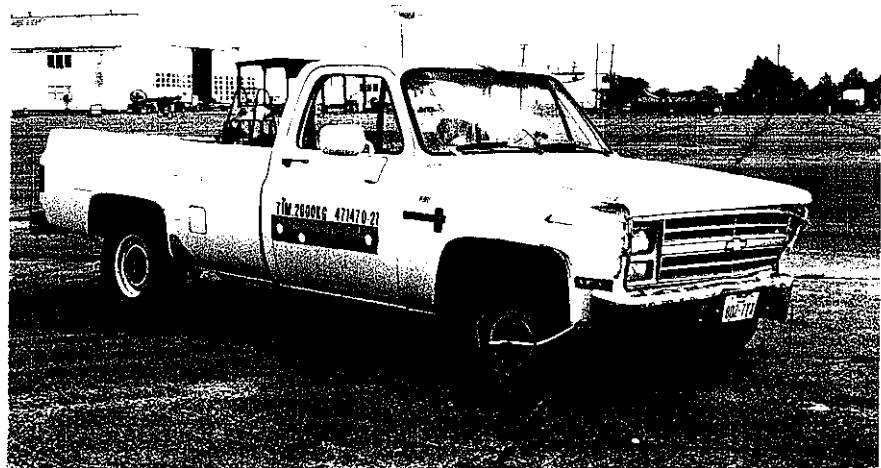
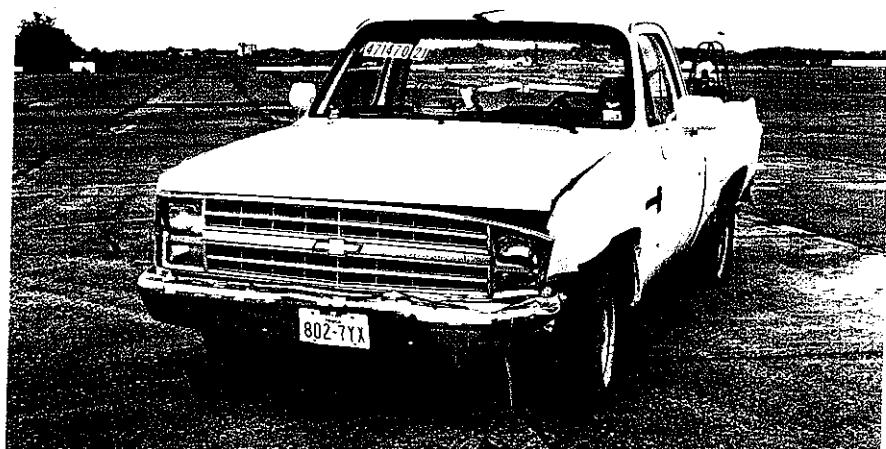
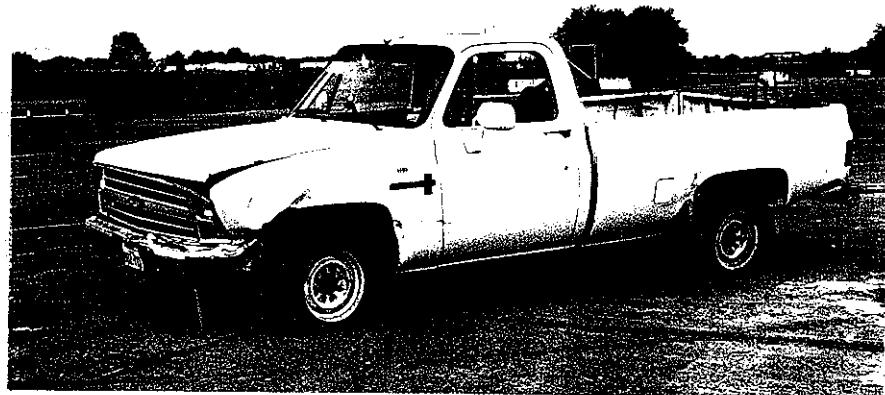
The vehicle sustained moderate damage to the left side as shown in figure 32. Maximum exterior crush at the left front corner at bumper height of the vehicle was 259 mm (10.2 in), and there was no intrusion into or deformation of the occupant compartment. Damage was sustained to the front bumper, grill, hood, and along the entire left side the body panels were dented and scraped. There was slight damage to the right front corner where the vehicle came to rest against the next installation downstream.

Figure 32. Vehicle after test 471470-21.

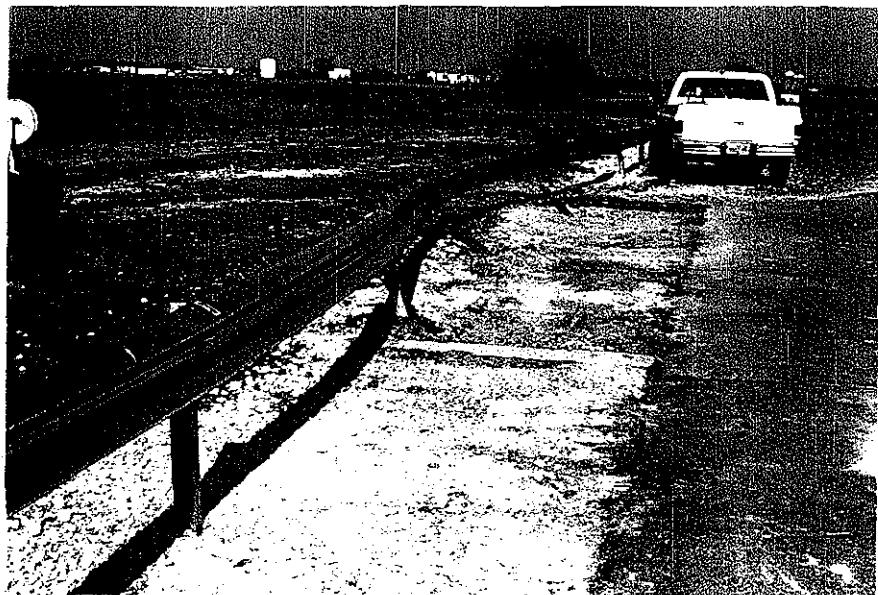
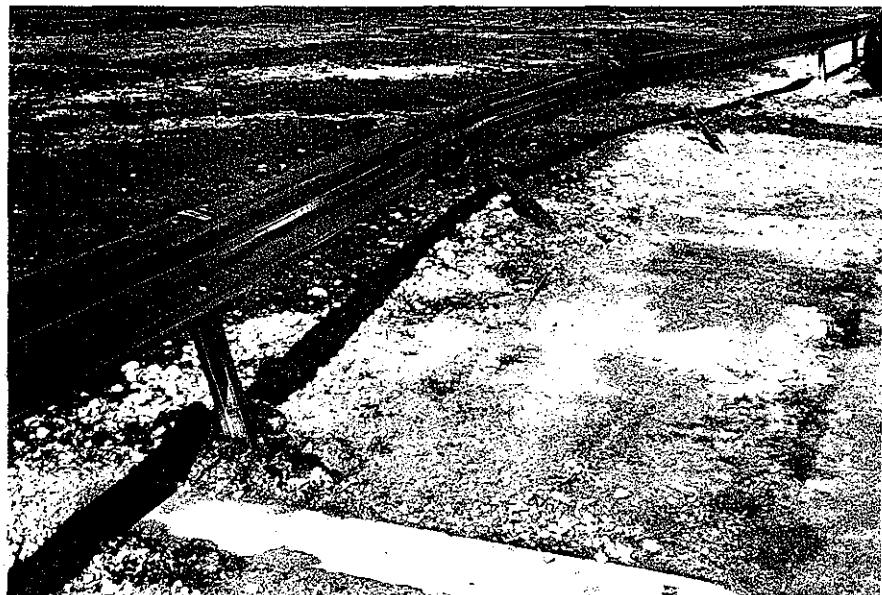
Figure 44. W-beam, weak-post (G2) guardrail after test 471470-22.

As can be seen in figures 44 and 45, the guardrail installation received considerable damage in the area of contact. There was evidence of movement on the first 9 posts. The W-beam slipped over the tops of posts 5 through 7 and the maximum permanent deformation of the W-beam was 1.3 m (4.2 ft). The vehicle was in contact with the installation for a total length of 15.7 m (51.7 ft).

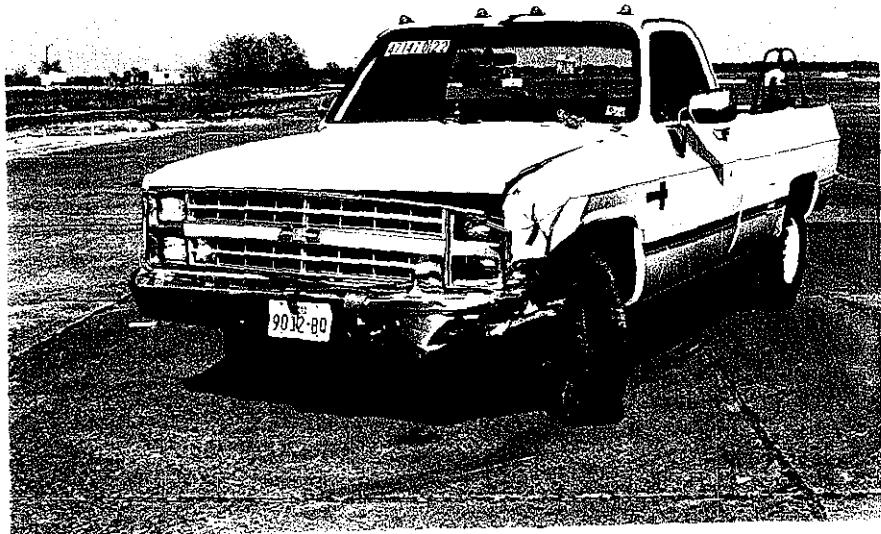
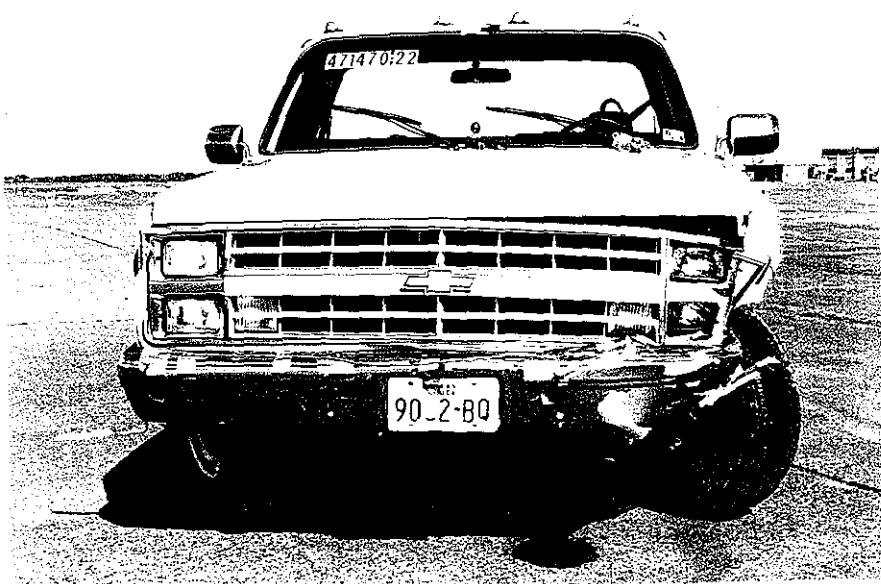
Figure 45. Vehicle after test 471470-22.

The vehicle sustained moderate damage to the left side, as shown in figure 46. Maximum exterior crush at the left front corner at bumper height of the vehicle was 231mm (9.1 in), and there was no intrusion into or deformation of the occupant compartment. Damage was sustained to the front bumper, grill, hood, left front lower A-arm assembly, and along the left side the body panels were dented and scraped through the driver's door.

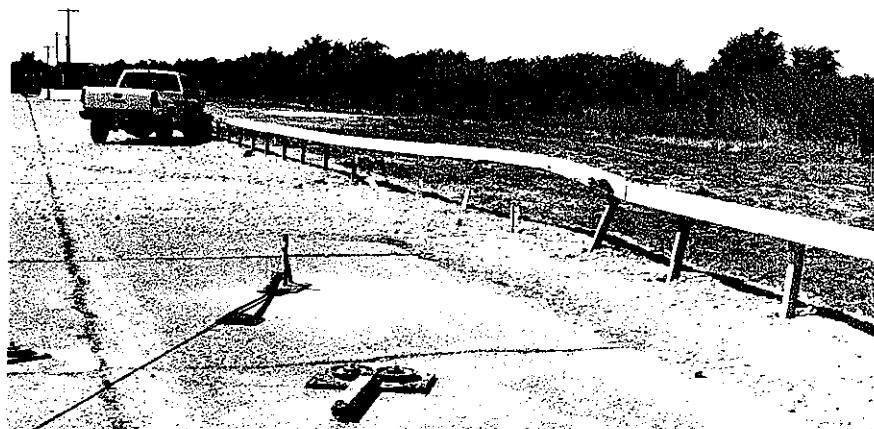
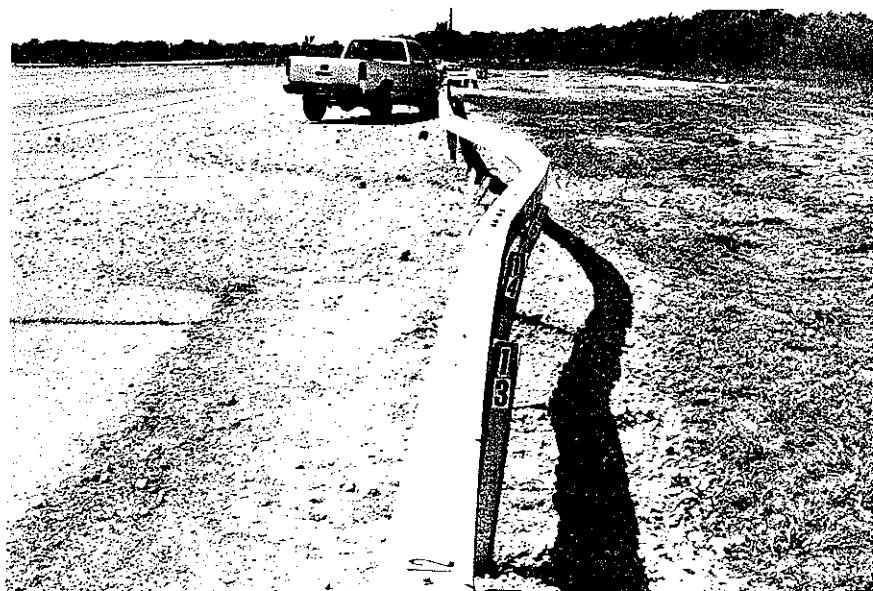
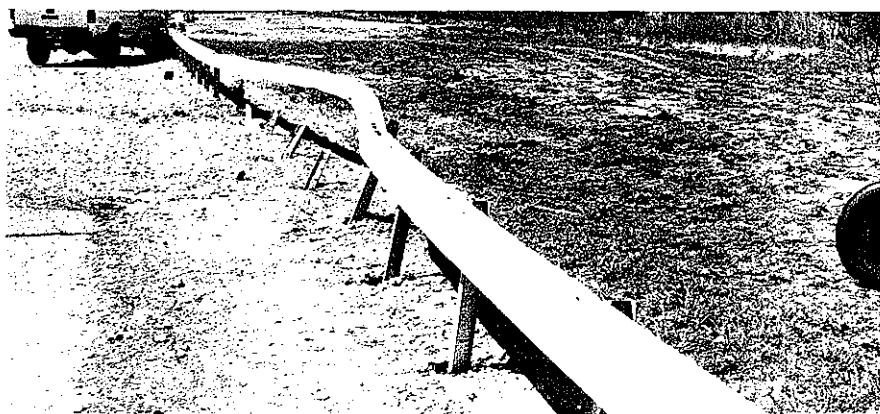
Figure 59. Box-beam (G3) guardrail after test 471470-33.

As seen in figures 59 through 61, the guardrail installation received moderate damage. There were tire marks on the face of the box-beam rail element from posts 15 through 21, and on posts 15 through 20. The box-beam rail element was separated from posts 16 through 20, and these posts were bent at ground level. The lateral deflections recorded at posts 12 through 22 are noted in table 3.

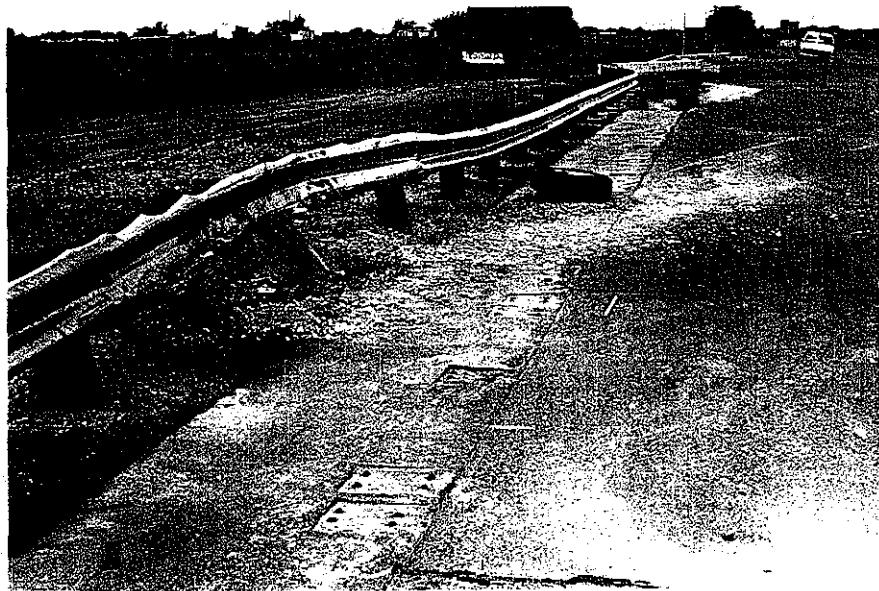
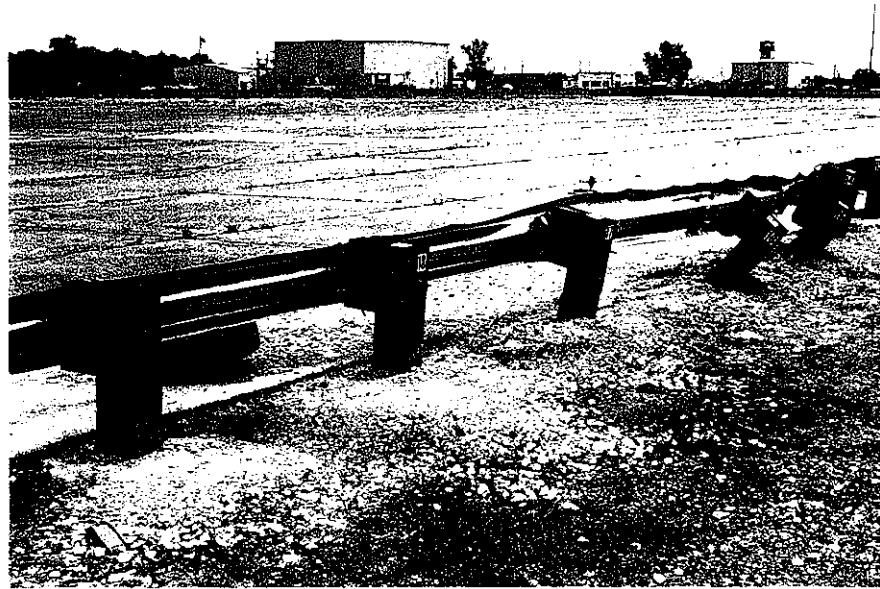
Figure 75. W-beam, wood-post (G4(2W)) guardrail installation after test 471470-26.

As can be seen in figures 75 and 76, the installation received moderate damage. The bolts were pulled out of the W-beam rail element at posts 15 and 16, and the blockout on post 16 was split. None of the posts broke off, but some posts were pushed back. The displacements of the posts are shown in table 4.

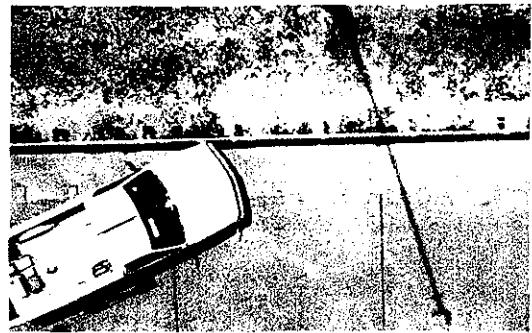
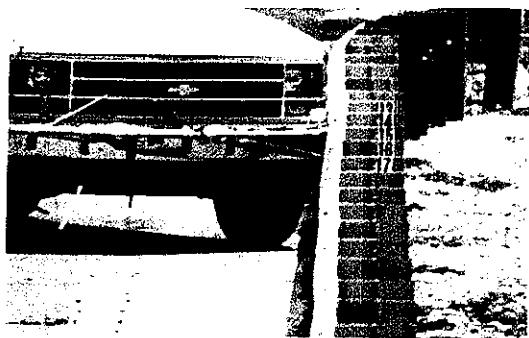
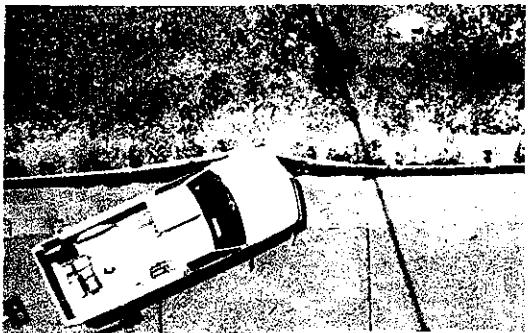
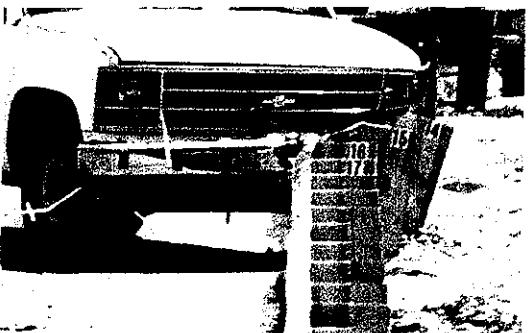
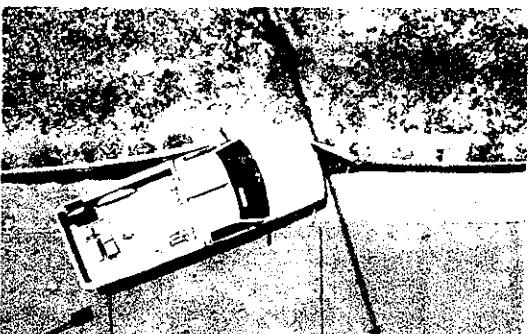
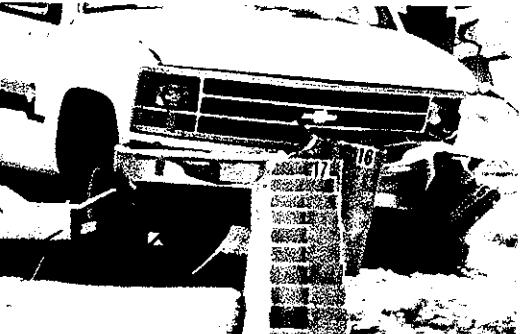
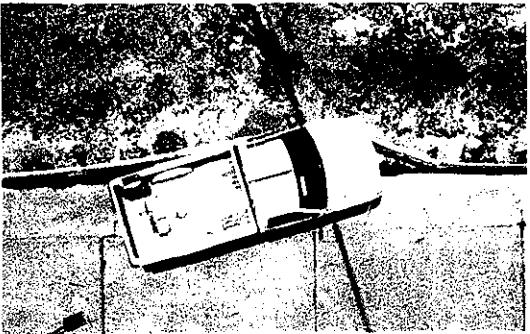
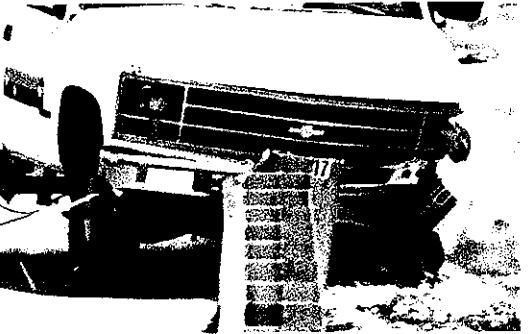
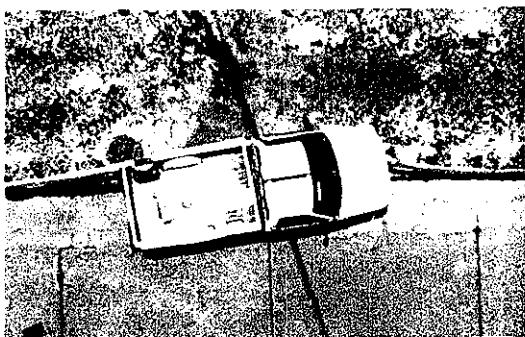
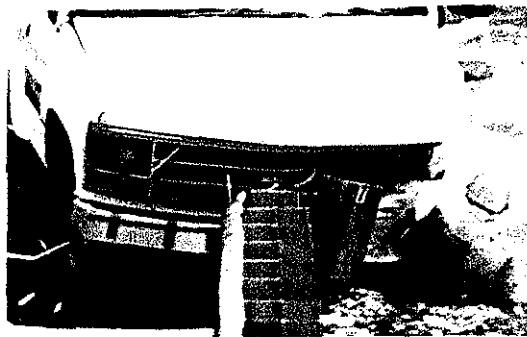
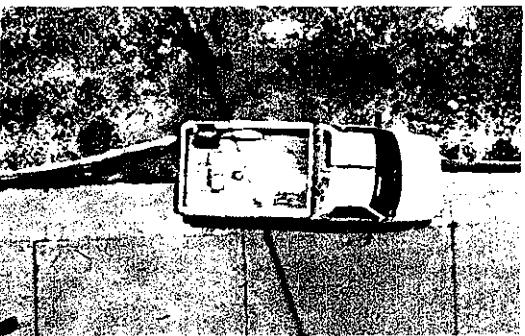
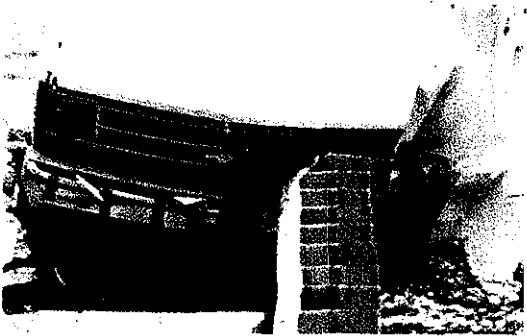
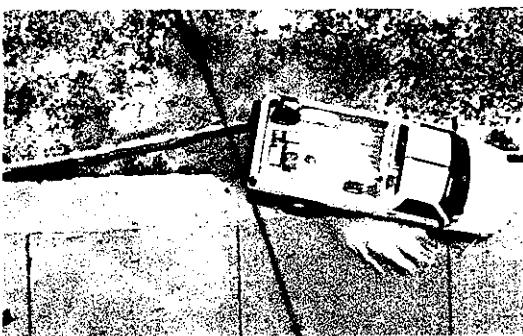
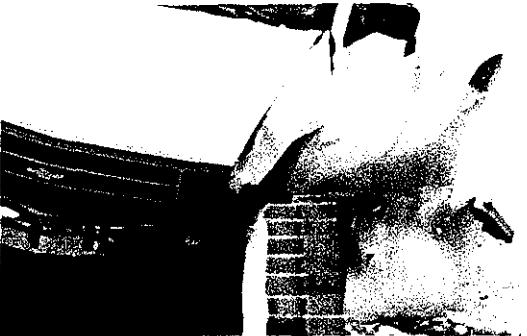
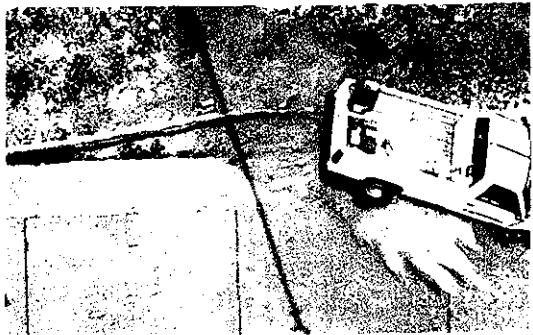
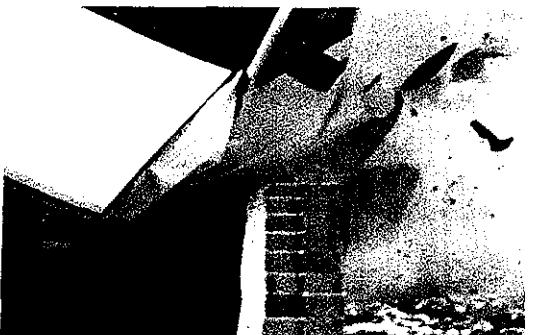
Figure 88. Sequential photographs for test 471470-27
(overhead and frontal views).

counterclockwise and was yawing clockwise. As the damaged front end of the vehicle contacted the ground, the vehicle continued to roll onto its left side and subsequently slid to rest on its left side 34 m (112 ft) downstream and 6.7 m (22 ft) forward of the point of impact. Sequential photographs are shown in figures 88 and 89.

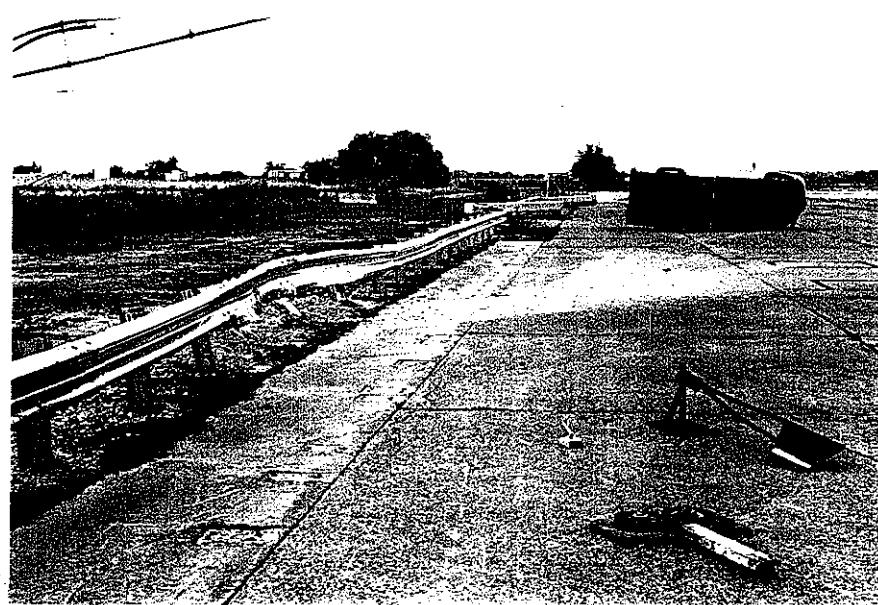
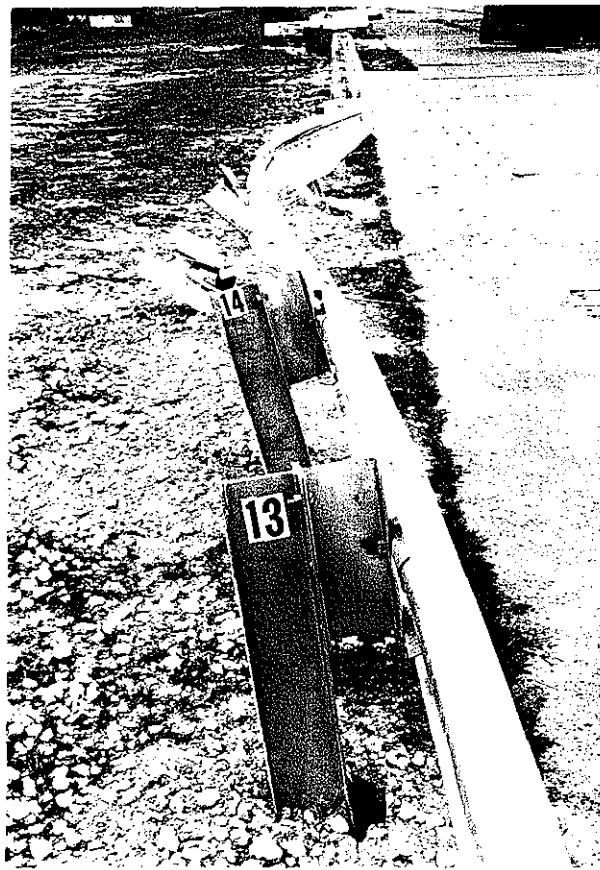
Figure 90. W-beam, steel-post (G4(1S)) guardrail installation after test 471470-27.

As can be seen in figures 90 and 91, the installation received moderate damage. The MELT anchor on the upstream end had pulled up slightly and moved laterally 44.5 mm (1.75 in). The buffered end nose was pulled off the end post (post 1). The bolts were pulled out of the W-beam rail element at posts 15, 16, and 17, and the posts and blockouts were bent. All the steel posts upstream of impact were disturbed, with measurable displacements as shown in table 5.

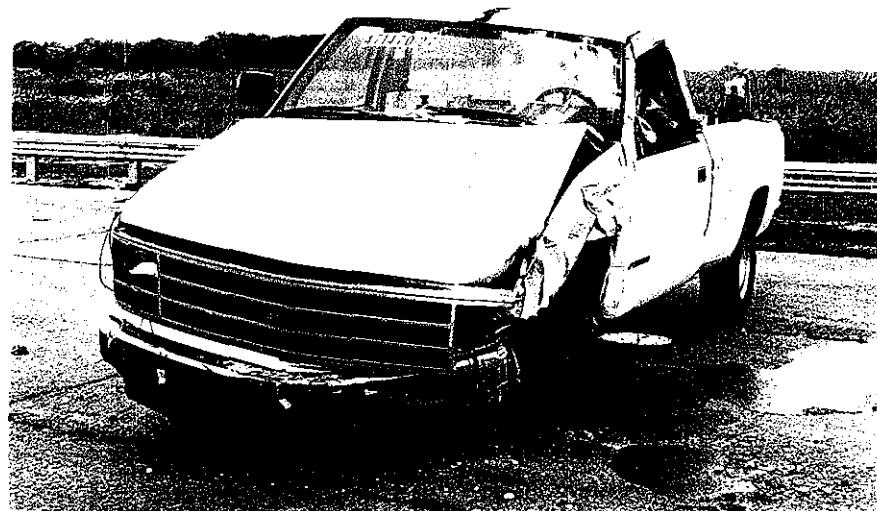
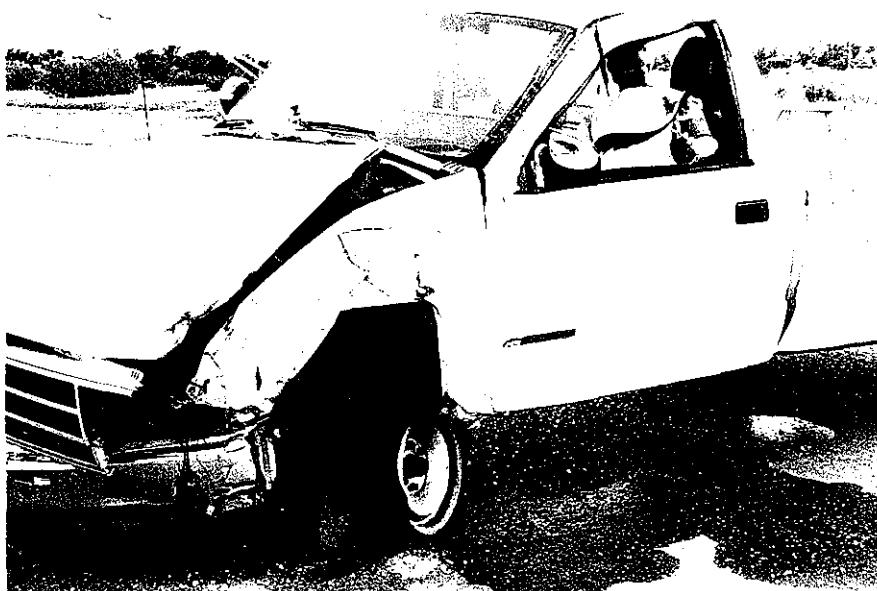
Figure 93. Vehicle after being uprighted, test 471470-27.

The vehicle sustained moderate damage, as shown in figures 92 and 93. The stabilizer bar, upper and lower A-arms, and tie rods on the left side were damaged, and the frame at the left front was bent. The left front spindle, wheel, and tire were damaged. The front bumper, grill, hood, radiator, windshield, and entire left side also were damaged. Maximum exterior crush at the left front corner of the vehicle was 570 mm (22.4 in) at bumper height. There was 53-mm (2.1-in) deformation of the occupant compartment in the floor pan area on the driver's side.

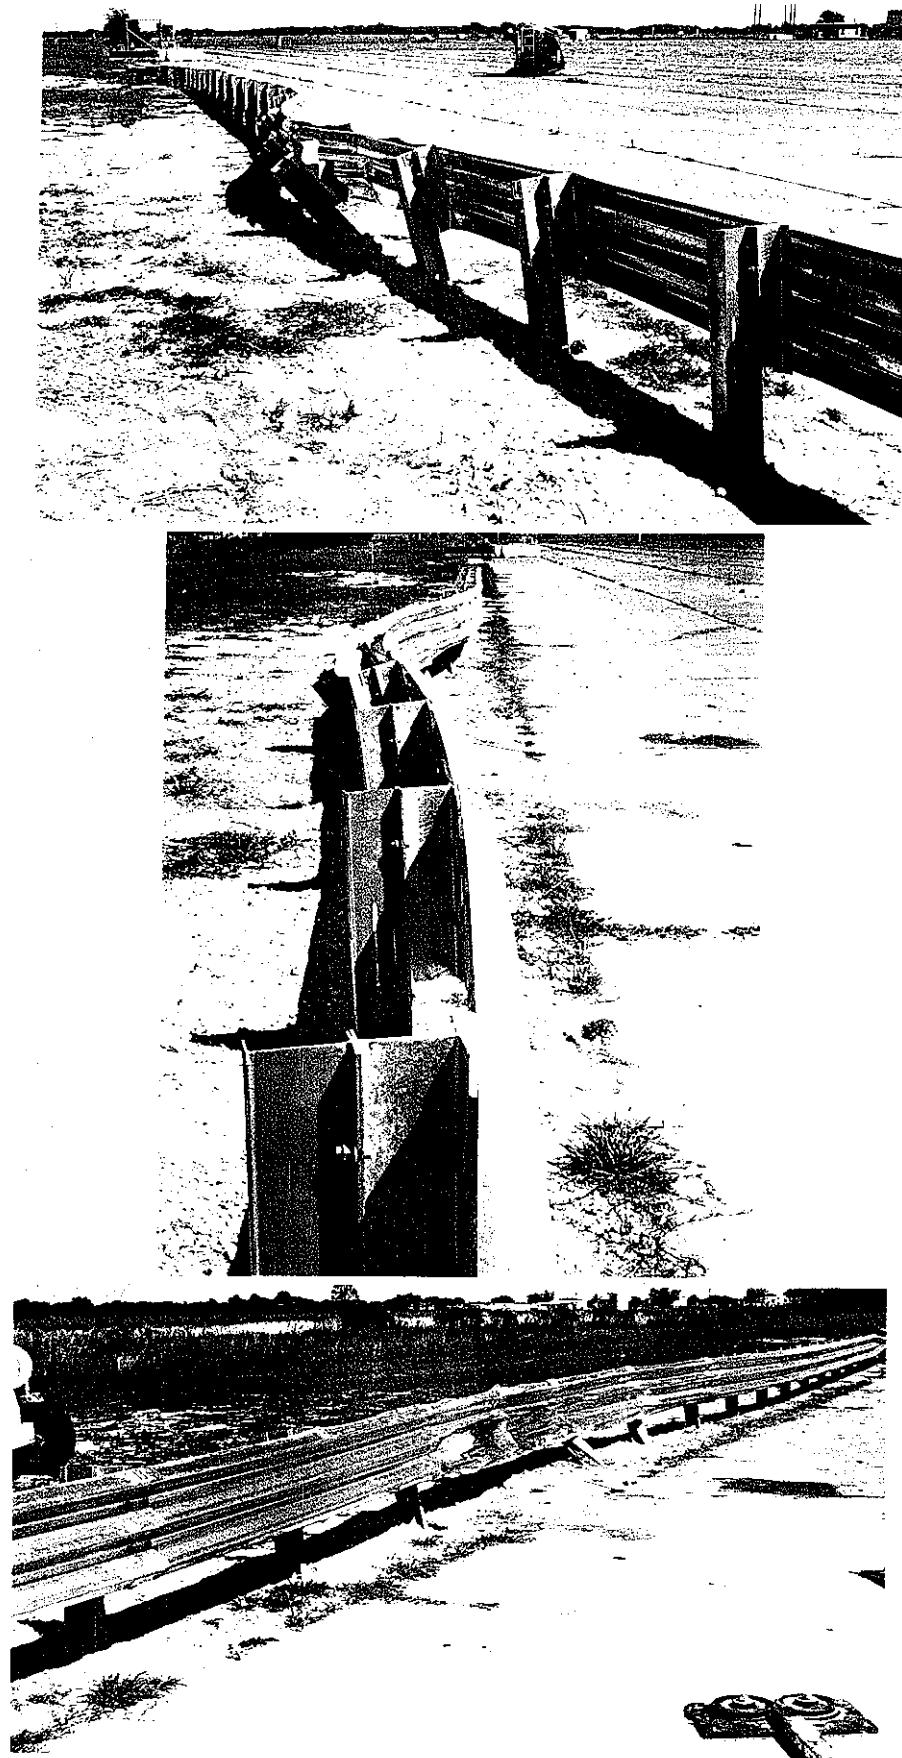
Figure 107. Thrie-beam (G9) guardrail after test 471470-31.

As seen in figures 107 through 109, the test installation received moderate damage. There were tire marks on the face of the three-beam rail element from post 15 through post 19, and on the face of posts 16 and 17. The three-beam rail element was separated from post 16, and the flanges on post 17 showed evidence of wheel contact. Posts 15 through 19 were twisted severely. The lateral deflections recorded at posts 13 through 20 are noted in table 6.

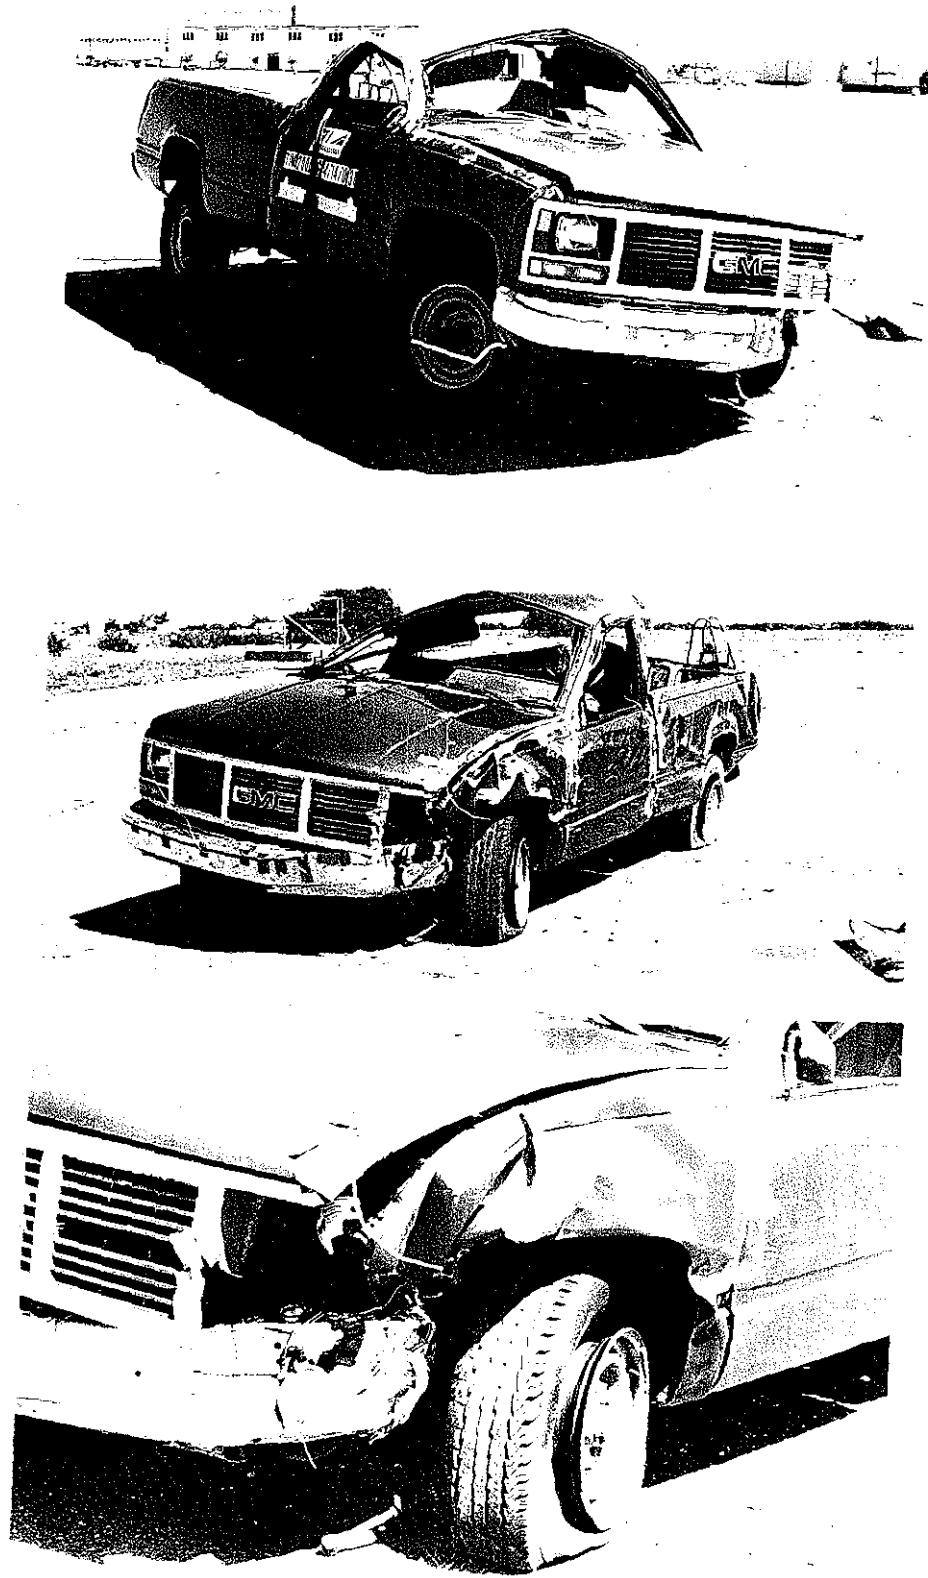
Figure 110. Vehicle after test 471470-31.

The vehicle sustained extensive damage, as shown in figure 110. The upper and lower A-arms, stabilizer bar, frame, and tie rod ends on the left side were damaged. The front bumper, grill, hood, left front quarter panel, both doors, and the left front and rear wheels also were damaged. The windshield and windows were broken and the roof was damaged due to the rollover. Maximum exterior crush at the left front corner of the vehicle was 420 mm (16.5 in), and maximum deformation of the occupant compartment was 144 mm (4.5 in) downward from the roof area on the passenger side.

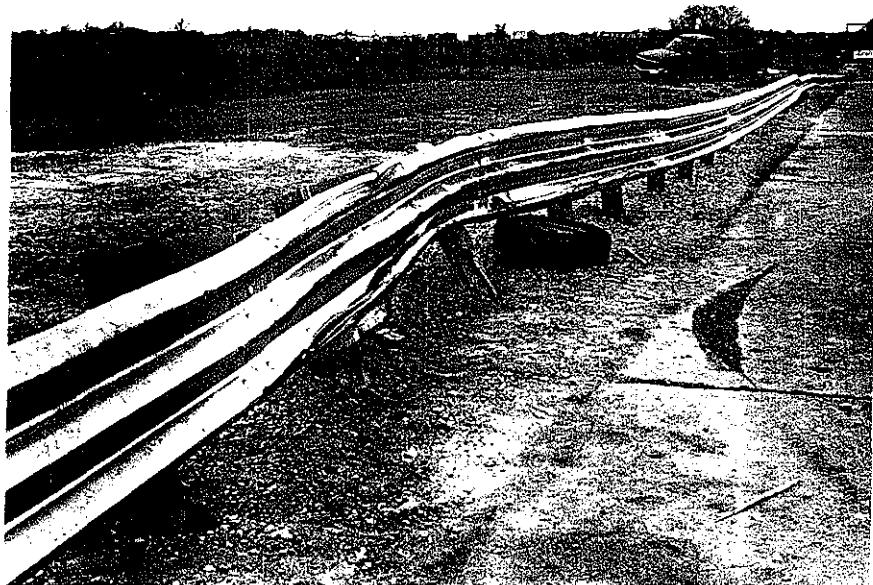
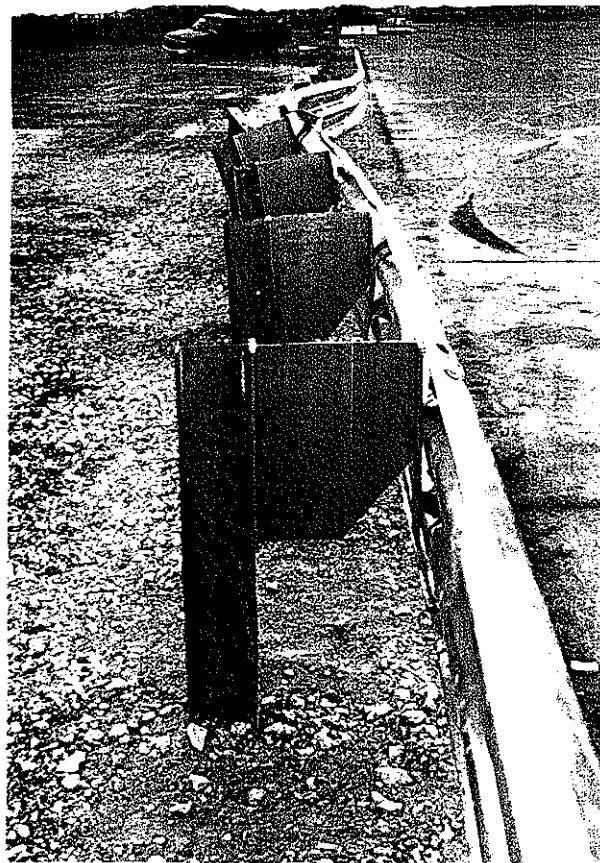
Figure 124. Modified three-beam guardrail after test 471470-30.

As seen in figures 124 through 128, the installation received moderate damage. There were tire marks on the face of the thrie-beam rail element from post 15 through post 19, and on

the face of post 16 and the back side of post 17. The thrie-beam rail element was separated from post 17, and the flanges on post 17 showed evidence of wheel contact. Posts 16, 17, and 18 were twisted severely. The lateral deflections recorded at posts 14 through 20 are noted in table 7.

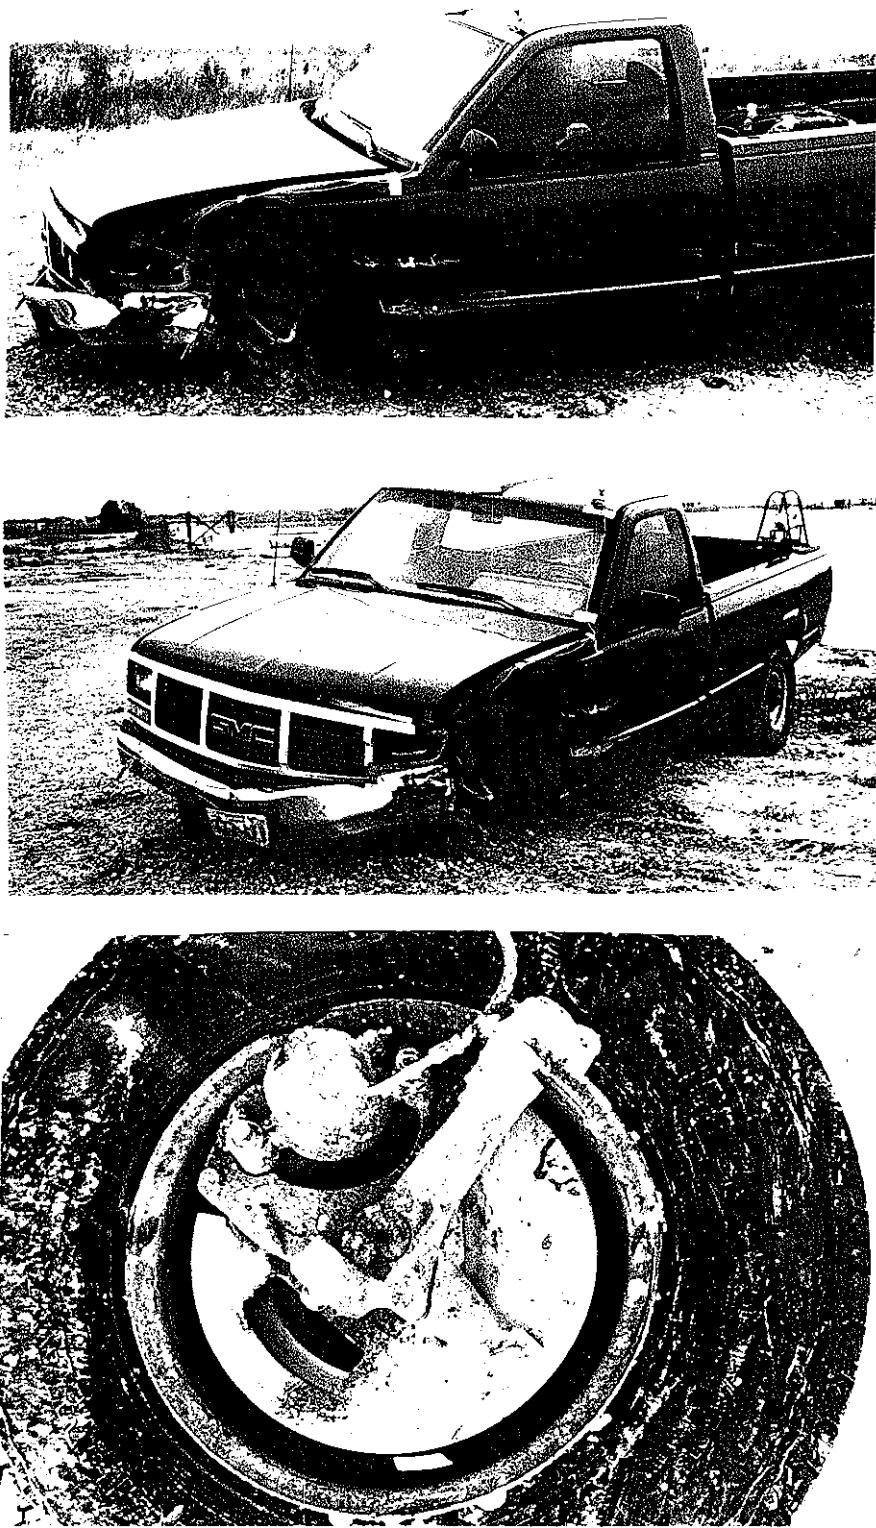
Figure 129. Vehicle after test 471470-30.

The vehicle sustained moderate damage, as shown in figure 129. The upper and lower A-arms, stabilizer bar, frame, tie rod ends, and spindle on the left side were damaged. The left front wheel assembly was torn from the vehicle's axle. The front bumper, grill, left front quarter panel, and both doors also were damaged. Maximum exterior crush at the left front corner of the vehicle was 430 mm (16.9 in) and there was deformation at the floorpan area of 16 mm (0.6 in).
