# Performance and Improvement of Texas Poor Boy Continuous Bridge Deck Details: Final Report

Technical Report 0-7013-R1

Cooperative Research Program

TEXAS A&M TRANSPORTATION INSTITUTE  
COLLEGE STATION, TEXAS

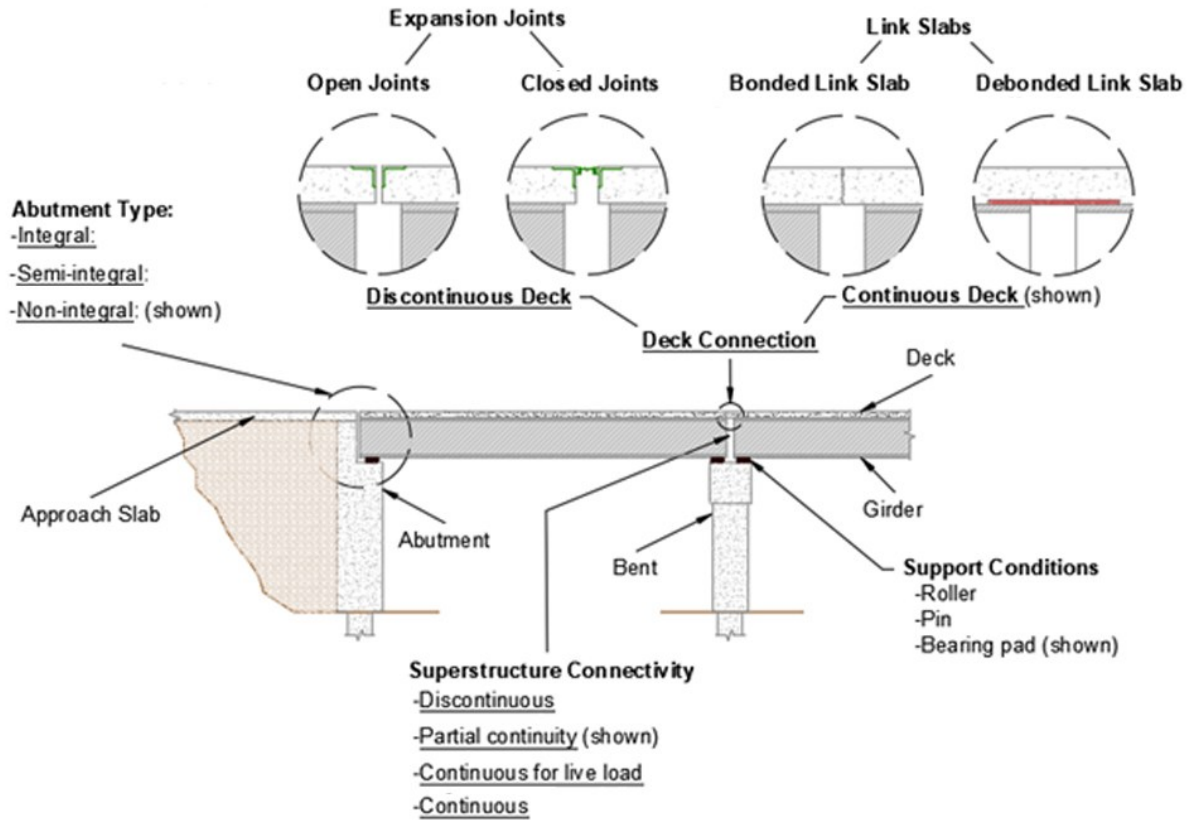
Figure 2.1. Nomenclature diagram for bridge components.

The design for bridge deck deformations, forces, and performance should not only consider the deck and connection but also the rest of the superstructure and substructure. Similarities in the terminology used in the literature to describe bridge, deck, and joint characteristics make clarifying these terms an important step in examination of the literature. To support this, Figure 2.1 and Figure 2.2 provide an overview of the bridge characteristics.

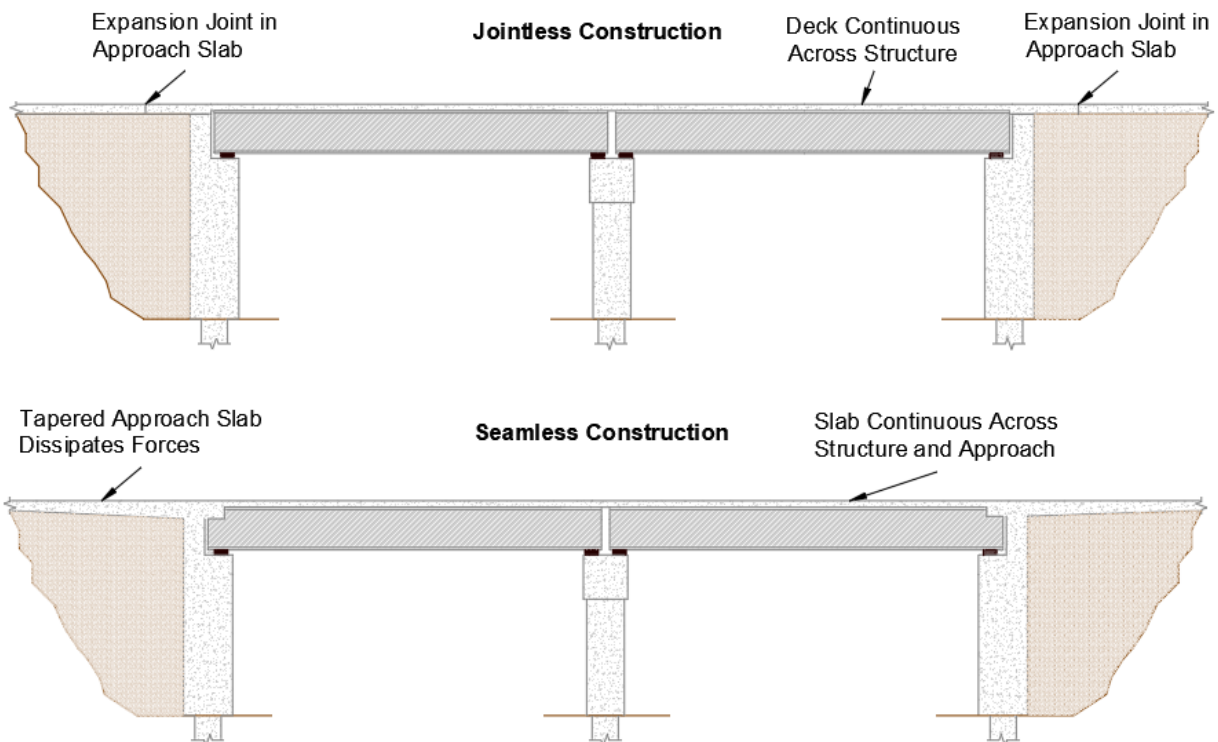
Figure 2.2. Bridge system nomenclature diagram.

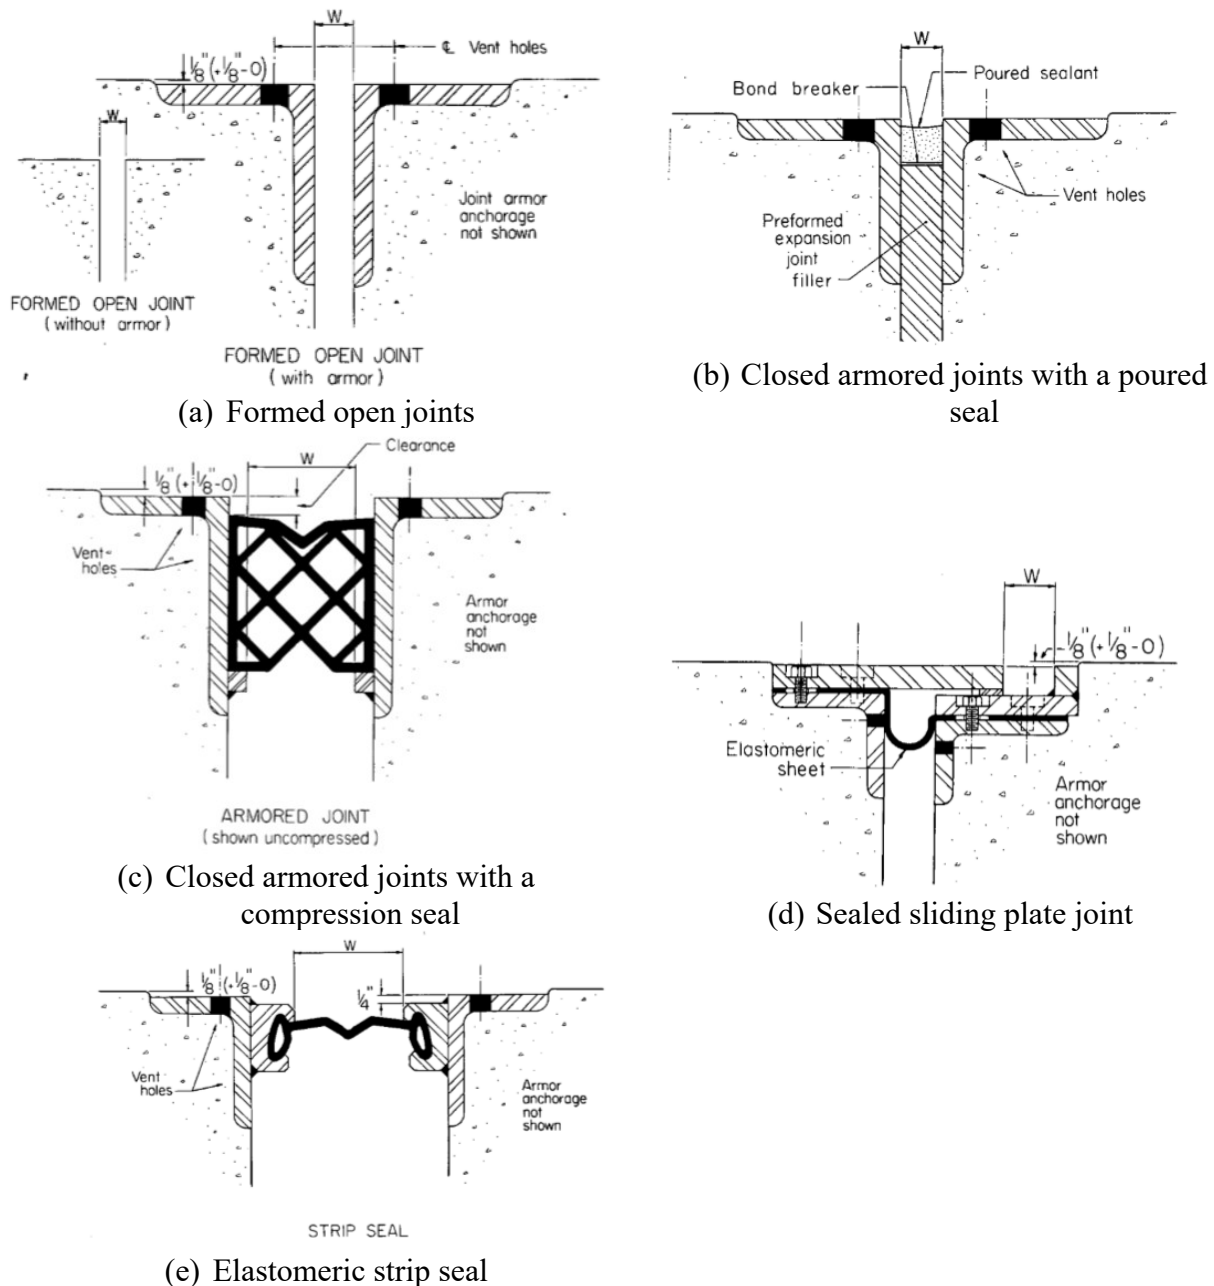
Joints may be broadly categorized as either open or closed. Open joints include formed joints (see Figure 2.3) and finger-plate joints that allow water and debris to pass through. Closed joints include various types of seals (see Figure 2.3[b–c]) and sliding plates. Poured seals are limited to small deflections. They may include additional elements such as backer rods, bond-breaking material between the sealant and joint filler, or angled steel to reinforce the top edges. Compression seals, which consist of cellular elastomeric structures, may incorporate larger displacements. Cellular seals are a similar concept made of foams. Sliding plate joints (see Figure 2.3[d]) are typically used for displacements up to 4 in. While simple to construct and harder than elastomeric options, they will allow water to permeate if not sealed and are vulnerable to damage from vertical deflections. Prefabricated elastomeric seals may be sheet or strip style (see Figure 2.3[e]), incorporating deflections up to around 4 in. or more complex plank seals for large deflections up to 13 in. While the performance of deck joints is an area of concern for bridge engineers, the deck itself must also be durable, especially when it comes to controlling cracking that leads to corrosion.

**Figure 2.3. Examples of joints in discontinuous decks, reprinted from Burke Jr. (1989).**

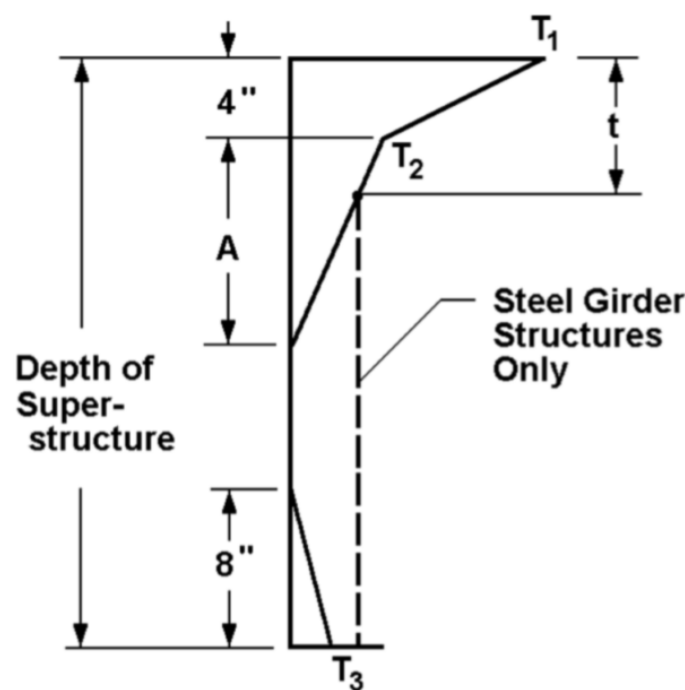
Regarding temperature gradient, positive temperature gradient values are chosen with a map and table. Negative gradient values are found similarly and then modified based on deck surface material. These temperatures are applied to a standard thermal gradient (AASHTO Figure 3.12.3-2, shown in Figure 2.4), with dimensions defined by superstructure depth. AASHTO Section 4.6.6 specifies that axial deformation, bending deformation, and associated stresses should be calculated using this temperature gradient. AASHTO Equations C4.6.6.-1 through C4.6.6.-7 may be used to find axial deformation, axial strain, curvature, bending and axial end forces, and internal stresses.

**Figure 2.4. Girder temperature gradient, reprinted from AASHTO (2017).**

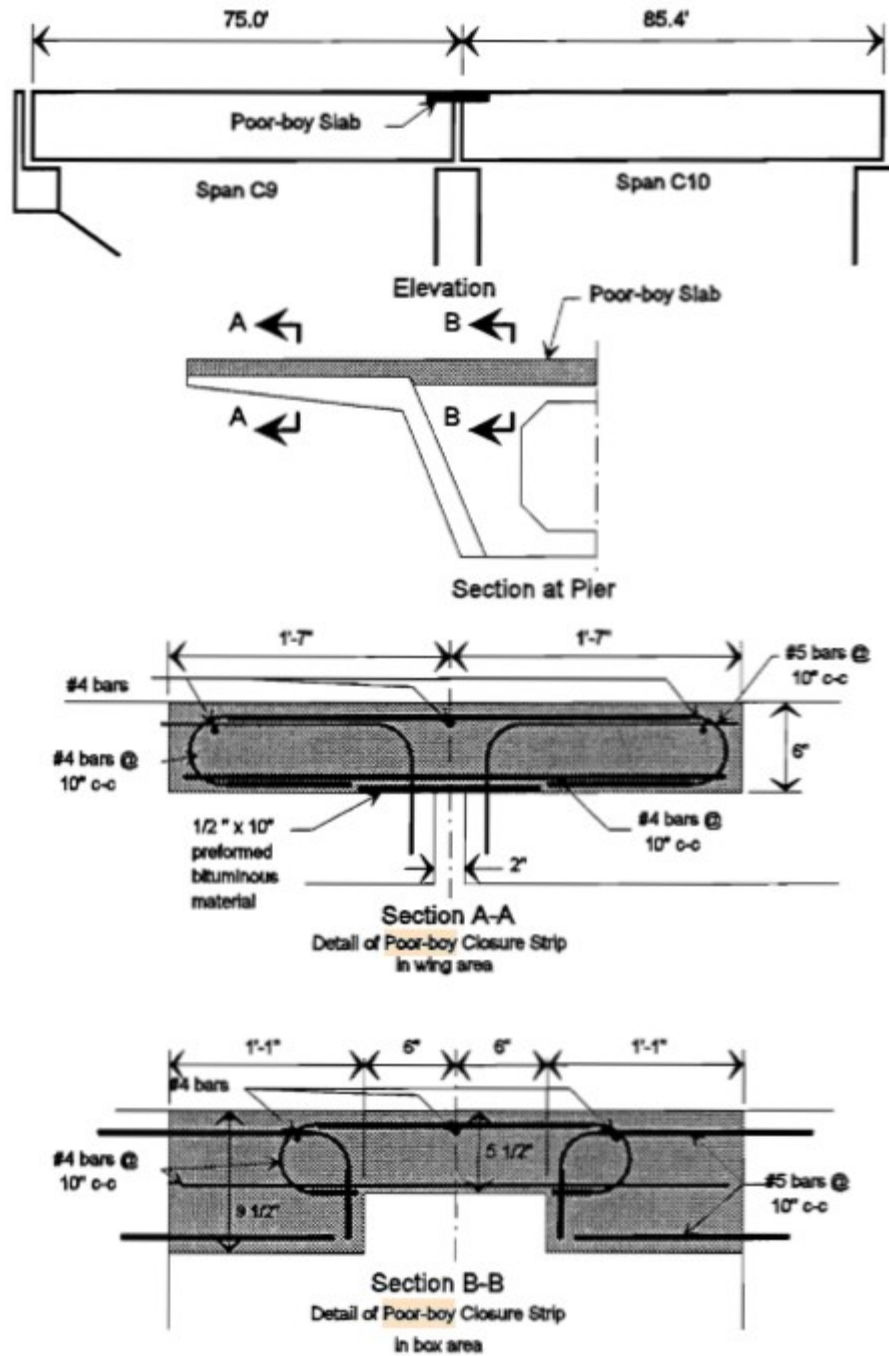
Roberts et al. (1993) conducted a field study of the San Antonio “Y” project, which included one highway span joined with poor boy connectivity. The spans consisted of segmental post-tensioned box girders. One two-span segment was left as simply supported over the bent with poor boy continuity in the deck (see Figure 2.14). Such a detail was novel for TxDOT segmental box girder structures. The spans were 75 and 85 ft long and were not connected with continuous tendons. The primary unknowns were whether the joint would cause partially continuous behavior.

Figure 2.14. Poor boy continuous slab details, reprinted from Roberts et al. (1993).

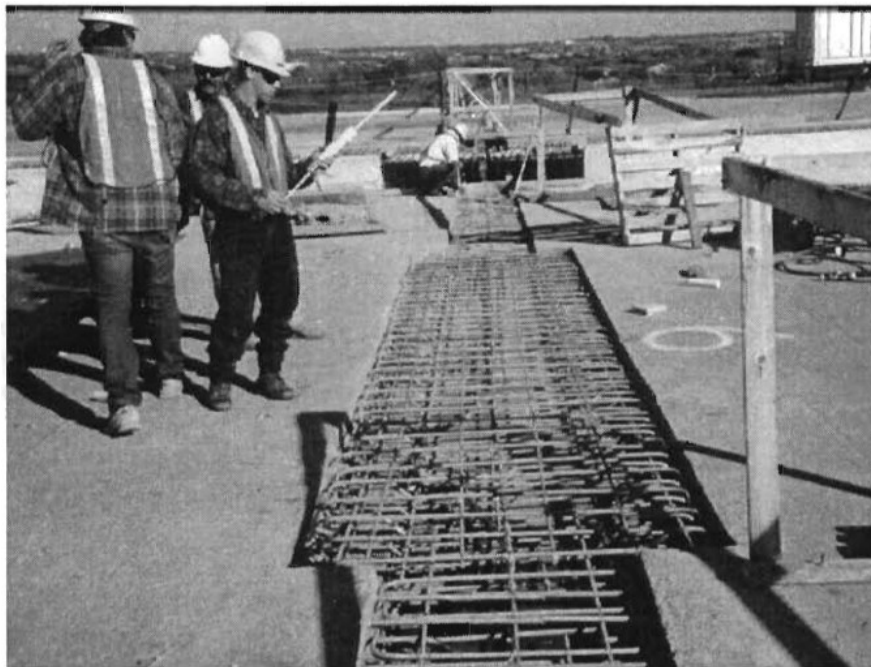
**Figure 2.17. Poor boy continuous joint pour, reprinted from Davis et al. (1999).**

construction and service. Because of complications with designing and constructing the spans as continuous, especially due to difficulty with post-tensioning continuity between spans, much of the structure was designed with simply supported spans. The deck between simple spans was made continuous with poor boy continuity for two to three spans by casting closure decks between the flanges of the box girders (see Figure 2.17). These joint slabs were designed to carry vehicle loads without transferring significant moment between girders. A poor boy continuous slab detail was chosen to reduce the number of expansion joints and because TxDOT has found that “the durability and ride quality of these slabs has proven to be excellent when properly detailed.”

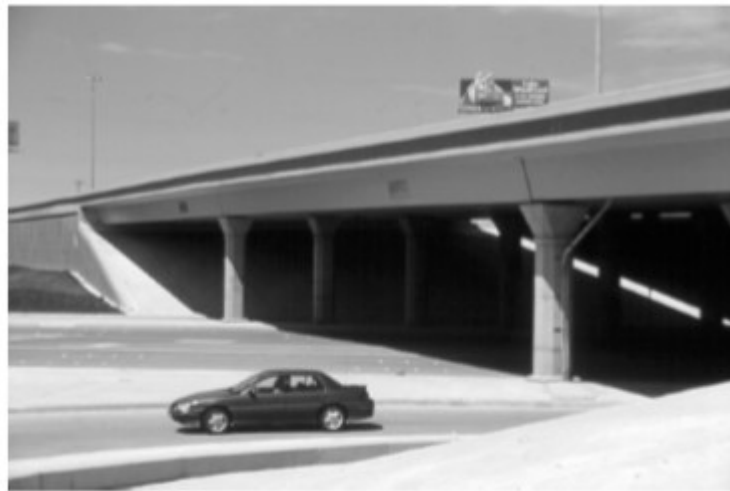
**Figure 2.19. Louetta bridge, reprinted from Gross and Burns (2000).**

Gross and Burns (2000) evaluated two prestressed HPC girder bridges, both with poor boy continuity in their decks. However, the first deck on a bridge in Louetta utilized a continuously

cast deck with a construction joint over the bents (see Figure 2.19), while the second deck on a bridge in San Angelo utilized separately poured decks connected by closure pours at each bent. The spans were instrumented with vibrating wire strain gages to determine structural continuity. The San Angelo bridge deck behaved as a simply supported span since negligible strain was recorded in the poor boy link slab. Likewise, minimal strains were recorded in the Louetta deck, indicating simply supported behavior and negligible continuity. Both bridges made use of elastomeric bearing pads, which deform easily in shear, preventing the formation of couple moments at the connection. Given that the connections performed as expected, no design changes were recommended to TxDOT.

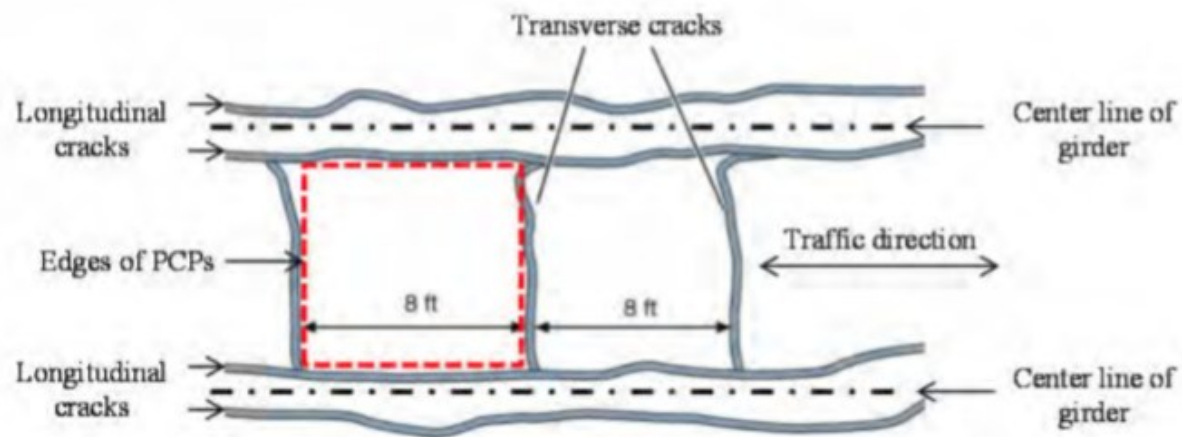
**Figure 2.20. Crack pattern for CIP-PCP bridge deck, reprinted from Folliard et al. (2003).**

The current Texas poor boy detail retains much of the simplicity of older designs. The deck is not debonded from the girders, and no closure pour is provided between the beam ends. With the widespread use of PCPs in Texas bridge construction, researchers have investigated the behavior of such systems in the region of the poor boy joint. Bayrak et al. (2013) investigated the optimization of reinforcement and cracking behavior of bridge decks composed of PCPs and CIP concrete, including those with poor boy continuity. The goals of the project included determining whether a reduced amount of top-mat reinforcement in the CIP slabs was acceptable and managing cracking in the PCPs in order to reduce the cost of damaged materials. Joints between panels and interfaces between PCPs and CIP concrete over supports are vulnerable to cracking due to shrinkage and creep (see Figure 2.20).

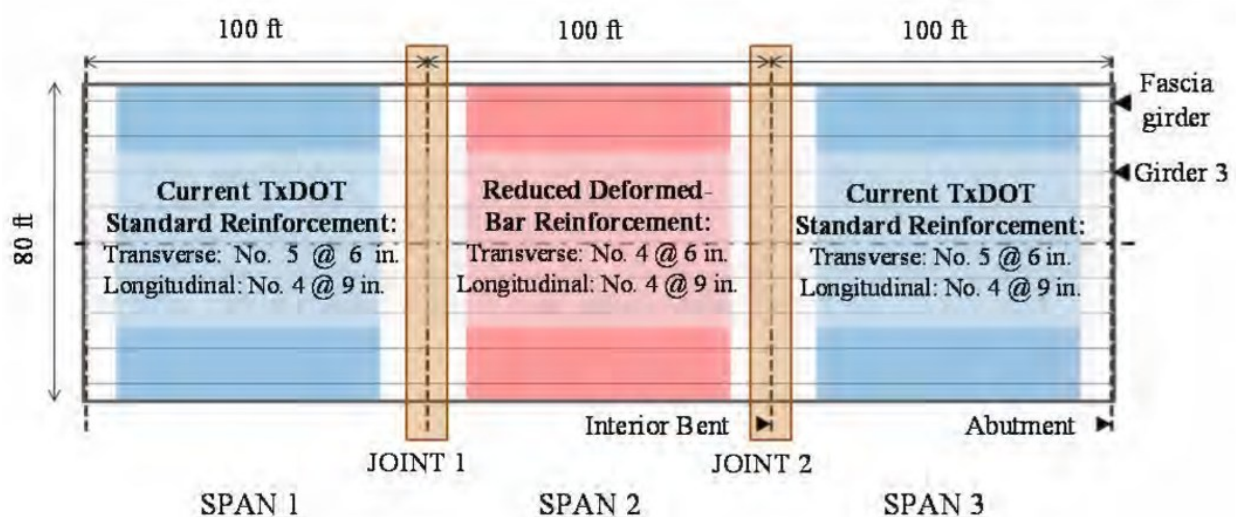
**Figure 2.21. Deck reinforcement scheme on Wharton-Weems Overpass, reprinted from Bayrak et al. (2013).**

Researchers instrumented poor boy details with gages during construction of two bridge structures with 8-in. deep decks in order to record crack widths. The first structure was the newly constructed Wharton-Weems Overpass, a three-span bridge at the crossing of Choate Road and Shoreacres Boulevard in Houston, Texas. Two exterior spans included standard TxDOT reinforcement, while the third span was designed with reduced transverse reinforcement, #4 bars at 6 in. One of the two poor boy details contained standard reinforcement, while the other contained the reduced reinforcement (see Figure 2.21).

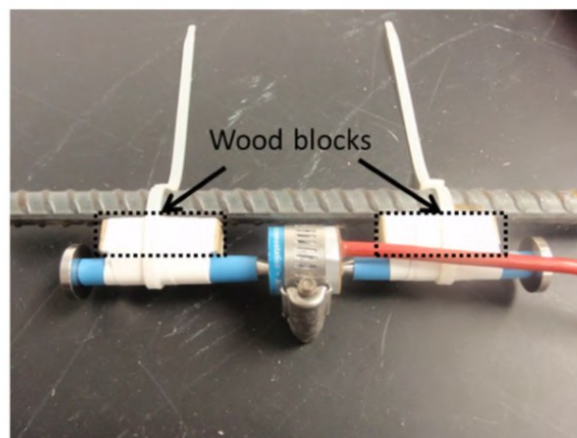
**Figure 2.22. Vibrating wire strain gage installation on rebar, reprinted from Bayrak et al. (2013).**

The top-mat reinforcement was instrumented with 16 vibrating wire (VW) strain gages (see Figure 2.22 and Figure 2.23). The gages transmitted data every 30 minutes. The deck was cast in nine hours using concrete with a compressive strength of 4000 psi. Crack formers, known as zip strips, were placed at the poor boy details (see Figure 2.24).

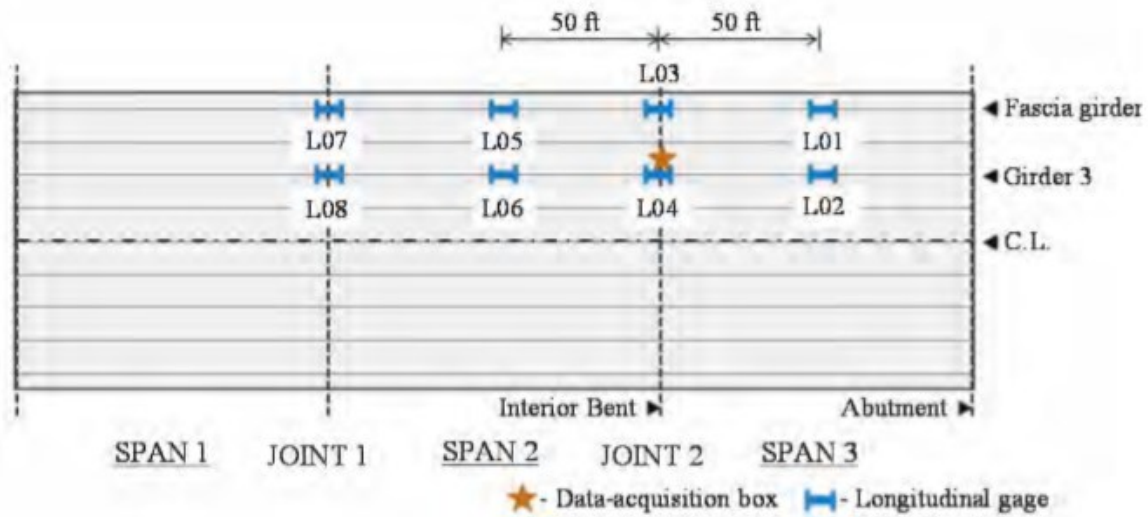
Figure 2.23. Longitudinal bar VW gage layout for the Wharton-Weems Overpass, reprinted from Bayrak et al. (2013).

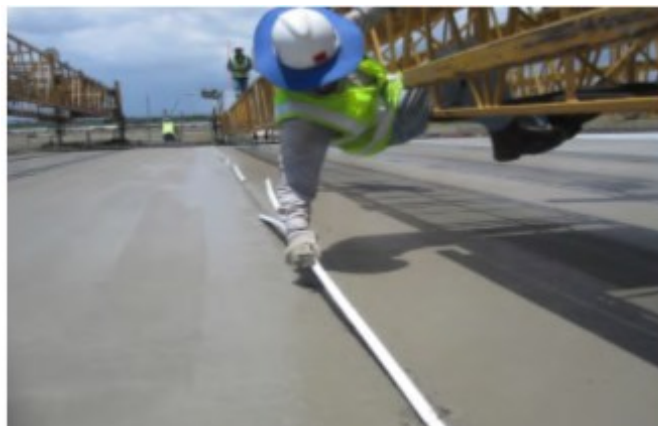
Figure 2.24. Installation of zip strip crack former, reprinted from Bayrak et al. (2013).

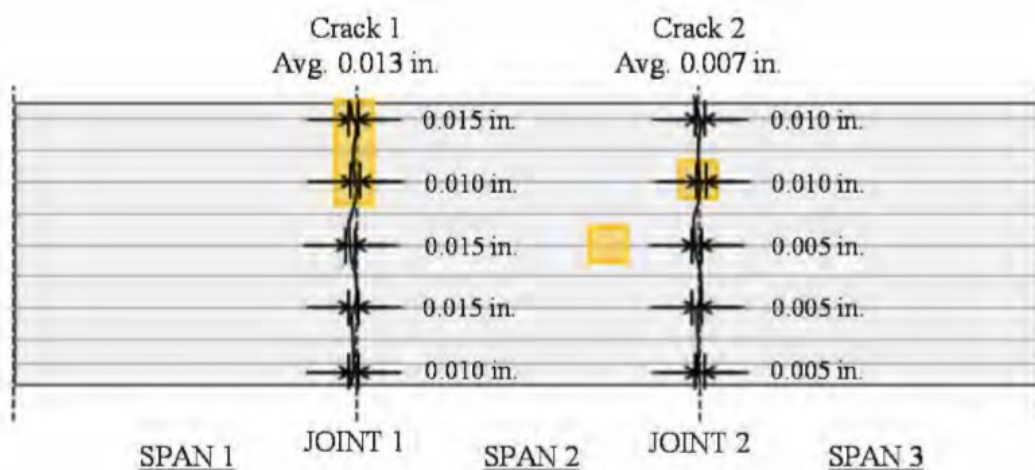
Figure 2.25. Crack widths found in the first inspection of the Wharton-Weems Overpass, reprinted from Bayrak et al. (2013).

Prior to the application of traffic loads, crack widths were measured two times—once prior to the installation of roadway barriers and once after barrier installation. The transverse cracks at the poor boy slab details in the first inspection measured, on average, 0.013 in. and 0.007 in. wide. These measurements were taken across the entire slab width (see Figure 2.25). The second inspection only considered the half-width of the span that had been instrumented (see Figure 2.26). The average crack width over both bents was found to be 0.010 in. Other transverse cracks were also recorded at PCP joints. The cracking behavior harmonized with a theoretical cracking prediction that used the VW strain gage data to estimate concrete stress. The inspections included applying water on the concrete surface, which reveals cracks after the surface water evaporates.

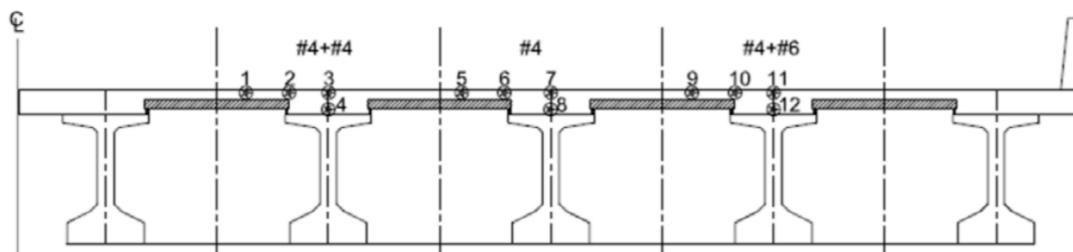
**Figure 2.32. Gage placement diagram, reprinted from Munsterman (2017).**

TxDOT deck reinforcement, consisting of #4 bars at 9 in. in both the longitudinal and transverse directions, was instrumented over a bent to provide a comparison to alternate reinforcement details. Two alternative reinforcement schemes were installed by tying additional bars to the standard reinforcement. The length of added bars was calculated using development length of a #6 bar. Gages were placed on top-mat reinforcement over the bent with an additional gage placed over the girder in order to define the deck's strain profile, as shown in Figure 2.32. The VW gages were attached to bars with zip ties, with additional instruments attached to the gage with clamps (see Figure 2.33).

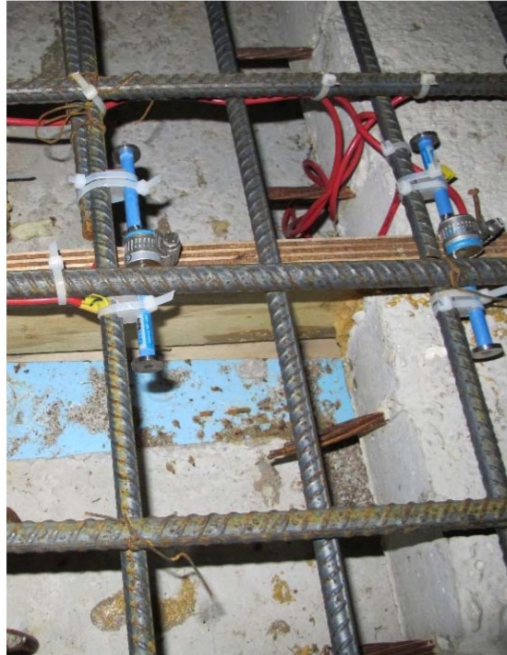
**Figure 2.33. Gage attachment on reinforcement, reprinted from Munsterman (2017).**

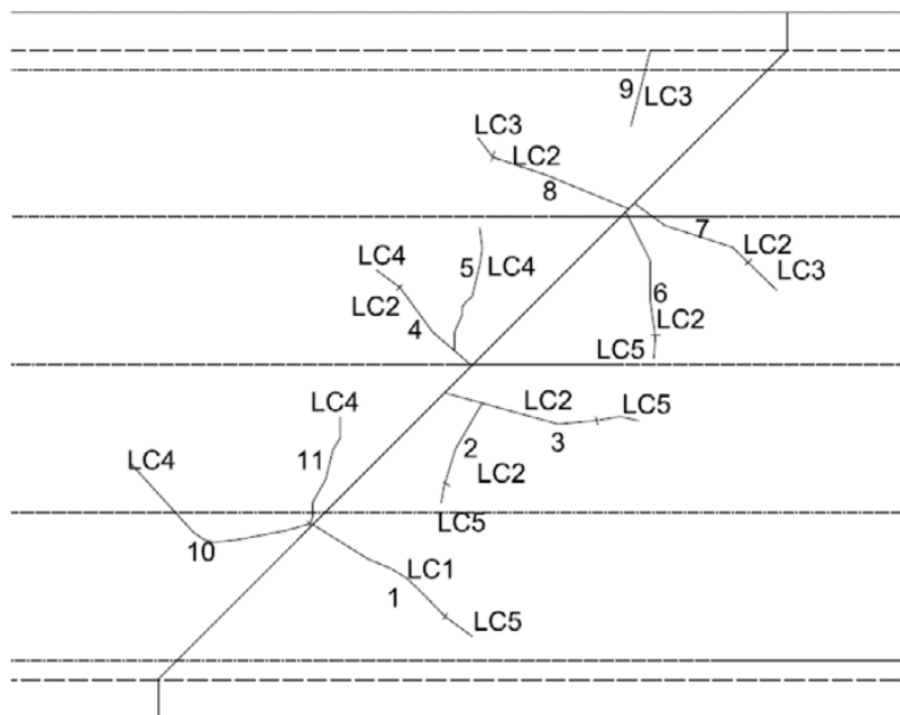
**Figure 2.37. Crack propagation from crack former, reprinted from Munsterman (2017).**

During live load testing, initial cracking was found to propagate from the location of zip strips in the poor boy joint (see Figure 2.37). The researchers theorized that the high skew of the bridge triggered such a cracking pattern. Crack widths were small enough that attempts to determine their size with a crack gage were unsuccessful, and the cracks closed after the trucks left the structure. Live load tests showed that increasing steel area led to a decrease in strain at the gage locations, with the addition of the #4 and #6 bars leading to 18.6 percent and 50.3 percent reductions, respectively. Compression strains were recorded in the lower gages, demonstrating flexural forces in the poor boy slab.

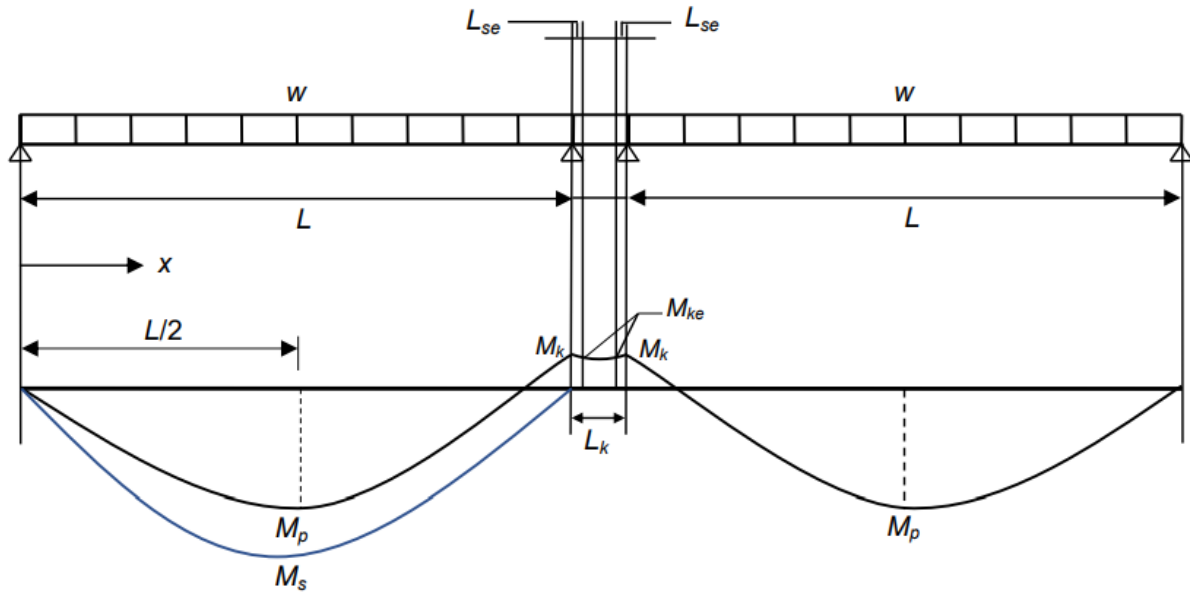
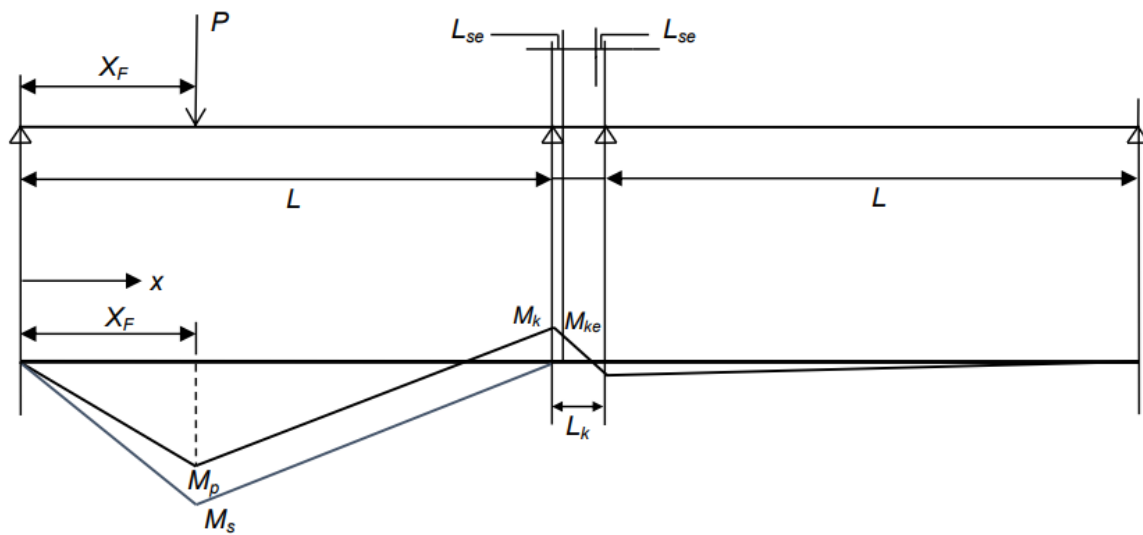
**Figure 2.48. Moment diagrams, reprinted from Gergess (2019).**

A basic analysis was conducted using elastic beam theory, considering cracked section properties for the singly reinforced link slab and gross section properties for the prestressed beams and deck slab. Differential equations were developed for each segment and loading condition and solved using Wolfram Mathematica software. This analysis was used to develop closed-form solutions for the ratio of link slab moment to girder span moment (see Figure 2.48) and the ratio of link span shear force to a point load applied in the girder span (see Figure 2.49). Notably, the analysis did not consider longitudinal deformations or compression reinforcement in the slab.

Moment diagram due to a uniformly distributed load  $w$  applied continuously

Moment diagram due to a concentrated load  $P$  applied at distance  $X_F$

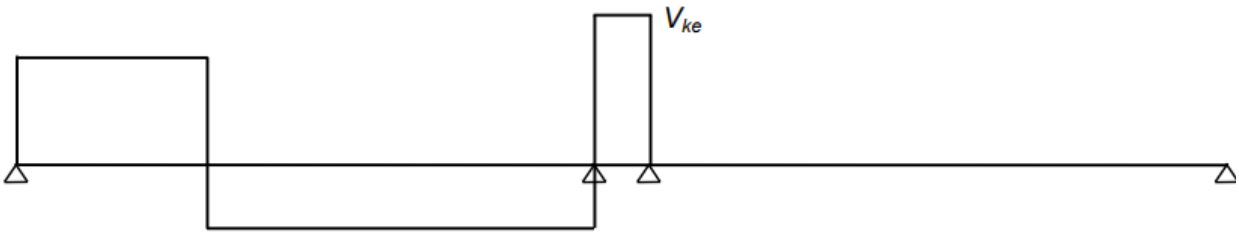
**Figure 2.49. Shear force, reprinted from Gergess (2019).**

Shear force diagram due to a concentrated load  $P$  applied at distance  $X_F$   
(also representative of the case where the uniform load  $w$  is applied in one span)

For shear analysis, forces are amplified in the link slab by asymmetrically applied loading with pinned support conditions. However, including the flexibility of the elastomeric bearing support decreases the shear across the link slab. For certain AASHTO girders, shear capacity was found to limit the slab's reinforcement ratio.

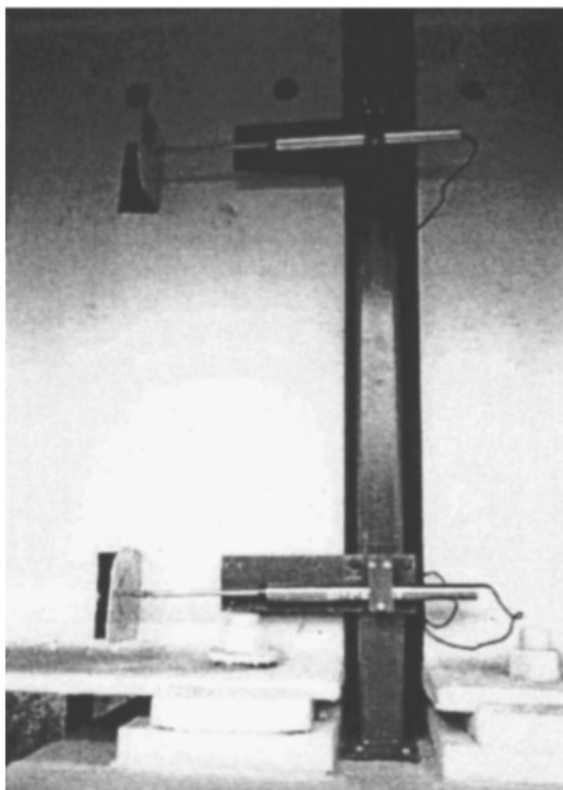
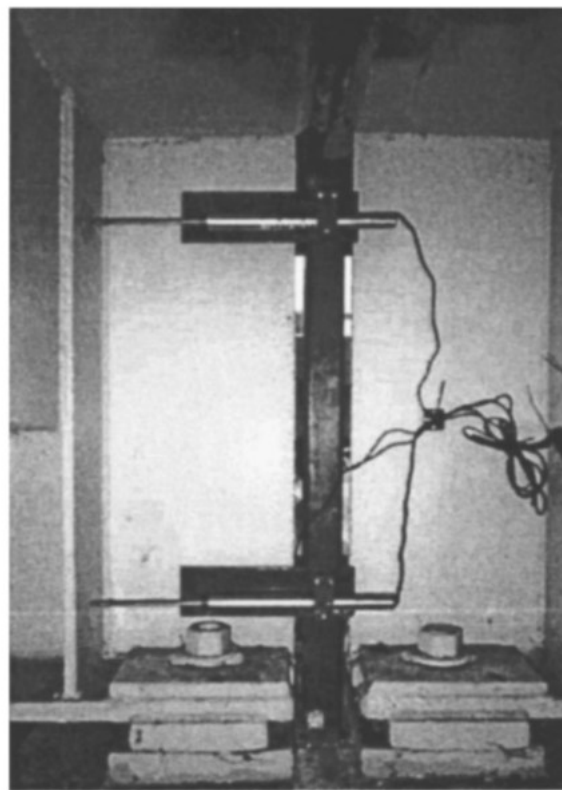
**Figure 2.51. LVDT placement at girder ends, reprinted from Wing and Kowalsky (2005).**

**Exterior stand on girder line 5**

**Interior stand on girder line 4**

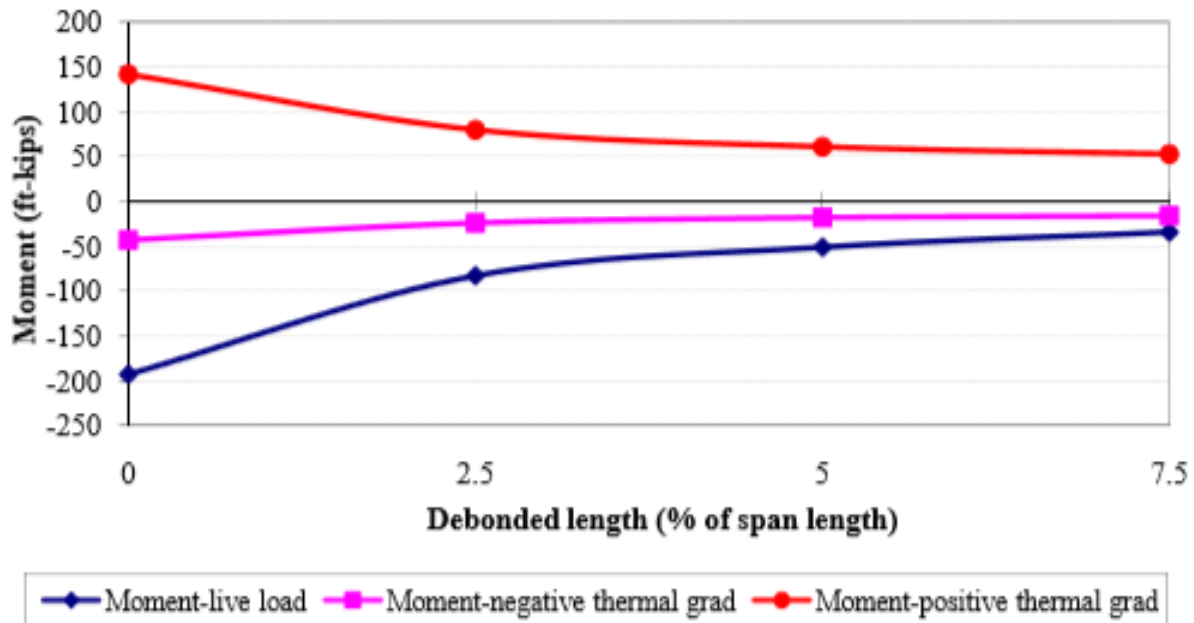
**Figure 2.52. Moment demand for different debonded lengths, reprinted from Aktan et al. (2008).**

Debonding a length of the link slab effectively reduced link slab moment but led to only a limited reduction after about 5 percent span length debonding (see Figure 2.52). Increased girder depth caused additional axial force in the link slab. Increased girder stiffness, however, reduced the force and moment in the link slab as girder end rotations decreased.

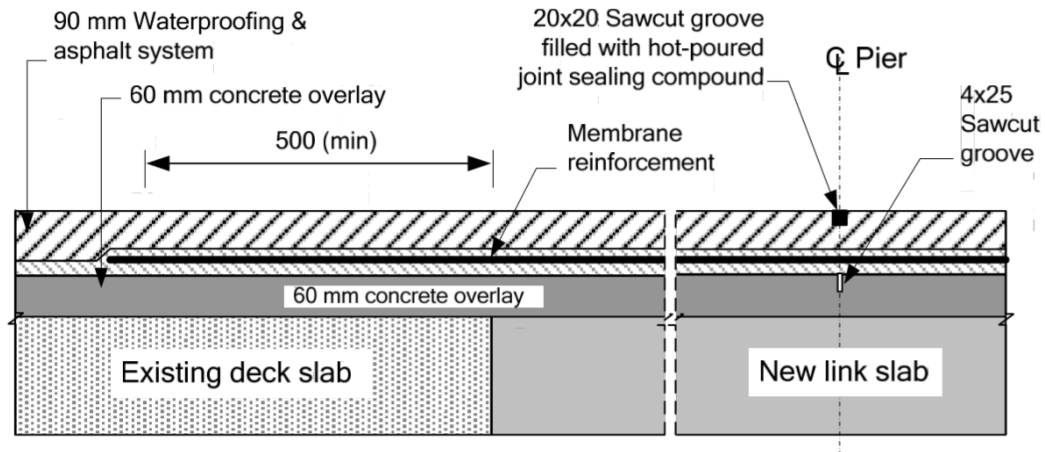
**Figure 2.55. Water protection and crack-control details, reprinted from Lam et al. (2008).**

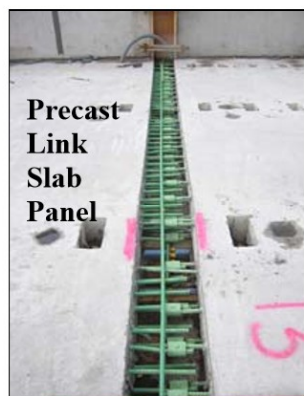
(a) Reinforced continuity provided by mechanical couplers

(b) Prefabricated link slab panel showing expansion joint in parapet well

**Figure 2.56. Prefabricated link slab construction, reprinted from Lam et al. (2008).**

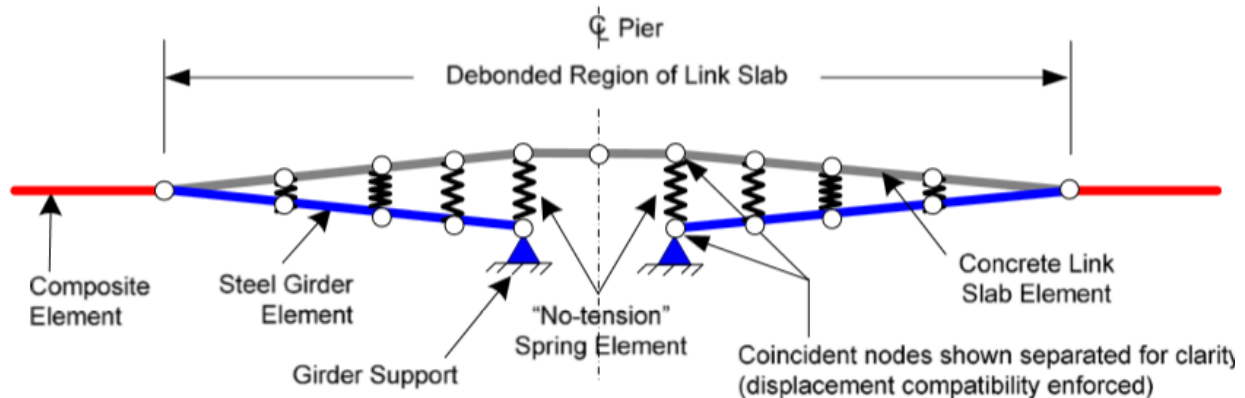
**Figure 2.62. Spring model of link slab, reprinted from Au et al. (2013).**

The results were compared to the output of an S-FRAME 7.02 model, which utilized tensionless, rigid spring elements to simulate the debonded connection (see Figure 2.62). Axial loads were not considered, but this effect was considered negligible based on prior findings. The link slab model included an estimate of cracking in the negative moment region based on a reduced moment of inertia. This reduced section was calculated iteratively for each load step based on the value of the applied moment. After the strains in the rebar were calculated from the moment, crack width was estimated based on the strain listed in the Canadian Highway Bridge Design Code provisions.

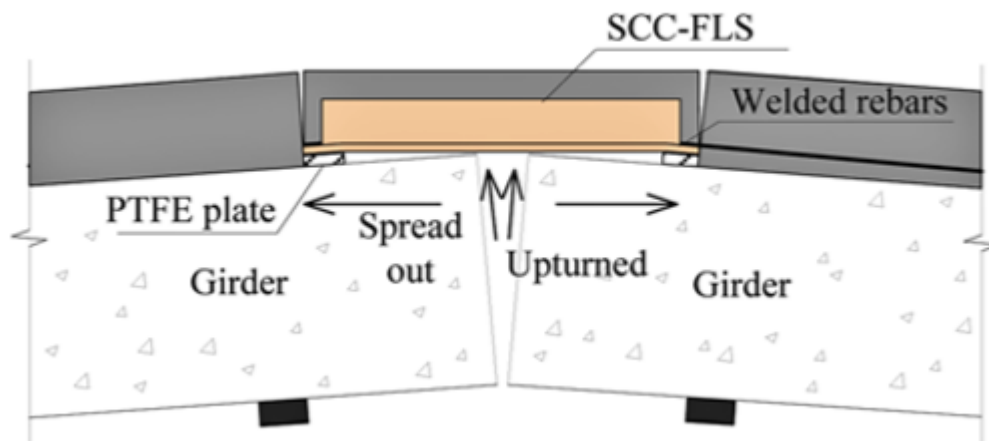
**Figure 2.63. Composite link slab design, reprinted from Wang et al. (2019).**

developed a design for a composite link slab with reinforced concrete atop steel sections. The steel section includes a void above the girder ends, such that they are able to rotate without contacting the link slab above. The steel section is able to translate atop polytetrafluoroethylene (PTFE) plate supports, and reinforcing bars are welded to the steel, leaving an intentional gap in the concrete at the ends of the link slab (see Figure 2.63).

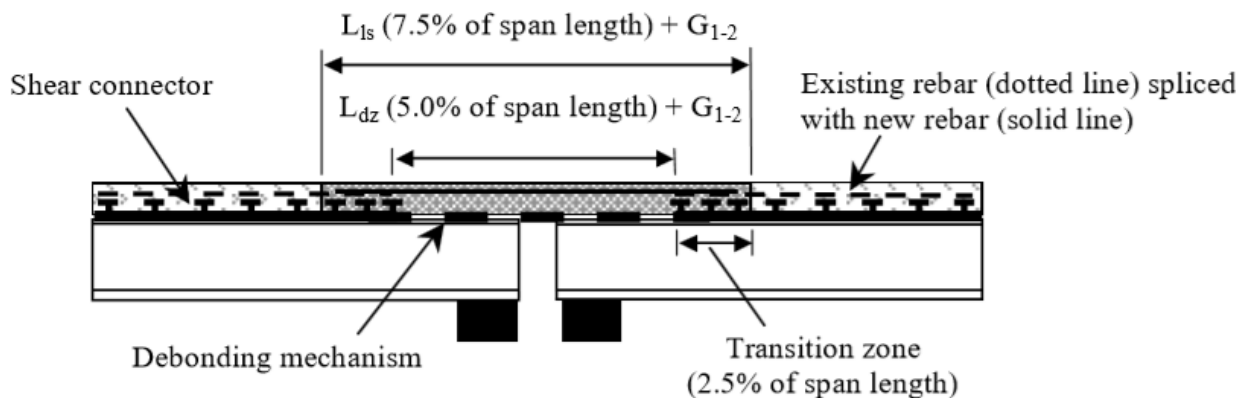
**Figure 2.66. Debonded ECC link slab diagram.**

Lepech and Li (2005) described the use of debonded ECCs in link slabs in Michigan (see Figure 2.66). Using ECCs makes possible a reduction of reinforcing steel that would be used for crack control, which reduces the stiffness of the link slab. While normal concrete link slab designs were found to deteriorate quickly due to poor placement of steel and construction issues,

The link slab's transition from an ECC to normal concrete was designed with 50 percent more shear stud reinforcement than the deck slab to account for the high-shear stresses near the interface. The design of the link slab followed standard methods, using the rotation of the girder ends to calculate the moment in the link slab. The steel reinforcement was then chosen based on a working stress design and assuming elastic-perfectly-plastic behavior of the ECC. After selecting reinforcement, the link slab was checked to ensure that maximum material strains were not exceeded due to live load, temperature, or shrinkage.

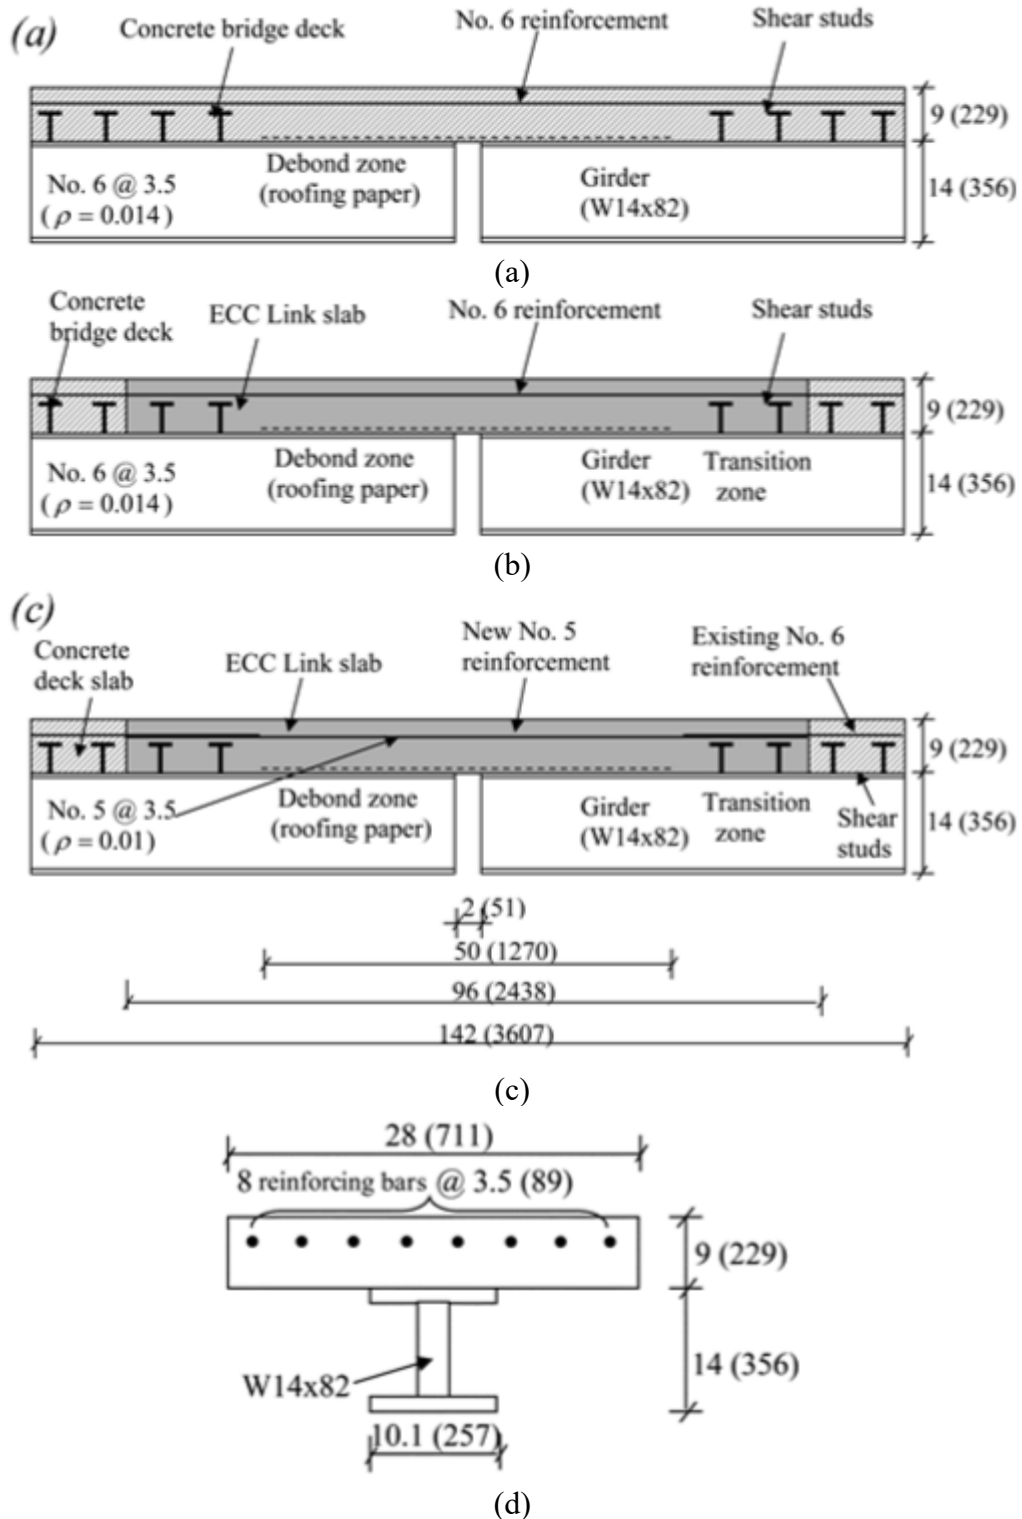
Figure 2.69. The three experimental link slab specimens (a, b, c) and a section view of the specimens (d), reprinted from Qian et al. (2009).

Experimental testing was conducted using three full-scale link slab units (see Figure 2.69). The specimens were built to represent (a) new construction with conventional materials, (b) new construction using ECC in the link slab, and (c) a retrofit using an ECC link slab. The slabs were subjected to 100,000 load cycles. The ECC link slabs successfully prevented cracking in the transition zones. Microcracking was limited to the debonded zones of the ECC slabs, while much wider cracks were generated in the normal concrete link slab.

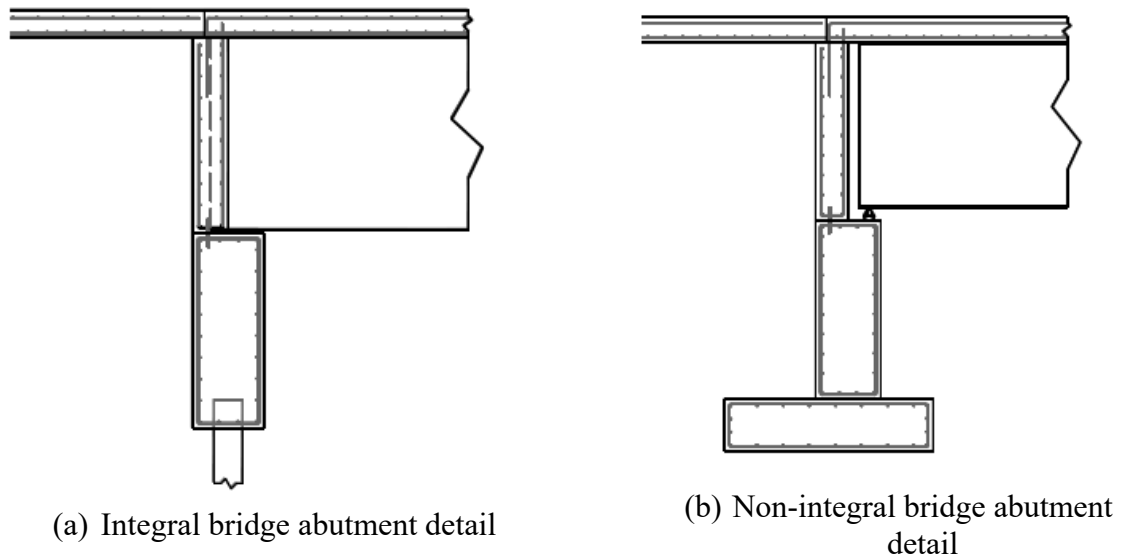
Stringer and Burgueño (2012) investigated the issue of deck cracking in jointless bridges. Such structures may be classified by the level of connection at their abutments. Integral bridges have the abutment and girder cast together, while non-integral bridges have only the continuous deck connecting into the abutment (see Figure 2.75).

**Figure 2.75. Abutment details: (a) integral and (b) non-integral; reprinted from Stringer and Burgueño (2012).**
