# Performance and Improvement of Texas Poor Boy Continuous Bridge Deck Details: Final Report

Technical Report 0-7013-R1

Cooperative Research Program

TEXAS A&M TRANSPORTATION INSTITUTE  
COLLEGE STATION, TEXAS

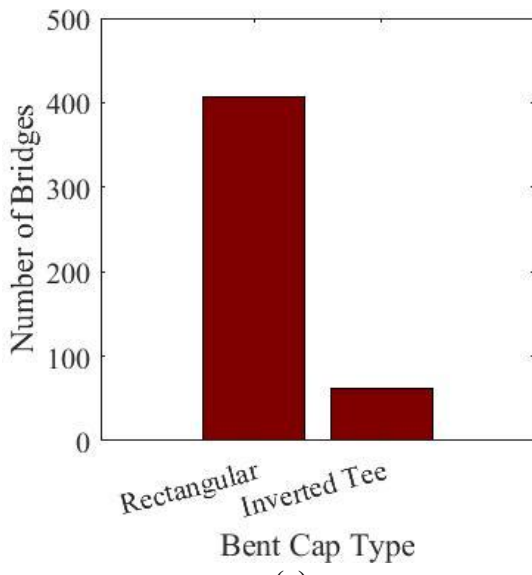
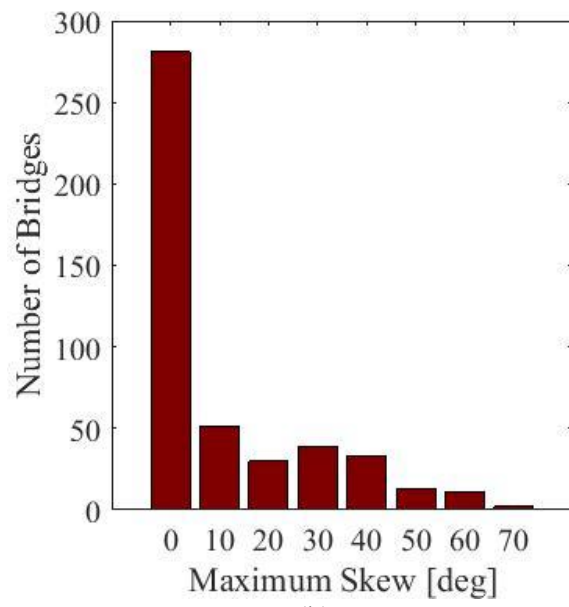
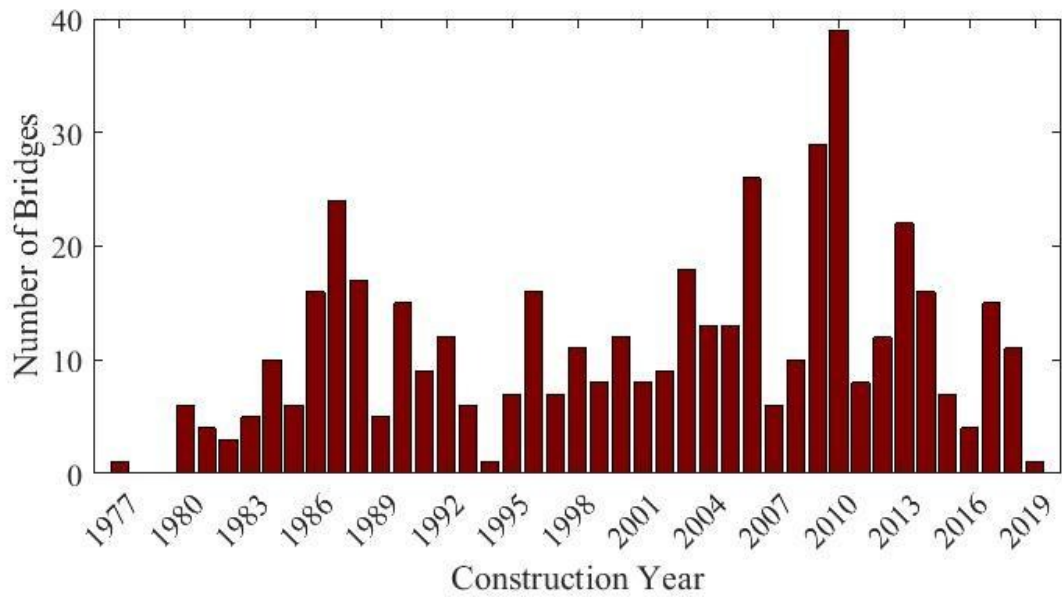
**Figure 3.3. Histograms of overall bridge characteristics.**

Figure 3.1 and Figure 3.2 show the locations of bridges used in the database. Figure 3.3 through Figure 3.6 provide histograms summarizing characteristics of bridges in the database.

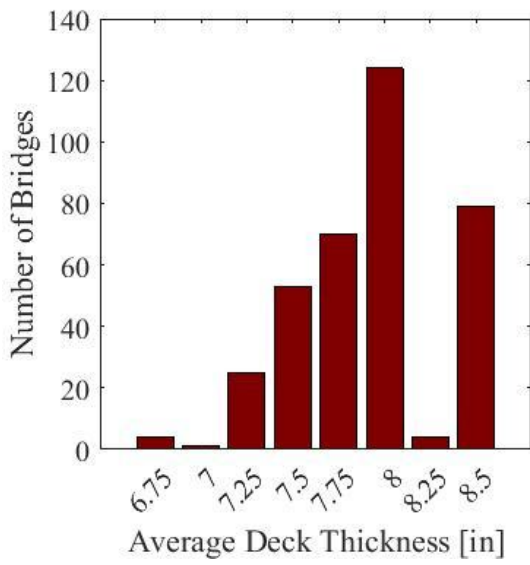
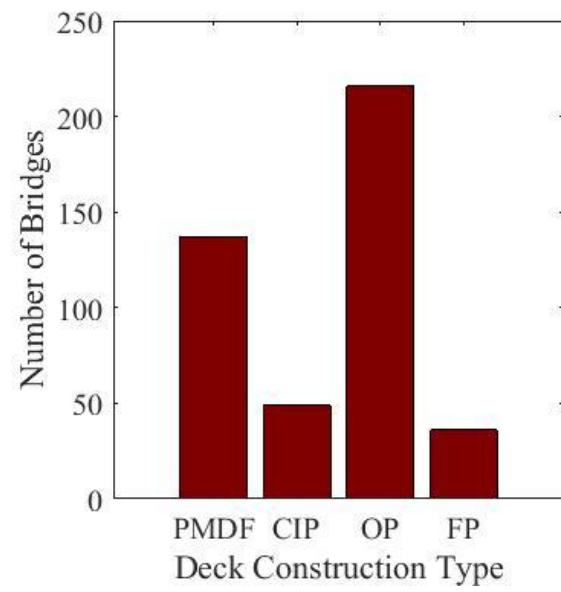
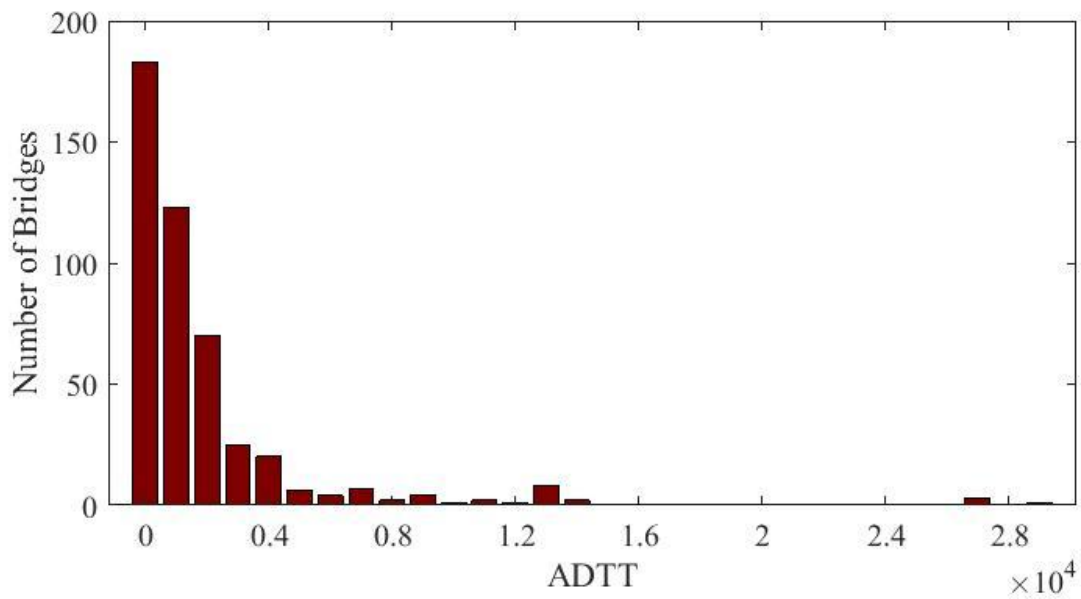
**Figure 3.4. Histograms of deck characteristics.**

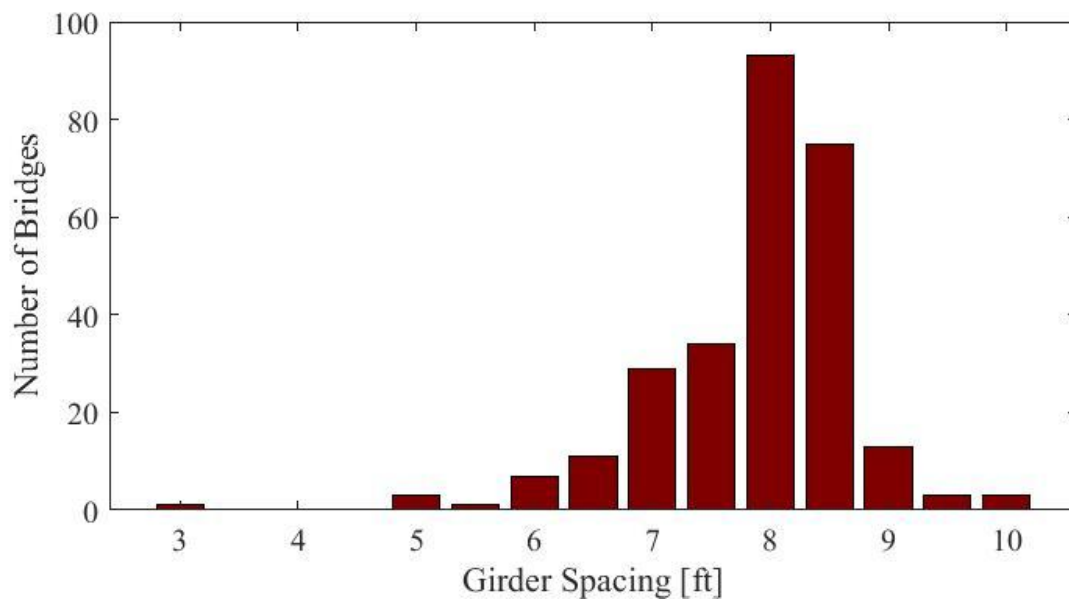
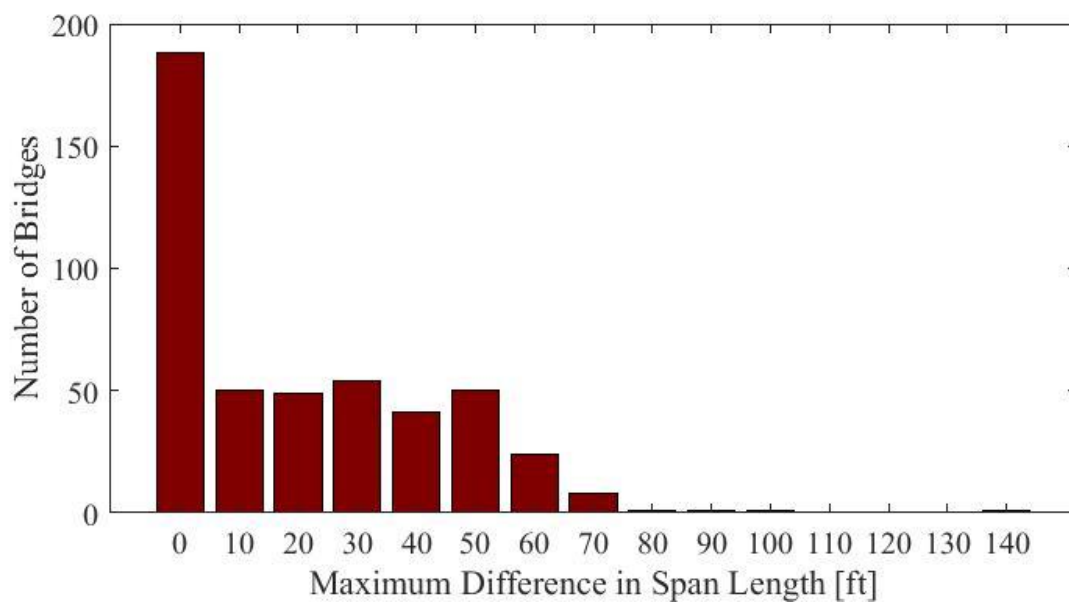
**Figure 3.5. Histograms of span characteristics.**

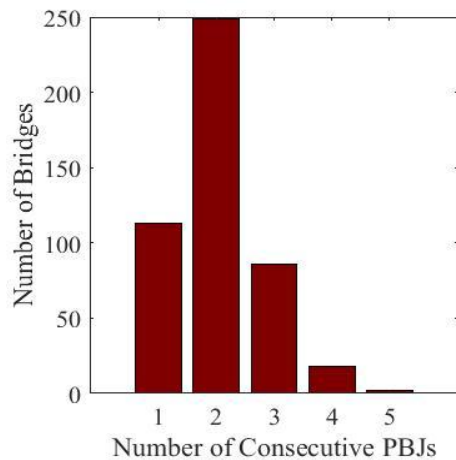
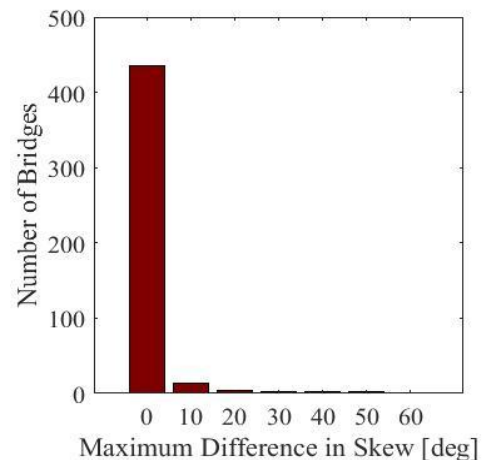
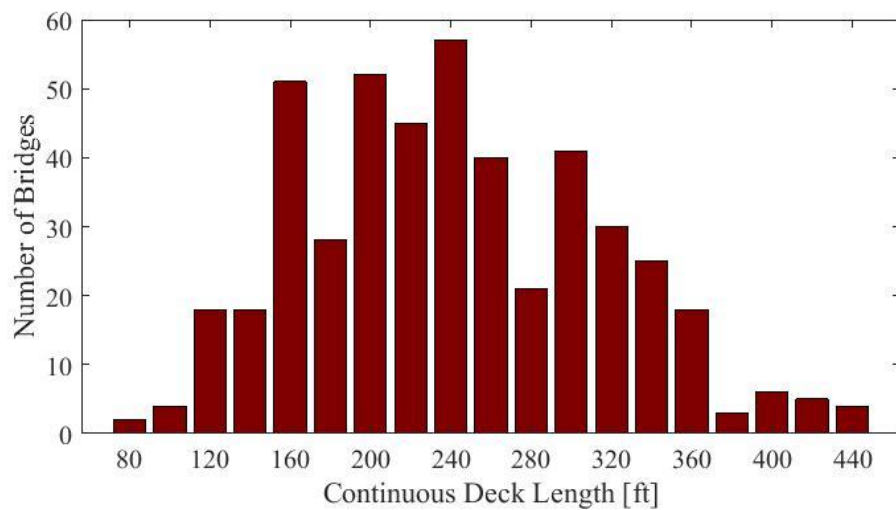
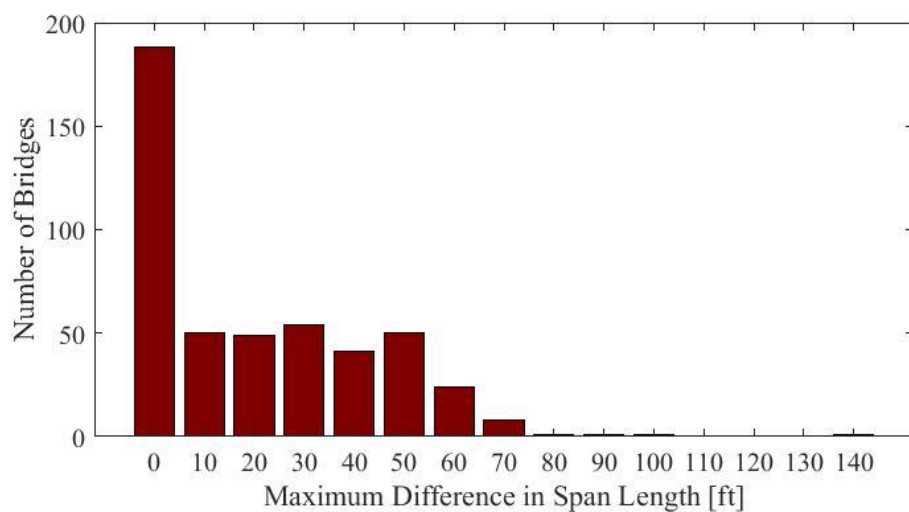
**Figure 3.6. Histograms of continuous unit characteristics.**

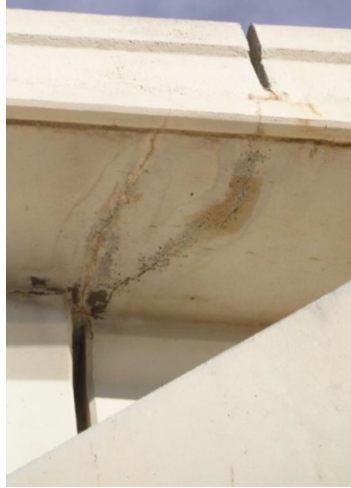
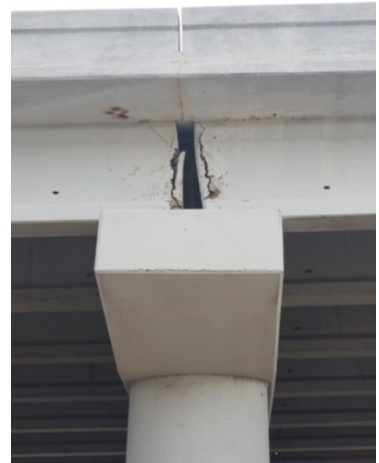
(a) Cracking and spalling on top of deck

(b) Cracking on bottom of overhang

(c) Girder end damage

**Figure 3.7. Example of damage reducing the PBJ-R.**

To meet the desired goals of this study, a unique poor boy joint rating (PBJ-R) was created for each bridge. The PBJ-R is on a scale of 1–4, with 4 being the highest and indicating no reported damage. For each bridge, a rating of 4 was initially assumed, with the score then reduced by 1 for each reported instance of cracking, spalling, rust, or delamination in the deck or for damage at the end of the girders. Examples are shown in Figure 3.7.

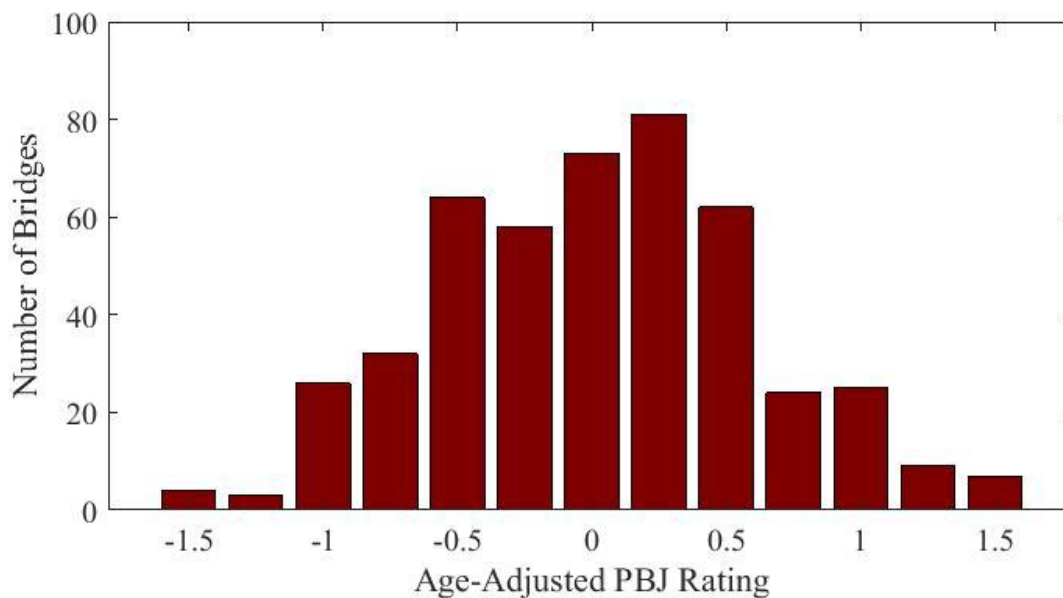
**Figure 3.9. Histogram of age-adjusted PBJ ratings.**

Because of the distinct difference in PBJ ratings between the two regions, the PBJ-AAR for each bridge was calculated using the linear fit for its region. This helped account for factors such as construction or maintenance practices, weather conditions and deicing practices, and other unforeseen differences between the regions that affect bridge deterioration. Figure 3.9 provides a histogram of age-adjusted ratings.

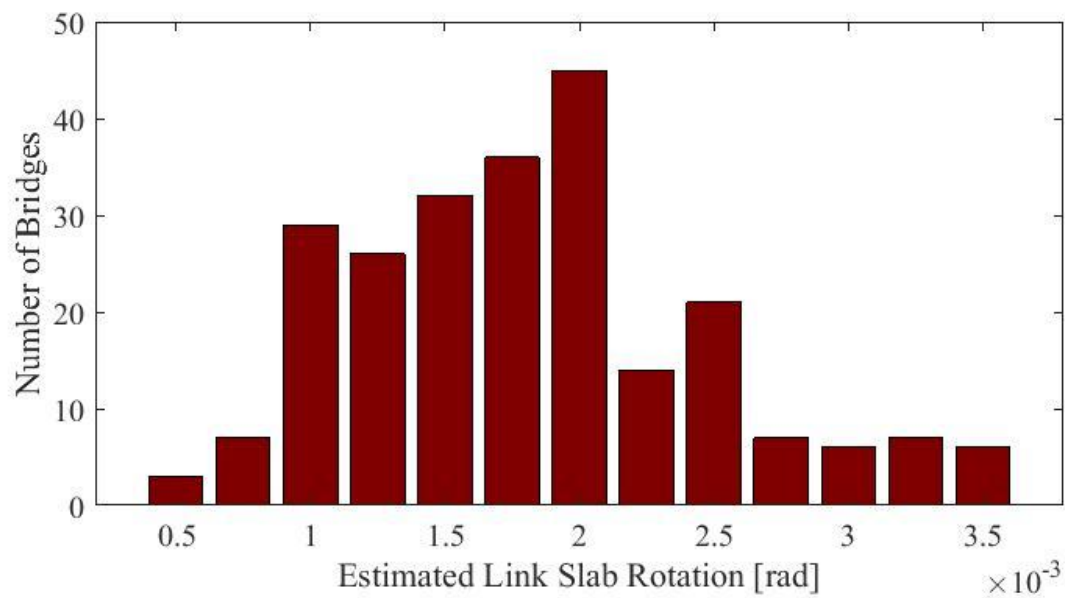
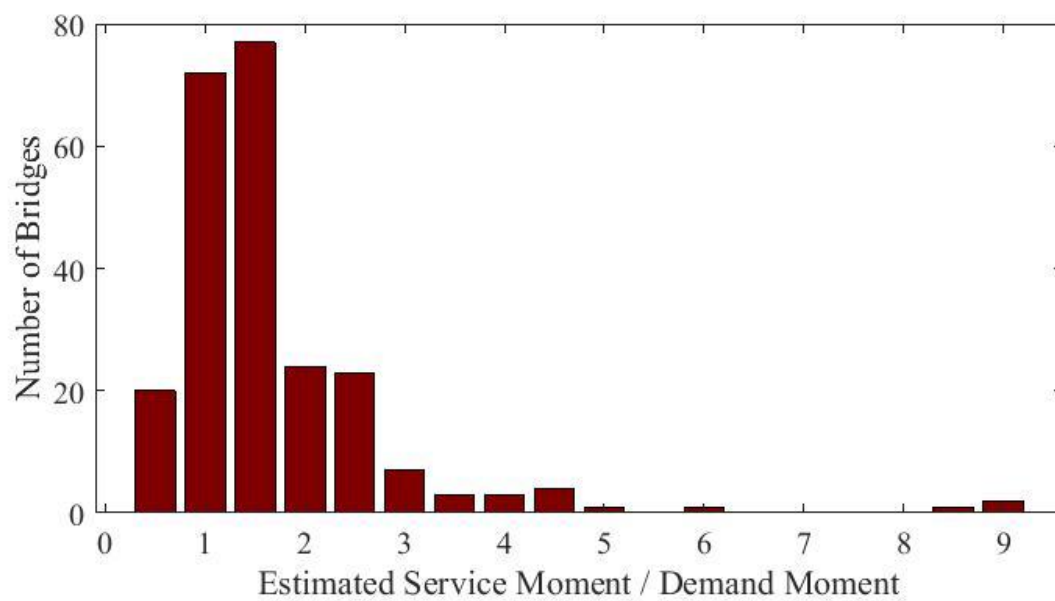
**Figure 3.10. Histograms of link slab response.**

In addition to the characteristics previously summarized, rotations were estimated and then used to estimate service demands that were compared to the service capacity. Figure 3.10 summarizes these demands.

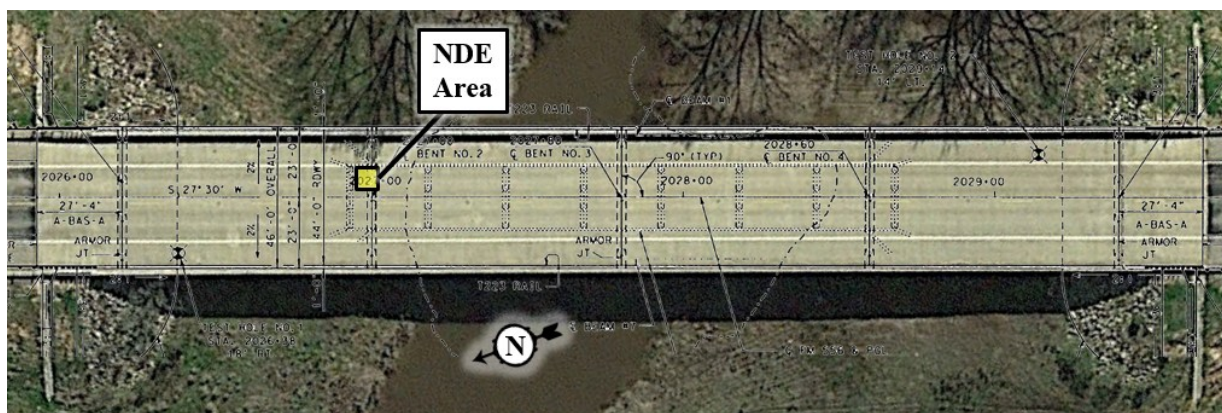
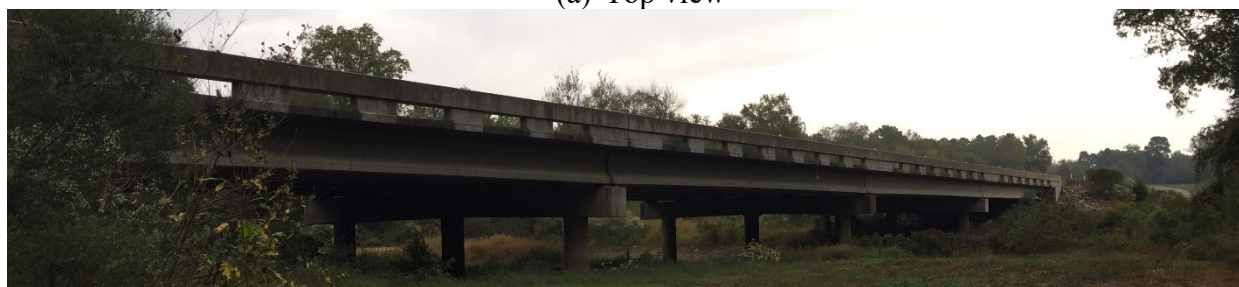
(a) Top view

(b) Elevation view

**Figure 4.2. Site conditions at Bridge ATL1 (FM 556 over Lilly Creek).**

Bridge ATL1, shown in Figure 4.2, was built in 2012; it carries FM 556 over Lilly Creek in Camp County, Texas. The 46-ft wide bridge has seven Type C prestressed concrete I-girders spaced at 6.667 ft with 3-ft overhangs. The bridge carries two 12-ft wide traffic lanes, with 10-ft wide shoulders on both sides.

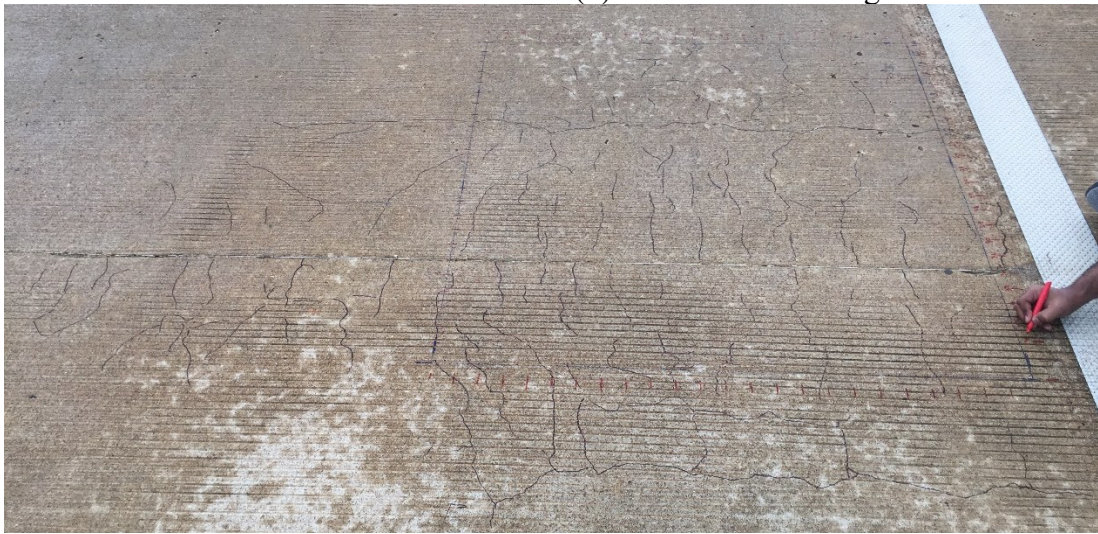
(a) PMDF at Bent 4

(b) Bottom of overhang at Bent 4

(c) Marked cracks in the NDE region at Bent 2

**Figure 4.3. Link slab condition for Bridge ATL1 (FM 556 over Lilly Creek).**

Visual inspection of the bridge confirmed the inspection report damage of minor spalling at the construction joint. The conditions of the continuous deck regions at Bent 2 and Bent 4 were similar. Figure 4.3 shows the condition of the link slab region at Bent 4 from below the deck and the top of the deck at Bent 2. The PMDF was in good condition, with no indication of rust or other damage. In the overhang, some minor spalling was observed at the PBJ crack, but no cracking was noted. Visual observations on the top side of the deck indicated that zip strips were used to form the main PBJ crack. The zip strip was still intact, but some minor spalling was observed at several locations along the length. Figure 4.3(c) shows the marked cracks in the NDE region. Secondary PBJ cracks were present at approximately the end of the portion of the deck where PMDFs were used. The secondary PBJ cracks were 0.014–0.016 in. wide in the NDE region. Hairline cracks were present in the link slab region and in the main deck, and they were primarily longitudinal, with an occasional transverse crack.

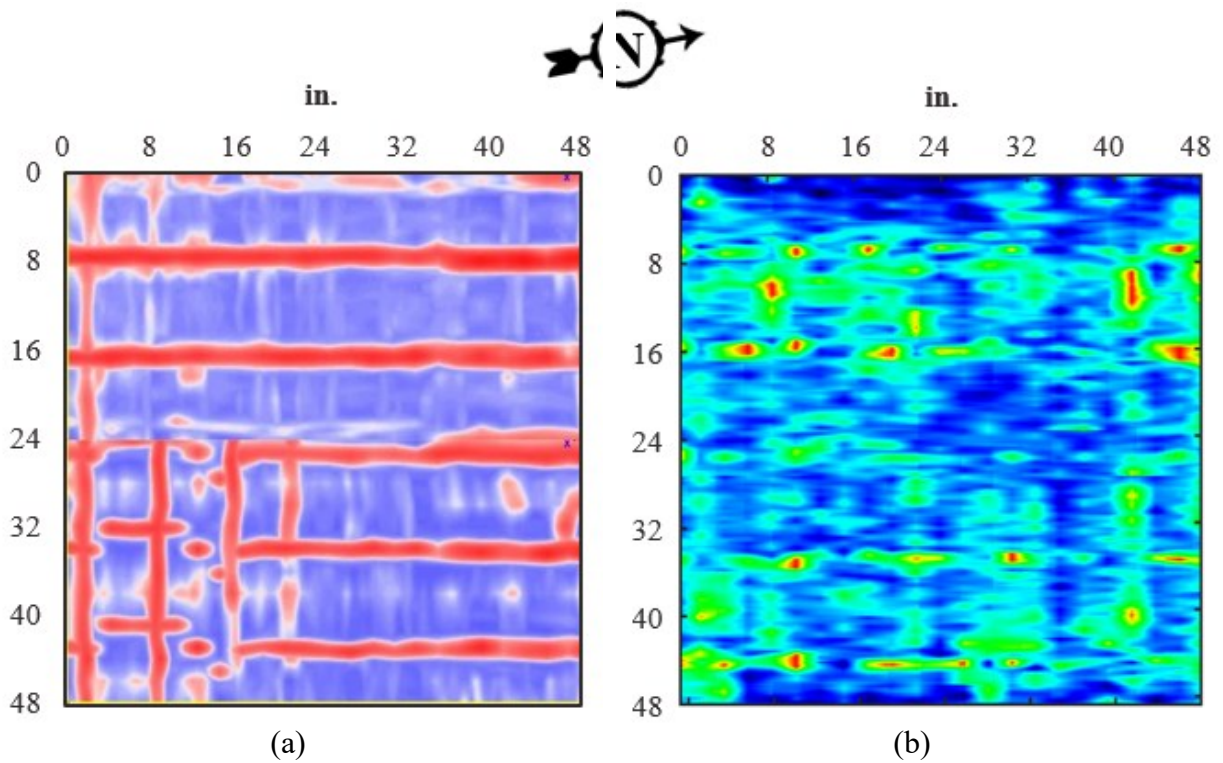
Figure 4.5. ATL1 results for (a) GPR and (b) UST of top longitudinal reinforcement at depth 2.73 in.

Figure 4.5 through Figure 4.9 show 2D views of GPR and UST scans at various depths. Figure 4.5 confirms longitudinal reinforcement spacing at 9 in., while Figure 4.6 and Figure 4.7 confirm transverse reinforcement spacing of 6 in., as specified in the as-built drawings. Transverse reinforcement is shown in two views for clarity; evaluation of 3D images reveals the transverse reinforcement to be at the same depth throughout the link slab region.

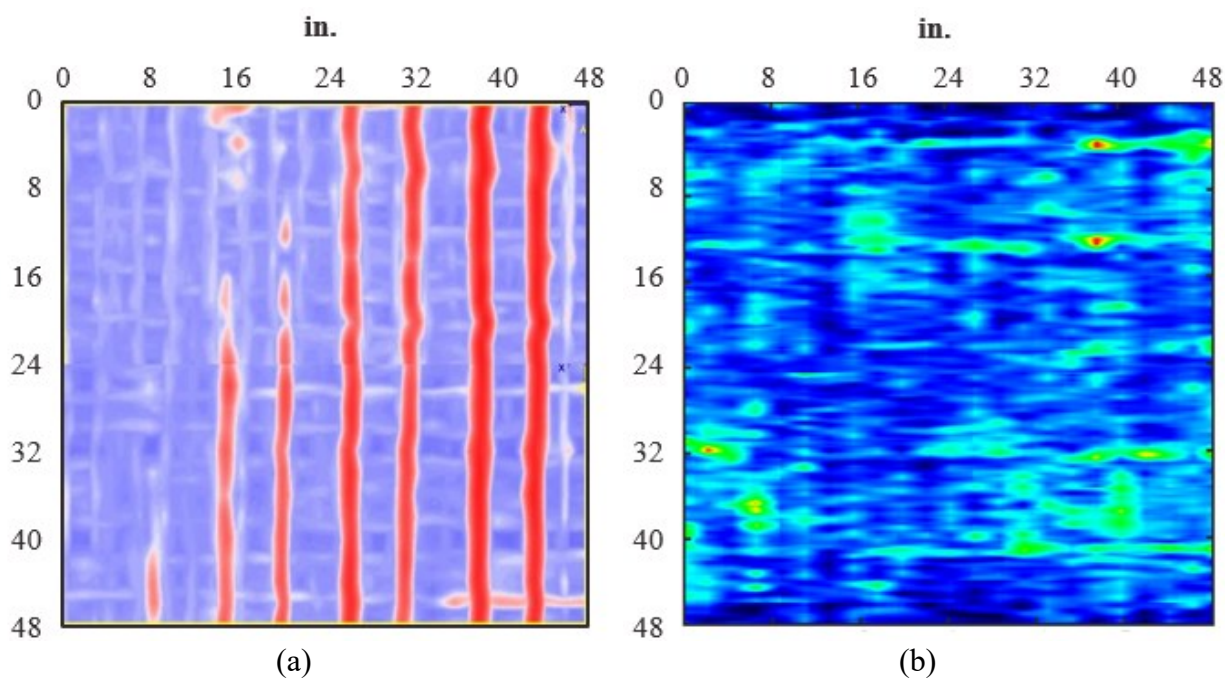
**Figure 4.7. ATL1 results for (a) GPR and (b) UST of top transverse reinforcement at depth 2.23 in.**

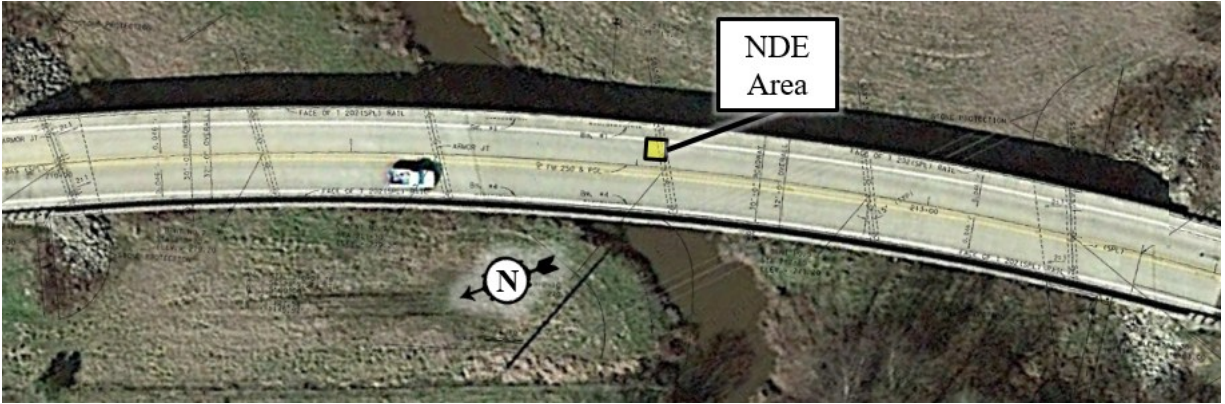
(a) Top view

(b) Elevation view

**Figure 4.10. Site conditions at Bridge ATL2 (FM 250 over Black Cypress Creek).**

Bridge ATL2, shown in Figure 4.10, was built in 2003 and carries FM 250 over Black Cypress Creek near Hughes Springs, Texas. The 32-ft wide bridge has two lanes on four Type C

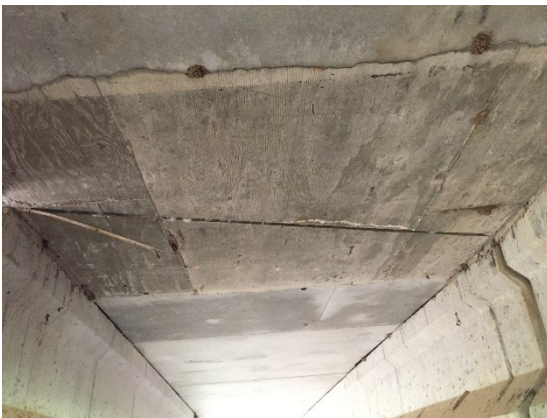
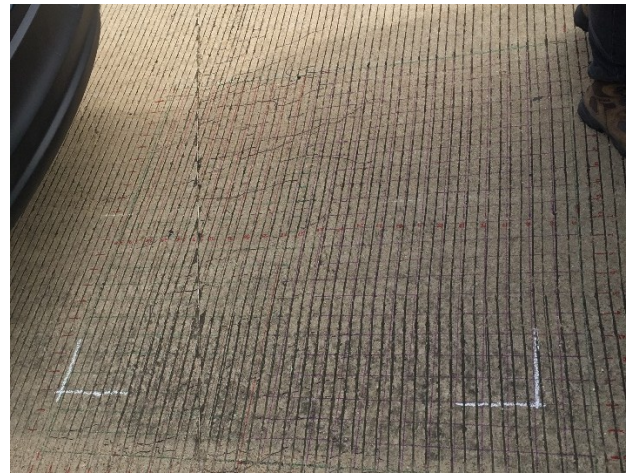
(a) CIP at continuous deck detail

(b) Cracks in NDE region

**Figure 4.11. Typical link slab condition for Bridge ATL2 (FM 250 over Black Cypress Creek).**

Visual inspection of the bridge confirmed the inspection report damage. The condition of all continuous deck regions was similar. Figure 4.11 shows representative conditions of the link slab regions. Visual observations on the top side indicated that zip strips were used to form the main PBJ crack. The zip strip was still intact, but some minor spalling was observed at several locations along the length. There were no distinct secondary PBJ cracks. Aside from the main PBJ crack, random cracks were present. The maximum cracks were 0.008 in. near the exterior side of the girder, but most cracks were 0.007 in. or less.

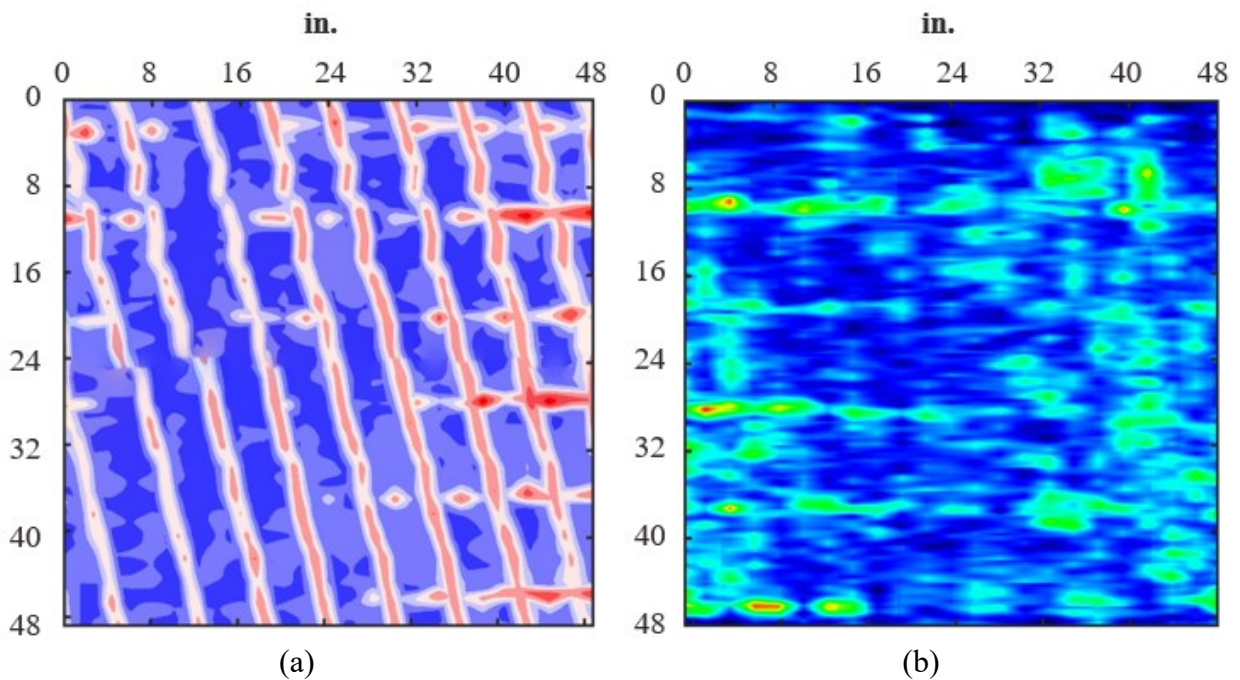
**Figure 4.14. ATL2 results for (a) GPR and (b) UST of top transverse reinforcement at depth 2.98 in.**

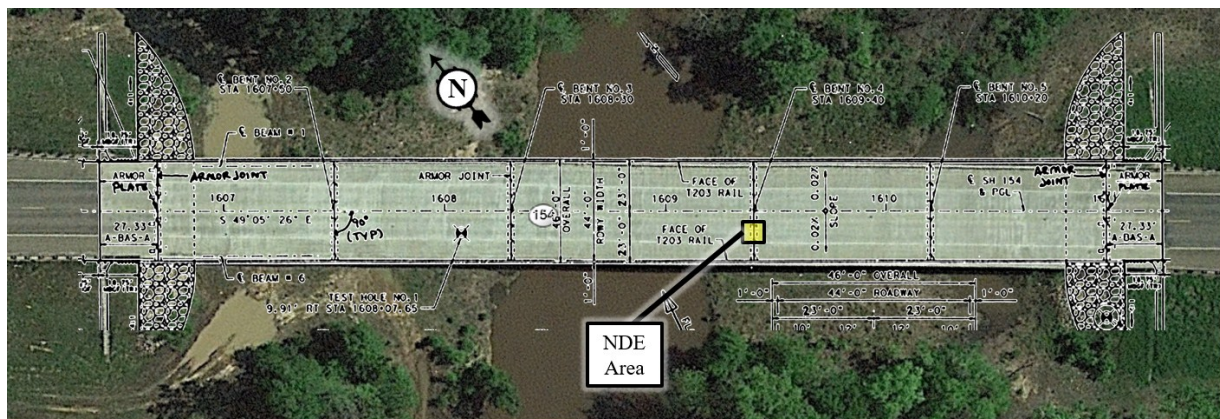
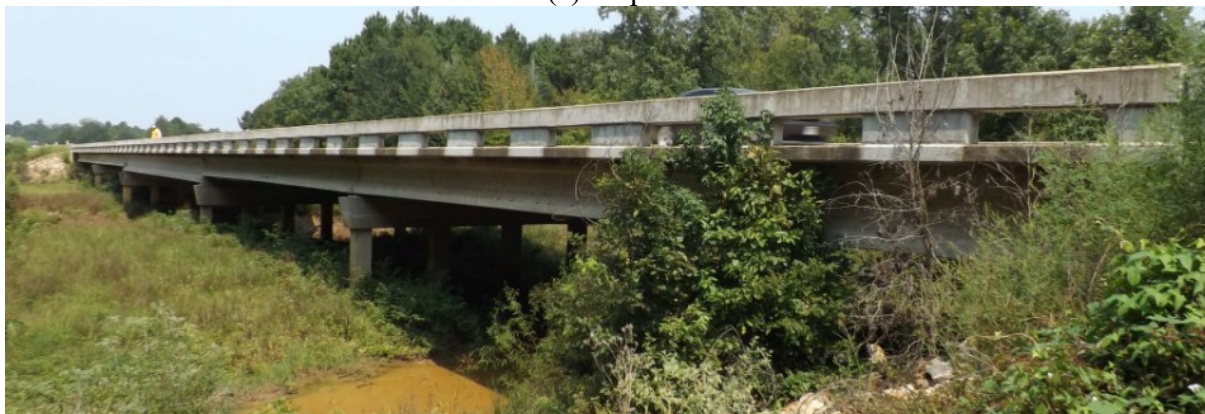
(a) Top view

(b) Elevation view

**Figure 4.17. Site conditions at Bridge ATL3 (FM 154 over Little Cypress Bayou).**

Bridge ATL3, shown in Figure 4.17, was built in 2010 and carries FM 154 over Little Cypress Bayou near Harleton, Texas. The 46-ft wide bridge has two lanes on six prestressed concrete I-girders spaced at 8 ft with 3-ft overhangs. Type C girders are used for four of five spans, with Type IV girders at the middle span.

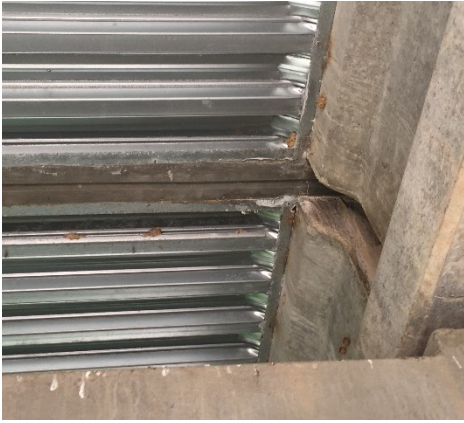
(a) PMDF at continuous deck

(b) Main and secondary PBJ cracks

(c) Cracks in NDE region

**Figure 4.18. Typical link slab condition for Bridge ATL3 (FM 154 over Little Cypress Bayou).**

Visual inspection of the bridge confirmed the damage indicated in the inspection reports, with all PBJ regions having similar damage characteristics. Figure 4.18 shows the condition of the PMDF below the continuous deck and the pattern of cracking on the top of the deck. Efflorescence was observed at the ends of the girders, and small gaps in the PMDF were present below the location of the main PBJ crack. Otherwise, the PMDF was in good condition with no indication of rust.

Figure 4.18(b) shows the main and secondary PBJ cracks typical of all continuous deck joints. The main PBJ crack was formed with a zip strip that was still located in the deck. There was moderate spalling along the main crack, larger than observed in the other bridges inspected in the Atlanta District. The location of the secondary cracks relative to the main PBJ crack varied, occurring as close as 5 in. at the girders or as far as 11 in. between the girders. The width of the secondary cracks varied from 0.020–0.025 in. and was smallest over the girders. Similar crack patterns were observed in the overhang, but the widths were 0.014–0.016 in. Figure 4.18(c) shows the marked cracks in the NDE region. In addition to the main and secondary PBJ cracks, cracking was consistent with the rest of the deck, with most of the cracks being longitudinal cracks and measuring as hairline cracks.

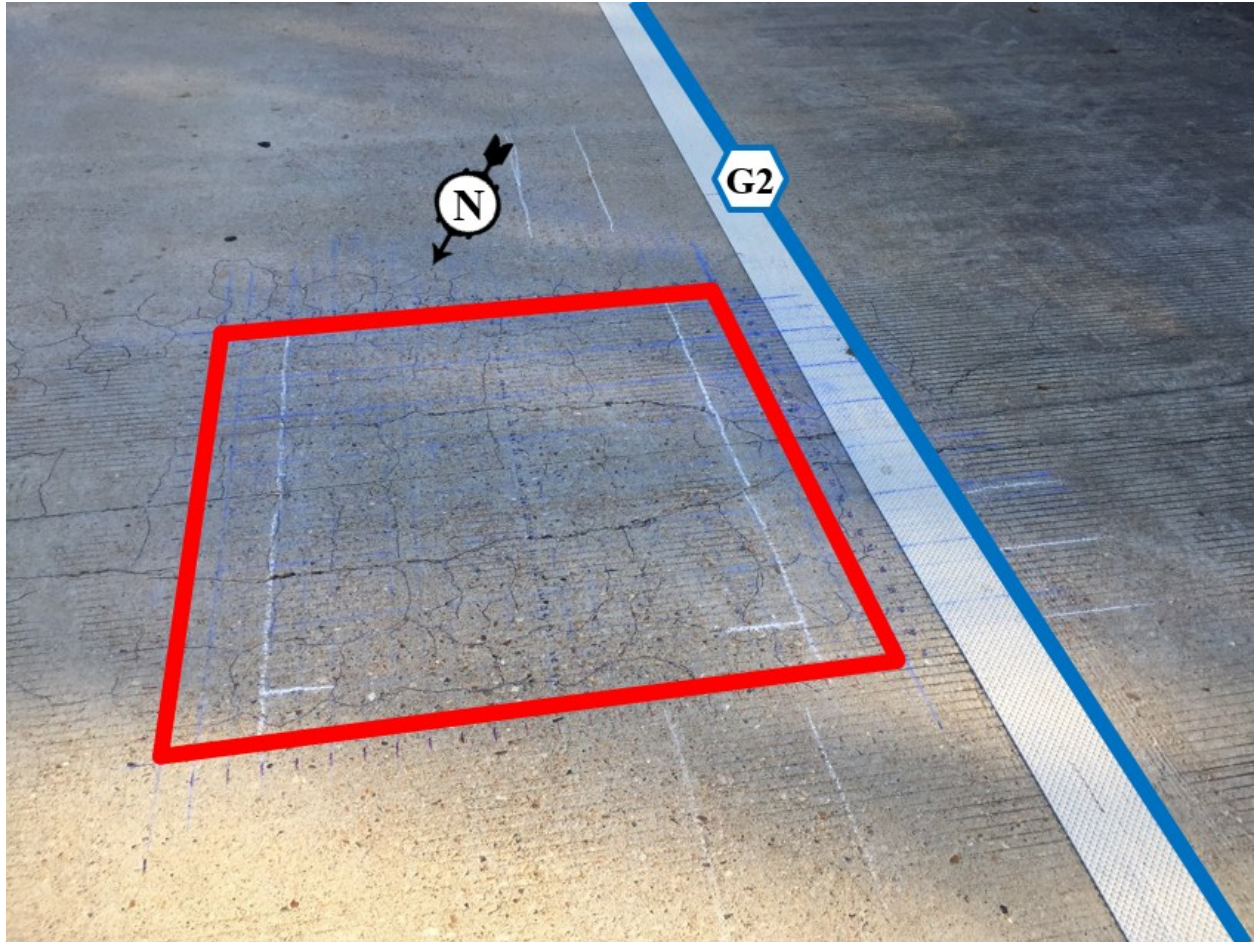
**Figure 4.19. NDE region at Bent 3 for Bridge A3 (FM 154 over Little Cypress Bayou).**

The NDE region was a 4-ft by 4-ft region at Bent 3, shown in Figure 4.19, located in the east/southbound lane. The region was centered on the main PBJ crack and captured both secondary cracks, plus an extension beyond the secondary cracks.

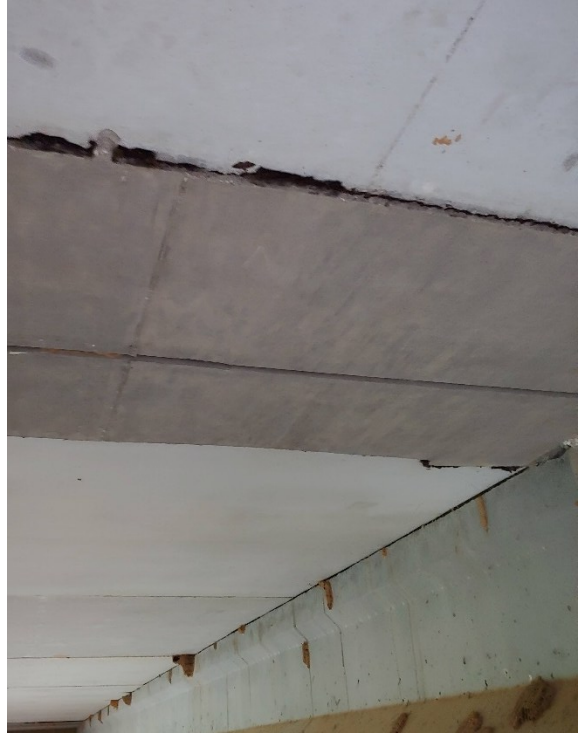
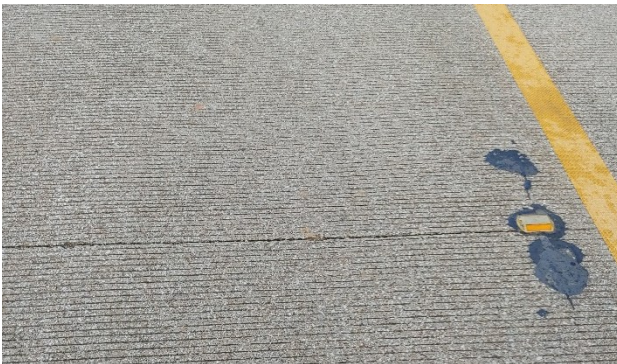
(a) Bottom of overhang

(b) Bottom of CIP region between girders

(c) Main PBJ crack

(d) Main NDE region

**Figure 4.26. Typical link slab condition for Bridge ATL4 (FM 968 over Clarks Creek).**

Visual inspection indicated that the condition of the three continuous deck regions was similar, and while the PBJs were overall in great condition, there was some very minor damage not indicated in the inspection report. Minor efflorescence was observed on the overhang shown in Figure 4.26(a). Between the girders, link slabs were in excellent condition, without any visible cracks or other damage, as shown in Figure 4.26(b). Visual observations on the top side indicated that some longitudinal cracks were present in the NDE region. The cracks were mostly hairline and measured 0.007 in. at the most. Zip strips were used to form the main PBJ crack. The extent of cracking and spalling along the main PBJ crack was much less than observed in other bridges evaluated. Figure 4.26(d) shows the marked cracks in the NDE region. Secondary PBJ cracks formed at approximately the end of the portion of the deck where PMDFs were used. The secondary PBJ cracks were 0.014–0.016 in. wide in the NDE region. Hairline cracks were present in the link slab region and in the main deck, and they were primarily longitudinal, with an occasional transverse crack.

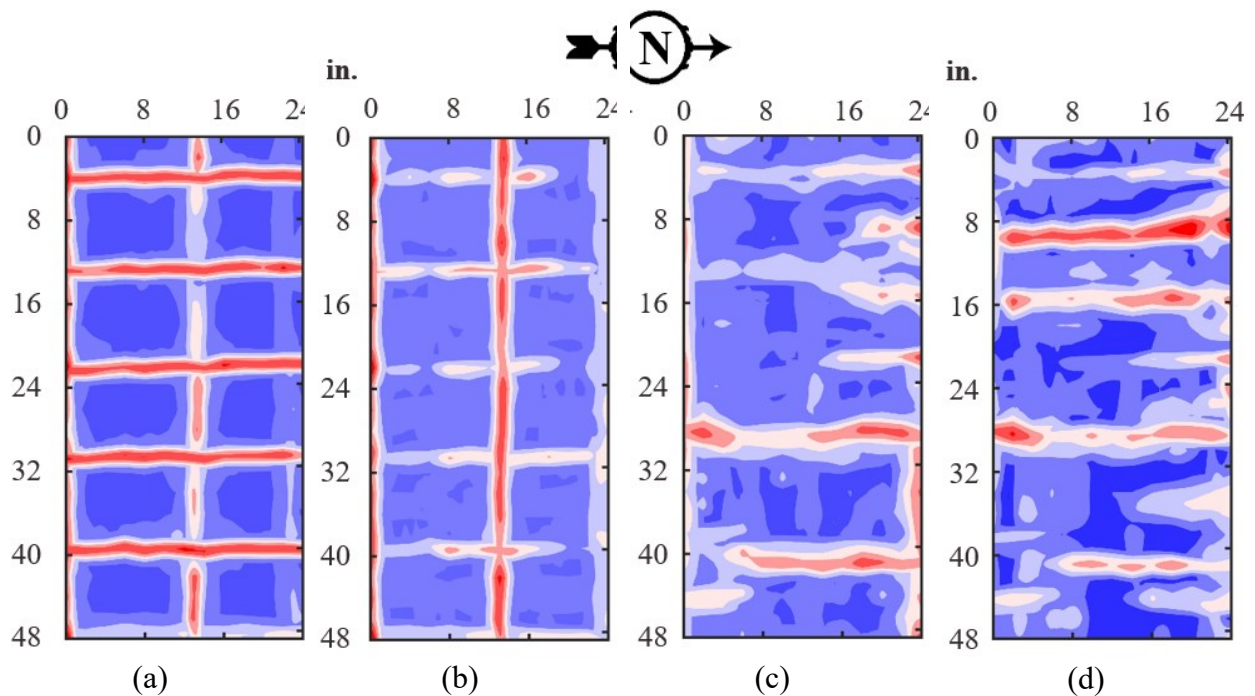
**Figure 4.32. ATL4 GPR results in the overhang for (a) top transverse reinforcement at depth 4.23 in., (b) top longitudinal reinforcement at depth 4.98 in., (c) bottom reinforcement at 8.23 in., and (d) bottom reinforcement at 8.73 in.**

Figure 4.32 shows GPR images of the reinforcement placement in the overhang NDE region. Figure 4.32(a) and (b) show similar top-layer reinforcement spacing as in the primary NDE region between the girders. Figure 4.32(c) and (d), however, are less conclusive for the bottom reinforcement but still show that bottom transverse reinforcement appears to be placed deeper in the PBJ region. No evidence of voids or delaminations was discovered using IR images.

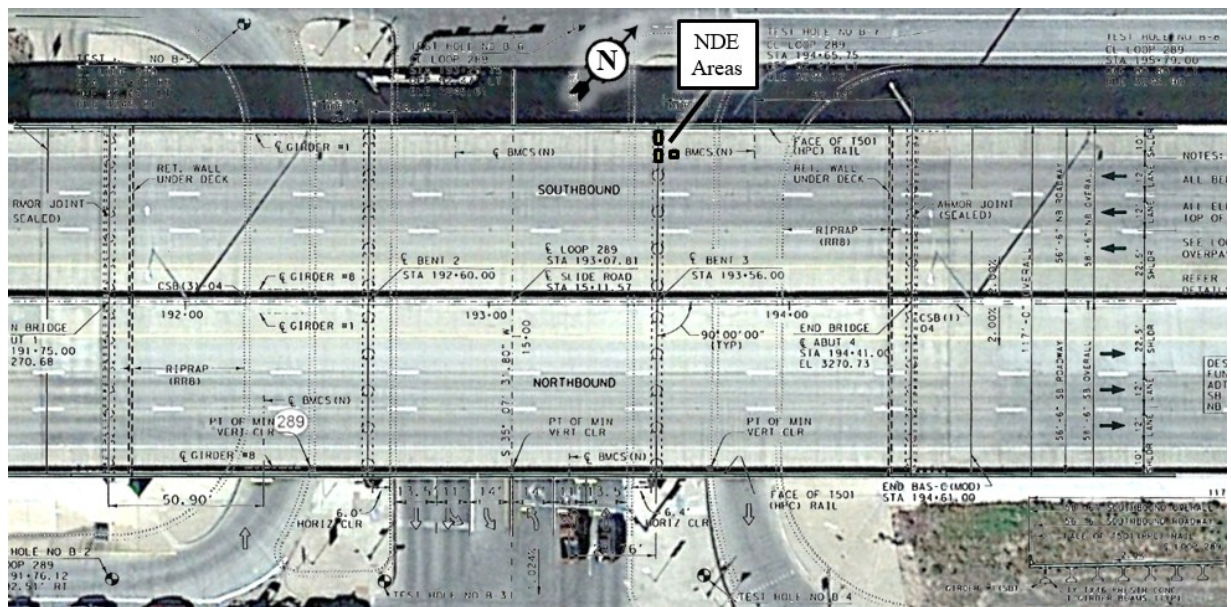
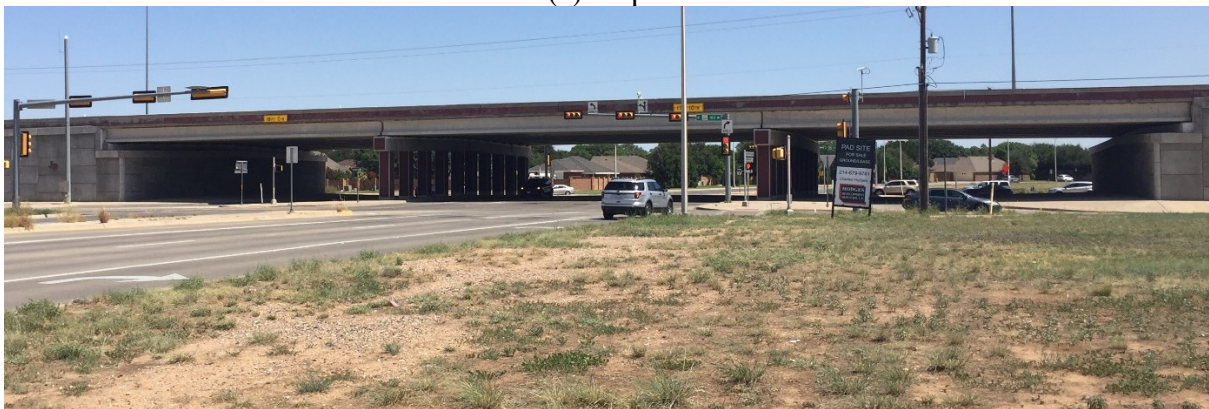
(a) Top view

(b) Elevation view

**Figure 4.33. Site conditions at Bridge LUB1 (SB Loop 289 over Slide Rd./4th St.).**

Bridge LUB1, shown in Figure 4.33, was built in 2010 and carries the southbound lanes of Loop 289 over Slide Rd./4th St. in Lubbock, Texas. The 58-ft 6-in. wide bridge has three lanes on eight Tx46 prestressed concrete I-girders spaced at 7.5 ft with 3-ft overhangs; a center barrier is shared with the adjacent bridge carrying northbound lanes, and a CIP region of deck connects the two bridges (Figure 4.34a).

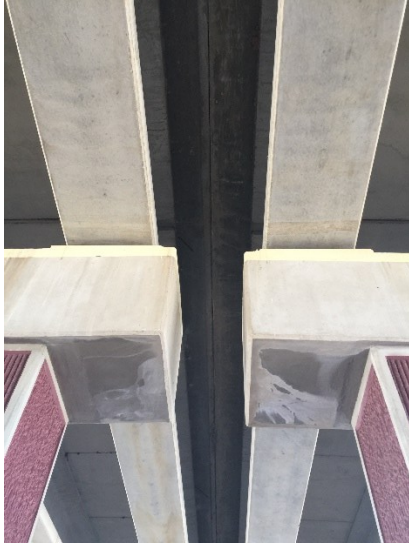
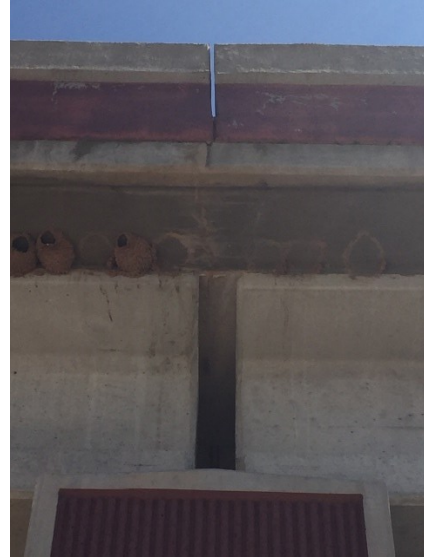
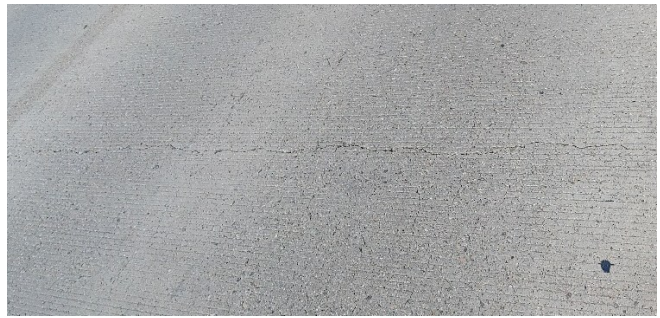
(a) CIP deck between northbound and southbound lanes

(b) Cracking and efflorescence in overhang

(c) Panels at interior bent

(d) Main PBJ crack

(e) Marked cracks in NDE regions

**Figure 4.34. Typical link slab condition for Bridge LUB1 (SB Loop 289 over Slide Rd./4th St.).**

Visual inspection of the bridge confirmed the inspection report damage, and the condition of all continuous deck regions was similar. Figure 4.34 shows representative conditions of the link slab regions. Visual observations below the deck indicated confirmed cracking and efflorescence in the CIP overhangs. While the PCPs were in excellent condition, the gap between flush panels had some material hanging loss, and water stains were clearly present on the bent caps. On the top of the deck, the extensive cracking was confirmed. The main PBJ crack formed naturally (no zip strip). Between girders, the maximum width was 0.030 in. In the overhang, the maximum width was 0.025 in. Minor spalling was present in several locations along the main PBJ crack. Aside from the main PBJ crack, extensive cracks were present in the link slab region and the overall deck. Most cracks were no larger than 0.008 in., but one longitudinal crack was measured as 0.012 in. and several other longitudinal cracks as 0.010 in. While there were no distinct secondary PBJ cracks spanning the width of the bridge, NDE Area #3 contained a large transverse crack located 35.625 in. from the main PBJ crack with a width of 0.016–0.025 in.
