# Performance and Improvement of Texas Poor Boy Continuous Bridge Deck Details: Final Report

Technical Report 0-7013-R1

Cooperative Research Program

TEXAS A&M TRANSPORTATION INSTITUTE  
COLLEGE STATION, TEXAS

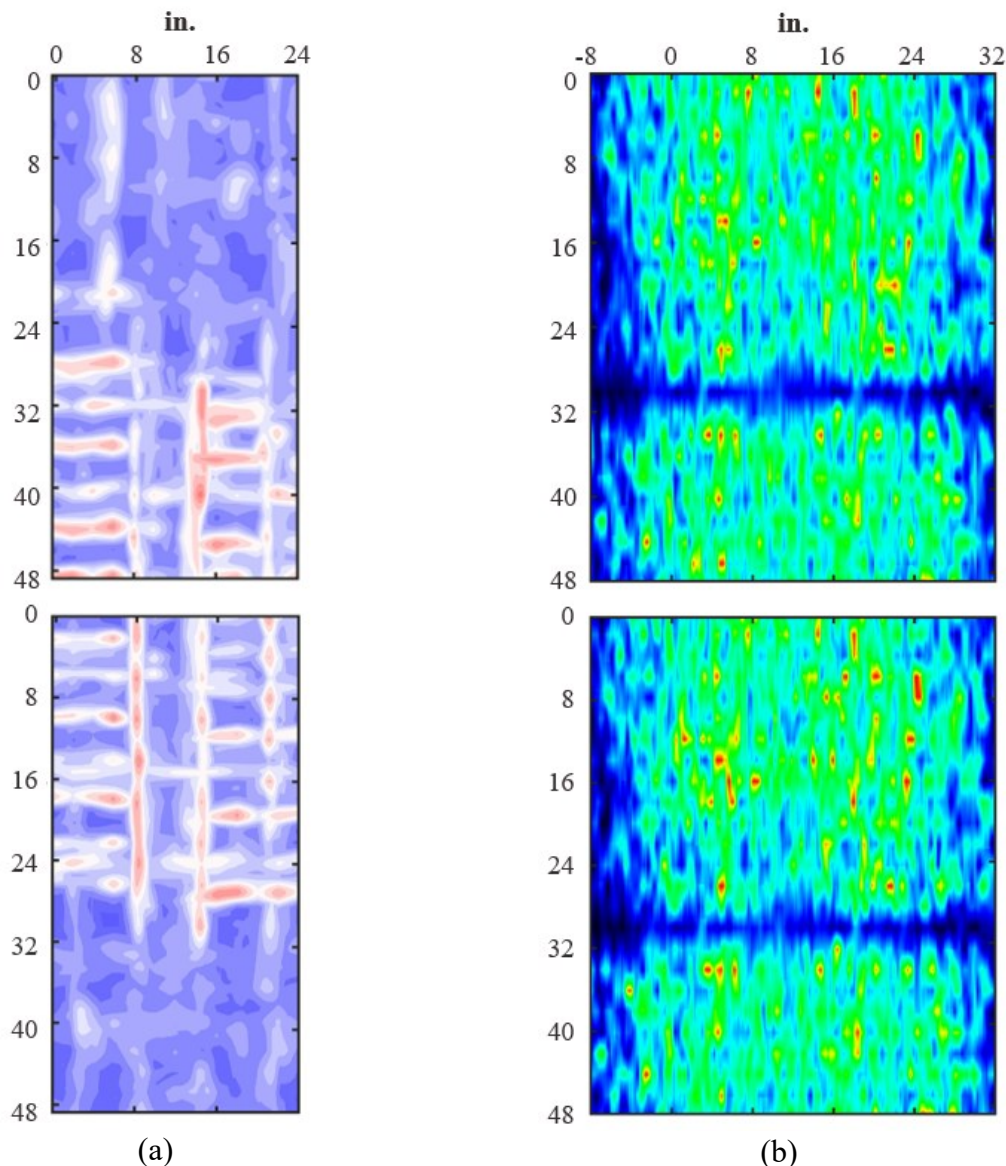
**Figure 4.39. LUB1 results for bottom reinforcement at depth 6.98 in. for (a) GPR in NDE Regions 1 and 2, and (b) UST in Regions 1 and 2.**

Figure 4.37 and Figure 4.38 confirm the spacing of the top longitudinal and transverse reinforcement in the as-built drawings as 9 in. and 6 in., respectively. Additionally, the dark horizontal areas in Figure 4.37(b), Figure 4.38(b), and Figure 4.39(b) at approximately 32 in. on the vertical axis appear to show a reflection caused by the edge of the girders. Figure 4.39 confirms that bottom longitudinal reinforcement is clustered between the girder lines, while bars are not placed directly over the girders, which is consistent with the design drawings. No evidence of voids or delaminations was discovered using IR images.

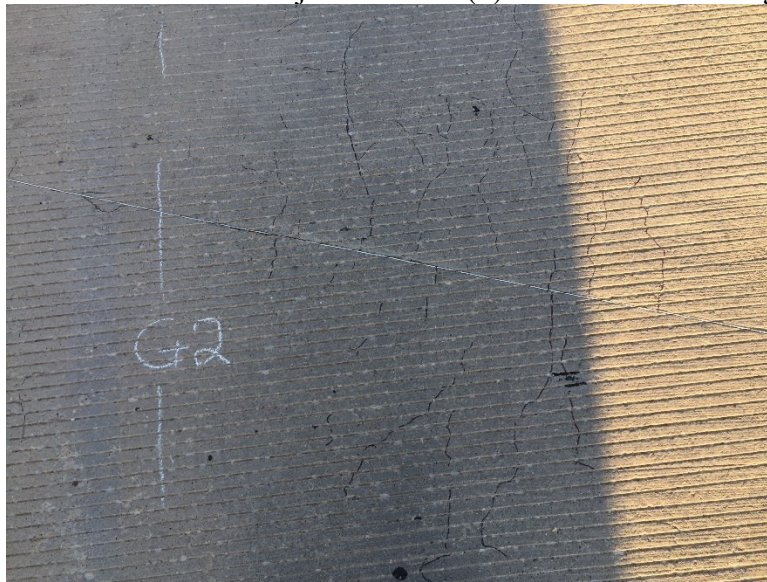
(a) Flush panels at continuous deck joint

(b) Continuous deck region in shoulder

(c) Marked cracks in NDE region

**Figure 4.48. Typical link slab condition for Bridge LUB3 (US 62 over Research Blvd.).**

Visual inspection of the bridge confirmed the excellent condition. Some hairline cracks were present in the deck, consisting mainly of longitudinal cracks. Figure 4.48(c) shows the marked cracks in the NDE region. No spalling was observed along the main PBJ crack in the NDE region. The main PBJ crack measured 0.025 in. wide. Visual inspection from the ground beneath the bridge did not indicate any cracking or efflorescence in the overhang, and the panels and girder ends were all in excellent condition except for filler material between some panels hanging loose below the main PBJ crack.

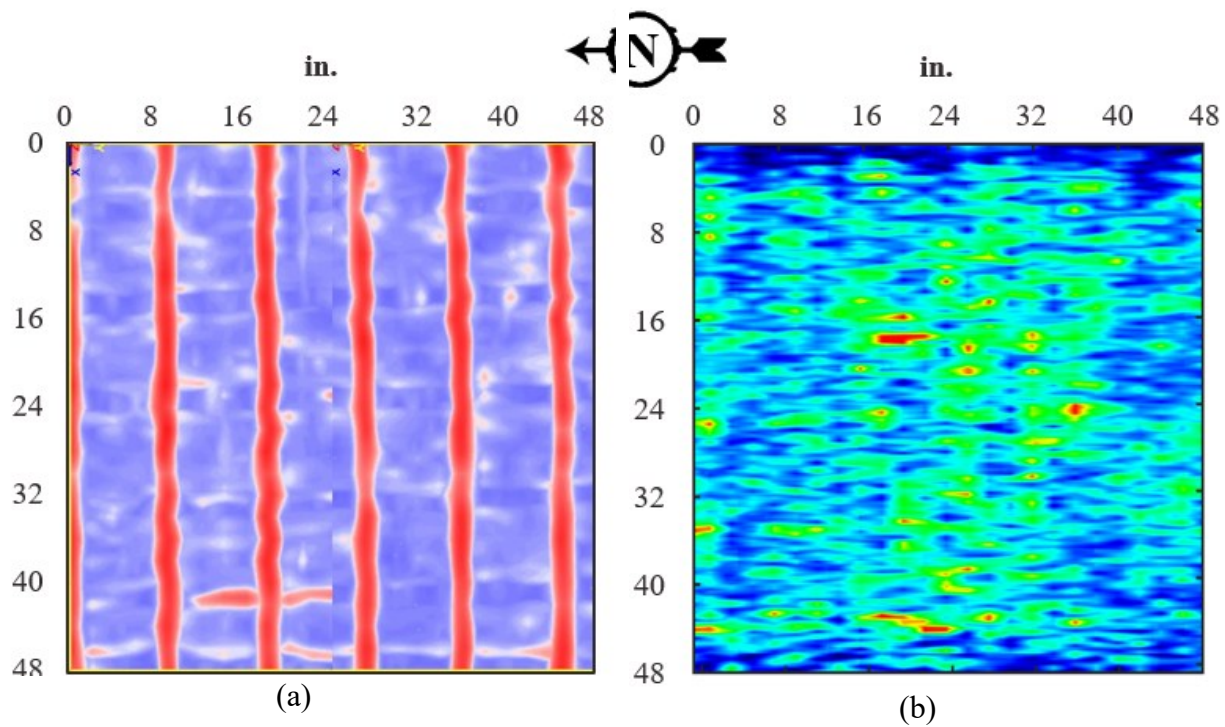
**Figure 4.58. LUB4 results for the primary NDE area for (a) GPR and (b) UST of top longitudinal reinforcement at depth 2.73 in.**

Figure 4.58, Figure 4.59, and Figure 4.60 show that the top and bottom longitudinal and transverse reinforcement appears to be spaced according to the design drawings. Figure 4.61 shows the PMDF at the bottom of the link slab. The longitudinal reinforcement spacing is consistent in the overhang, shown in Figure 4.62 and Figure 4.64. However, Figure 4.63 shows

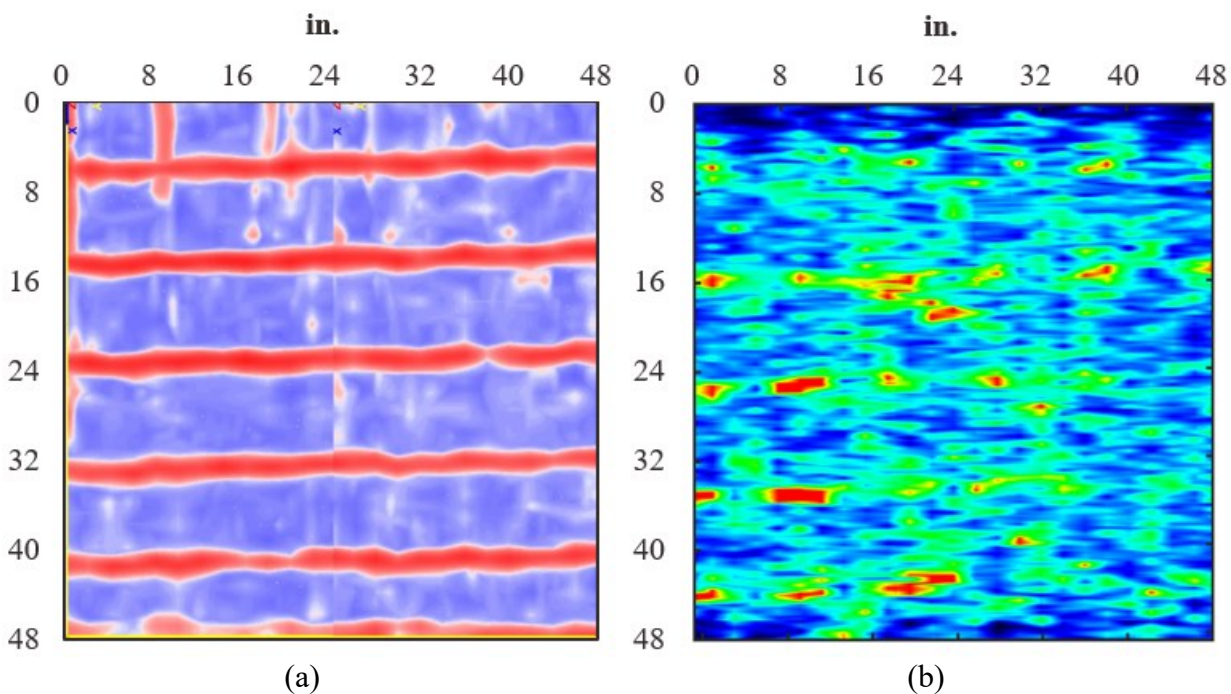
**Figure 4.59. LUB4 results for the primary NDE area for (a) GPR and (b) UST of top transverse reinforcement at depth 3.5 in.**

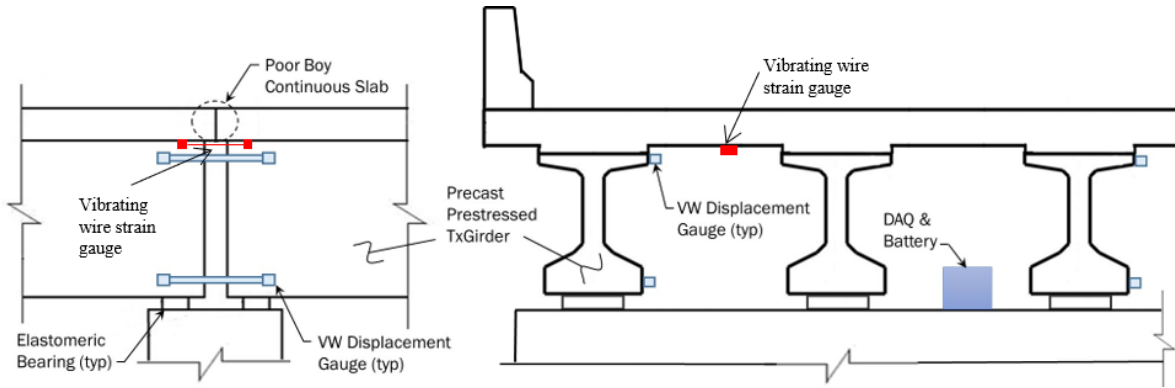
**Figure 5.2. General layout of instrumentation at girder ends.**

Figure 5.2 shows the general configuration of instrumentation for the bridges. Figure 5.3 shows an example of instruments attached in the field. Vibrating wire strain gages, indicated by diamonds on the instrumentation plans, were placed on the bottom of the deck spanning the location (or presumed location) of the main PBJ crack. Pairs of VW displacement gages, indicated by triangles on the instrumentation plans, were located at the top and bottom of the girders to capture the relative displacement between the girders ends at the bents, or the girder end relative to the abutment. Each sensor included a thermistor to measure temperatures. The pairs of displacement gages were used to calculate the relative rotation. Generally, these pairs were provided at the PBJs (referred to as PBJ pairs), but on some bridges were also provided at SEJs (referred to as SEJ pairs) to provide a comparison between the response at the two joint types. Where pairs were installed at PBJs, 1-in. stroke length gages were used; 4-in. stroke length gages were used at SEJs. At the abutments, 4-in. stroke gages were located on the bottom flange to capture the full change in length of the girders under thermal loads.

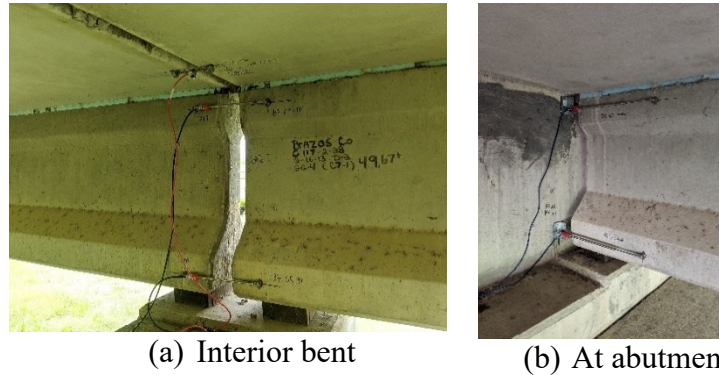
**Figure 5.3. Example of gage attachment (shown installed on Bridge BRY3).**

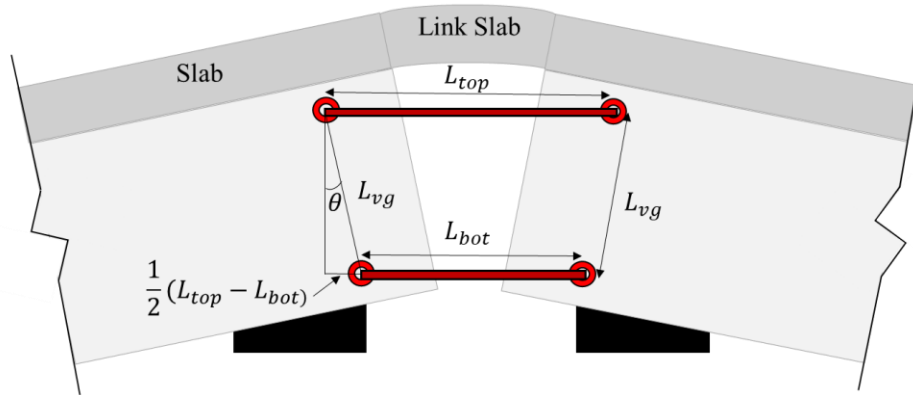
**Figure 5.4. Variables used for the calculation of girder end rotations from displacement gages.**

The data from the displacement gages were used to calculate the rotation at the ends of the girders. Figure 5.4 shows the notation used for the calculations.

where  $L_{top}$  is the length of the top gage,  $L_{bot}$  is the length of the bottom gage, and  $L_{vg}$  is the vertical distance between gage ends.

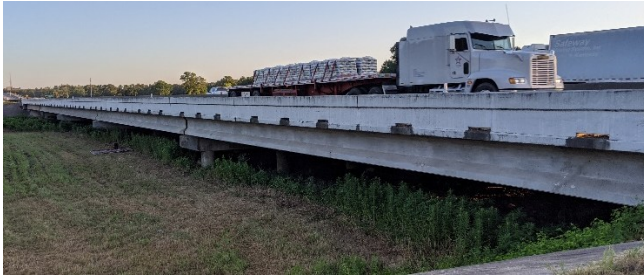
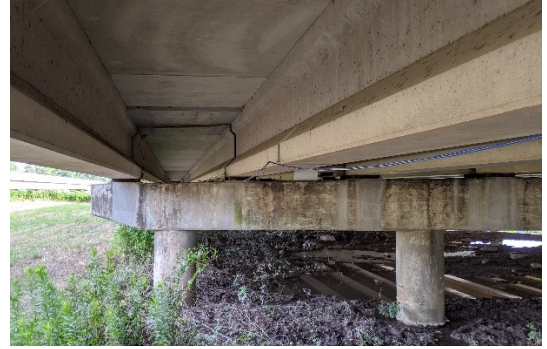
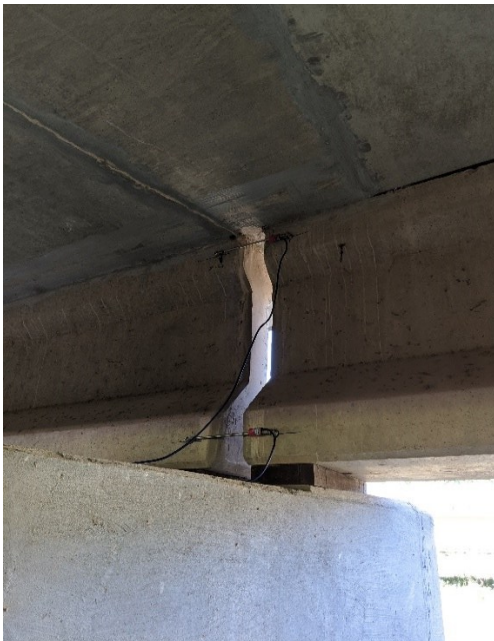
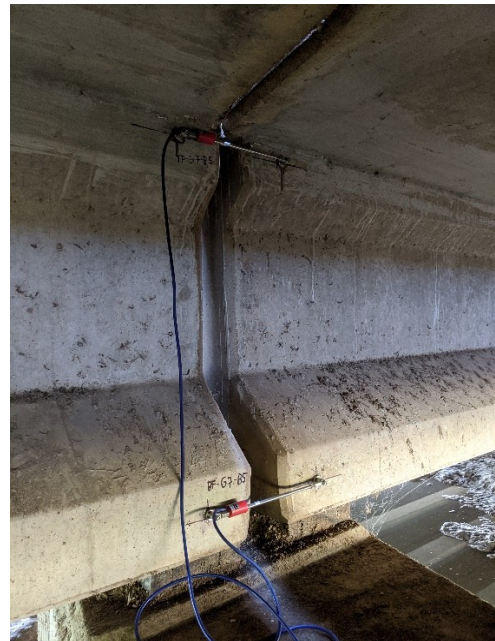
(a) Elevation view of bridge

(b) View beneath bridge

(c) Close-up at PBJ

(d) Close-up at SEJ

**Figure 5.6. Overview of Bridge BRY1 (SH 6 over Peach Creek).**

Bridge BRY1, shown in Figure 5.6, was built in 1996 and carries SH 6 over Peach Creek near Millican, Texas. The 94-ft wide bridge has four lanes with a median on 14 Type C prestressed concrete I-girders at 6.769-ft spacing with 3-ft overhangs. The bridge has a constant skew of

The bridge is 425 ft long and is made up of five simple spans forming three continuous deck units. Unit 1 and Unit 3 are single 85-ft spans. Unit 2 has three equal 85-ft spans. The deck is 7.25 in. thick, made up of 4-in. PCPs with a 3.25-in. thick CIP top. At PBJ joints, the link slab is fully CIP and is thicker than the adjacent deck. The thickened slab appeared to be implementation of the SEJ thickened slab detail at the PBJ. Overhangs are fully CIP.

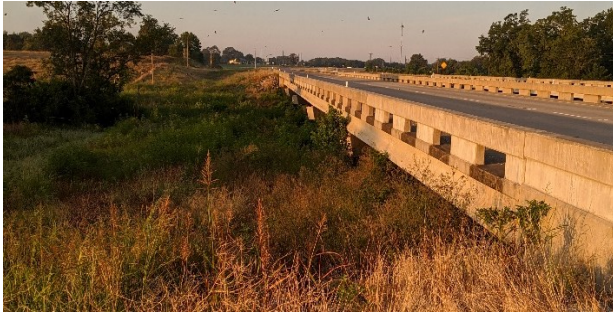
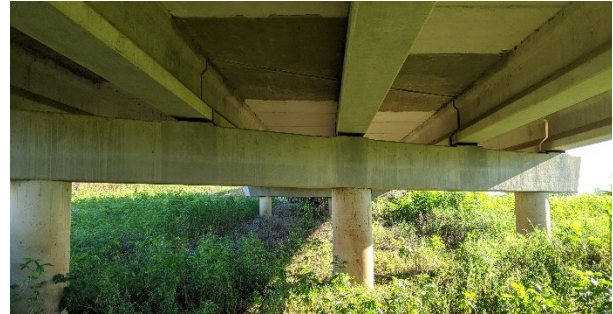
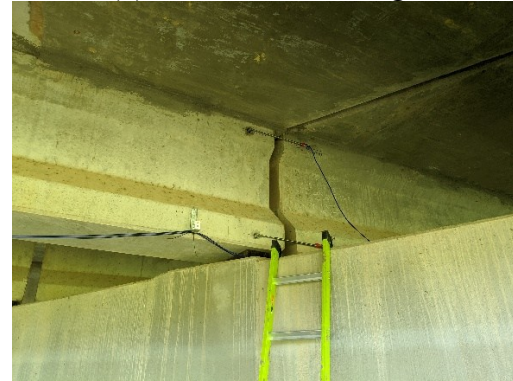
(a) Elevation view of bridge

(b) View beneath bridge

(c) Close-up at PBJ

(d) Close-up at SEJ

**Figure 5.8. Overview of Bridge BRY2 (FM 60 over Old River).**

Bridge BRY2, shown in Figure 5.8, was built in 2010 and carries eastbound FM 60 over Old River near Snook, Texas. The 40-ft wide bridge has two lanes on five Type C prestressed concrete I-girders spaced at 8 ft 6 in. with 3-ft 0-in. overhangs. The bridge has a constant skew of 30 degrees.

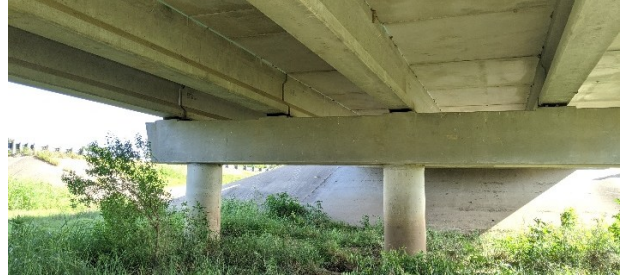
(a) Elevation view of bridge

(b) View beneath bridge

(c) Close-up at PBJ

(d) Close-up at SEJ

**Figure 5.10. Overview of Bridge BRY3 (SH 21/US 190 over Old Cedar Creek).**

Bridge BRY3, shown in Figure 5.10, was built in 2013 and carries eastbound SH 21 over Old Cedar Creek near Kurten, Texas. The 40-ft wide bridge has two lanes on five Type B prestressed concrete I-girders spaced at 8 ft 6 in. with 3-ft 0-in. overhangs.

The bridge is 350 ft long and is made up of seven simple spans forming three continuous deck units. Unit 1 is two equal 50-ft spans, Unit 2 is three equal 50-ft spans, and Unit 3 is two equal 50-ft spans. The deck is 8 in. thick, made up of 4-in. thick PCPs with a 4-in. CIP top. At PBJ joints, flush PCPs are used. As-built drawings do not provide the details used; it is assumed that the top deck reinforcement in the link slab is the same as that in the decks.

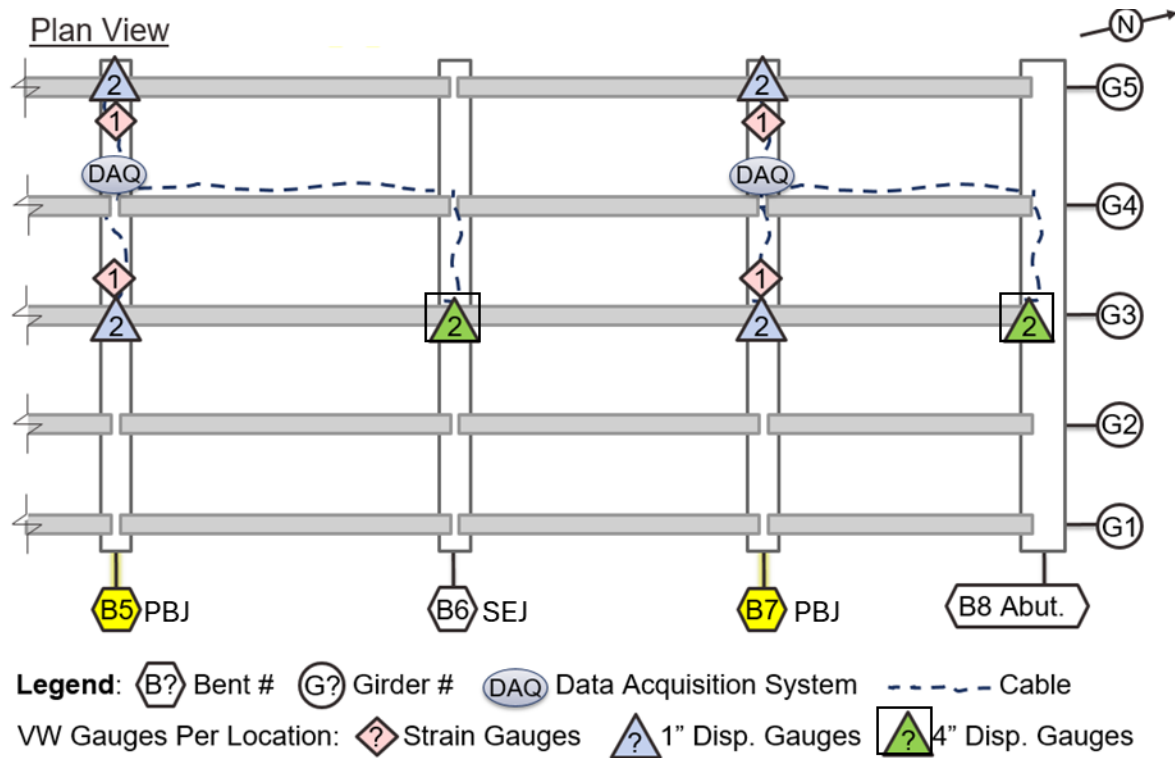
**Figure 5.11. Instrumentation plan for Bridge BRY3 (SH 21/US 190 over Old Cedar Creek).**

Figure 5.11 shows the instrumentation plan for Bridge BRY3. The primary locations of monitoring were at the continuous deck over B5 and B7 (part of the three-span Unit 2 and the two-span Unit 3). Instrumentation was identical at these bents, with PBJ pairs of gages installed at the top and bottom flange of girder lines G3 (center) and G5 (east exterior). Strain gages were located at the bottom of the deck adjacent to the interior side of G5 and the east side of G3. SEJ pairs of gages were installed at the top and bottom flange of the center girder line (G3) at B6 (between Unit 2 and Unit 3) and abutment at the north end of Unit 3 (B8 Abut.). Instrumentation was installed on July 21, 2020, and remained in place until July 30, 2020.

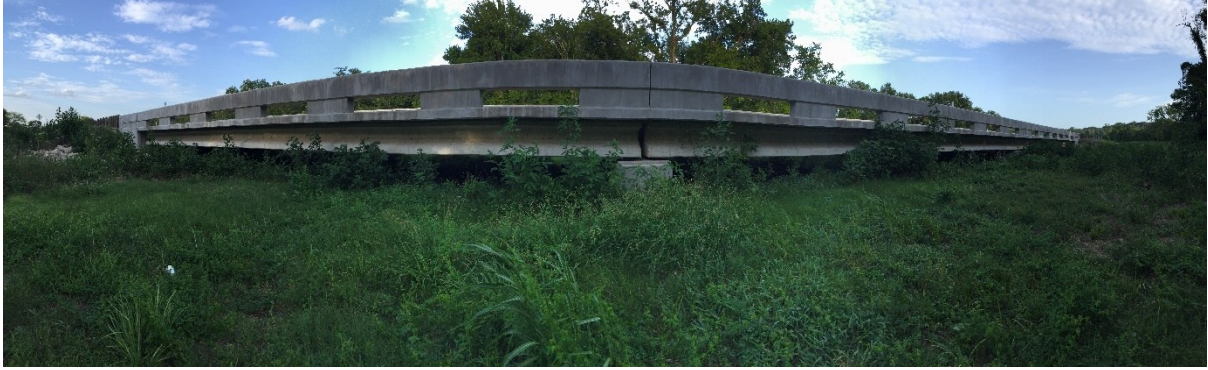
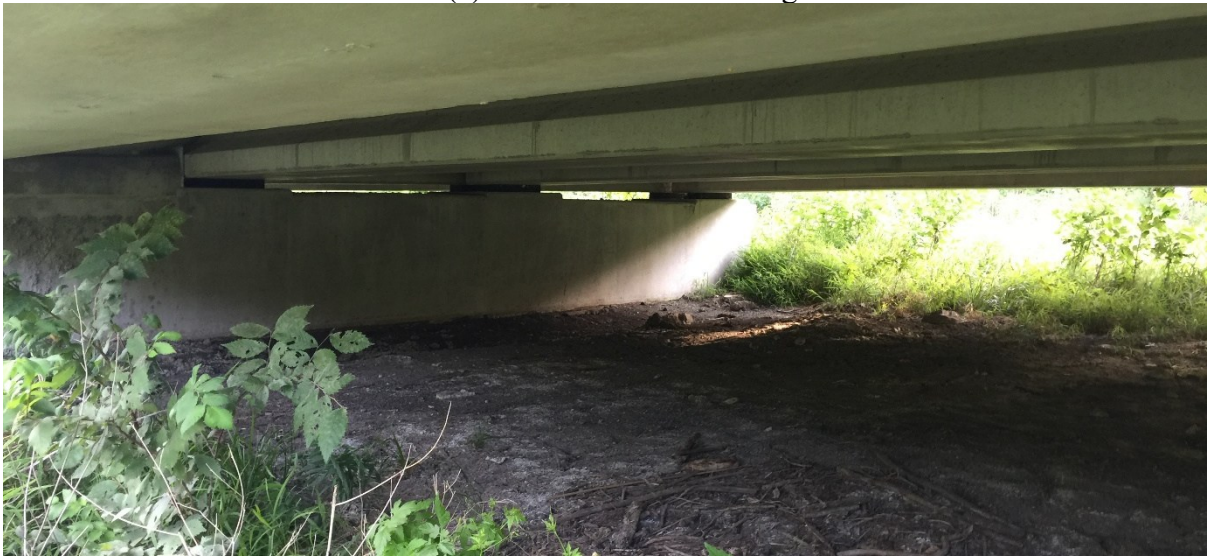
(a) Elevation view of bridge

(b) View beneath bridge

**Figure 5.12. Overview of Bridge BRY4 (FM 3090 at Spring/Holland Relief).**

Bridge BRY4, shown in Figure 5.12, was built in 2017 and carries FM 3090 over a relief area for Spring Creek and Holland Creek near Navasota, Texas. The 34-ft wide bridge has two lanes on four Tx28 prestressed concrete I-girders at 9-ft 4-in. spacing with 3-ft 0-in. overhangs.

The bridge is 195 ft long and is made up of three 65-ft long simple spans forming one continuous deck unit. The deck is 8 in. thick, made up of 4-in. thick PCPs with a 4-in. CIP top. At PBJs, fully CIP link slabs are used; while the as-builts do not include the details used, from the age of the bridge, it is assumed that details similar to those in Bridge BRY2 were used. PBJ top reinforcement is assumed the same as the adjacent deck. Bottom reinforcement is assumed to be #5 @ 6 in. in the transverse direction and #5 @ 9 in. in the longitudinal direction.

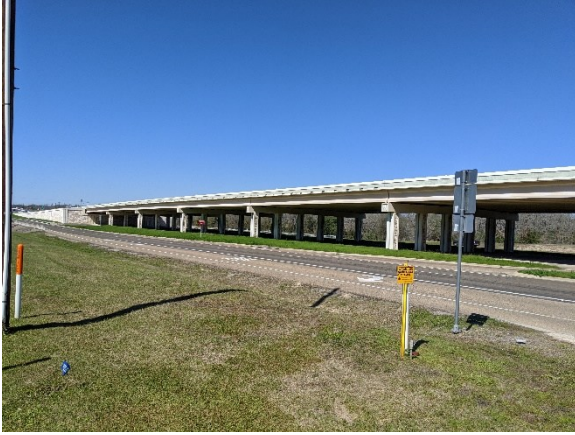
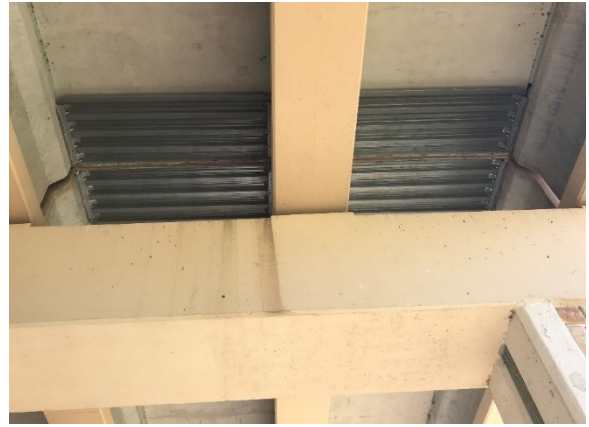
(a) Elevation view of bridge

(b) Close-up at PBJ

**Figure 5.14. Overview of Bridge BRY5 (SH 6 over Nantucket Dr.).**

Bridge BRY5, shown in Figure 5.14, was built in 2006 and carries SH 6 over Nantucket Dr. near College Station, Texas. The 94-ft wide bridge has four lanes on 11 Type IV prestressed concrete I-girders at 8.8-ft spacing with 3-ft overhangs.

The bridge is 795 ft long and is made up of eight simple spans forming three continuous deck units. Unit 1 is one 115-ft span and two 105-ft spans, Unit 2 is three equal 105-ft spans, and Unit 3 consists of a 90-ft span and a 65-ft span. The deck is 8 in. thick made up of 4-in. thick PCPs with a 4-in. thick CIP top. At PBJ joints, the link slab region is full-depth CIP on PMDF. PBJ top reinforcement is assumed to be the same as the adjacent deck. Bottom reinforcement is assumed be #5 @ 6 in. in the transverse direction and #5 @ 9 in. in the longitudinal direction.

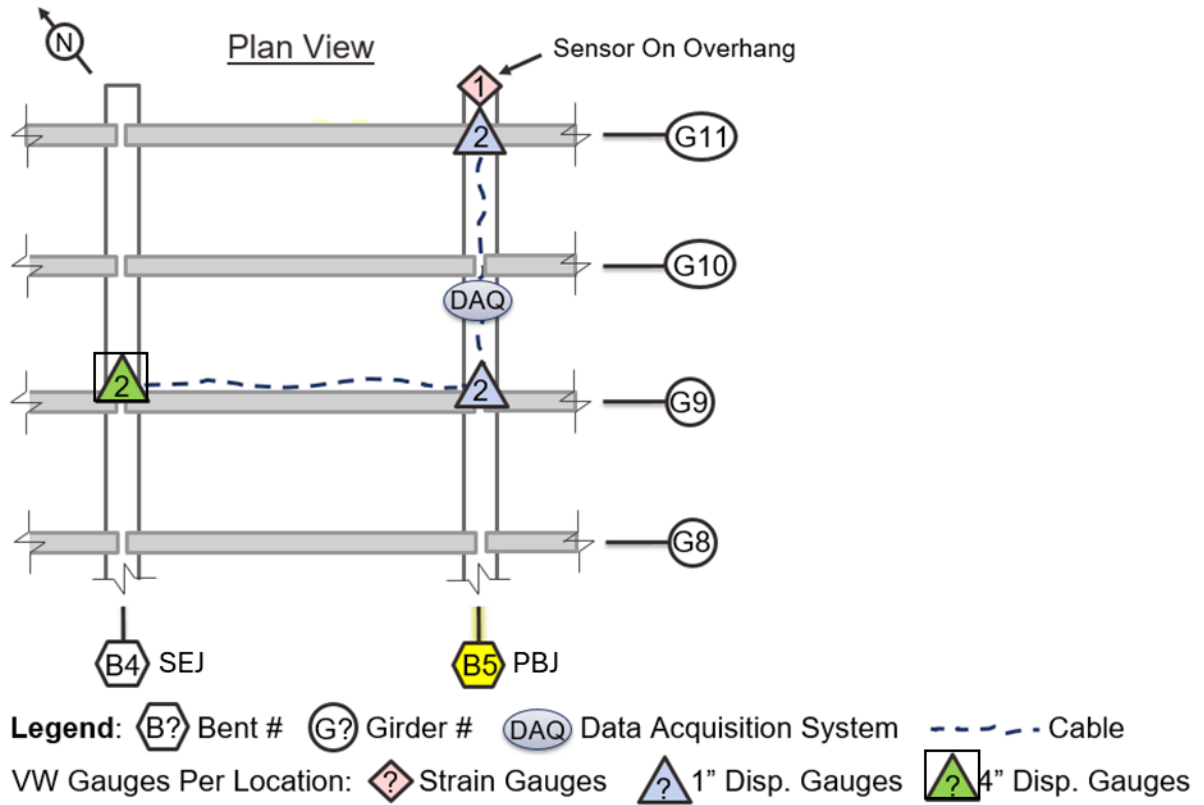
**Figure 5.15. Instrumentation plan for Bridge BRY5 (SH 6 over Nantucket Dr.).**

Figure 5.15 shows the instrumentation plan for Bridge BRY5. Monitoring was limited relative to the other bridges since the primary objective was to capture deformations in a bridge with PMDF detail. The primary location of monitoring was at the continuous deck over B5 (part of the three-span Unit 2). PBJ pairs of gages were installed at the top and bottom flange of an outer girder line (G11) and an interior girder line (G9). Strain gages were placed on the bottom of the deck in the overhang because this was the only location where it was practical to attach the gage since between girders had PMDF. An SEJ pair of gages was installed at the top and bottom flange of interior girder line (G9) at B4.

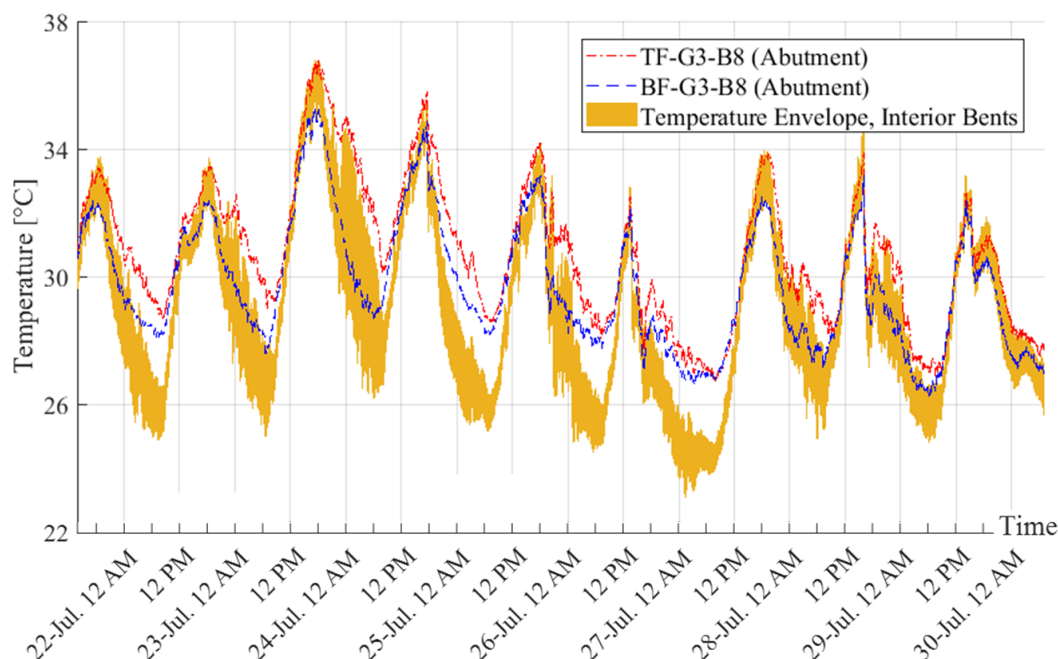
**Figure 5.16. Temperature envelope for BRY3.**

Each gage on a bridge provided a temperature reading, with measured values varying at locations throughout an individual bridge. When examining the data holistically, researchers observed a noticeable difference in temperatures at the interior bents and those at the abutments. Figure 5.16 provides an example of the temperatures collected for the BRY3 bridge. The yellow area provides an envelope of temperatures at the interior bents. The blue and red lines provide the temperatures measured at the abutments. The higher temperatures at the abutment are a result of the abutment backwall retaining heat and resulting in slower drops in temperature in the evening and morning, compared to that of the interior bents. Temperatures are highest in the evening and lowest in the morning hours.

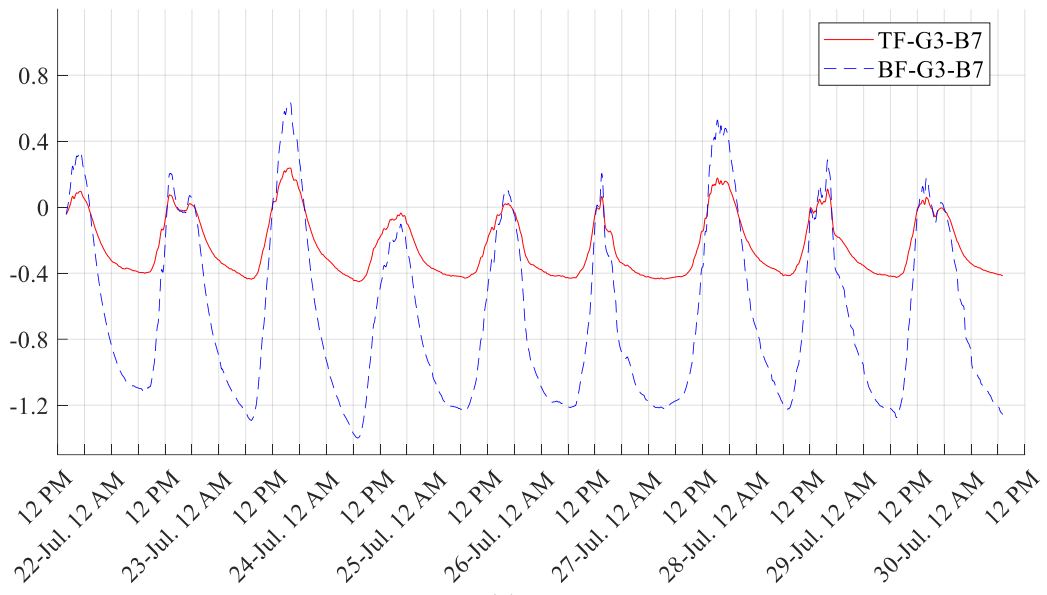
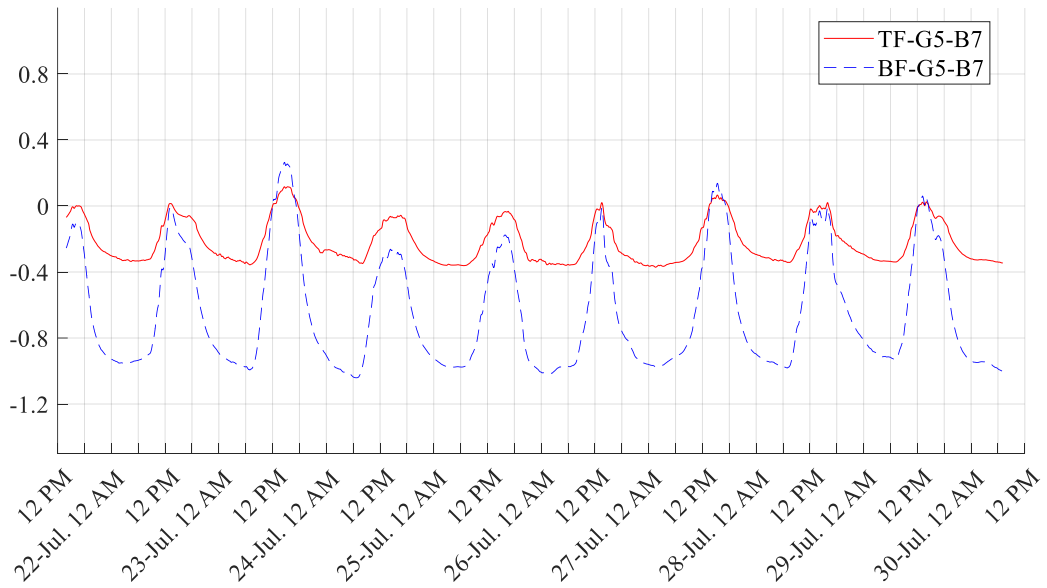
(a) G3

(b) G5

**Figure 5.18. Thermal deformations of gages in BRY3 at PBJs at B7.**

Deformation histories for gages on BRY3 are provided in Figure 5.17 and Figure 5.18 at PBJ locations and Figure 5.19 for SEJ locations. Figure 5.20 shows the strain history for strain gages located on either side of G3.

A comparison of the deformations at the PBJ and SEJ indicates a difference in the general trends of deformation in the top and bottom gages. At the PBJ locations, displacements of the top gages (those starting with TF and shown as a solid red line) are smaller than those of the bottom gages (those starting with BF and shown as a dashed blue line). For SEJ, the displacements are larger at the top flanges. This fundamental difference in the response is an indication that the center of rotation is different between the two locations. At SEJs, the center of rotation is located within the height of the girder. For PBJs, the continuity provided by the deck shifts the center of rotation higher toward or within the slab.

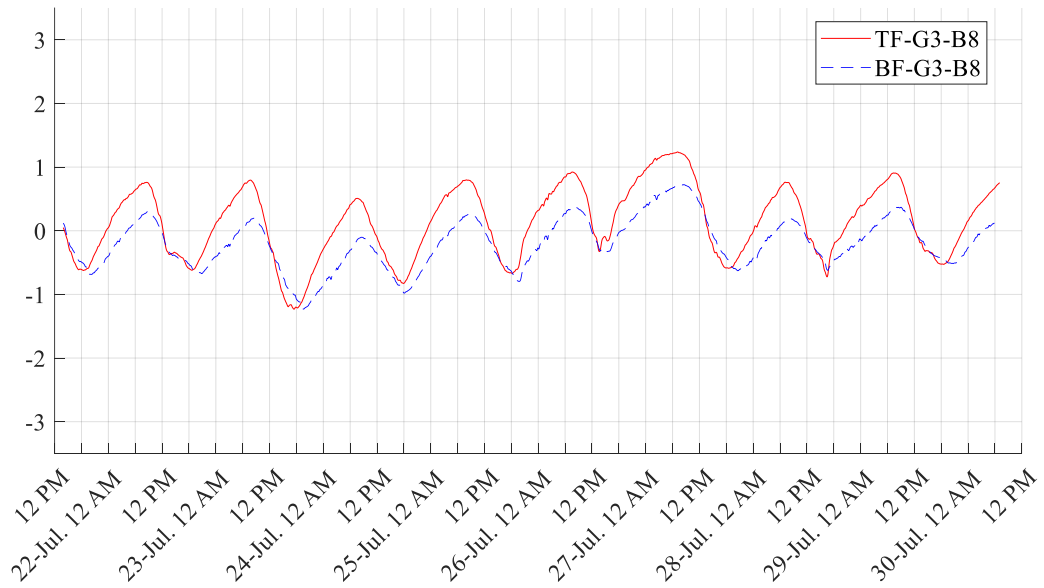
(a) B6

(b) B8

**Figure 5.19. Thermal deformations of gages in BRY3 at SEJs along G3.**

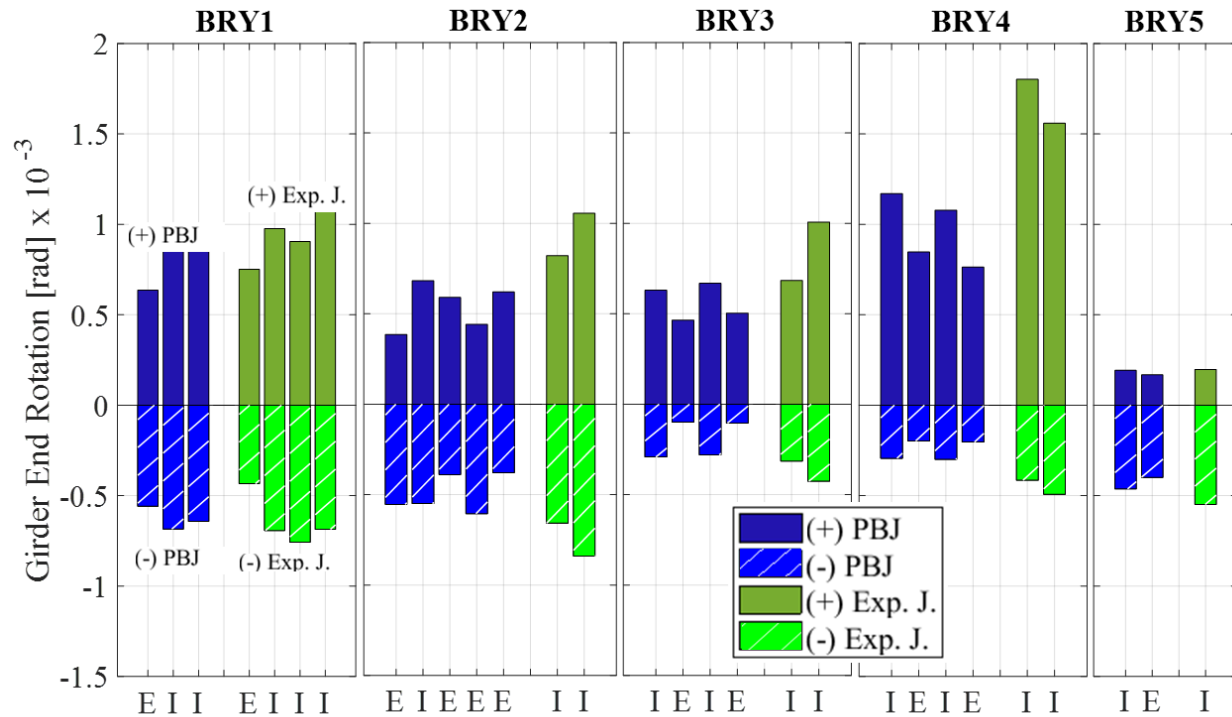
**Figure 5.22. Maximum positive and negative thermal rotations.**

The prior discussion shows the time history for individual bridges and limited locations. Similar trends in the history are seen in the time history for all collected and calculated data. To allow for a more comprehensive comparison of the data collected in relation to bridge characteristics and location of the measurements, the maximum positive and negative rotation values at each were identified and are shown in Figure 5.22. Each bar represents an individual monitoring location, with blue bars showing PBJ rotations and green bars showing SEJ rotations. Positive values are shown as solid, and negative values are shown as hatched. Below each bar, the transverse location is indicated, with E indicating an exterior girder and I indicating an interior girder.

For BRY1, the rotations at the PBJs are larger at interior girders. The interior girder rotation is measured under the median (G10) and under the traffic lane (G5). The larger positive rotations occur under the median, and the larger negative rotations occur under the traffic lane. At the exterior G1, the positive rotations are slightly larger at the SEJ, but the PBJ rotation is larger magnitude for negative bending. At the interior G5, the largest magnitude rotation occurs at the abutment SEJ.

For BRY2, PBJs were monitored at one interior girder (G3) and at four total locations along both exterior girders instrumented (G1 and G5). SEJs were monitored only on the interior G3. When comparing the SEJ and PBJ rotation along G3, researchers observed a noticeable reduction in rotation provided by the continuity of the slab, with the difference greater than observed for BRY1. For the exterior PBJ values, there is inconsistency between which locations have larger positive or negative values. Two bridge characteristics are captured in these four locations—the side of the skewed bridge and the number of units on the span. Figure 5.23 shows the relevant BRY2 data from Figure 5.22, with these details clarified. PBJ values are shown for two-span (yellow) and three-span (red) units. The x-axis labels indicate the specific exterior girder lines. The positive values are larger along G5 (north edge), and the negative values are larger along G1 (south edge). The positive rotations, regardless of location, are larger on the two-span units.

For BRY3, the center girder line (G3) provided rotations at both PBJ and SEJs, with the girders having slightly larger magnitude rotations at the interior SEJs. The smallest magnitude rotations are at the abutment SEJs. The exterior girder line was instrumented only at the PBJs, with both bents having similar rotations throughout the monitoring period. BRY3 provides another opportunity for comparison of two- and three-span units, with the relevant data included in Figure 5.22. As with BRY2, there is larger positive rotation in the two-span units. The negative rotation is similar or slightly smaller when negative bending is considered. This finding is slightly different than for BRY2, but it may be due in part to the inclusion of interior girder data and the fact that BRY3 is not skewed while BRY2 is skewed.

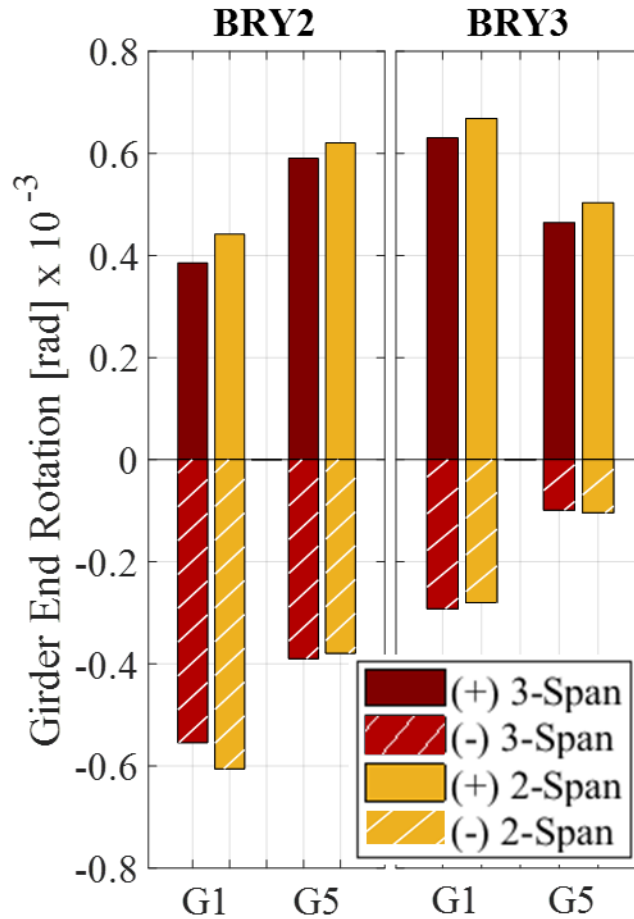
**Figure 5.23. Thermal rotations for BRY2 and BRY3, with bars indicating number of continuous spans in a unit (red bars indicate three-span units and yellow bars indicate two-span units).**

Figure 5.27 shows the live load rotations for two- and three-span units in BRY2 and BRY3. Presentation of the data is the same as that for the thermal loads shown in Figure 5.23. Rotations are generally larger for three-span units under positive bending and larger for two-span bridges under negative bending.

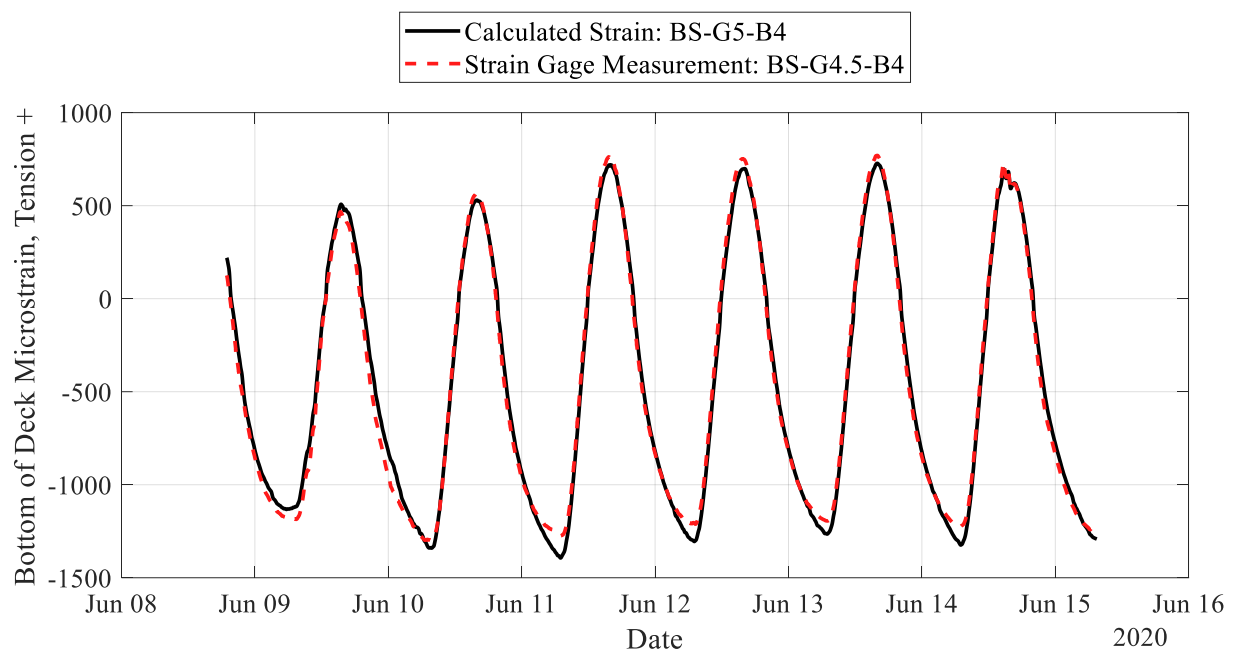
**Figure 5.29. Comparison of measured and estimated strains for BRY1.**

From gage displacements and girder rotation, the strains in the deck can be estimated and compared to the measured strain. The measured strains were located slightly off from the girder edges, but it was assumed that the strains were similar to those immediately over the girder line. By estimating strains for a range of possible effective link slab lengths in 0.5-in. increments, the effective length could be identified as the length that minimizes the difference between the measured and estimated strains. An example of the estimated and measured strains is shown for BRY1 in Figure 5.29.

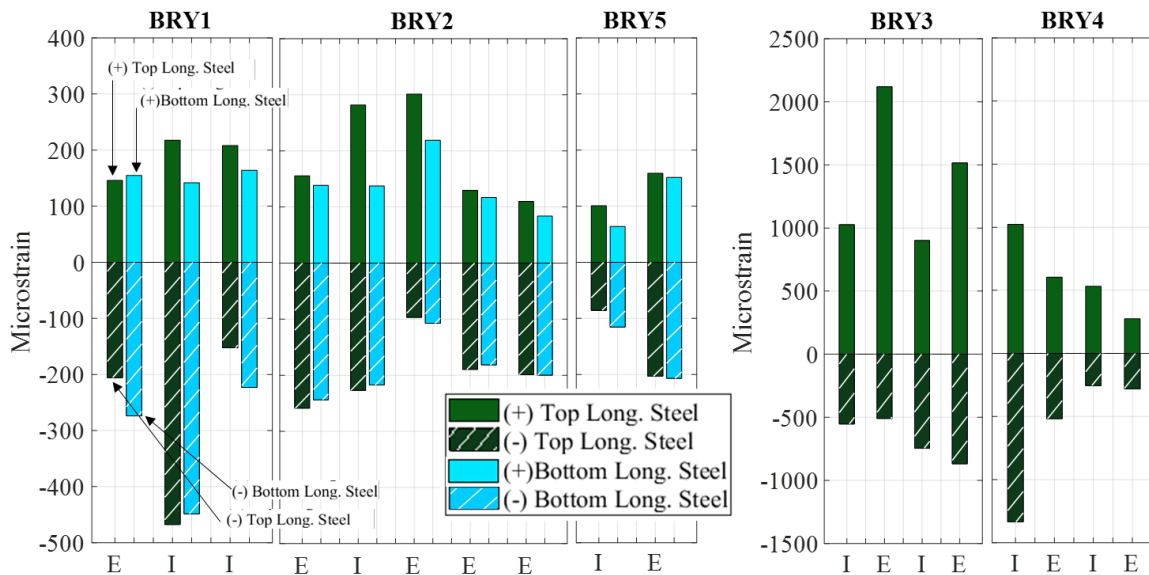
(a) Concrete strains

(b) Longitudinal rebar strain

**Figure 5.31. Thermal strain range estimated at each PBJ for each bridge (E = exterior girders and I = interior girders).**

Live load strains are shown in Figure 5.31. Bridges are grouped as non-flush panels (BRY1, BRY2, and BRY5) and flush panels (BRY3 and BRY4). The strains for individual events are considered and include both positive and negative strains. Note that this is the strain due to the live load event, not the total strain. The strains are larger magnitude in the flush panel bridges, indicating concentration of deformation where the panels meet.

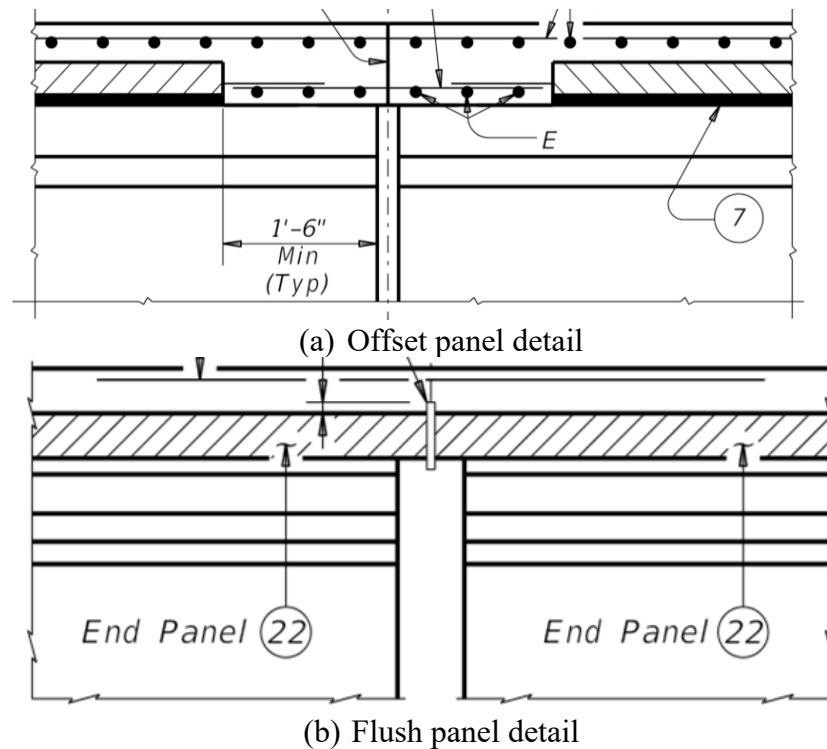
**Figure 6.1. TxDOT PBJ detailing with partial-depth PCPs.**

TxDOT standards offers two options for continuous deck detailing when partial-depth PCPs are used: offset panels and flush panels (see Figure 6.1).

When offset panels are used (Figure 6.1[a]), the panels end a minimum of 1 ft 6 in. from the end of the girders, with the deck full-depth CIP between the ends of the panel. The top reinforcement is the same as that in the remainder of the deck, while bottom reinforcement is provided spliced with dowel bars extending from the panels. Per the standard details, the intent of the detail is that the deck in the link slab region be the same thickness as the deck elsewhere. This is notably different than for a thickened deck at the ends of girders where expansion joints are used. At bridges with offset panel detailing visited as part of this project, researchers observed a slight thickening of the slab where there were continuous decks. Although measurement of the thickness increase was not possible, it appeared to be similar to the increase in thickness at expansion joint locations. While such a deviation will have limited impact on the stiffness and strength of the deck, it is worth considering in making recommendations for future changes to standard details.

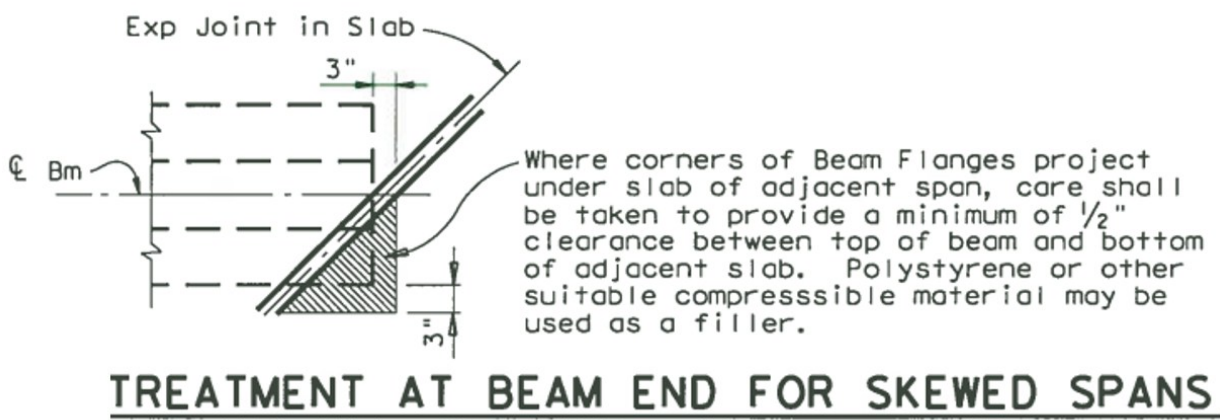
Figure 6.6. Miscellaneous slab details of 1998.

The prestressed concrete beam span details of 1971 (see Figure 6.5) continued the use of the foam insert. In 1998, the foam insert detail changed slightly to mandate 3 in. of foam extension past the edge of the girder, as shown in Figure 6.6.

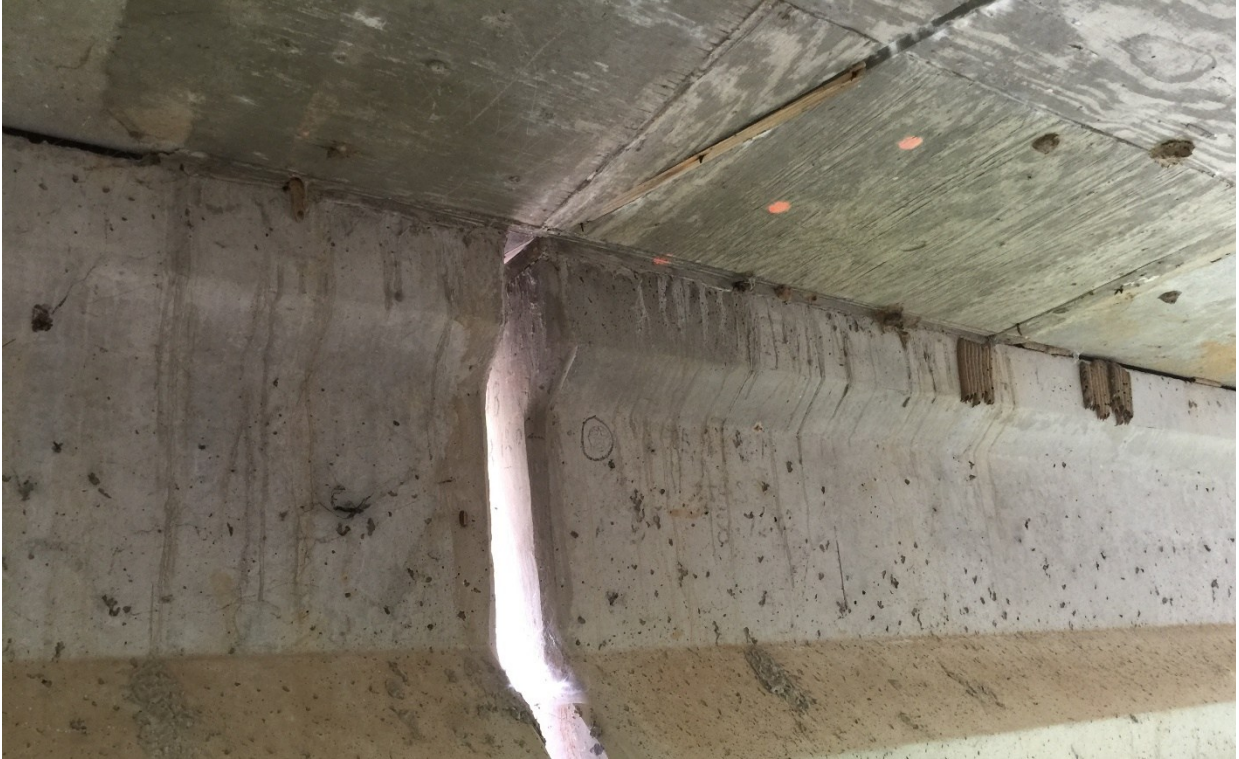
**Figure 6.13. Atlanta District bridge without a foam insert or skewed girder end detail.**

Despite the availability of two standard detail options, there is evidence that contractors have not provided either detail at some bridges. For instance, at Old River Bridge (Bridge ID 17-026-0648-03-020), neither skewed girder ends nor a visible foam insert was used to prevent the girder ends from contacting the slab of the adjacent span, as shown in Figure 6.10. The skew at all bents of Old River Bridge is 30 degrees. Figure 6.11 shows possible damage from contact between the slab and protruding girder at an expansion joint. At Peach Creek Bridge (Bridge ID 17-021-0050-02-135), no skewed girder or foam insert detail is visible, despite the deck crack between spans running beneath the edge of the girder end (see Figure 6.12). Peach Creek Bridge has supports with 15-degree skew. At Bridge 2.2 in the Atlanta District (Bridge ID 19-034-00946-01-013), which has a 15-degree skew, no skewed girder or foam insert detail is visible at the girder ends (see Figure 6.13).
