# Performance and Improvement of Texas Poor Boy Continuous Bridge Deck Details: Final Report

Technical Report 0-7013-R1

Cooperative Research Program

TEXAS A&M TRANSPORTATION INSTITUTE  
COLLEGE STATION, TEXAS

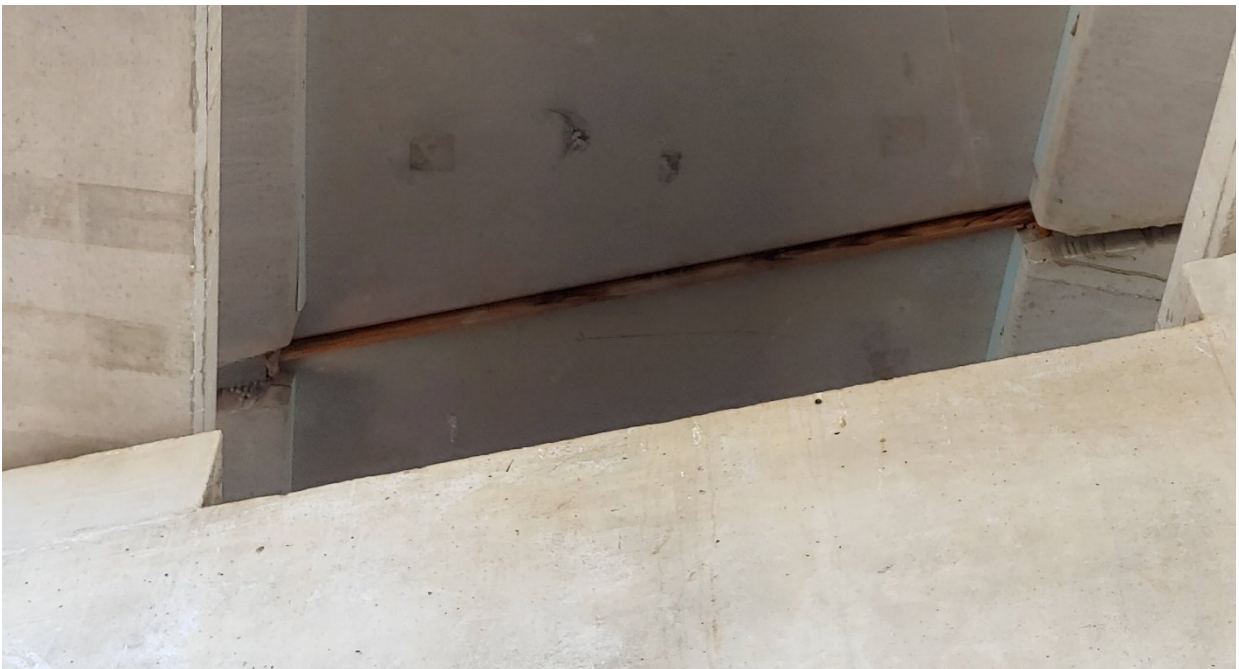
**Figure 6.14. Lubbock District bridge with skewed girder end details.**

An as-built example of a skewed girder end detail is shown in Figure 6.14 on a bridge in the Lubbock District on Highway 62 (Bridge ID 5-152-00380-01-236). This bridge has a 19-degree skew. Of the four skewed bridges with visible details that the project team assessed as part of Task 3, only one had a visible skewed end detail. The application of these details appears to be inconsistent.

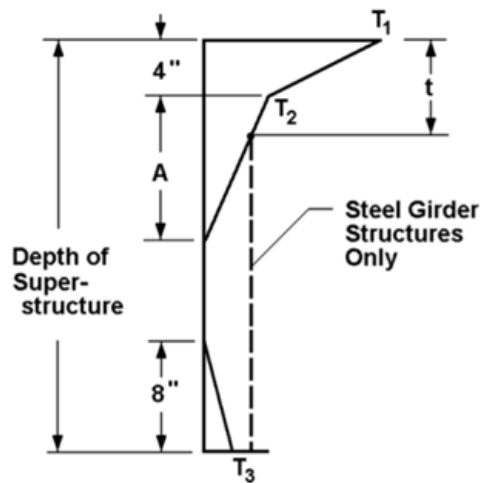
**Figure 7.1. Temperature gradient from AASHTO LRFD specification.**

The effect of temperature gradient is accounted for using Section 3.12.3 of the AASHTO specifications. The profile of AASHTO's temperature gradient is shown in Figure 7.1. To simplify rotation calculations, this nonlinear gradient was simplified as a linear gradient with endpoints T1 at the top of the superstructure and T3 equal to zero at the bottom of the superstructure. For positive bending in the girders, a negative gradient is used, which applies a factor of  $-0.30$  to the AASHTO specified values. For each prototype bridge, rotations due to thermal loading were found by integrating the temperature gradient. Values are shown as absolute values in Figure 7.2. Positive thermal values are for positive thermal gradients and correspond to negative girder bending. Negative thermal values are for negative thermal gradients and correspond to positive girder bending. The magnitudes of thermal rotations are typically larger than live load rotations, except for very flexible bridges, in which the live load values exceed the negative thermal loading values.

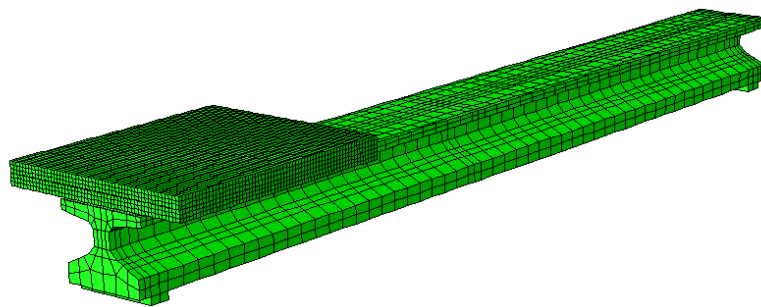
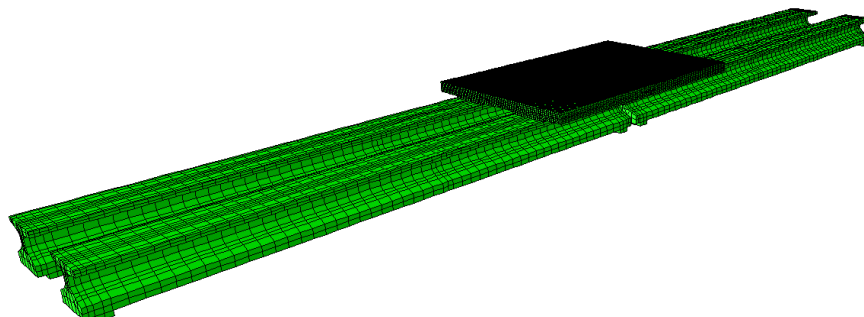
(a) Single girder modeled

(b) Mirrored longitudinally

(c) Mirrored longitudinally and transversely

**Figure 8.1. Mirroring of symmetric models.**

To maintain computing efficiency, multiple girder lines and girder parts were reduced to a single girder and slab section for some models. As shown in Figure 8.1, using a symmetrical single-girder model allowed for mirroring of the model along lines of symmetry. Thus, a single-girder model with symmetrical constraints across two directions of the slab could be used to obtain more efficient results. Both concrete faces and the ends of continuous reinforcement were marked as symmetrical using boundary conditions in the analysis, creating continuity along mirrored faces. The single-girder line model was used to study a variety of link slab cases. While material properties were simplified for the concrete girders, the deck and deck reinforcement used the nonlinear material models described in Section 8.2.1.

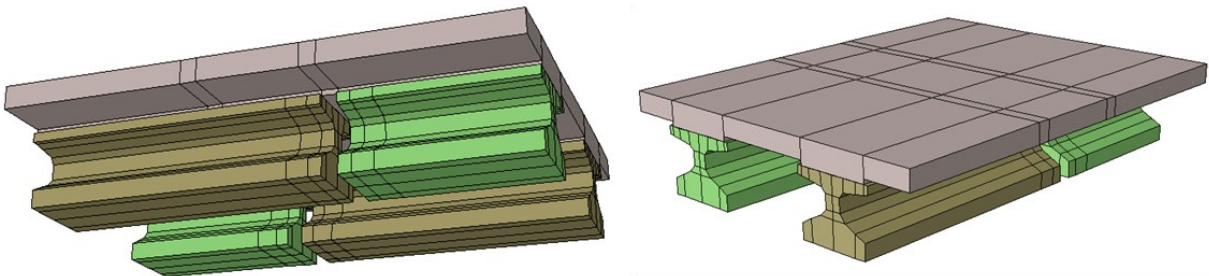
**Figure 8.3. Dual-girder model for skewed girder configuration without clipped girders.**

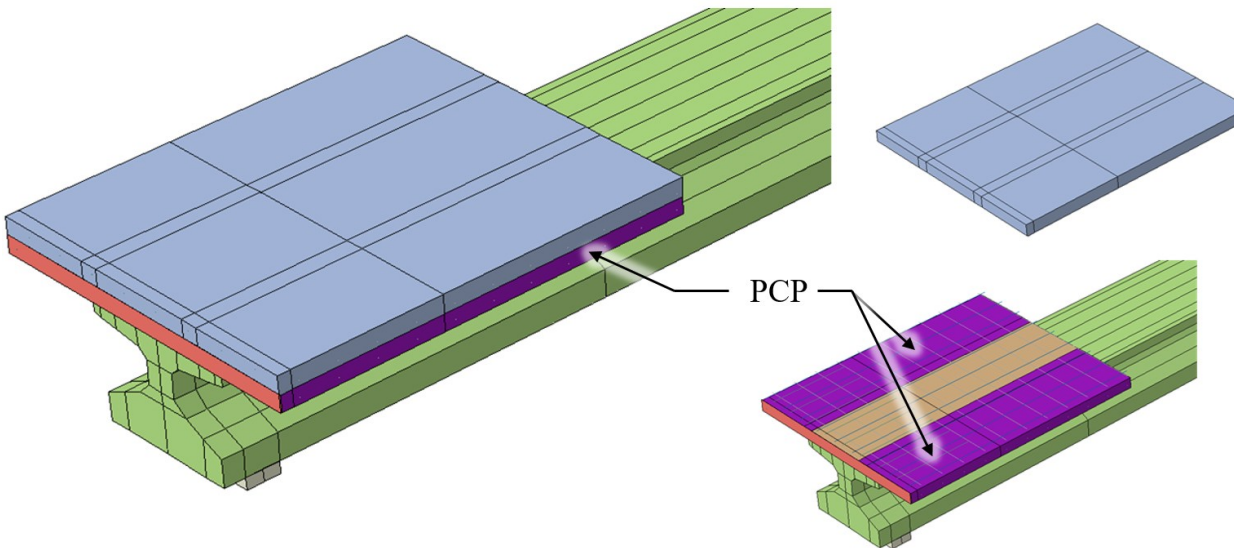
**Figure 8.7. Partial-depth debonded model used with flush panel configuration.**

length, reducing bending curvature and delaying or eliminating cracking. A partial-depth debonded model, shown in Figure 8.7, has the upper section of slab debonded from the lower slab and PCPs at the level of the PCP top face. Figure 8.8 shows a full-depth debonded model, where a section of slab is debonded at the girder face.

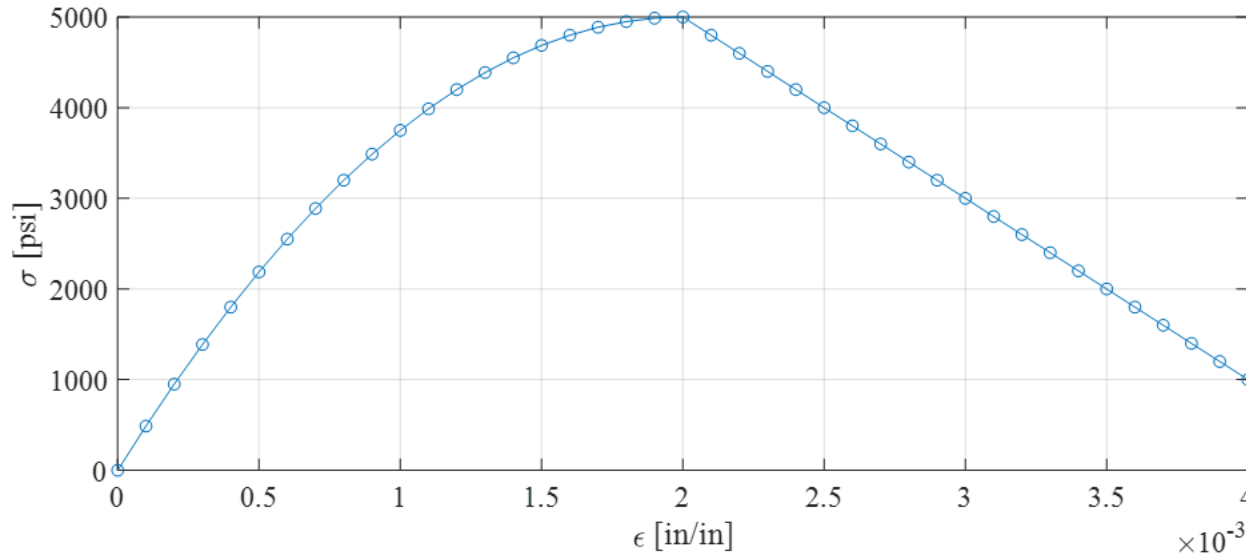
**Figure 8.13. Unconfined Kent-Park concrete model for ultimate compressive strength of 5000 psi.**

Nonlinear concrete compressive models that were considered include the Hognestad model (shown in Figure 8.12) and the unconfined Kent-Park model (shown in Figure 8.13); presented results use the Kent-Park model. Both models utilize a parabolic rise in stress to ultimate strength, with linear post-peak behavior. While both models provided reasonable results and have been used in literature for concrete deck slabs (Al-Rousan et al. 2020; Chaudhari and Chakrabarti 2012), the unconfined Kent-Park model was chosen as the primary compressive concrete material model.

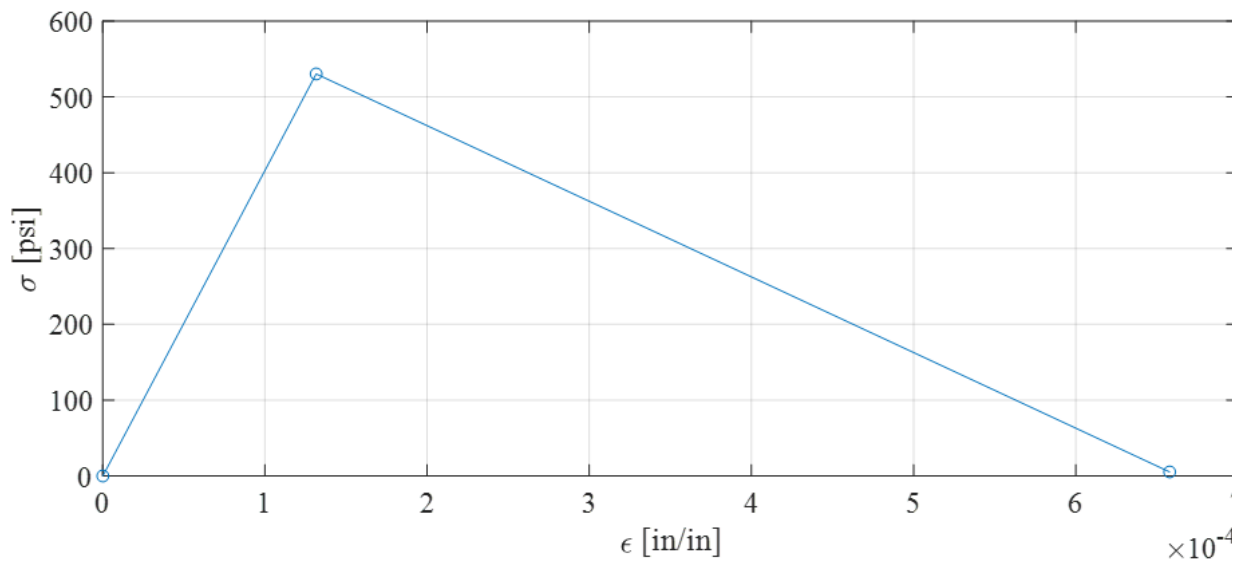
**Figure 8.14. Bilinear tension model for concrete.**

To model tensile behavior of concrete, the simple bilinear model shown in Figure 8.14 was chosen based on experience with convergence issues and suggestions for use with the concrete damaged plasticity model in ABAQUS. This bilinear example is for 5000 psi concrete and defines constant slope of stress before and after rupture. For steel reinforcement, a bilinear elastic-perfectly-plastic model was chosen for typical Grade 60 reinforcing bars.

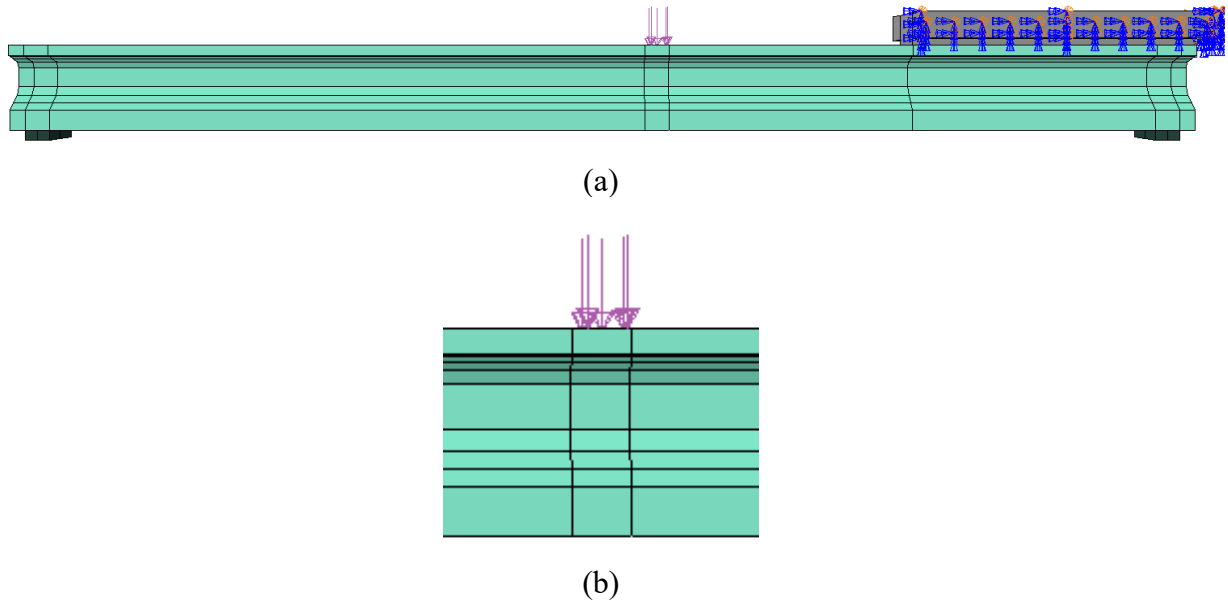
**Figure 8.18. Loading on top girder face.**

Loading of the model was designed to simulate the loading conditions of the experimental test setup, as shown in Figure 8.18. A pressure load (b) was applied to the top girder face near midspan (a), far from the slab section in order to avoid localized effects due to loading. For single-girder models, the symmetrical boundary conditions meant that each mirrored span has an equivalent pressure load applied. Models with multiple girder lines required increased computing time but allowed for asymmetrical loading conditions. The vertical load on the girder face caused

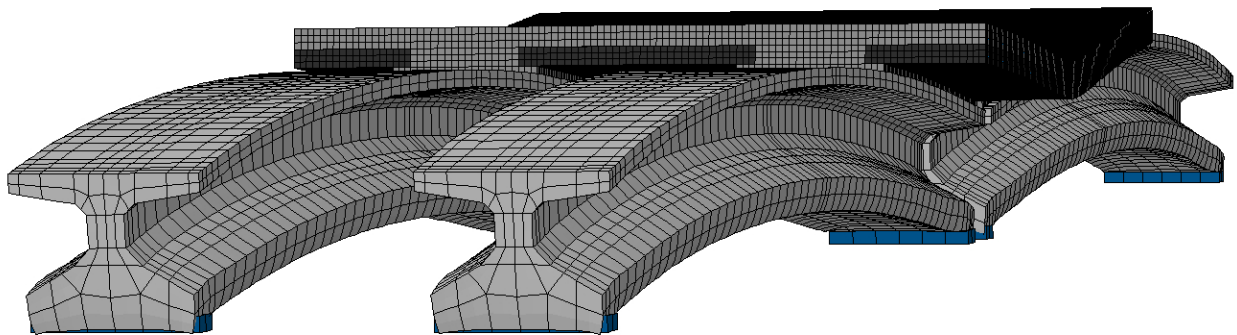
**Figure 8.19. Negative bending due to thermal gradient with deformation exaggerated to show girder curvature.**

In order to investigate the effects of thermal gradient and negative bending of the girders, temperature loading was applied in some models. A preliminary analysis step was used to designate initial temperature conditions of the girders. During the loading step, the temperature of the bottom face of the girder was decreased, producing negative girder end rotations (see Figure 8.19) and tensile forces in the bottom of the link slab. Uniform temperature loading was also used to investigate deck shrinkage effects.

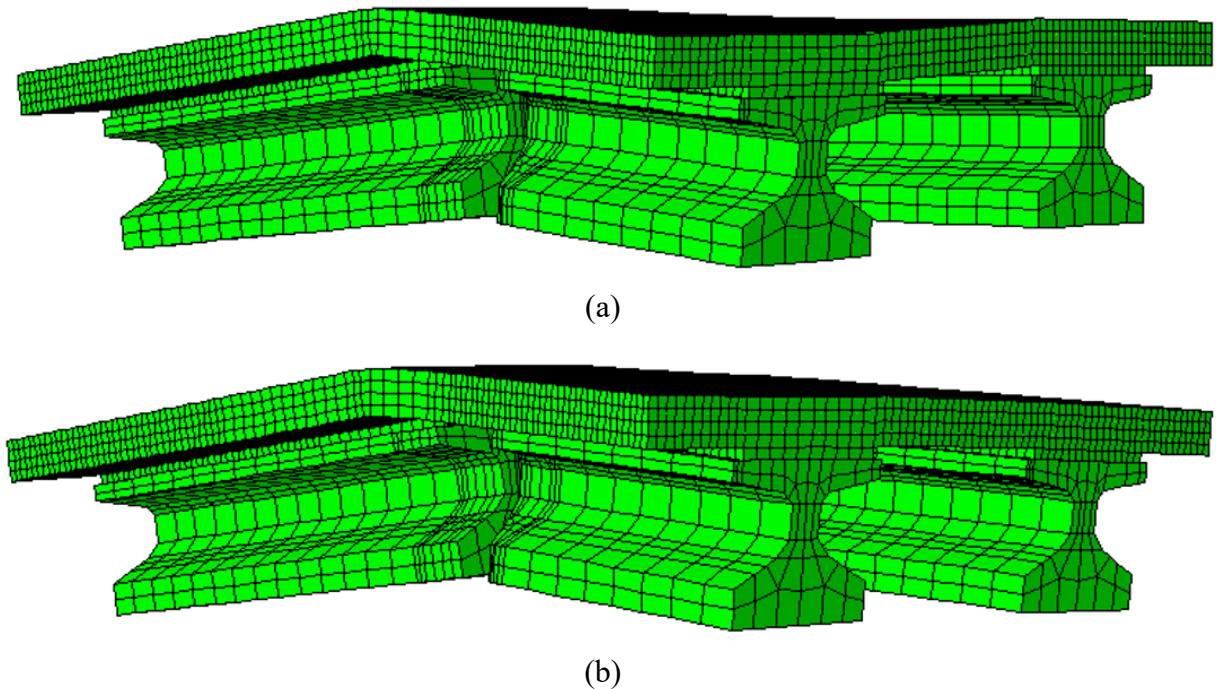
**Figure 8.20. Deformation of girder stub model, at 20 times scale, showing deformation of (a) one girder line and (b) both girder lines.**

Since midspan loading is not possible for girder stub models, the exterior girder ends were displaced using rotation boundary conditions for each girder line. This displacement loading (see Figure 8.20) rotates both exterior ends of one girder by 0.005 rad (a), and then rotates the second girder line in the same way (b) while the first girder line is held in its rotated state. Thus, stresses in the deck can be seen propagating from over one girder line to the next.

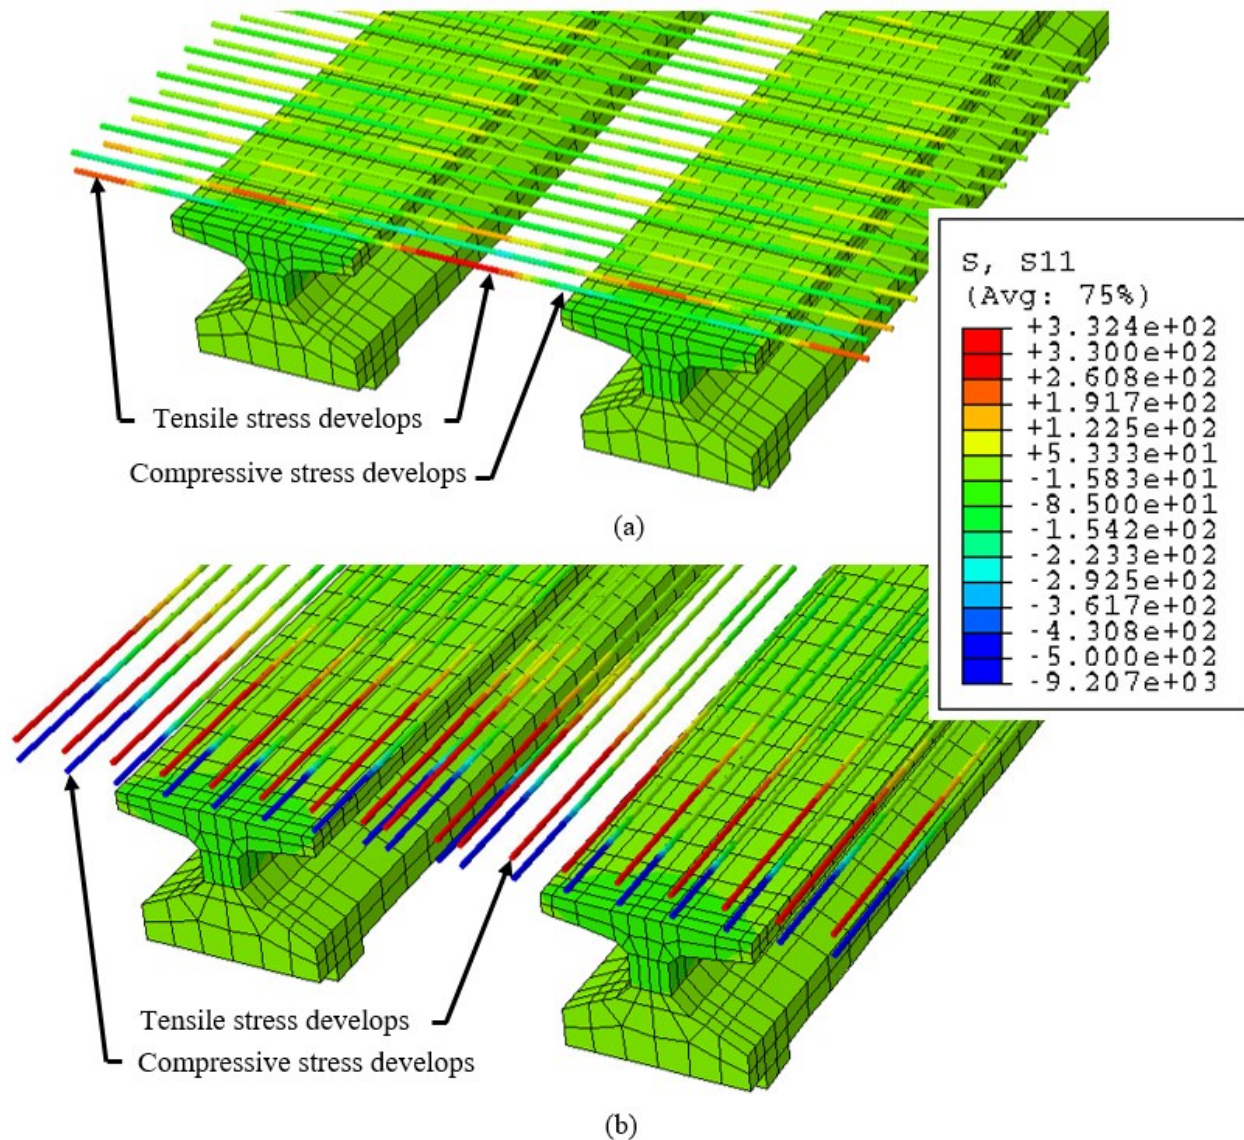
**Figure 8.23. Longitudinal stresses in reinforcement (psi) for (a) transverse bars and (b) longitudinal bars at the onset of cracking.**

Figure 8.23 shows reinforcement stresses corresponding to the partial cracking in the slab over the girder in Figure 8.22(a). Figure 8.23(a) shows the transverse reinforcement at the PBJ developing mild tensile stresses between the girders and in the overhang, as well as mild compressive stresses over the girders. Figure 8.23(b) shows the top longitudinal reinforcement

developing mild tensile stresses (around 330 psi), while the bottom longitudinal reinforcement develops higher compressive stresses (around 9200 psi). In Figure 8.24, steel stresses are shown for cracking across the entire width of the section, as shown in Figure 8.22(b). Figure 8.24(a) shows similar stresses in the transverse reinforcement as in the initial cracking phase. Figure 8.24(b) shows the top layer of steel developing larger tensile stresses close to the PBJ as the concrete no longer resists the rotation of the link slab across the crack. The stress drops in the bottom longitudinal steel.

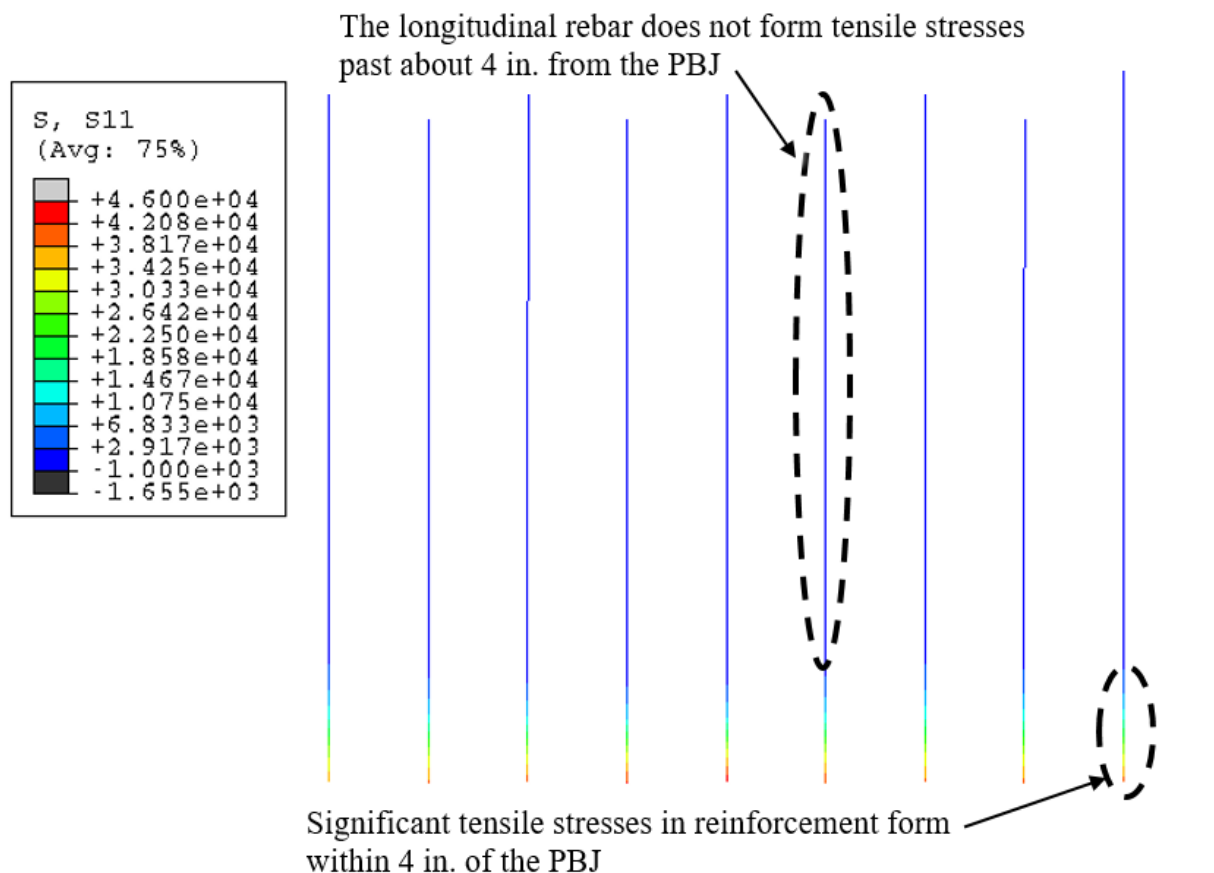
**Figure 8.30. Close-up of embedded longitudinal steel reinforcement showing that tensile stresses are focused near the PBJ.**

At higher rotations, with the PBJ long since cracked, longitudinal tensile stresses form over the reinforcement embedded within the slab, as shown in Figure 8.29. Furthermore, compressive stresses form farther back in the slab over the girders. The tensile stress within the top longitudinal steel, shown in Figure 8.30, reveals that the bulk of the tensile stress in the steel is constrained to the first 4 in. of bar length on each side of the joint. Cracking reaches the full depth of the CIP concrete over the timber board.

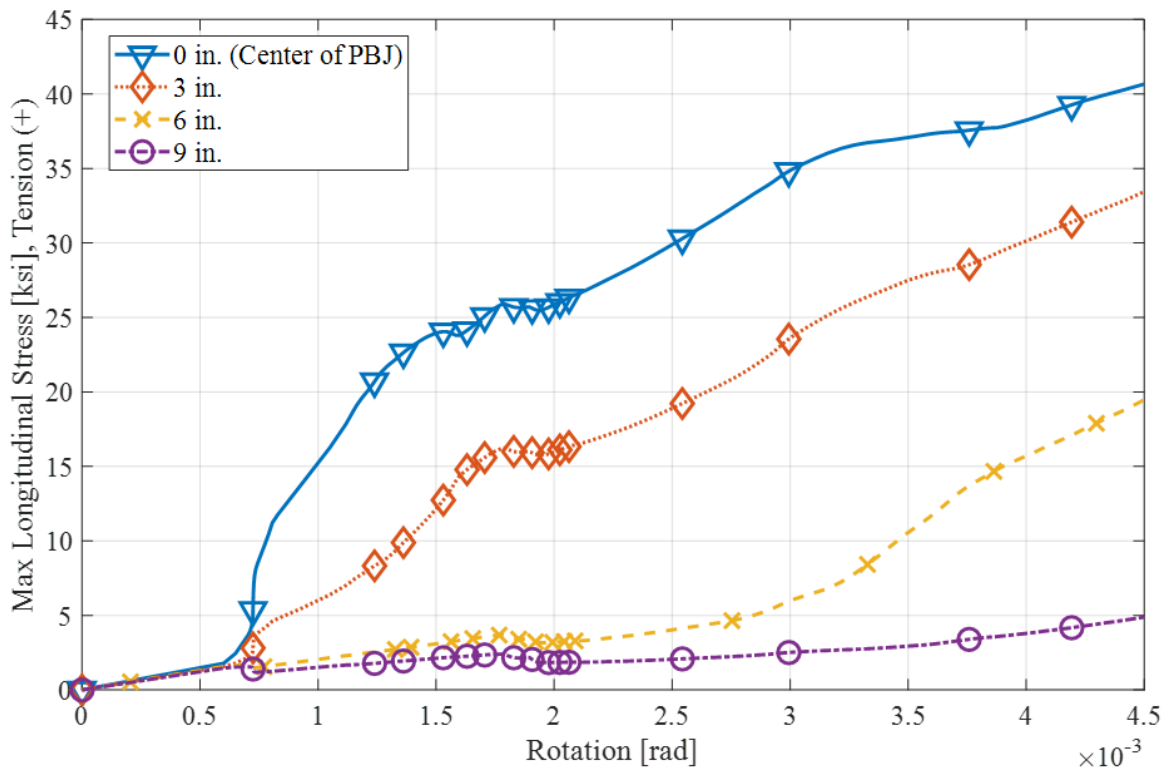
(a) Concrete stress, top of slab

(b) Rebar stress (raised 5-ft supplemental bars)

**Figure 8.38. (a) Strains in the concrete and (b) raised supplemental longitudinal bars for the 35-in. partial-depth DLS with elevated reinforcement.**

Results for the partial-depth debonded flush panel model and partial-depth debonded flush panel model with raised reinforcement are shown in Figure 8.37 and Figure 8.38, respectively. Concrete and steel stresses are presented at the center of the PBJ (0 in.) and at 3 in., 6 in., and 9 in. from the center.

The results of these two models show that there is minimal difference in concrete stress at the PBJ with the alternative reinforcement. The standard longitudinal reinforcement goes briefly into compression prior to cracking of the section. The raised longitudinal reinforcement, however, bears tensile forces throughout loading, before and after cracking.

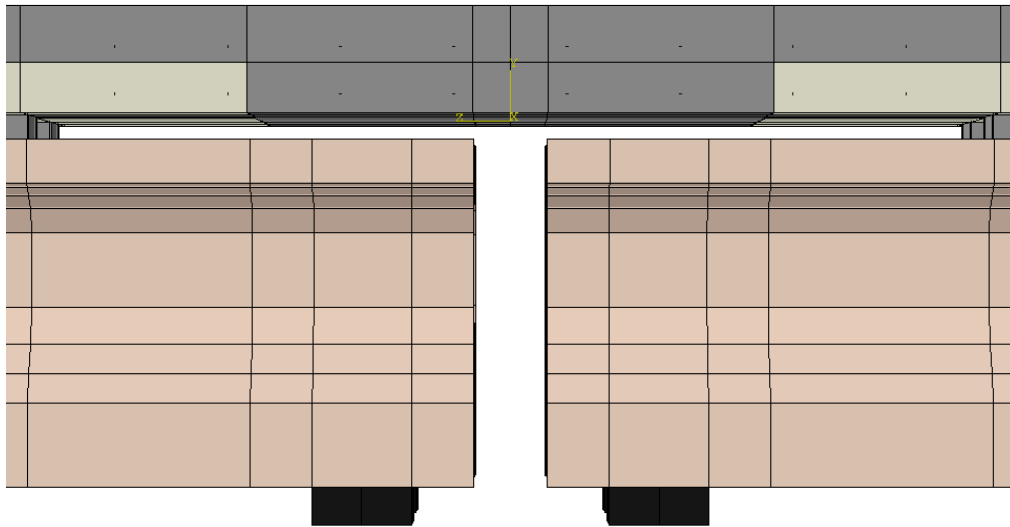
**Figure 8.44. Debonded offset panel model with the girder haunch removed, creating a 2-in. vertical gap between the girder and the bottom of the slab.**

The vertical gap between the debonded concrete faces was found to be a key factor in the effectiveness of debonded details. Four dual-girder models were developed to investigate debonding length effects and the effectiveness of a vertical gap over the debonded length. One debonded model with the girder haunch removed was compared to the bonded detail and two debonded details with different debonded lengths. Figure 8.44 shows the debonded model with the girder haunch removed, creating a vertical gap of 2 in. in the debonded region. Figure 8.45 shows a comparison of the concrete stresses at first cracking for these four models. While increasing debonded lengths caused a small delay in the onset of cracking, including a vertical gap over the debonded length yielded large improvements to cracking behavior. Figure 8.46 shows the plastic principal strains for the same models. The magnitude of these plastic strains

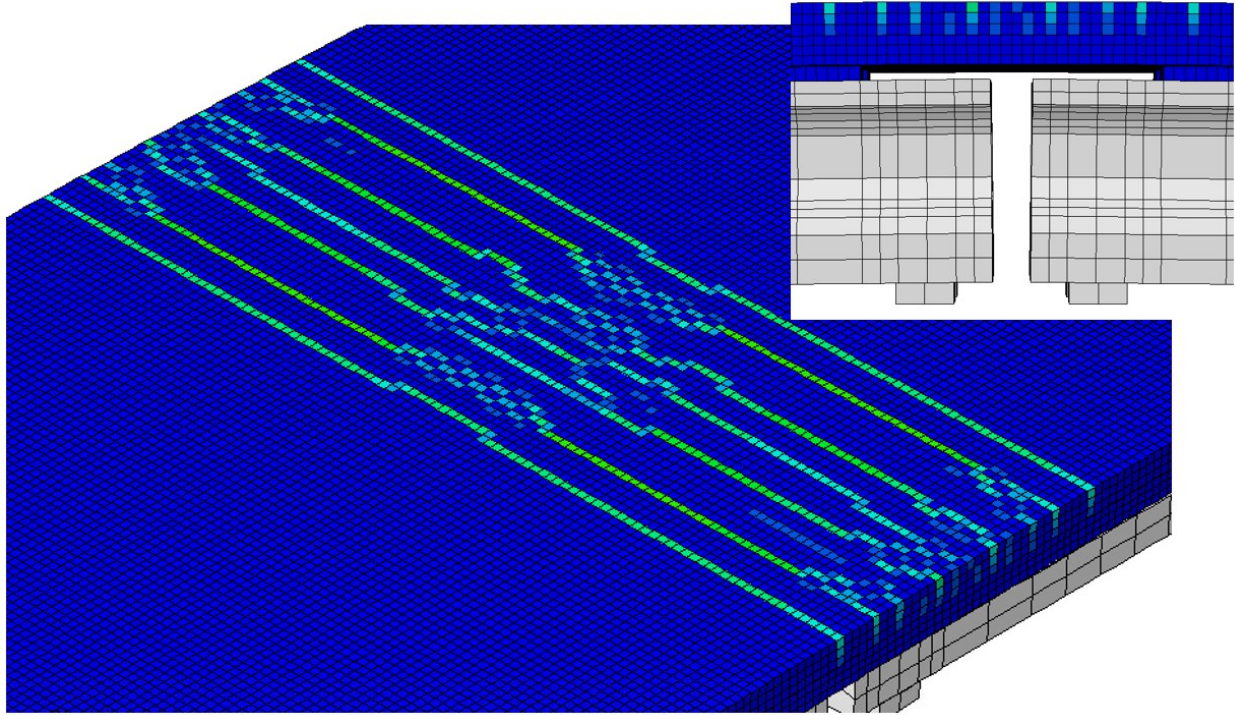
**Figure 8.47.** Cracking pattern for an offset precast panel model, debonded for 18 in. with a vertical gap along the debonded length, and squared ends of the debonded region.

Furthermore, the geometry of the vertical gap over the debonded length was investigated to determine whether a tapered end to the debonded length would improve performance, perhaps by avoiding stress concentrations at the end of the debonded region. Figure 8.47 shows a simple squared end to the haunch gap and the corresponding deck cracking pattern. Figure 8.48 shows a tapered end to the haunch gap and the corresponding cracking pattern. Little difference in cracking behavior can be seen between the two models. Figure 8.49 shows the principal stress at the location of first cracking for both models. The tapered haunch gap model does not delay the onset of cracking.

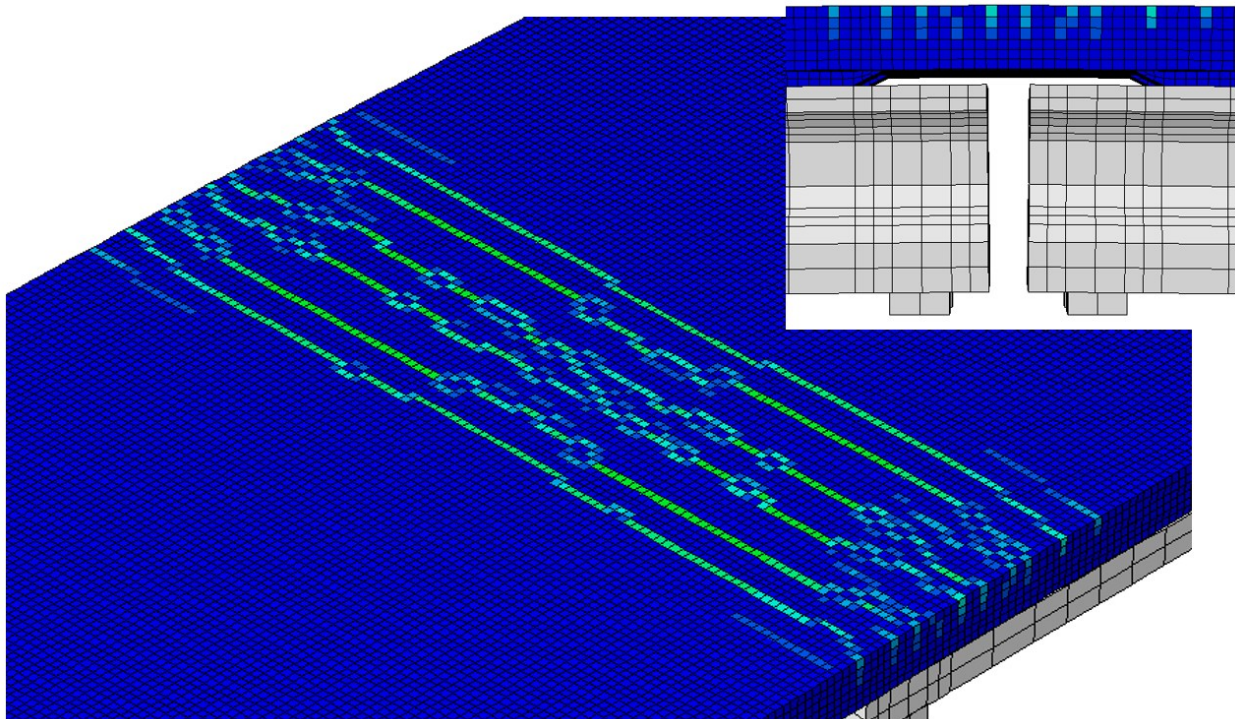
**Figure 8.48.** Cracking pattern for an offset precast panel model, debonded for 18 in. with a vertical gap along the debonded length, and tapered ends of the debonded region.

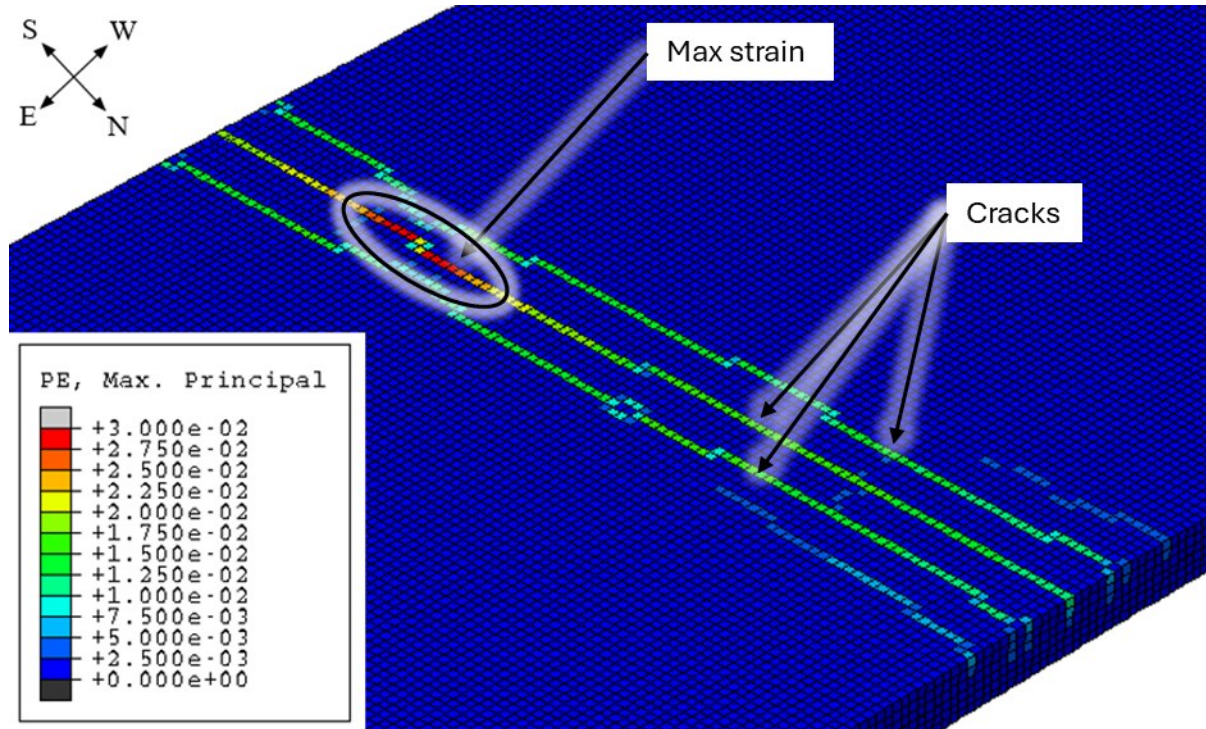
**Figure 8.51. Cracking pattern for a model simulating PBJ-OP2, with added longitudinal reinforcement in the north half of the deck.**

For test specimen PBJ-OP2, #4 bars were added to the north half of the deck in the longitudinal direction between existing longitudinal bars. A model matching this test setup, shown in Figure 8.51, indicated that the increased reinforcement in the north deck would cause a more distributed cracking pattern, while the south deck would see fewer, wider cracks.

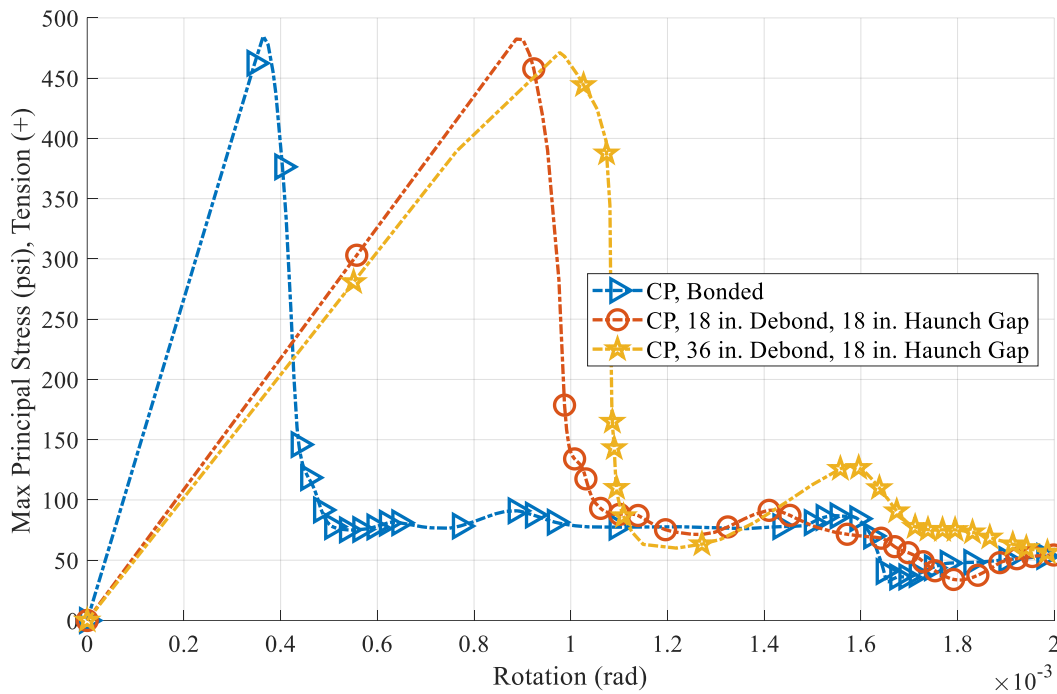
**Figure 8.59. Comparison of first cracking behavior for continuous panel models.**

The initial cracking behavior of the three continuous panel models is compared in Figure 8.59. Debonding the continuous panel model for 18 in. on each girder with a 0.5-in. haunch gap for the full 18-in. length delays cracking in the slab for 0.00052 rad of girder end rotation. An increased debonded length of 36 in., but with a haunch gap for only 18 in. along that length, gives a modest improvement of 0.00009 rad of rotation before cracking. Debonding is effective in delaying the onset of cracking, but not including the haunch gap for the debonded length limits the effectiveness of debonding.

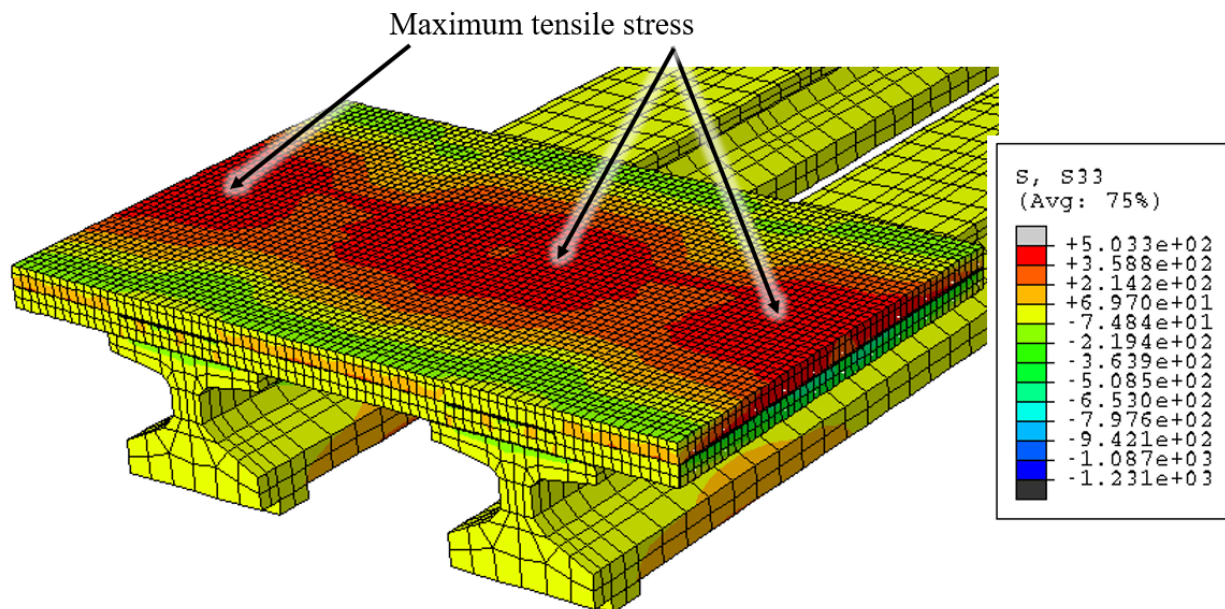
**Figure 8.60. Longitudinal concrete stresses formed by uniform shrinkage in the deck, causing potential cracking within the section.**

When evidence of cracking due to concrete shrinkage was noticed after fabrication of the flush panel laboratory specimens, a model was developed to investigate shrinkage. This model, shown in Figure 8.60, is built to mimic the laboratory test specimen with a flush precast panel detail. By imposing a uniform temperature change on only the CIP portion of the deck, it was possible to simulate the effect of drying shrinkage. Reducing the deck's temperature causes the deck to contract, which generates forces in the slab since the girders do not have a similar temperature change.

Results showed the potential for cracking in the deck, especially over the girders, which restrain the movement of the slab. Cracking initiates in the middle of the deck, rather than at the PBJ, suggesting that deformation at the supports prevents the buildup of stress in the deck between the girder ends. However, no such relief for deformation is possible at the interior of the slab since a perfect bond between the deck and girder is assumed.

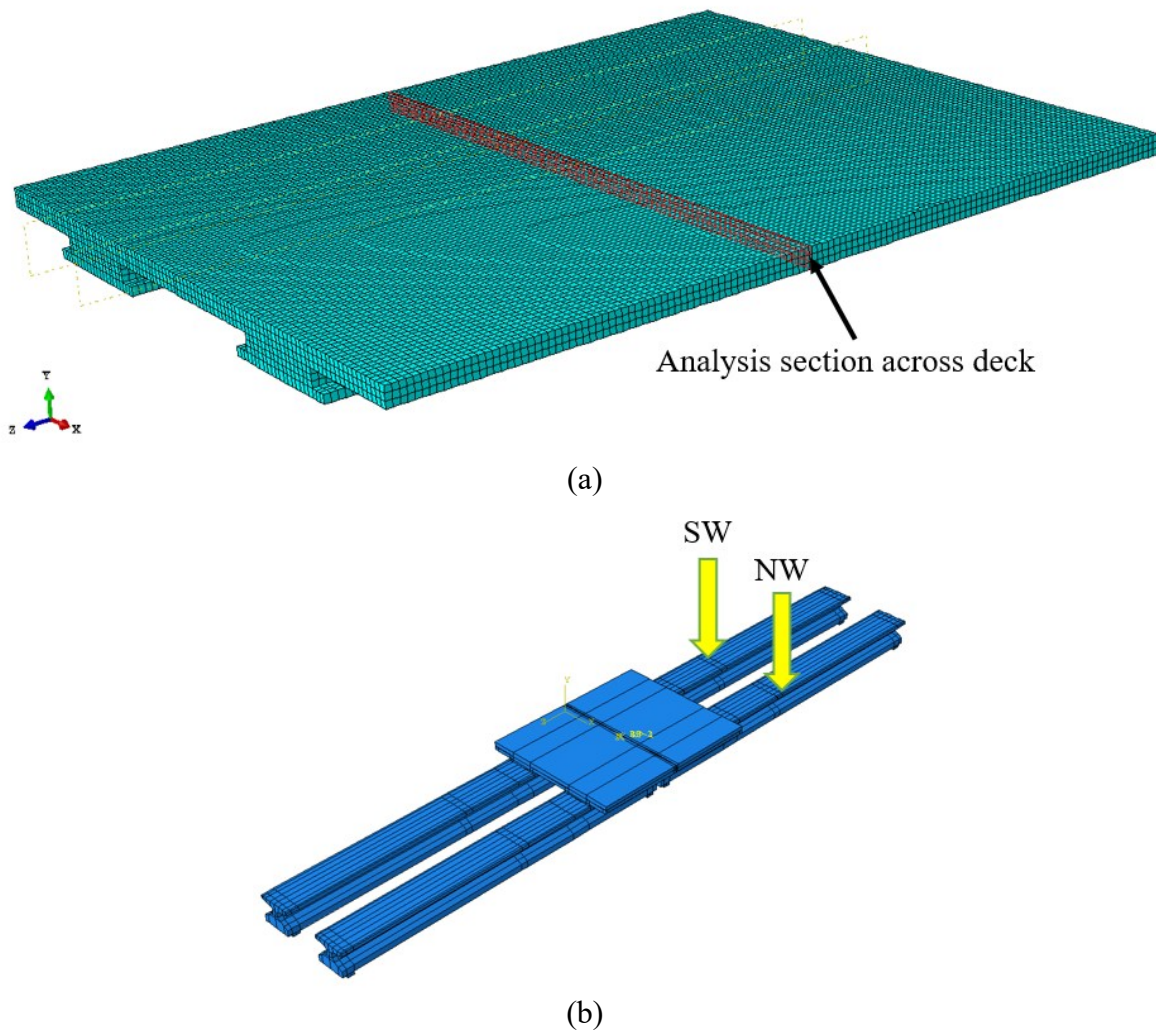
**Figure 8.65. (a) Deck model used to analyze tensile forces across the PBJ, and (b) loading diagram for the flush PCP model.**

A concern for PBJ behavior is that additional tensile forces in the deck may worsen cracking. In order to investigate the longitudinal tensile force through the PBJ, researchers drew an analytical section through the center of the PBJ region. The section through the deck, shown in Figure 8.65(a), was used to sum longitudinal forces across all concrete elements bisected by the plane. When summed with the longitudinal forces from all rebars bisected by the plane, a total

force in the deck could be calculated. The models were loaded on both girders in one span according to Figure 8.65(b).

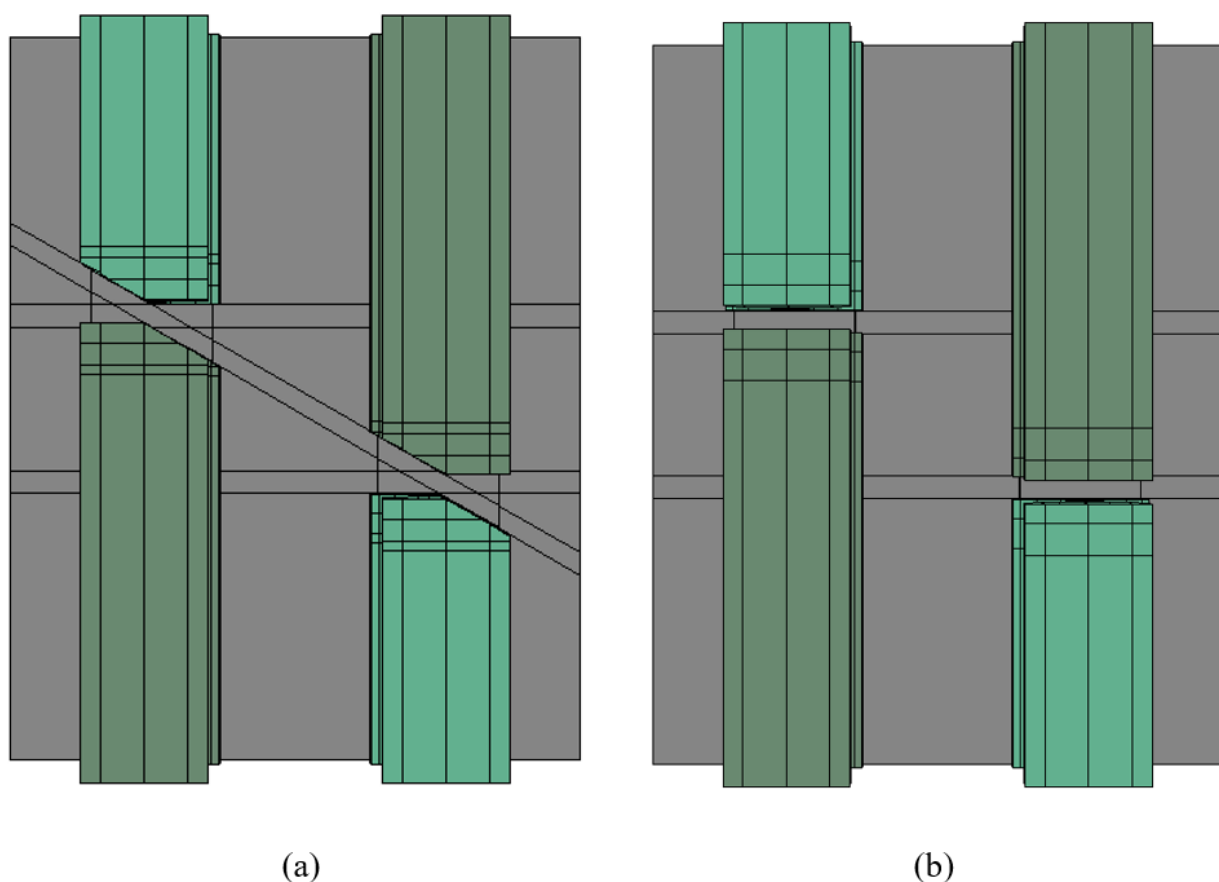
**Figure 8.67. Underside of skewed stub models, showing (a) a skewed girder end condition and (b) a flat girder end condition.**

Two primary girder stub model types were developed: with and without coped girder ends. TxDOT design standards call for the use of either skewed girder ends or foam filler above girder ends above skewed supports. These standards provide clearance between the girder end and the slab in the adjacent span, preventing contact between the girder end and slab that could result in damage under repeated loading. However, field investigations in the Bryan, Lubbock, and Atlanta Districts showed that some existing structures used neither skewed girder ends nor foam inserts above the girder end corners. Case (a) in Figure 8.67 shows a model with skewed girder ends, while case (b) shows a model without skewed ends or inserts. These two models allowed for comparisons between the different conditions for skewed girder ends. Both models had a skew of 30 degrees. Each stub model included standard longitudinal and transverse reinforcement within a CIP slab.

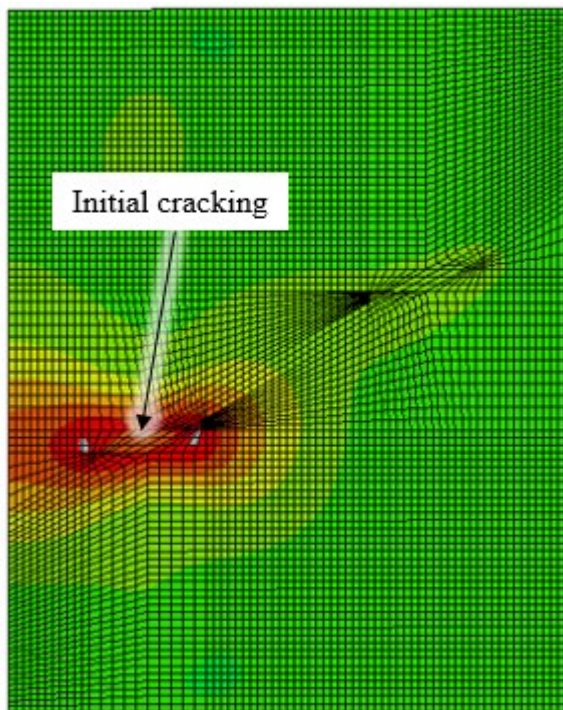
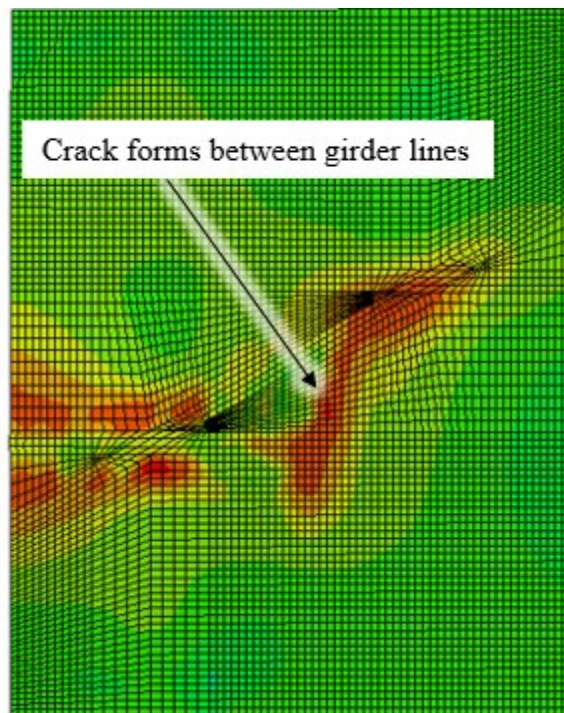
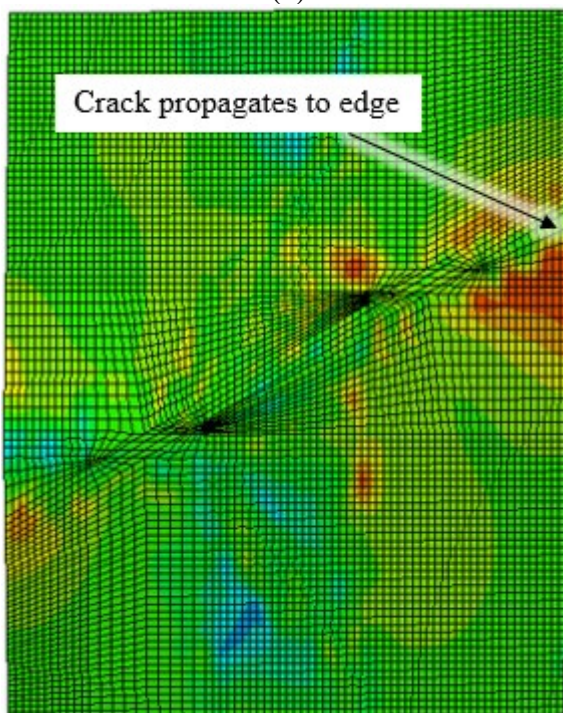
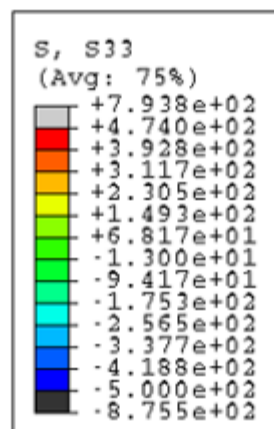
Figure 8.68. Longitudinal stress propagation in the deck of the skewed girder end model.

The stress propagation for the skewed girder end model is shown in Figure 8.68. As illustrated in Figure 8.68 (a), the left girder line's displacement produces initial cracking between the girder ends. Cracking initiates between the girder ends and propagates outward toward the other girder line and the edge of the deck. In Figure 8.68 (b), the movement of the left girder line causes crack propagation toward the right girder line. However, the cracking pattern does not directly follow the skew of the support but rather causes nearly longitudinal cracking between the girder lines. In Figure 8.68(c), the right girder line is rotated, causing cracking from between the girder ends to the edge of the slab. Isolated pockets of tensile stress develop over the longitudinal reinforcement in the cracked deck.

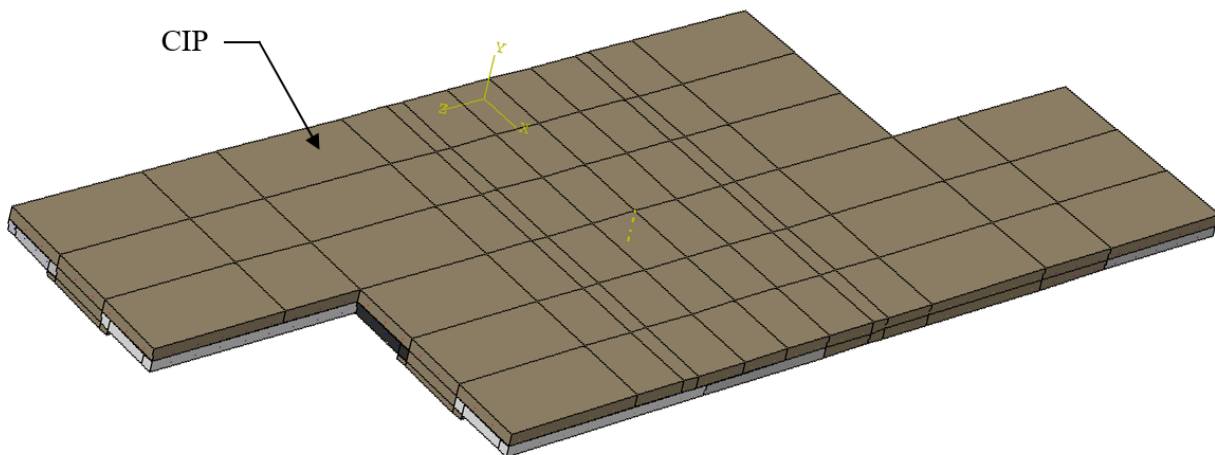
**Figure 8.73. Top view of the deck for the dual-girder skewed model.**
