# Performance and Improvement of Texas Poor Boy Continuous Bridge Deck Details: Final Report

Technical Report 0-7013-R1

Cooperative Research Program

TEXAS A&M TRANSPORTATION INSTITUTE  
COLLEGE STATION, TEXAS

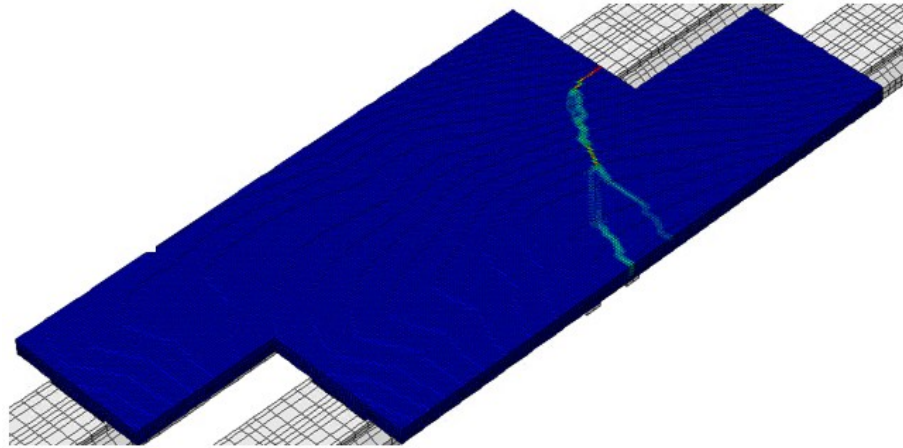
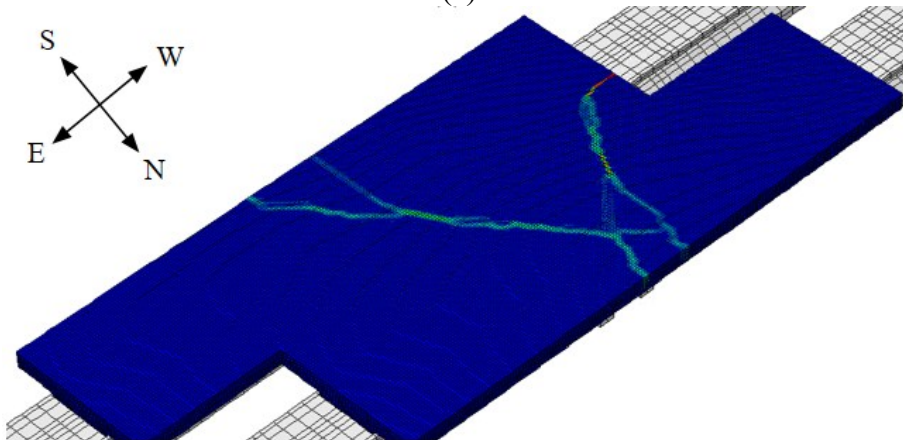
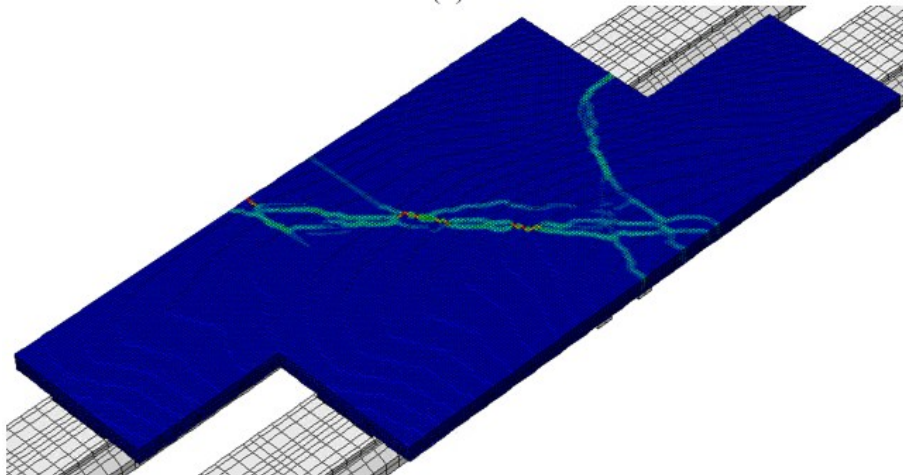
**Figure 8.81. Crack propagation in the debonded dual-girder skewed model with offset panels for loading progressing from the (a) northwest girder, (b) southwest girder, and (c) southeast and northeast girders.**

The debonded skewed model was loaded in the same steps as the bonded skewed model, starting with the northwest girder in Figure 8.81(a), then the southwest girder in Figure 8.81(b), and finally the northeast and southeast girders together in Figure 8.81(c). Load from the previous step was retained on the girder for subsequent load steps. The cracking pattern in step (a) began over the girder at the end of the debonded region, propagating to the north edge of the slab and curving in an L-shape above the edge of the precast panel to the west edge of the slab. Cracks formed independently on the west edge of the slab over the girder edge and joined with the crack emanating from the PBJ. A secondary crack also formed over the northeast girder in the debonded region. This crack propagated to the slab edge in one direction and southwest to join the initial crack. The crack branches on the north edge of the deck were on either side of the girder end gap in the debonded regions.

Cracking continued in step (b) with a diagonal crack between the girder lines and a second horizontal crack over the debonded region of the southwest girder, reaching the south edge of the slab. A secondary crack then formed over the southeast girder in the debonded region. This crack

ran diagonally across the deck to join the main PBJ crack. Finally, in step (c), additional secondary cracks formed on the north side of the slab past the northwest debonded region. Multiple branches also formed along the diagonal crack across the deck.

A comparison of the initial cracking behavior of the bonded and debonded skewed models showed the effects of debonding. Figure 8.85 shows that the debonded model delayed initial cracking by 0.00025 rad of girder end rotation. Furthermore, examination of Figure 8.76(c) and Figure 8.81(c) shows that the overall cracking pattern at high rotations was more dispersed in the debonded model. Debonding the link slab, even for a modest length of 18 in., caused multiple additional cracks to form within and outside of the debonded region. In the bonded model, cracking was more consolidated, forming larger singular cracks. Figure 8.86 shows the longitudinal stress in the top longitudinal steel adjacent to the point of first cracking in the decks. At higher rotations, stress in the steel of the bonded model exceeded that of the debonded model by as much as 20 ksi, indicating that crack widths are reduced with the dispersed cracking pattern.

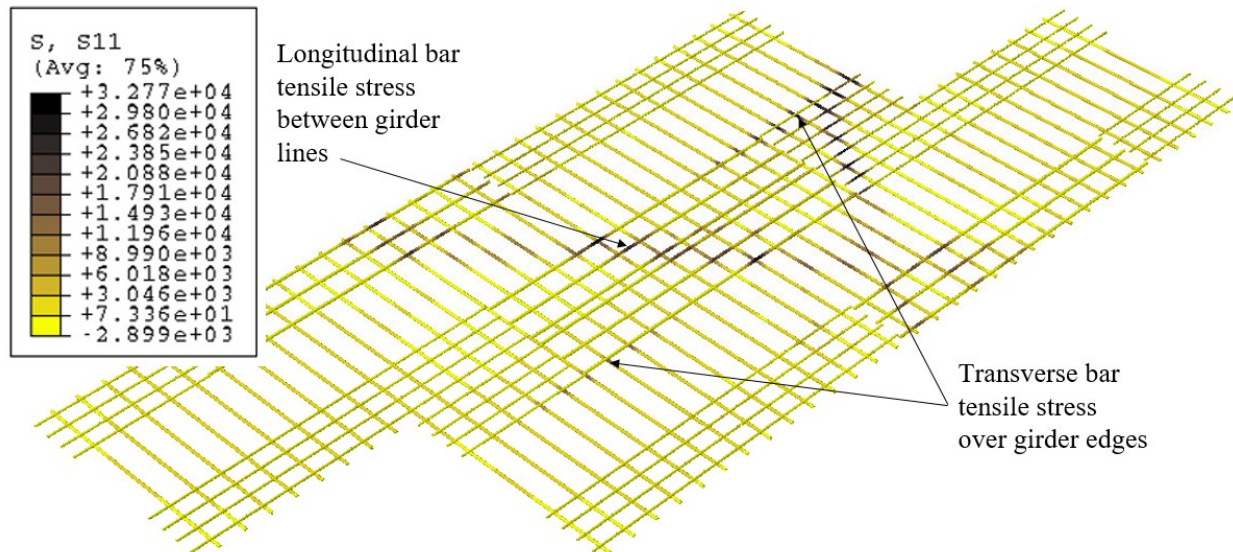
**Figure 8.84. Stress in the bottom longitudinal and transverse bars for the debonded skewed model, showing tensile stresses forming over the girder edges, with stresses extending diagonally between girder lines following the cracking pattern.**

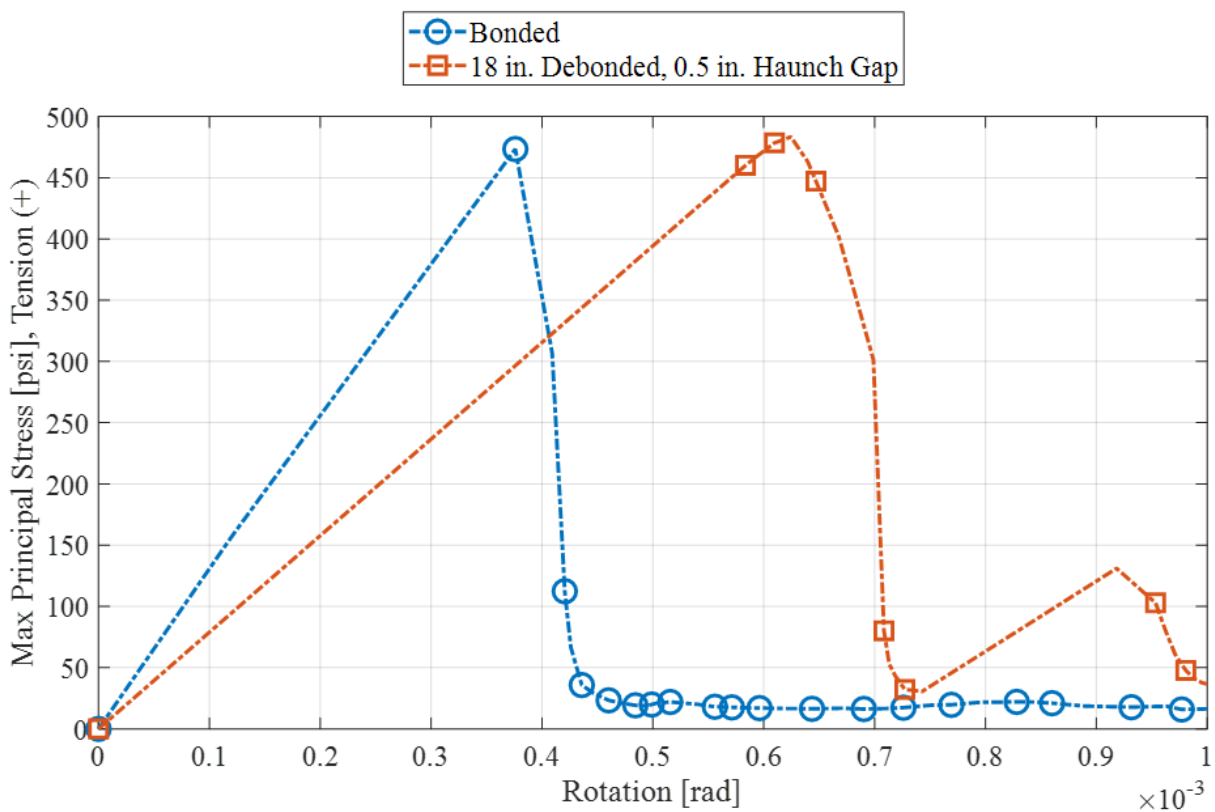
**Figure 8.85. Bonded and debonded comparison of dual-girder skewed models, showing maximum principal stress at the location of first cracking in each deck.**

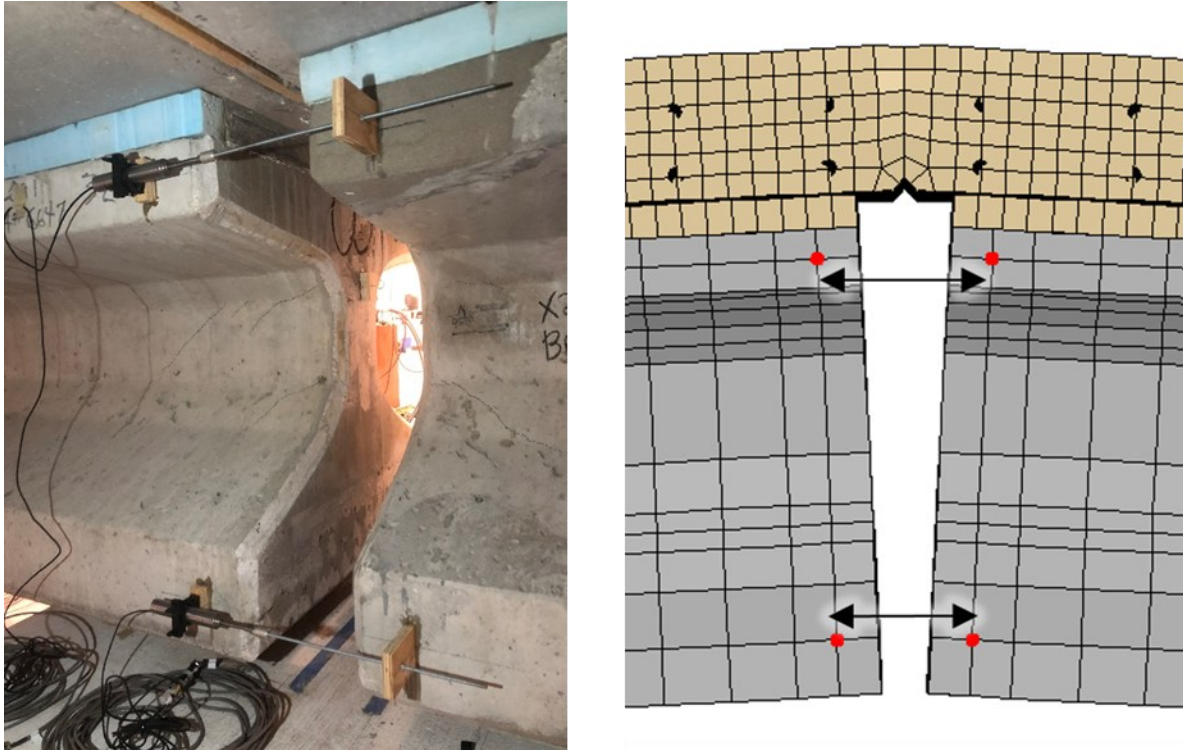
**Figure 8.89. LVDTs recording deformation at the girder ends (left) and nodes of matching LVDT connection points on the FEM (right).**

Since girder end rotation is the primary input for link slab deformation, comparing the deformation behavior in the PBJ region at different girder end rotations between the experimental test and FEM results reveals how well an FEM matches an experimental test. LVDTs installed at the girder ends, shown in Figure 8.89, may be used to make this comparison. The continuity provided by the link slab causes the girder ends to rotate about an axis in the link slab. If the stiffness properties and cracking behavior of the slab differ between the FEM and test, the location of this axis of rotation will also differ. Furthermore, differences in stiffness, cracking behavior, or support stiffness may cause differences in the axial deformation of the girder ends. These differences in the deformation characteristics of the link slab region cause different LVDT deformation values for a given rotation.

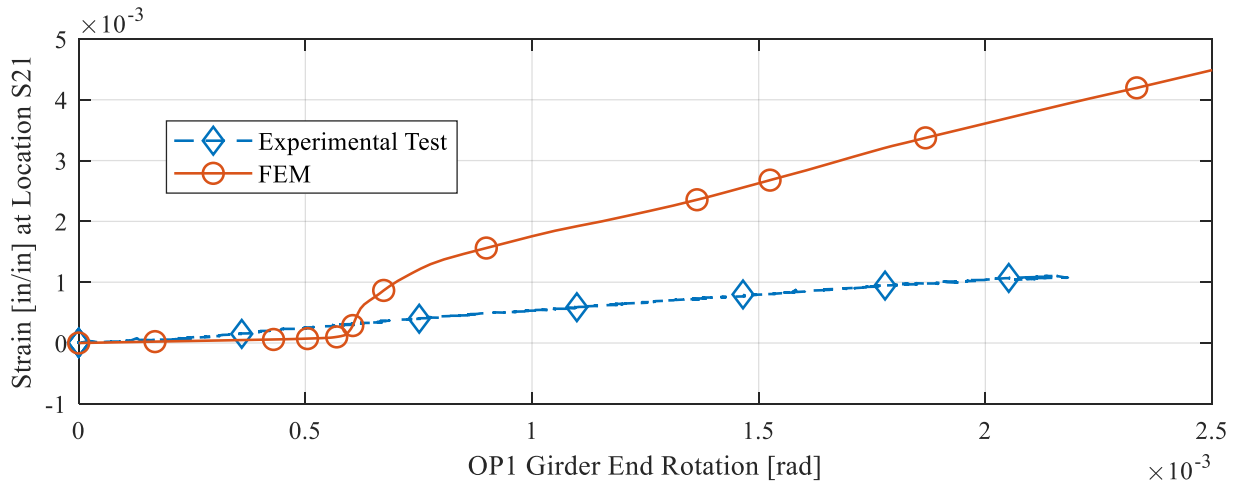
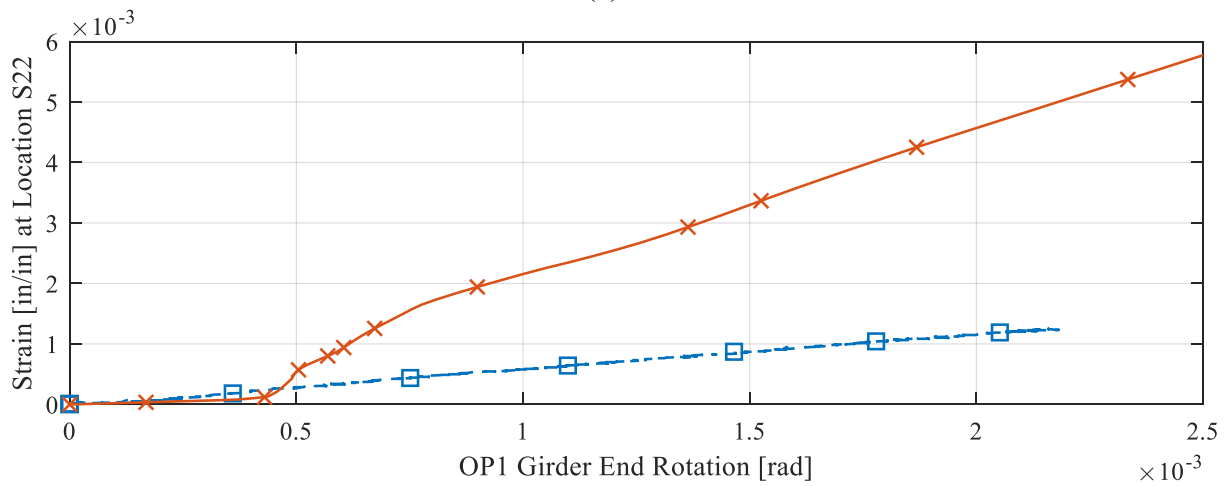
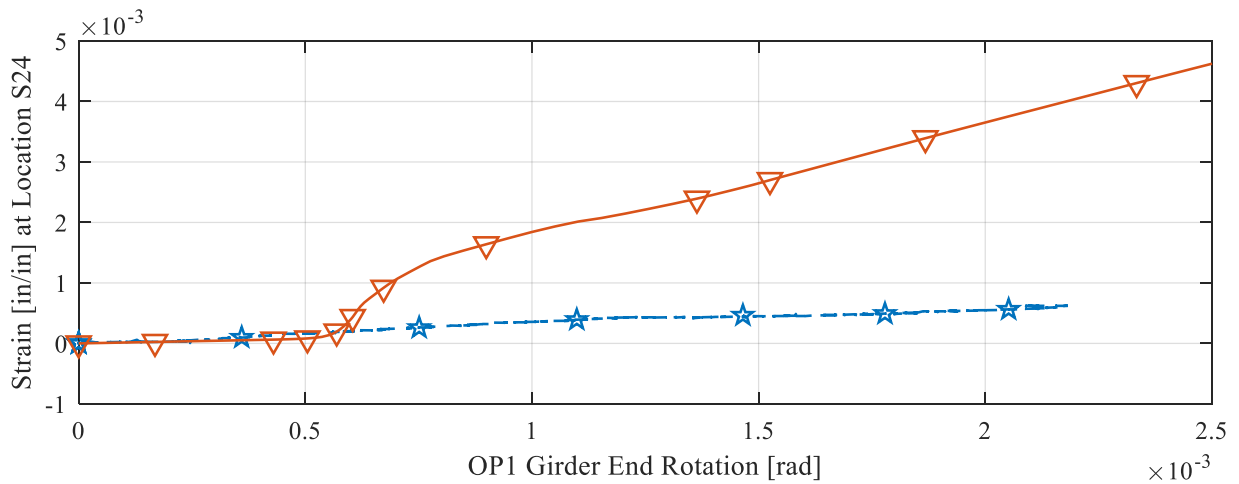
**Figure 8.92. Comparison of strains (a) at the center of the deck, (b) over the girder, and (c) in the overhang at the level of the top longitudinal reinforcement.**

Figure 8.92 shows a comparison of strains from embedded strain gages and from cracked elements in the FEM at the same locations: over the longitudinal reinforcement at the PBJ between the girder lines (a), over the girder line (b), and in the overhang (c). While the embedded gages showed a gradual increase in strains over the gage length, the FEM results showed nonlinear cracking behavior indicative of a crack opening at a specific element.

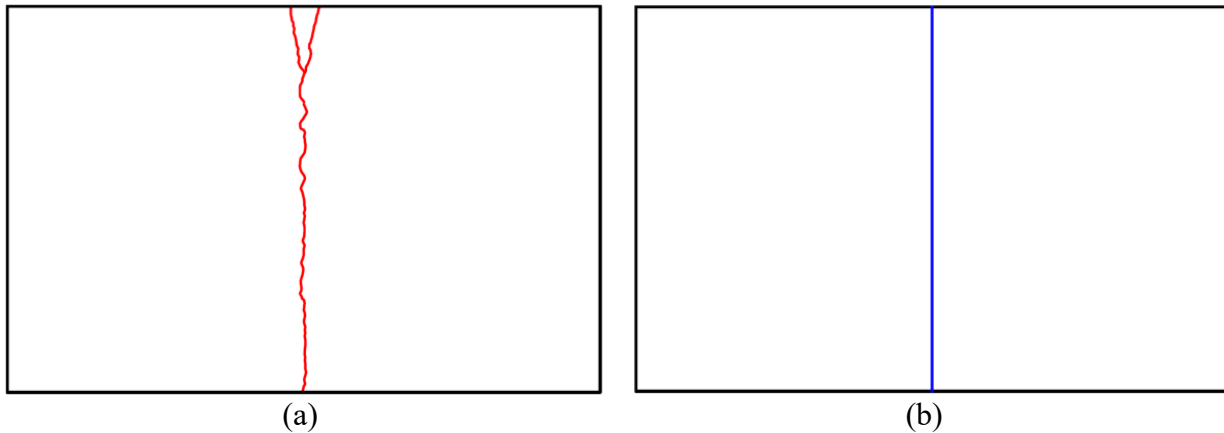
**Figure 8.93. Crack patterns of model FP1 for (a) the experimental test and (b) the FEM.**

Crack patterns may also be used to confirm that the FEM is accurately capturing test behavior. Cracking in the top of the deck for model FP1, presented in Figure 8.93, showed a crack above the timber board at the center of the PBJ reaching the full depth of the reduced CIP section above the board. The crack pattern was similar between the test and FEM, with the primary difference being a branched cracking pattern in the overhang of the experimental test deck.

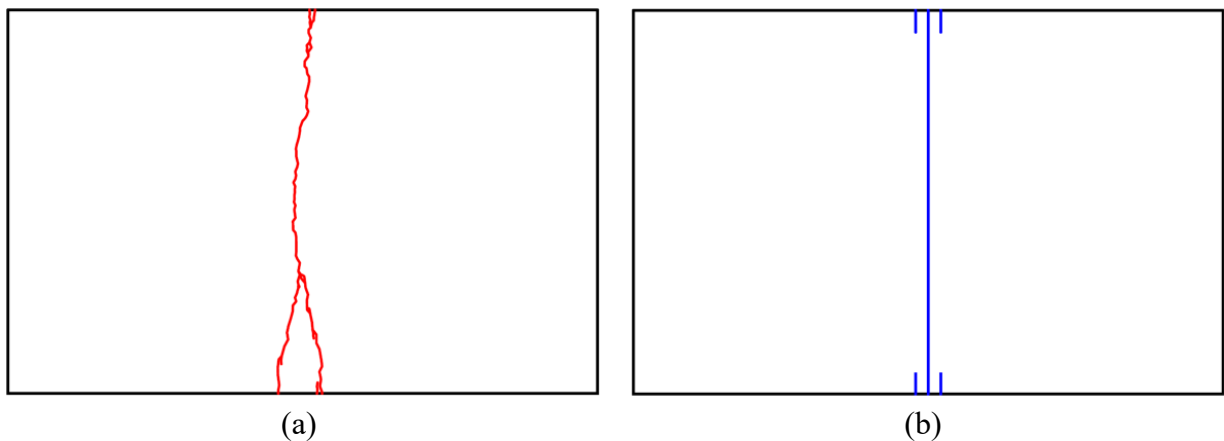
**Figure 8.94. Crack patterns of model OP1 for (a) the experimental test and (b) the FEM.**

Similarly, for test OP1, a main crack ran over the center of the PBJ, as shown in Figure 8.94. Branched cracks formed in the overhang for both the experimental testing and FEM. Cracks in the FEM did not reach the full depth of the deck, while the overhangs in the experimental test showed a full-depth main crack and branched cracks.

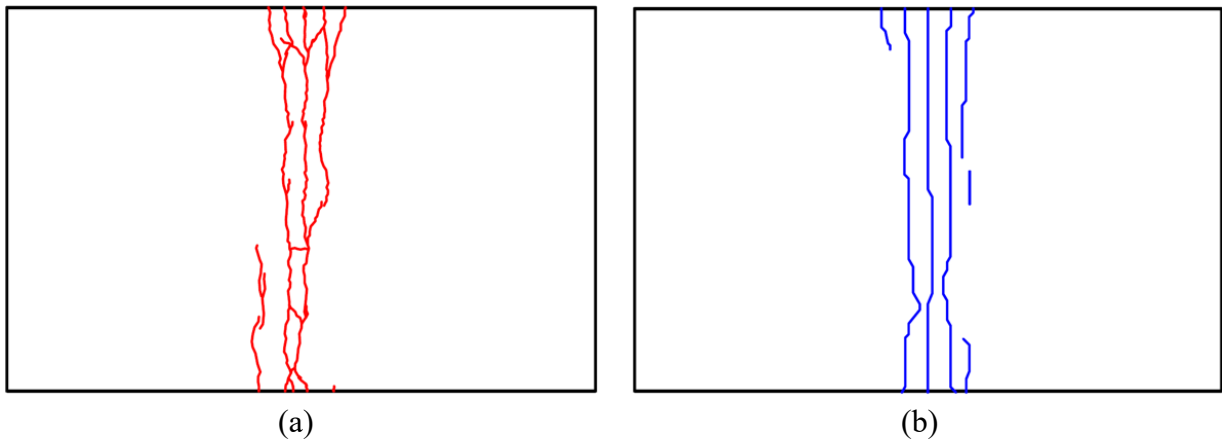
Comparison of cracking patterns for OP2 in Figure 8.95 showed similar secondary and branched cracking patterns. The addition of top longitudinal reinforcement in the northern side of the deck created a more dispersed crack pattern in the north deck in both the test and the FEM. The crack depth in overhang for OP2 was consistent between the experimental test and the FEM. Cracks

did not reach full depth, and the center crack reached the deepest, while subsequent offset cracks were less deep.

**Figure 8.95. Crack patterns of model OP2 for (a) the experimental test and (b) the FEM.**

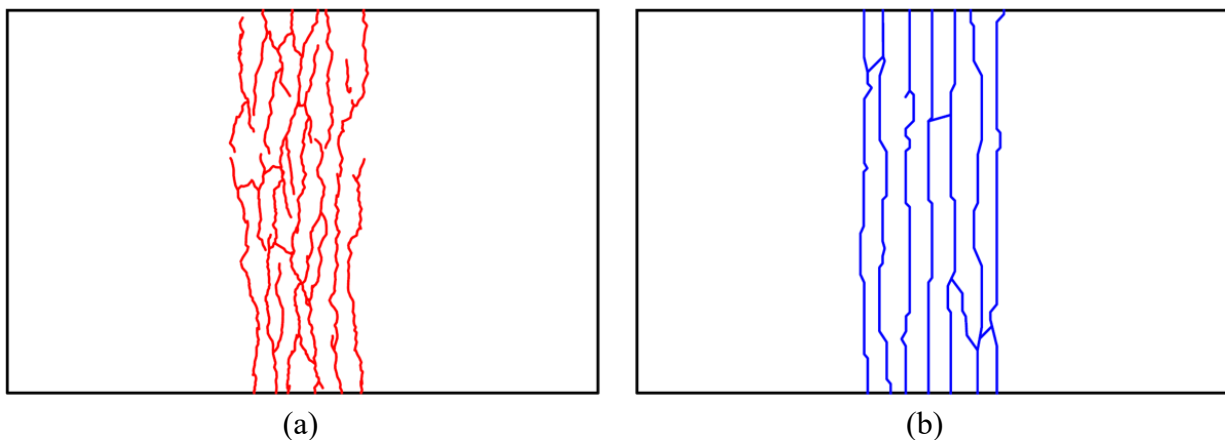
For test CP1, comparison of cracking patterns in Figure 8.96 showed a much more distributed pattern with secondary and tertiary cracks, as well as branches connecting these horizontal cracks. While cracks in the overhang did not reach full depth in the FEM, some full-depth cracks were visible in the experimental test. Furthermore, while offset tertiary cracks were not as deep as the primary and secondary cracks in the FEM, some tertiary cracks in the experimental test reached full depth.

**Figure 8.96. Crack patterns of model CP1 for (a) the experimental test and (b) the FEM.**

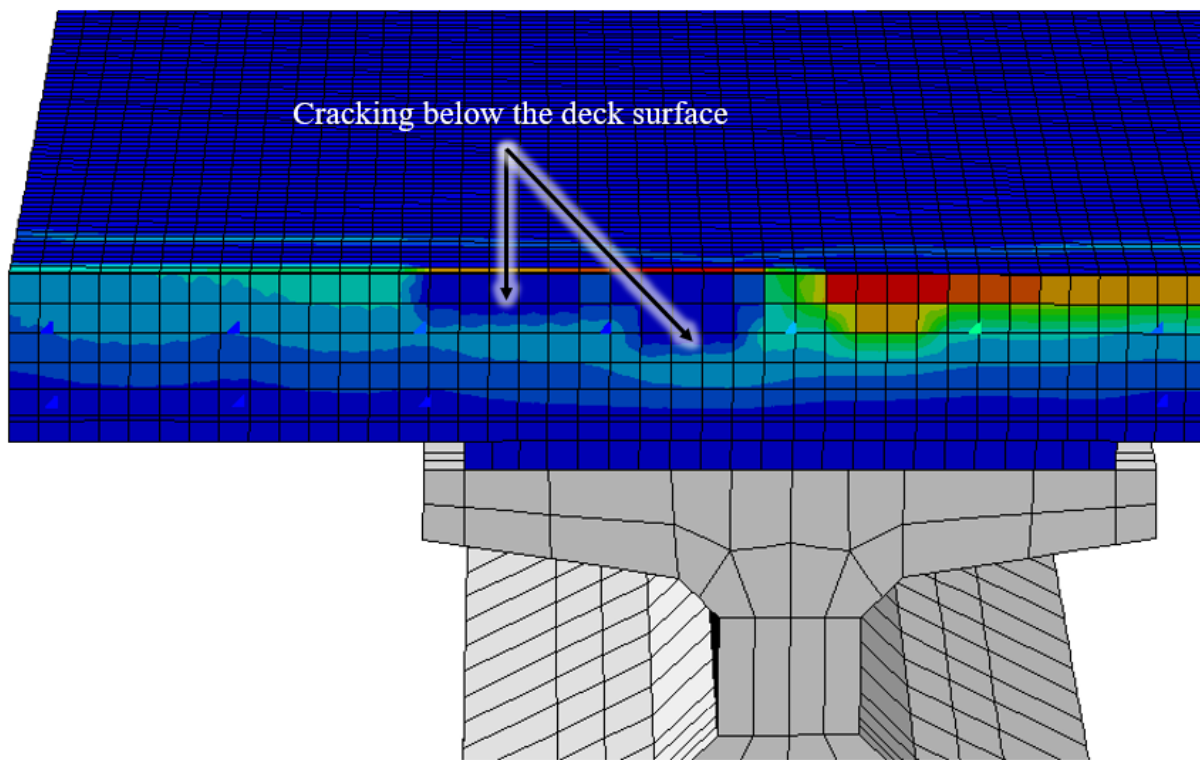
Finite element results for this test setup showed that taking a section cut at a slight angle to the top surface revealed similar behavior, as shown in Figure 8.97. Since the angle of cracks vary across the width of a specimen, taking an angled cross-section will intersect cracks beneath the surface while the concrete directly above is not visibly cracked.

**Figure 8.97. Angled section cut of the deck revealing cracking behavior below the deck surface similar to the behavior observed in laboratory testing.**

Experimental test specimen OP2 was observed to have peculiar cracking behavior over the girder edges at the poor boy joint. When the specimen was demolished after testing, a crack was observed on a cross-section of the deck that had formed below the top surface of the slab but did not extend to the top surface.

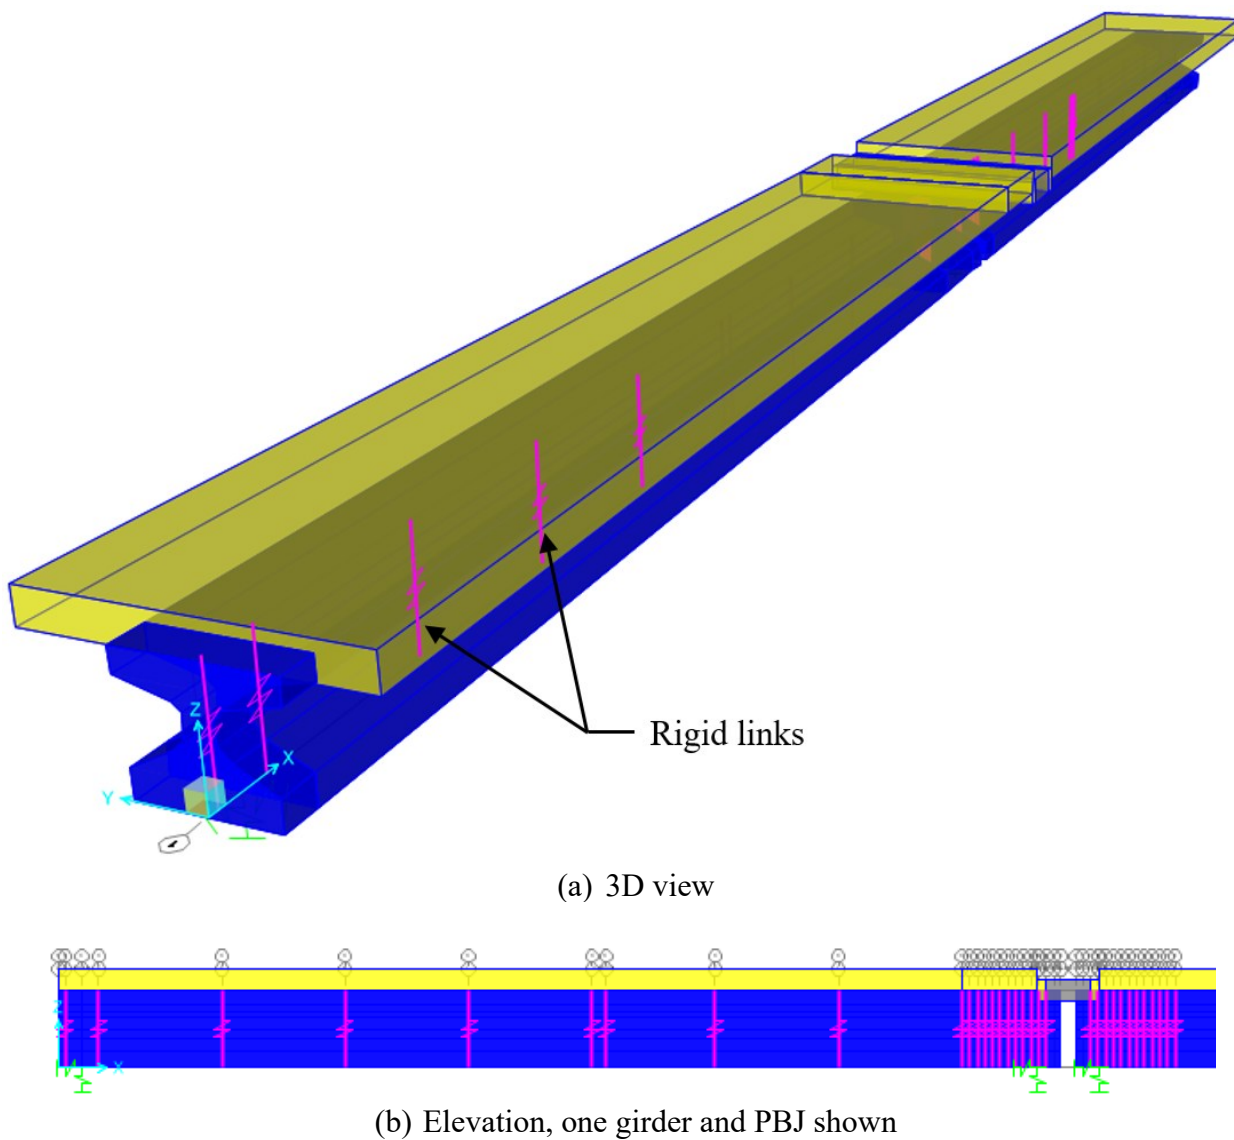
Simplified SAP2000 girder line models, such as the one shown in Figure 8.98, were used to verify elements of the laboratory test program and ABAQUS results. These models were limited to using concrete material properties in the elastic region (see Table 8.4) and therefore provided upper bounds for girder end deformation and slab rotation. SAP2000 models were not used to verify deck deformations and stresses from ABAQUS at high loads since material nonlinearity

would lead to dissimilar results. Both the deck and girder were modeled with beam elements. Continuity between the girder and slab was provided by rigid links.

**Figure 8.98. Simplified SAP2000 model using a single girder line with offset beam elements connected with rigid links.**

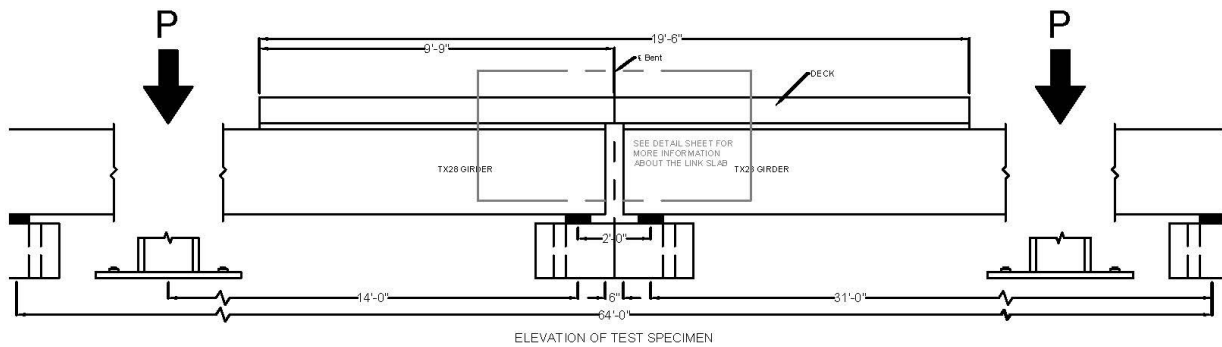
**Figure 9.5. Generic elevation of specimens showing geometry.**

Figure 9.2 shows a schematic overview of the experimental test setup. The specimen was designed as a two-span, two-girder bridge with deck only in the central portion of the specimen. One actuator was used in each span, with a spreader beam transferring load to each individual girder. Figure 9.3 through Figure 9.5 show generic cross-section, plan, and elevation views of the setup to provide dimensions; specific details for each link slab test are provided in Section 9.2, with full drawings of each specimen provided in Appendix B.

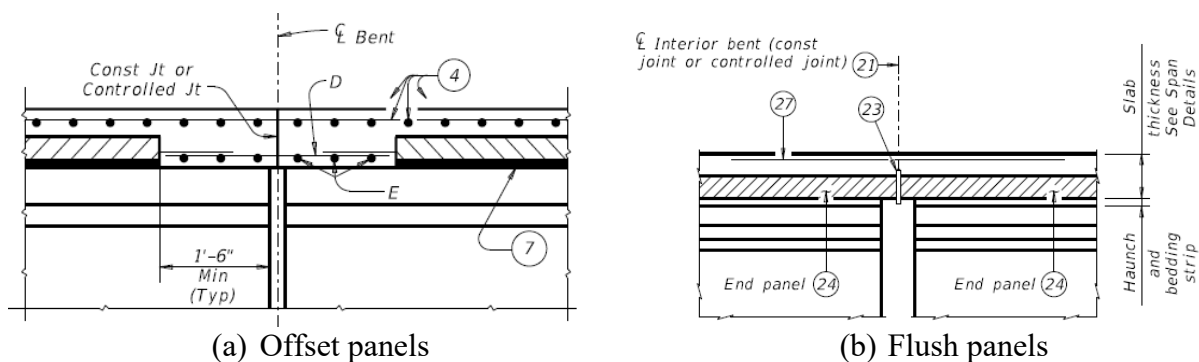
The details of the specimens are discussed here in relationship to the standard detail used by TxDOT at the time of this project. Figure 9.6(a) shows OP details that have been in place for many years. More recently, the use of the FP detailing shown in Figure 9.6(b) was introduced in response to preferences from contractors to avoid formwork for the CIP region.

**Figure 9.6. TxDOT standard drawing options for continuous deck details.**

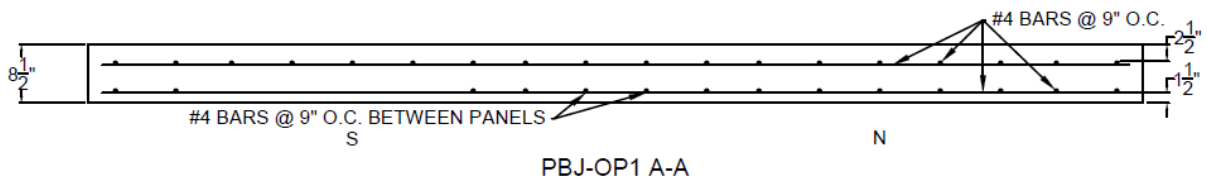
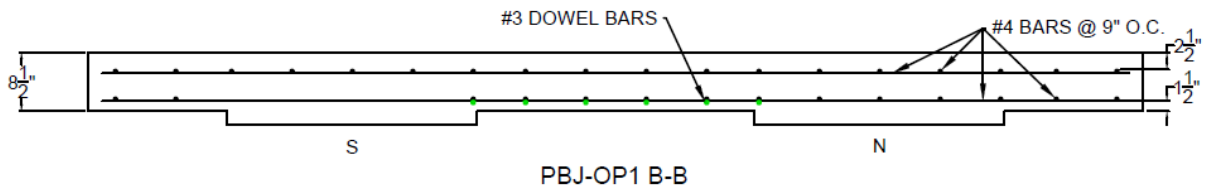
The offset panel reference specimen is named PBJ-OP1; details are shown in Figure 9.9. The panels are set 1 ft 6 in. from the end of the girder, with full-depth cast-in-place concrete in the deck between the ends of the panel. At the bottom of the slab, a preformed notch is located at the center of the continuous deck. The result is that the two overhangs are the same, unlike on FP1 and FP1R. As with prior tests, the bedding strip on the exterior of the girder is the only difference from the overhang detailing in standard TxDOT bridges.

The top reinforcement is the same as the longitudinal deck reinforcement, #4 @ 9 in. The same reinforcement is specified in the bottom of the CIP region. Over the south girder line, there is no longitudinal reinforcement, consistent with the TxDOT standard detail in place at the time of this research. Over the north girder line, bottom longitudinal reinforcement was included to consider design recommendation for inclusion of reinforcement for the purpose of positive bending in the link slab. A plane of weakness at the panel edges are avoided by providing #3 dowel bars extending from the panels, spaced at 6 in. Due to miscommunication with the fabricator, these dowels were not provided. Dowel bars were post-installed at 9 in. on center. While this is slightly different from the standard detail, it provides continuity with the bottom reinforcement in the CIP region. The post-installed dowels were confirmed to provide adequate capacity for demands expected during testing. On the north end of the panel, a dowel bar was included over the edge of the girder; this was not done on the south side.

The typical offset panel detail specifies a zip strip as a crack former on the top center of the continuous deck and a  $\frac{3}{4}$ -in. chamfer on the bottom. Similar to the PBJ-FP1 test, PBJ-OP1 does not include the zip strip but does include the chamfer on the bottom of the detail.

**Figure 9.9. PBJ-OP1 geometry and reinforcement: (a) elevation view and (b) select cross-sections.**

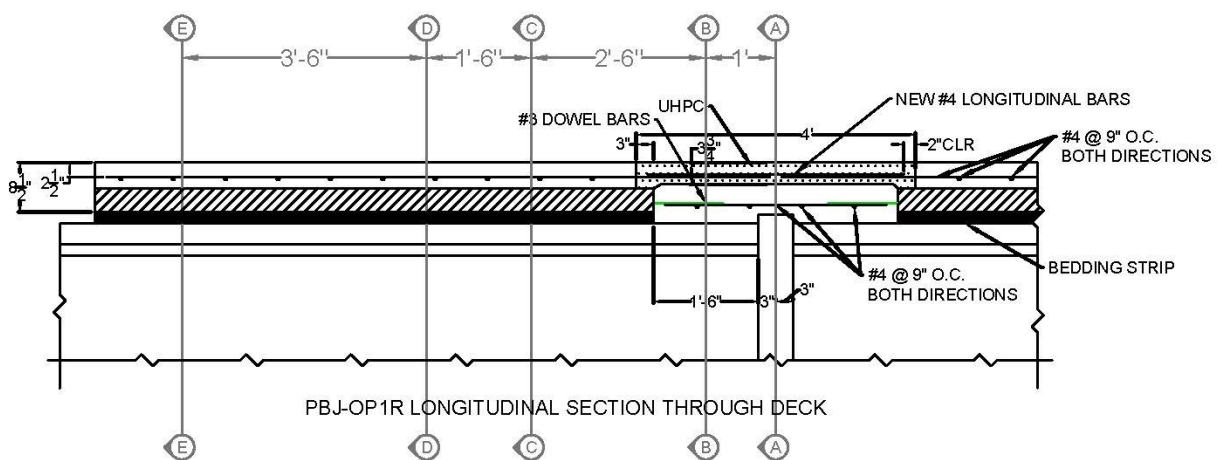
After testing, PBJ-OP1 was retrofitted to specimen PBJ-OP1R. Figure 9.10 shows the elevation view of the retrofit. Figure 9.11 shows the cross-section. The objective of this retrofit was to investigate the behavior of a link slab with HPC. Such a link slab is expected to be stiffer and form multiple small cracks compared to a single large crack. The details of the retrofit were intended to enable a quick investigation of the performance of a link slab using HPC while

The length of the retrofit region extended 3 in. beyond the edges of the panels. This ensured that damage from prior testing (cracks at edge of panel) was removed and did not influence the retrofit behavior. The depth of the retrofit was sufficient to install new longitudinal reinforcement given that yielding occurred in PBJ-OP1. The depth of the removal was 3.75 in., which provided 0.75 in. below the top reinforcement, a requirement of the TxDOT Concrete Repair Manual.

**Figure 9.10. PBJ-OP1R elevation view.**

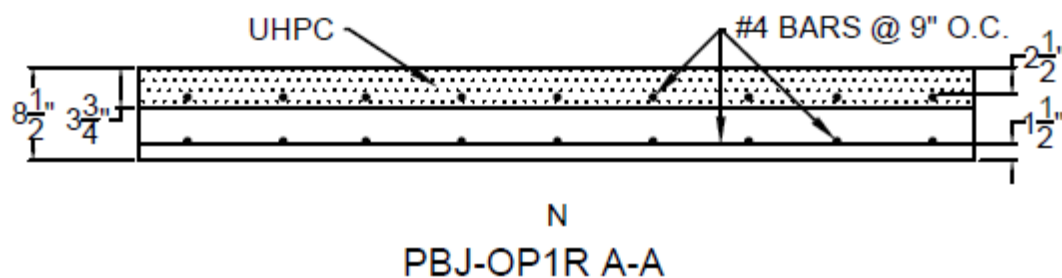
The existing longitudinal bars were retained except for a 2-in. section in the middle. This provided a splice between the new bar and the existing deck steel. The transverse reinforcement was removed for simplicity of demolition and construction. It was not replaced given the nature of the planned loading. HPC was bonded to the existing concrete. A nonproprietary mix developed for TxDOT Research Project 0-6982 was utilized.

**Figure 9.11. PBJ-OP1R cross-section at center of link slab (Section A-A).**

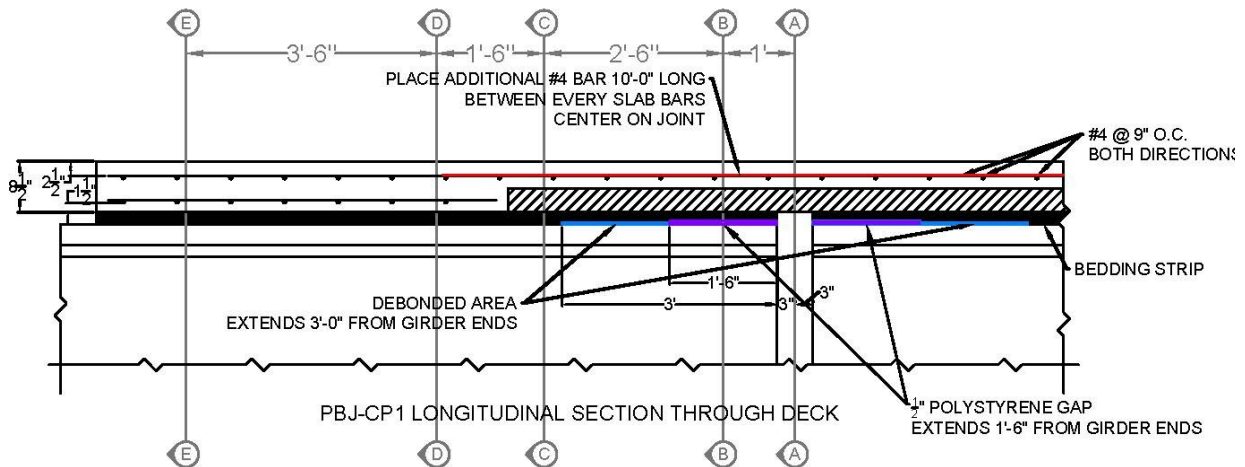
PBJ-CP1 is a proposed design alternative for link slabs with the precast panel continuous over the ends of the girders. This detail is referred to as the continuous panel detail. Figure 9.13 shows the elevation view of the design. The objective here was to eliminate aspects that contribute to the formation of cracks to allow for more distributed cracking. As a part of this, a small gap was included between the top of the girder and the haunch. The design modification included debonding, increased reinforcement, and no chamfer on the deck bottom. Figure 9.14 provides a cross-section at the gap; full drawings of the details can be found in Appendix B.

Two key features of the design differentiated it from the PBJ-OP2 proposed design alternative. The first was the continuous panel. The goal of this was to eliminate weak sections in the link slab that would provide a location for deformation, and therefore damage, to concentrate. A single panel was used in this test, with the panel length of 8 ft extending 4 ft on either side of the center of the link slab. The second was a 0.5-in. gap between the top of the girder and the haunch concrete. The goal was to eliminate the initiation of cracking from the girder end pushing into the deck concrete. Such detailing is used in standard details used by other jurisdictions. Since a physical gap is not practical to construct and provides potential location for water intrusion, the gap was formed with a weak polystyrene. The length of the polystyrene gap was 1.5 ft.

**Figure 9.13. PBJ-CP1 details—elevation view.**

Like the PBJ-OP2 proposed design, a major distinguishing feature from existing tests was debonding the deck from the top of the girder. The debonding in PBJ-CP1 was the same as that for PBJ-OP2 and was done in the same manner. As with PBJ-OP2, the bottom chamfer was eliminated to support avoiding regions where deformation and therefore damage concentrate.

The reinforcement in PBJ-CP1 contained #4 @ 9 in. in both the transverse and longitudinal directions, with additional longitudinal #4 bars added between the deck longitudinal reinforcement. This was notionally the same as the reinforcement in the flush panel details and was selected due to the smaller crack widths in PBJ-FP1 compared to PBJ-OP1. The PBJ-CP1 north reinforcement was different from PBJ-FP1 in that the bars extended 10 ft on each side of the center to ensure adequate development in the DLS. The only difference in reinforcement in the north and south half of PBJ-CP1 was that the north girder line had longitudinal bottom reinforcement (proposed detailing), while the south did not (current TxDOT detailing).

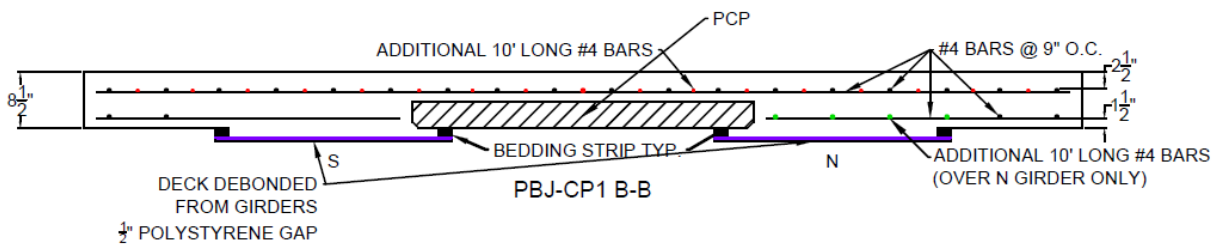
**Figure 9.14. PBJ-CP1 details—cross-section (B-B) showing details where gap is present at end of girders.**

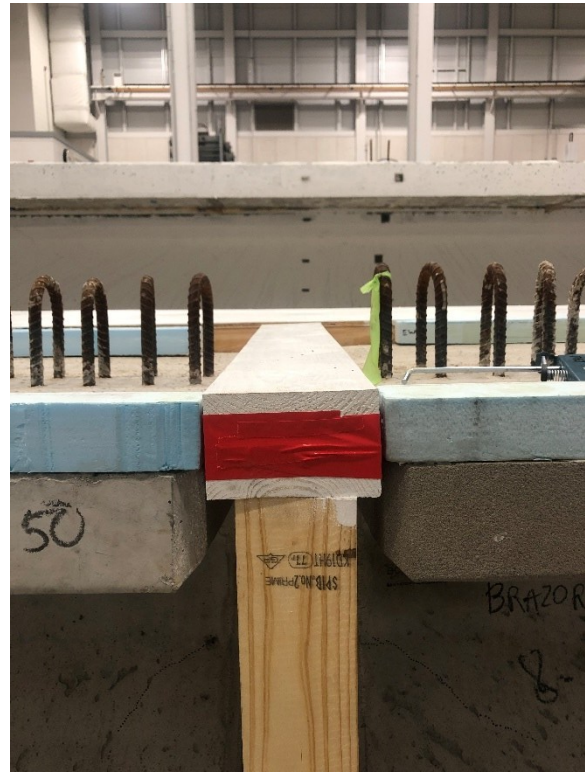
**Figure 9.17. Formwork used between girder ends for PBJ-FP1.**

In the flush and offset designs, formwork was also needed between the ends of the girders. One challenge was fitting formwork in a narrow space with inconsistent dimensions while ensuring that concrete would not leak through a gap. Figure 9.17 shows the approach used in PBJ-FP1. A subassembly of 2×6s supported on a frame of 2×4s was placed between the girder ends. This left only a small gap between the formwork and the ends of the girders, which was filled with a backer rod with caulk above. This approach had been validated with a trial batch in a small mockup prior to casting concrete. However, when implemented in the actual specimen, there was significant difficulty in removing the formwork because the self-weight of the concrete and effects of shrinkage led to a small compressive force acting on the formwork. At the backer rods, the pressure from concrete caused a sag, contributing to the difficulty in removal. In offset panel construction (PBJ-OP1 and PBJ-OP2), the bedding strip foam was used instead (Figure 9.18). While compression was still present after casting and curing the deck, the foam was easier to remove.

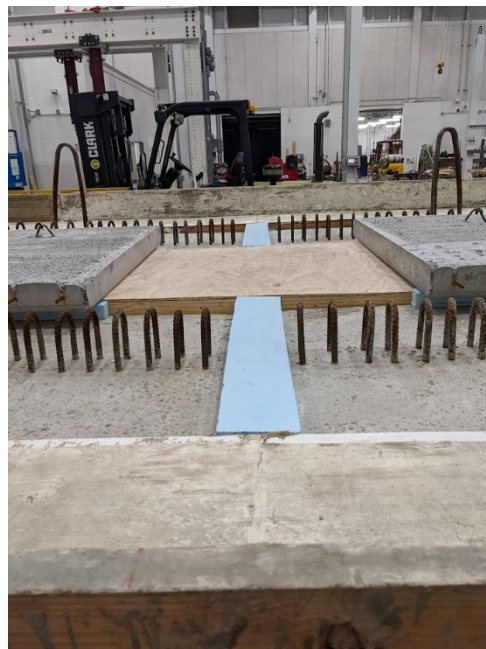
**Figure 9.18. Formwork used between girder ends for offset panel tests (PBJ-OP1 shown); post-installed dowel bars not present.**

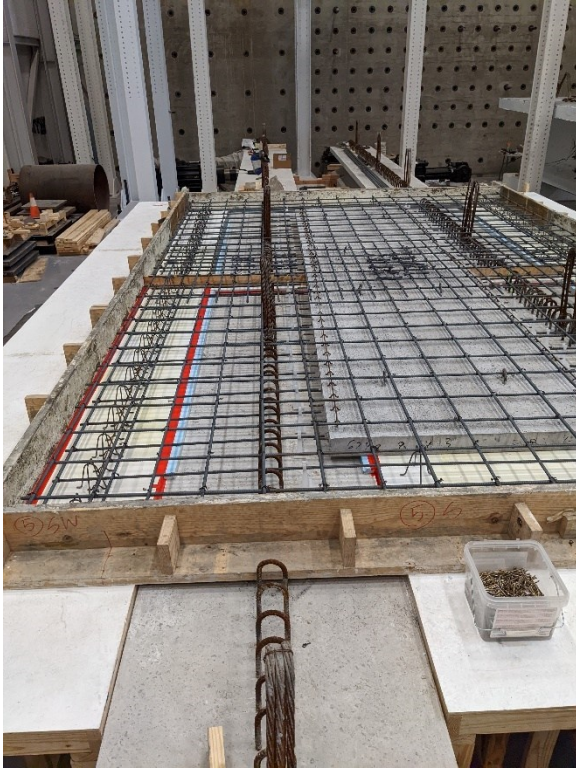
**Figure 9.19. FP1 prior to casting concrete.**

(a) Looking west

(b) North overhang

In the north overhang, the notch on the bottom of the deck was created by attaching a  $\frac{3}{4}$ -in. triangle-shaped piece of molding to the bottom formwork (visible in Figure 9.19[b]). This did not shift during placement and was successful in forming the notch seen in a typical overhang.

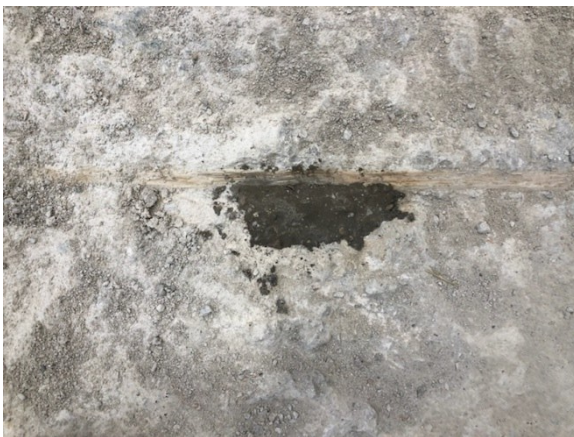
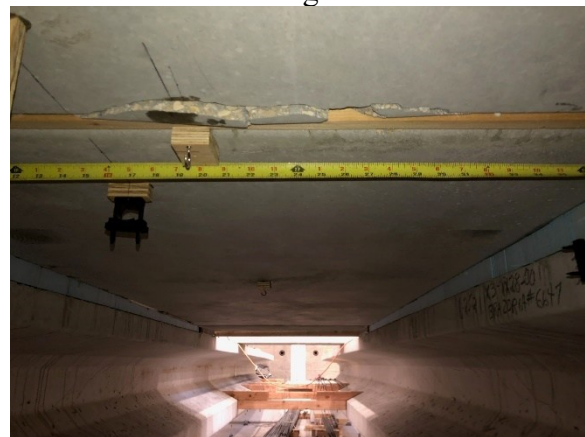
**Figure 9.23. Damage to CIP concrete during demolition for FP1R.**

(a) Crack in southeast overhang

(b) Hole adjacent to board between north girders

(c) Patched hole

(d) PCP damage at board

During removal of the concrete, some damage occurred to the bottom portion of the deck. In the south overhang, a diagonal crack formed, as shown in Figure 9.23(a). This crack was located 13 in. east (at the bottom) of the center of the link slab. While the crack formed during use of the jackhammer and may simply have been the result of the force applied to the unsupported deck, the location suggests the possibility that preexisting damage played a role. The distance from the center was approximately the same as the distance to where secondary cracks were located. The east secondary crack in the south overhang was not observed to extend to the edge of the deck following testing. It is possible that microcracks had formed and developed to a visible crack during demolition. Figure 9.23(b) shows a 2-in. diameter punch out adjacent to the west face of the board between the north girders. The hole was patched with a DOT-approved repair mix (Figure 9.23[c]). Figure 9.23(d) shows damage to PCPs adjacent to the board; the damage was unable to easily be removed without risk of further damage. Thus, no repair was completed.

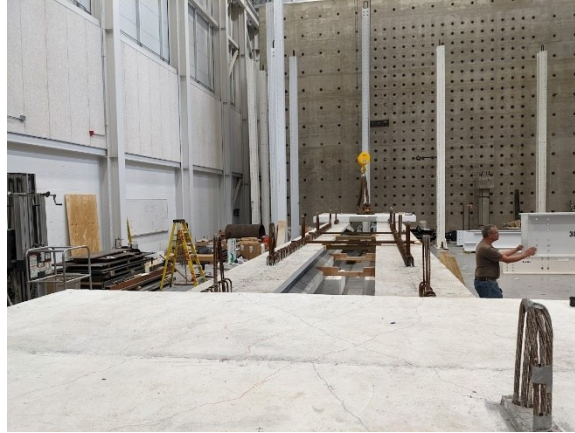
**Figure 9.25. Girders in place for PBJ-OP1 deck construction (far ends of the girders have the deck from the PBJ-FP1R test).**

The spans were swapped so that the northeast and northwest girders became the southeast and southwest girders, and vice versa. The bearing pads were not moved from the previous locations, ensuring that the support locations were equal between each test. As a result of the damage imposed in prior tests, the elevations of the girder ends were slightly different, but not sufficient to be of concern to the performance of the test. For OP1 deck construction, the difference is accounted for in the bedding strips, which are custom fit on each girder edge to ensure a level and consistent depth deck. Figure 9.25 shows the girders in place to begin construction on OP1.

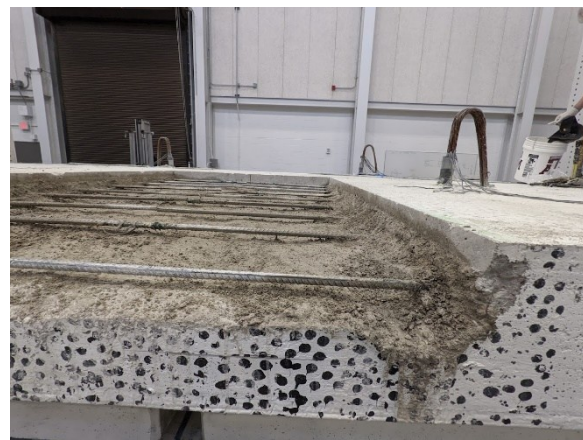
**Figure 9.28. (a) Saw cutting and (b) concrete removal from OP1 in preparation for OP1R.**

A full-depth, longitudinal saw cut was made on all deck regions (tested region and far ends of girders containing deck from PBJ-FP1 and PBJ-FP1R). This enabled retrofit and testing of only the north half without influence from the south half. Following cutting, the deck of the north girder tilted slightly such that the inner side was higher than the overhang. Partial-depth transverse saw cuts were made at the boundary of the retrofit region. The cut was approximately 2 in. deep to avoid cutting the reinforcement. The top 3.75 in. of concrete was removed by jackhammer and chipping hammer. Transverse reinforcement was removed to help accelerate the demolition. At the edges of the deck, minor damage occurred during removal, with the removal depth essentially being slightly larger in isolated locations. This is shown in Figure 9.28(b).

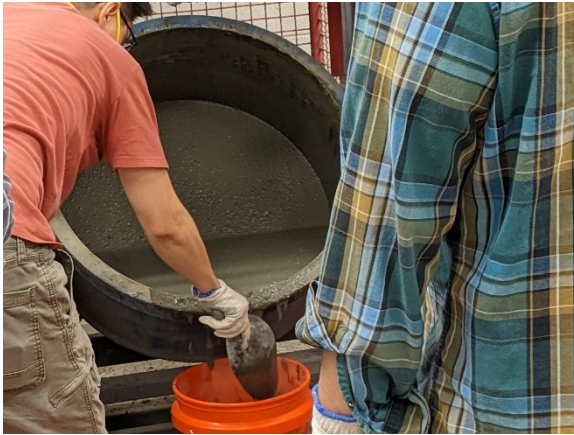
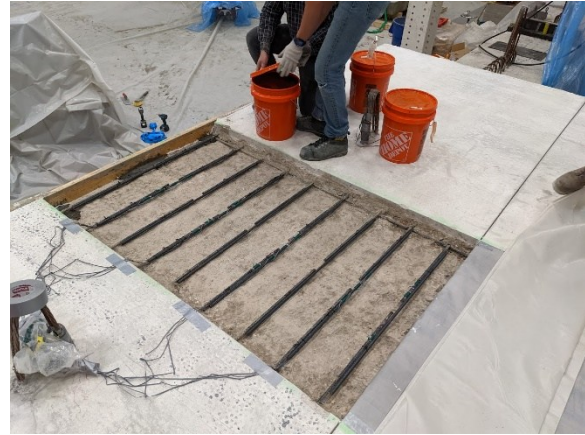
**Figure 9.29. PBJ-OP1R (a) mixing of HPC and (b) formwork with buckets staged for placement.**

Concrete was placed on December 6, 2022. Figure 9.29 shows photos from the mixing and placement. HPC was mixed in a high-shear mixer with a 1.9 ft<sup>3</sup> capacity, led by TxDOT 0-6982 team members. Small batches of approximately 1.25 ft<sup>3</sup> (less than 70 percent of the mixer capacity) were performed to ensure sufficient power to mix HPC. Seven batches were made,

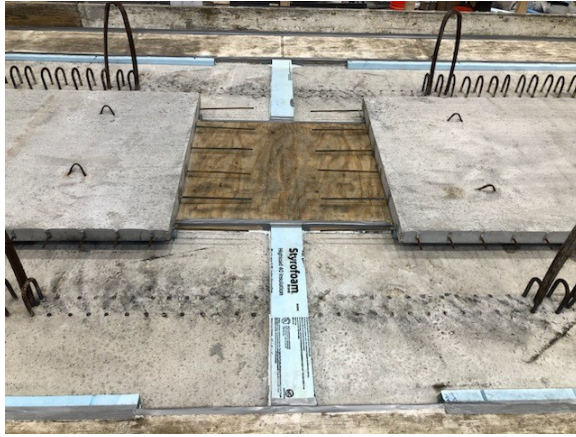
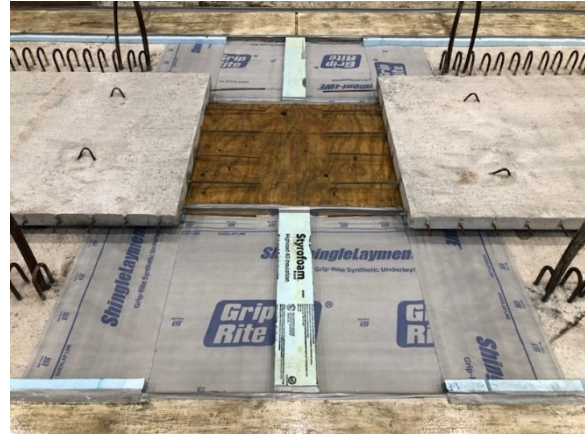
**Figure 9.31. PBJ-OP2 (a) R-bars removed in debonded region and (b) roofing paper to debonded deck concrete from top of girder.**

The R-bars were cut and ground flush with the top of the girders (Figure 9.31[a]) for the first 3 ft of each girder. The final bar cut was one prior to the lifting hook, allowing the lifting hook to be used as a reference point for the debonded region during testing. Roofing paper was placed on top of the girder (Figure 9.31[b]) to prevent bonding of the deck concrete to the girder. Two pieces were used on each girder to ensure the full surface was covered, accounting for the smaller width at the panel due to a bedding strip. A small amount of epoxy was used to keep the roofing paper in place on top of the girder. Figure 9.32 shows the completed formwork with rebar placed.
