# Performance and Improvement of Texas Poor Boy Continuous Bridge Deck Details: Final Report

Technical Report 0-7013-R1

Cooperative Research Program

TEXAS A&M TRANSPORTATION INSTITUTE  
COLLEGE STATION, TEXAS

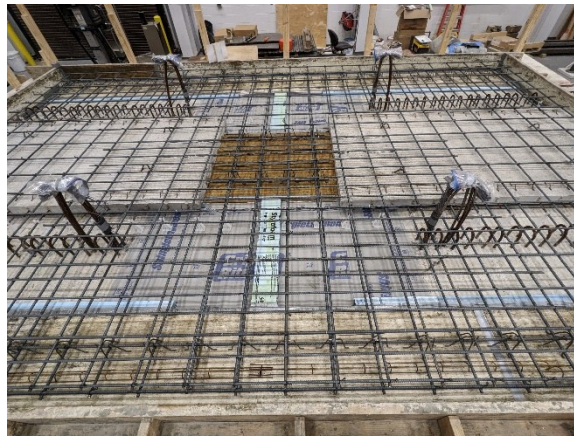
**Figure 9.32. PBJ-OP2 formwork with all rebar (the north girder is at bottom and has supplemental top bars).**

The R-bars were cut and ground flush with the top of the girders (Figure 9.31[a]) for the first 3 ft of each girder. The final bar cut was one prior to the lifting hook, allowing the lifting hook to be used as a reference point for the debonded region during testing. Roofing paper was placed on top of the girder (Figure 9.31[b]) to prevent bonding of the deck concrete to the girder. Two pieces were used on each girder to ensure the full surface was covered, accounting for the smaller width at the panel due to a bedding strip. A small amount of epoxy was used to keep the roofing paper in place on top of the girder. Figure 9.32 shows the completed formwork with rebar placed.

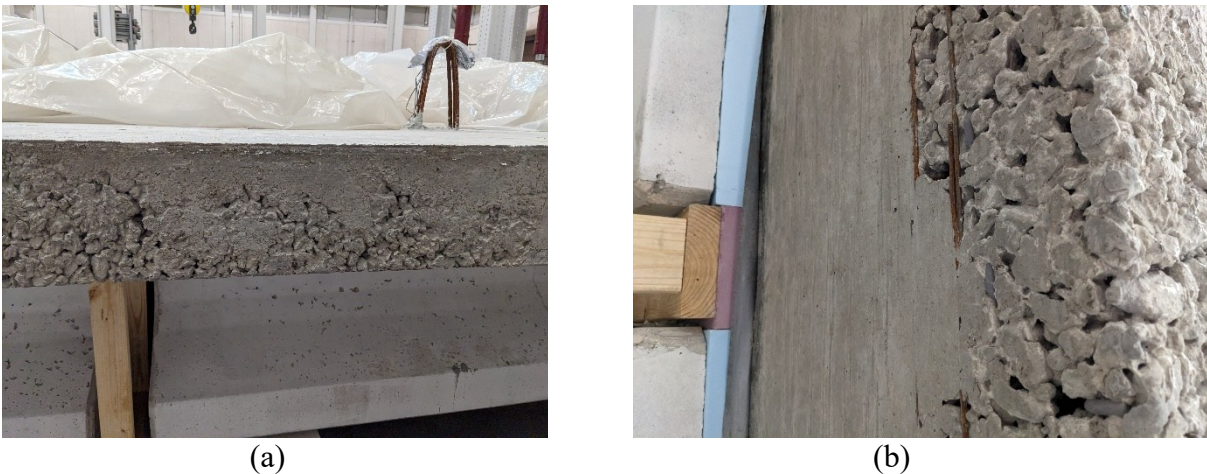
**Figure 9.34. PBJ-CP1 honeycombing in south overhang prior to repair.**

Concrete was placed on May 3, 2023. Concrete was placed from west to east for simplicity of construction. When formwork was removed, researchers saw that the south overhang at the link slab center was not well vibrated, leading to honeycombing. Figure 9.34 shows the honeycombing prior to repair following the specifications of the TxDOT Concrete Repair Manual (2021). During testing, no adverse effects of the repair were noted.

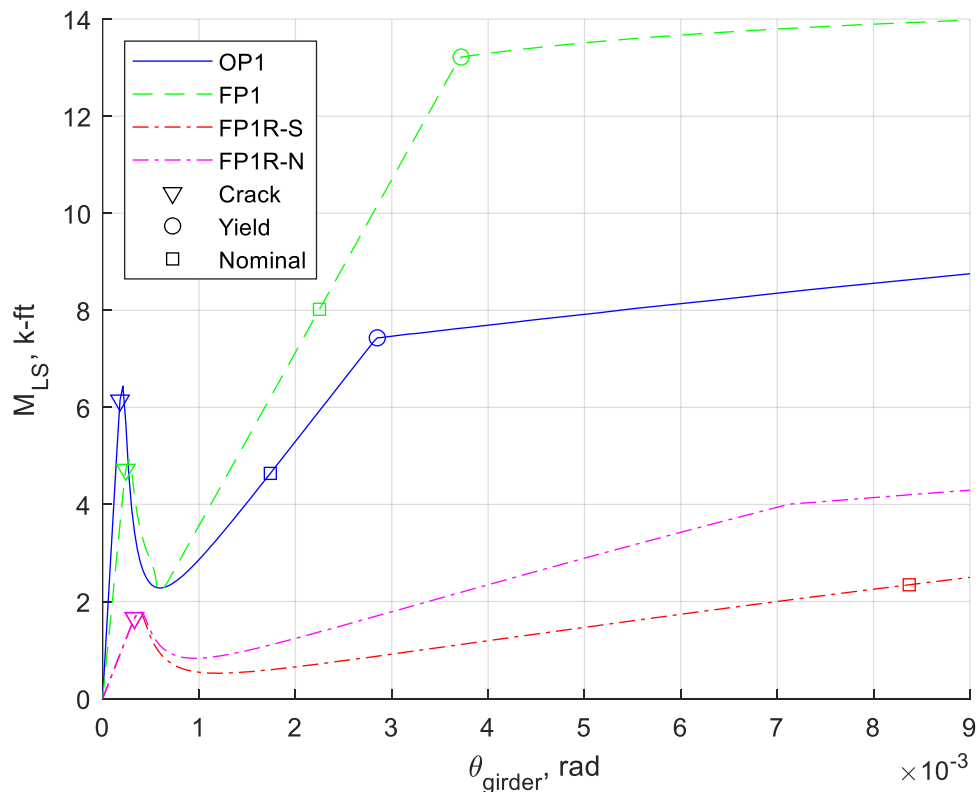
**Figure 9.35. Moment-rotation response of link slab for design material properties and assumed link slab length of 12 in.**

Figure 9.35 provides a preliminary analysis of the expected response of the link slab. Moment-curvature analysis was conducted using design material properties. Curvature was converted to rotation assuming a 12-in. link slab length. While each design was expected to have a different effective link slab length, the same length was used for simplicity in predicting the response prior to testing.

For each response, cracking was marked with a triangle marker, yield with a circle, and 60 percent of yield with a square. For FP1R-N, a yield point is not shown because the strain was not recorded in the supplemental steel. However, the change in stiffness around 0.007 rad was yield of the supplemental steel. Rotation limits were not the maximum capacity but were rather

The OP1 and FP1 designs had similar cracking rotations, although the cracking moment was larger in OP1. After cracking, FP1 had greater stiffness than OP1, as well as a larger yield moment and rotation. This finding was a result of the supplemental reinforcing bars. In the FP1 responses, the strengths dropped significantly. However, since the design of link slabs is a deformation-controlled design, the strength was not a concern. Compared to OP1 and FP1, the cracking moment and rotation were only slightly larger. However, the post crack stiffness was much lower, resulting in large rotations before the key values for the strain in the steel were reached.

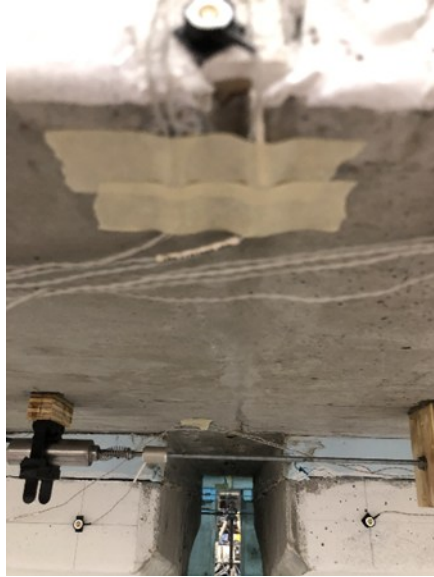
**Figure 9.39. Surface strain measurements on bottom of deck using LVDTs.**

Figure 9.38 provides generic plans for measuring surface strains. Figure 9.39 shows an example installation of a gage. As best possible, the surface strains were at the same transverse locations as the steel strain gages to allow for assessment of strain profile. Measurements were all at the longitudinal center of the continuous deck. On the top of the deck, strain gages were used accordingly. Strain gages were not practical on the bottom due to the board (flush panels) or notch (overhang and offset panels), so LVDTs were used to measure the relative displacement of either side of the center for use in estimating strain.

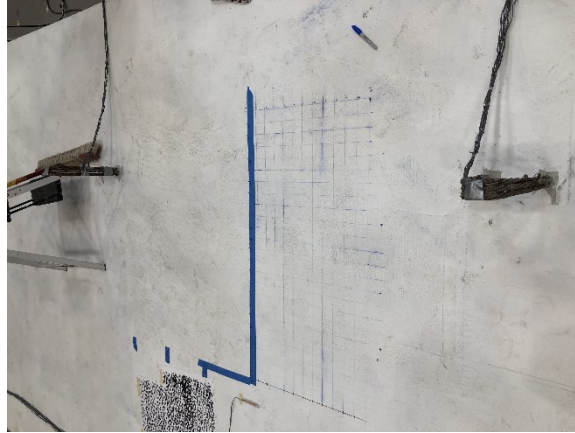
Prior to and/or after the tests, small regions of the decks were evaluated using nondestructive evaluation methods used in the prior part of the project. NDE methods used were GPR and UST. The goal was to try to capture how well the CIP concrete was bonded to the existing concrete prior to testing, and to see if there were any changes during the test. Figure 9.44 shows the location of NDE on each specimen.

In PBJ-FP1 and FP1R, a 2-ft by 4-ft grid was located over the northwest portion of the link slab. The edge was along the main crack and adjacent to the DIC region so that the grid would not interfere with the DIC processing. NDE data were collected prior to the first test and after the final test in FP1, and after the final test in FP1R.

**Figure 9.44. Locations of NDE grids.**

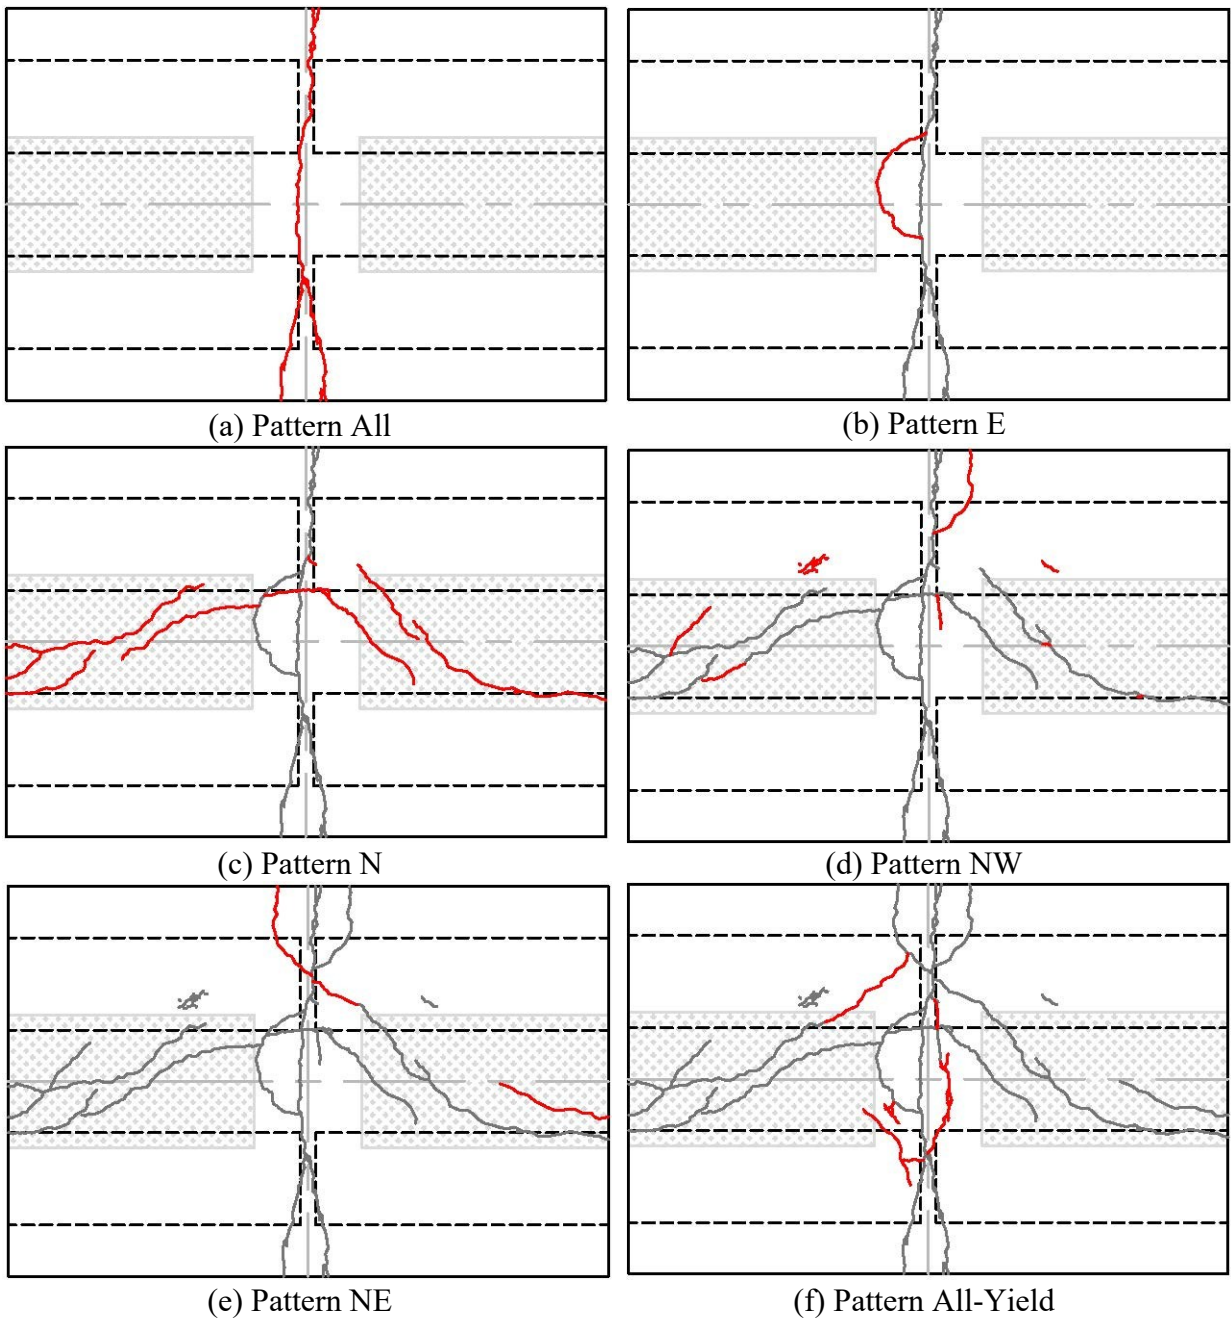
Figure 9.49 shows the cracks for all PBJ-OP1 load patterns. While there were no cracks present before testing, initial cracking occurred very early at a load less than 20 kips during the initial loading, Pattern All-1. The initial crack spanned the full width of the deck over the interior flanges of girders and between the girder lines. The crack angled inward at the center of the girders, crossing over the center of the link slab and continuing on the east side. On the south overhang, the crack presented as a portion of a branched main crack (angled near girder and transverse at edge). On the north overhang, the crack was an offset crack (primarily transverse). Both overhang cracks had a small branch or parallel crack adjacent to them. During the pause at 120 kips, another branched main crack formed on the south overhang, this time on the west side, at a distance farther from the center than the east branch crack.

**Figure 9.49. PBJ-OP1: Cracks for all load patterns.**

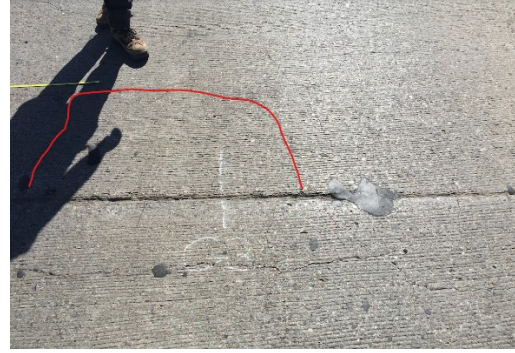
During the initial asymmetric patterns, only one new crack formed. In Pattern E-1, a D-shaped crack formed on the west side of the link slab center (Figure 9.50). The D was not centered transversely, with the north leg over the girder flange and the south leg slightly north of the south girder edge. The transverse portion of the D was located over the edge of the panel. The crack was hairline at formation and fully closed after unloading. This was the first such damage observed in the experimental test but was similar to damage that was seen on one bridge in field evaluations.

**Figure 9.50. PBJ-OP1 D-shaped crack: (a) formed during Pattern E-1 and (b) similar damage observed in LUB4.**

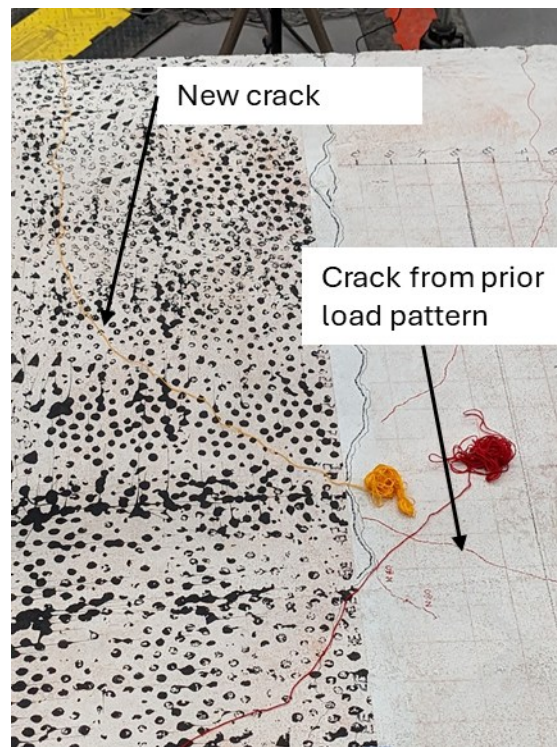
**Figure 9.51. PBJ-OP1: North overhang cracks formed during Pattern NW-1 (red sharpie) and Pattern NE-1 (gold string) (right edge of speckled region is center of link slab).**

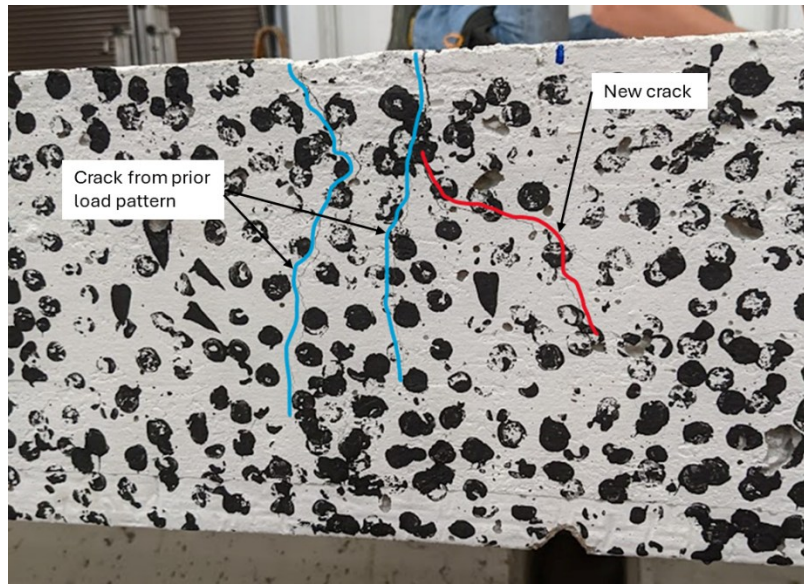
**Figure 9.52. PBJ-OP1: East offset crack on north edge of deck at 430 kips in Pattern All-Yield (cracks at prior load steps shown in blue, new crack shown in red).**

During Pattern All-Yield, new cracks formed and significant widths were measured for existing cracks. The first new crack to form was an offset crack between the girder lines, located approximately 6 in. east of the center, which was farther back than the west offset crack. The crack angled toward the center near the girders, ending near the center of the girders where it converged with existing cracks. The crack was not visible at the beginning of the pause but had appeared by the time crack widths had been documented. At loads of 360 kips and higher, some additional new cracks formed near the end of the southwest girder; these cracks did not match any of the typical crack damage documented in the field. Loading was terminated at 430 kips because one of the strain gages had a large spike; the gage was located near the location of the offset crack (formed during the initial load pattern), which had grown to 2 mm (0.0787 in.) in width. On the north edge of the deck, the east offset crack branched into a longitudinal crack at the depth of the top reinforcement for approximately 1 in. before continuing as a vertical crack (Figure 9.52). After unloading, the 2 mm (0.0787 in.) wide crack had closed significantly.

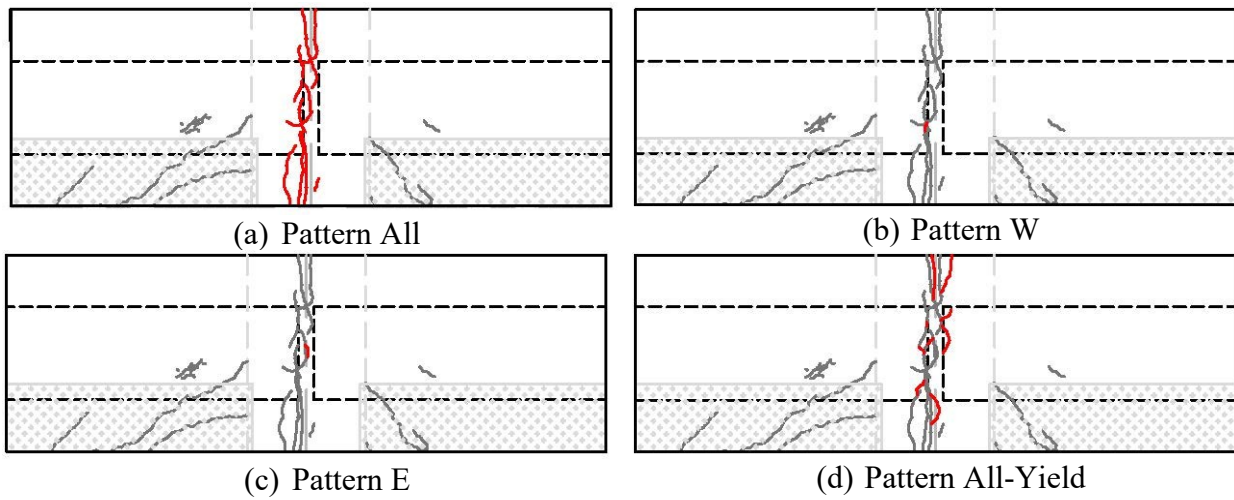
Figure 9.53 shows the cracks for all load patterns applied to PBJ-OP1R. Existing cracks, including those in the south half of the deck, are shown in gray.

**Figure 9.53. PBJ-OP1R: Cracks for all tests, with hatched region not tested (gray cracks are from prior test [PBJ-OP1]).**

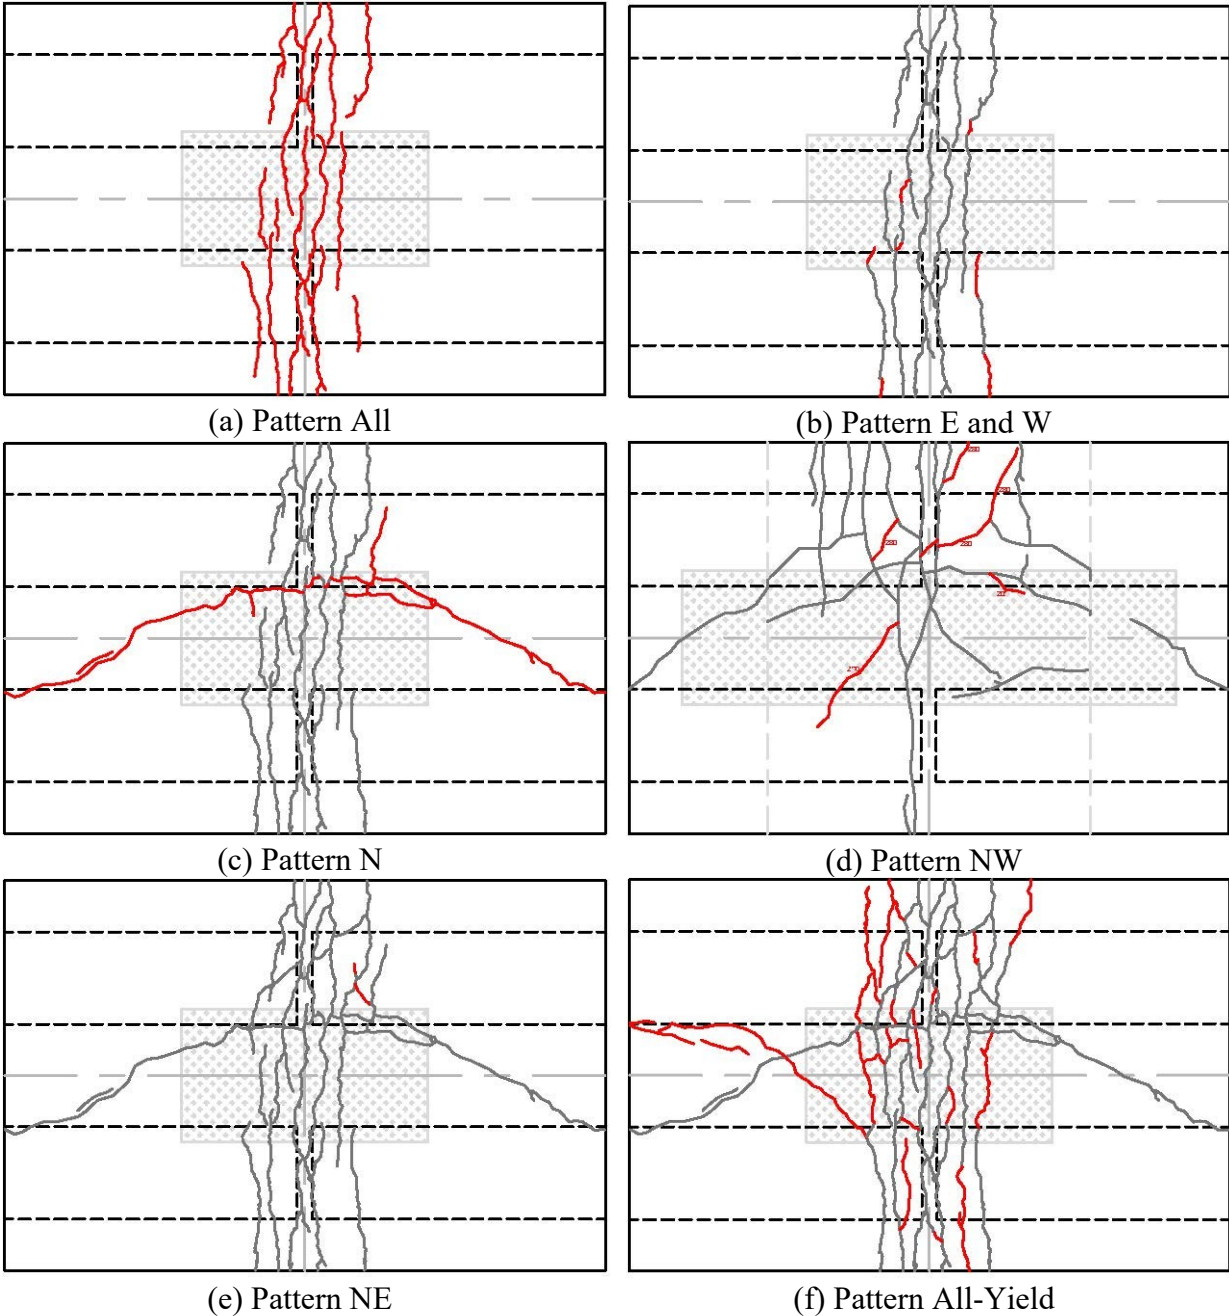
Figure 9.58 shows the cracks from all load patterns.

**Figure 9.58. PBJ-CP1: Cracks for all load patterns.**

During the single-girder line loading suite of Patterns N, NW, and NE, the new cracks observed were primarily diagonal cracks between the girders; these cracks were consistent with the other specimens during other loading patterns. Longitudinal cracks formed along the south edge of the north girder line from the ends of the girders, extending along the length of the debonded region. These longitudinal cracks extended farther than in other tests, although researchers could not determine conclusively if this finding was directly the result of detailing of the specimen or indirectly influenced by the large quantity of cracks formed during the prior loading patterns of PBJ-CP1. Other crack formations were primarily extensions of preexisting cracks. Notably, new cracks did not form in the north overhang, but the east main branch crack did extend to full depth at a load of 80 kips during Pattern N, though the crack was only hairline and extended only approximately 0.25 in. from the edge of the deck on the bottom of the overhang.

During Pattern All-Yield, additional transverse cracks formed throughout the debonded region of the link slab. No other cracks were full depth at completion of testing, but many, particularly on the south edge, were nearly full depth. No cracks were observed on the bottom of the PCPs, other than those that formed during the north load suite.

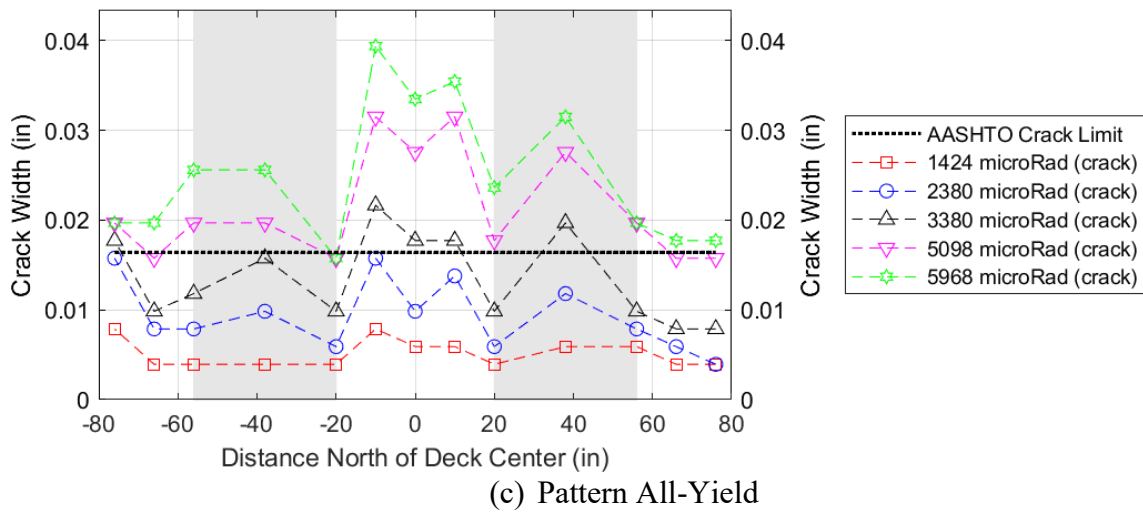
**Figure 10.2. PBJ-FP1: Crack width profiles for select patterns.**

For PBJ-FP1, which is constructed with the current TxDOT offset panel detail, crack width profiles are shown in Figure 10.3. The shape of the crack width profiles is similar for all rotation demands and patterns. This is a common trend for most tests. For PBJ-FP1, the crack widths are larger between the girders and in the overhang than over the girders. Cracks exceed the AASHTO limit at demands greater than approximately 0.003. This finding suggests that flush panel details should be avoided on bridges with design girder end rotations exceeding 3000 microradians.

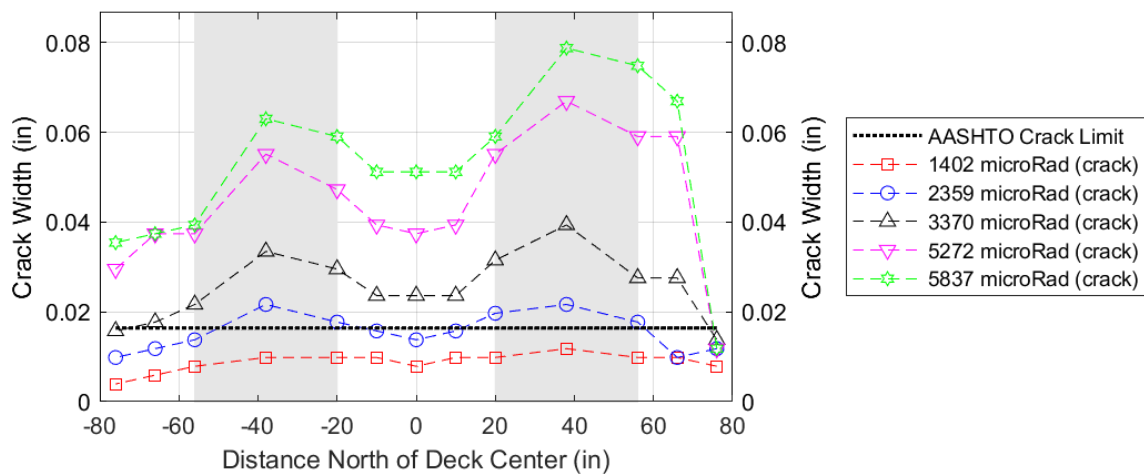
(a) Pattern All

(b) Pattern W

(c) Pattern All-Yield

**Figure 10.3. PBJ-OP1: Crack width profiles for select patterns.**

Figure 10.3 provides crack widths for PBJ-OP1, the design with the current TxDOT offset panel detail. Crack widths are generally the same shape for all patterns and rotations presented. The crack widths are larger over the girder than between the girders or in the overhangs; this is opposite that of PBJ-FP1. The widths are slightly larger over the north girder. While there are slight differences in the reinforcement (north girder has bottom bars over the girders, while the south does not), it is not believed that this influences the crack widths. Instead, the crack pattern shows that there is a single crack over the north girder line, while on the south side, the main crack in overhang is a branched main crack with the branch starting near the center of the girder line, so there are two locations for deformation to impact the crack width.

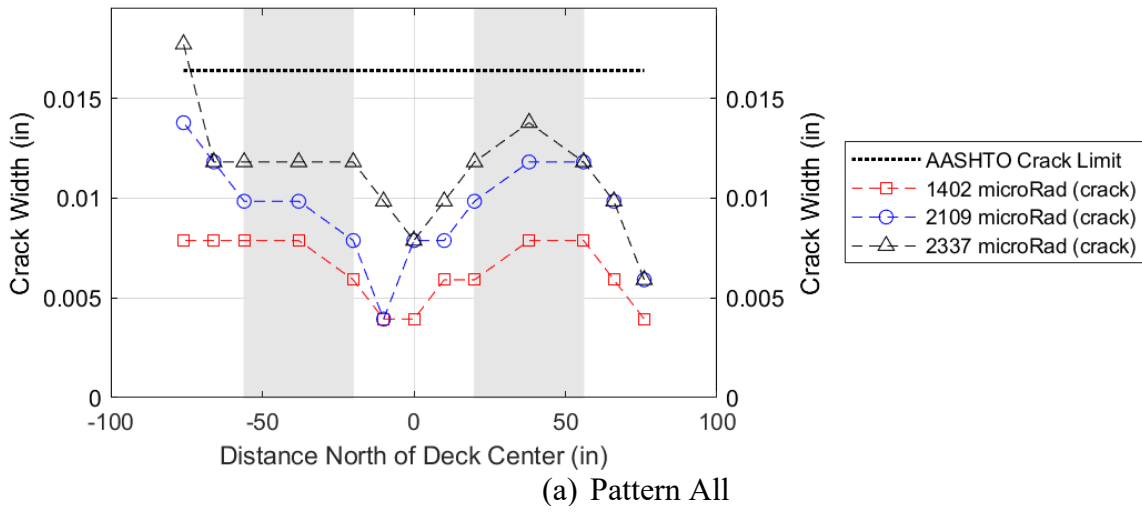
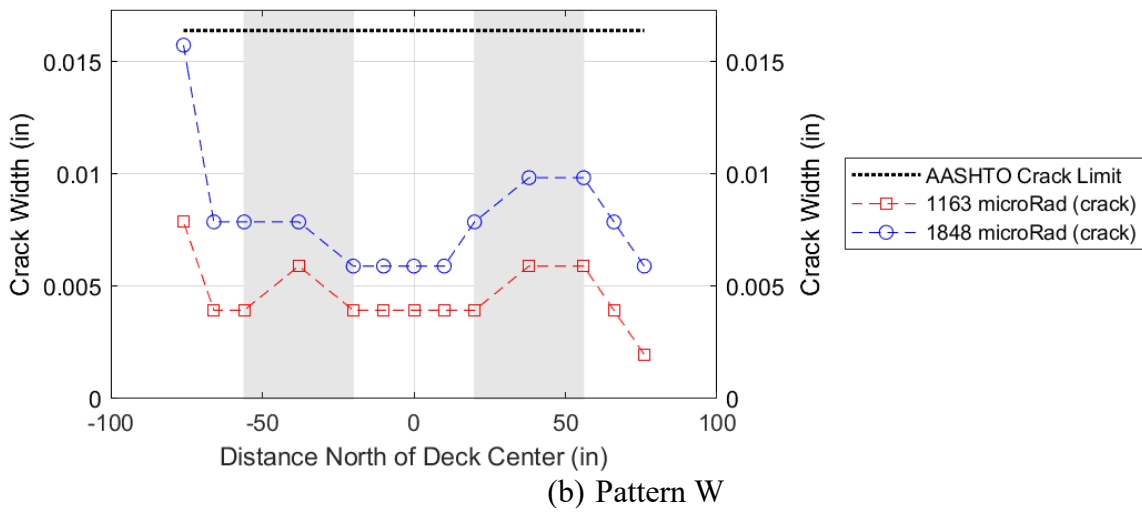
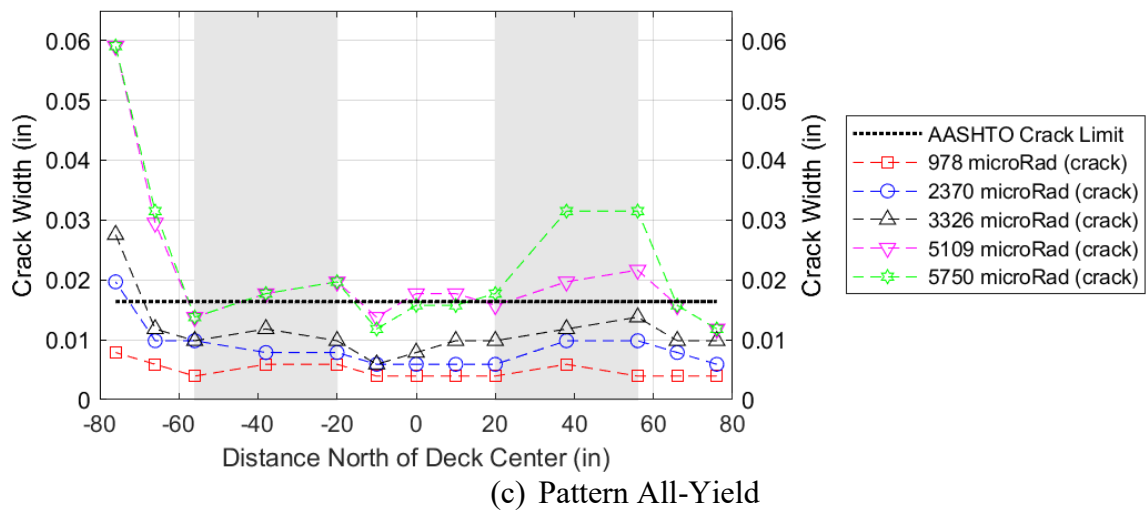
**Figure 10.4. PBJ-OP2: Crack width profiles for select patterns.**

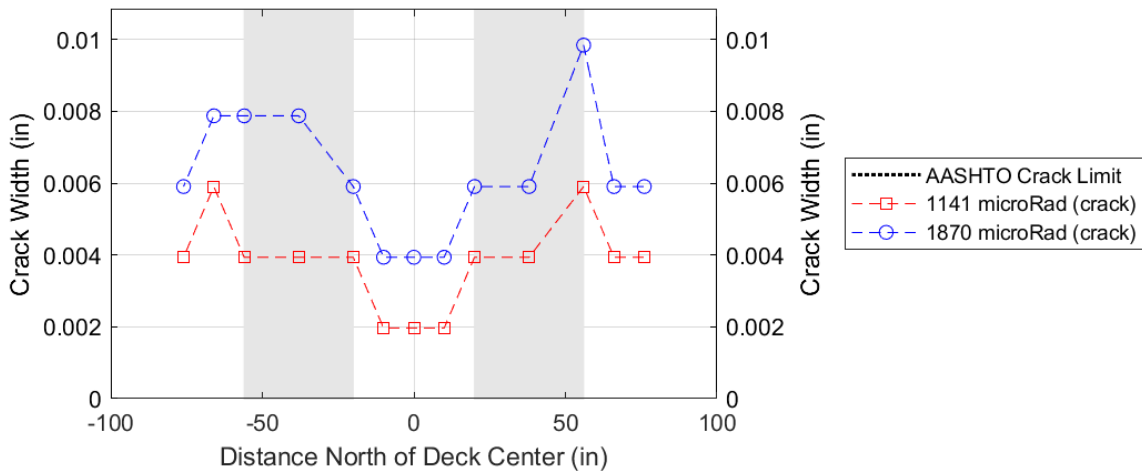
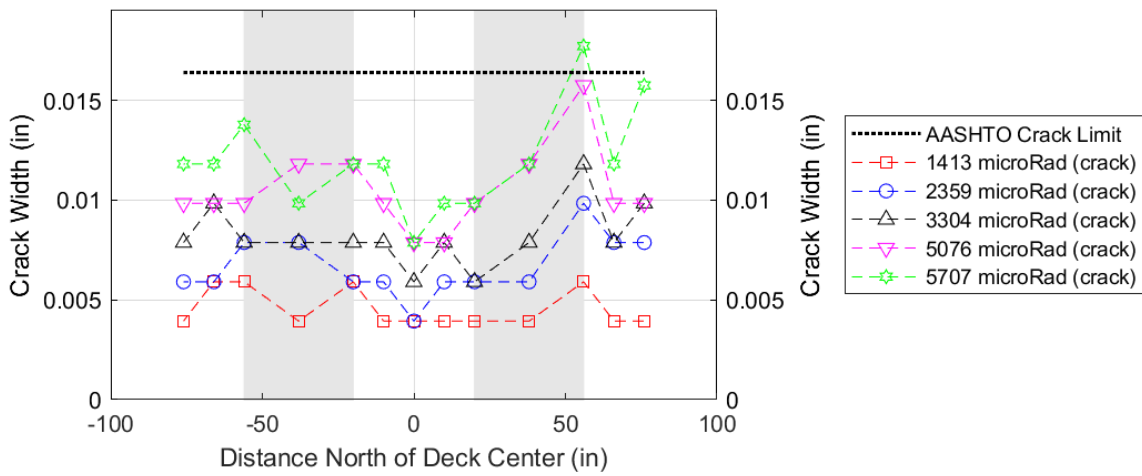
(a) Pattern All

(b) Pattern W

(c) Pattern All-Yield

PBJ-OP2 tested an offset panel detail with a DLS. Crack widths are shown in Figure 10.4. The primary difference of OP2 relative to OP1 was debonding. Comparison of the data for Pattern All for the two tests shows that the crack widths are considerably lower than those for at approximately 0.002 rad girder rotation. While the OP1 cracks exceed the crack width limits for at this demand, the cracks in OP2 do not, with the exception of the single crack in the south overhang (left side of figure). Excluding the single large crack in the overhang, the OP2 design

PBJ-OP2 used two different reinforcement amounts for the top longitudinal reinforcement. In the south half, the reinforcement is that of the deck (#4 @ 9 in.) and is the same as that in PBJ-OP1. In the north half of the deck, reinforcement also includes supplemental bars between the main deck reinforcement, resulting in twice as much steel. Comparing the south (left) and north (right) half in Figure 10.4 reveals minimal difference in the crack widths, with the north cracks slightly larger for some profiles shown. In interpreting this finding, it is important to consider that the profiles present the crack widths along the main crack only. The crack pattern shows that there are two cracks in the link slab over the south girder and three over the north girder, so the overall distribution of cracks and their widths should be considered. Despite this, there is still limited impact of the additional reinforcement, but it is likely more an artifact of the limited distribution of cracking. On both halves of the deck, the cracks formed at the ends of the girders, suggesting the performance would be improved by including the haunch gap used in PBJ-CP1.

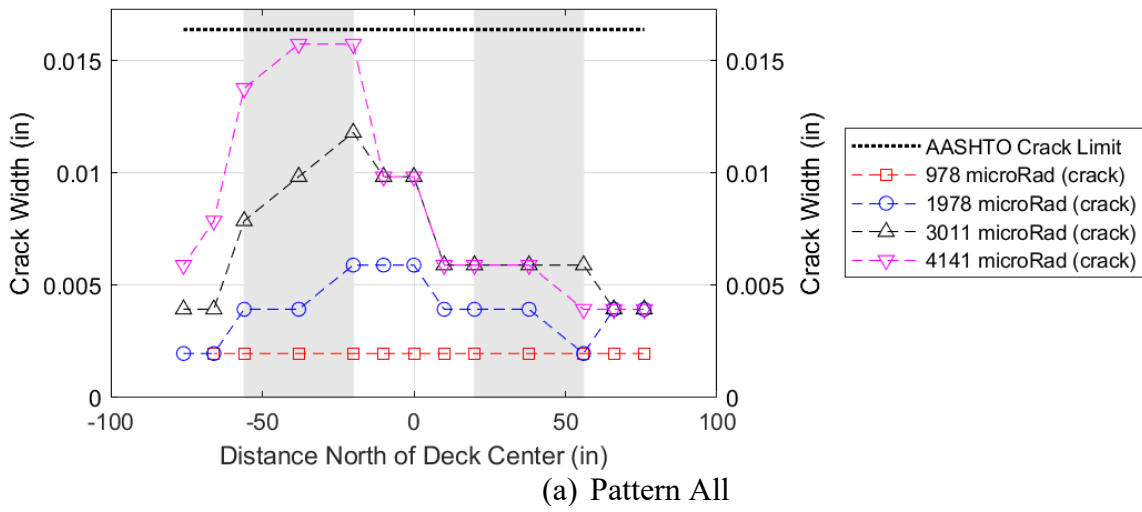
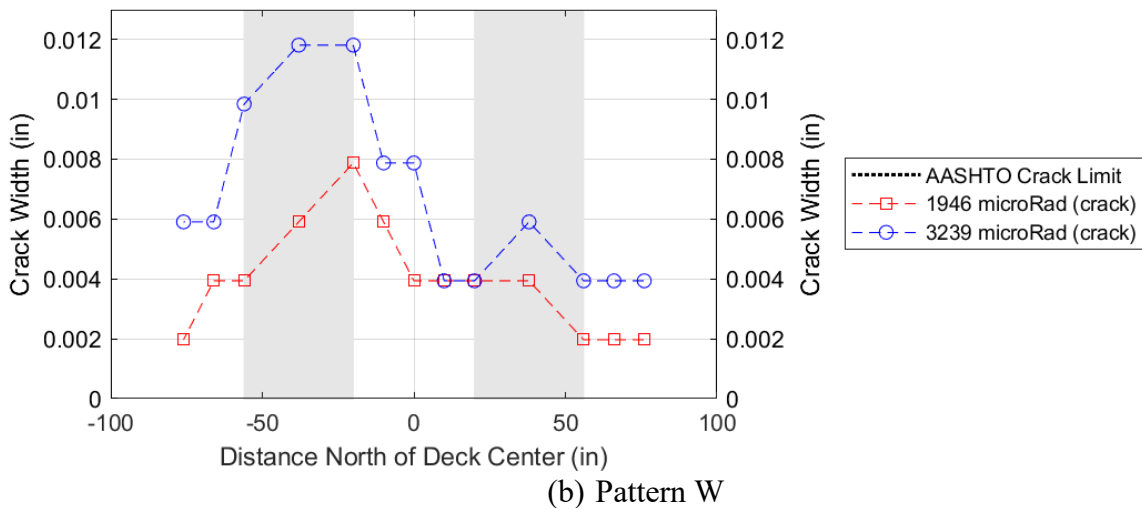
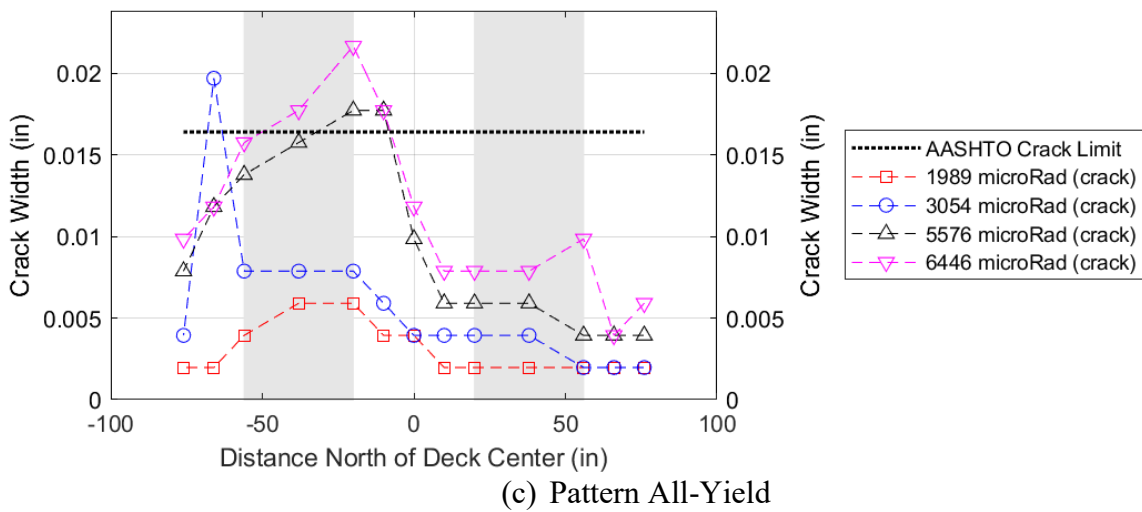
**Figure 10.5. PBJ-CP1: Crack width profiles for select patterns.**

Figure 10.5 provides the crack widths for PBJ-CP1, which was a debonded link slab with continuous panel and a haunch gap. The reinforcement utilized supplemental bars between the main longitudinal reinforcement.

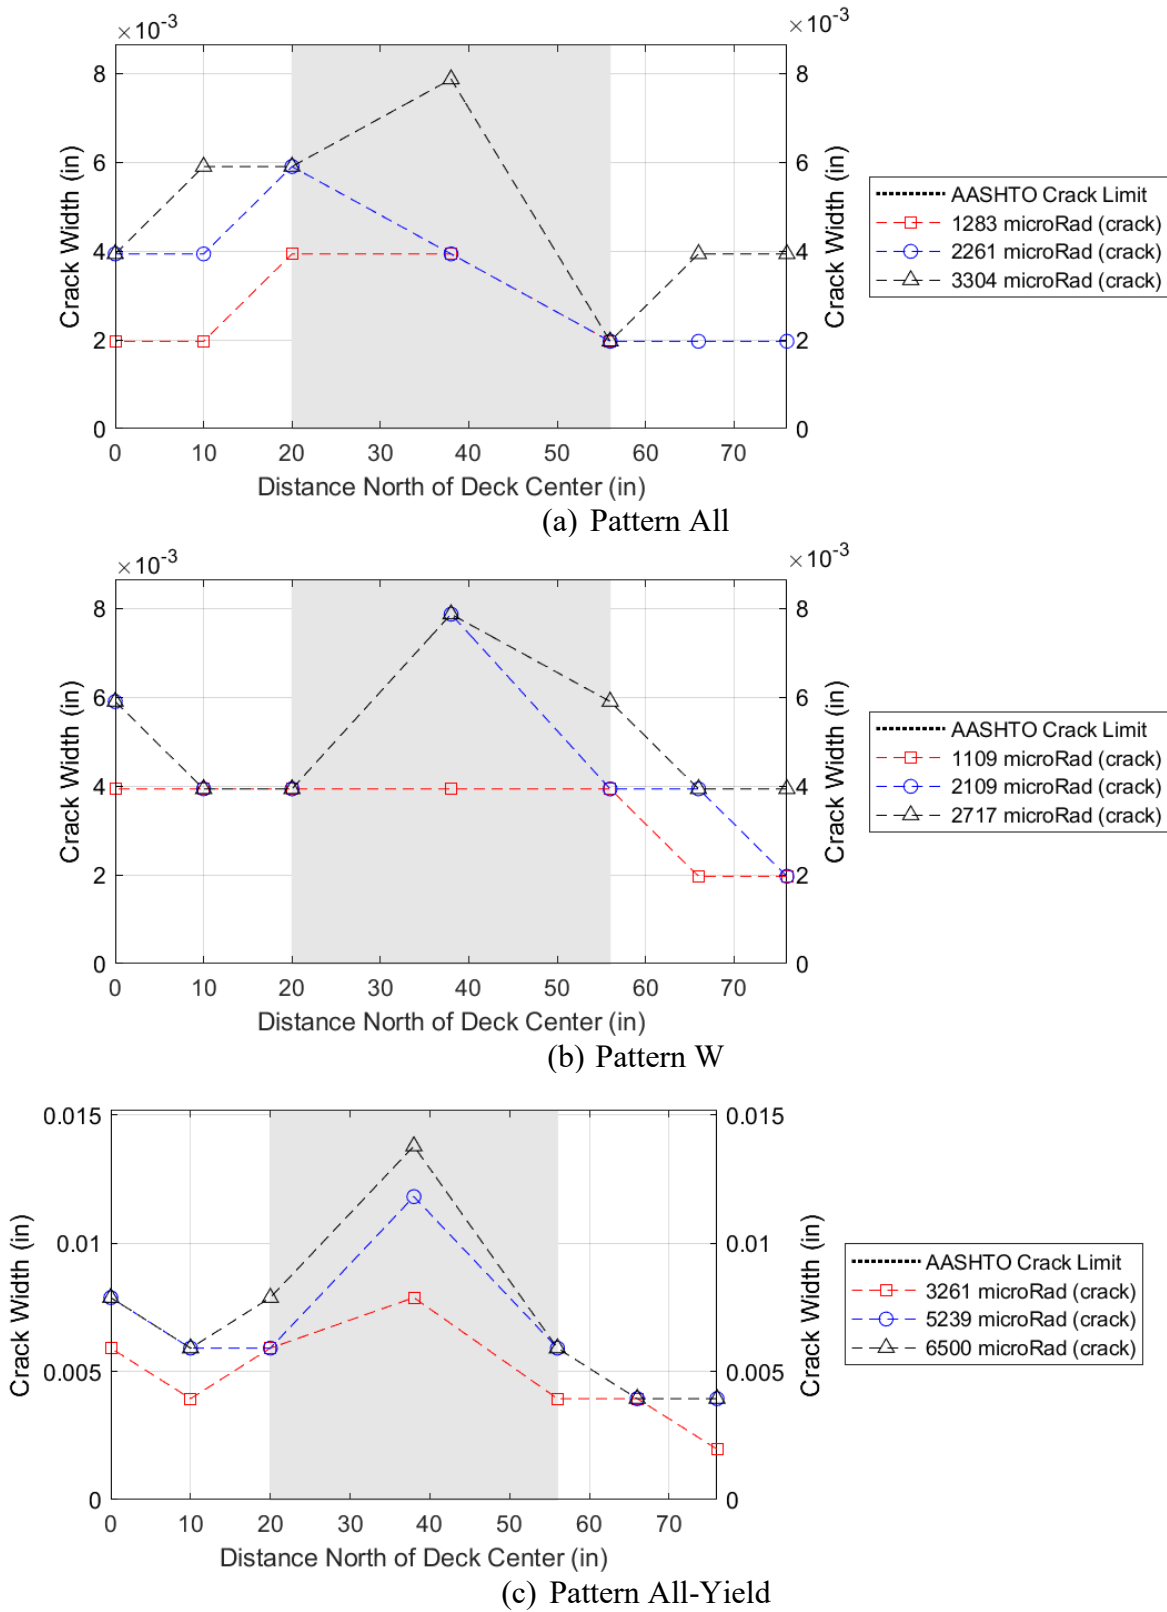
**Figure 10.6. PBJ-FP1R: Crack width profiles for select patterns.**

Crack widths for PBJ-FP1R are shown in Figure 10.6. This retrofit design used a partial-depth DLS, in which the top concrete was replaced and debonded from the bottom portion of the deck. As seen in the crack map for the specimen, a greater number of cracks occurs than in the original deck (PBJ-FP1). As seen in the crack width profiles, the crack widths are significantly smaller in the retrofit design. Crack widths are larger over the girders than in the overhang, which is different from PBJ-FP1 but consistent with PBJ-OP1. Two different reinforcement patterns were used in the deck. Both have the same reinforcement as PBJ-FP1, but in the north half (right side of figure), the supplement bars are raised to have lower cover. There are a greater number of cracks in the north half, and as seen in Figure 10.6, the crack widths are significantly smaller, never exceeding the AASHTO crack width limit despite reaching a girder end rotation of nearly 0.0065 rad. In the south half, the cracks were wider, but still significantly smaller than in the PBJ-FP1 test. The south half exceeded the AASHTO crack width limit at a rotation exceeding 0.005 rad.

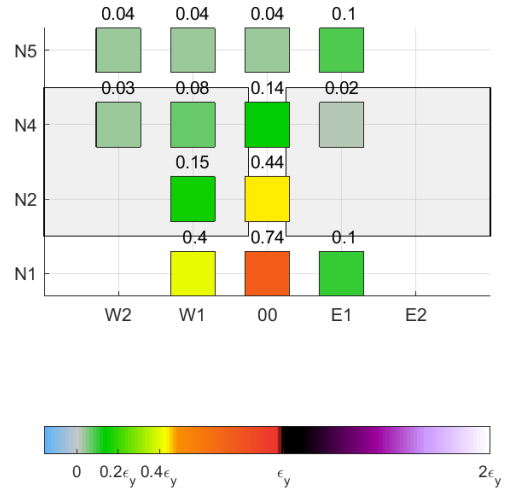
(a) PBJ-FP1R (4163 microradians)

(b) PBJ-OP1R (1663 microradians)

**Figure 10.19. Strain maps for retrofit designs at the peak load during Pattern All.**

Figure 10.19 and Figure 10.20 present the strain maps for the retrofit specimens (PBJ-FP1R and PBJ-OP1R) for Pattern All and Pattern All-Yield, respectively.

For PBJ-FP1R, the strains should be analyzed separately for the north and south half due to the different reinforcement. While the PBJ-FP1 test had strains larger between the girders, the PBJ-FP1R test had strains larger over the girders like most other specimens. The overhang strains were larger in the south half; however, this observation should consider that not only was the reinforcement different, but also the board between the panels extended into the south overhang. Most notably for PBJ-FP1R, the strains did not exceed yield strains at any point during the tests, including the final pattern that went to rotation demands of nearly 0.0065 rad, higher than any design values for bridges considered in this study.

For PBJ-OP1R, larger strains were observed in the south portion of the deck. In the north portion of the deck, strains were nearly zero. Note that debonding of the interface between new and existing concrete may be a factor, and strain gages were not available on bottom reinforcing bars to see if demand was present in that portion of the deck. However, Section 10.6.2 presents concrete surface strains in the north overhang that support the theory that load transfer is happening more in the bottom portion of the deck. Looking at the strains in the south portion of the deck shows that strains are larger at the center of the link slab.

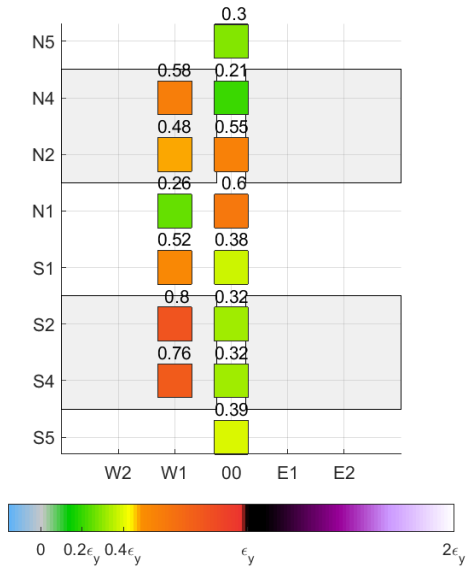
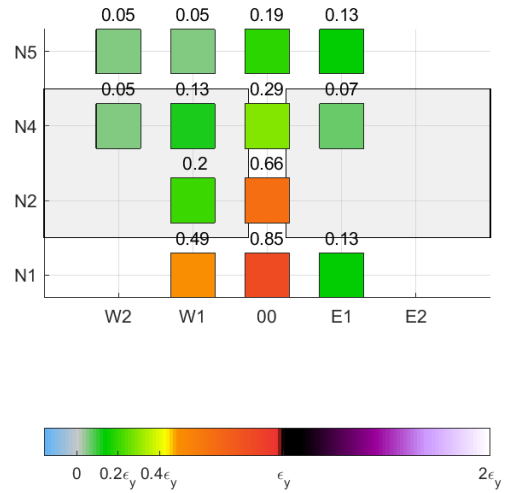
(a) PBJ-FP1R (6478 microradians)

(b) PBJ-OP1R (3457 microradians)

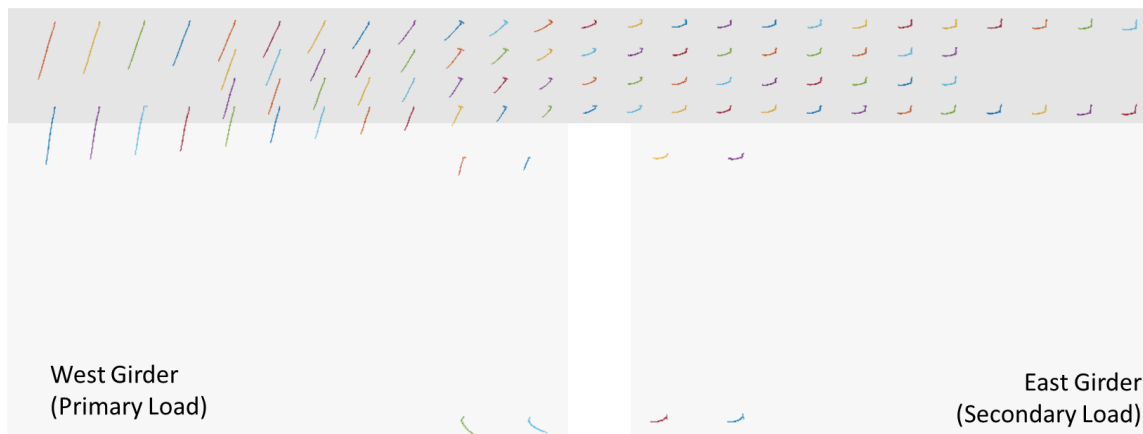
**Figure 10.21. PBJ-FP1: Optotrak target displacement history for Pattern W.**

Figure 10.21 shows the displacement history of each target on PBJ-FP1 during Pattern W. The girder and deck are shown as gray rectangles. Each colored line represents a target and is a series of points showing the position over the course of loading, with displacement magnified 50 times to be easily viewable. On the deck over the west girder (primarily loaded girder), the lines are mostly vertical, with the target starting at the top of the line and moving toward the ground as the test progresses. This is expected given the expected displaced shape confirmed by the displacement profiles presented in Figure 10.1.

The findings are more interesting in the deck over the east girder, where the path history is an L-shape laying on its side. The shorter vertical leg of the path history occurs when the 40-kip load is placed in the secondary girder (east in this case). At higher loads in the primary girder (west), the east load is held constant. During that portion of the load pattern, the east deck targets have the longer horizontal leg of the L response. This observation is referred to as drag or tug of the deck on the secondary girder. It suggests an axial deformation of the deck that may explain the offset and secondary cracks that form during the asymmetric loading and are observed in the field. Such a behavior has not been suggested as a design considered in the literature. Further exploration of this behavior, including for other tests, is needed. It is worth mentioning that these findings have been compared to results from finite element models, and it was shown that the behavior matched.

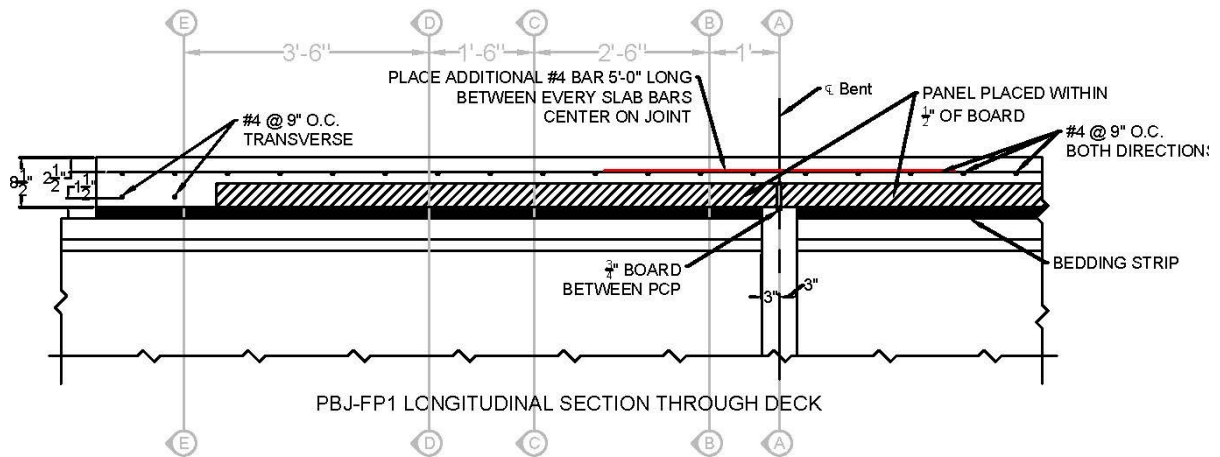
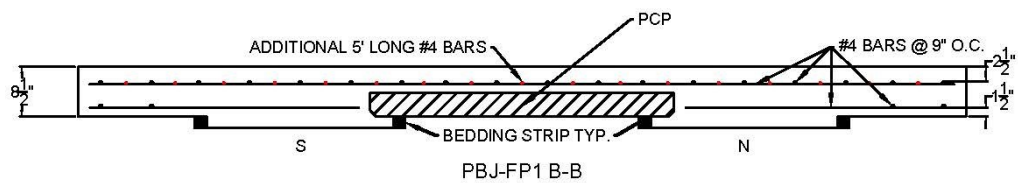
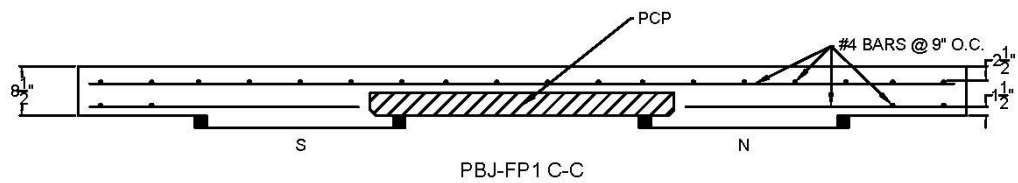
**Figure B.1. PBJ-FP1: construction drawings.**

For individual specimens, detailed construction drawings are provided in this appendix. Cross-section views are available at consistent locations. Section A-A is located at the center of the continuous deck and has a consistent 8.5-in. thickness for the full width. The remaining sections are located over the girders and have the additional haunch on top of the girder shown (haunch dimension is generic). Section B-B is located at the center of the bearing pads and thus within the full-depth CIP region for offset panel designs.
