# Performance and Improvement of Texas Poor Boy Continuous Bridge Deck Details: Final Report

Technical Report 0-7013-R1

Cooperative Research Program

TEXAS A&M TRANSPORTATION INSTITUTE  
COLLEGE STATION, TEXAS

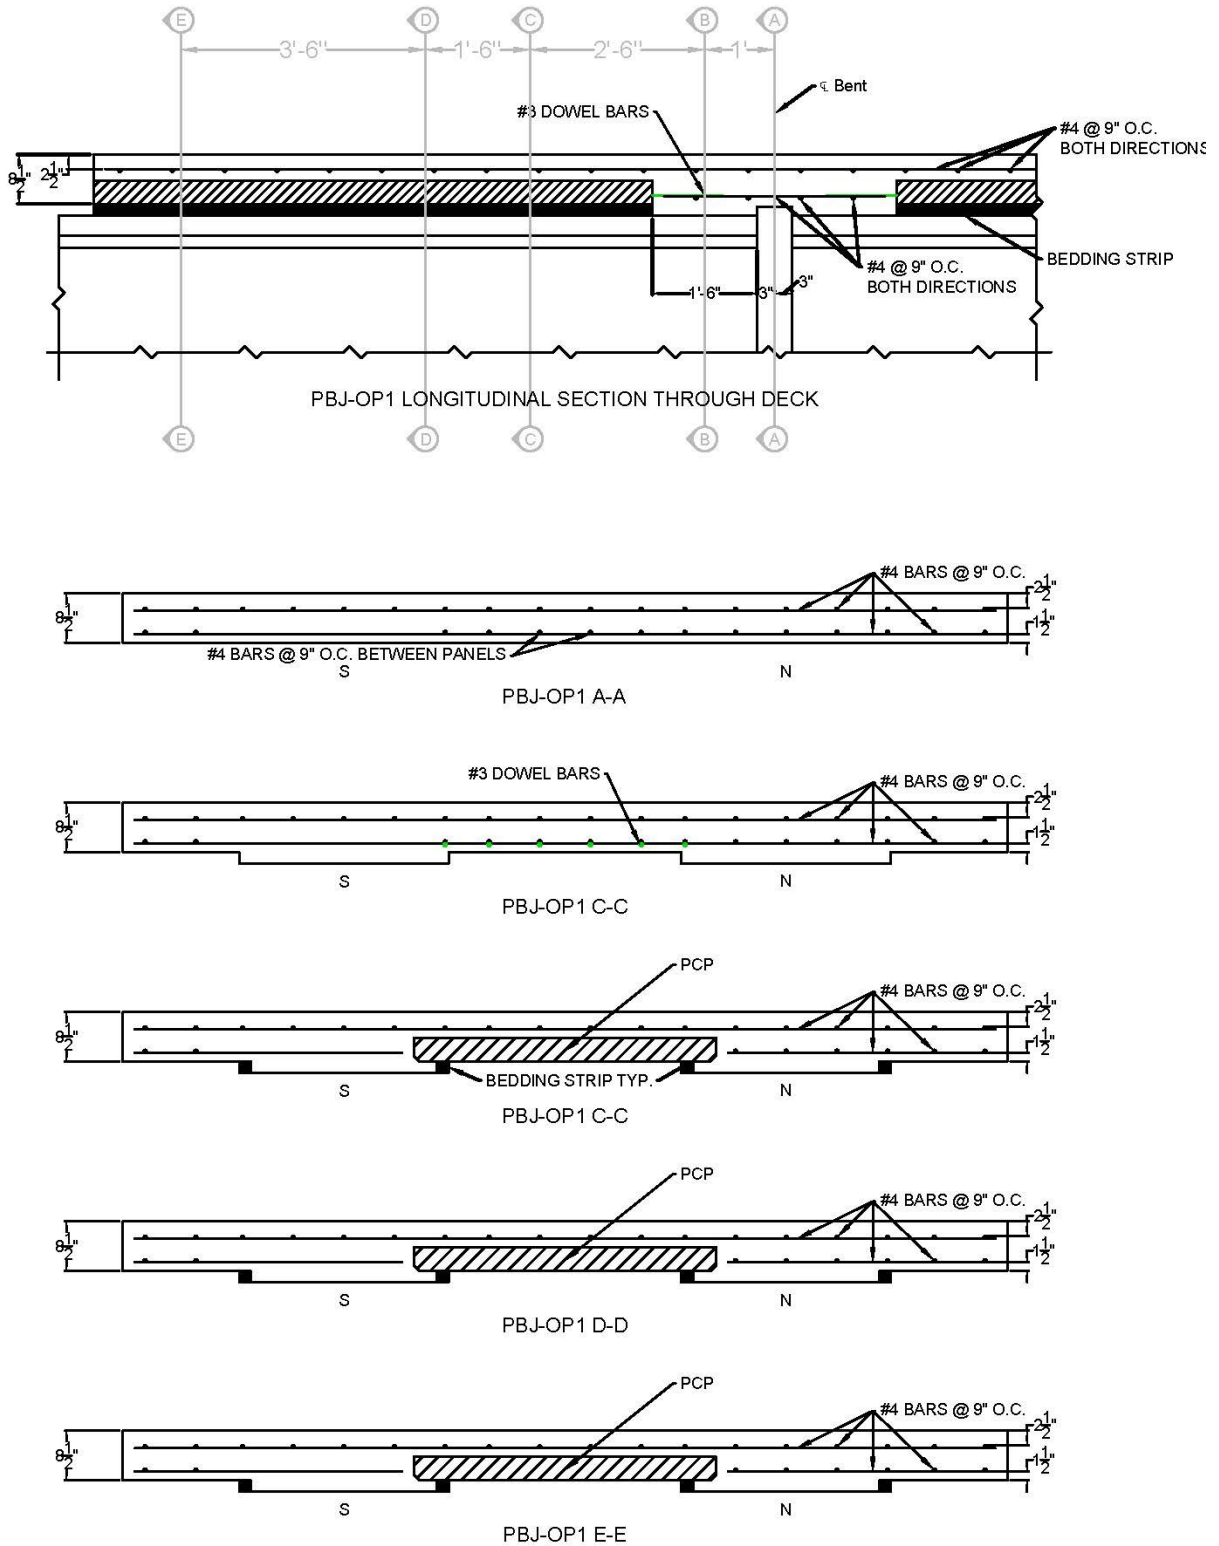
**Figure B.3. PBJ-OP1: construction drawings.**

For individual specimens, detailed construction drawings are provided in this appendix. Cross-section views are available at consistent locations. Section A-A is located at the center of the continuous deck and has a consistent 8.5-in. thickness for the full width. The remaining sections are located over the girders and have the additional haunch on top of the girder shown (haunch dimension is generic). Section B-B is located at the center of the bearing pads and thus within the full-depth CIP region for offset panel designs.
