**Test Report No. 0-7021-01-R1**

**DEVELOPING AN ENHANCED PROTECTION OF MEDIAN OPENINGS  
BETWEEN PARALLEL BRIDGE STRUCTURES**

Sponsored by the  
**Texas Department of Transportation  
and the  
Federal Highway Administration**

**TEXAS A&M TRANSPORTATION INSTITUTE PROVING GROUND**

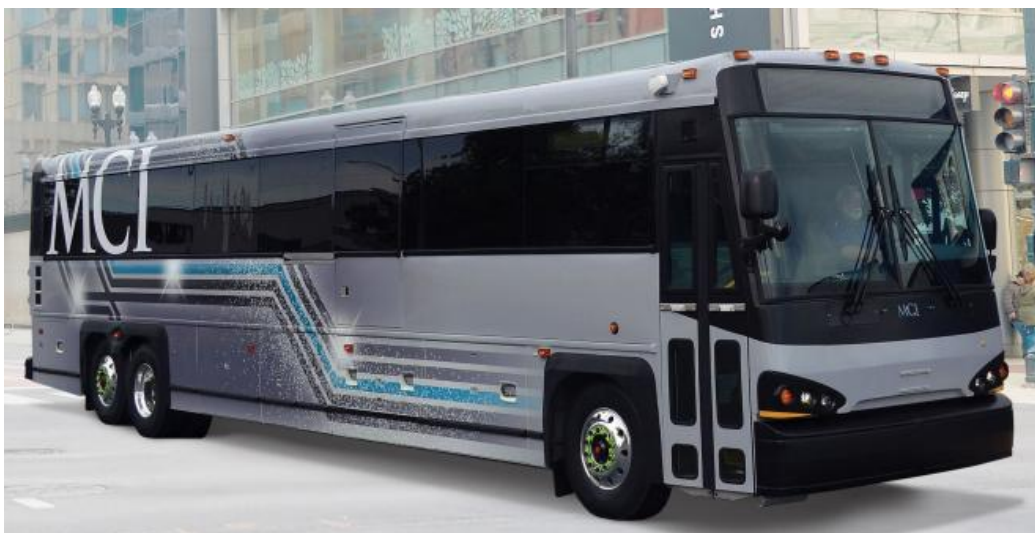
**Figure 2.5. Example of an MCI D4500 (2).**

The most common Class 8 vehicle was the MCI Intercity D4500. The year of the D4500 buses ranged from 1993 to 2018. Figure 2.5 shows an example of the Les Autobus MCI motorcoach. Table 2.10 shows the crash counts for each model year of the MCI Intercity D4500.

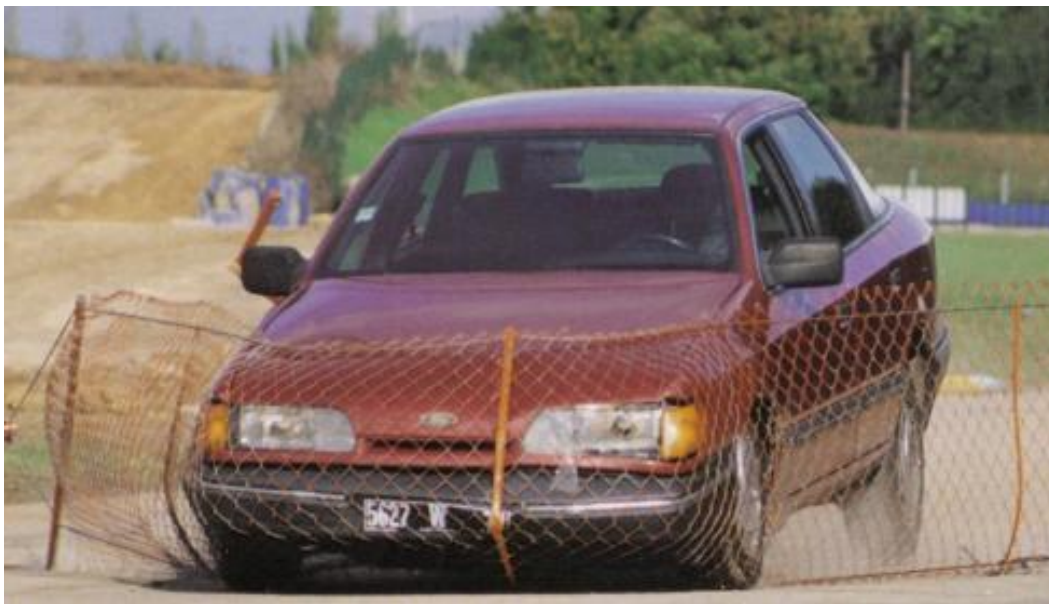
**Figure 3.1. Vehicle Arresting Net (3).**

The Dragnet vehicle arresting barrier (3) system uses a mesh net to span between two end posts. This mesh is connected to a set of steel tapes that unspool during a vehicular impact. The pull out of this steel tape dissipates the impact energy and safely brings the vehicle to a stop. The two end posts are bolted to concrete piers that are embedded 4 ft below grade. The span distance of the net can vary depending on the installation, and the top of the net rests at approximately 48 inches above grade. Because the net is anchored at the two ends, additional measures must be taken to maintain proper height above grade when installed in a sloped median. Figure 3.1 shows a photo of this system.

The Dragnet can safely stop a 20,000-lb truck traveling 52 mi/h in 200 ft. The Dragnet can stop a lighter passenger vehicle in a much shorter distance, depending on the impacting speed. The Dragnet also has modifications available to arrest much larger vehicles traveling at faster speeds. Maintenance is relatively simple after an impact, with the replacement of only the steel tapes and mesh net. Standard groundskeeping or median maintenance is also relatively simple. While the net prevents large equipment from mowing in that specific area, the equipment can easily drive around the system and resume mowing. Groundskeeping teams can then mow closely around the system with smaller equipment.

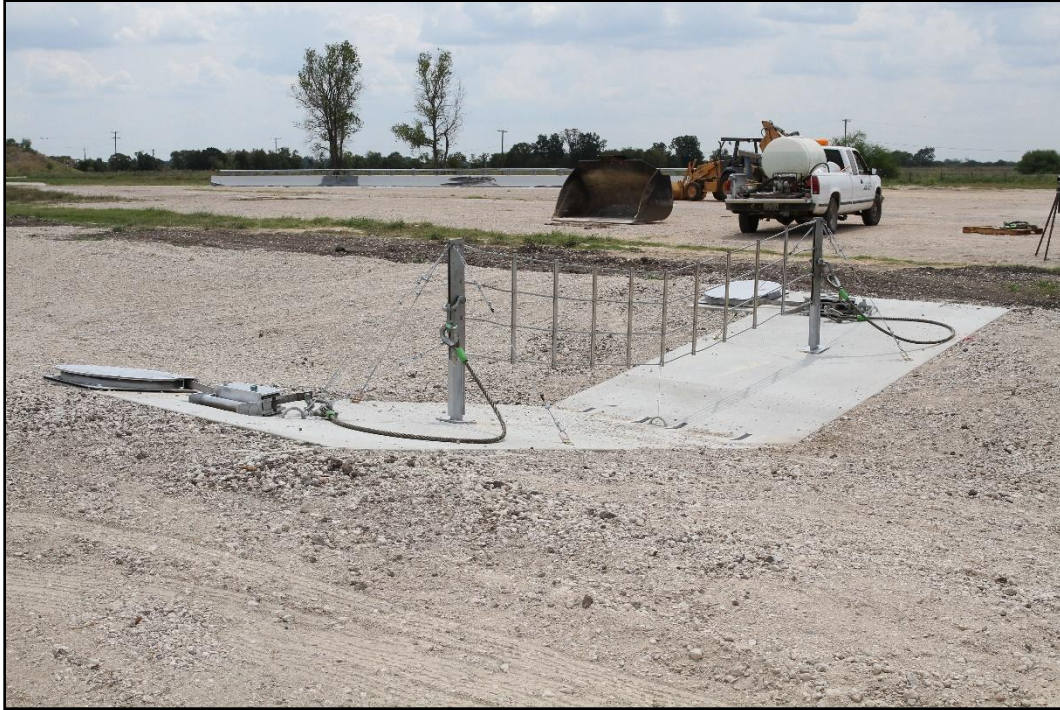
**Figure 4.7. Second Median Opening Protection System Net prior to Crash Tests 440210-01-1&2.**

Figure 4.1 presents the overall information on the MOPS, Figure 4.2 presents the overall information for the first net, and Figure 4.3 through Figure 4.8 provide photographs of the installation. Appendix A provides further details on the MOPS. Drawings were provided by TTI Proving Ground, and construction was performed by TTI Proving Ground personnel and Impact Absorption installers. TTI Proving Ground personnel supervised installation efforts.

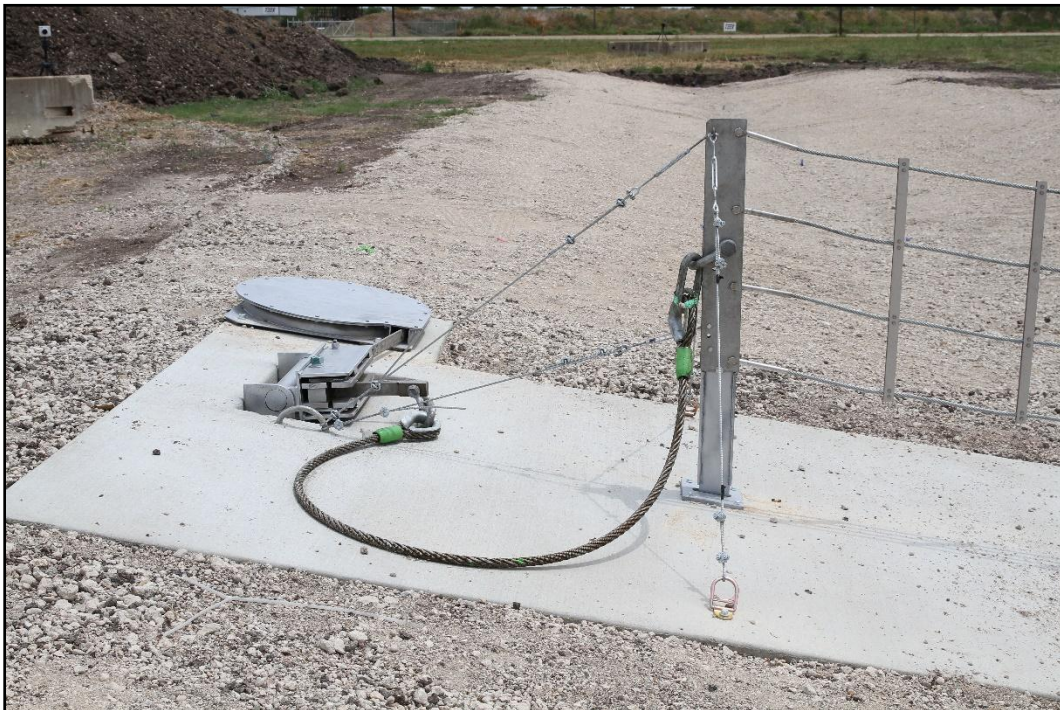
**Figure 4.8. Anchor Hardware for the Second Median Opening Protection System Net prior to Crash Tests 440210-01-1&2.**

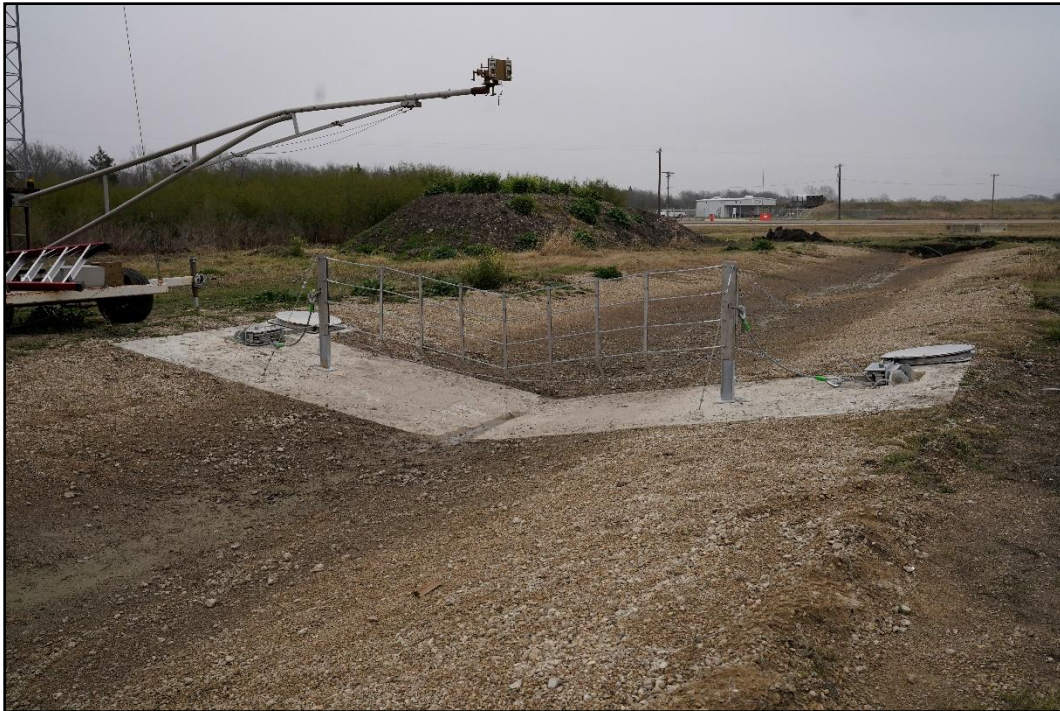
**Figure 4.10. Second Median Opening Protection System Net prior to Crash Tests 440210-01-4, 440211-01-3, 440211-01-5, and 440213-01-6.**

In Crash Test 440210-01-2, the test vehicle impacted the second net, causing the swivel mount for the second net's energy absorber to release the energy absorber. This was not intended in the design and was undesirable for future testing. Therefore, a new swivel mount was designed and utilized for all subsequent testing, including a retest of Test 440210-01-2 (440210-01-4). Test 3-40 (440210-01-1) was not repeated because the test vehicle did not contact the second net, and therefore the swivel mount design had no effect on the test results. Figure 4.9 presents the overall information for the second net after modifications, and Figure 4.10 through Figure 4.13 provide photographs of the installation.

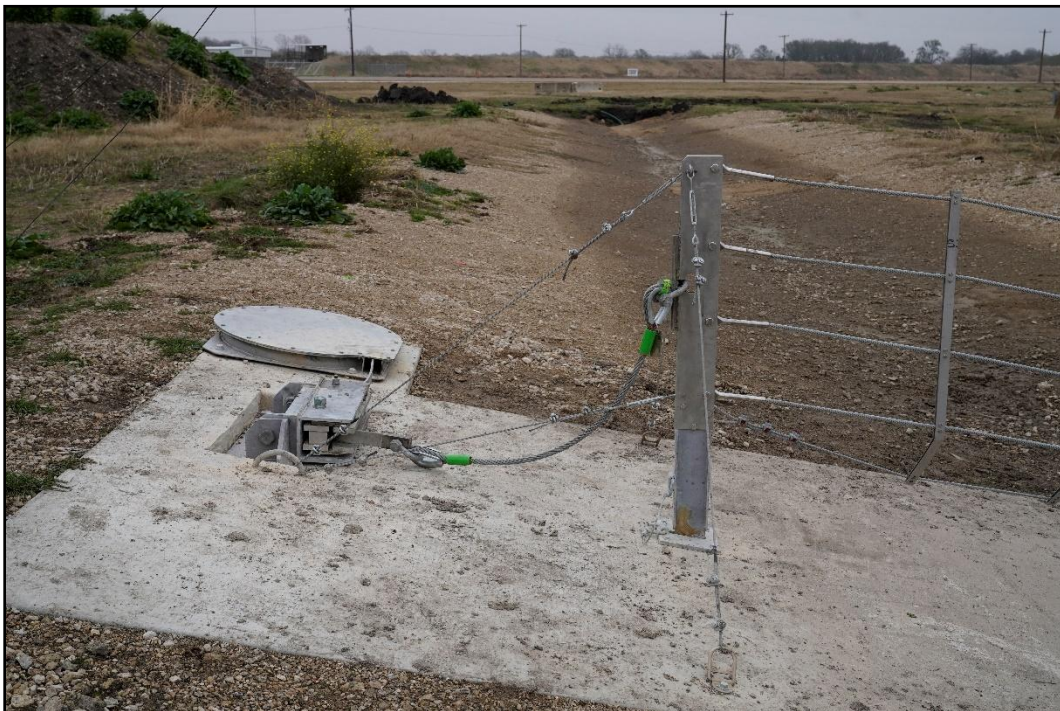
**Figure 4.11. Anchor Hardware for the Second Median Opening Protection System Net prior to Crash Tests 440210-01-4, 440211-01-3, 440211-01-5, and 440213-01-6.**

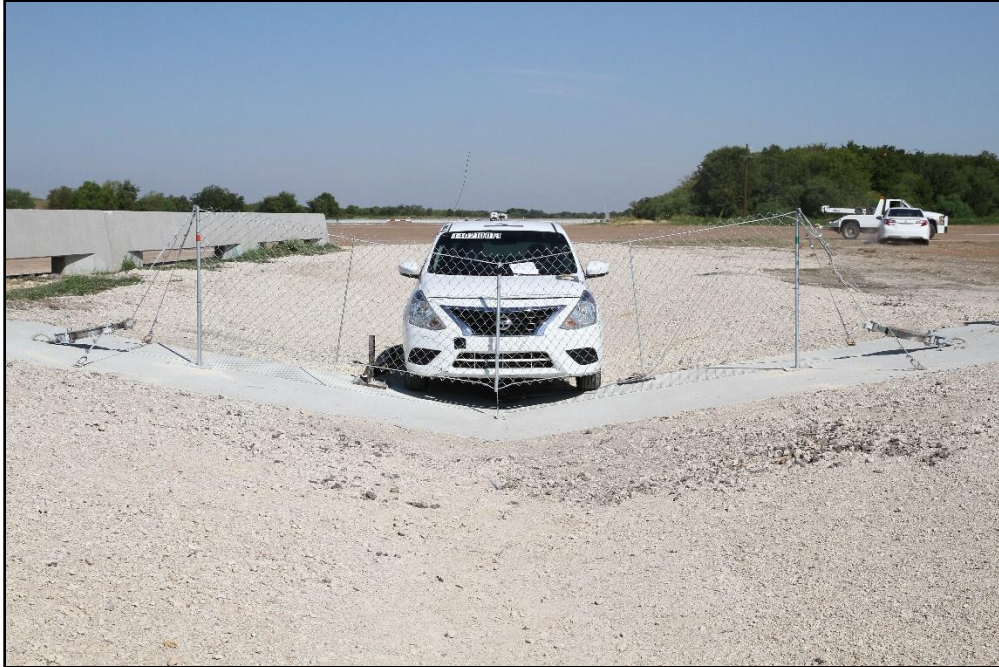
**Figure 7.1. MOPS/Test Vehicle Geometrics for Test 440210-01-1.**

See Table 7.1 for the *MASH* impact conditions and Table 7.2 for the exit parameters for Test 440210-01-1. Figure 7.1 and Figure 7.2 depict the target impact setup.

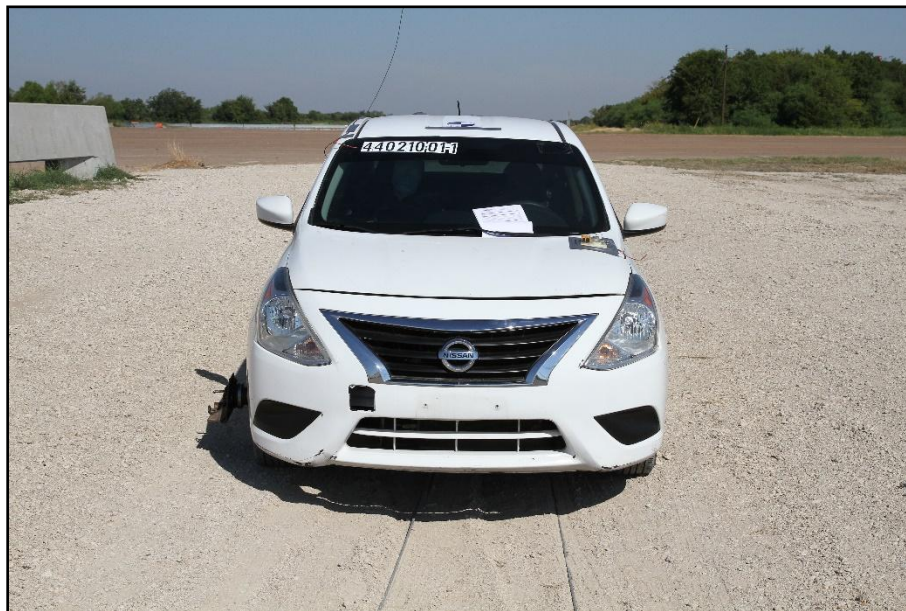
**Figure 7.3. Front of Test Vehicle before Test 440210-01-1.**

Figure 7.3 and Figure 7.4 show the 2016 Nissan Versa used for the crash test. Table 7.4 shows the vehicle measurements. Figure B.1 in Appendix B.1 gives additional dimensions and information on the vehicle.

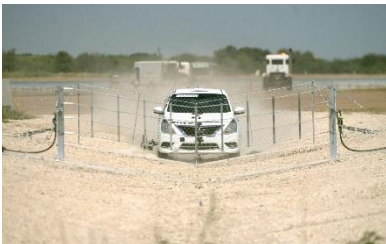
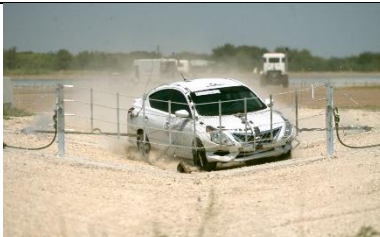
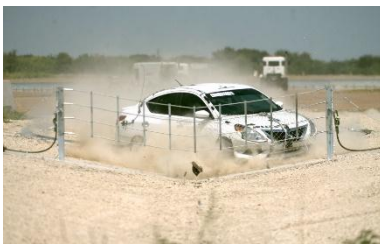
**Figure 7.11. Summary of Results for MASH Test 3-40 on MOPS.**

Figure 7.11 summarizes the results of *MASH* Test 440210-01-1.

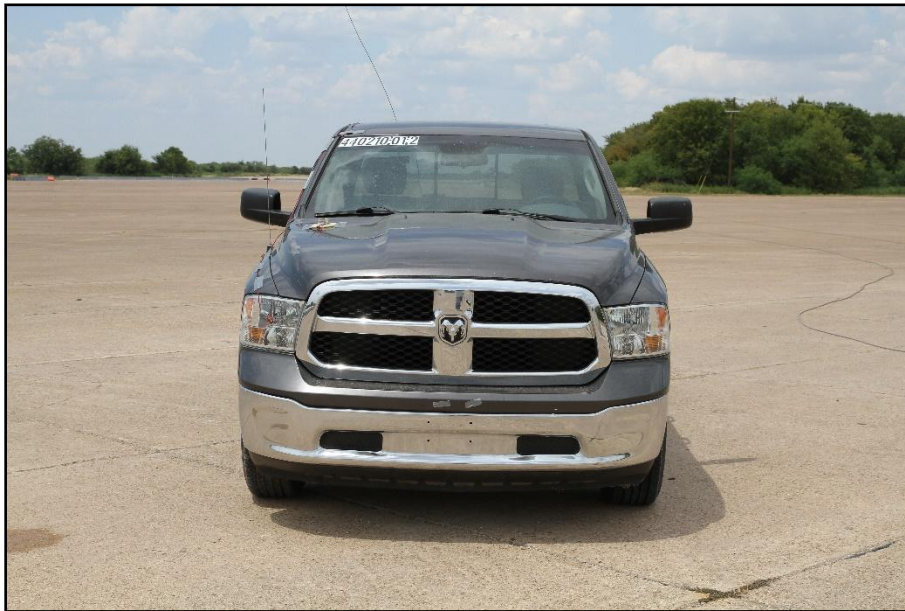
**Figure 8.3. Front of Test Vehicle before Test 440210-01-2.**

Figure 8.3 and Figure 8.4 show the 2015 RAM 1500 used for the crash test. Table 8.4 shows the vehicle measurements. Figure C.1 in Appendix C.1 gives additional dimensions and information on the vehicle.

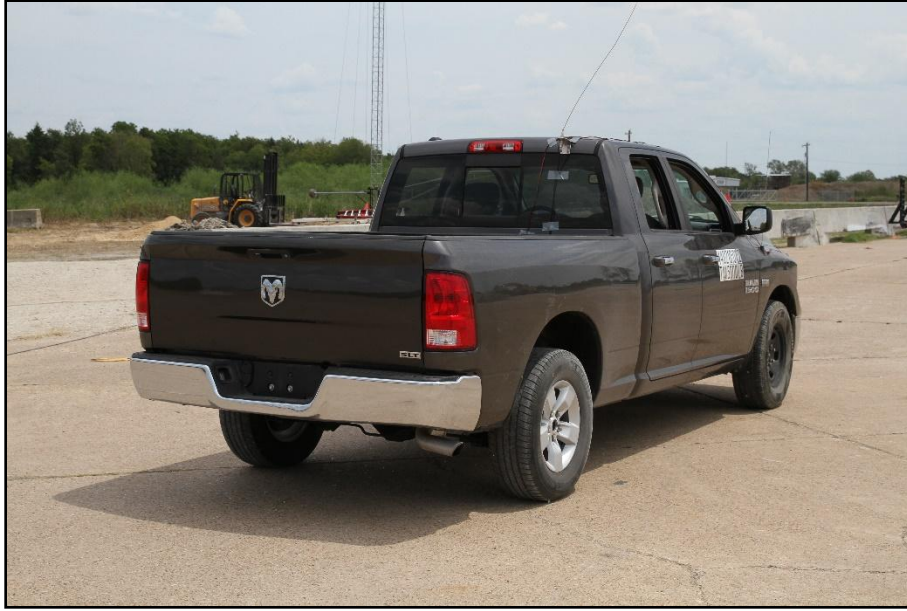
**Figure 8.4. Back of Test Vehicle before Test 440210-01-2.**

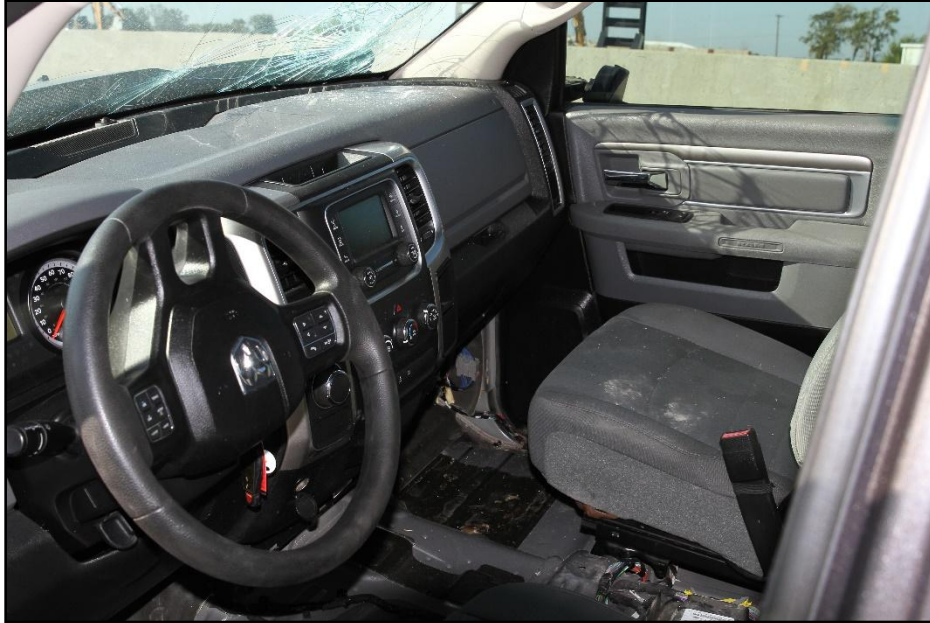
**Figure 8.9. Overall Interior of Test Vehicle after Test 440210-01-2.**

Figure 8.7 and Figure 8.8 show the damage sustained by the vehicle. Figure 8.9 and Figure 8.10 show the interior of the test vehicle. Table 8.7 and Table 8.8 provide details on the occupant compartment deformation and exterior vehicle damage. Figures C.2 and C.3 in Appendix C.1 provide exterior crush and occupant compartment measurements.

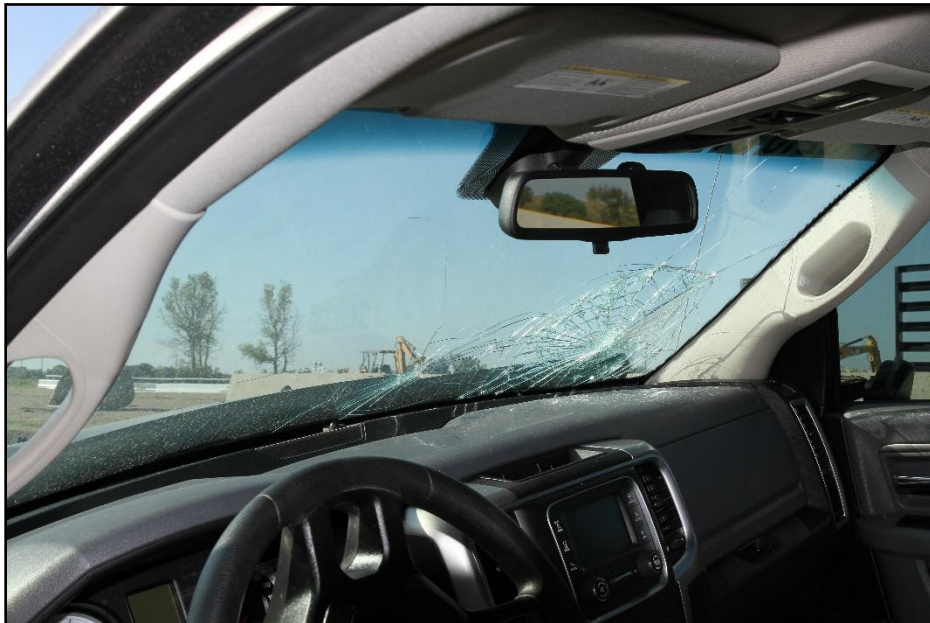
**Figure 8.10. Upper Interior of Test Vehicle after Test 440210-01-2.**

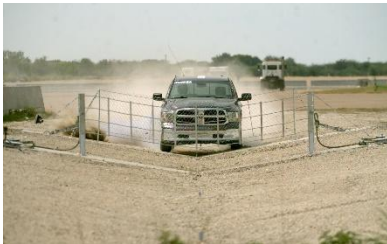
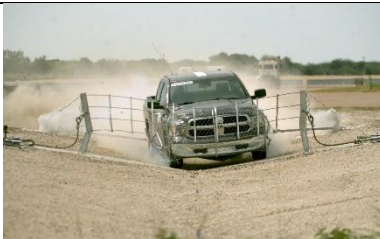
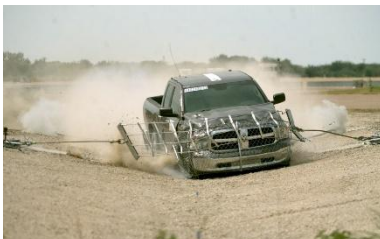
**Figure 8.11. Summary of Results for MASH Test 3-41 on MOPS.**

Figure 8.11 summarizes the results of *MASH* Test 440210-01-2. In Test 440210-01-2, the test vehicle impacted the second net, causing the swivel mount for the second net's energy absorber to release the energy absorber. This was not intended in the design and was undesirable for future testing. Therefore, a new swivel mount was designed and utilized for all subsequent testing, including a retest of 440210-01-2 (440210-01-4).

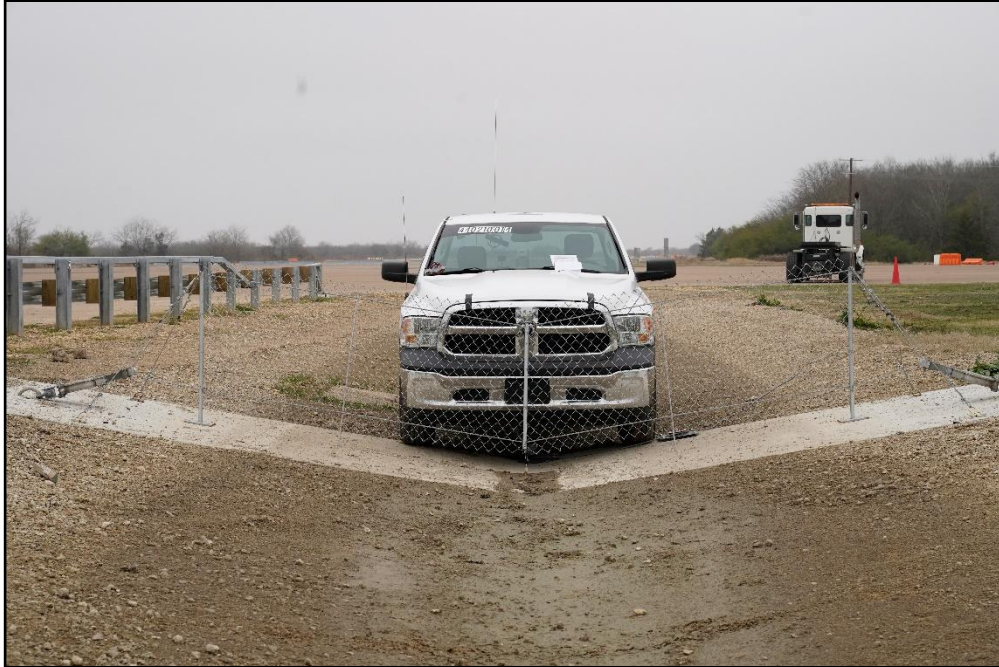
**Figure 9.1. MOPS/Test Vehicle Geometrics for Test 440210-01-4.**

See Table 9.1 for the *MASH* impact conditions and Table 9.2 for the exit parameters for Test 440210-01-4. Figure 9.1 and Figure 9.2 depict the target impact setup.

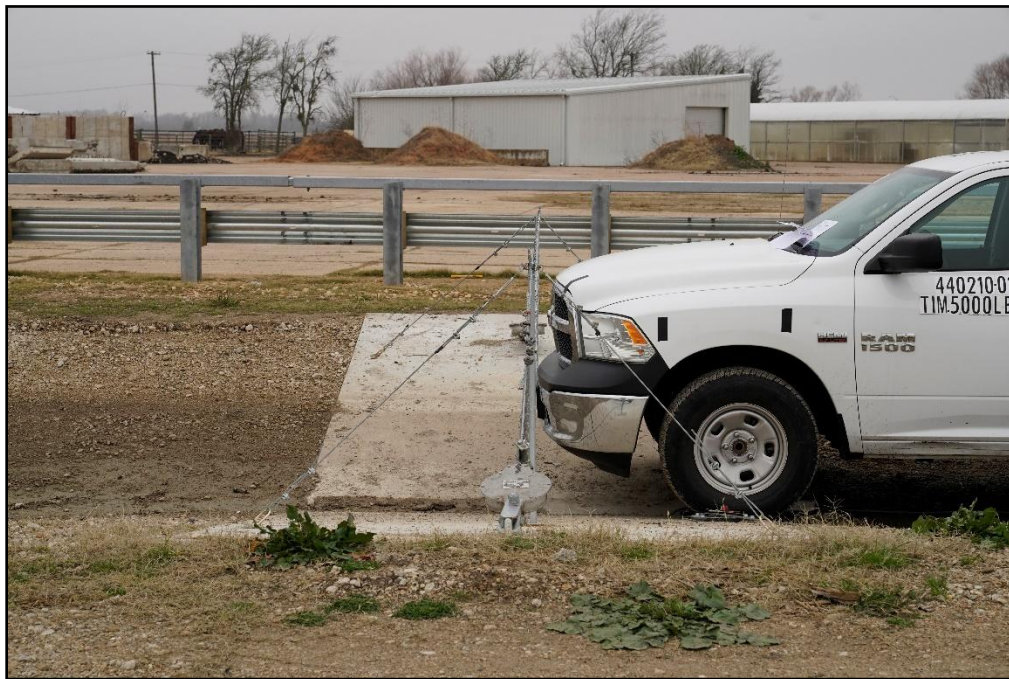
**Figure 9.2. MOPS/Test Vehicle Impact Location for Test 440210-01-4.**

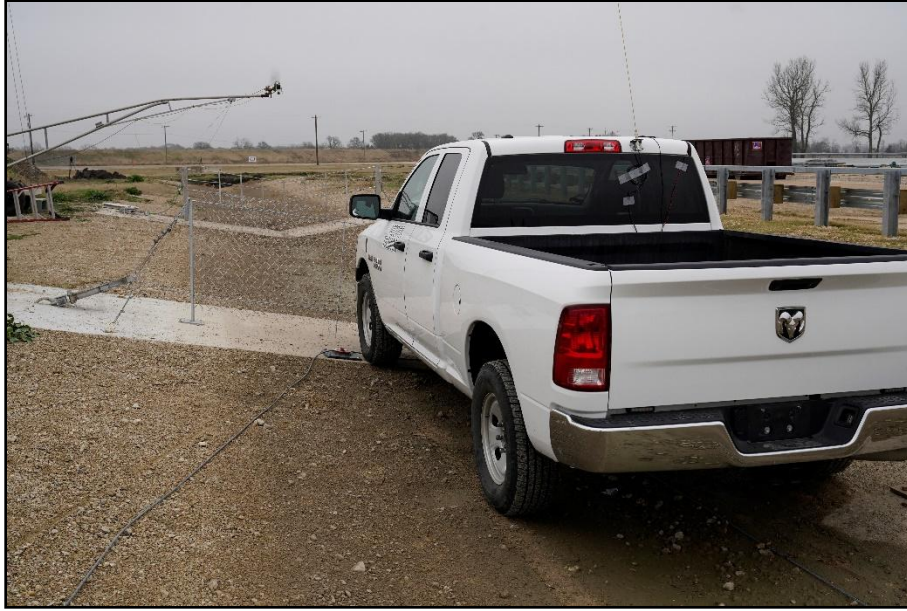
**Figure 9.4. Back of Test Vehicle before Test 440210-01-4.**

Figure 9.3 and Figure 9.4 show the 2016 RAM 1500 used for the crash test. Table 9.4 shows the vehicle measurements. Figure D.1 in Appendix D.1 gives additional dimensions and information on the vehicle.

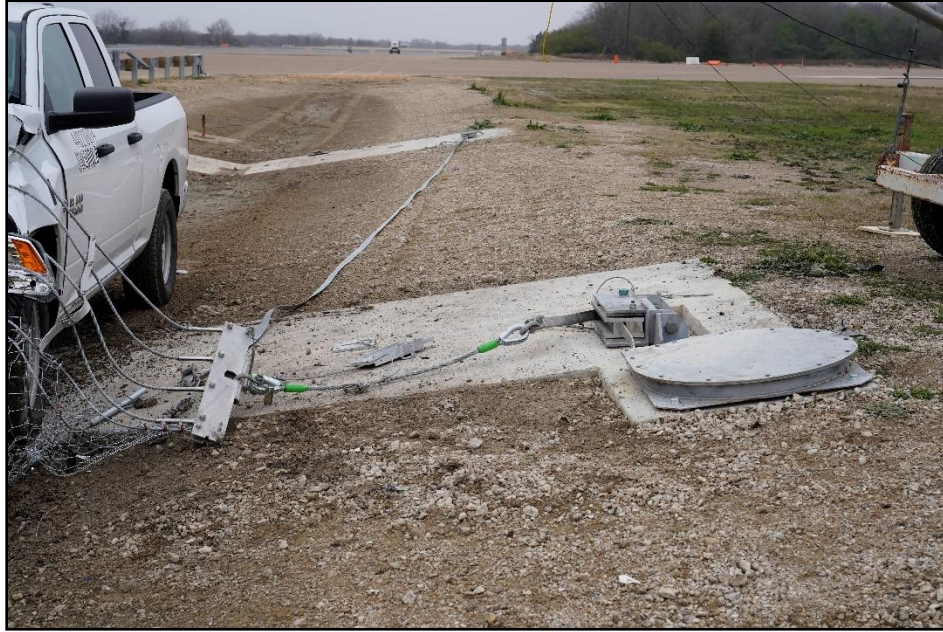
**Figure 9.6. Second Net Swivel Anchor and Energy Absorbers after Test 440210-01-4.**

The first net was wrapped around the front bumper of the vehicle, while the second net was wrapped over the hood. Both nets remained attached to their straps. There was some slight gouging of the concrete at the second net. Table 9.6 describes the deflection and working width of the MOPS. Figure 9.5 and Figure 9.6 show the damage to the MOPS.

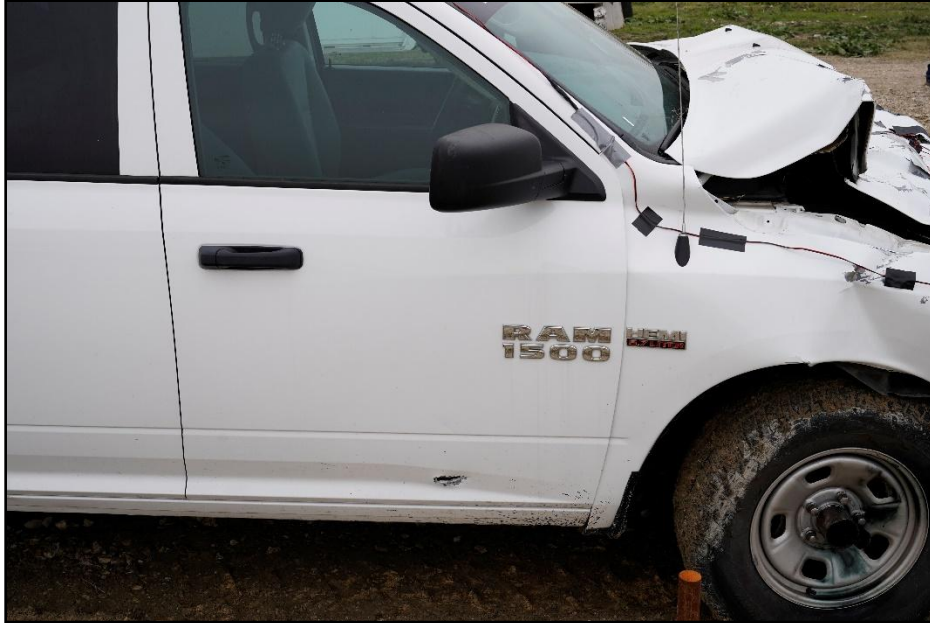
**Figure 9.8. Right Side of Test Vehicle after Test 440210-01-4.**

Figure 9.7 and Figure 9.8 show the damage sustained by the vehicle. Figure 9.9 and Figure 9.10 show the interior of the test vehicle. Table 9.7 and Table 9.8 provide details on the occupant compartment deformation and exterior vehicle damage. Figures D.2 and D.3 in Appendix D.1 provide exterior crush and occupant compartment measurements.

| <b>Description of Damage to Vehicle:</b> | The front bumper, hood, grill, right and left headlights, radiator and support, right and left fender, and right door were damaged. The right front door had a 3-inch-long and 1-inch-wide cut on the lower front corner. There was no penetration into the occupant compartment. |

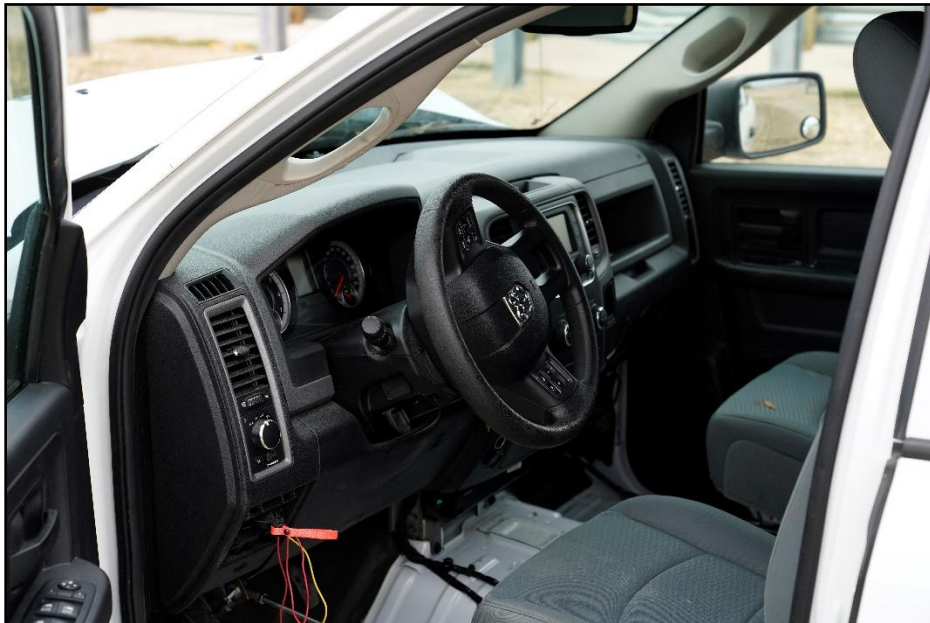
**Figure 9.9. Overall Interior of Test Vehicle after Test 440210-01-4.**

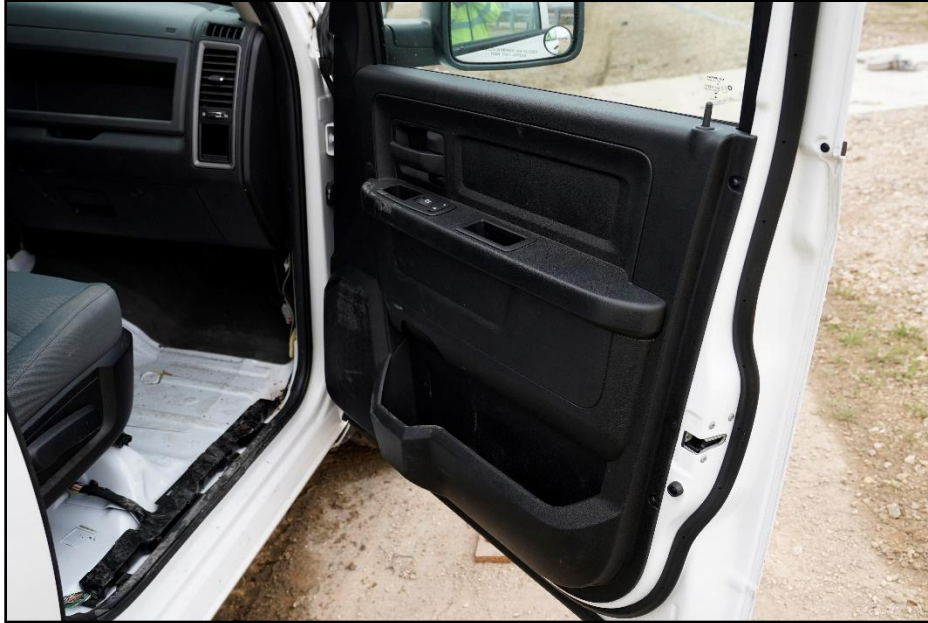
**Figure 9.10. Right-Side Interior of Test Vehicle after Test 440210-01-4.**

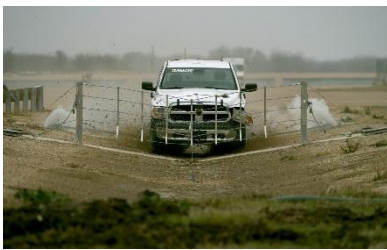
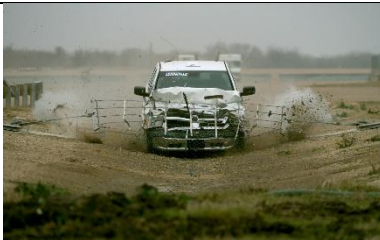
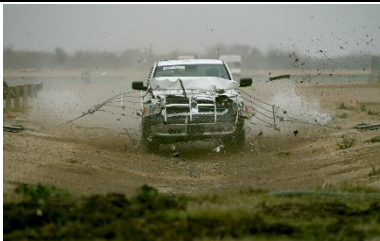
**Figure 9.11. Summary of Results for MASH Test 3-41 on MOPS.**

Figure 9.11 summarizes the results of *MASH* Test 440210-01-4.

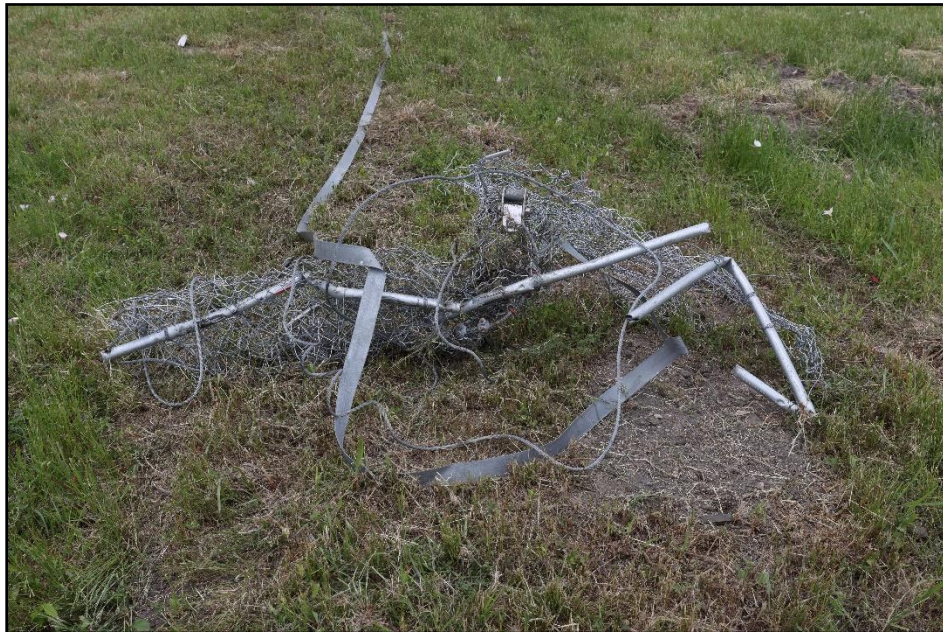
**Figure 10.2. Second Net after Test 440211-01-3.**

The steel straps from the first net landed 197 ft downstream and 268 ft downstream, and the first net was 312 ft downstream. The second net ruptured and was still attached to the right side of the test vehicle and was laying 15 ft to the right from center. Table 10.6 describes the deflection and working width of the MOPS. Figure 10.1 and Figure 10.2 show the damage to the MOPS.

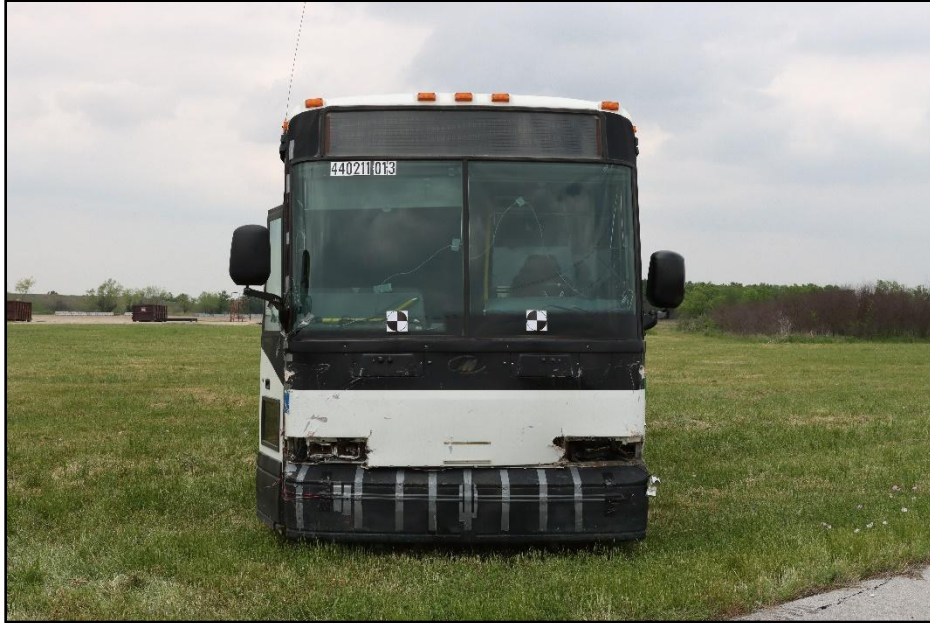
**Figure 10.3. Front of Test Vehicle after Test 440211-01-3.**

Figure 10.3 and Figure 10.4 show the damage sustained by the vehicle. Figure 10.5 and Figure 10.6 show the interior of the test vehicle. Table 10.7 provide details on the exterior vehicle damage. Due to the failure of the installation, occupant compartment deformation was not measured.

| <b>Description of Damage to Vehicle:</b> | The front bumper, headlights, and front side panels were damaged. |

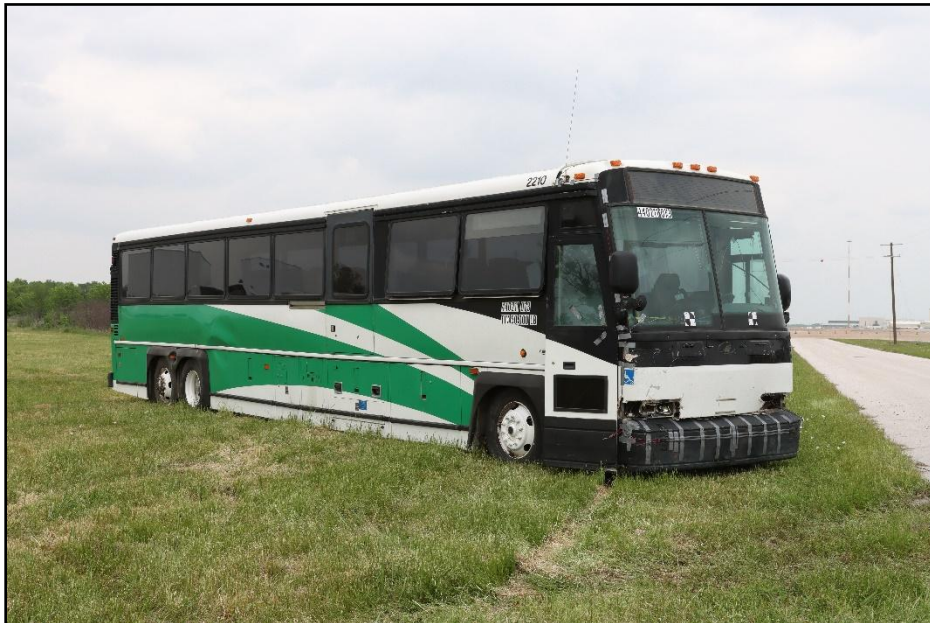
**Figure 10.4. Oblique View of Test Vehicle after Test 440211-01-3.**

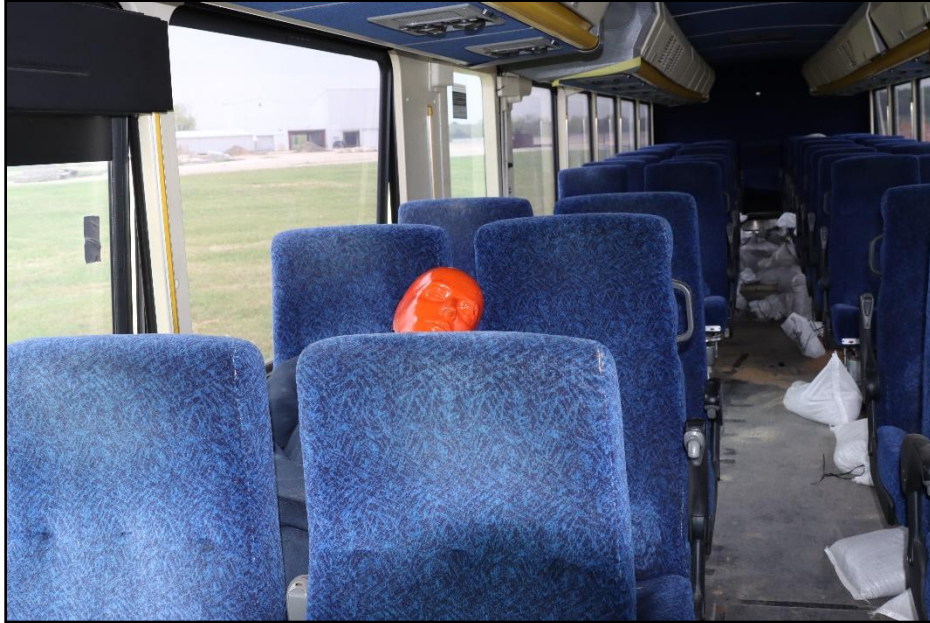
**Figure 10.5. Overall Rear Interior of Test Vehicle after Test 440211-01-3.**

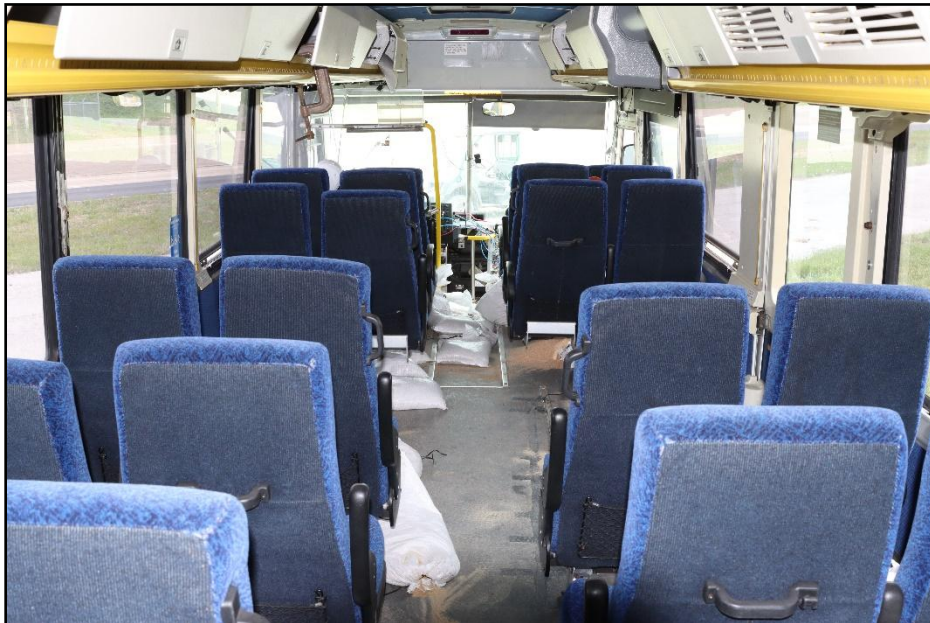
**Figure 10.6. Overall Front Interior of Test Vehicle after Test 440211-01-3.**

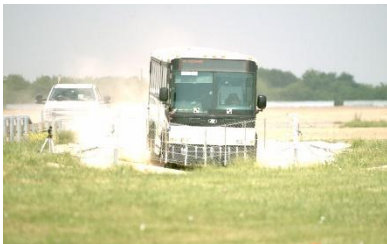
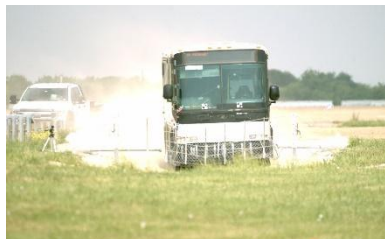
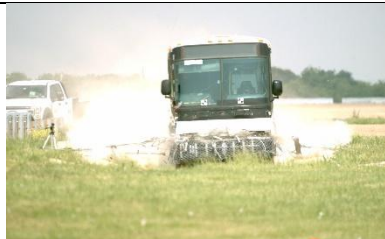
**Figure 10.7. Summary of Results for Research and Development Test on MOPS.**

Figure 10.7 summarizes the results of Test 440211-01-3. The second net's wire rope cables failed during the impact. Upon inspection of the damaged test article, it was determined that swage fittings on each of the wire ropes were not installed correctly in the factory. This caused the wire ropes to slip out from the swage fittings and

consequently allowed the test vehicle to penetrate through the net. Therefore, the research team performed the test again with properly manufactured nets, and this effort is documented in the next chapter.

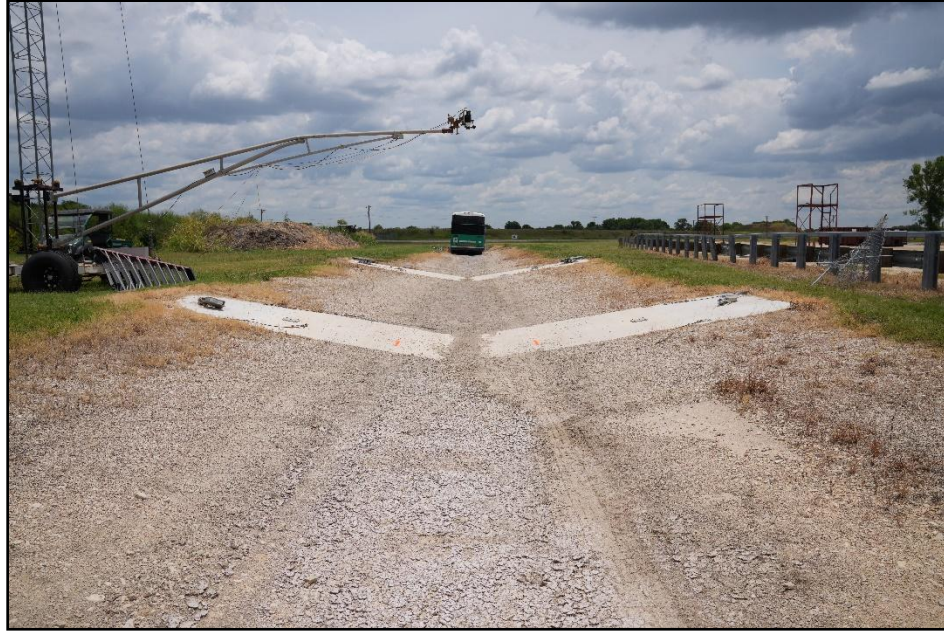
**Figure 11.1. Crash Site after Test 440211-01-5.**

The strap from the left cannister on the first net ruptured. The first net landed to the right of impact. The strap from the left cannister on the second net spooled out 71.5 ft. The strap from the right cannister on the second net ruptured and wrapped around the front of the bus. Table 11.6 describes the deflection and working width of the MOPS. Figure 11.1 and Figure 11.2 show the damage to the MOPS.

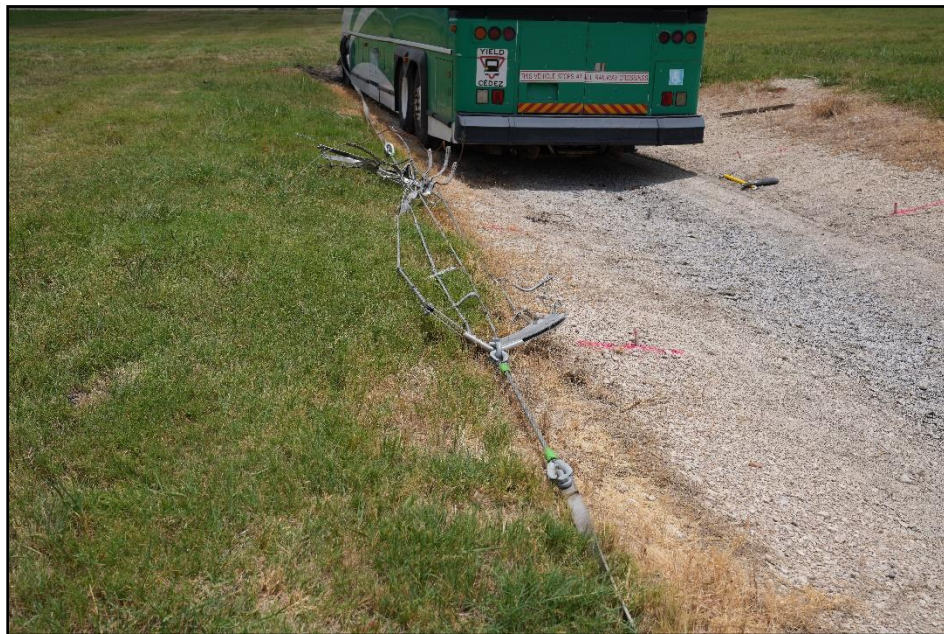
**Figure 11.2. MOPS after Test 440211-01-5.**

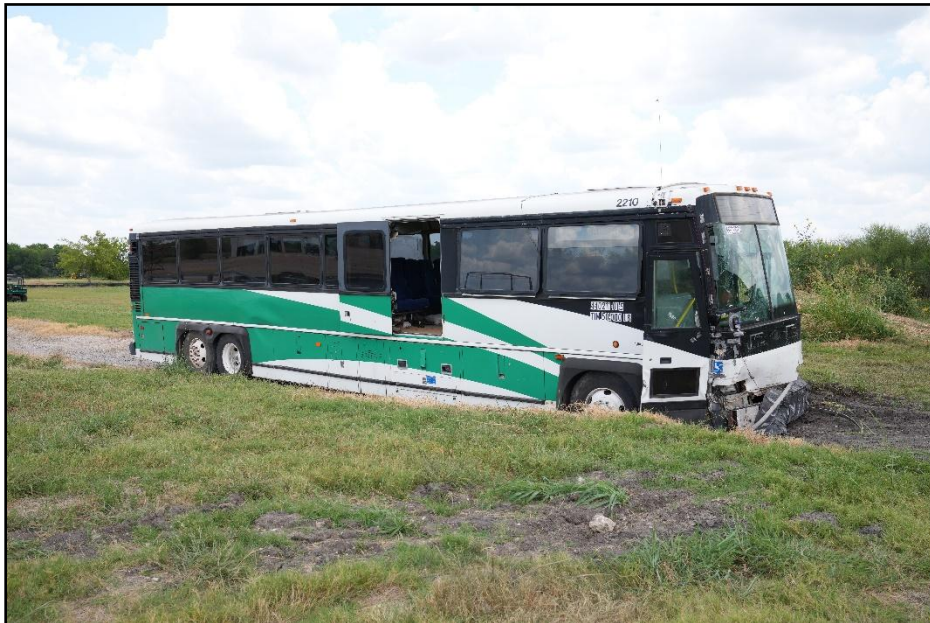
**Figure 11.4. Oblique View of Test Vehicle after Test 440211-01-5.**

Figure 11.3 and Figure 11.4 show the damage sustained by the vehicle. Figure 11.5 and Figure 11.6 show the interior of the test vehicle. Table 11.7 provides details on the exterior vehicle damage. Due to the failure of the installation, occupant compartment deformation was not measured.

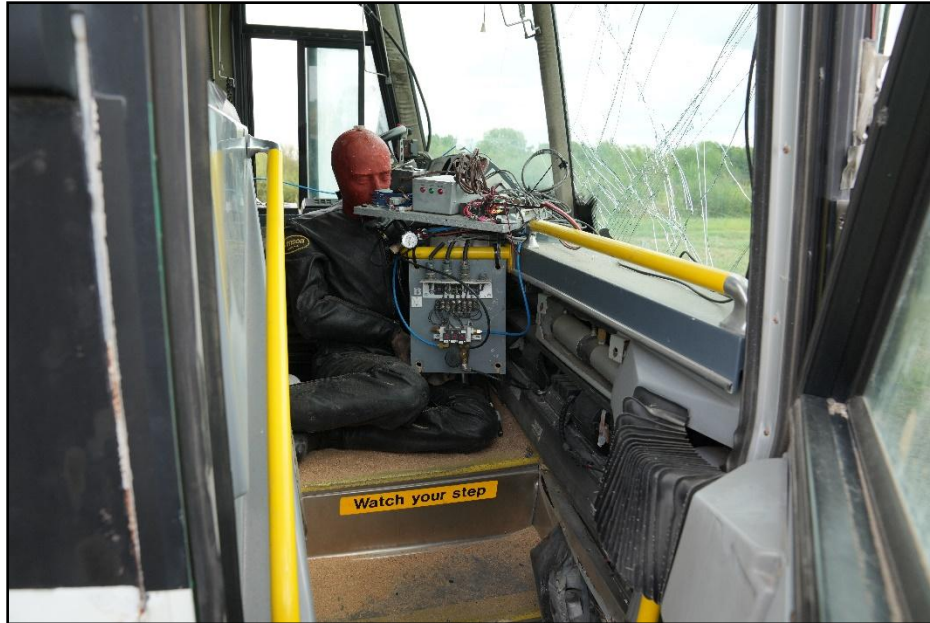
**Figure 11.5. Overall Interior of Front of Test Vehicle after Test 440211-01-5.**

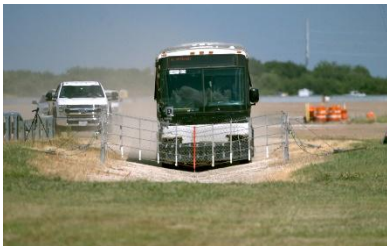
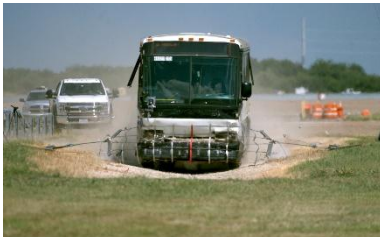
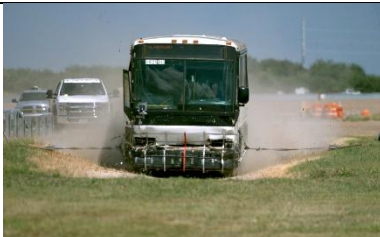
Figure 11.7. Summary of Results for Research and Development Test on MOPS.

Figure 11.7 summarizes the results of Test 440211-01-5. Upon investigation of the damaged test article, it was determined the bearings in the energy absorber failed during the impact. These bearings were reused throughout the previous tests without repair or replacement. The lack of repair or replacement following an impact event was believed to be the cause of the bearing failure and subsequent strap rupture. Because of the failing bearings, the test was repeated with new bearings installed within the energy absorbers. This identification of component failure and the need to replace the bearings after impact events provided additional information for future in-field use and maintenance planning.

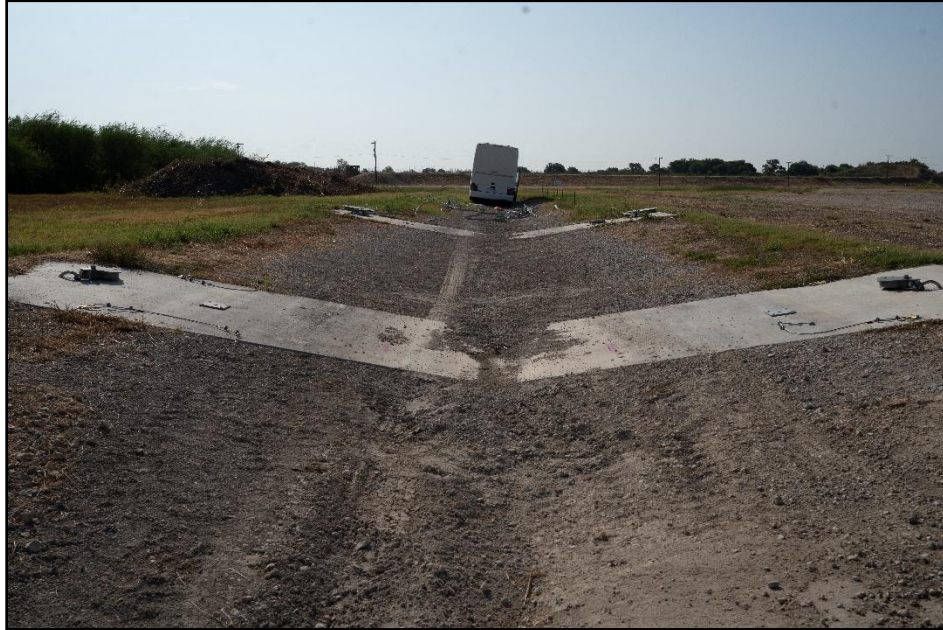
**Figure 12.1. Crash Site after Test 440213-01-6.**

Both straps on the first net paid out before releasing from their cannisters. The cable on the left side of the second net failed after spooling out 50 ft. Table 12.6 describes the deflection and working width of the MOPS. Figure 12.1 and Figure 12.2 show the damage to the MOPS.

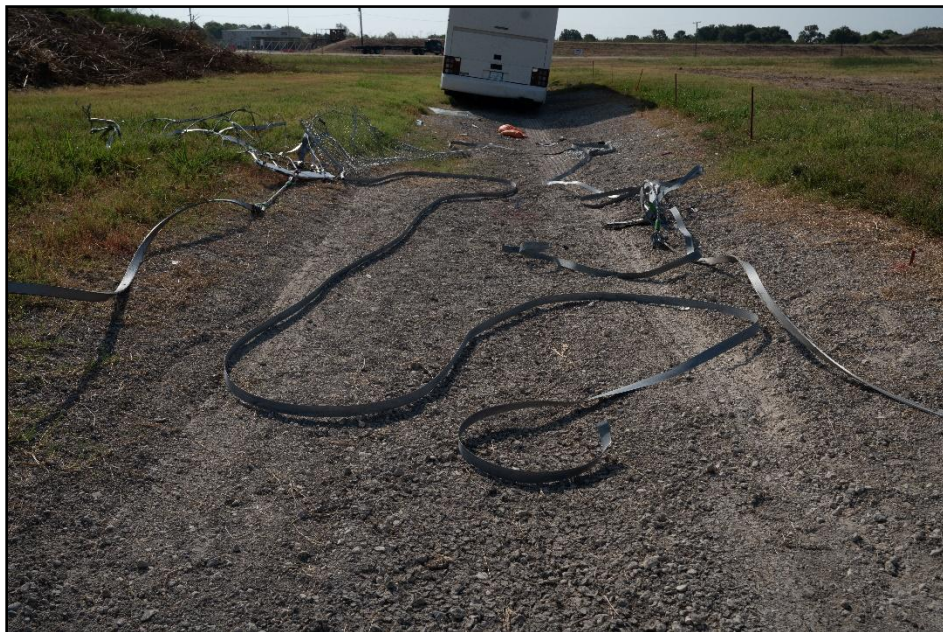
**Figure 12.2. Second Net after Test 440213-01-6.**
