**Test Report No. 0-7021-01-R1**

**DEVELOPING AN ENHANCED PROTECTION OF MEDIAN OPENINGS  
BETWEEN PARALLEL BRIDGE STRUCTURES**

Sponsored by the  
**Texas Department of Transportation  
and the  
Federal Highway Administration**

**TEXAS A&M TRANSPORTATION INSTITUTE PROVING GROUND**

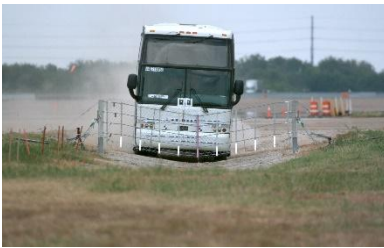
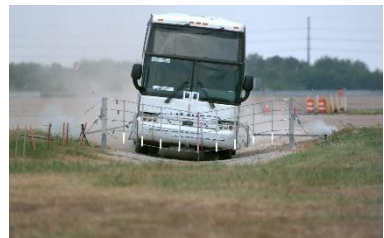
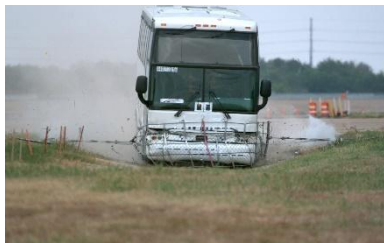
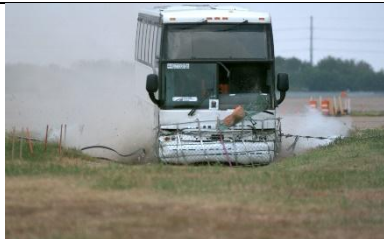
**Figure 12.7. Summary of Results for Research and Development Test on MOPS.**

| 0.000 s | <table><tr><td colspan="2">TEST ARTICLE</td></tr><tr><td>Type</td><td>Non-Redirective Crash Cushions</td></tr><tr><td>Name</td><td>MOPS</td></tr><tr><td>Length</td><td>50 ft</td></tr><tr><td>Key Materials</td><td>Wire mesh nets, wire rope net, energy absorbers</td></tr><tr><td>Soil Type and Condition</td><td>AASHTO M147-65(2004), Type 1, Grade D Crushed Concrete</td></tr></table> | TEST ARTICLE | | Type | Non-Redirective Crash Cushions | Name | MOPS | Length | 50 ft | Key Materials | Wire mesh nets, wire rope net, energy absorbers | Soil Type and Condition | AASHTO M147-65(2004), Type 1, Grade D Crushed Concrete | | | | | | | | | | | | | | | | | | | | |
| | <table><tr><td colspan="2">TEST VEHICLE</td></tr><tr><td>Type/Designation</td><td>Passenger Bus</td></tr><tr><td>Year, Make and Model</td><td>2002 Van Hool Commuter C2045 USA</td></tr><tr><td>Curb (lb)</td><td>34,120</td></tr><tr><td>Inertial Weight (lb)</td><td>50,140</td></tr></table> | TEST VEHICLE | | Type/Designation | Passenger Bus | Year, Make and Model | 2002 Van Hool Commuter C2045 USA | Curb (lb) | 34,120 | Inertial Weight (lb) | 50,140 | | | | | | | | | | | | | | | | | | | | | | |
| 0.100 s | <table><tr><td colspan="2">IMPACT CONDITIONS</td></tr><tr><td>Impact Speed (mi/h)</td><td>50.0</td></tr><tr><td>Impact Angle (deg)</td><td>0.7</td></tr><tr><td>Impact Location</td><td>Centerline of the vehicle aligned 16.6 inches to the right of the centerline of the first MOPS net and 7.3 inches to the right of the centerline of the second net</td></tr><tr><td>Kinetic Energy (kip-ft)</td><td>4190.4</td></tr></table> | IMPACT CONDITIONS | | Impact Speed (mi/h) | 50.0 | Impact Angle (deg) | 0.7 | Impact Location | Centerline of the vehicle aligned 16.6 inches to the right of the centerline of the first MOPS net and 7.3 inches to the right of the centerline of the second net | Kinetic Energy (kip-ft) | 4190.4 | | | | | | | | | | | | | | | | | | | | | | |
| | <table><tr><td colspan="2">EXIT CONDITIONS</td></tr><tr><td>Exit Speed (mi/h)</td><td>N/A</td></tr><tr><td>Stopping Distance</td><td>180 ft downstream<br/>1.5 ft to the left side</td></tr></table> | EXIT CONDITIONS | | Exit Speed (mi/h) | N/A | Stopping Distance | 180 ft downstream<br>1.5 ft to the left side | | | | | | | | | | | | | | | | | | | | | | | | | | |
| | <table><tr><td colspan="2">VEHICLE DAMAGE</td></tr><tr><td>VDS</td><td>12FC1</td></tr><tr><td>CDC</td><td>12FCEN1</td></tr><tr><td>Max. Ext. Deformation (inches)</td><td>Not measured</td></tr><tr><td>Max Occupant Compartment Deformation</td><td>Not measured</td></tr></table> | VEHICLE DAMAGE | | VDS | 12FC1 | CDC | 12FCEN1 | Max. Ext. Deformation (inches) | Not measured | Max Occupant Compartment Deformation | Not measured | | | | | | | | | | | | | | | | | | | | | | |

Figure 12.7 summarizes the results of Test 440213-01-6. After investigation of the test results, the research team believed unequal loading between the wire ropes of the second net caused the wire ropes to rupture. Once the wire ropes began to rupture, a zipper-like behavior occurred, with other wire ropes rupturing soon after. A modification in the wire rope design is recommended for evaluation in future research.

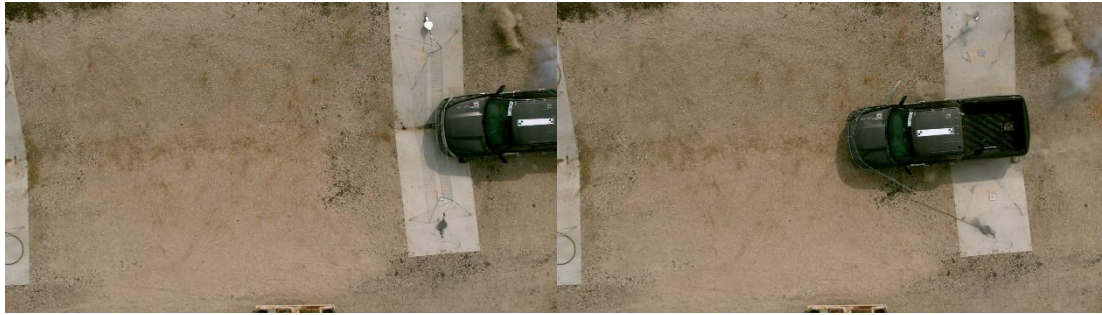
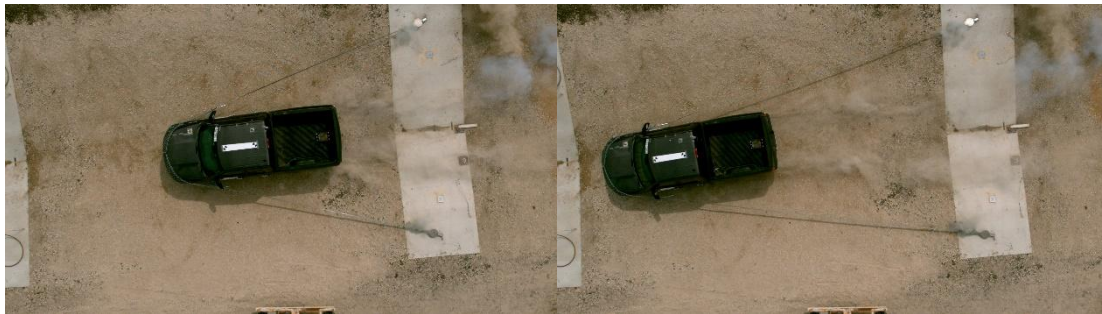
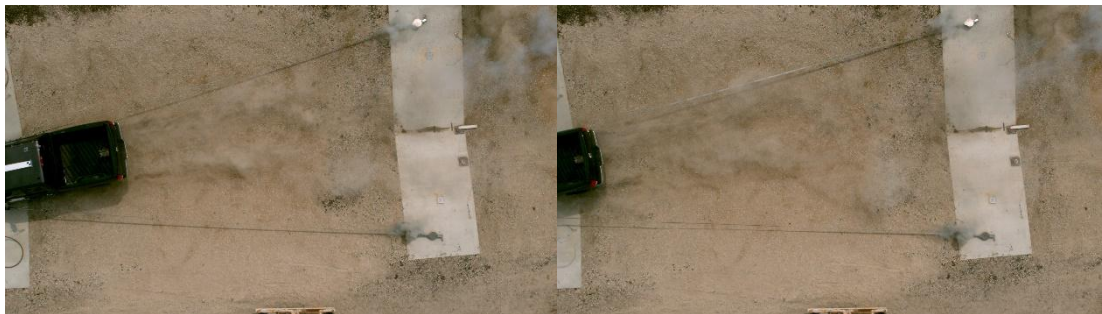
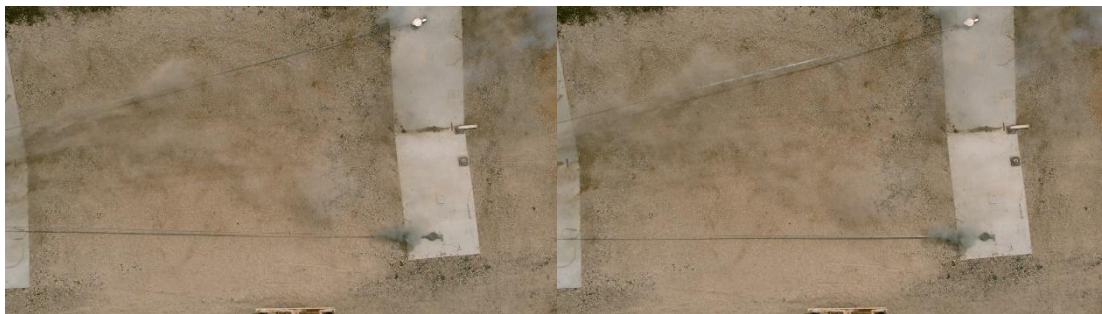
**Figure C.4. Sequential Photographs for Test 440210-01-2 (Overhead Views).**

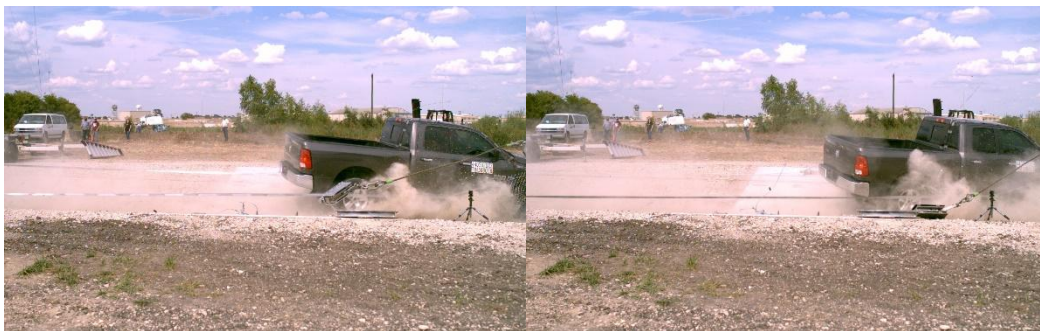
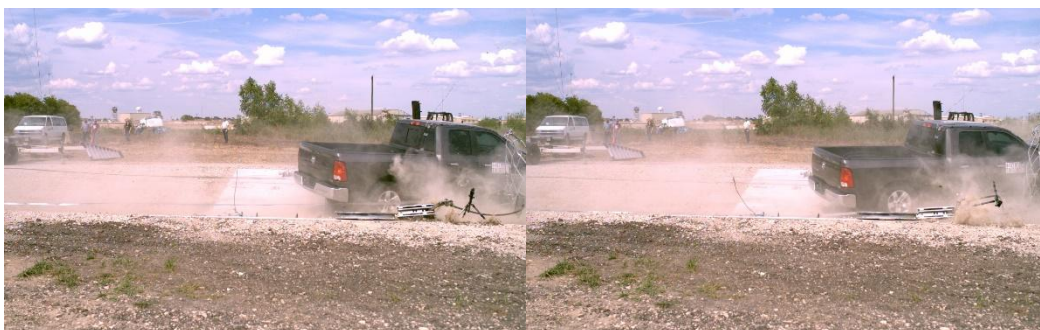
**Figure C.7. Sequential Photographs for Test 440210-01-2 (Right Angle Views).**

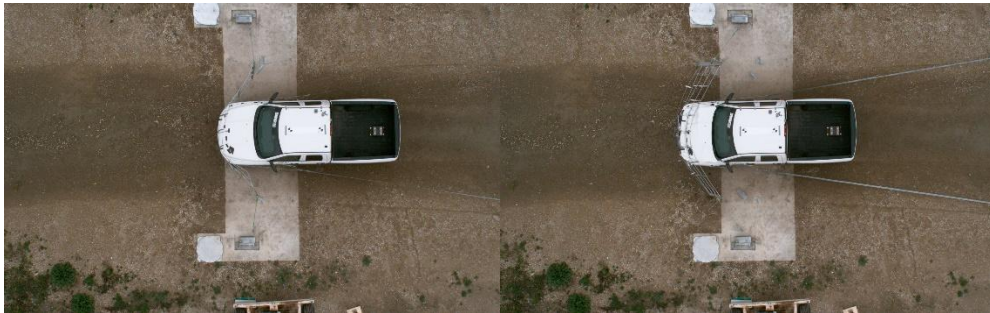
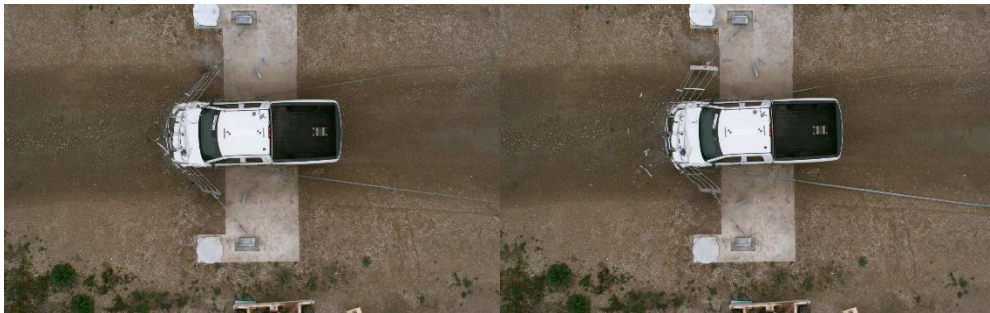
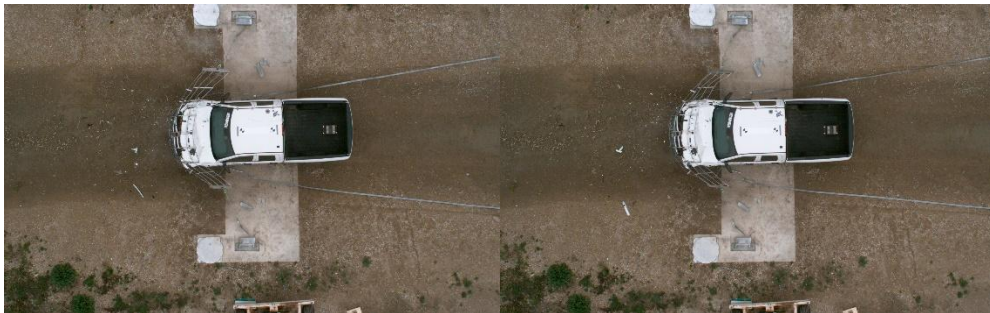
**Figure D.4. Sequential Photographs for Test 440210-01-4 (Overhead Views).**

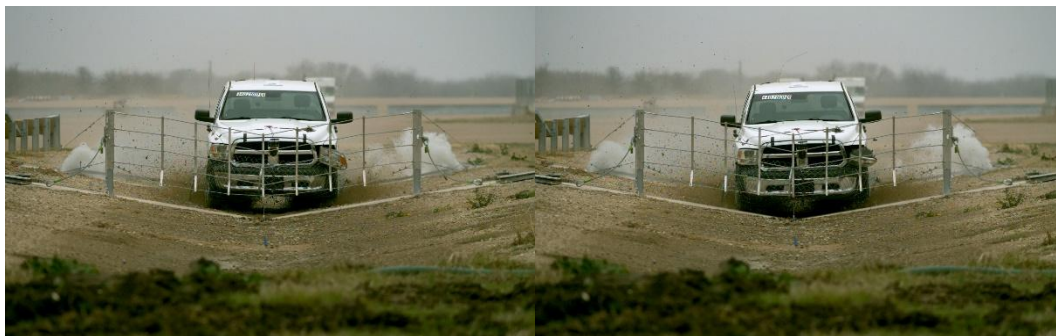
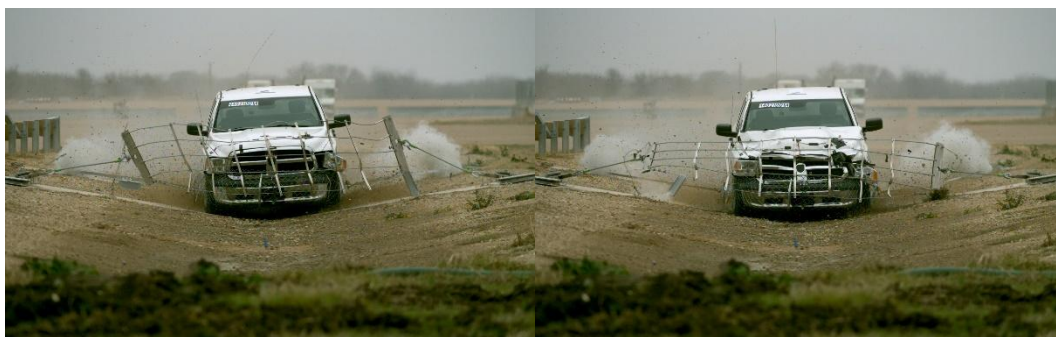
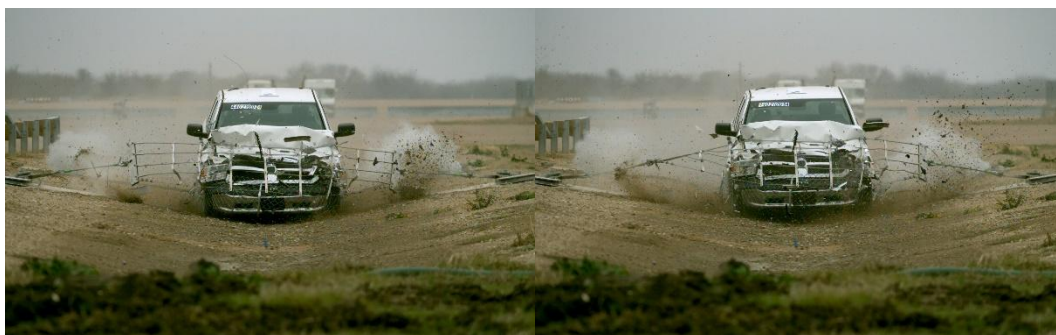
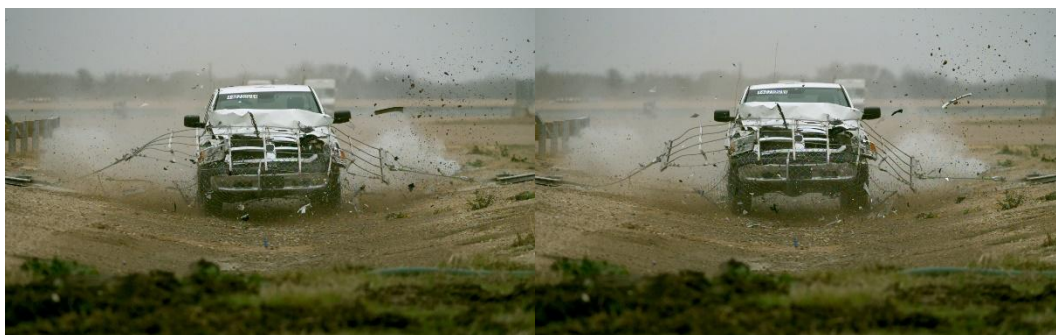
**Figure D.5. Sequential Photographs for Test 440210-01-4 (Frontal Views).**

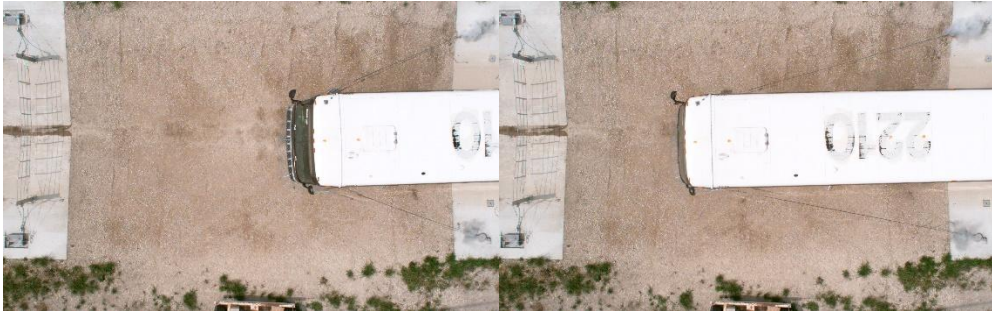
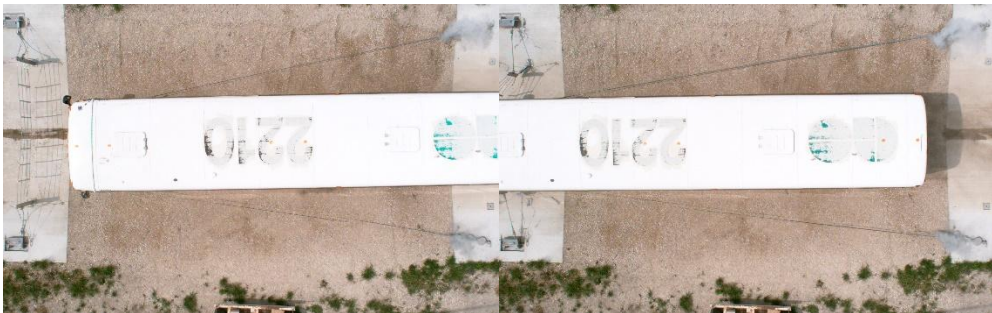
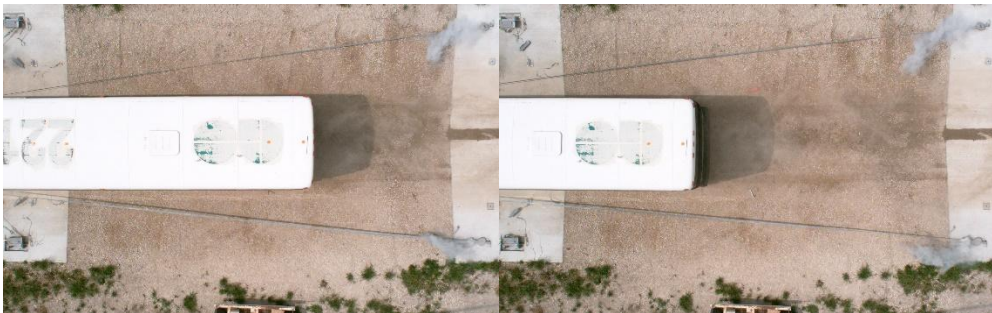
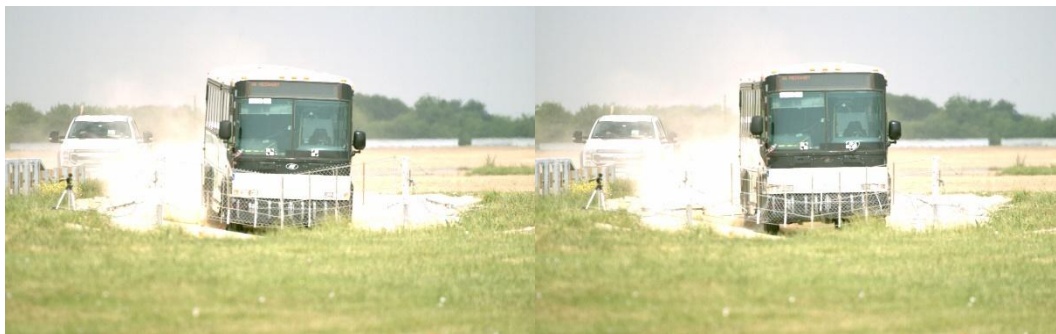
**Figure E.2. Sequential Photographs for Test 440211-01-3 (Overhead Views).**

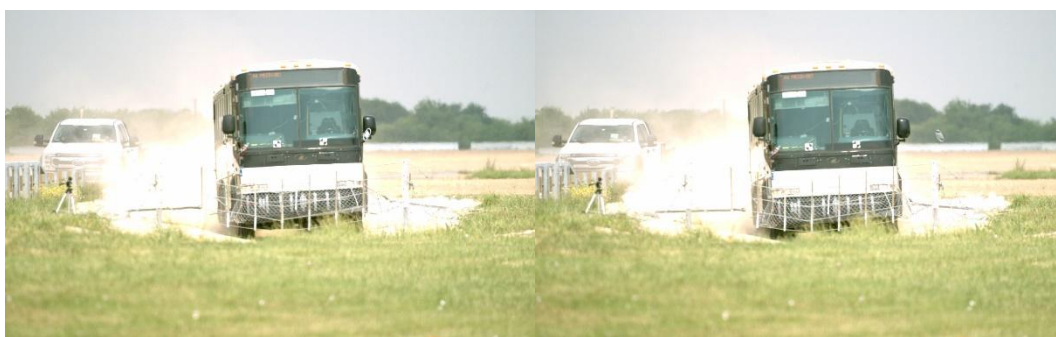
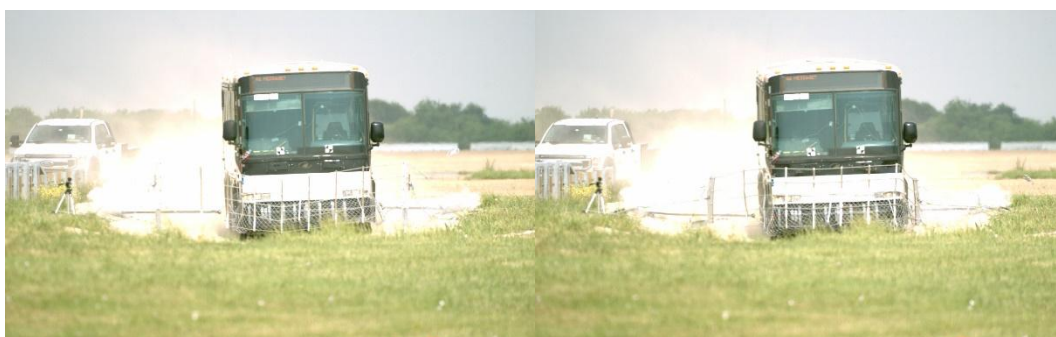
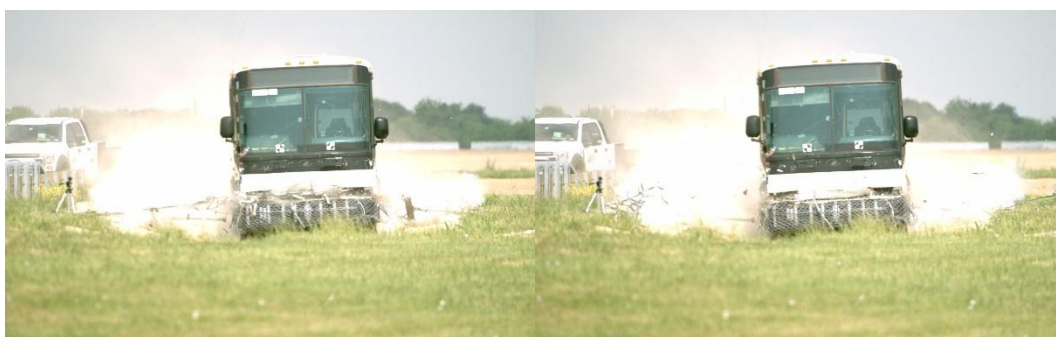
**Figure E.3. Sequential Photographs for Test 440211-01-3 (Frontal Views).**

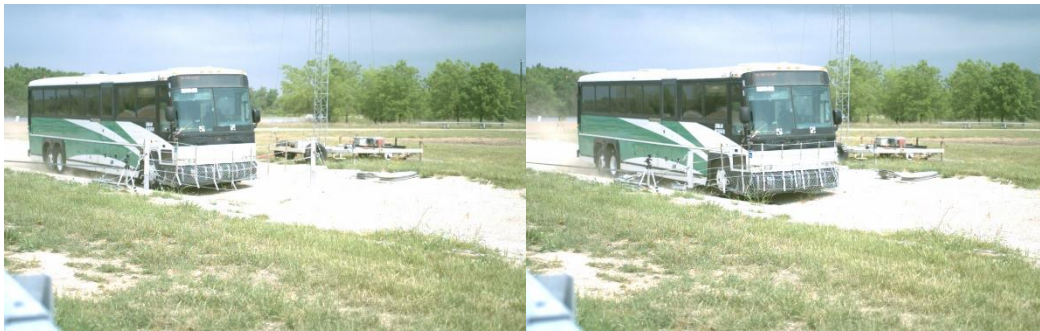
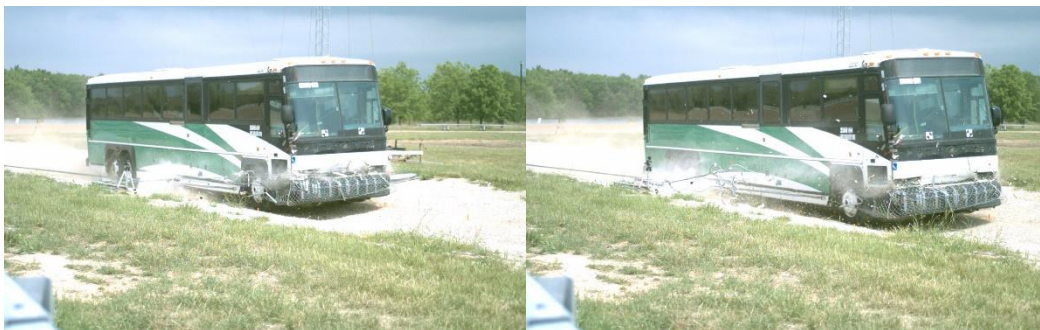
**Figure E.4. Sequential Photographs for Test 440211-01-3 (Oblique Views).**

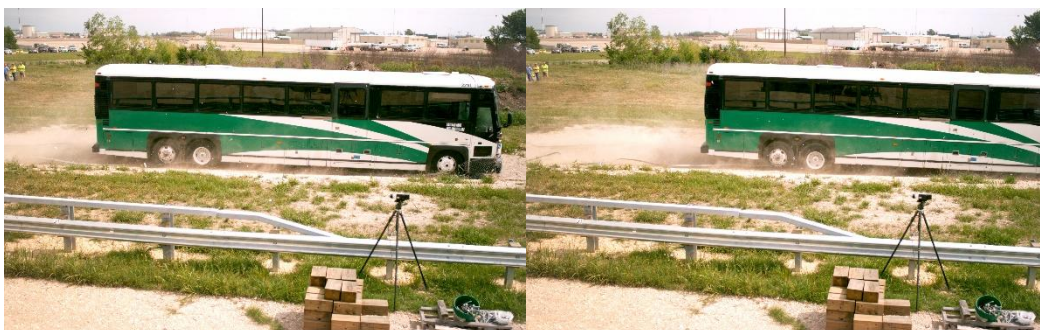
**Figure E.5. Sequential Photographs for Test 440211-01-3 (Right Angle Views).**

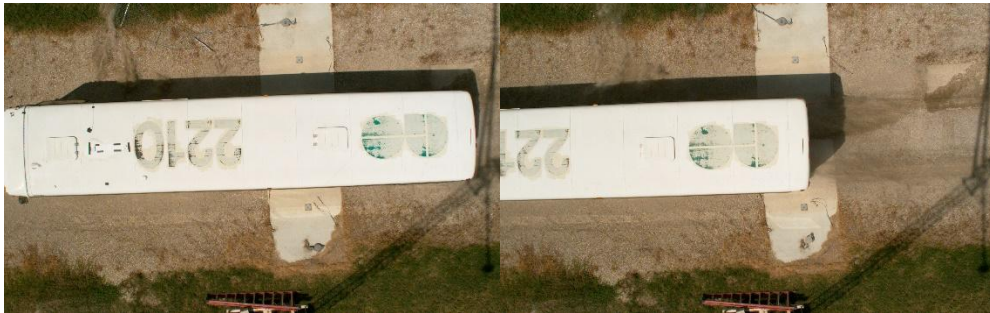
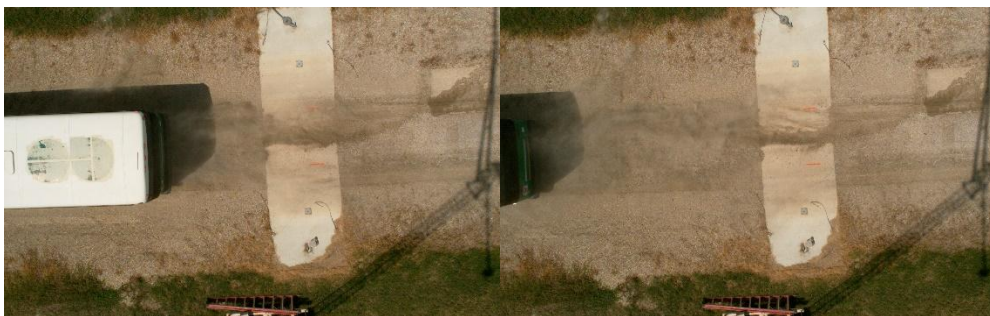
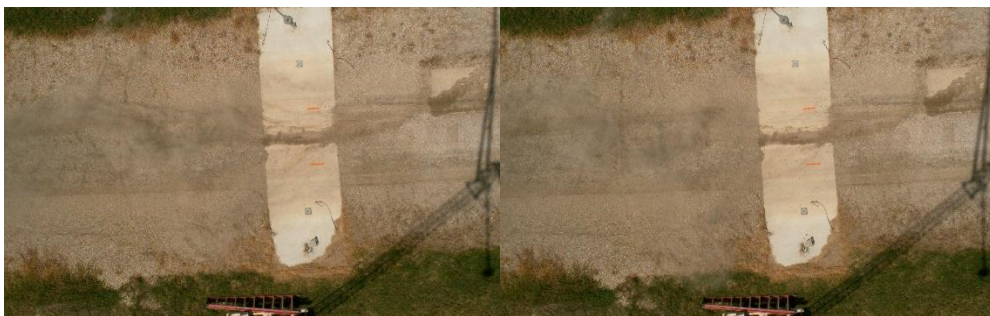
**Figure F.2. Sequential Photographs for Test 440211-01-5 (Overhead Views).**

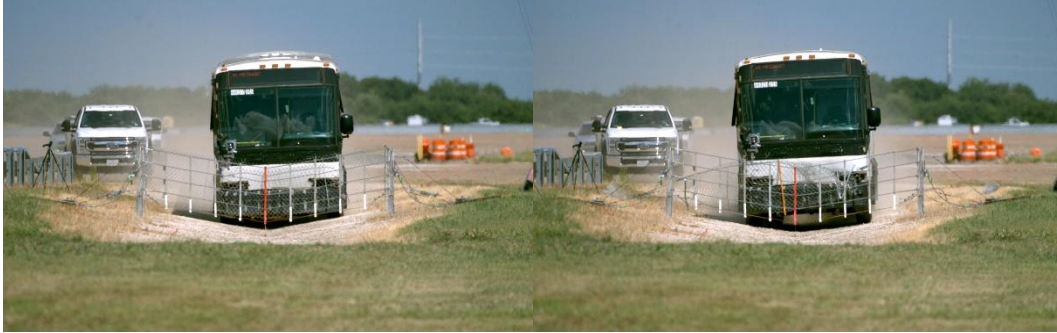
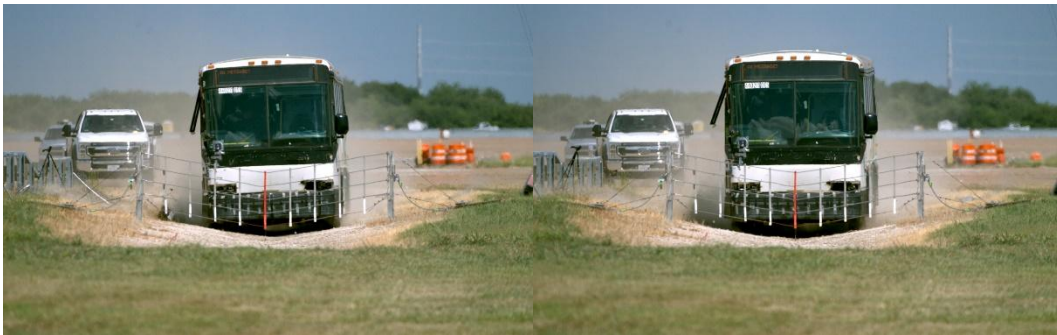
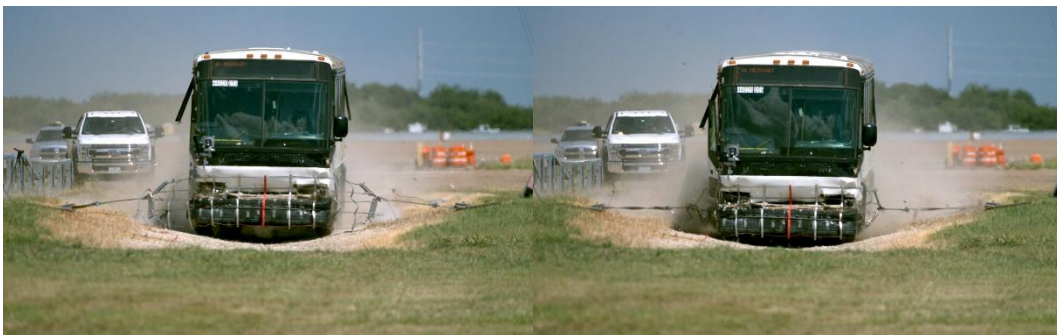
**Figure F.3. Sequential Photographs for Test 440211-01-5 (Frontal Views).**

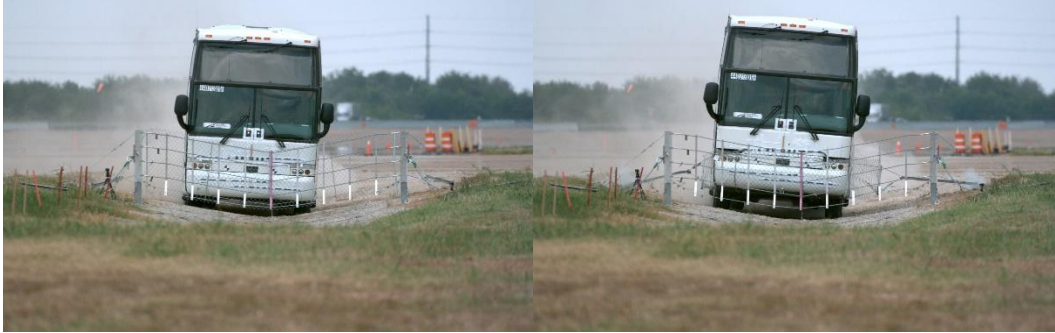
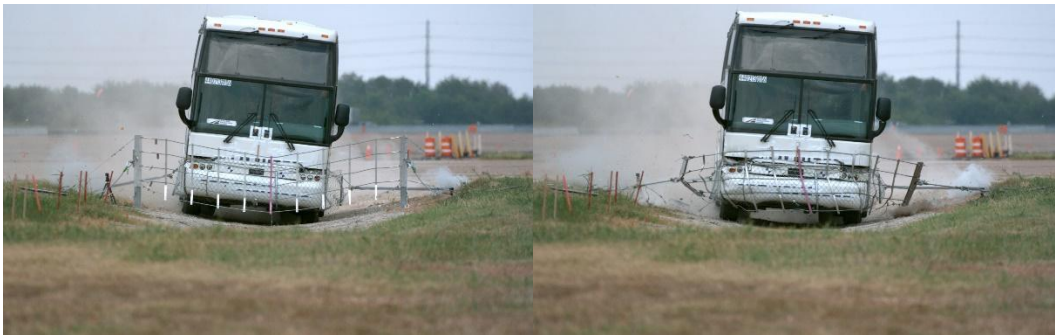
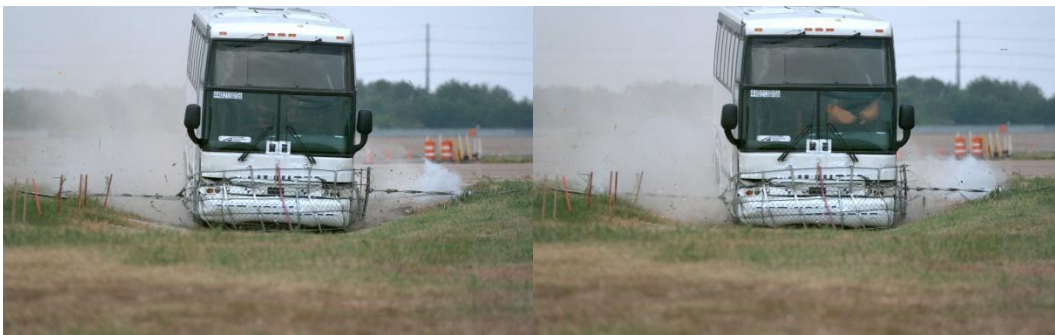
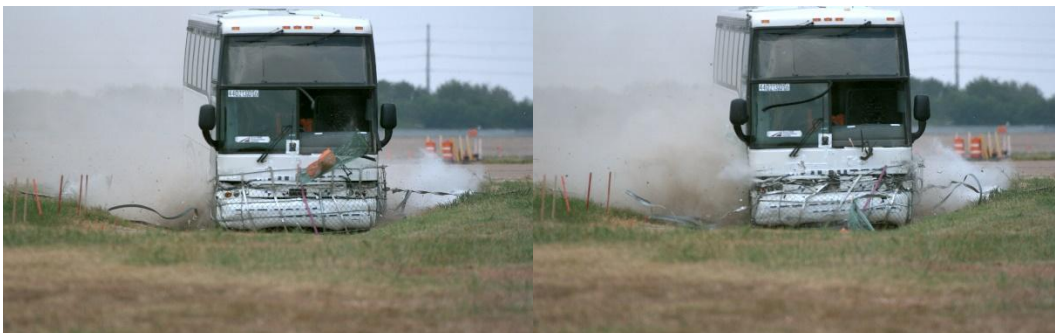
(a) 0.000 s

(b) 0.300 s

(c) 0.600 s

(d) 0.900 s

(e) 1.200 s

(f) 1.500 s

(g) 1.800 s

(h) 2.100 s

**Figure G.3. Sequential Photographs for Test 440213-01-6 (Frontal Views).**

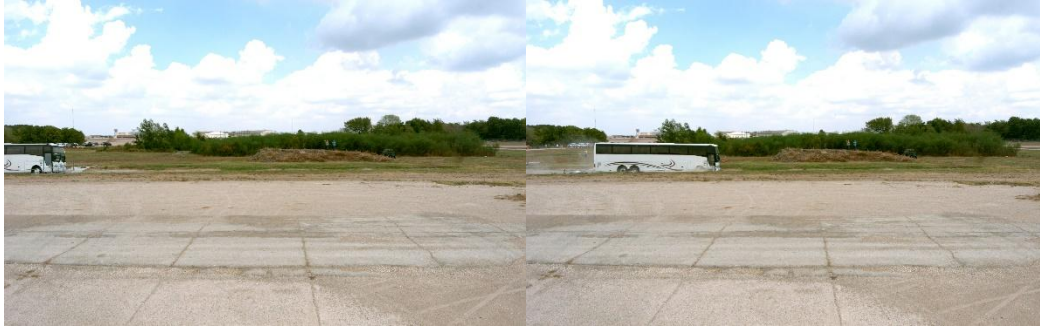
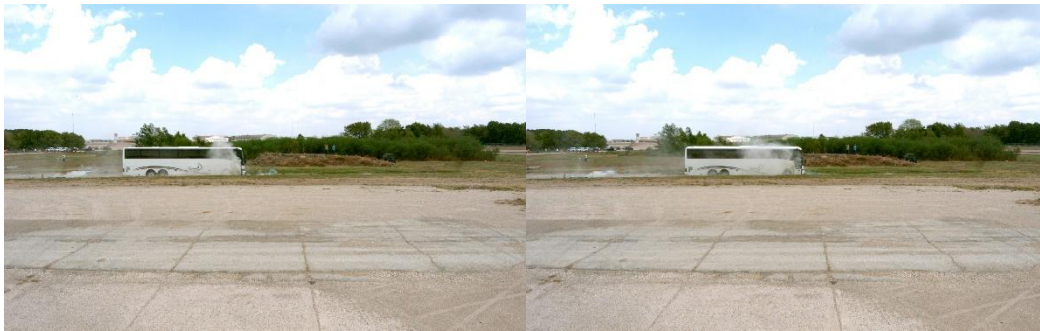
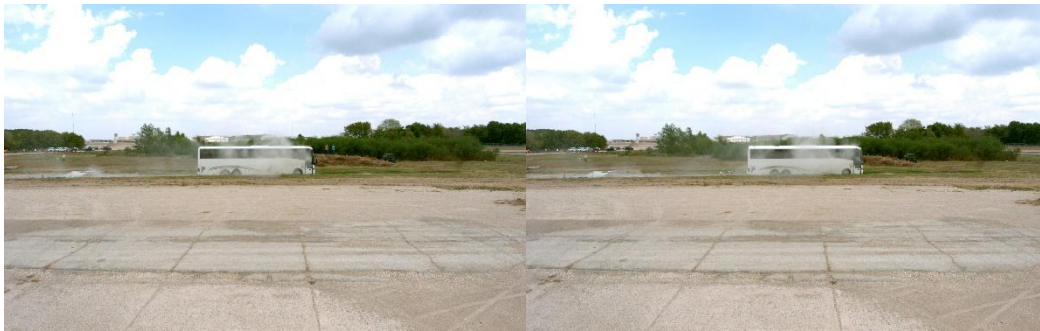
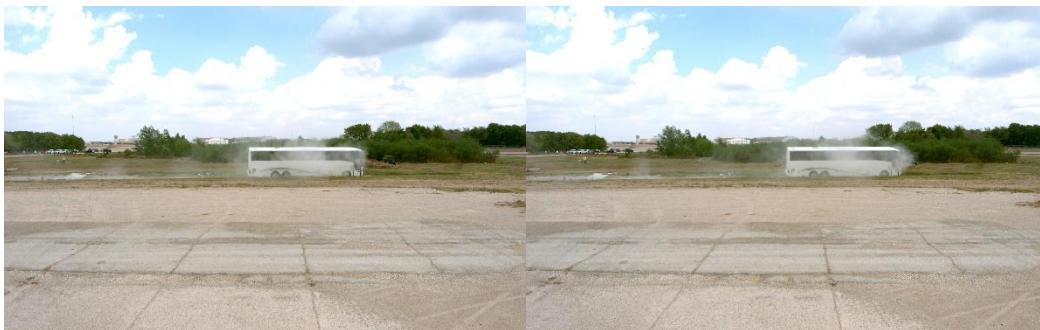
(a) 0.000 s

(b) 0.100 s

(c) 0.200 s

(d) 0.300 s

(e) 0.400 s

(f) 0.500 s

(g) 0.600 s

(h) 0.700 s

**Figure G.4. Sequential Photographs for Test 440213-01-6 (Right Angle Views).**
