# Evaluating Candidate Projects for Seal Coat Stability

Technical Report 0-7106-R1

TEXAS A&M TRANSPORTATION INSTITUTE  
COLLEGE STATION, TEXAS

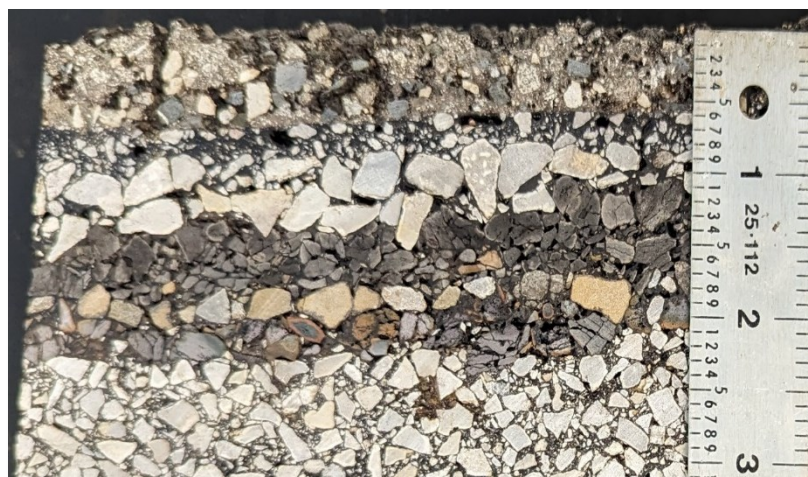
**Figure 2. Pavement Core with Multiple Seal Coats.**

With TxDOT's strong preventive maintenance program, many roads in Texas are performing very well with multiple seal coats; however, others are not. Figure 1 shows examples of potential issues with multiple seal coats on pavement sections and Figure 2 shows a pavement core with multiple seal coats.

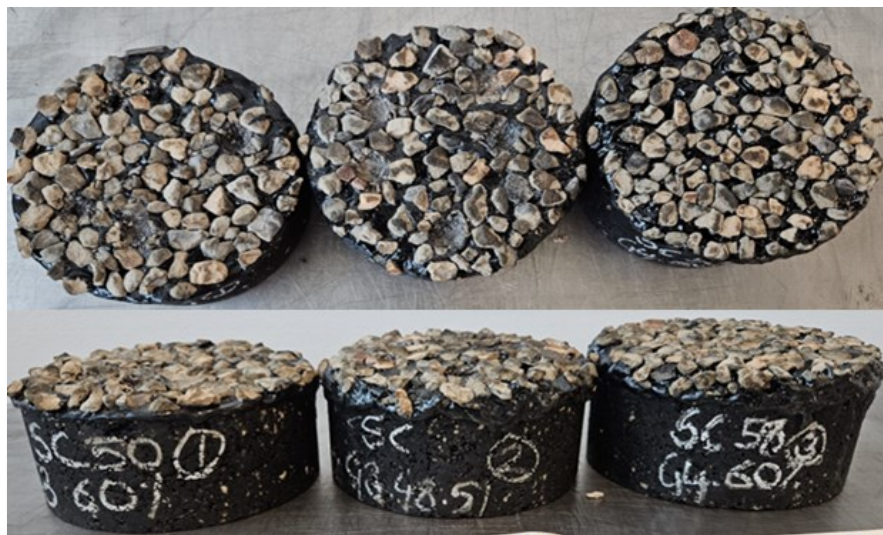
In the laboratory, the research team prepared 6-inch diameter hot mixed asphaltic concrete (HMA) specimens surfaced with different aggregates, binder types, surface layers, and aggregate embedment depths to assess the stability of the seal coat as layers were added. Figure 3, from left to right, shows 1, 2, and 3 seal coat layers on lab-prepared specimens. As part of the test-specimen preparation, the binder and aggregates were heated for 2 hours to the compaction temperature before they were applied to the surface of the HMA specimens. Table 1 and Table 2 list the application rates for the aggregates and binders, respectively. The material producer's *name* was changed to a *code* (pseudonym) to protect individual source data. The application rates varied depending on the embedment, aggregate grade, binder type, and substrate absorption. The application temperatures for emulsions (catatonic rapid setting polymer-modified asphalt, CRS-2P) and for asphaltic cements and aged residues (AC20-5TR, AR) were 150°F and 350°F, respectively.

Figure 3. Laboratory Seal Coat Specimens with 1, 2, and 3 Layers.

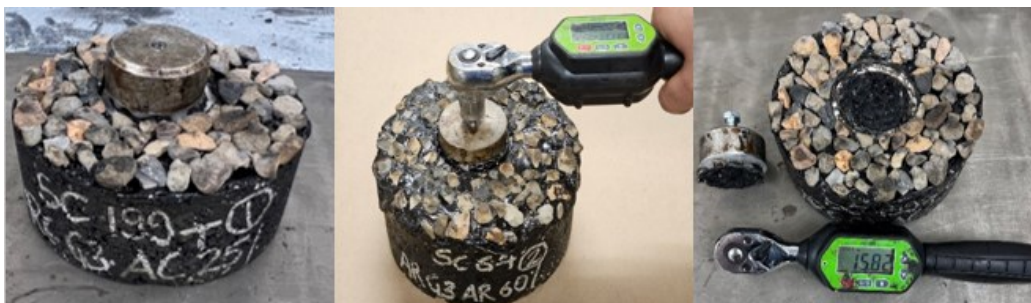
One characteristic of the seal coat surface is that it resists horizontal shear due to traffic, especially when vehicles are turning and braking. Typical tests, such as the asphalt bond shear test, are challenging to apply on a seal coat. Instead, researchers determined that the most suitable test to determine the shear strength of a seal coat along the horizontal plane is a torsion test (Figure 8), which measures the amount of torque force required for the seal surface layers to fail along the horizontal plane. This test is not without issue. The test requires that a plate be glued on the surface of a specimen. The amount of glue needed is highly subjective and varies for different aggregate sizes. These different glue amounts may skew the test results. A technician must minimize erroneous results due to gluing; more errors are expected with relatively large aggregates. In this research, some results, especially for the grade 3 aggregates, may be suspect. Table 5, Table 6, and Table 7 list the raw torsion test results with the AC20-5TR, AR, and CRS-2P binders, respectively.

**Figure 8. Torsion Test Example.**

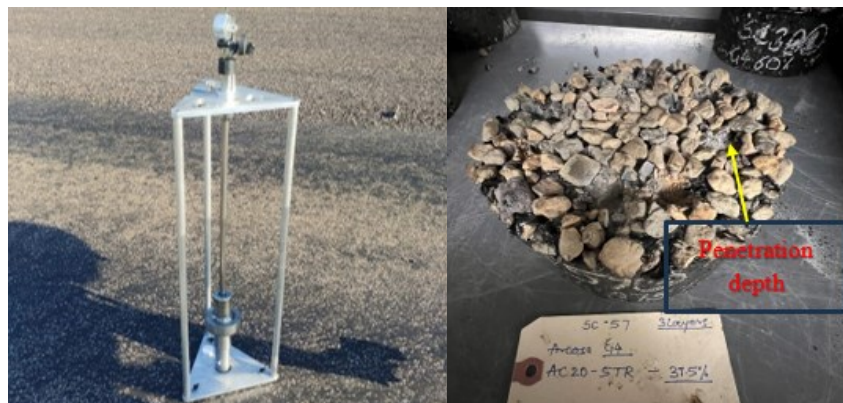
To assess the stability of the seal coat on the lab-prepared HMA specimens, the research team performed a ball penetration test (Figure 12), among other tests. Specifically, the modified dynamic cone penetrometer (MDCP) test involves pushing a steel ball into a seal coat surface with the drop (blow) of a hammer. The research team performed two blows per test location; blow 1 was taken as a seating load and blow 2 was used as a penetration reading. Each specimen was tested in five locations; the average of these locations was used as the ball penetration value for a specimen. In total, 106 specimens were tested. Table 8, Table 9, and Table 10 detail the ball penetration test results with the AC20-5TR, AR, and CRS-2P binders, respectively. Table 11 details the averaged results by binder type and layer. Figure 13 displays these results graphically.

**Figure 12. Ball Penetration Test Equipment and Sample Outcome.**

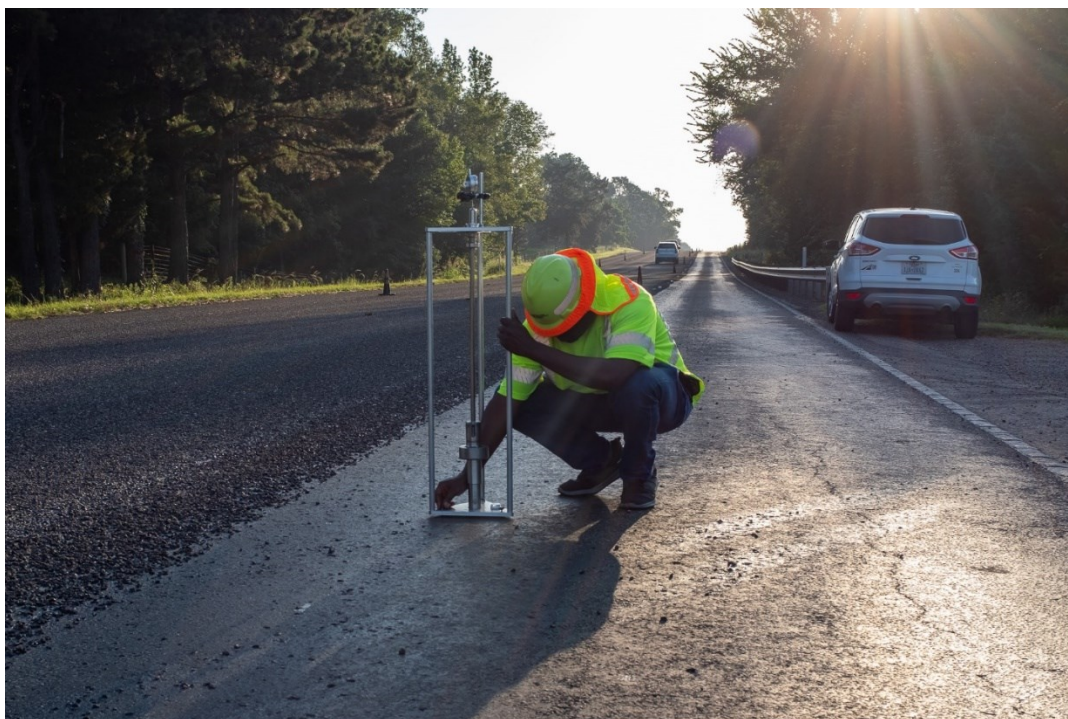
Ball penetration measurements were taken at three locations on the old surface: in the left and right wheel paths (LWP and RWP) and between the wheel paths (BWP). The surface between the wheel paths was typically more brittle with little to no bleeding, whereas the wheel path surfaces were bleeding and flushing in most cases. Figure 24 shows the MDCP in operation on US 67 near Mt. Pleasant, Texas. Table 13 summarizes the test results. A temperature factor was developed in the laboratory to correlate the field ball penetration measurements to 104°F (40°C).

**Figure 24. MDCP Field Test on US 67 near Mt. Pleasant, Texas.**

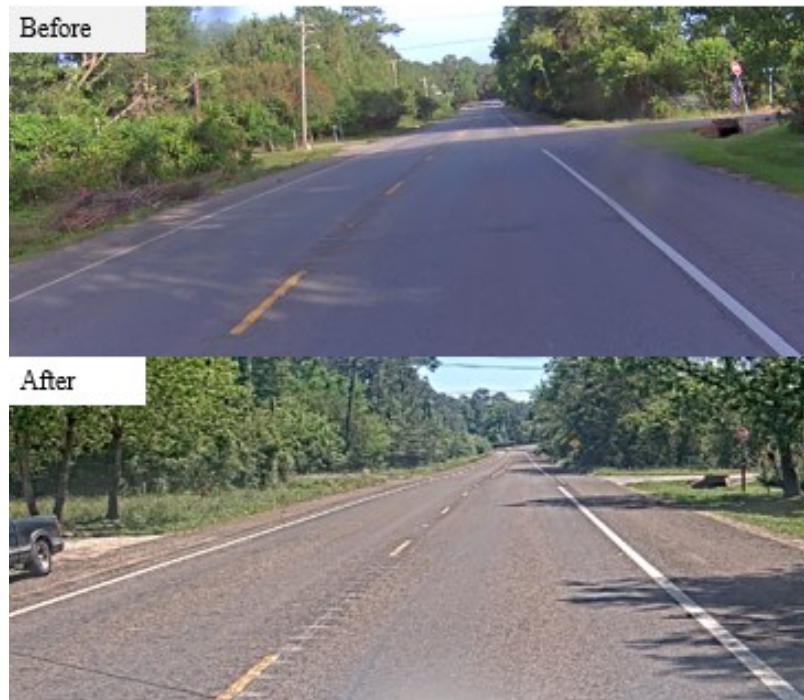
The roadways selected for field evaluation are located in TxDOT's Atlanta, Brownwood, Bryan, and Beaumont Districts. Only one roadway required maintenance work just after construction due to excessive bleeding. All other roadways held up well 1 year after construction. Figure 27, Figure 28, and Figure 29 show before and after images along FM 563 in TxDOT's Beaumont District, FM 1155 in TxDOT's Bryan District, and US 67 in TxDOT's Brownwood District, respectively. These example pavement sections had no visual issues with the seal coat.

**Figure 27. FM 563 in TxDOT's Beaumont District Before and After Construction.**

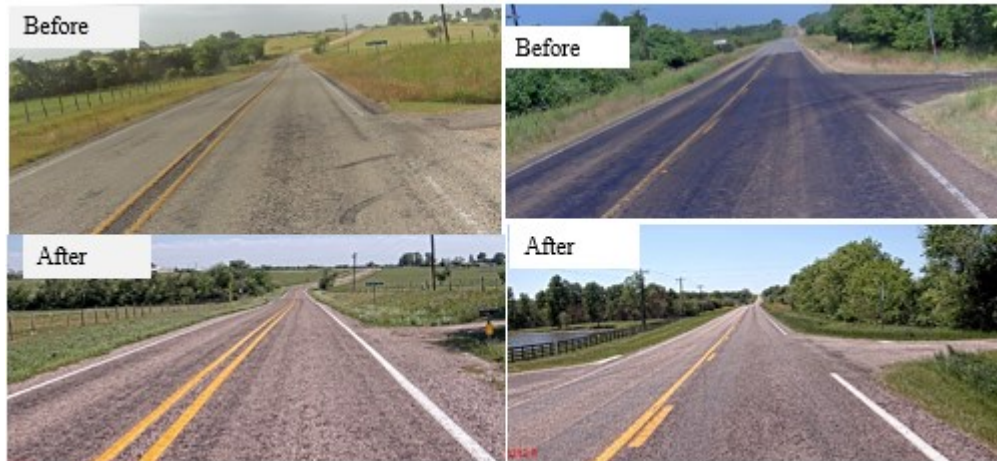
**Figure 28. FM 1155 in TxDOT's Bryan District Before and After Construction.**

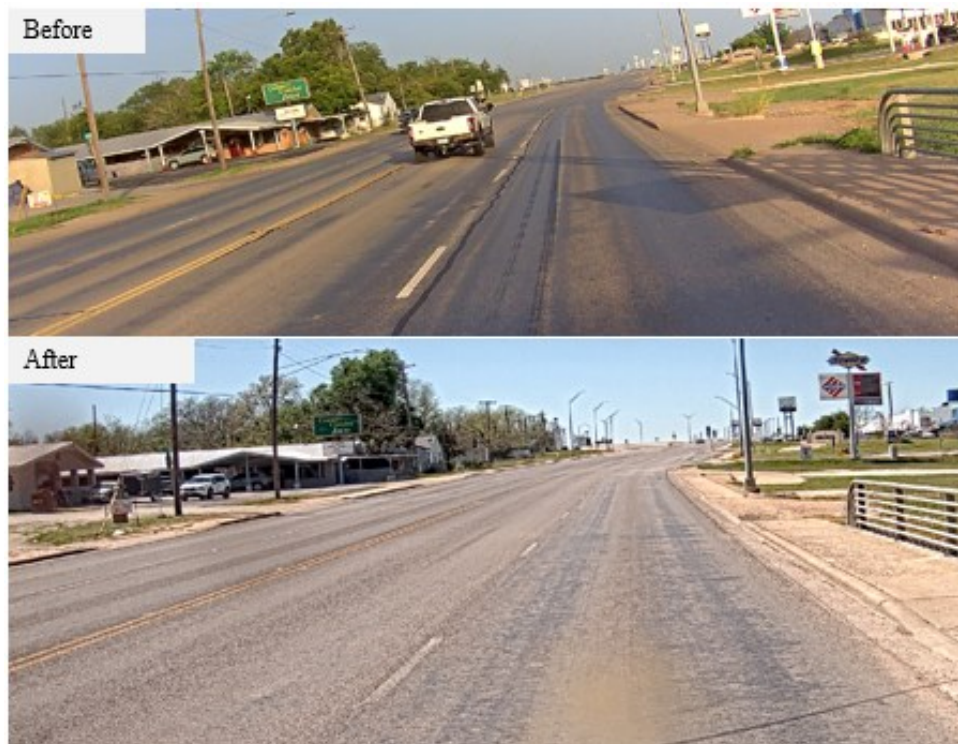
**Figure 29. US 67 near Comanche, Texas, in TxDOT's Brownwood District Before and After Construction.**

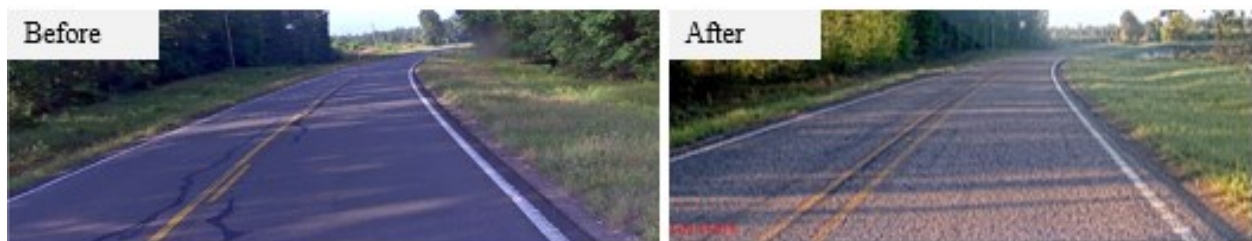
Field site 2 is in TxDOT's Atlanta District, in Cass County, on SH 43 from the railroad overpass to the Marion county line. Table 17 lists the summary data for this site, and Figure 31 shows the before and after seal coat construction images.

**Figure 31. Site 2 Before and After Seal Coat Construction.**

| Description | Results |
|---|---|
| Observations | Seal coat was applied at a good rate with no excessive flushing or rock loss. |

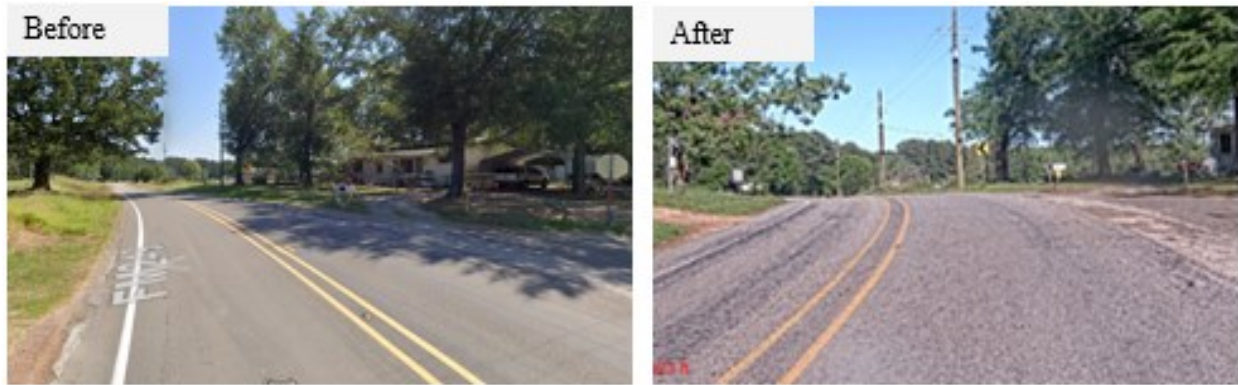
Field site 3 is in TxDOT's Atlanta District, in Cass County, on FM 249 from FM 3129 to the Arkansas state line. Table 18 lists the summary data for this site, and Figure 32 shows the before and after seal coat construction images.

**Figure 32. Site 3 Before [9] and After Seal Coat Construction.**

| <b>Description</b> | <b>Results</b> |
|---|---|
| Observations | Seal coat was applied at a good rate with no excessive flushing or rock loss. However, some signs of flushing were observed. |

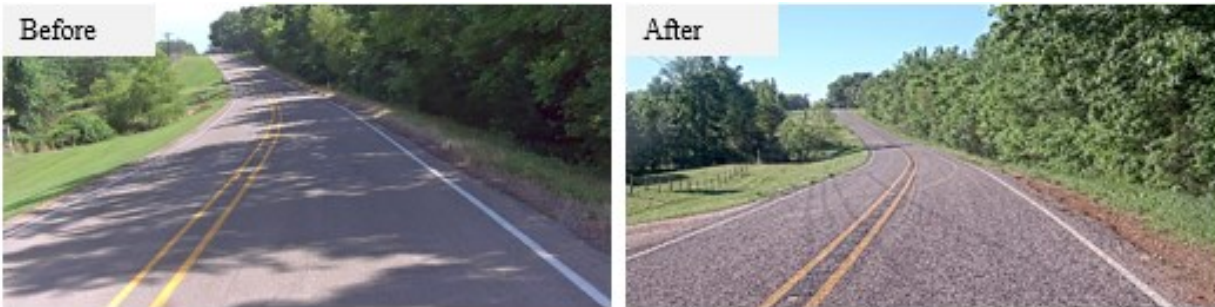
Field site 6 is in TxDOT's Atlanta District, in Morris County, on FM 144 from US 259 north to US 67. Table 21 lists the summary data for this site, and Figure 35 shows the before and after seal coat construction images.

**Figure 35. Site 6 Before and After Seal Coat Construction.**

| <b>Description</b> | <b>Results</b> |
|---|---|
| Observations | Seal coat was applied at a good rate with no excessive flushing or rock loss. |

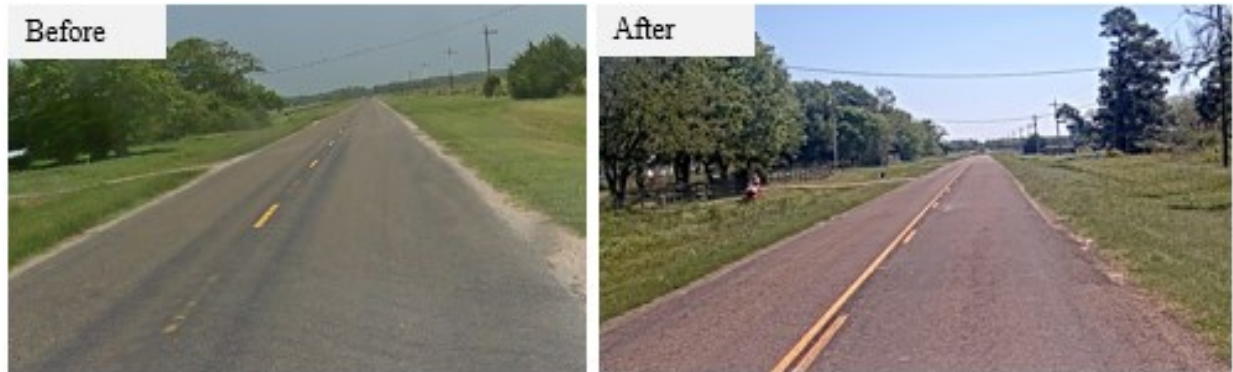
Field site 7 is in TxDOT's Beaumont District, in Chambers County, on FM 2936 from the end of maintenance to FM 562. Table 23 lists the summary data for this site, and Figure 37 shows the before and after seal coat construction images.

**Figure 37. Site 7 Before and After Seal Coat Construction.**

| Description | Results |
|---|---|
| Observations | Seal coat was applied at a good rate with no excessive flushing or rock loss. |

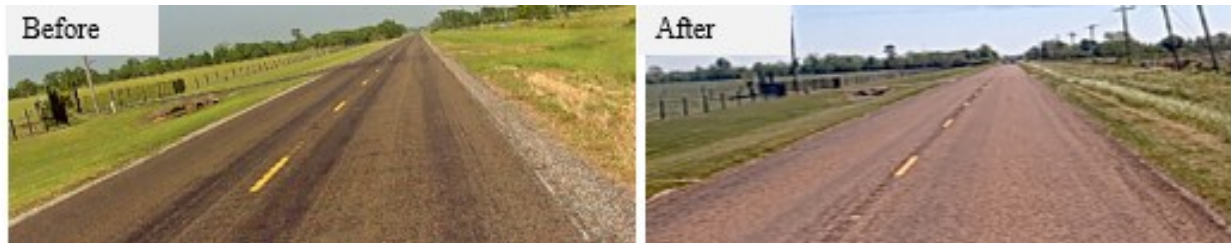
Field site 9 is in TxDOT's Beaumont District, in Chambers County, on FM 1663 from SH 61 East to 1.2 miles south. Table 25 lists the summary data for this site, and Figure 39 shows the before and after seal coat construction images.

**Figure 39. Site 9 Before and After Seal Coat Construction.**

| Description | Results |
|---|---|
| Observations | Existing flushing affected the new seal coat. Otherwise, the seal coat was applied at a good rate with no excessive flushing or rock loss. |

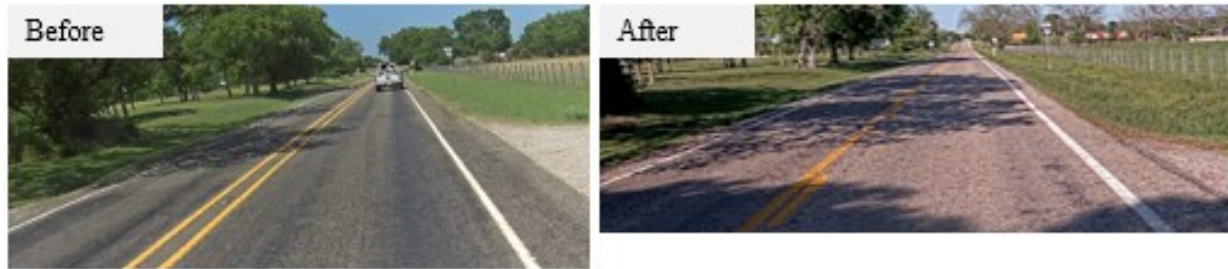
**Figure 43. Site 14 Before and After Seal Coat Construction.**

Field site 14 is in TxDOT's Bryan District, in Washington County, on FM 390 from SH 36 to FM 50. Table 29 lists the summary data for this site, and Figure 43 shows the before and after seal coat construction images.

| <b>Description</b> | <b>Results</b> |
|---|---|
| Observations | Seal coat was applied at a good rate with no excessive flushing or rock loss. |

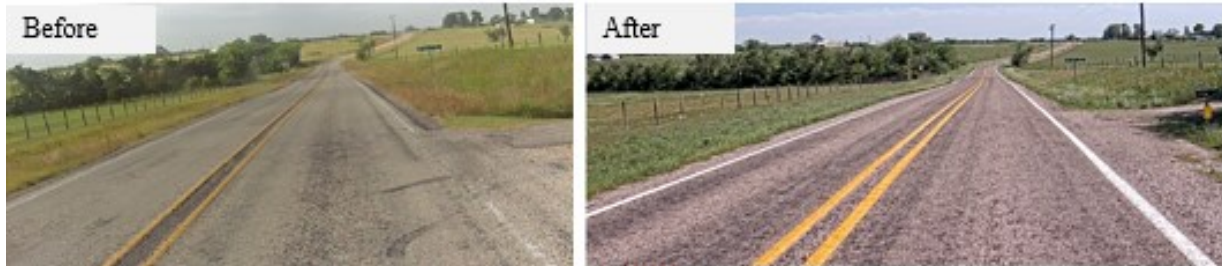
**Figure 44. Site 15 Before and After Seal Coat Construction.**

Field site 15 is in TxDOT's Bryan District, in Washington County, on FM 1155 from FM 912 to FM 2726. Table 30 lists the summary data for this site, and Figure 44 shows the before and after seal coat construction images.

| Description | Results |
|---|---|
| Observations | Seal coat was applied at a good rate with no excessive flushing or rock loss. |

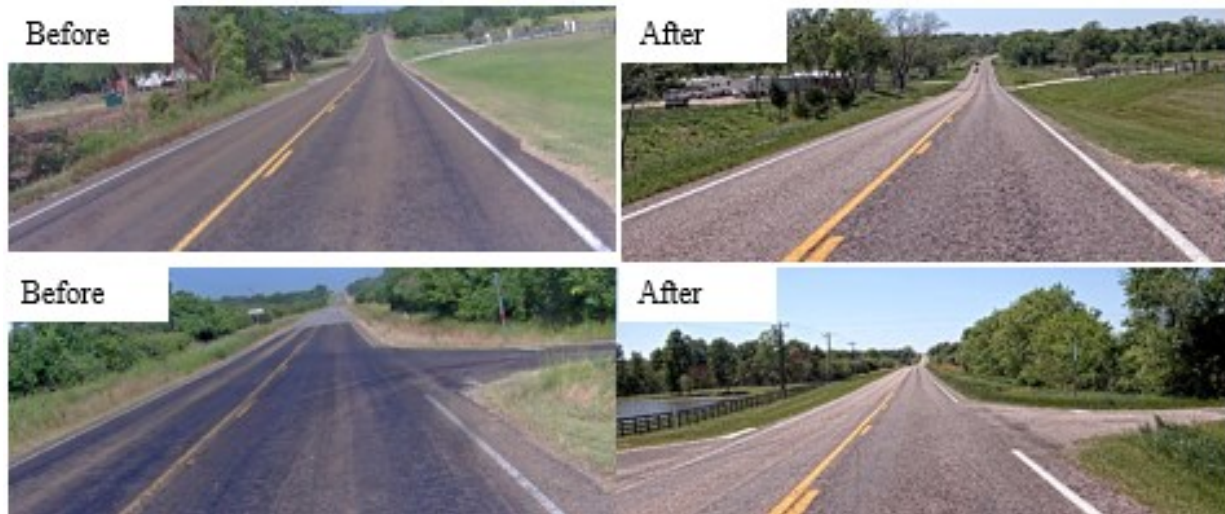
**Figure 45. Site 16 Before and After Seal Coat Construction.**

Field site 16 is in TxDOT's Bryan District, in Washington County, on FM 1155 from FM 2726 to FM 2193. Table 31 lists the summary data for this site, and Figure 45 shows the before and after seal coat construction images.

| Description | Results |
|---|---|
| Observations | Seal coat was applied at a good rate with no excessive flushing or rock loss. |

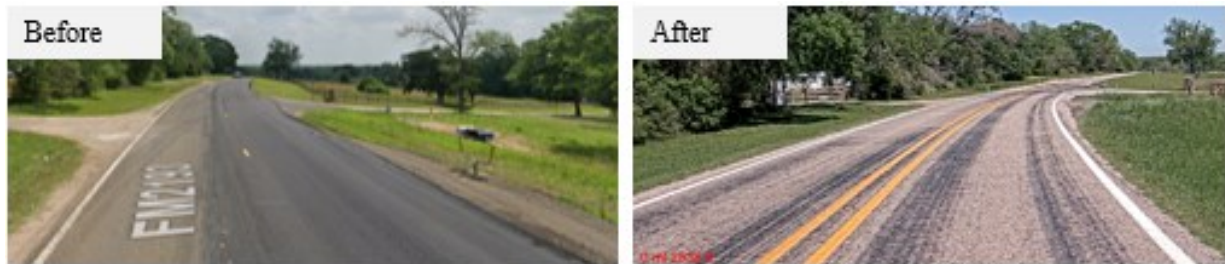
**Figure 46. Site 17 Before [10] and After Seal Coat Construction.****Field Site 18**

Field site 17 is in TxDOT's Bryan District, in Washington County, on FM 2193 from SH 105 to FM 1155. Table 32 lists the summary data for this site, and Figure 46 shows the before and after seal coat construction images.

| Description | Results |
|---|---|
| Observations | Preparatory work affected the seal coat. The seal coat application rate led to flushing in the wheel paths; however, no rock loss was observed between the wheel paths. |

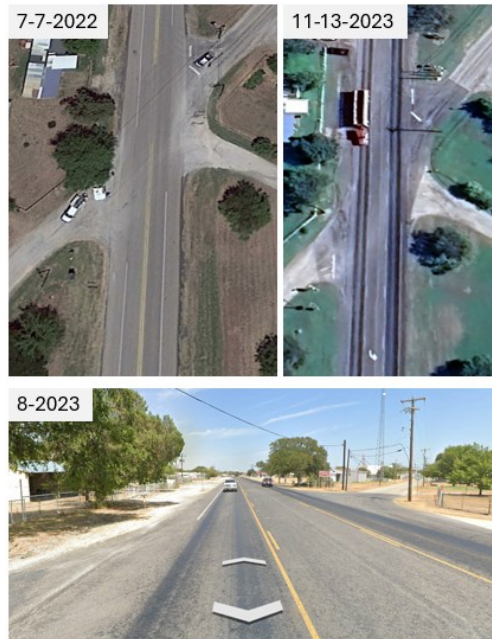
**Figure 47. Site 18 Before and After Seal Coat Construction [11].**

Field site 18 is in TxDOT's Brownwood District, in Comanche County, on SH 36 from 0.4 miles south of FM 1702 (east) to 0.5 miles north of FM 1476. Table 33 lists the summary data for this site, and Figure 47 shows the before and after seal coat construction images.

| Description | Results |
|---|---|
| Observations | Flushing was observed in the wheel paths. Seal coat application rate was high. |

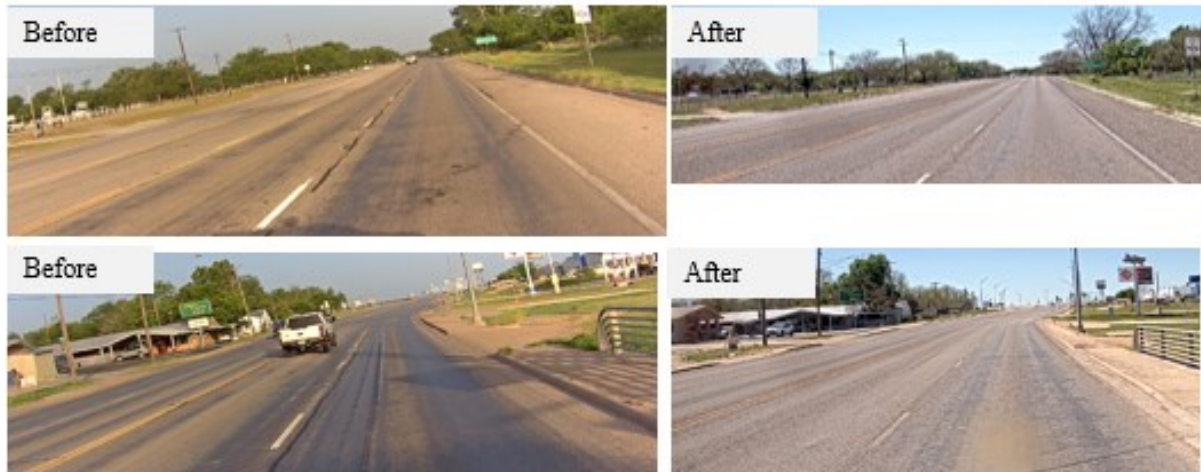
**Figure 48. Site 19 Before and After Seal Coat Construction.**

Field site 19 is in TxDOT's Brownwood District, in Comanche County, on US 67 from Elm Street to 0.5 miles west of Indian Creek. Table 34 lists the summary data for this site, and Figure 48 shows the before and after seal coat construction images.

| Description | Results |
|---|---|
| Observations | Existing flushing affected the seal coat. Minor rock loss was observed between the wheel paths. |

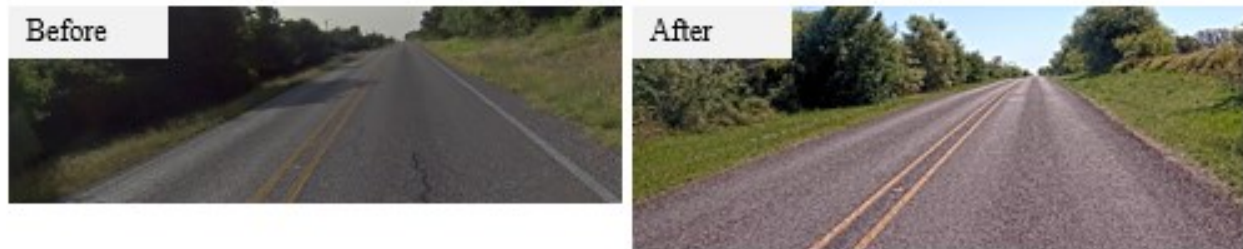
**Figure 49. Site 20 Before and After Seal Coat Construction.**

Field site 20 is in TxDOT's Brownwood District, in Comanche County, on FM 591 from FM 1476 East to FM 1702. Table 35 lists the summary data for this site, and Figure 49 shows the before and after seal coat construction images.

| <b>Description</b> | <b>Results</b> |
|---|---|
| Observations | Seal coat was applied at a good rate with no excessive flushing or rock loss. |

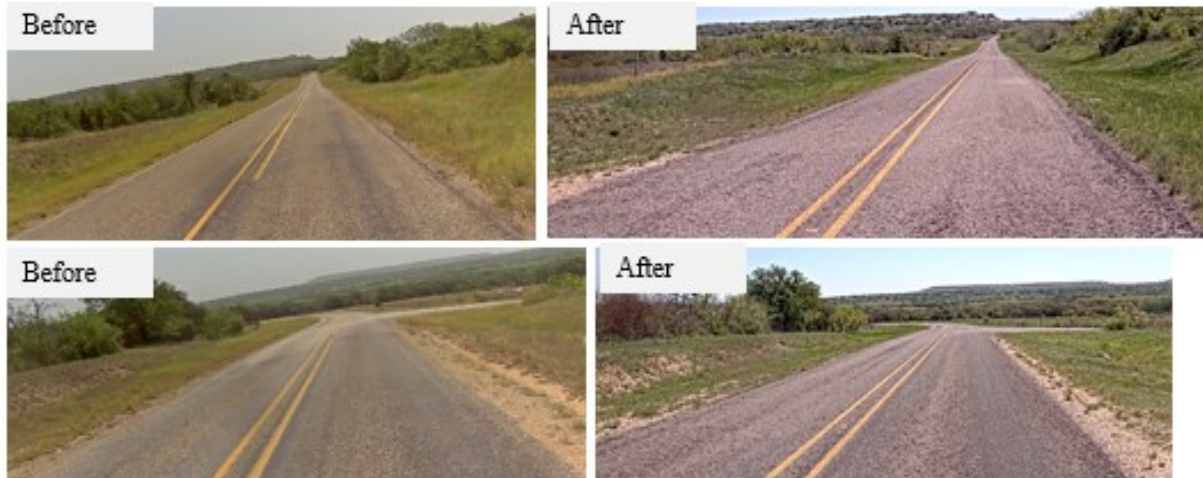
**Figure 50. Site 21 Before and After Seal Coat Construction.**

Field site 21 is in TxDOT's Brownwood District, in Comanche County, on FM 2561 from FM 1476 East to FM 1702. Table 36 lists the summary data for this site, and Figure 50 shows the before and after seal coat construction images.

| <b>Description</b> | <b>Results</b> |
|---|---|
| Observations | Seal coat was applied at a good rate with no excessive flushing or rock loss. |

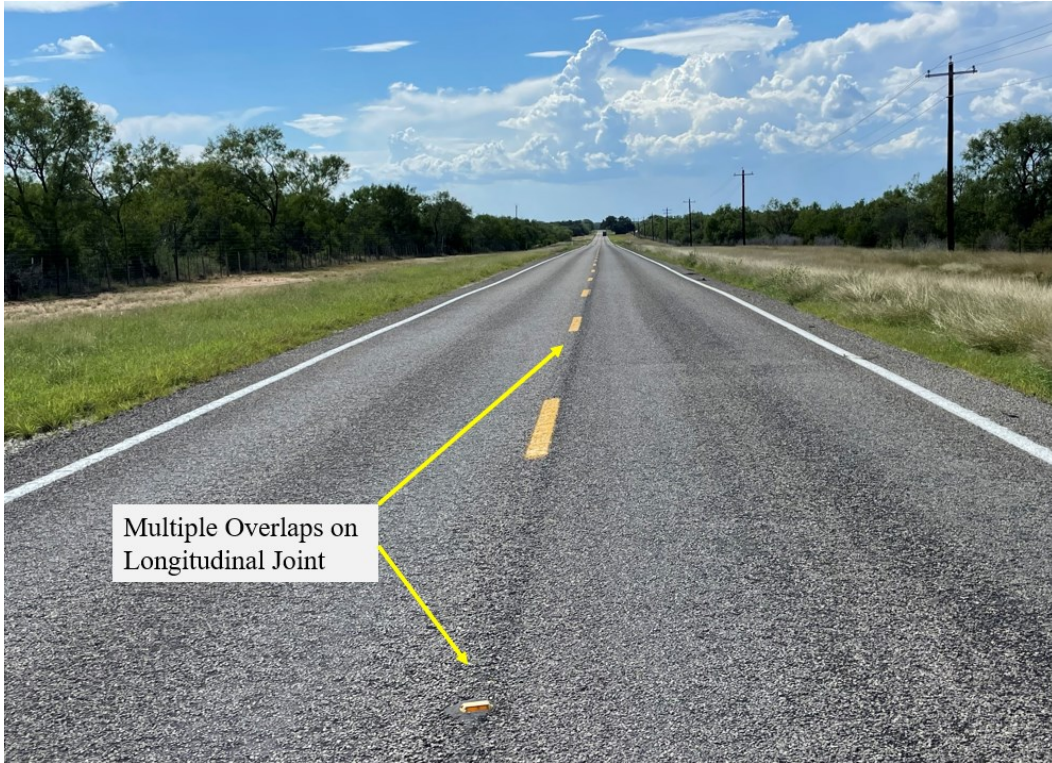
**Figure 52. Example of Multiple Seal Coats Overlapping Along a Longitudinal Joint.**

- Multiple seal coats overlapping along longitudinal construction joints (Figure 52).
- Surface irregularities in a seal coat, such as *shoving* and *washboards* (Figure 53).

2. Perform a visual evaluation of the roadway to ensure that there have not been any significant changes since the PA data was collected. If the existing roadway has a seal coat surface, note any issues with the existing seal coat. Figure 52 through Figure 57 show examples of surface condition concerns.

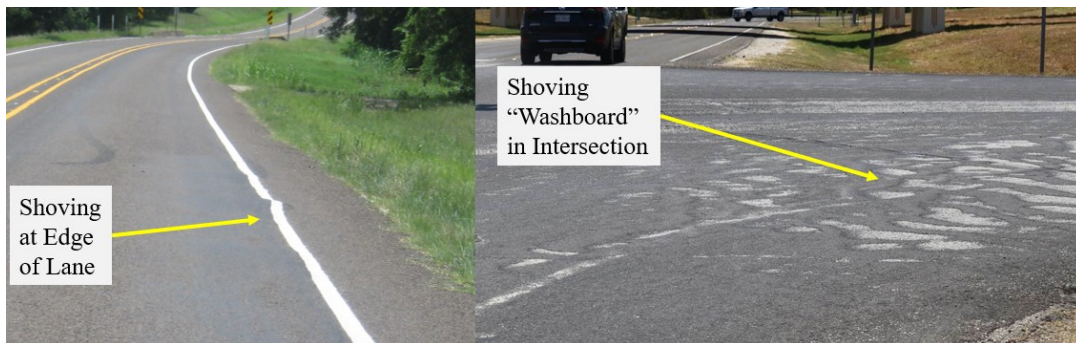
**Figure 53. Examples of Shoving at an Edge Line and Intersection.**
