Highway-Railway At-Grade Crossing Rehabilitation Practices to Enhance Long-Term Performances: Criteria and Evaluations

Jerry G. Rose, Ph.D., P.E., Professor of Civil Engineering
University of Kentucky, 161 Raymond Building
Lexington, KY 40506-0281, 859 257-4278, jerry.rose@uky.edu

2013 National Highway-Rail Grade Crossing Safety Training Conference, Texas Transportation Institute, Ft. Worth, TX, November 3-6, 2013.

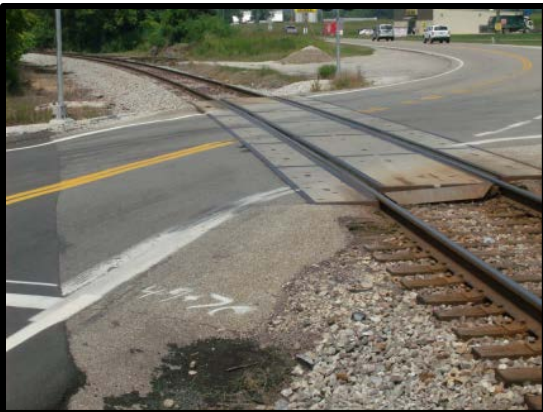
Figure 2a. CSX Crossing on WV Route 2 at Ashton, WV, Perfect Condition after 11 years.

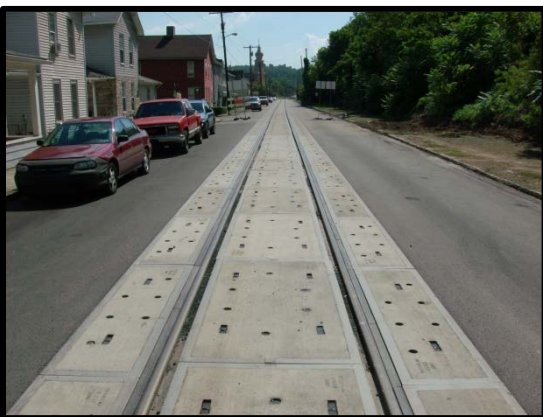
Figure 2c. NS Crossing in West Brownsville, PA, the 3226-ft (983-m) long Crossing is being Replaced in Segments over four years.

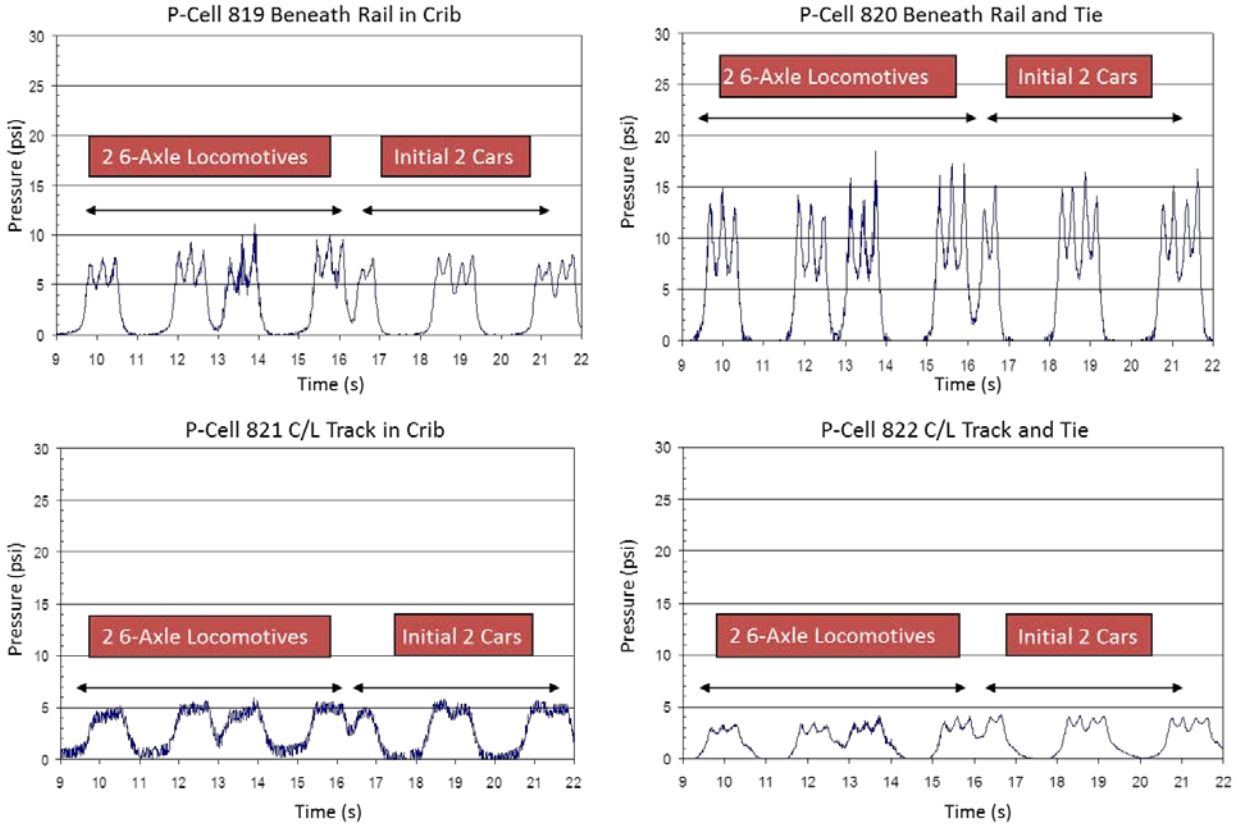
Loaded Coal Train at Richmond

Figure 3. Typical Pressure on Asphalt in Trackbed for Loaded Coal Train.

Geokon Model 3500-2 earth pressure cells have been used to measure pressures on top of the asphalt layer. These were strategically positioned during the renewal of crossings prior to placement of the ballast. Detailed descriptions for this testing program is provided elsewhere (Rose and Tucker, 2002) (Rose, et al., 2009 (2F)). The pressure distribution within the trackbed is extremely variable. Peak dynamic pressures for rail and highway traffic develop directly below the rail/tie interface.

Figure 3 contains a sample plot of a loaded coal train. The axle loads range from 33 to 36 tons (30 to 32 metric tons) and train speed was about 40 mph. Note that cell 820, located beneath the rail/tie interface, recorded the maximum dynamic pressure on top of the asphalt of about 15 psi (103 kPa) for the locomotives and initial two loaded hopper cars.

Peak Dynamic Pressures at the top of asphalt layer (below ballast) typically range from 13 to 17 psi (90 to 120 kPa) under the rail/tie intersection for highway crossings under 286,000 lb (130 metric ton) railway loadings. Transmitted pressures are considerably lower in magnitude within the crib area or center of track.

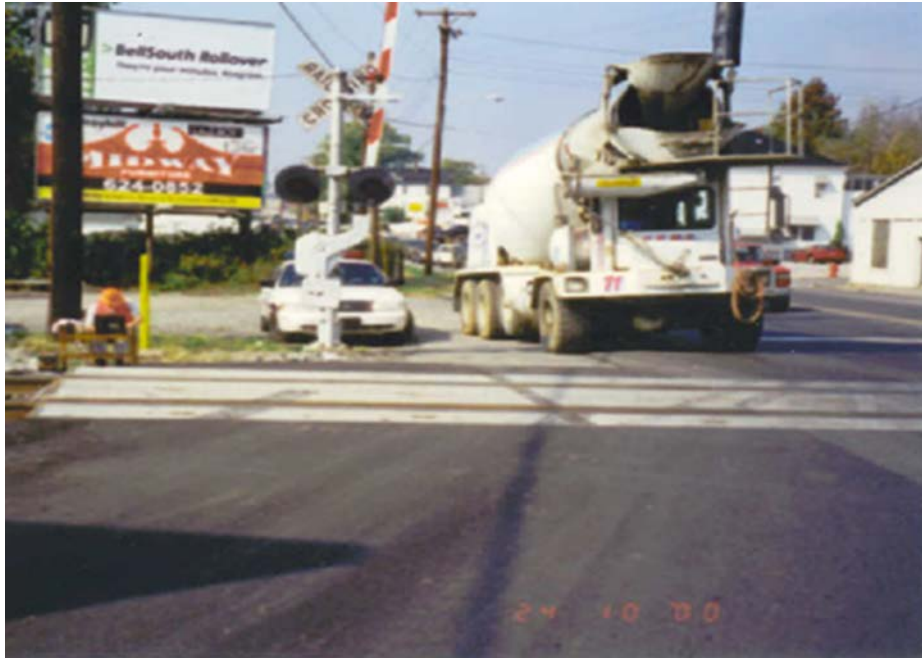
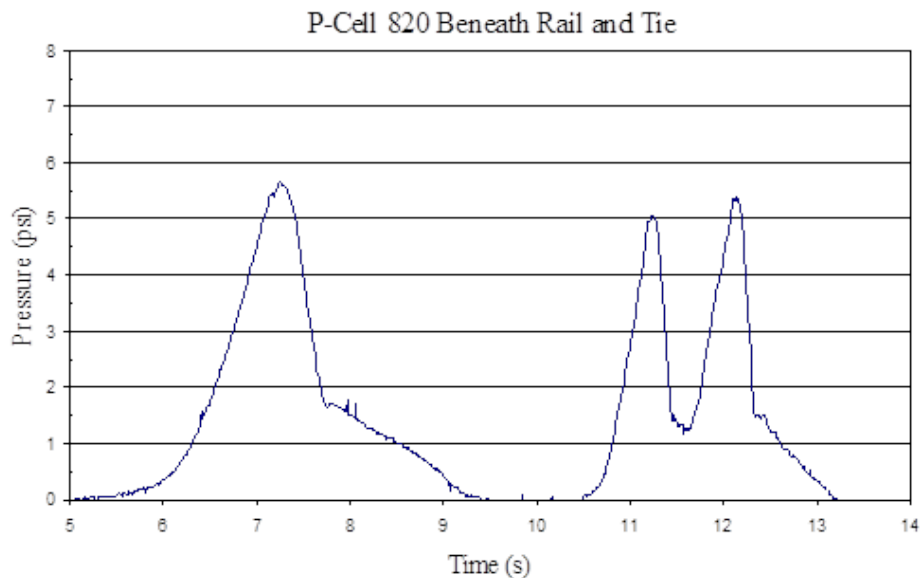
Loaded Concrete Truck at Richmond

Figure 4. Typical Pressure on Asphalt Layer in Trackbed for 80,000-lb (36,300 kg) Concrete Truck, Front Tire (left) and Rear Tires (right).

Figure 4 contains a sample plot of a loaded 80,000-lb (36 metric ton) gross weight concrete truck. The truck wheels traversed the cell directly below the rail/tie interface. The maximum dynamic pressure on top of the asphalt layer is about 5 psi (35 kPa). Pressures for passenger cars and small trucks are typically 0.5 psi (3 kPa) and lower.

Peak Dynamic Pressures at the top of asphalt layer (below ballast) typically range from 4 to 6 psi (28 to 41 kPa) under the rail/tie intersection for highway crossings under heavily loaded highway trucks and less than 1 psi (7 kPa) for passenger cars. The instrumented crossings remain very smooth, minimizing impact forces.

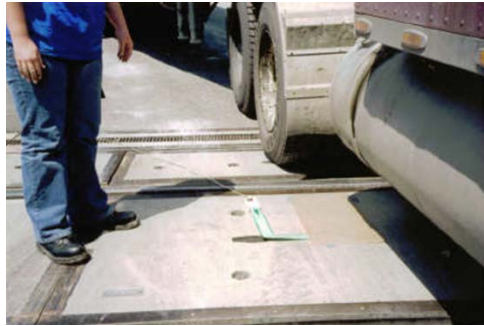
Figure 5. Imprint of Tractor Rear Tire of Loaded Coal Truck on Concrete Crossing.

Thin matrix-based pressure sensitive ink sensors, manufactured by Tekscan, Inc., have been used to measure surface contact pressures between rubber-tired highway vehicles and crossing surfaces. Detailed descriptions for this testing program is provided elsewhere (Rose, et al., 2009 (2F)). The recorded pressures are very close to the actual tire inflation pressures.

Figure 5 shows the testing procedure and data for a typical 22-wheel, 150,000-lb (68 metric ton) gross weight loaded coal truck. The green areas indicate higher pressure intensities than the blue areas. The white areas are indicative of the tread which does not contact the pavement. Note that the calculated static contact pressure

was 135 psi (930 kPa). The measured tire inflation pressure was 138 psi (950 kPa), very close to the Tekscan measurement calculated pressure. This is typical of maximum contact pressures experienced by crossing surfaces.

Static Surface Pressures at the tire/pavement interface on highway/railway crossings for highway vehicles are very close to the respective tire inflation pressures. These range from 135 psi (930 kPa) for heavily loaded trucks to around 75 psi (515 kPa) for utility trucks.

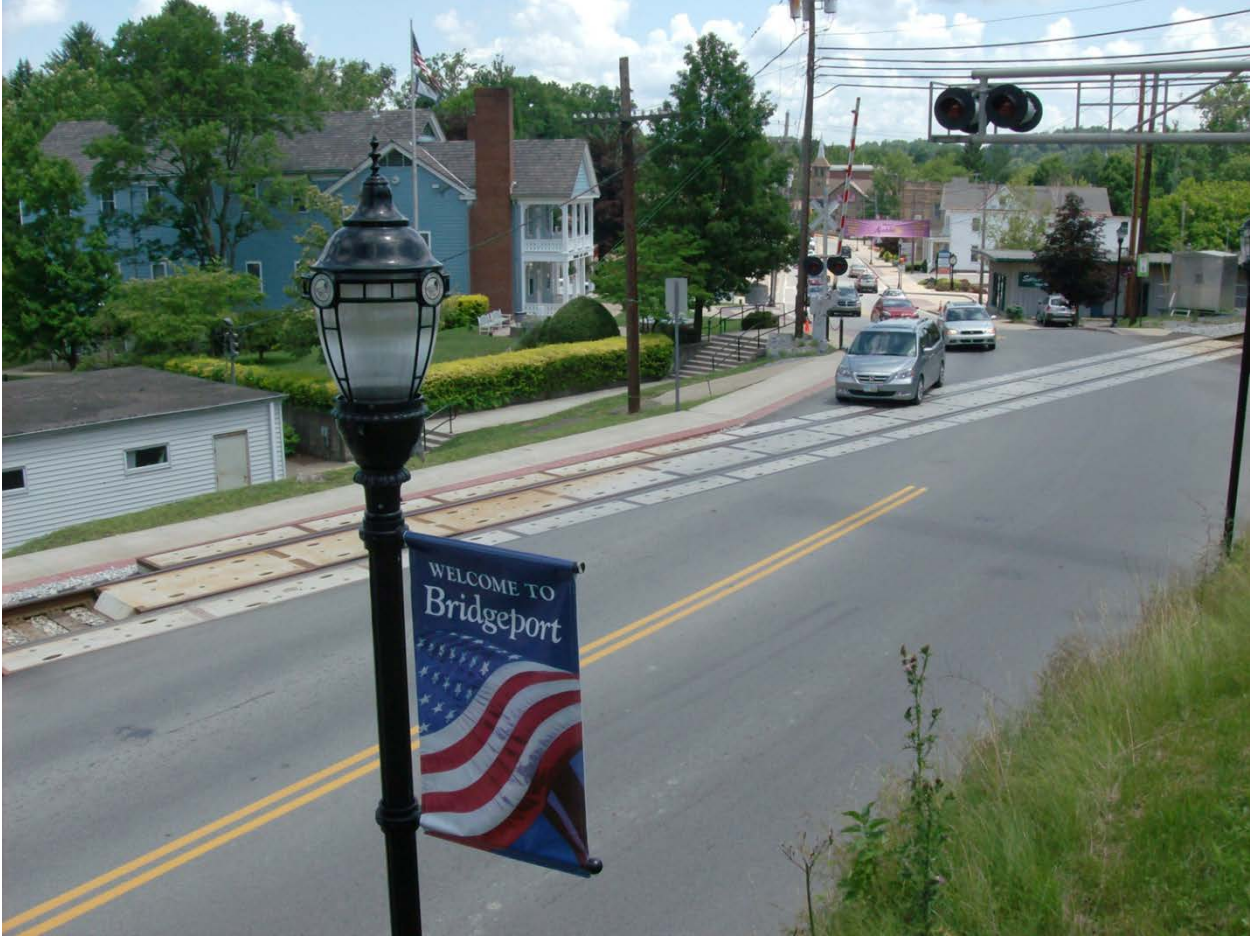
Figure 8. Recently Completed 144-ft (44-m) long Crossing on US 50 on CSX Line in Bridgeport, WV.

service life. On crossing rehabilitation projects, WVDOT pays for crossing materials differential, asphalt underlayment, traffic control, drainage pipe, and tie differential. Since the program began, no crossings have failed due to lack of substructure support or excessive settlement, as they have all remained smooth and serviceable. When WVDOT funds are used for crossing rehabilitation projects, the use of asphalt underlayment is considered as a standard practice. Figure 8 shows a recently completed crossing on US 50 in Bridgeport, WV.

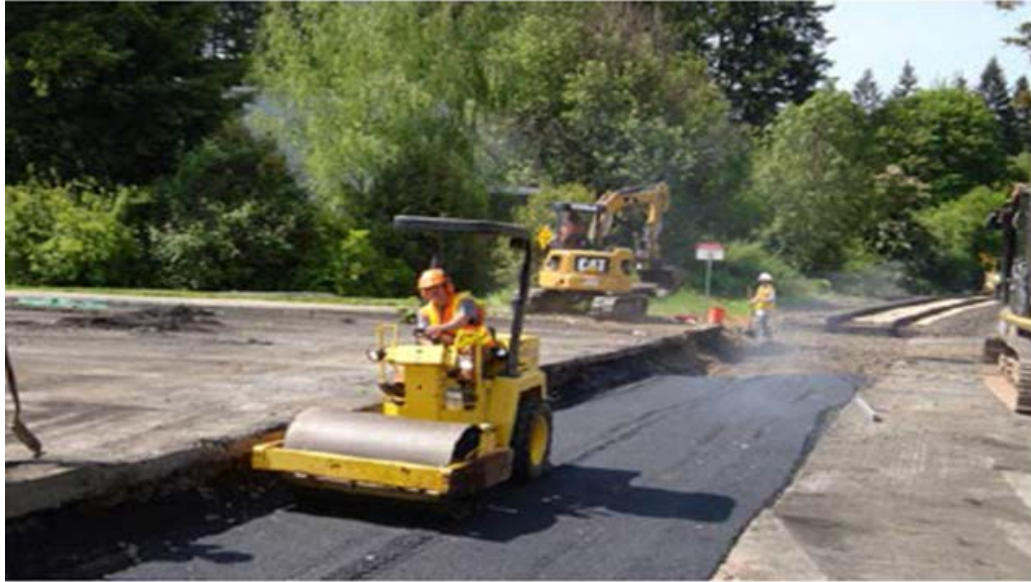
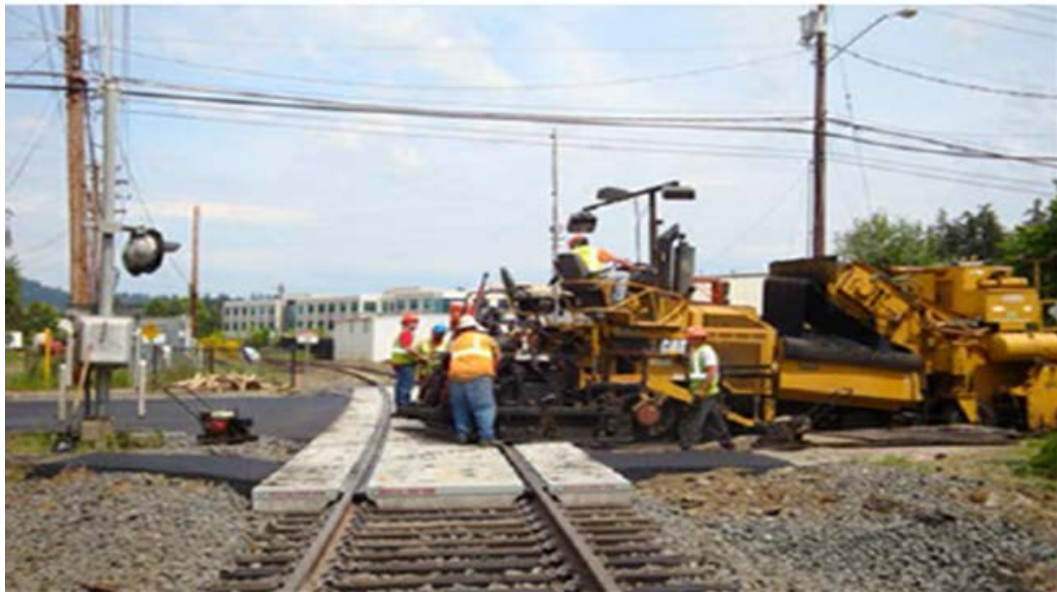
Figure 9. WES Commuter Line Crossing (SW Durham Road) on Portland & Western RR near Portland, OR, one of 13 Crossings Underlain with Asphalt.

The Genessee and Wyoming (G&W) Shortline Railroad began using asphalt underlayment on its Portland and Western (P&W) Railroad line in the state of Oregon about six years ago. P&W rehabilitates 12 to 15 crossings per year with asphalt underlayments. The TRIMET Westside Express Service (WES) commuter line, which stretches from Beaverton to Wilsonville in the Portland Metropolitan Area, utilized asphalt underlayment on 18 public crossings rehabilitated on the old Oregon Electric Line during the re-construction of the line for commuter service. These crossings have performed perfectly since the asphalt underlayment has been installed, having avoided problems with mud and requiring no additional surfacing or maintenance. Figure 9 is a view of the installation of the SW Durham Road crossing on the WES commuter line.

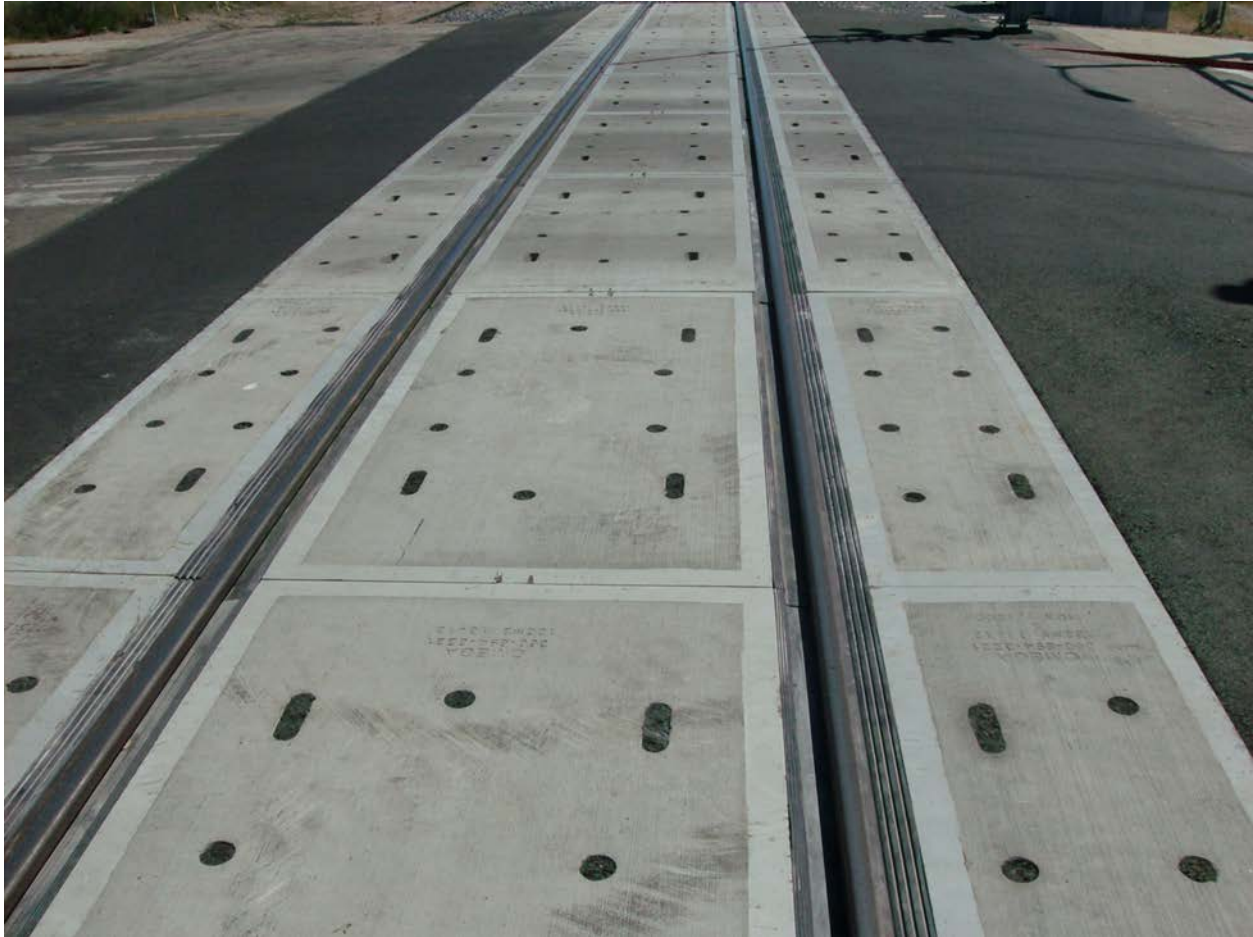
Figure 10. Recently Completed Metrolink Osborne Street Crossing on the Antelope Valley Line in the Sun Valley Area of Los Angeles.

crossings with asphalt underlayments and Metrolink continues to install asphalt underlayments under all new crossings and rehabilitated crossings. The performance has been excellent with minimal settlement and long-term smooth crossings. Standard practices are similar to those used by Caltrain, described previously. Figure 10 shows a recently completed Metrolink Osborne Street Crossing on the Antelope Valley Line in the Sun Valley Area of Los Angeles.
