# Studies to Improve Temporary Guide Signs in Work Zones

Technical Report 0-7046-R1

TEXAS A&M TRANSPORTATION INSTITUTE  
COLLEGE STATION, TEXAS

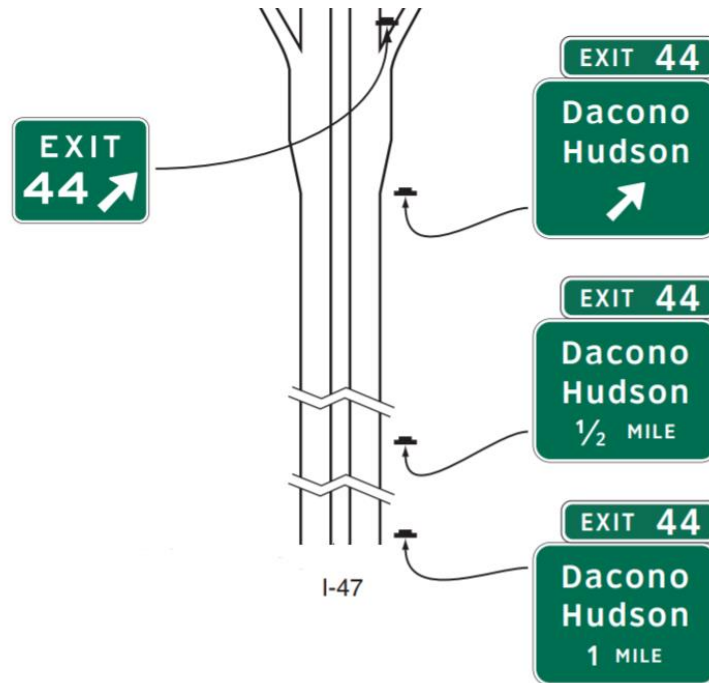
**Figure 1. Interchange Exit Ramp Sign Sequence from TMUTCD (1).**

Section 2E of the TMUTCD provides standards, support, and guidance for a uniform and effective system of signing freeways and expressways, including configuration, sequencing, and spacing of guide signs. Figure 1 shows an example of a sign sequence for an interchange exit ramp. The sequence typically includes:

- One or more *advance guide signs* that give notice well in advance of the exit point of the principal destinations served by the next interchange and the distance to that interchange (e.g., 1 mile or ½ mile).
- An *exit direction sign* that repeats the route and destination information that was displayed on the advance guide signs. This is intended to assure road users of the destination(s) served by the interchange. The arrow on the sign confirms whether the road user needs to exit to the right or left. The exit direction sign is normally placed at the beginning of the deceleration lane (if present) or at the beginning of the departure point.
- An *exit gore sign* that indicates the exiting point or place of departure from the main roadway. Consistent placement of this sign in the gore area is important for good guidance (1).

A closer look at Figure 1 and Figure 2 shows two different types of arrows that are used on guide signs. The FSH describes guide sign arrows in more detail, as shown in Figure 3 and summarized as follows:

- Type A arrows are upward-angled arrows that are primarily used on exit direction and exit gore signs where a single lane exits (as shown in Figure 1). The upward angle slants left or right, depending on the direction of the exit.
- Type B arrows are similar to Type A arrows, except shorter, and are used for multi-lane exit signs.
- Type C arrows are downward-pointing arrows that are used only on overhead guide signs to indicate the use of specific lanes to reach specific destination(s) or route(s) (as shown in Figure 2[b]). Type C arrows must not be used unless an arrow can point to each lane that can be used to reach the destination or route shown on the sign (2,3).

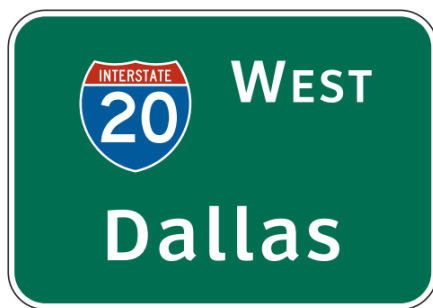
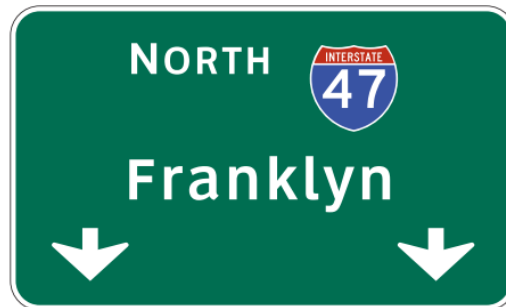
**Figure 2. Examples of Interchange Pull-Through Signs from TMUTCD (1).**

Figure 2 shows examples of *pull-through signs*, which are overhead guide signs intended for through traffic (i.e., traffic not intending to exit the freeway). Pull-through signs should be used where the geometrics of a given interchange are such that it is not clear to the road user as to which lanes are the through roadway, or where additional route guidance is desired. The TMUTCD notes three situations where pull-through signs with down arrows should be used:

- Where the alignment of the through lanes is curved and the exit direction is straight ahead.
- Where the number of through lanes is not readily evident.
- At multi-lane exits where there is a reduction in the number of through lanes.

(a) Pull-through sign

(b) Pull-through sign with down arrows

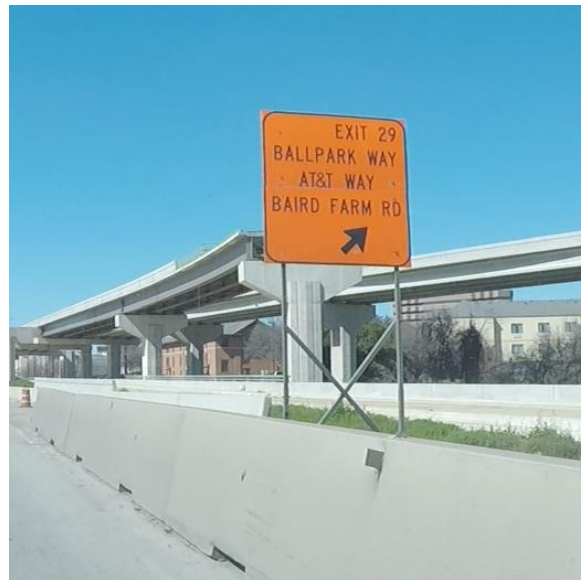
**Figure 4. Exit Direction Sign with Smaller Legend.**

Figure 4 shows an example of a sign with a smaller legend. In this case, limited space was available for sign deployment. In this phase of construction, the exit ramps for all three arterials

were combined into a single exit ramp. In addition, the exit number is typically shown on a separate plaque mounted at the top of the sign, as shown in Figure 1.

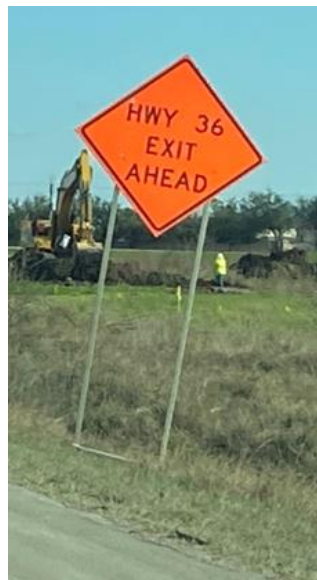
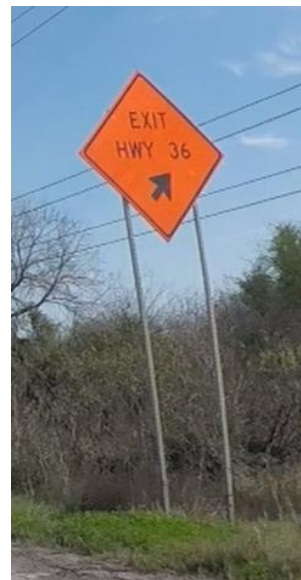
**Figure 5. Temporary Guide Sign Information on Diamond-Shaped Signs.**

Figure 5 shows two signs that appear to be providing guidance information, but these signs are diamond-shaped, like typical work zone warning signs. Warning signs are used to notify road users of specific situations or conditions that might not otherwise be apparent. This does not include destination information. The shape of these signs is inconsistent with guide sign expectations. Thus, motorists looking for guidance information may not expect to find it on signs of this shape.

(a) Advance guide sign

(b) Exit direction sign

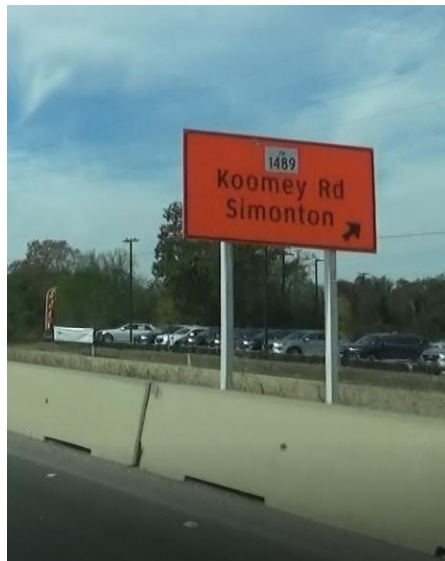
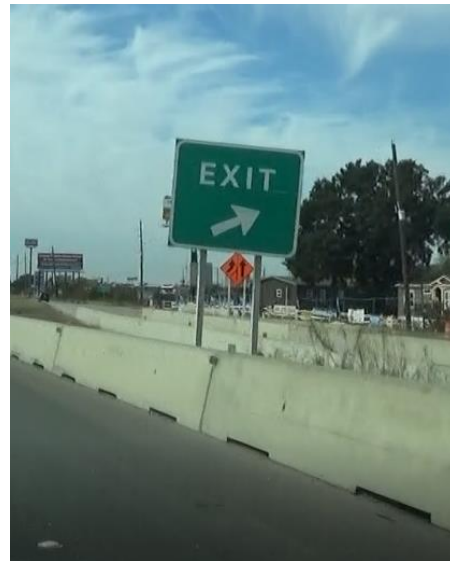
**Figure 6. Advance Guide Sign Missing from Sign Sequence.**

Several work zones were deficient in displaying the standard sequence of exit signs (i.e., advance guide sign, exit direction sign, and exit gore sign). In one case, there was no advance guide sign present upstream of the exit direction and exit gore signs (shown in Figure 6). A review of project progress and online mapping indicates that the exit has not changed locations but that the existing permanent sign was likely removed to make way for construction. The researchers believe that a temporary advance guide sign was present in a previous phase but was not upright (Figure 7). Signs being blown over or knocked over were a concern that came out of the discussions with TxDOT district personnel. Nonetheless, the advance guide sign was not present when the researchers visited the work zone. The absence of this sign may leave drivers unprepared for the exit and create last-minute decisions near the gore area.

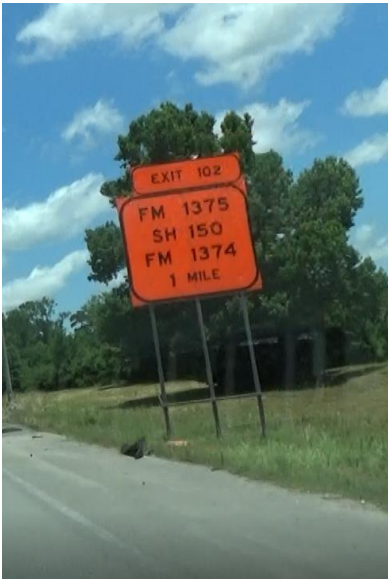
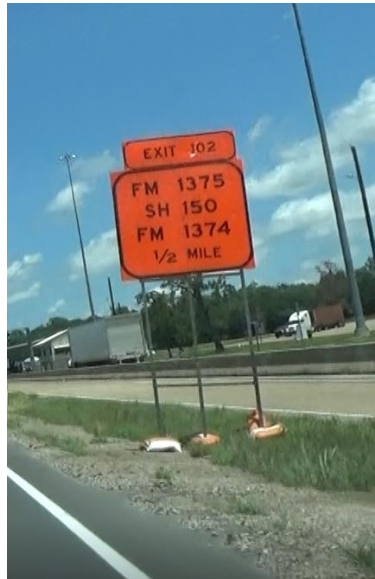
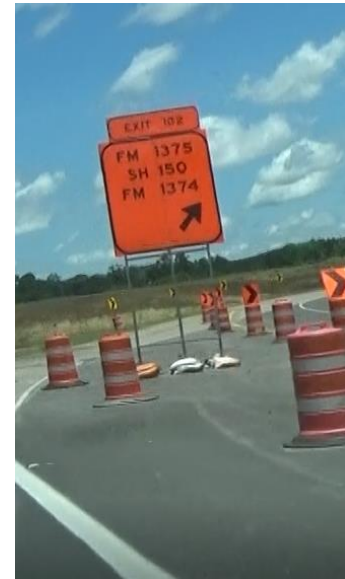
**Figure 8. Placement of Exit Direction Sign in Exit Gore.**

Figure 8 shows another example. In this case, the exit ramp locations for all three roadways had been moved to a single exit. The images in Figure 8(a) and (b) show the advance guide signs, while Figure 8(c) shows the exit direction sign located where the exit gore sign typically would have been placed. A review of the constructions plan sheets for this project showed that the signs were placed in accordance with those plans (Figure 9). It is not known if a lack of space where the exit direction sign would have normally been placed led the designers to move the sign to the exit gore sign location. However, this sign location significantly violates driver expectancy, given that drivers normally see this sign before the need to make an exit maneuver.

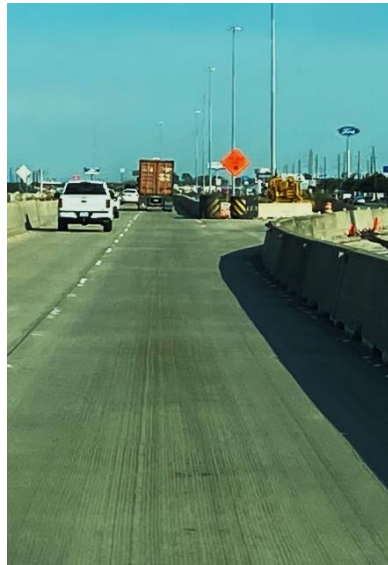
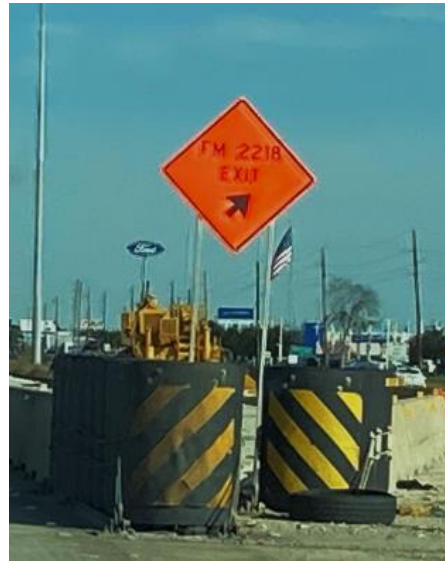
**Figure 10. Improper Placement and Substandard Design of Exit Direction Sign.**

Another example (Figure 10) shows the exit direction sign placed in the gore area. The use of a smaller font decreased the legibility of the sign. Also, the exit gore sign was fabricated using a diamond shape instead of the rectangular shape that would normally be used for guide signs. Both of these factors violate driver expectancy.

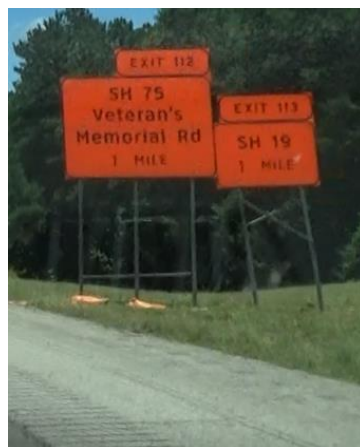
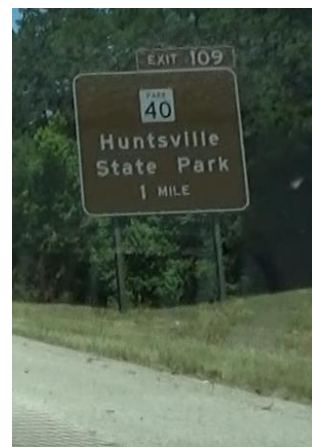
**Figure 11. Advance Guide Signs for Exit 109.**

In one work zone, two exits were closed, and this traffic was being temporarily diverted to another exit ramp located several miles upstream. The temporary advance guide signs for exits 112 and 113, shown in Figure 11(a), were located approximately 0.3 miles upstream of the permanent advance guide sign for exit 109, shown in Figure 11(b). Given the spacing between the advance guide signs, it is not known if motorists understand that a single exit is in use for all destinations and routes on these signs.

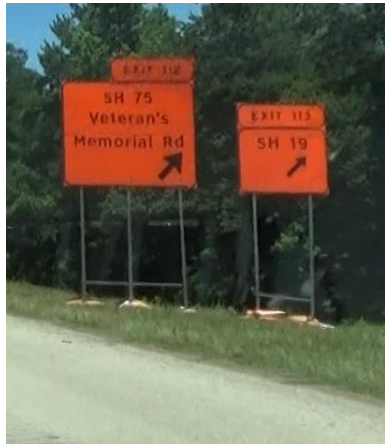
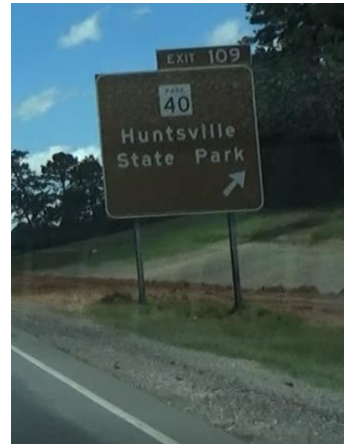
**Figure 12. Exit Direction Signs for Exit 109.**

The temporary exit direction signs for exits 112 and 113, shown in Figure 12(a), were located much closer (approximately 700 feet) to the permanent exit direction sign for exit 109, shown in Figure 12(b). It is not known if maintaining the original exit number(s) on temporary signs that move around is better understood by motorists than changing the exit number to match the new exit location (e.g., exit 109).

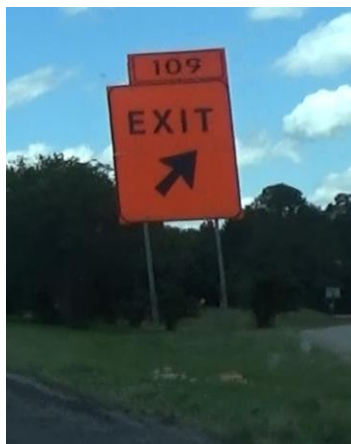
**Figure 13. Exit Gore Sign for Exit 109.**

Figure 13 shows the exit gore sign for exit 109. It is not known if motorists understand that this is also the appropriate exit point for exits 112 and 113.

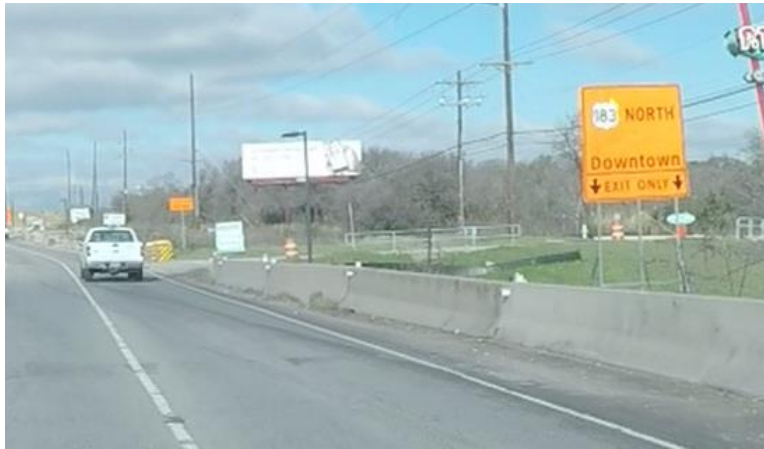
**Figure 14. Temporary Lane Guidance Sign with Down Arrows Used on Roadside.**

Figure 14 and Figure 15 show some lane guidance signs found at one of the work zones. In Figure 14, the sign with two down arrows was located on the roadside of a four-lane freeway section. While this sign is similar to a pull-through sign, down arrows are only allowed on overhead signs (where there is one arrow per lane). In Figure 14, it is not clear to which lanes the signs are referring. In Figure 15, the sign with two up arrows was located on the roadside of

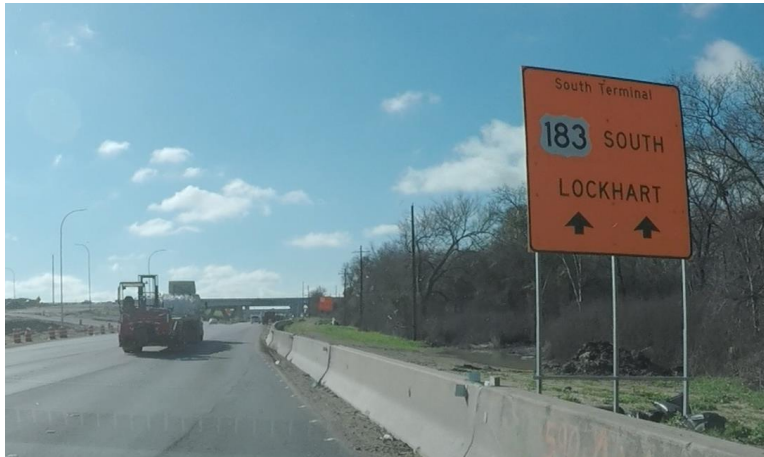
**Figure 15. Temporary Lane Guidance Sign with Up Arrows Used on Roadside.**

another four-lane freeway section. While this sign is similar to an overhead arrow-per-lane sign, it does not conform to any guide sign standard found in the TMUTCD.

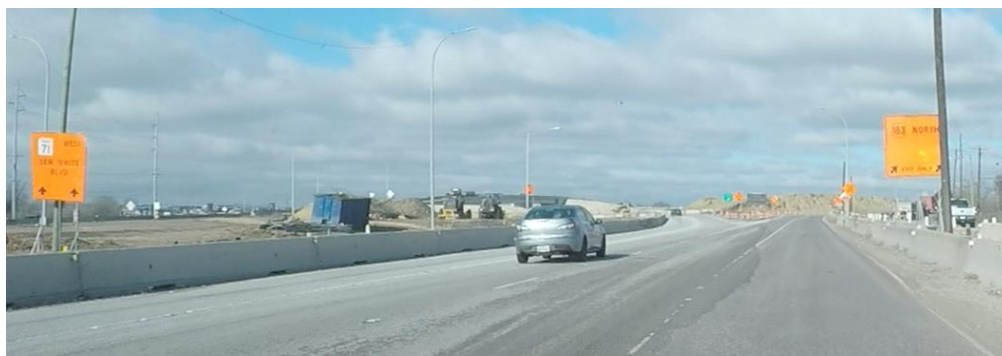
**Figure 16. Temporary Lane Guidance Signs at Interchange Exit.**

In another example at the same work zone, temporary lane guidance signs were located on both sides of the road (Figure 16). In this case, the intent of the signs is to provide one arrow per lane (i.e., two left lanes for SH-71 and two right lanes for US-183). It is unclear if this signage would be as effective in heavier traffic (where motorists may not be able to see both signs at the same time).

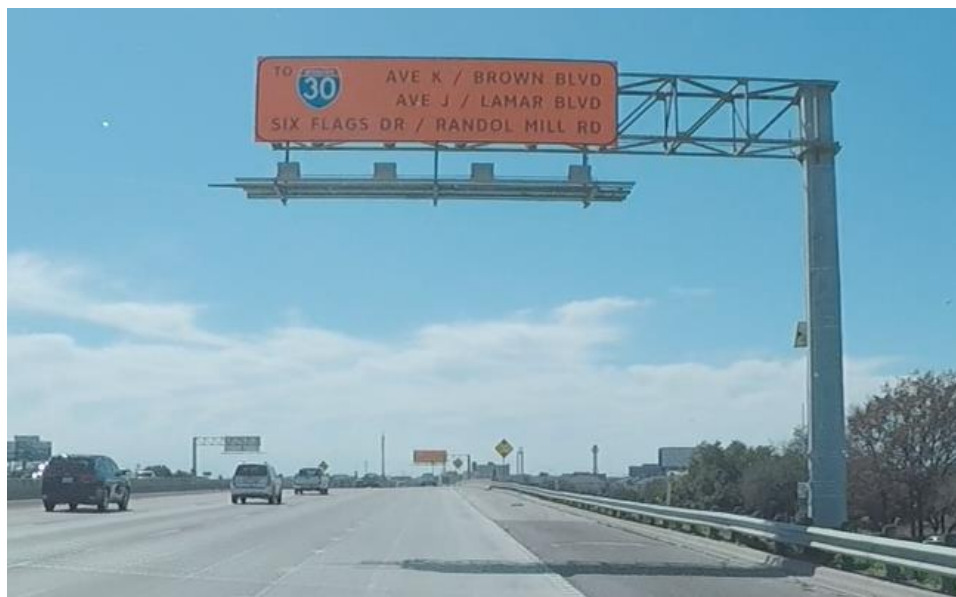
**Figure 17. Information Overloading on Temporary Guide Sign.**

Figure 17 shows an overhead guide sign that appears to provide information for seven destinations or routes. In this case, the construction project included two different cities, which had each independently assigned street names to their respective segments of these arterials. Previous research performed at the Texas A&M Transportation Institute (TTI) indicated that motorists' route-selection accuracy decreases as the number of route choices increases (6). In addition, TMUTCD and FSH guidelines state that no more than two destination names or street names should be shown on any advance guide sign or exit direction sign (1,3).

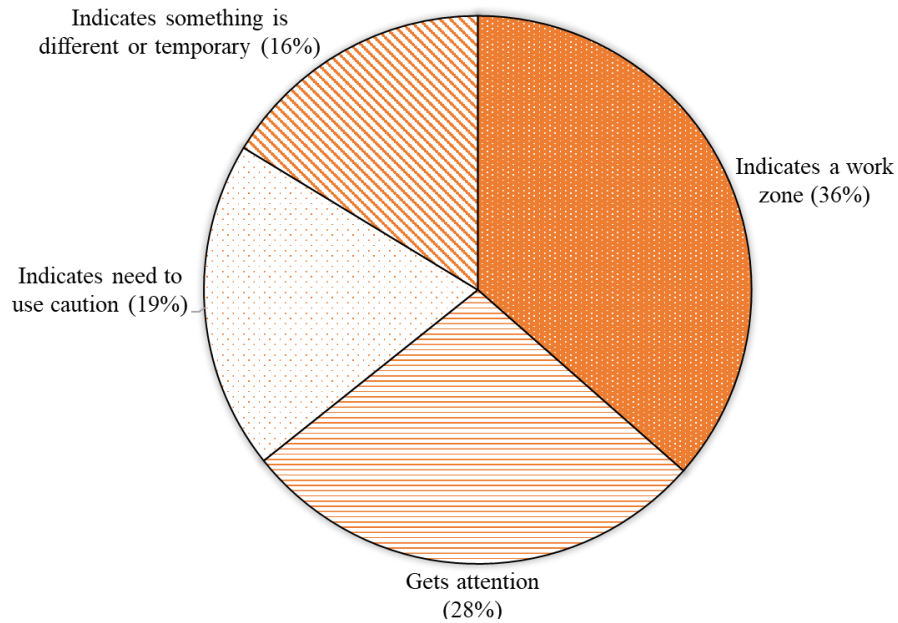
**Figure 28. Reasons Given for Preferring the Orange Exit Gore Sign.**

The scores indicate that the most likely explanation for the orange sign was that it was a temporary sign for an exit ramp that had not changed location, but the permanent green exit gore sign had been removed due to construction. To further assess driver understanding of the orange exit gore sign, a follow-up question asked if the survey participant had a color preference for exit gore signs if the exit is in a work zone. Of 474 responses received, 341 (72 percent) preferred orange, 58 (12 percent) preferred green, and 76 (16 percent) had no preference. When those who preferred orange were asked to elaborate on their preference, 392 comments were received, and some comments contained multiple ideas. Individual comments were reviewed and categorized. Figure 28 shows the results.

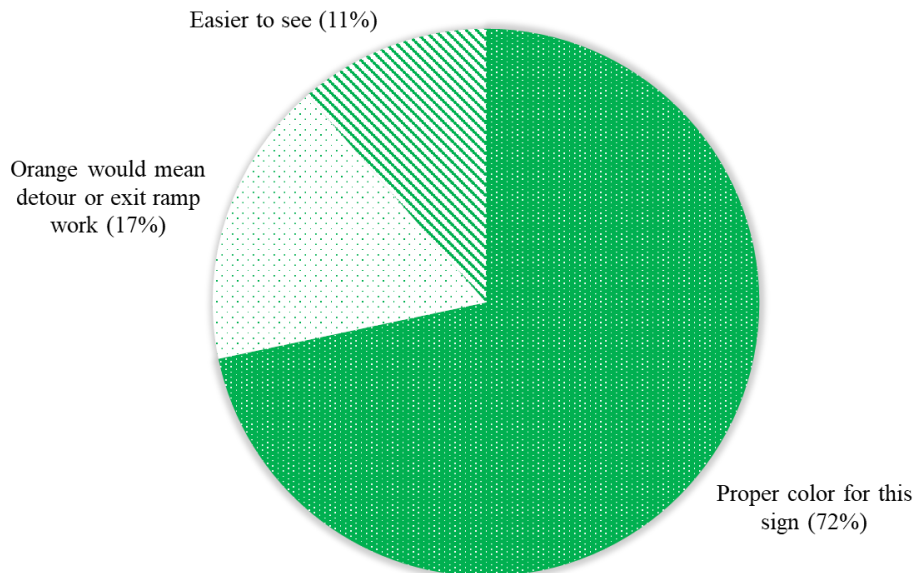
**Figure 29. Reasons Given for Preferring the Green Exit Gore Sign.**

For those who expressed preference for a green exit gore sign, 53 individual comments were reviewed and categorized. Figure 29 shows the results.
