# Laboratory and Field Performance of PGxx-28 and PGxx-34 Binders and New Binder Type Selection Catalog

Technical Report 5-6674-01-R1

TEXAS A&M TRANSPORTATION INSTITUTE  
COLLEGE STATION, TEXAS

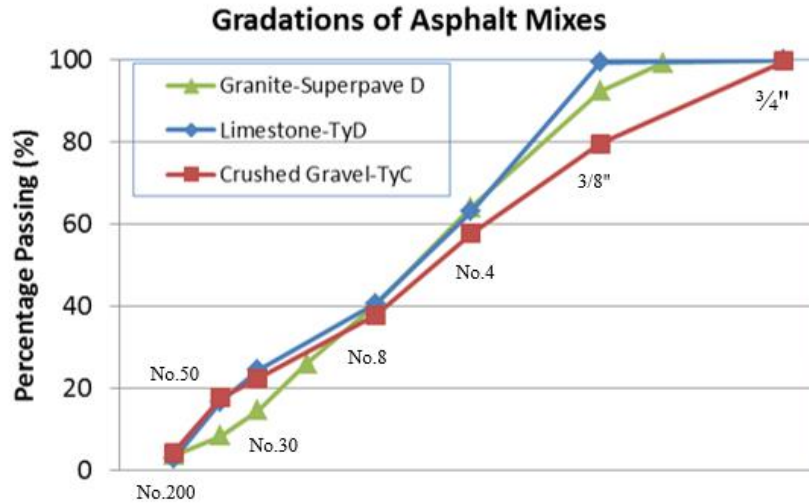
**Figure 2. Aggregate Gradations of Mixes Used in This Study.**

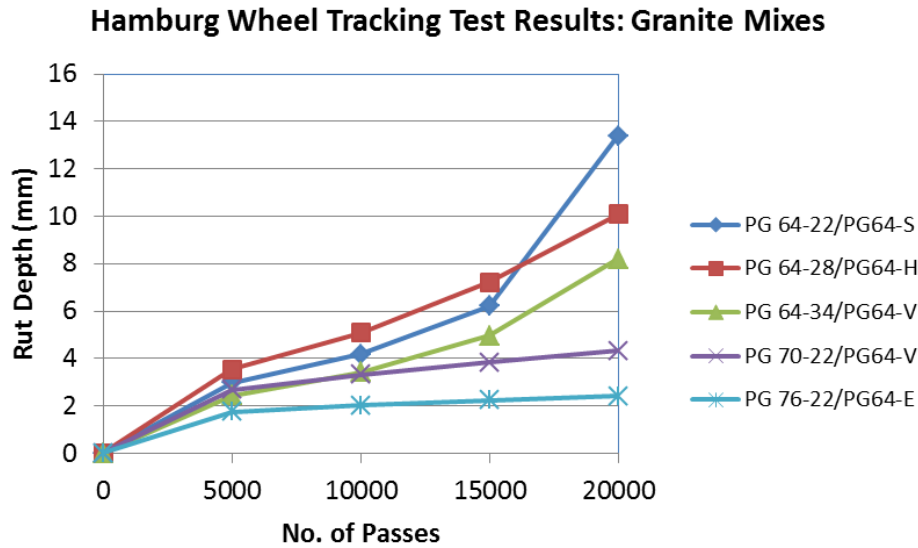
**Figure 5. HWTT Results of Granite Mixes with Five Binders.**

HWTT is the standard test for evaluating the rutting resistance of asphalt mixes in Texas. So HWTT was selected here to assess the validity of the MSCR binder test. HWTT was conducted at a temperature of 50°C following TEX-242-F, *Test Procedure for Hamburg Wheel-Tracking Test (HWTT)*. A Superpave gyratory compactor was used to mold cylindrical specimens with a diameter of 150 mm and a height of 62 mm. A masonry saw was used to cut along the edge of the cylindrical specimens. The target air void of specimens was 7 percent  $\pm$  1 percent. To evaluate the rutting susceptibility and moisture resistance, specimens were submerged under water at a temperature of 50°C during the test, and a linear variable differential transducer device measured deformations of specimens. The stop criterion was a rut depth of 12.5 mm or 20,000 passes.

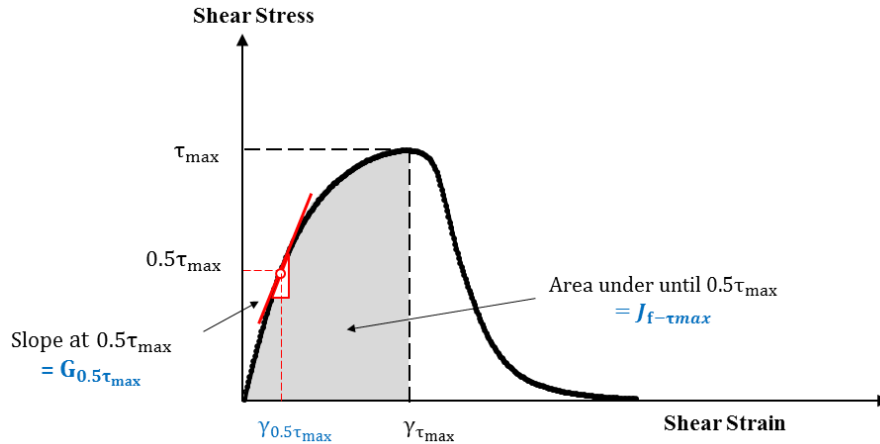
**Figure 10. PLAS Test and Analysis: An Illustration.**

Herein,  $J_{f-\tau_{max}}$  is the shear fracture energy calculated until maximum shear stress (see Figure 10),  $G_{0.5\tau_{max}}$  is the calculated shear modulus at the point of half of the maximum shear stress, and  $\gamma_{0.5\tau_{max}}$  is the shear strain at the point of half of the maximum shear stress.

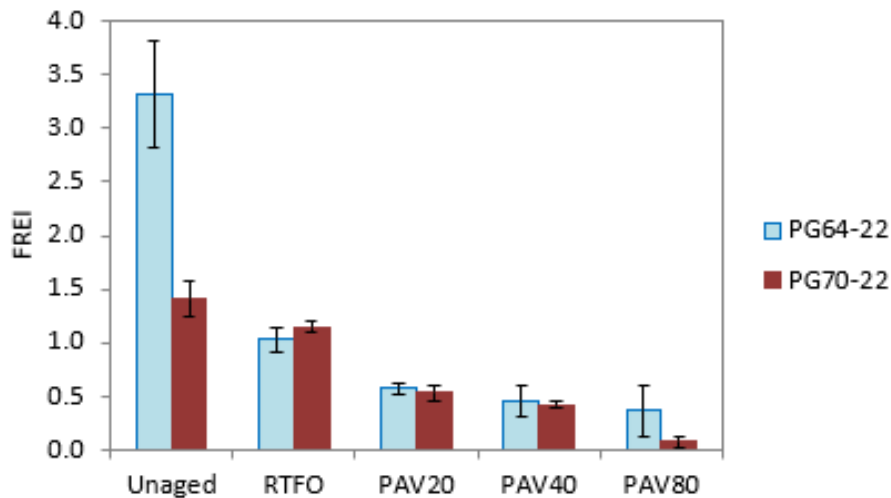
**Figure 12. PLAS Test Results: Effect of Chemical Aging.**

The same two asphalt binders used to identify the deficiency of the LAS test were used to evaluate the effect of aging on fatigue cracking resistance of asphalt binders at intermediate temperature using the PLAS test. For each asphalt binder, the PLAS test was performed at 15°C for five aging conditions: OB, RTFO, PAV20, PAV40, and PAV80. For each aging condition, two replicates were used. Figure 12 shows the averaged FREI value for each asphalt binder at each specific aging condition. The figure indicates that the FREI is a true indicator of asphalt binder fatigue resistance—the aged binders have lower values of FREI and, thereby, poorer fatigue resistance.

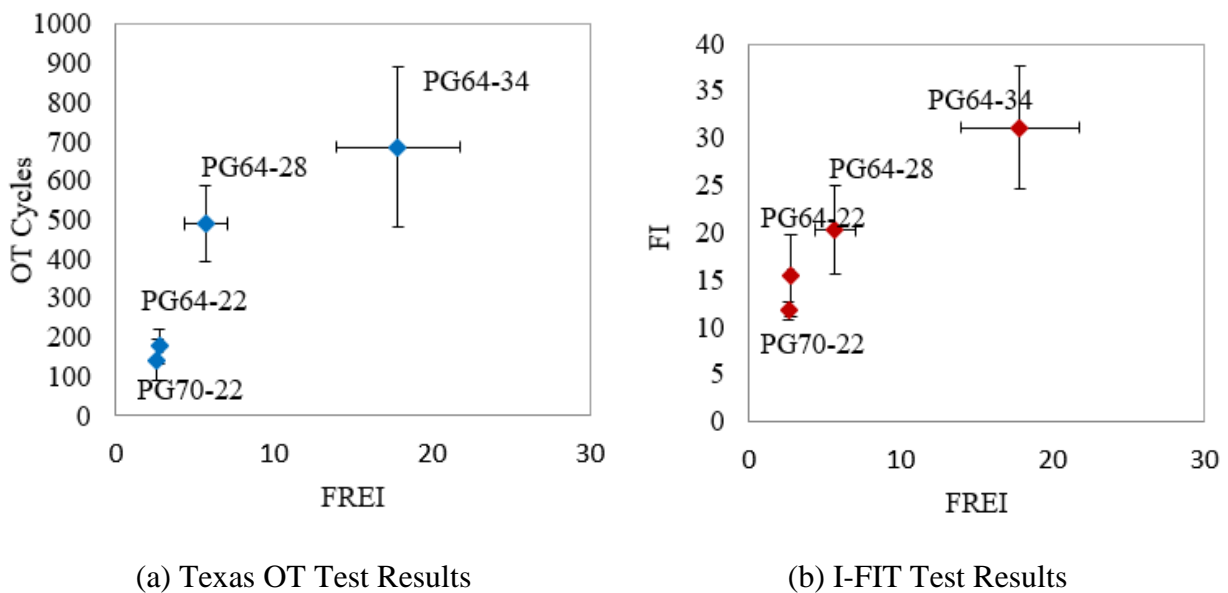
**Figure 14. PLAS Test Results: Correlation with Mixture Cracking Results.**

The same four asphalt binders were characterized under the PLAS test at 15°C. Figure 14 also presents the calculated FREI for each asphalt binder. A comparison of the calculated FREI values and those mixture cracking results clearly shows that the rankings of cracking resistance between the PLAS test and mixture cracking tests on these four asphalt binders are the same (from the best to the worst): PG64-34, PG64-28, PG-64-22, and PG70-22.

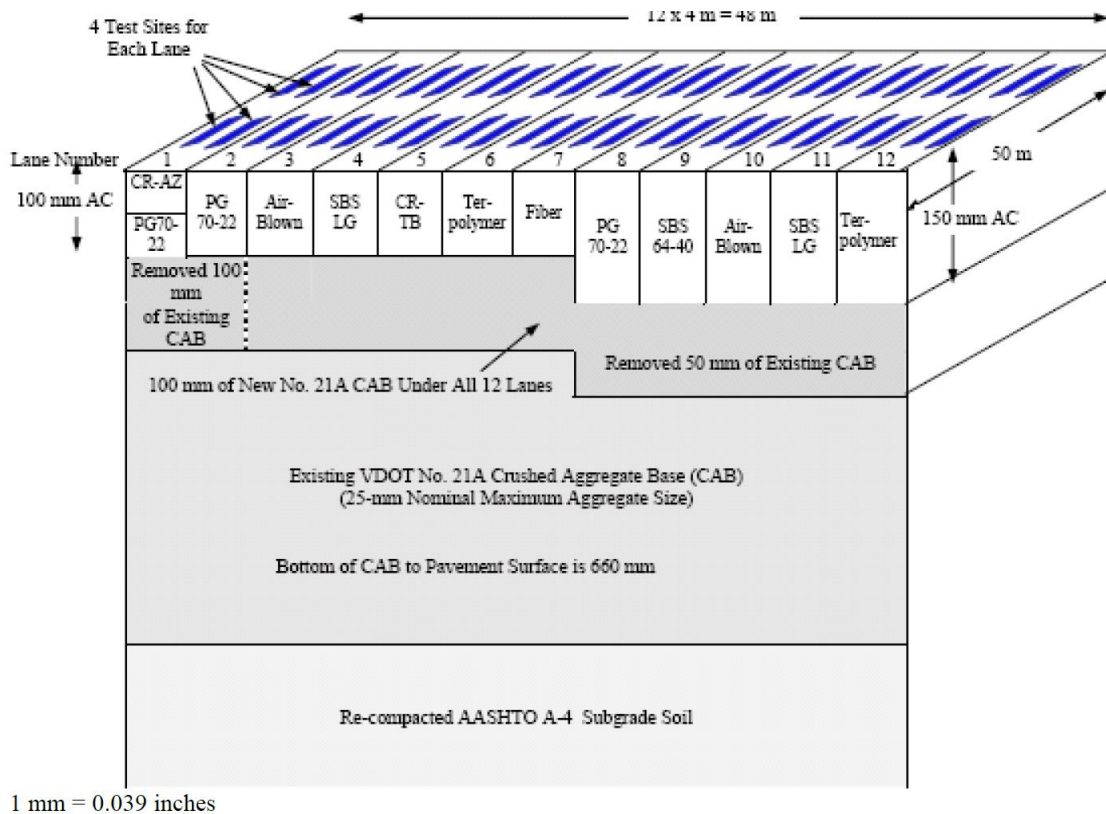
**Figure 15. Three-Dimensional Layout of the FHWA-ALF Test Section (Gibson et al. 2012).**

To further validate the asphalt binder PLAS test, TTI researchers employed the fatigue data from FHWA-ALF testing on polymer-modified asphalt binders (Gibson et al. 2012). Twelve full-scale lanes of pavement with various modified asphalt binders were constructed at FHWA-ALF under Pooled Fund Study TPF-5(019) in summer 2002. Figure 15 shows the layout of the 12 test lanes. All 12 lanes have an asphalt binder layer and a granular base (GB) course over a uniformly prepared subgrade. The pavements were loaded with super single tires (74 kN [16.6 kips] and 827.4 kPa [120 psi]) at 19°C (66°F). Lanes 2 to 6 had clear bottom-up fatigue cracking, so these five lanes were used for validating the asphalt binder PLAS test.

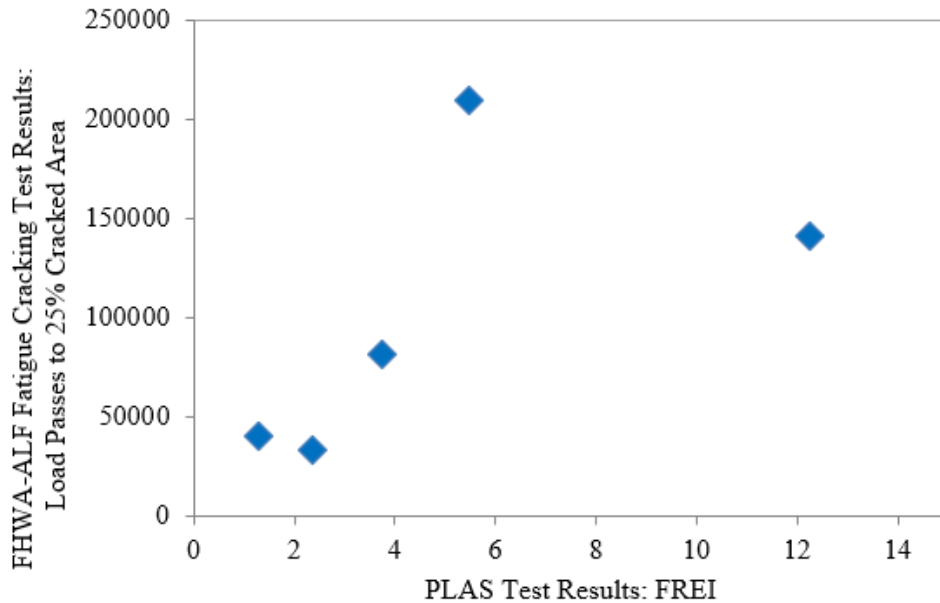
**Figure 16. PLAS Test Results: Correlation with FHWA-ALF Cracking Test Results.**

Although the FHWA-ALF testing was completed long ago, original asphalt binders from Lanes 2, 3, 4, 5, and 6 were stored and available for validation. To match the FHWA-ALF testing temperature, the PLAS tests on the RTFO-aged original asphalt binders were run at 19°C as well. Figure 16 compares the asphalt binder fracture index (FREI), and the load passes to a 25 percent cracked area measured from FHWA-ALF. The PLAS test results match the overall trend of the FHWA-ALF fatigue data. An imperfect relationship shown in Figure 16 is expected because many factors impact field fatigue performance. The asphalt binder is not the only one, as mentioned in this report's introduction. Thus, the full-scale field fatigue data results also indicated that the PLAS test is effective for evaluating asphalt binder fatigue resistance.

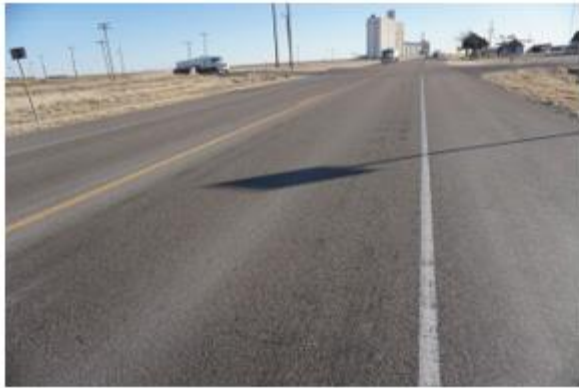
Alligator Cracking: 03/07/2017

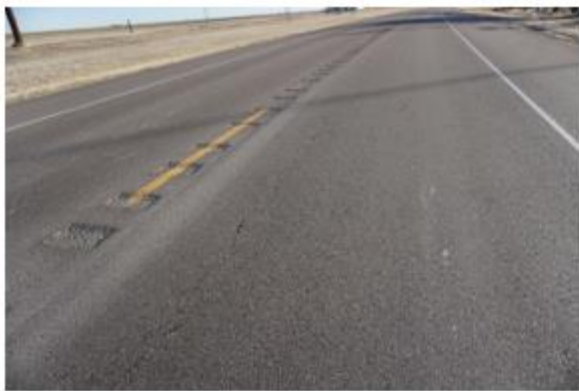
Longitudinal Cracking: 03/07/2017

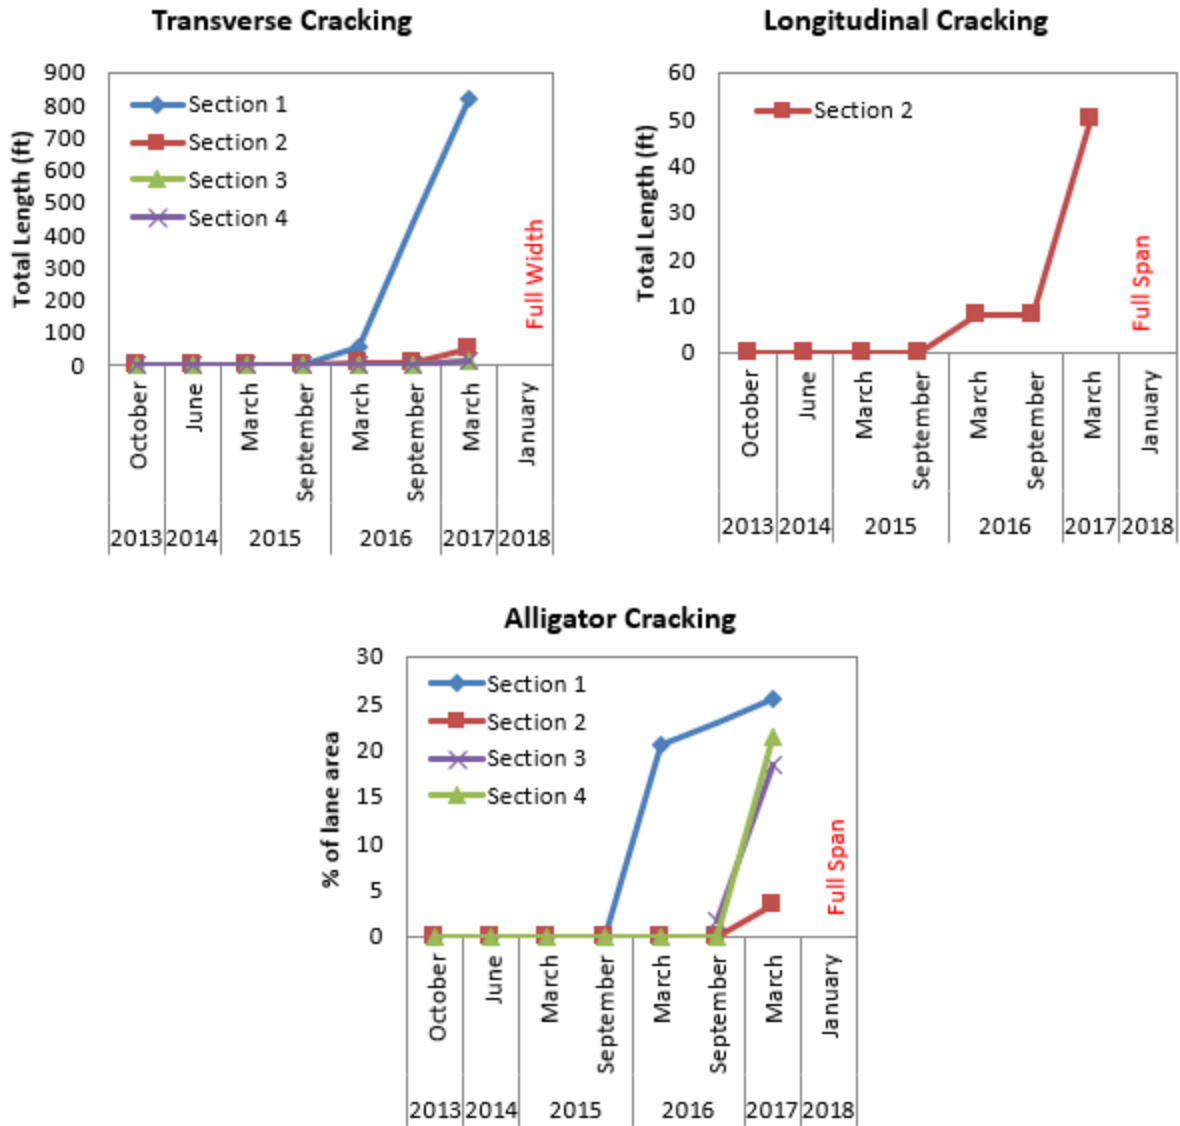
**Figure 22. SH 15 Test Sections: Survey Results.**

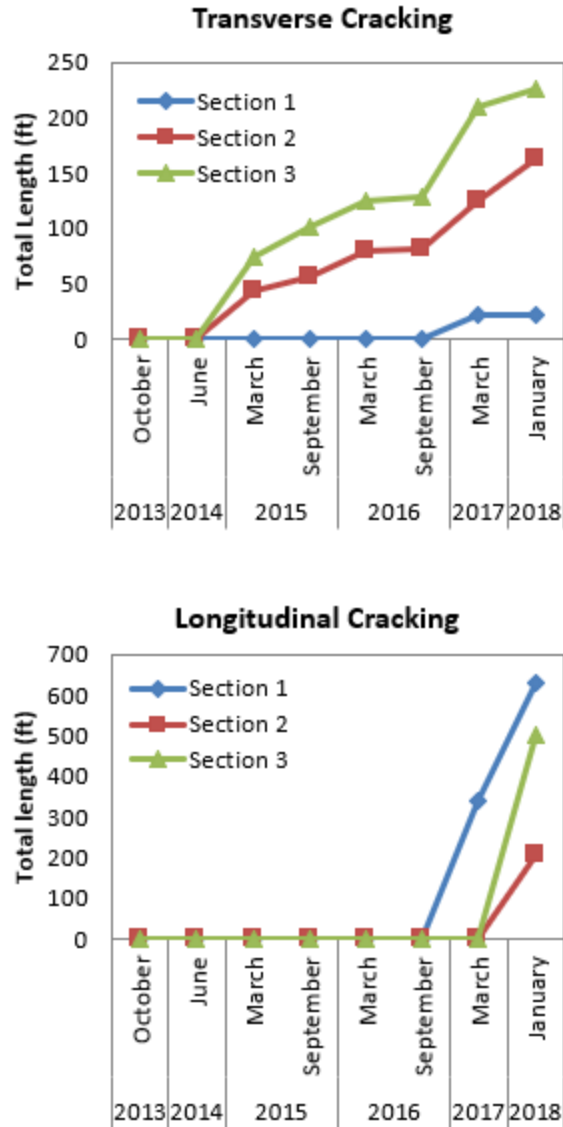
**Figure 27. US 62 Test Sections: Survey Results.**

**Section 3:** Researchers first observed transverse cracks in this section in March 2015 (see Figure 27). The total number of these cracks remained almost the same, from 19 cracks that totaled 588 ft/mile in March 2015 to 20 cracks that totaled 1170 ft/mile in January 2018. Similarly, researchers observed longitudinal cracks in this section first in January 2018. Ten longitudinal cracks totaled 3917 ft/mile.

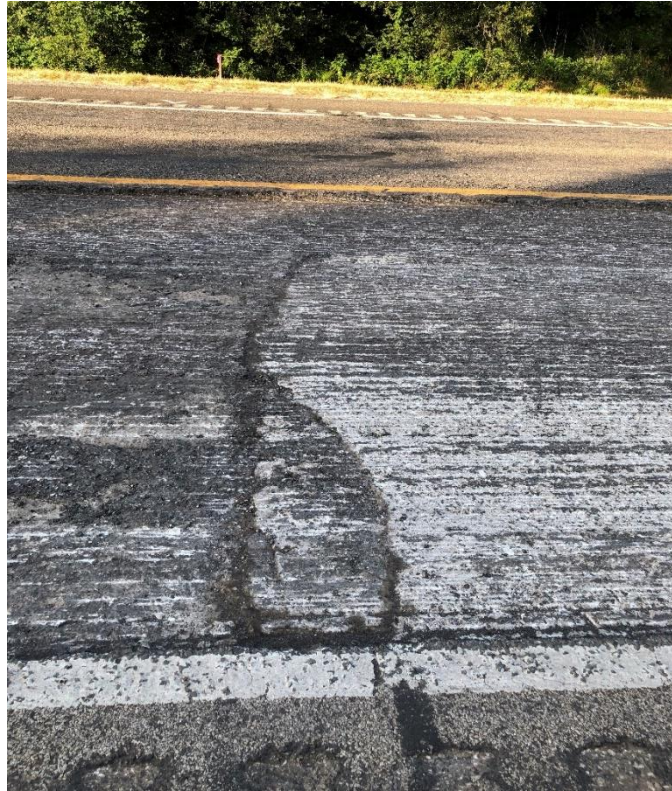
**Figure 38. Example of SH 7 Pavement Condition after the 2-In. Milling.**

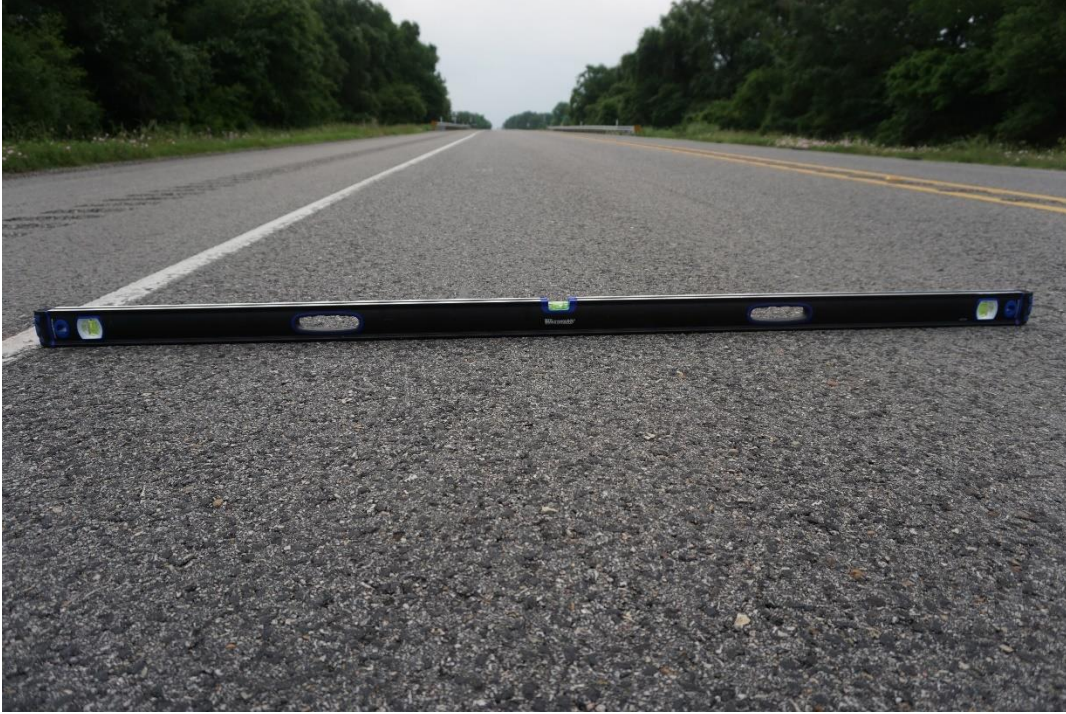
**Figure 42. No Rutting on Both Test Sections on SH 7.**

Since the construction in June 2020, the research team has continuously monitored the sections. The latest field survey was completed on May 5, 2022. No rutting was observed in either test section (Figure 42). Two cracks were observed on the control test section with PG64-22, as shown in Figure 43. No cracking was seen on the test section with PG64-28 (Figure 44).

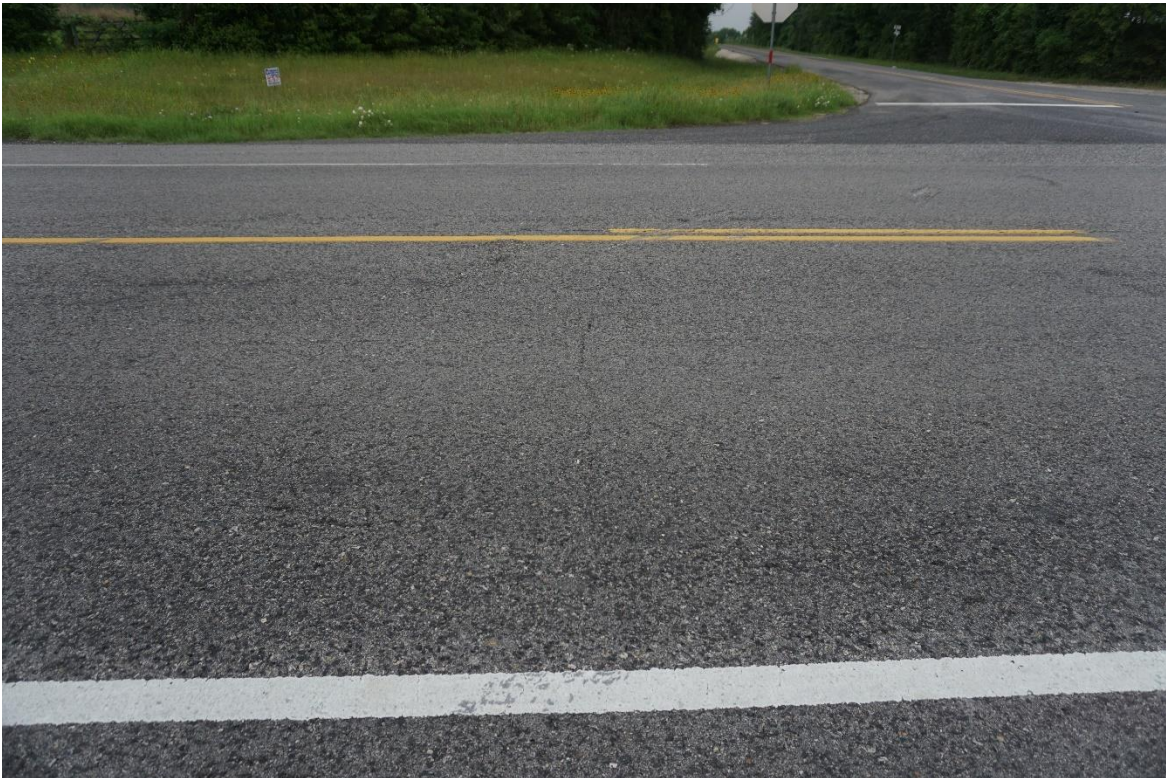
**Figure 43. Cracking Observed on Control Section with PG64-22.**

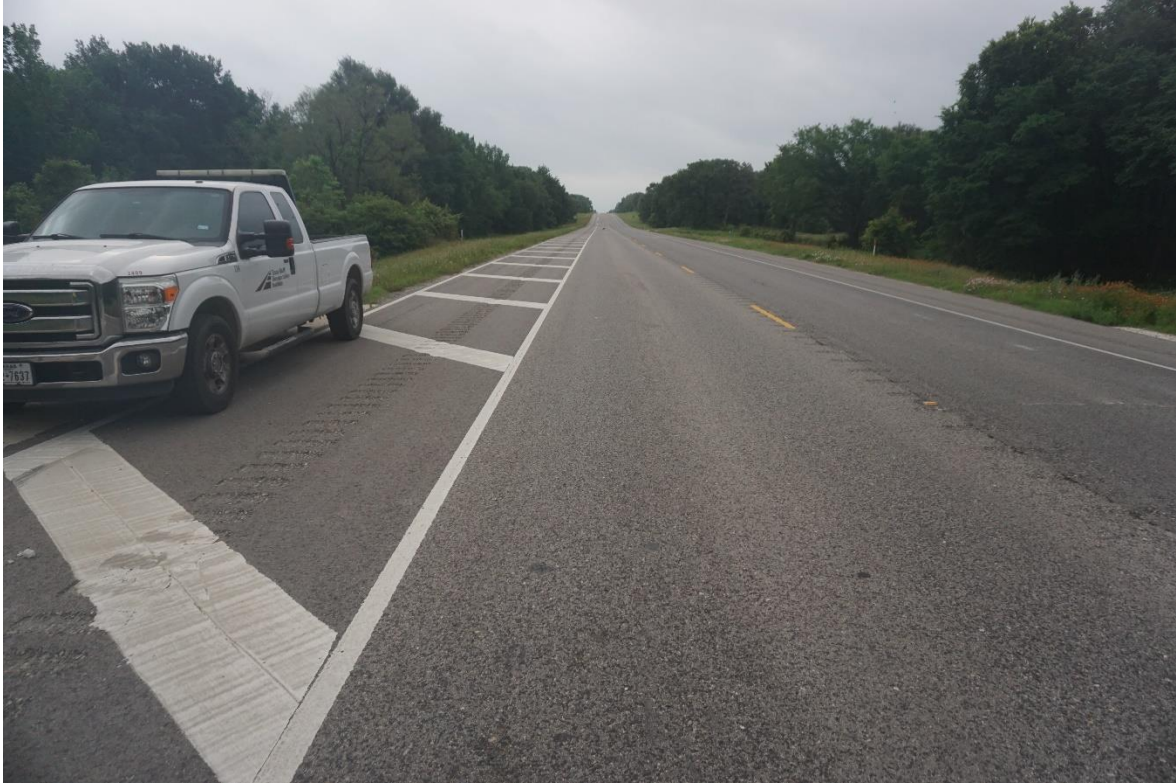
**Figure 44. No Cracking on Test Section with PG64-28.**

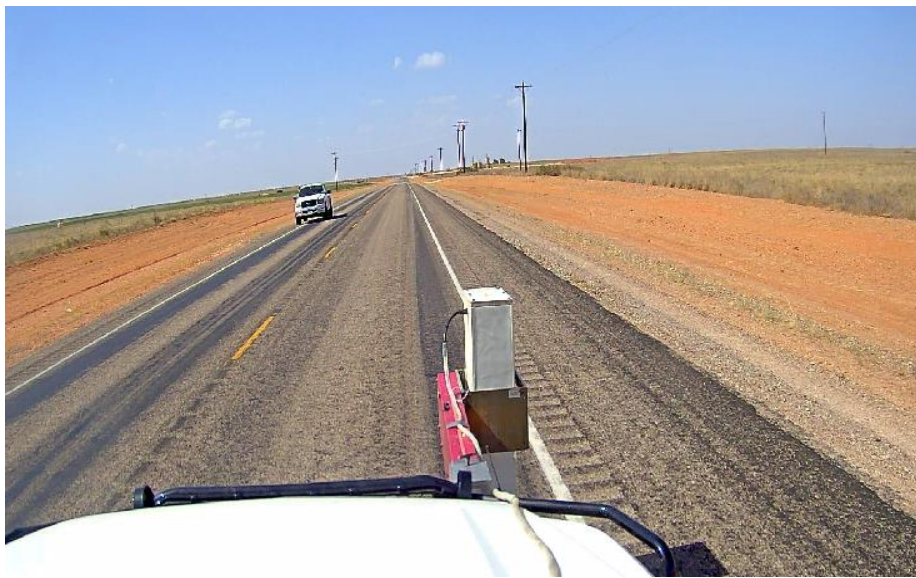
**Figure 46. Pavement Condition of SH 214.**

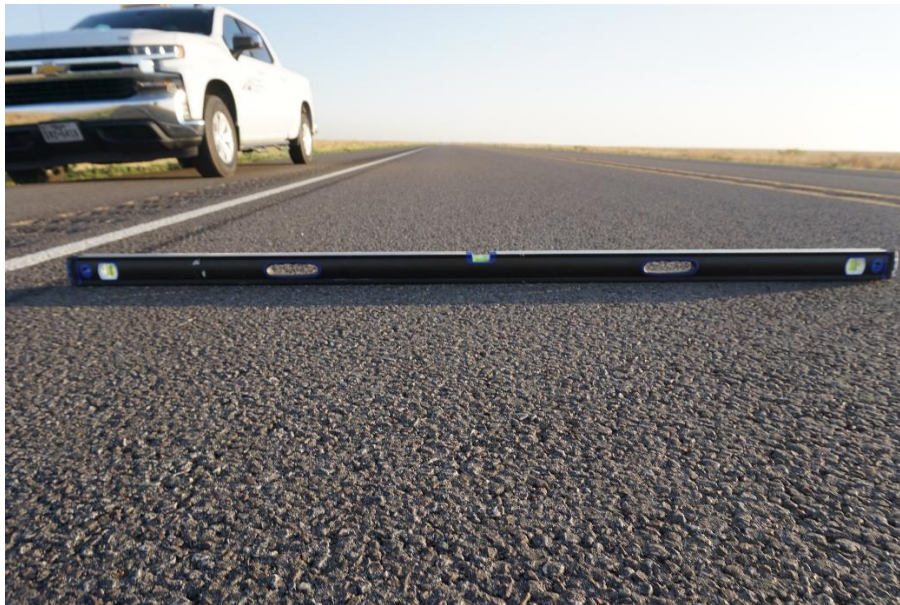
**Figure 51. No Rutting on the Test Section with PG64-34 on SH 214.**

Since the construction in April 2021, researchers have continuously monitored the sections. The latest field survey was completed on May 10, 2022. Neither rutting nor cracking was observed in either test section, as shown in Figure 51 through Figure 54.

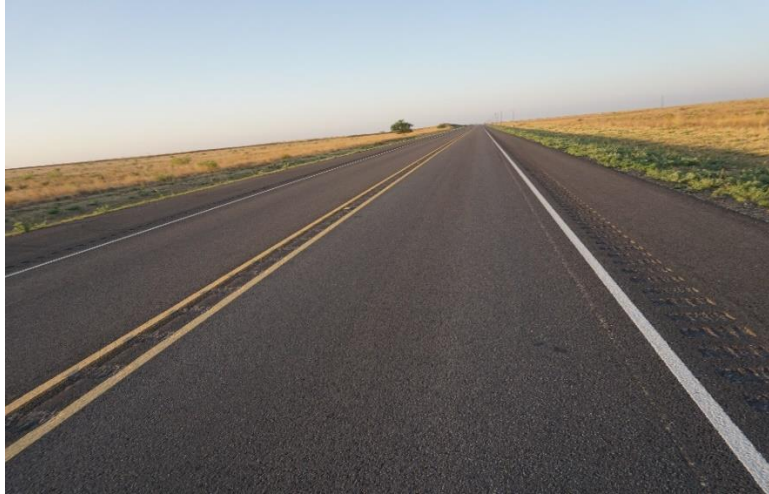
**Figure 52. No Cracking on the Test Section with PG64-34 on SH 214.**

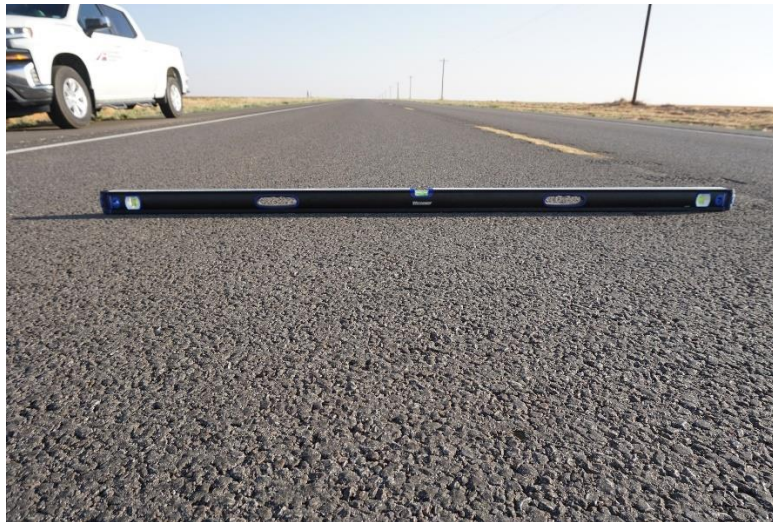
**Figure 53. No Rutting on the Test Section with PG70-28 on SH 214.**

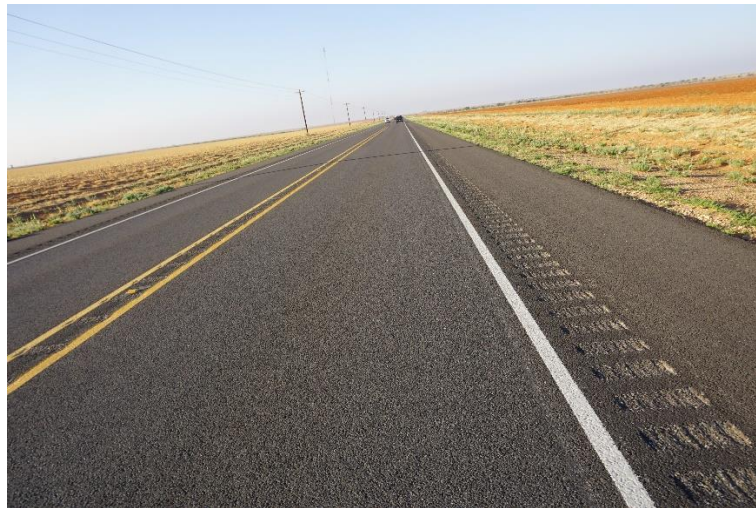
**Figure 54. No Cracking on the Test Section with PG70-28 on SH 214.**

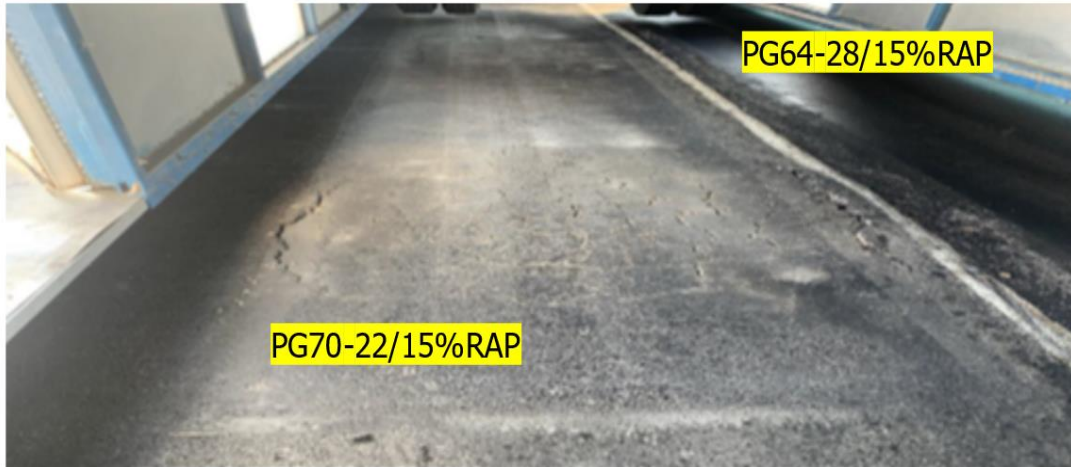
- Mix 2: PG70-22 with 15% RAP -64% fatigue cracking after 350,000 passes
- Mix 4: PG64-28 with 15% RAP -57% fatigue cracking after 350,000 passes

**Figure 59. Fatigue Cracking on Test Section O with PG70-22 (Left) and Section P with PG64-28 (Right).**

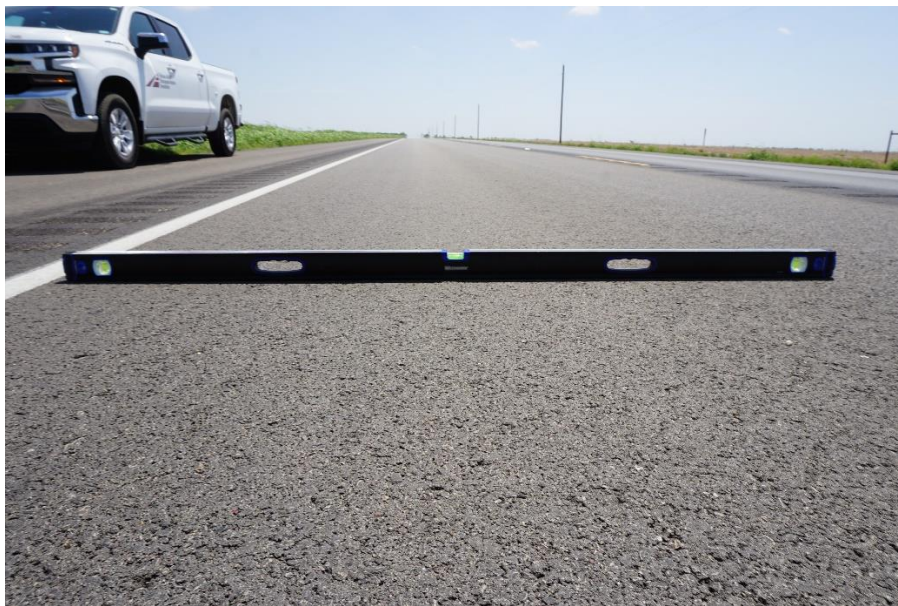
**Figure 64. No Rutting on the Test Section with PG70-28 on FM 2105.**

Since the construction in April 2021, the research team has continuously monitored the sections. The latest field survey was completed on May 11, 2022. Neither rutting nor cracking was observed in either test section, as shown in Figure 64 through Figure 67.

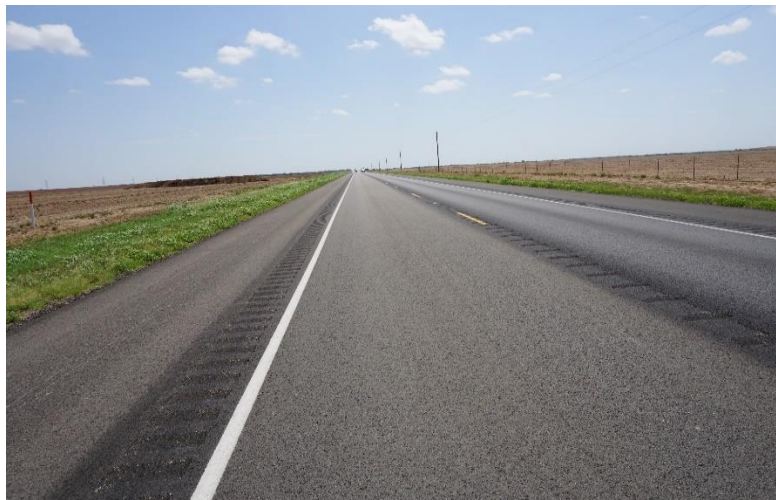
**Figure 65. No Cracking on the Test Section with PG70-28 on FM 2105.**

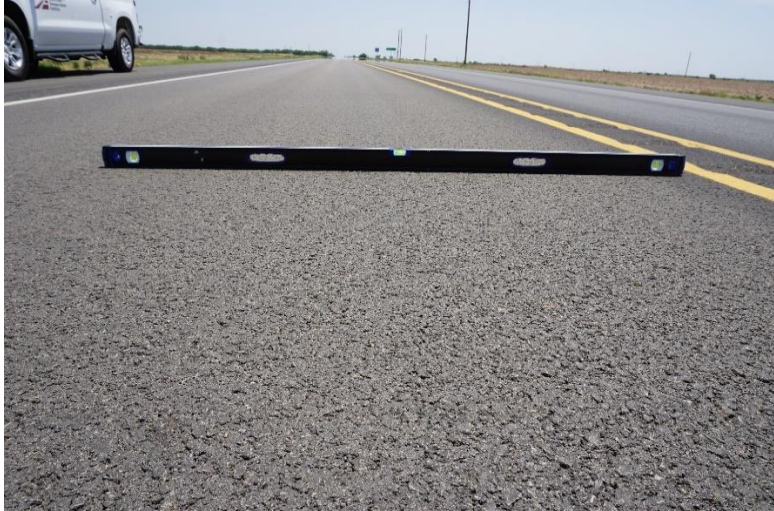
**Figure 66. No Rutting on the Test Section with PG70-22 on FM 2105.**

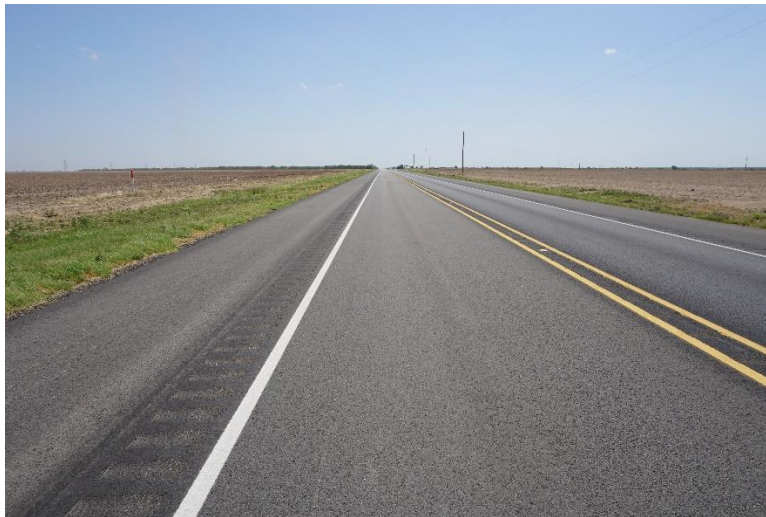
**Figure 67. No Cracking on the Test Section with PG70-22 on FM 2105.**

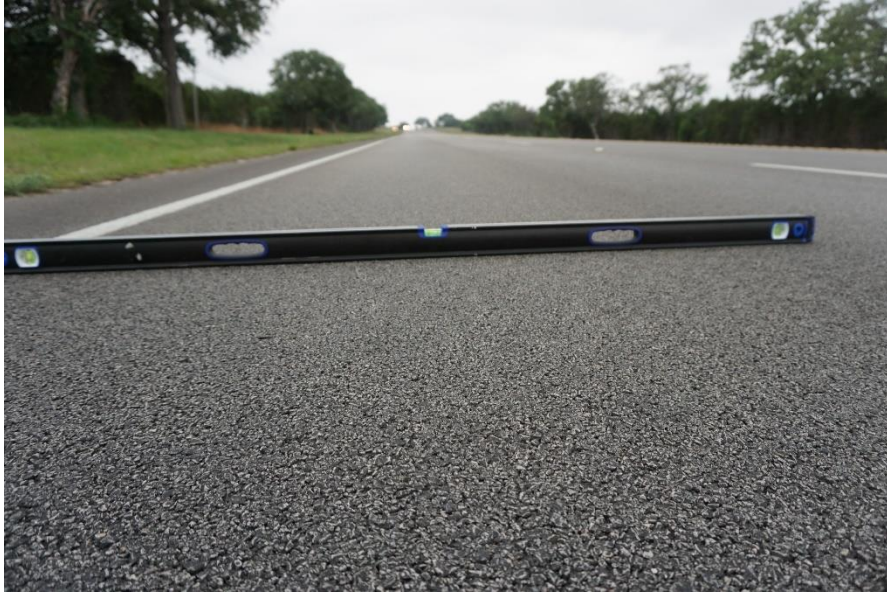
**Figure 71. No Rutting on the Test Section with PG70-28 on SH 71.**

Since the construction in June 2021, the research team has been monitoring the sections. The latest field survey was completed on May 4, 2022. Neither rutting nor cracking was observed in either test section, as shown in Figure 71 through Figure 74.

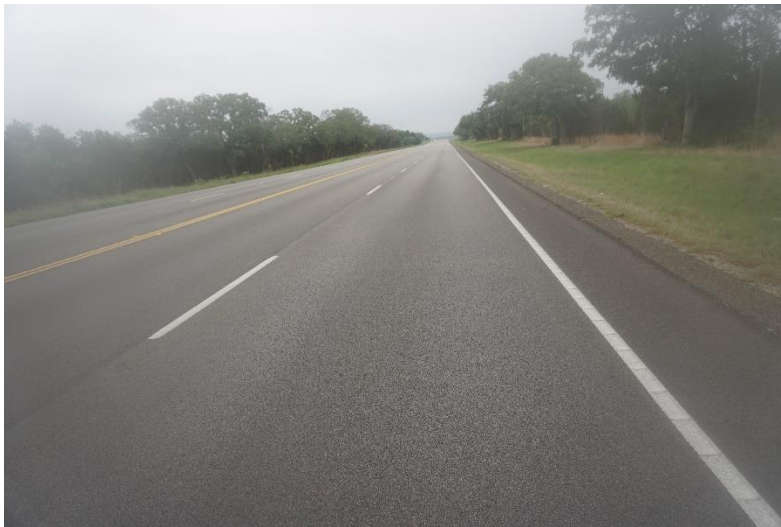
**Figure 72. No Cracking on the Test Section with PG70-28 on SH 71.**

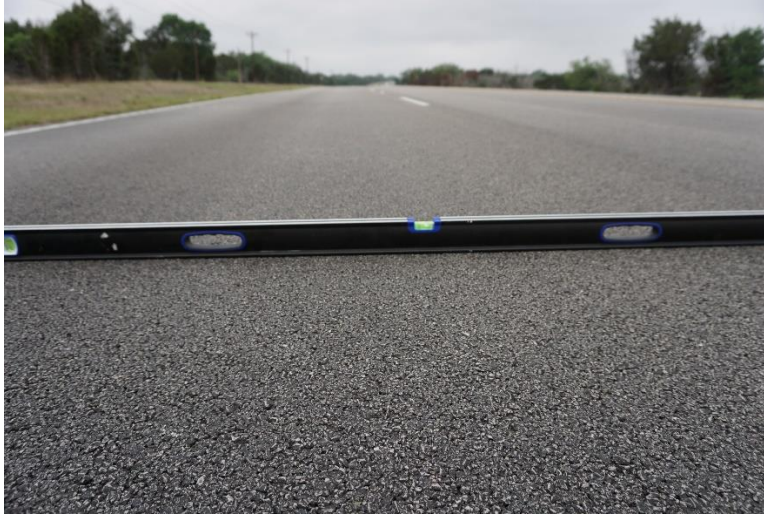
**Figure 73. No Rutting on the Test Section with PG70-22 on SH 71.**

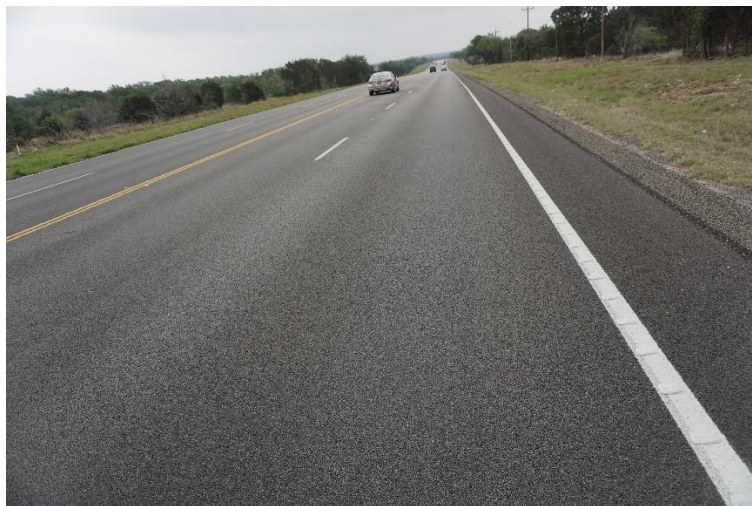
**Figure 74. No Cracking on the Test Section with PG70-22 on SH 71.**

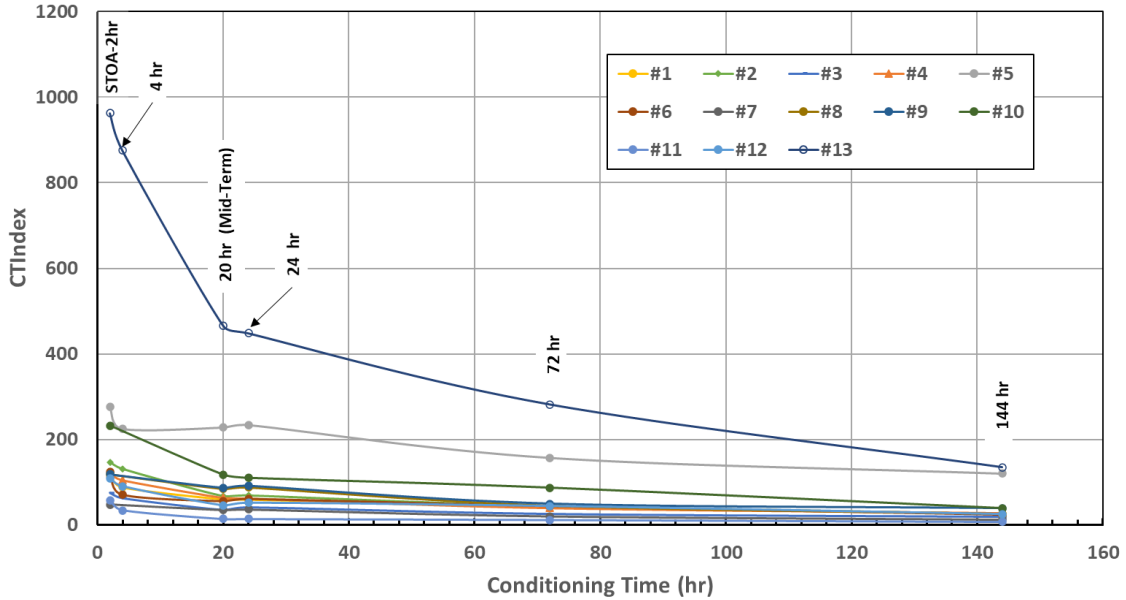
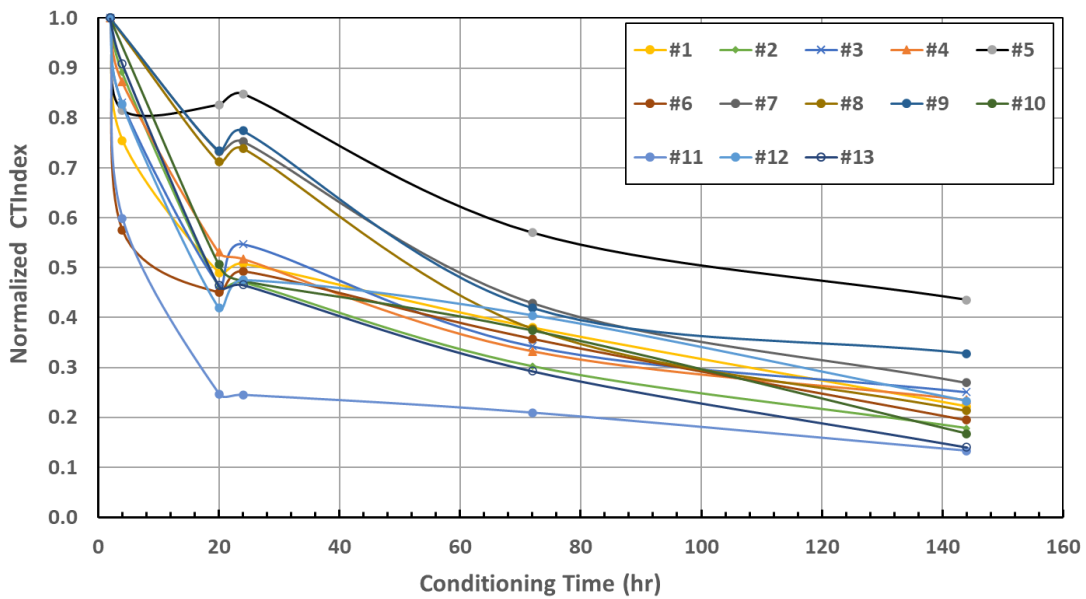
(a) Cracking resistance with conditioning

(b) Normalized cracking resistance with conditioning

**Figure 81. Cracking Resistance Evolution of Each Mix with Conditioning Time (or Level).**

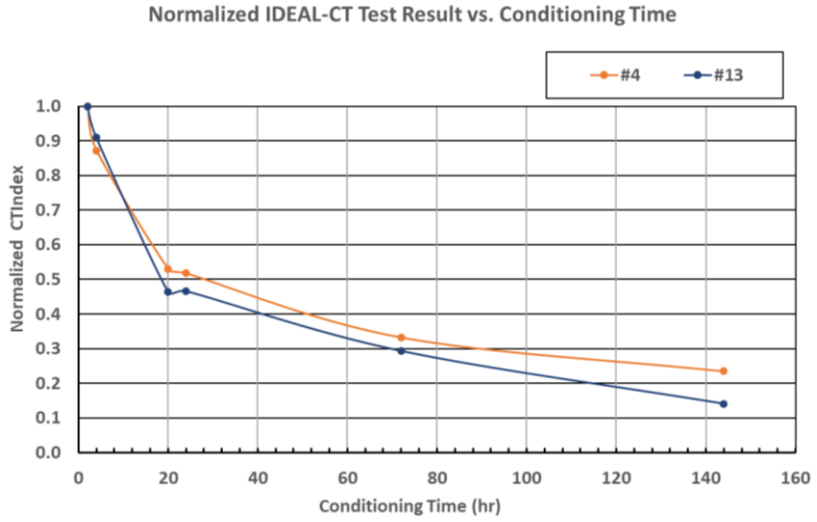
(a) Mix Type: SMA versus Superpave

(c) Rejuvenator versus others

Figure 82. Cracking Resistance Evolution or Each Mix with Conditioning Time (or Level).

(d) RAP content: 0 versus 15% versus 20%

(f) Asphalt absorption: Mixes 5 versus 12

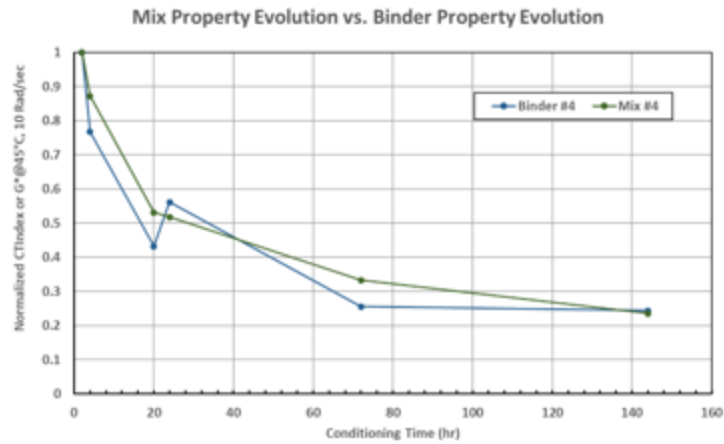
**Figure 85. Comparison between Mix and Binder Property Evolution under Six Conditioning Protocols.**
